# ST STEPHEN PARISH COUNCIL

You are summoned to a **Community & Leisure Committee meeting.**

To take place on **Thursday 23 May 2024 at 7.30pm**

- 2425/CL/012 To consider and agree response to structures on allotment plots installed without permission and make a recommendation to Full Council to amend the Allotment Conditions of Tenancy.

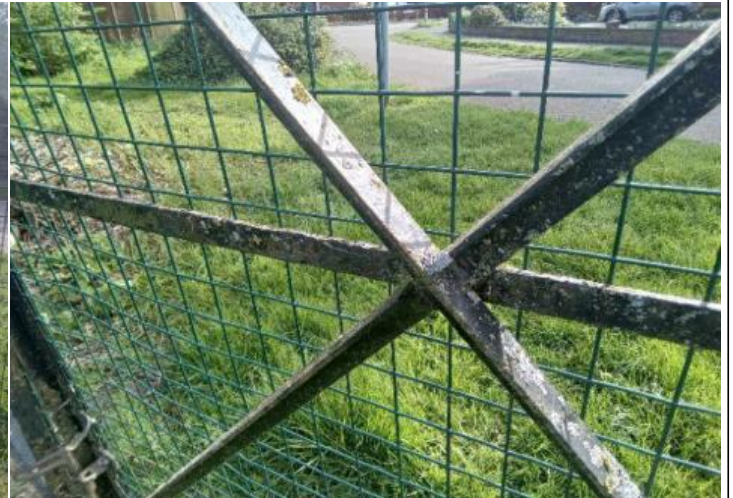
**Finding:** The paintwork on this item has been damaged or worn exposing the metal underneath which is rusting / corroding

**Action:** Treat affected areas and repaint

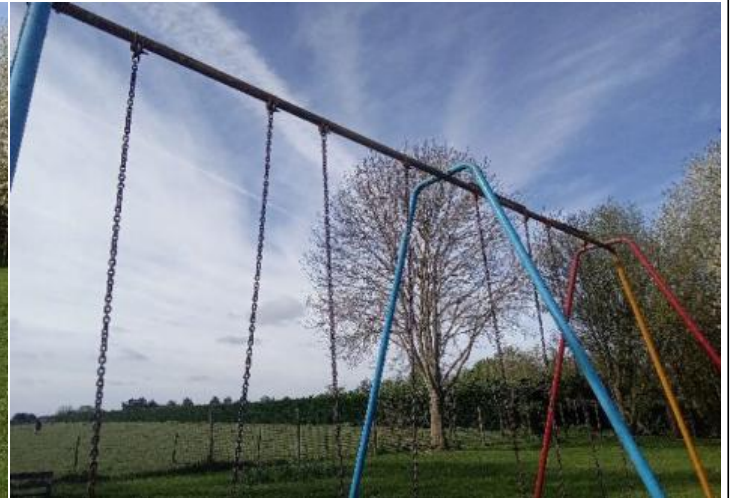
**Finding:** The fixings or components for this item were in excess of 2.5m above the standing surface and could not be fully accessed by the inspector. We have completed a visual inspection of the fixings from ground level but a maintenance inspection should be undertaken to assess the condition, security and wear of the components at intervals in accordance with the manufacturers recommendations.

**Action:** Inspect in accordance with the manufacturers recommendations

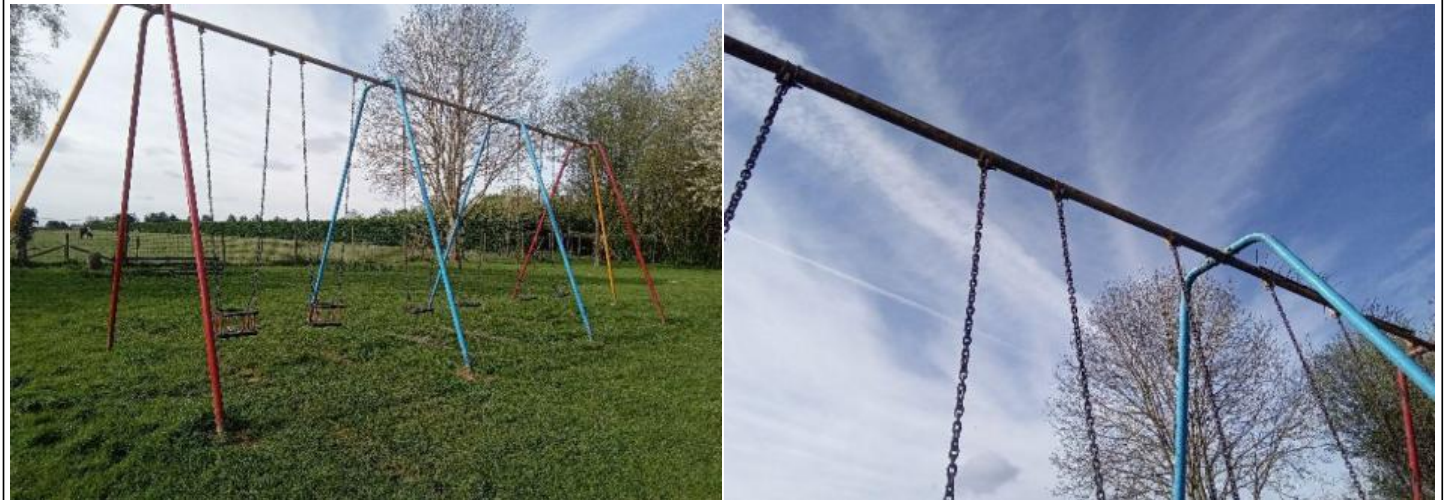
<b>Finding:</b>	There is some wear to the shackles	<b>Action:</b>	Monitor for any further deterioration and replace when 40% worn
-----------------	------------------------------------	----------------	---

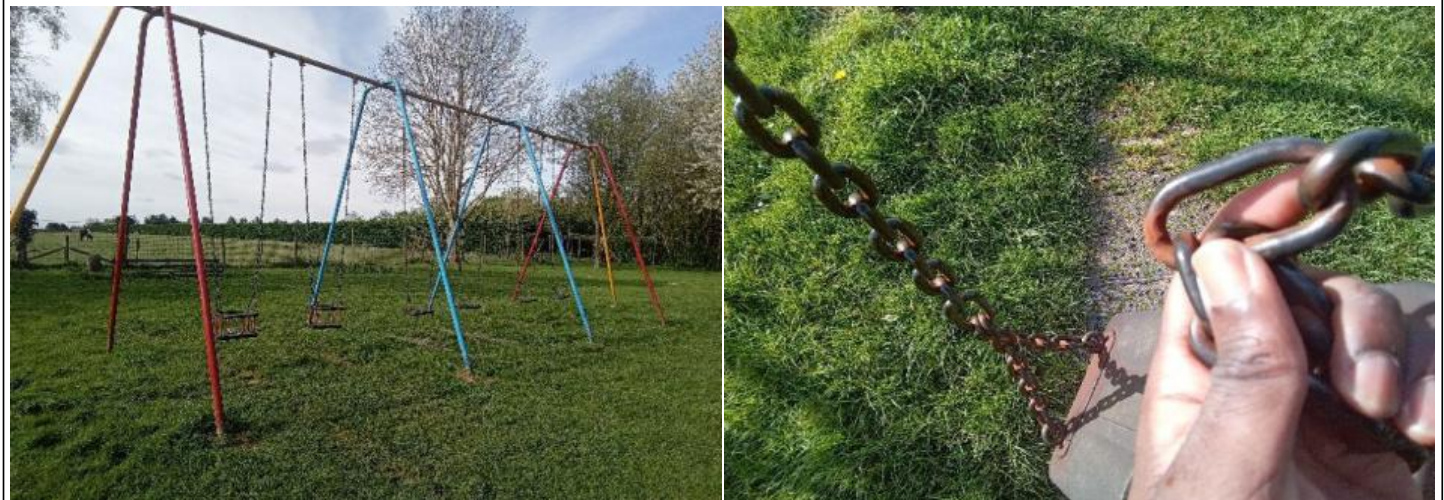
<b>Finding:</b>	There is some notable evidence of connecting link wear	<b>Action:</b>	Monitor for any further deterioration and replace when 40% worn
-----------------	--	----------------	---

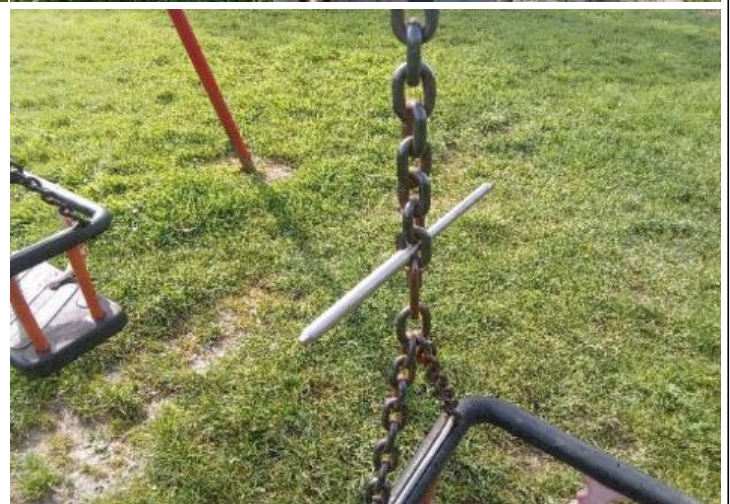
**Finding:** The chain openings are in excess of the 8.6mm as recommended by BS EN 1176 **Action:** Monitor - No remedial work recommended

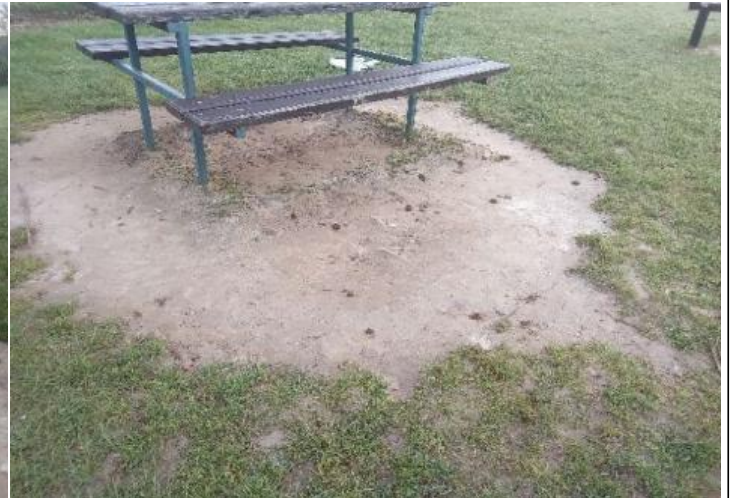
**Finding:** The surface has eroded in some areas and may be slippery in wet conditions  
**Action:** Reinstate the surface

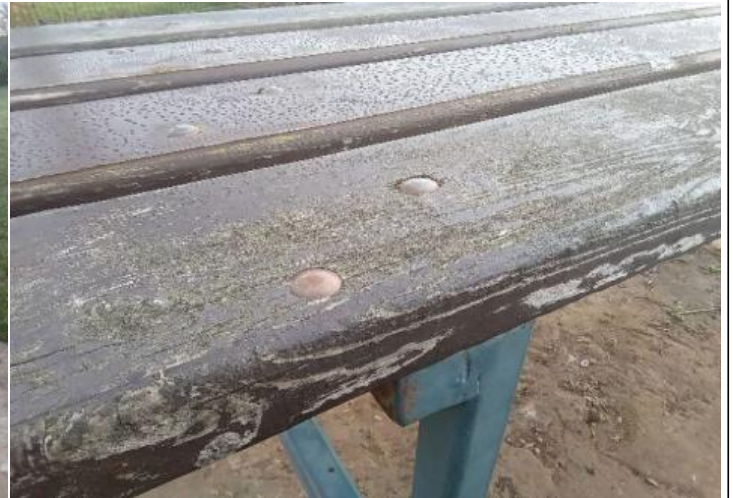
**Finding:** The timber stain is in poor condition

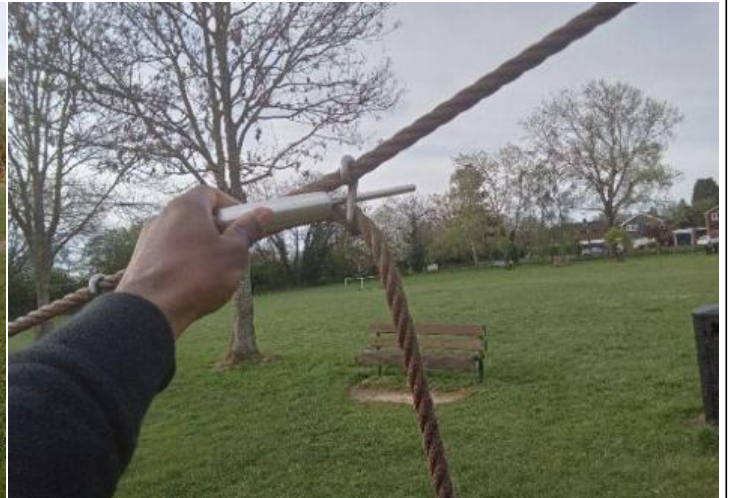
**Finding:** There is/are finger entrapment/s in the rope connections and the item fails to meet the requirements of BS EN 1176 Part 1 4.2.7.6 Entrapment of fingers

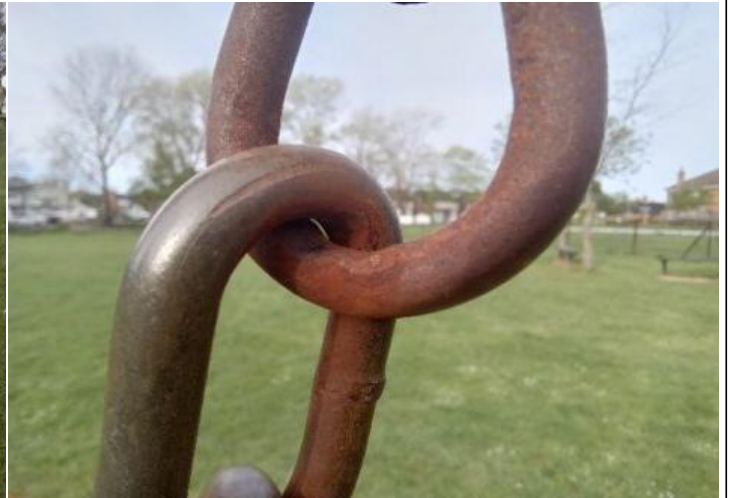
**Finding:** There is some wear to the shackles.

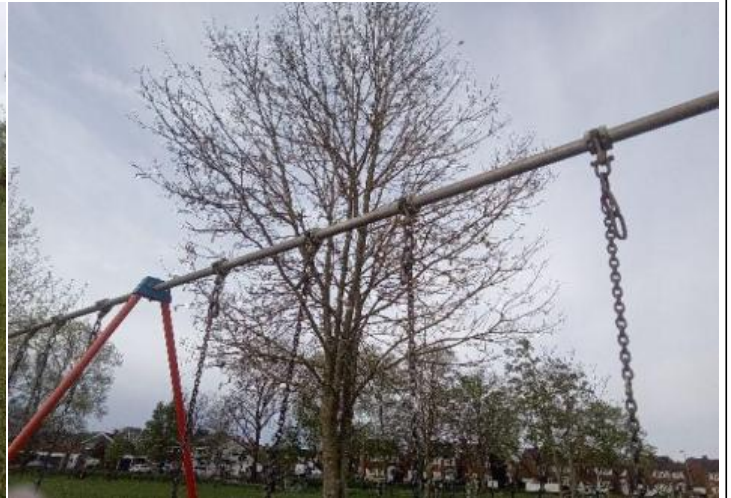
**Finding:** The fixings or components for this item were in excess of 2.5m above the standing surface and could not be fully accessed by the inspector. We have completed a visual inspection of the fixings from ground level but a maintenance inspection should be undertaken to assess the condition, security and wear of the components at intervals in accordance with the manufacturers recommendations.

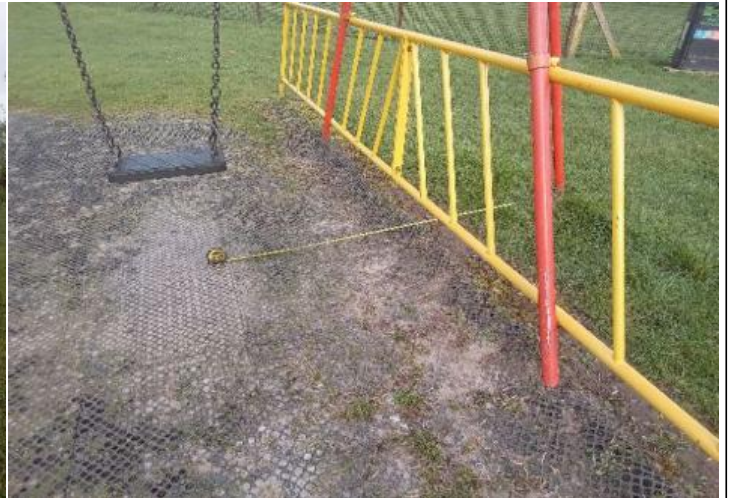
**Finding:** BS EN 1176 Part 2: Annex A makes a recommendation that fences or enclosures should be upto 1.50m from the edges of the swing seat to the sides, and subject to risk assessment, from the edge of the impact area. This is however, a low risk finding and no remedial action is recommended.

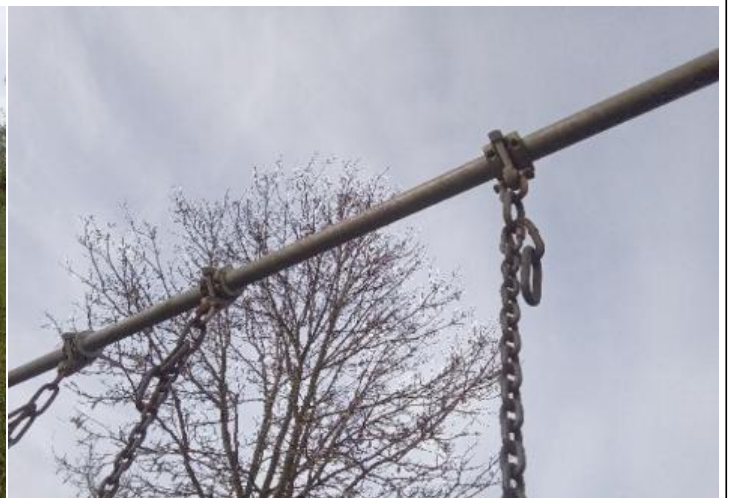
**Finding:** The bushes are worn or missing

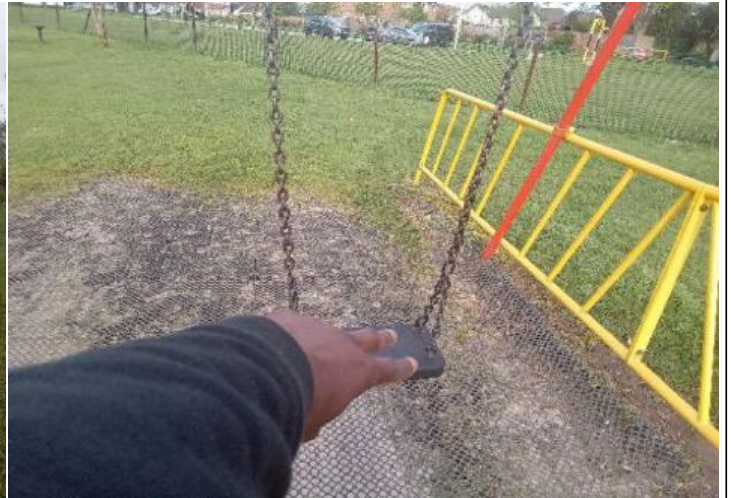
**Finding:** The swing seat connectors are loose

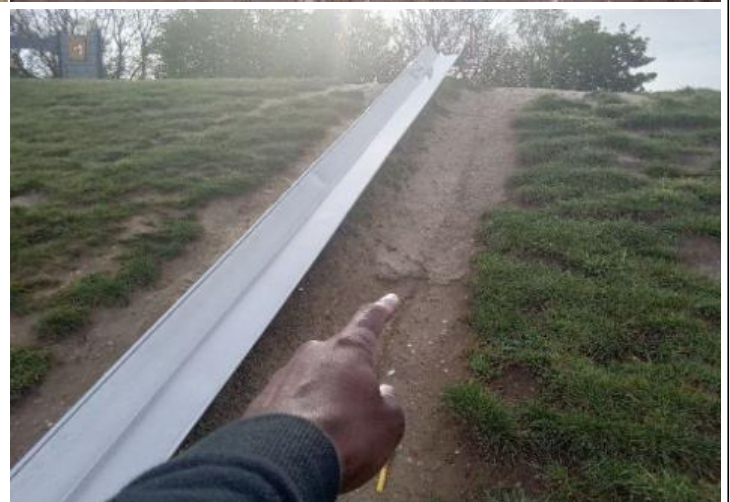
**Finding:** The concrete foundation forms a projecting obstacle / hard object within the free space of the equipment, in contravention of the requirements of BS EN 1176 Part 1

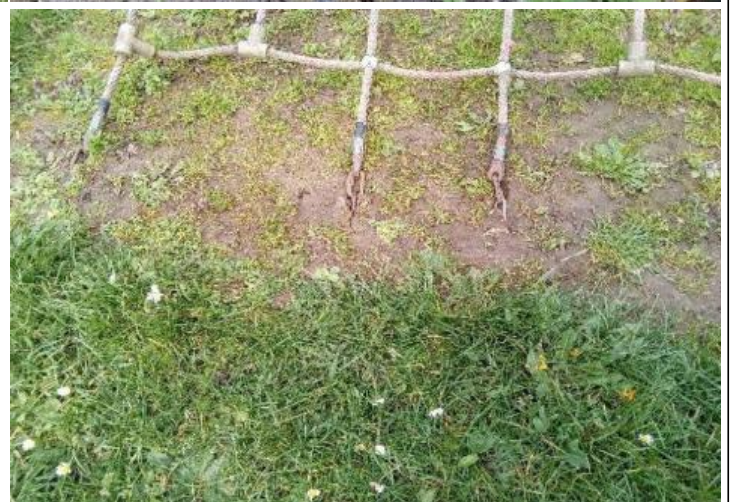
**Finding:** The connecting links are worn in excess of 40% and require renewing

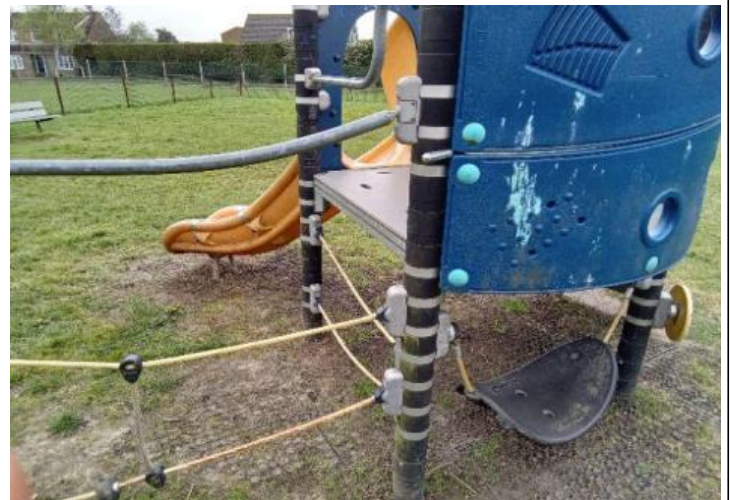
**Finding:** There is/are finger entrapment/s in the barrier next to access element and the item fails to meet the requirements of BS EN 1176 Part 1 4.2.7.6 Entrapment of fingers  
**Action:** Monitor - No remedial work recommended

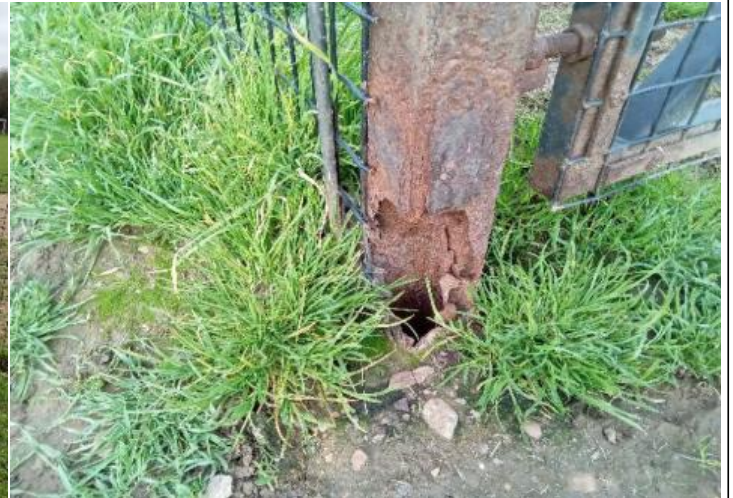
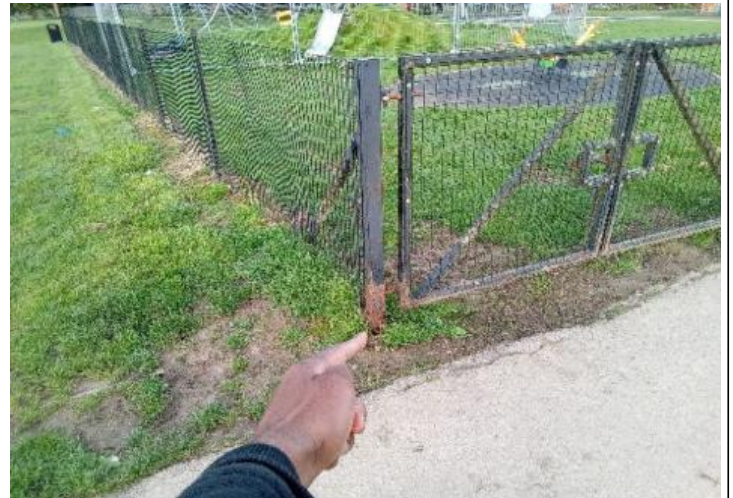
**Finding:** Parts of the steel on this item have corroded excessively and the metal has perforated in places

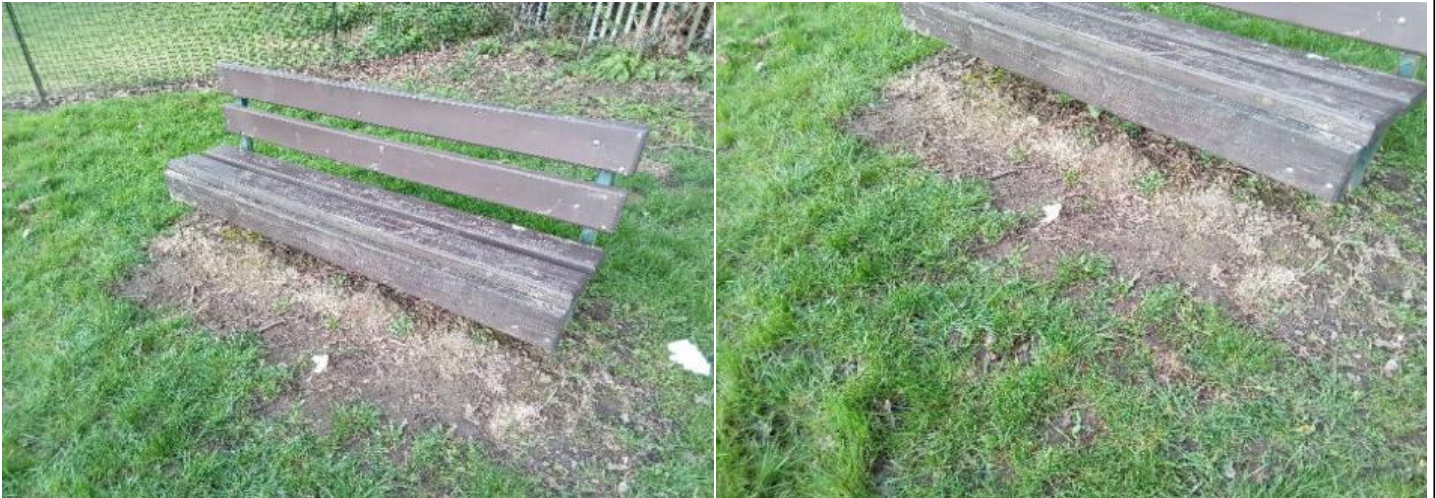
**Finding:** The surface has eroded in some areas and may be slippery in wet conditions  
**Action:** Reinstate the surface

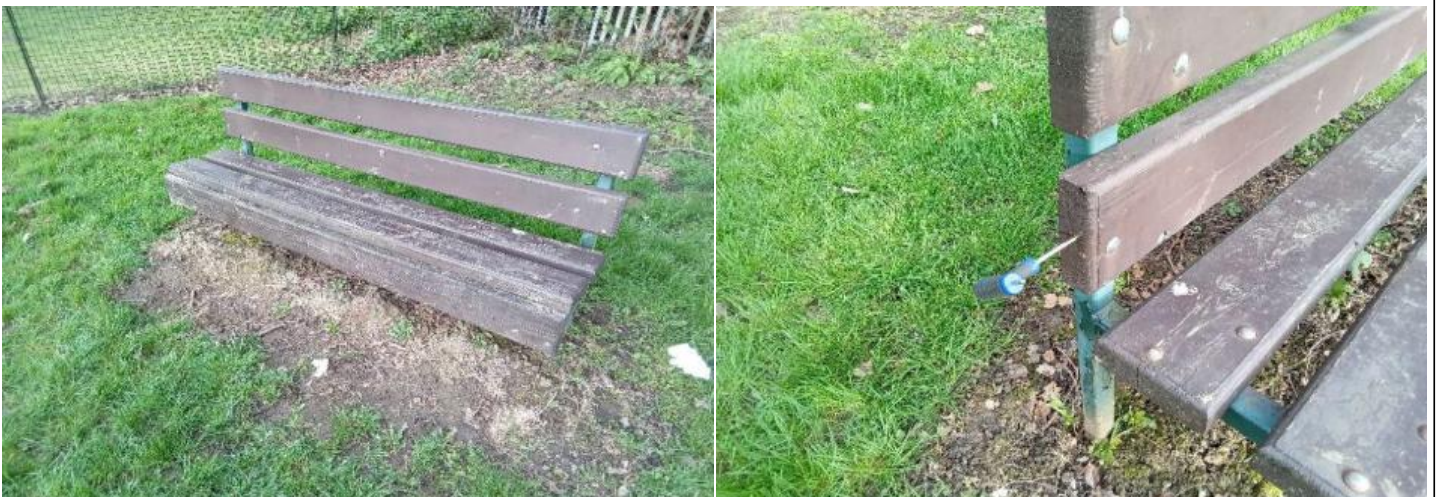
**Finding:** There is some evidence of rot in the timber  
**Action:** Monitor for any further deterioration and replace as required

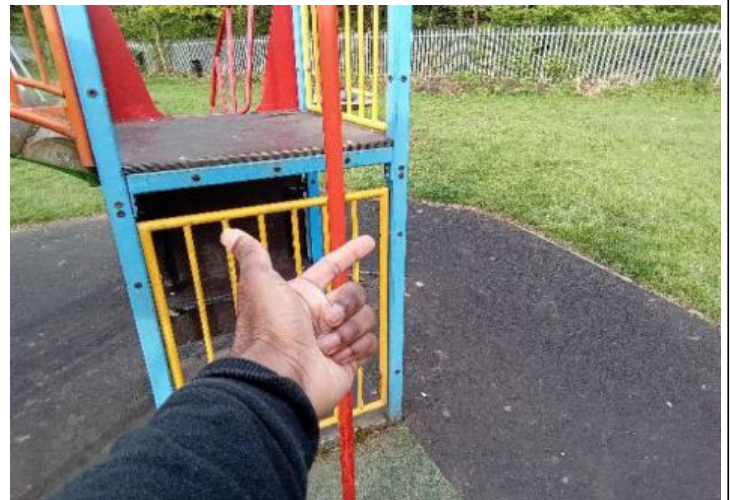
**Finding:** Fixings are damaged and/or have sharp edges

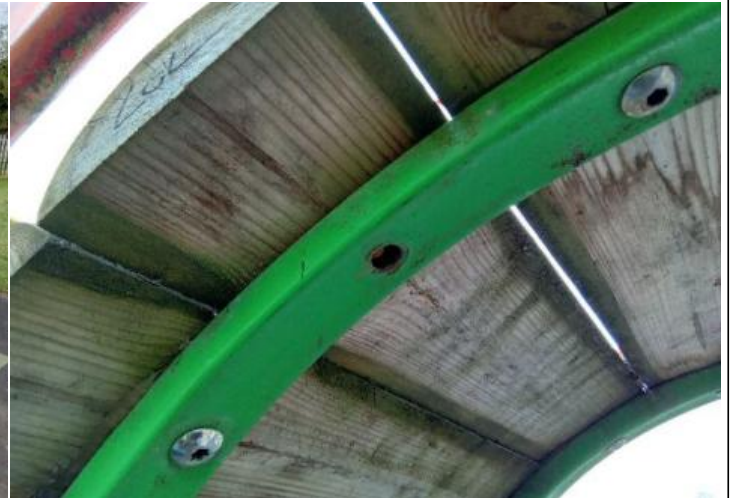
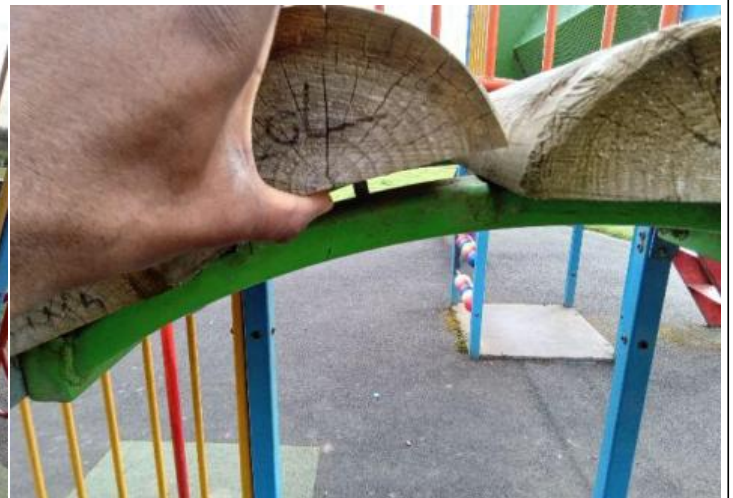
**Finding:** There is or are fixings missing on the item
