ST STEPHEN PARISH COUNCIL

You are summoned to the Fixed Assets Committee meeting
To take place on **Thursday 30 May 2024 at 7.30pm**
at St Stephen Suite, Parish Centre, Station Road, Bricket Wood, AL2 3PJ

- 2425/AC/07 To receive Annual Play Inspection Report and Grounds Team Action Report. Play Reports and Grounds Team Report attached.**
- 2425/AC/08 To discuss the option of creating additional allotment plots and possible beginner plots at Watford Road allotment site or North Close. Allotment report attached.**

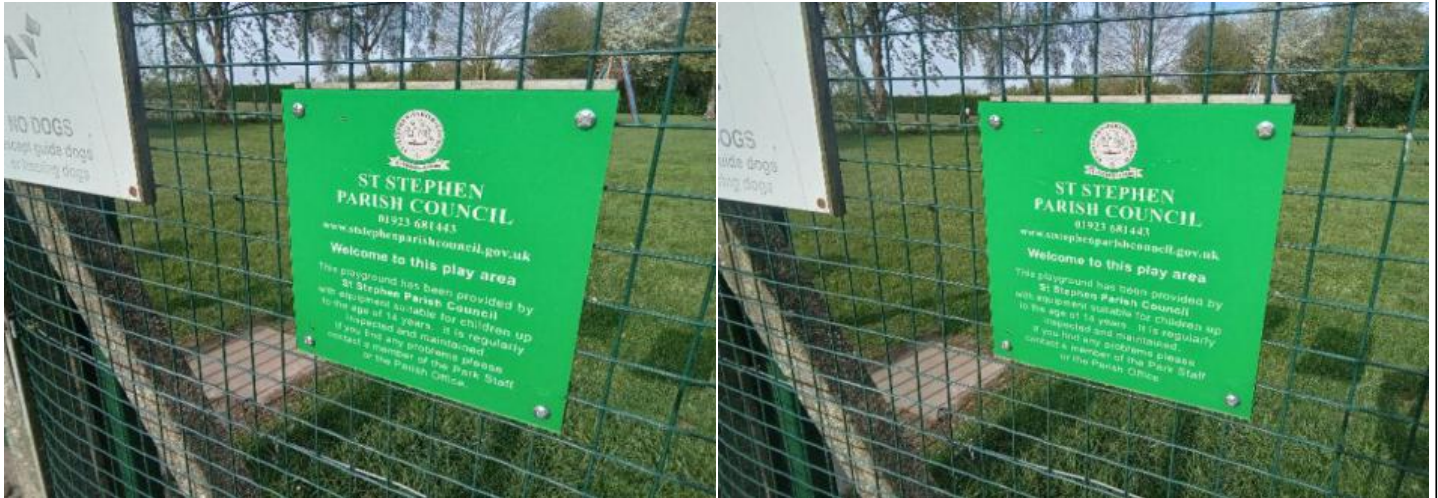
Risk Level: V - Very Low Risk
Surface: N/A

Finding: BS EN 1176 Part 7 recommends that signage shall include the site name / address
Action: Provide additional information

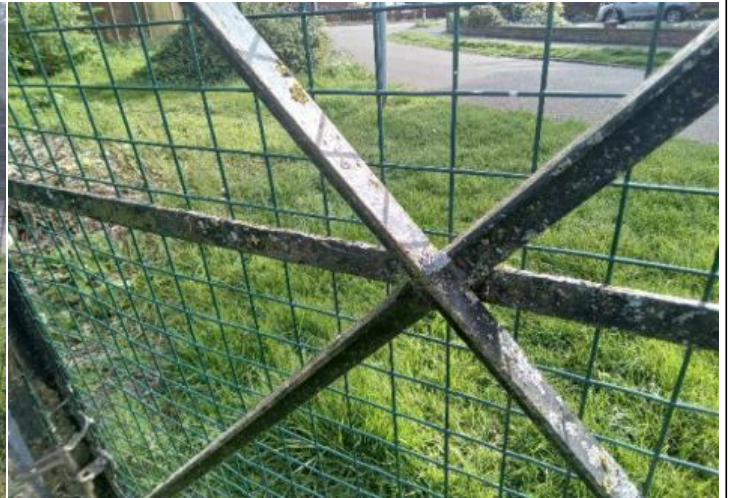
Risk Level: L - Low Risk
Surface: Grass

Finding: The paintwork on this item has been damaged or worn exposing the metal underneath which is rusting / corroding

Action: Treat affected areas and repaint

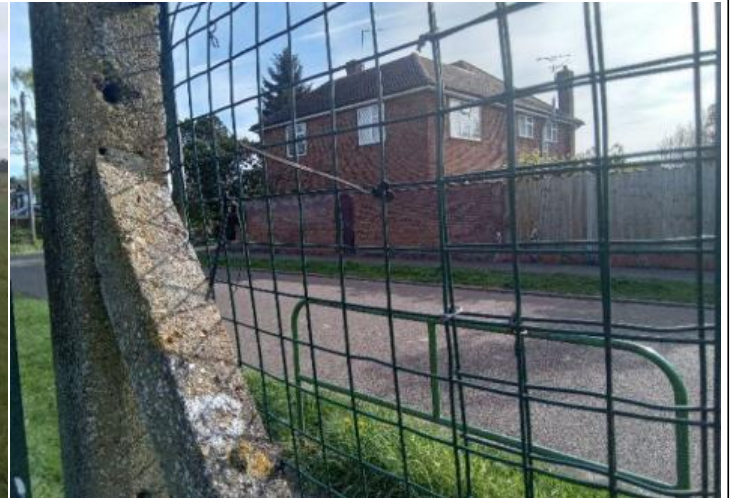
Risk Level: L - Low Risk
Surface: Grass

Finding: Cable ties have been used on the item and there are sharp projecting ends

Action: Remove if not required or replace with a more appropriate alternative fixing method if used as a fixing

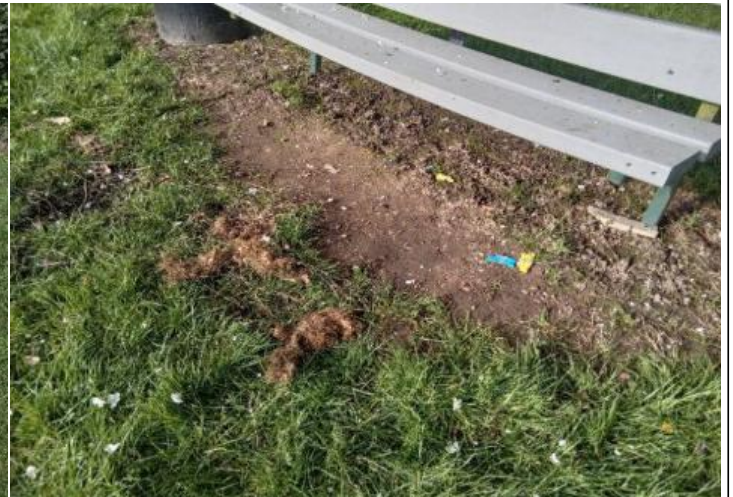
Risk Level: L - Low Risk
Surface: Grass

Finding: The surface has eroded in some areas and may be slippery in wet conditions

Action: Reinstate the surface

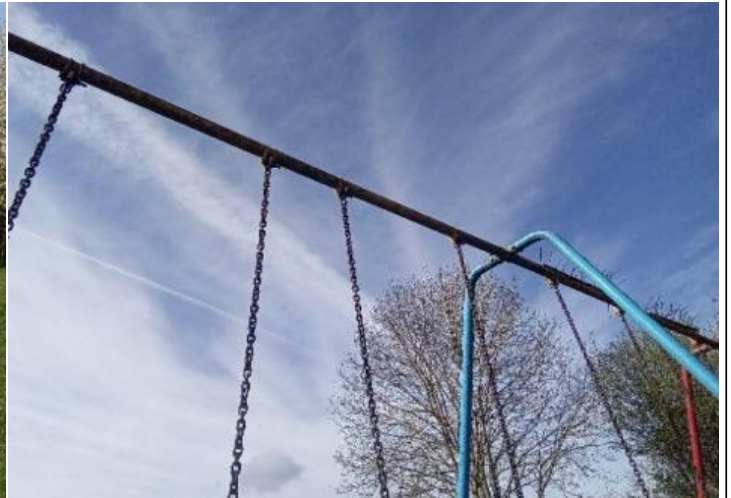
Risk Level: L - Low Risk
Surface: Grass Matrix Tiles

Finding: There is some wear to the shackles

Action: Monitor for any further deterioration and replace when 40% worn

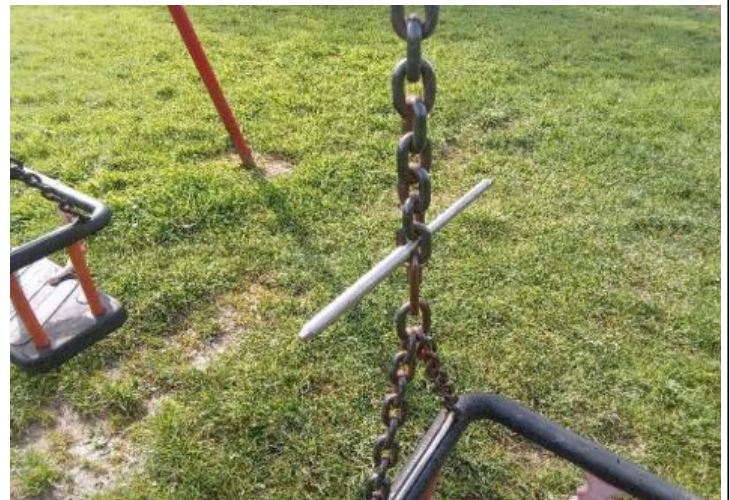
Risk Level: V - Very Low Risk
Surface: Grass Matrix Tiles

Finding: The chain openings are in excess of the 8.6mm as recommended by BS EN 1176 **Action:** Monitor - No remedial work recommended

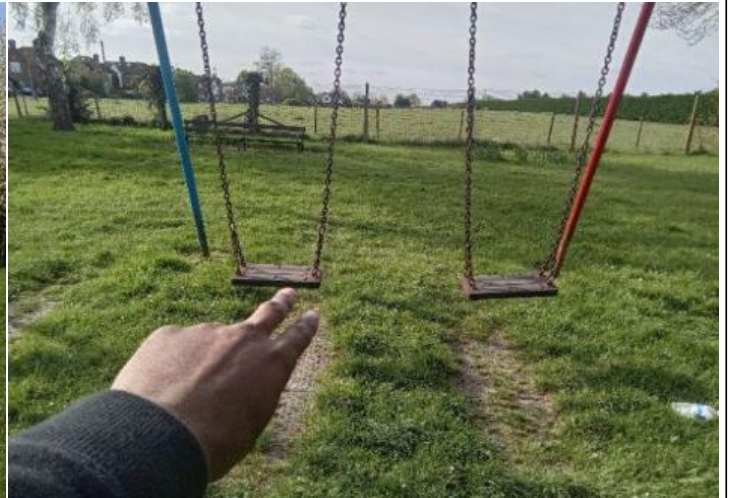
Risk Level: L - Low Risk
Surface: Grass Matrix Tiles

Finding: The swing seat connectors are loose

Action: Tighten to secure

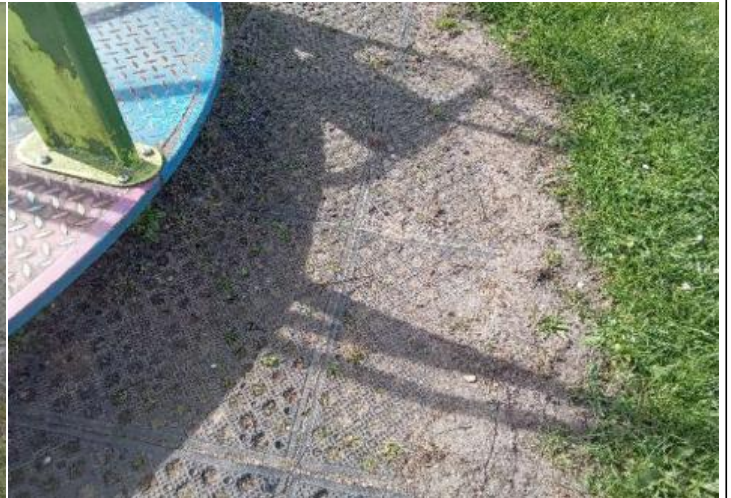
Risk Level: L - Low Risk
Surface: Grass Matrix Tiles

Finding: The surface has subsided in some areas

Action: Monitor for any further deterioration and repair as required

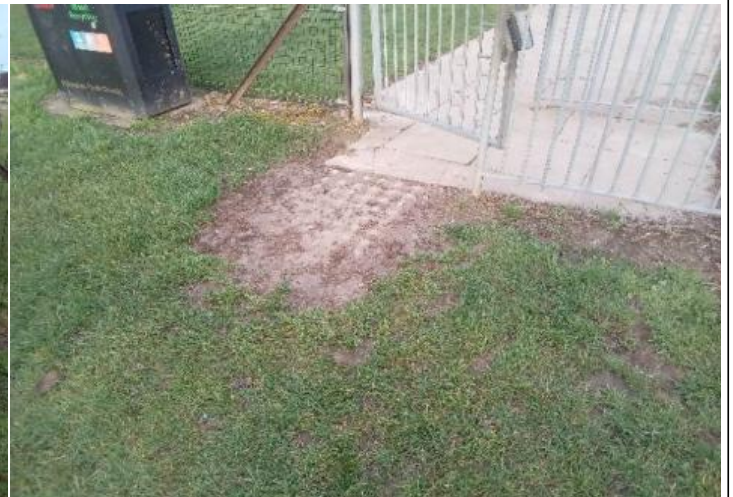
Risk Level: L - Low Risk
Surface: Paving Slabs

Finding: The surface has eroded in some areas and may be slippery in wet conditions

Action: Reinstate the surface

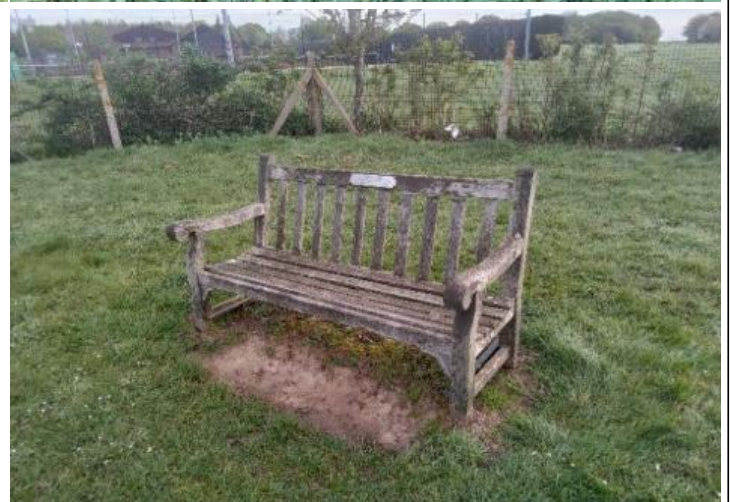
Risk Level: V - Very Low Risk
Surface: Grass

Finding: There is some strimmer / machinery damage apparent on the posts, this can penetrate the preservative applied to the timber and accelerate the rotting process

Action: Monitor for any deterioration (rot) and replace as required

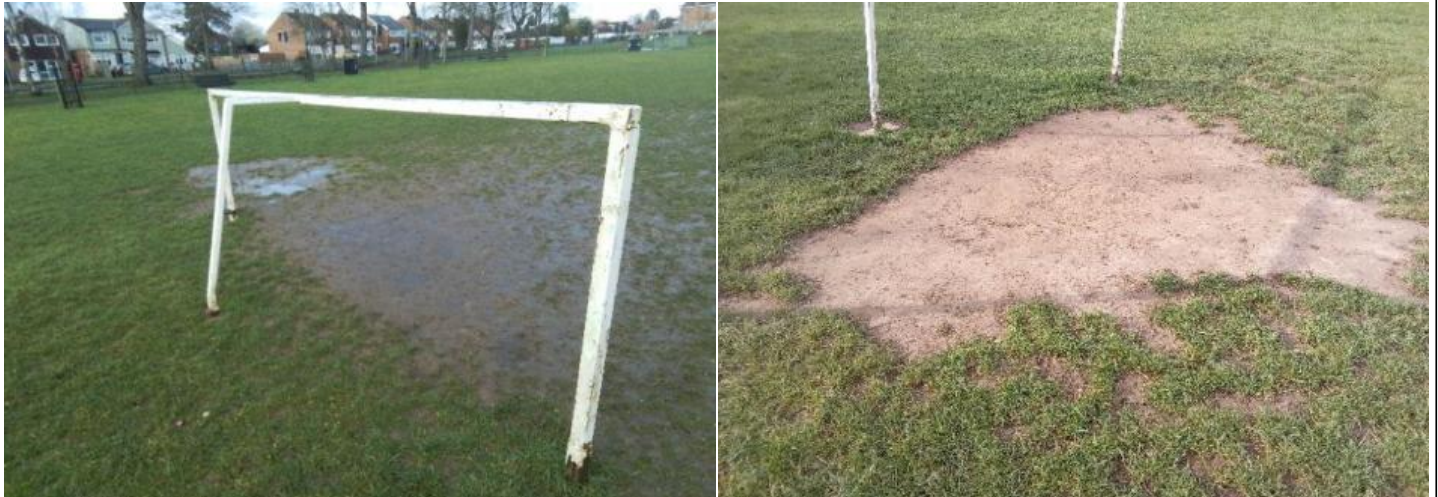
Risk Level: L - Low Risk
Surface: Grass

Finding: The surface has eroded in some areas and may be slippery in wet conditions

Action: Reinstate the surface

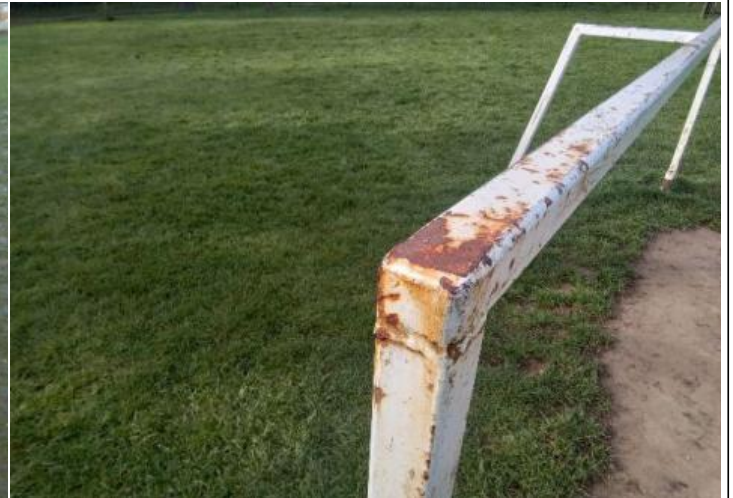
Risk Level: L - Low Risk
Surface: Grass

Finding: The paintwork on this item has been damaged or worn exposing the metal underneath which is rusting / corroding

Action: Treat affected areas and repaint

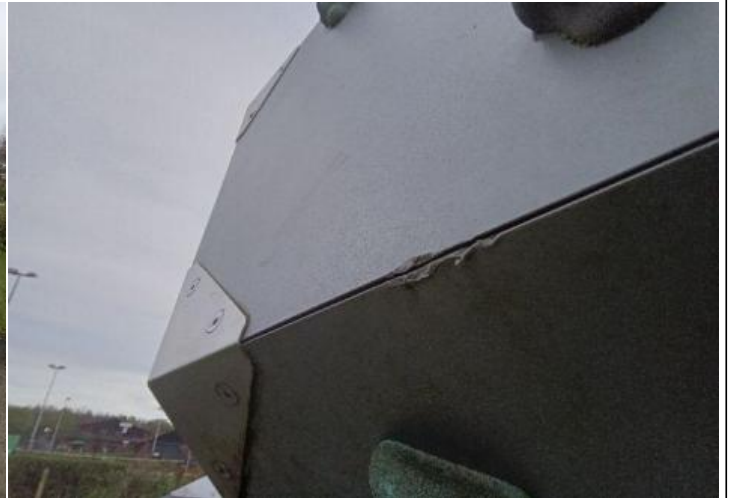
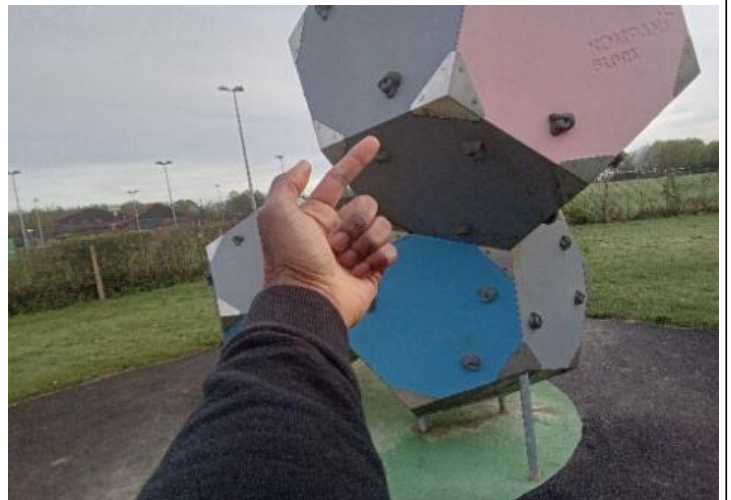
Risk Level: L - Low Risk
Surface: Wet Pour

Finding: There is some damage to the item

Action: Monitor for any further deterioration and repair as required

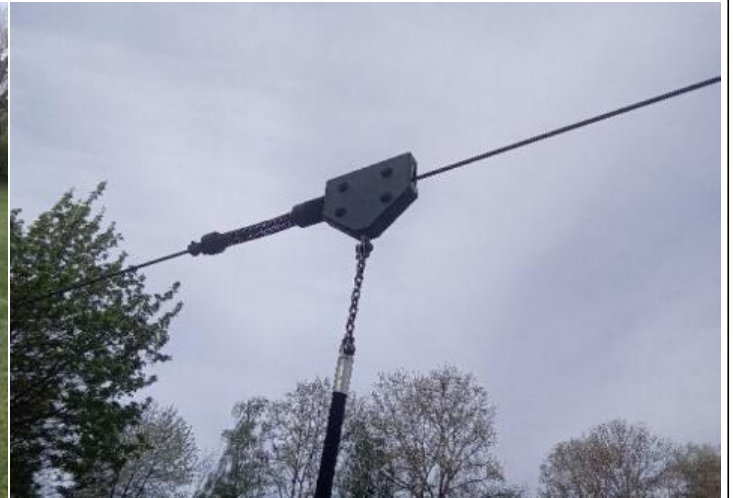
Risk Level: N - Risk Assessment not Undertaken
Surface: Grass Matrix Tiles

Finding: We have completed a visual inspection of the suspension links, cable and fixing points from ground level, however it is not possible to fully inspect these areas without either hiring equipment to gain access or removing the cable and suspension and inspecting at ground level. We recommend that the main cable and fixing security is thoroughly inspected at least in accordance with the manufacturers recommendations to check for wear, damage, security or internal rusting; this will help to ensure the continued safe use of the equipment

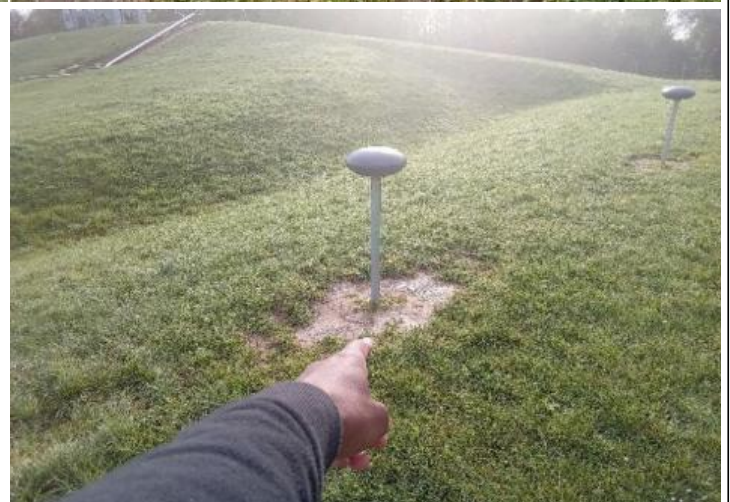
Risk Level: L - Low Risk
Surface: Grass Matrix Tiles

Finding: There is moderate damage to the grass matrix tile surface **Action:** Repair the damaged areas of surfacing

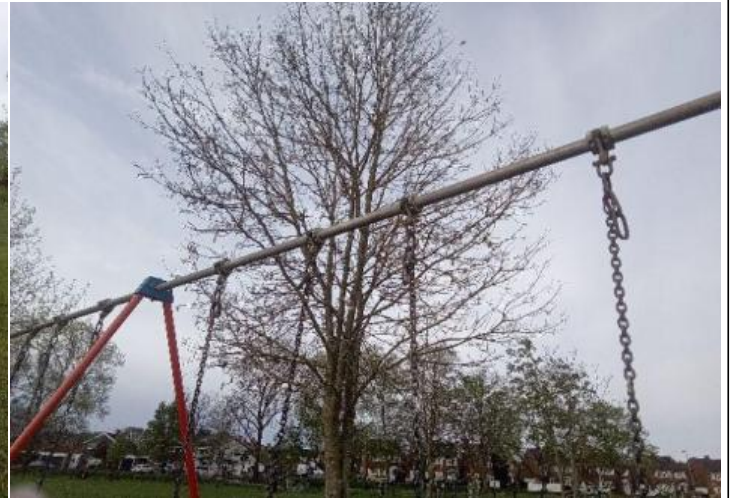
Risk Level: N - Risk Assessment not Undertaken
Surface: Grass Matrix Tiles

Finding: The fixings or components for this item were in excess of 2.5m above the standing surface and could not be fully accessed by the inspector. We have completed a visual inspection of the fixings from ground level but a maintenance inspection should be undertaken to assess the condition, security and wear of the components at intervals in accordance with the manufacturers recommendations.

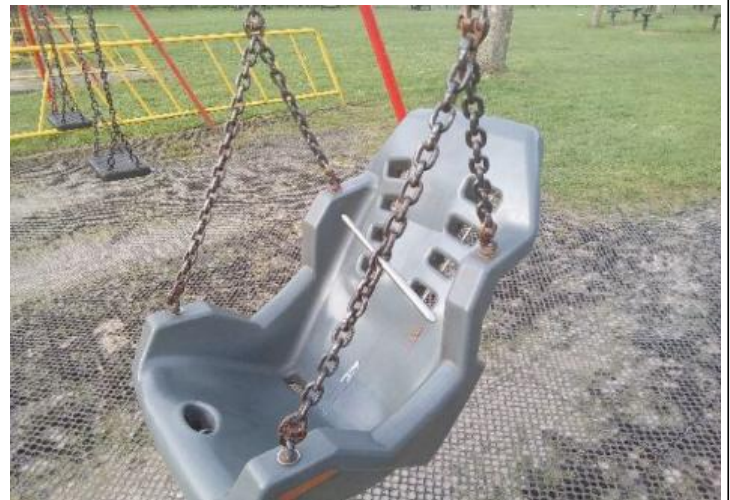
Risk Level: V - Very Low Risk
Surface: Grass Matrix Tiles

Finding: The chain openings are in excess of the 8.6mm as recommended by BS EN 1176 **Action:** Monitor - No remedial work recommended

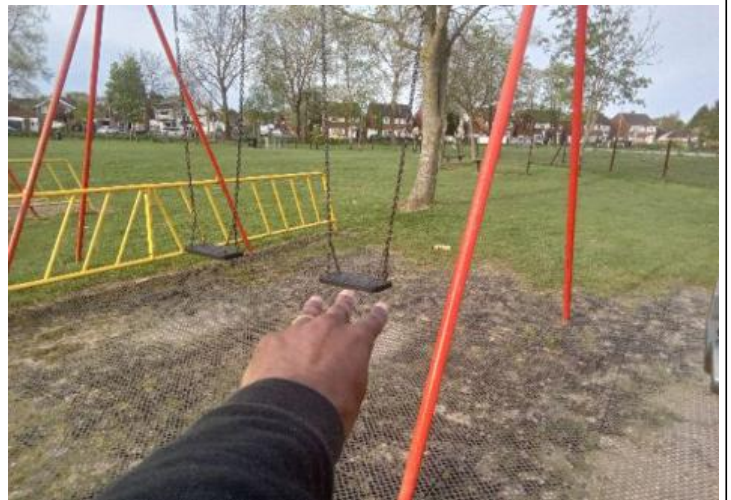
Risk Level: L - Low Risk
Surface: Grass Matrix Tiles

Finding: The swing seat connectors are loose

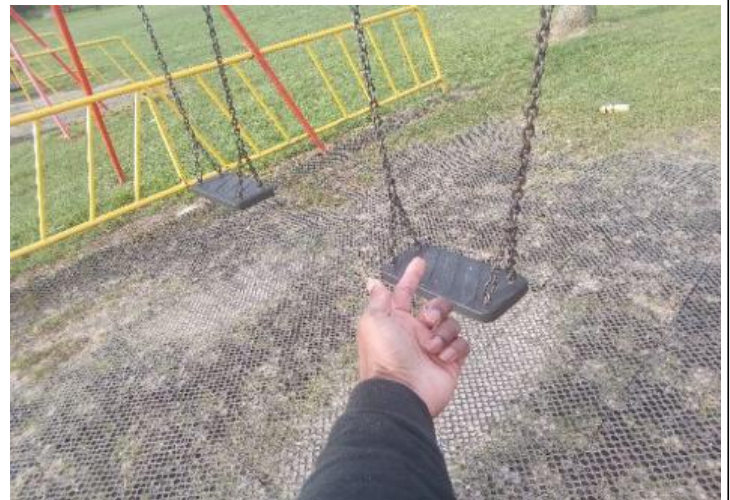
Risk Level: M - Moderate Risk
Surface: Grass Matrix Tiles

Finding: The connecting link is cut/ damaged

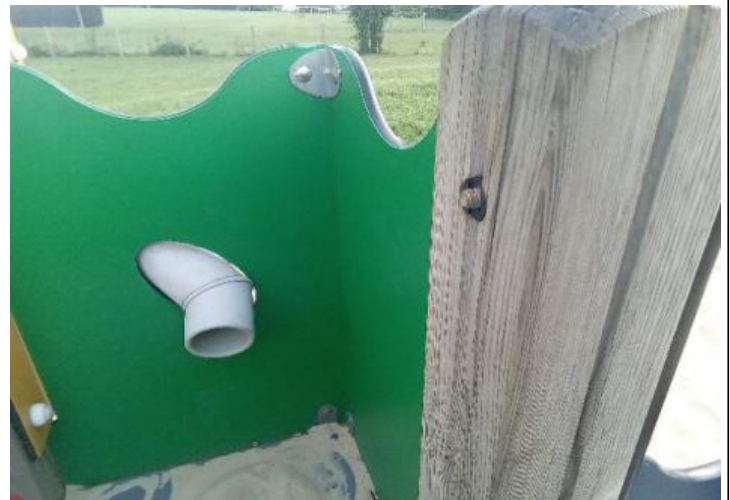
Risk Level: V - Very Low Risk
Surface: Sand

Finding: There is/are bolt cap covers missing or damaged on the item

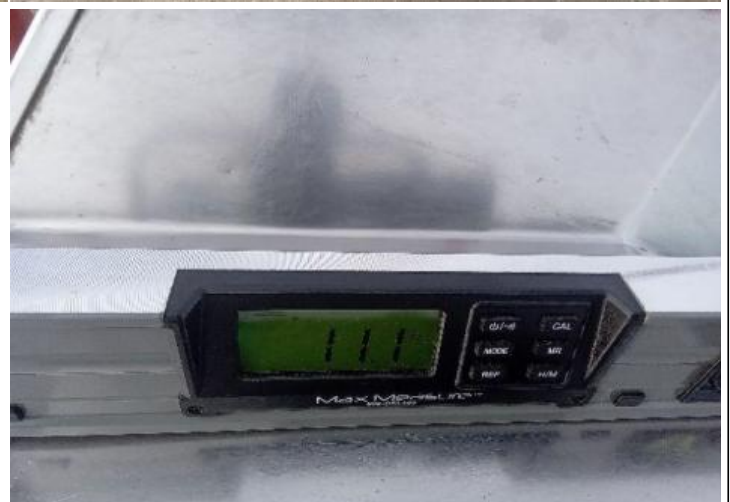
Risk Level: V - Very Low Risk
Surface: Grass

Finding: The slide start section incline is not in the direction of travel; it should slope towards the direction of the sliding surface to meet the requirements of BS EN 1176 Part 3

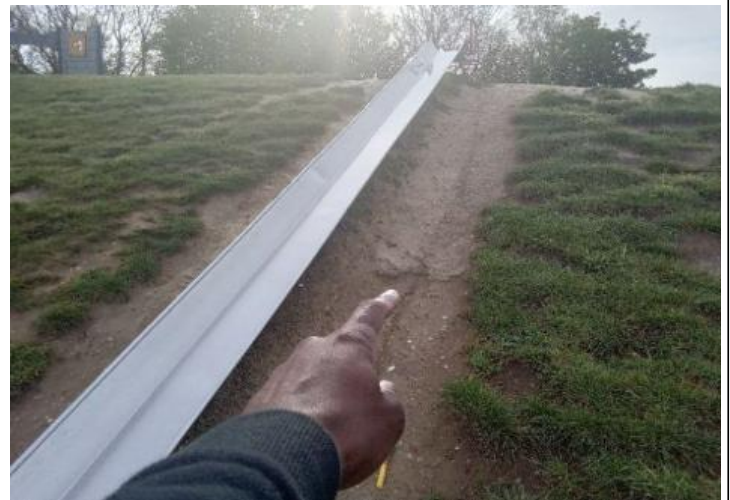
Risk Level: L - Low Risk
Surface: Grass

Finding: The concrete foundation forms a projecting obstacle / hard object within the free space of the equipment, in contravention of the requirements of BS EN 1176 Part 1

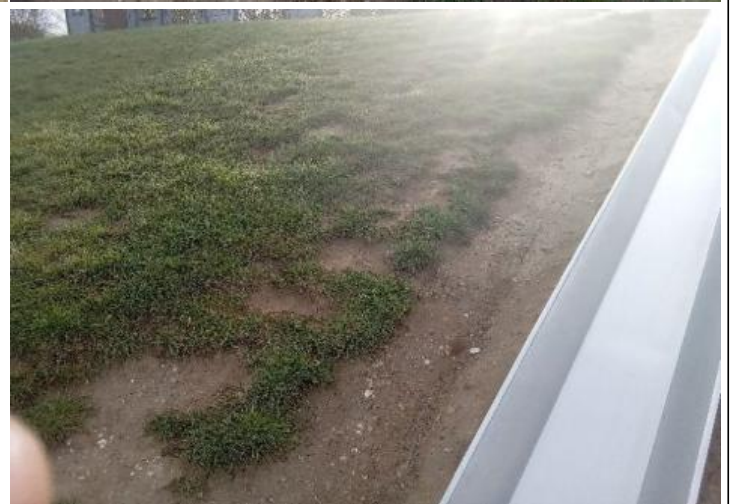
Risk Level: L - Low Risk
Surface: Grass

Finding: The surface has eroded in some areas and may be slippery in wet conditions
Action: Reinstate the surface

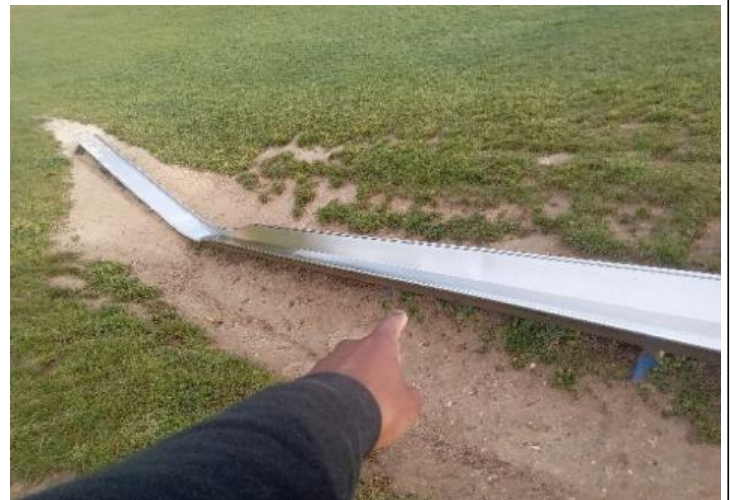
Risk Level: L - Low Risk
Surface: Grass

Finding: A number of fixing(s) have worked loose

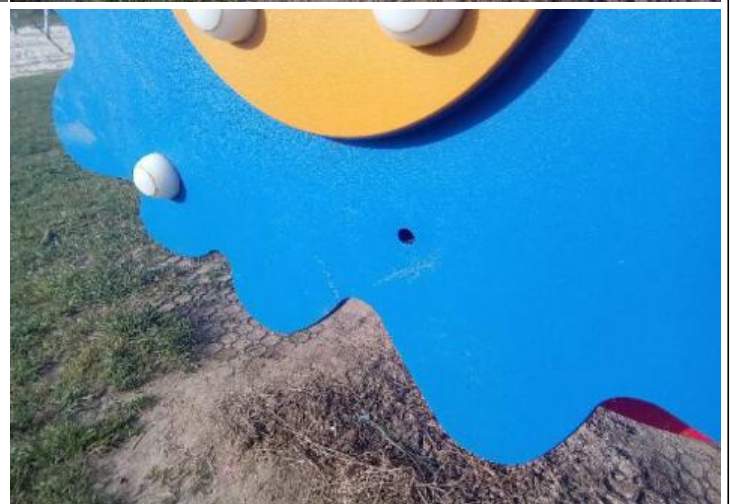
Risk Level: L - Low Risk
Surface: Grass Matrix Tiles

Finding: There is or are fixings missing on the item causing finger entrapment
Action: Replace all missing fixings to remove entrapment

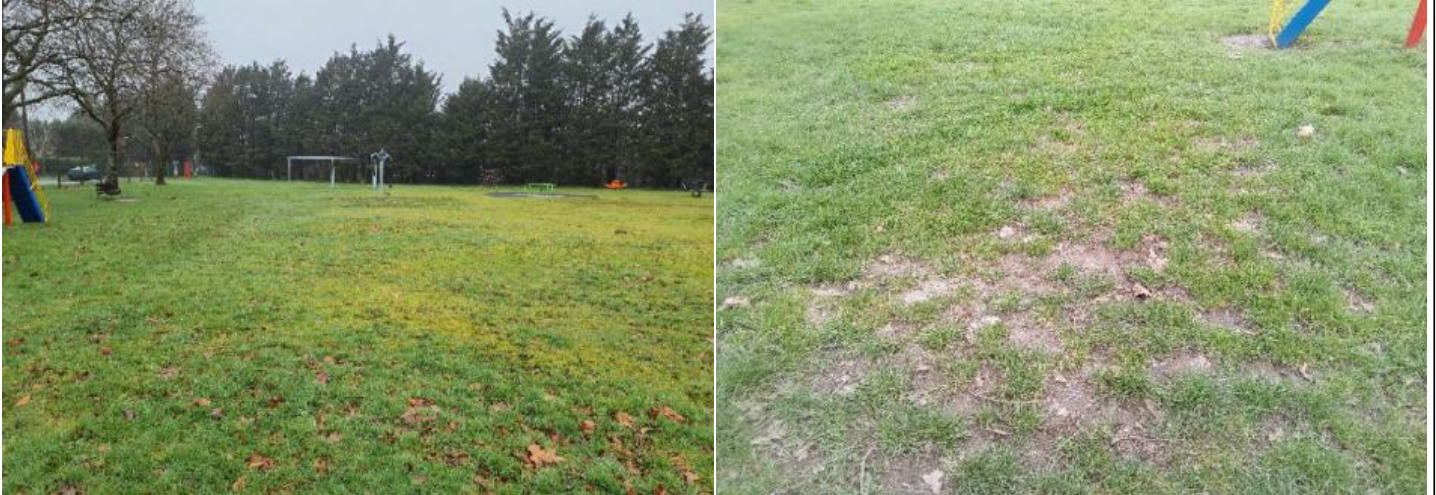
Item:	Ancillary Items - Site General	Risk Level:	L - Low Risk
Manufacturer:	Owner/Operator	Surface:	N/A

Finding: The surface has eroded in some areas and may be slippery in wet conditions
Action: Reinstate the surface

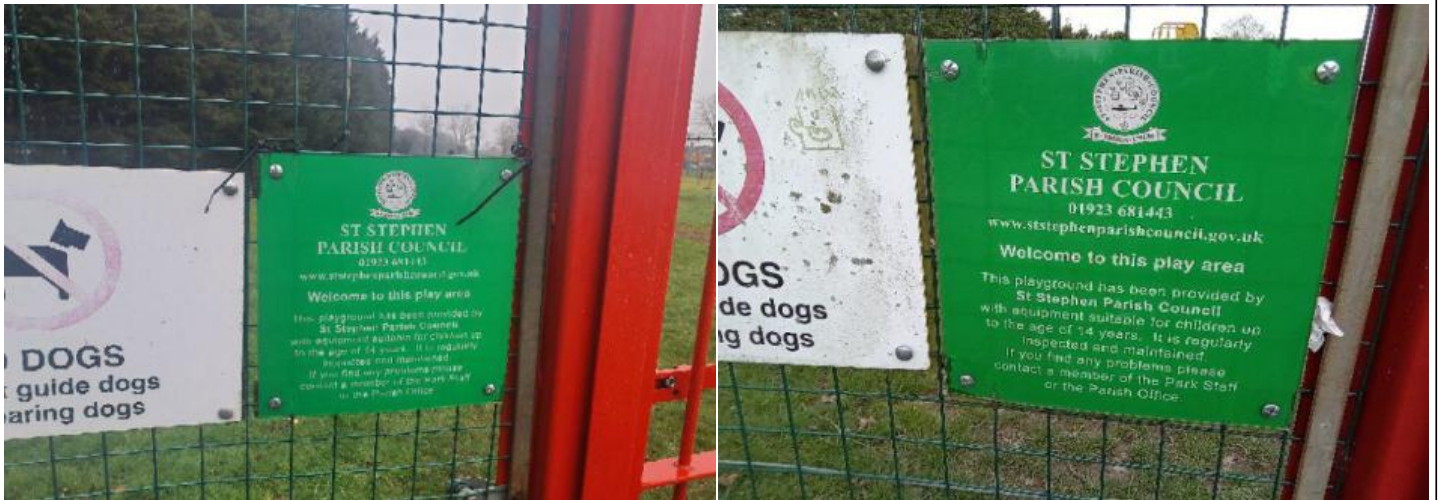
Risk Level: V - Very Low Risk
Surface: N/A

Finding: BS EN 1176 Part 7 recommends that signage shall include the site name / address
Action: Provide additional information

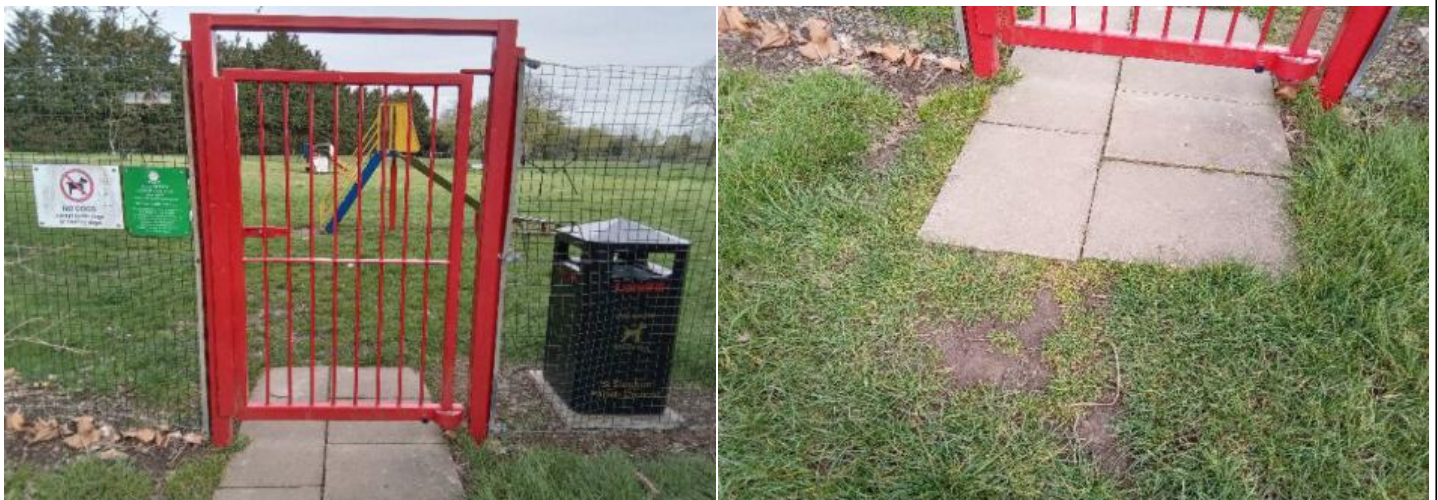
Risk Level: L - Low Risk
Surface: Grass

Finding: There are trip hazards at the edges of the surface
Action: Reinstate surrounding surface levels to remove the trip points

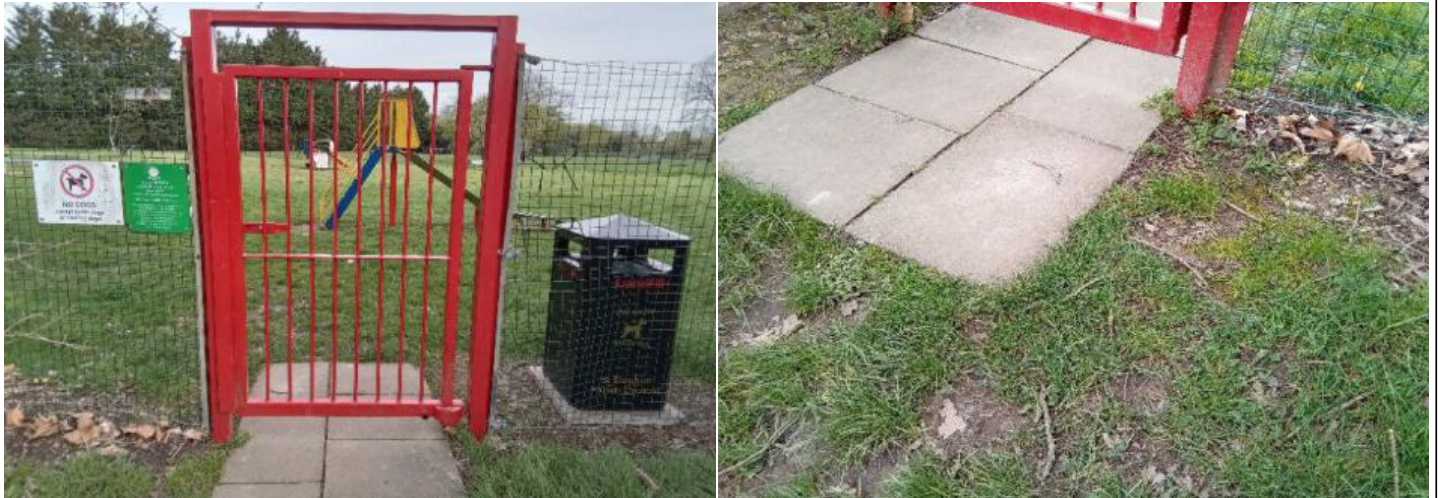
Risk Level: L - Low Risk
Surface: Grass

Finding: The surface has eroded in some areas and may be slippery in wet conditions
Action: Reinstate the surface

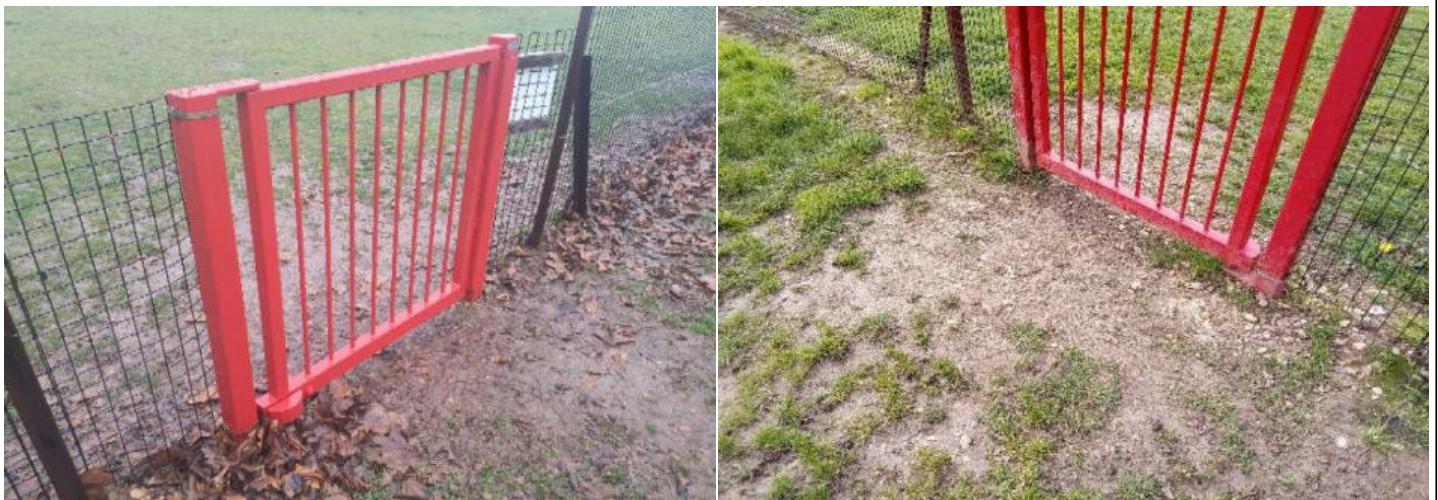
Risk Level: L - Low Risk
Surface: Grass

Finding: The surface has eroded in some areas and may be slippery in wet conditions
Action: Reinstate the surface

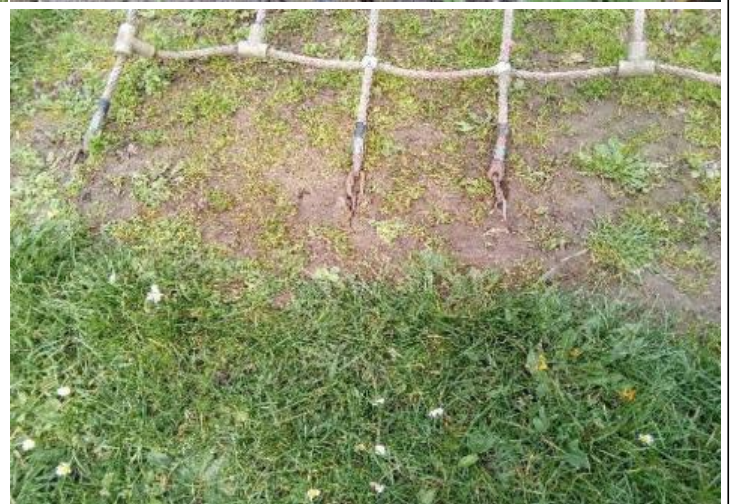
Risk Level: L - Low Risk
Surface: Grass Matrix Tiles

Finding: The connecting links are worn in excess of 40% and require renewing

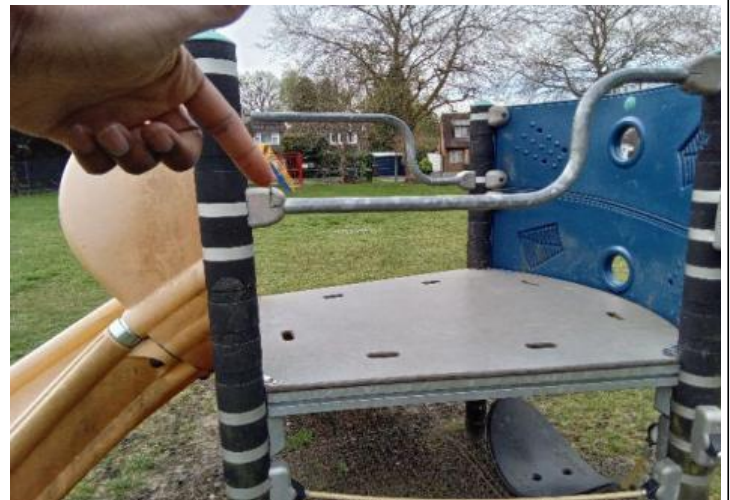
Risk Level: L - Low Risk
Surface: Grass Matrix Tiles

Finding: A number of fixing(s) have worked loose on guardrail

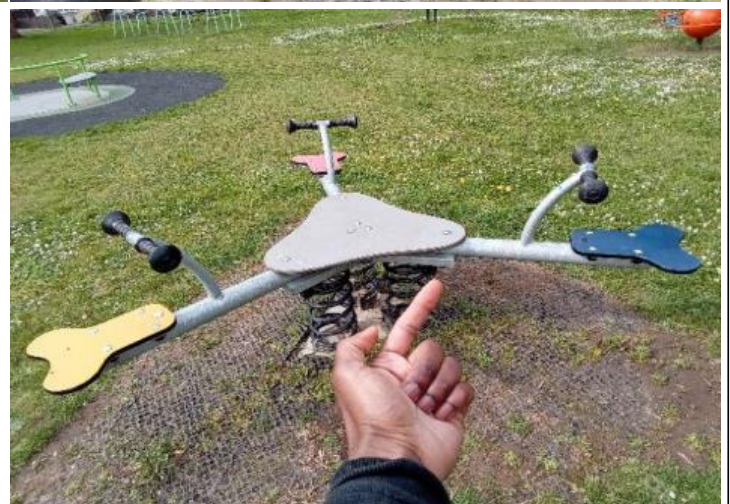
Risk Level: L - Low Risk
Surface: Grass Matrix Tiles

Finding: There is or are fixings missing on the item

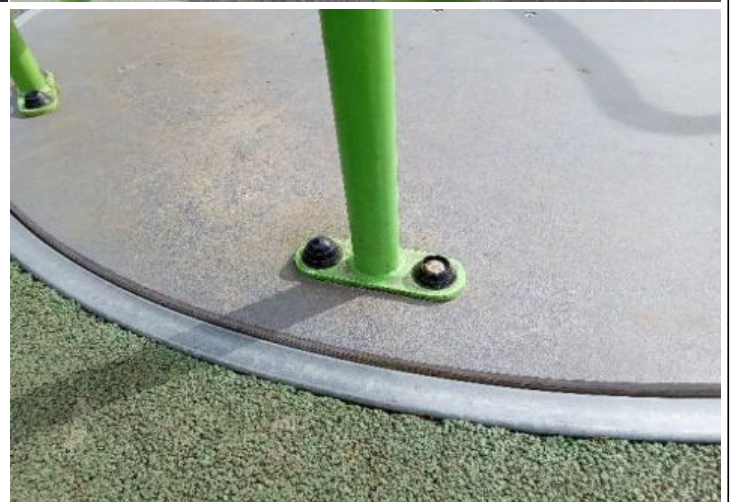
Risk Level: V - Very Low Risk
Surface: Wet Pour

Finding: There is/are bolt cap covers missing or damaged on the item

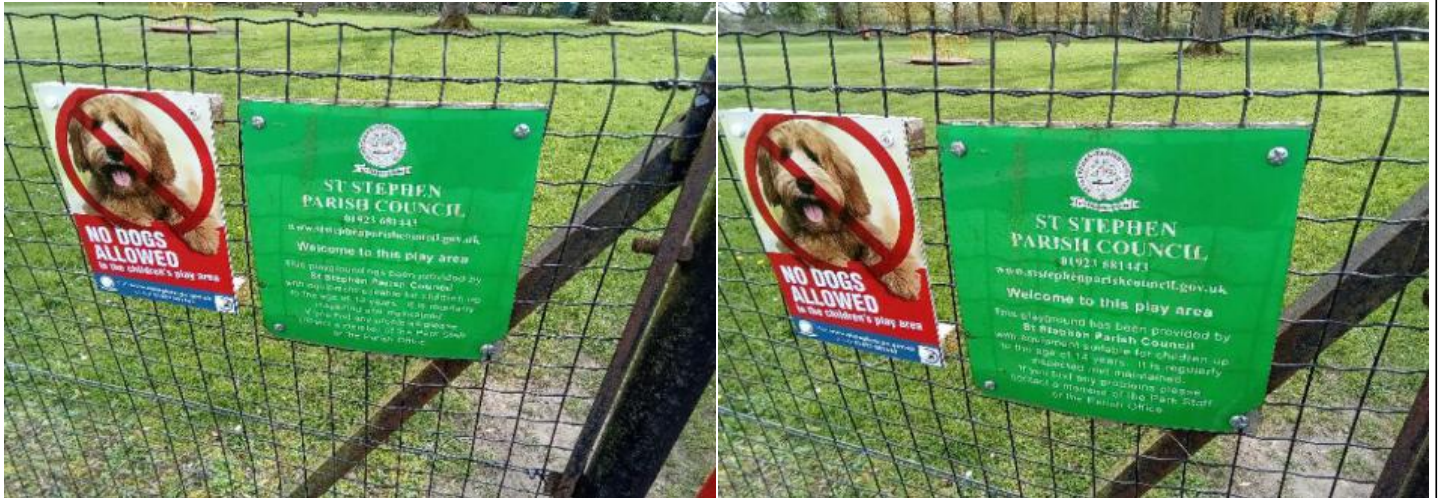
Risk Level: V - Very Low Risk
Surface: N/A

Finding: BS EN 1176 Part 7 recommends that signage shall include the site name / address
Action: Provide additional information

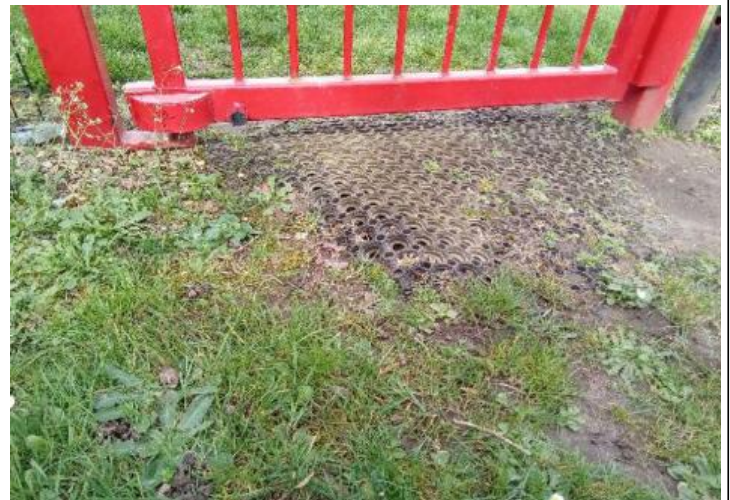
Risk Level: L - Low Risk
Surface: Grass Matrix Tiles

Finding: There are trip hazards caused by the grass matrix tiles at the edges of the surface

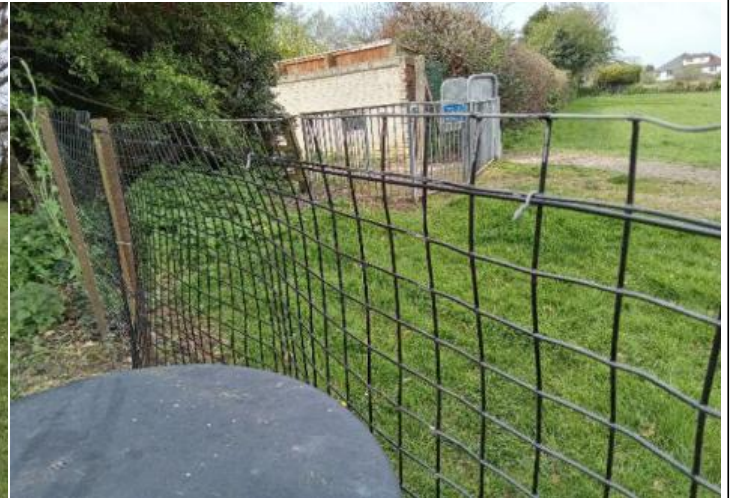
Risk Level: L - Low Risk
Surface: Grass

Finding: Cable ties have been used on the item and there are sharp projecting ends

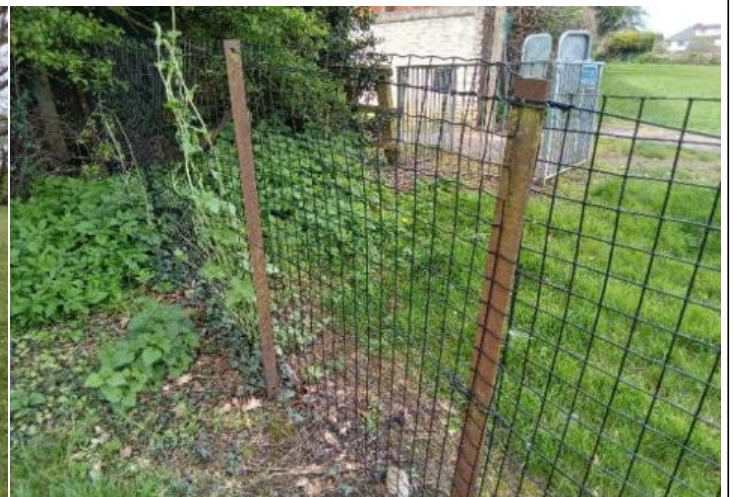
Risk Level: L - Low Risk
Surface: Grass

Finding: There are a number of loose posts around the fence

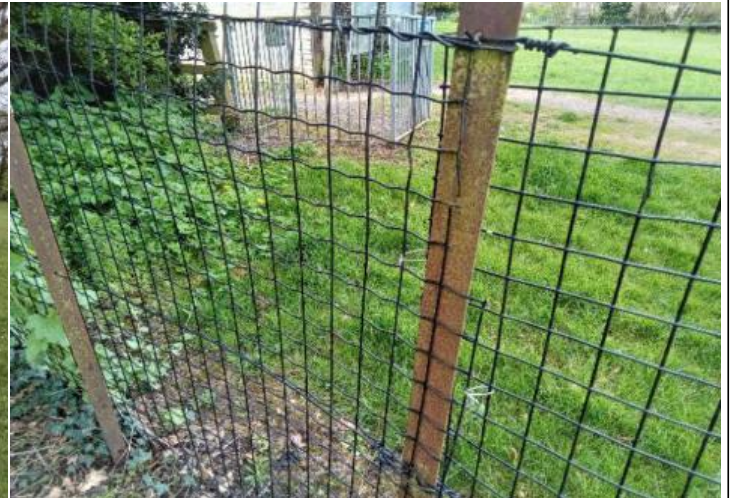
Risk Level: L - Low Risk
Surface: Grass

Finding: The paintwork on this item has been damaged or worn exposing the metal underneath which is rusting / corroding

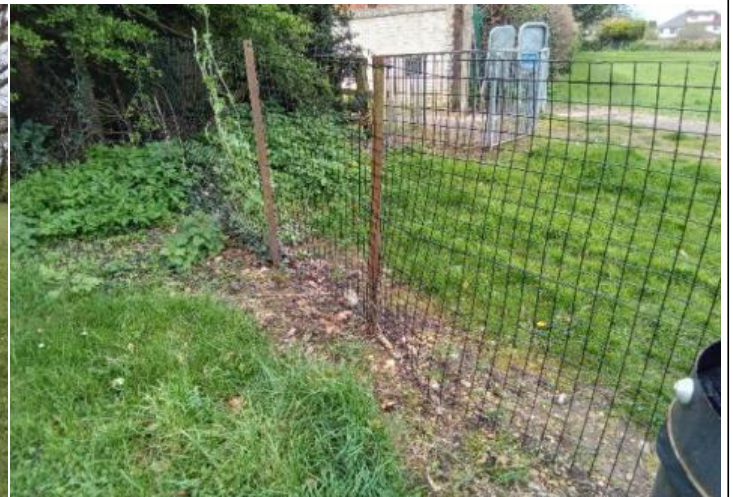
Risk Level: L - Low Risk
Surface: Grass

Finding: There is some damage to the fence sections

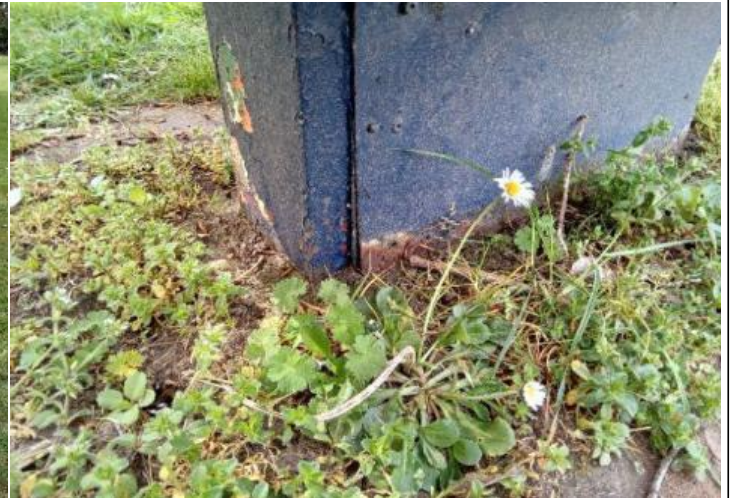
Risk Level: L - Low Risk
Surface: Grass Matrix Tiles

Finding: There is surface corrosion / rust present on the item

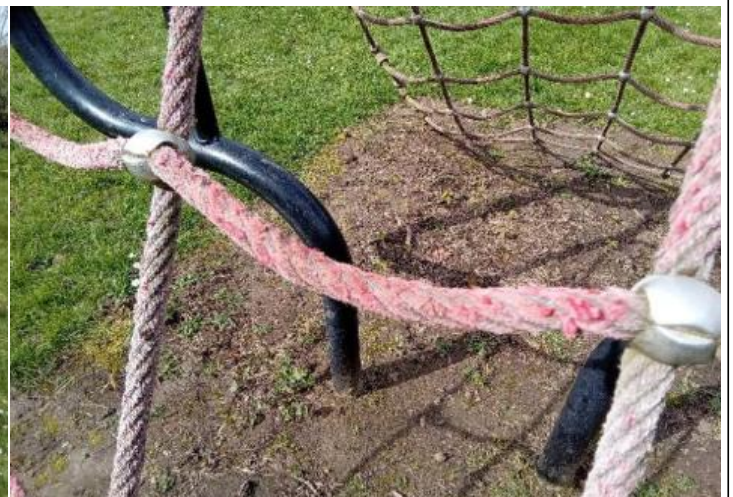
Risk Level: L - Low Risk
Surface: Grass Matrix Tiles

Finding: The rope has worn and wire strands are exposed

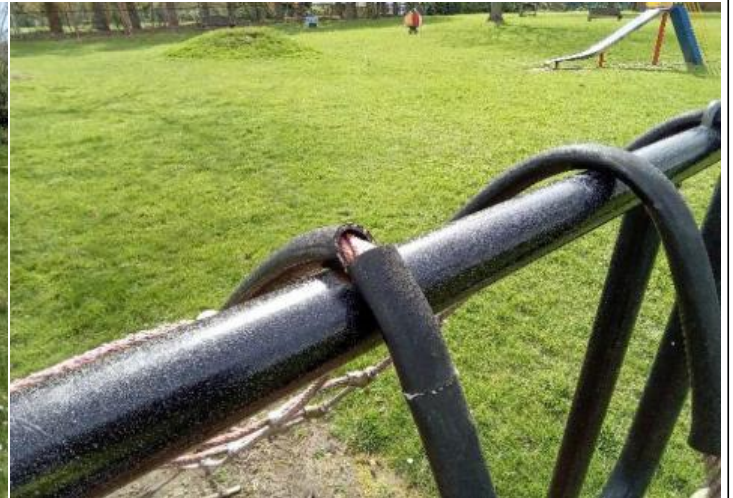
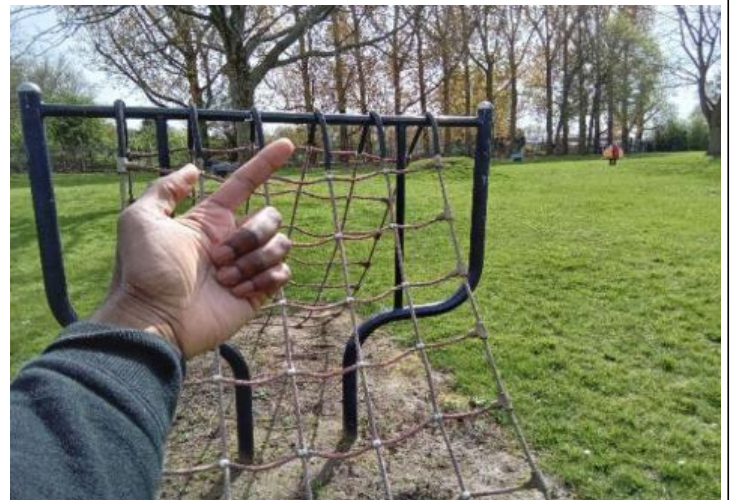
Risk Level: L - Low Risk
Surface: Grass Matrix Tiles

Finding: The chain/rope covering is damaged

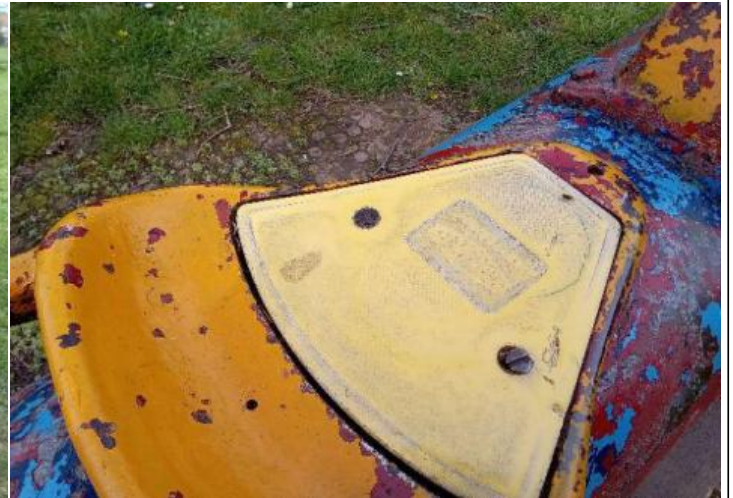
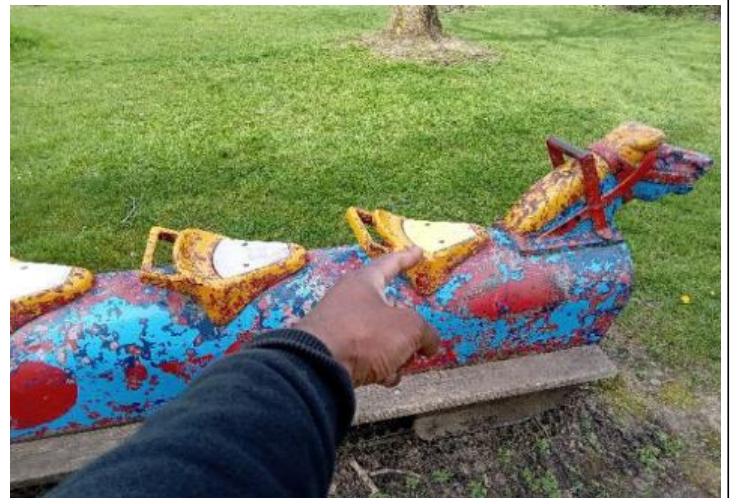
Risk Level: L - Low Risk
Surface: Grass Matrix Tiles

Finding: There is some damage to the seat

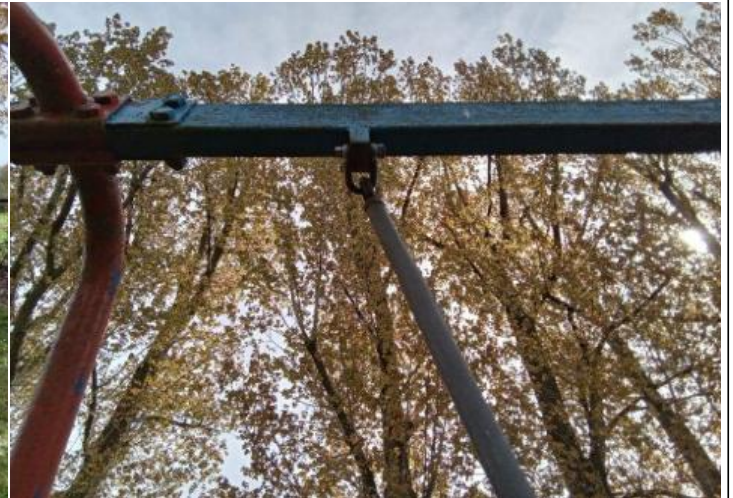
Risk Level: L - Low Risk
Surface: Grass Matrix Tiles

Finding: There is some wear to the shackles.

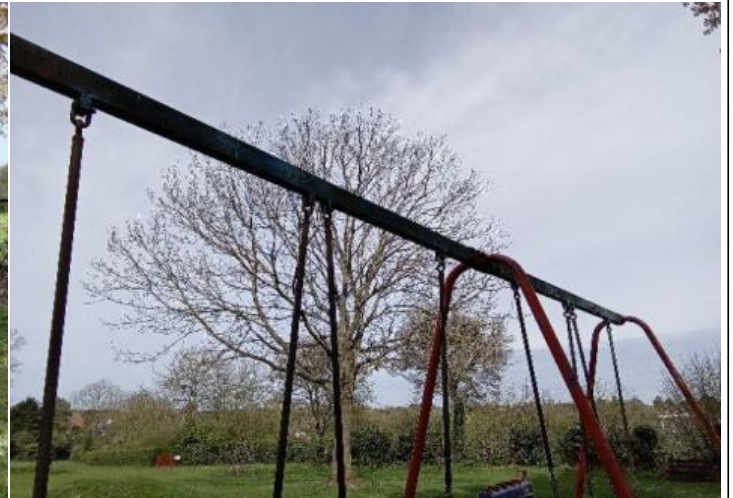
Risk Level: N - Risk Assessment not Undertaken
Surface: Grass Matrix Tiles

Finding: The fixings or components for this item were in excess of 2.5m above the standing surface and could not be fully accessed by the inspector. We have completed a visual inspection of the fixings from ground level but a maintenance inspection should be undertaken to assess the condition, security and wear of the components at intervals in accordance with the manufacturers recommendations.
