ST STEPHEN PARISH COUNCIL

You are summoned to the Fixed Assets Committee meeting
To take place on **Thursday 30 May 2024 at 7.30pm**
at St Stephen Suite, Parish Centre, Station Road, Bricket Wood, AL2 3PJ

- 2425/AC/07 To receive Annual Play Inspection Report and Grounds Team Action Report. Play Reports and Grounds Team Report attached.**
- 2425/AC/08 To discuss the option of creating additional allotment plots and possible beginner plots at Watford Road allotment site or North Close. Allotment report attached.**

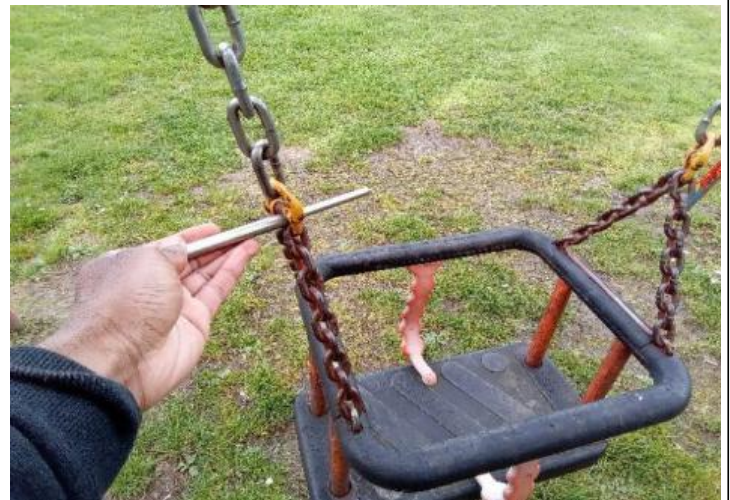
Risk Level: V - Very Low Risk
Surface: Grass Matrix Tiles

Finding: The chain openings are in excess of the 8.6mm as recommended by BS EN 1176 **Action:** Monitor - No remedial work recommended

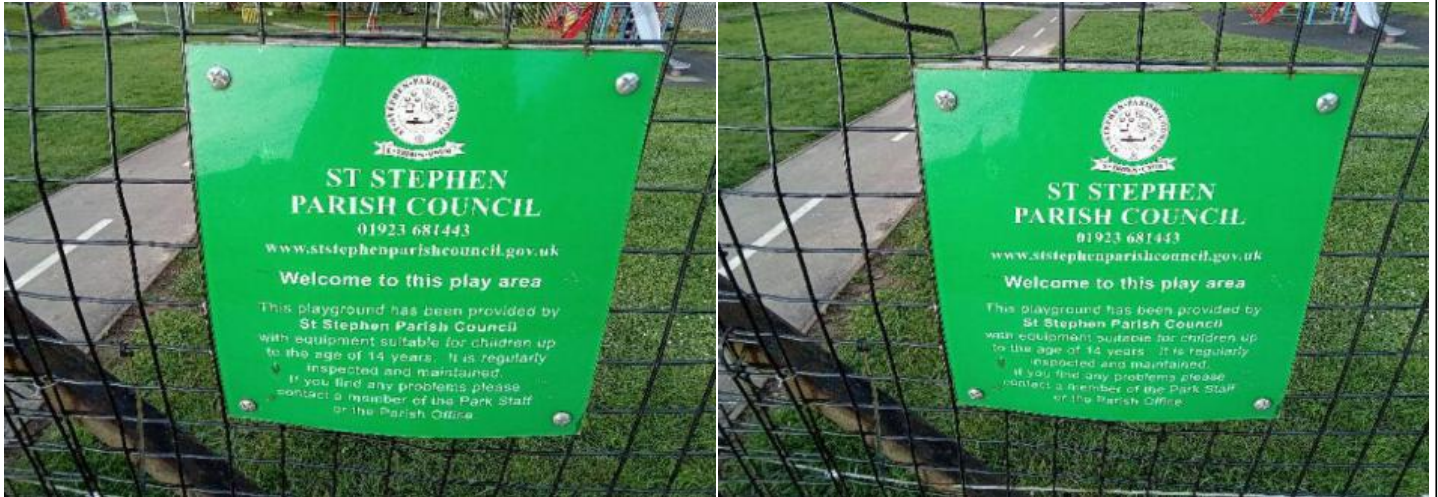
Risk Level: V - Very Low Risk
Surface: Grass

Finding: BS EN 1176 Part 7 recommends that signage shall include the site name / address
Action: Provide additional information

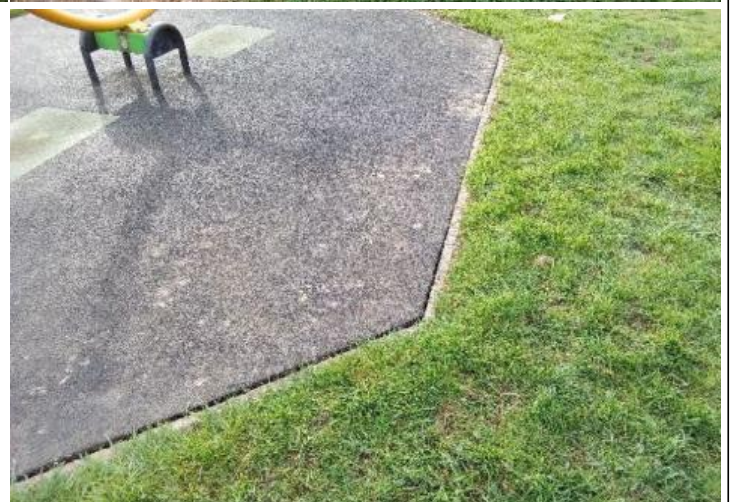
Risk Level: L - Low Risk
Surface: N/A

Finding: There are gaps opening between the surfacing and the edging surround or between the joints in the surfacing
Action: Monitor for any further deterioration and repair as required

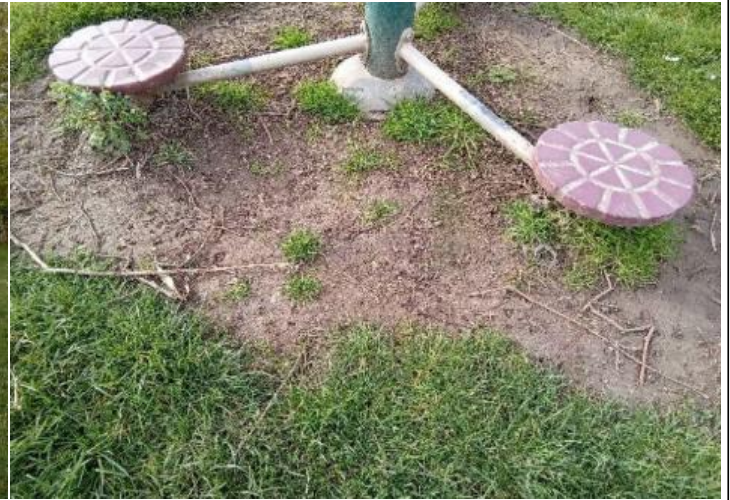
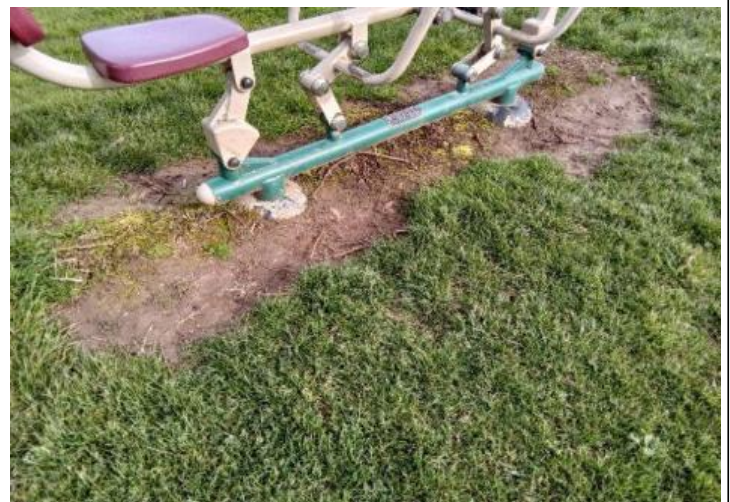
Risk Level: L - Low Risk
Surface: N/A

Finding: The surface has eroded in some areas and may be slippery in wet conditions
Action: Reinstate the surface

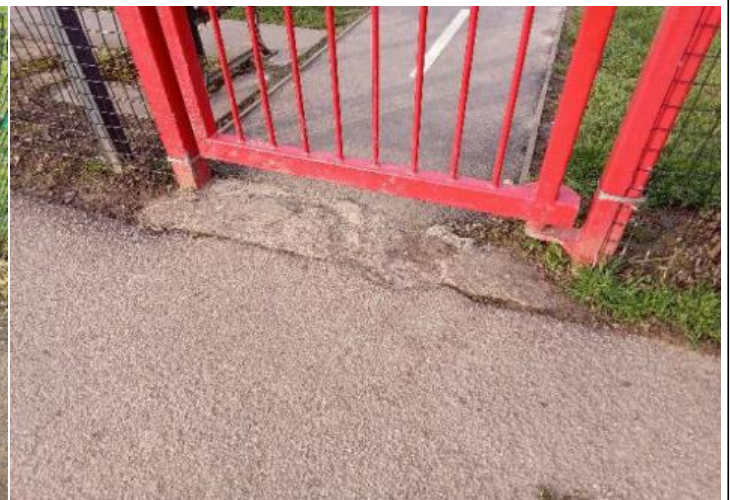
Risk Level: V - Very Low Risk
Surface: Grass

Finding: There is some minor damage to the surface

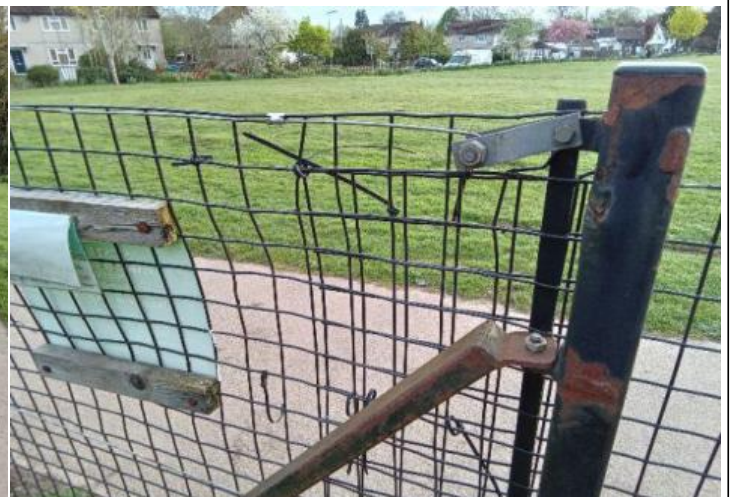
Risk Level: L - Low Risk
Surface: Grass

Finding: Cable ties have been used on the item and there are sharp projecting ends

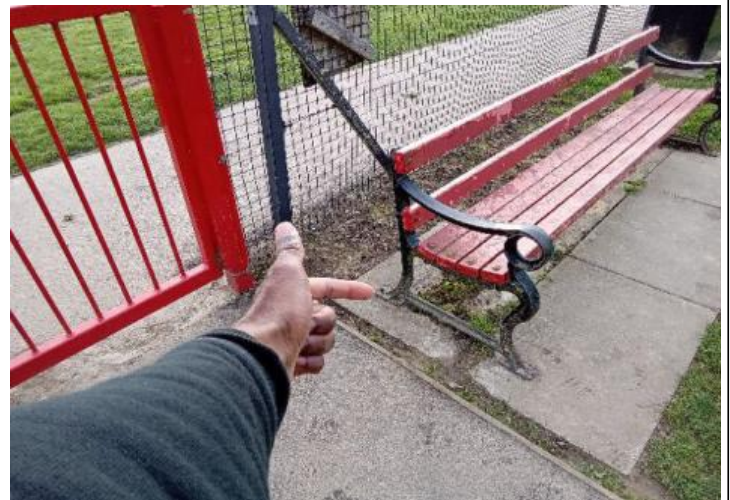
Risk Level: L - Low Risk
Surface: Paving Slabs

Finding: A number of fixing(s) have worked loose

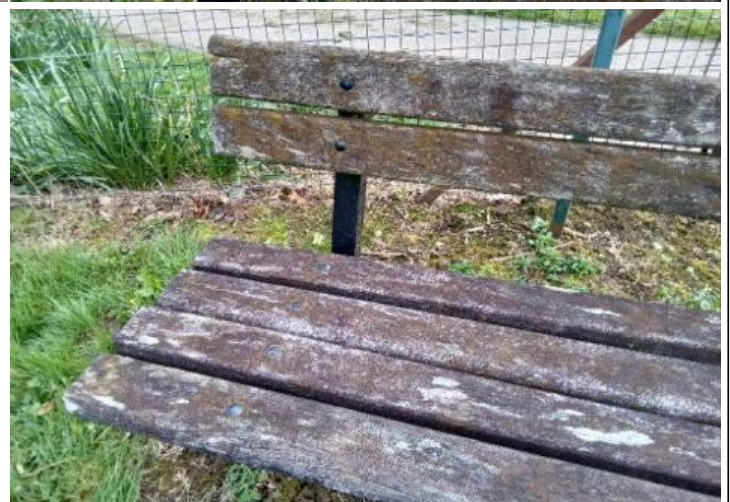
Risk Level: L - Low Risk
Surface: Grass

Finding: There is some evidence of rot in the timber

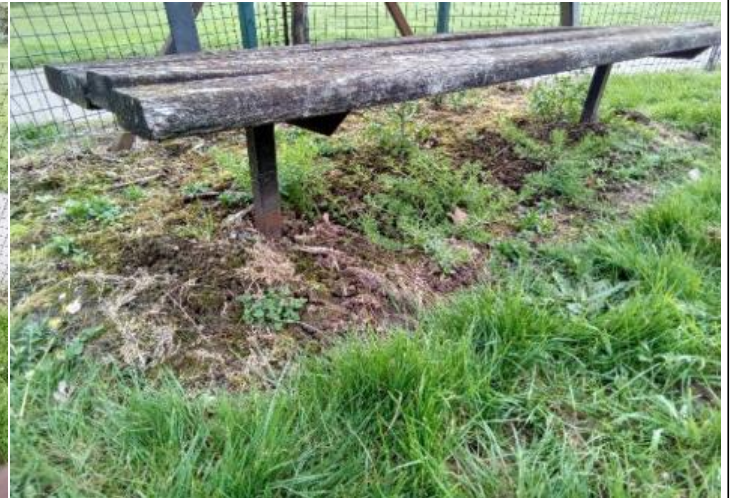
Risk Level: L - Low Risk
Surface: Grass

Finding: The item is slightly loose in its foundations

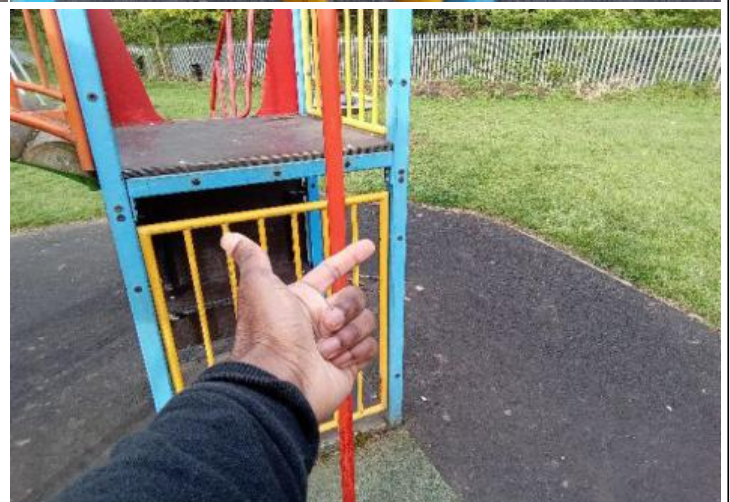
Risk Level: L - Low Risk
Surface: Wet Pour

Finding: Fixings are damaged and/or have sharp edges

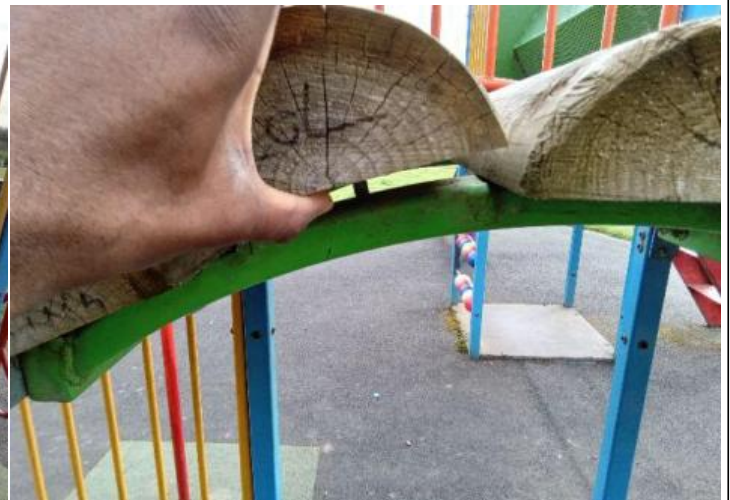
Risk Level: L - Low Risk
Surface: Wet Pour

Finding: There is or are fixings missing on the item

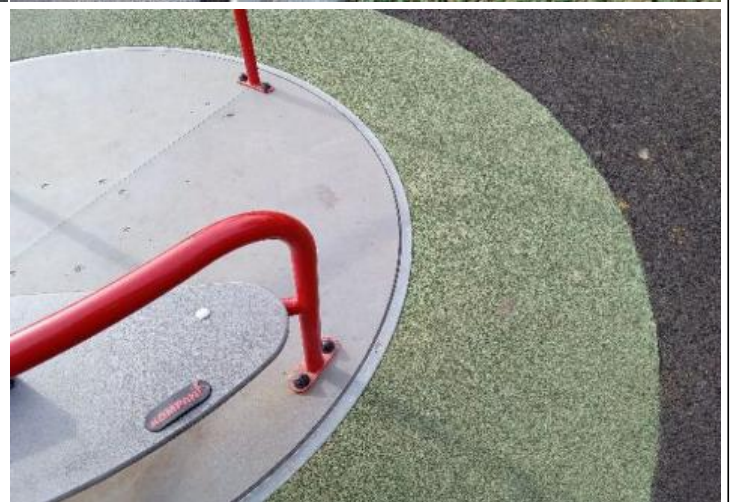
Risk Level: V - Very Low Risk
Surface: Wet Pour

Finding: Roundabout is snagging against outer edge causing difficulty in rotating

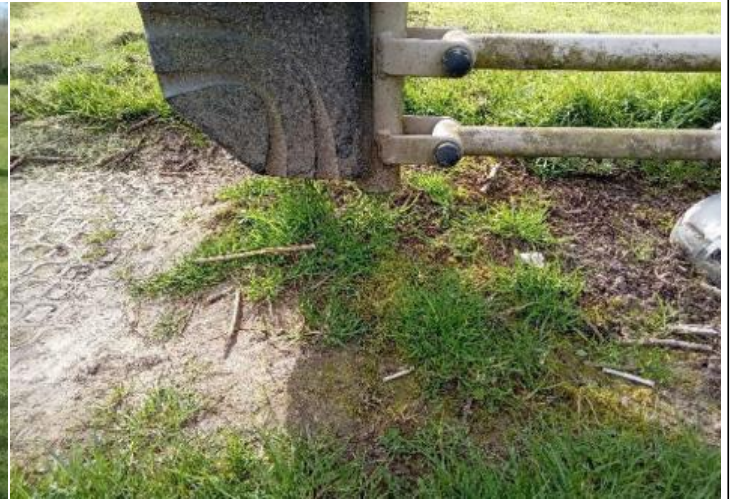
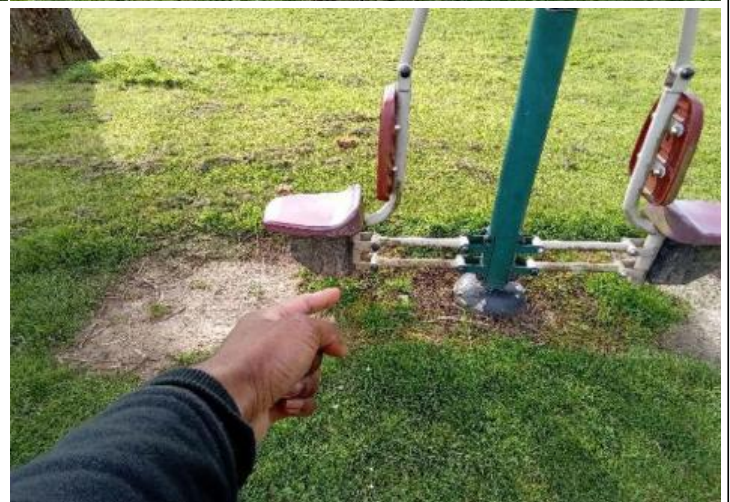
Risk Level: L - Low Risk
Surface: Grass Matrix Tiles

Finding: The distance between the underside of the item and the ground is less than the 60mm required by BS EN 16630

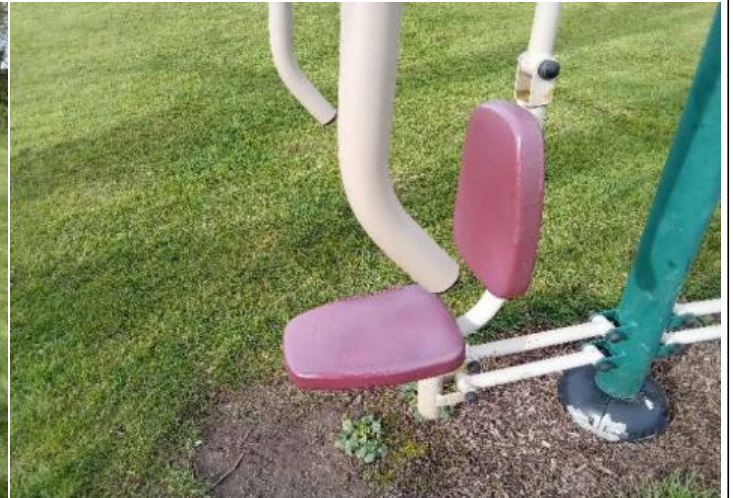
Risk Level: L - Low Risk
Surface: Grass Matrix Tiles

Finding: One or more handgrip(s) are damaged or missing. **Action:** Replace missing or damaged handgrips

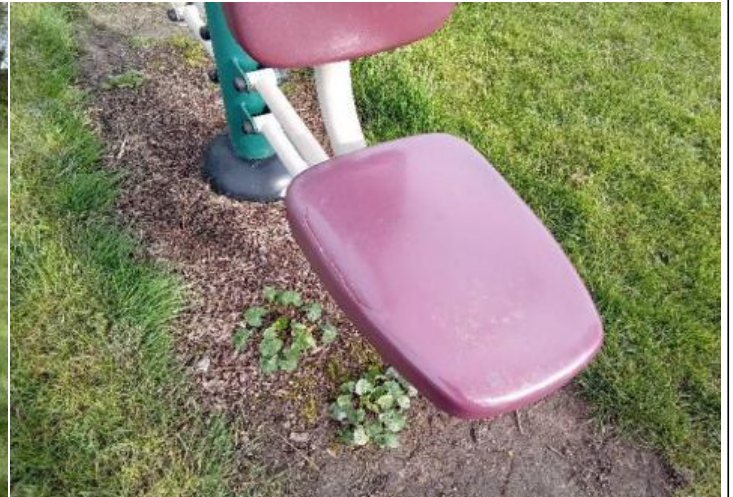
Risk Level: L - Low Risk
Surface: Grass Matrix Tiles

Finding: The seat has been damaged
