# Product Safety Evaluation

## KIR evaluation

PCM-CUSTOM 726038

## Annual Inspection

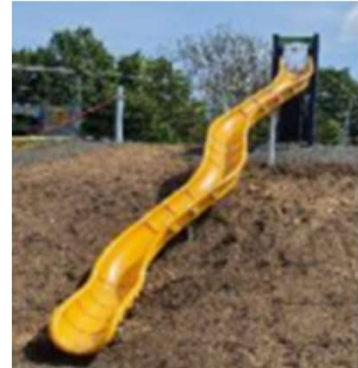
Two incidents reported on the same slide where children were suffering minor injuries as they were bumping from side to side in the turns of the slide.

We generally recommend this type of slide for children aged 4 years and more. This is due to the bumps related to the turns. We know that children will bump into the sides when the direction is changed and the younger and thereby smaller the child is the heavier impact the turns will have.

For the time being we will not initiate any action in line of product modification, but we will as always keep the report for future references.

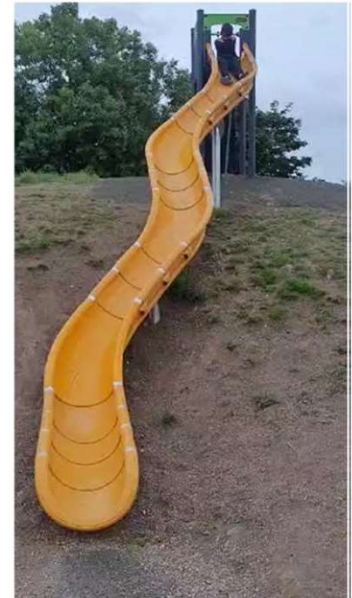
Whilst going down the slide on the hill – [redacted] leg got stuck on the bend of the slide which twisted [redacted] leg and bent [redacted] foot forward. This resulted in [redacted] breaking [redacted] left tibia bone. [redacted] Auntie also went down the slide and received friction burns along both arms. We also passed another Mum who had just come back from receiving first aid from the local café for burns her 2 daughters had got from the slide.

Used the yellow slide once. It was faster than expected. Hit his head on bottom bend and flew off end of slide.  
Bumped head on side of slide near bottom. Cut corner of his eye lid.

As we understand the first reported injury, the [redacted] was sliding and [redacted] shoe was caught and the leg twisted. This is a very unfortunate situation almost impossible to prevent. When very young children are sliding they are not able to fill up the slide bed and they can easily tilt a little.

The incident from 25/10 seems very similar to the ones reported earlier. Bumping from side to side will happen on a slide with turns. In most cases it is not a problem, but sometimes it unfortunately leads to bruises or in this case a small wound.

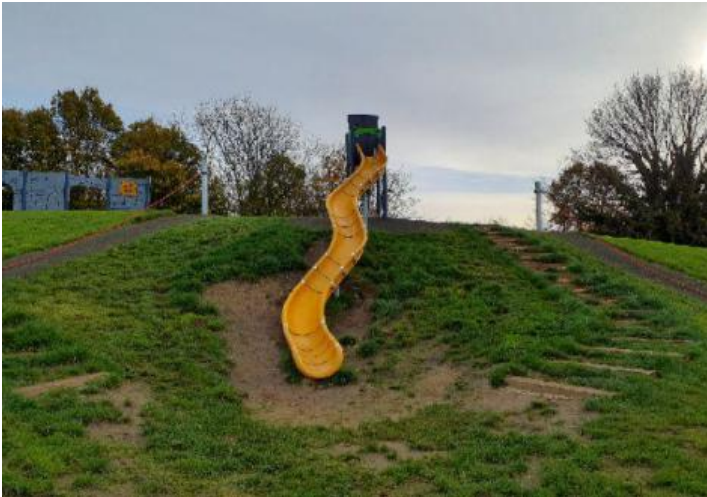
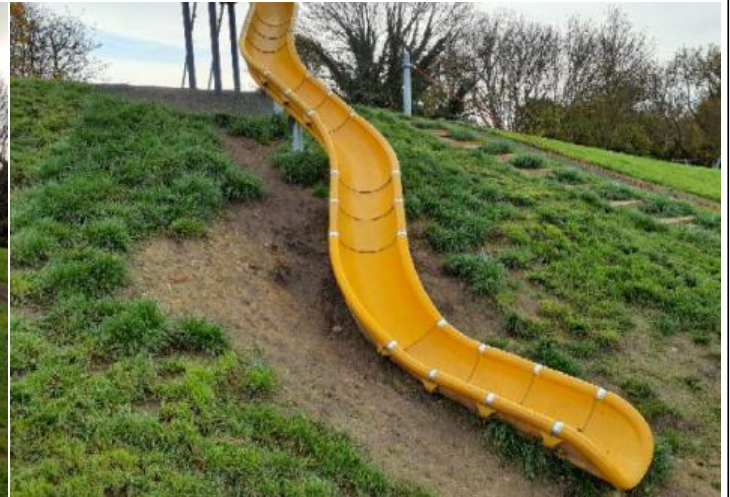
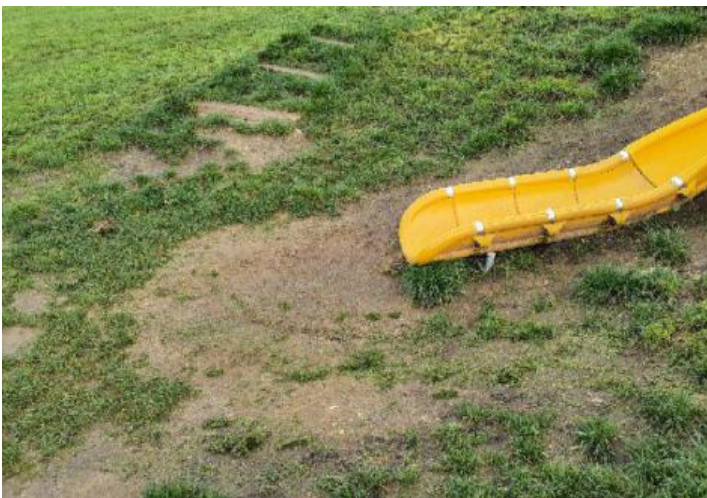
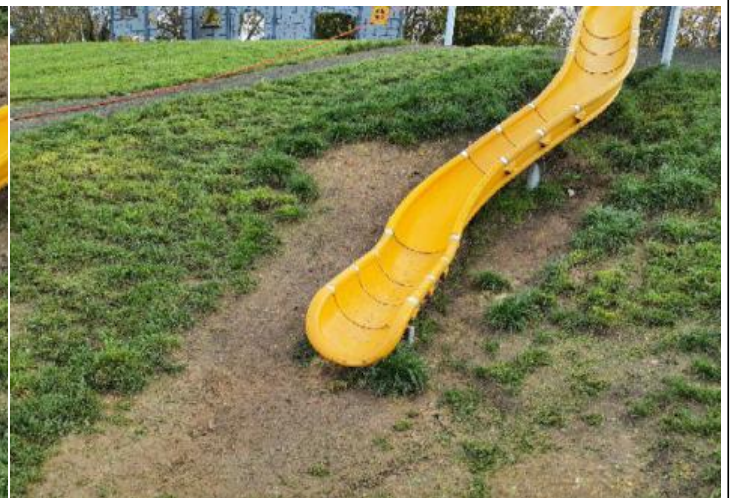
**i** 10 - Low Risk (Finding 1)

The grass has eroded within the impact area of the equipment and may not provide the necessary impact attenuating properties for the equipment fall height; the surface may also be slippery in wet weather - Reinstate the grass or provide an all weather surface

**Finding:** The grass has eroded within the impact area of the equipment and may not provide the necessary impact attenuating properties for the equipment fall height; the surface may also be slippery in wet weather  
**Action:** Reinststate the grass or provide an all weather surface

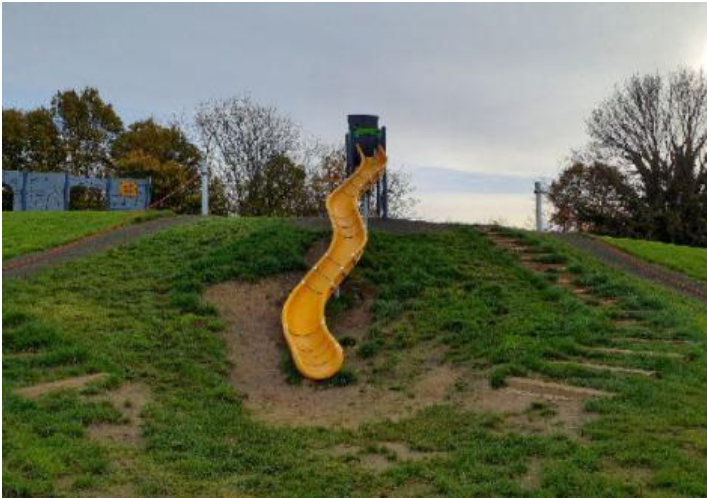
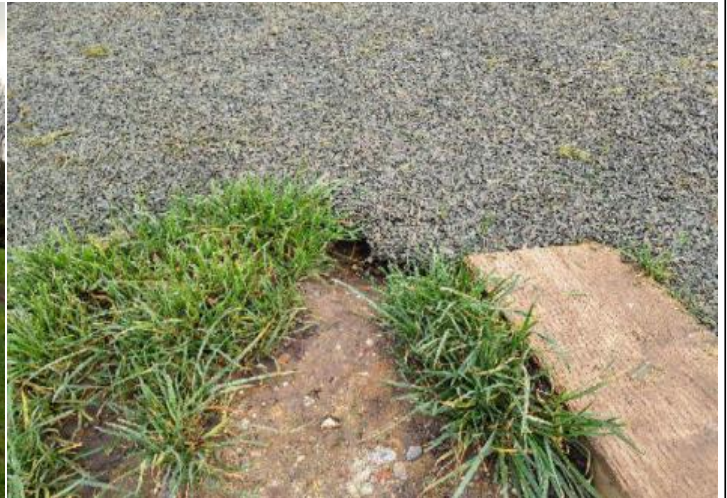
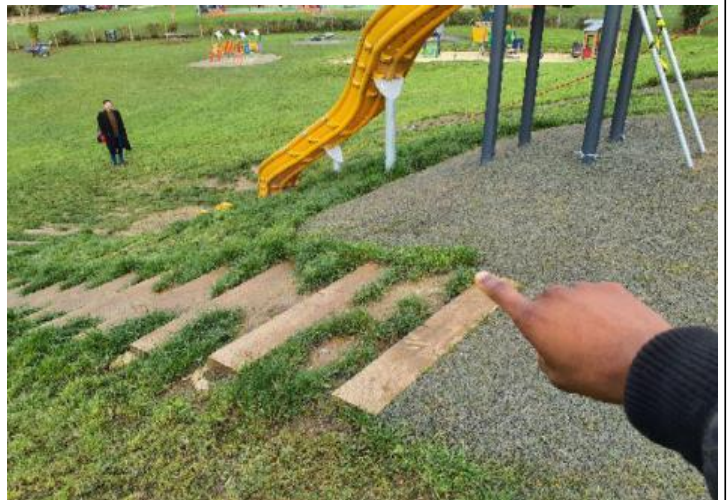
**i** 8 - Low Risk (Finding 2)

There are trip hazards at the edges of the surface - Remove trip hazard

**Finding:** There are trip hazards at the edges of the surface **Action:** Remove trip hazard

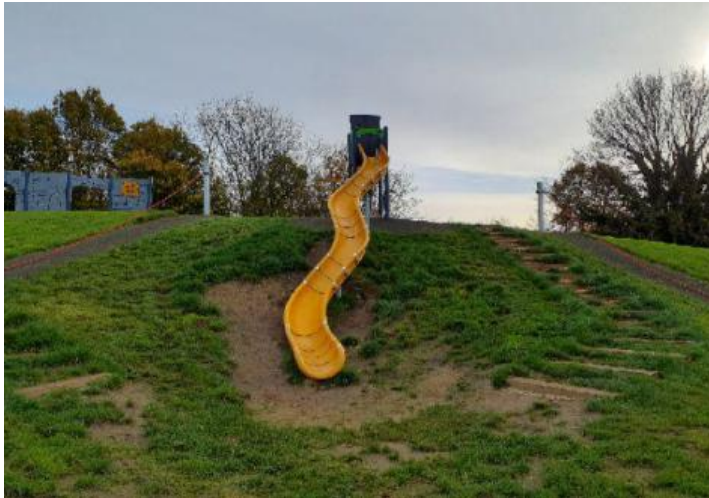
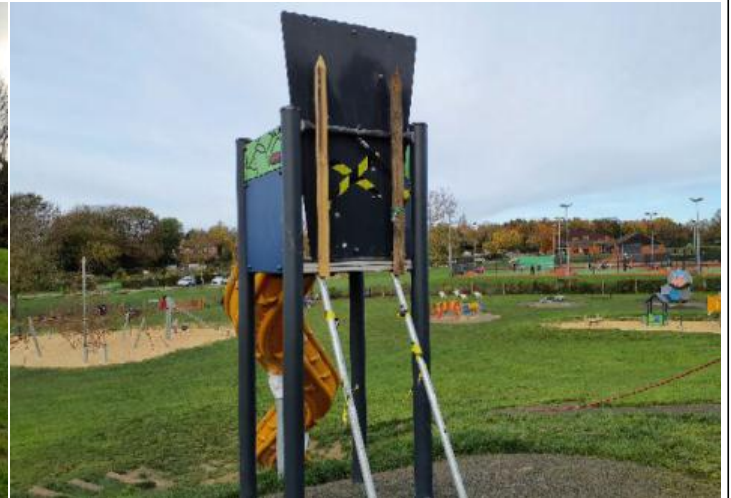
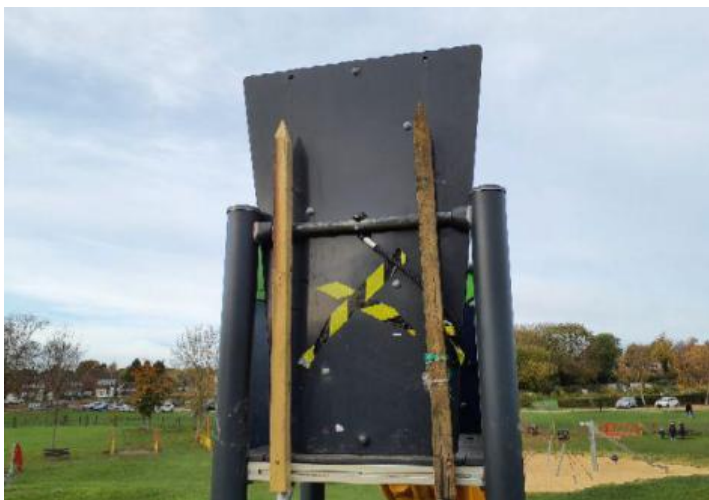
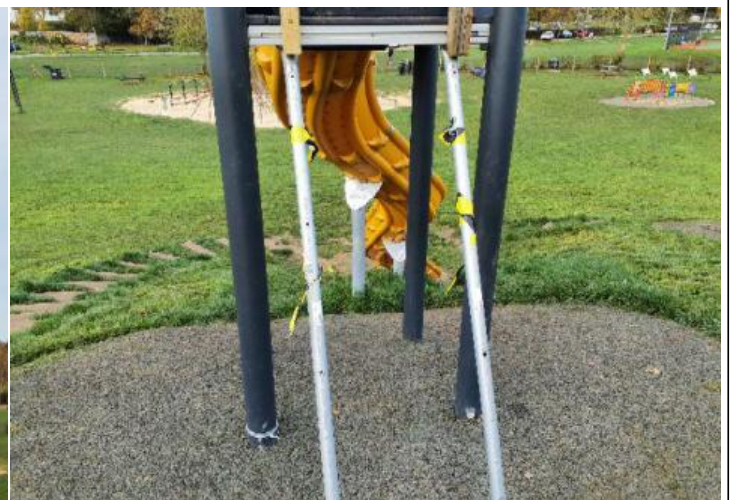
**i** 0 - Risk Assessment not Undertaken (Finding 3)

**Finding:** NOTE - The item has been isolated from use due to accidents that have occurred. The access element has been removed and a full inspection could not be undertaken of the platform / starting area

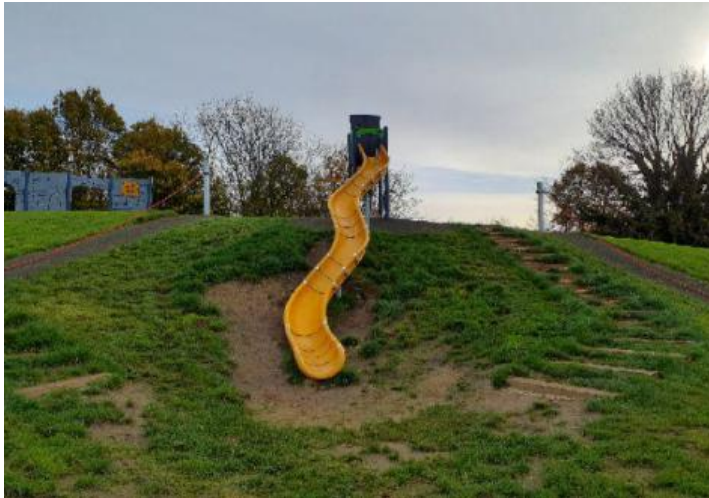
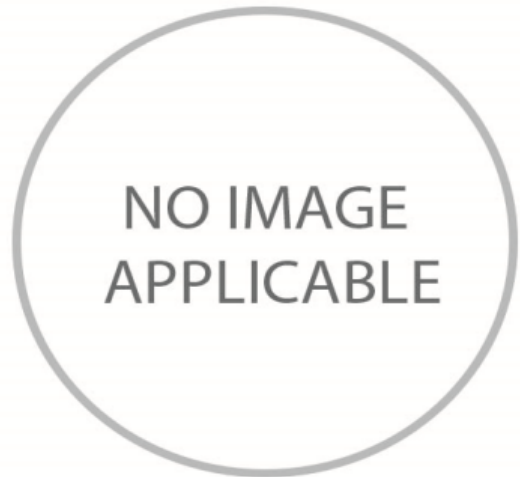
**i** 0 - Risk Assessment not Undertaken (Finding 4)

**Finding:** NOTE 2 - We understand that accidents have occurred on this slide, however the design of the slide itself appears to meet the requirements outlined in BS EN 1176 Part 3 (aside from potentially the eroded ground as previously mentioned). It should be noted that playgrounds are not risk free environments, and there is always a chance that accidents will occur. This subject is addressed in the Introduction to BS EN 1176 (a copy of the text can be provided if required).
