ST STEPHEN PARISH COUNCIL

You are summoned to attend the **Full Council Meeting**

Tree Condition Survey & Management Report

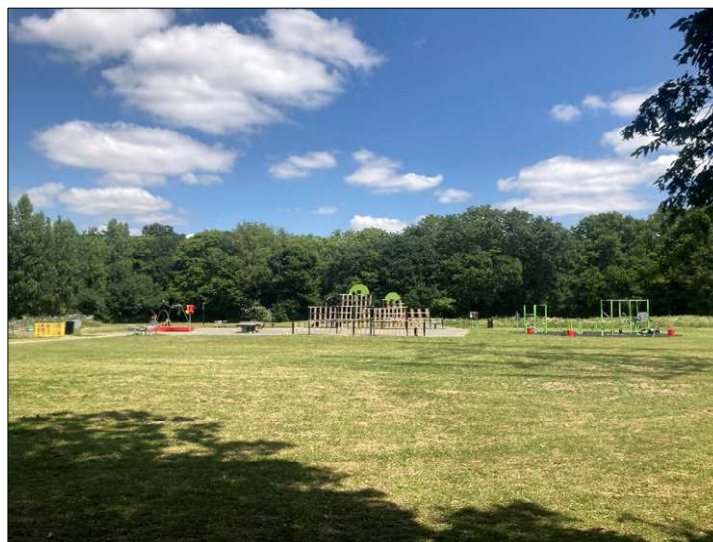
Figure 2: Image of the newly refurbished Woodbury Field play area surrounding by the mature woodland.

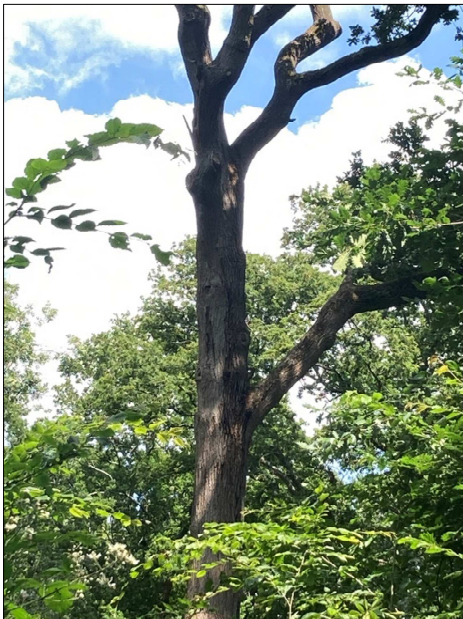
- 3.2.1 Phytophthora ramorum the casual organism responsible for Sudden Oak Death (SOD) was identified to be causing significant damage to Oak trees within Green Black Woods.

- 3.2.4 SOD is thought to be dispersed locally by rain splash, wind-driven rain or irrigation or ground water. Long distance spread may be by movement of contaminated plant material, growing media, and in soil carried on vehicles, machinery, footwear or animals.

Figure 3: Image of Oak within Green Black Woods exhibiting signs of decline attributed to SOD

- 3.2.5 For this reason I would recommend that all material either remains on site or alternatively is suitably disposed of.

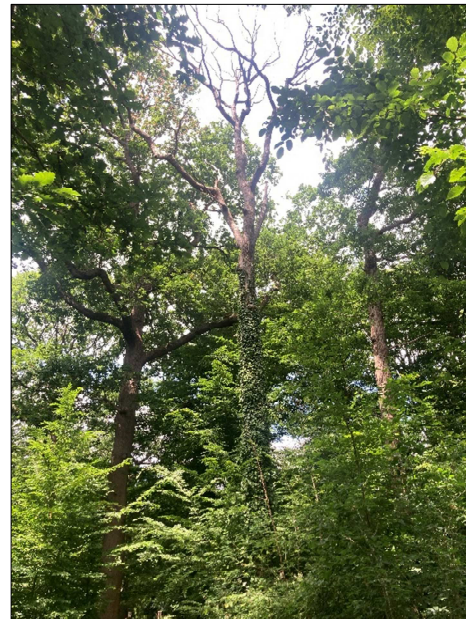
Figure 4: Image of dead standing Oak within Green Black Woods

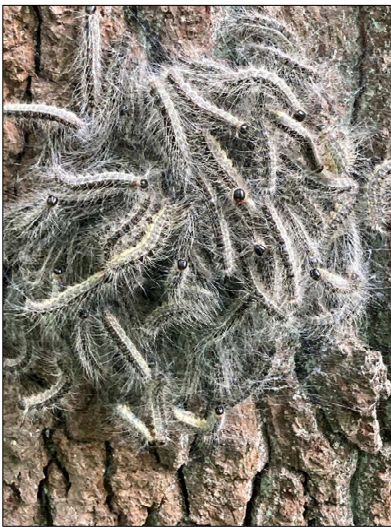
- 3.2.9 Oak Processionary Moth (OPM) has been identified on oak trees across several sites within the Parish, with notable infestations observed in the woodland areas of Greenwood Park, the adjoining North Close Play Area, and Green Wood Park.

- 3.2.11 In addition to its ecological impact, OPM poses a significant public health risk. The older larval stages (3rd to 6th instars) are covered in microscopic, barbed hairs containing a urticating toxin known as thaumetopoein. Contact with these hairs, or their inhalation, can cause dermatological and allergic reactions, including rashes, conjunctivitis, and respiratory irritation.

Figure 6: Image of Oak Processionary Moth caterpillars

- 3.2.12 To accurately assess the extent of the infestation and determine the precise locations of affected Oak trees and OPM nests within the Parish, it is recommended that a comprehensive survey be conducted. This will support an informed risk assessment and enable the planning and implementation of appropriate management and control measures where necessary.
- 3.2.13 With the survey I have noted the presence of OPM upon trees highlighted for additional works. To prevent putting the climbing operative at unnecessary exposure the nest must be dealt with prior to these works being carried out. Please note only trained and certified professionals should undertake any control or removal measures.

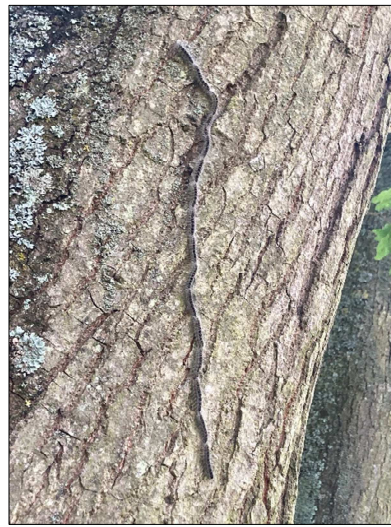
Figure 7: Image of caterpillars on main stem
