ST STEPHEN PARISH COUNCIL

You are summoned to the Fixed Assets Committee meeting

AGENDA

| 2526/AC/013 | To receive Annual Play Inspection Reports. Reports attached. |

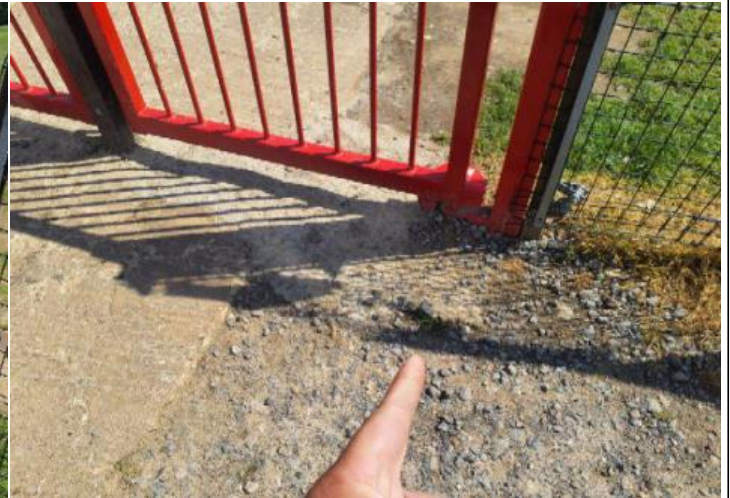
Finding: There are trip hazards at the edges of the surface **Action:** Remove trip hazard

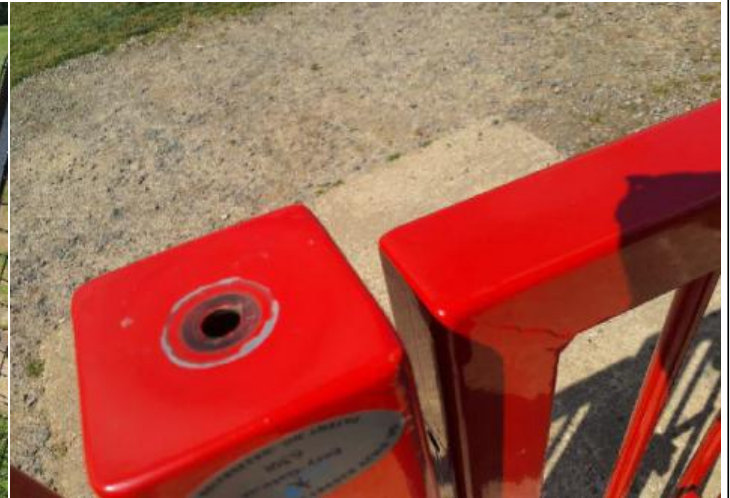
Finding: The gate latch is damaged or missing

Action: Repair or replace

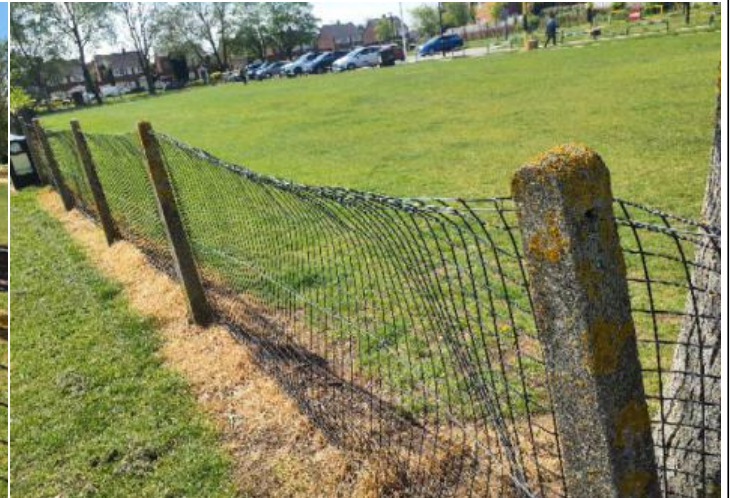
Finding: There is some damage to the fence sections

Action: Monitor for any further deterioration and repair as required

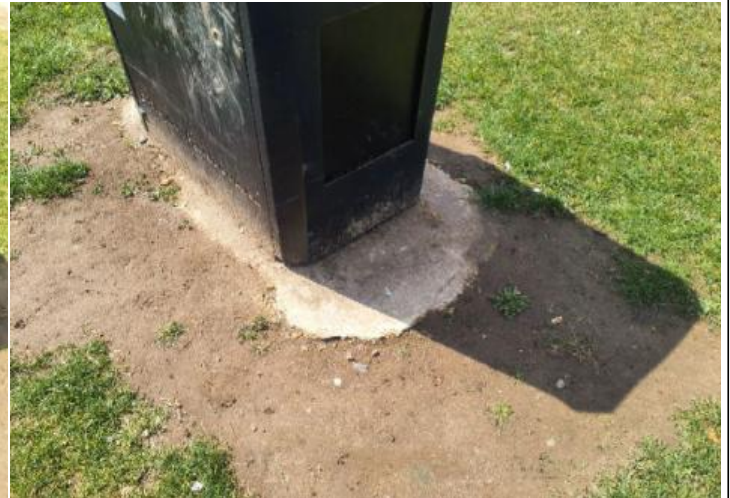
Finding: The surface has eroded and the foundations are exposed

Action: Reinstate surrounding surfaces to cover the foundations

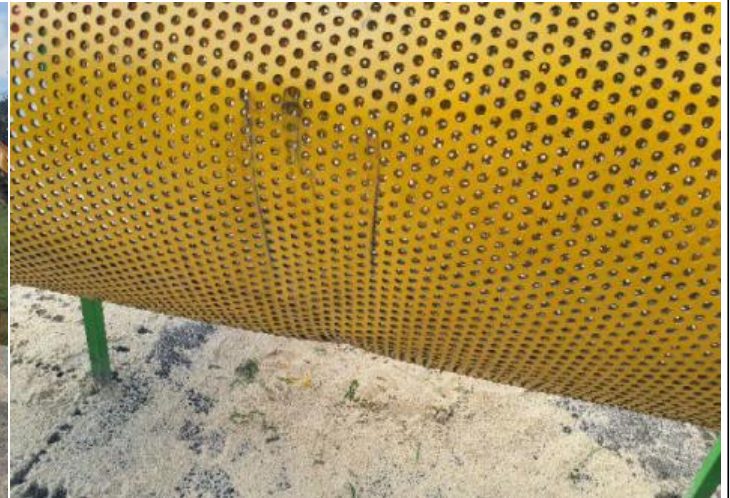
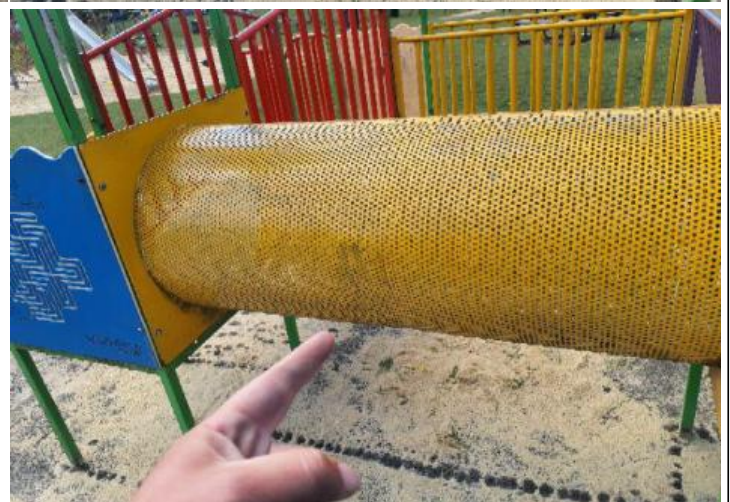
Finding: The tunnel has been damaged

Action: Monitor for any further deterioration and replace as required

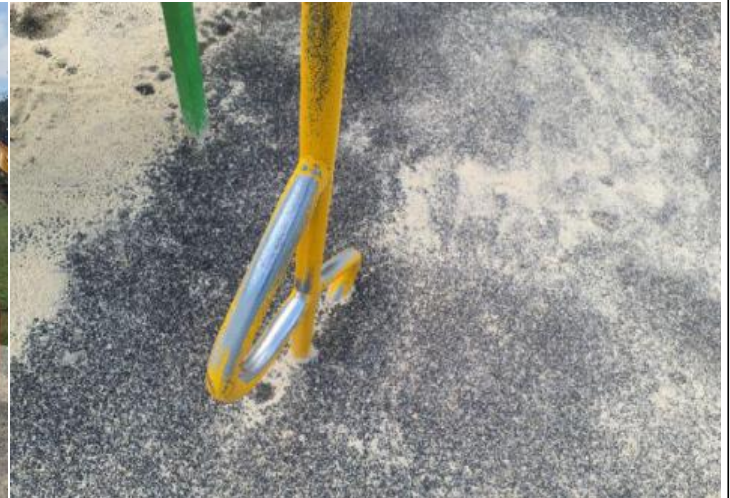
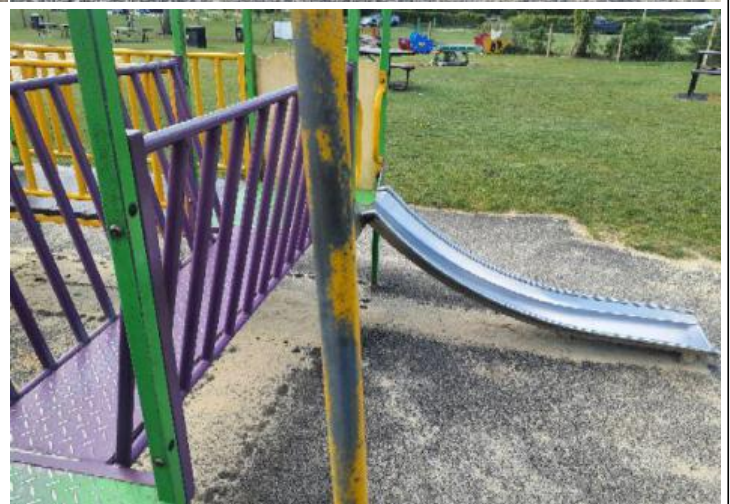
Finding: The paint has worn off the metalwork

Action: Rub down and re-paint

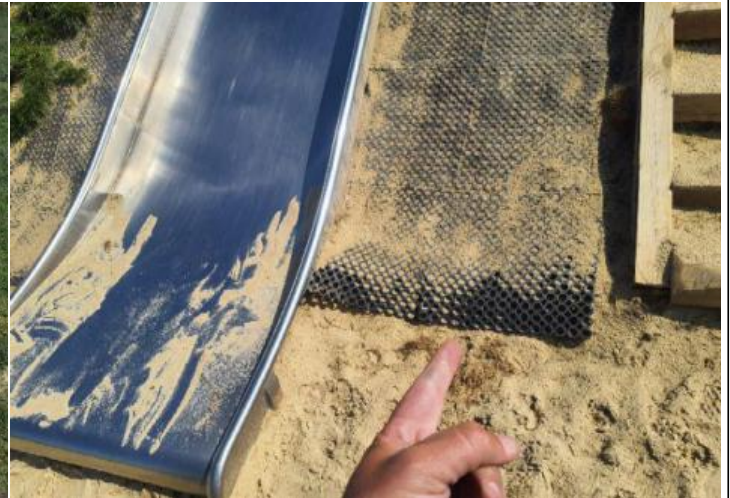
Finding: The edges of the grass mat surface are raised / lifting above the surrounding surface

Action: Tuck in or pin edges of grass mats as per the API Code of Practice to remove trip hazards

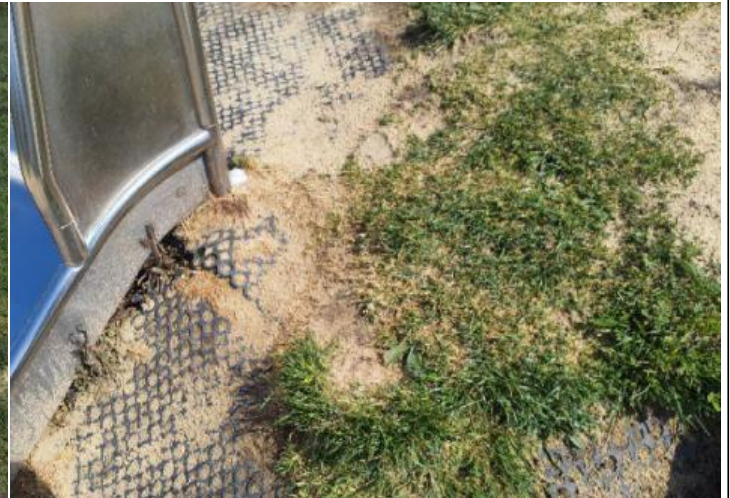
Finding: There are gaps opening in between the tiles

Action: Monitor for any further deterioration and repair as required

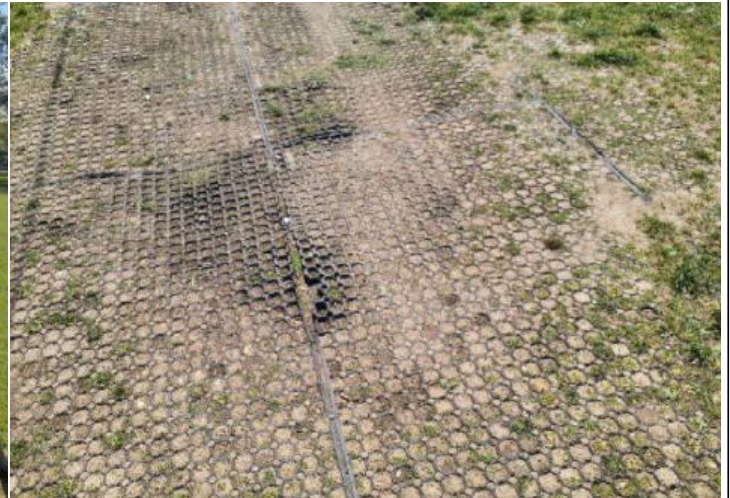
Finding: There is moderate damage to the surface

Action: Repair the damaged areas of surfacing

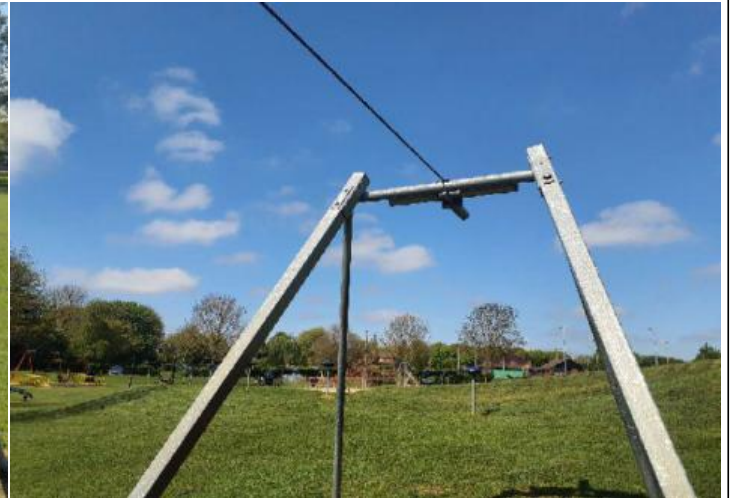
Finding: We have completed a visual inspection of the suspension links, cable and fixing points from ground level, however it is not possible to fully inspect these areas without either hiring equipment to gain access or removing the cable and suspension and inspecting at ground level. We recommend that the main cable and fixing security is thoroughly inspected at least in accordance with the manufacturers recommendations to check for wear, damage, security or internal rusting; this will help to ensure the continued safe use of the equipment

Action: Inspect in accordance with the manufacturers recommendations

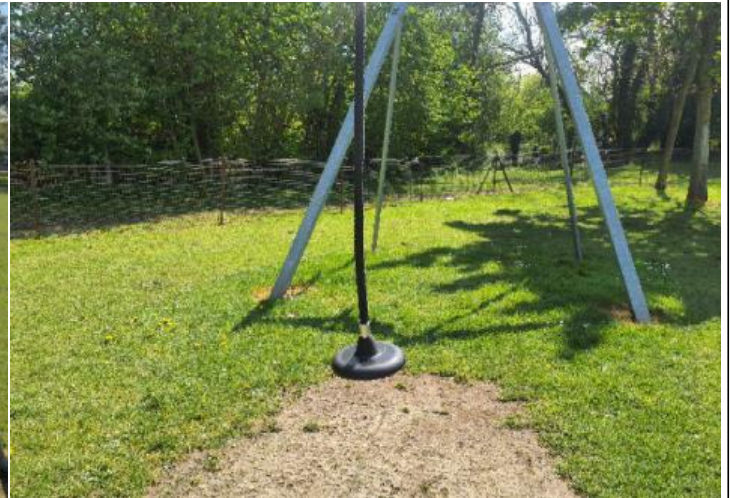
Finding: The seat connection cannot be inspected without dismantling the seat

Action: Dismantle the seat to inspect the seat connection for wear

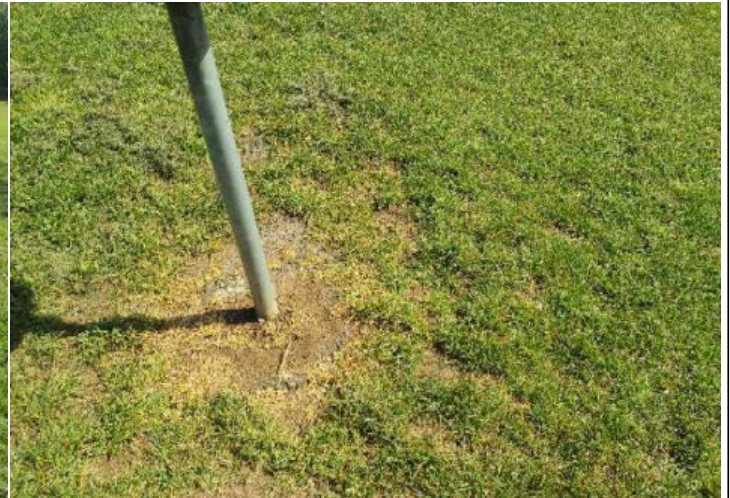
Finding: There is moderate damage to the grass matrix tile surface **Action:** Repair the damaged areas of surfacing

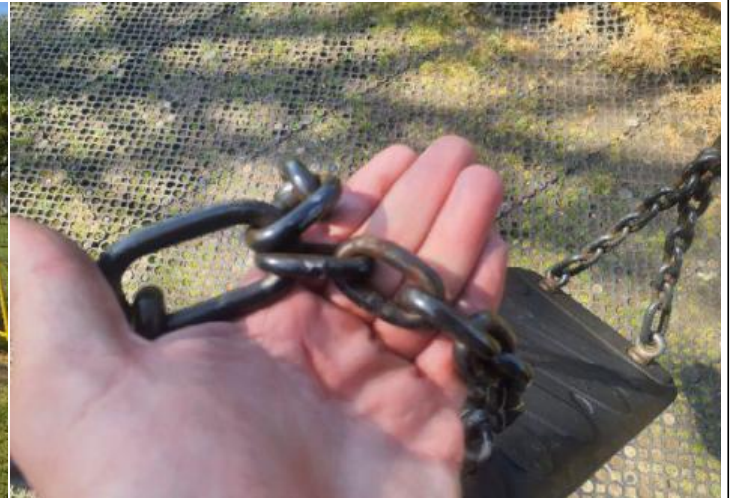
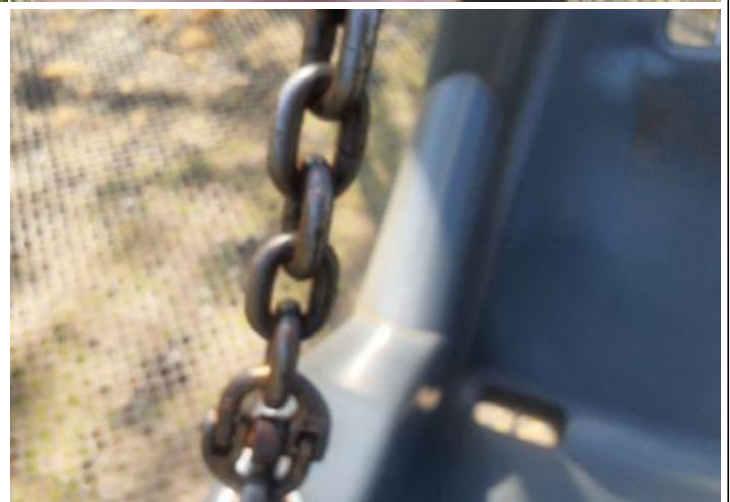
Finding: There is some notable evidence of chain wear

Action: Monitor for any further deterioration and replace when 40% worn

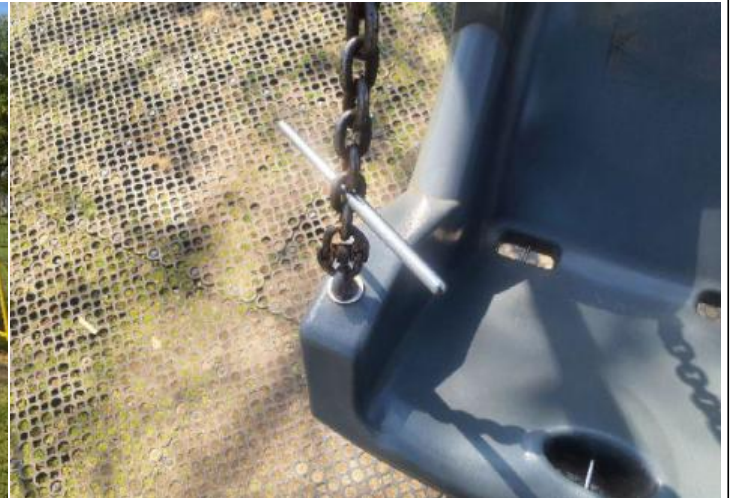
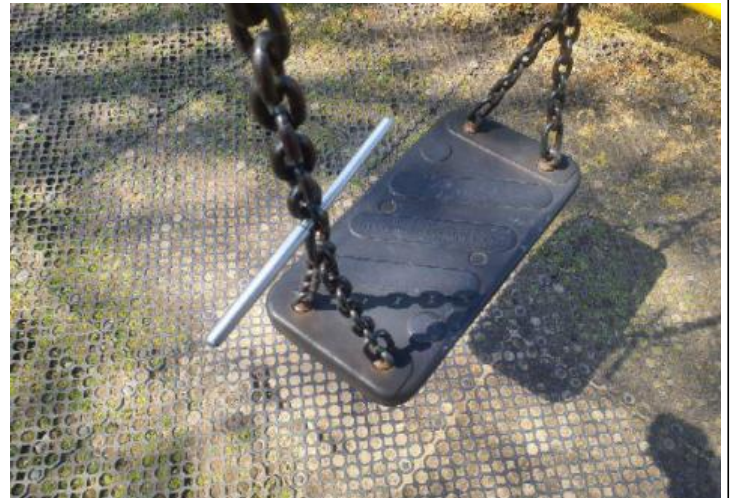
Finding: The chain openings are in excess of 8.6mm and do not meet the recommendations of BS EN 1176 Part 1

Action: Monitor - No action given the risk assessment

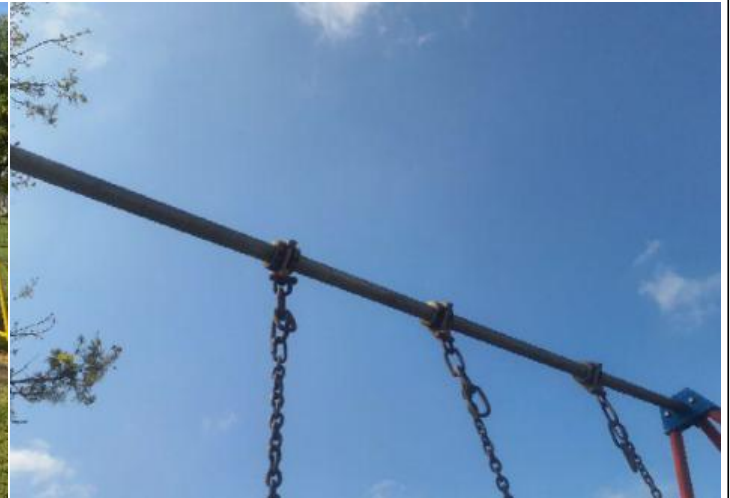
Finding: There is some wear to the shackles

Action: Monitor for any further deterioration and replace when 40% worn

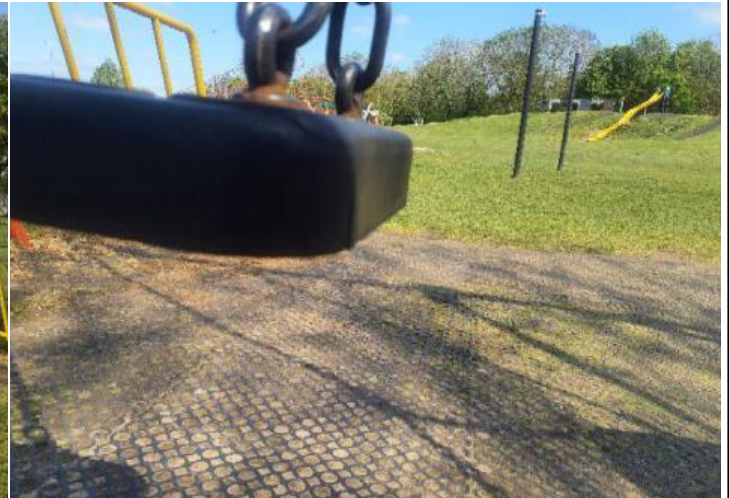
Finding: The seat has minor damage or wear

Action: Monitor for any further deterioration and replace as required

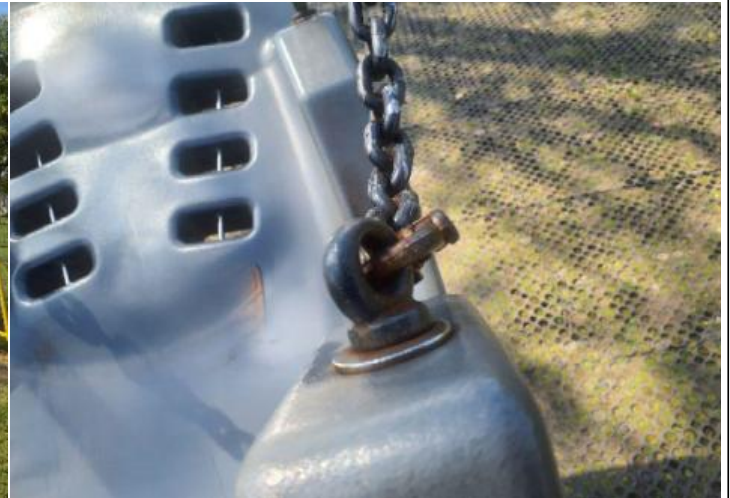
Finding: The swing seat connectors have some wear present

Action: Monitor for further deterioration and replace when 40% worn

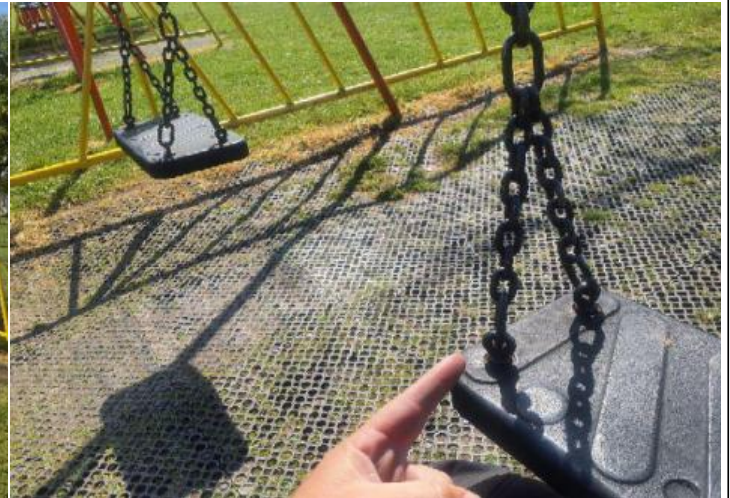
Finding: The swing seat connectors are loose

Action: Tighten to secure

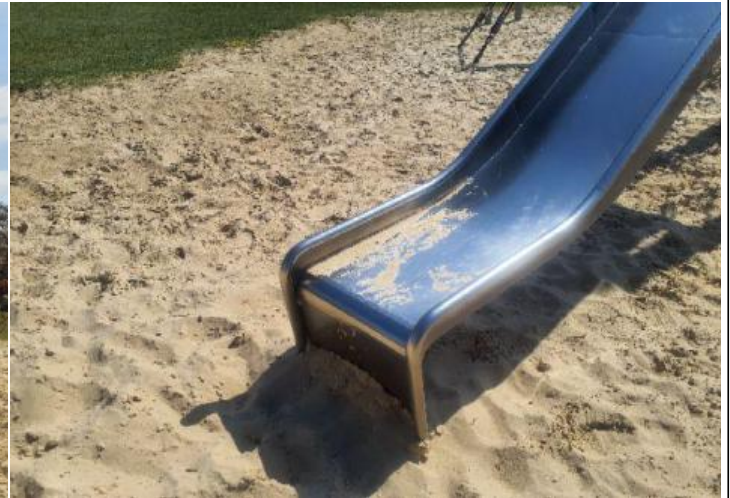
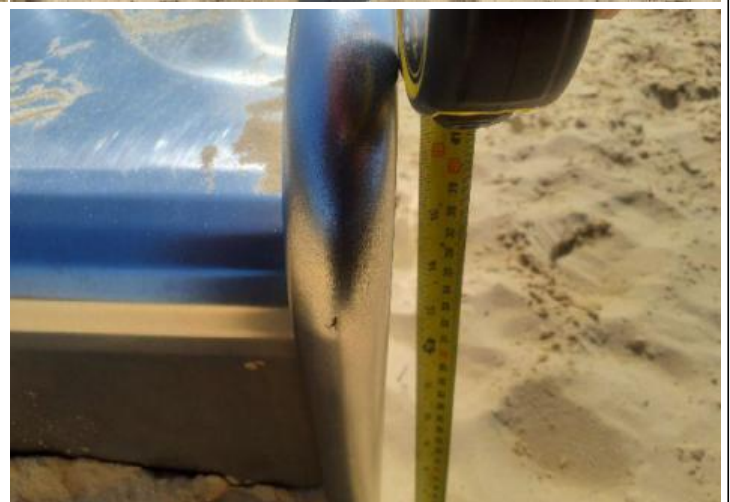
Finding: The height of the slide runout is in excess of 350mm and does not meet the requirements of BS EN 1176: levels Part 3

Action: Top up surrounding surfaces to recommended

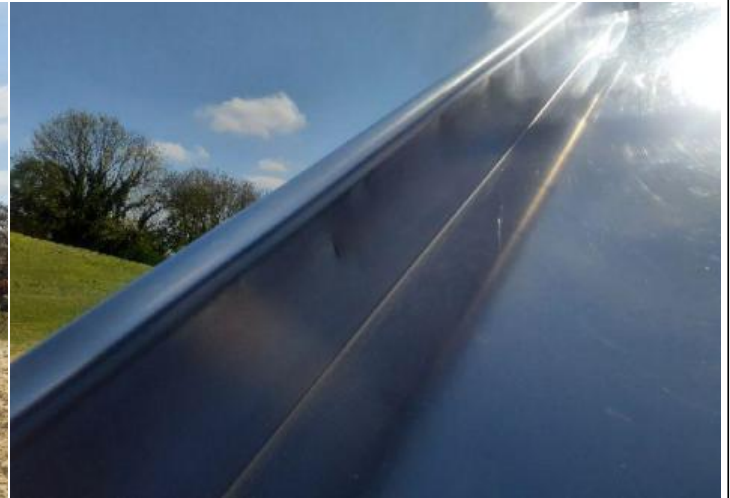
Finding: The side of the slide is damaged

Action: Monitor for any further deterioration and repair as required

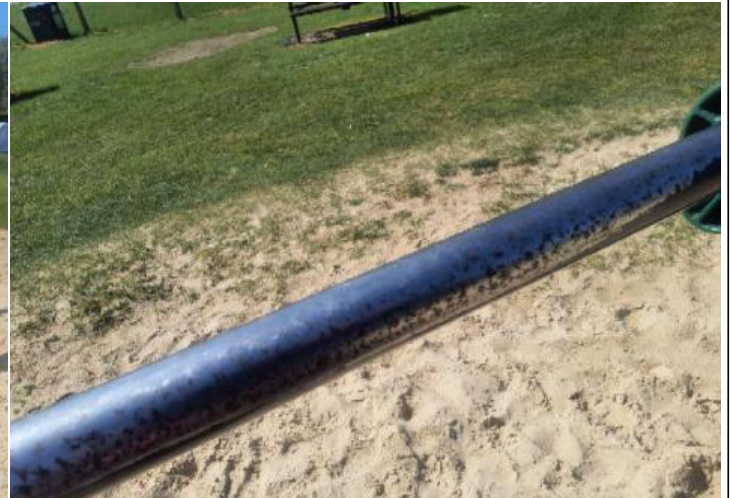
Finding: The paintwork on this item has been damaged or worn exposing the metal underneath which is rusting / corroding

Action: Treat affected areas and repaint

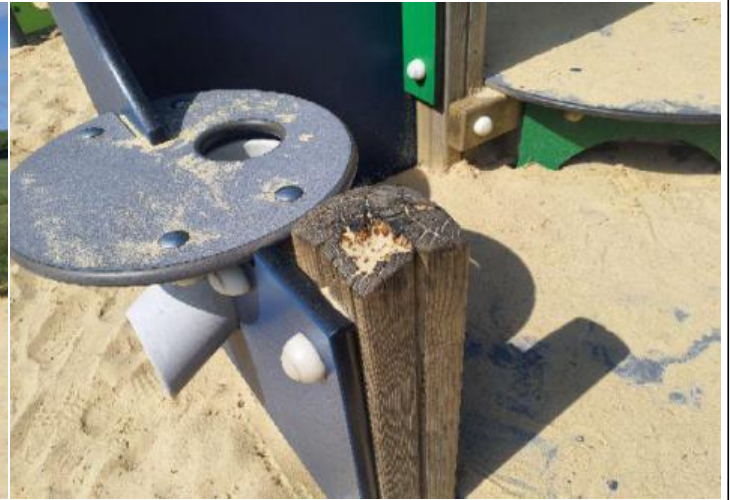
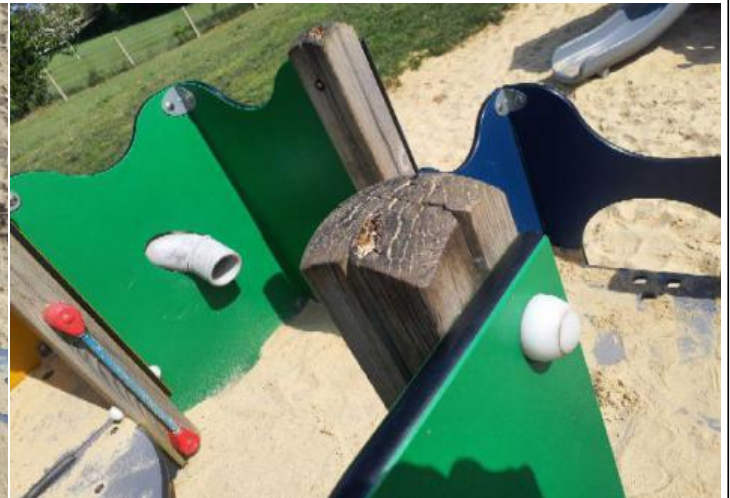
Finding: There is some evidence of rot in the timber posts

Action: Monitor for any further deterioration and replace as required

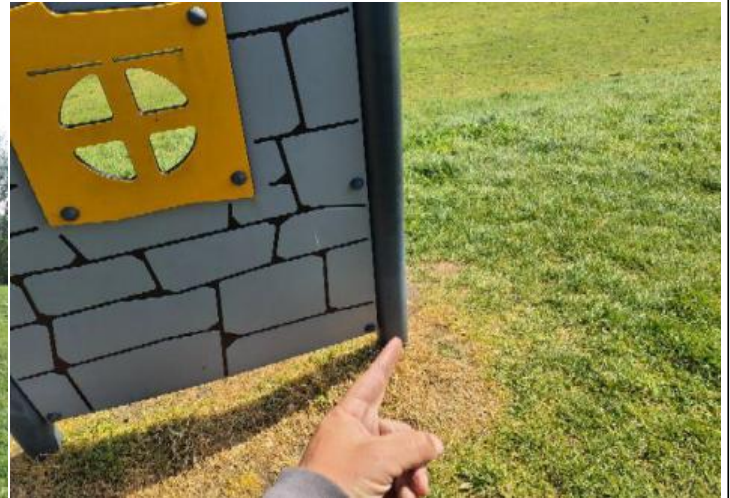
Finding: The item is slightly loose in its foundations

Action: Monitor for any further deterioration and repair as required

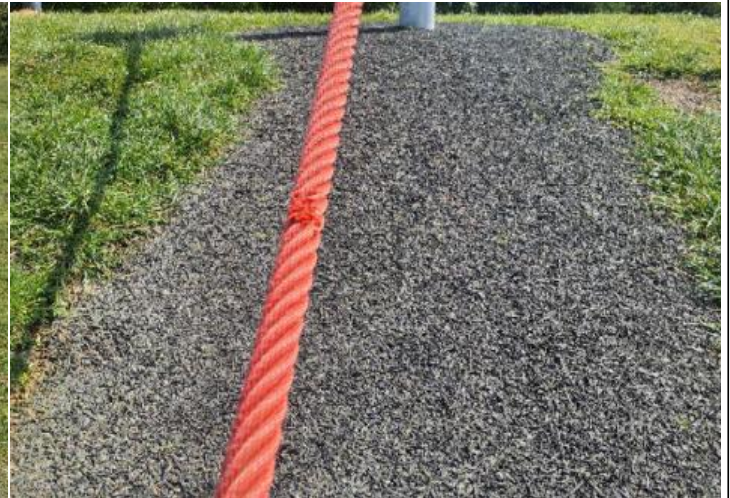
Finding: The ropes/nets are worn/damaged in places

Action: Monitor for any further deterioration and repair or replace as required

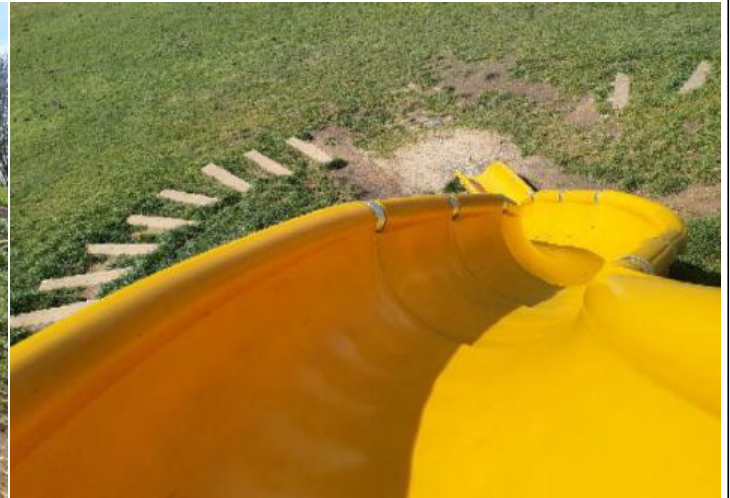
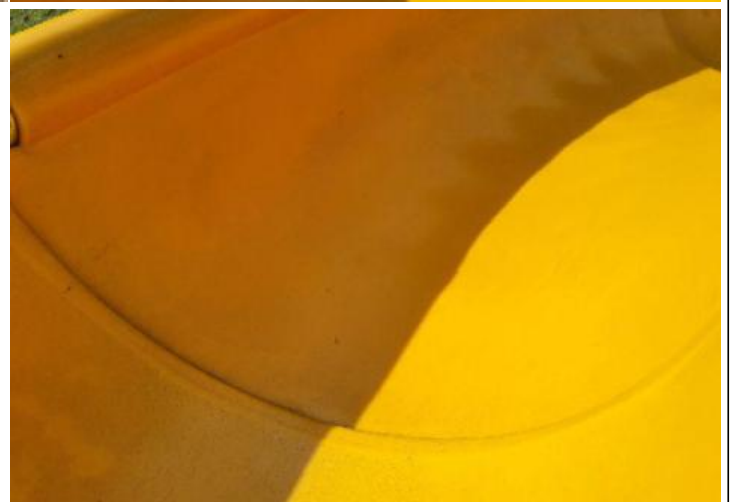
Finding: The slide surface has been damaged

Action: Monitor for any further deterioration and replace as required

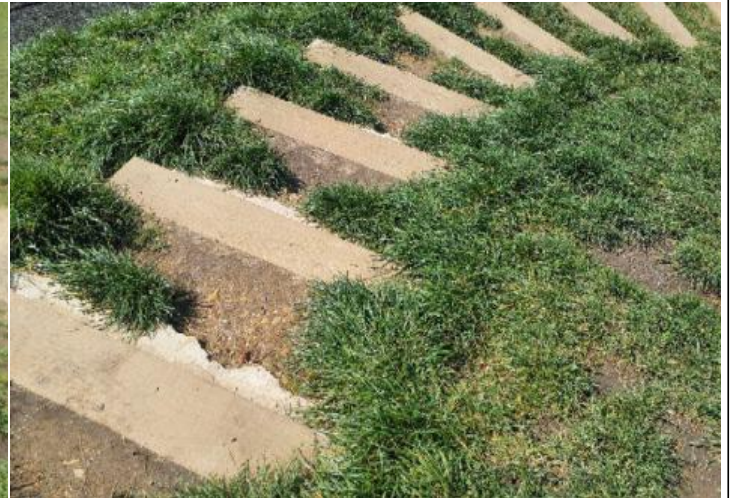
Finding: The grass is overgrown within the play area and may hide hazards

Action: Reduce the length of grass to an acceptable height and maintain

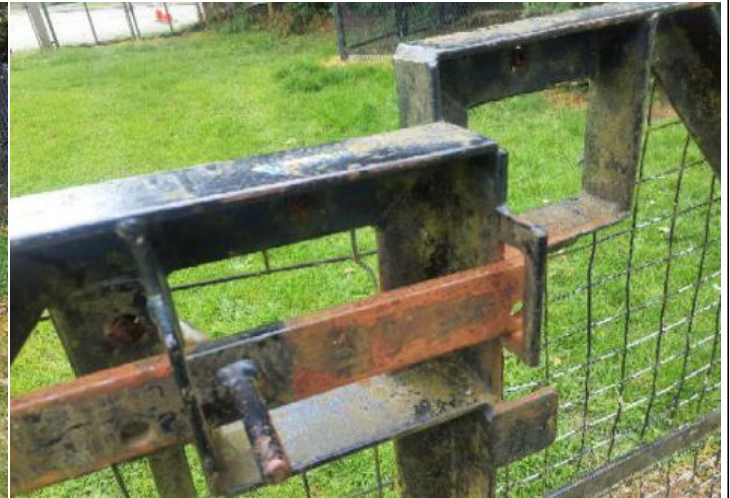
Finding: The paintwork on this item has been damaged or worn exposing the metal underneath which is rusting / corroding

Action: Treat affected areas and repaint

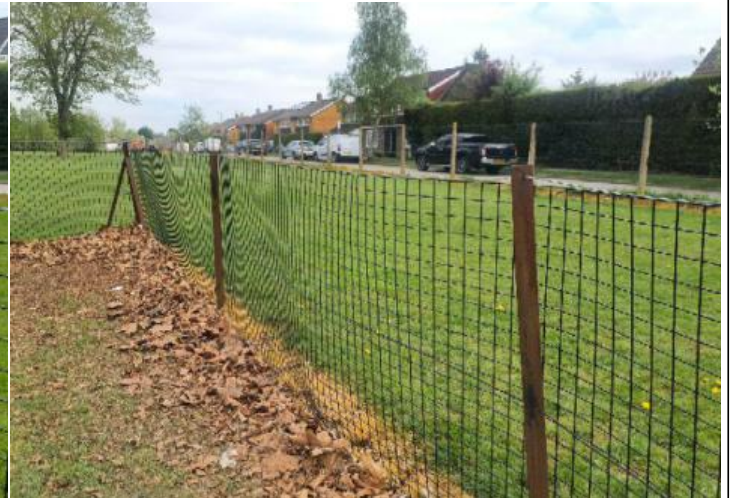
Finding: There are a number of loose posts around the fence

Action: Monitor for any further deterioration and reset as required

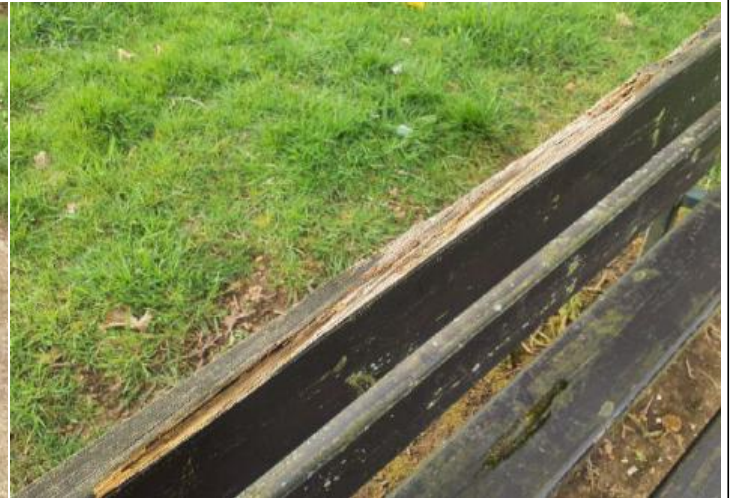
Finding: There are areas or parts of the timber on the structure that have rotted

Action: Replace all affected timbers

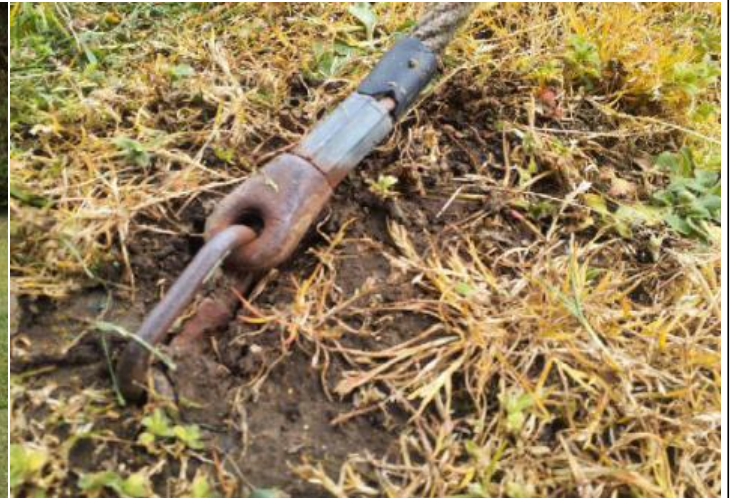
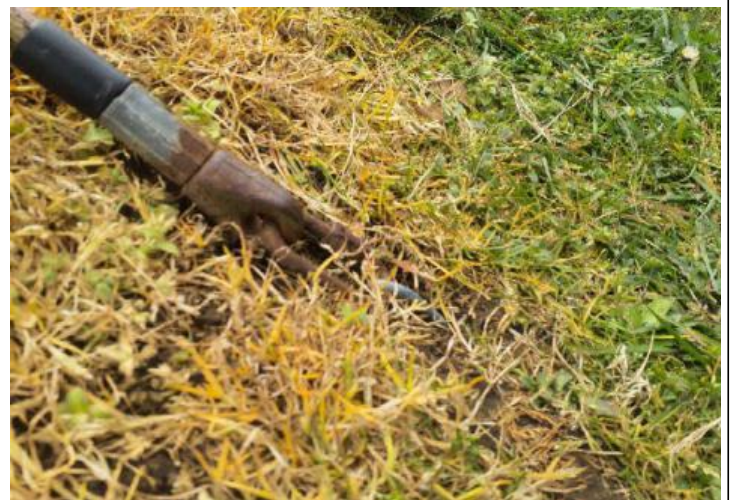
Finding: The shackles are worn in excess of 40% and require renewing

Action: Replace worn shackles

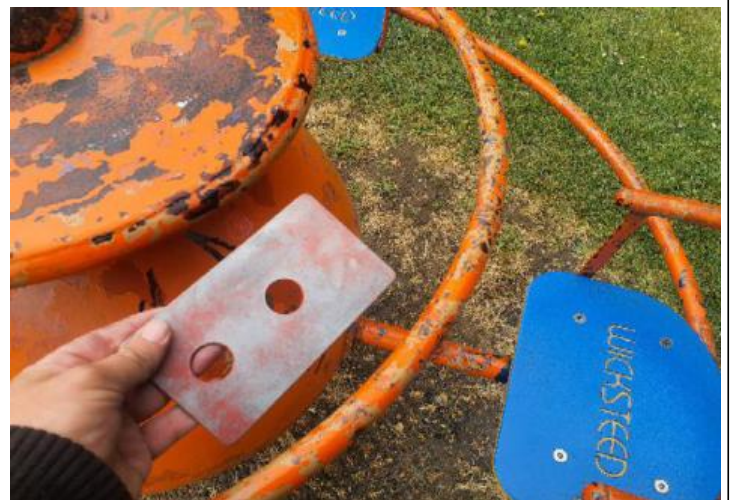
Finding: The item fails to meet the requirements of BS EN 1176 Part 1 4.2.7.2 for head and neck entrapment in the framework

Action: Monitor - No action given the risk assessment

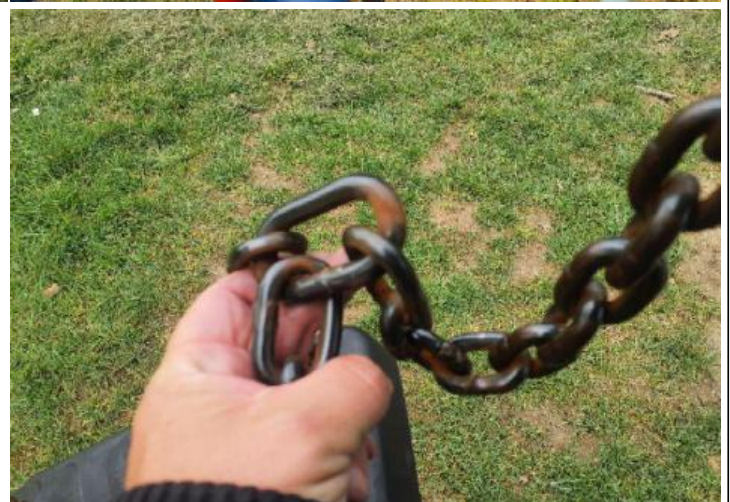
Finding: There is some notable evidence of chain wear

Action: Monitor for any further deterioration and replace when 40% worn

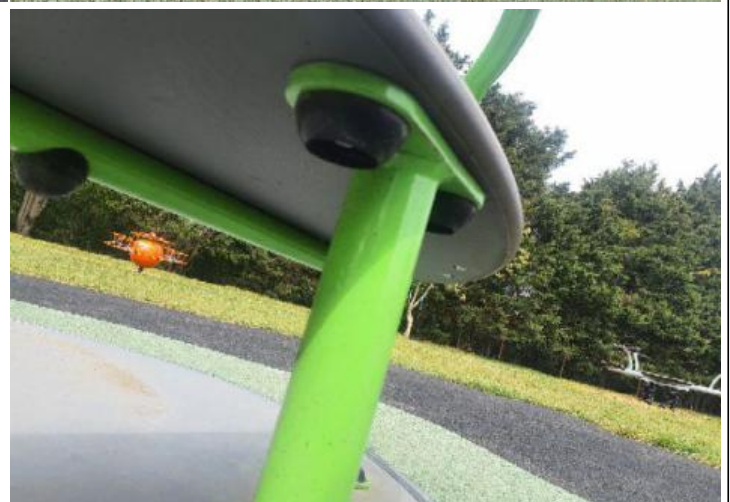
Finding: There is/are bolt cap covers missing or damaged on the item

Action: Replace missing or damaged bolt cap covers

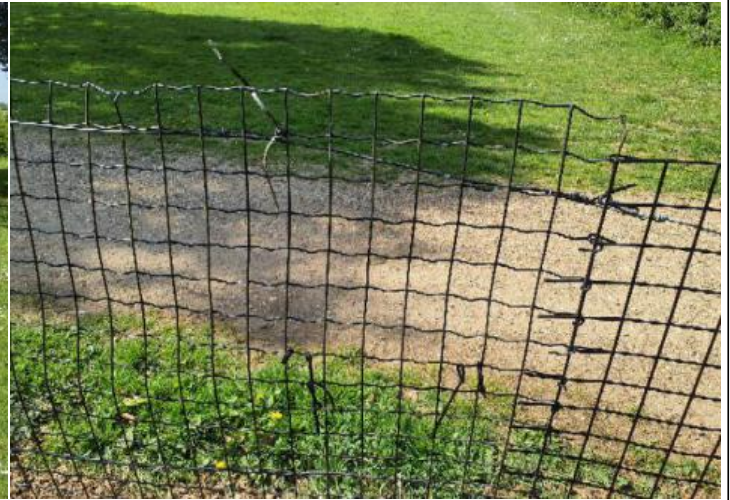
Finding: Cable ties are present and there are sharp projecting ends

Action: Replace with a more appropriate fixing method

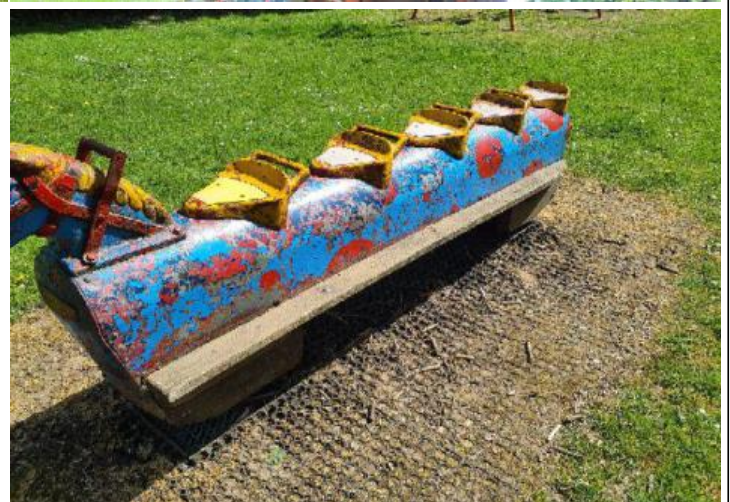
Finding: There is no gaiter protection for accessible moving parts (possible shear trap) as recommended in BS EN 1176 Part 1; 4.2.6 Moving Parts

Action: Monitor - No action given the risk assessment

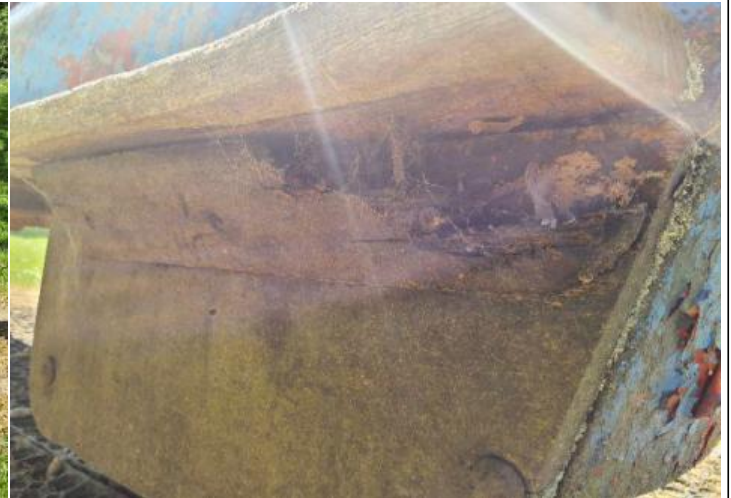
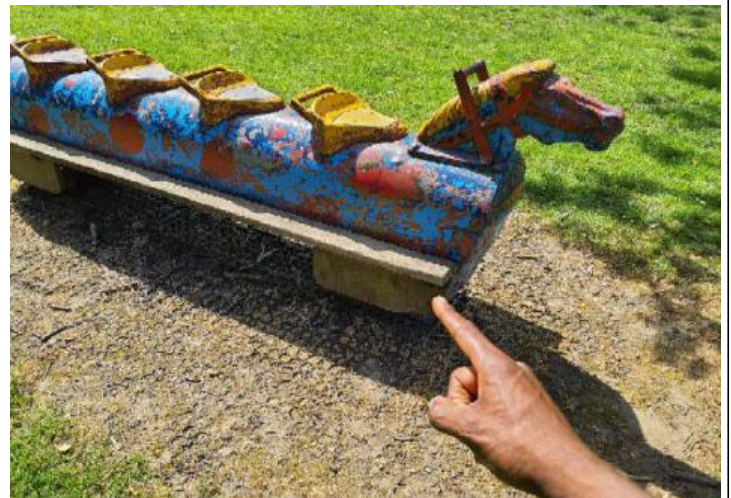
Finding: There are areas or parts of the timber on the structure that have rotted

Action: Replace all affected timbers

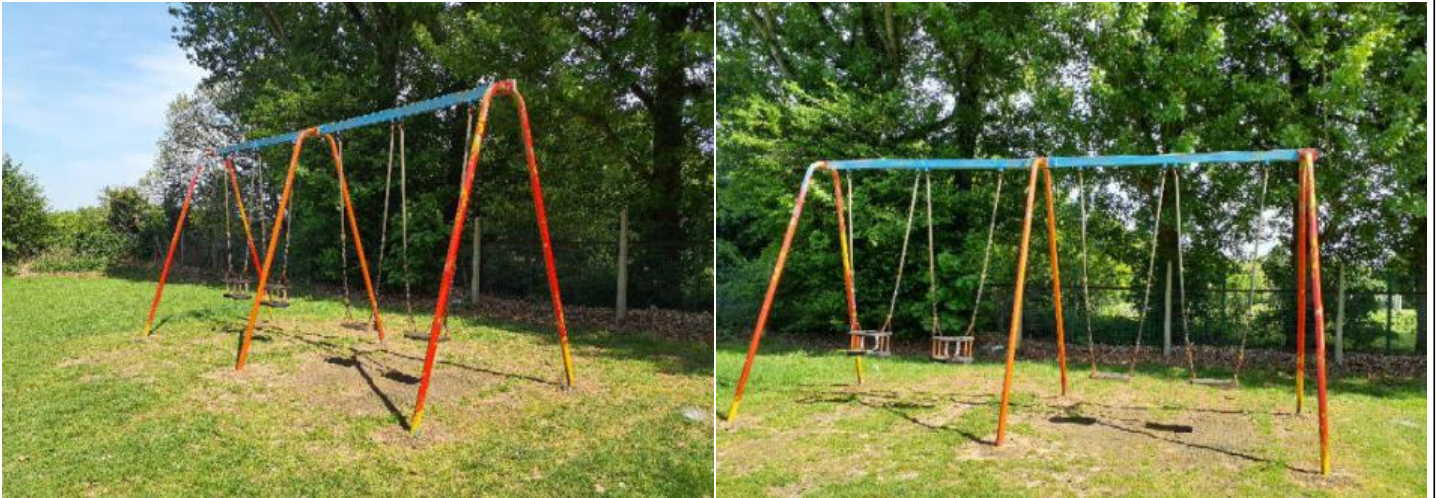
Finding: The fixings or components for this item were in excess of 2.5m above the standing surface and could not be fully accessed by the inspector. We have completed a visual inspection of the fixings from ground level but a maintenance inspection should be undertaken to assess the condition, security and wear of the components at intervals in accordance with the manufacturers recommendations.

Action: Inspect in accordance with the manufacturers recommendations

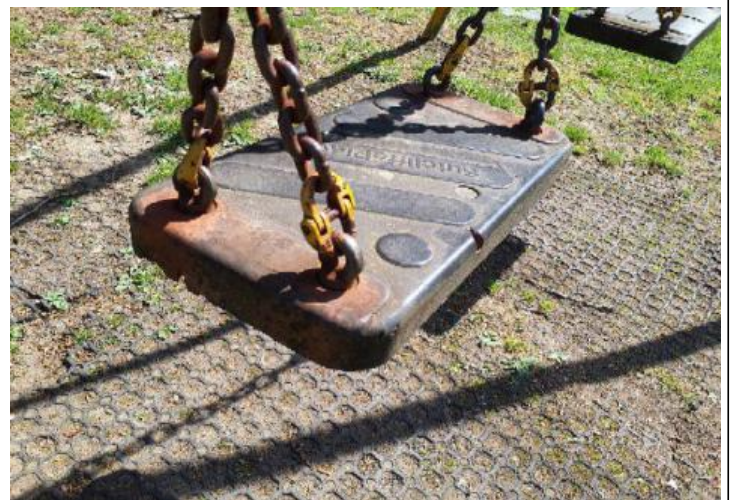
Finding: The seat has minor damage or wear

Action: Monitor for any further deterioration and replace as required

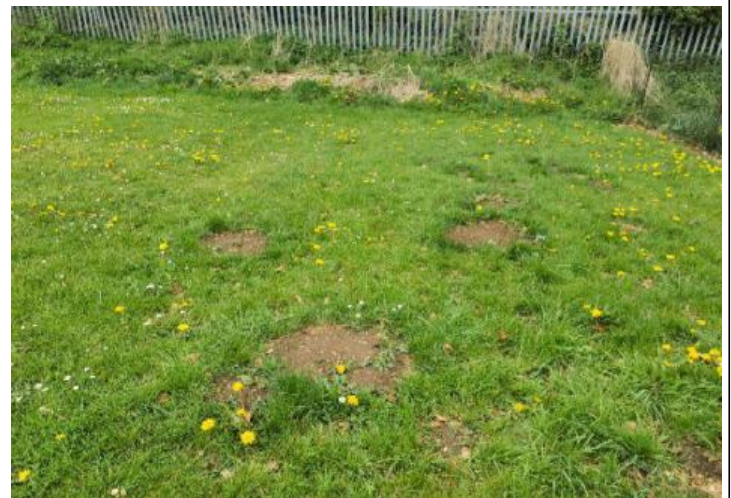
Finding: There are a number of molehills within the area and these may present unforeseen hazards for users

Action: Remove moles by appropriate means, reinstate surfaces to level and maintain the area

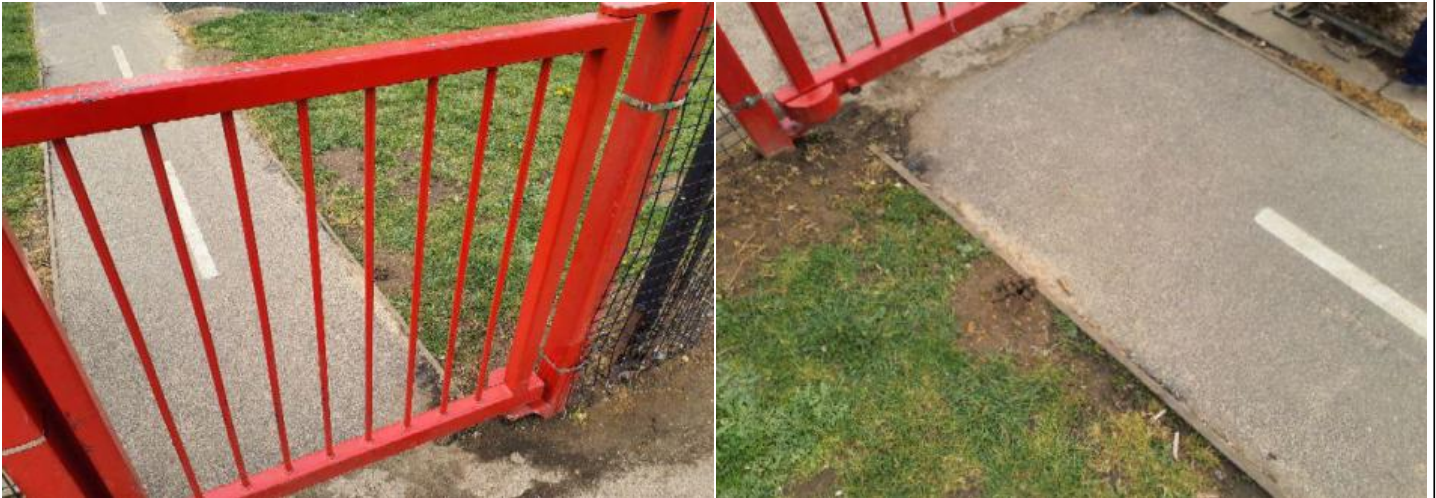
Finding: There are trip hazards at the edges of the surface **Action:** Remove trip hazard

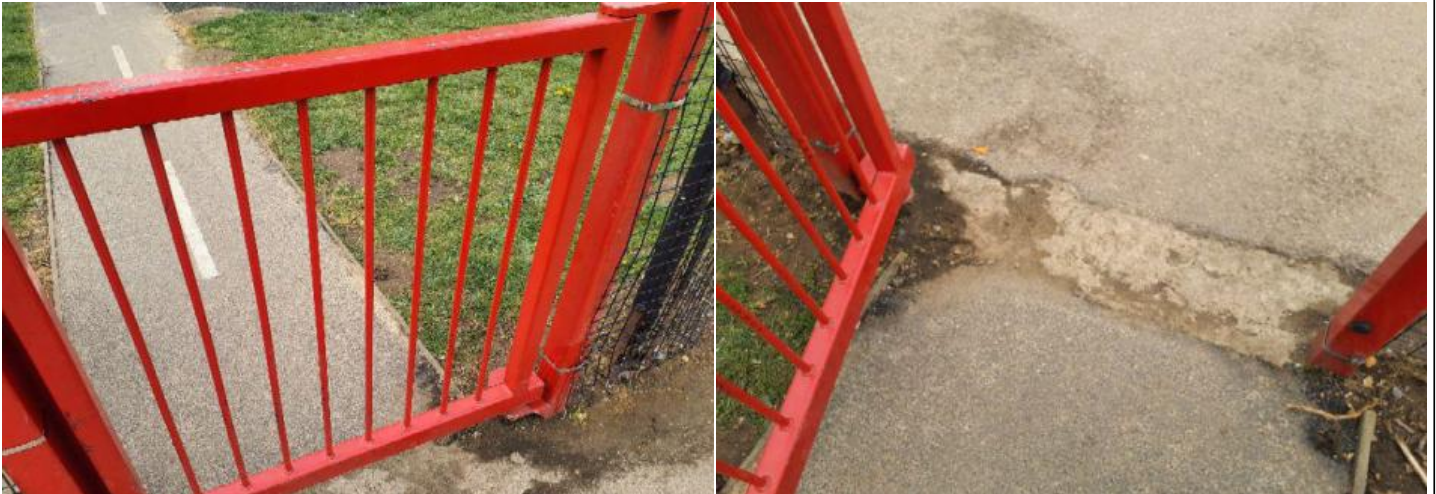
Finding: The bitumen surface is worn or damaged **Action:** Repair the bitumen to provide a uniform surface

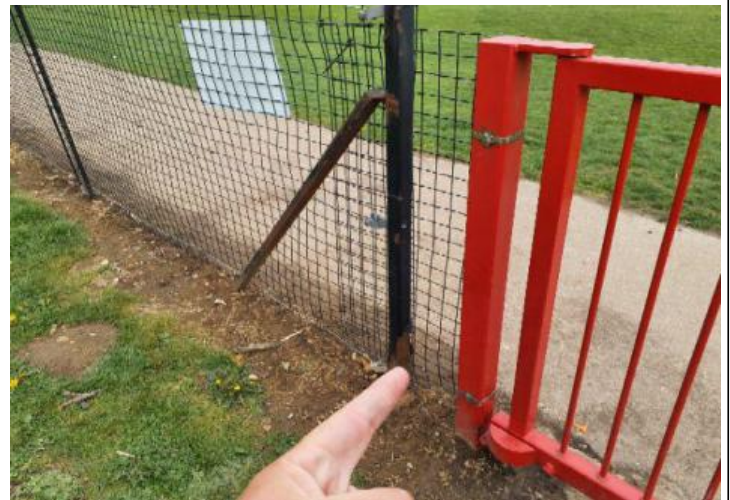
Finding: Parts of the steel on this item have corroded excessively and the metal has perforated in places

Action: Ensure all affected areas are treated and repaired

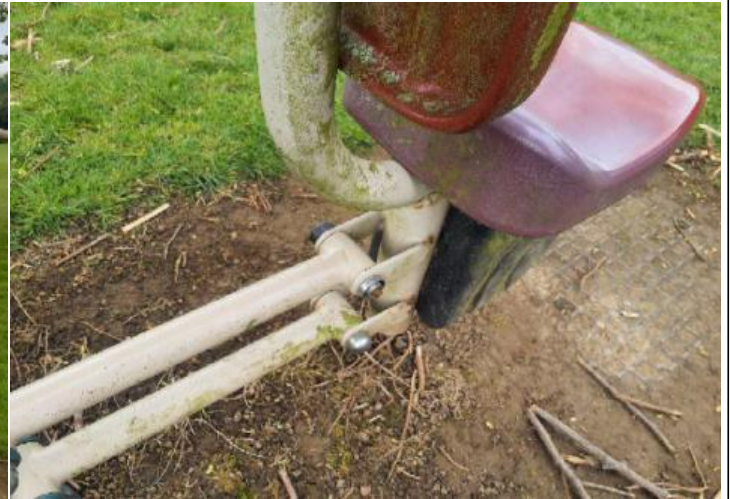
Finding: There is/are bolt cap covers missing or damaged on the item

Action: Replace missing or damaged bolt cap covers

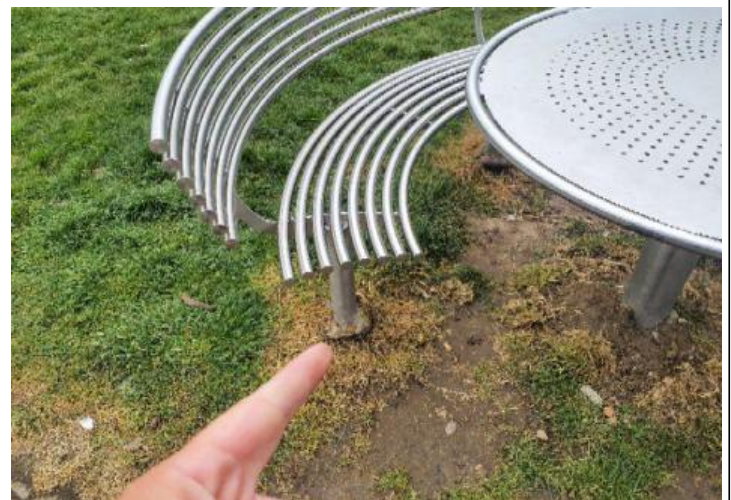
Finding: The surface has eroded and the foundations are exposed

Action: Reinstall surrounding surfaces to cover the foundations

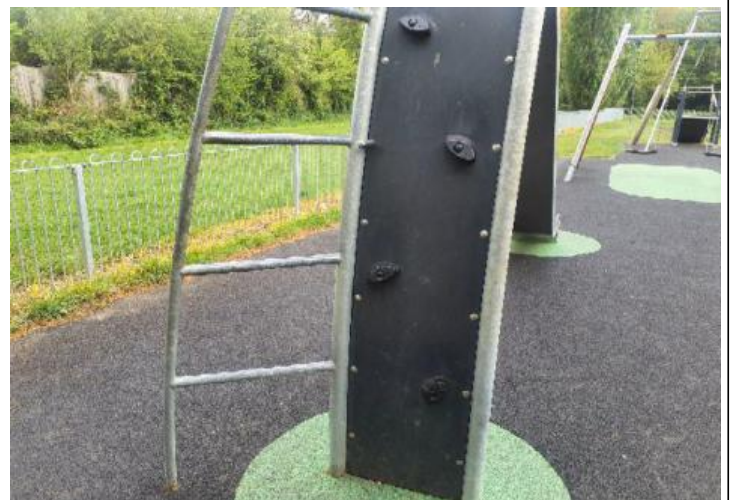
Finding: There is/are finger entrapment/s due to missing fixings and the item fails to meet the requirements of BS EN 1176 Part 1 4.2.7.6 Entrapment of fingers

Action: Replace missing fixings to remove entrapment
