ST STEPHEN PARISH COUNCIL

You are summoned to the Fixed Assets Committee meeting

AGENDA

| 2526/AC/013 | To receive Annual Play Inspection Reports. Reports attached. |

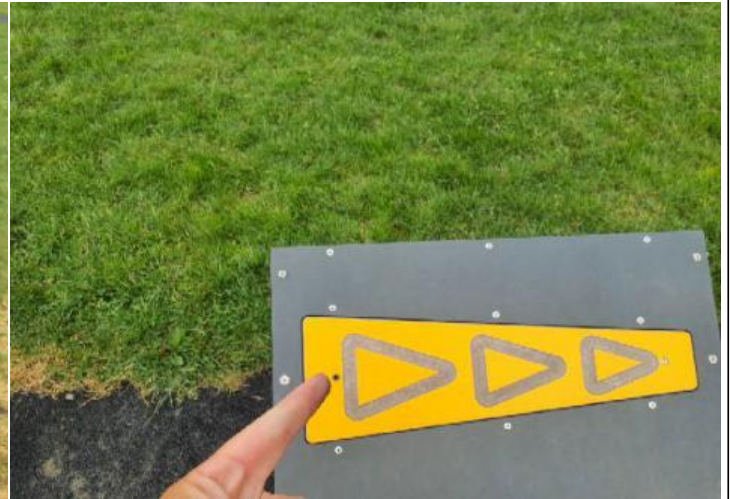
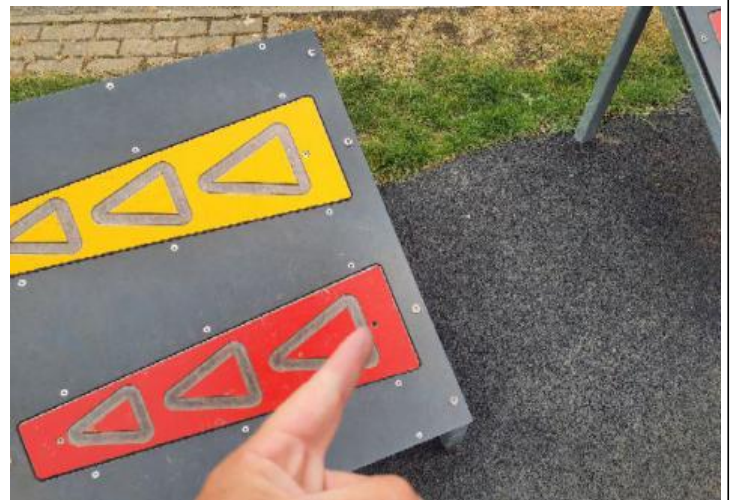
Finding: There is or are fixings missing on the item

Action: Replace all missing fixings

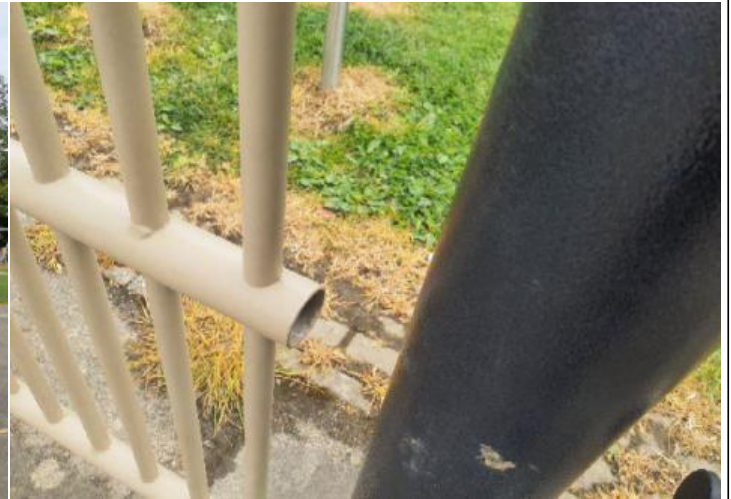
Finding: There is / are post or end caps missing / damaged on the item
Action: Replace missing / damaged post or end caps

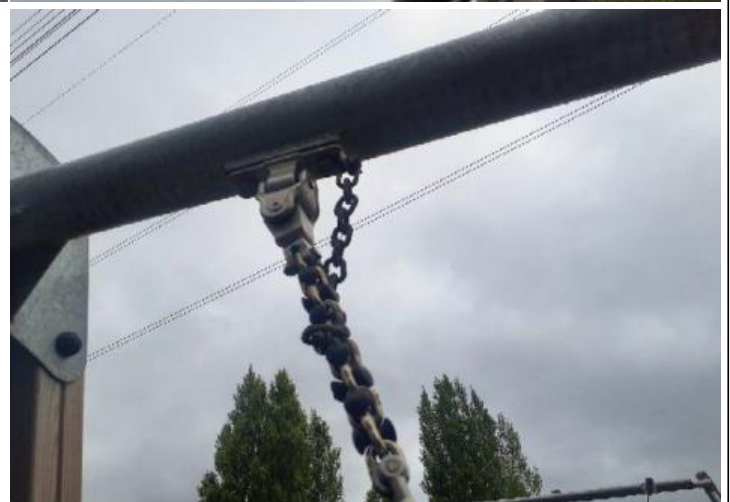
Finding: The secondary safety shackles are worn in excess of 40% and require renewing **Action:** Replace worn shackles

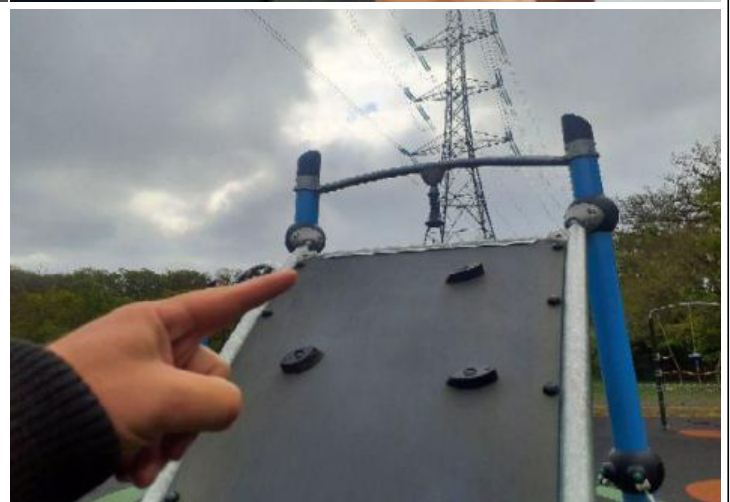
Finding: There is/are finger entrapment/s in the framework / climbing wall and the item fails to meet the requirements of BS EN 1176 Part 1 4.2.7.6 Entrapment of fingers
Action: Monitor - No action given the risk assessment

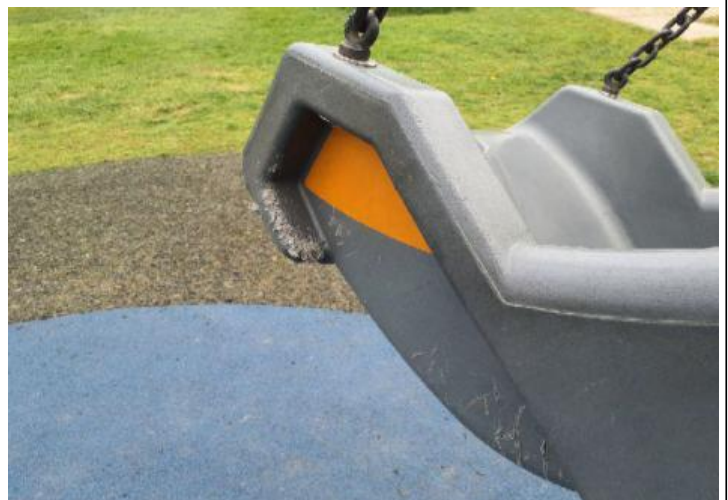
Finding: The seat has been damaged

Action: Monitor for any further deterioration and replace as required

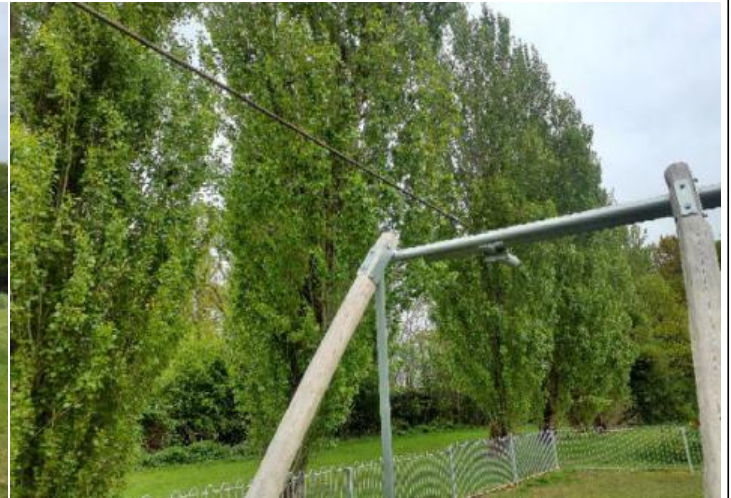
Finding: We have completed a visual inspection of the suspension links, cable and fixing points from ground level, however it is not possible to fully inspect these areas without either hiring equipment to gain access or removing the cable and suspension and inspecting at ground level. We recommend that the main cable and fixing security is thoroughly inspected at least in accordance with the manufacturers recommendations to check for wear, damage, security or internal rusting; this will help to ensure the continued safe use of the equipment

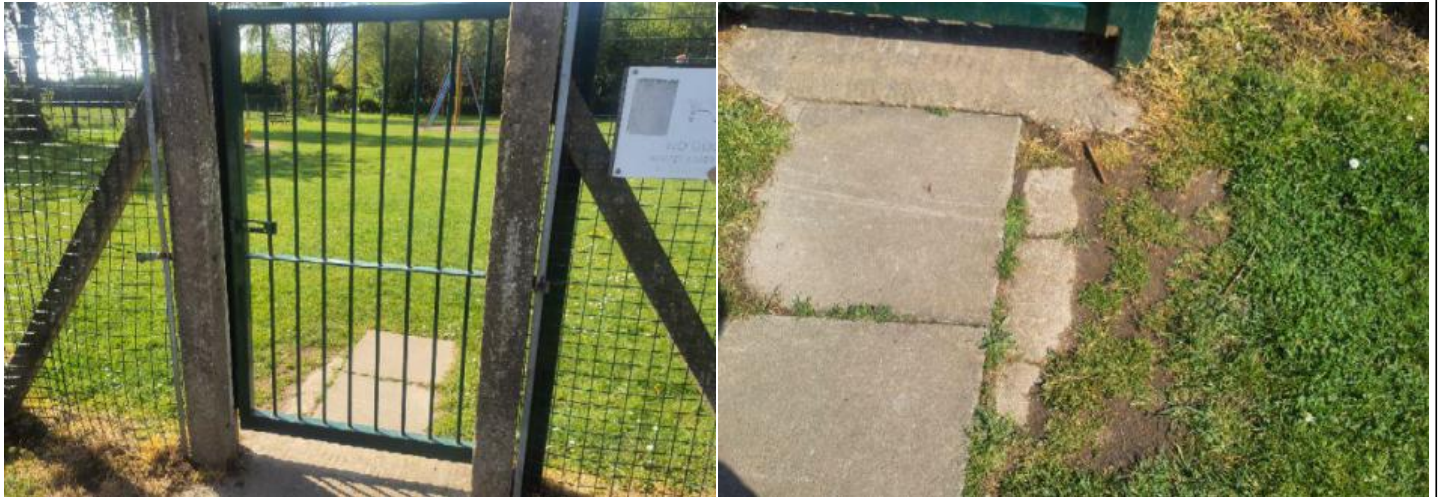
Finding: There are trip hazards at the edges of the surface **Action:** Remove trip hazard

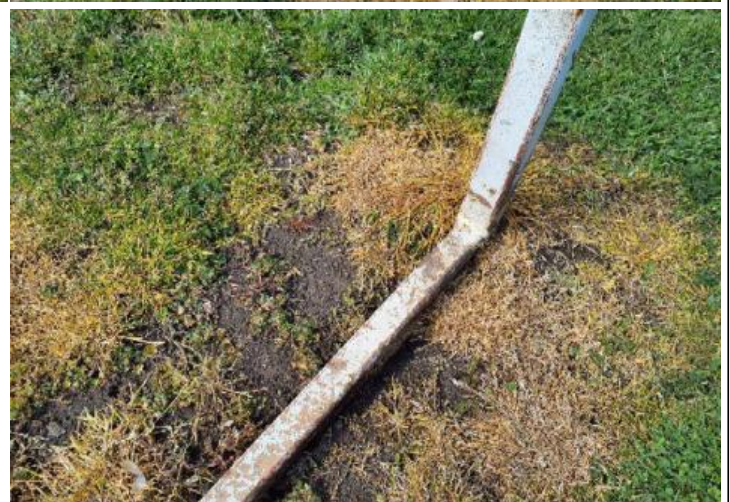
Finding: The goal frame has only been secured at one end

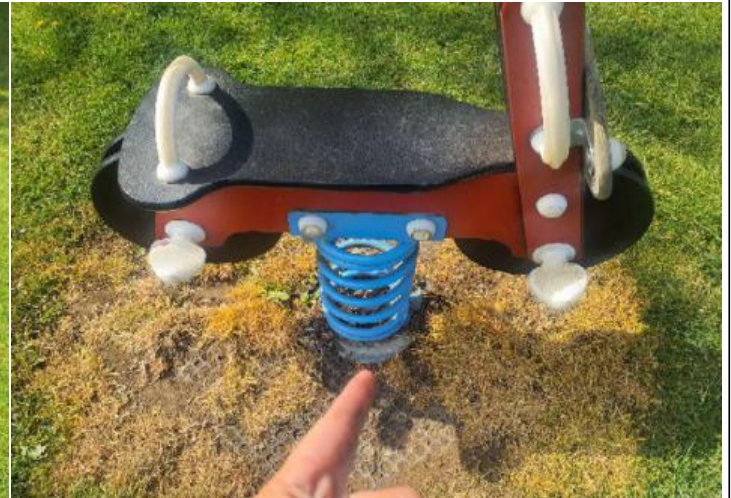
Finding: The item is slightly loose in its foundations

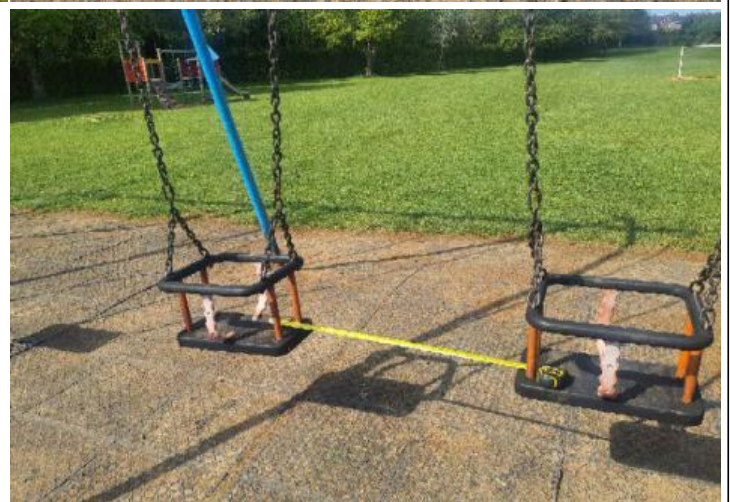
Finding: The seats are too close to each other as defined in BS EN 1176 Part 2; this is a low risk failure and no remedial action is required

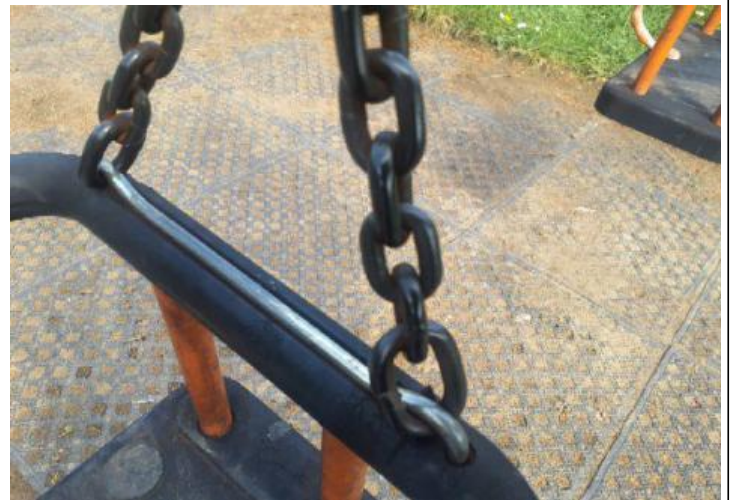
Finding: There is some notable evidence of chain wear

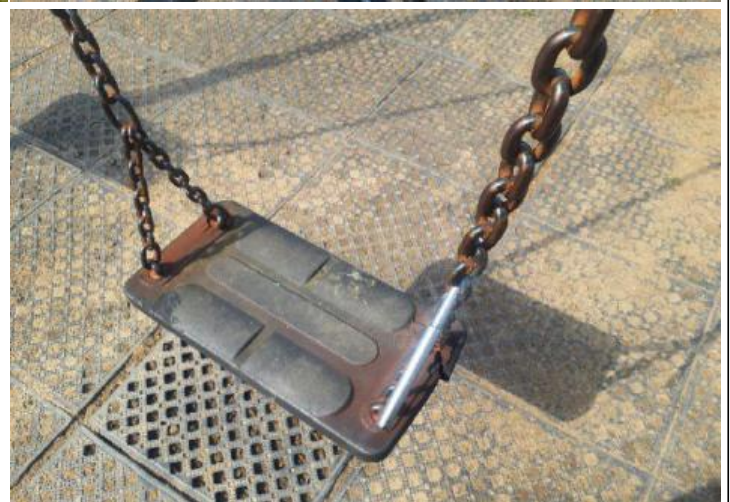
Finding: The chain openings are in excess of 8.6mm and do not meet the recommendations of BS EN 1176 Part 1

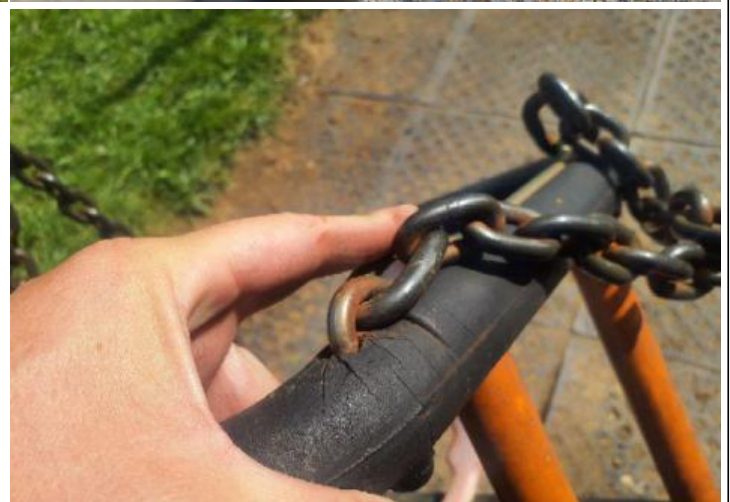
Finding: The swing seat connectors have some wear present

Action: Monitor for further deterioration and replace when 40% worn
