# ST STEPHEN PARISH COUNCIL

You are summoned to a **Community & Leisure Committee meeting.**

To take place on **Thursday 23 May 2024 at 7.30pm**

- 2425/CL/012 To consider and agree response to structures on allotment plots installed without permission and make a recommendation to Full Council to amend the Allotment Conditions of Tenancy.

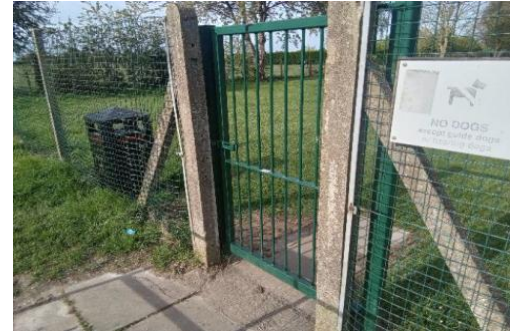
**Item:** Gate  
**Manufacturer:** Not Identified  
**Surface Type:** Paving Slabs  
**Item Quantity:** 2  
**Equipment Compliance:** N/A  
**Surface Area Compliance:** N/A

There are trip hazards at the edges of the surface - Reinstate surrounding surface levels to remove the trip points

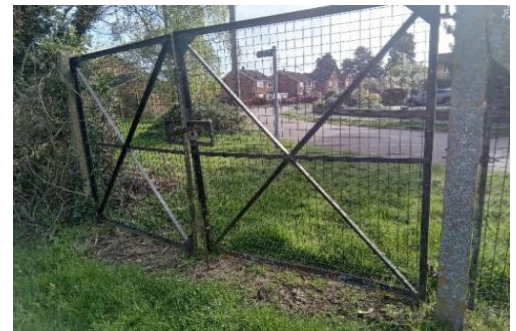
**Item:** Gate - Maintenance  
**Manufacturer:** Not Identified  
**Surface Type:** Grass  
**Item Quantity:** 1  
**Equipment Compliance:** N/A  
**Surface Area Compliance:** N/A

The paintwork on this item has been damaged or worn exposing the metal underneath which is rusting / corroding - Treat affected areas and repaint

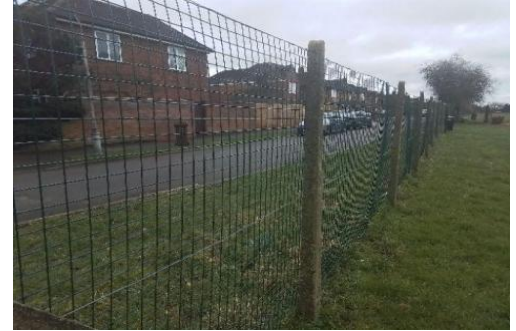
**Item:** Fence - Steel Mesh  
**Manufacturer:** Not Identified  
**Surface Type:** Grass  
**Item Part Number:**  
**Item Quantity:** 1  
**Equipment Compliance:** N/A  
**Surface Area Compliance:** N/A  
**Total Findings:** 1

Cable ties have been used on the item and there are sharp projecting ends - Remove if not required or replace with a more appropriate alternative fixing method if used as a fixing

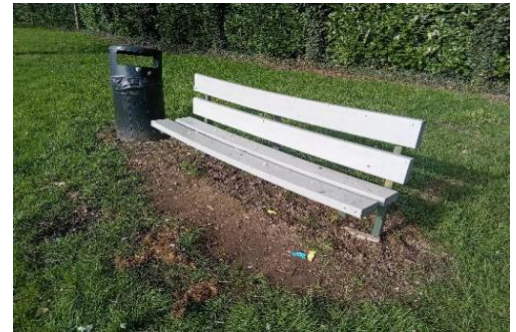
**Item:** Bench  
**Manufacturer:** Not Identified  
**Surface Type:** Grass  
**Item Quantity:** 1  
**Equipment Compliance:** N/A  
**Surface Area Compliance:** N/A  
**Total Findings:** 1

The surface has eroded in some areas and may be slippery in wet conditions - Reinstate the surface

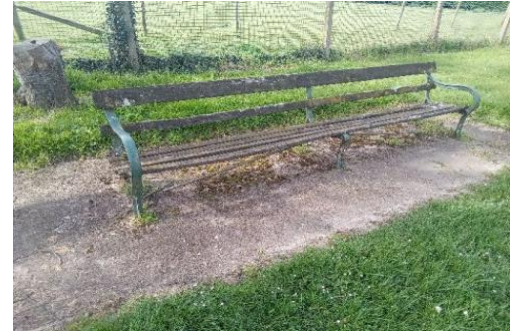
**Item:** Bench  
**Manufacturer:** Not Identified  
**Surface Type:** Concrete  
**Item Quantity:** 1  
**Equipment Compliance:** N/A  
**Surface Area Compliance:** N/A

There is algae, silt or moss growth on the surface resulting in slippery conditions - Clean and treat appropriately

There is some damage to the item - repair or replace as required

The paintwork on this item has been damaged or worn exposing the metal underneath which is rusting / corroding - Treat affected areas and repaint

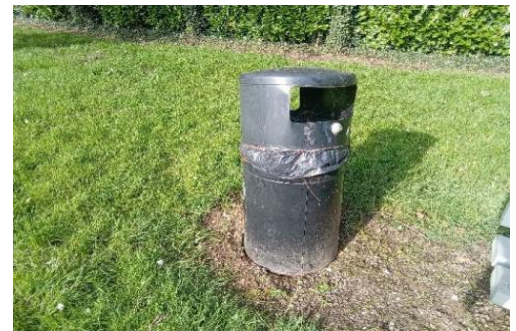
**Item:** Litter Bin  
**Manufacturer:** Not Identified  
**Surface Type:** Grass  
**Item Quantity:** 1  
**Equipment Compliance:** N/A  
**Surface Area Compliance:** N/A

The paintwork on this item has been damaged or worn exposing the metal underneath which is rusting / corroding - Treat affected areas and repaint

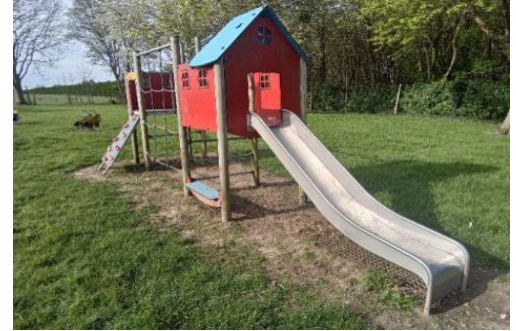
**Item:** Multi Play (Junior)  
**Manufacturer:** Kompan Ltd  
**Surface Type:** Grass Matrix Tiles  
**Item Quantity:** 1  
**Equipment Compliance:** Yes  
**Surface Area Compliance:** Yes

There are a number of dents in the slide surface - Monitor for any further deterioration and repair as required

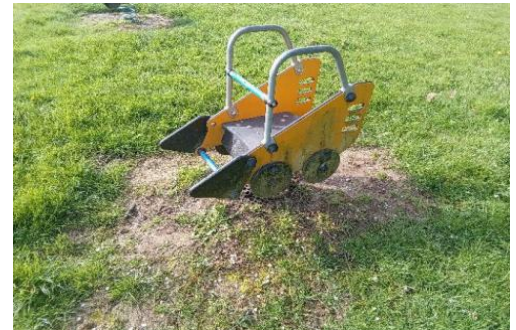
**Item:** Spring Bulldozer  
**Manufacturer:** Kompan Ltd  
**Surface Type:** Grass Matrix Tiles  
**Item Quantity:** 1  
**Equipment Compliance:** Yes  
**Surface Area Compliance:** Yes

There is/are bolt cap covers missing or damaged on the item - Replace missing or damaged bolt cap covers

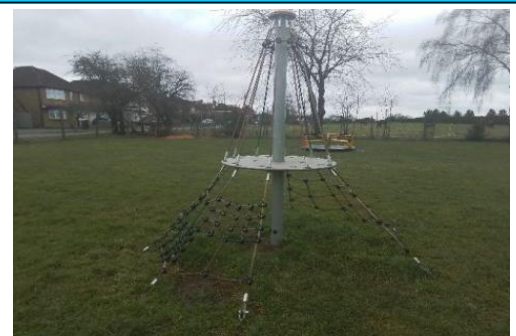
**Item:** Rope Climber  
**Manufacturer:** Kompan Ltd  
**Surface Type:** Grass Matrix Tiles  
**Item Quantity:** 1  
**Equipment Compliance:** Yes  
**Surface Area Compliance:** Yes  
**Total Findings:** 1

There is/are bolt cap covers missing or damaged on the item - Replace missing or damaged bolt cap covers

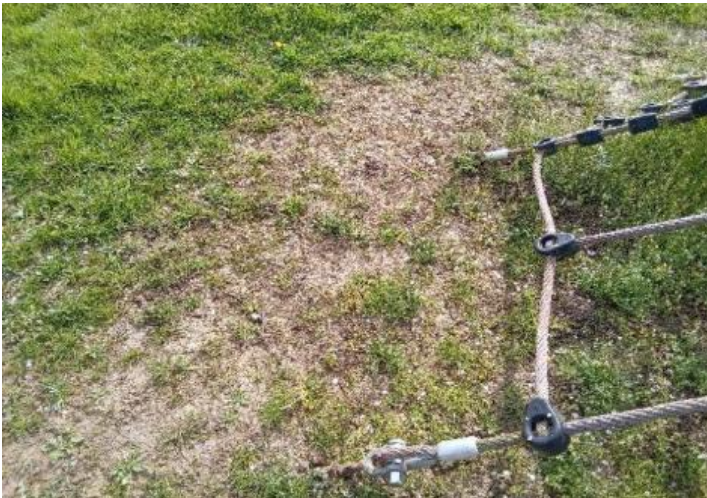
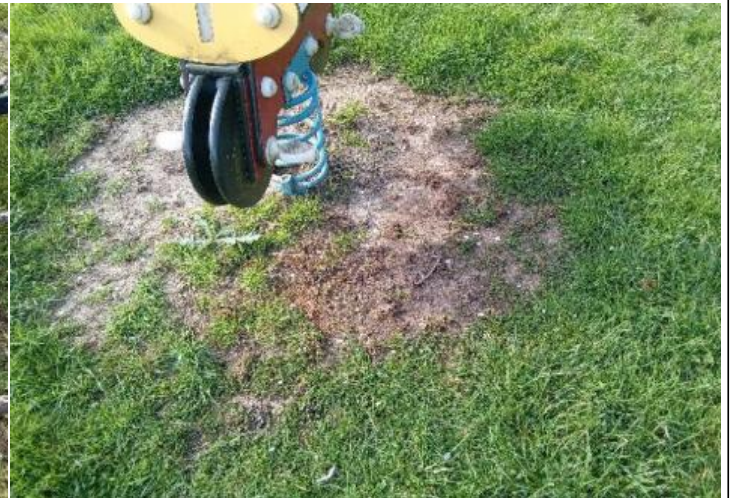
**Item:** Ancillary Items - Site General  
**Manufacturer:** Owner/Operator

**Finding:** The grass mats are silted up, the soil is compacted **Action:** Reinststate as required and the area will become very slippery when the soil is wet.

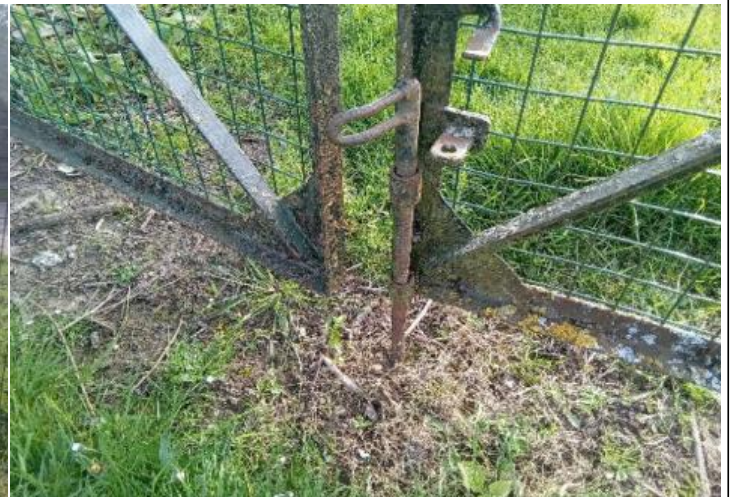
**Item:** Gates - Gate - Maintenance  
**Manufacturer:** Not Identified

**Finding:** The gate has no drop bolt sleeves and/or drop bolts fitted

**Action:** Provide drop bolt sleeves and/or drop bolts

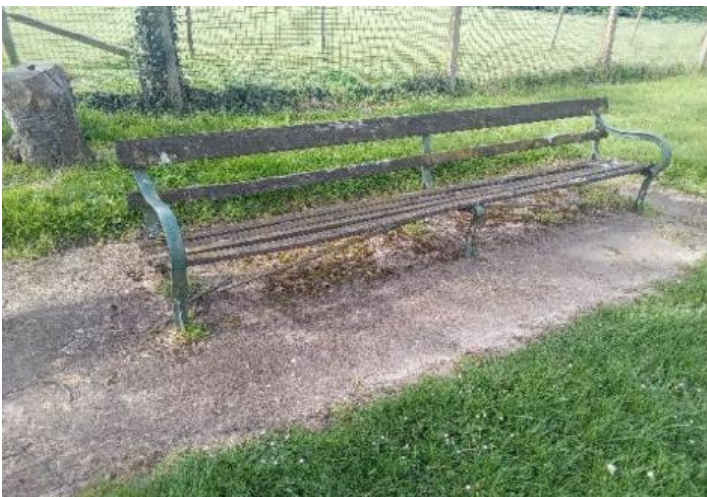
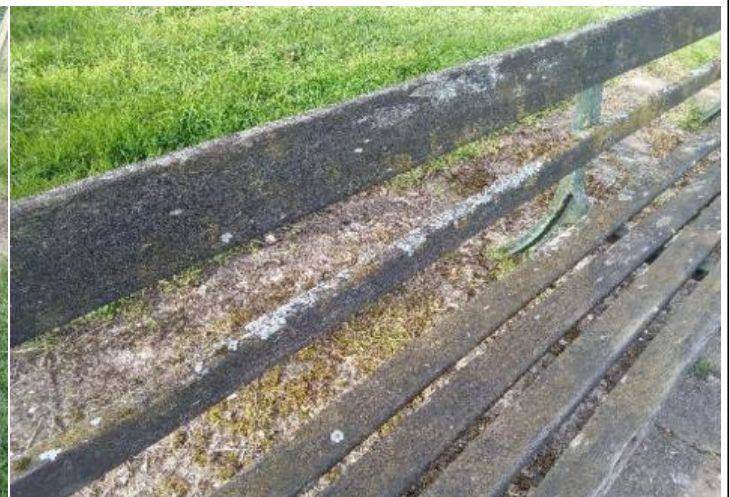
**Item:** Ancillary Items - Bench  
**Manufacturer:** Not Identified

**Finding:** There is algae or moss on the surface of the equipment  
**Action:** Clean and treat appropriately

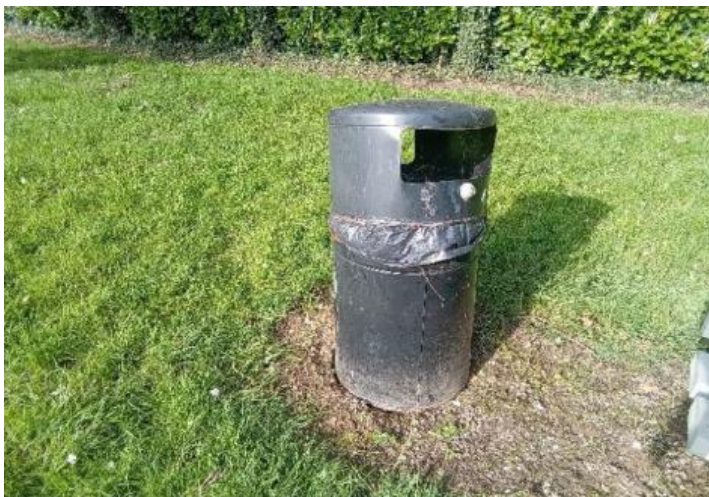
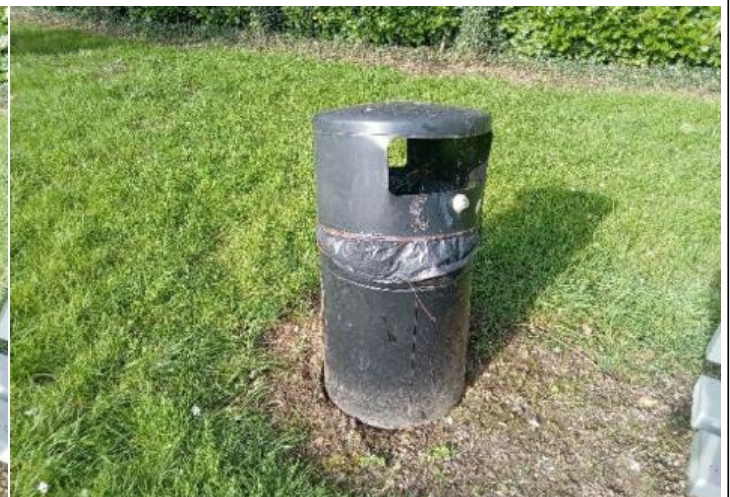
**Item:** Ancillary Items - Litter Bin  
**Manufacturer:** Not Identified

**Finding:** The lid or door of the litter bin is not secured

**Action:** Ensure the lid or door is kept locked

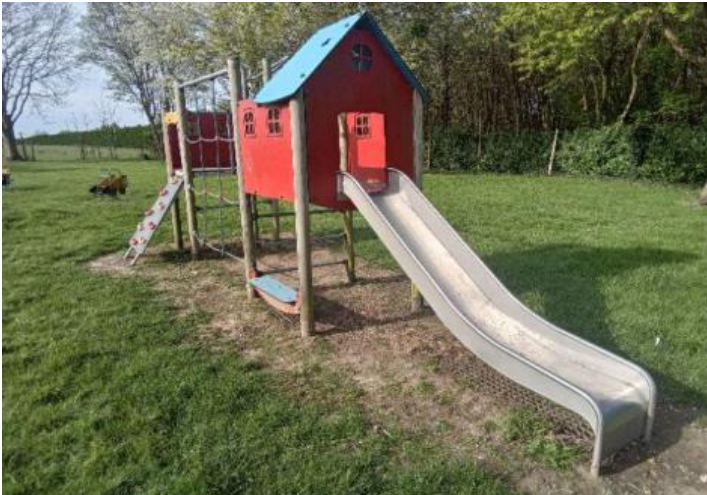
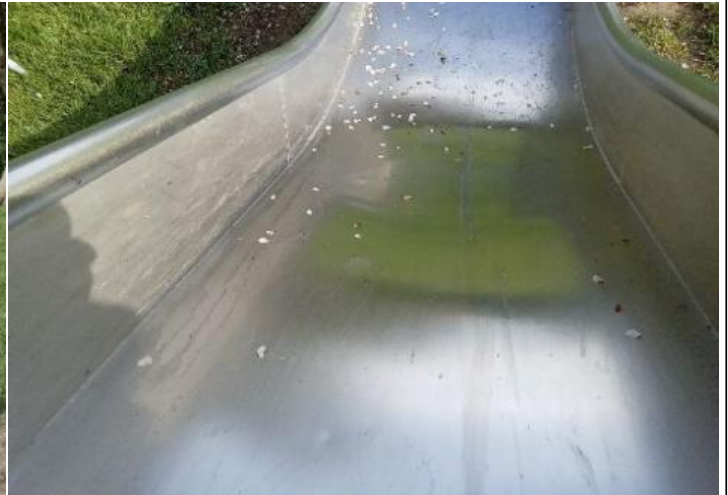
**Item:** Activity Equipment - Multi Play (Junior)  
**Manufacturer:** Kompan Ltd

**Finding:** There are a number of dents in the slide surface

**Action:** Monitor for any further deterioration and repair as required

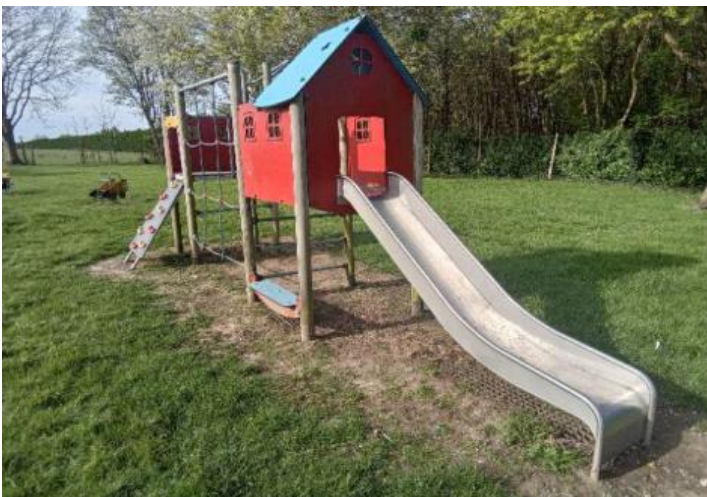
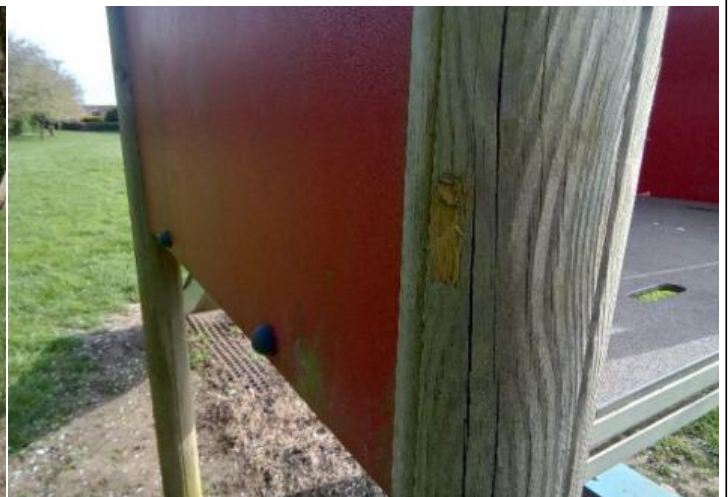
**Item:** Activity Equipment - Multi Play (Junior)  
**Manufacturer:** Kompan Ltd

**Finding:** Parts of the timber are rough or splintered

**Action:** Remove all rough or sharp edges

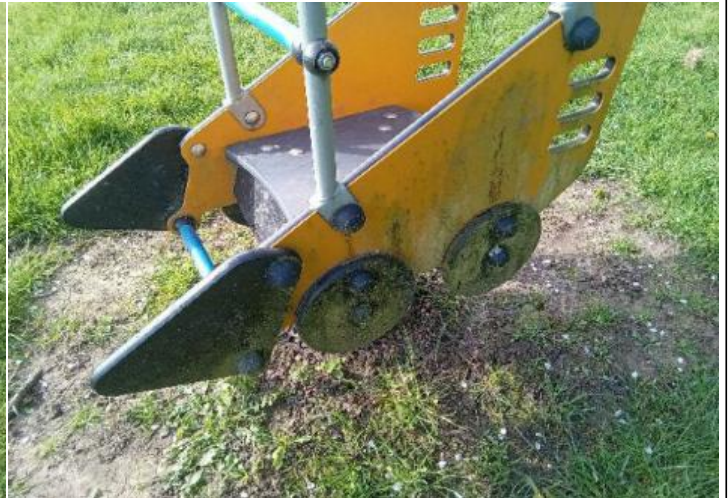
**Item:** Rocking Equipment - Spring Bulldozer  
**Manufacturer:** Kompan Ltd

**Finding:** There is algae or moss on the surface of the equipment

**Action:** Clean and treat appropriately

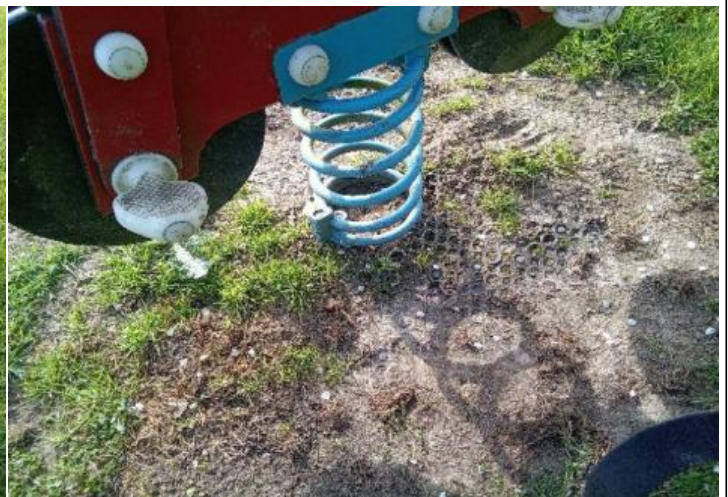
**Item:** Rocking Equipment - Spring Bike  
**Manufacturer:** Kompan Ltd

**Finding:** The item is slightly loose in its foundations

**Action:** Monitor for any further deterioration and repair as required

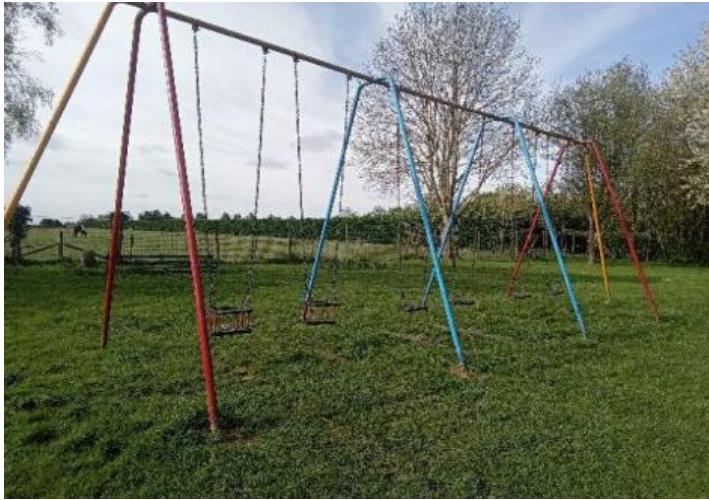
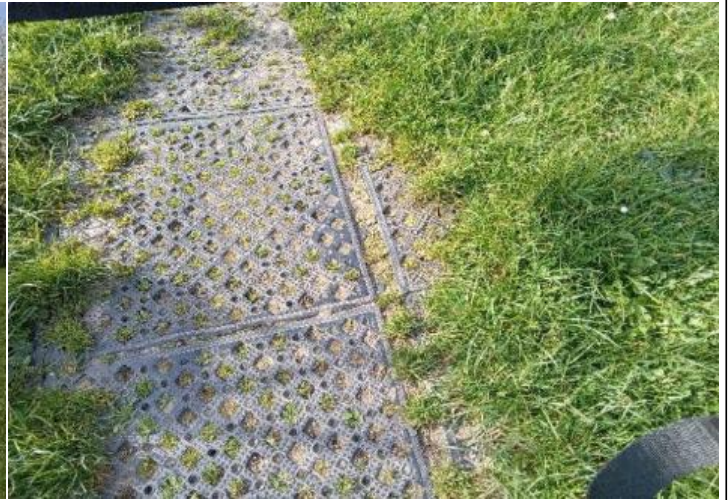
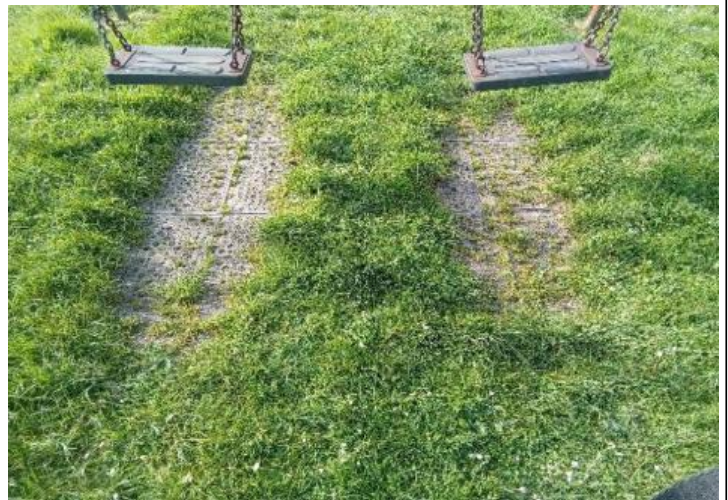
**Item:** Swings - 3 Bay Swing  
**Manufacturer:** Hags

**Finding:** There are gaps opening between the grass mat tiles

**Action:** Provide additional ties or secure / reinstate surface

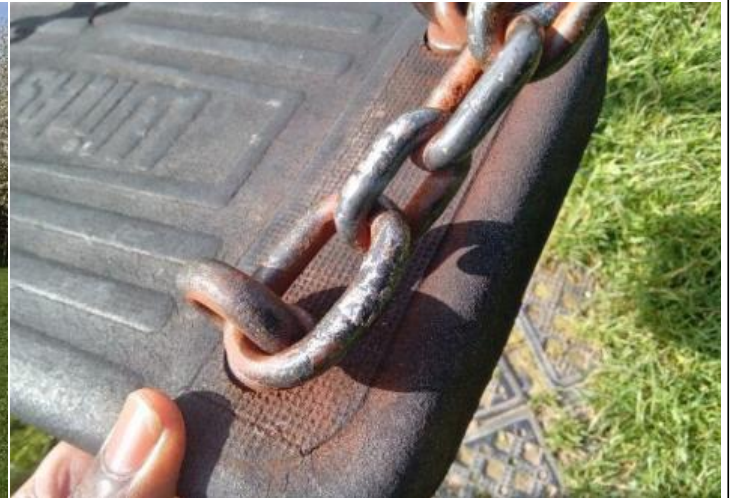
**Item:** Swings - 3 Bay Swing  
**Manufacturer:** Hags

**Finding:** There is some notable evidence of chain wear

**Action:** Monitor for any further deterioration and replace when 40% worn

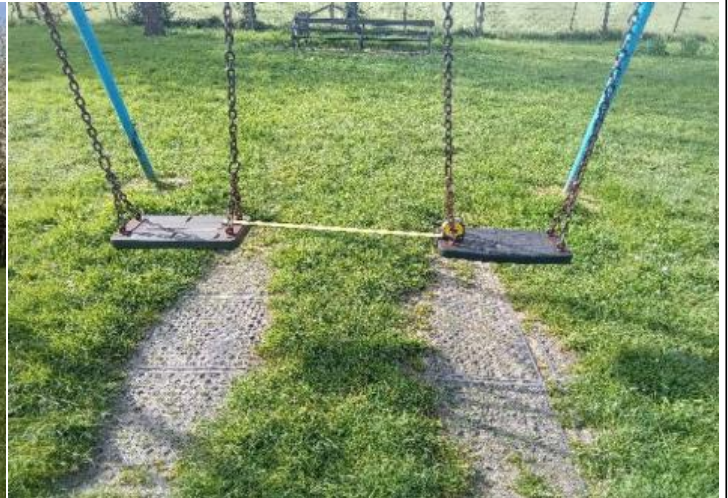
**Item:** Swings - 3 Bay Swing  
**Manufacturer:** Hags

**Finding:** The seats are too close to each other as defined in BS EN 1176 Part 2; this is a low risk failure and no remedial action is required  
**Action:** Monitor - No remedial work recommended

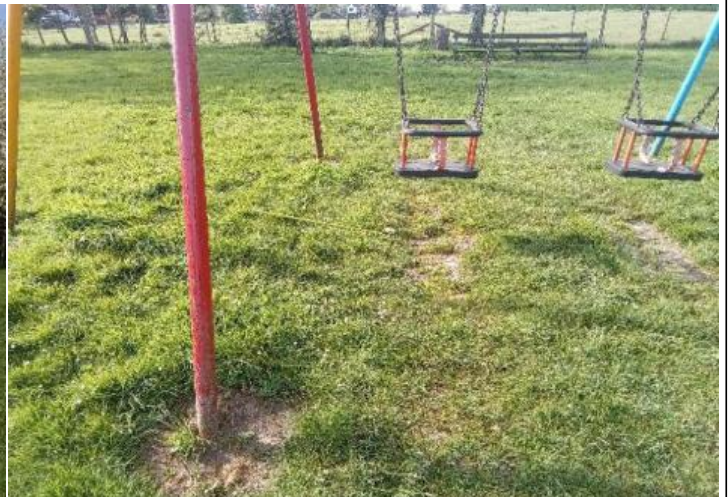
The seats are too close to the frame as defined in BS EN 1176 Part 2; this is a low risk failure and no remedial action is required - Monitor - No remedial work recommended

**Item:** Swings - 3 Bay Swing  
**Manufacturer:** Hags

**Finding:** The seats are too close to the frame as defined in BS EN 1176 Part 2; this is a low risk failure and no remedial action is required  
**Action:** Monitor - No remedial work recommended

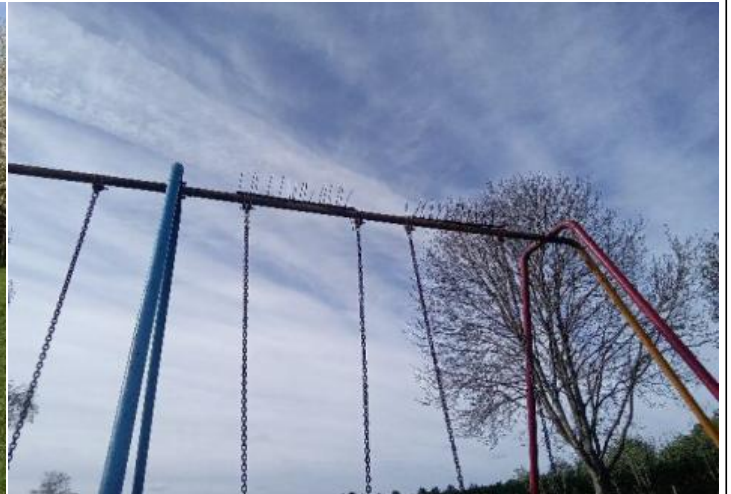
**Item:** Swings - 3 Bay Swing  
**Manufacturer:** Hags

**Finding:** There are Anti-bird devices attached to the crossbeam

There are Anti-bird devices attached to the crossbeam - Remove and replace with upturned cable ties

**Action:** Remove and replace with upturned cable ties

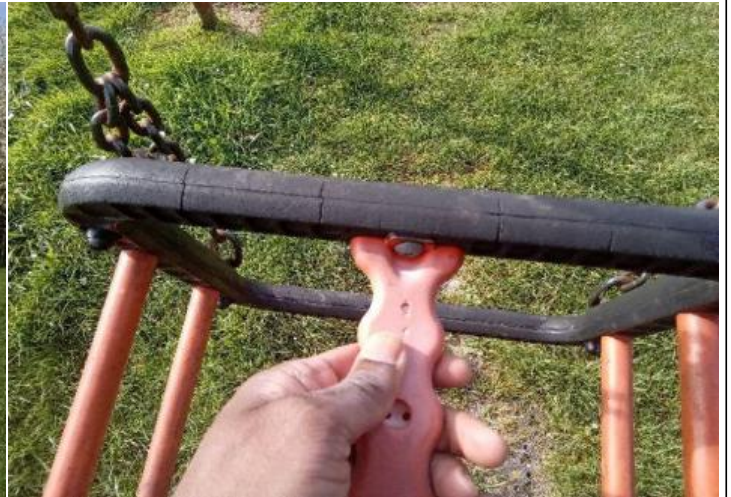
**Item:** Swings - 3 Bay Swing  
**Manufacturer:** Hags

**Finding:** The seat has minor damage or wear

The seat has minor damage or wear - Monitor for any further deterioration and replace as required

**Action:** Monitor for any further deterioration and replace as required

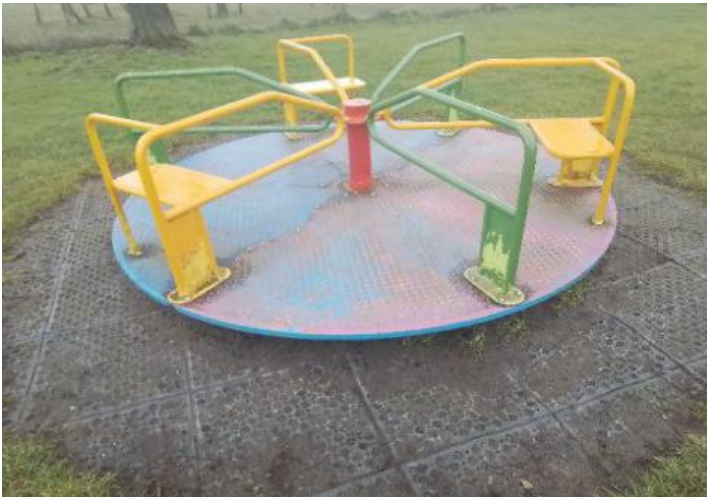
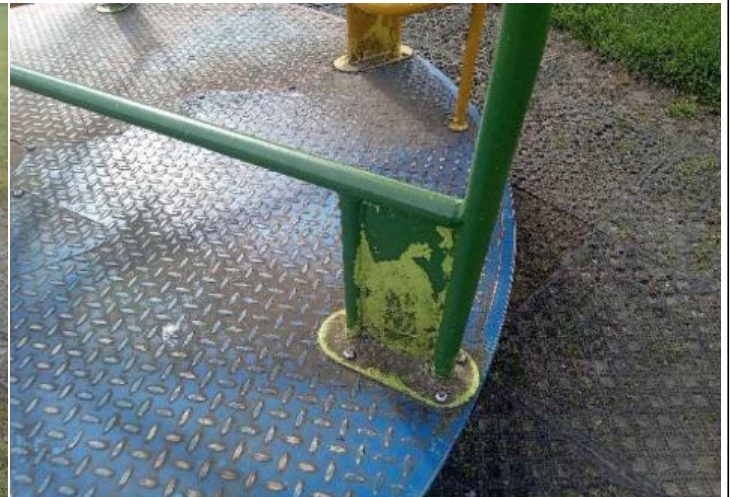
**Finding:** The paint is flaking off the metalwork  
**Action:** Rub down and re-paint

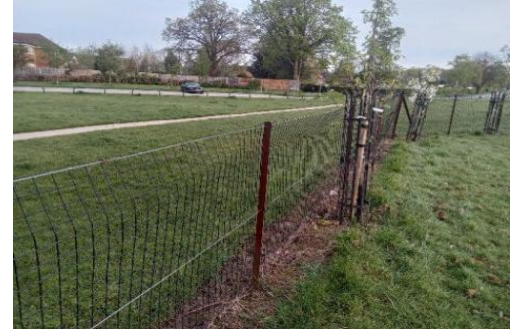
There are a number of loose posts around the fence - Monitor for any further deterioration and reset as required

There is some damage to the fence sections - Monitor for any further deterioration and repair as required

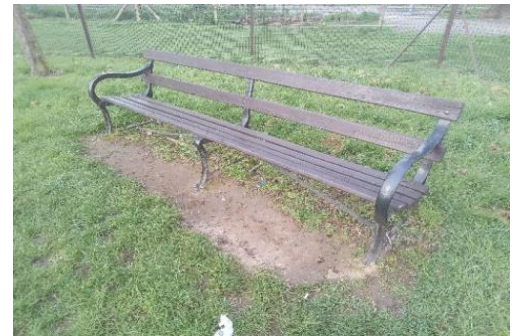
The surface has eroded in some areas and may be slippery in wet conditions - Reinstate the surface

There is some evidence of rot in the timber - Monitor for any further deterioration and replace as required

There is some damage to the item - Monitor for any further deterioration and repair as required

There is some strimmer / machinery damage apparent on the posts, this can penetrate the preservative applied to the timber and accelerate the rotting process - Monitor for any deterioration (rot) and replace as required

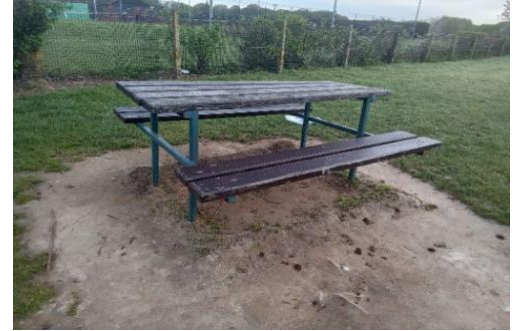
The surface has eroded in some areas and may be slippery in wet conditions - Reinstate the surface

The timber stain is in poor condition - Prepare all affected parts and re-stain with an appropriate preservative

There is some evidence of rot in the timber - Monitor for any further deterioration and replace as required

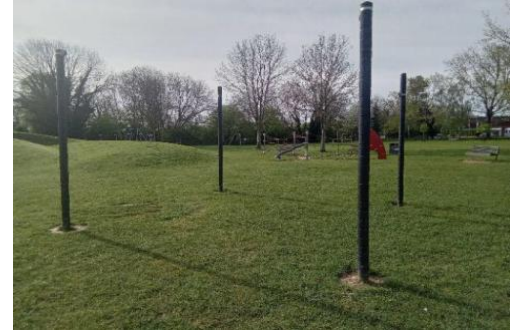
Canopy has been removed. Posts remain - Consider replacing canopy

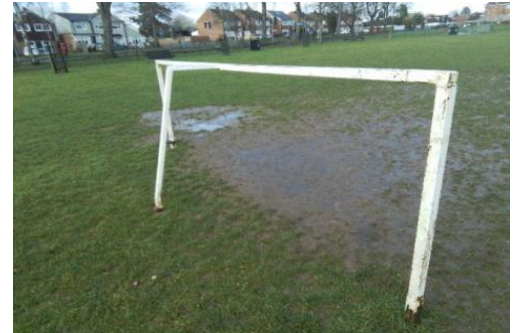
The surface has eroded in some areas and may be slippery in wet conditions - Reinstate the surface

The paintwork on this item has been damaged or worn exposing the metal underneath which is rusting / corroding - Treat affected areas and repaint

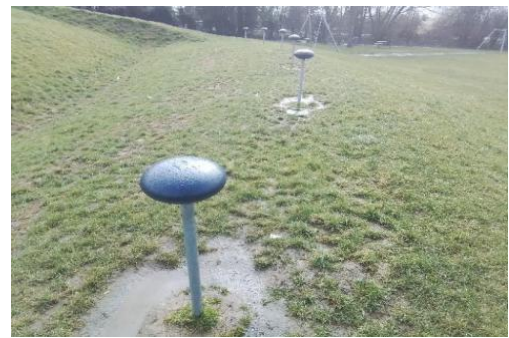
**Finding 1**  
 There is moderate damage to the grass matrix tile surface - Repair the damaged areas of surfacing

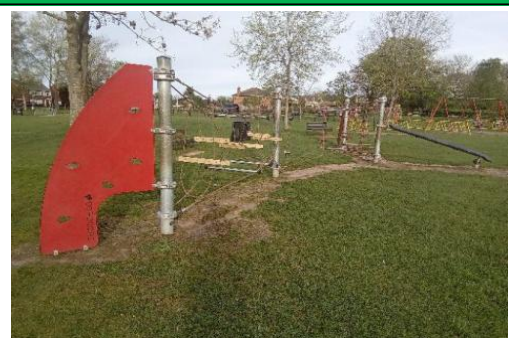
**Finding 1**  
 The grass mats are silted up, the soil is compacted and the area will become very slippery when the soil is wet. - Reinstated as required

**Finding 2**  
 There is some damage to the item - Monitor for any further deterioration and repair as required

**Finding 3**  
 There is/are finger entrapment/s in the rope connections and the item fails to meet the requirements of BS EN 1176 Part 1 4.2.7.6 Entrapment of fingers - Monitor - No remedial work recommended

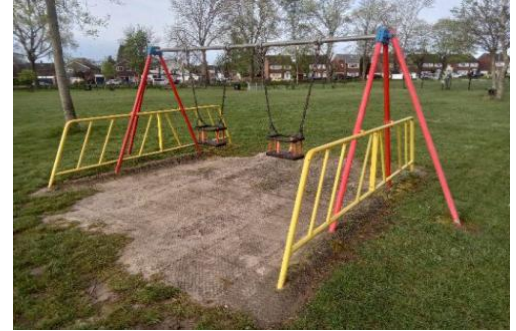
The surface has subsided in some areas - Monitor for any further deterioration and repair as required

There is some wear to the shackles. - Monitor for any further deterioration and replace when 40% worn

There is some notable evidence of chain wear - Monitor for any further deterioration and replace when 40% worn

The chain openings are in excess of the 8.6mm as recommended by BS EN 1176 - Monitor - No remedial work recommended

The seat has minor damage or wear - Monitor for any further deterioration and replace as required

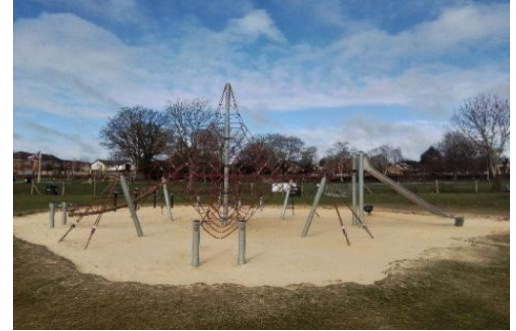
The side of the slide is damaged - Monitor for any further deterioration and repair as required

There are a number of dents in the slide surface - Monitor for any further deterioration and repair as required

The ropes/nets are worn/damaged in places - Monitor for any further deterioration and repair or replace as required

There is/are finger entrapment/s in the rope connections and the item fails to meet the requirements of BS EN 1176 Part 1 4.2.7.6 Entrapment of fingers - Monitor - No remedial work recommended

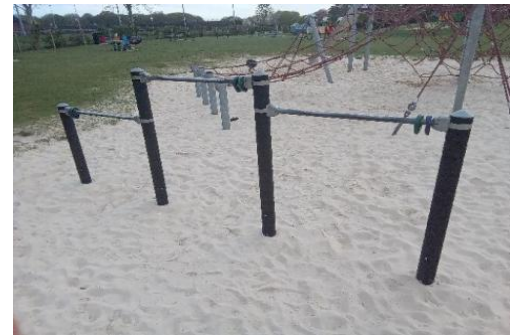
There is/are finger entrapment/s / crush in the Somersault bars fixing and the item fails to meet the requirements of BS EN 1176 Part 1 4.2.7.6 Entrapment of fingers - Monitor - No remedial work recommended

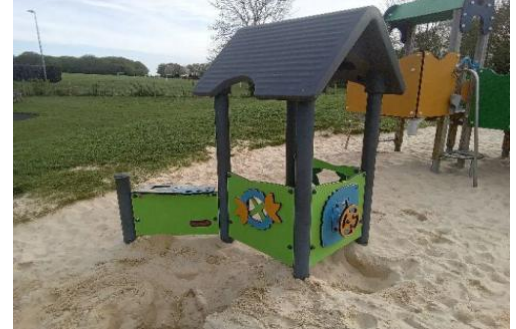
There is some damage to the item - Monitor for any further deterioration and repair as required

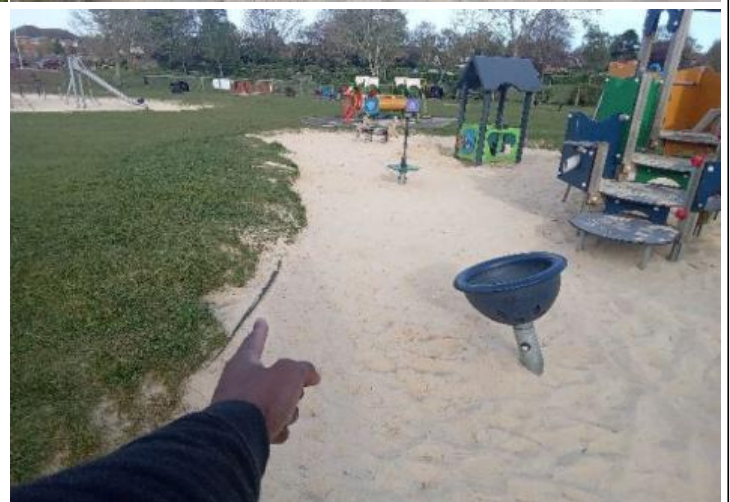
**Item:** Ancillary Items - Site General  
**Manufacturer:** Owner/Operator

**Finding:** The safety surface is low and the membrane is exposed creating trip points

**Action:** Remove or resecure the exposed membrane and top up the surface to the correct level

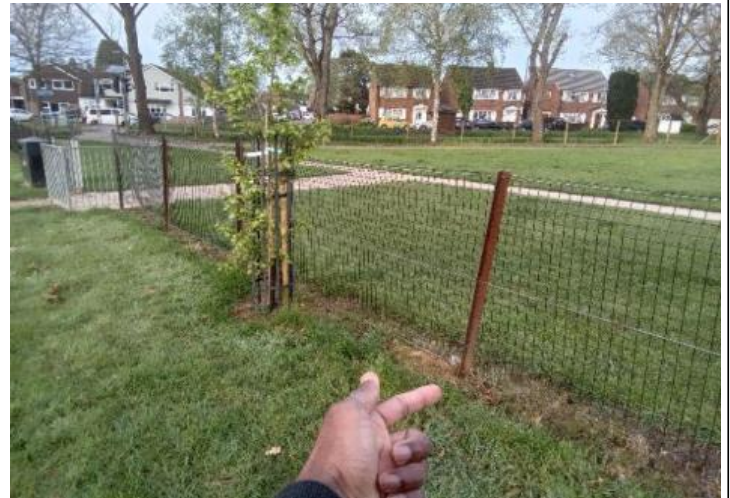
**Item:** Fences - Fence - Steel Mesh  
**Manufacturer:** Not Identified

**Finding:** There are a number of loose posts around the fence

**Action:** Monitor for any further deterioration and reset as required

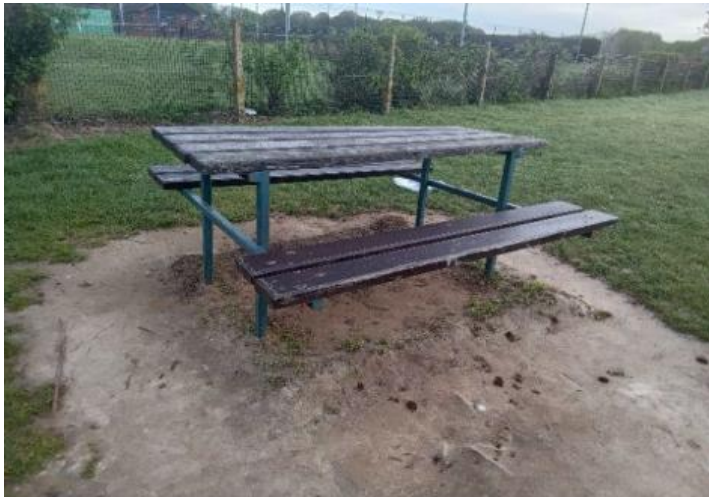
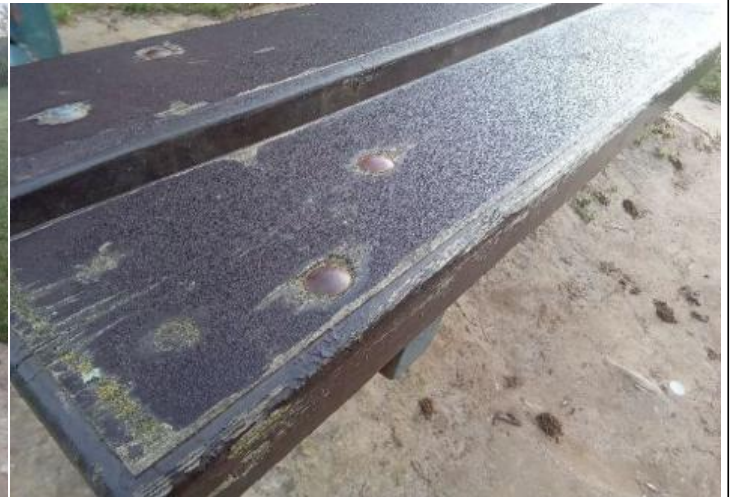
**i** 6 - Low Risk (Finding 2)

**Item:** Ancillary Items - Picnic Table  
**Manufacturer:** Not Identified

**Finding:** Parts of the timber are rough or splintered  
**Action:** Remove all rough or sharp edges

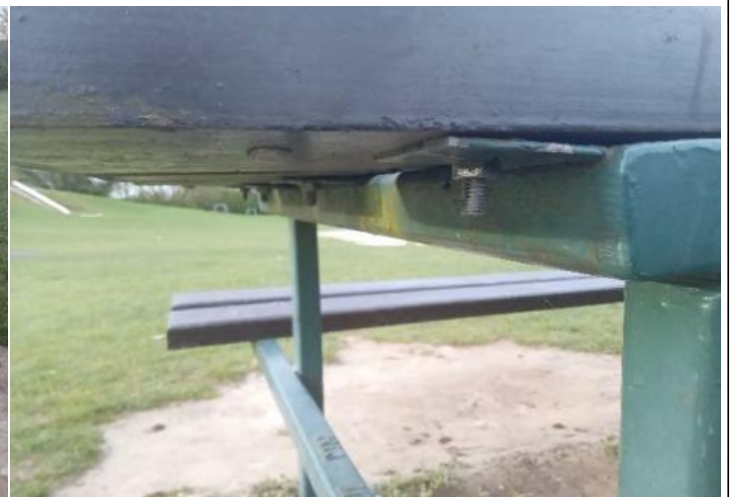
**Item:** Ancillary Items - Picnic Table  
**Manufacturer:** Not Identified

**Finding:** There are projecting bolt thread(s) present

**Action:** Remove excess thread length and deburr or provide cap

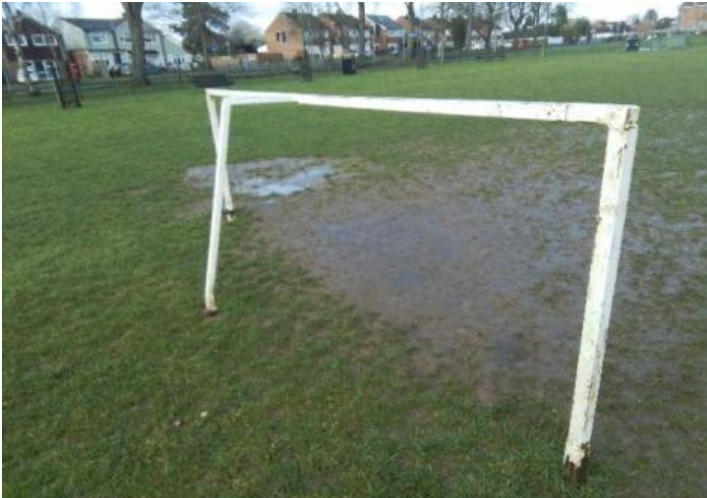
**Item:** Multi Use Games Area - 5 a side Goals  
**Manufacturer:** Not Identified

**Finding:** The paintwork on this item has been damaged or worn exposing the metal underneath which is rusting / corroding

**Action:** Treat affected areas and repaint

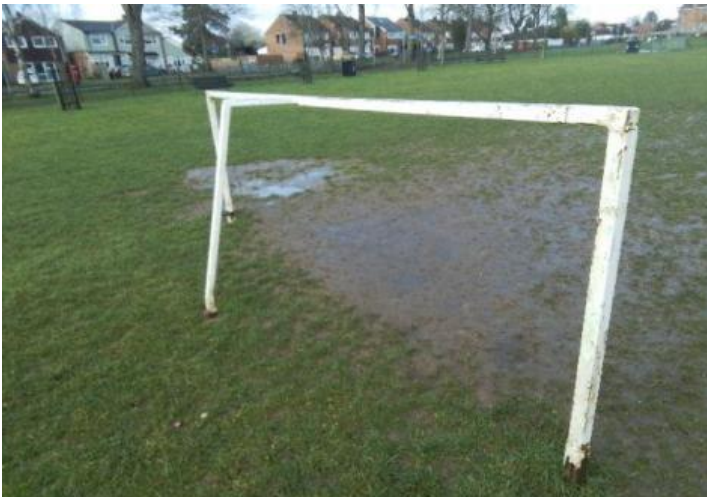
**Item:** Multi Use Games Area - 5 a side Goals  
**Manufacturer:** Not Identified

**Finding:** NB: We have undertaken a maintenance inspection only of the football goal(s); full load testing falls outside the scope of our inspection.

**Action:** Implement load testing as required

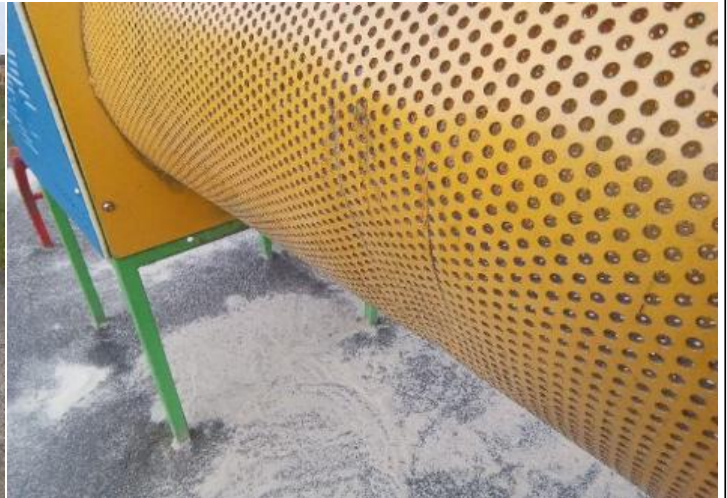
**Item:** Activity Equipment - Multi Play (Toddler)  
**Manufacturer:** Wicksteed Playgrounds

**Finding:** There is some damage to the item

**Action:** Monitor for any further deterioration and repair as required

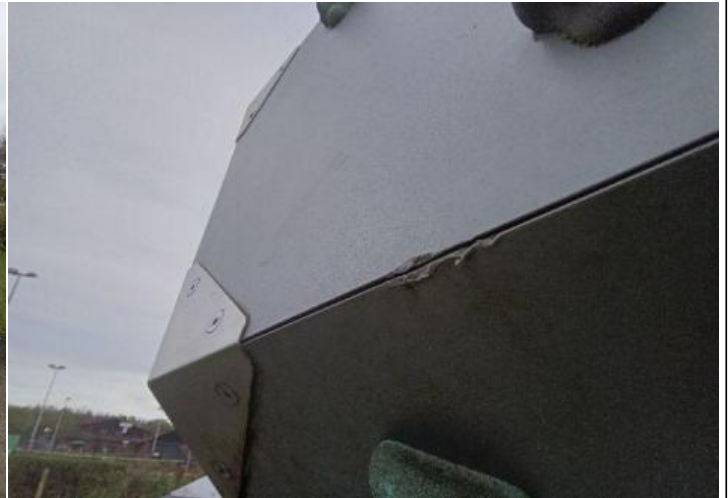
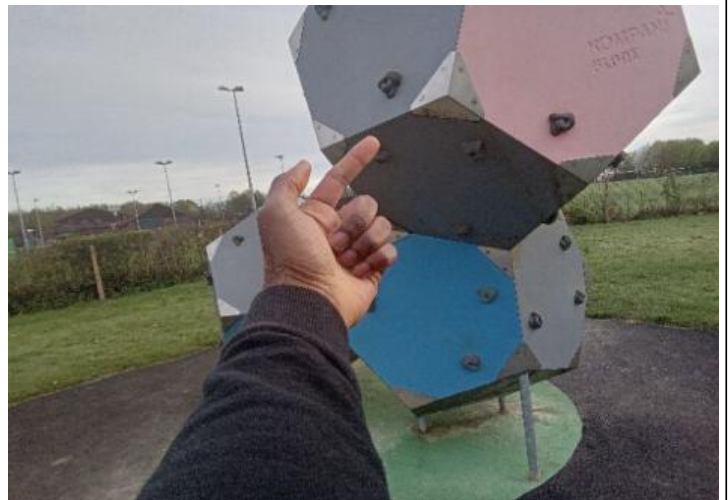
**Item:** Activity Equipment - Climbing Blocks  
**Manufacturer:** Kompan Ltd

**Finding:** There is some damage to the item

**Action:** Monitor for any further deterioration and repair as required

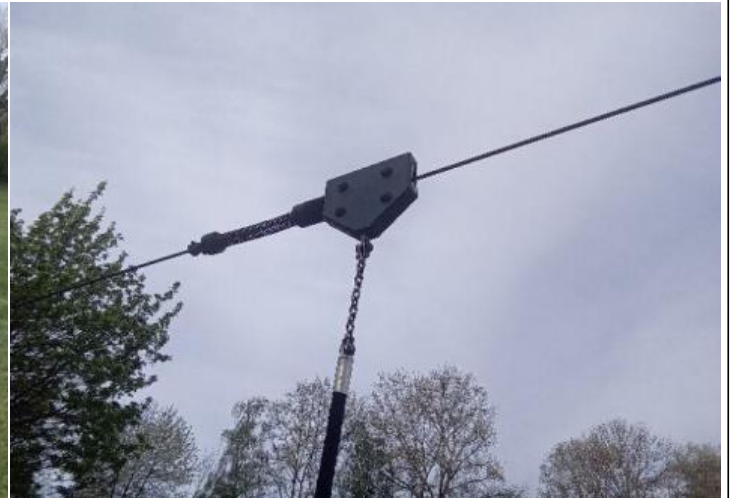
**Item:** Other - Cable Runway  
**Manufacturer:** Kompan Ltd

**Finding:** We have completed a visual inspection of the suspension links, cable and fixing points from ground level, however it is not possible to fully inspect these areas without either hiring equipment to gain access or removing the cable and suspension and inspecting at ground level. We recommend that the main cable and fixing security is thoroughly inspected at least in accordance with the manufacturers recommendations to check for wear, damage, security or internal rusting; this will help to ensure the continued safe use of the equipment

**Action:** Inspect in accordance with the manufacturers recommendations

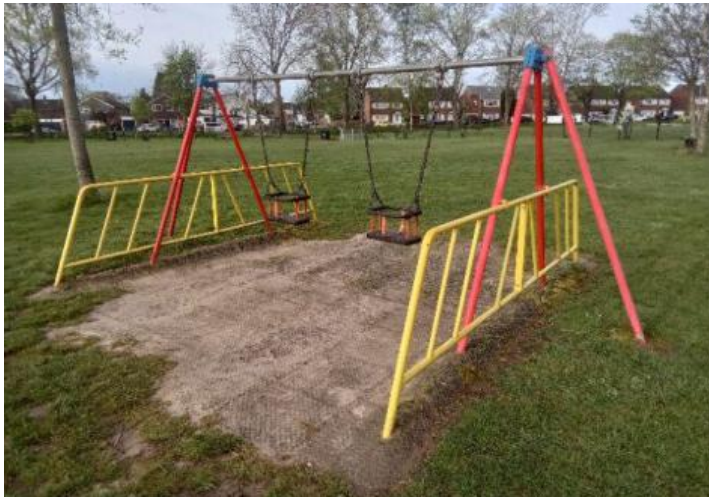
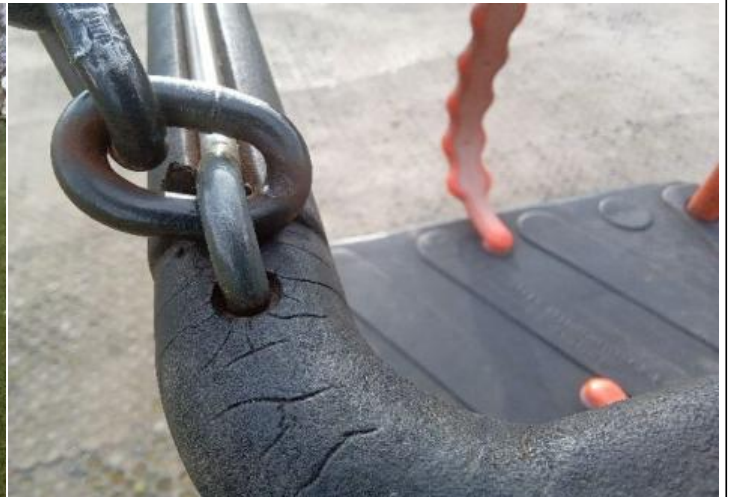
**Item:** Swings - 1 Bay 2 Seat (Cradle)  
**Manufacturer:** GL Jones

**Finding:** There is some notable evidence of chain wear

**Action:** Monitor for any further deterioration and replace when 40% worn

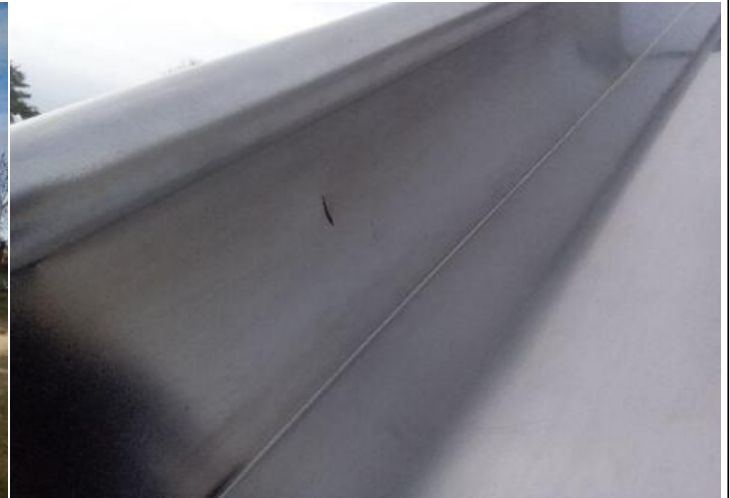
**Item:** Activity Equipment - Space Net  
**Manufacturer:** Corocord

**Finding:** The side of the slide is damaged

**Action:** Monitor for any further deterioration and repair as required

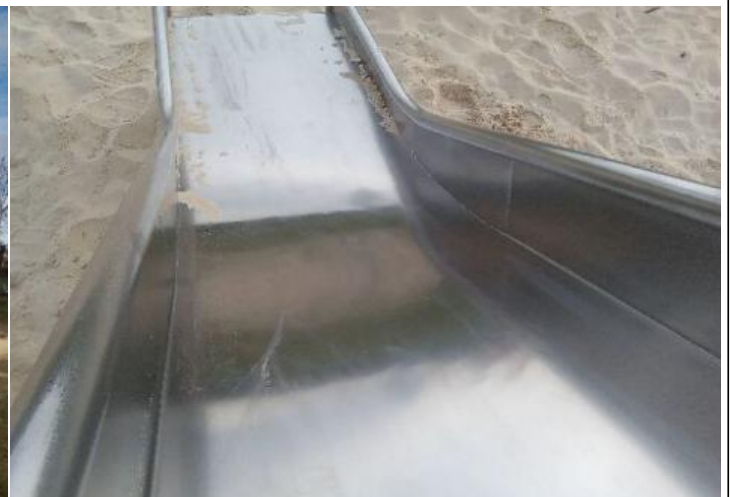
**Item:** Activity Equipment - Space Net  
**Manufacturer:** Corocord

**Finding:** There are a number of dents in the slide surface

**Action:** Monitor for any further deterioration and repair as required

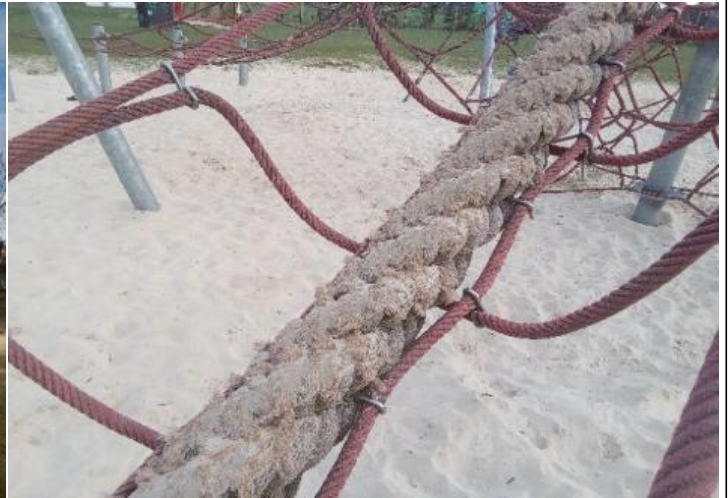
**Item:** Activity Equipment - Space Net  
**Manufacturer:** Corocord

**Finding:** The ropes/nets are worn/damaged in places

**Action:** Monitor for any further deterioration and repair or replace as required

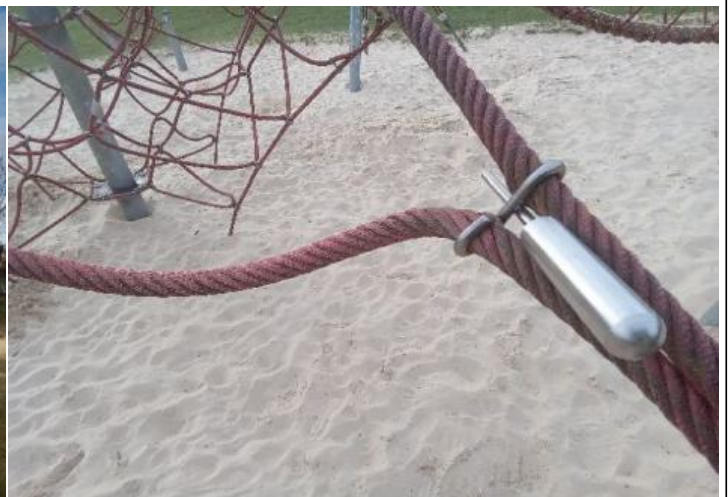
**Item:** Activity Equipment - Space Net  
**Manufacturer:** Corocord

**Finding:** There is/are finger entrapment/s in the rope connections and the item fails to meet the requirements of BS EN 1176 Part 1 4.2.7.6 Entrapment of fingers

**Action:** Monitor - No remedial work recommended

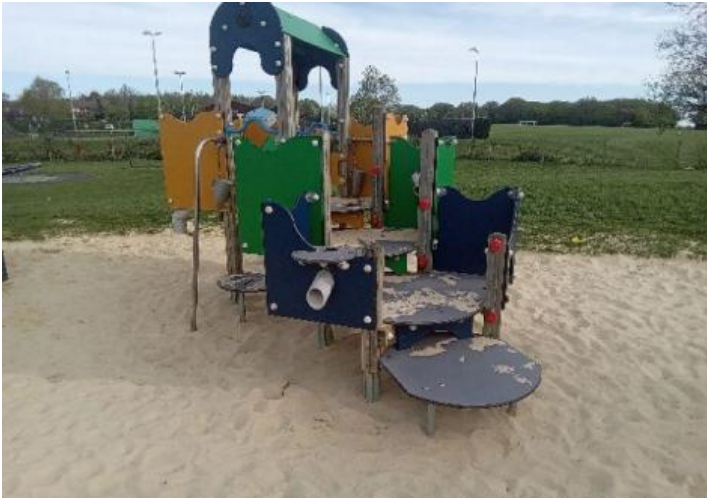
**Item:** Activity Equipment - Sand Play Unit  
**Manufacturer:** Kompan Ltd

**Finding:** There is/are bolt cap covers missing or damaged on the item

**Action:** Replace missing or damaged bolt cap covers

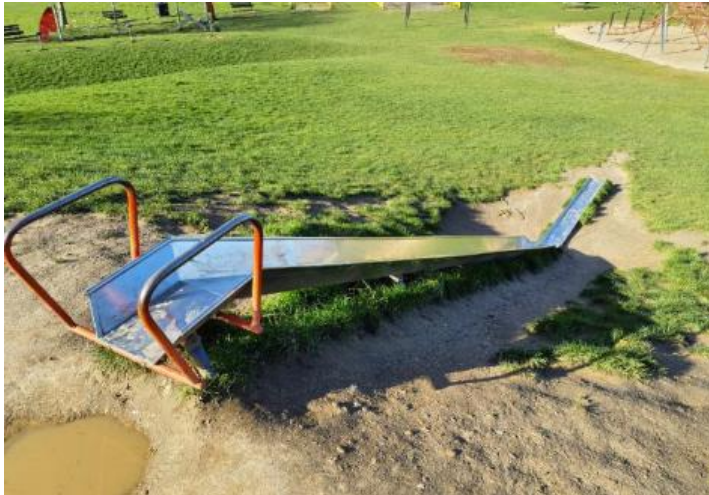
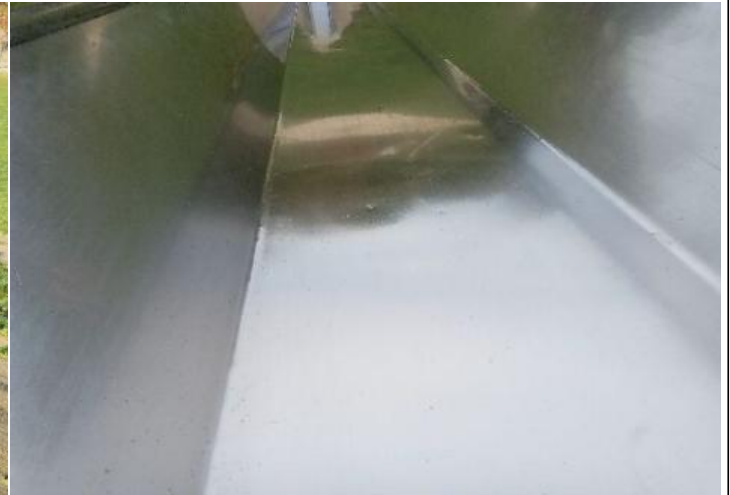
**Item:** Other - Embankment Slide  
**Manufacturer:** Not Identified

**Finding:** There are a number of dents in the slide surface

**Action:** Monitor for any further deterioration and repair as required
