# ST STEPHEN PARISH COUNCIL

You are summoned to a **Community & Leisure Committee meeting.**

To take place on **Thursday 23 May 2024 at 7.30pm**

- 2425/CL/012 To consider and agree response to structures on allotment plots installed without permission and make a recommendation to Full Council to amend the Allotment Conditions of Tenancy.

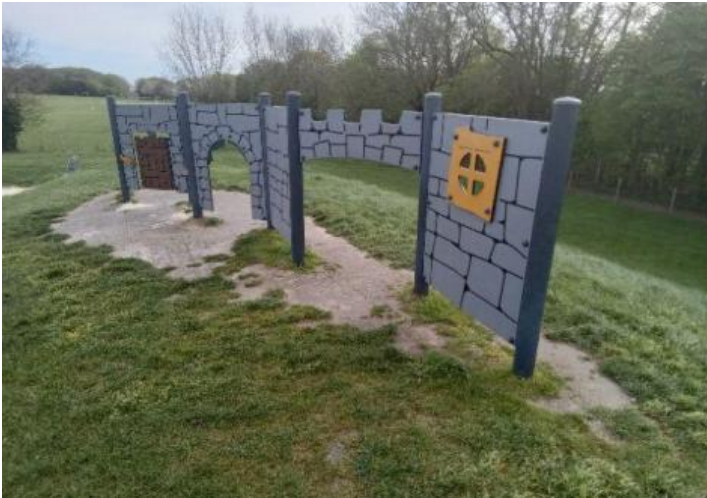
**Item:** Activity Equipment - Play Panel  
**Manufacturer:** Kompan Ltd

**Finding:** There is some damage to the item

**Action:** Monitor for any further deterioration and repair as required

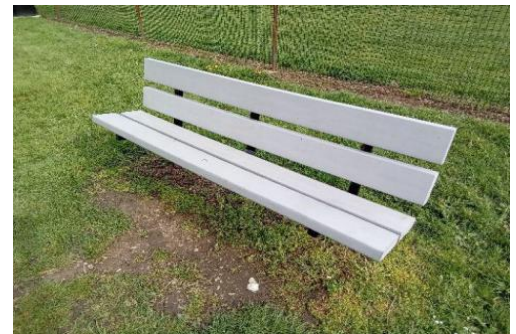
**Item:** Bench  
**Manufacturer:** Owner/Operator  
**Surface Type:** Grass  
**Item Quantity:** 2  
**Equipment Compliance:** N/A  
**Surface Area Compliance:** N/A

The surface has eroded in some areas and may be slippery in wet conditions - Reinstate the surface

There are areas or parts of the timber on the structure that have rotted - Replace all affected timbers

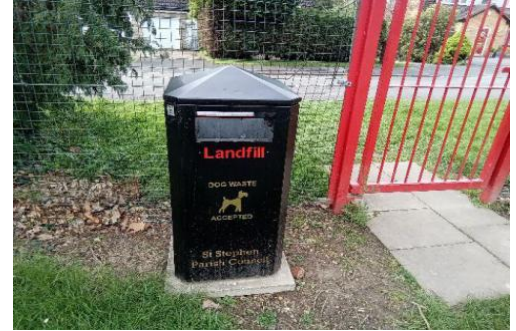
**Item:** Litter Bin  
**Manufacturer:** Owner/Operator  
**Surface Type:** Grass  
**Item Quantity:** 2  
**Equipment Compliance:** N/A  
**Surface Area Compliance:** N/A

The bin is not securely fixed to the surface and there is some possibility of the item tipping or rolling over - Secure the bin to the ground

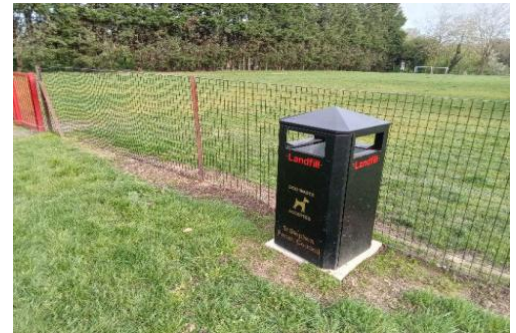
**Item:** Litter Bin  
**Manufacturer:** Broxap  
**Surface Type:** Paving Slabs  
**Item Quantity:** 1  
**Equipment Compliance:** N/A  
**Surface Area Compliance:** N/A

The bin is not securely fixed to the surface and there is some possibility of the item tipping or rolling over - Secure the bin to the ground

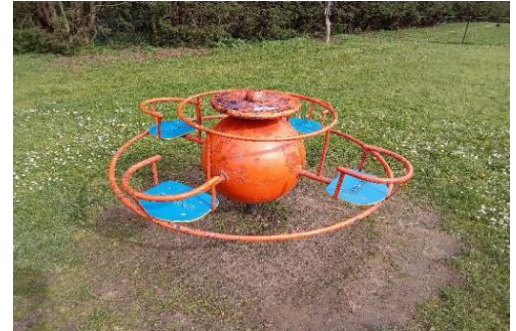
**Item:** Roundabout  
**Manufacturer:** Wicksteed Playgrounds  
**Surface Type:** Grass Matrix Tiles  
**Item Quantity:** 1  
**Equipment Compliance:** No  
**Surface Area Compliance:** Yes  
**Life Expectancy:** 3 - 5 Years  
**Total Findings:** 4

The item fails to meet the requirements of BS EN 1176 Part 1 4.2.7.2 for head and neck entrapment in the roundabout - Monitor - No remedial work recommended

The bearing is showing signs of wear - Monitor for any further deterioration and replace as required

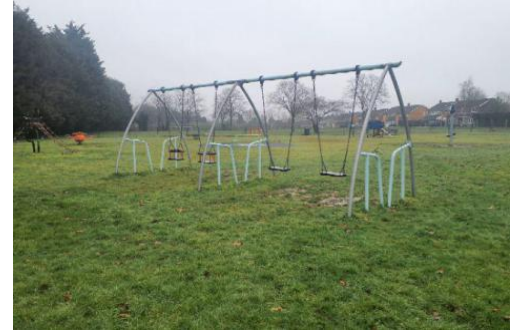
**Item:** 2 Bay (2 Flat, 2 Cradle)  
**Manufacturer:** Record RSS  
**Surface Type:** Grass Matrix Tiles  
**Item Quantity:** 1  
**Equipment Compliance:** No  
**Surface Area Compliance:** Yes  
**Life Expectancy:** >10 Years  
**Total Findings:** 9

There is some notable evidence of chain wear - Monitor for any further deterioration and replace when 40% worn

The chain openings are in excess of the 8.6mm as recommended by BS EN 1176 - Monitor - No remedial work recommended

The swing seat connectors are loose - Tighten to secure

The seat has minor damage or wear - Monitor for any further deterioration and replace as required

There is some wear to the shackles. - Monitor for any further deterioration and replace when 40% worn

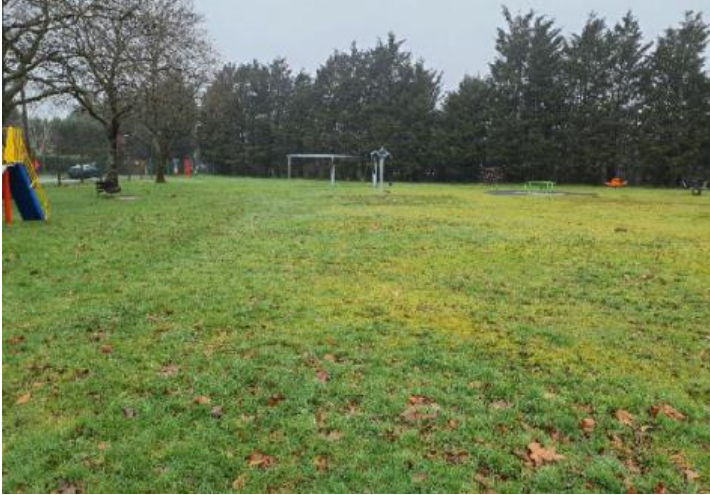
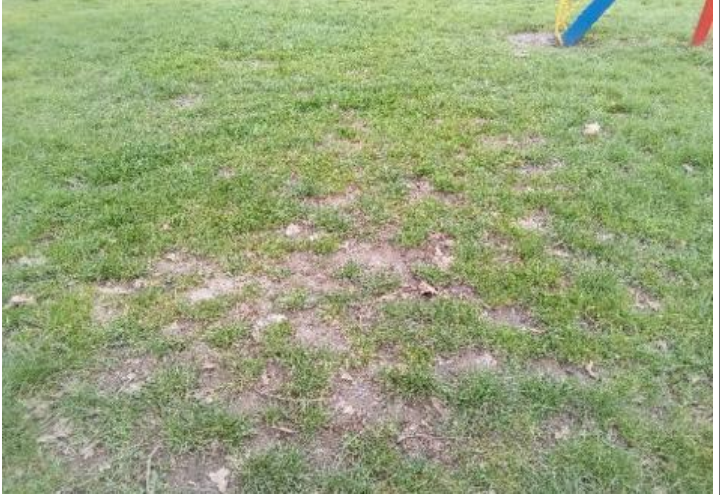
<span style="font-size: 1.2em; font-weight: bold;">i</span> 6 - Low Risk (Finding 1)			
<b>Item:</b>	Ancillary Items - Site General	<b>Risk Level:</b>	L - Low Risk
<b>Manufacturer:</b>	Owner/Operator	<b>Surface:</b>	N/A

<p><b>Finding:</b> The surface has eroded in some areas and may be slippery in wet conditions</p> <p><b>Action:</b> Reinstate the surface</p>

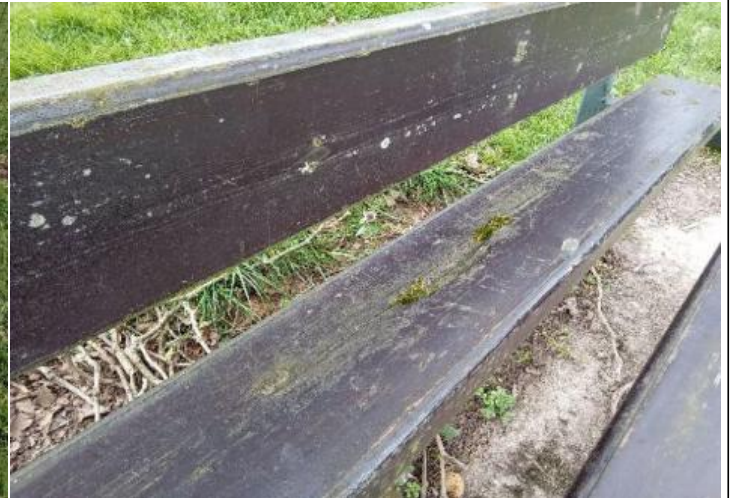
**Item:** Ancillary Items - Bench  
**Manufacturer:** Owner/Operator

**Finding:** Parts of the timber are rough or splintered

**Action:** Remove all rough or sharp edges

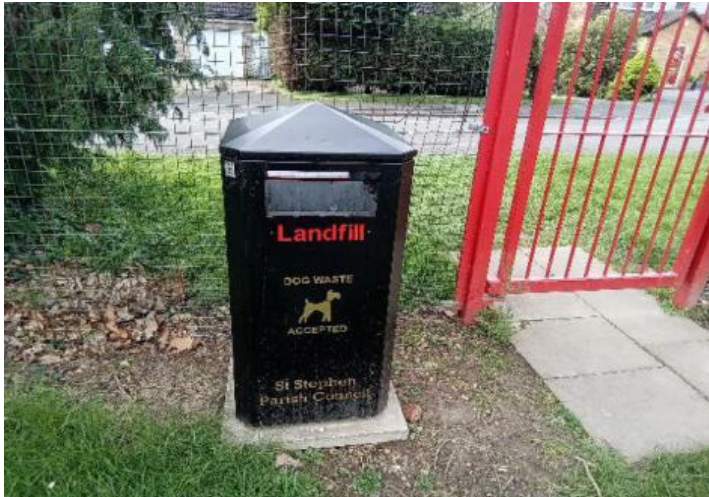
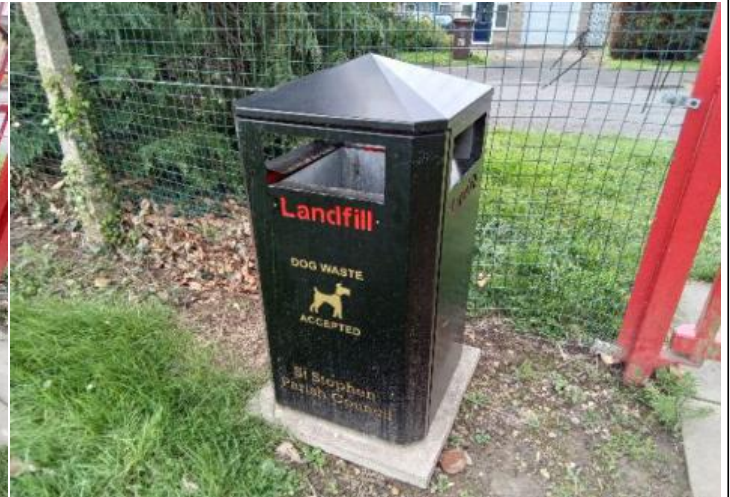
**Item:** Ancillary Items - Litter Bin  
**Manufacturer:** Owner/Operator

**Finding:** The bin is not securely fixed to the surface and there is some possibility of the item tipping or rolling over

**Action:** Secure the bin to the ground

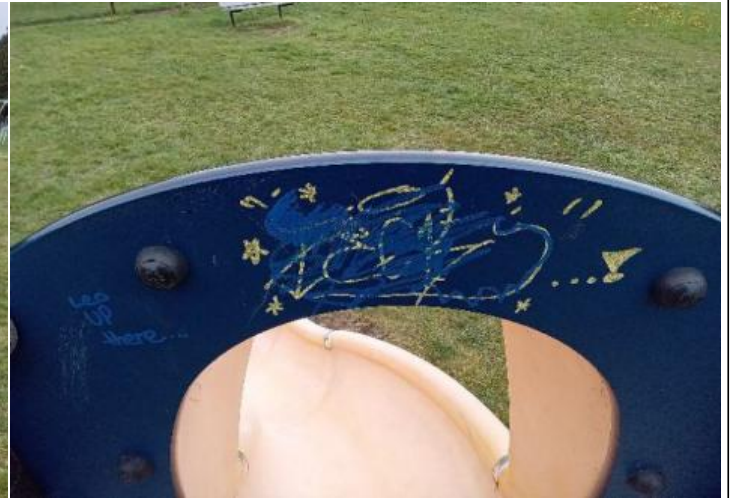
**Item:** Activity Equipment - Multi Play (Junior)  
**Manufacturer:** Kompan Ltd

**Finding:** There is some graffiti present

**Action:** Remove the graffiti

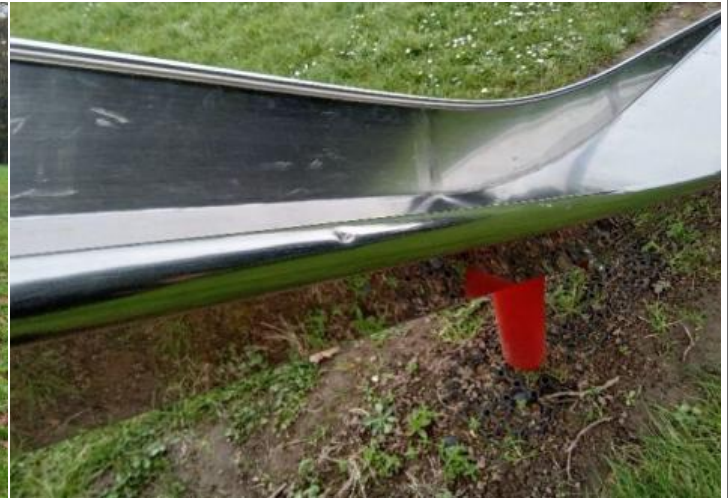
<b>Item:</b>	Other - Free Standing Slide	<b>Risk Level:</b>	L - Low Risk
<b>Manufacturer:</b>	G L Jones Playgrounds Ltd	<b>Surface:</b>	Grass Matrix Tiles

<b>Finding:</b> The side of the slide is damaged	<b>Action:</b> Monitor for any further deterioration and repair as required
--	---

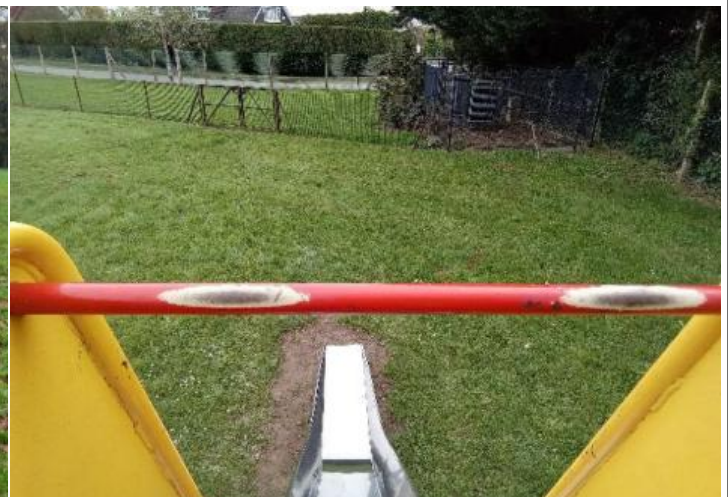
<b>Item:</b>	Other - Free Standing Slide	<b>Risk Level:</b>	L - Low Risk
<b>Manufacturer:</b>	G L Jones Playgrounds Ltd	<b>Surface:</b>	Grass Matrix Tiles

<b>Finding:</b> The paint is flaking off the metalwork	<b>Action:</b> Rub down and re-paint
--	--------------------------------------

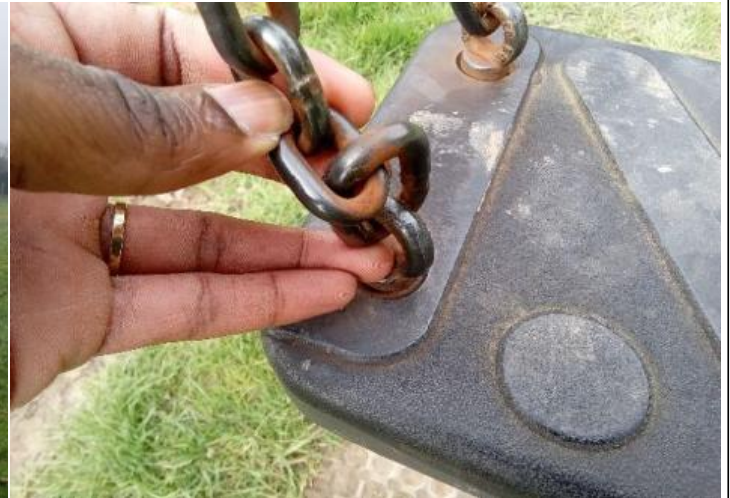
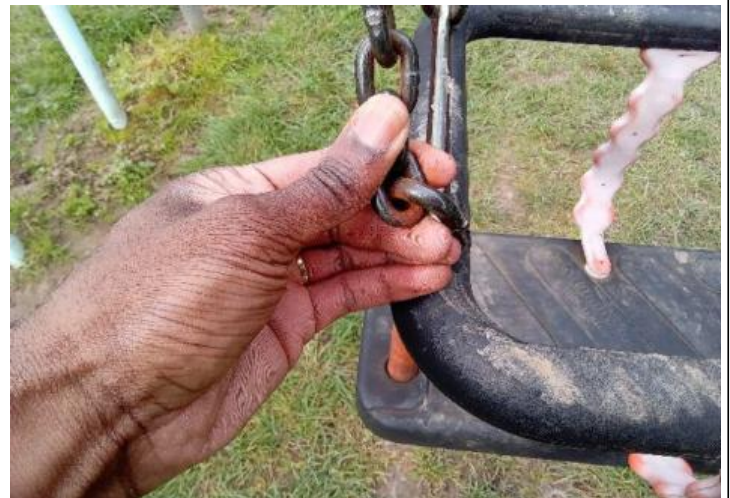
**Item:** Swings - 2 Bay (2 Flat, 2 Cradle)  
**Manufacturer:** Record RSS

**Finding:** There is some notable evidence of chain wear

**Action:** Monitor for any further deterioration and replace when 40% worn

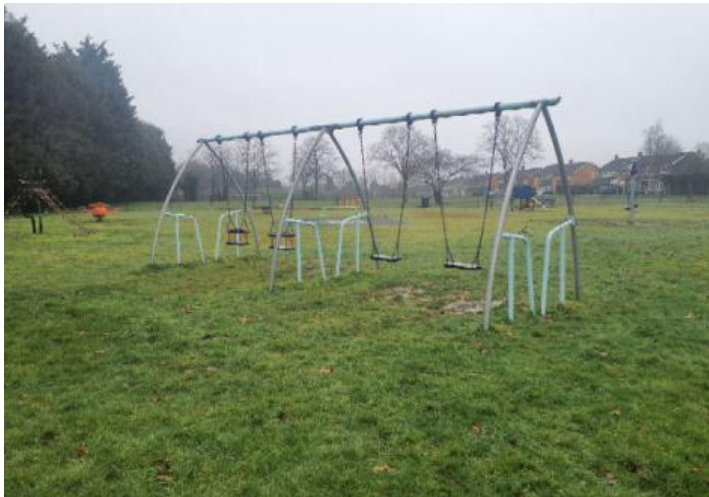
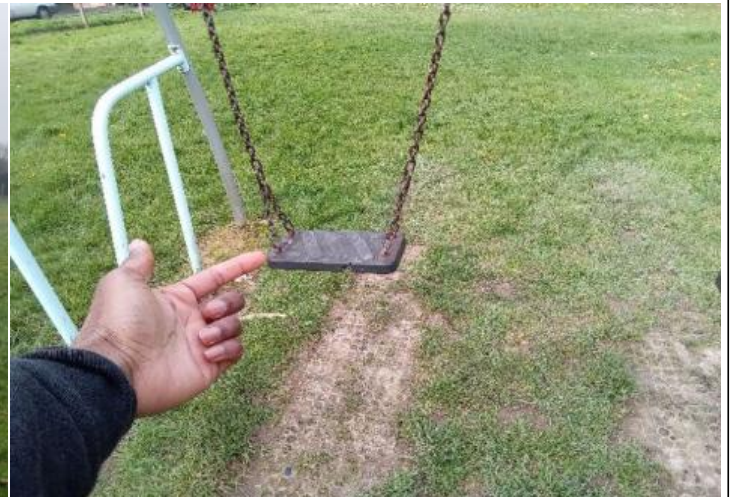
**Item:** Swings - 2 Bay (2 Flat, 2 Cradle)  
**Manufacturer:** Record RSS

**Finding:** The swing seat connectors are loose **Action:** Tighten to secure

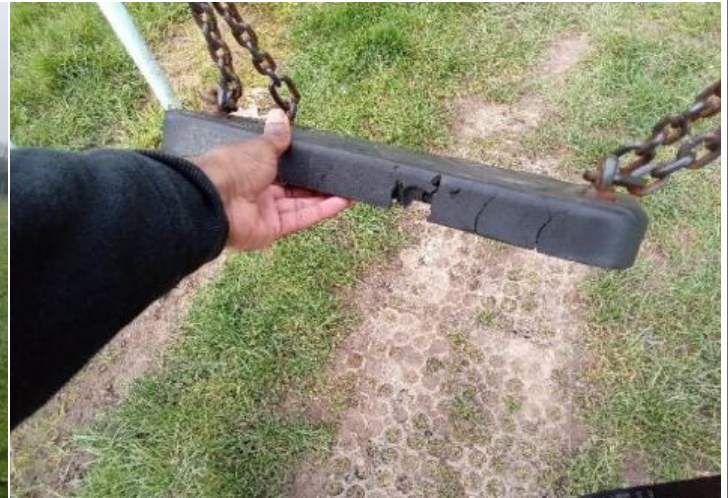
**Item:** Swings - 2 Bay (2 Flat, 2 Cradle)  
**Manufacturer:** Record RSS  
**Risk Level:** L - Low Risk  
**Surface:** Grass Matrix Tiles

**Finding:** The seat has minor damage or wear  
**Action:** Monitor for any further deterioration and replace as required

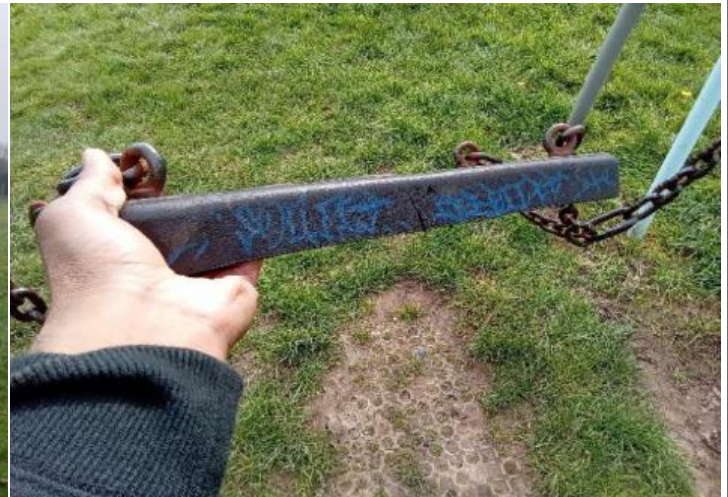
**Item:** Swings - 2 Bay (2 Flat, 2 Cradle)  
**Manufacturer:** Record RSS  
**Risk Level:** N - Risk Assessment not Undertaken  
**Surface:** Grass Matrix Tiles

**Finding:** There is some graffiti present  
**Action:** Remove the graffiti

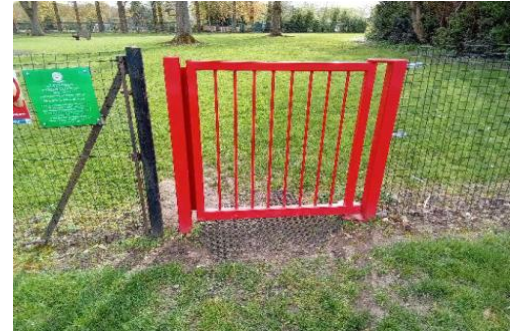
**Item:** Gate - Self Closing  
**Manufacturer:** Not Identified  
**Surface Type:** Grass Matrix Tiles  
**Item Quantity:** 1  
**Equipment Compliance:** N/A  
**Surface Area Compliance:** N/A

There are trip hazards caused by the grass matrix tiles at the edges of the surface - Adjust grass matrix tile and reinstaate surrounding surface levels to remove the trip points

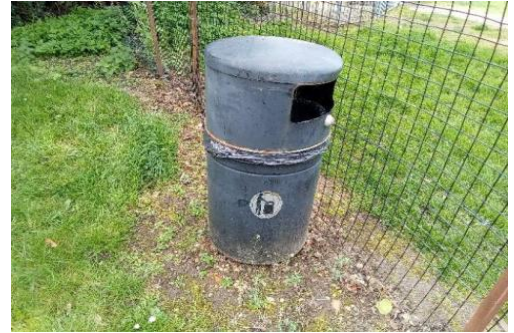
**Item:** Litter Bin  
**Manufacturer:** Not Identified  
**Surface Type:** Grass  
**Item Quantity:** 1  
**Equipment Compliance:** N/A  
**Surface Area Compliance:** N/A

| <b>Finding 1</b><br>The lid or door of the litter bin is not secured - Ensure the lid or door is kept locked | <b>Finding 2</b><br>The bin is not securely fixed to the surface and there is some possibility of the item tipping or rolling over - Secure the bin to the ground |
| <b>Finding 3</b><br>There is some damage to the item - Monitor for any further deterioration and repair as required | <b>Finding 4</b><br>The paintwork on this item has been damaged or worn exposing the metal underneath which is rusting / corroding - Treat affected areas and repaint |

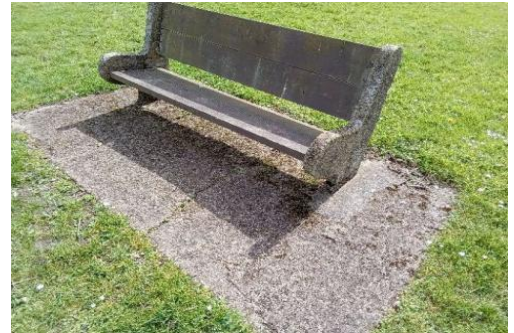
**Item:** Bench  
**Manufacturer:** Not Identified  
**Surface Type:** N/A  
**Item Quantity:** 1  
**Equipment Compliance:** N/A  
**Surface Area Compliance:** N/A

| <b>Finding 1</b><br>There is algae, silt or moss growth on the surface resulting in slippery conditions - Clean and treat appropriately | <b>Finding 2</b><br>There are trip hazards at the edges of the surface - Reinstate surrounding surface levels to remove the trip points |
| <b>Finding 3</b><br>There is some minor damage to the surface - Monitor for any further deterioration and repair as required | |

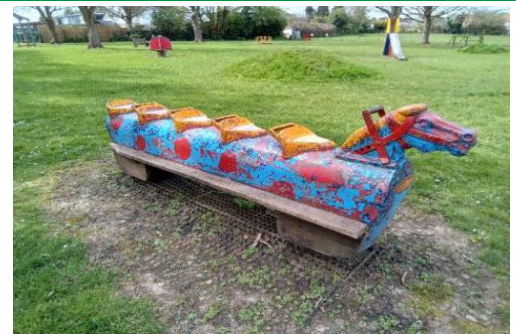
**Item:** Rocking Horse  
**Manufacturer:** Wicksteed Playgrounds  
**Surface Type:** Grass Matrix Tiles  
**Item Quantity:** 1  
**Equipment Compliance:** No  
**Surface Area Compliance:** Yes  
**Life Expectancy:** 5 -10 Years  
**Total Findings:** 5

There is some damage to the seat - Monitor for any further deterioration and repair as required

There are areas or parts of the timber on the structure that have rotted - Replace all affected timbers

The paintwork on this item has been damaged or worn exposing the metal underneath which is rusting / corroding - Treat affected areas and repaint

There is no gaiter protection for accessible moving parts (possible shear trap) as recommended in BS EN 1176 Part 1; 4.2.6 Moving Parts - Monitor - No remedial work recommended

There is/are finger entrapment/s in the rocking horse frame and the item fails to meet the requirements of BS EN 1176 Part 1 4.2.7.6 Entrapment of fingers - Remove the entrapment

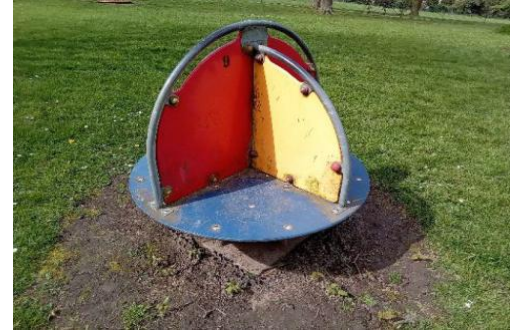
**Item:** Spring Board  
**Manufacturer:** Kompan Ltd  
**Surface Type:** Grass Matrix Tiles  
**Item Quantity:** 1  
**Equipment Compliance:** Yes  
**Surface Area Compliance:** Yes  
**Life Expectancy:** >10 Years  
**Total Findings:** 4

The grass mats are silted up, the soil is compacted and the area will become very slippery when the soil is wet. - Reinstate as required

There is/are bolt cap covers missing or damaged on the item - Replace missing or damaged bolt cap covers

The paintwork on the spring has been damaged or worn exposing the metal underneath which is rusting - Treat any rusting components and repaint

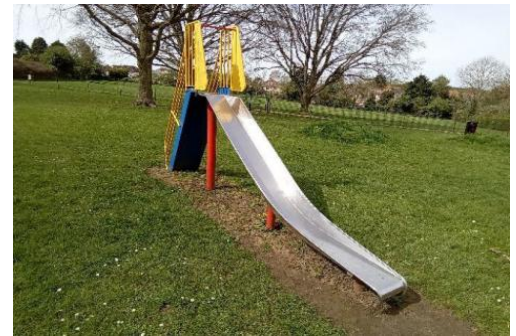
**Item:** Free Standing Slide  
**Manufacturer:** G L Jones Playgrounds Ltd  
**Surface Type:** Grass Matrix Tiles  
**Item Quantity:** 1  
**Equipment Compliance:** Yes  
**Surface Area Compliance:** Yes  
**Life Expectancy:** >10 Years  
**Total Findings:** 3

There are a number of dents in the slide surface - Monitor for any further deterioration and repair as required

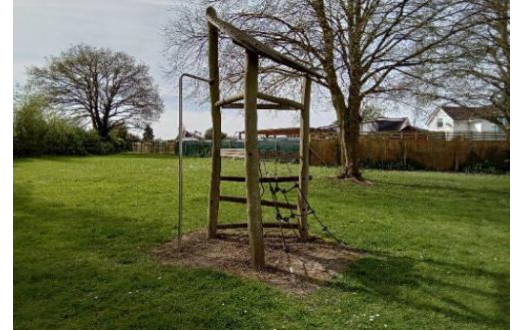
**Item:** Multi Play (Junior)  
**Manufacturer:** Kompan Ltd  
**Surface Type:** Grass Matrix Tiles  
**Item Quantity:** 1  
**Equipment Compliance:** Yes  
**Surface Area Compliance:** Yes

The item is slightly loose in its foundations - Monitor for any further deterioration and repair as required

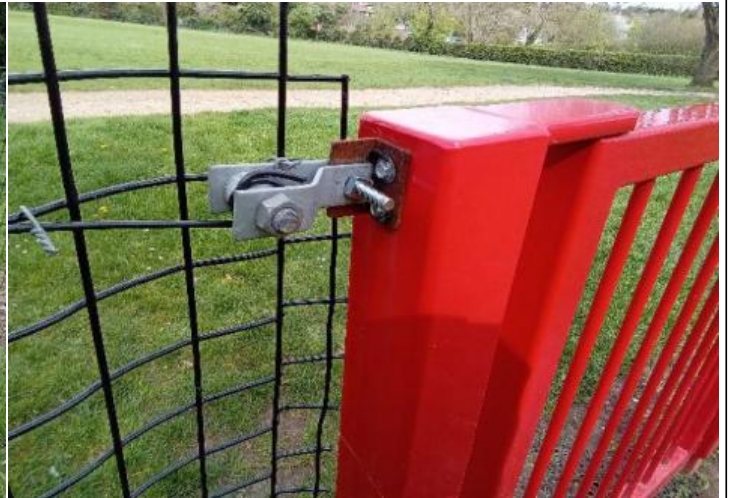
**Item:** Gates - Gate - Self Closing  
**Manufacturer:** Not Identified

**Finding:** There are projecting bolt thread(s) present

**Action:** Remove excess thread length and deburr or provide cap

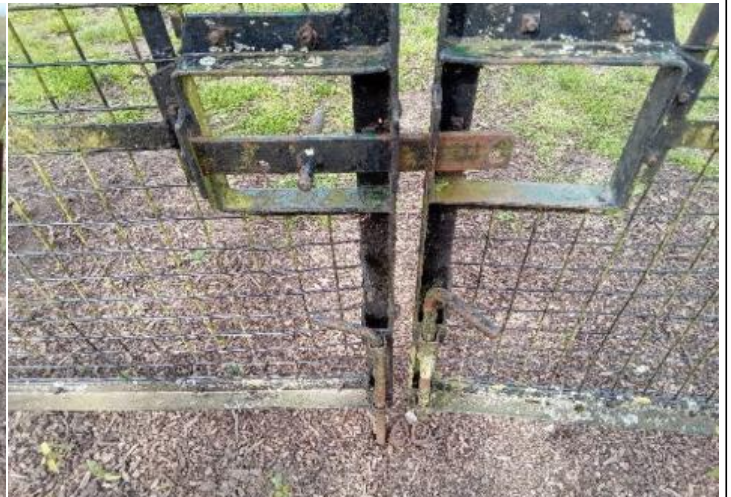
**Item:** Gates - Gate - Maintenance  
**Manufacturer:** Not Identified

**Finding:** There is no padlock on the maintenance gate

**Action:** Provide a padlock to secure the gate

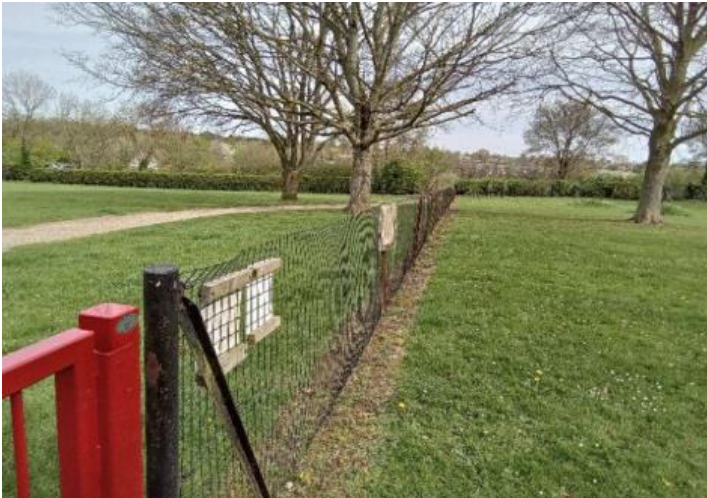
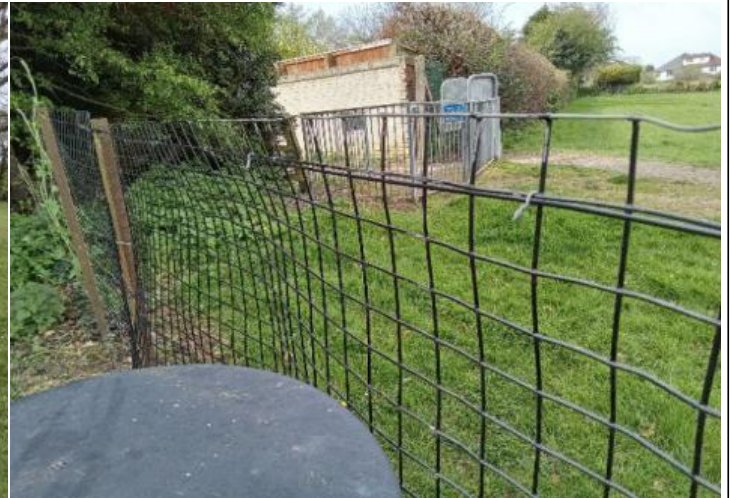
**Item:** Fences - Fence - Steel Mesh  
**Manufacturer:** Not Identified

**Finding:** Cable ties have been used on the item and there are sharp projecting ends

**Action:** Remove if not required or replace with a more appropriate alternative fixing method if used as a fixing

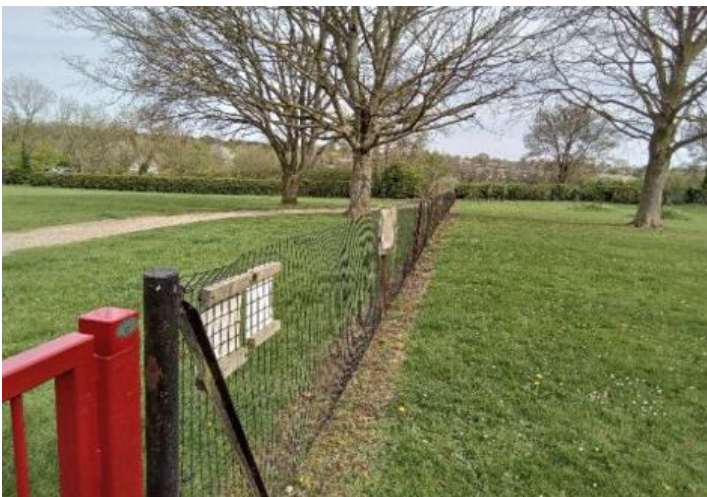
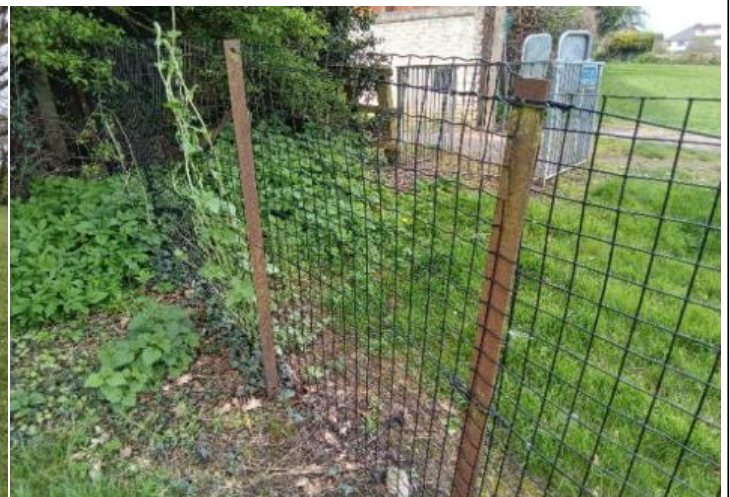
**Item:** Fences - Fence - Steel Mesh  
**Manufacturer:** Not Identified

**Finding:** There are a number of loose posts around the fence

**Action:** Monitor for any further deterioration and reset as required

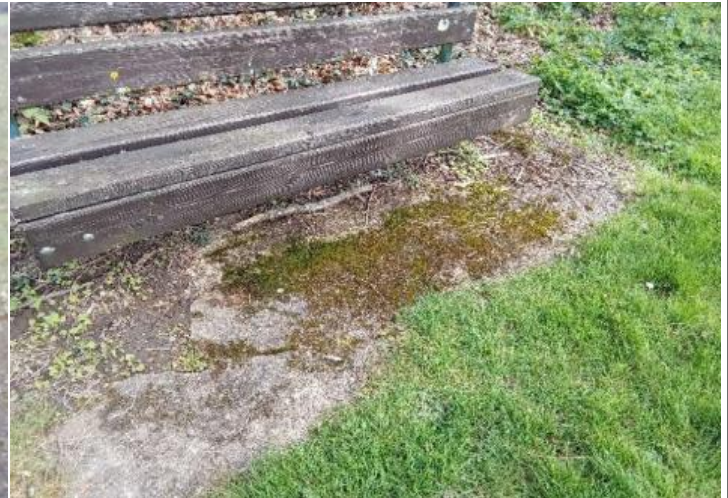
**i** 6 - Low Risk (Finding 1)

**Item:** Ancillary Items - Bench  
**Manufacturer:** Not Identified  
**Risk Level:** L - Low Risk  
**Surface:** Concrete

**Finding:** There is algae, silt or moss growth on the surface resulting in slippery conditions  
**Action:** Clean and treat appropriately

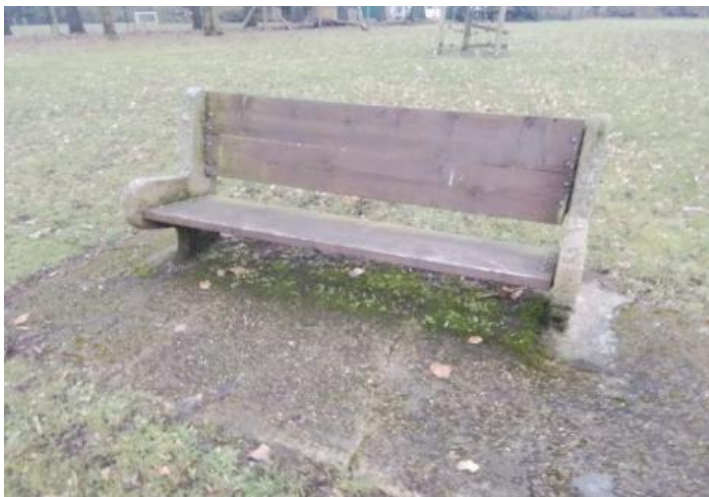
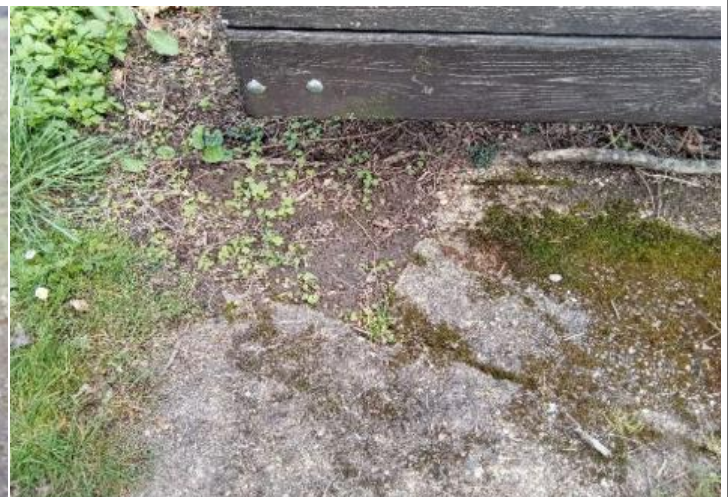
**i** 4 - Very Low Risk (Finding 2)

**Item:** Ancillary Items - Bench  
**Manufacturer:** Not Identified  
**Risk Level:** V - Very Low Risk  
**Surface:** Concrete

**Finding:** There is some minor damage to the surface  
**Action:** Monitor for any further deterioration and repair as required

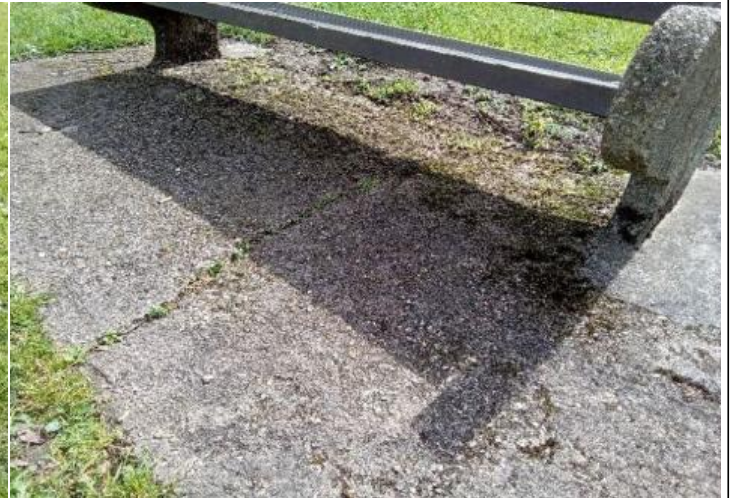
**Item:** Ancillary Items - Bench  
**Manufacturer:** Not Identified

**Finding:** There is algae, silt or moss growth on the surface resulting in slippery conditions

**Action:** Clean and treat appropriately

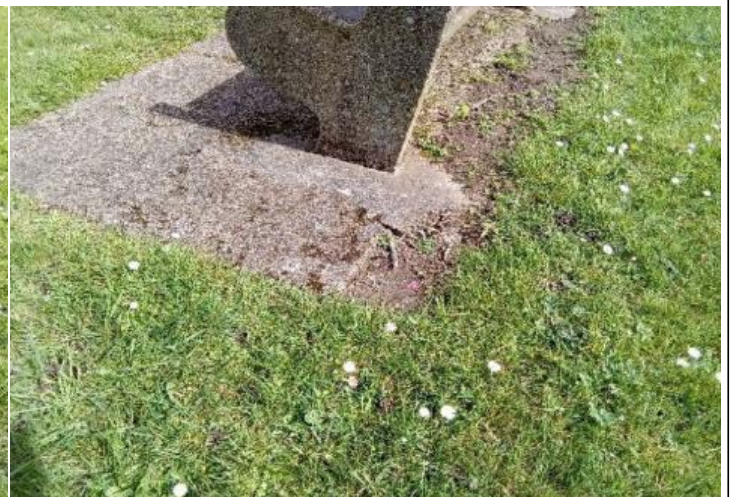
**Item:** Ancillary Items - Bench  
**Manufacturer:** Not Identified

**Finding:** There are trip hazards at the edges of the surface

**Action:** Reinstate surrounding surface levels to remove the trip points

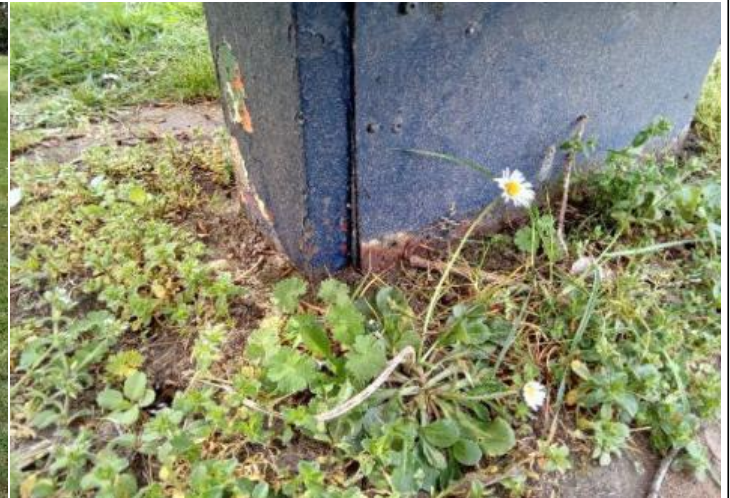
**Item:** Rocking Equipment - See Saw  
**Manufacturer:** Wicksteed Playgrounds

**Risk Level:** L - Low Risk  
**Surface:** Grass Matrix Tiles

**Finding:** There is surface corrosion / rust present on the item

**Action:** Consider treating the item

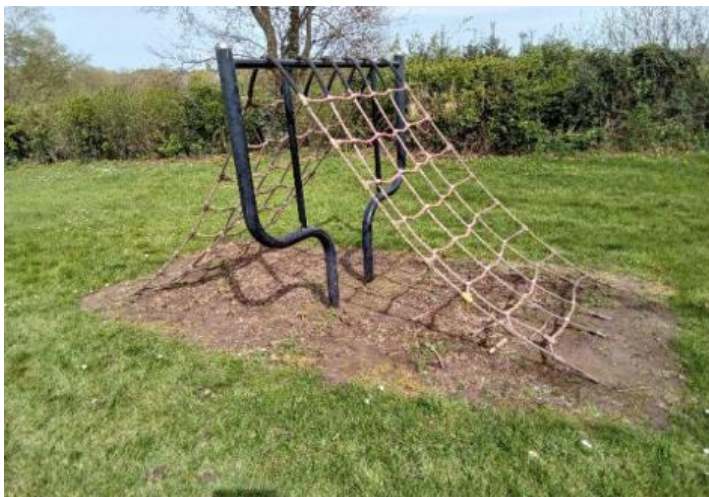
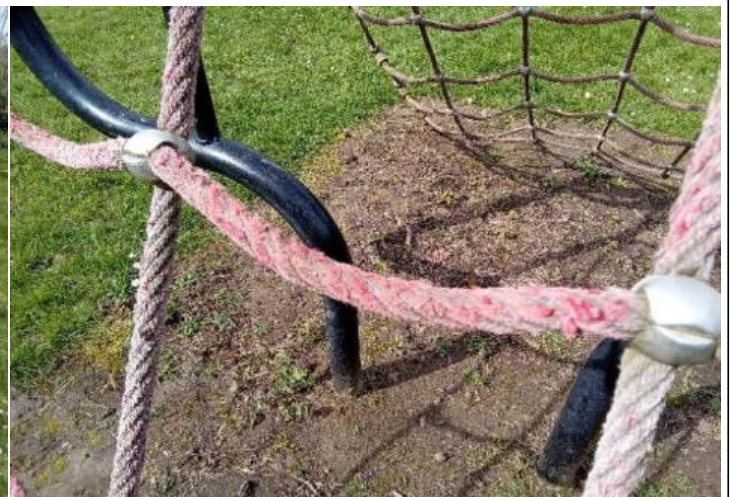
**Item:** Activity Equipment - Net Climber  
**Manufacturer:** Wicksteed Playgrounds

**Risk Level:** L - Low Risk  
**Surface:** Grass Matrix Tiles

**Finding:** The rope has worn and wire strands are exposed

**Action:** Replace rope or net

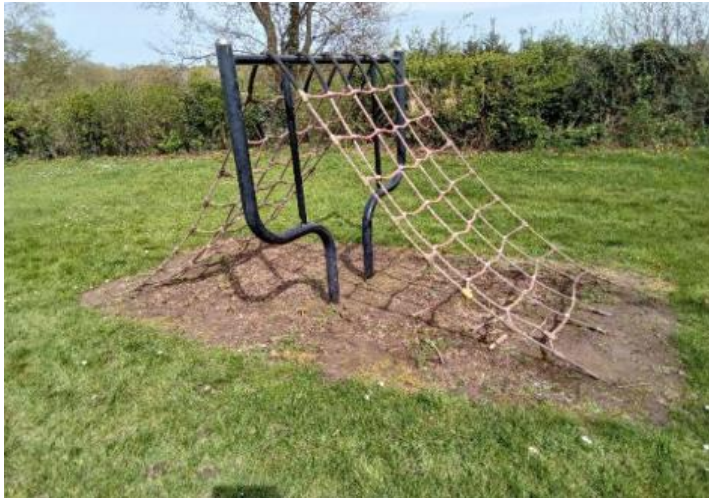
**Item:** Activity Equipment - Net Climber  
**Manufacturer:** Wicksteed Playgrounds

**Risk Level:** L - Low Risk  
**Surface:** Grass Matrix Tiles

**Finding:** The chain/rope covering is damaged

**Action:** Monitor for any further deterioration and replace as required

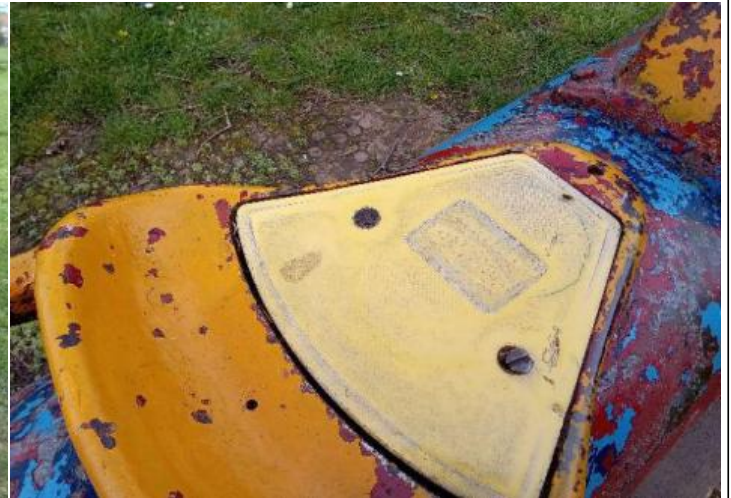
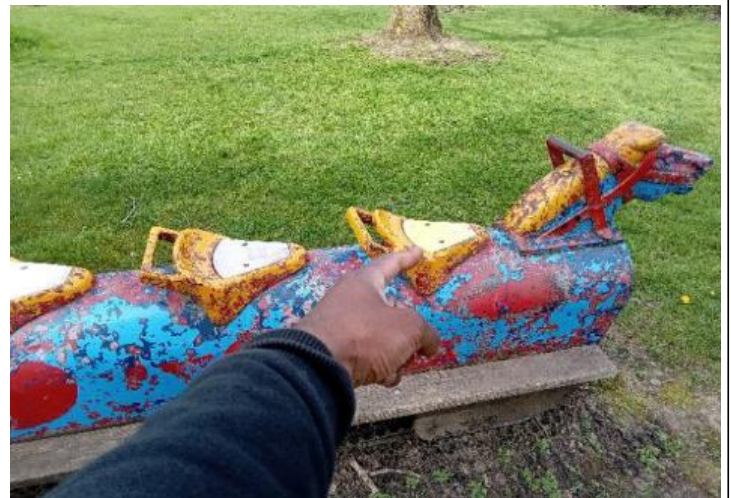
**Item:** Rocking Equipment - Rocking Horse  
**Manufacturer:** Wicksteed Playgrounds

**Risk Level:** L - Low Risk  
**Surface:** Grass Matrix Tiles

**Finding:** There is some damage to the seat

**Action:** Monitor for any further deterioration and repair as required

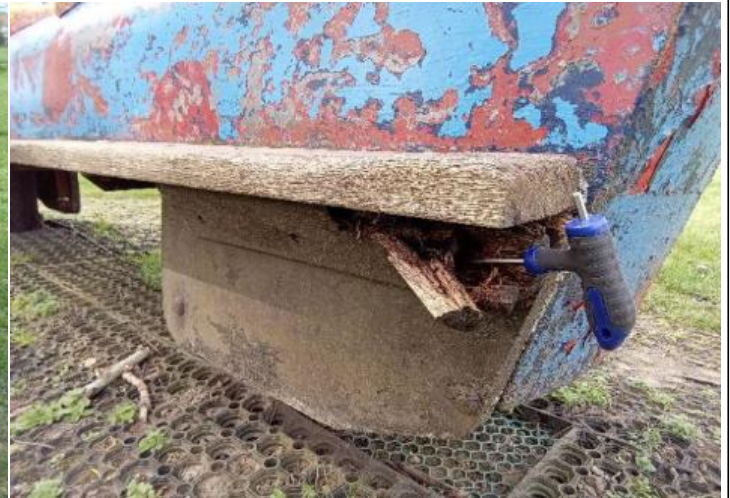
**Item:** Rocking Equipment - Rocking Horse  
**Manufacturer:** Wicksteed Playgrounds

**Risk Level:** L - Low Risk  
**Surface:** Grass Matrix Tiles

**Finding:** There are areas or parts of the timber on the structure that have rotted

**Action:** Replace all affected timbers

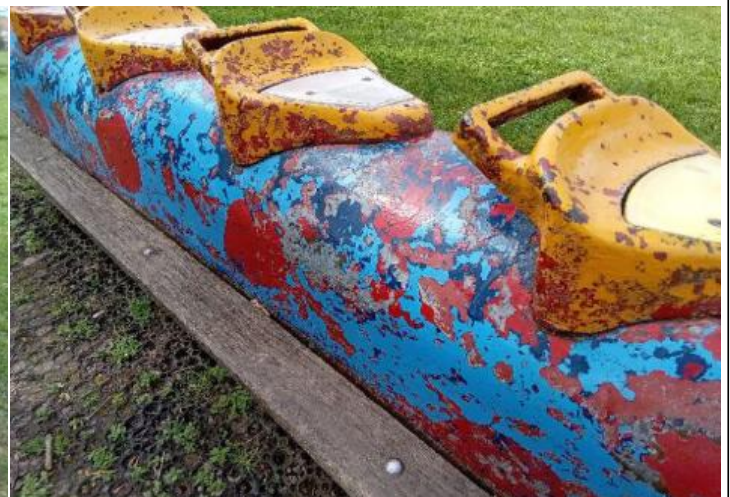
**Item:** Rocking Equipment - Rocking Horse  
**Manufacturer:** Wicksteed Playgrounds

**Risk Level:** L - Low Risk  
**Surface:** Grass Matrix Tiles

**Finding:** The paintwork on this item has been damaged or worn exposing the metal underneath which is rusting / corroding

**Action:** Treat affected areas and repaint

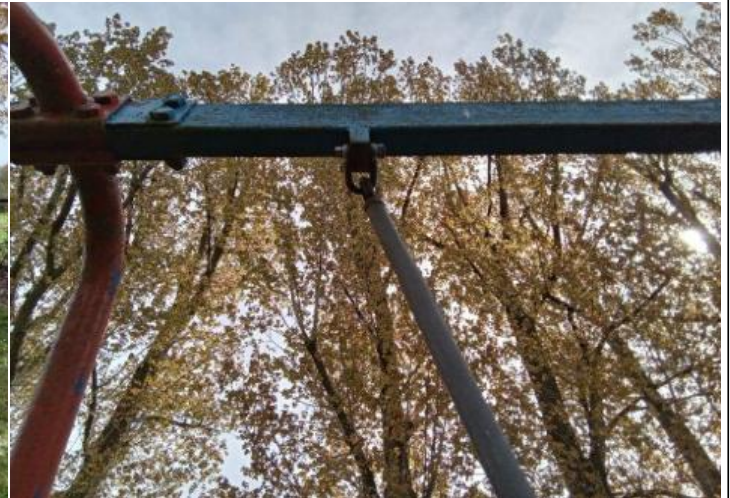
**Item:** Swings - 2 Bay (2 Flat, 2 Cradle)  
**Manufacturer:** S M P (Playgrounds Ltd)

**Risk Level:** L - Low Risk  
**Surface:** Grass Matrix Tiles

**Finding:** There is some wear to the shackles.

**Action:** Monitor for any further deterioration and replace when 40% worn

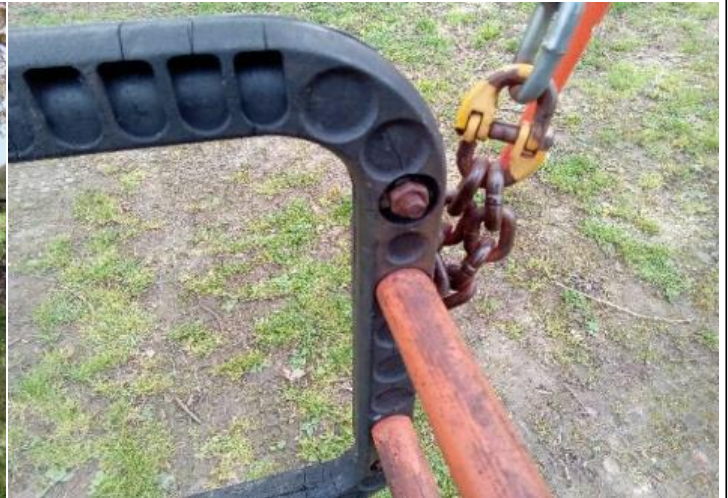
**Item:** Swings - 2 Bay (2 Flat, 2 Cradle)  
**Manufacturer:** S M P (Playgrounds Ltd)

**Risk Level:** L - Low Risk  
**Surface:** Grass Matrix Tiles

**Finding:** There are caps missing from the underside of the seats **Action:** Replace missing caps under the seats

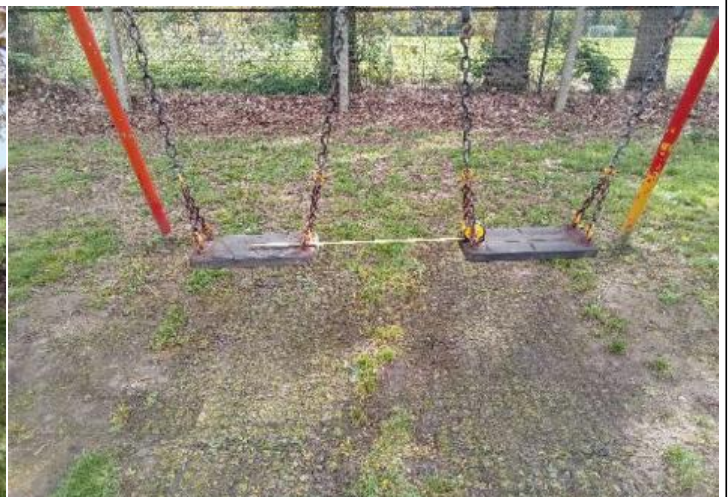
**Item:** Swings - 2 Bay (2 Flat, 2 Cradle)  
**Manufacturer:** S M P (Playgrounds Ltd)

**Risk Level:** V - Very Low Risk  
**Surface:** Grass Matrix Tiles

**Finding:** The seats are too close to each other as defined in BS EN 1176 Part 2; this is a low risk failure and no remedial action is required **Action:** Monitor - No remedial work recommended

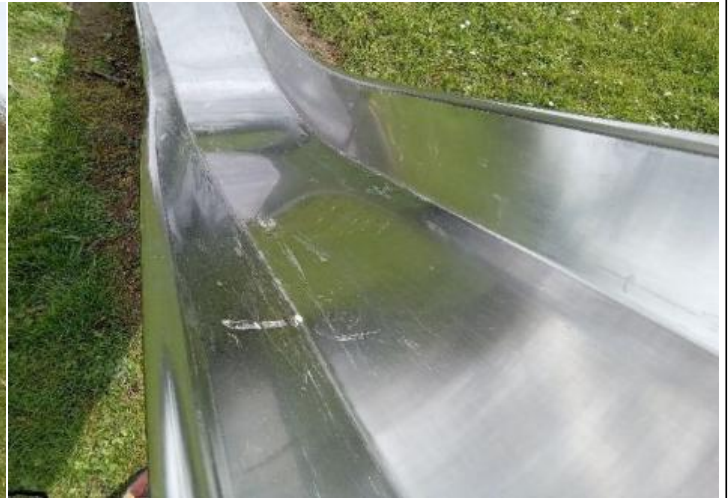
**Item:** Other - Free Standing Slide  
**Manufacturer:** G L Jones Playgrounds Ltd

**Risk Level:** V - Very Low Risk  
**Surface:** Grass Matrix Tiles

**Finding:** There are a number of dents in the slide surface

**Action:** Monitor for any further deterioration and repair as required

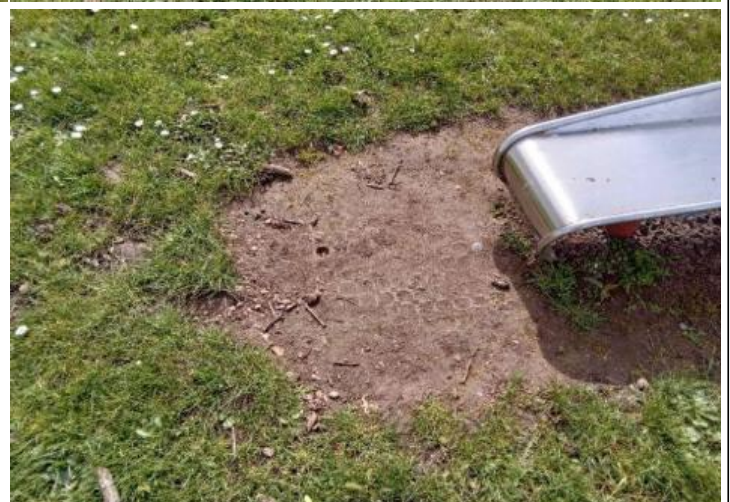
**Item:** Other - Free Standing Slide  
**Manufacturer:** G L Jones Playgrounds Ltd

**Risk Level:** L - Low Risk  
**Surface:** Grass Matrix Tiles

**Finding:** The grass mats are silted up, the soil is compacted and the area will become very slippery when the soil is wet. **Action:** Reinstate as required

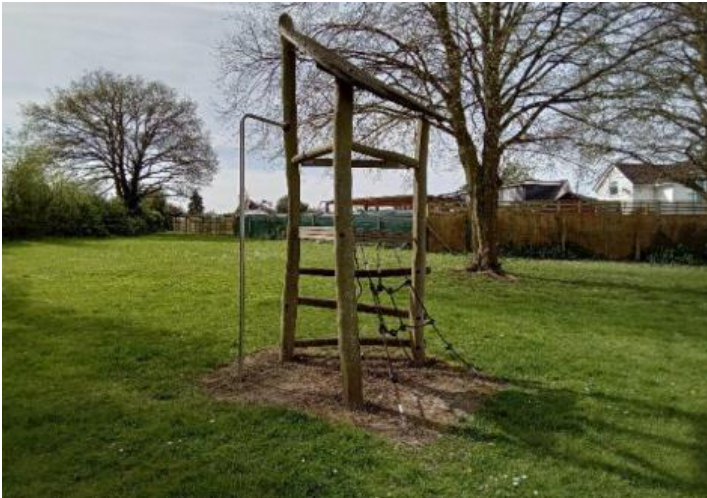
**Finding:** The chain openings are in excess of the 8.6mm as recommended by BS EN 1176  
**Action:** Monitor - No remedial work recommended

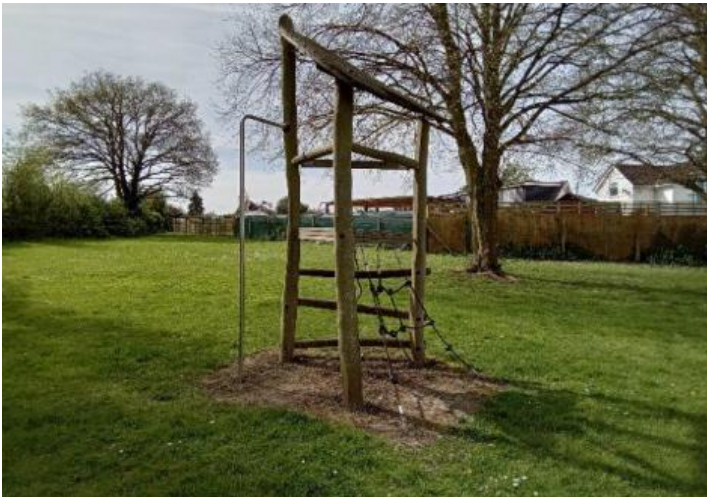
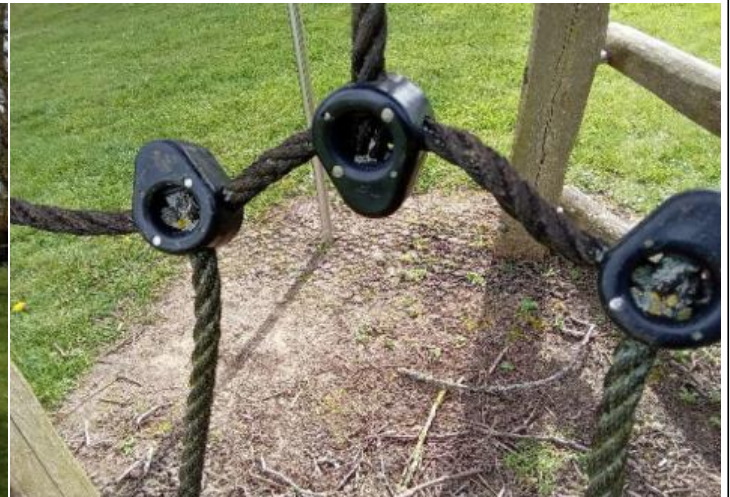
**Finding:** There is algae or moss on the surface of the equipment  
**Action:** Clean and treat appropriately

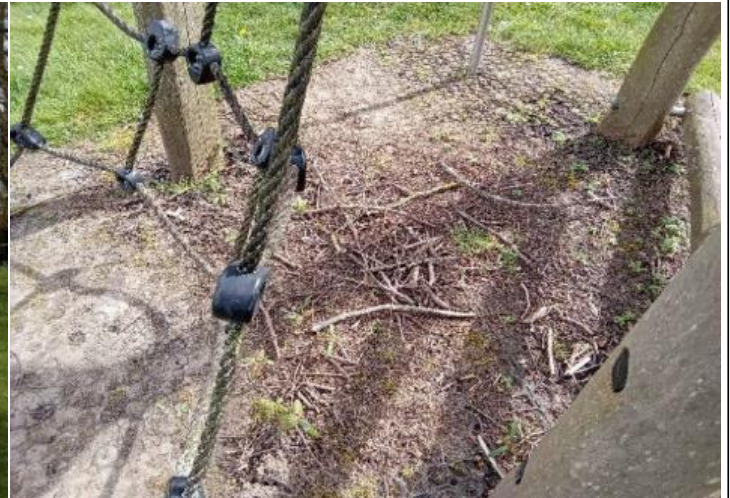
**Finding:** There is some tree debris on the surfacing

**Action:** Remove and maintain

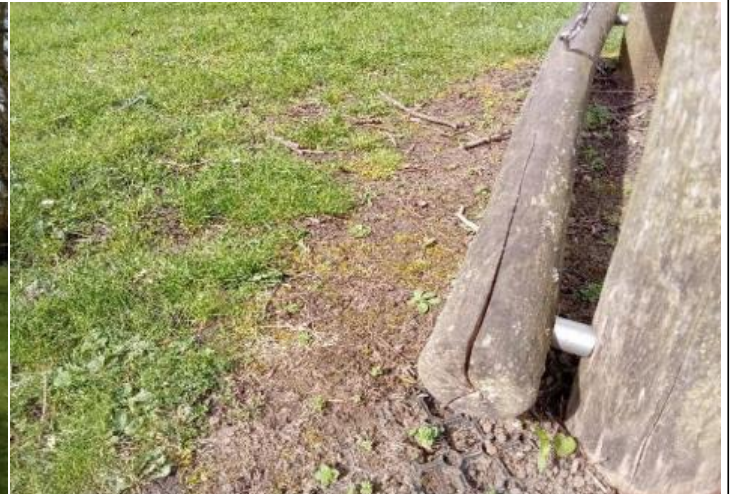
**Finding:** The timber has a number of splits/shakes or air cracks and this may affect the stability or allow water ingress which will accelerate the rotting process

**Action:** Monitor to ensure the splits do not cross through fixing points of the structure and/or cause any instability

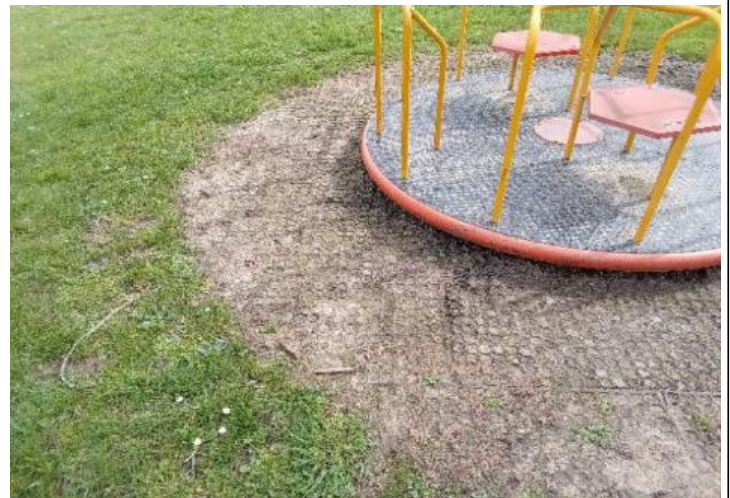
**Finding:** There are gaps opening between the grass mat tiles

**Action:** Provide additional ties or secure / reinstate surface

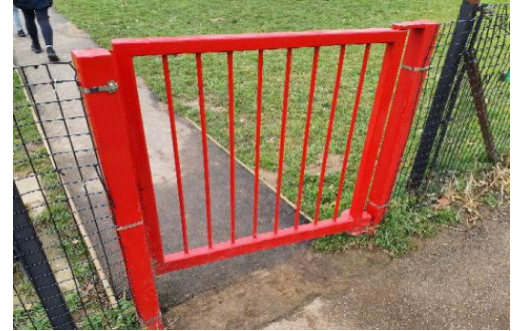
There is some minor damage to the surface - Monitor for any further deterioration and repair as required

There are trip hazards at the edges of the surface - Reinstate surrounding surface levels to remove the trip points

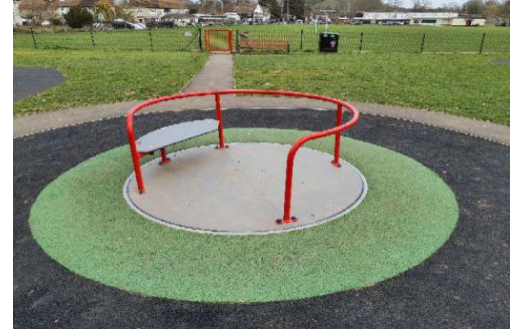
There is/are bolt cap covers missing or damaged on the item - Replace missing or damaged bolt cap covers

Roundabout is snagging against outer edge causing difficulty in rotating - Repair for rotation

There are trip hazards at the edges of the surface - Reinstate surrounding surface levels to remove the trip points
