# ST STEPHEN PARISH COUNCIL

You are summoned to a **Community & Leisure Committee meeting.**

To take place on **Thursday 23 May 2024 at 7.30pm**

- 2425/CL/012 To consider and agree response to structures on allotment plots installed without permission and make a recommendation to Full Council to amend the Allotment Conditions of Tenancy.

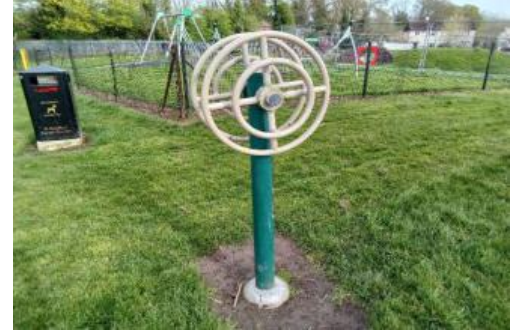
**Item:** Shoulder Flex  
**Manufacturer:** Fresh Air Fitness  
**Surface Type:** Grass Matrix Tiles  
**Item Quantity:** 1  
**Equipment Compliance:** Yes  
**Surface Area Compliance:** Yes  
**Life Expectancy:** 5 -10 Years  
**Total Findings:** 1

This item is satisfactory - no work required -

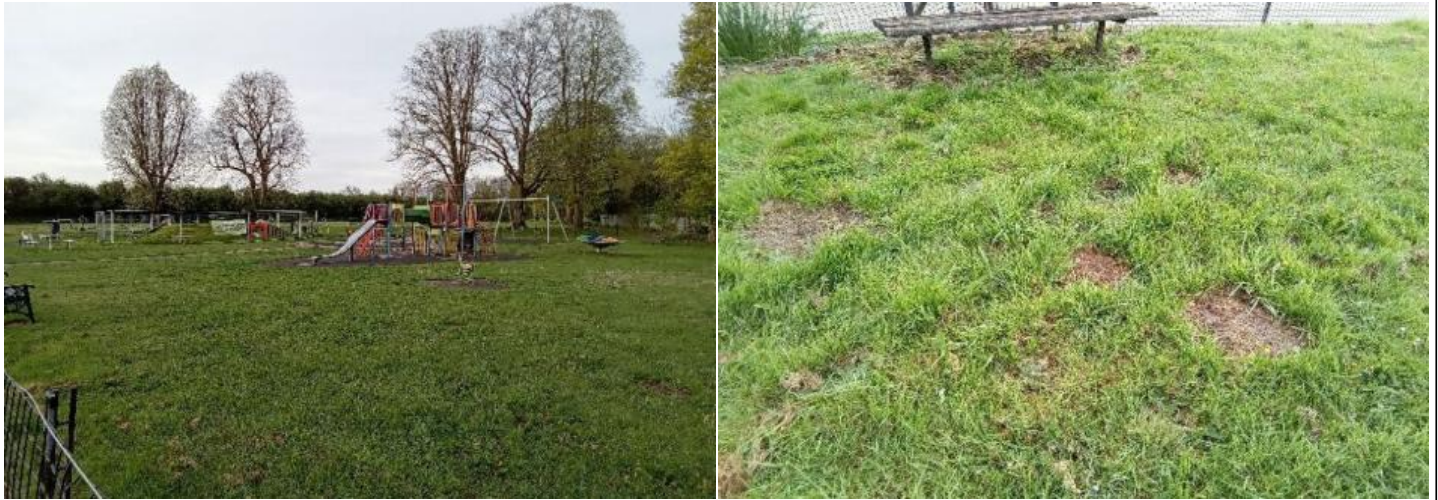
**Finding:** There are holes in surface that may have been created purposely by users.

**Action:** Infill to provide a sound reasonably level surface.

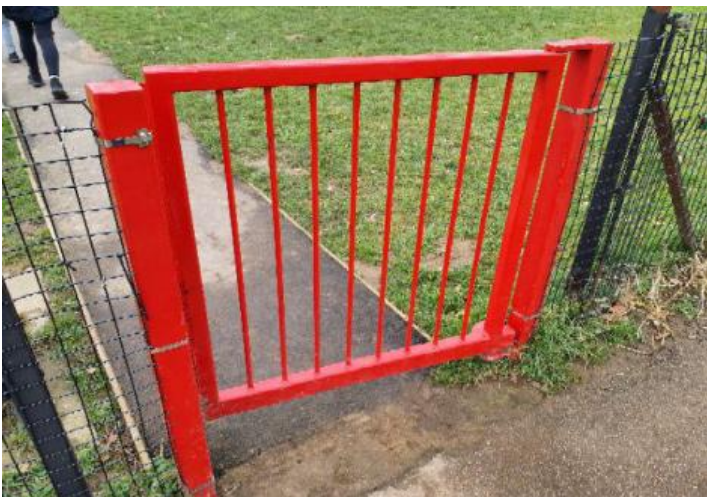
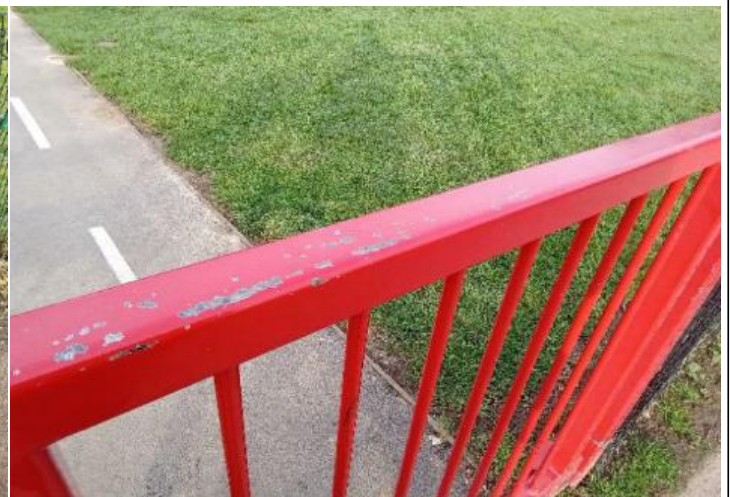
**Finding:** The paint is flaking off the metalwork

**Action:** Rub down and re-paint

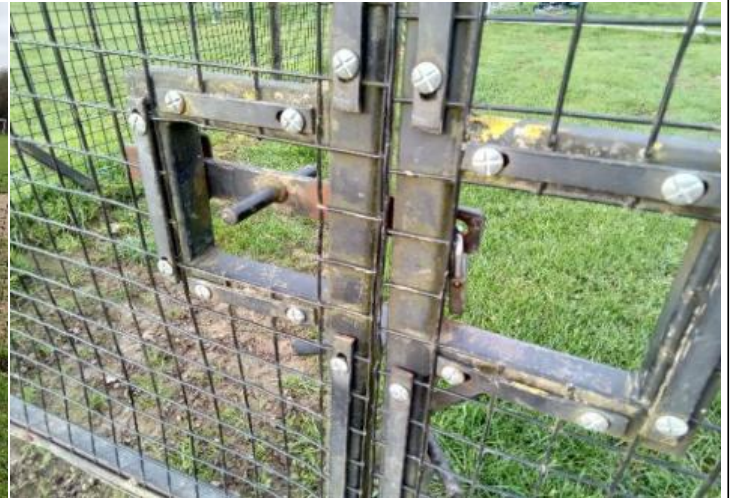
**Finding:** The maintenance gate was correctly padlocked at the time of inspection, however this means that the inspector was unable to fully assess the gate

**Action:** Ensure that there are 12mm gaps throughout the full range of motion on gate/s and between leaves where relevant

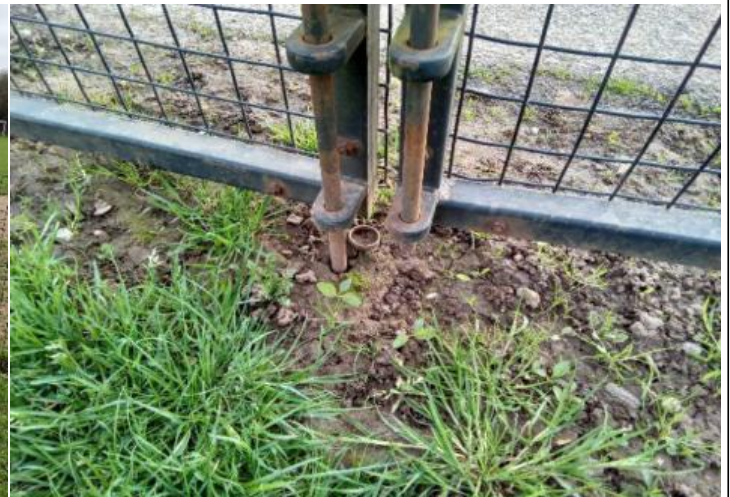
**Finding:** The gate has no drop bolt sleeves and/or drop bolts fitted

**Action:** Provide drop bolt sleeves and/or drop bolts

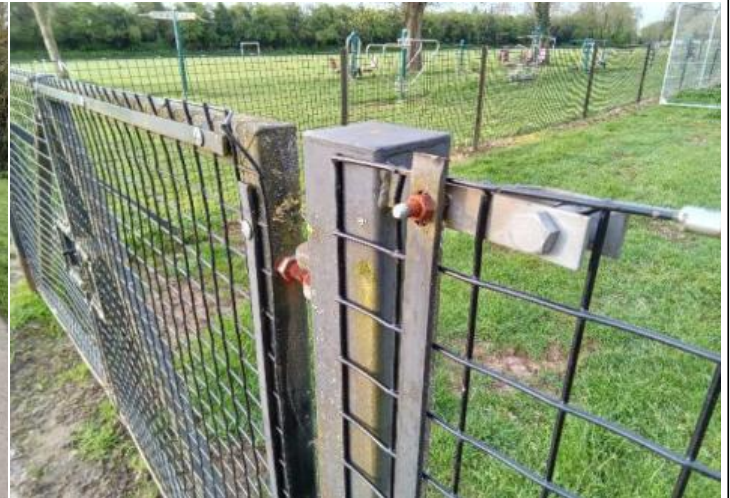
**Finding:** There are projecting bolt thread(s) present

**Action:** Remove excess thread length and deburr or provide cap

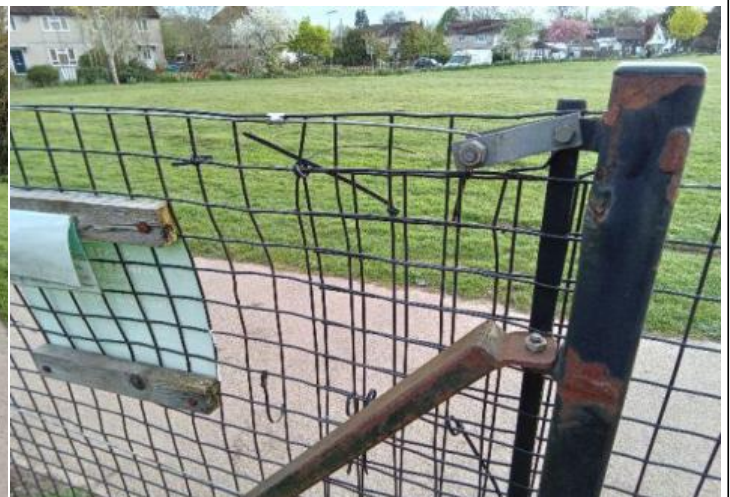
**Finding:** Cable ties have been used on the item and there are sharp projecting ends

**Action:** Remove if not required or replace with a more appropriate alternative fixing method if used as a fixing

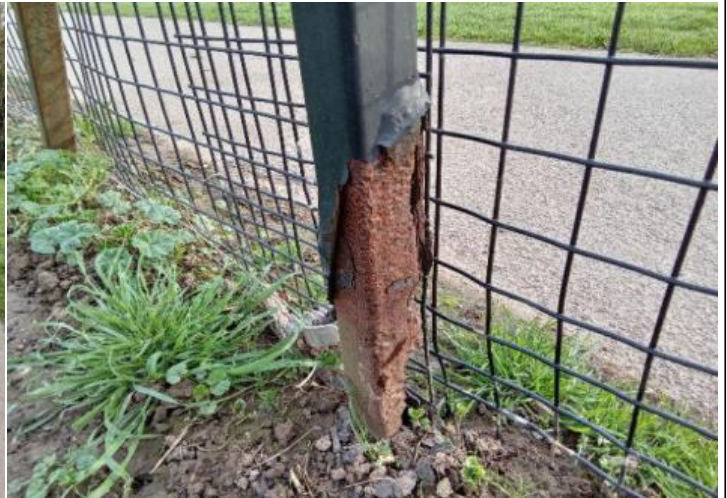
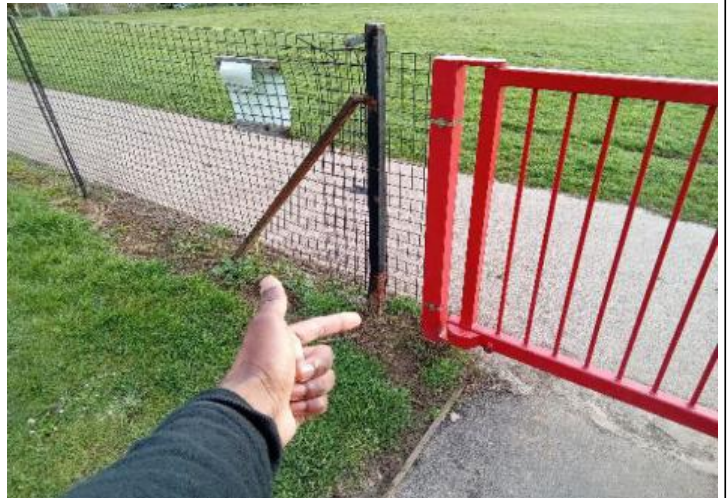
**Finding:** Parts of the steel on this item have corroded excessively and the metal has perforated in places

**Action:** Ensure all affected areas are treated and repaired

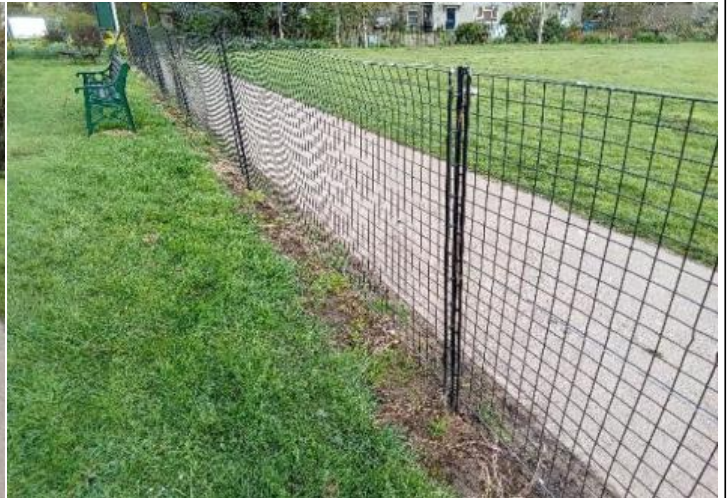
**Finding:** There are a number of loose posts around the fence

**Action:** Monitor for any further deterioration and reset as required

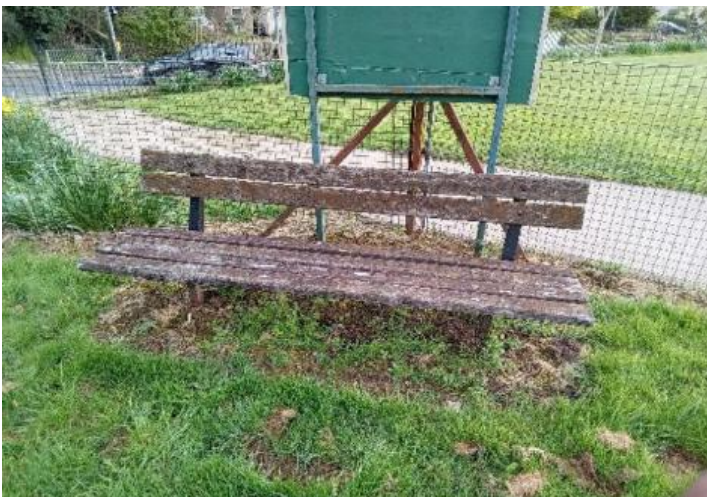
**Item:** Ancillary Items - Bench  
**Manufacturer:** Owner/Operator

**Finding:** The paint is flaking off the metalwork

**Action:** Rub down and re-paint

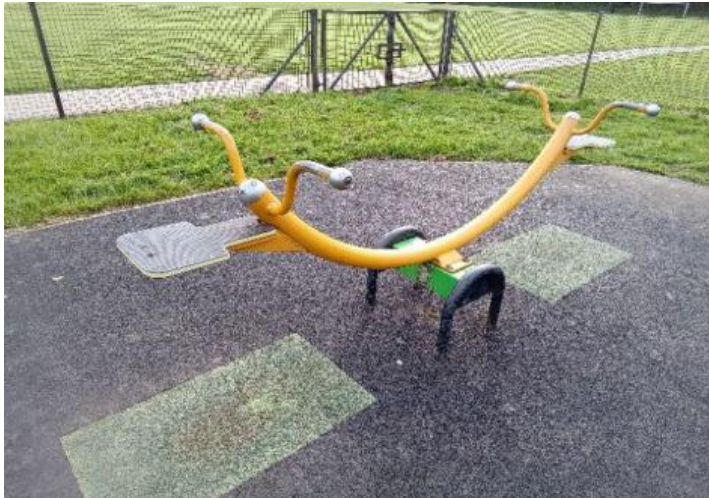
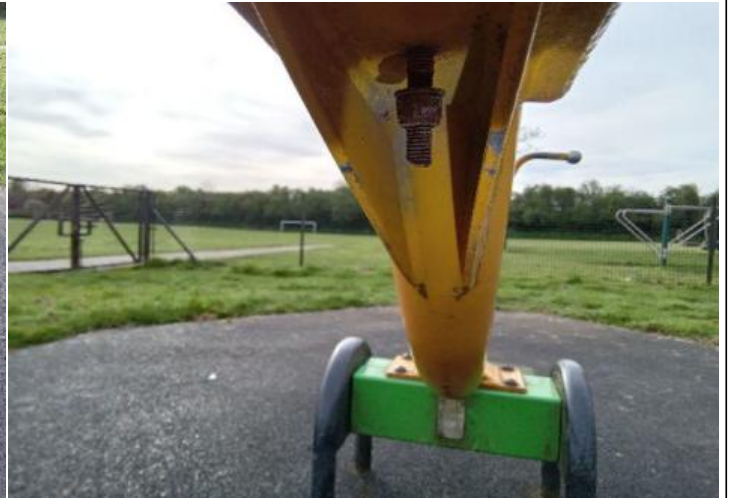
**Item:** Rocking Equipment - See Saw  
**Manufacturer:** Wicksteed Playgrounds

**Finding:** A number of fixing(s) have worked loose

**Action:** Secure all loose fixings

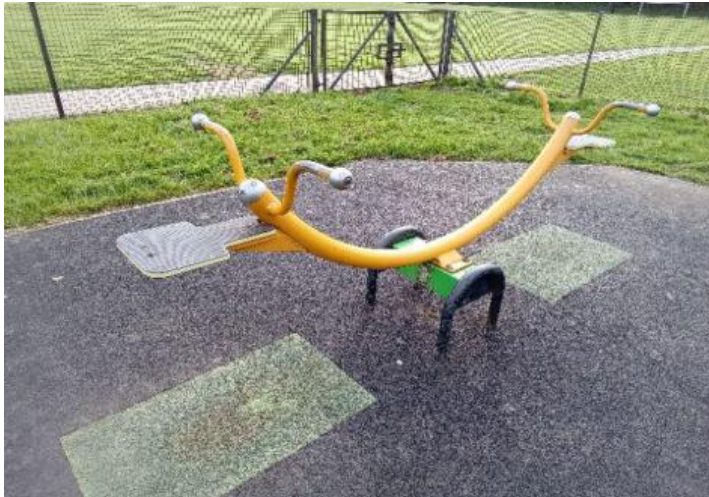
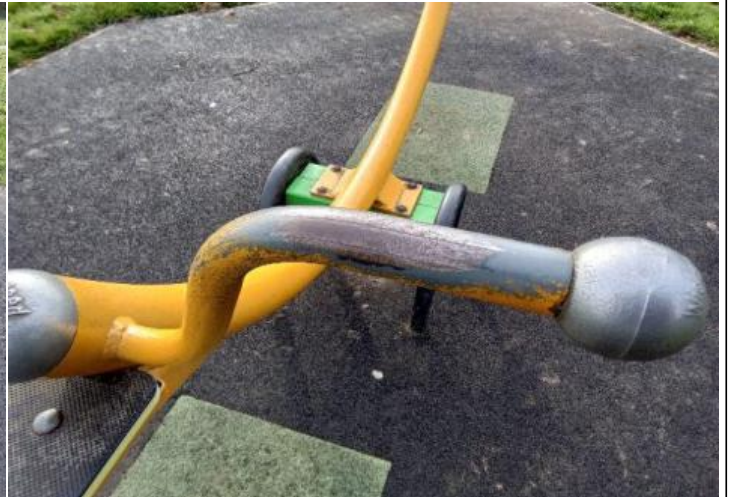
**Item:** Rocking Equipment - See Saw  
**Manufacturer:** Wicksteed Playgrounds

**Finding:** The paintwork on this item has been damaged or worn exposing the metal underneath which is rusting / corroding

**Action:** Treat affected areas and repaint

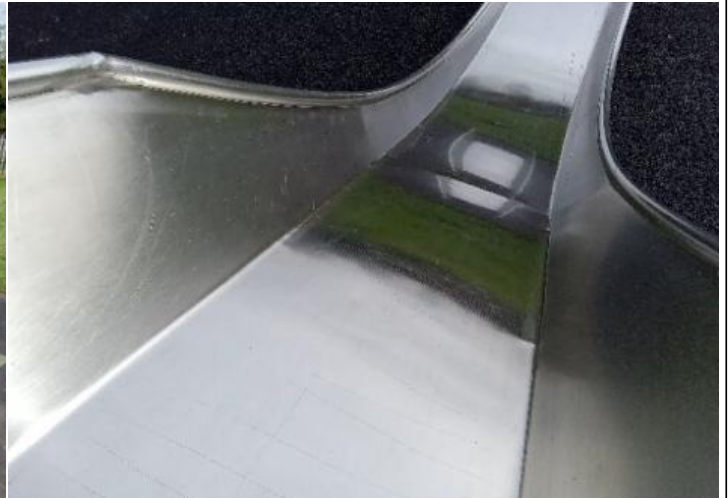
**Item:** Activity Equipment - Multi Play (Junior)  
**Manufacturer:** Wicksteed Playgrounds

**Finding:** There are a number of dents in the slide surface

**Action:** Monitor for any further deterioration and repair as required

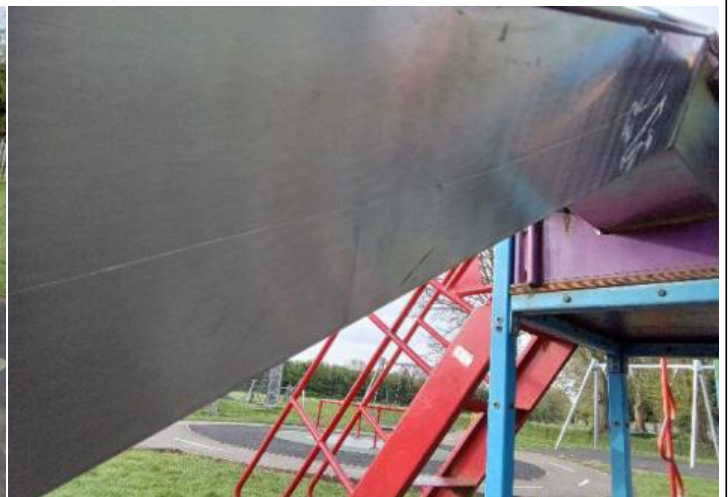
**Item:** Activity Equipment - Multi Play (Junior)  
**Manufacturer:** Wicksteed Playgrounds

**Finding:** The side of the slide is damaged

**Action:** Monitor for any further deterioration and repair as required

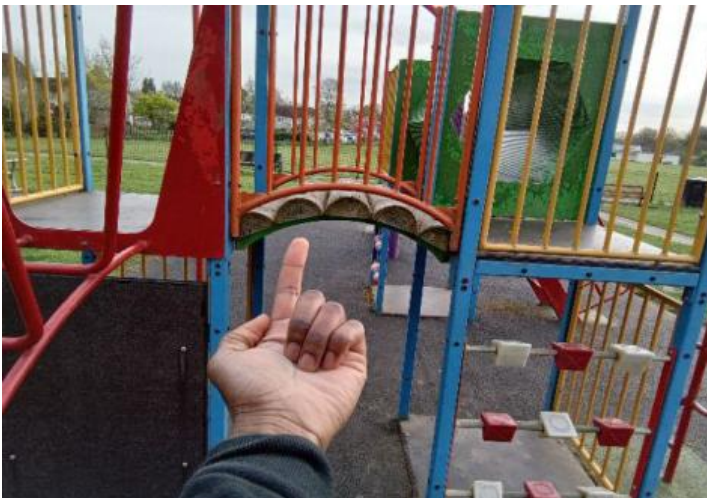
**Item:** Activity Equipment - Multi Play (Junior)  
**Manufacturer:** Wicksteed Playgrounds

**Finding:** There is or are fixings missing on the item

**Action:** Replace all missing fixings

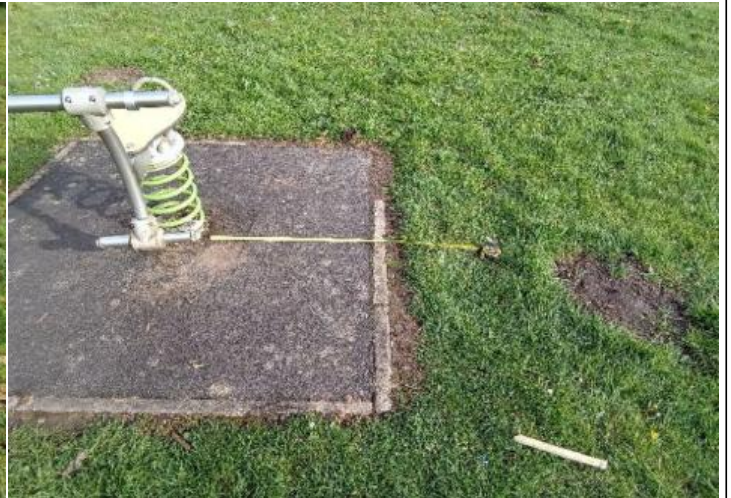
**Item:** Rocking Equipment - Spring Bike  
**Manufacturer:** Proludic

**Finding:** The surfacing dimensions are short and do not meet with the requirements of the current applicable standard

**Action:** Monitor - no remedial action recommended

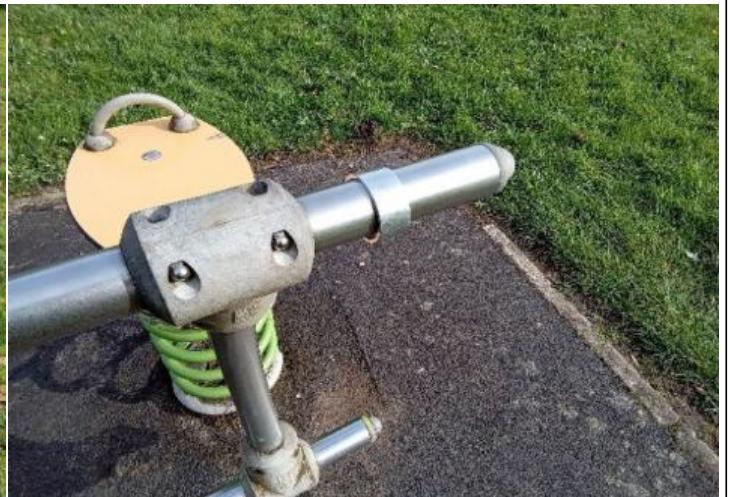
**Item:** Rocking Equipment - Spring Bike  
**Manufacturer:** Proludic

**Finding:** The end of handgrips and/or footrests have a cross section of less than 15cm<sup>2</sup> and fail to meet the requirements of BS EN 1176 Part 6

**Action:** Monitor - No remedial work recommended

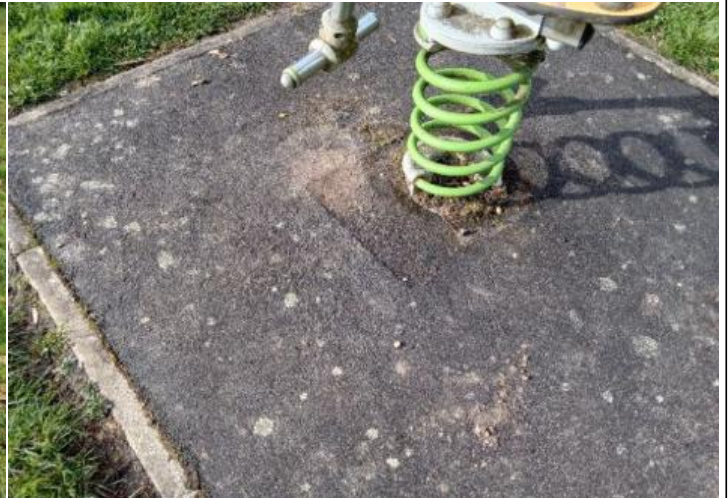
**Item:** Rocking Equipment - Spring Bike  
**Manufacturer:** Proludic

**Finding:** The safety surface around the area is beginning to wear

**Action:** Monitor for any further deterioration and repair as required

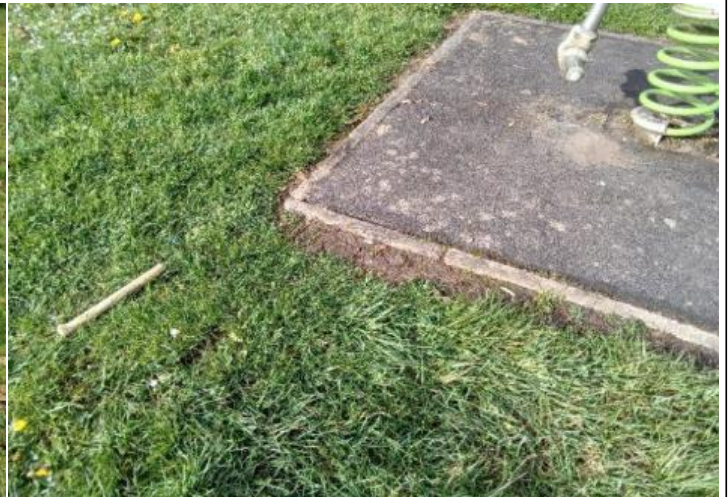
**Item:** Rocking Equipment - Spring Bike  
**Manufacturer:** Proludic

**Finding:** There are trip hazards at the edges of the surface

**Action:** Reinststate surrounding surface levels to remove the trip points

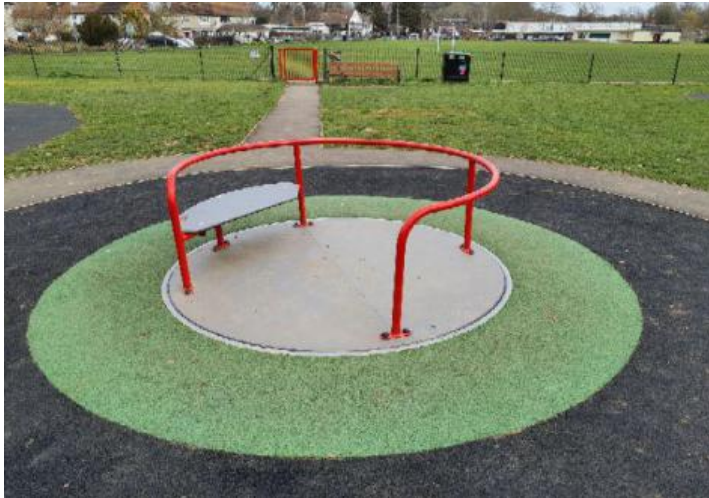
**Item:** Rotor Play - Inclusive Roundabout  
**Manufacturer:** Kompan Ltd

**Finding:** There is/are bolt cap covers missing or damaged on the item

**Action:** Replace missing or damaged bolt cap covers

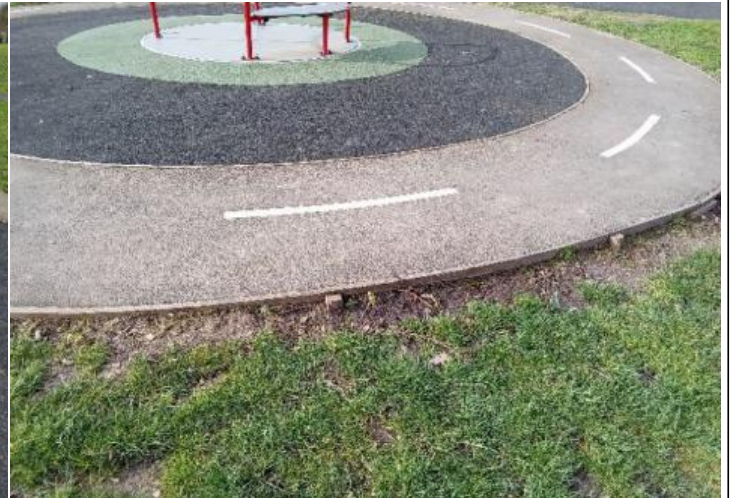
**Item:** Rotor Play - Inclusive Roundabout  
**Manufacturer:** Kompan Ltd

**Finding:** There are trip hazards at the edges of the surface

**Action:** Reinstate surrounding surface levels to remove the trip points

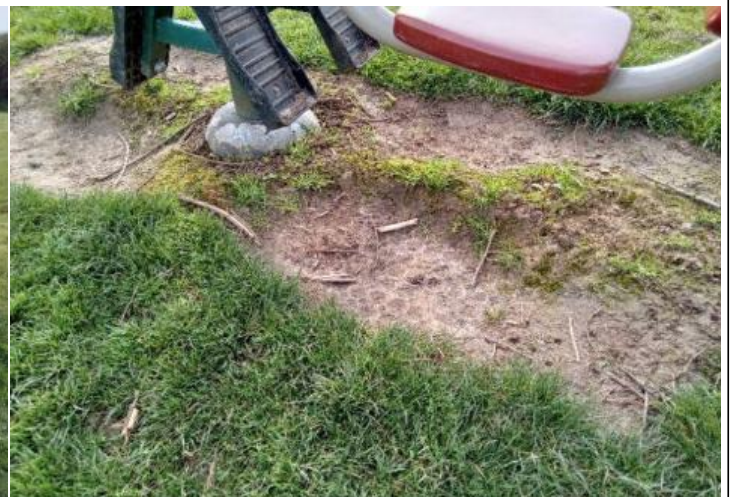
**Item:** Outdoor Fitness Equipment - Leg Press  
**Manufacturer:** Fresh Air Fitness

**Finding:** The surface has subsided in some areas

**Action:** Monitor for any further deterioration and repair as required

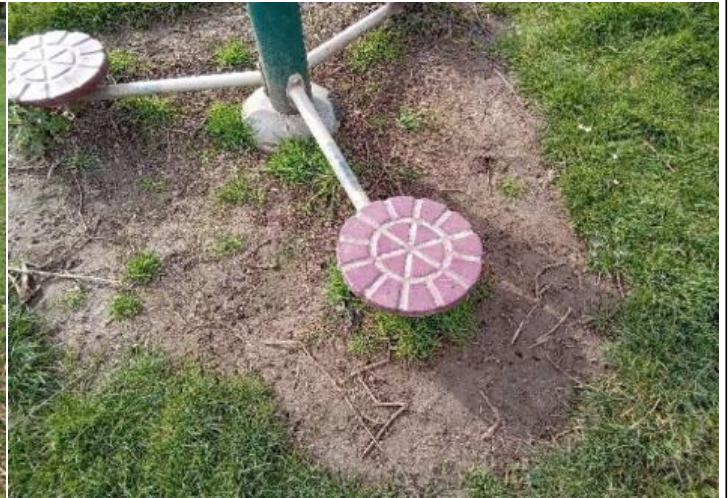
**Item:** Outdoor Fitness Equipment - Hip Twister  
**Manufacturer:** Fresh Air Fitness

**Finding:** The deflection of the rotating user station exceeds the maximum 105 degrees required by BS EN 16630  
**Action:** Monitor - No remedial work recommended

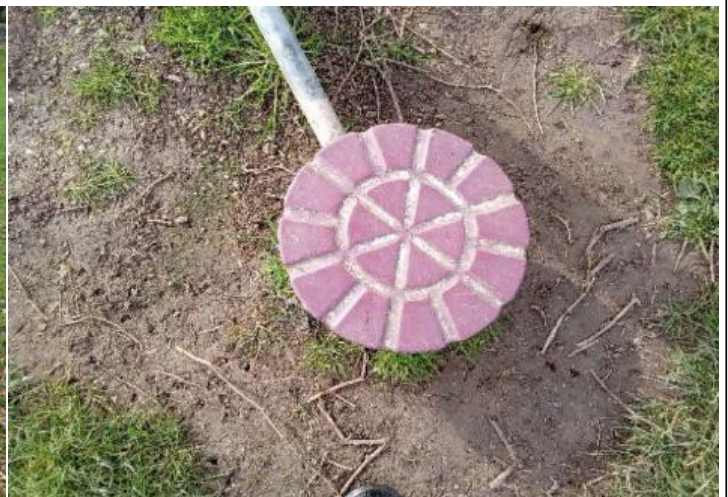
**Item:** Outdoor Fitness Equipment - Hip Twister  
**Manufacturer:** Fresh Air Fitness

**Finding:** The rotating user station is not appropriately marked with a guideline of user direction and/or the original position as required by BS EN 16630  
**Action:** Monitor - No remedial work recommended
