ST STEPHEN PARISH COUNCIL

You are summoned to the Fixed Assets Committee meeting
To take place on **Thursday 30 May 2024 at 7.30pm**
at St Stephen Suite, Parish Centre, Station Road, Bricket Wood, AL2 3PJ

- 2425/AC/07 To receive Annual Play Inspection Report and Grounds Team Action Report. Play Reports and Grounds Team Report attached.**
- 2425/AC/08 To discuss the option of creating additional allotment plots and possible beginner plots at Watford Road allotment site or North Close. Allotment report attached.**

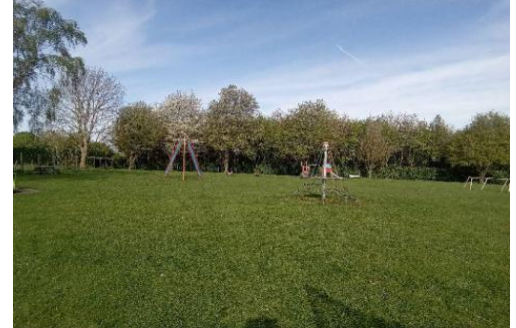
Item: Site General
Manufacturer: Owner/Operator
Surface Type: N/A
Item Quantity: 1
Equipment Compliance: N/A
Surface Area Compliance: N/A

The grass mats are silted up, the soil is compacted and the area will become very slippery when the soil is wet. - Reinststate as required

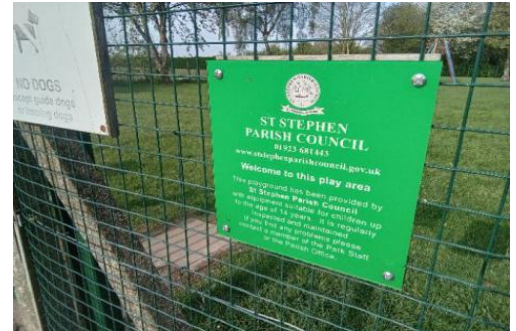
Item: Sign
Manufacturer: Owner/Operator
Surface Type: N/A
Item Quantity: 1
Equipment Compliance: N/A
Surface Area Compliance: N/A

BS EN 1176 Part 7 recommends that signage shall include the site name / address - Provide additional information

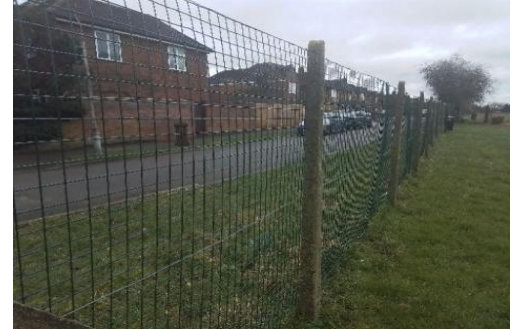
Item: Fence - Steel Mesh
Manufacturer: Not Identified
Surface Type: Grass
Item Part Number:
Item Quantity: 1
Equipment Compliance: N/A
Surface Area Compliance: N/A
Total Findings: 1

Cable ties have been used on the item and there are sharp projecting ends - Remove if not required or replace with a more appropriate alternative fixing method if used as a fixing

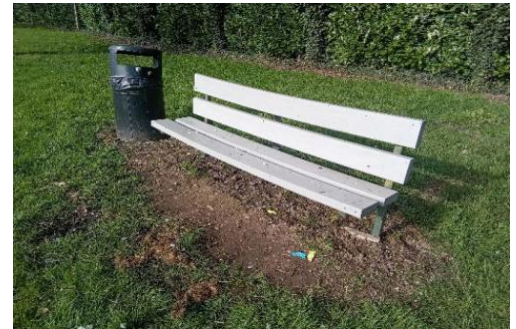
Item: Bench
Manufacturer: Not Identified
Surface Type: Grass
Item Quantity: 1
Equipment Compliance: N/A
Surface Area Compliance: N/A
Total Findings: 1

The surface has eroded in some areas and may be slippery in wet conditions - Reinstate the surface

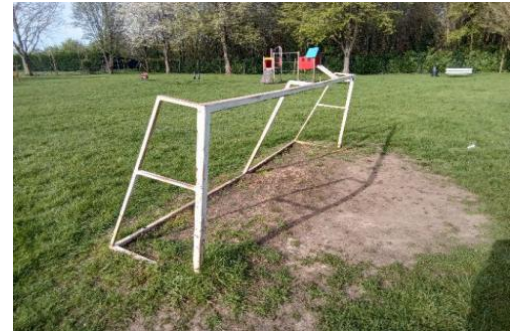
Item: 5 a side Goals
Manufacturer: Not Identified
Surface Type: Grass
Item Part Number:
Item Quantity: 1
Equipment Compliance: N/A
Surface Area Compliance: N/A
Life Expectancy: 5 -10 Years
Total Findings: 3

The surface has eroded in some areas and may be slippery in wet conditions - Reinstate the surface

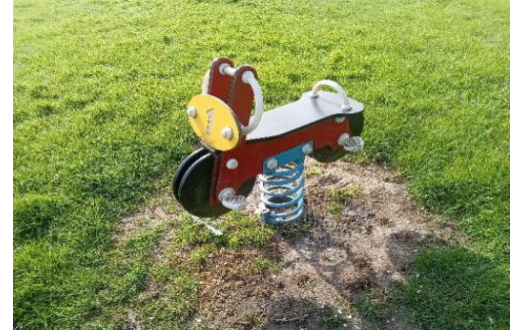
Item: Spring Bike
Manufacturer: Kompan Ltd
Surface Type: Grass Matrix Tiles
Item Quantity: 1
Equipment Compliance: Yes
Surface Area Compliance: Yes

The item is slightly loose in its foundations - Monitor for any further deterioration and repair as required

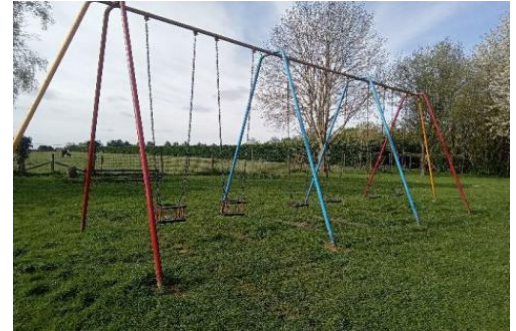
Item: 3 Bay Swing
Manufacturer: Hags
Surface Type: Grass Matrix Tiles
Item Quantity: 1
Equipment Compliance: No
Surface Area Compliance: Yes
Life Expectancy: >10 Years
Total Findings: 12

There are gaps opening between the grass mat tiles - Provide additional ties or secure / reinstate surface

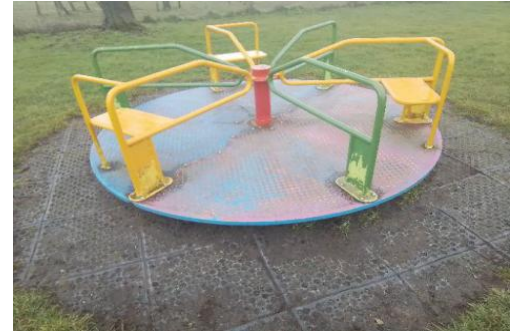
Item: Roundabout
Manufacturer: G L Jones Playgrounds Ltd
Surface Type: Grass Matrix Tiles
Item Quantity: 1
Equipment Compliance: No
Surface Area Compliance: Yes
Life Expectancy: >10 Years
Total Findings: 5

The surface has subsided in some areas - Monitor for any further deterioration and repair as required

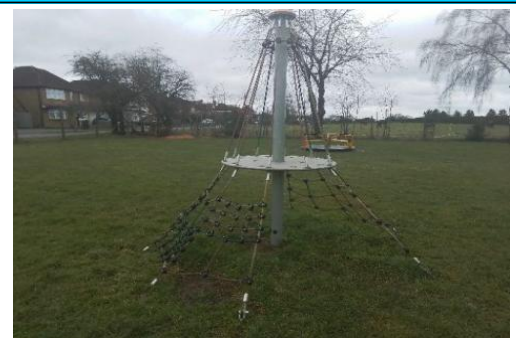
Item: Rope Climber
Manufacturer: Kompan Ltd
Surface Type: Grass Matrix Tiles
Item Quantity: 1
Equipment Compliance: Yes
Surface Area Compliance: Yes
Total Findings: 1

There is/are bolt cap covers missing or damaged on the item - Replace missing or damaged bolt cap covers

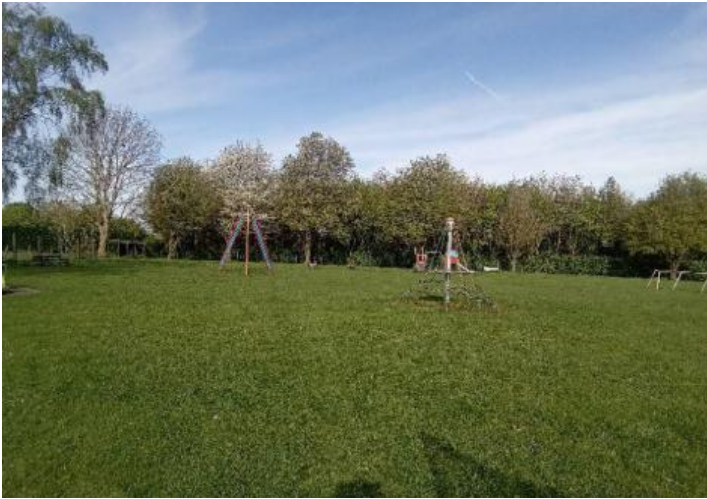
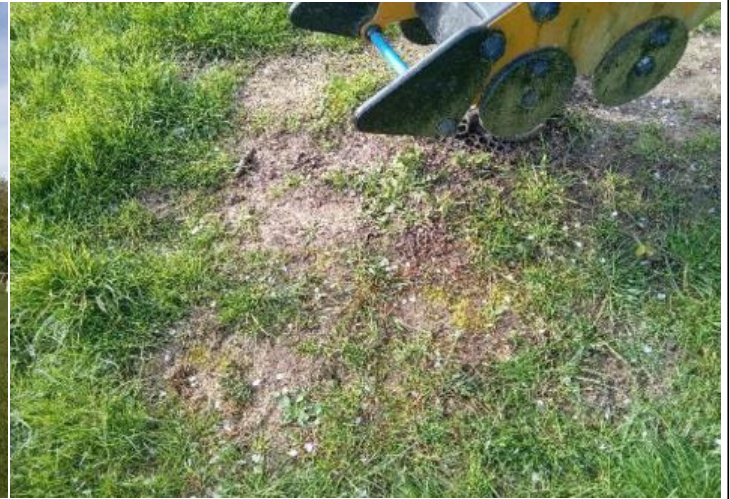
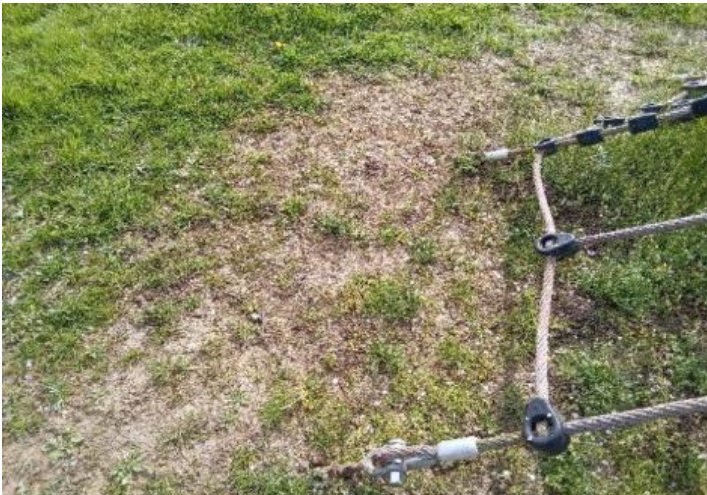
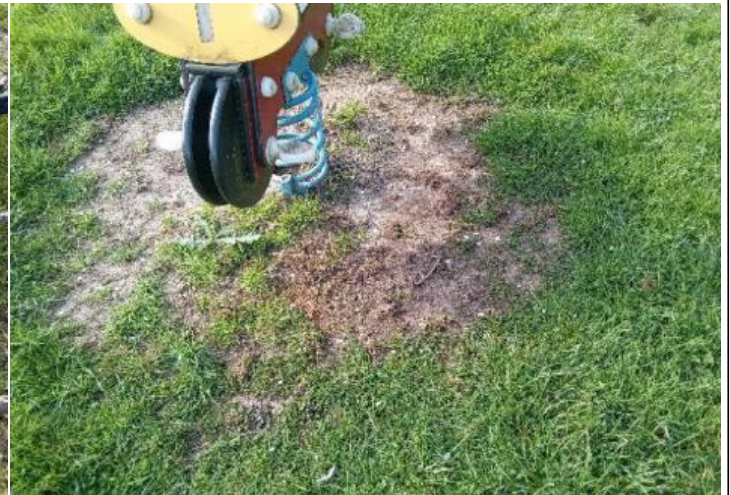
Item: Ancillary Items - Site General
Manufacturer: Owner/Operator

Finding: The grass mats are silted up, the soil is compacted **Action:** Reinststate as required and the area will become very slippery when the soil is wet.

i 5 - Very Low Risk (Finding 1)

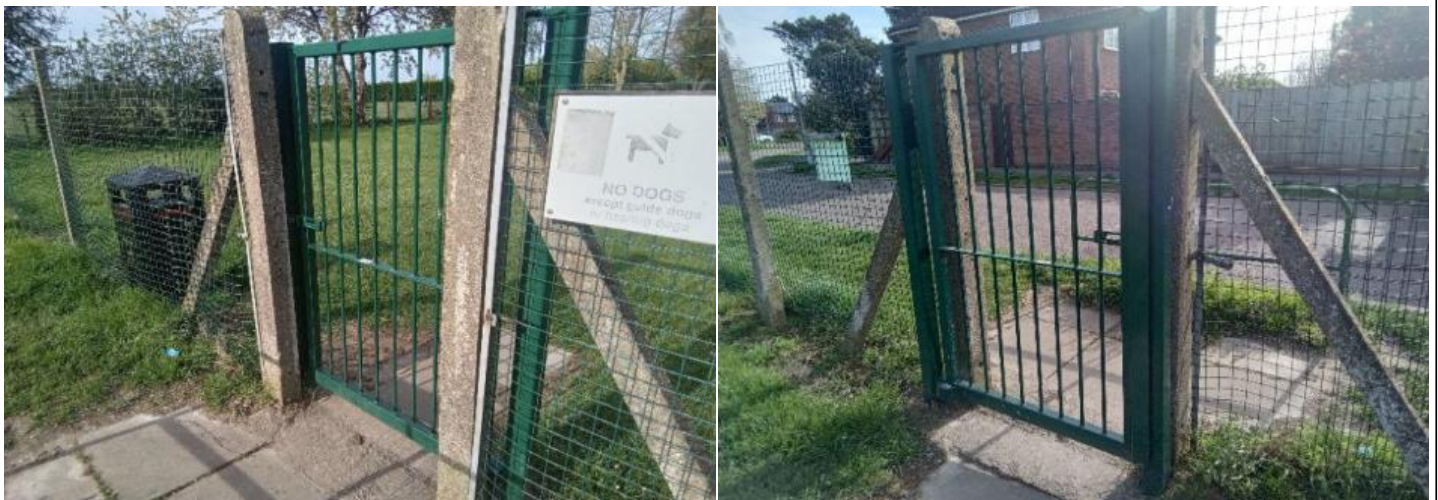
Item: Gates - Gate
Manufacturer: Not Identified

Finding: The gate is closing too slowly (in excess of 8 seconds)

Action: Take effective action to ensure the gate closes between 4 and 8 seconds

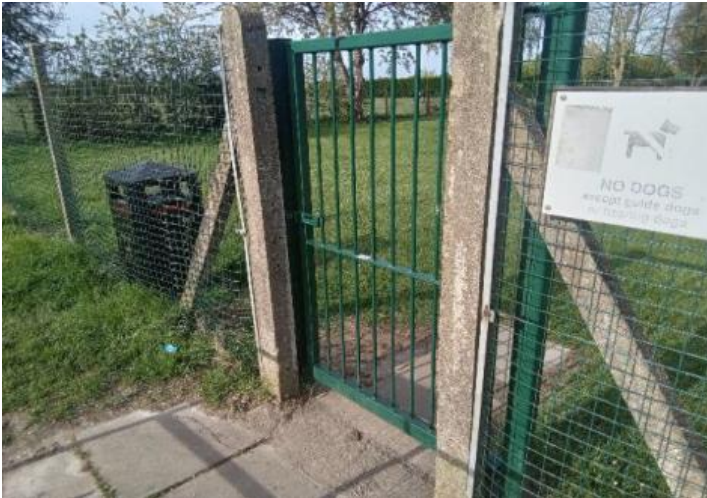
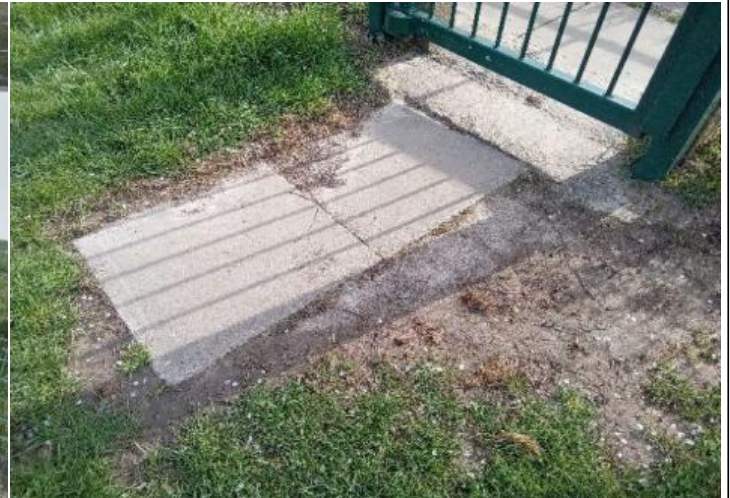
Item: Gates - Gate
Manufacturer: Not Identified

Finding: There are trip hazards at the edges of the surface

Action: Reinstate surrounding surface levels to remove the trip points

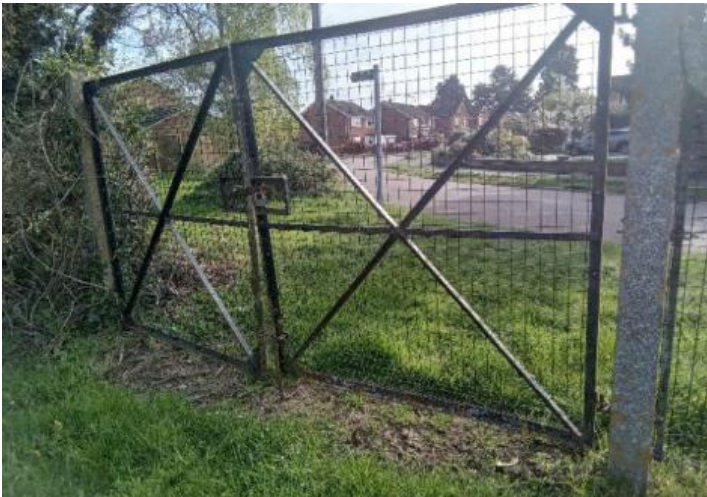
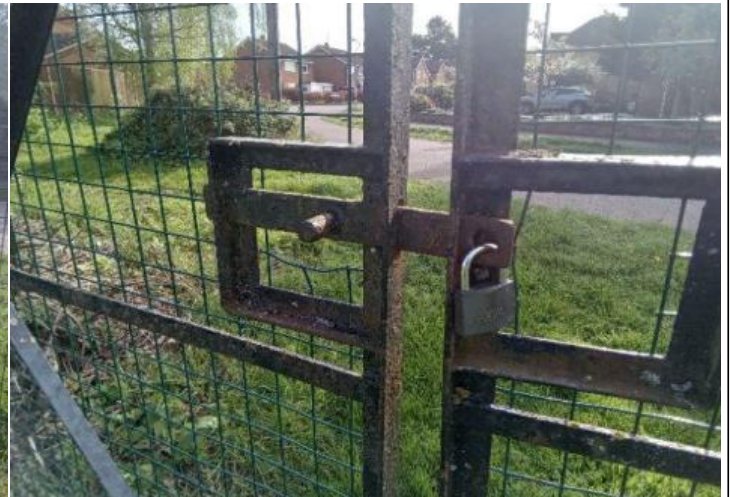
Item: Gates - Gate - Maintenance
Manufacturer: Not Identified

Finding: The maintenance gate was correctly padlocked at the time of inspection, however this means that the inspector was unable to fully assess the gate

Action: Ensure that there are 12mm gaps throughout the full range of motion on gate/s and between leaves where relevant

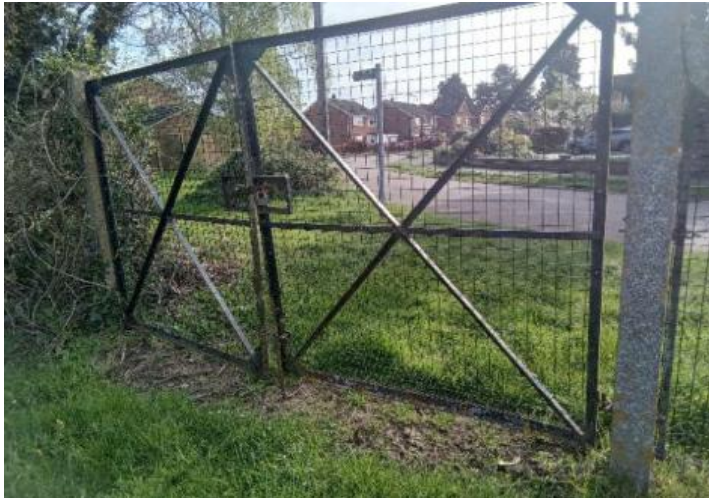
Item: Gates - Gate - Maintenance
Manufacturer: Not Identified

Finding: The paintwork on this item has been damaged or worn exposing the metal underneath which is rusting / corroding

Action: Treat affected areas and repaint

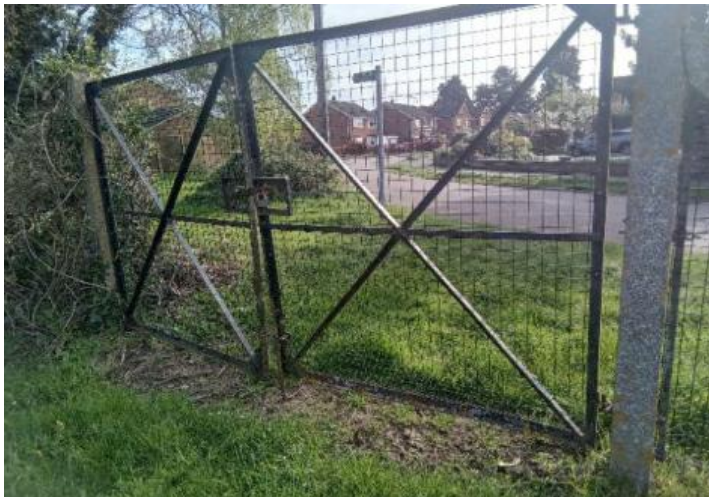
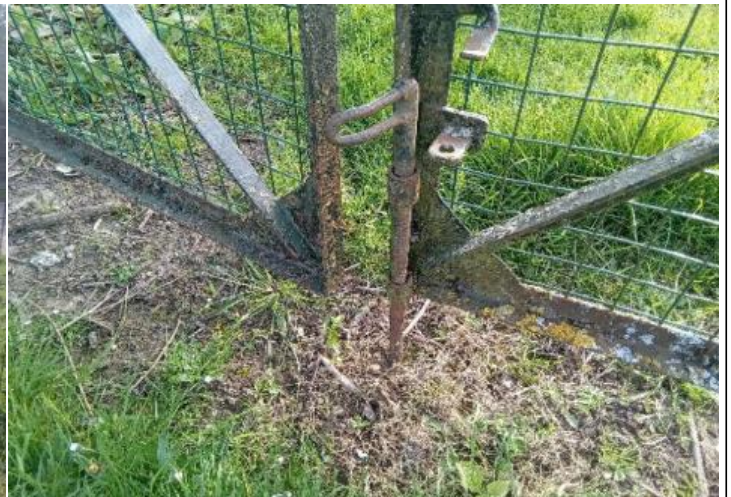
Item: Gates - Gate - Maintenance
Manufacturer: Not Identified

Finding: The gate has no drop bolt sleeves and/or drop bolts fitted

Action: Provide drop bolt sleeves and/or drop bolts

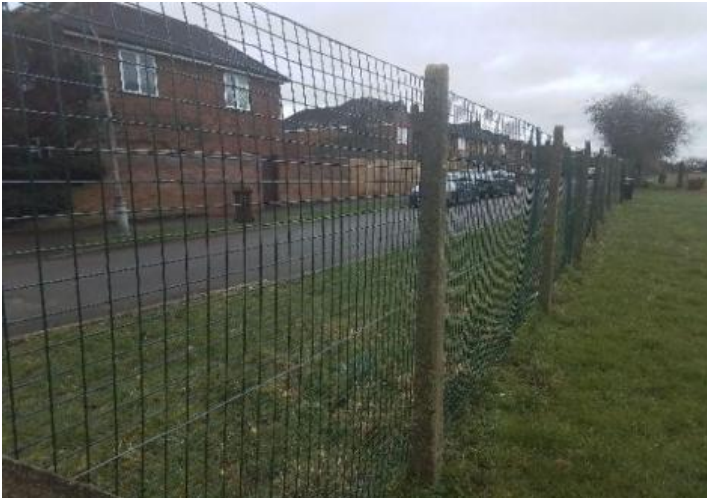
Item: Fences - Fence - Steel Mesh
Manufacturer: Not Identified

Finding: Cable ties have been used on the item and there are sharp projecting ends

Action: Remove if not required or replace with a more appropriate alternative fixing method if used as a fixing

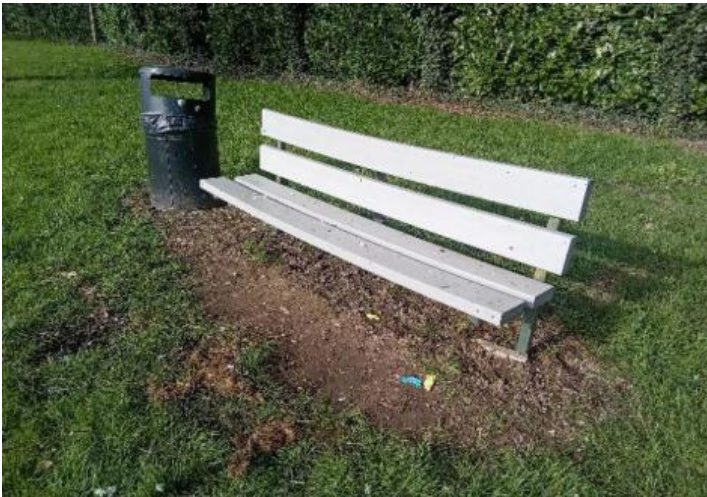
Item: Ancillary Items - Bench
Manufacturer: Not Identified

Finding: The surface has eroded in some areas and may be slippery in wet conditions

Action: Reinstate the surface

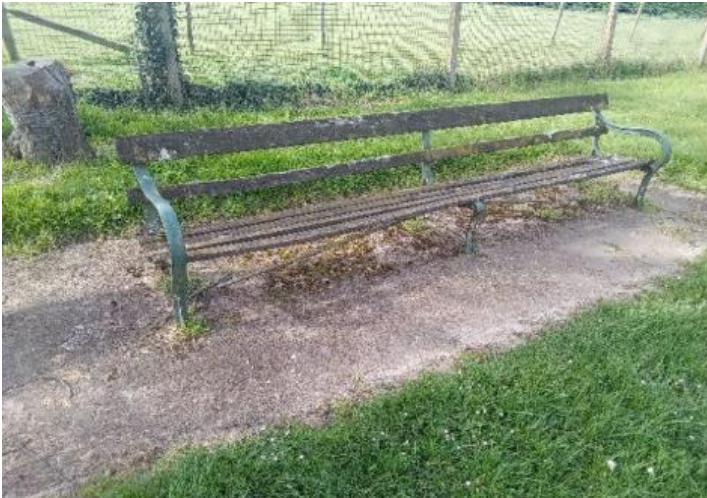
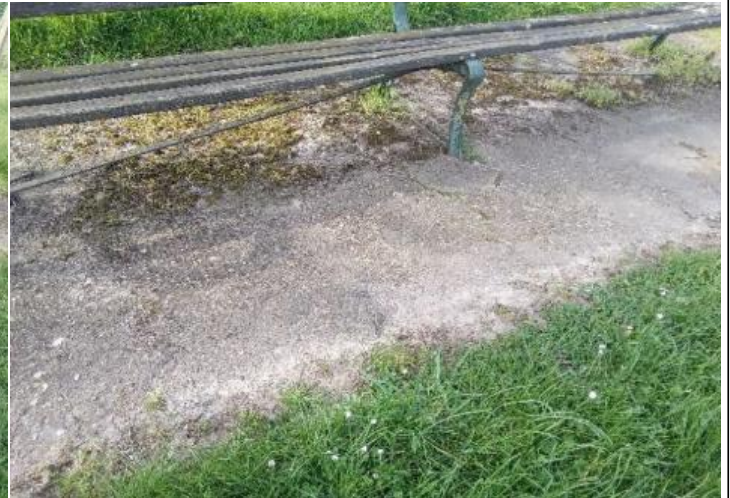
Item: Ancillary Items - Bench
Manufacturer: Not Identified
Risk Level: L - Low Risk
Surface: Concrete

Finding: There is algae, silt or moss growth on the surface resulting in slippery conditions
Action: Clean and treat appropriately

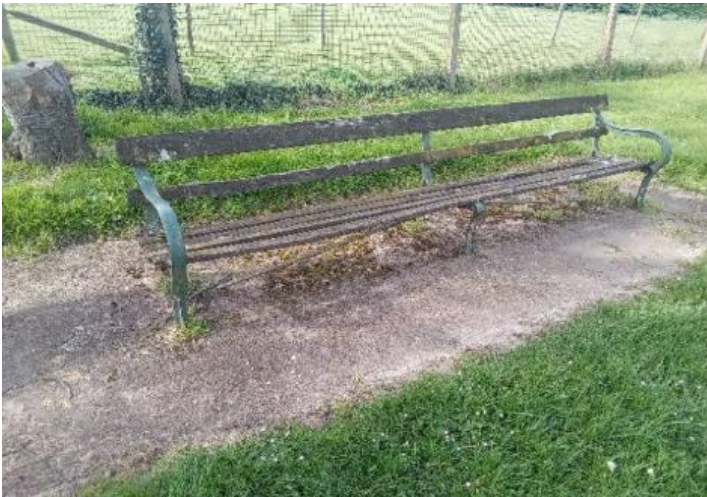
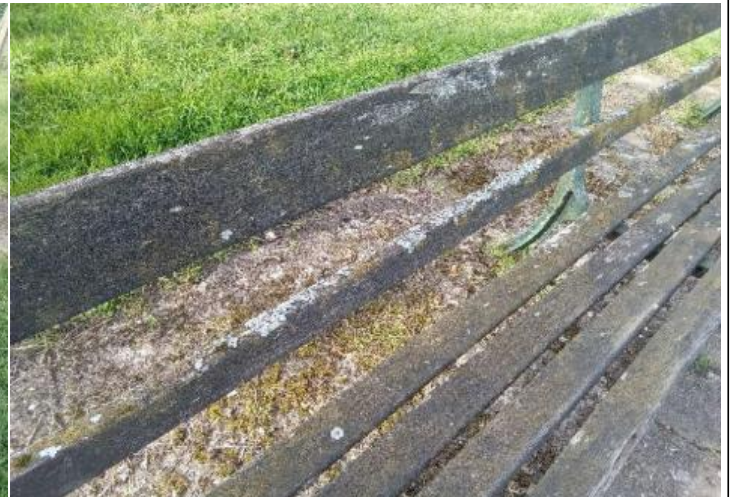
Item: Ancillary Items - Bench
Manufacturer: Not Identified
Risk Level: L - Low Risk
Surface: Concrete

Finding: There is algae or moss on the surface of the equipment
Action: Clean and treat appropriately

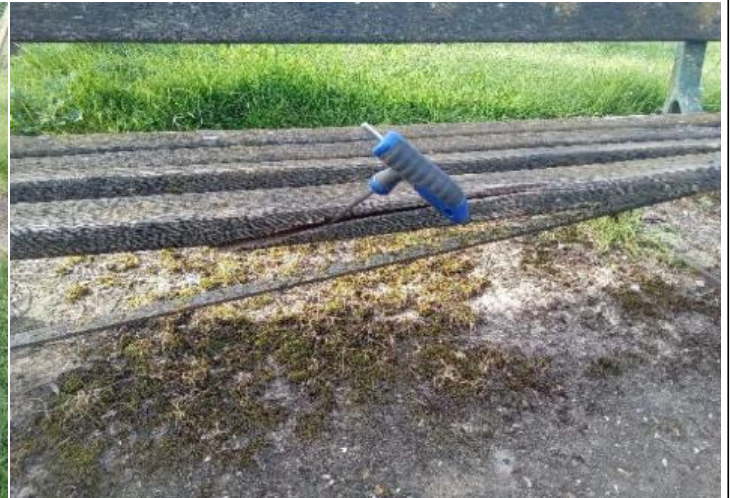
Item: Ancillary Items - Bench
Manufacturer: Not Identified

Finding: There is some damage to the item

Action: repair or replace as required

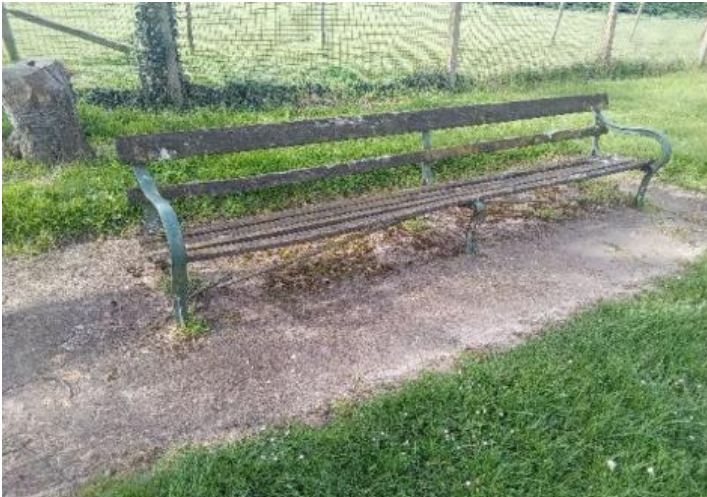
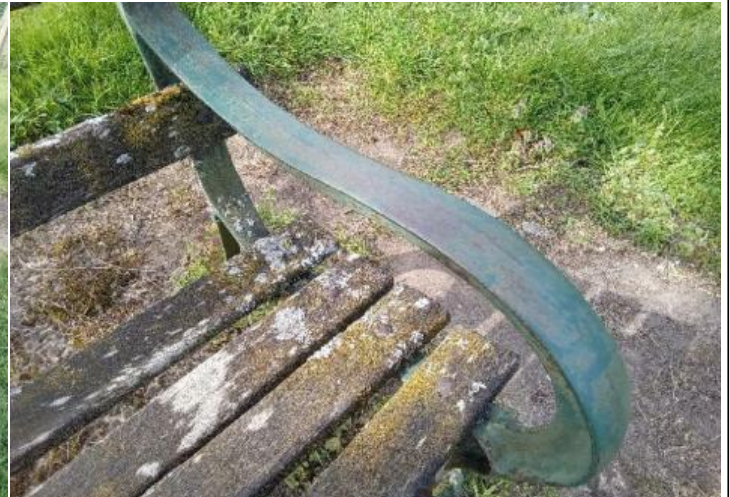
Item: Ancillary Items - Bench
Manufacturer: Not Identified

Finding: The paintwork on this item has been damaged or worn exposing the metal underneath which is rusting / corroding

Action: Treat affected areas and repaint

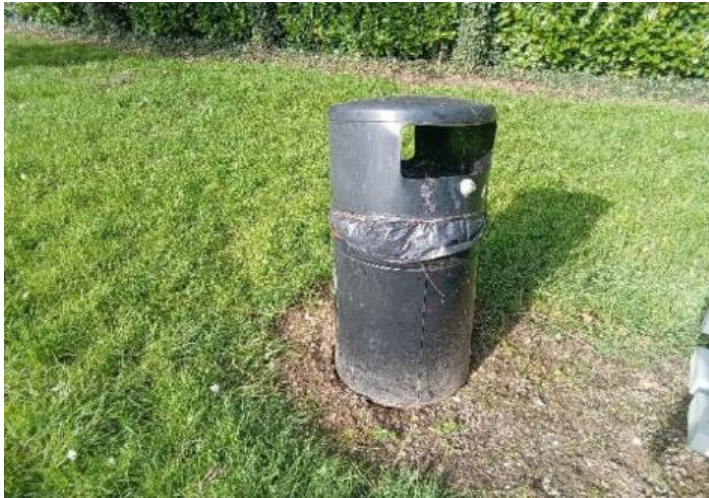
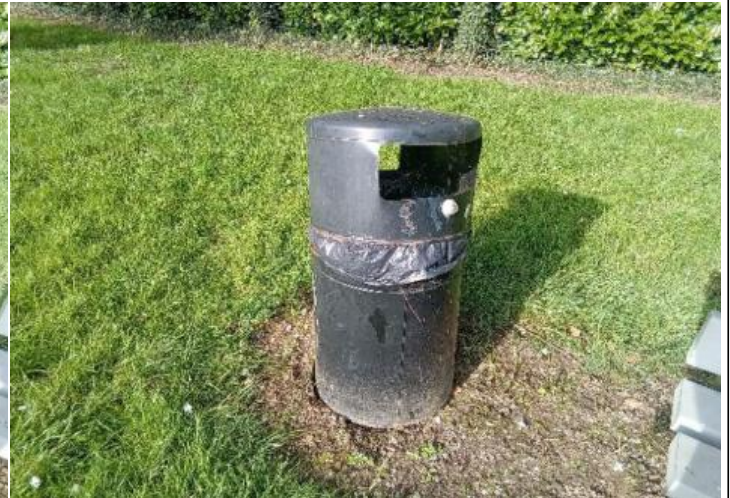
Item: Ancillary Items - Litter Bin
Manufacturer: Not Identified

Finding: The bin is not securely fixed to the surface and there is some possibility of the item tipping or rolling over

Action: Secure the bin to the ground

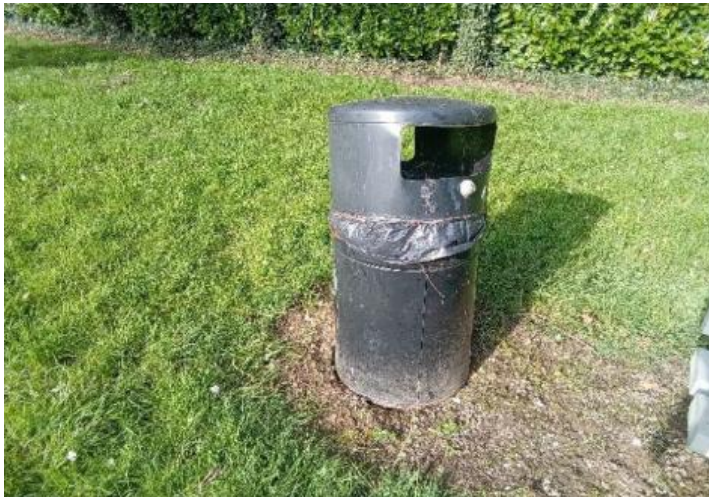
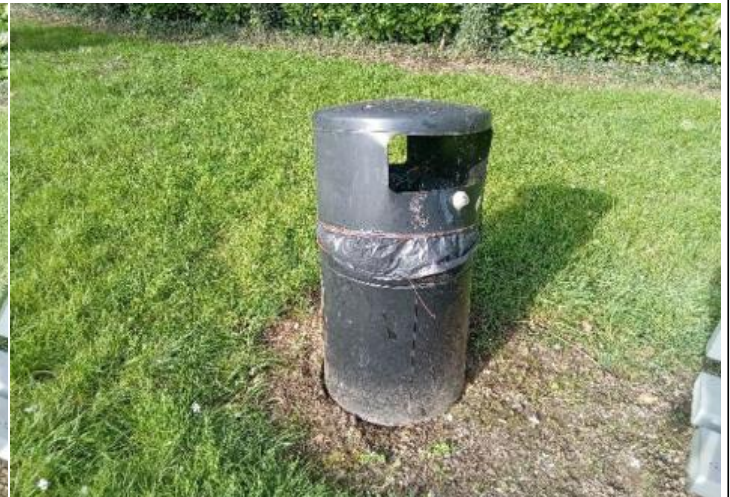
Item: Ancillary Items - Litter Bin
Manufacturer: Not Identified

Finding: The lid or door of the litter bin is not secured

Action: Ensure the lid or door is kept locked

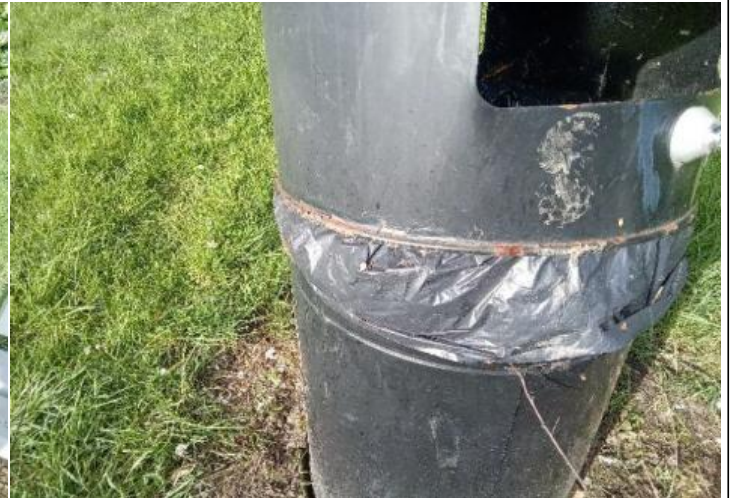
Item: Ancillary Items - Litter Bin
Manufacturer: Not Identified

Finding: The paintwork on this item has been damaged or worn exposing the metal underneath which is rusting / corroding

Action: Treat affected areas and repaint

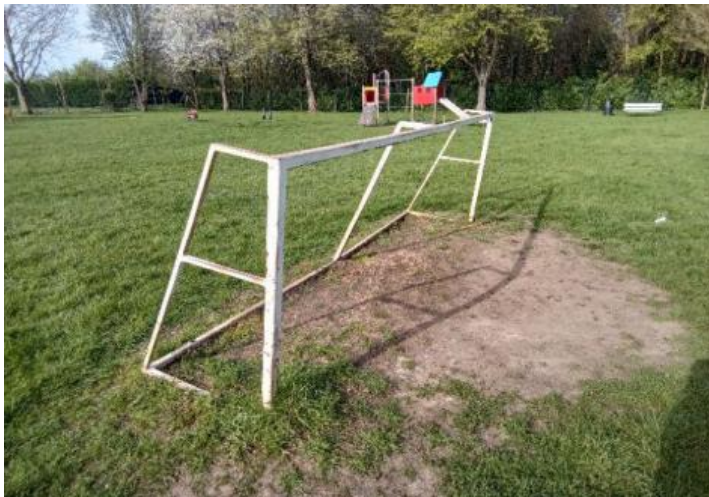
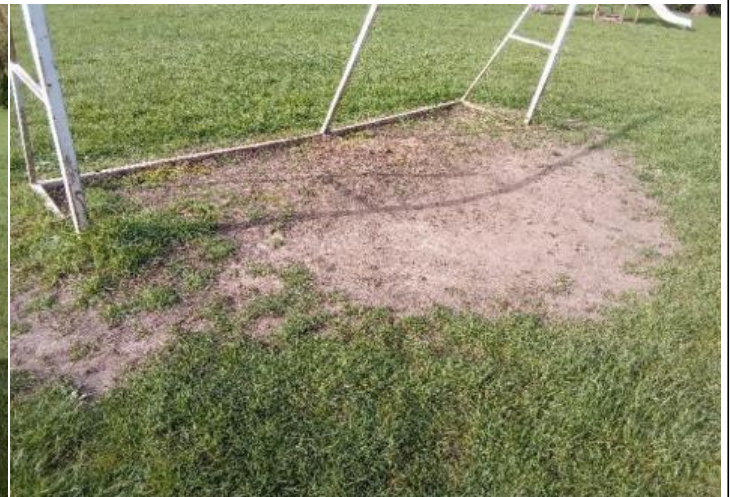
Item: Multi Use Games Area - 5 a side Goals
Manufacturer: Not Identified

Finding: The surface has eroded in some areas and may be slippery in wet conditions

Action: Reinstate the surface

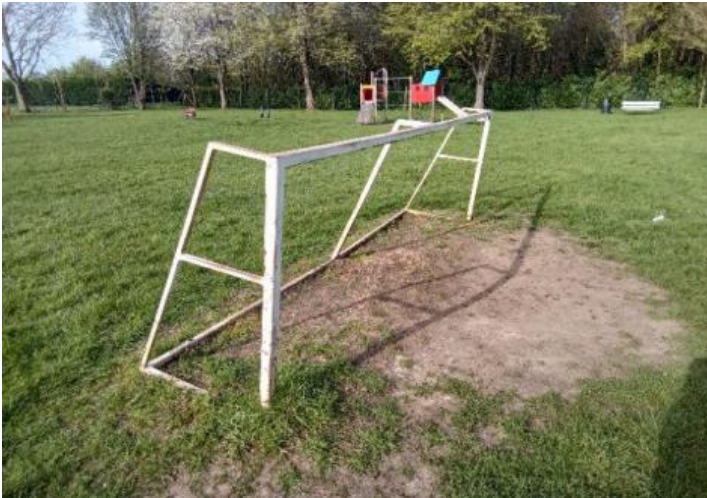
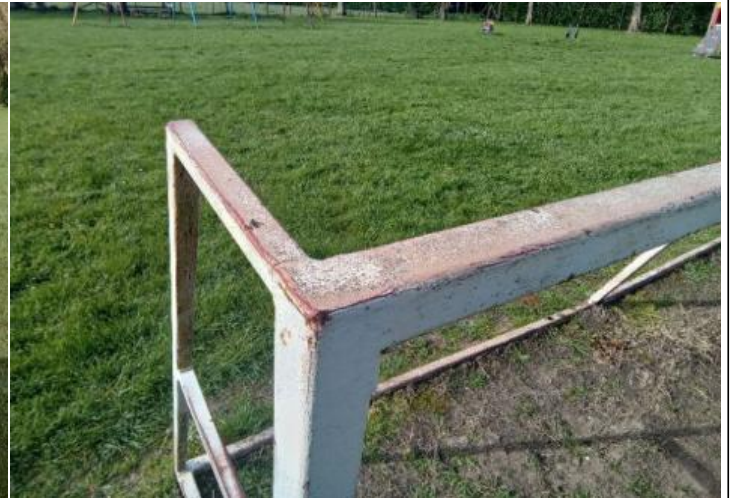
Item: Multi Use Games Area - 5 a side Goals
Manufacturer: Not Identified

Finding: The paintwork on this item has been damaged or worn exposing the metal underneath which is rusting / corroding

Action: Treat affected areas and repaint

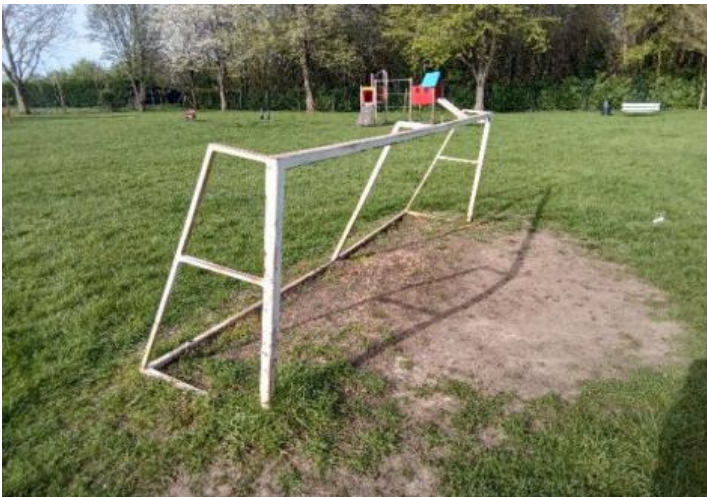
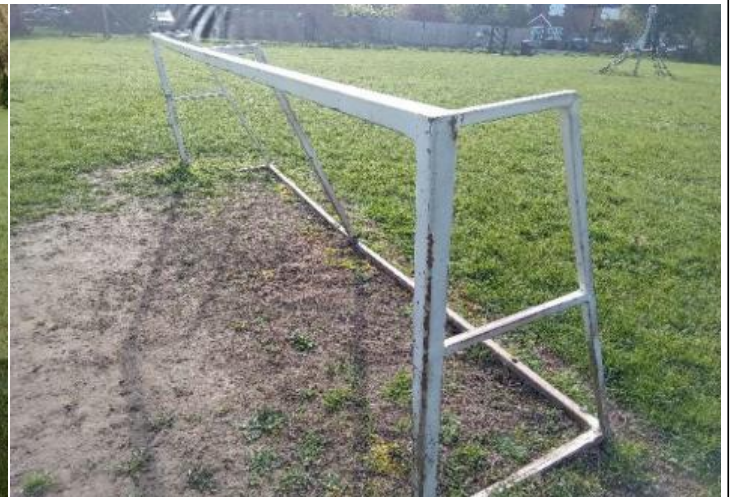
Item: Multi Use Games Area - 5 a side Goals
Manufacturer: Not Identified

Finding: NB: We have undertaken a maintenance inspection only of the football goal(s); full load testing falls outside the scope of our inspection.

Action: Implement load testing as required

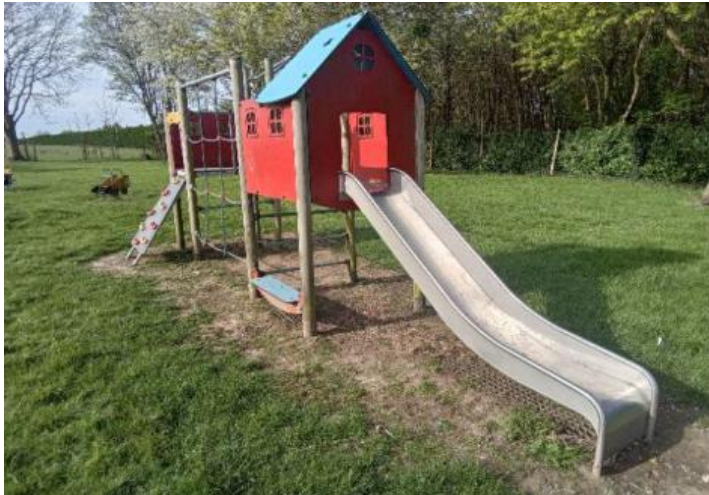
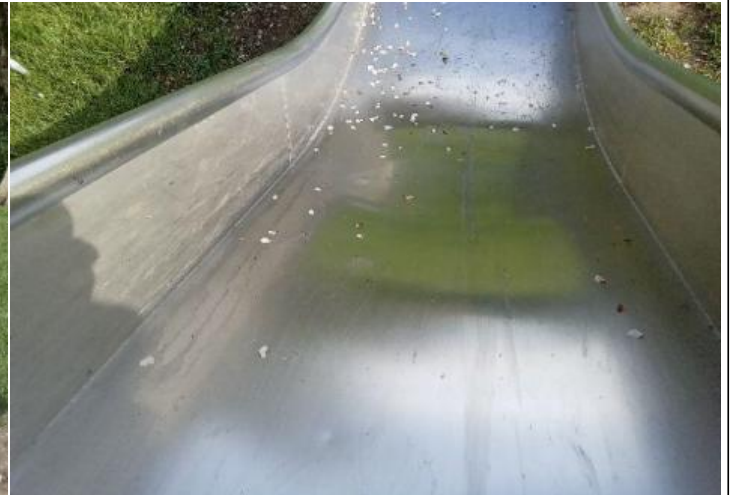
Item: Activity Equipment - Multi Play (Junior)
Manufacturer: Kompan Ltd

Finding: There are a number of dents in the slide surface

Action: Monitor for any further deterioration and repair as required

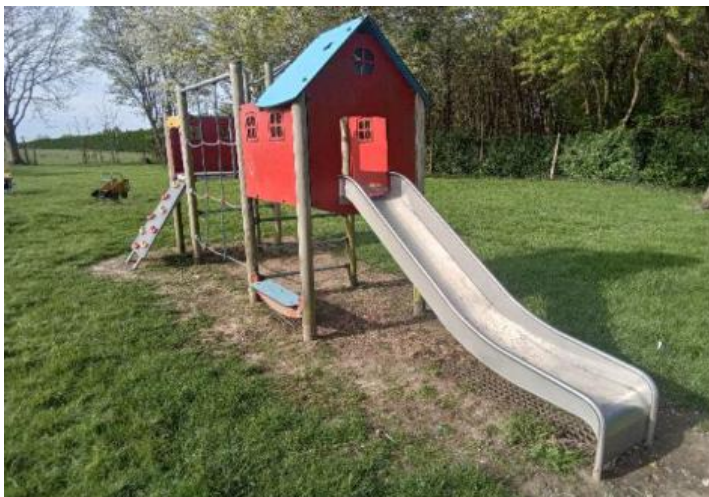
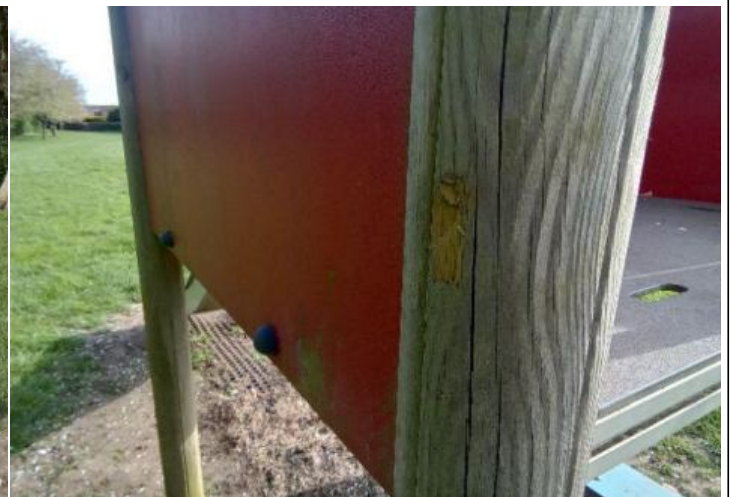
Item: Activity Equipment - Multi Play (Junior)
Manufacturer: Kompan Ltd

Finding: Parts of the timber are rough or splintered

Action: Remove all rough or sharp edges

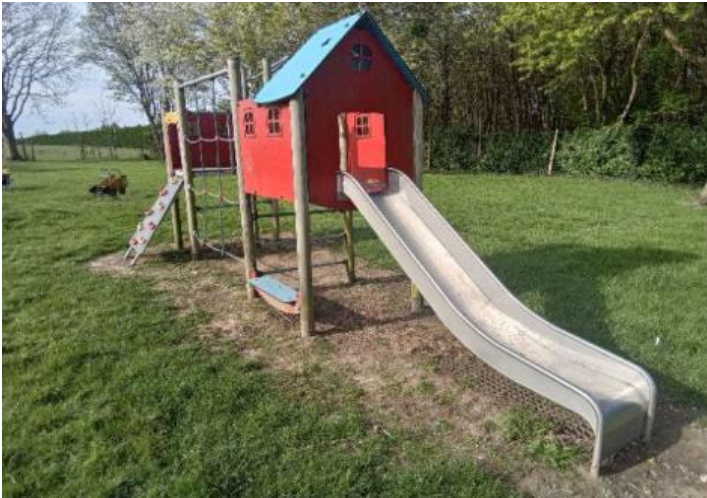
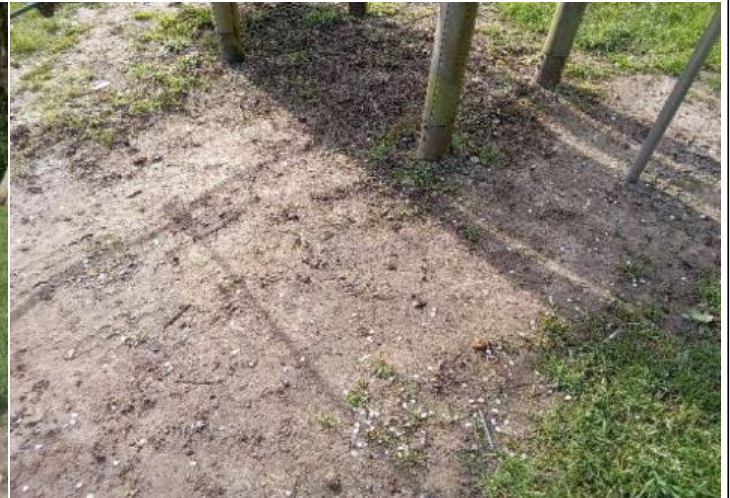
Item: Activity Equipment - Multi Play (Junior)
Manufacturer: Kompan Ltd

Finding: The grass mats are silted up, the soil is compacted and the area will become very slippery when the soil is wet. **Action:** Reinstate as required

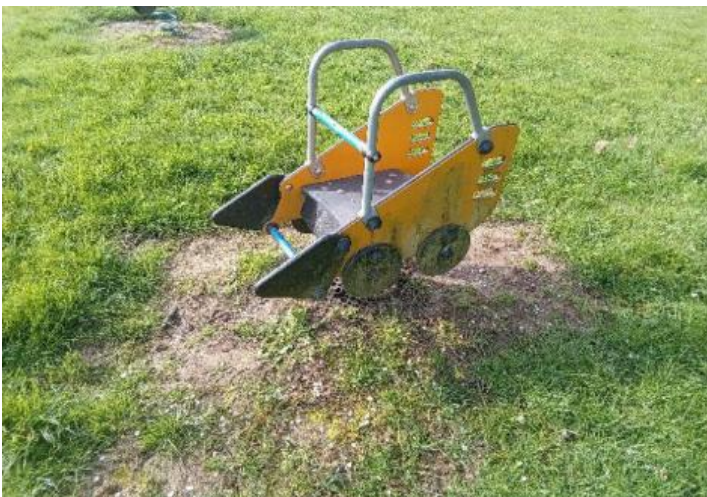
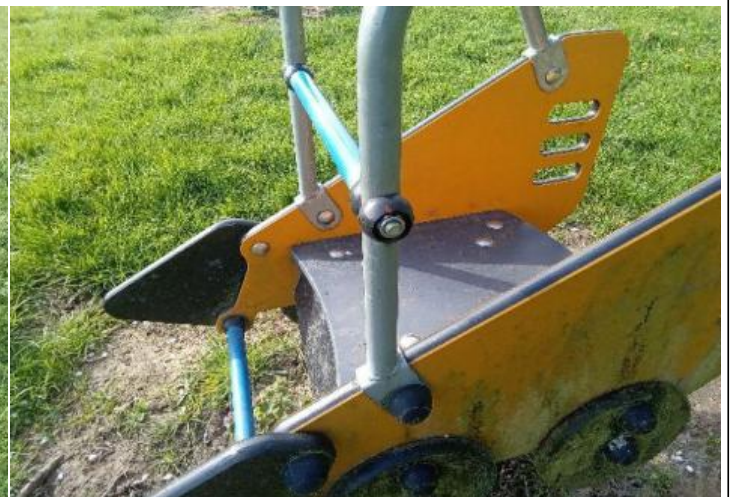
Item: Rocking Equipment - Spring Bulldozer
Manufacturer: Kompan Ltd

Finding: There is/are bolt cap covers missing or damaged on the item **Action:** Replace missing or damaged bolt cap covers

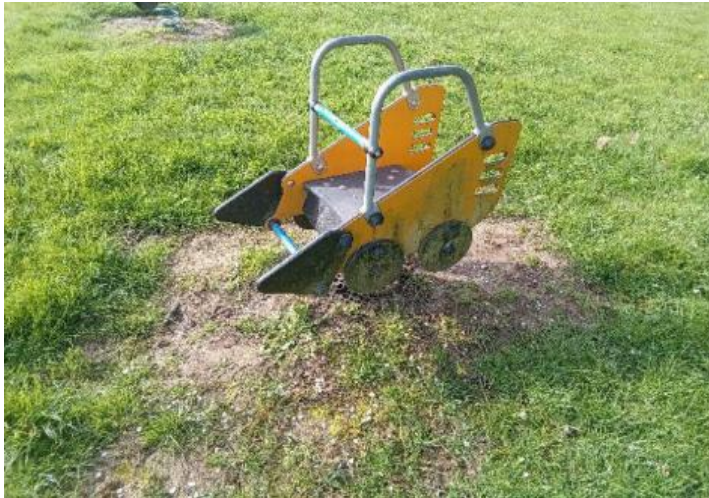
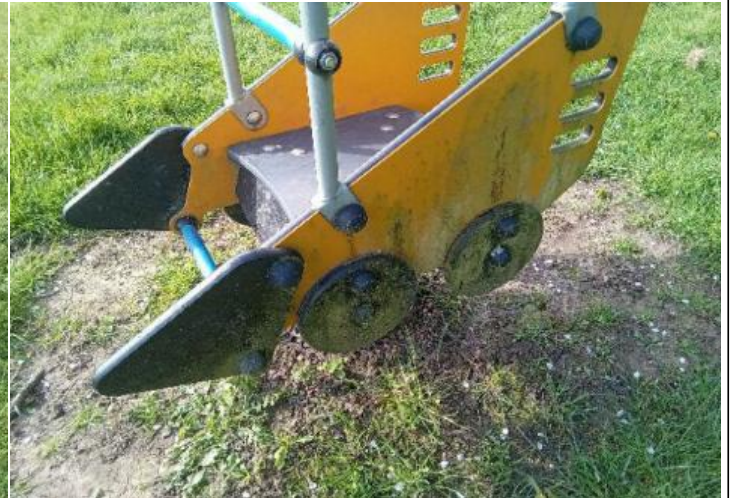
Item: Rocking Equipment - Spring Bulldozer
Manufacturer: Kompan Ltd

Finding: There is algae or moss on the surface of the equipment

Action: Clean and treat appropriately

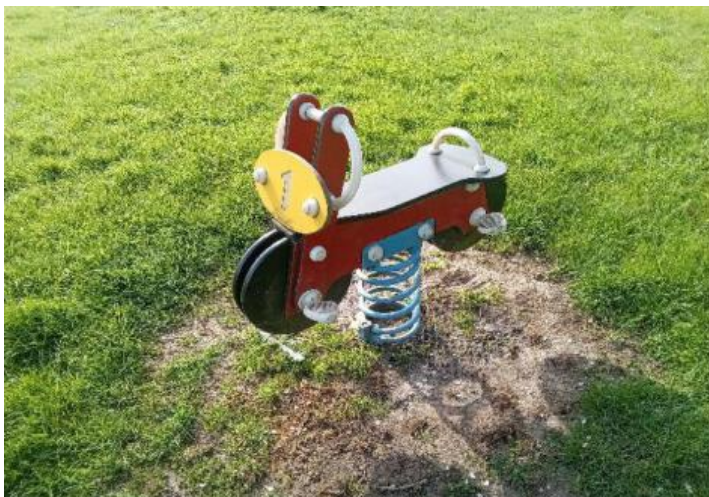
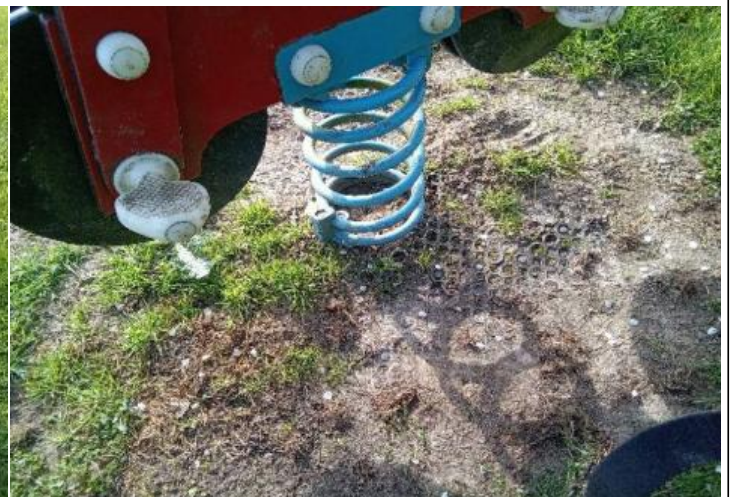
Item: Rocking Equipment - Spring Bike
Manufacturer: Kompan Ltd

Finding: The item is slightly loose in its foundations

Action: Monitor for any further deterioration and repair as required

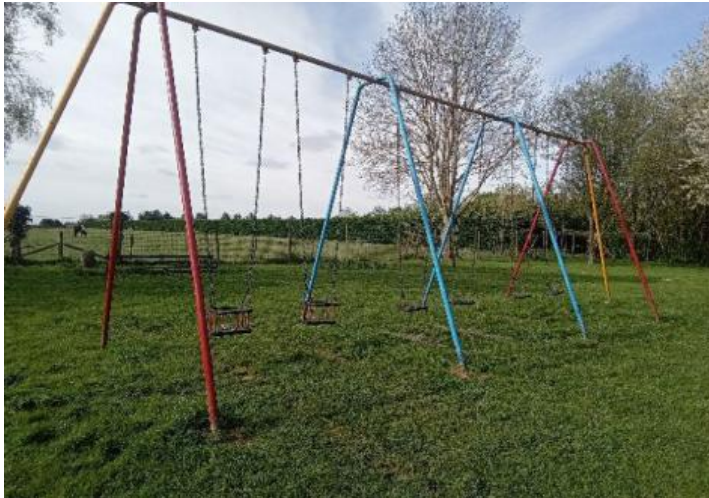
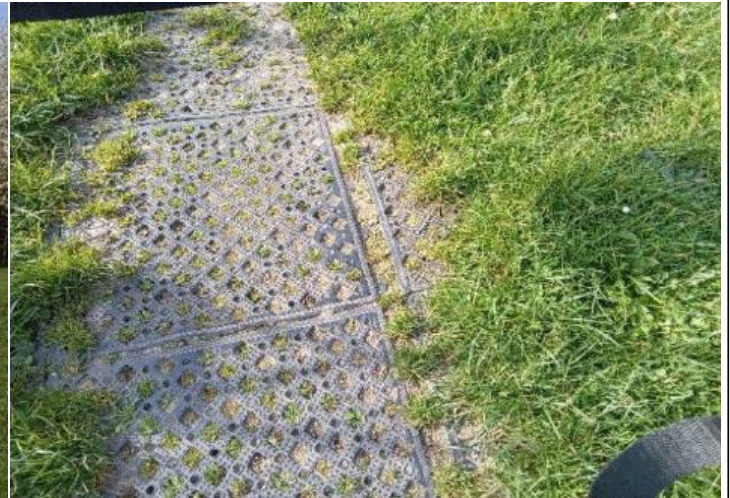
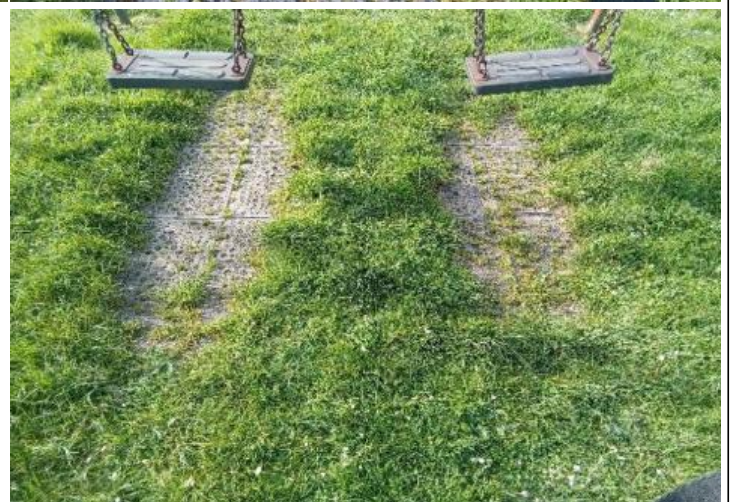
Item: Swings - 3 Bay Swing
Manufacturer: Hags

Risk Level: L - Low Risk
Surface: Grass Matrix Tiles

Finding: There are gaps opening between the grass mat tiles

Action: Provide additional ties or secure / reinstate surface

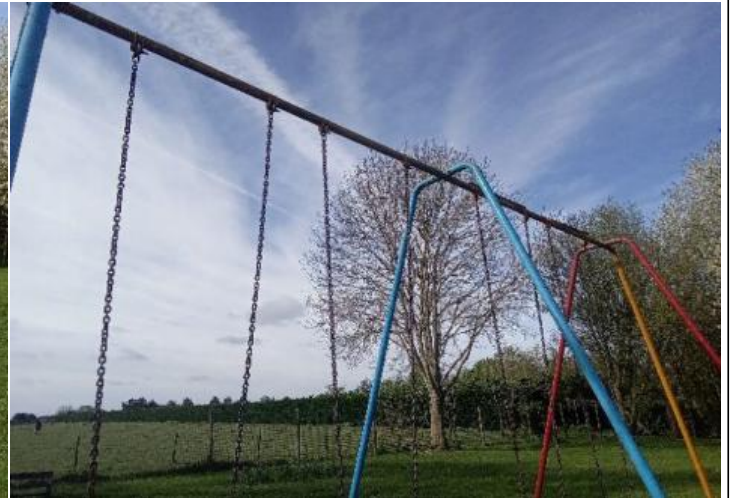
Item: Swings - 3 Bay Swing
Manufacturer: Hags

Risk Level: N - Risk Assessment not Undertaken
Surface: Grass Matrix Tiles

Finding: The fixings or components for this item were in excess of 2.5m above the standing surface and could not be fully accessed by the inspector. We have completed a visual inspection of the fixings from ground level but a maintenance inspection should be undertaken to assess the condition, security and wear of the components at intervals in accordance with the manufacturers recommendations.

Action: Inspect in accordance with the manufacturers recommendations

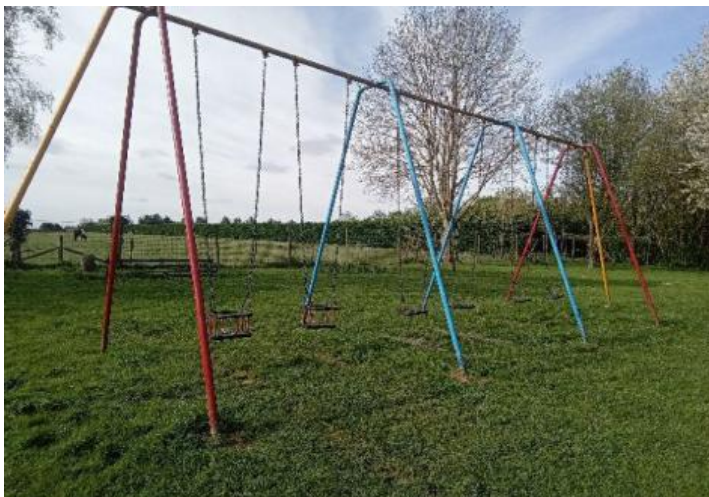
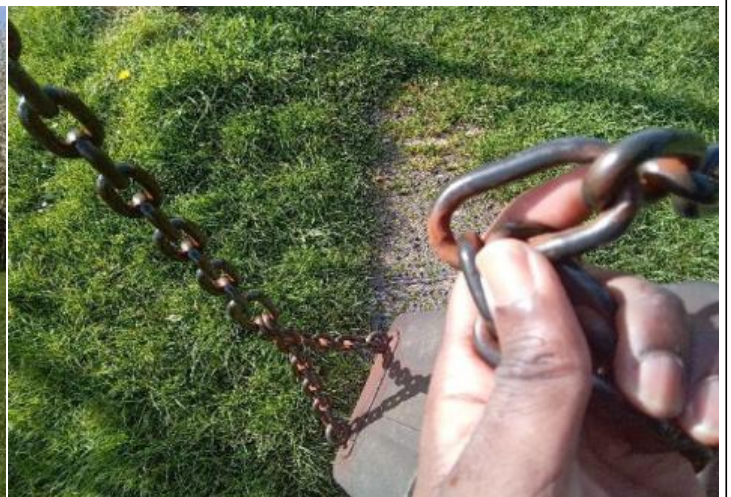
Item: Swings - 3 Bay Swing
Manufacturer: Hags

Risk Level: L - Low Risk
Surface: Grass Matrix Tiles

Finding: There is some notable evidence of connecting link wear

Action: Monitor for any further deterioration and replace when 40% worn

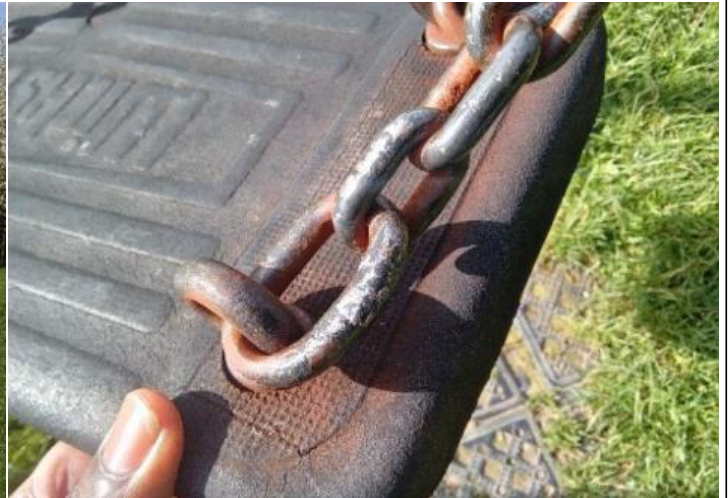
Item: Swings - 3 Bay Swing
Manufacturer: Hags

Risk Level: L - Low Risk
Surface: Grass Matrix Tiles

Finding: There is some notable evidence of chain wear

Action: Monitor for any further deterioration and replace when 40% worn
