ST STEPHEN PARISH COUNCIL

You are summoned to the Fixed Assets Committee meeting
To take place on **Thursday 30 May 2024 at 7.30pm**
at St Stephen Suite, Parish Centre, Station Road, Bricket Wood, AL2 3PJ

- 2425/AC/07 To receive Annual Play Inspection Report and Grounds Team Action Report. Play Reports and Grounds Team Report attached.**
- 2425/AC/08 To discuss the option of creating additional allotment plots and possible beginner plots at Watford Road allotment site or North Close. Allotment report attached.**

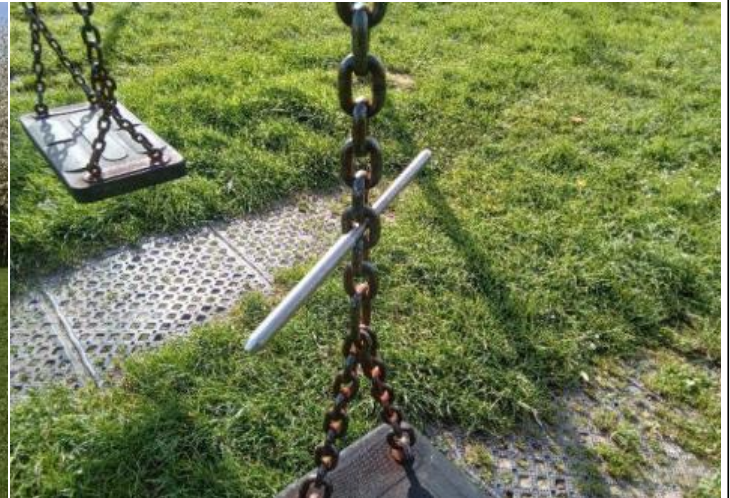
Item: Swings - 3 Bay Swing
Manufacturer: Hags

Risk Level: V - Very Low Risk
Surface: Grass Matrix Tiles

Finding: The chain openings are in excess of the 8.6mm as recommended by BS EN 1176 **Action:** Monitor - No remedial work recommended

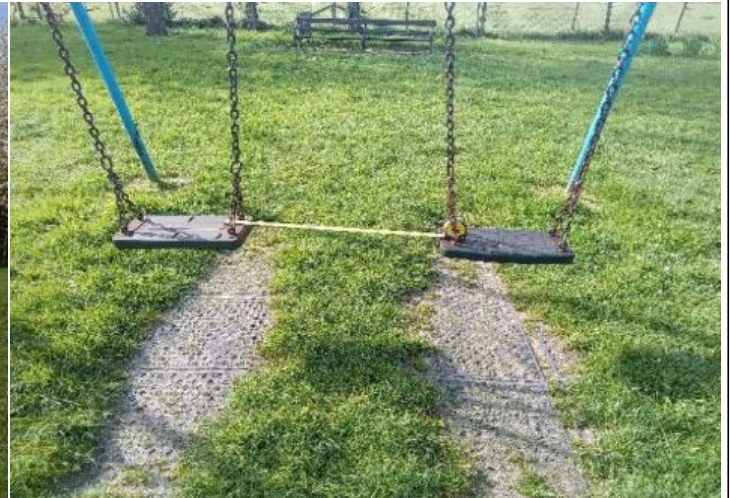
Item: Swings - 3 Bay Swing
Manufacturer: Hags

Risk Level: V - Very Low Risk
Surface: Grass Matrix Tiles

Finding: The seats are too close to each other as defined in BS EN 1176 Part 2; this is a low risk failure and no remedial action is required
Action: Monitor - No remedial work recommended

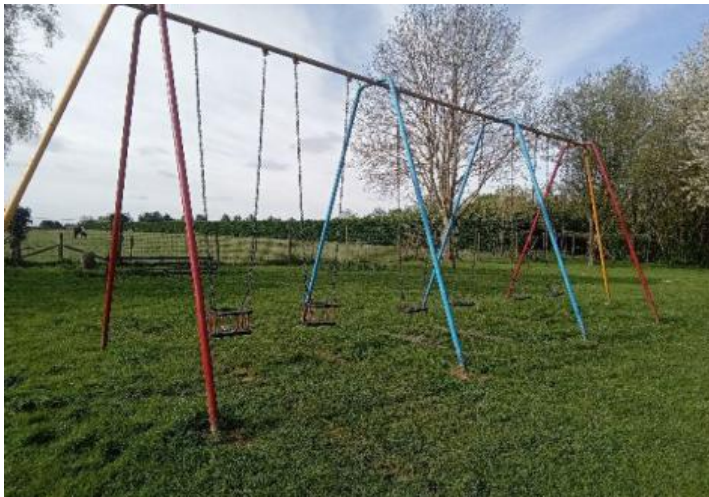
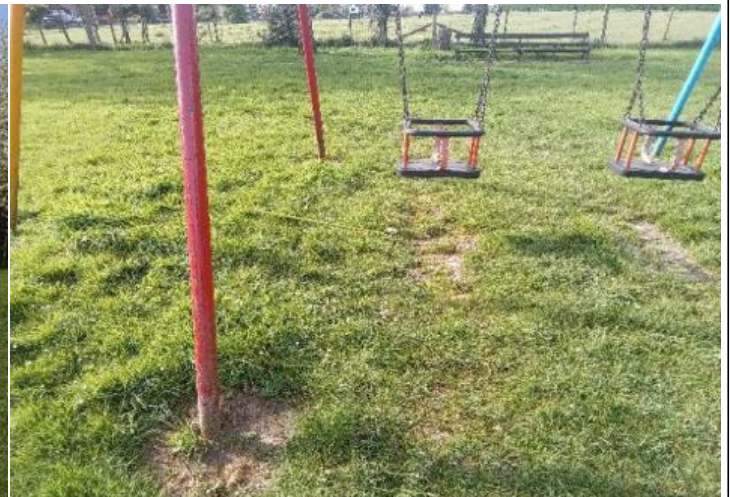
Item: Swings - 3 Bay Swing
Manufacturer: Hags

Risk Level: V - Very Low Risk
Surface: Grass Matrix Tiles

Finding: The seats are too close to the frame as defined in BS EN 1176 Part 2; this is a low risk failure and no remedial action is required
Action: Monitor - No remedial work recommended

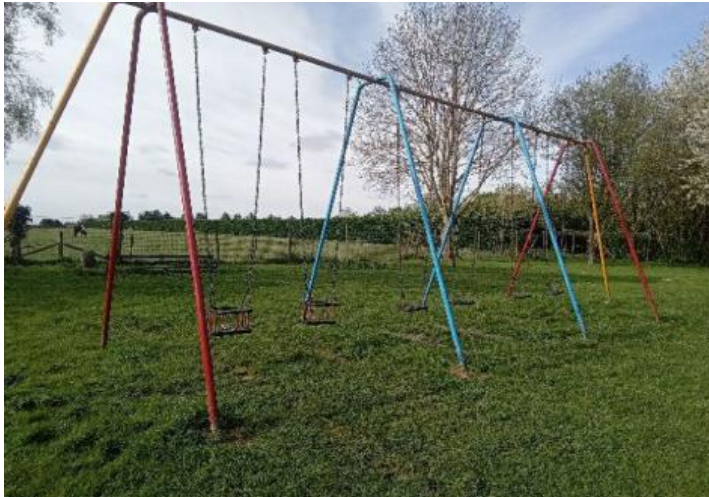
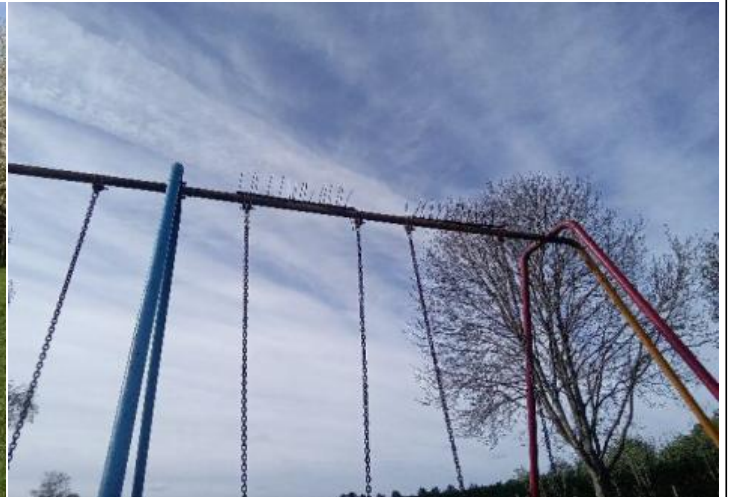
Item: Swings - 3 Bay Swing
Manufacturer: Hags

Risk Level: L - Low Risk
Surface: Grass Matrix Tiles

Finding: There are Anti-bird devices attached to the crossbeam

Action: Remove and replace with upturned cable ties

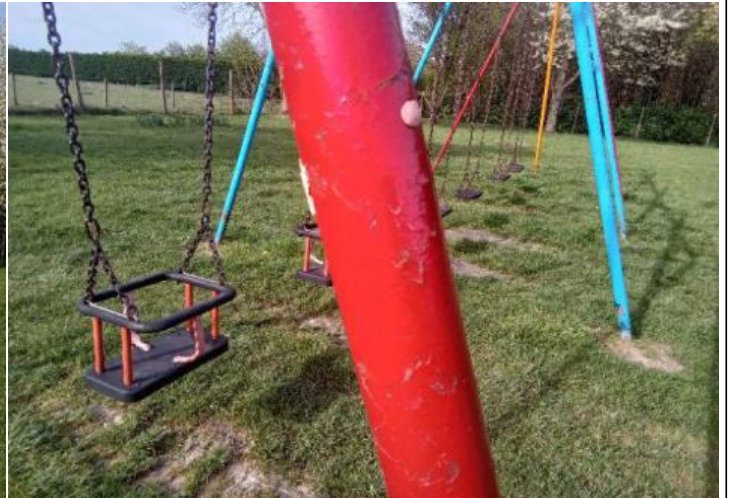
Item: Swings - 3 Bay Swing
Manufacturer: Hags

Risk Level: L - Low Risk
Surface: Grass Matrix Tiles

Finding: The paint is flaking off the metalwork

Action: Rub down and re-paint

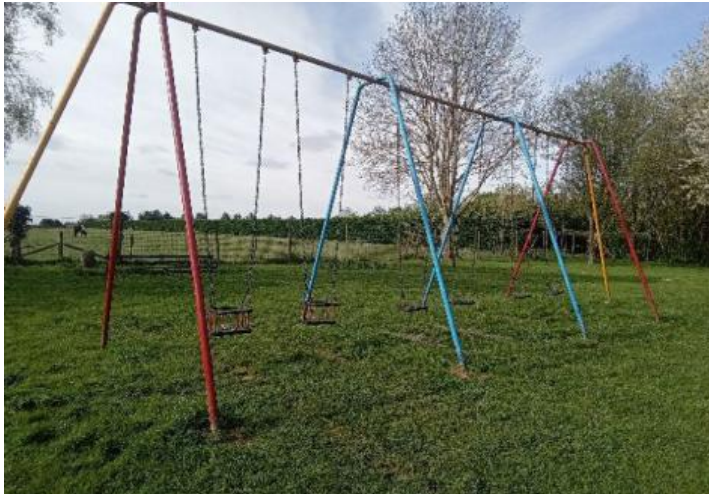
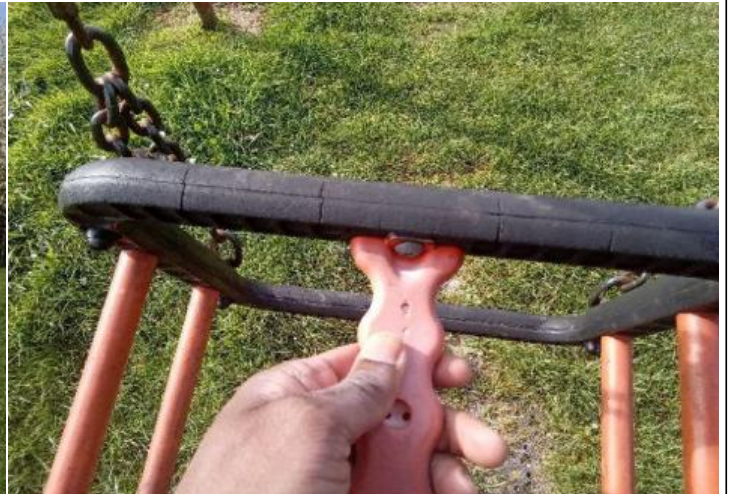
Item: Swings - 3 Bay Swing
Manufacturer: Hags

Risk Level: L - Low Risk
Surface: Grass Matrix Tiles

Finding: The seat has minor damage or wear

Action: Monitor for any further deterioration and replace as required

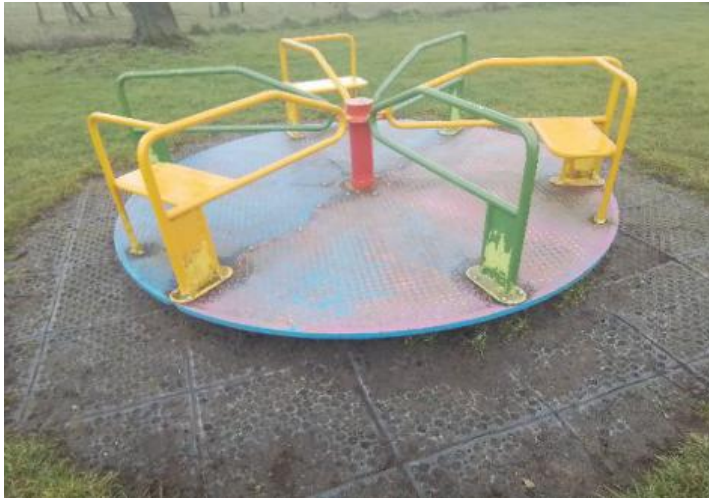
Item: Rotor Play - Roundabout
Manufacturer: G L Jones Playgrounds Ltd

Risk Level: L - Low Risk
Surface: Grass Matrix Tiles

Finding: The surface has subsided in some areas

Action: Monitor for any further deterioration and repair as required

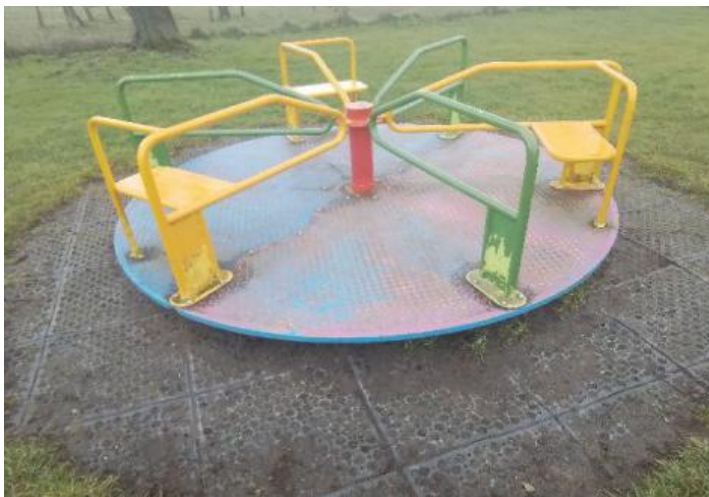
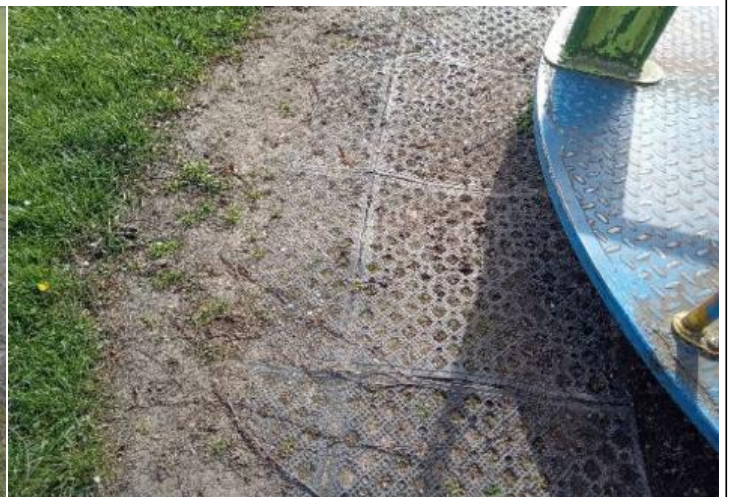
Item: Rotor Play - Roundabout
Manufacturer: G L Jones Playgrounds Ltd

Risk Level: L - Low Risk
Surface: Grass Matrix Tiles

Finding: There are gaps opening between the grass mat tiles

Action: Provide additional ties or secure / reinstate surface

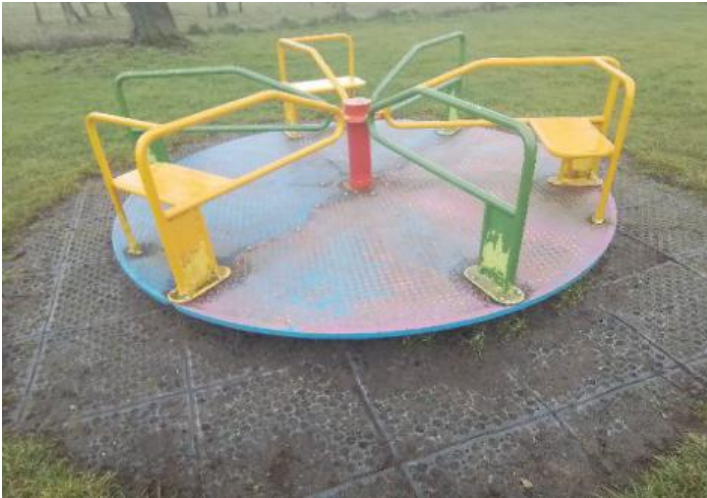
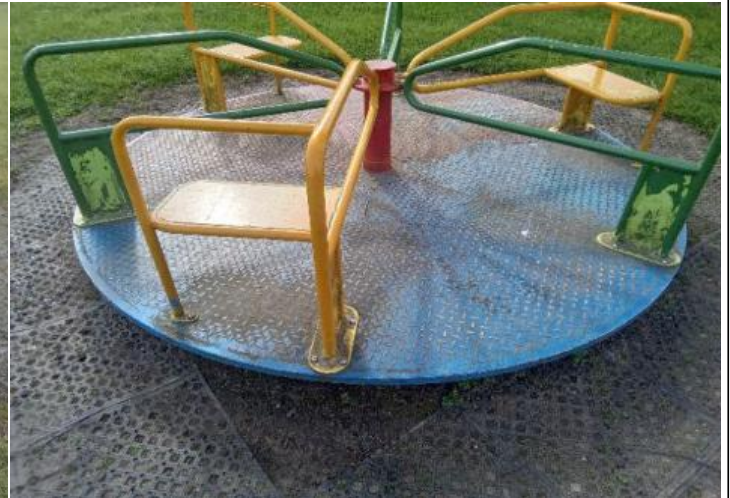
Item: Rotor Play - Roundabout
Manufacturer: G L Jones Playgrounds Ltd

Risk Level: L - Low Risk
Surface: Grass Matrix Tiles

Finding: The bearing is worn / damaged and the item is not operating correctly
Action: Repair / replace

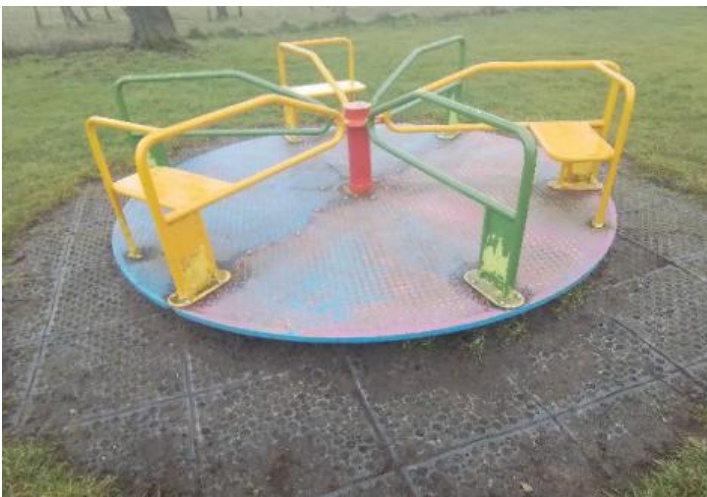
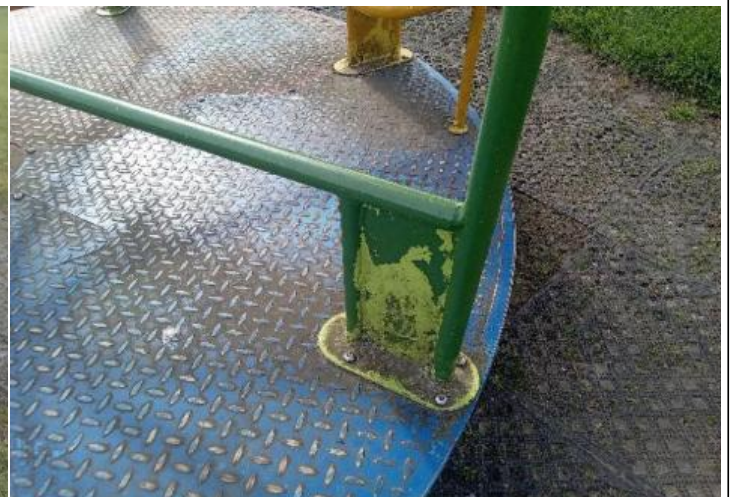
Item: Rotor Play - Roundabout
Manufacturer: G L Jones Playgrounds Ltd

Risk Level: L - Low Risk
Surface: Grass Matrix Tiles

Finding: The paint is flaking off the metalwork
Action: Rub down and re-paint

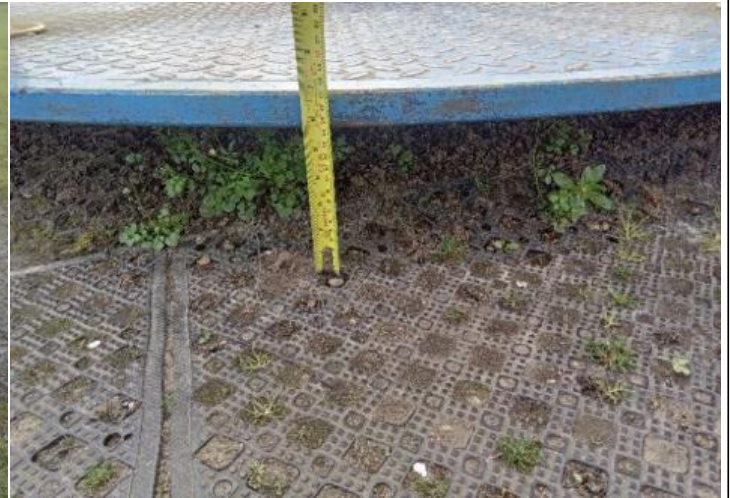
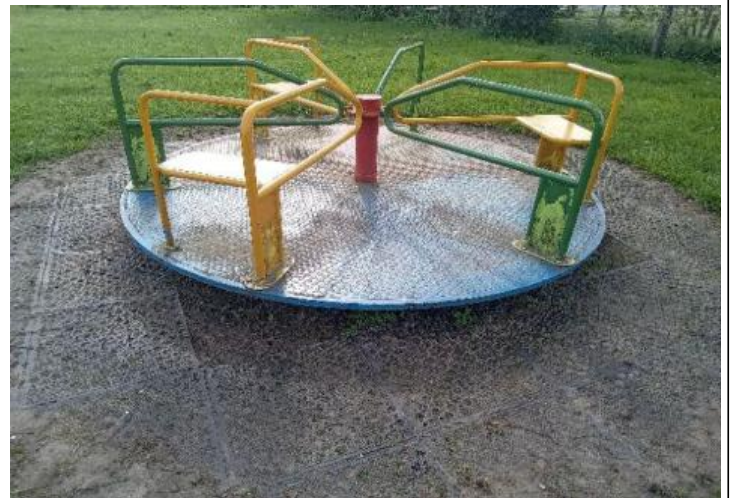
Item: Rotor Play - Roundabout
Manufacturer: G L Jones Playgrounds Ltd

Risk Level: L - Low Risk
Surface: Grass Matrix Tiles

Finding: The distance between the underside of the roundabout platform and the playing surface is in excess of 110mm and contravenes the requirements of BS EN 1176 Part 5 which requires that the distance be maintained between 60mm-110mm - for the entire circumference of the roundabout

Action: Monitor - No remedial work recommended

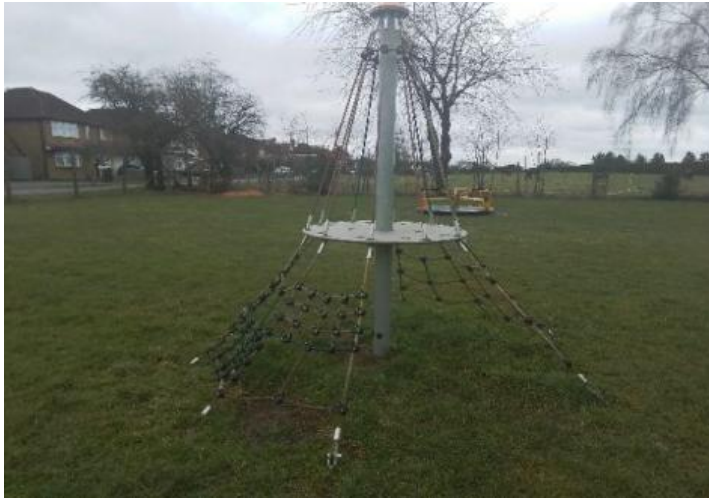
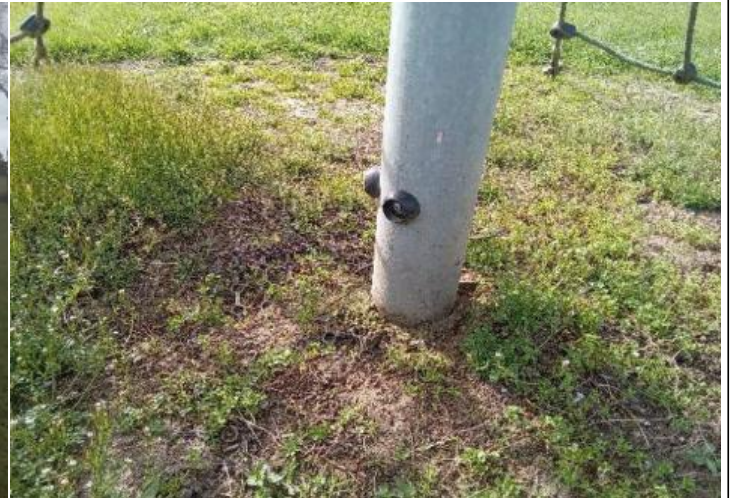
Item: Activity Equipment - Rope Climber
Manufacturer: Kompan Ltd

Risk Level: V - Very Low Risk
Surface: Grass Matrix Tiles

Finding: There is/are bolt cap covers missing or damaged on the item

Action: Replace missing or damaged bolt cap covers

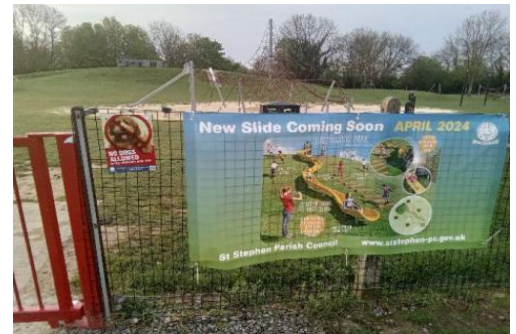
Item: Sign
Manufacturer: Owner/Operator
Surface Type: Grass
Item Quantity: 1
Equipment Compliance: N/A
Surface Area Compliance: N/A

It is recommended that signage, with information including the site address, contact information for maintenance issues and emergency contact details are provided for the facility - Provide in accordance with the recommendations

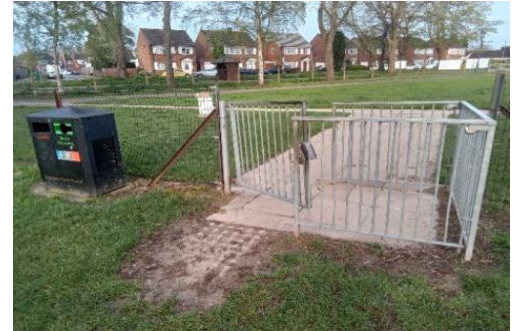
Item: Kissing Gate
Manufacturer: Not Identified
Surface Type: Paving Slabs
Item Quantity: 1
Equipment Compliance: N/A
Surface Area Compliance: N/A

The surface has eroded in some areas and may be slippery in wet conditions - Reinstate the surface

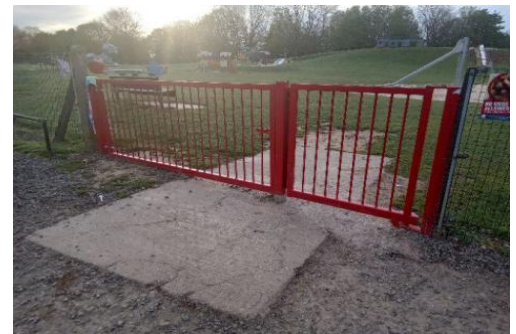
Item: Gate - Maintenance
Manufacturer: Not Identified
Surface Type: Concrete
Item Quantity: 1
Equipment Compliance: N/A
Surface Area Compliance: N/A

There are trip hazards at the edges of the surface - Reinstate surrounding surface levels to remove the trip points

The surface has eroded in some areas and may be slippery in wet conditions - Reinstate the surface

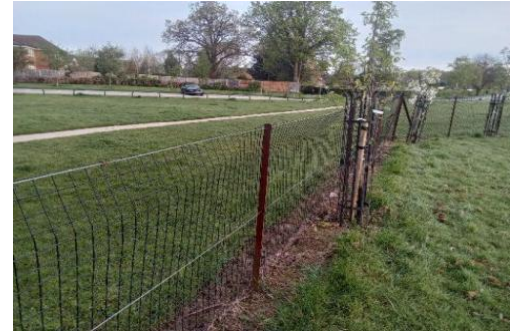
Item: Fence - Steel Mesh
Manufacturer: Not Identified
Surface Type: Grass
Item Quantity: 1
Equipment Compliance: N/A
Surface Area Compliance: N/A

There are a number of loose posts around the fence - Monitor for any further deterioration and reset as required

There is some damage to the fence sections - Monitor for any further deterioration and repair as required

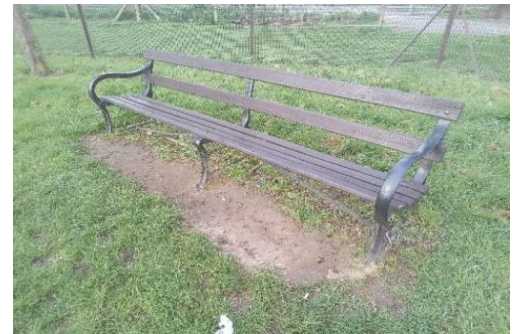
Item: Bench
Manufacturer: Not Identified
Surface Type: Grass
Item Quantity: 7
Equipment Compliance: N/A
Surface Area Compliance: N/A

The surface has eroded in some areas and may be slippery in wet conditions - Reinstate the surface

There is some evidence of rot in the timber - Monitor for any further deterioration and replace as required

There is some damage to the item - Monitor for any further deterioration and repair as required

There is some strimmer / machinery damage apparent on the posts, this can penetrate the preservative applied to the timber and accelerate the rotting process - Monitor for any deterioration (rot) and replace as required

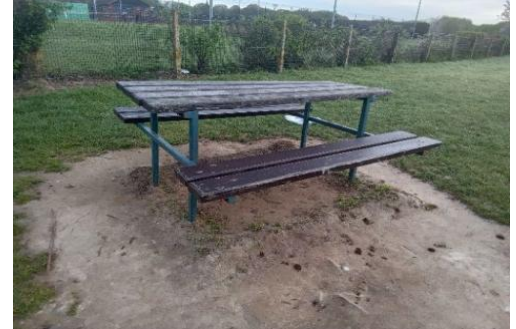
Item: Picnic Table
Manufacturer: Not Identified
Surface Type: Grass
Item Quantity: 4
Equipment Compliance: N/A
Surface Area Compliance: N/A

The surface has eroded in some areas and may be slippery in wet conditions - Reinstate the surface

The timber stain is in poor condition - Prepare all affected parts and re-stain with an appropriate preservative

There is some evidence of rot in the timber - Monitor for any further deterioration and replace as required

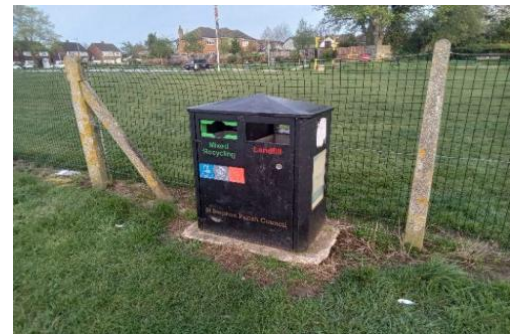
Item: Litter Bin
Manufacturer: Not Identified
Surface Type: Concrete
Item Quantity: 5
Equipment Compliance: N/A
Surface Area Compliance: N/A

The surface has eroded and the foundations are exposed - Reinstate surrounding surfaces to cover the foundations

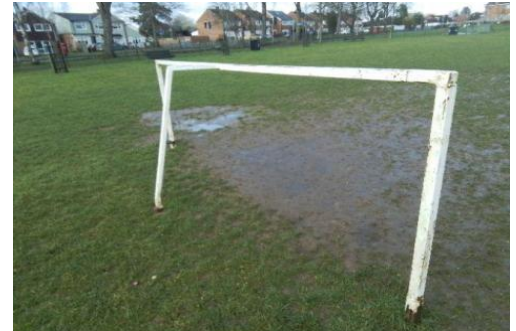
Item: 5 a side Goals
Manufacturer: Not Identified
Surface Type: Grass
Item Quantity: 1
Equipment Compliance: N/A
Surface Area Compliance: N/A
Life Expectancy: 5 -10 Years
Total Findings: 3

The surface has eroded in some areas and may be slippery in wet conditions - Reinstate the surface

The paintwork on this item has been damaged or worn exposing the metal underneath which is rusting / corroding - Treat affected areas and repaint

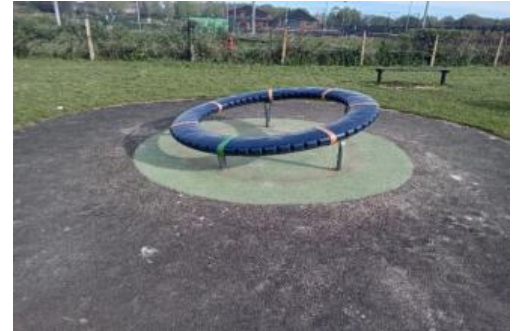
Item: Supernova
Manufacturer: Kompan Ltd
Surface Type: Wet Pour
Item Quantity: 1
Equipment Compliance: Yes
Surface Area Compliance: Yes
Life Expectancy: 5 -10 Years
Total Findings: 1

This item is satisfactory - no work required -

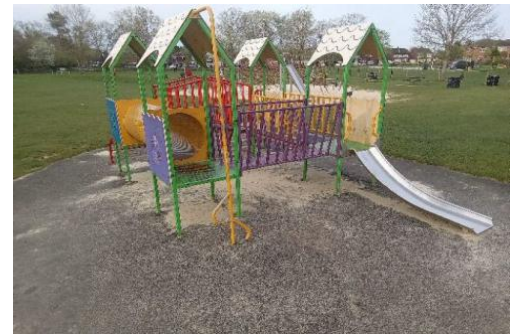
Item: Multi Play (Toddler)
Manufacturer: Wicksteed Playgrounds
Surface Type: Wet Pour
Item Quantity: 1
Equipment Compliance: Yes
Surface Area Compliance: Yes
Life Expectancy: 5 -10 Years
Total Findings: 3

There are a number of dents in the slide surface - Monitor for any further deterioration and repair as required

The paintwork on this item has been damaged or worn exposing the metal underneath which is rusting / corroding - Treat affected areas and repaint

There is some damage to the item - Monitor for any further deterioration and repair as required

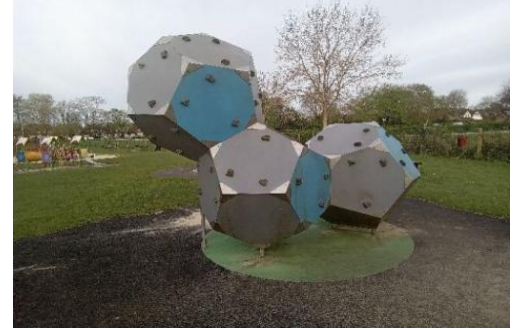
Item: Climbing Blocks
Manufacturer: Kompan Ltd
Surface Type: Wet Pour
Item Quantity: 1
Equipment Compliance: Yes
Surface Area Compliance: Yes
Life Expectancy: >10 Years
Total Findings: 1

There is some damage to the item - Monitor for any further deterioration and repair as required

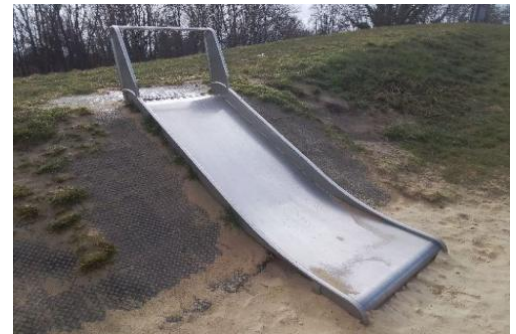
Item: Embankment Slide
Manufacturer: R&T Stainless A/S
Surface Type: Mixed Surface
Item Quantity: 1
Equipment Compliance: Yes
Surface Area Compliance: Yes
Life Expectancy: 5 -10 Years
Total Findings: 4

The surface has eroded in some areas and may be slippery in wet conditions - Reinstate the surface

The edges of the grass mat surface are raised / lifting above the surrounding surface - Tuck in or pin edges of grass mats as per the API Code of Practice to remove trip hazards

There are a number of dents in the slide surface - Monitor for any further deterioration and repair as required

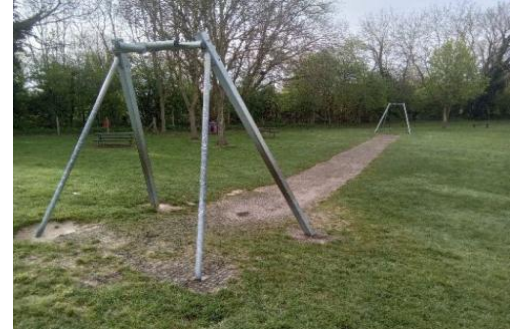
Item: Cable Runway
Manufacturer: Kompan Ltd
Surface Type: Grass Matrix Tiles
Item Quantity: 1
Equipment Compliance: No
Surface Area Compliance: Yes

We have completed a visual inspection of the suspension links, cable and fixing points from ground level, however it is not possible to fully inspect these areas without either hiring equipment to gain access or removing the cable and suspension and inspecting at ground level. We recommend that the main cable and fixing security is thoroughly inspected at least in accordance with the manufacturers recommendations to check for wear, damage, security or internal rusting; this will help to ensure the continued safe use of the equipment - Inspect in accordance with the manufacturers recommendations

The nylon inserts are worn or missing at the point the cable enters the traveller - Replace worn or missing inserts as required

The seat connection cannot be inspected without dismantling the seat - Dismantle the seat to inspect the seat connection for wear

The chain links are worn in excess of 40% and require renewing - Replace worn chains

The surface has eroded in some areas and may be slippery in wet conditions - Reinstate the surface

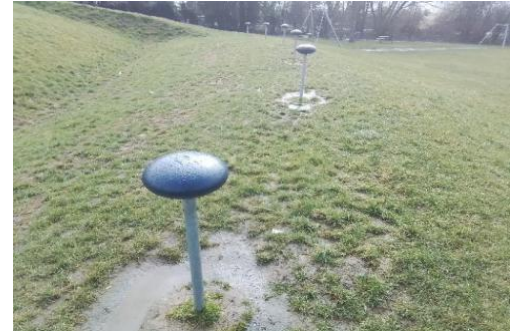
Item: Leap Frog
Manufacturer: Kompan Ltd
Surface Type: Grass Matrix Tiles
Item Quantity: 1
Equipment Compliance: Yes
Surface Area Compliance: Yes
Life Expectancy: 5 -10 Years
Total Findings: 1

There is moderate damage to the grass matrix tile surface - Repair the damaged areas of surfacing

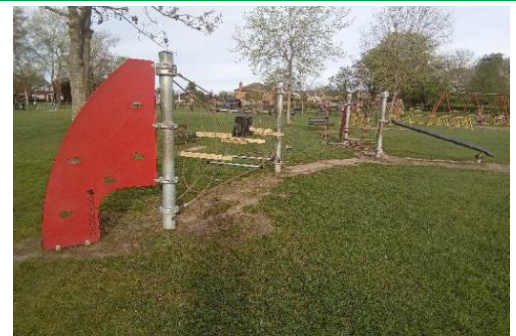
Item: Activity Trail
Manufacturer: Corocord
Surface Type: Grass Matrix Tiles
Item Quantity: 1
Equipment Compliance: No
Surface Area Compliance: Yes

The grass mats are silted up, the soil is compacted and the area will become very slippery when the soil is wet. - Reinststate as required

There is some damage to the item - Monitor for any further deterioration and repair as required

There is/are finger entrapment/s in the rope connections and the item fails to meet the requirements of BS EN 1176 Part 1 4.2.7.6 Entrapment of fingers - Monitor - No remedial work recommended

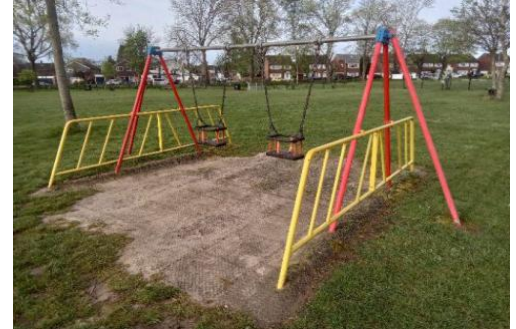
Item: 1 Bay 2 Seat (Cradle)
Manufacturer: GL Jones
Surface Type: Grass Matrix Tiles
Item Quantity: 1
Equipment Compliance: No
Surface Area Compliance: Yes
Life Expectancy: 5 -10 Years
Total Findings: 5

The surface has subsided in some areas - Monitor for any further deterioration and repair as required

There is some wear to the shackles. - Monitor for any further deterioration and replace when 40% worn

There is some notable evidence of chain wear - Monitor for any further deterioration and replace when 40% worn

The chain openings are in excess of the 8.6mm as recommended by BS EN 1176 - Monitor - No remedial work recommended

The seat has minor damage or wear - Monitor for any further deterioration and replace as required

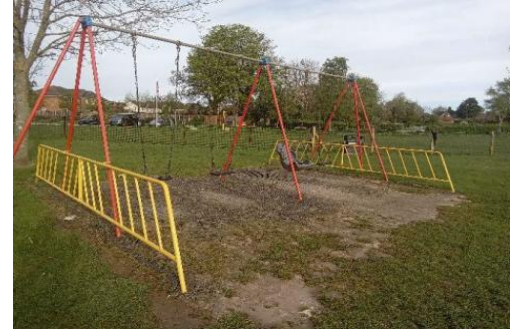
Item: 2 Bay 3 Flat 1 Inclusive Seat
Manufacturer: G L Jones Playgrounds Ltd
Surface Type: Grass Matrix Tiles
Item Quantity: 1
Equipment Compliance: No
Surface Area Compliance: Yes
Life Expectancy: 5 -10 Years
Total Findings: 8

The fixings or components for this item were in excess of 2.5m above the standing surface and could not be fully accessed by the inspector. We have completed a visual inspection of the fixings from ground level but a maintenance inspection should be undertaken to assess the condition, security and wear of the components at intervals in accordance with the manufacturers recommendations. - Inspect in accordance with the manufacturers recommendations

BS EN 1176 Part 2: Annex A makes a recommendation that fences or enclosures should be upto 1.50m from the edges of the swing seat to the sides, and subject to risk assessment, from the edge of the impact area. This is however, a low risk finding and no remedial action is recommended. - Monitor - No remedial work recommended

The bushes are worn or missing - Replace worn or missing bushes

There is some wear to the shackles. - Monitor for any further deterioration and replace when 40% worn

The chain openings are in excess of the 8.6mm as recommended by BS EN 1176 - Monitor - No remedial work recommended

There is some notable evidence of chain wear - Monitor for any further deterioration and replace when 40% worn

The swing seat connectors are loose - Tighten to secure

The connecting link is cut/ damaged - Replace damaged link

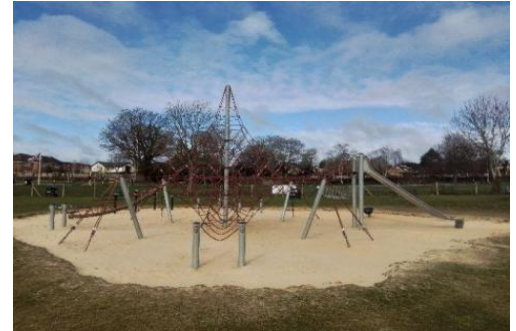
Item: Space Net
Manufacturer: Corocord
Surface Type: Sand
Item Quantity: 1
Equipment Compliance: No
Surface Area Compliance: Yes

The side of the slide is damaged - Monitor for any further deterioration and repair as required

There are a number of dents in the slide surface - Monitor for any further deterioration and repair as required

The ropes/nets are worn/damaged in places - Monitor for any further deterioration and repair or replace as required

There is/are finger entrapment/s in the rope connections and the item fails to meet the requirements of BS EN 1176 Part 1 4.2.7.6 Entrapment of fingers - Monitor - No remedial work recommended

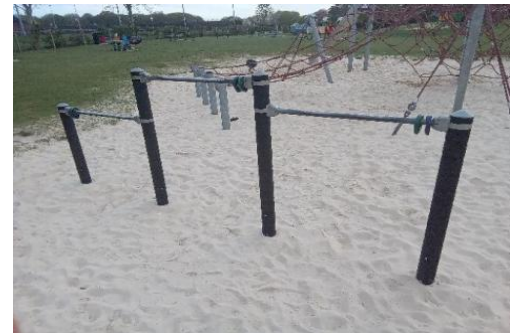
Item: Somersault Bars
Manufacturer: Kompan Ltd
Surface Type: Sand
Item Quantity: 1
Equipment Compliance: No
Surface Area Compliance: Yes

There is/are finger entrapment/s / crush in the Somersault bars fixing and the item fails to meet the requirements of BS EN 1176 Part 1 4.2.7.6 Entrapment of fingers - Monitor - No remedial work recommended

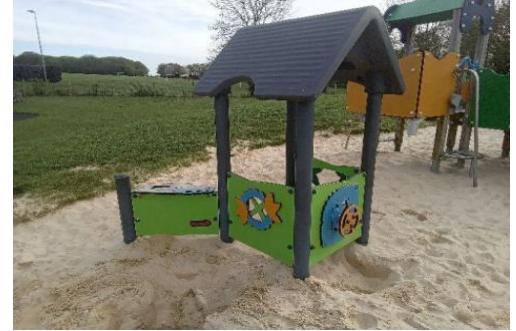
Item: Playhouse
Manufacturer: Kompan Ltd
Surface Type: Sand
Item Quantity: 1
Equipment Compliance: Yes
Surface Area Compliance: N/A

There is some damage to the item - Monitor for any further deterioration and repair as required

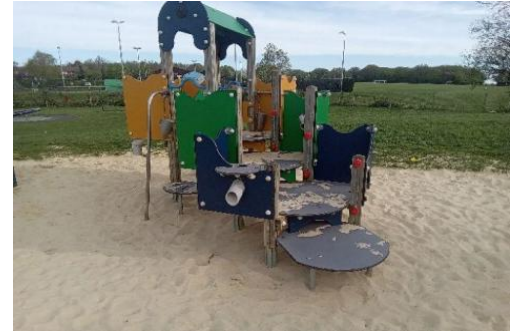
Item: Sand Play Unit
Manufacturer: Kompan Ltd
Surface Type: Sand
Item Quantity: 1
Equipment Compliance: Yes
Surface Area Compliance: Yes

There is/are bolt cap covers missing or damaged on the item - Replace missing or damaged bolt cap covers

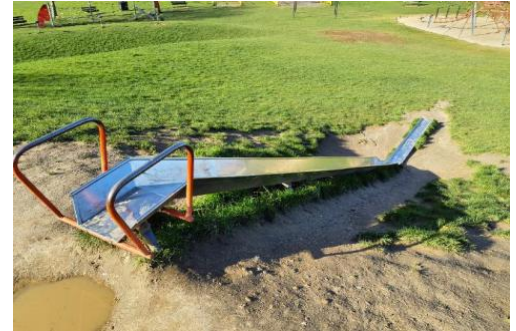
Item: Embankment Slide
Manufacturer: Not Identified
Surface Type: Grass
Item Quantity: 1
Equipment Compliance: No
Surface Area Compliance: Yes

The surface has eroded and the foundations are exposed - Reinstate surrounding surfaces to cover the foundations

The paintwork on this item has been damaged or worn exposing the metal underneath which is rusting / corroding - Treat affected areas and repaint

The slide start section incline is not in the direction of travel; it should slope towards the direction of the sliding surface to meet the requirements of BS EN 1176 Part 3 - Monitor - No remedial work recommended

There are a number of dents in the slide surface - Monitor for any further deterioration and repair as required

The concrete foundation forms a projecting obstacle / hard object within the free space of the equipment, in contravention of the requirements of BS EN 1176 Part 1 - Reinstate the surface

The surface has eroded in some areas and may be slippery in wet conditions - Reinstate the surface

A number of fixing(s) have worked loose - Secure all loose fixings

The weld(s) on this item have failed - Repair item

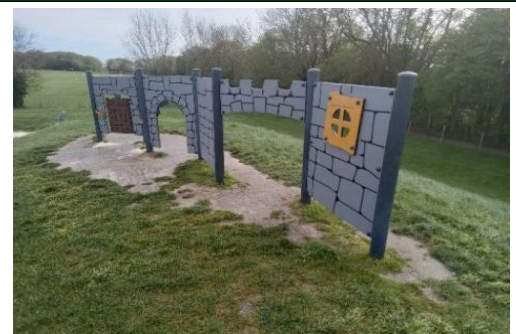
Item: Play Panel
Manufacturer: Kompan Ltd
Surface Type: Grass Matrix Tiles
Item Quantity: 1
Equipment Compliance: Yes
Surface Area Compliance: N/A

The item is slightly loose in its foundations - Monitor for any further deterioration and repair as required

There is some damage to the item - Monitor for any further deterioration and repair as required

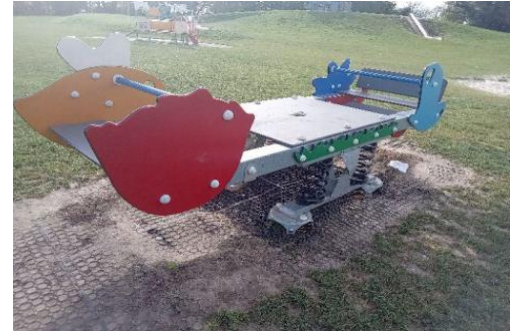
Item: See Saw
Manufacturer: Kompan Ltd
Surface Type: Grass Matrix Tiles
Item Quantity: 1
Equipment Compliance: Yes
Surface Area Compliance: Yes

There is or are fixings missing on the item causing finger entrapment - Replace all missing fixings to remove entrapment

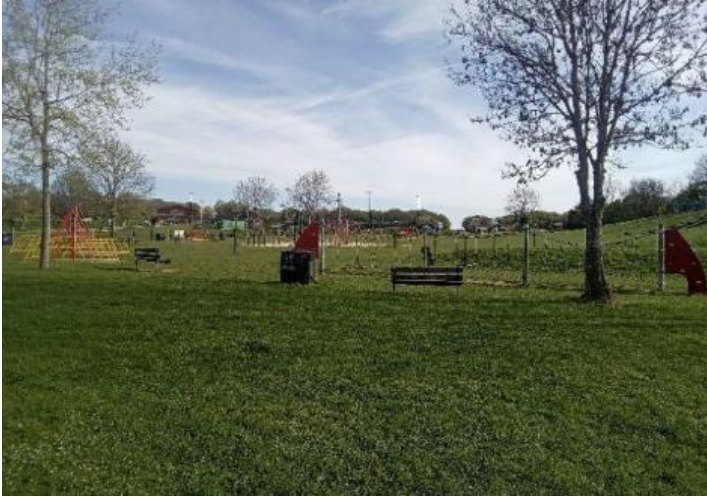
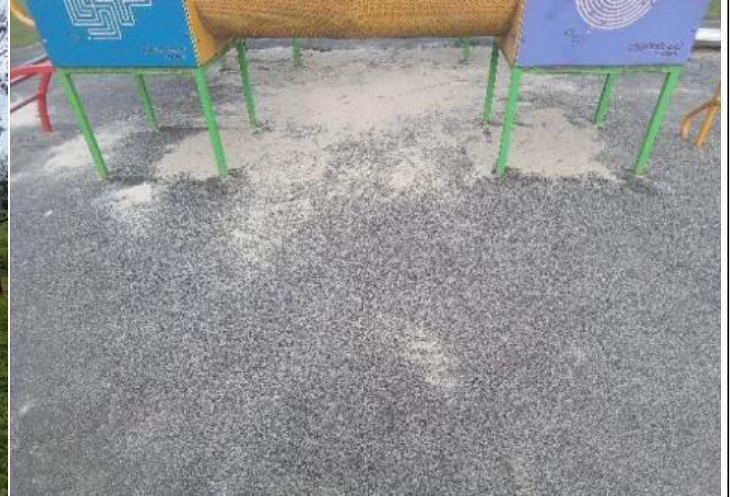
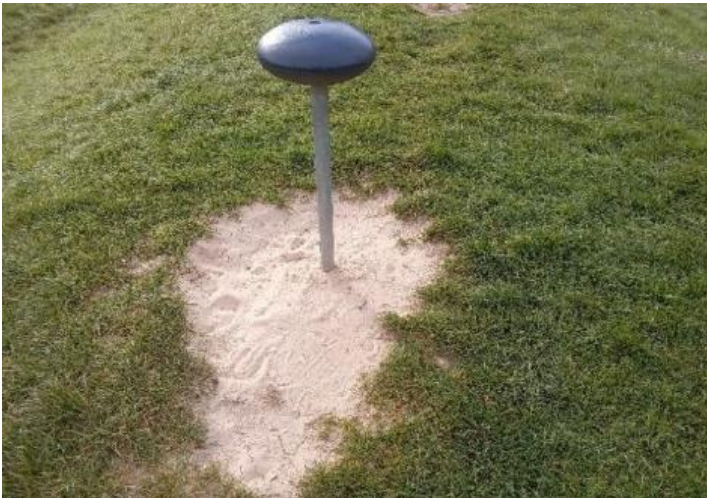
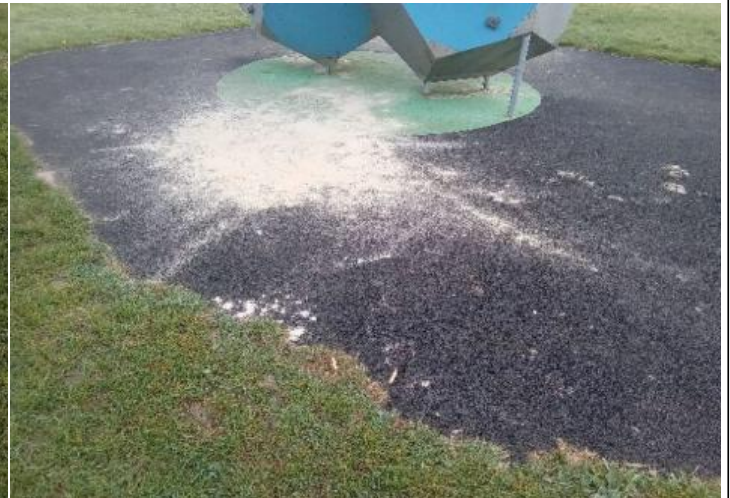
Finding: There is sand on the surface

Action: Remove sand from surface

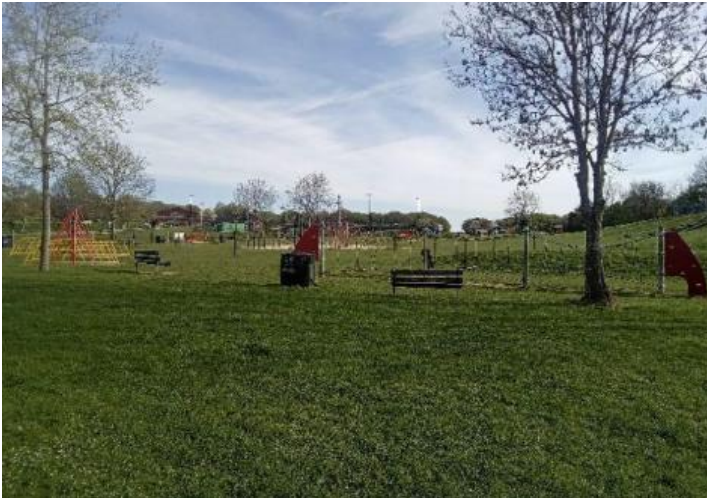
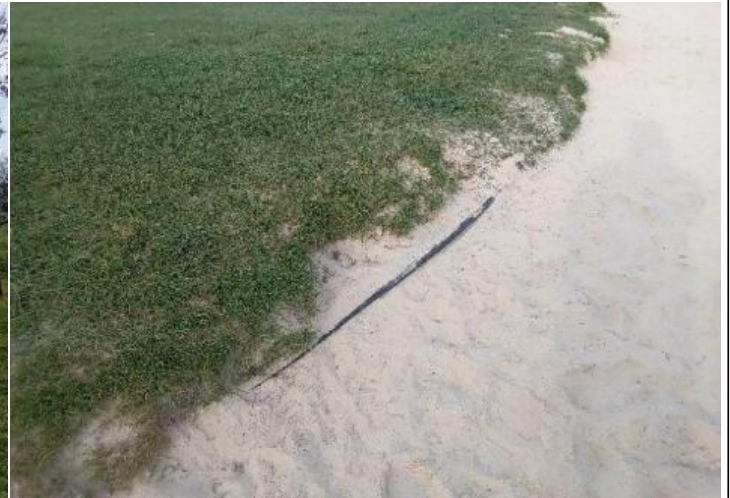
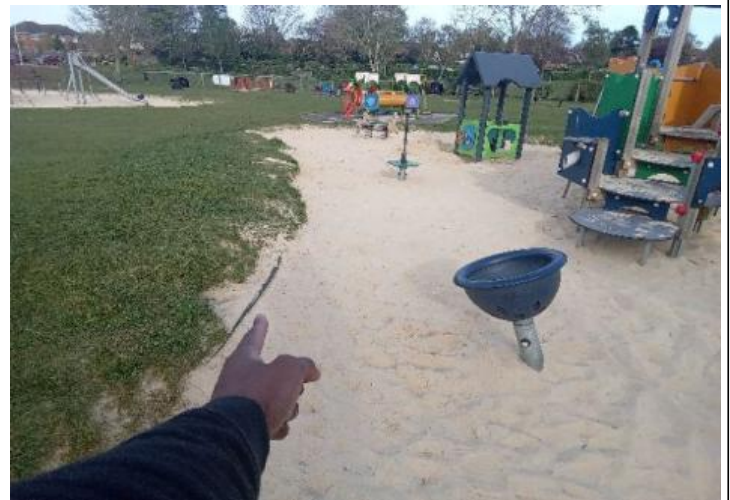
Finding: The safety surface is low and the membrane is exposed creating trip points

Action: Remove or resecure the exposed membrane and top up the surface to the correct level

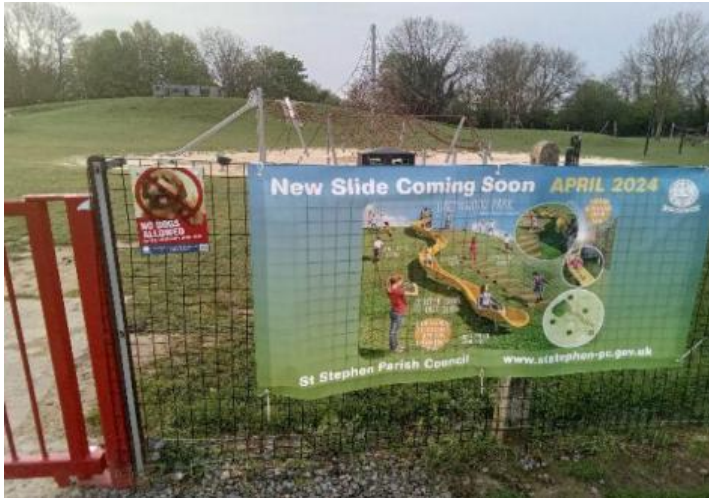
Finding: It is recommended that signage, with information including the site address, contact information for maintenance issues and emergency contact details are provided for the facility

Action: Provide in accordance with the recommendations

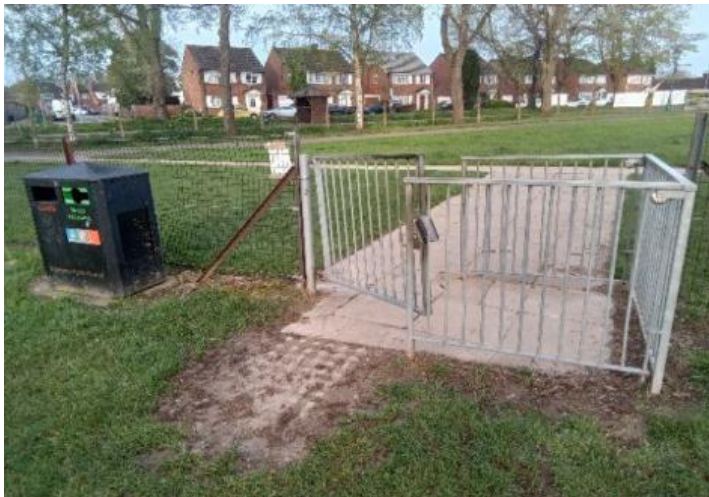
Finding: The surface has eroded in some areas and may be slippery in wet conditions

Action: Reinstate the surface

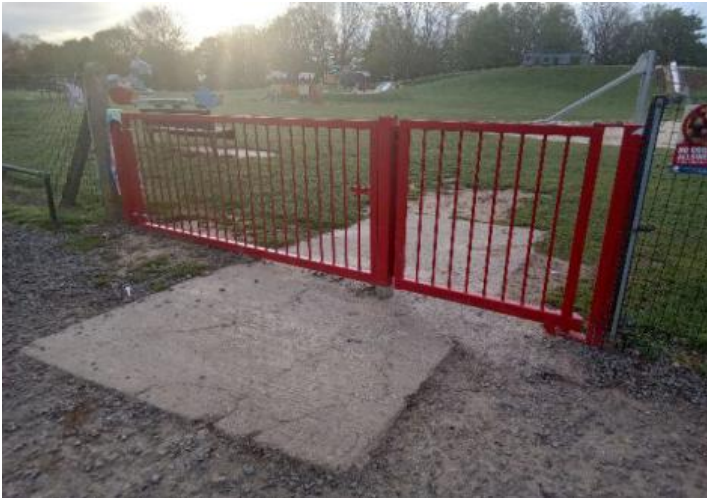
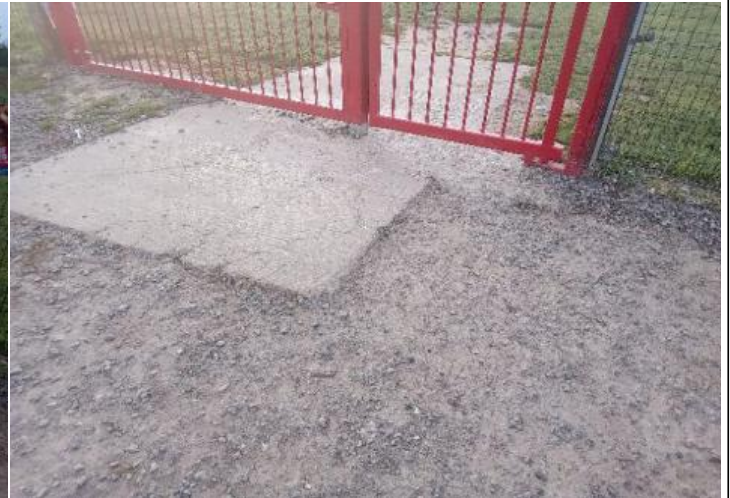
Finding: There are trip hazards at the edges of the surface

Action: Reinstate surrounding surface levels to remove the trip points

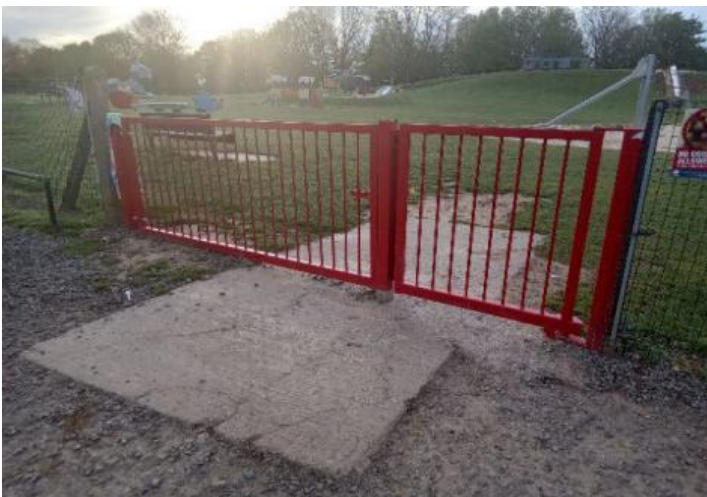
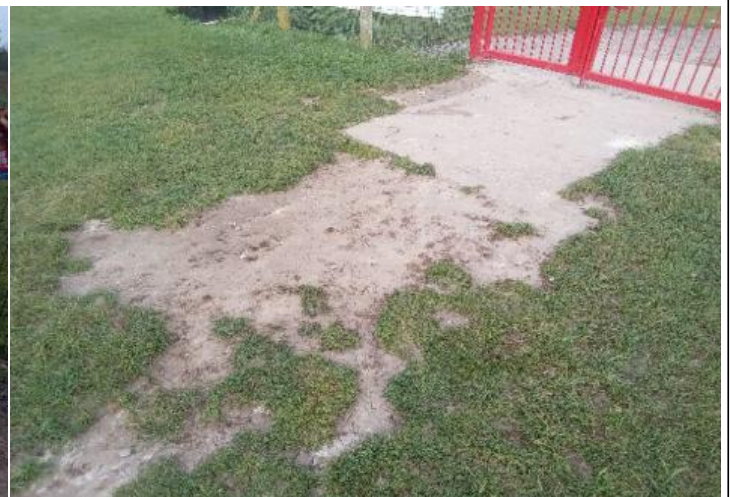
Finding: The surface has eroded in some areas and may be slippery in wet conditions

Action: Reinstate the surface

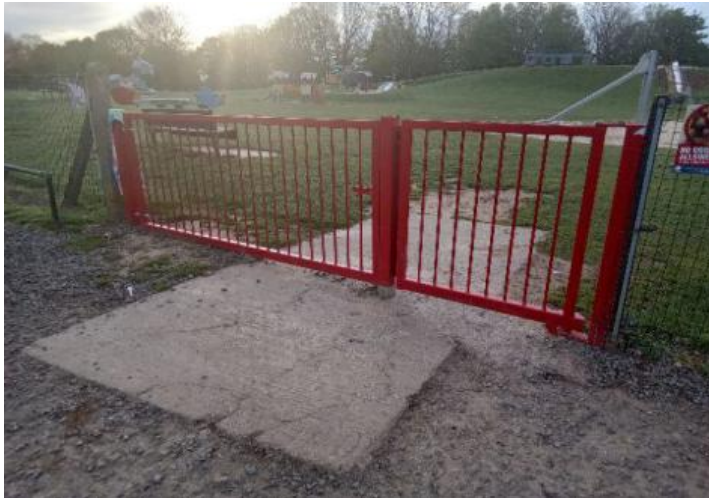
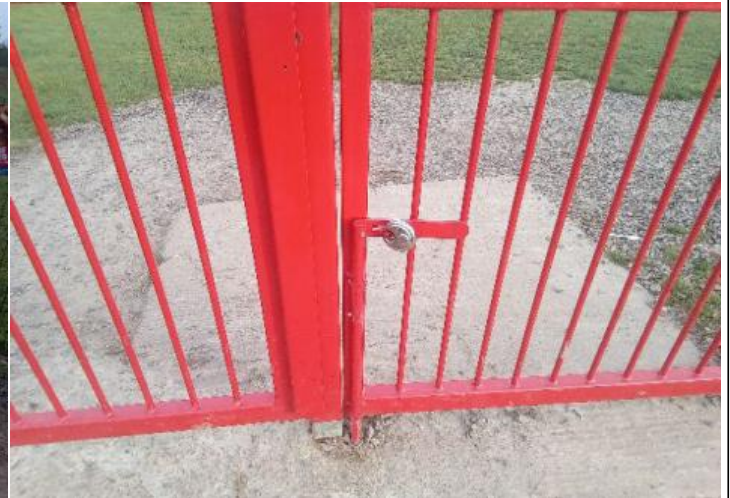
Finding: The maintenance gate was correctly padlocked at the time of inspection, however this means that the inspector was unable to fully assess the gate

Action: Ensure that there are 12mm gaps throughout the full range of motion on gate/s and between leaves where relevant

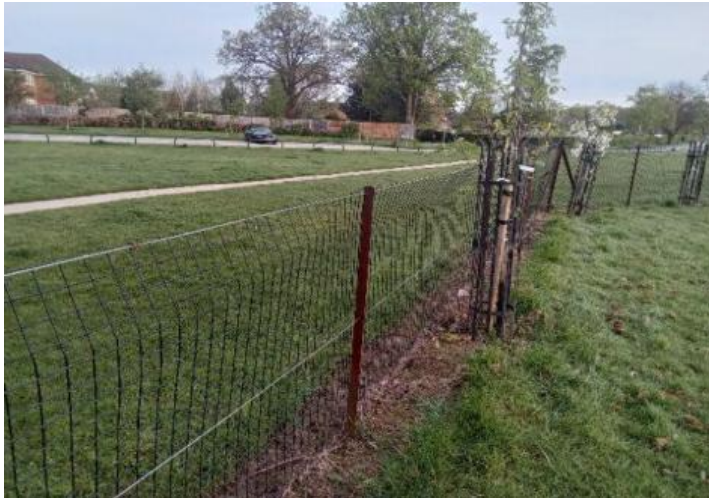
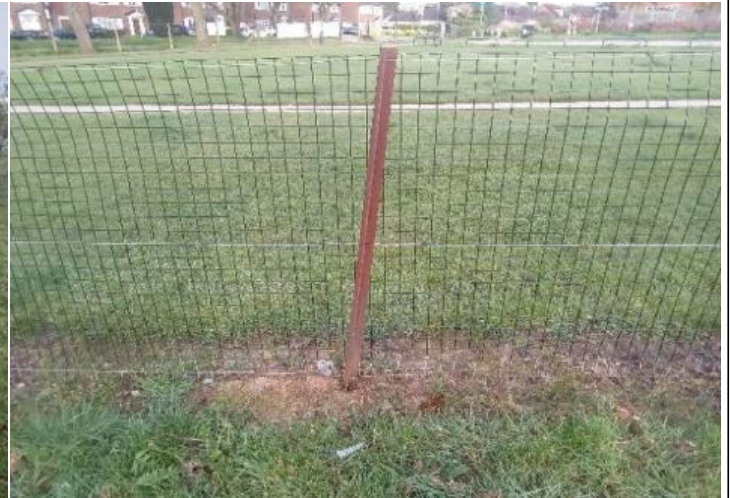
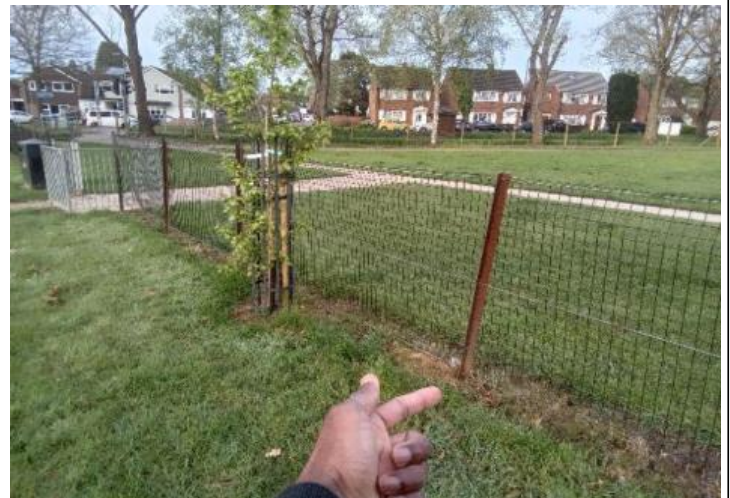
Finding: There are a number of loose posts around the fence

Action: Monitor for any further deterioration and reset as required
