ST STEPHEN PARISH COUNCIL

You are summoned to the Fixed Assets Committee meeting
To take place on **Thursday 30 May 2024 at 7.30pm**
at St Stephen Suite, Parish Centre, Station Road, Bricket Wood, AL2 3PJ

- 2425/AC/07 To receive Annual Play Inspection Report and Grounds Team Action Report. Play Reports and Grounds Team Report attached.**
- 2425/AC/08 To discuss the option of creating additional allotment plots and possible beginner plots at Watford Road allotment site or North Close. Allotment report attached.**

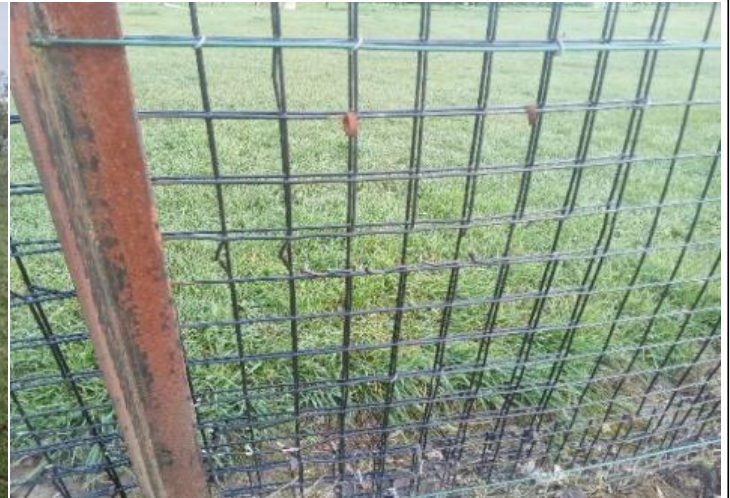
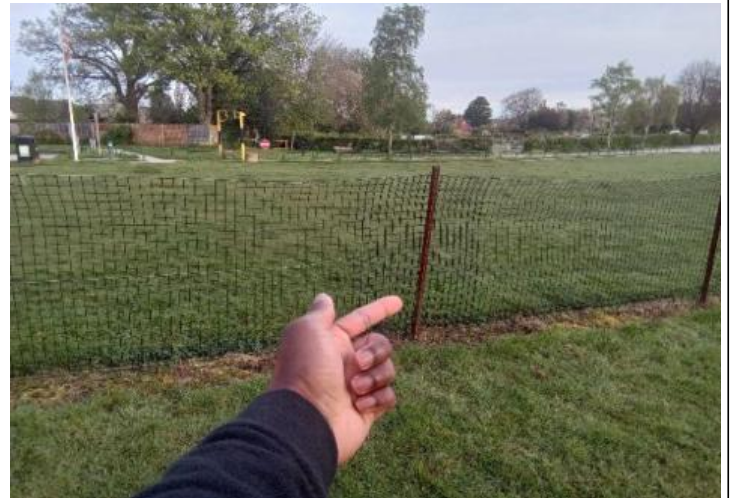
Finding: There is some damage to the fence sections

Action: Monitor for any further deterioration and repair as required

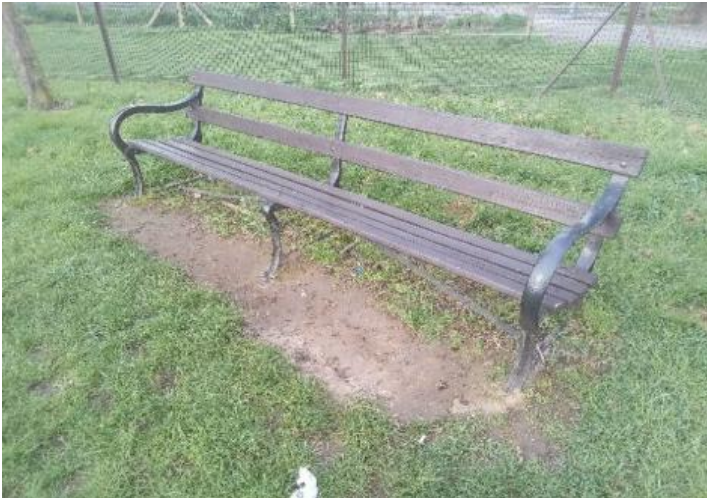
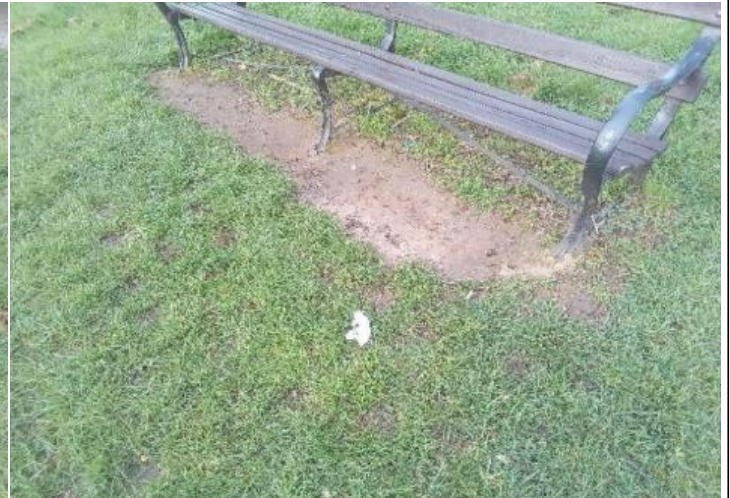
Item: Ancillary Items - Bench
Manufacturer: Not Identified

Risk Level: L - Low Risk
Surface: Grass

Finding: The surface has eroded in some areas and may be slippery in wet conditions
Action: Reinststate the surface

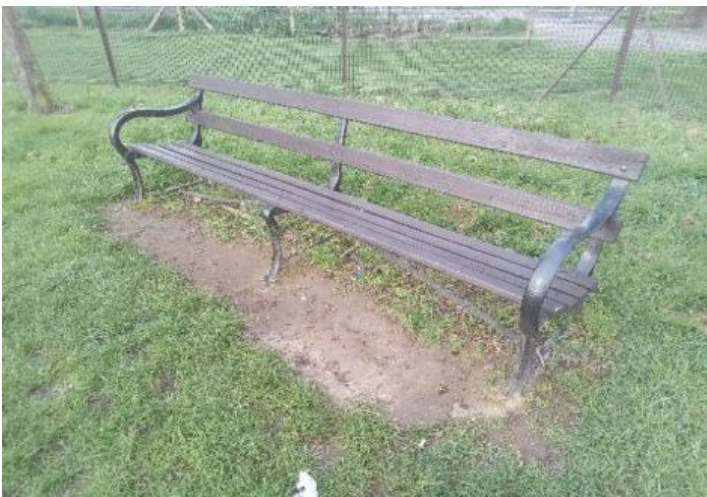
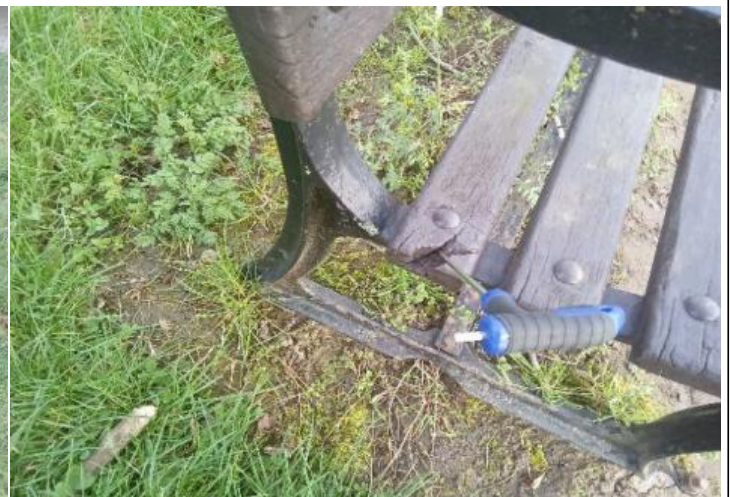
i 6 - Low Risk (Finding 2)

Item: Ancillary Items - Bench
Manufacturer: Not Identified

Risk Level: L - Low Risk
Surface: Grass

Finding: There is some evidence of rot in the timber

Action: Monitor for any further deterioration and replace as required

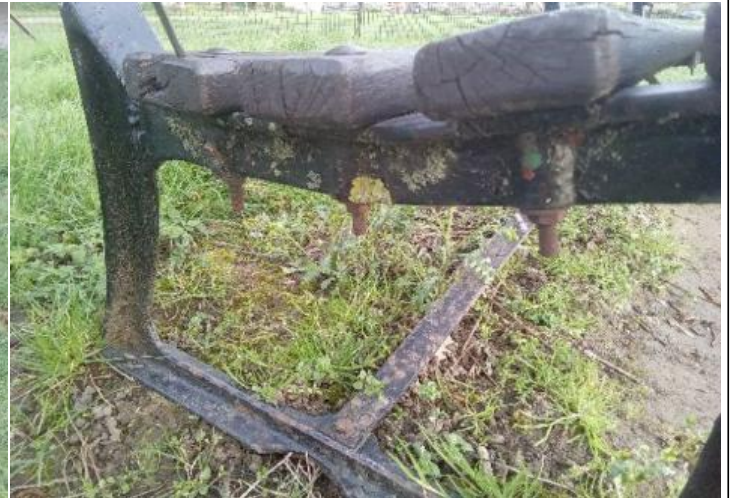
Item: Ancillary Items - Bench
Manufacturer: Not Identified

Risk Level: L - Low Risk
Surface: Grass

Finding: There are projecting bolt thread(s) present

Action: Remove excess thread length and deburr or provide cap

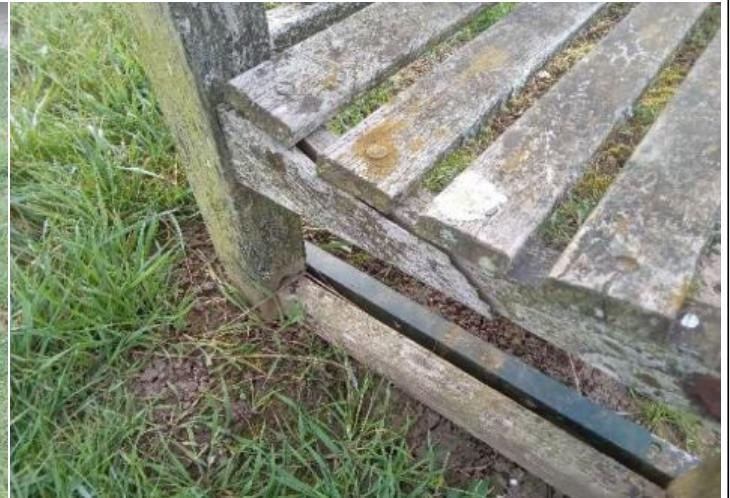
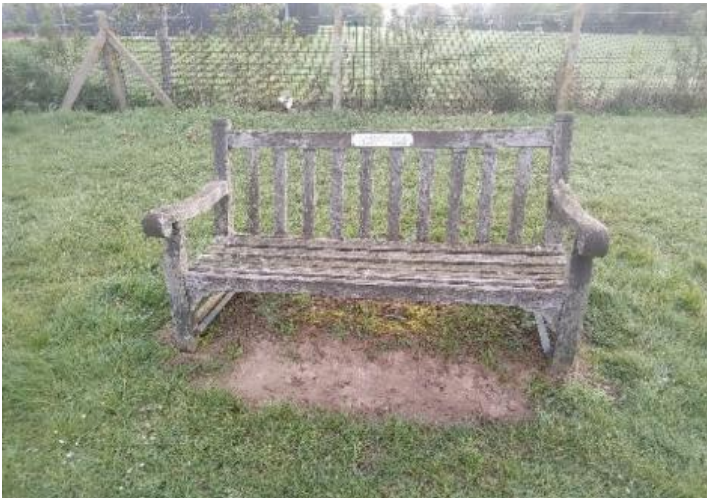
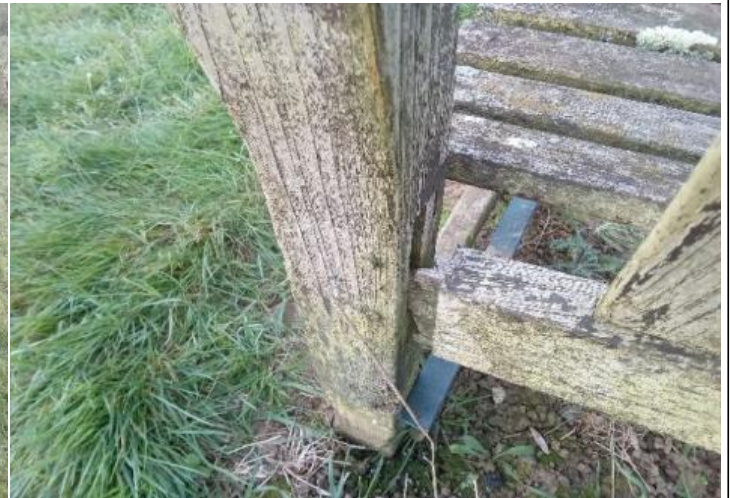
Item: Ancillary Items - Bench
Manufacturer: Not Identified

Risk Level: L - Low Risk
Surface: Grass

Finding: There is some damage to the item

Action: Monitor for any further deterioration and repair as required

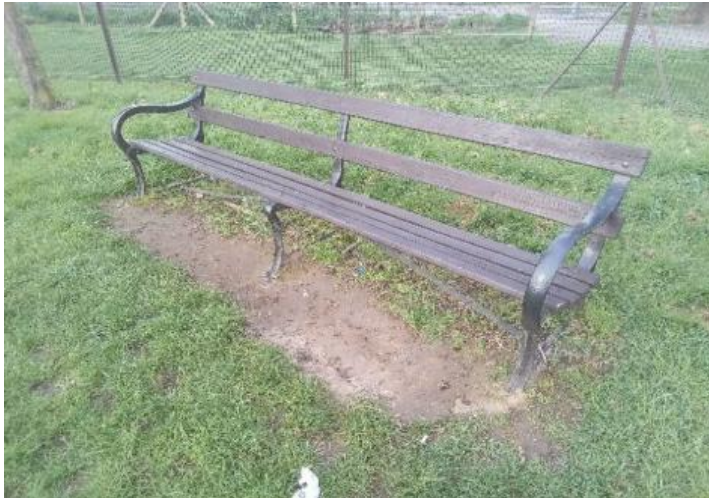
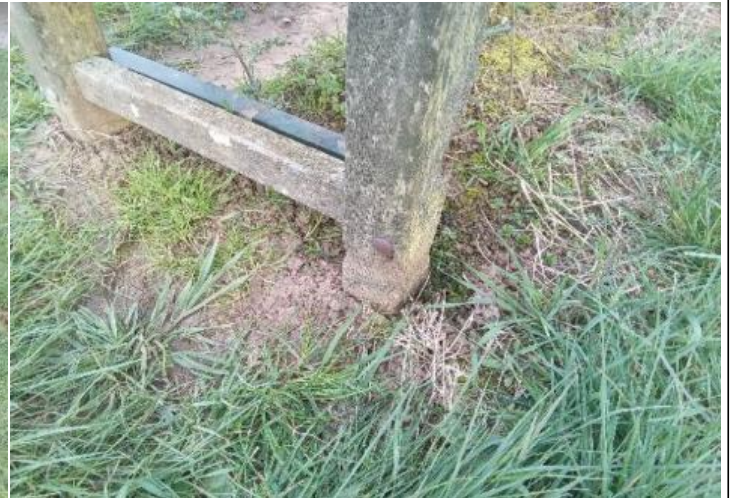
Item: Ancillary Items - Bench
Manufacturer: Not Identified

Risk Level: V - Very Low Risk
Surface: Grass

Finding: There is some strimmer / machinery damage apparent on the posts, this can penetrate the preservative applied to the timber and accelerate the rotting process

Action: Monitor for any deterioration (rot) and replace as required

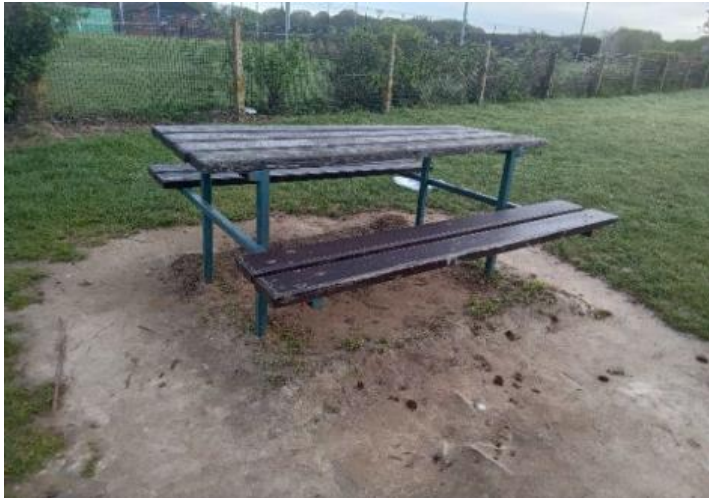
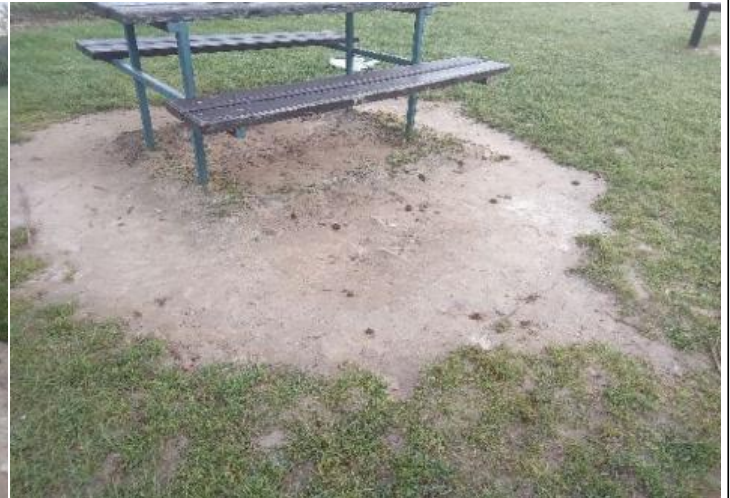
Item: Ancillary Items - Picnic Table
Manufacturer: Not Identified

Risk Level: L - Low Risk
Surface: Grass

Finding: The surface has eroded in some areas and may be slippery in wet conditions
Action: Reinstate the surface

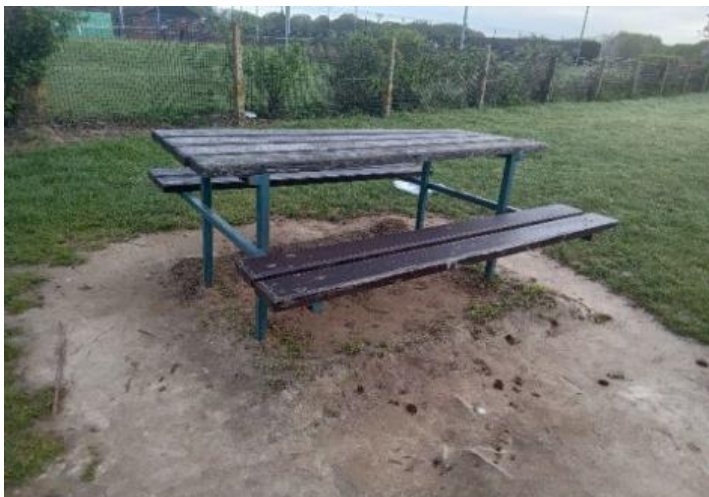
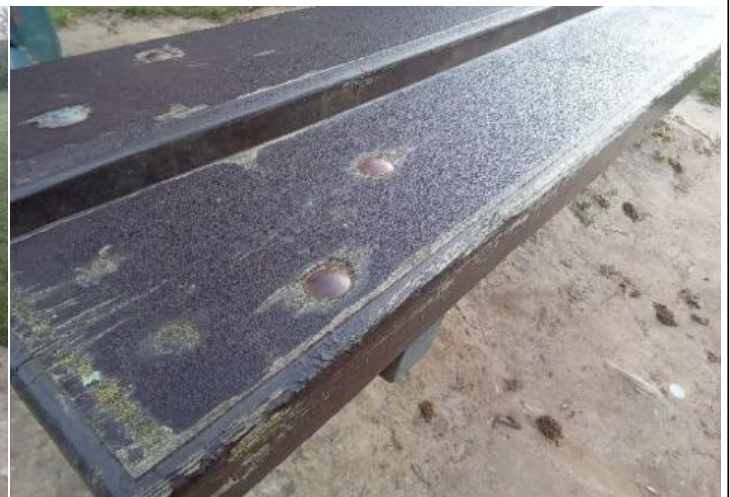
i 6 - Low Risk (Finding 2)

Item: Ancillary Items - Picnic Table
Manufacturer: Not Identified

Risk Level: L - Low Risk
Surface: Grass

Finding: Parts of the timber are rough or splintered
Action: Remove all rough or sharp edges

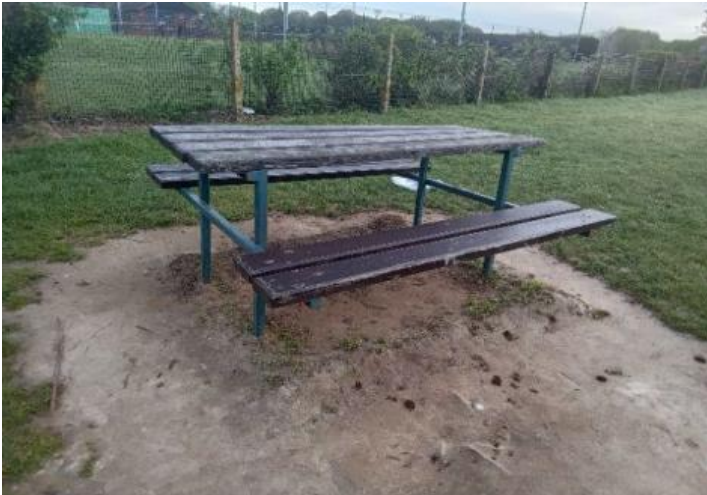
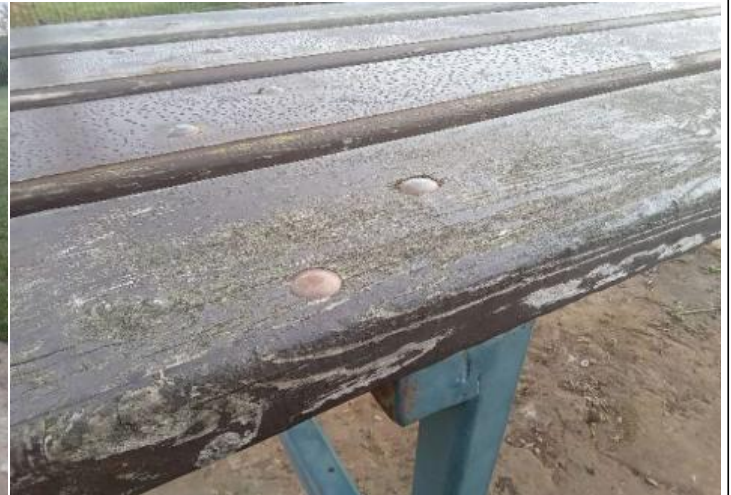
i 6 - Low Risk (Finding 3)

Item: Ancillary Items - Picnic Table
Manufacturer: Not Identified

Risk Level: L - Low Risk
Surface: Grass

Finding: The timber stain is in poor condition

Action: Prepare all affected parts and re-stain with an appropriate preservative

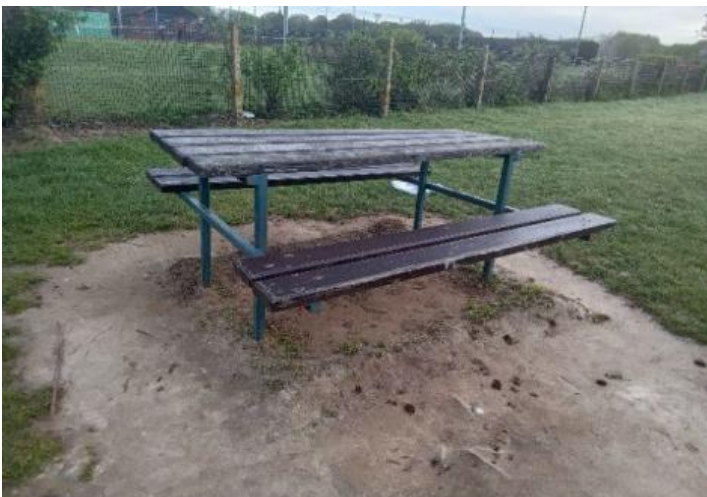
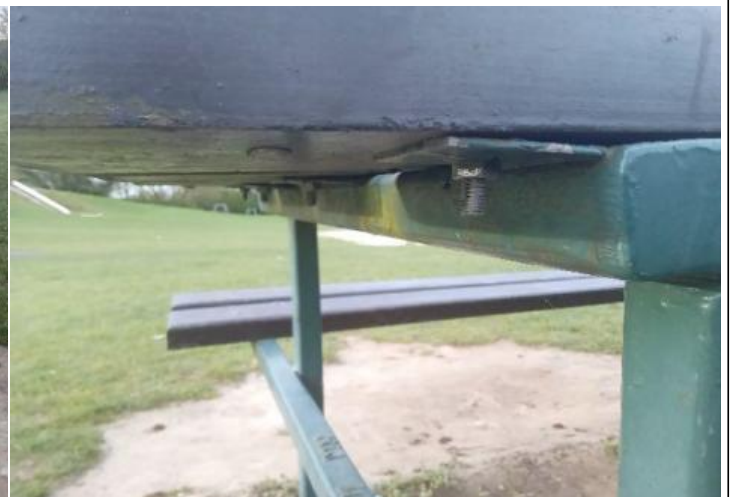
Item: Ancillary Items - Picnic Table
Manufacturer: Not Identified

Risk Level: V - Very Low Risk
Surface: Grass

Finding: There are projecting bolt thread(s) present

Action: Remove excess thread length and deburr or provide cap

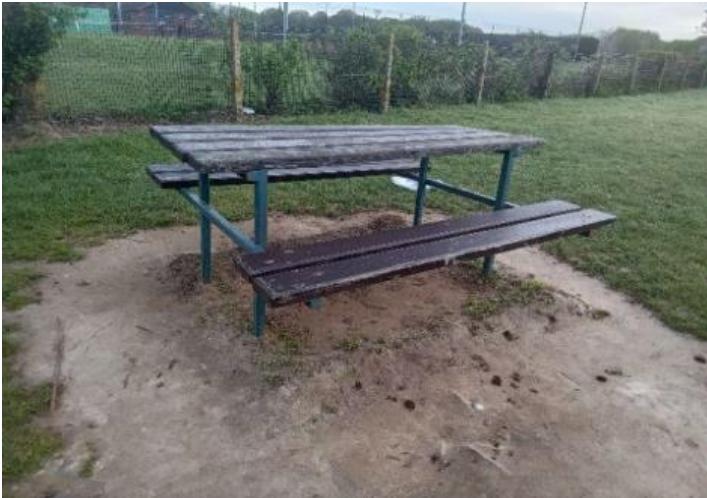
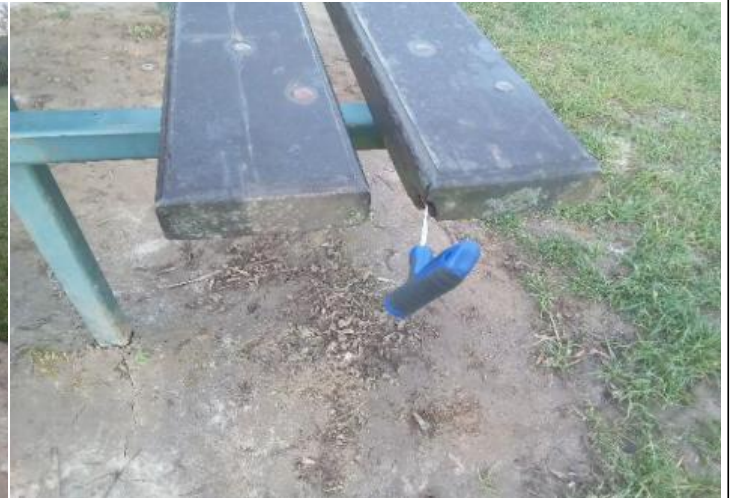
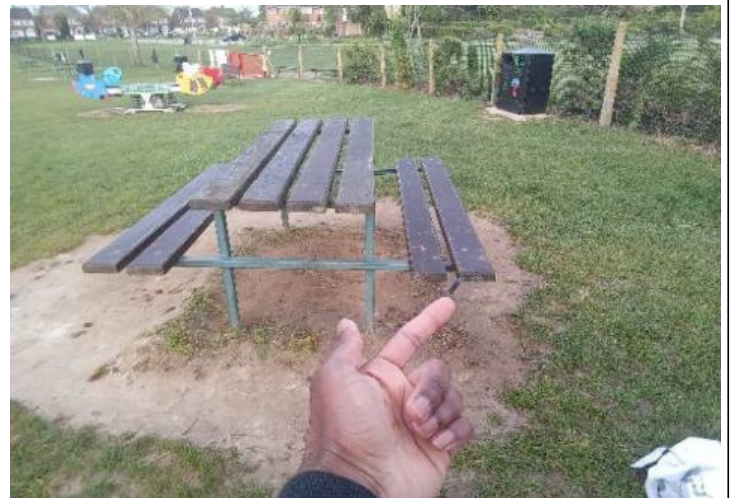
Item: Ancillary Items - Picnic Table
Manufacturer: Not Identified

Risk Level: L - Low Risk
Surface: Grass

Finding: There is some evidence of rot in the timber

Action: Monitor for any further deterioration and replace as required

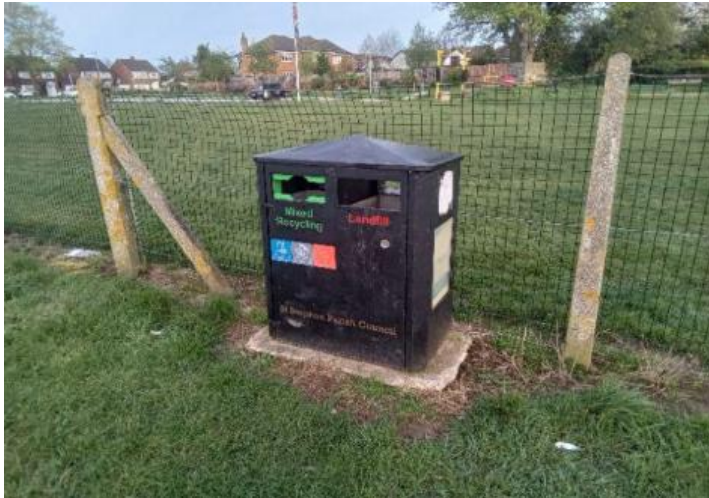
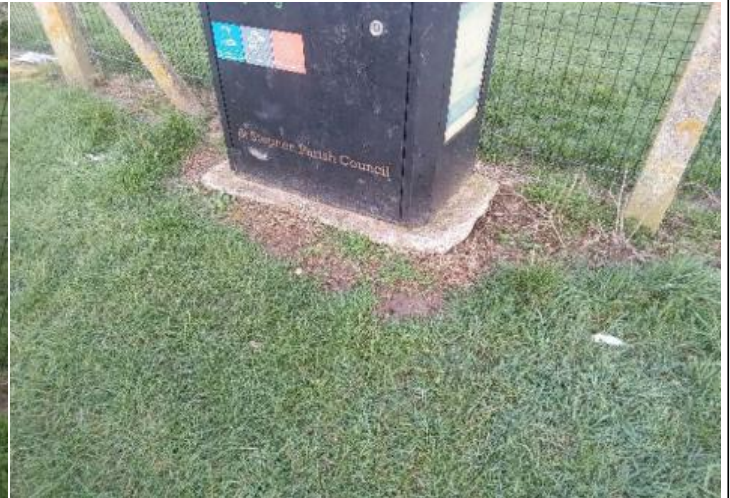
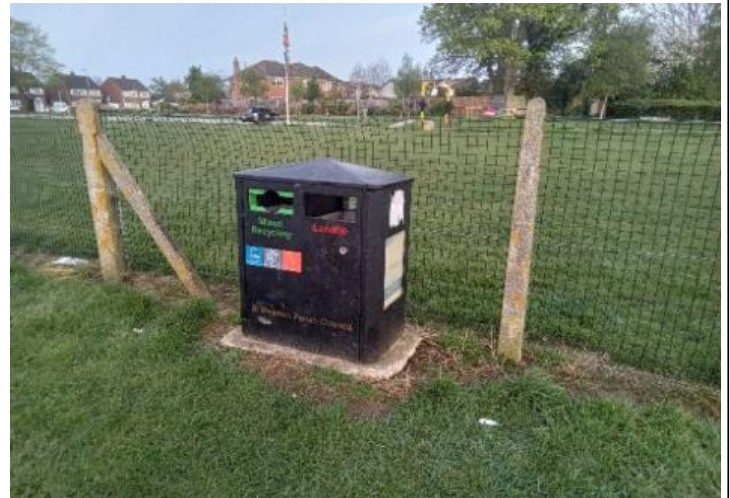
Item: Ancillary Items - Litter Bin
Manufacturer: Not Identified

Risk Level: L - Low Risk
Surface: Concrete

Finding: The surface has eroded and the foundations are exposed

Action: Reinststate surrounding surfaces to cover the foundations

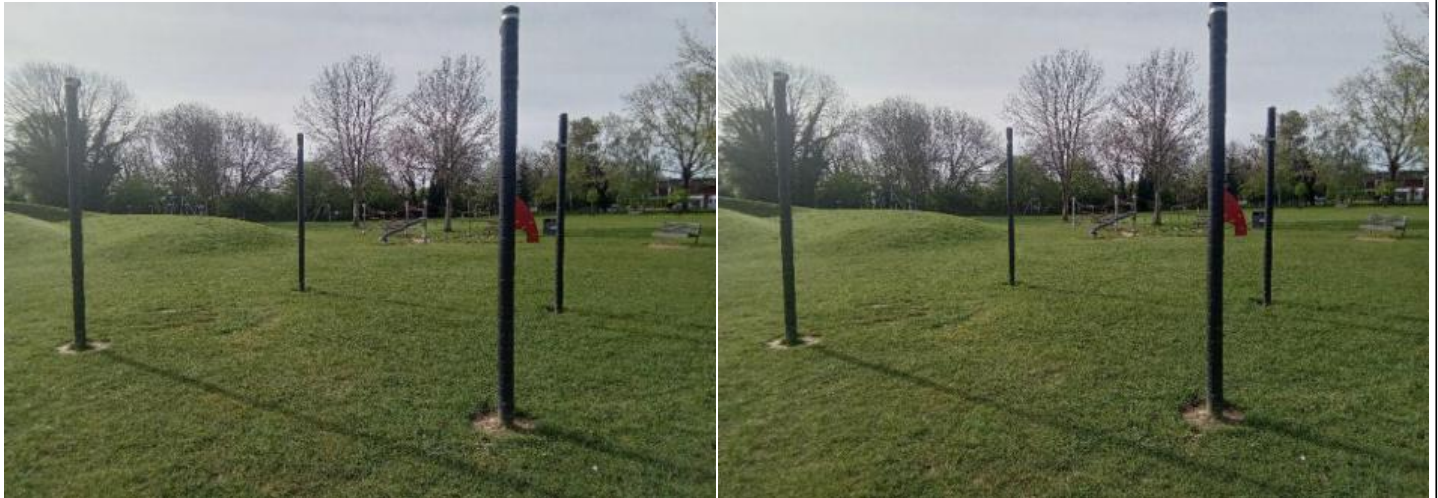
Item: Ancillary Items - Sun Canopy
Manufacturer: Not Identified

Risk Level: V - Very Low Risk
Surface: Grass

Finding: Canopy has been removed. Posts remain

Action: Consider replacing canopy

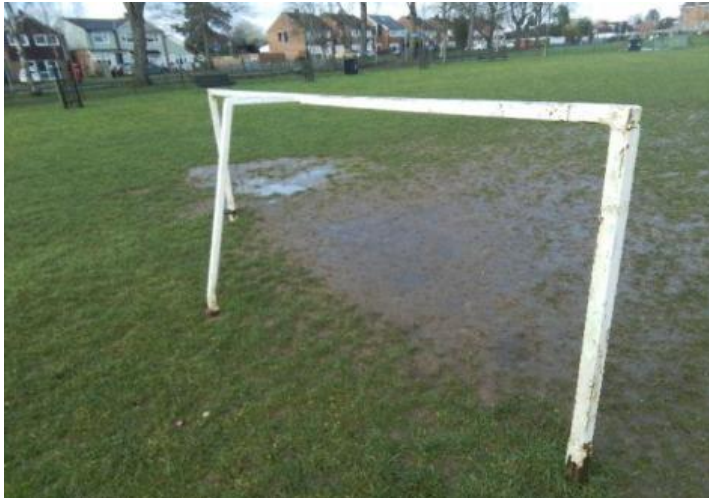
Item: Multi Use Games Area - 5 a side Goals
Manufacturer: Not Identified

Risk Level: L - Low Risk
Surface: Grass

Finding: The paintwork on this item has been damaged or worn exposing the metal underneath which is rusting / corroding

Action: Treat affected areas and repaint

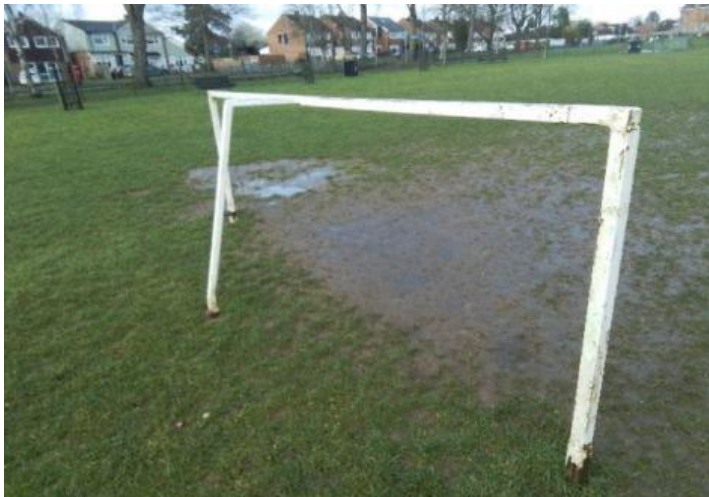
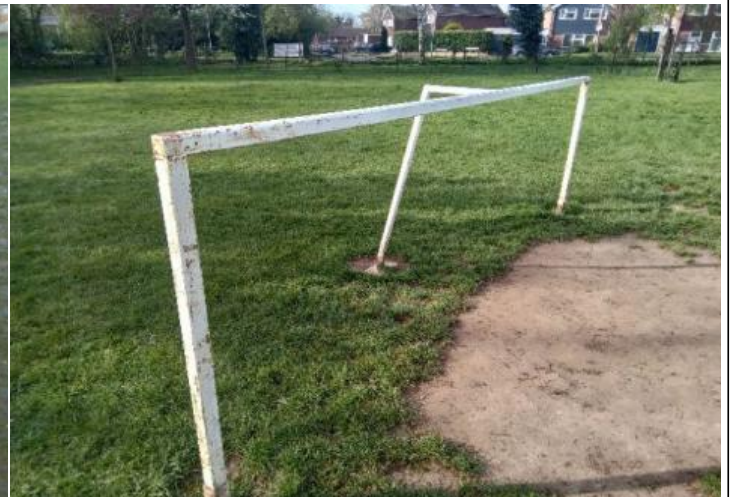
Item: Multi Use Games Area - 5 a side Goals
Manufacturer: Not Identified

Risk Level: N - Risk Assessment not Undertaken
Surface: Grass

Finding: NB: We have undertaken a maintenance inspection only of the football goal(s); full load testing falls outside the scope of our inspection.

Action: Implement load testing as required

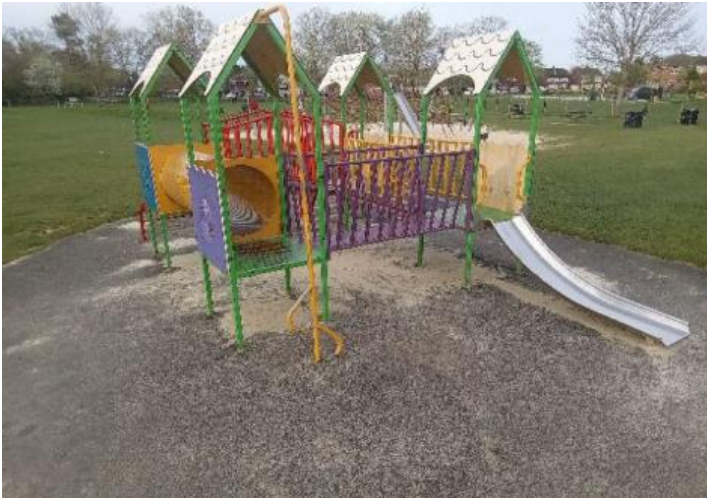
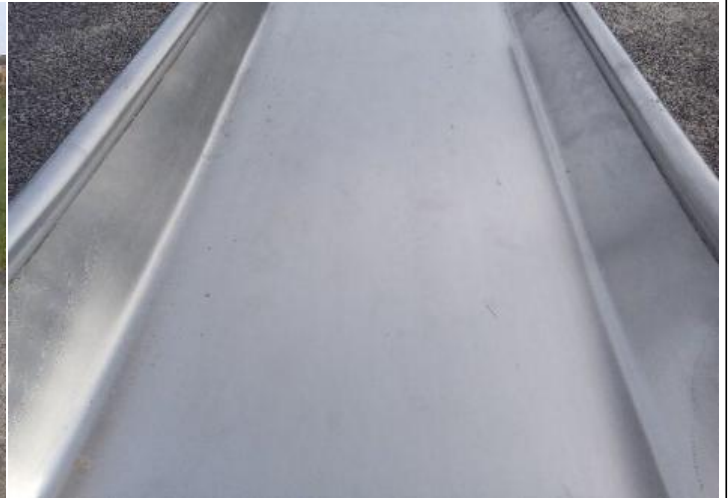
Item: Activity Equipment - Multi Play (Toddler)
Manufacturer: Wicksteed Playgrounds

Risk Level: V - Very Low Risk
Surface: Wet Pour

Finding: There are a number of dents in the slide surface

Action: Monitor for any further deterioration and repair as required

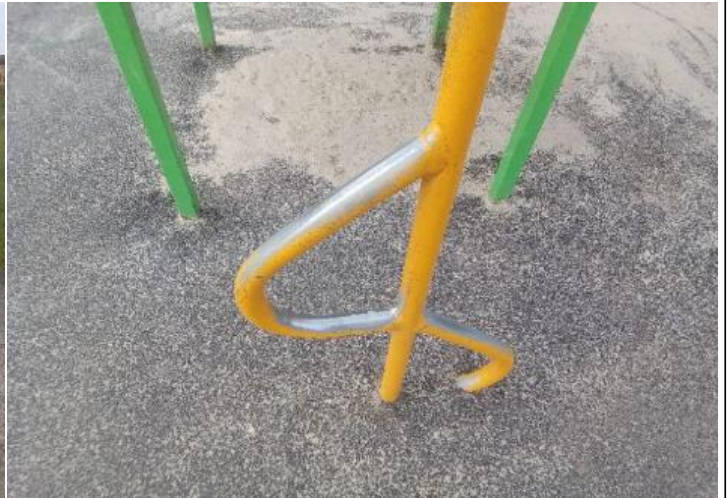
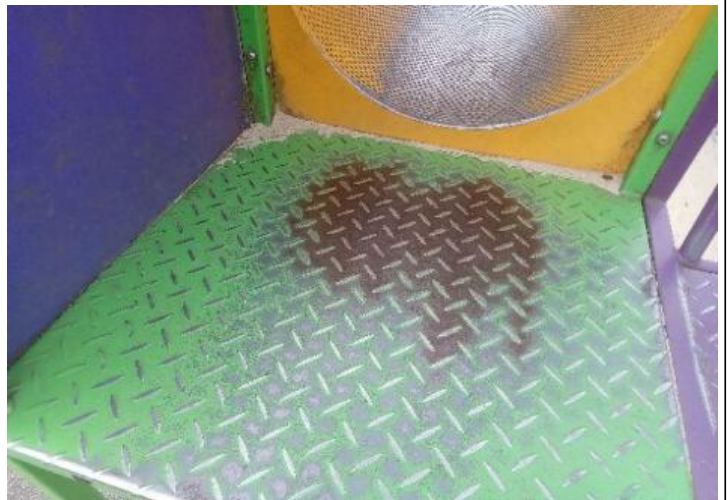
Item: Activity Equipment - Multi Play (Toddler)
Manufacturer: Wicksteed Playgrounds

Risk Level: L - Low Risk
Surface: Wet Pour

Finding: The paintwork on this item has been damaged or worn exposing the metal underneath which is rusting / corroding

Action: Treat affected areas and repaint

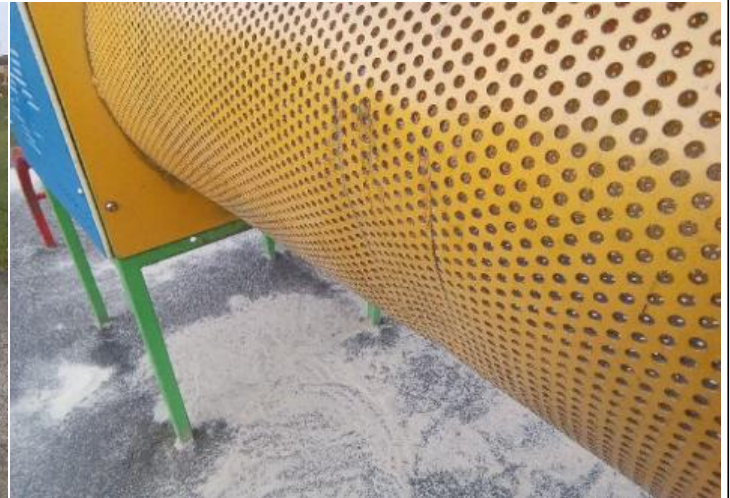
Item: Activity Equipment - Multi Play (Toddler)
Manufacturer: Wicksteed Playgrounds

Risk Level: L - Low Risk
Surface: Wet Pour

Finding: There is some damage to the item

Action: Monitor for any further deterioration and repair as required

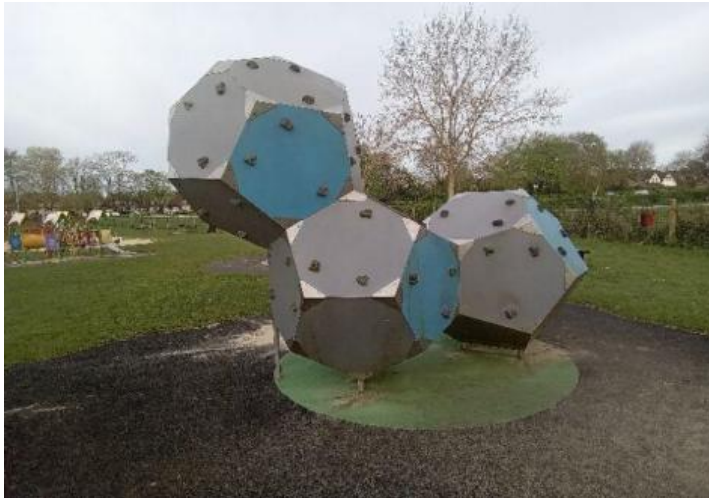
Item: Activity Equipment - Climbing Blocks
Manufacturer: Kompan Ltd

Risk Level: L - Low Risk
Surface: Wet Pour

Finding: There is some damage to the item

Action: Monitor for any further deterioration and repair as required

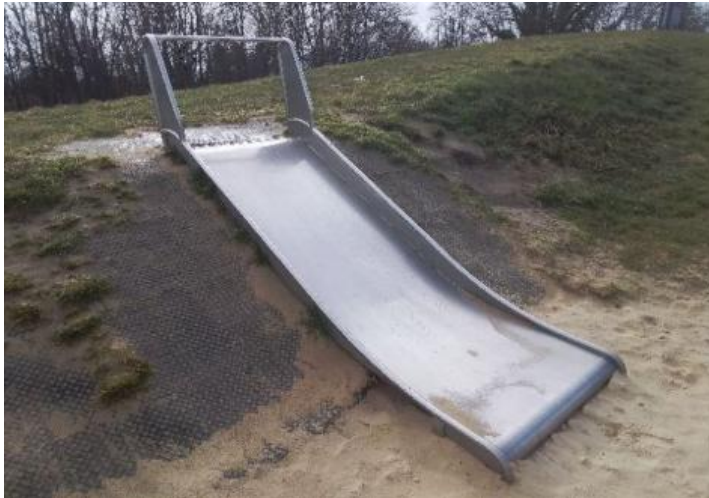
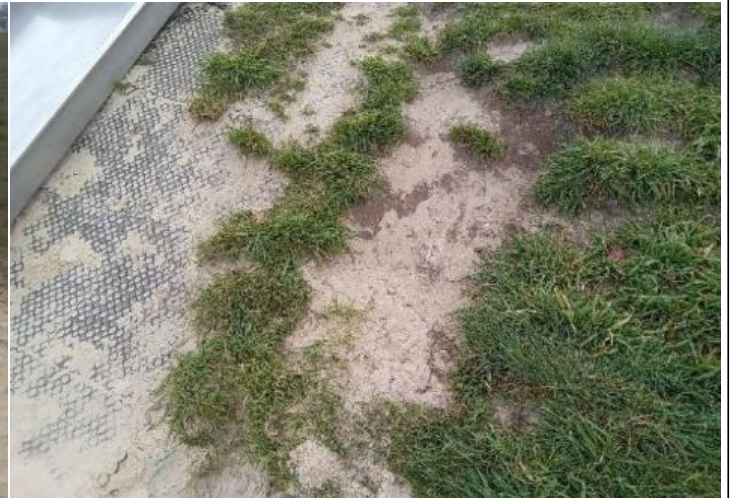
Item: Other - Embankment Slide
Manufacturer: R&T Stainless A/S

Risk Level: L - Low Risk
Surface: Mixed Surface

Finding: The surface has eroded in some areas and may be slippery in wet conditions
Action: Reinststate the surface

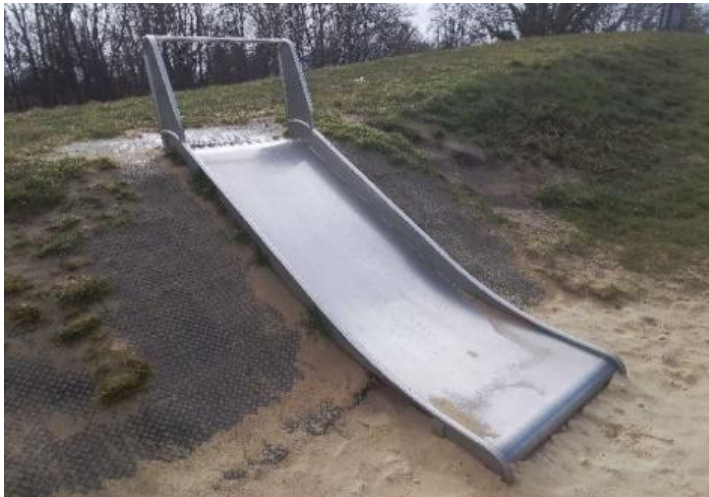
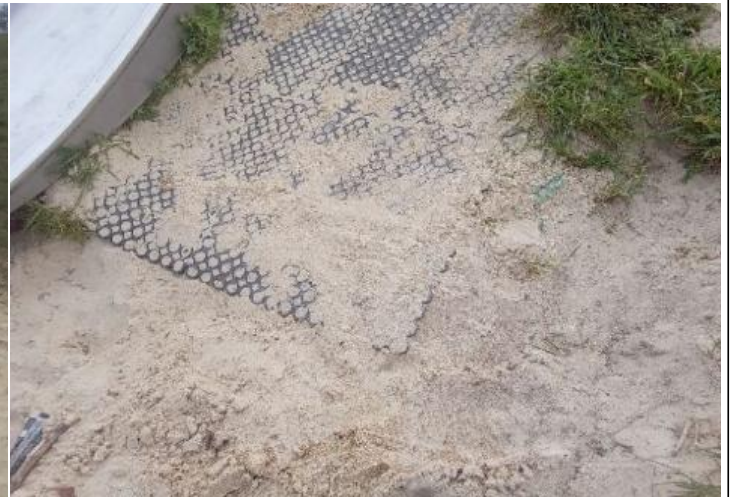
i 8 - Low Risk (Finding 2)

Item: Other - Embankment Slide
Manufacturer: R&T Stainless A/S

Risk Level: L - Low Risk
Surface: Mixed Surface

Finding: The edges of the grass mat surface are raised / lifting above the surrounding surface
Action: Tuck in or pin edges of grass mats as per the API Code of Practice to remove trip hazards

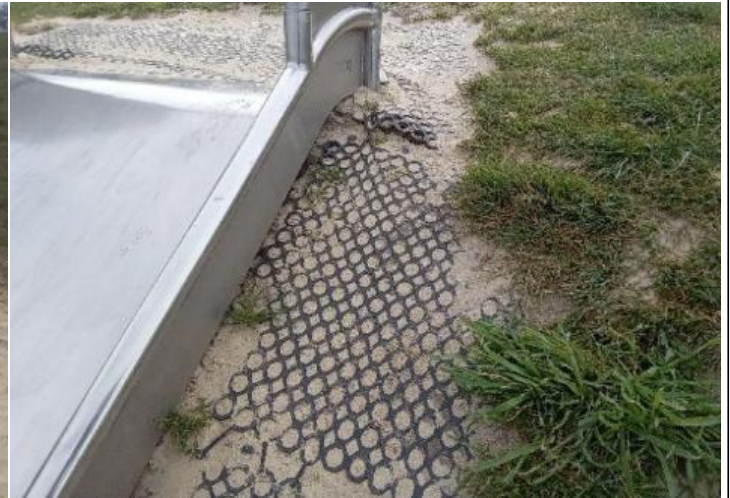
i 6 - Low Risk (Finding 3)

Item: Other - Embankment Slide
Manufacturer: R&T Stainless A/S

Risk Level: L - Low Risk
Surface: Mixed Surface

Finding: There are gaps opening between the grass mat tiles

Action: Provide additional ties or secure / reinstate surface

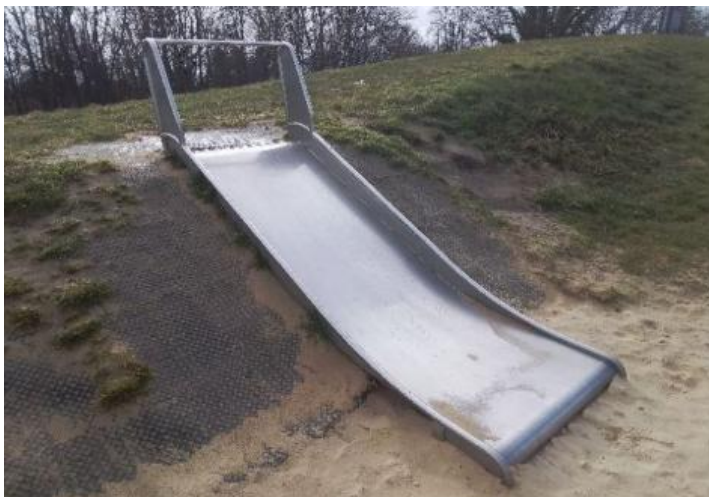
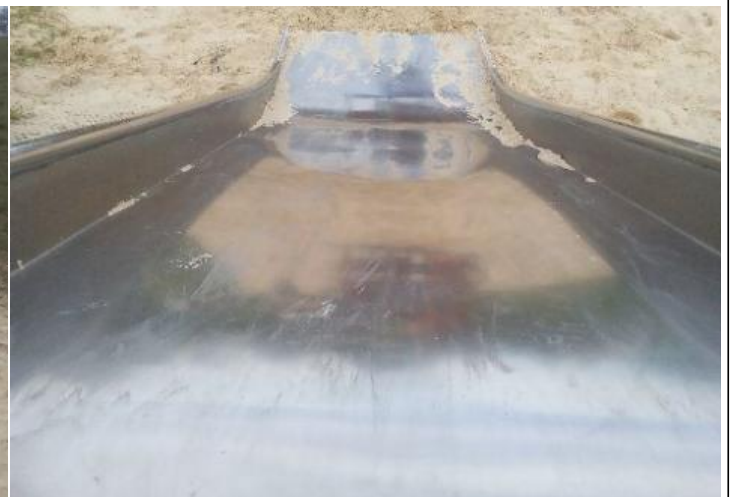
Item: Other - Embankment Slide
Manufacturer: R&T Stainless A/S

Finding: There are a number of dents in the slide surface

Action: Monitor for any further deterioration and repair as required

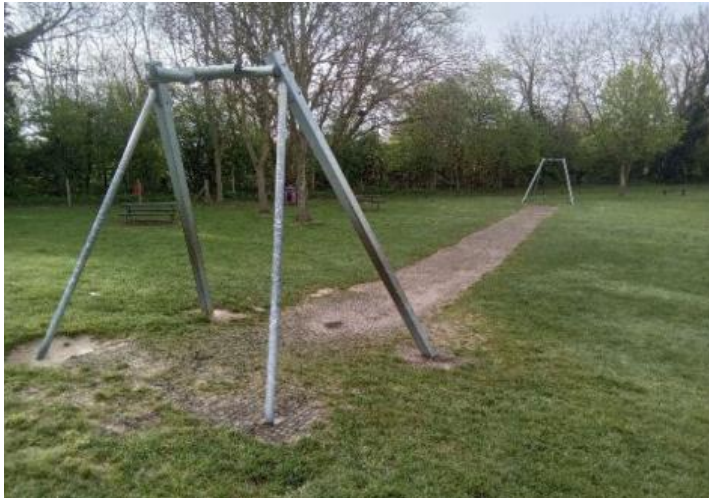
Item: Other - Cable Runway
Manufacturer: Kompan Ltd

Finding: We have completed a visual inspection of the suspension links, cable and fixing points from ground level, however it is not possible to fully inspect these areas without either hiring equipment to gain access or removing the cable and suspension and inspecting at ground level. We recommend that the main cable and fixing security is thoroughly inspected at least in accordance with the manufacturers recommendations to check for wear, damage, security or internal rusting; this will help to ensure the continued safe use of the equipment

Action: Inspect in accordance with the manufacturers recommendations

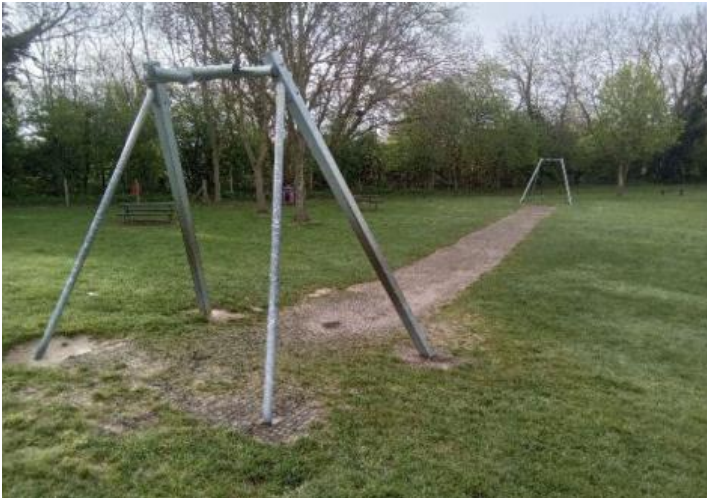
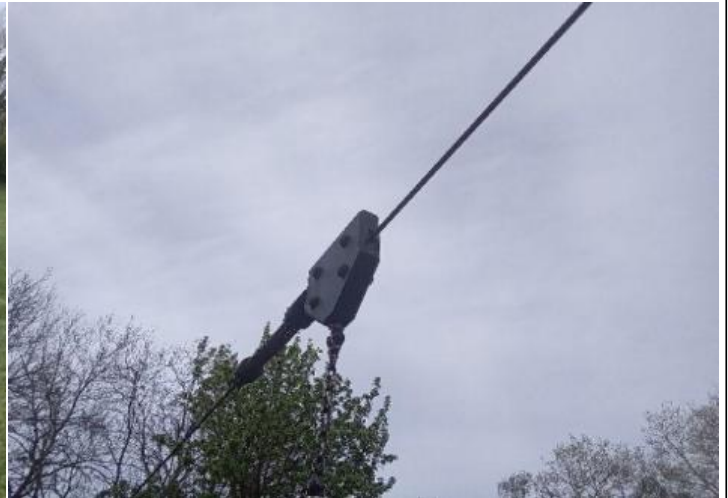
Item: Other - Cable Runway
Manufacturer: Kompan Ltd

Finding: The nylon inserts are worn or missing at the point the cable enters the traveller

Action: Replace worn or missing inserts as required

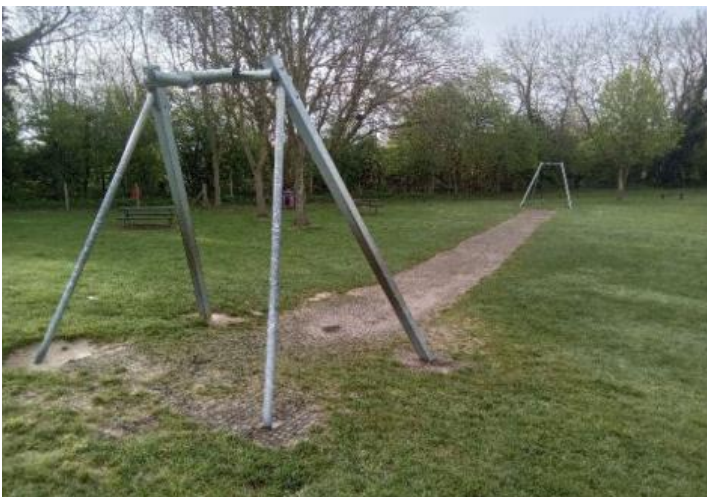
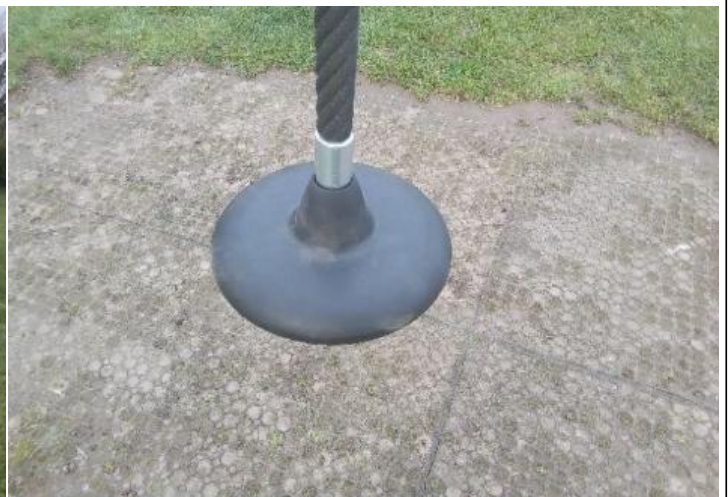
Item: Other - Cable Runway
Manufacturer: Kompan Ltd

Finding: The seat connection cannot be inspected without dismantling the seat

Action: Dismantle the seat to inspect the seat connection for wear

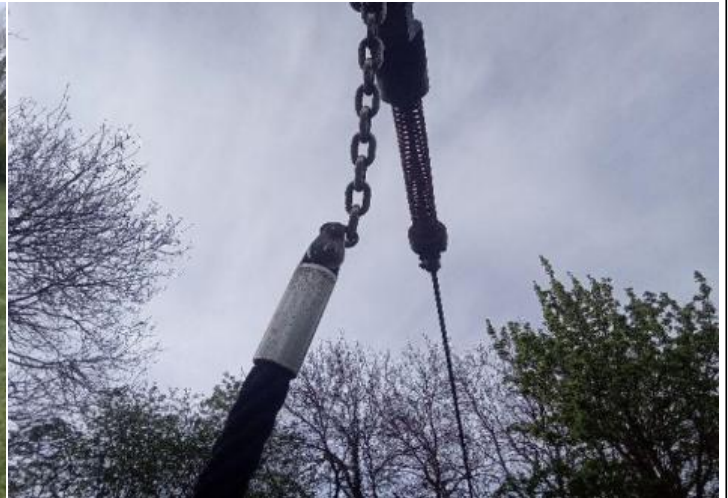
Item: Other - Cable Runway
Manufacturer: Kompan Ltd

Finding: The chain links are worn in excess of 40% and require renewing

Action: Replace worn chains

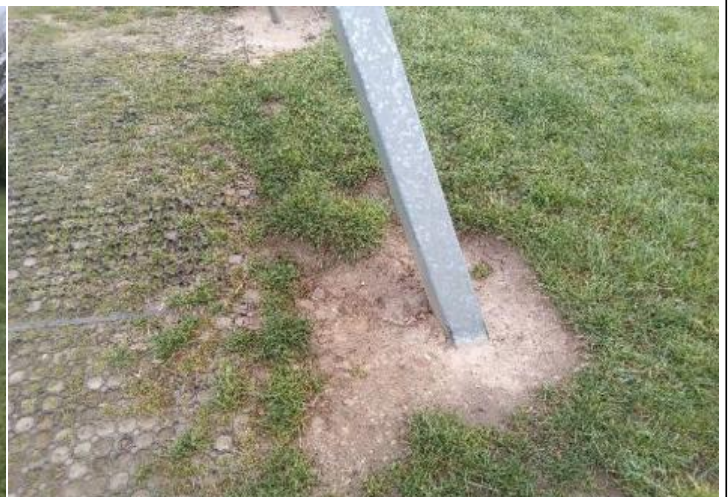
Item: Other - Cable Runway
Manufacturer: Kompan Ltd

Finding: The surface has eroded in some areas and may be slippery in wet conditions

Action: Reinstate the surface

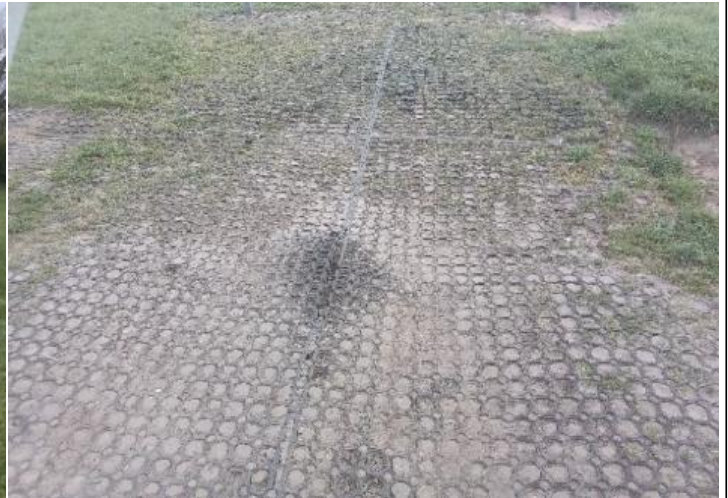
Item: Other - Cable Runway
Manufacturer: Kompan Ltd

Finding: There are gaps opening between the grass mat tiles

Action: Provide additional ties or secure / reinstate surface tiles

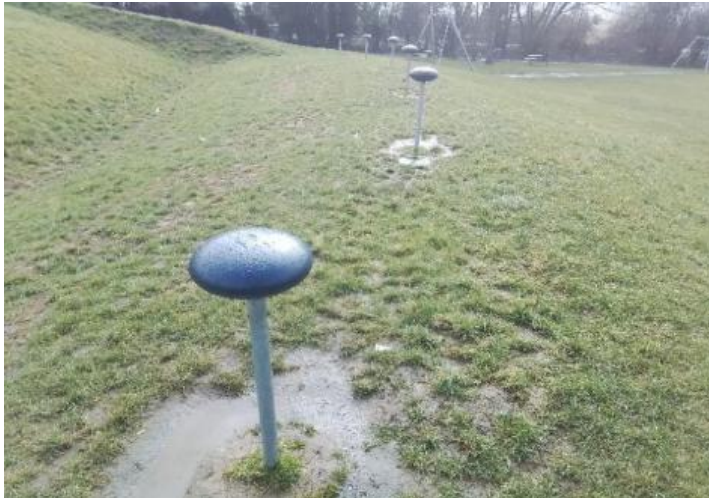
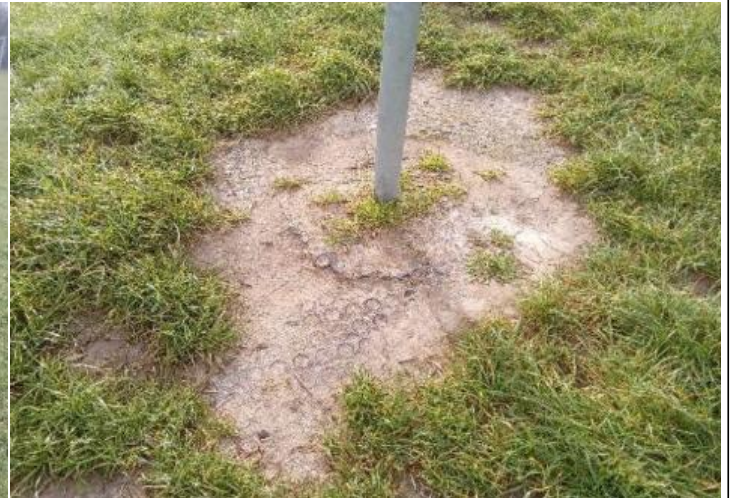
Item: Activity Equipment - Leap Frog
Manufacturer: Kompan Ltd

Finding: There is moderate damage to the grass matrix tile surface **Action:** Repair the damaged areas of surfacing

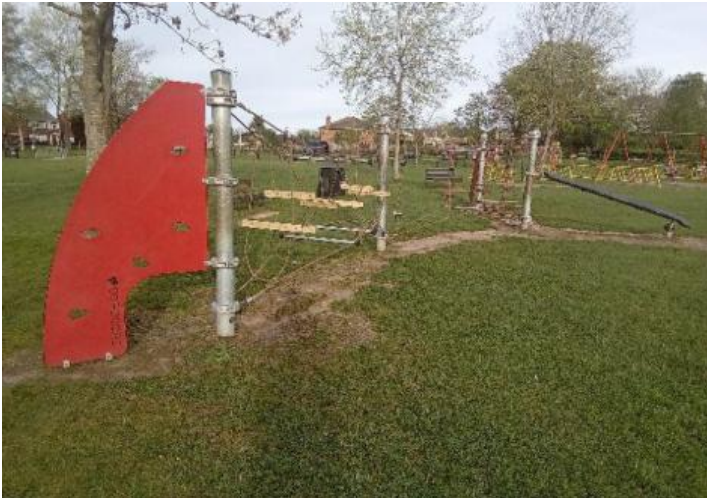
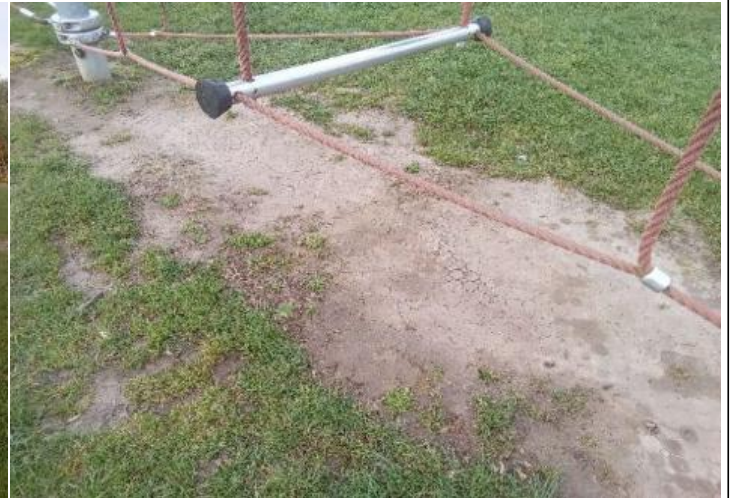
Item: Activity Equipment - Activity Trail
Manufacturer: Corocord

Finding: The grass mats are silted up, the soil is compacted and the area will become very slippery when the soil is wet. **Action:** Reinstate as required
