ST STEPHEN PARISH COUNCIL

You are summoned to the Fixed Assets Committee meeting
To take place on **Thursday 30 May 2024 at 7.30pm**
at St Stephen Suite, Parish Centre, Station Road, Bricket Wood, AL2 3PJ

- 2425/AC/07 To receive Annual Play Inspection Report and Grounds Team Action Report. Play Reports and Grounds Team Report attached.**
- 2425/AC/08 To discuss the option of creating additional allotment plots and possible beginner plots at Watford Road allotment site or North Close. Allotment report attached.**

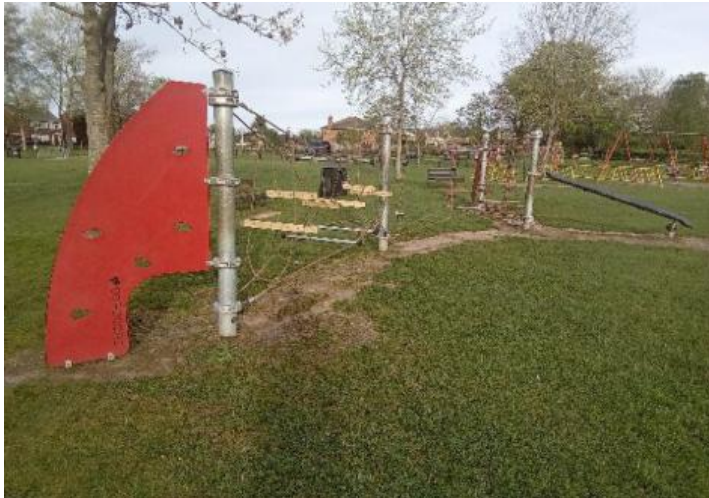
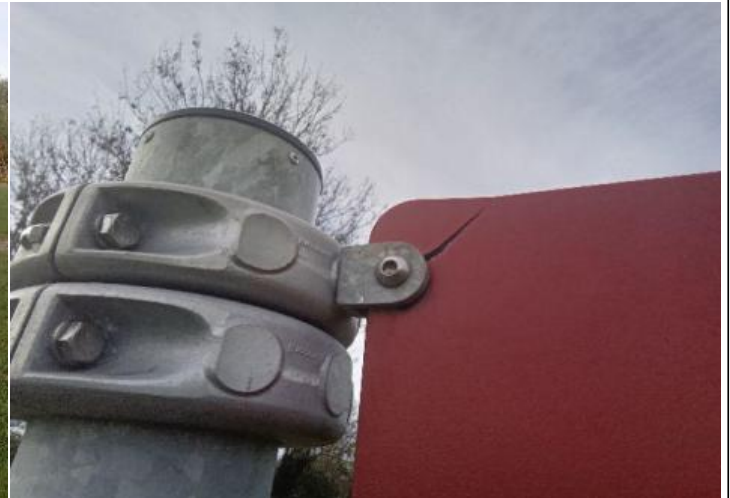
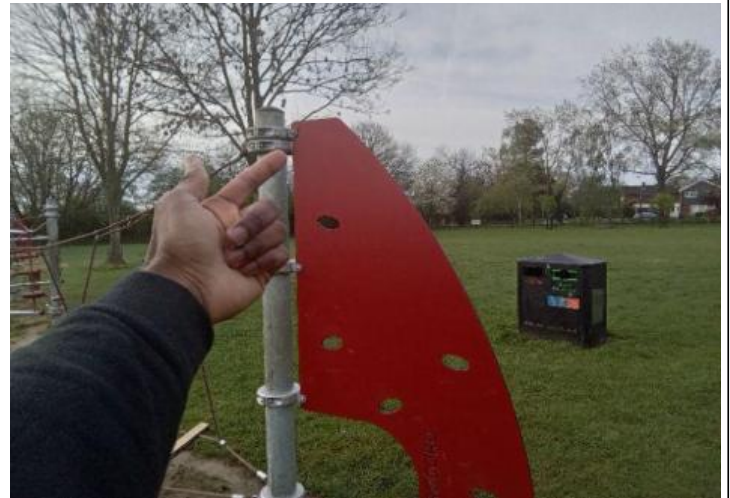
Item: Activity Equipment - Activity Trail
Manufacturer: Corocord

Finding: There is some damage to the item

Action: Monitor for any further deterioration and repair as required

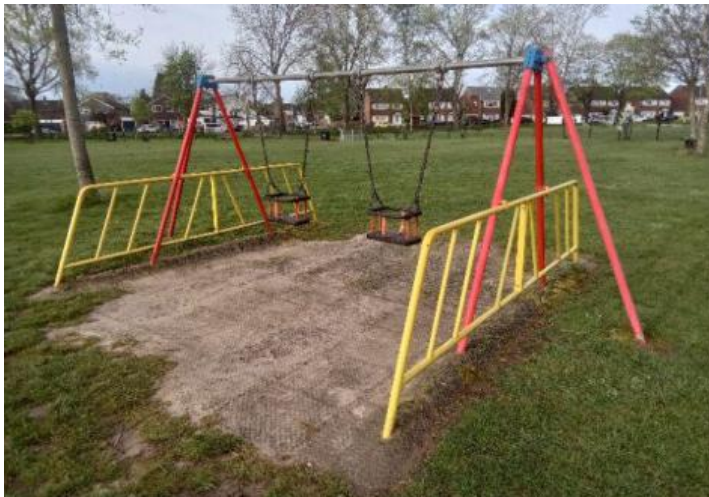
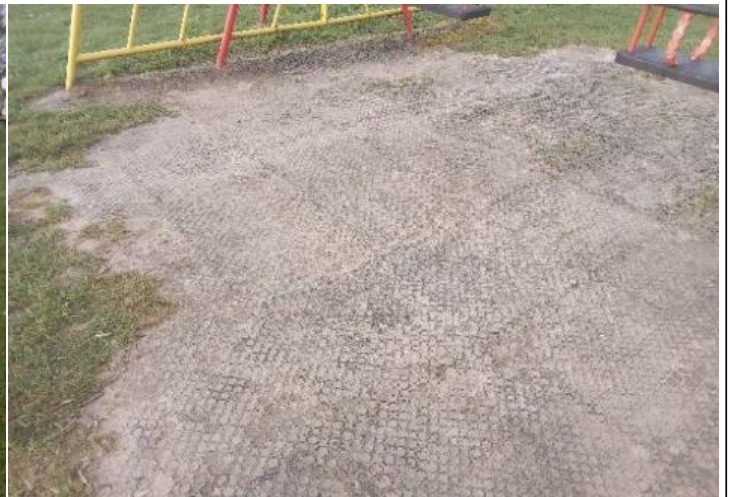
Item: Swings - 1 Bay 2 Seat (Cradle)
Manufacturer: GL Jones

Finding: The surface has subsided in some areas

Action: Monitor for any further deterioration and repair as required

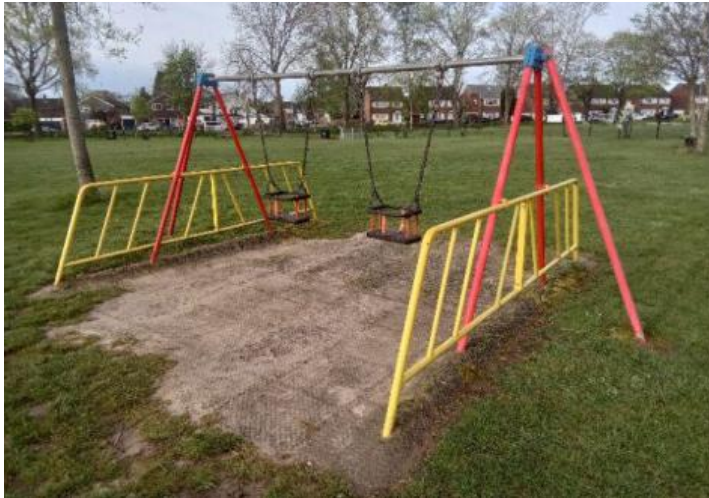
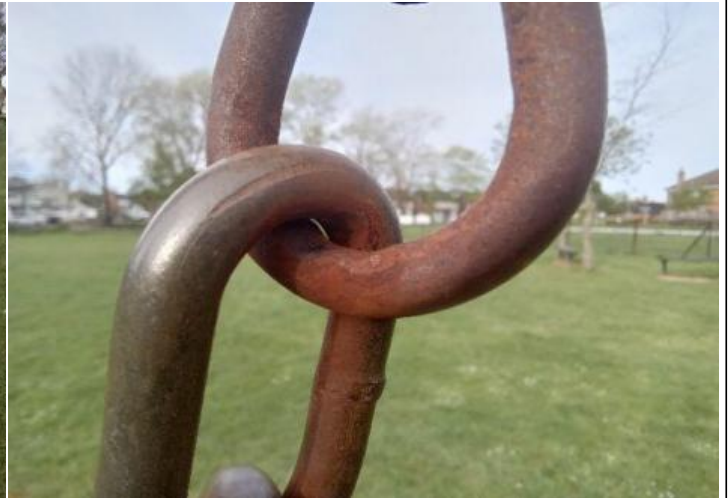
Item: Swings - 1 Bay 2 Seat (Cradle)
Manufacturer: GL Jones

Finding: There is some wear to the shackles.

Action: Monitor for any further deterioration and replace when 40% worn

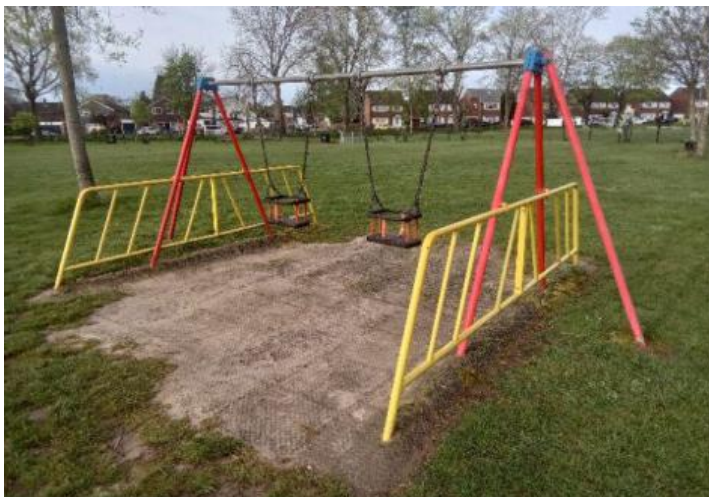
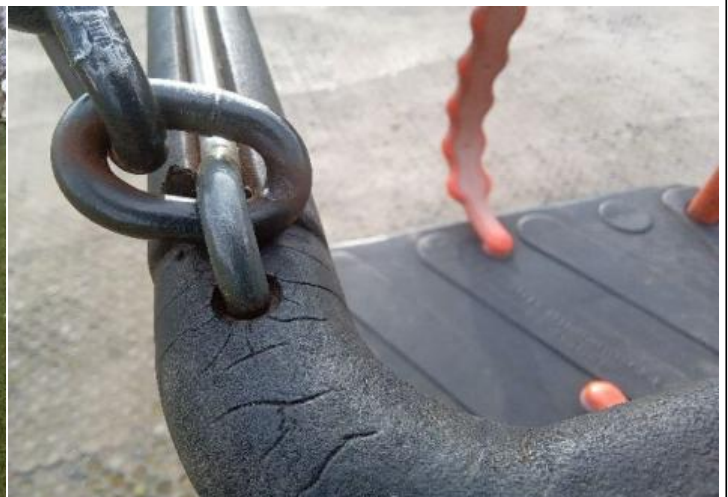
Item: Swings - 1 Bay 2 Seat (Cradle)
Manufacturer: GL Jones

Finding: There is some notable evidence of chain wear

Action: Monitor for any further deterioration and replace when 40% worn

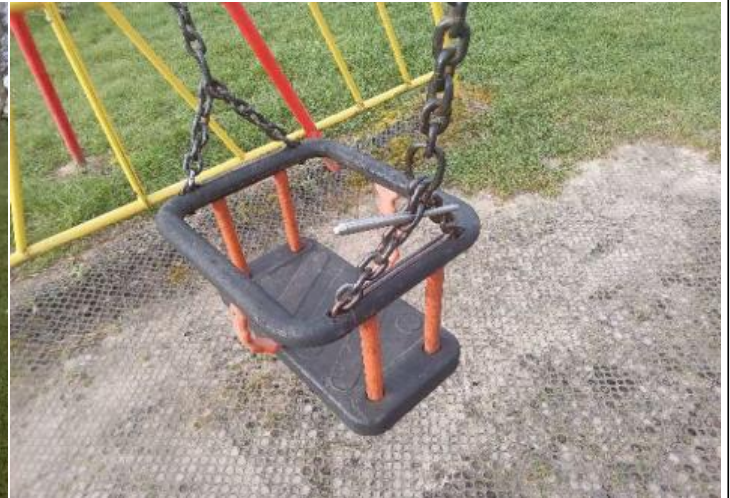
Item: Swings - 1 Bay 2 Seat (Cradle)
Manufacturer: GL Jones

Finding: The chain openings are in excess of the 8.6mm as recommended by BS EN 1176 **Action:** Monitor - No remedial work recommended

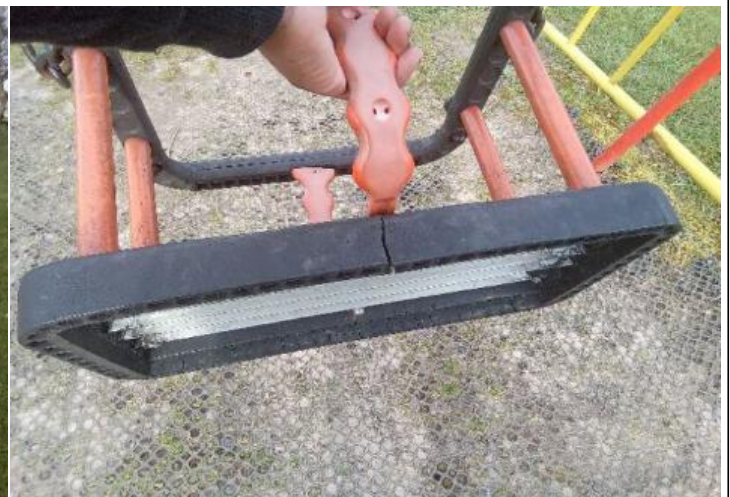
Item: Swings - 1 Bay 2 Seat (Cradle)
Manufacturer: GL Jones

Finding: The seat has minor damage or wear **Action:** Monitor for any further deterioration and replace as required

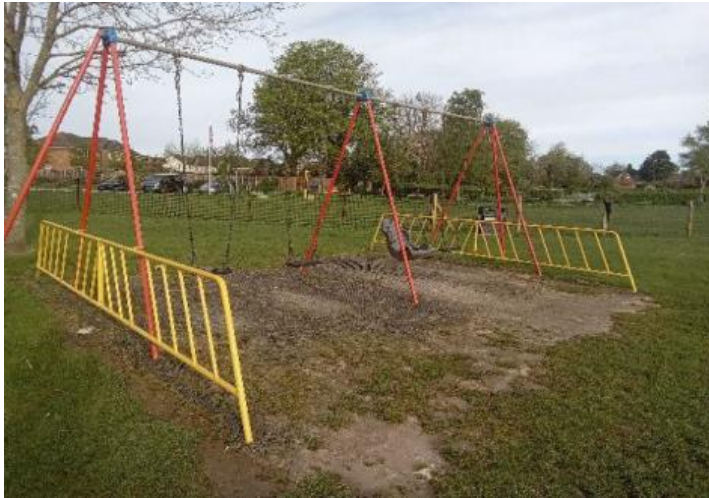
Item: Swings - 2 Bay 3 Flat 1 Inclusive Seat
Manufacturer: G L Jones Playgrounds Ltd

Finding: The fixings or components for this item were in excess of 2.5m above the standing surface and could not be fully accessed by the inspector. We have completed a visual inspection of the fixings from ground level but a maintenance inspection should be undertaken to assess the condition, security and wear of the components at intervals in accordance with the manufacturers recommendations.

Action: Inspect in accordance with the manufacturers recommendations

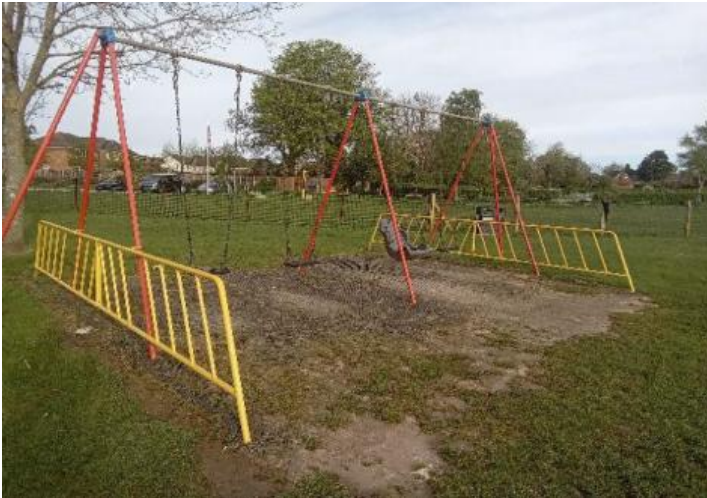
Item: Swings - 2 Bay 3 Flat 1 Inclusive Seat
Manufacturer: G L Jones Playgrounds Ltd

Finding: BS EN 1176 Part 2: Annex A makes a recommendation that fences or enclosures should be upto 1.50m from the edges of the swing seat to the sides, and subject to risk assessment, from the edge of the impact area. This is however, a low risk finding and no remedial action is recommended.

Action: Monitor - No remedial work recommended

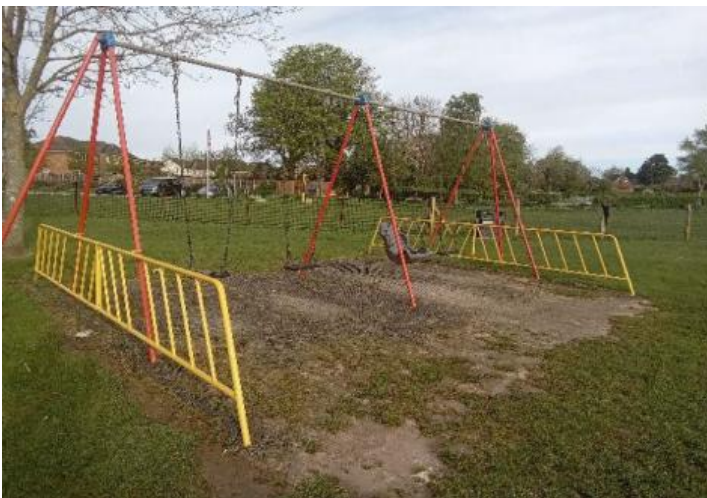
Item: Swings - 2 Bay 3 Flat 1 Inclusive Seat
Manufacturer: G L Jones Playgrounds Ltd

Finding: The bushes are worn or missing

Action: Replace worn or missing bushes

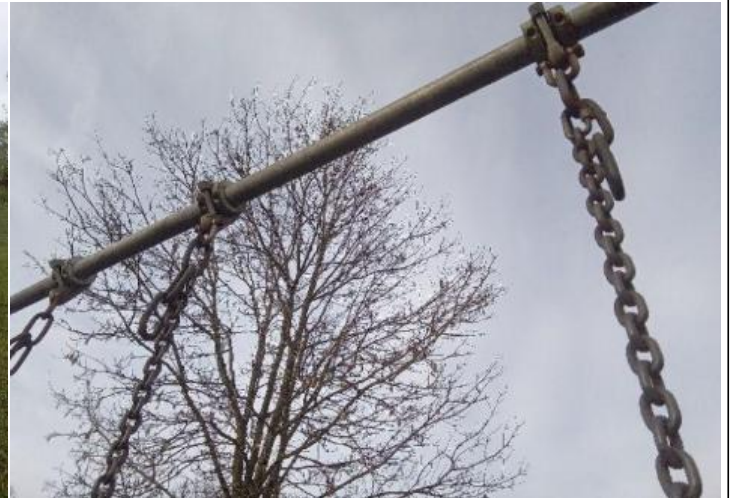
Item: Swings - 2 Bay 3 Flat 1 Inclusive Seat
Manufacturer: G L Jones Playgrounds Ltd

Finding: There is some wear to the shackles.

Action: Monitor for any further deterioration and replace when 40% worn

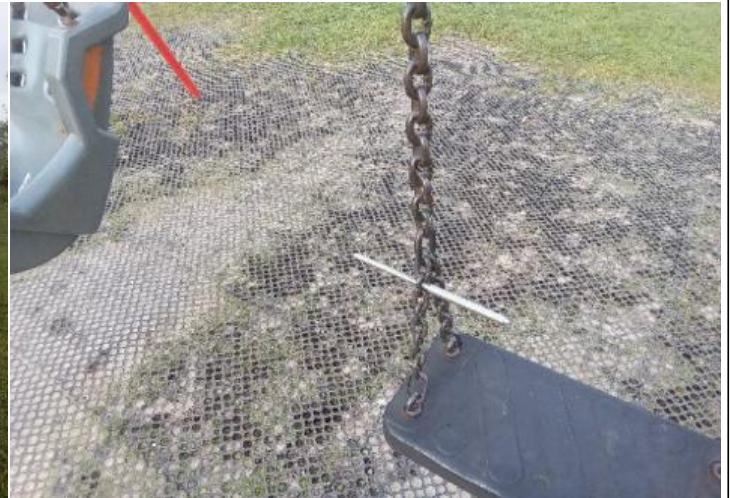
Item: Swings - 2 Bay 3 Flat 1 Inclusive Seat
Manufacturer: G L Jones Playgrounds Ltd

Finding: The chain openings are in excess of the 8.6mm as recommended by BS EN 1176 **Action:** Monitor - No remedial work recommended

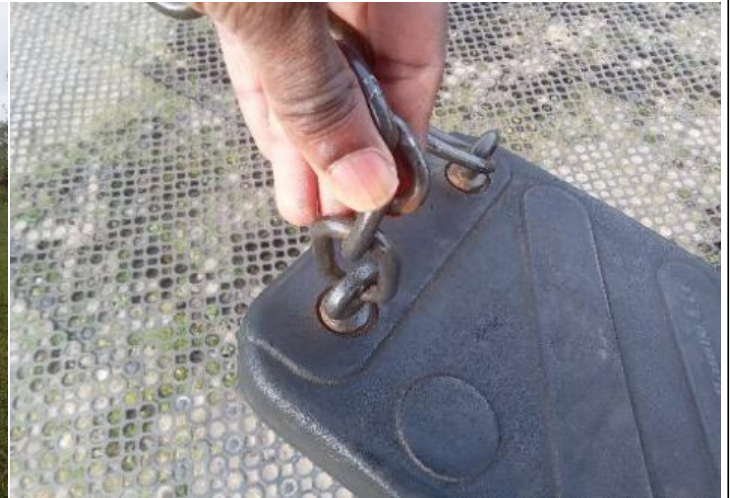
Item: Swings - 2 Bay 3 Flat 1 Inclusive Seat
Manufacturer: G L Jones Playgrounds Ltd

Finding: There is some notable evidence of chain wear

Action: Monitor for any further deterioration and replace when 40% worn

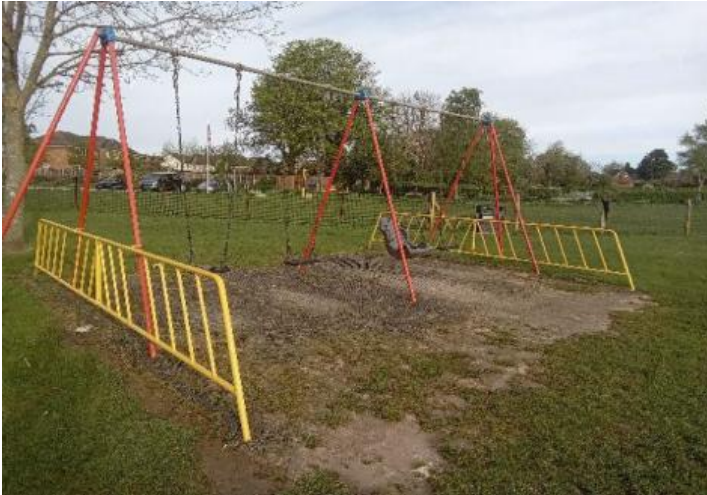
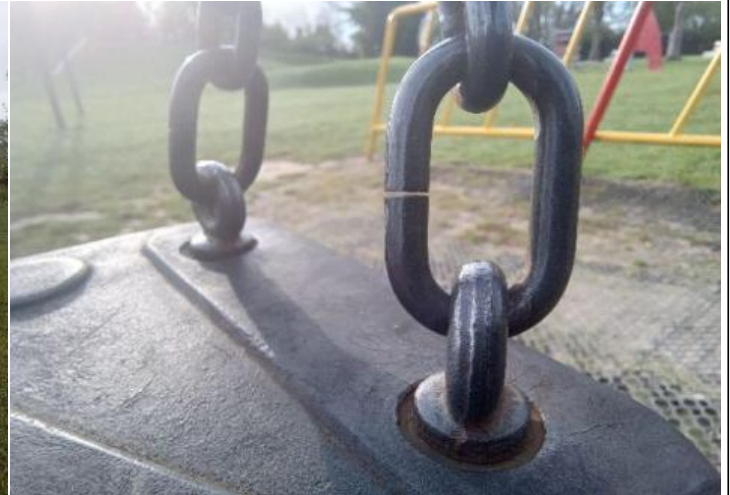
Item: Swings - 2 Bay 3 Flat 1 Inclusive Seat
Manufacturer: G L Jones Playgrounds Ltd

Finding: The connecting link is cut/ damaged

Action: Replace damaged link

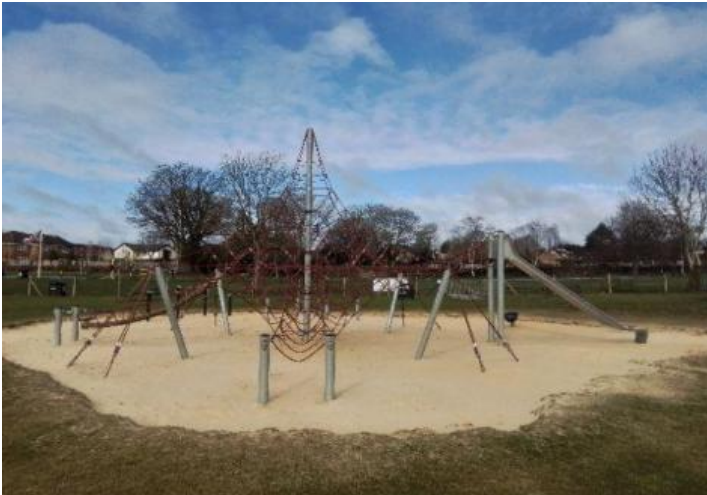
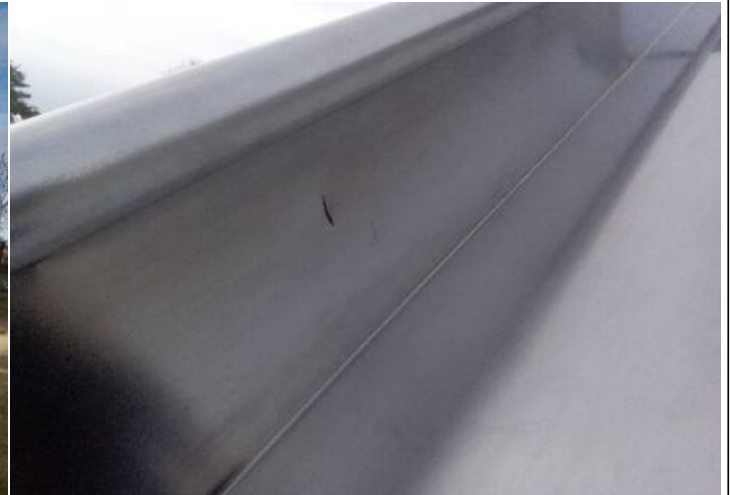
Item: Activity Equipment - Space Net
Manufacturer: Corocord
Risk Level: L - Low Risk
Surface: Sand

Finding: The side of the slide is damaged
Action: Monitor for any further deterioration and repair as required

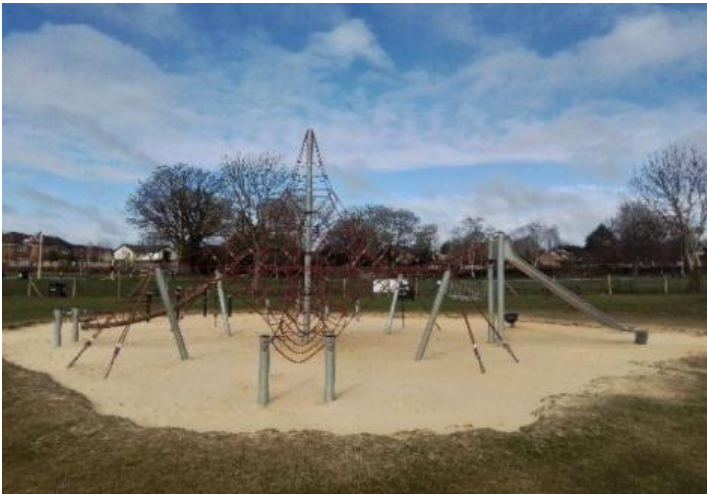
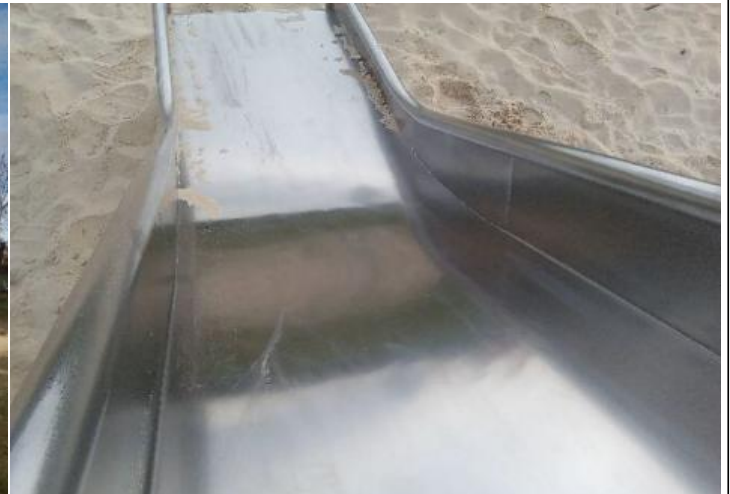
Item: Activity Equipment - Space Net
Manufacturer: Corocord
Risk Level: V - Very Low Risk
Surface: Sand

Finding: There are a number of dents in the slide surface
Action: Monitor for any further deterioration and repair as required

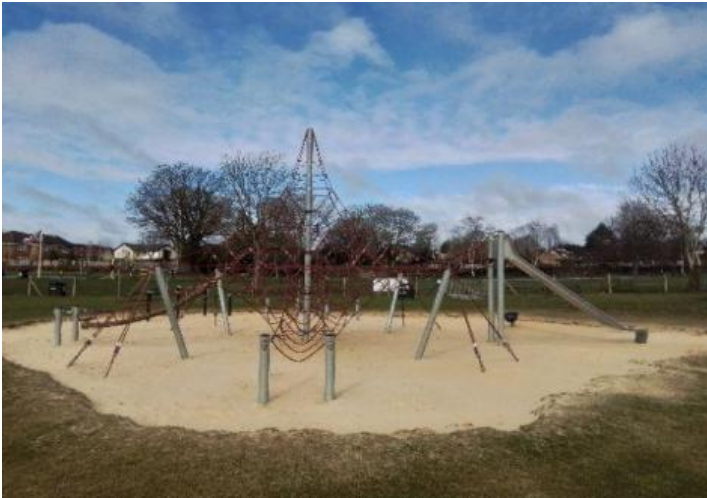
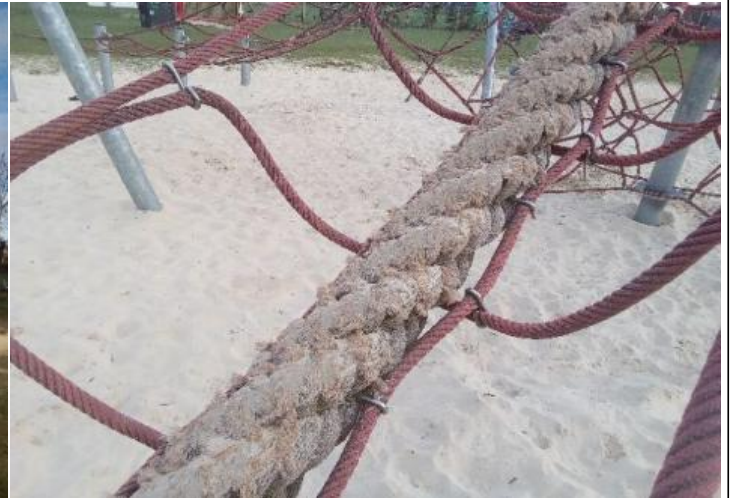
Item: Activity Equipment - Space Net
Manufacturer: Corocord

Finding: The ropes/nets are worn/damaged in places

Action: Monitor for any further deterioration and repair or replace as required

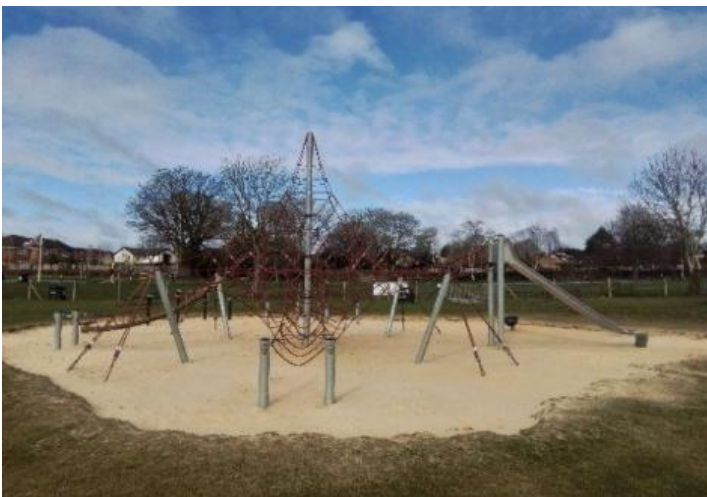
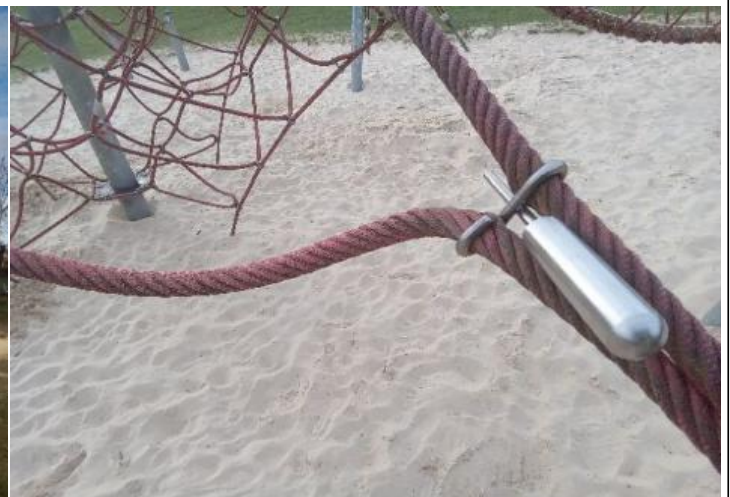
Item: Activity Equipment - Space Net
Manufacturer: Corocord

Finding: There is/are finger entrapment/s in the rope connections and the item fails to meet the requirements of BS EN 1176 Part 1 4.2.7.6 Entrapment of fingers

Action: Monitor - No remedial work recommended

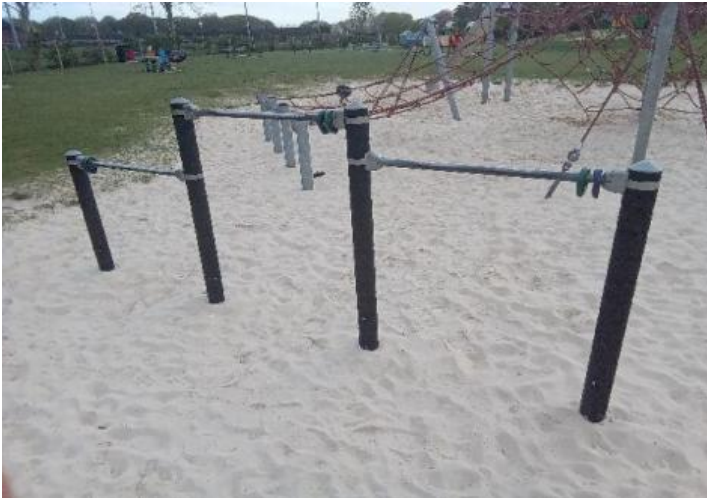
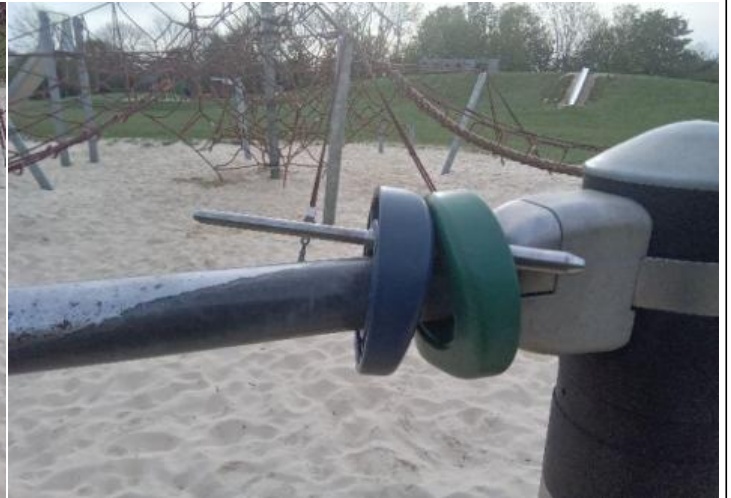
Item: Activity Equipment - Somersault Bars
Manufacturer: Kompan Ltd

Finding: There is/are finger entrapment/s / crush in the Somersault bars fixing and the item fails to meet the requirements of BS EN 1176 Part 1 4.2.7.6 Entrapment of fingers

Action: Monitor - No remedial work recommended

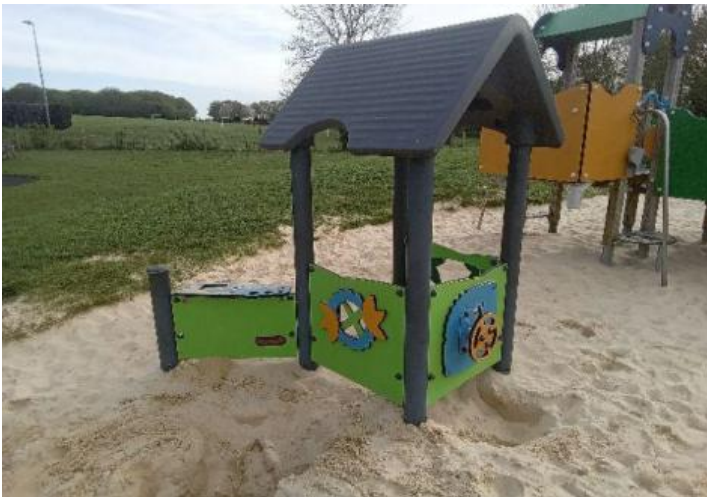
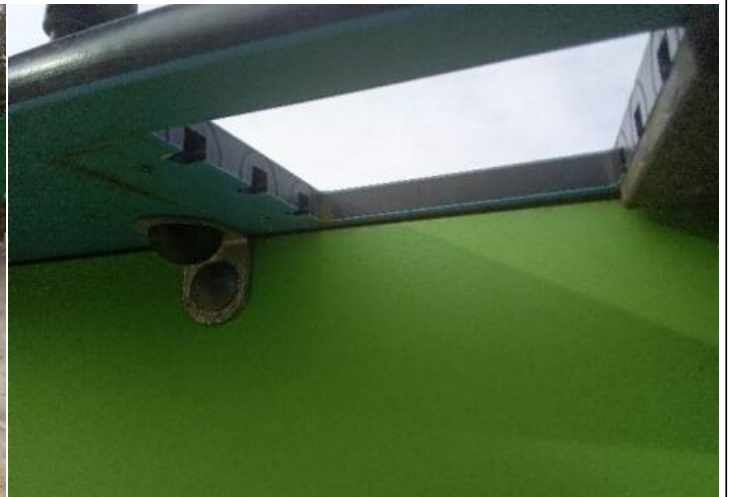
Item: Activity Equipment - Playhouse
Manufacturer: Kompan Ltd

Finding: There is some damage to the item

Action: Monitor for any further deterioration and repair as required

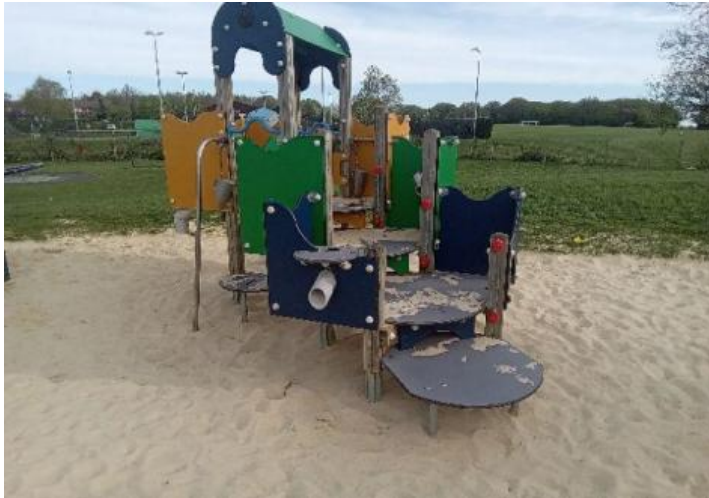
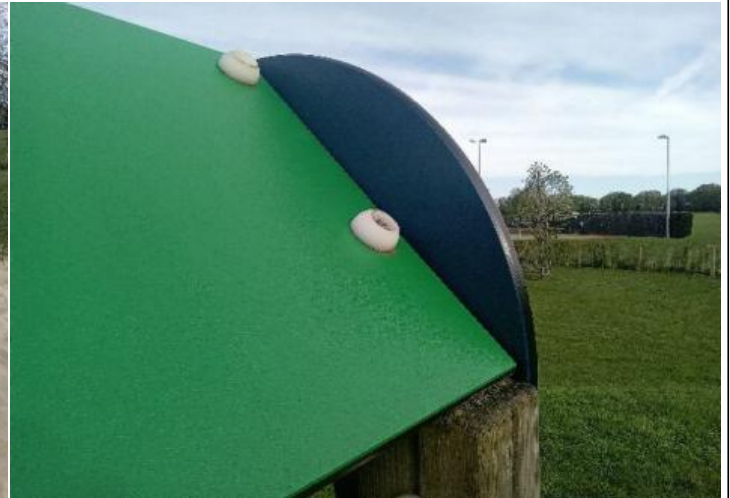
Item: Activity Equipment - Sand Play Unit
Manufacturer: Kompan Ltd

Finding: There is/are bolt cap covers missing or damaged on the item

Action: Replace missing or damaged bolt cap covers

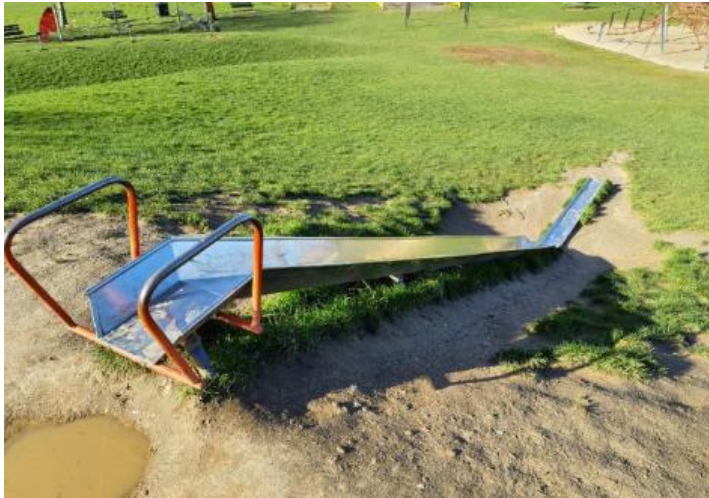
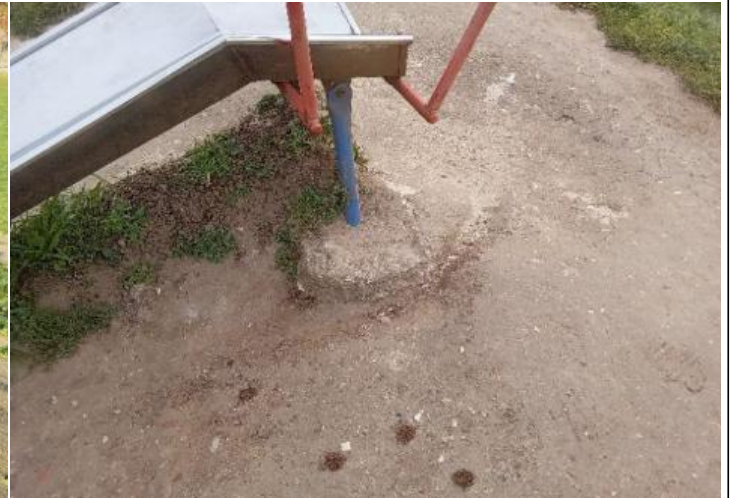
Item: Other - Embankment Slide
Manufacturer: Not Identified

Finding: The surface has eroded and the foundations are exposed

Action: Reinstate surrounding surfaces to cover the foundations

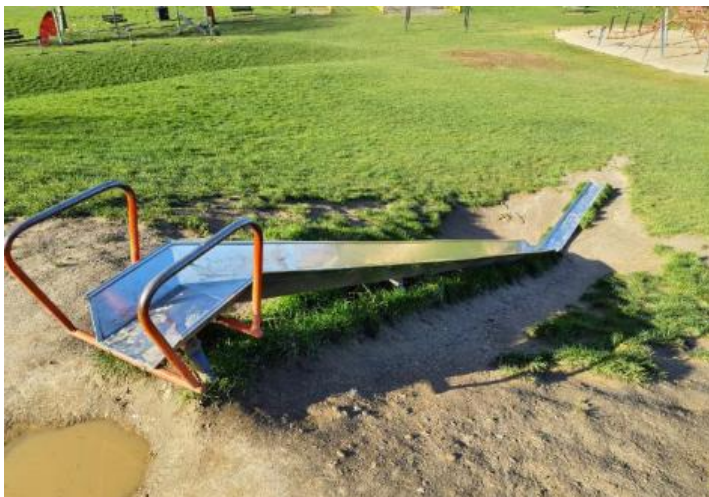
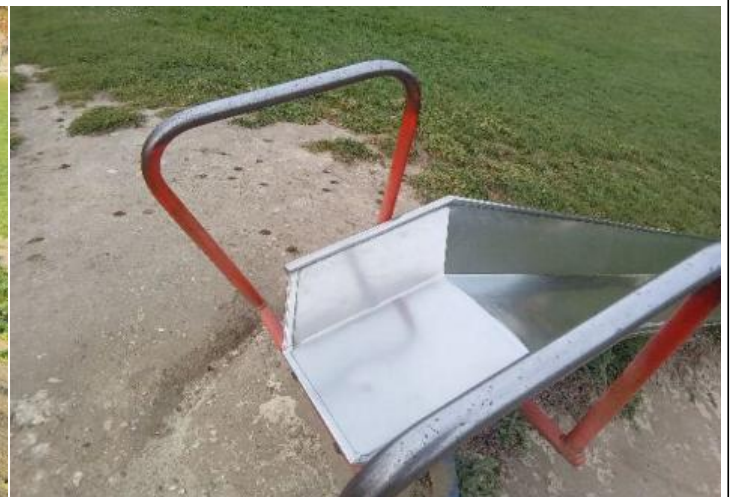
Item: Other - Embankment Slide
Manufacturer: Not Identified

Finding: The paintwork on this item has been damaged or worn exposing the metal underneath which is rusting / corroding

Action: Treat affected areas and repaint

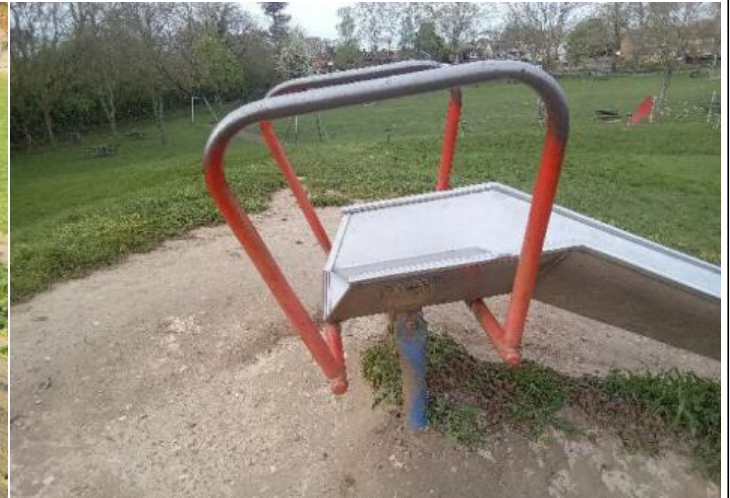
Item: Other - Embankment Slide
Manufacturer: Not Identified

Finding: The slide start section incline is not in the direction of travel; it should slope towards the direction of the sliding surface to meet the requirements of BS EN 1176 Part 3

Action: Monitor - No remedial work recommended

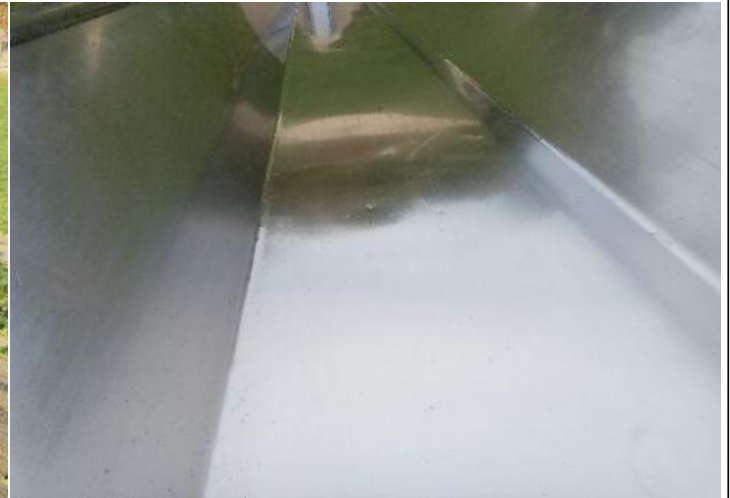
Item: Other - Embankment Slide
Manufacturer: Not Identified

Finding: There are a number of dents in the slide surface

Action: Monitor for any further deterioration and repair as required

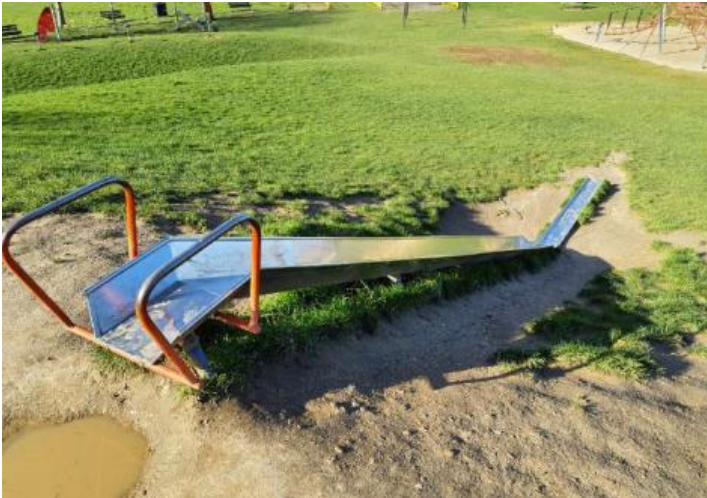
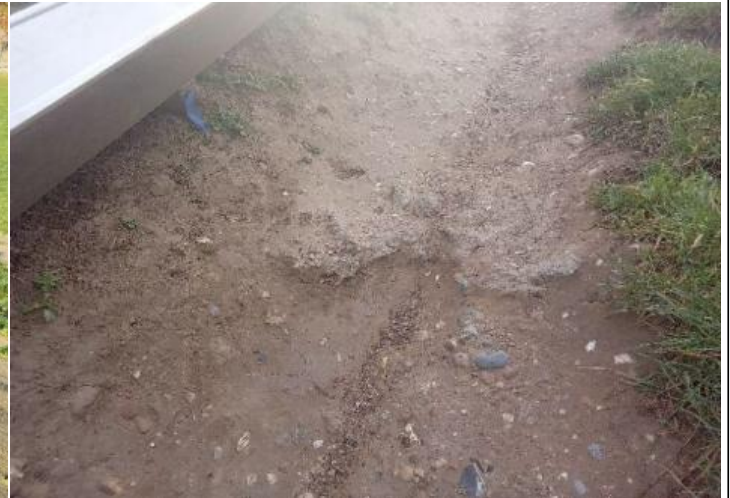
Item: Other - Embankment Slide
Manufacturer: Not Identified

Finding: The concrete foundation forms a projecting obstacle / hard object within the free space of the equipment, in contravention of the requirements of BS EN 1176 Part 1

Action: Reinststate the surface

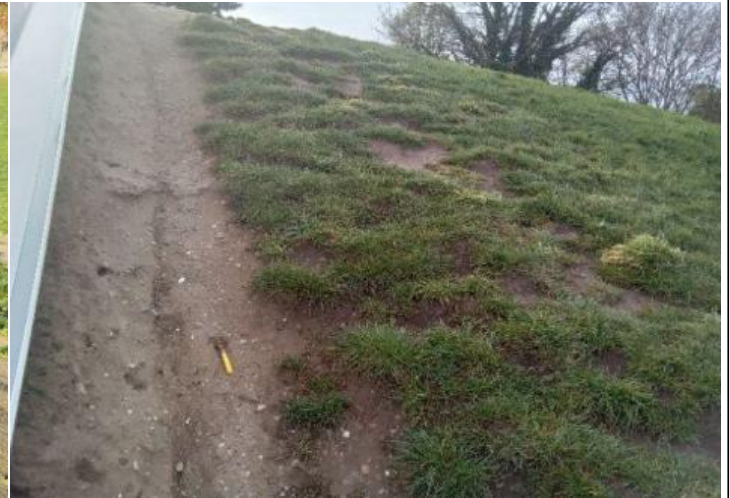
Item: Other - Embankment Slide
Manufacturer: Not Identified

Finding: The surface has eroded in some areas and may be slippery in wet conditions
Action: Reinstate the surface

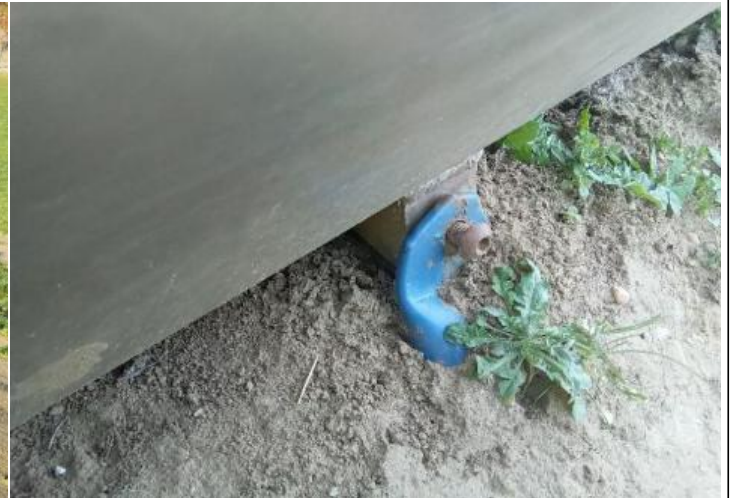
Item: Other - Embankment Slide
Manufacturer: Not Identified

Finding: A number of fixing(s) have worked loose

Action: Secure all loose fixings

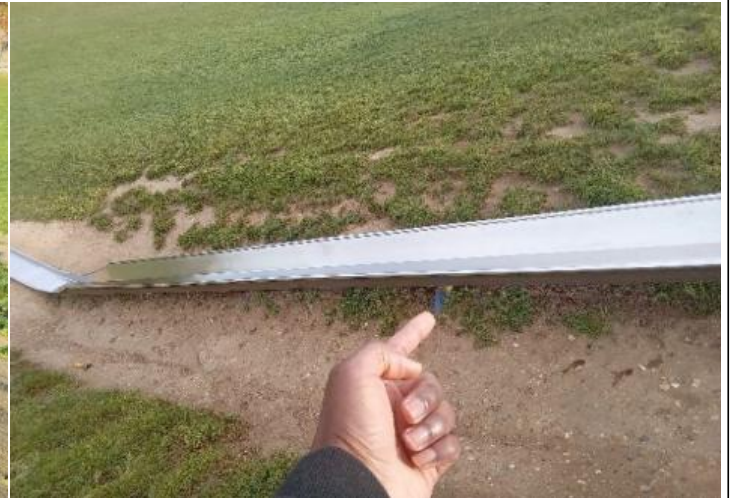
Item: Other - Embankment Slide
Manufacturer: Not Identified

Finding: The weld(s) on this item have failed

Action: Repair item

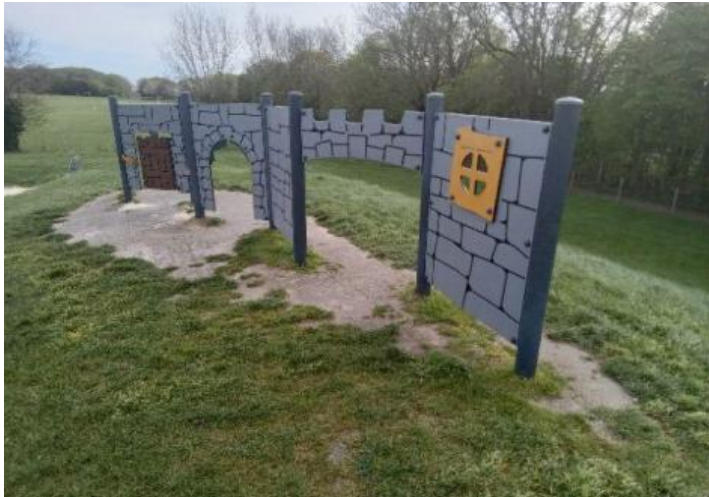
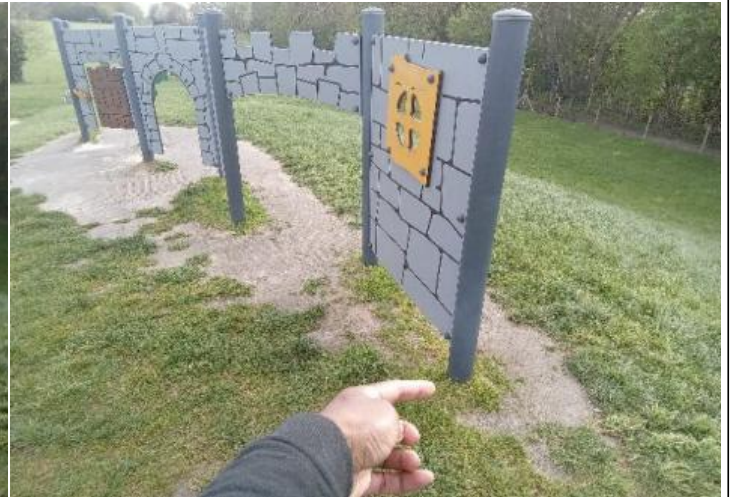
Item: Activity Equipment - Play Panel
Manufacturer: Kompan Ltd

Finding: The item is slightly loose in its foundations

Action: Monitor for any further deterioration and repair as required

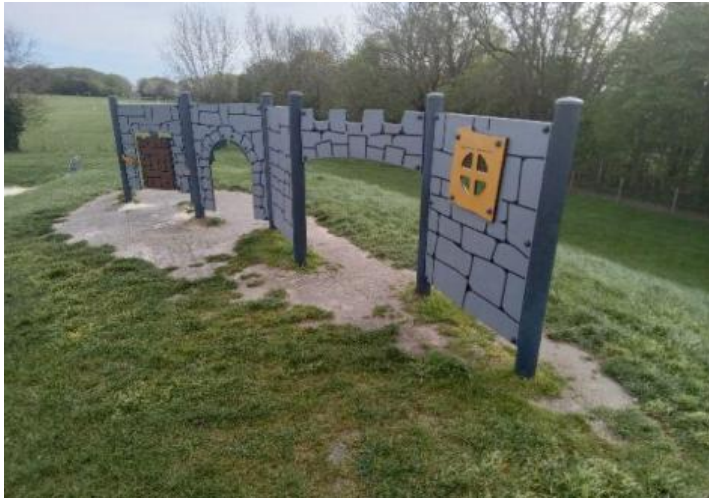
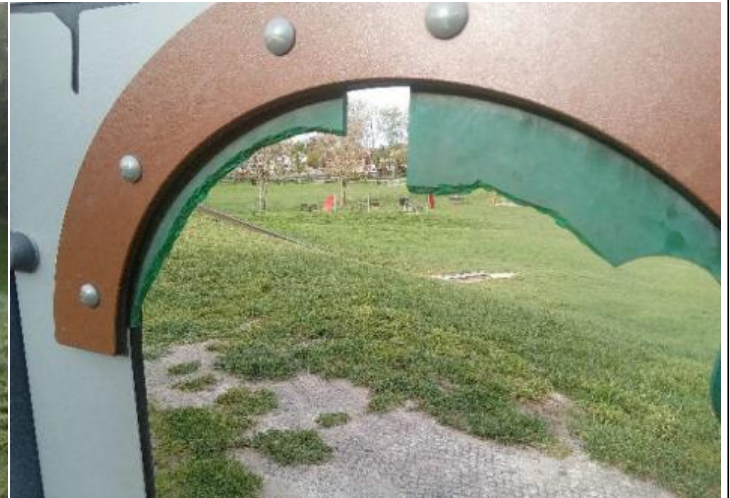
Item: Activity Equipment - Play Panel
Manufacturer: Kompan Ltd

Finding: There is some damage to the item

Action: Monitor for any further deterioration and repair as required

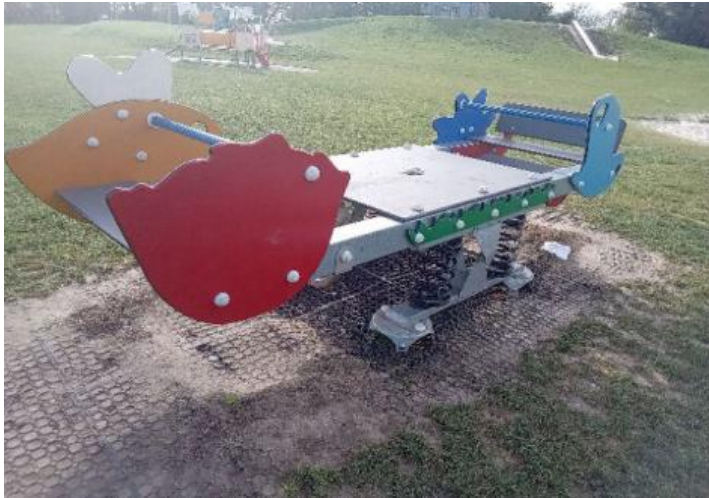
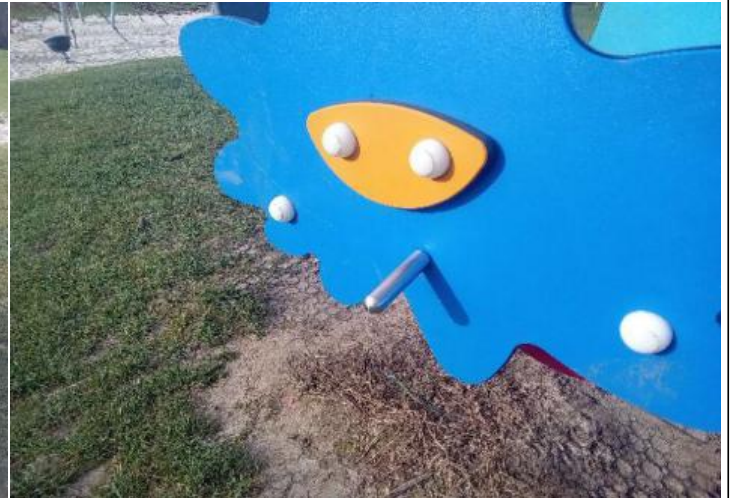
Item: Rocking Equipment - See Saw
Manufacturer: Kompan Ltd

Finding: There is or are fixings missing on the item causing finger entrapment
Action: Replace all missing fixings to remove entrapment

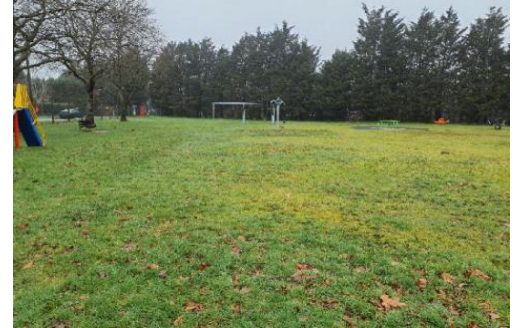
Item: Site General
Manufacturer: Owner/Operator
Surface Type: N/A
Item Quantity: 1
Equipment Compliance: N/A
Surface Area Compliance: N/A

The surface has eroded in some areas and may be slippery in wet conditions - Reinststate the surface

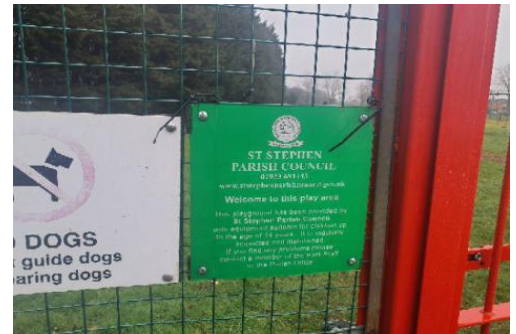
Item: Sign
Manufacturer: Owner/Operator
Surface Type: N/A
Item Quantity: 1
Equipment Compliance: N/A
Surface Area Compliance: N/A

BS EN 1176 Part 7 recommends that signage shall include the site name / address - Provide additional information

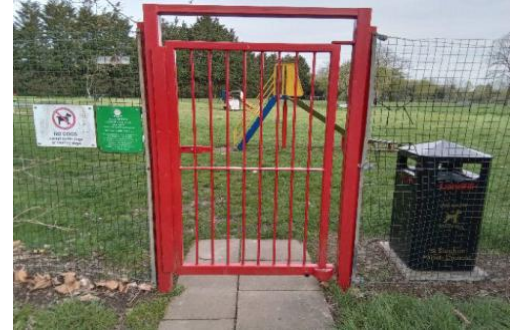
Item: Gate - Self Closing
Manufacturer: Not Identified
Surface Type: Grass
Item Quantity: 2
Equipment Compliance: N/A
Surface Area Compliance: N/A

There are trip hazards at the edges of the surface - Reinstate surrounding surface levels to remove the trip points

The surface has eroded in some areas and may be slippery in wet conditions - Reinstate the surface

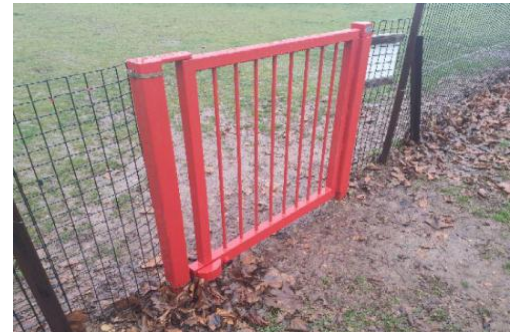
Item: Gate - Self Closing
Manufacturer: Easy Gate Ltd
Surface Type: Grass
Item Quantity: 1
Equipment Compliance: N/A
Surface Area Compliance: N/A

The surface has eroded in some areas and may be slippery in wet conditions - Reinstate the surface

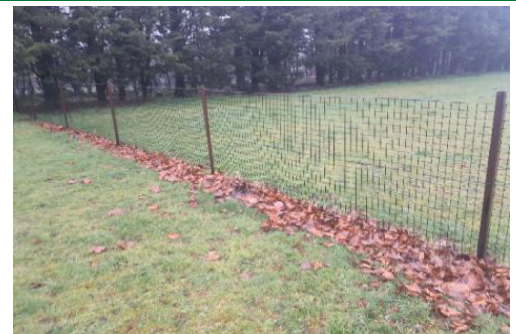
Item: Fence - Chainlink
Manufacturer: Owner/Operator
Surface Type: Grass
Item Quantity: 1
Equipment Compliance: N/A
Surface Area Compliance: N/A

The paintwork on this item has been damaged or worn exposing the metal underneath which is rusting / corroding - Treat affected areas and repaint

Cable ties have been used on the item and there are sharp projecting ends - Remove if not required or replace with a more appropriate alternative fixing method if used as a fixing

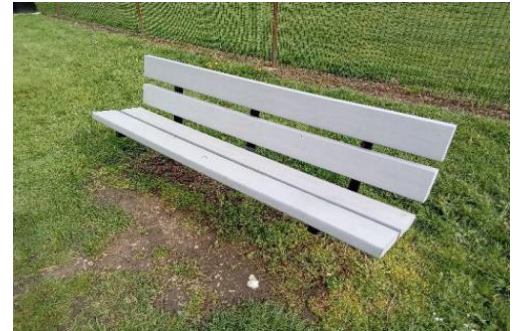
Item: Bench
Manufacturer: Owner/Operator
Surface Type: Grass
Item Quantity: 2
Equipment Compliance: N/A
Surface Area Compliance: N/A

The surface has eroded in some areas and may be slippery in wet conditions - Reinstate the surface

There are areas or parts of the timber on the structure that have rotted - Replace all affected timbers

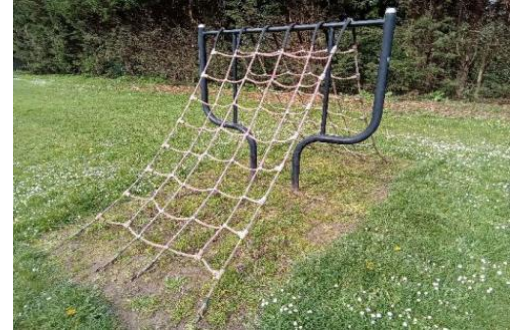
Item: Net Climber
Manufacturer: Wicksteed Playgrounds
Surface Type: Grass Matrix Tiles
Item Quantity: 1
Equipment Compliance: Yes
Surface Area Compliance: Yes
Life Expectancy: 5 -10 Years
Total Findings: 2

The rope has worn and wire strands are exposed - Replace rope or net

The connecting links are worn in excess of 40% and require renewing - Replace worn chains

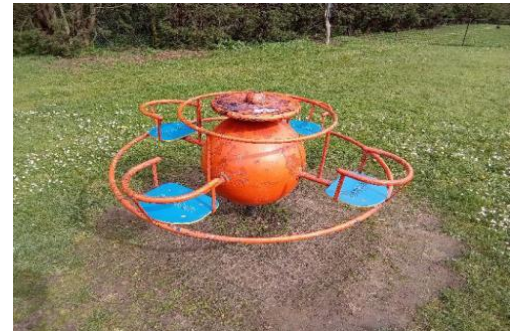
Item: Roundabout
Manufacturer: Wicksteed Playgrounds
Surface Type: Grass Matrix Tiles
Item Quantity: 1
Equipment Compliance: No
Surface Area Compliance: Yes
Life Expectancy: 3 - 5 Years
Total Findings: 4

The item fails to meet the requirements of BS EN 1176 Part 1 4.2.7.2 for head and neck entrapment in the roundabout - Monitor - No remedial work recommended

The bearing is showing signs of wear - Monitor for any further deterioration and replace as required

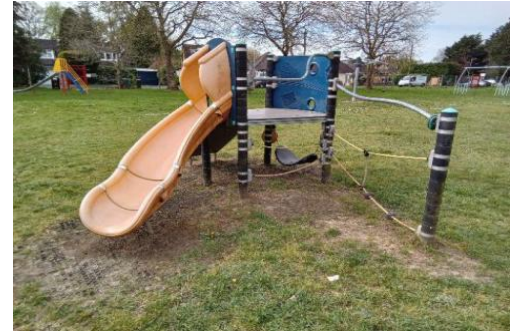
Item: Multi Play (Junior)
Manufacturer: Kompan Ltd
Surface Type: Grass Matrix Tiles
Item Quantity: 1
Equipment Compliance: No
Surface Area Compliance: Yes
Life Expectancy: >10 Years
Total Findings: 4

A number of fixing(s) have worked loose on guardrail - Secure all loose fixings

There is/are finger entrapment/s in the barrier next to access element and the item fails to meet the requirements of BS EN 1176 Part 1 4.2.7.6 Entrapment of fingers - Monitor - No remedial work recommended

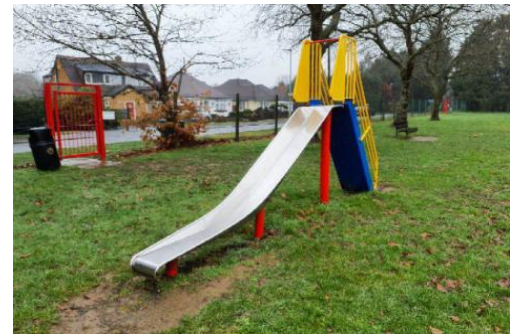
Item: Free Standing Slide
Manufacturer: G L Jones Playgrounds Ltd
Surface Type: Grass Matrix Tiles
Item Quantity: 1
Equipment Compliance: Yes
Surface Area Compliance: Yes
Life Expectancy: 5 -10 Years
Total Findings: 4

The grass mats are silted up, the soil is compacted and the area will become very slippery when the soil is wet. - Reinstate as required

The side of the slide is damaged - Monitor for any further deterioration and repair as required

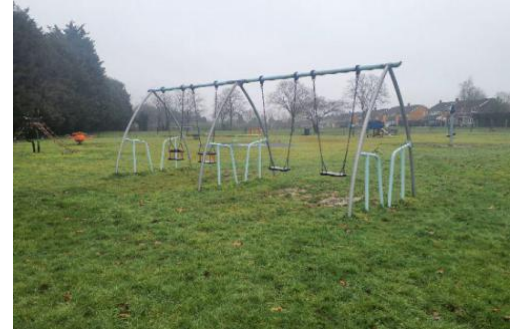
Item: 2 Bay (2 Flat, 2 Cradle)
Manufacturer: Record RSS
Surface Type: Grass Matrix Tiles
Item Quantity: 1
Equipment Compliance: No
Surface Area Compliance: Yes
Life Expectancy: >10 Years
Total Findings: 9

There is some notable evidence of chain wear - Monitor for any further deterioration and replace when 40% worn

The chain openings are in excess of the 8.6mm as recommended by BS EN 1176 - Monitor - No remedial work recommended

The swing seat connectors are loose - Tighten to secure

The seat has minor damage or wear - Monitor for any further deterioration and replace as required

There is some wear to the shackles. - Monitor for any further deterioration and replace when 40% worn
