ST STEPHEN PARISH COUNCIL

You are summoned to the Fixed Assets Committee meeting
To take place on **Thursday 30 May 2024 at 7.30pm**
at St Stephen Suite, Parish Centre, Station Road, Bricket Wood, AL2 3PJ

- 2425/AC/07 To receive Annual Play Inspection Report and Grounds Team Action Report. Play Reports and Grounds Team Report attached.**
- 2425/AC/08 To discuss the option of creating additional allotment plots and possible beginner plots at Watford Road allotment site or North Close. Allotment report attached.**

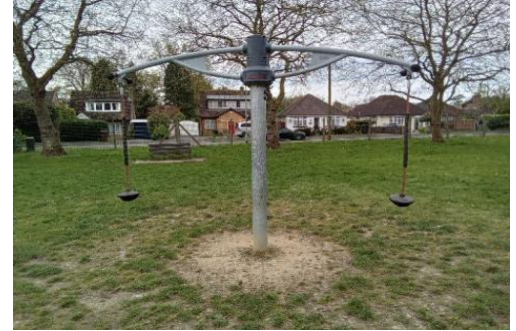
Item: Overhead Rotator
Manufacturer: Kompan Ltd
Surface Type: Grass Matrix Tiles
Item Quantity: 1
Equipment Compliance: Yes
Surface Area Compliance: Yes

The seat has been damaged - Monitor for any further deterioration and replace as required

The seat connection cannot be inspected without dismantling the seat - Dismantle the seat to inspect the seat connection for wear

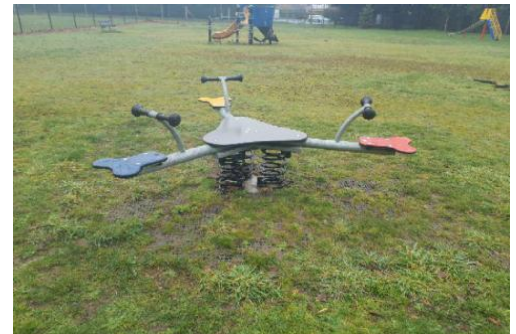
Item: Three Way Springer
Manufacturer: Kompan Ltd
Surface Type: Grass Matrix Tiles
Item Quantity: 1
Equipment Compliance: Yes
Surface Area Compliance: Yes

There is or are fixings missing on the item - Replace all missing fixings

The Handgrips/Footrests rotate and may cause an unexpected movement for the user - Secure Handgrips/Footrests to prevent rotation.

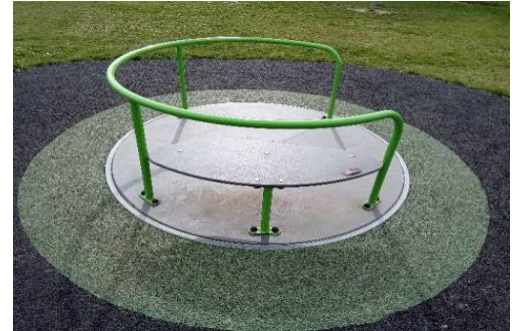
Item: Inclusive Roundabout
Manufacturer: Kompan Ltd
Surface Type: Wet Pour
Item Quantity: 1
Equipment Compliance: Yes
Surface Area Compliance: Yes

There is/are bolt cap covers missing or damaged on the item - Replace missing or damaged bolt cap covers

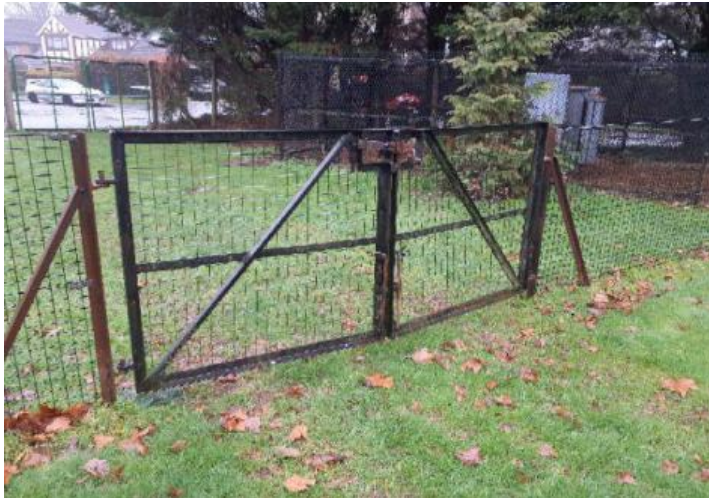
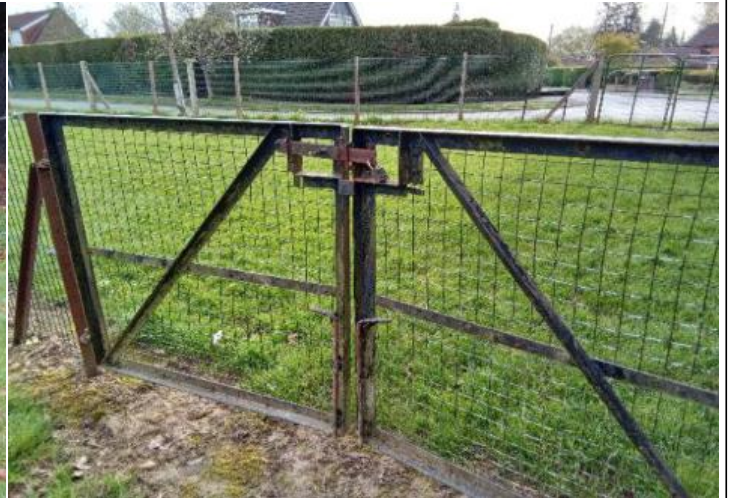
Item: Gates - Gate - Maintenance
Manufacturer: Owner/Operator

Finding: The maintenance gate was correctly padlocked at the time of inspection, however this means that the inspector was unable to fully assess the gate

Action: Ensure that there are 12mm gaps throughout the full range of motion on gate/s and between leaves where relevant

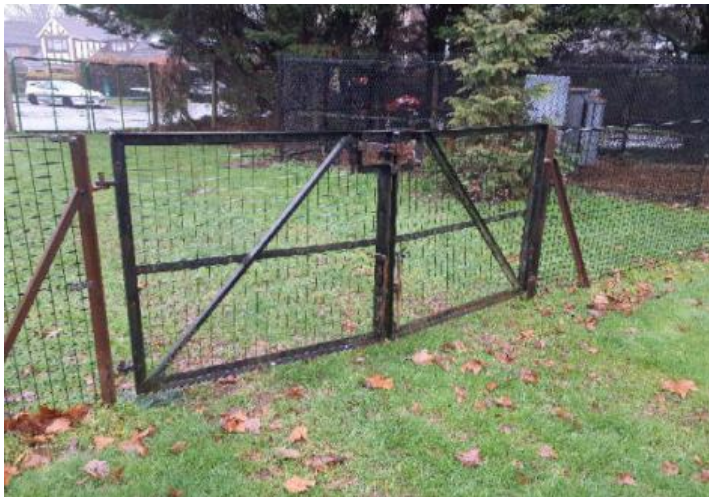
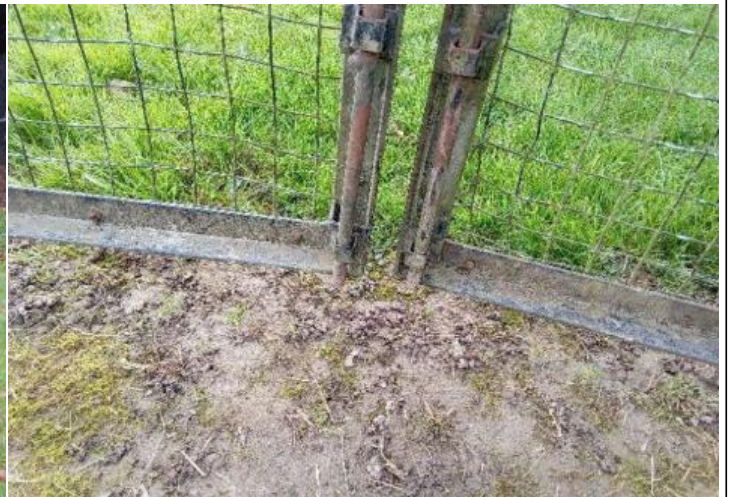
Item: Gates - Gate - Maintenance
Manufacturer: Owner/Operator

Finding: The gate has no drop bolt sleeves and/or drop bolts fitted

Action: Provide drop bolt sleeves and/or drop bolts

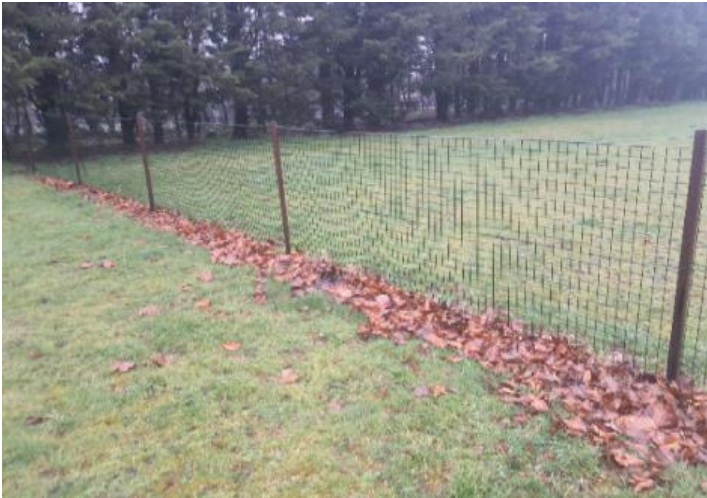
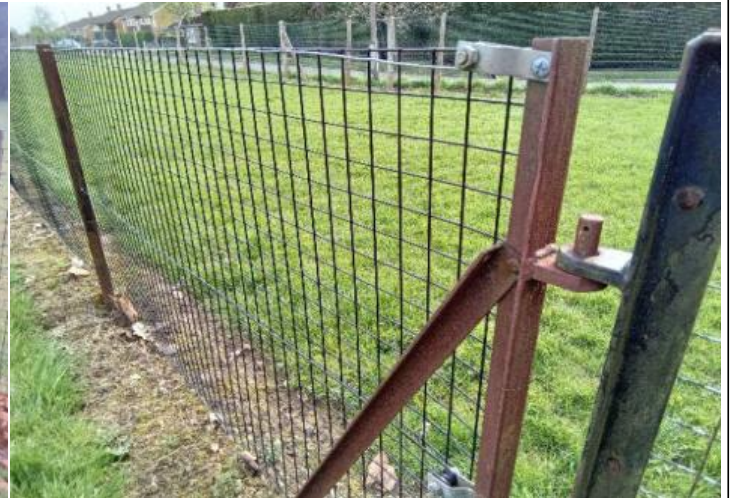
Item: Fences - Fence - Chainlink
Manufacturer: Owner/Operator

Finding: The paintwork on this item has been damaged or worn exposing the metal underneath which is rusting / corroding

The paintwork on this item has been damaged or worn exposing the metal underneath which is rusting / corroding - Treat affected areas and repaint

Action: Treat affected areas and repaint

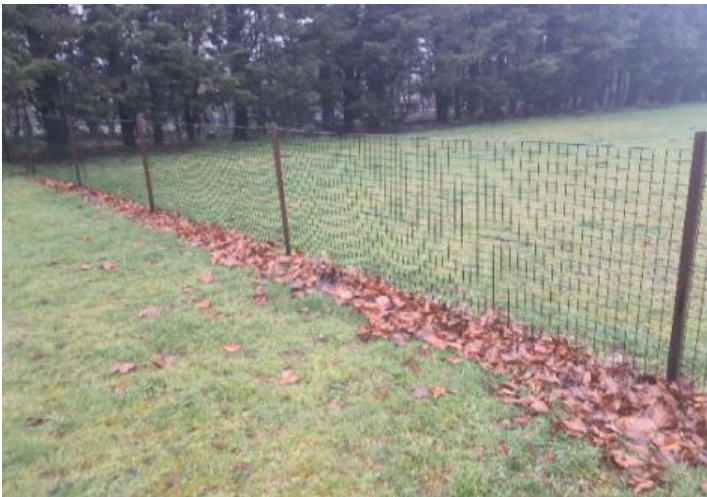
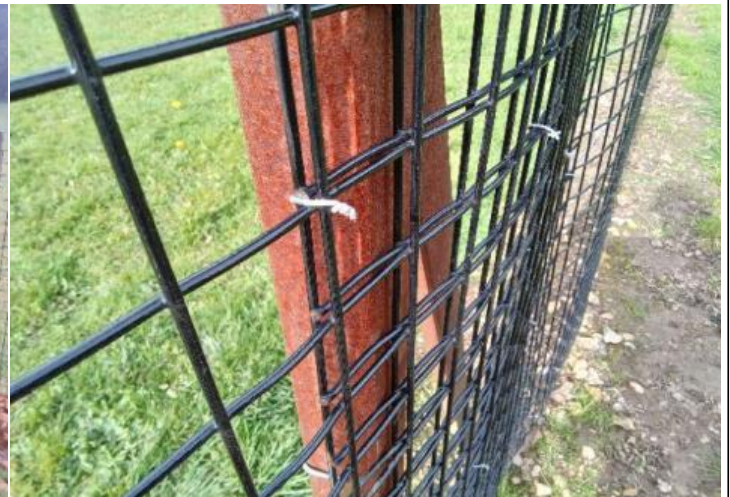
Item: Fences - Fence - Chainlink
Manufacturer: Owner/Operator

Finding: Cable ties have been used on the item and there are sharp projecting ends

Cable ties have been used on the item and there are sharp projecting ends - Remove if not required or replace with a more appropriate alternative fixing method if used as a fixing

Action: Remove if not required or replace with a more appropriate alternative fixing method if used as a fixing

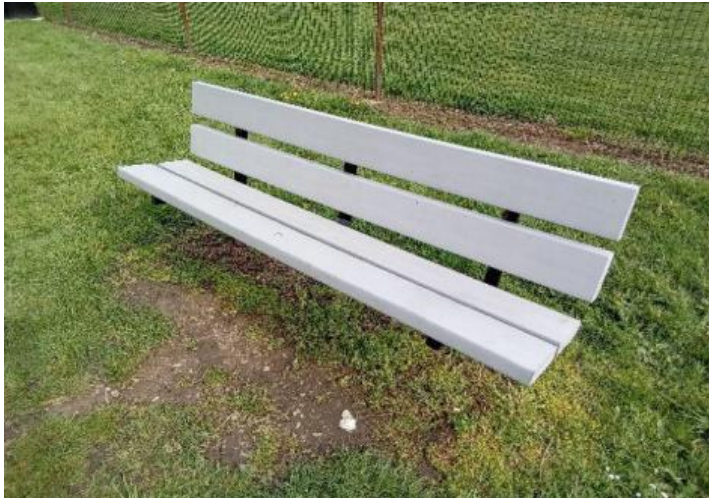
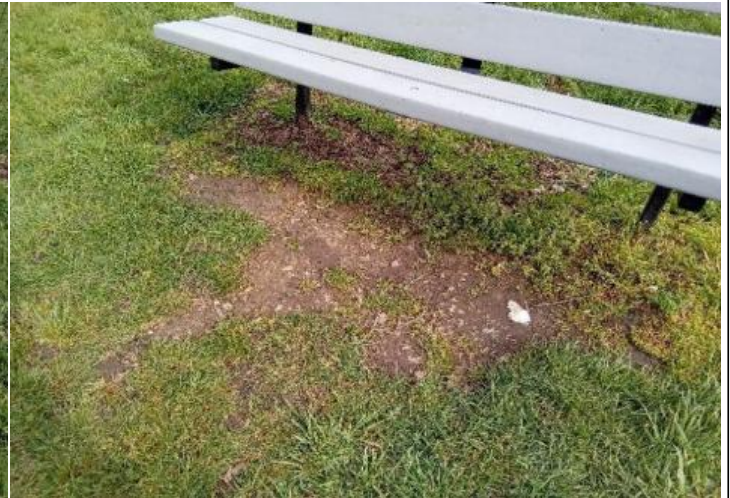
Item: Ancillary Items - Bench
Manufacturer: Owner/Operator

Finding: The surface has eroded in some areas and may be slippery in wet conditions
Action: Reinststate the surface

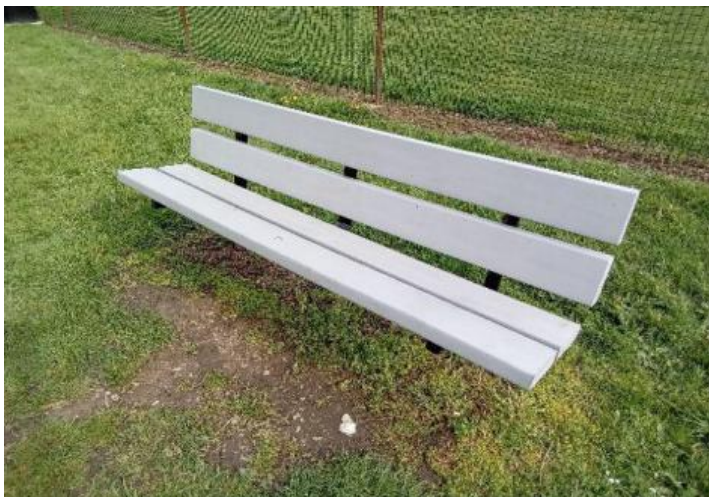
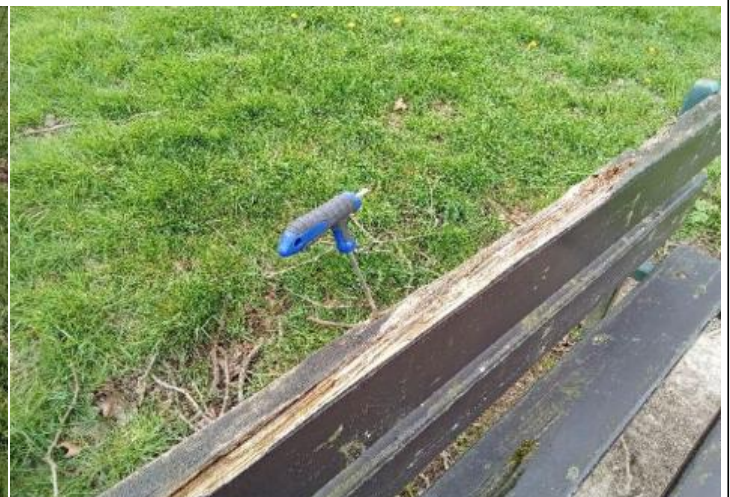
Item: Ancillary Items - Bench
Manufacturer: Owner/Operator

Finding: There are areas or parts of the timber on the structure that have rotted
Action: Replace all affected timbers

There are areas or parts of the timber on the structure that have rotted - Replace all affected timbers

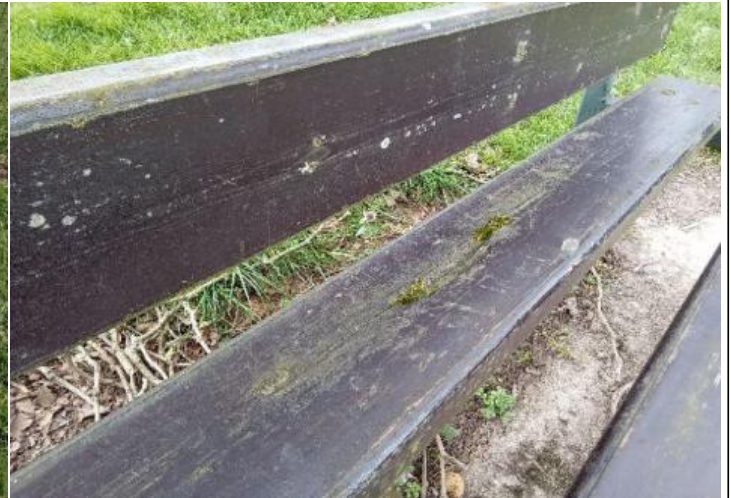
Item: Ancillary Items - Bench
Manufacturer: Owner/Operator

Finding: Parts of the timber are rough or splintered

Action: Remove all rough or sharp edges

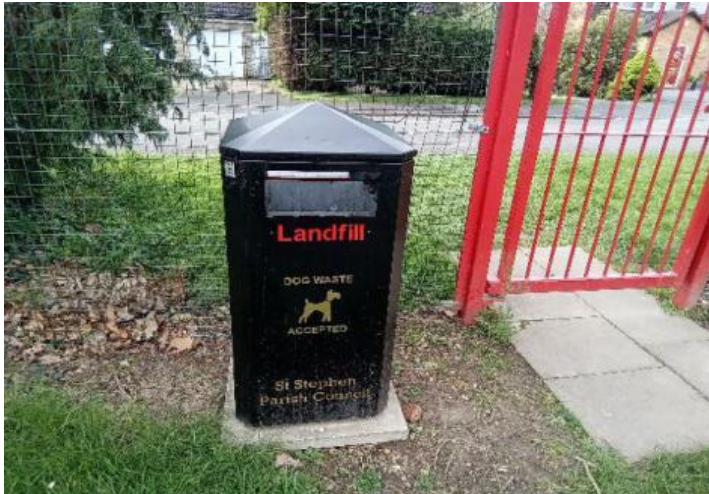
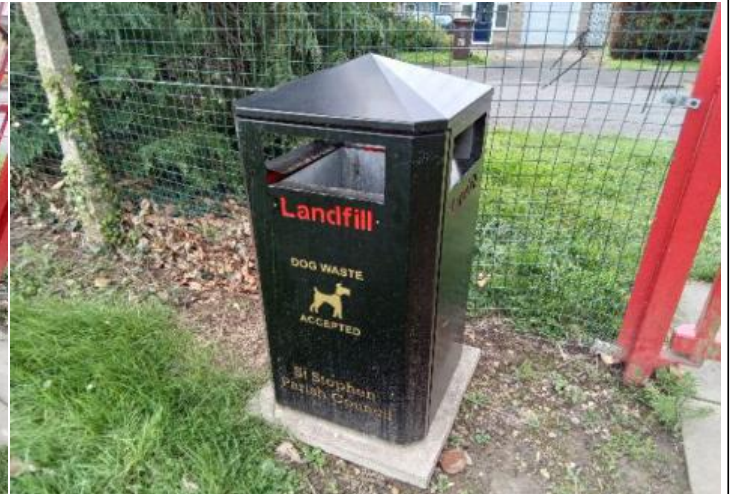
Item: Ancillary Items - Litter Bin
Manufacturer: Owner/Operator

Finding: The bin is not securely fixed to the surface and there is some possibility of the item tipping or rolling over

Action: Secure the bin to the ground

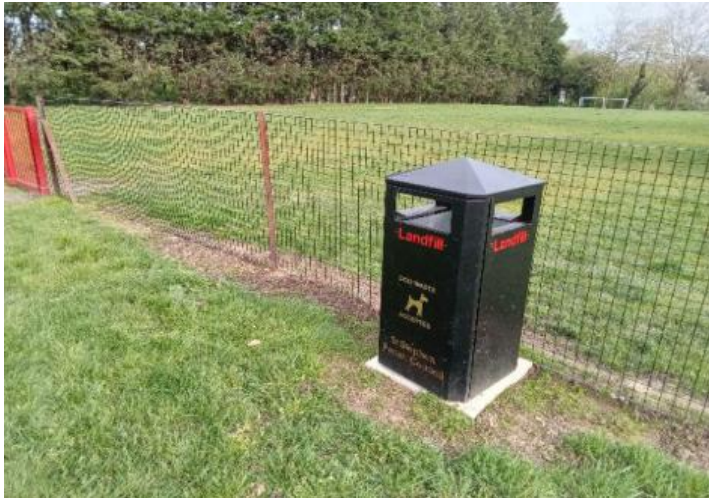
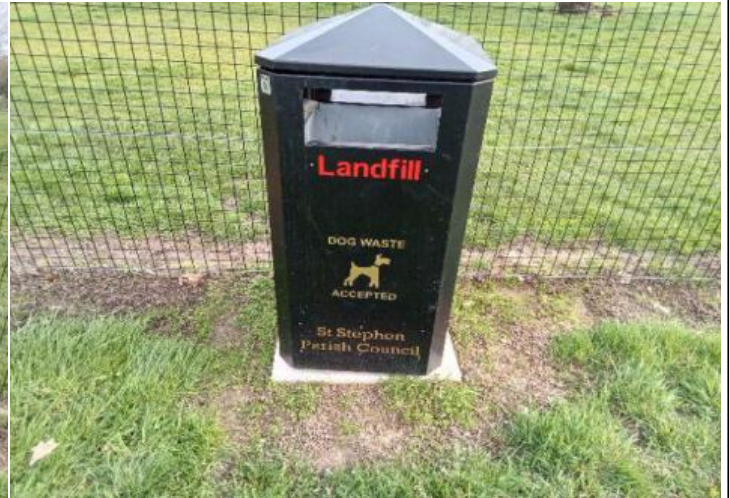
Item: Ancillary Items - Litter Bin
Manufacturer: Broxap

Finding: The bin is not securely fixed to the surface and there is some possibility of the item tipping or rolling over

Action: Secure the bin to the ground

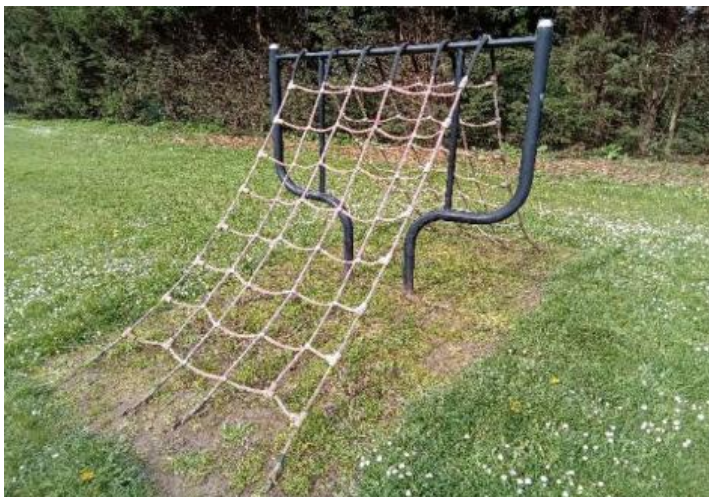
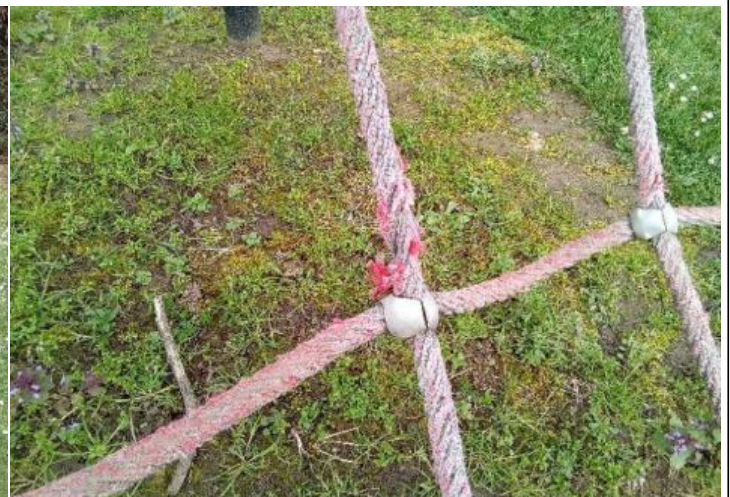
Item: Activity Equipment - Net Climber
Manufacturer: Wicksteed Playgrounds

Finding: The rope has worn and wire strands are exposed

The rope has worn and wire strands are exposed - Replace rope or net

Action: Replace rope or net

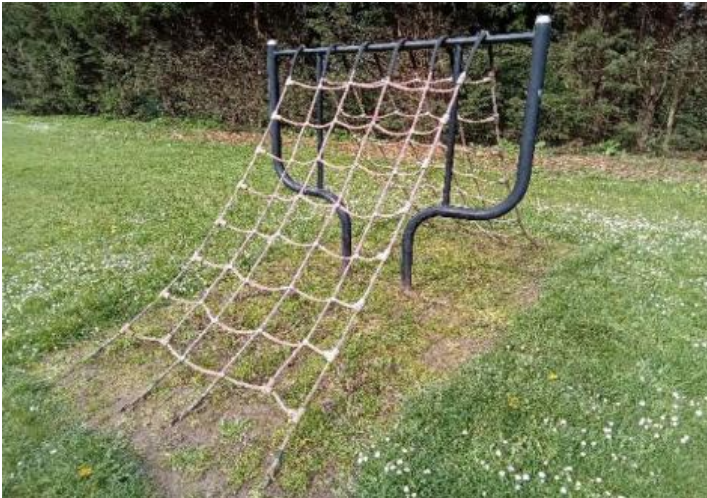
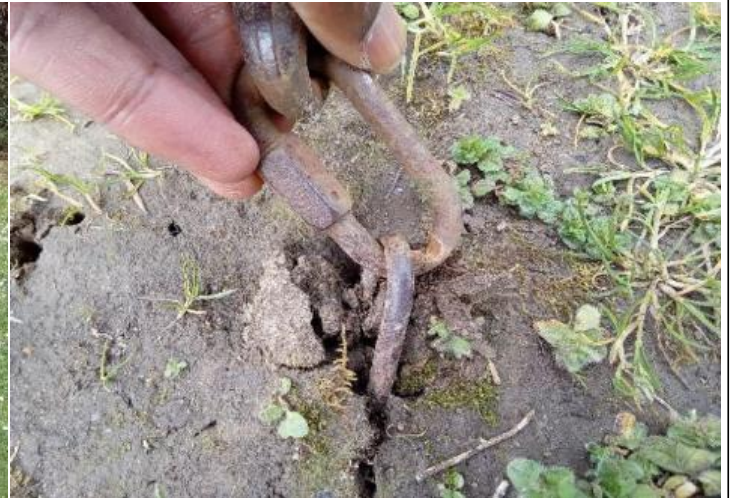
Item: Activity Equipment - Net Climber
Manufacturer: Wicksteed Playgrounds

Finding: The connecting links are worn in excess of 40% and require renewing

The connecting links are worn in excess of 40% and require renewing - Replace worn chains

Action: Replace worn chains

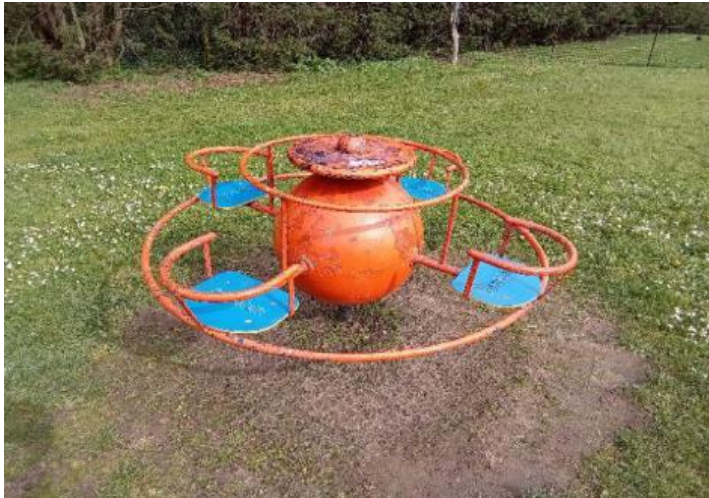
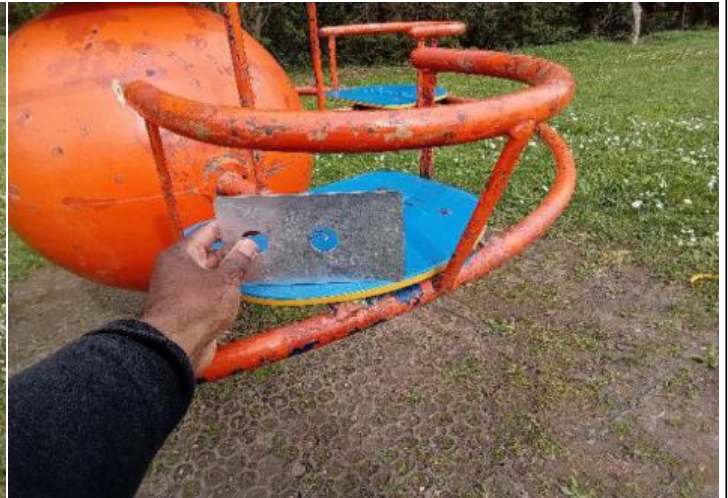
The item fails to meet the requirements of BS EN 1176 Part 1 4.2.7.2 for head and neck entrapment in the roundabout - Monitor - No remedial work recommended

Item: Rotor Play - Roundabout
Manufacturer: Wicksteed Playgrounds

Finding: The item fails to meet the requirements of BS EN 1176 Part 1 4.2.7.2 for head and neck entrapment in the roundabout

Action: Monitor - No remedial work recommended

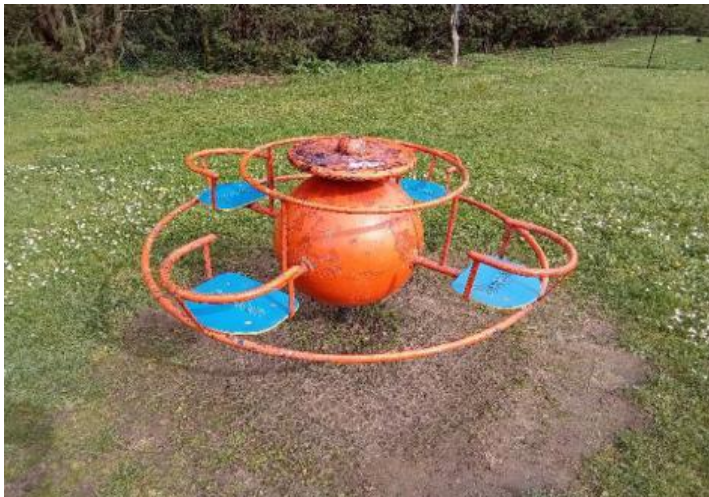
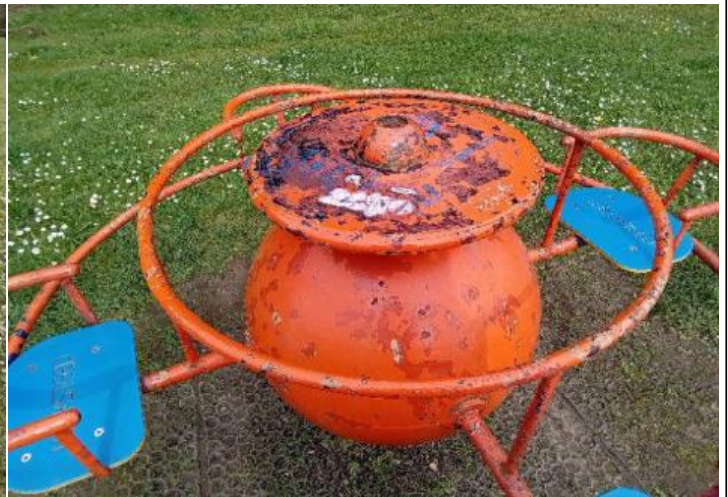
Item: Rotor Play - Roundabout
Manufacturer: Wicksteed Playgrounds

Finding: The paint is flaking off the metalwork

Action: Rub down and re-paint

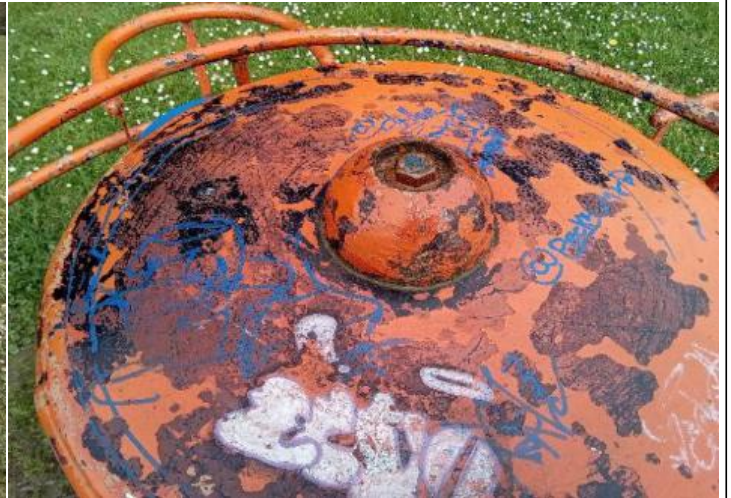
Item: Rotor Play - Roundabout
Manufacturer: Wicksteed Playgrounds

Finding: There is some graffiti present

Action: Remove the graffiti

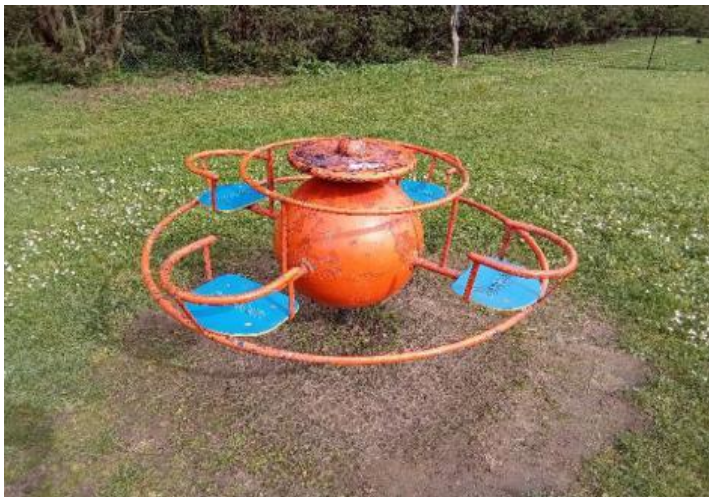
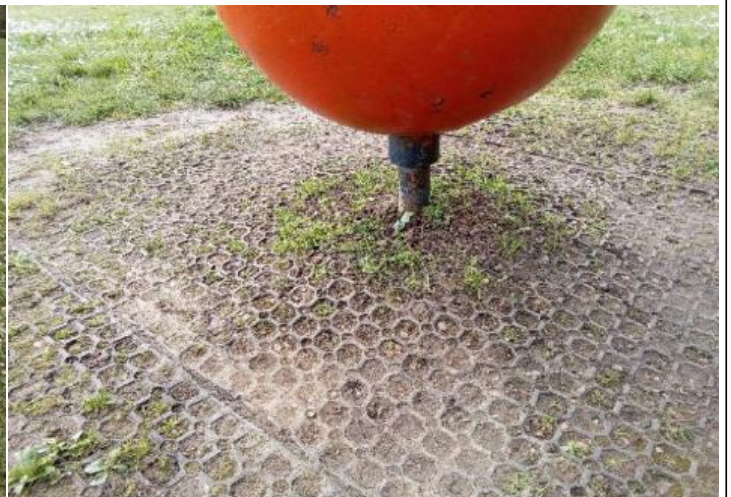
Item: Rotor Play - Roundabout
Manufacturer: Wicksteed Playgrounds

Finding: The bearing is showing signs of wear

The bearing is showing signs of wear - Monitor for any further deterioration and replace as required

Action: Monitor for any further deterioration and replace as required

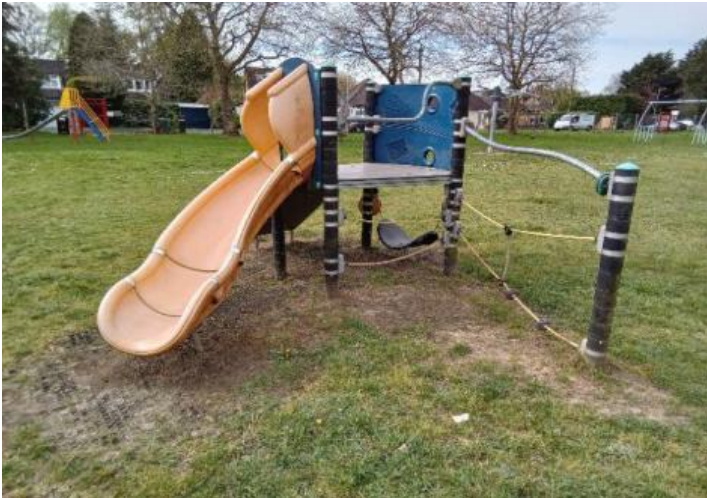
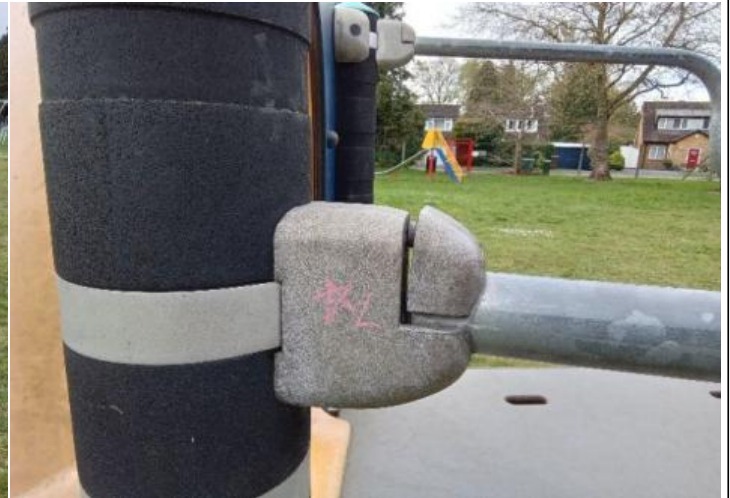
Item: Activity Equipment - Multi Play (Junior)
Manufacturer: Kompan Ltd

Finding: A number of fixing(s) have worked loose on guardrail

A number of fixing(s) have worked loose on guardrail - Secure all loose fixings

Action: Secure all loose fixings

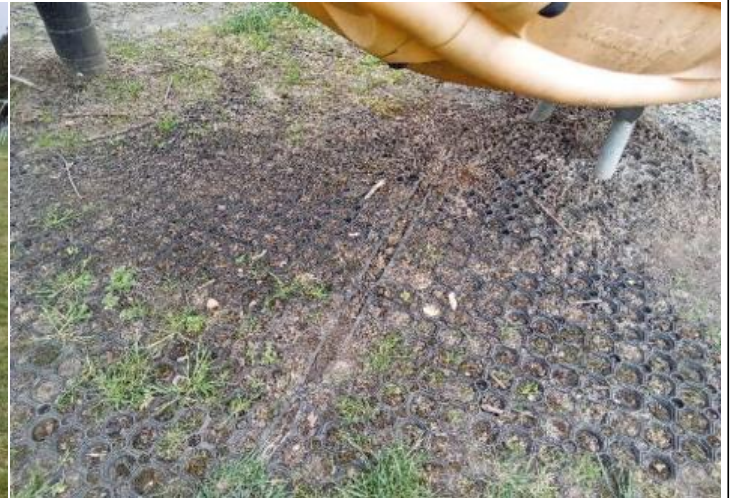
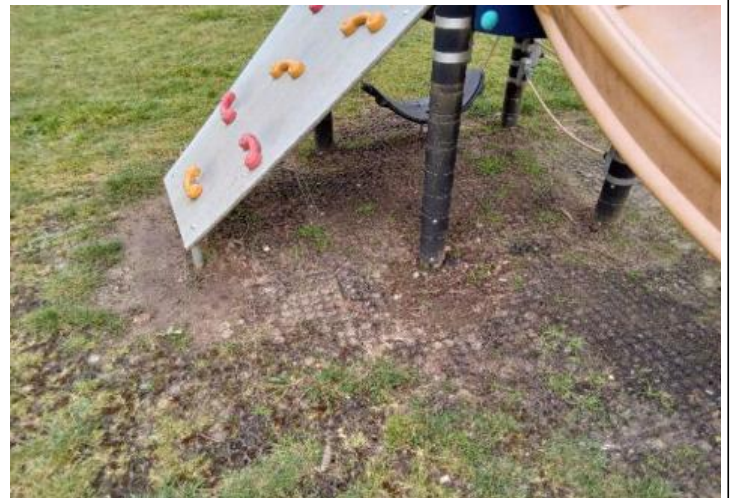
Item: Activity Equipment - Multi Play (Junior)
Manufacturer: Kompan Ltd

Finding: There are gaps opening between the grass mat tiles

Action: Provide additional ties or secure / reinstate surface

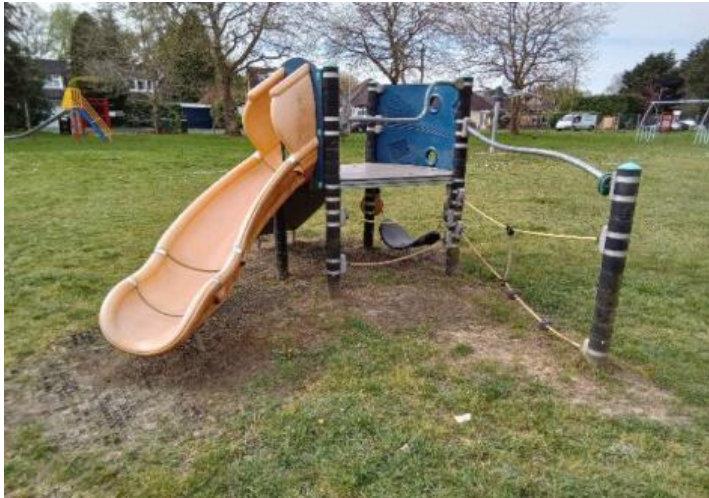
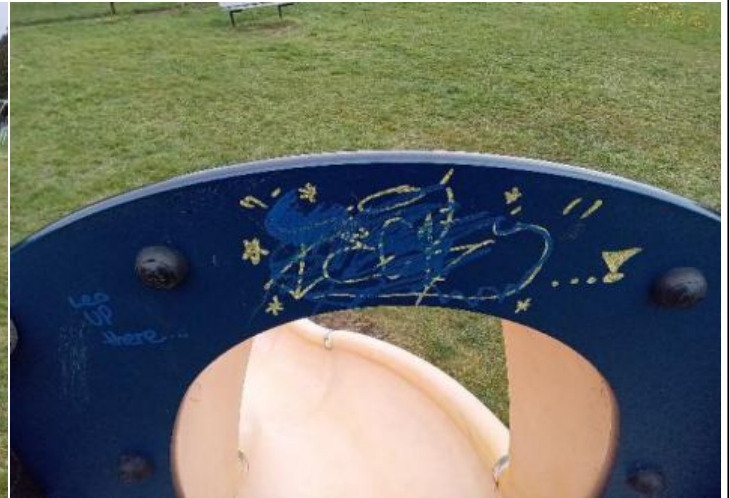
Item: Activity Equipment - Multi Play (Junior)
Manufacturer: Kompan Ltd

Finding: There is some graffiti present

Action: Remove the graffiti

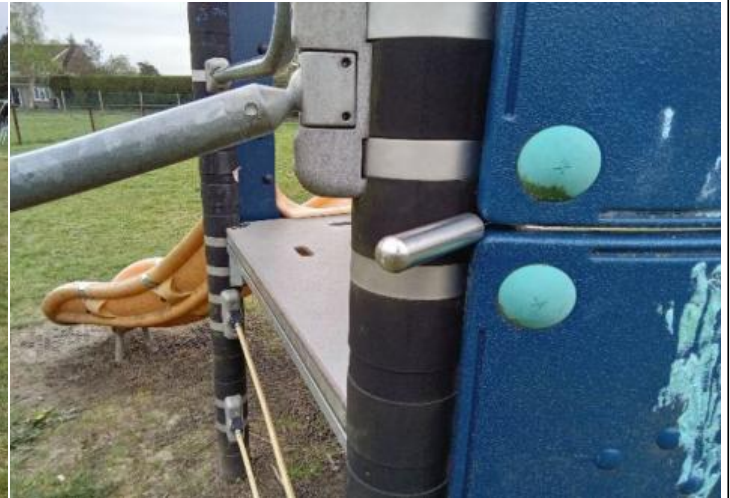
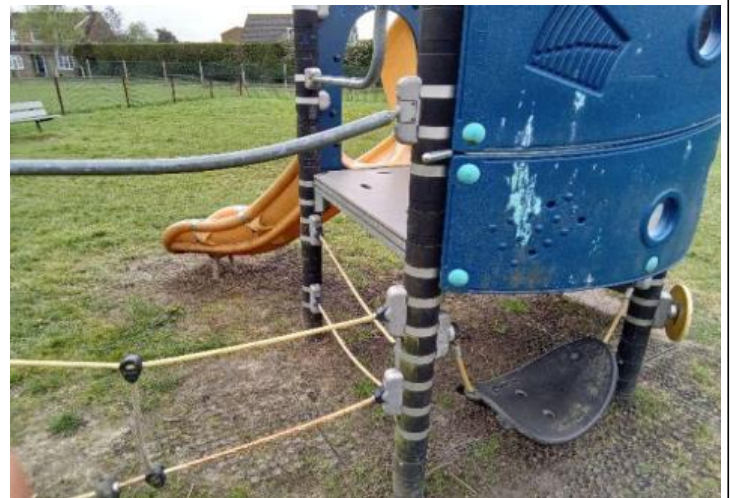
There is/are finger entrapment/s in the barrier next to access element and the item fails to meet the requirements of BS EN 1176 Part 1 4.2.7.6 Entrapment of fingers - Monitor - No remedial work recommended

Item: Activity Equipment - Multi Play (Junior)
Manufacturer: Kompan Ltd

Finding: There is/are finger entrapment/s in the barrier next to access element and the item fails to meet the requirements of BS EN 1176 Part 1 4.2.7.6 Entrapment of fingers
Action: Monitor - No remedial work recommended

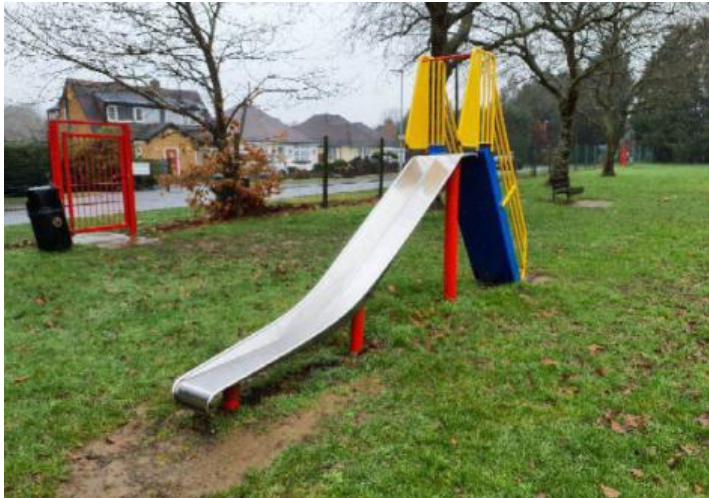
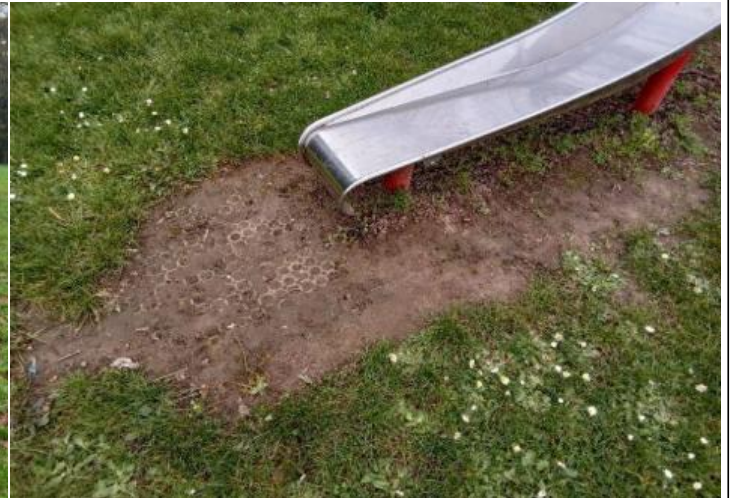
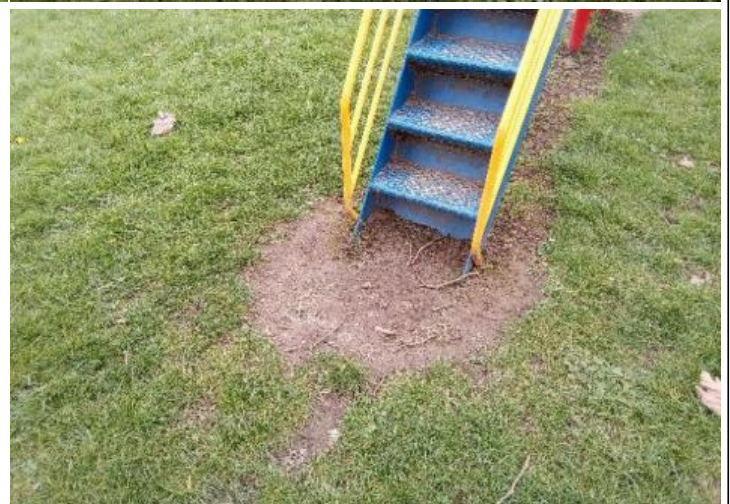
Item: Other - Free Standing Slide
Manufacturer: G L Jones Playgrounds Ltd

Risk Level: L - Low Risk
Surface: Grass Matrix Tiles

Finding: The grass mats are silted up, the soil is compacted and the area will become very slippery when the soil is wet. **Action:** Reinstate as required

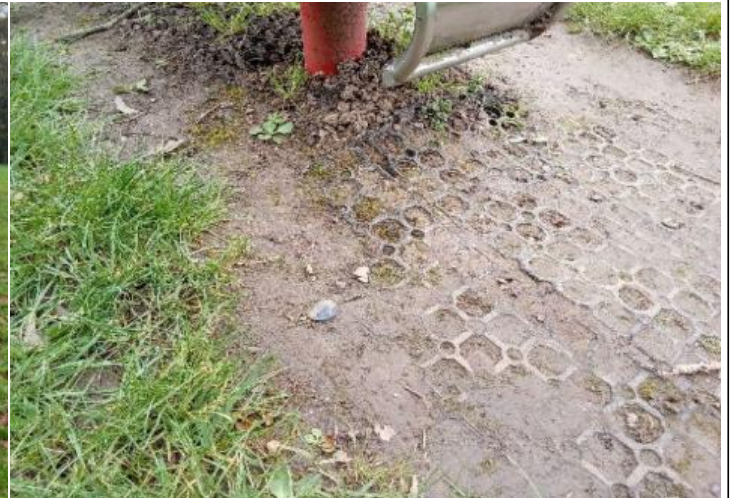
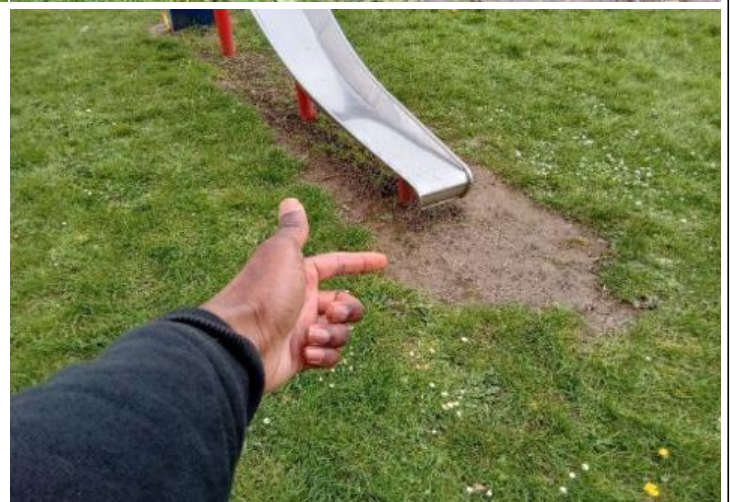
Item: Other - Free Standing Slide
Manufacturer: G L Jones Playgrounds Ltd

Risk Level: V - Very Low Risk
Surface: Grass Matrix Tiles

Finding: Fixing Pins have been installed in the impact areas of the grass mats
Action: Remove pins from impact areas

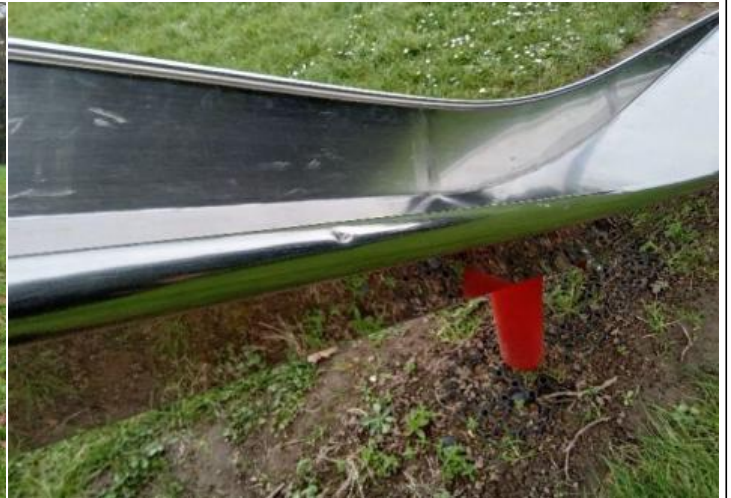
Item: Other - Free Standing Slide
Manufacturer: G L Jones Playgrounds Ltd

Risk Level: L - Low Risk
Surface: Grass Matrix Tiles

Finding: The side of the slide is damaged

Action: Monitor for any further deterioration and repair as required

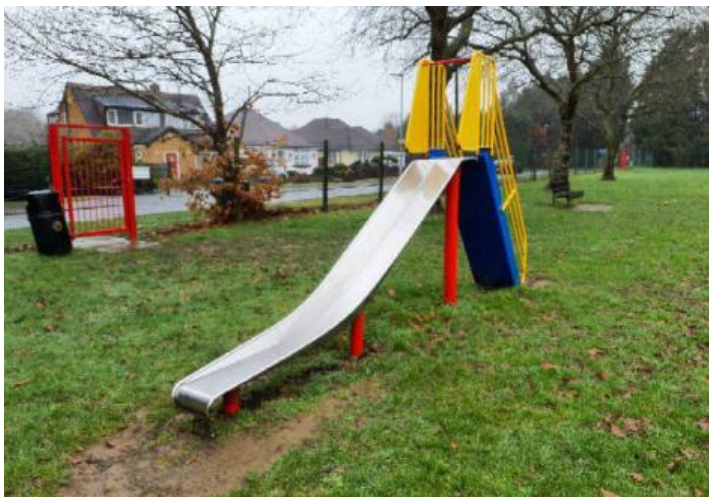
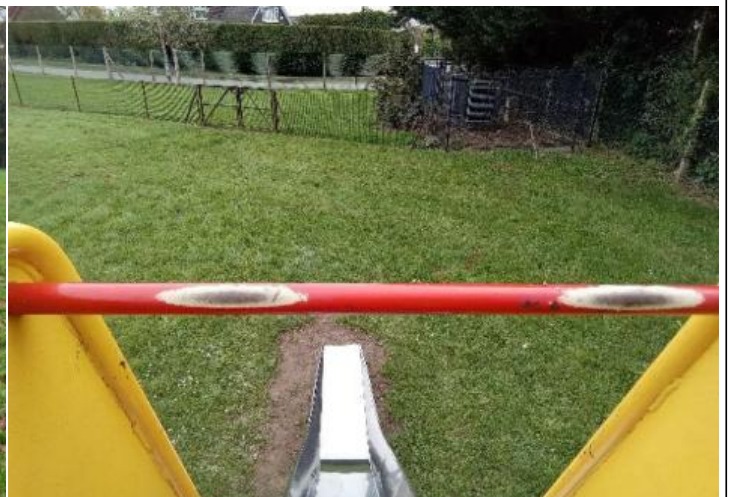
Item: Other - Free Standing Slide
Manufacturer: G L Jones Playgrounds Ltd

Risk Level: L - Low Risk
Surface: Grass Matrix Tiles

Finding: The paint is flaking off the metalwork

Action: Rub down and re-paint

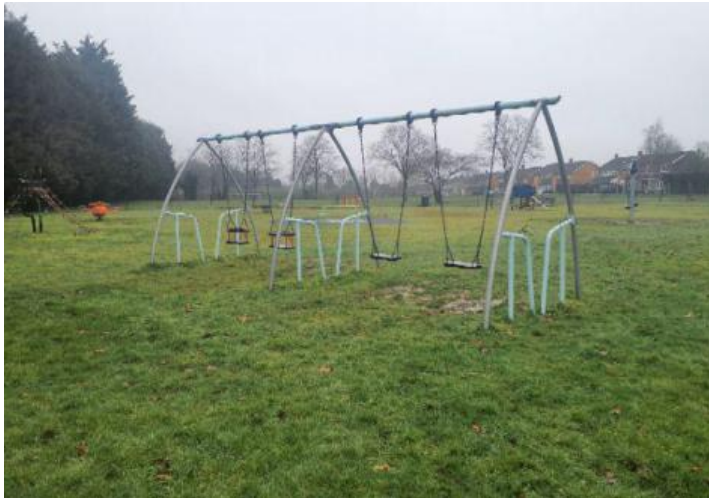
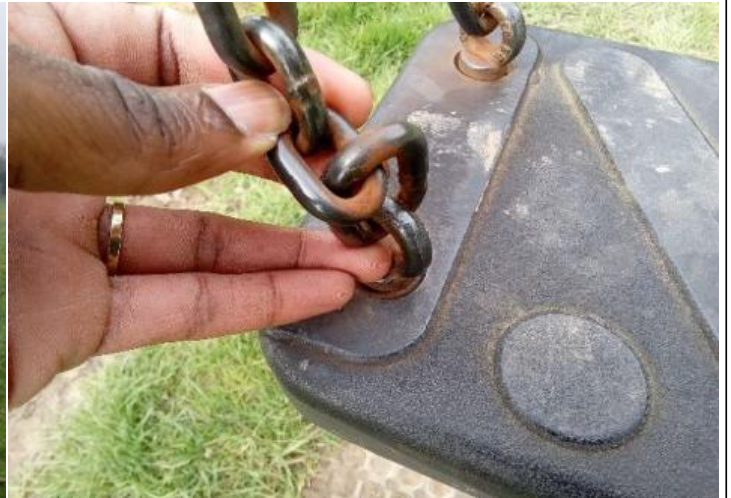
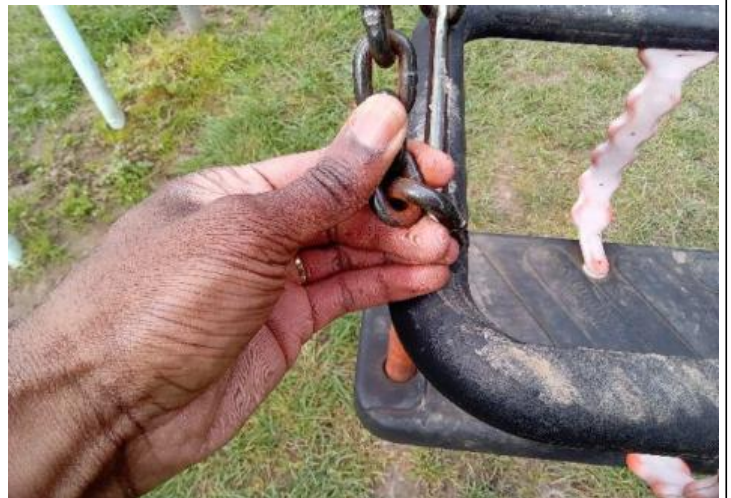
Item: Swings - 2 Bay (2 Flat, 2 Cradle)
Manufacturer: Record RSS

Risk Level: L - Low Risk
Surface: Grass Matrix Tiles

Finding: There is some notable evidence of chain wear

Action: Monitor for any further deterioration and replace when 40% worn

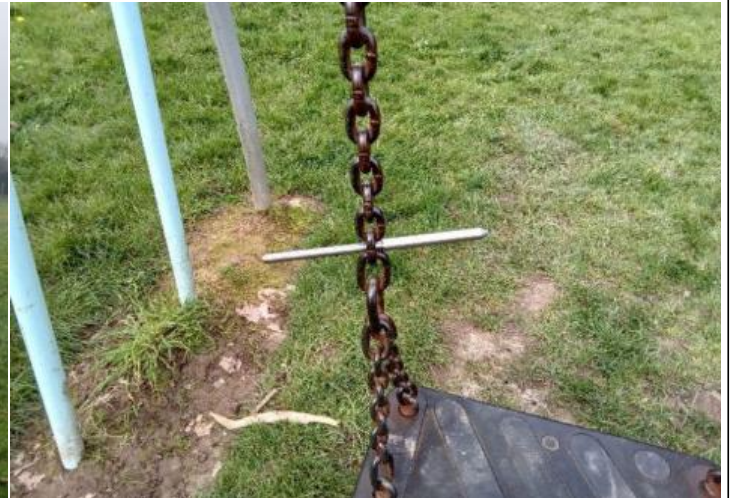
Item: Swings - 2 Bay (2 Flat, 2 Cradle)
Manufacturer: Record RSS

Risk Level: V - Very Low Risk
Surface: Grass Matrix Tiles

Finding: The chain openings are in excess of the 8.6mm as recommended by BS EN 1176 **Action:** Monitor - No remedial work recommended

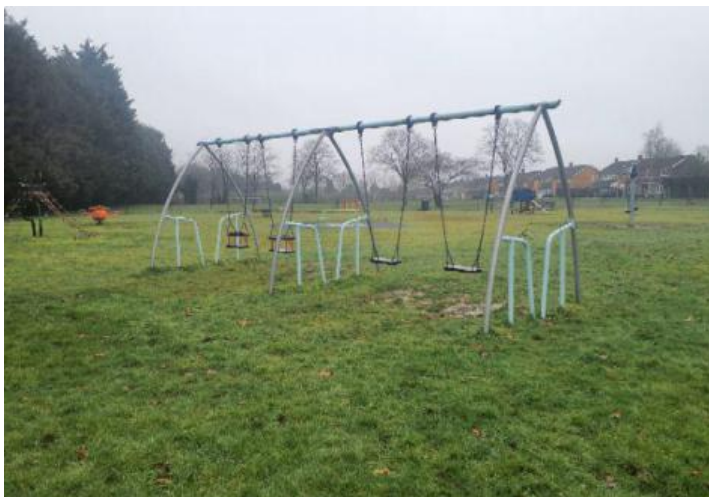
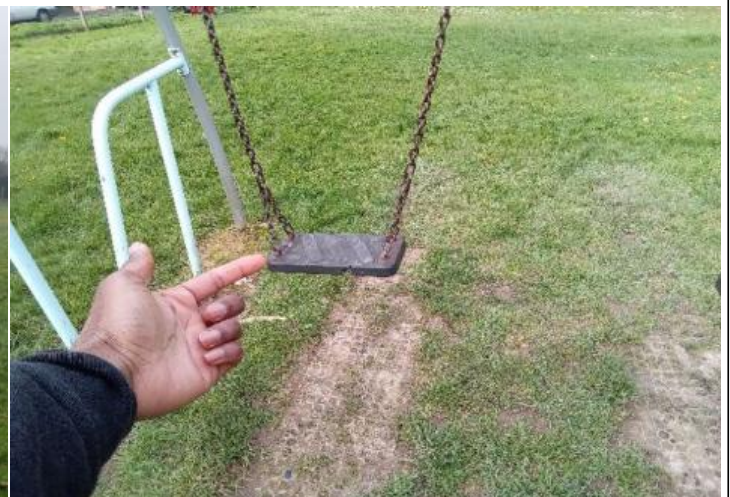
Item: Swings - 2 Bay (2 Flat, 2 Cradle)
Manufacturer: Record RSS

Risk Level: L - Low Risk
Surface: Grass Matrix Tiles

Finding: The swing seat connectors are loose **Action:** Tighten to secure

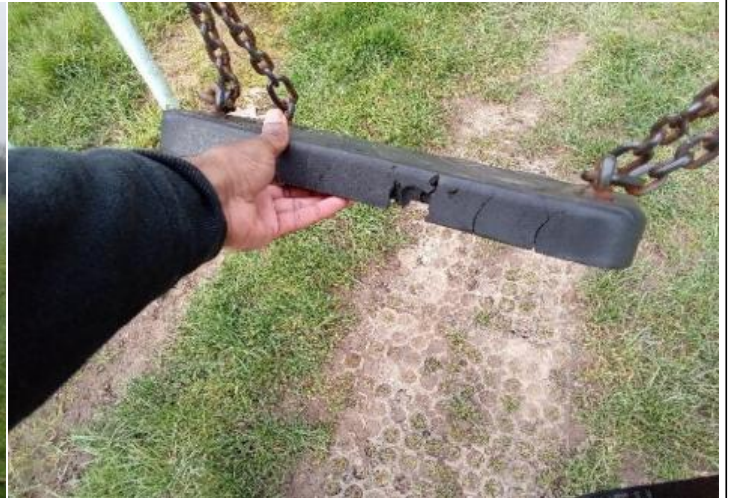
Item: Swings - 2 Bay (2 Flat, 2 Cradle)
Manufacturer: Record RSS

Risk Level: L - Low Risk
Surface: Grass Matrix Tiles

Finding: The seat has minor damage or wear

Action: Monitor for any further deterioration and replace as required

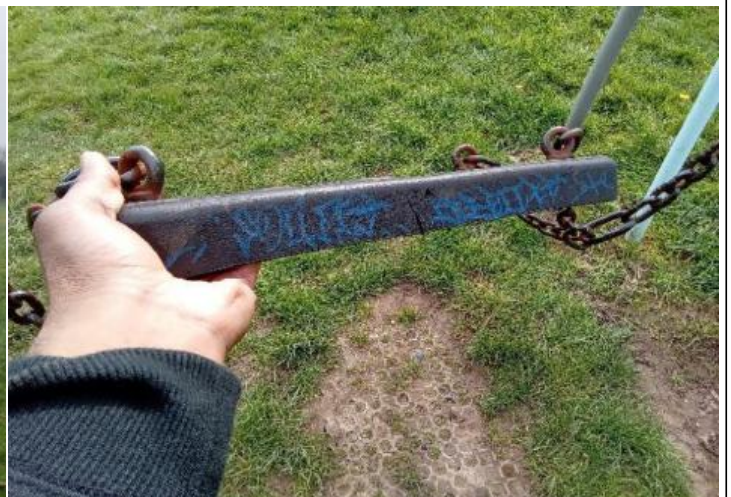
Item: Swings - 2 Bay (2 Flat, 2 Cradle)
Manufacturer: Record RSS

Risk Level: N - Risk Assessment not Undertaken
Surface: Grass Matrix Tiles

Finding: There is some graffiti present

Action: Remove the graffiti

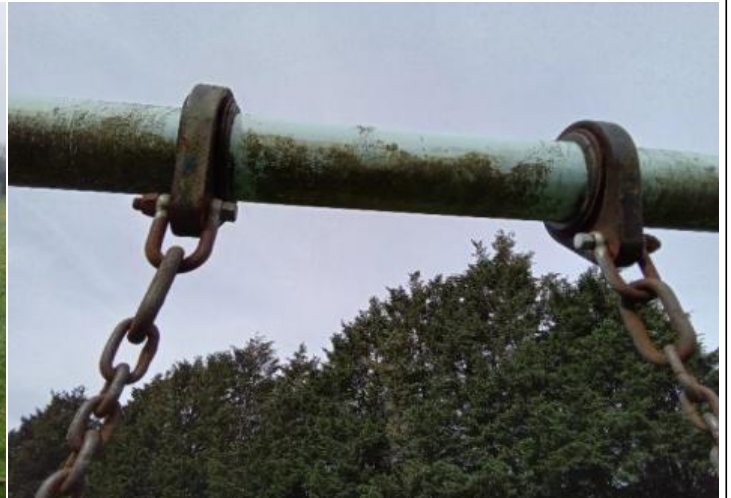
Item: Swings - 2 Bay (2 Flat, 2 Cradle)
Manufacturer: Record RSS

Risk Level: L - Low Risk
Surface: Grass Matrix Tiles

Finding: There is some wear to the shackles.

Action: Monitor for any further deterioration and replace when 40% worn

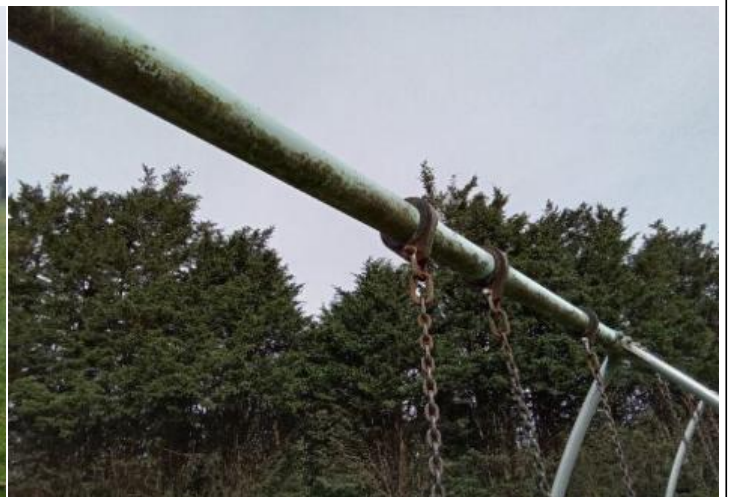
Item: Swings - 2 Bay (2 Flat, 2 Cradle)
Manufacturer: Record RSS

Risk Level: L - Low Risk
Surface: Grass Matrix Tiles

Finding: There is algae or moss on the surface of the equipment

Action: Clean and treat appropriately
