ST STEPHEN PARISH COUNCIL

You are summoned to the Fixed Assets Committee meeting
To take place on **Thursday 30 May 2024 at 7.30pm**
at St Stephen Suite, Parish Centre, Station Road, Bricket Wood, AL2 3PJ

- 2425/AC/07 To receive Annual Play Inspection Report and Grounds Team Action Report. Play Reports and Grounds Team Report attached.**
- 2425/AC/08 To discuss the option of creating additional allotment plots and possible beginner plots at Watford Road allotment site or North Close. Allotment report attached.**

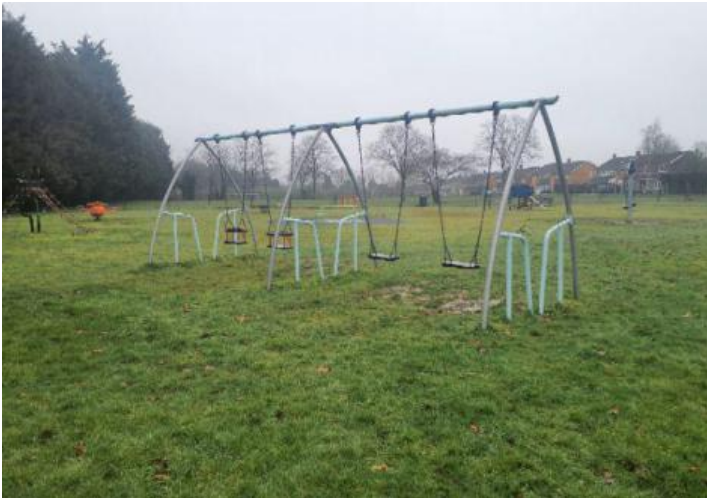
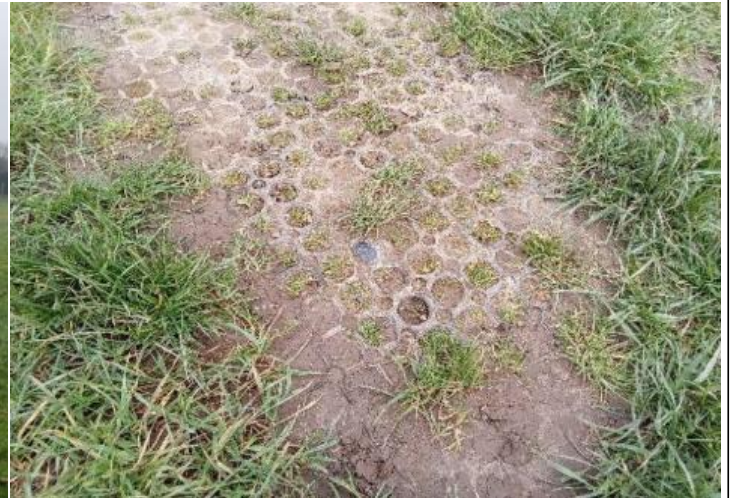
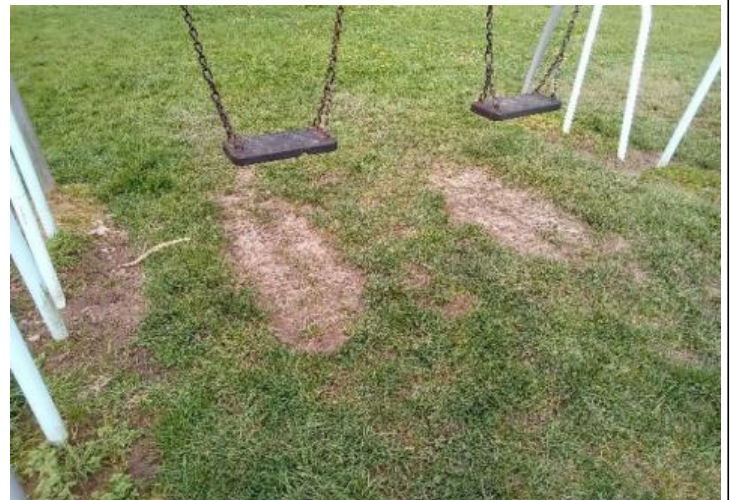
Item: Swings - 2 Bay (2 Flat, 2 Cradle)
Manufacturer: Record RSS

Risk Level: L - Low Risk
Surface: Grass Matrix Tiles

Finding: Fixing Pins have been installed in the impact areas **Action:** Remove pins from impact areas of the grass mats

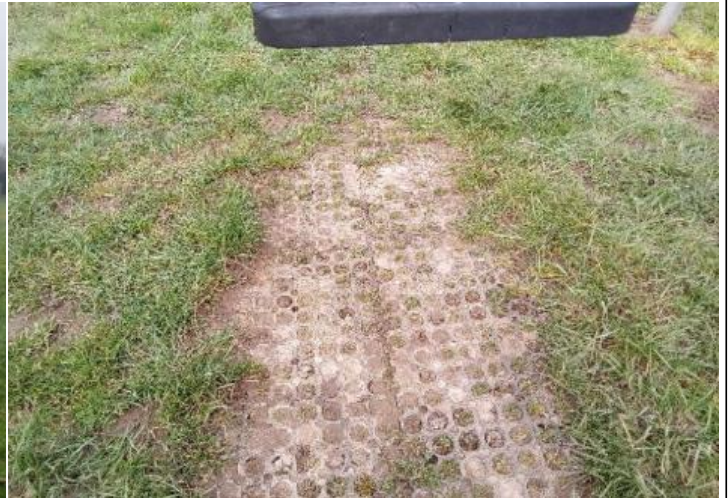
Item: Swings - 2 Bay (2 Flat, 2 Cradle)
Manufacturer: Record RSS

Risk Level: L - Low Risk
Surface: Grass Matrix Tiles

Finding: There are gaps opening between the grass mat tiles

Action: Provide additional ties or secure / reinstate surface

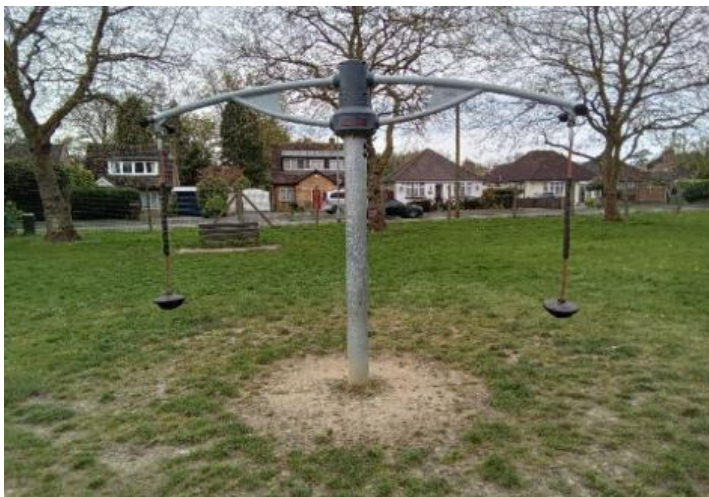
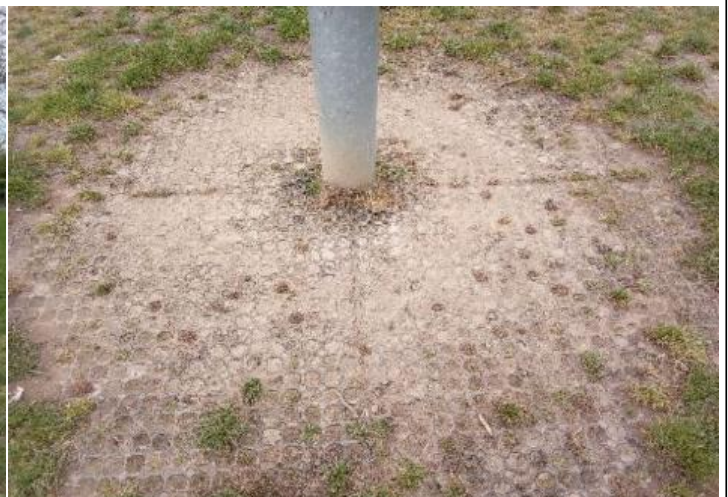
Item: Rotor Play - Overhead Rotator
Manufacturer: Kompan Ltd

Risk Level: L - Low Risk
Surface: Grass Matrix Tiles

Finding: The grass mats are silted up, the soil is compacted and the area will become very slippery when the soil is wet.

Action: Reinstate as required

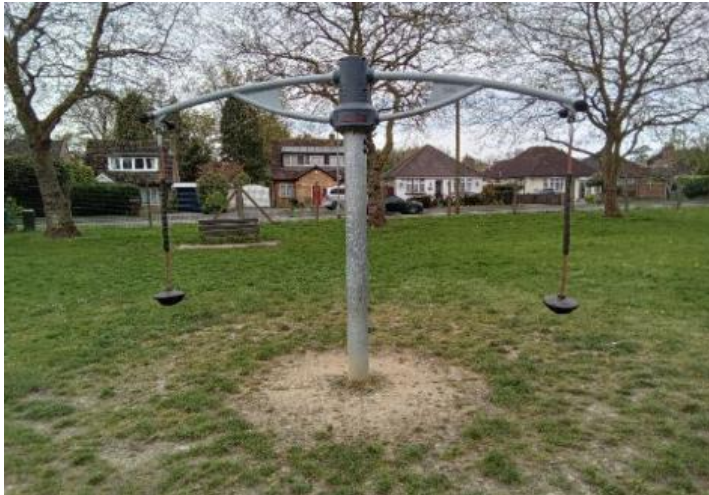
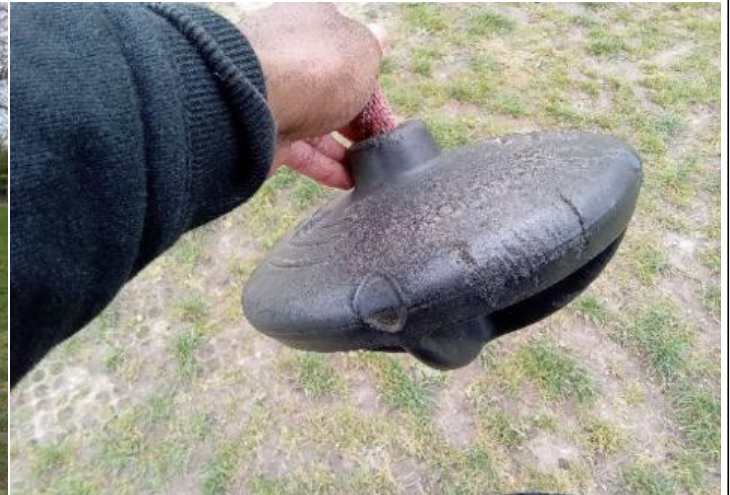
Item: Rotor Play - Overhead Rotator
Manufacturer: Kompan Ltd

Risk Level: L - Low Risk
Surface: Grass Matrix Tiles

Finding: The seat has been damaged

Action: Monitor for any further deterioration and replace as required

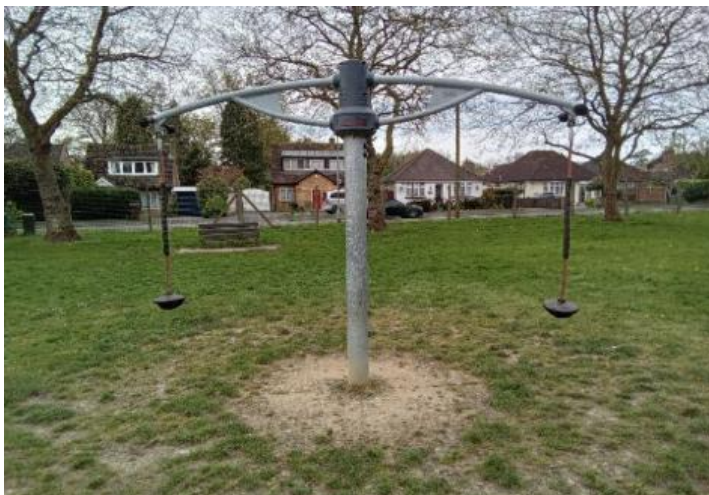
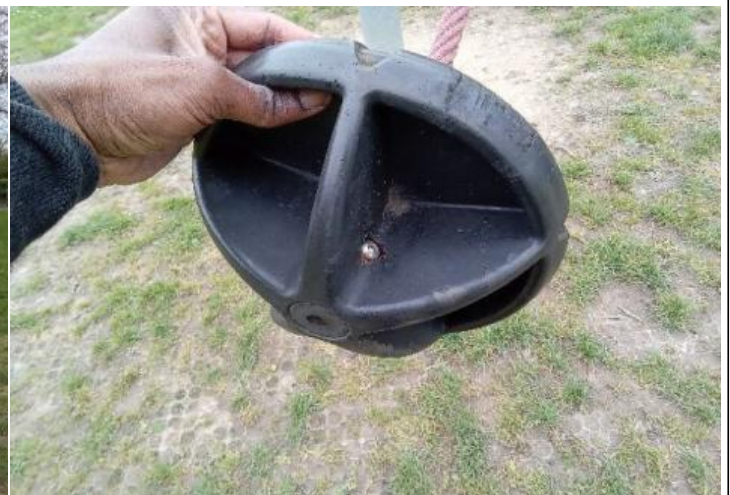
Item: Rotor Play - Overhead Rotator
Manufacturer: Kompan Ltd

Risk Level: N - Risk Assessment not Undertaken
Surface: Grass Matrix Tiles

Finding: The seat connection cannot be inspected without dismantling the seat

Action: Dismantle the seat to inspect the seat connection for wear

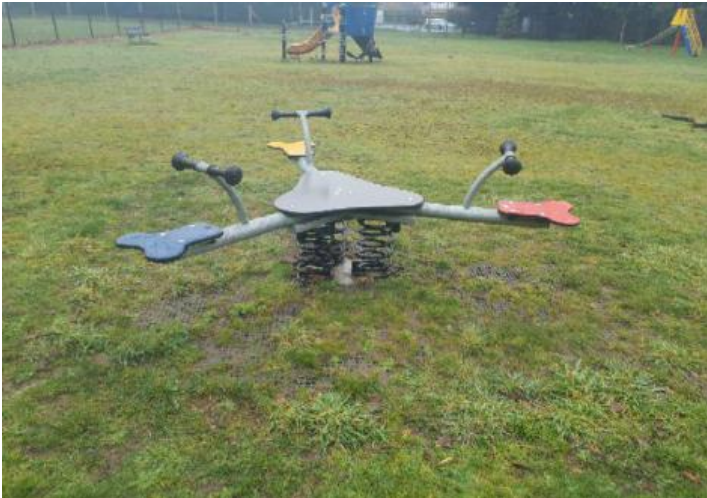
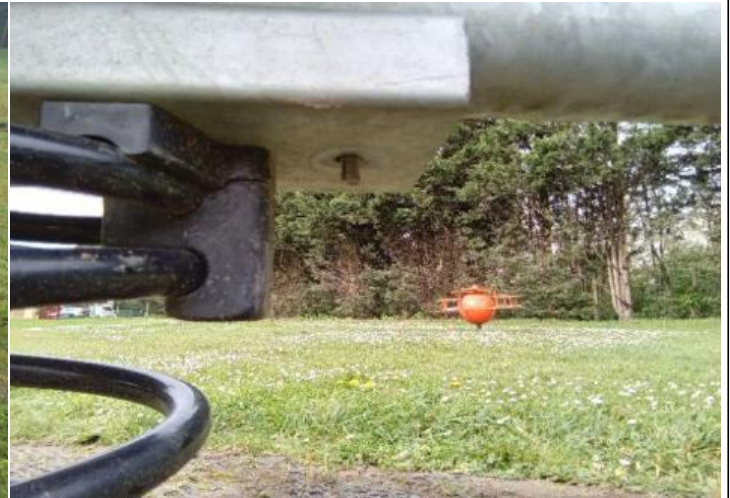
Item: Rocking Equipment - Three Way Springer
Manufacturer: Kompan Ltd

Risk Level: L - Low Risk
Surface: Grass Matrix Tiles

Finding: There is or are fixings missing on the item

Action: Replace all missing fixings

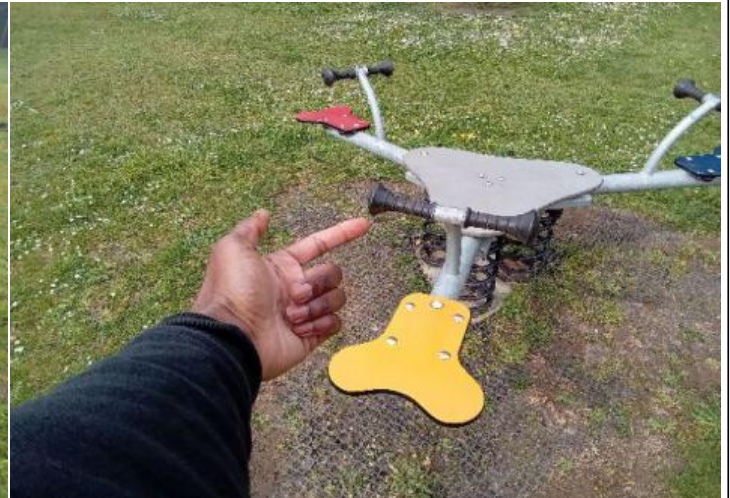
Item: Rocking Equipment - Three Way Springer
Manufacturer: Kompan Ltd

Risk Level: L - Low Risk
Surface: Grass Matrix Tiles

Finding: The Handgrips/Footrests rotate and may cause an unexpected movement for the user
Action: Secure Handgrips/Footrests to prevent rotation.

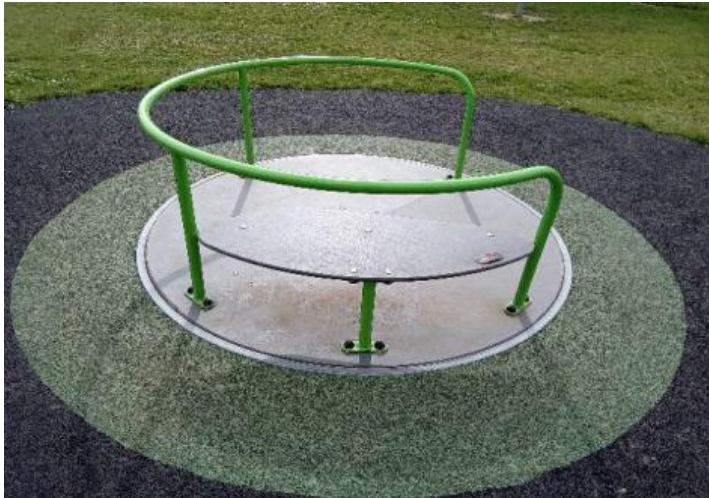
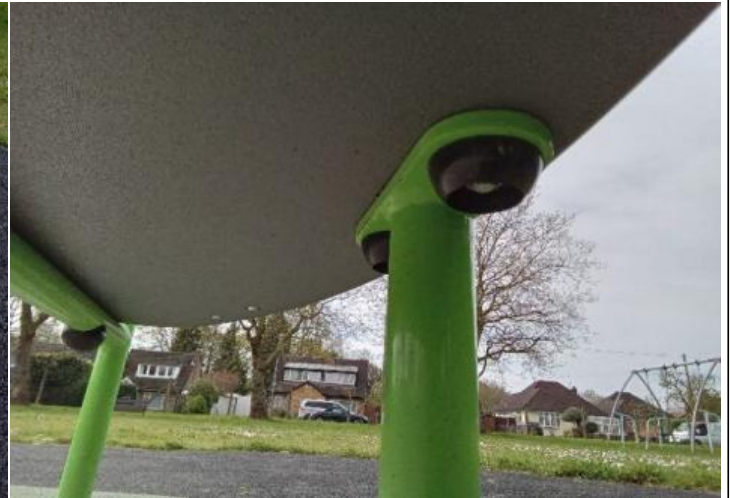
Item: Rotor Play - Inclusive Roundabout
Manufacturer: Kompan Ltd

Risk Level: V - Very Low Risk
Surface: Wet Pour

Finding: There is/are bolt cap covers missing or damaged on the item

Action: Replace missing or damaged bolt cap covers

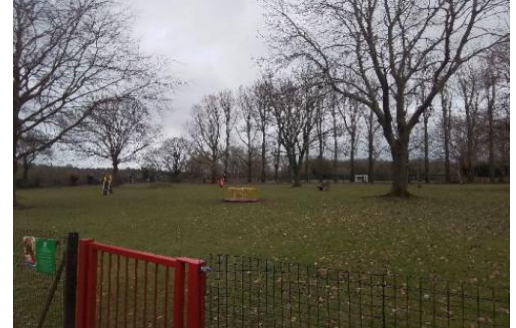
Item: Site General
Manufacturer: Owner/Operator
Surface Type: N/A
Item Quantity: 1
Equipment Compliance: N/A
Surface Area Compliance: N/A

The signage is damaged or missing - Replace signage

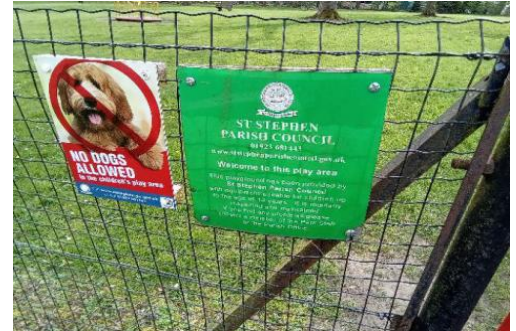
Item: Sign
Manufacturer: Owner/Operator
Surface Type: N/A
Item Quantity: 1
Equipment Compliance: N/A
Surface Area Compliance: N/A

BS EN 1176 Part 7 recommends that signage shall include the site name / address - Provide additional information

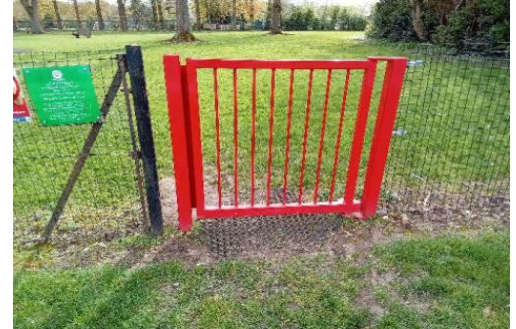
Item: Gate - Self Closing
Manufacturer: Not Identified
Surface Type: Grass Matrix Tiles
Item Quantity: 1
Equipment Compliance: N/A
Surface Area Compliance: N/A

There are trip hazards caused by the grass matrix tiles at the edges of the surface - Adjust grass matrix tile and reinstaate surrounding surface levels to remove the trip points

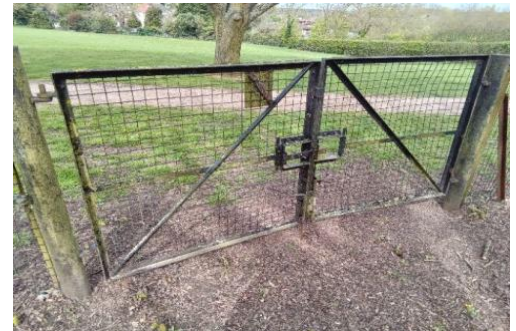
Item: Gate - Maintenance
Manufacturer: Not Identified
Surface Type: Grass
Item Quantity: 1
Equipment Compliance: N/A
Surface Area Compliance: N/A

The paintwork on this item has been damaged or worn exposing the metal underneath which is rusting / corroding - Treat affected areas and repaint

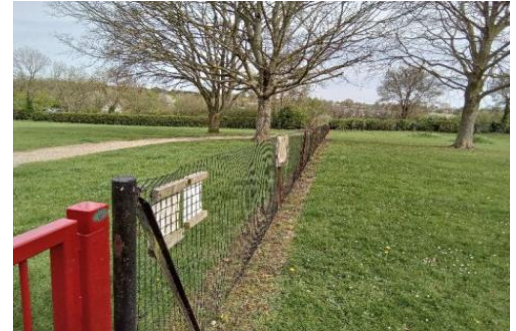
Item: Fence - Steel Mesh
Manufacturer: Not Identified
Surface Type: Grass
Item Quantity: 1
Equipment Compliance: N/A
Surface Area Compliance: N/A

Cable ties have been used on the item and there are sharp projecting ends - Remove if not required or replace with a more appropriate alternative fixing method if used as a fixing

There are a number of loose posts around the fence - Monitor for any further deterioration and reset as required

The paintwork on this item has been damaged or worn exposing the metal underneath which is rusting / corroding - Treat affected areas and repaint

There is some damage to the fence sections - Monitor for any further deterioration and repair as required

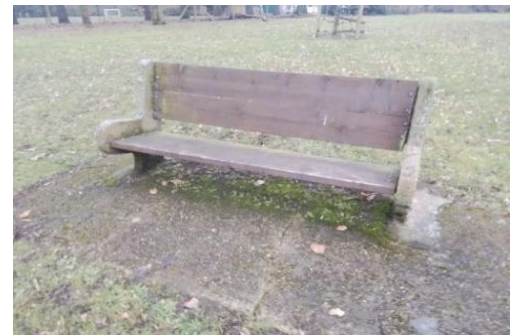
Item: Bench
Manufacturer: Not Identified
Surface Type: Concrete
Item Quantity: 3
Equipment Compliance: N/A
Surface Area Compliance: N/A

There is algae, silt or moss growth on the surface resulting in slippery conditions - Clean and treat appropriately

There is some minor damage to the surface - Monitor for any further deterioration and repair as required

There are areas or parts of the timber on the structure that have rotted - Replace all affected timbers

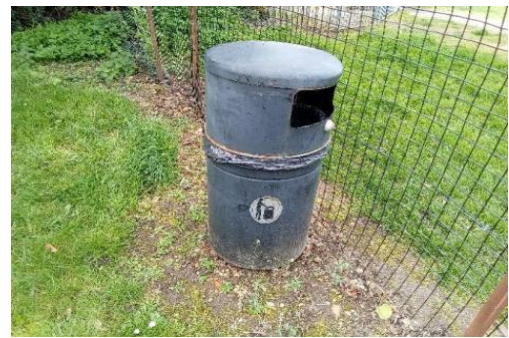
Item: Litter Bin
Manufacturer: Not Identified
Surface Type: Grass
Item Quantity: 1
Equipment Compliance: N/A
Surface Area Compliance: N/A

The lid or door of the litter bin is not secured - Ensure the lid or door is kept locked</p> <p>Finding 3
 There is some damage to the item - Monitor for any further deterioration and repair as required</p> | <p>Finding 2
 The bin is not securely fixed to the surface and there is some possibility of the item tipping or rolling over - Secure the bin to the ground</p> <p>Finding 4
 The paintwork on this item has been damaged or worn exposing the metal underneath which is rusting / corroding - Treat affected areas and repaint</p> |

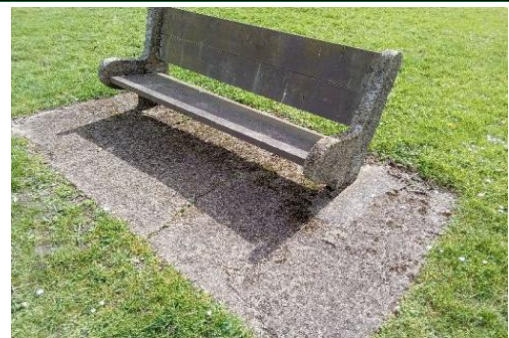
Item: Bench
Manufacturer: Not Identified
Surface Type: N/A
Item Quantity: 1
Equipment Compliance: N/A
Surface Area Compliance: N/A

There is algae, silt or moss growth on the surface resulting in slippery conditions - Clean and treat appropriately</p> <p>Finding 3
 There is some minor damage to the surface - Monitor for any further deterioration and repair as required</p> | <p>Finding 2
 There are trip hazards at the edges of the surface - Reinstate surrounding surface levels to remove the trip points</p> |

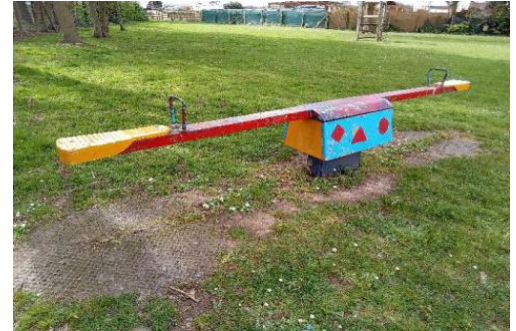
Item: See Saw
Manufacturer: Wicksteed Playgrounds
Surface Type: Grass Matrix Tiles
Item Quantity: 1
Equipment Compliance: No
Surface Area Compliance: Yes
Life Expectancy: 5 -10 Years
Total Findings: 8

The surface has subsided in some areas - Monitor for any further deterioration and repair as required

The surface has eroded in some areas and may be slippery in wet conditions - Reinstate the surface

The item fails to meet the requirements of BS EN 1176 Part 1 4.2.7.2 for head and neck entrapment in the see saw handles - Monitor - No remedial work recommended

There is no gaiter protection for accessible moving parts (possible shear trap) as recommended in BS EN 1176 Part 1; 4.2.6 Moving Parts - Monitor - No remedial work recommended

There is some minor damage to the surface - Monitor for any further deterioration and repair as required

The seat has been damaged - Monitor for any further deterioration and replace as required

There is surface corrosion / rust present on the item - Consider treating the item

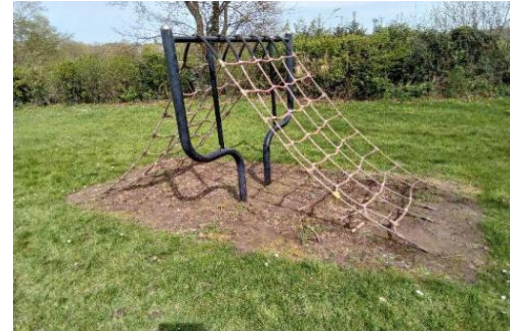
Item: Net Climber
Manufacturer: Wicksteed Playgrounds
Surface Type: Grass Matrix Tiles
Item Quantity: 1
Equipment Compliance: No
Surface Area Compliance: Yes
Life Expectancy: 5 -10 Years
Total Findings: 2

The rope has worn and wire strands are exposed - Replace rope or net

The chain/rope covering is damaged - Monitor for any further deterioration and replace as required

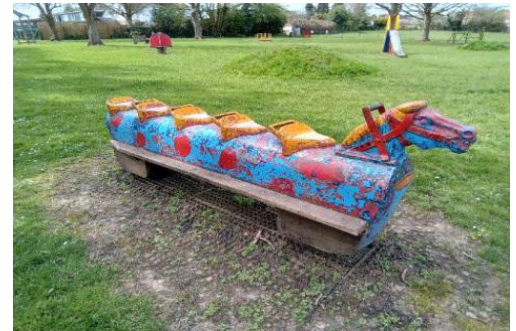
Item: Rocking Horse
Manufacturer: Wicksteed Playgrounds
Surface Type: Grass Matrix Tiles
Item Quantity: 1
Equipment Compliance: No
Surface Area Compliance: Yes
Life Expectancy: 5 -10 Years
Total Findings: 5

There is some damage to the seat - Monitor for any further deterioration and repair as required

There are areas or parts of the timber on the structure that have rotted - Replace all affected timbers

The paintwork on this item has been damaged or worn exposing the metal underneath which is rusting / corroding - Treat affected areas and repaint

There is no gaiter protection for accessible moving parts (possible shear trap) as recommended in BS EN 1176 Part 1; 4.2.6 Moving Parts - Monitor - No remedial work recommended

There is/are finger entrapment/s in the rocking horse frame and the item fails to meet the requirements of BS EN 1176 Part 1 4.2.7.6 Entrapment of fingers - Remove the entrapment

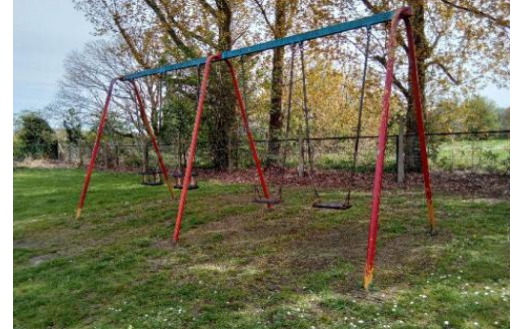
Item: 2 Bay (2 Flat, 2 Cradle)
Manufacturer: S M P (Playgrounds Ltd)
Surface Type: Grass Matrix Tiles
Item Quantity: 1
Equipment Compliance: No
Surface Area Compliance: Yes
Life Expectancy: 5 -10 Years
Total Findings: 10

There is some wear to the shackles. - Monitor for any further deterioration and replace when 40% worn

The fixings or components for this item were in excess of 2.5m above the standing surface and could not be fully accessed by the inspector. We have completed a visual inspection of the fixings from ground level but a maintenance inspection should be undertaken to assess the condition, security and wear of the components at intervals in accordance with the manufacturers recommendations. - Inspect in accordance with the manufacturers recommendations

There is some notable evidence of chain wear - Monitor for any further deterioration and replace when 40% worn

The chain openings are in excess of the 8.6mm as recommended by BS EN 1176 - Monitor - No remedial work recommended

The seat has minor damage or wear - Monitor for any further deterioration and replace as required

There are caps missing from the underside of the seats - Replace missing caps under the seats

The seats are too close to each other as defined in BS EN 1176 Part 2; this is a low risk failure and no remedial action is required - Monitor - No remedial work recommended

The seats are too close to the frame as defined in BS EN 1176 Part 2; this is a low risk failure and no remedial action is required - Monitor - No remedial work recommended

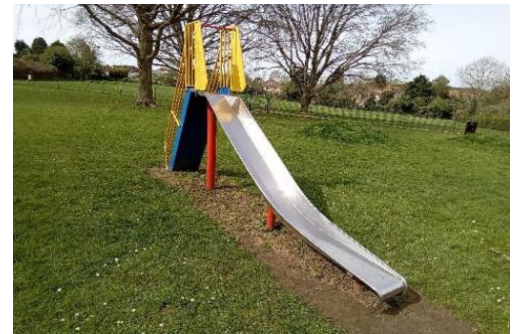
Item: Free Standing Slide
Manufacturer: G L Jones Playgrounds Ltd
Surface Type: Grass Matrix Tiles
Item Quantity: 1
Equipment Compliance: Yes
Surface Area Compliance: Yes
Life Expectancy: >10 Years
Total Findings: 3

There are a number of dents in the slide surface - Monitor for any further deterioration and repair as required

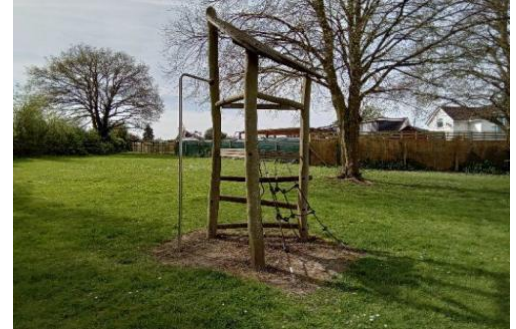
Item: Multi Play (Junior)
Manufacturer: Kompan Ltd
Surface Type: Grass Matrix Tiles
Item Quantity: 1
Equipment Compliance: Yes
Surface Area Compliance: Yes

The item is slightly loose in its foundations - Monitor for any further deterioration and repair as required

The chain openings are in excess of the 8.6mm as recommended by BS EN 1176 - Monitor - No remedial work recommended

The timber has a number of splits/shakes or air cracks and this may affect the stability or allow water ingress which will accelerate the rotting process - Monitor to ensure the splits do not cross through fixing points of the structure and/or cause any instability

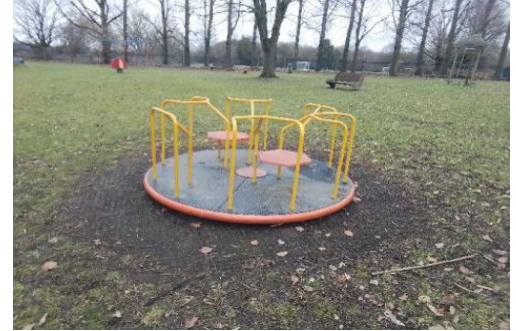
Item: Roundabout
Manufacturer: Wicksteed Playgrounds
Surface Type: Grass Matrix Tiles
Item Quantity: 1
Equipment Compliance: No
Surface Area Compliance: Yes
Life Expectancy: >10 Years
Total Findings: 3

There are gaps opening between the grass mat tiles -
 Provide additional ties or secure / reinstate surface

The distance between the underside of the roundabout platform and the playing surface is less than 60mm and contravenes the requirements of BS EN 1176 Part 5 which requires that the distance be maintained between 60mm-110mm for the entire circumference of the roundabout - Monitor - No remedial work recommended

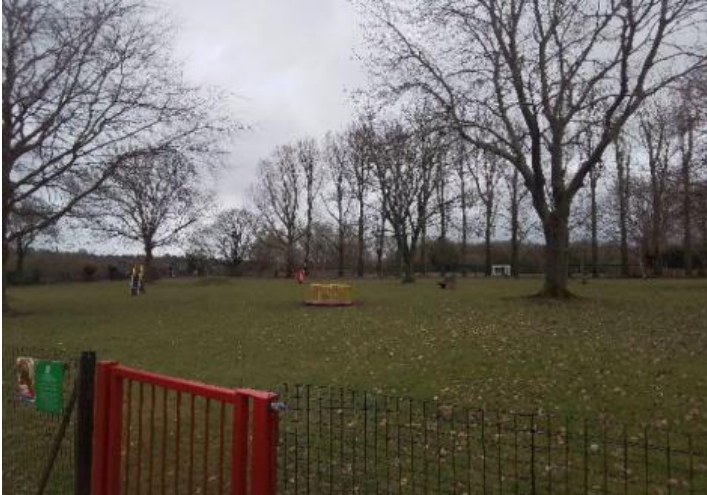
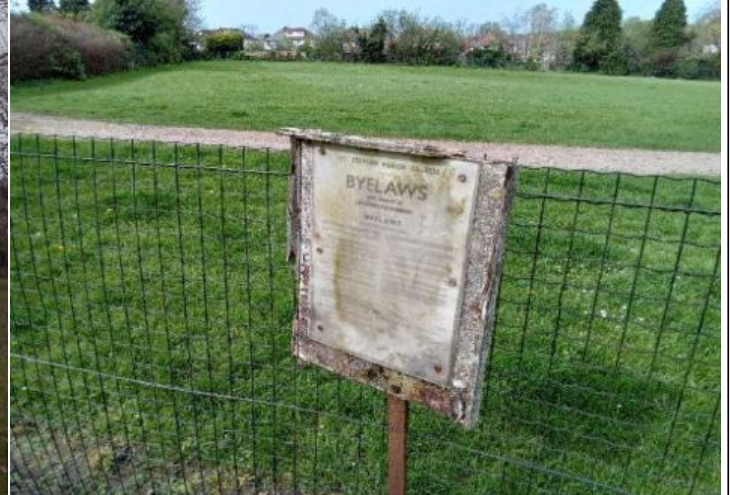
Item: Ancillary Items - Site General
Manufacturer: Owner/Operator

Finding: The signage is damaged or missing

Action: Replace signage

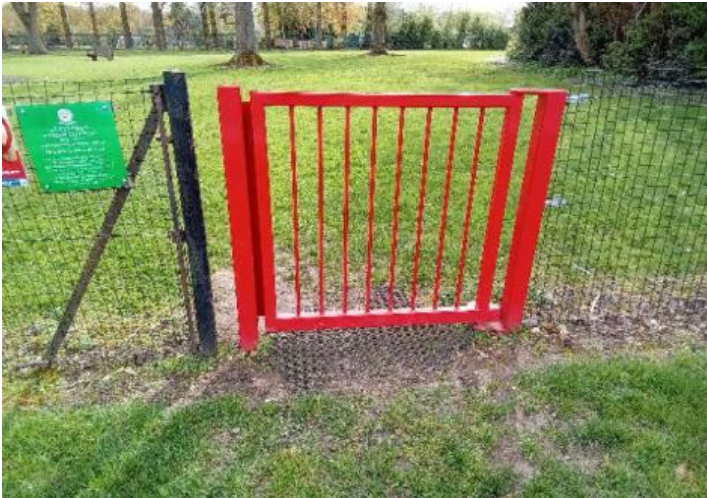
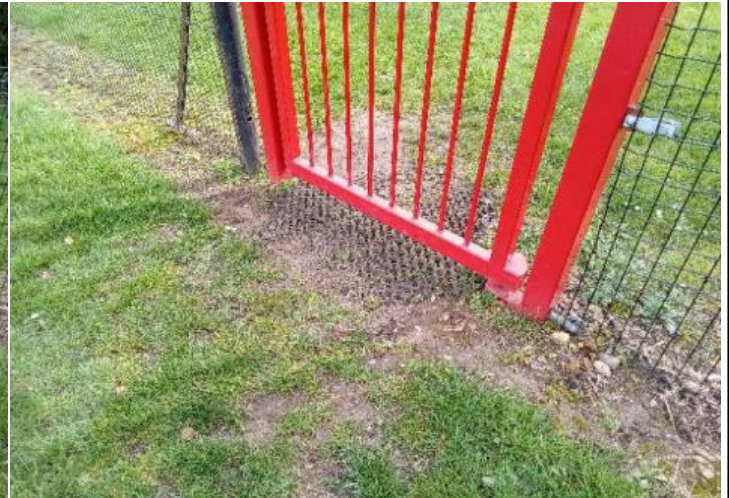
Item: Gates - Gate - Self Closing
Manufacturer: Not Identified

Finding: There are trip hazards caused by the grass matrix tiles at the edges of the surface

Action: Adjust grass matrix tile and reinstate surrounding surface levels to remove the trip points

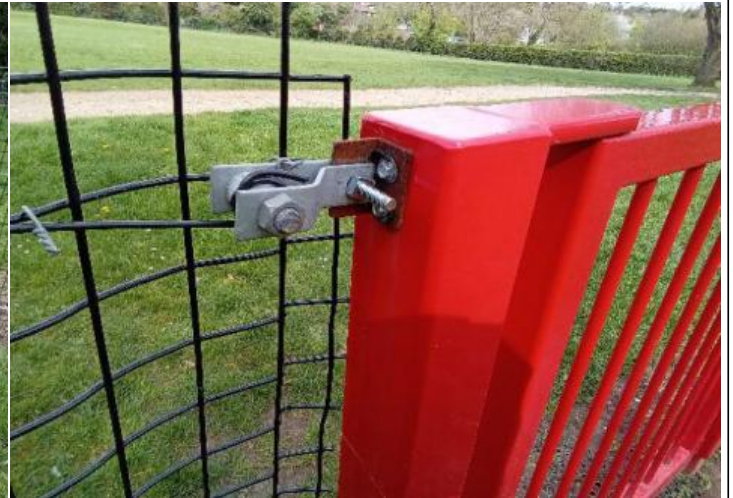
Item: Gates - Gate - Self Closing
Manufacturer: Not Identified

Finding: There are projecting bolt thread(s) present

Action: Remove excess thread length and deburr or provide cap

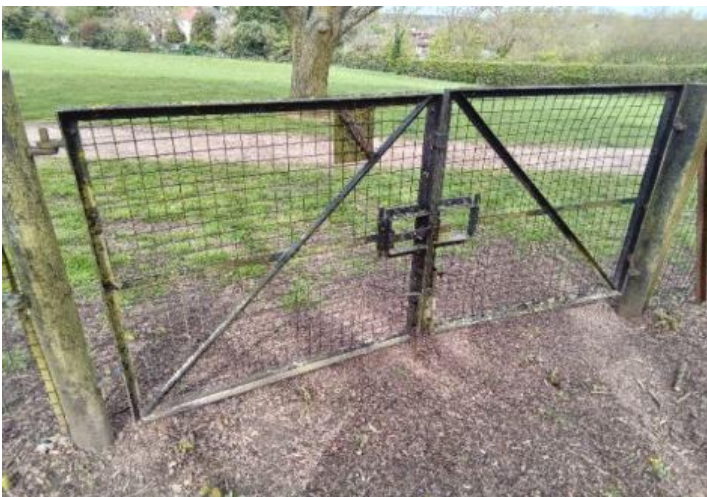
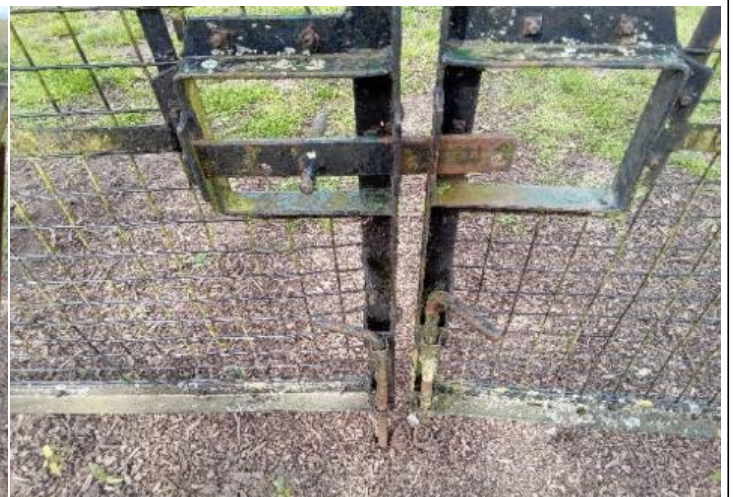
Item: Gates - Gate - Maintenance
Manufacturer: Not Identified

Finding: There is no padlock on the maintenance gate

Action: Provide a padlock to secure the gate

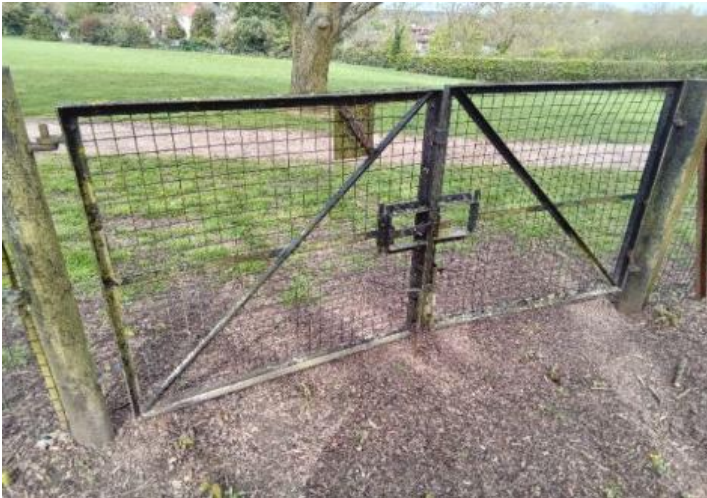
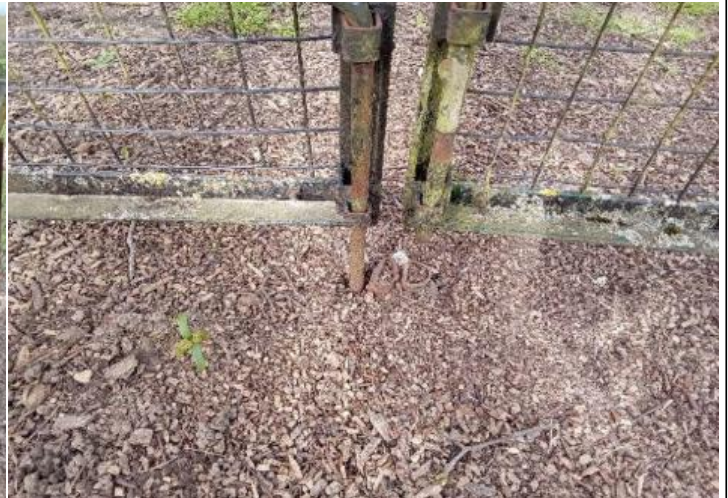
Item: Gates - Gate - Maintenance
Manufacturer: Not Identified

Finding: The gate has no drop bolt sleeves and/or drop bolts fitted

Action: Provide drop bolt sleeves and/or drop bolts

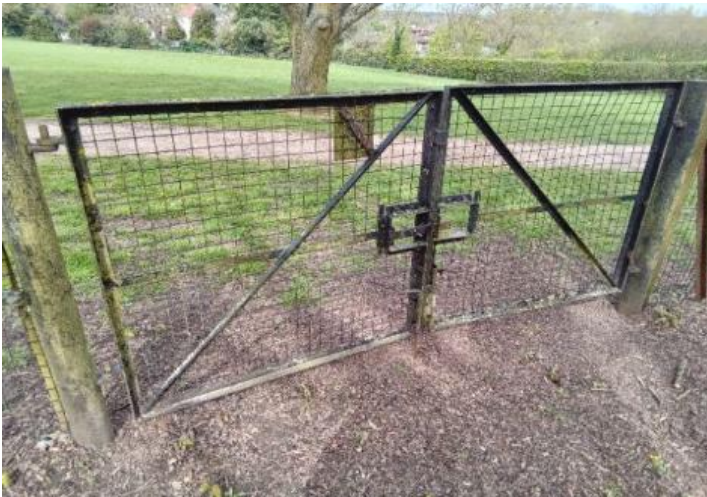
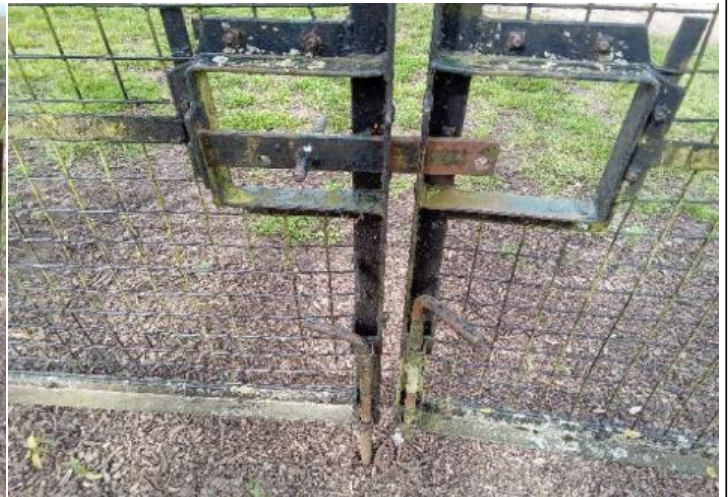
Item: Gates - Gate - Maintenance
Manufacturer: Not Identified

Finding: The paintwork on this item has been damaged or worn exposing the metal underneath which is rusting / corroding

Action: Treat affected areas and repaint

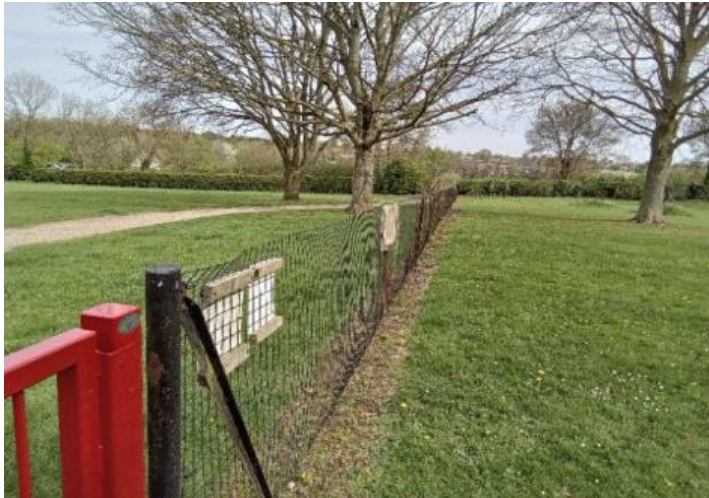
Item: Fences - Fence - Steel Mesh
Manufacturer: Not Identified

Finding: Cable ties have been used on the item and there are sharp projecting ends

Action: Remove if not required or replace with a more appropriate alternative fixing method if used as a fixing

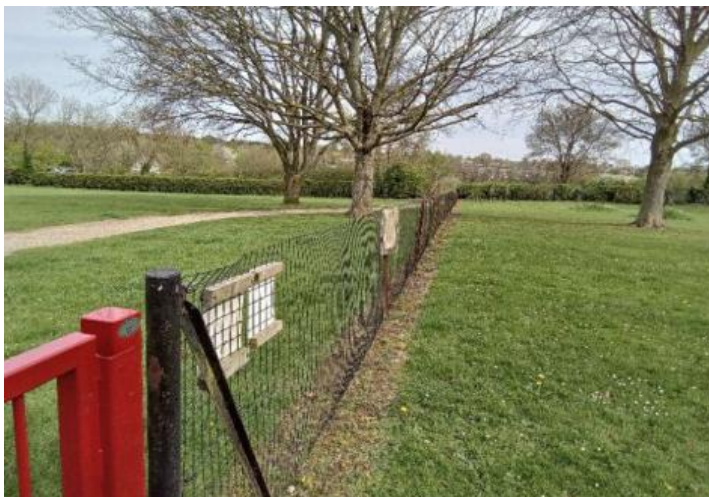
Item: Fences - Fence - Steel Mesh
Manufacturer: Not Identified

Finding: There are a number of loose posts around the fence

Action: Monitor for any further deterioration and reset as required

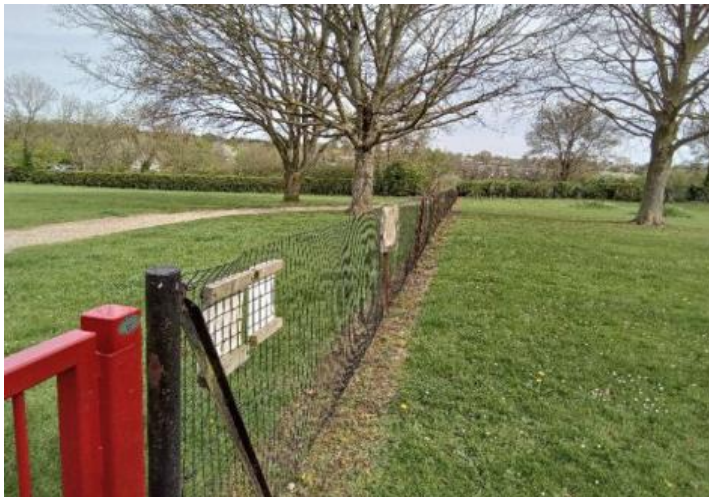
Item: Fences - Fence - Steel Mesh
Manufacturer: Not Identified

Finding: There is some damage to the fence sections

Action: Monitor for any further deterioration and repair as required

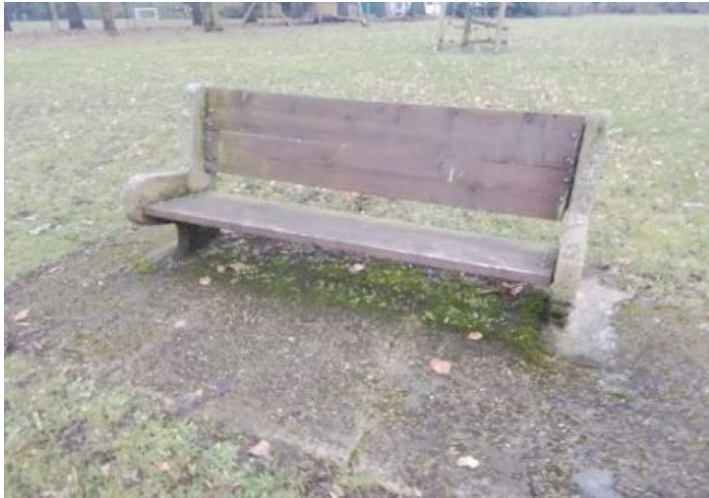
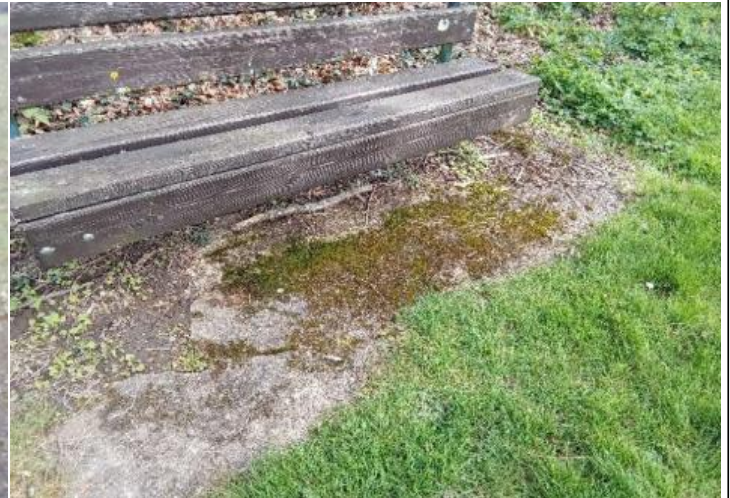
Item: Ancillary Items - Bench
Manufacturer: Not Identified
Risk Level: L - Low Risk
Surface: Concrete

Finding: There is algae, silt or moss growth on the surface resulting in slippery conditions
Action: Clean and treat appropriately

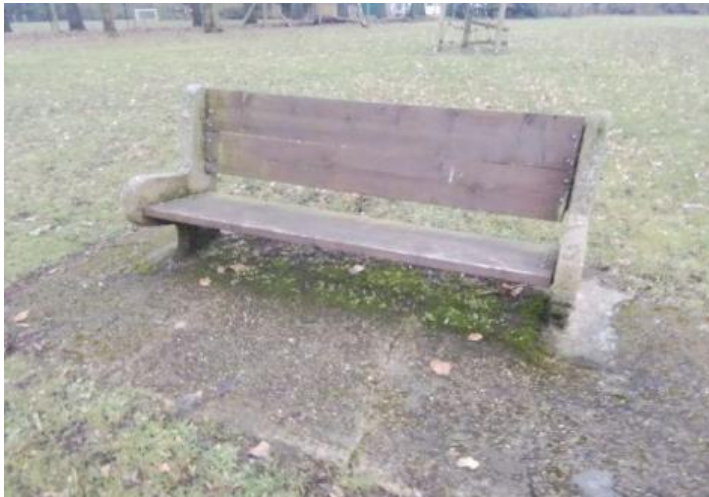
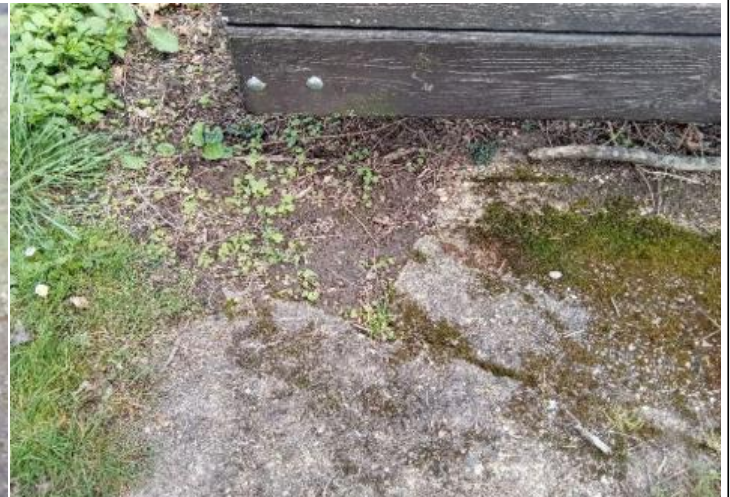
Item: Ancillary Items - Bench
Manufacturer: Not Identified
Risk Level: V - Very Low Risk
Surface: Concrete

Finding: There is some minor damage to the surface
Action: Monitor for any further deterioration and repair as required

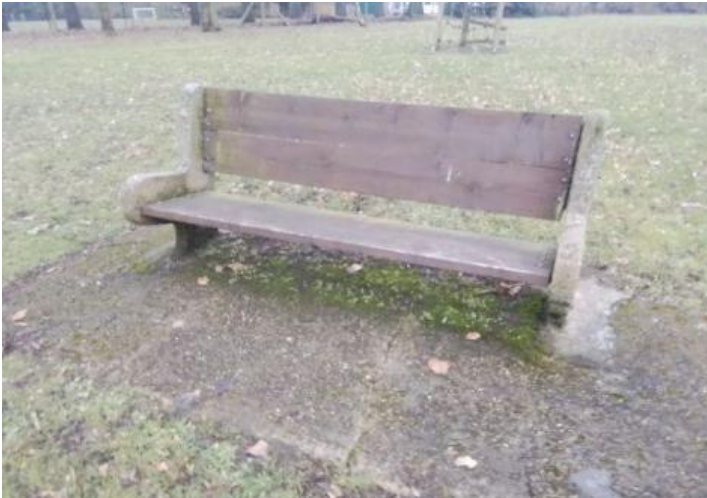
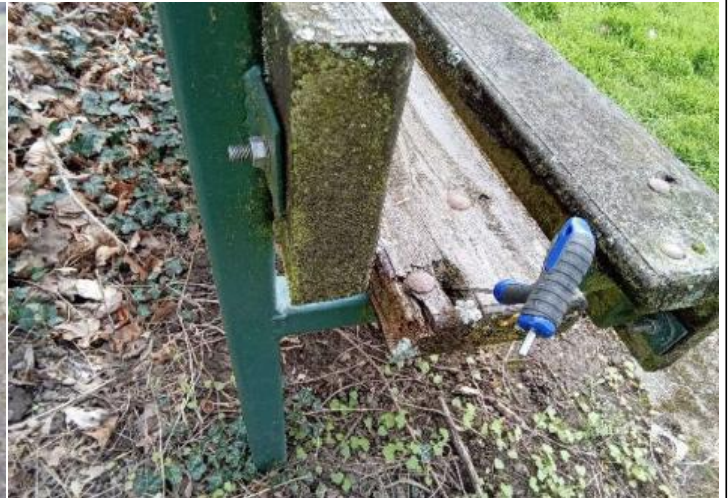
Item: Ancillary Items - Bench
Manufacturer: Not Identified

Finding: There are areas or parts of the timber on the structure that have rotted

Action: Replace all affected timbers

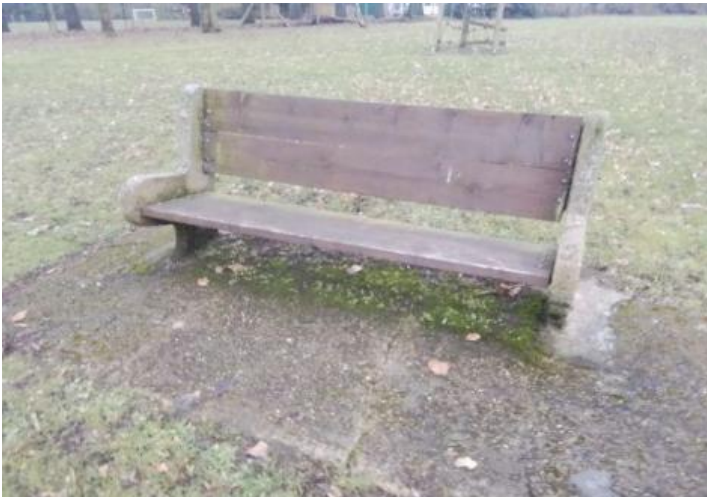
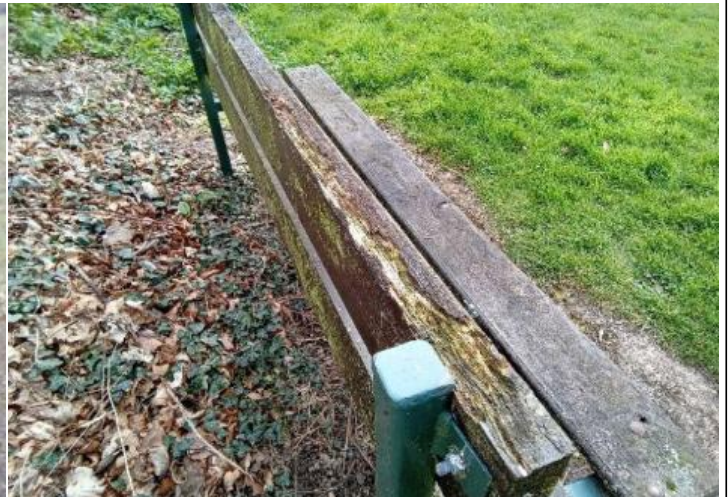
Item: Ancillary Items - Bench
Manufacturer: Not Identified

Finding: Parts of the timber are rough or splintered

Action: Remove all rough or sharp edges

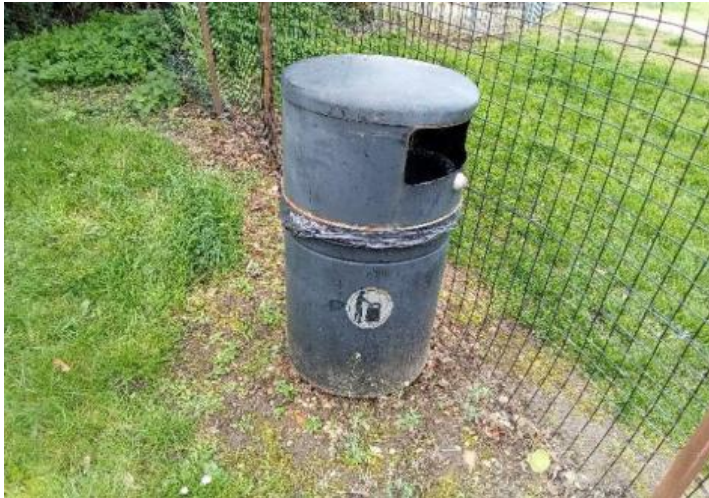
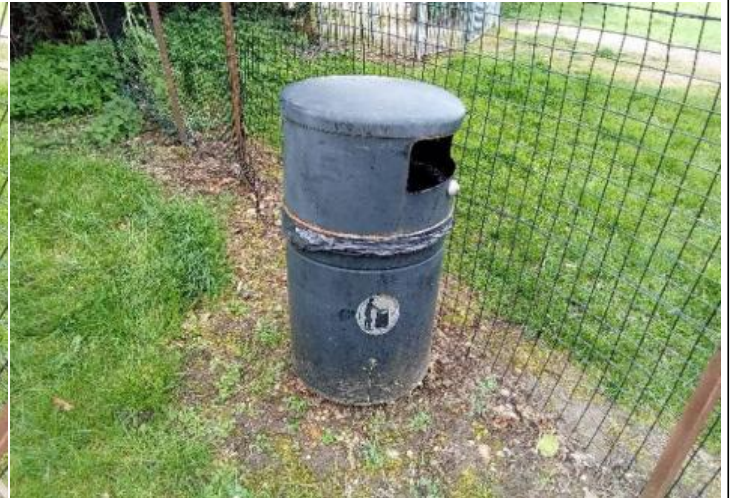
Item: Ancillary Items - Litter Bin
Manufacturer: Not Identified

Finding: The lid or door of the litter bin is not secured

Action: Ensure the lid or door is kept locked

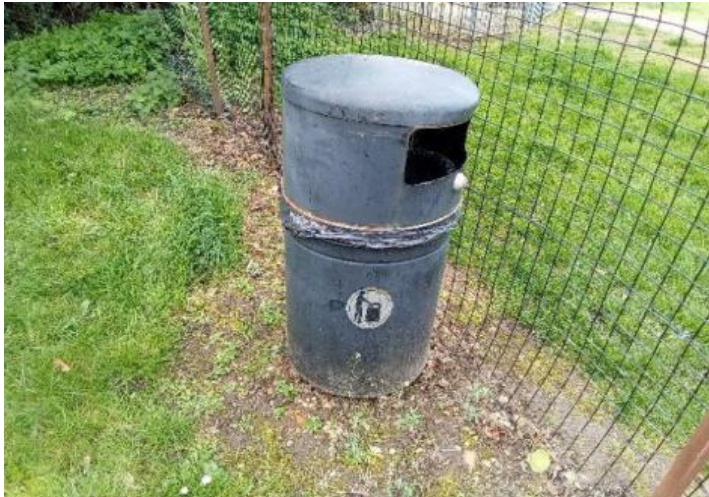
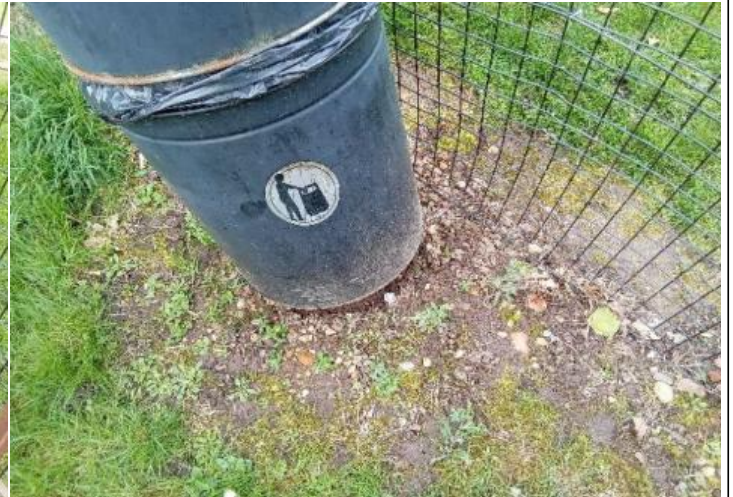
Item: Ancillary Items - Litter Bin
Manufacturer: Not Identified

Finding: The bin is not securely fixed to the surface and there is some possibility of the item tipping or rolling over

Action: Secure the bin to the ground

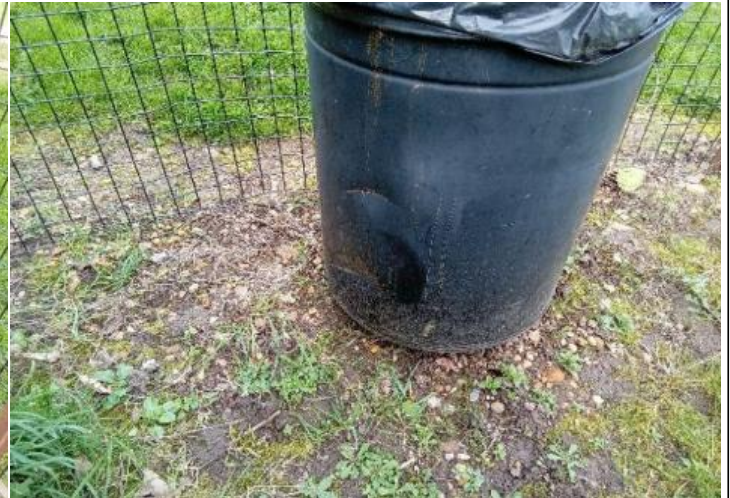
Item: Ancillary Items - Litter Bin
Manufacturer: Not Identified

Finding: There is some damage to the item

Action: Monitor for any further deterioration and repair as required

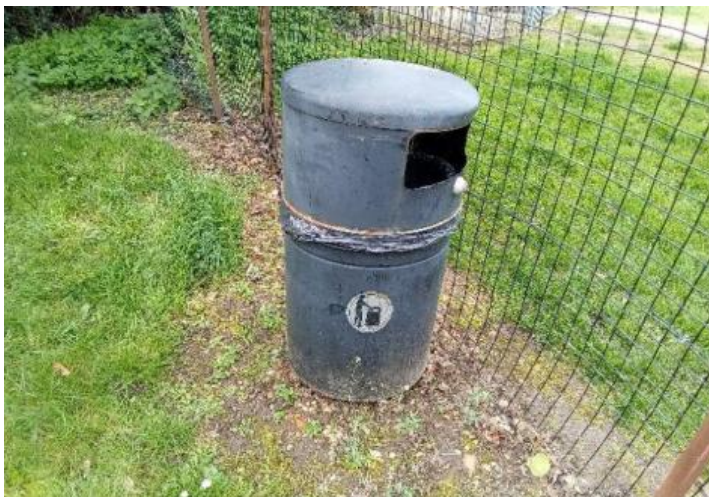
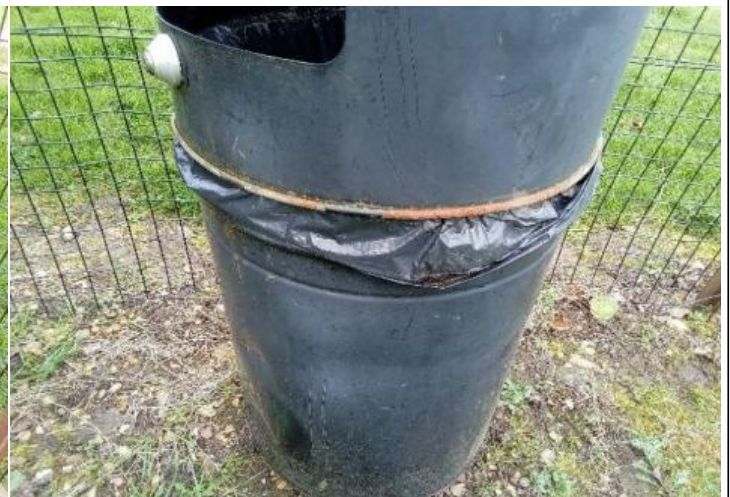
Item: Ancillary Items - Litter Bin
Manufacturer: Not Identified

Finding: The paintwork on this item has been damaged or worn exposing the metal underneath which is rusting / corroding

Action: Treat affected areas and repaint
