ST STEPHEN PARISH COUNCIL

You are summoned to the Fixed Assets Committee meeting
To take place on **Thursday 30 May 2024 at 7.30pm**
at St Stephen Suite, Parish Centre, Station Road, Bricket Wood, AL2 3PJ

- 2425/AC/07 To receive Annual Play Inspection Report and Grounds Team Action Report. Play Reports and Grounds Team Report attached.**
- 2425/AC/08 To discuss the option of creating additional allotment plots and possible beginner plots at Watford Road allotment site or North Close. Allotment report attached.**

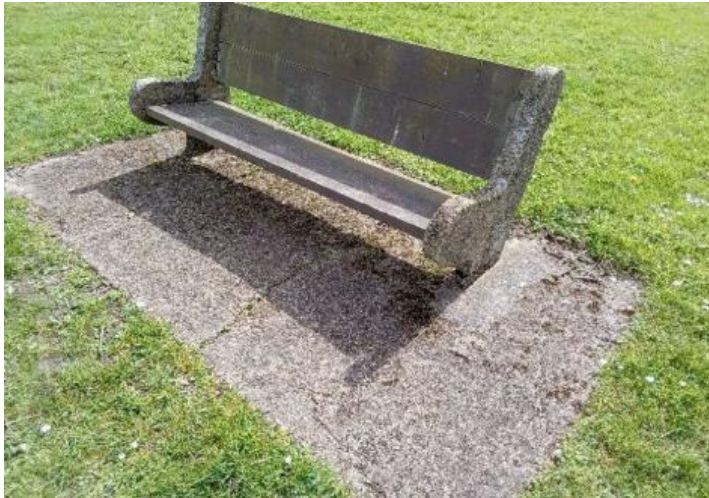
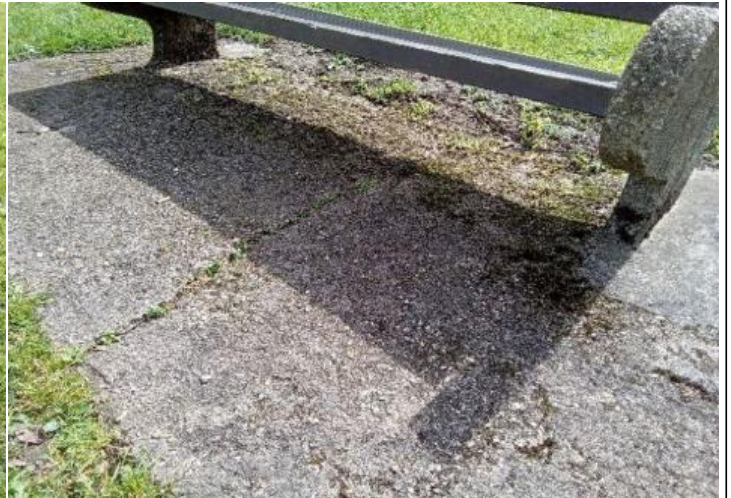
Item: Ancillary Items - Bench
Manufacturer: Not Identified

Risk Level: L - Low Risk
Surface: N/A

Finding: There is algae, silt or moss growth on the surface resulting in slippery conditions

Action: Clean and treat appropriately

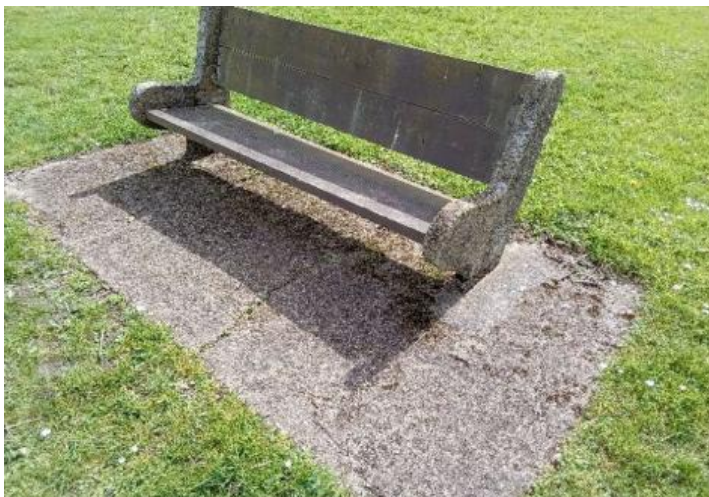
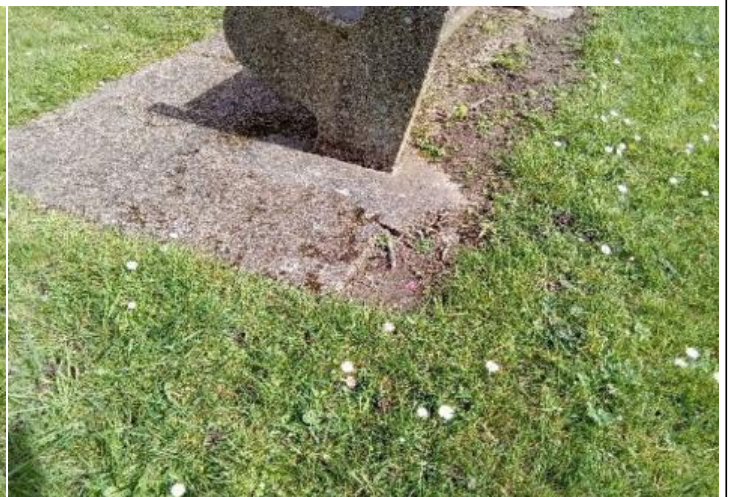
Item: Ancillary Items - Bench
Manufacturer: Not Identified

Risk Level: L - Low Risk
Surface: N/A

Finding: There are trip hazards at the edges of the surface

Action: Reinstate surrounding surface levels to remove the trip points

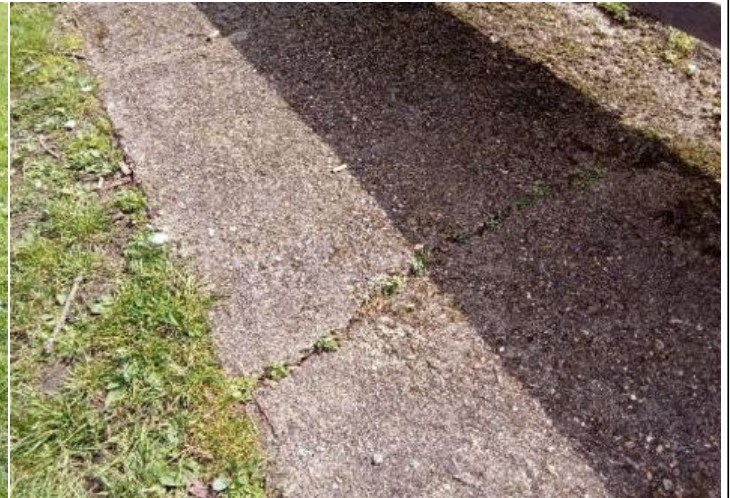
Item: Ancillary Items - Bench
Manufacturer: Not Identified

Risk Level: V - Very Low Risk
Surface: N/A

Finding: There is some minor damage to the surface

Action: Monitor for any further deterioration and repair as required

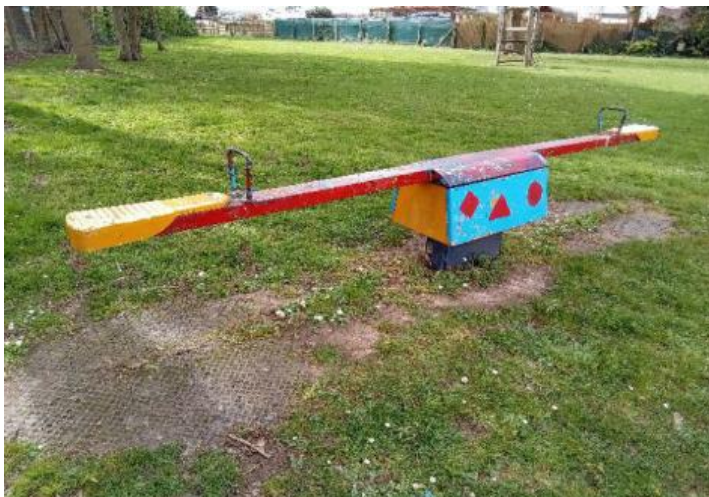
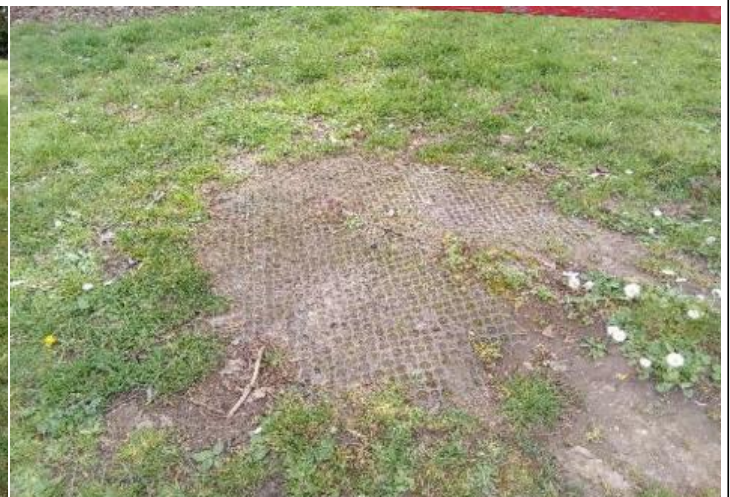
Item: Rocking Equipment - See Saw
Manufacturer: Wicksteed Playgrounds

Risk Level: L - Low Risk
Surface: Grass Matrix Tiles

Finding: The surface has subsided in some areas

Action: Monitor for any further deterioration and repair as required

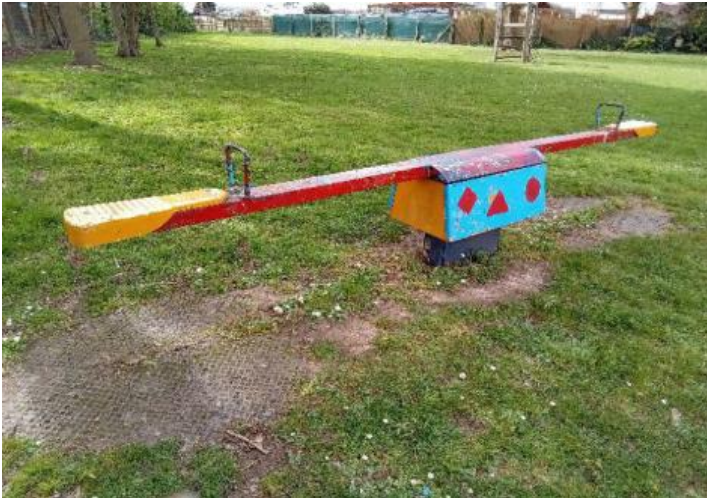
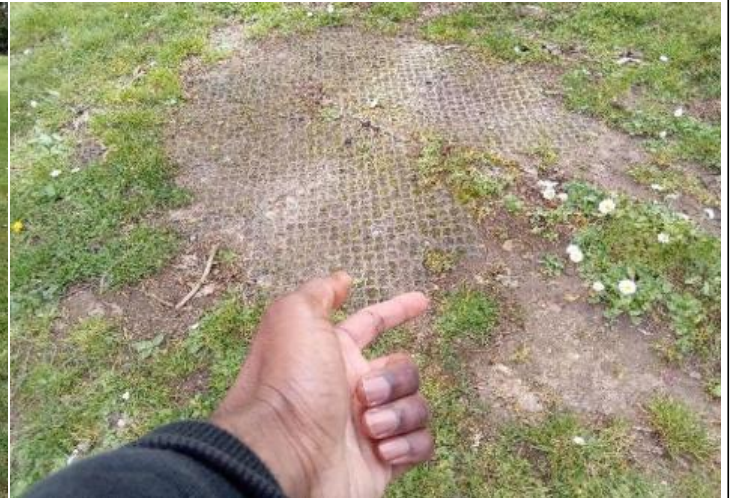
Item: Rocking Equipment - See Saw
Manufacturer: Wicksteed Playgrounds

Risk Level: V - Very Low Risk
Surface: Grass Matrix Tiles

Finding: There is some minor damage to the surface

Action: Monitor for any further deterioration and repair as required

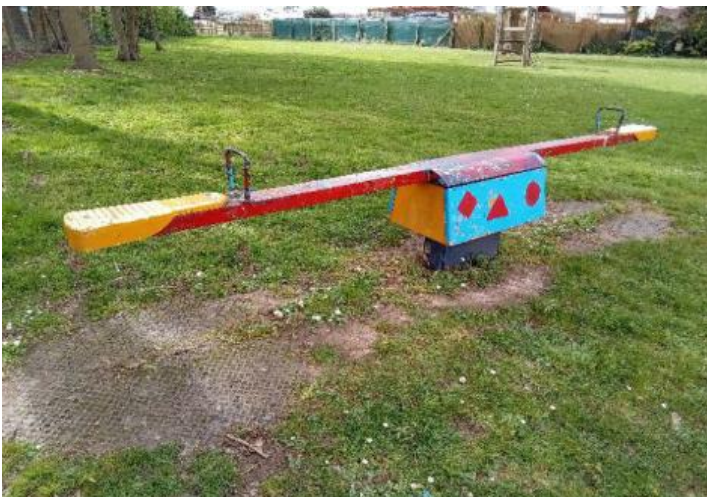
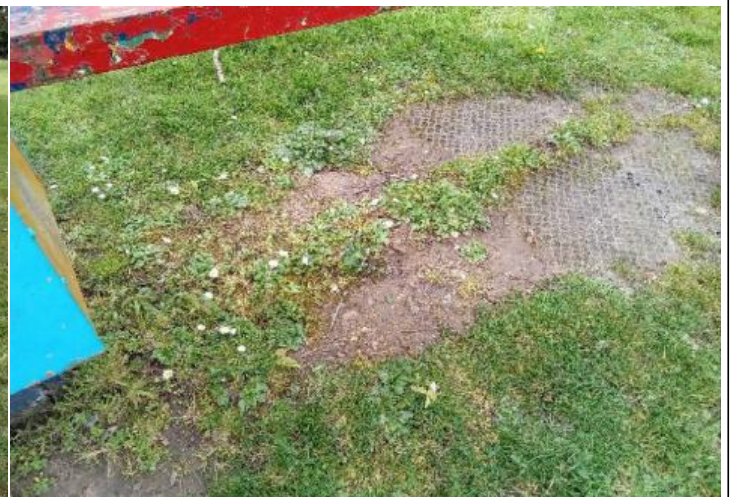
Item: Rocking Equipment - See Saw
Manufacturer: Wicksteed Playgrounds

Risk Level: L - Low Risk
Surface: Grass Matrix Tiles

Finding: The surface has eroded in some areas and may be slippery in wet conditions

Action: Reinstate the surface

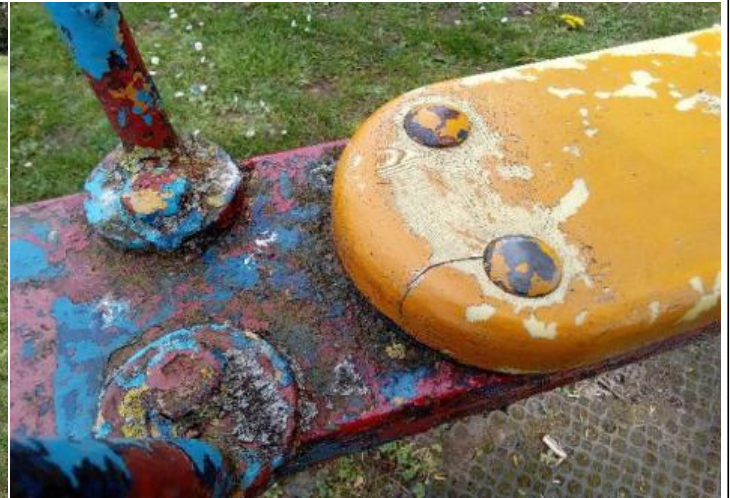
Item: Rocking Equipment - See Saw
Manufacturer: Wicksteed Playgrounds

Risk Level: L - Low Risk
Surface: Grass Matrix Tiles

Finding: The seat has been damaged

Action: Monitor for any further deterioration and replace as required

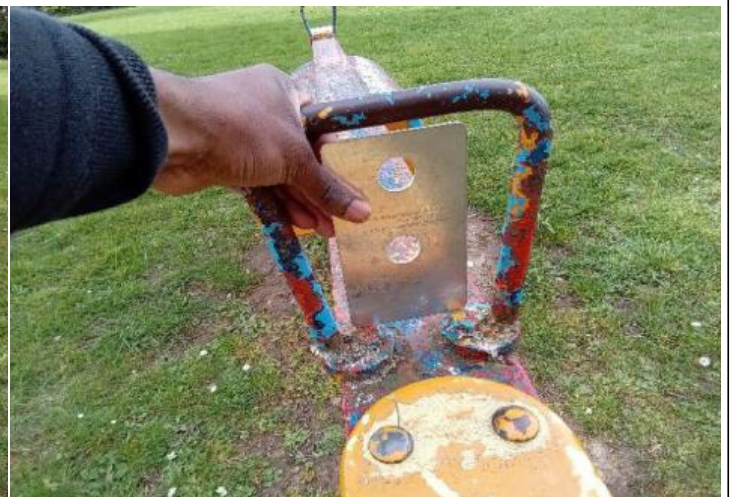
Item: Rocking Equipment - See Saw
Manufacturer: Wicksteed Playgrounds

Risk Level: V - Very Low Risk
Surface: Grass Matrix Tiles

Finding: The item fails to meet the requirements of BS EN 1176 Part 1 4.2.7.2 for head and neck entrapment in the see saw handles

Action: Monitor - No remedial work recommended

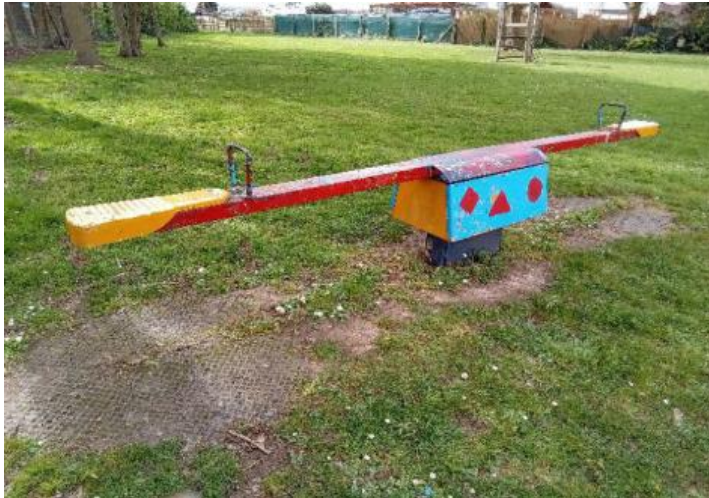
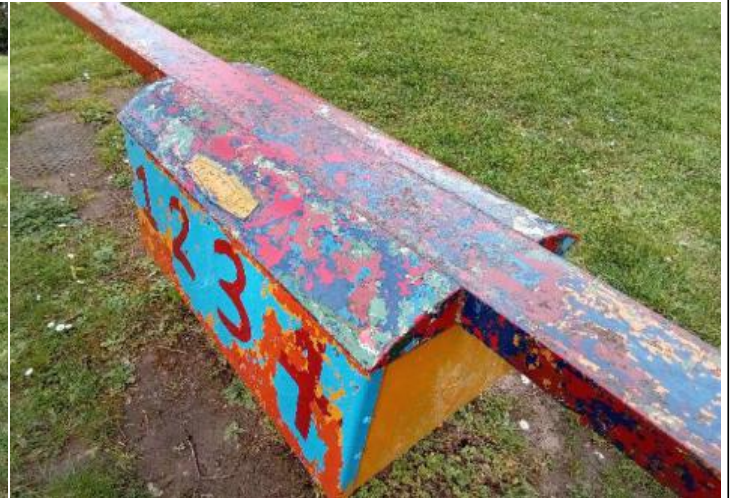
Item: Rocking Equipment - See Saw
Manufacturer: Wicksteed Playgrounds

Risk Level: L - Low Risk
Surface: Grass Matrix Tiles

Finding: The paint is flaking off the metalwork

Action: Rub down and re-paint

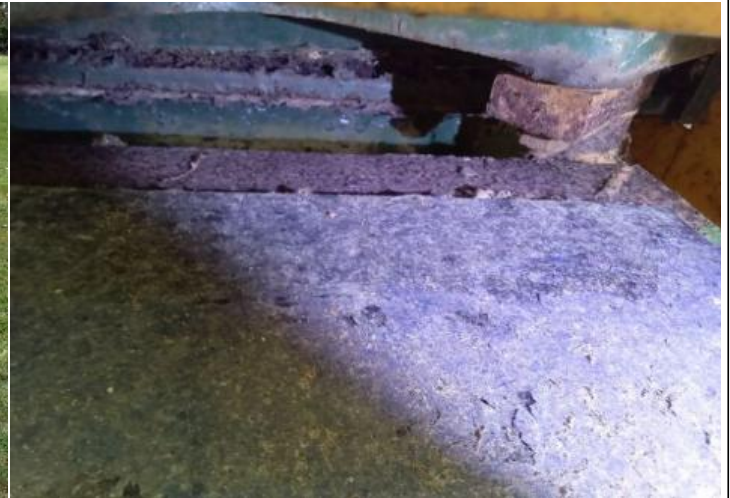
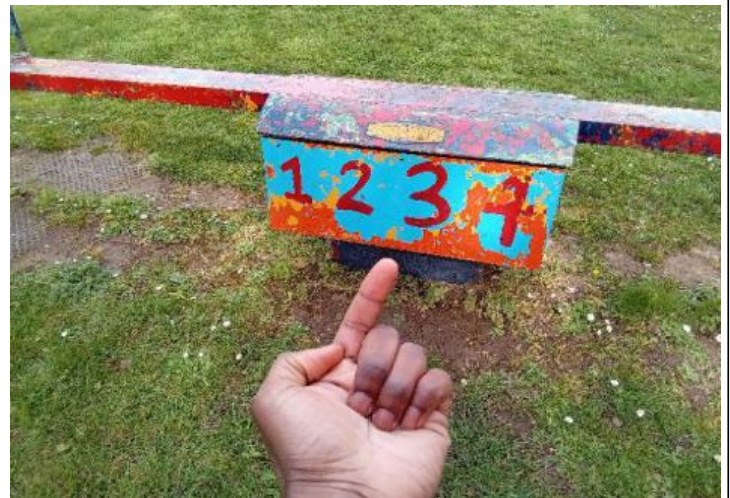
Item: Rocking Equipment - See Saw
Manufacturer: Wicksteed Playgrounds

Risk Level: V - Very Low Risk
Surface: Grass Matrix Tiles

Finding: There is no gaiter protection for accessible moving parts (possible shear trap) as recommended in BS EN 1176 Part 1; 4.2.6 Moving Parts

Action: Monitor - No remedial work recommended

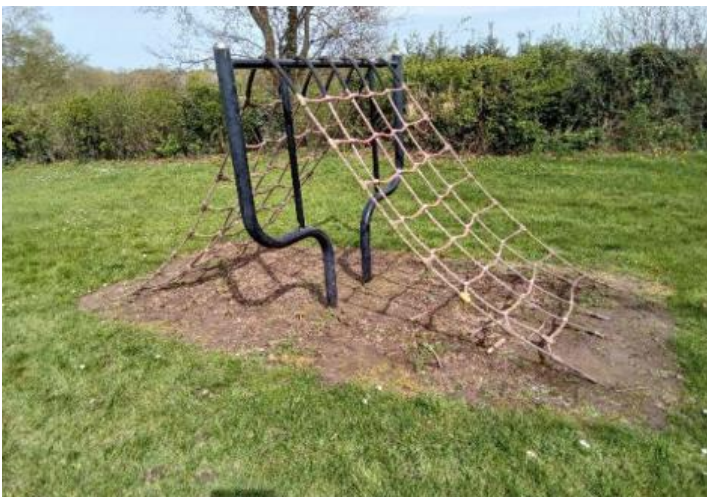
Item: Activity Equipment - Net Climber
Manufacturer: Wicksteed Playgrounds

Risk Level: L - Low Risk
Surface: Grass Matrix Tiles

Finding: The rope has worn and wire strands are exposed

Action: Replace rope or net

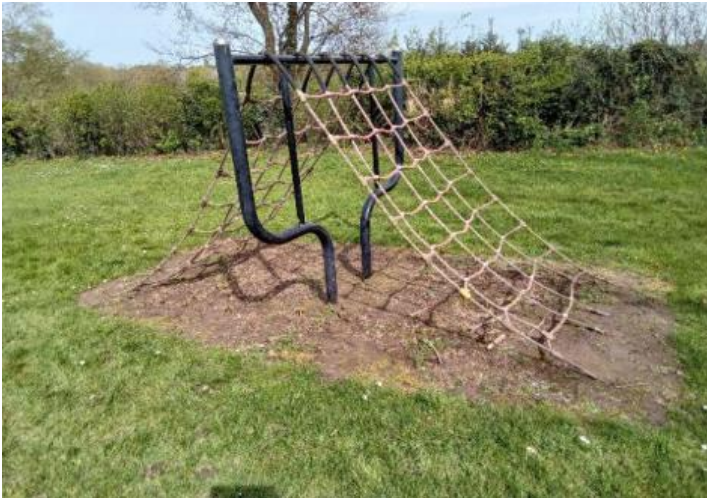
Item: Activity Equipment - Net Climber
Manufacturer: Wicksteed Playgrounds

Risk Level: L - Low Risk
Surface: Grass Matrix Tiles

Finding: The chain/rope covering is damaged

Action: Monitor for any further deterioration and replace as required

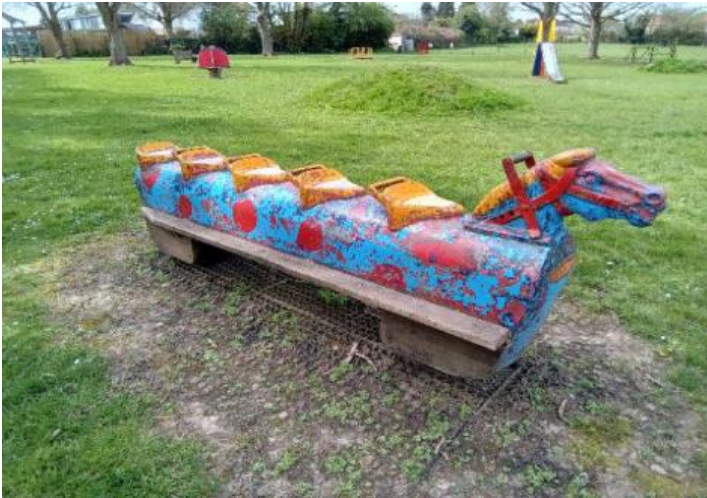
Item: Rocking Equipment - Rocking Horse
Manufacturer: Wicksteed Playgrounds

Risk Level: L - Low Risk
Surface: Grass Matrix Tiles

Finding: There is some damage to the seat

Action: Monitor for any further deterioration and repair as required

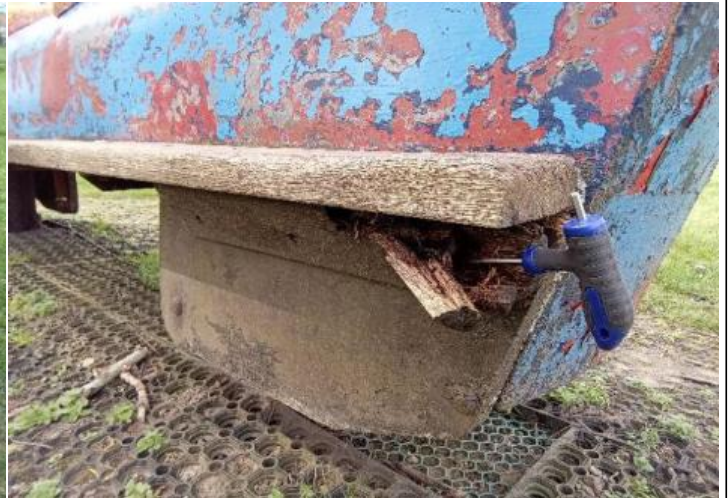
Item: Rocking Equipment - Rocking Horse
Manufacturer: Wicksteed Playgrounds

Risk Level: L - Low Risk
Surface: Grass Matrix Tiles

Finding: There are areas or parts of the timber on the structure that have rotted

Action: Replace all affected timbers

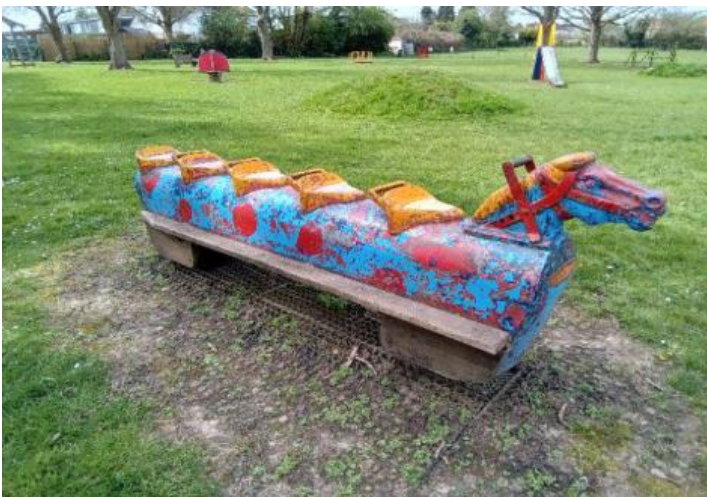
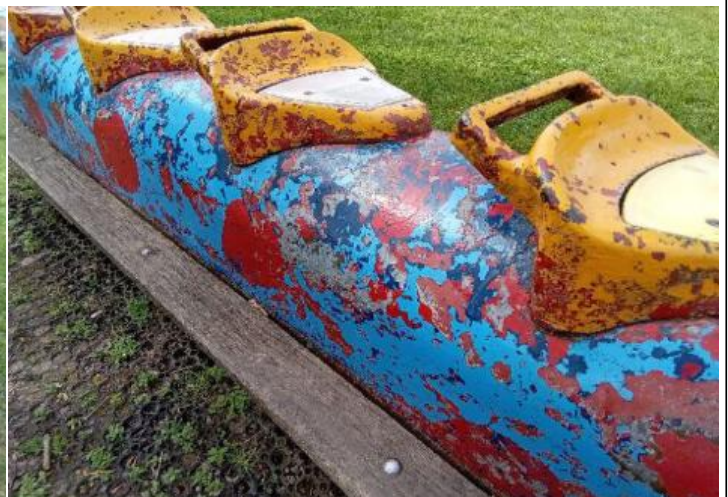
Item: Rocking Equipment - Rocking Horse
Manufacturer: Wicksteed Playgrounds

Risk Level: L - Low Risk
Surface: Grass Matrix Tiles

Finding: The paintwork on this item has been damaged or worn exposing the metal underneath which is rusting / corroding

Action: Treat affected areas and repaint

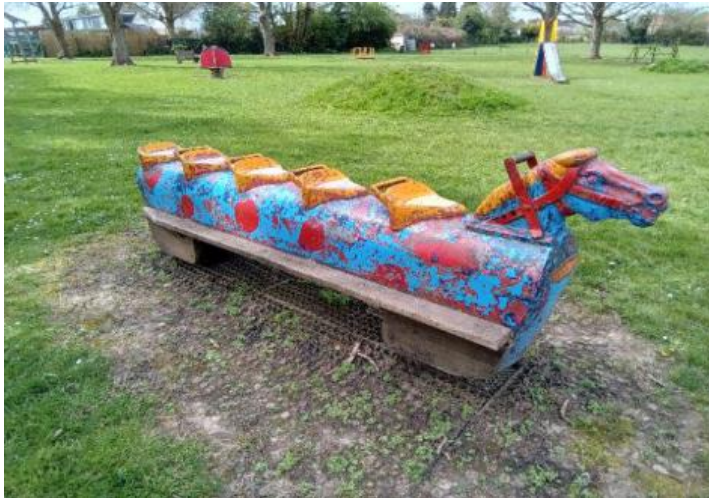
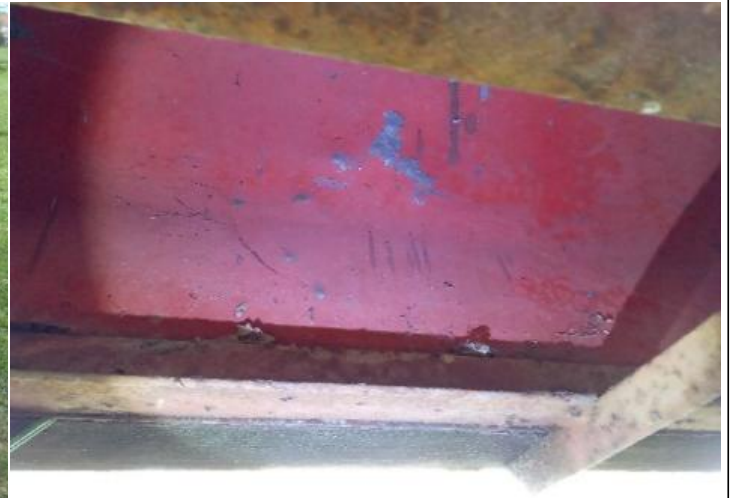
Item: Rocking Equipment - Rocking Horse
Manufacturer: Wicksteed Playgrounds

Risk Level: V - Very Low Risk
Surface: Grass Matrix Tiles

Finding: There is no gaiter protection for accessible moving parts (possible shear trap) as recommended in BS EN 1176 Part 1; 4.2.6 Moving Parts

Action: Monitor - No remedial work recommended

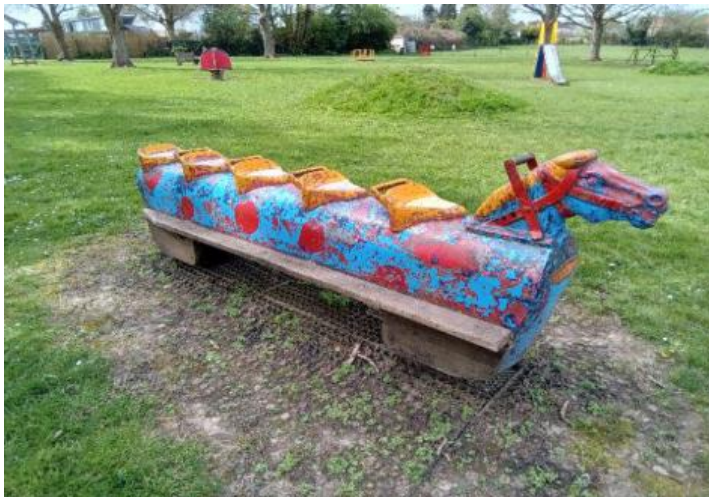
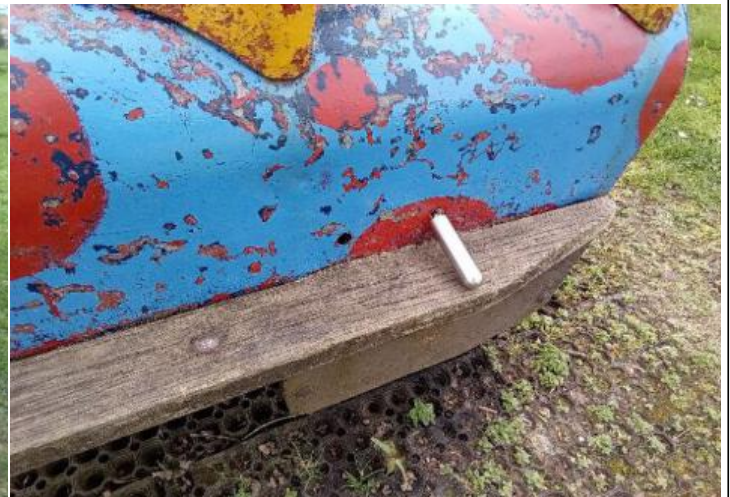
Item: Rocking Equipment - Rocking Horse
Manufacturer: Wicksteed Playgrounds

Risk Level: V - Very Low Risk
Surface: Grass Matrix Tiles

Finding: There is/are finger entrapment/s in the rocking horse frame and the item fails to meet the requirements of BS EN 1176 Part 1 4.2.7.6 Entrapment of fingers

Action: Remove the entrapment

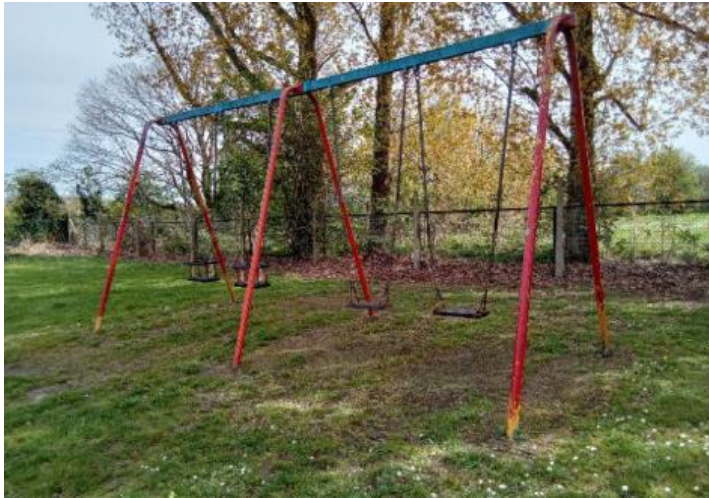
Item: Swings - 2 Bay (2 Flat, 2 Cradle)
Manufacturer: S M P (Playgrounds Ltd)

Risk Level: L - Low Risk
Surface: Grass Matrix Tiles

Finding: There is some wear to the shackles.

Action: Monitor for any further deterioration and replace when 40% worn

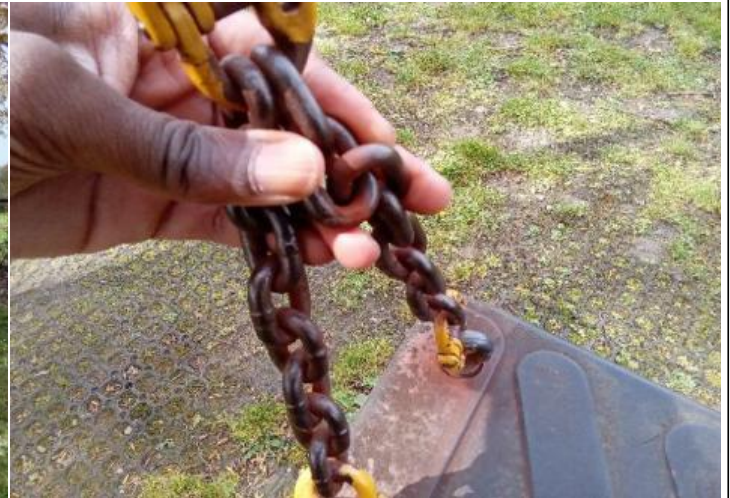
Item: Swings - 2 Bay (2 Flat, 2 Cradle)
Manufacturer: S M P (Playgrounds Ltd)

Risk Level: L - Low Risk
Surface: Grass Matrix Tiles

Finding: There is some notable evidence of chain wear

Action: Monitor for any further deterioration and replace when 40% worn

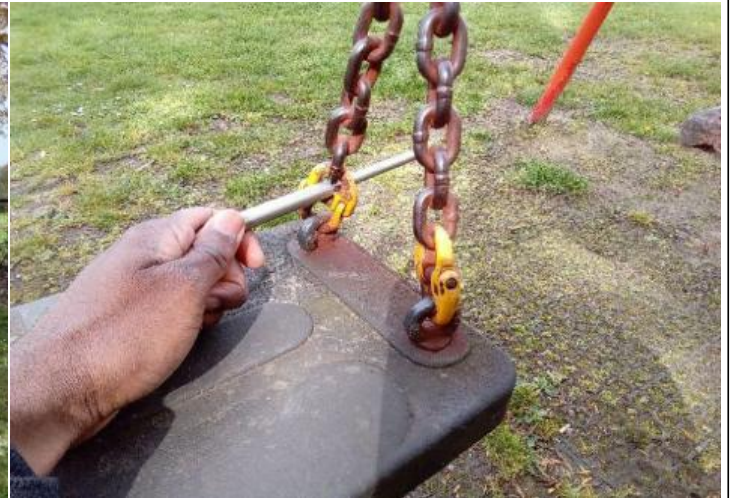
Item: Swings - 2 Bay (2 Flat, 2 Cradle)
Manufacturer: S M P (Playgrounds Ltd)

Risk Level: V - Very Low Risk
Surface: Grass Matrix Tiles

Finding: The chain openings are in excess of the 8.6mm as recommended by BS EN 1176 **Action:** Monitor - No remedial work recommended

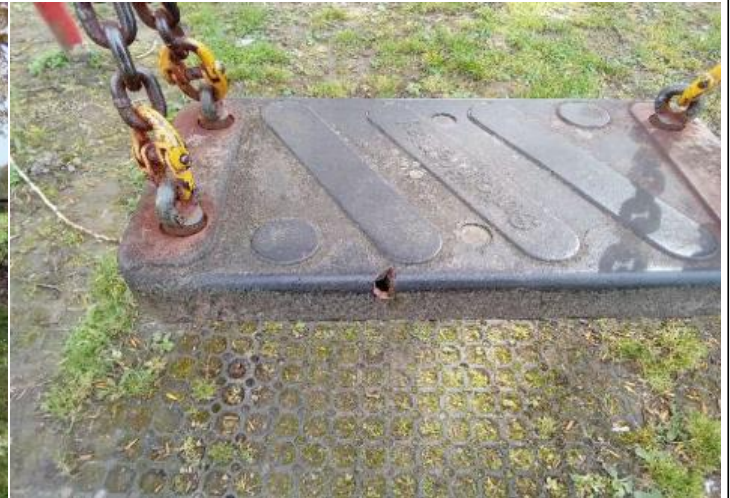
Item: Swings - 2 Bay (2 Flat, 2 Cradle)
Manufacturer: S M P (Playgrounds Ltd)

Risk Level: L - Low Risk
Surface: Grass Matrix Tiles

Finding: The seat has minor damage or wear

Action: Monitor for any further deterioration and replace as required

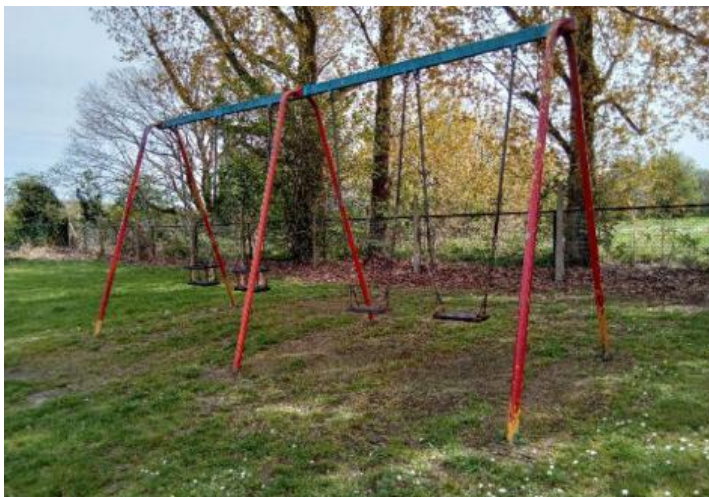
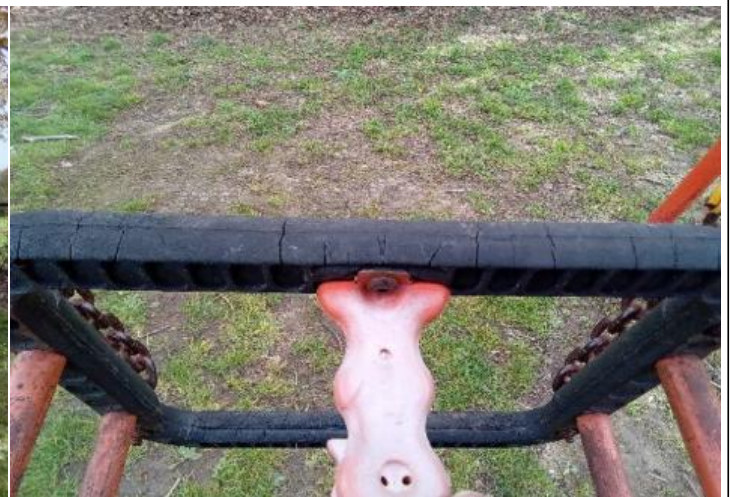
Item: Swings - 2 Bay (2 Flat, 2 Cradle)
Manufacturer: S M P (Playgrounds Ltd)

Risk Level: L - Low Risk
Surface: Grass Matrix Tiles

Finding: The seat has minor damage or wear

Action: Monitor for any further deterioration and replace as required

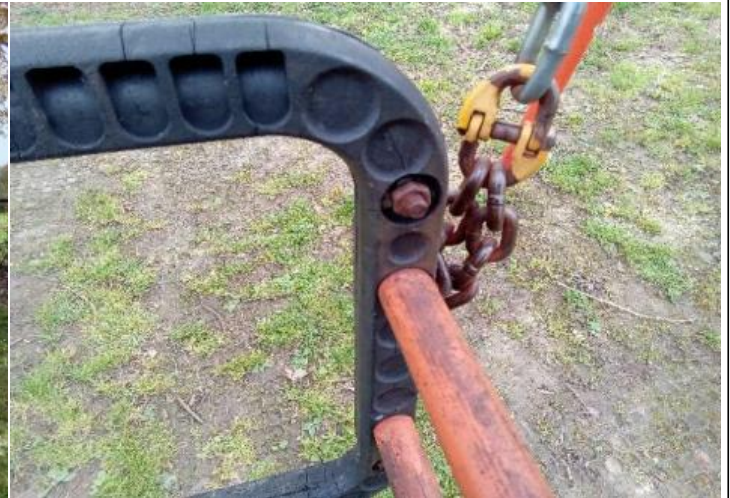
Item: Swings - 2 Bay (2 Flat, 2 Cradle)
Manufacturer: S M P (Playgrounds Ltd)

Risk Level: L - Low Risk
Surface: Grass Matrix Tiles

Finding: There are caps missing from the underside of the seats **Action:** Replace missing caps under the seats

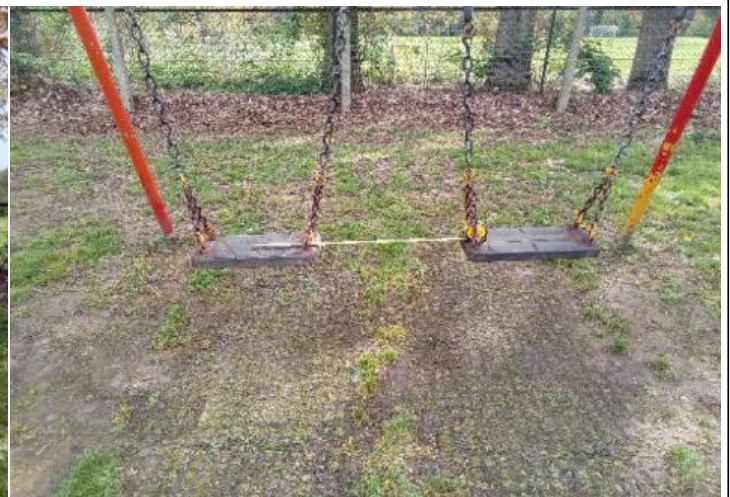
Item: Swings - 2 Bay (2 Flat, 2 Cradle)
Manufacturer: S M P (Playgrounds Ltd)

Risk Level: V - Very Low Risk
Surface: Grass Matrix Tiles

Finding: The seats are too close to each other as defined in BS EN 1176 Part 2; this is a low risk failure and no remedial action is required **Action:** Monitor - No remedial work recommended

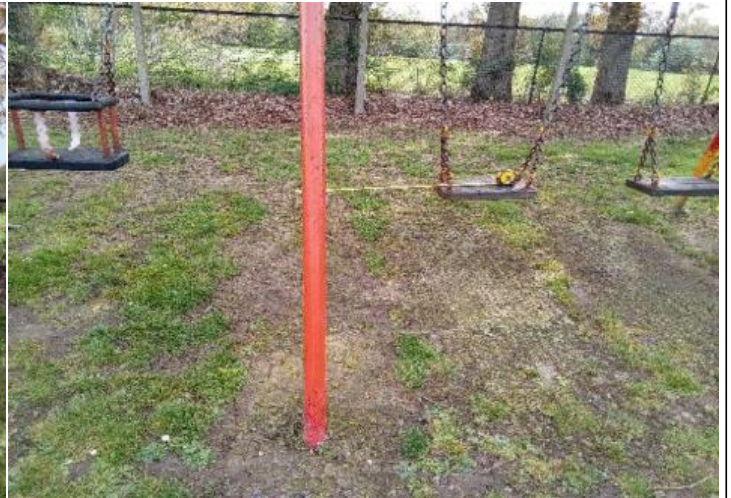
Item: Swings - 2 Bay (2 Flat, 2 Cradle)
Manufacturer: S M P (Playgrounds Ltd)

Risk Level: V - Very Low Risk
Surface: Grass Matrix Tiles

Finding: The seats are too close to the frame as defined in BS EN 1176 Part 2; this is a low risk failure and no remedial action is required

Action: Monitor - No remedial work recommended

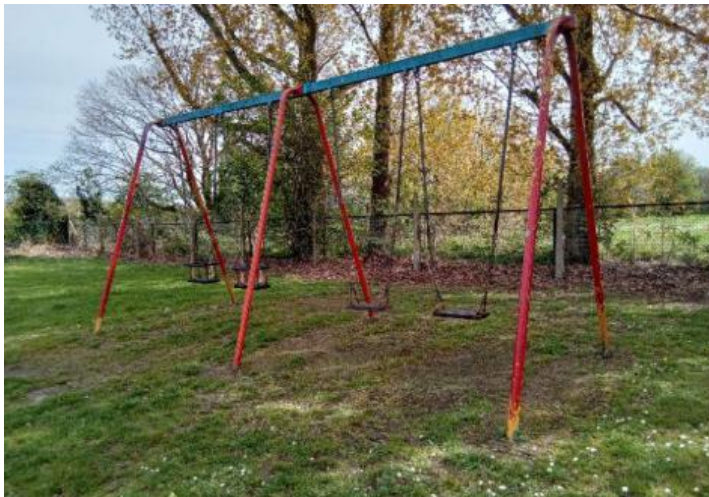
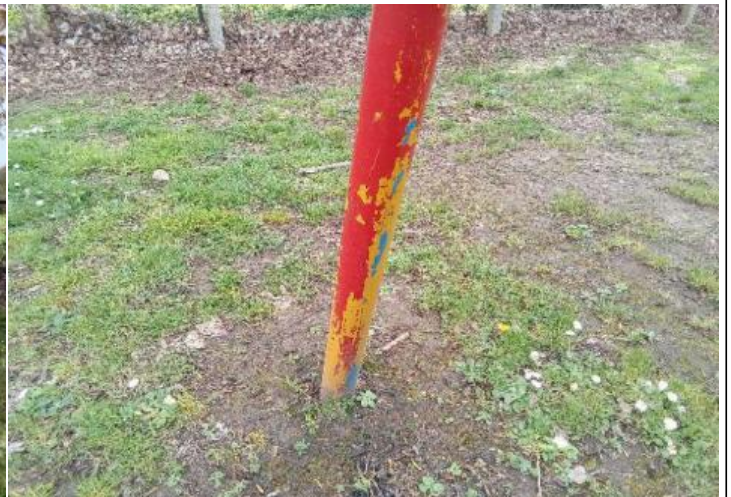
Item: Swings - 2 Bay (2 Flat, 2 Cradle)
Manufacturer: S M P (Playgrounds Ltd)

Risk Level: L - Low Risk
Surface: Grass Matrix Tiles

Finding: The paint is flaking off the metalwork

Action: Rub down and re-paint

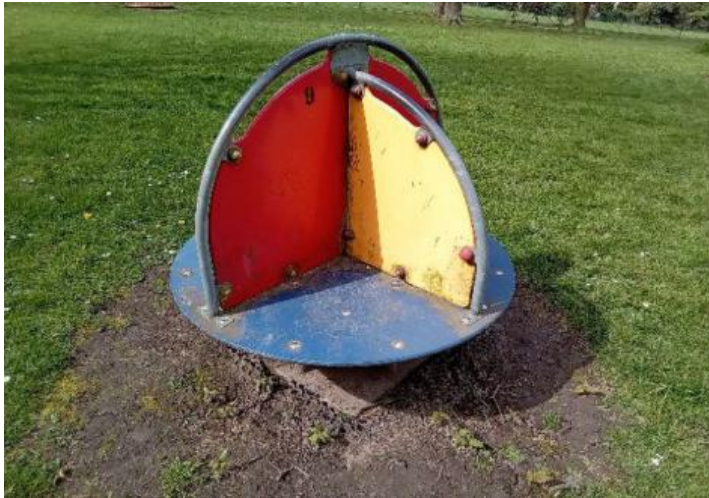
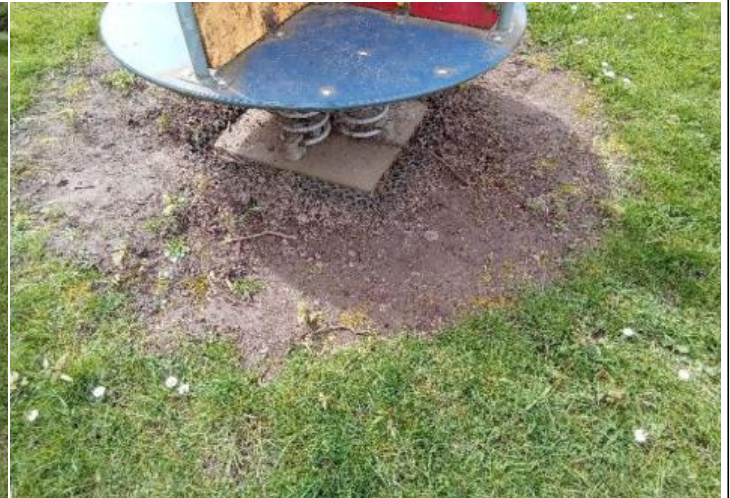
Item: Rocking Equipment - Spring Board
Manufacturer: Kompan Ltd

Risk Level: L - Low Risk
Surface: Grass Matrix Tiles

Finding: The grass mats are silted up, the soil is compacted and the area will become very slippery when the soil is wet. **Action:** Reinstate as required

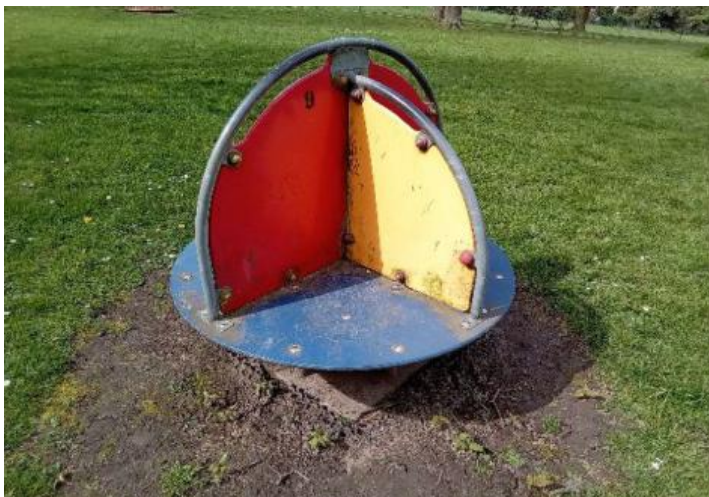
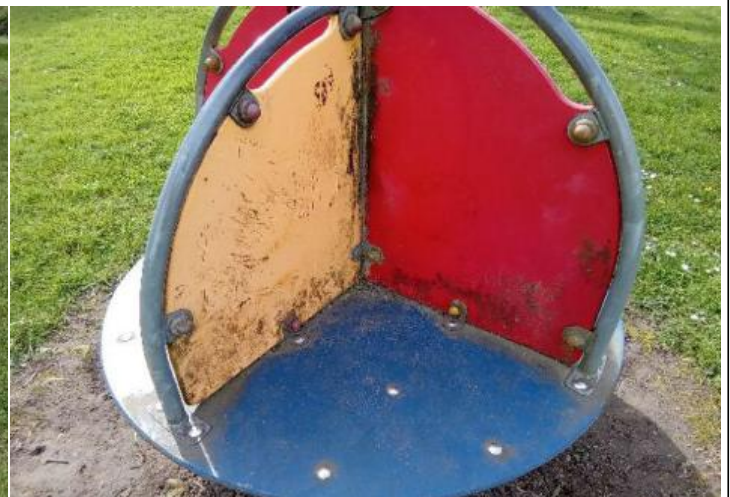
Item: Rocking Equipment - Spring Board
Manufacturer: Kompan Ltd

Risk Level: L - Low Risk
Surface: Grass Matrix Tiles

Finding: There is algae or moss on the surface of the equipment **Action:** Clean and treat appropriately

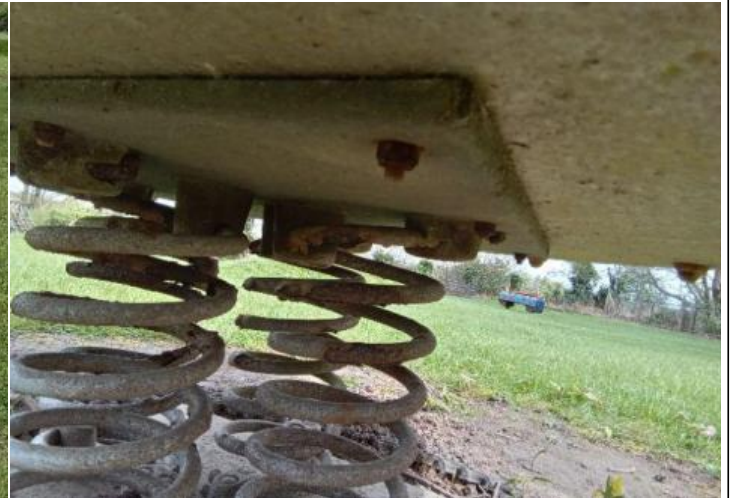
i 4 - Very Low Risk (Finding 3)

Item: Rocking Equipment - Spring Board
Manufacturer: Kompan Ltd

Risk Level: V - Very Low Risk
Surface: Grass Matrix Tiles

Finding: There is/are bolt cap covers missing or damaged on the item

Action: Replace missing or damaged bolt cap covers

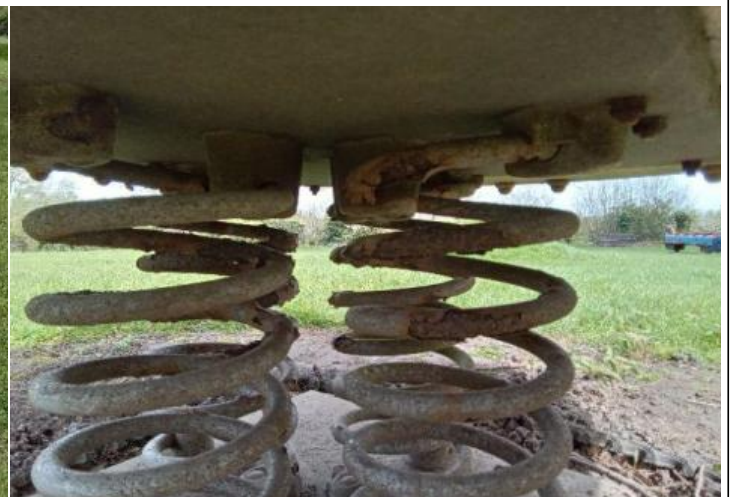
Item: Rocking Equipment - Spring Board
Manufacturer: Kompan Ltd

Risk Level: L - Low Risk
Surface: Grass Matrix Tiles

Finding: The paintwork on the spring has been damaged or worn exposing the metal underneath which is rusting

Action: Treat any rusting components and repaint

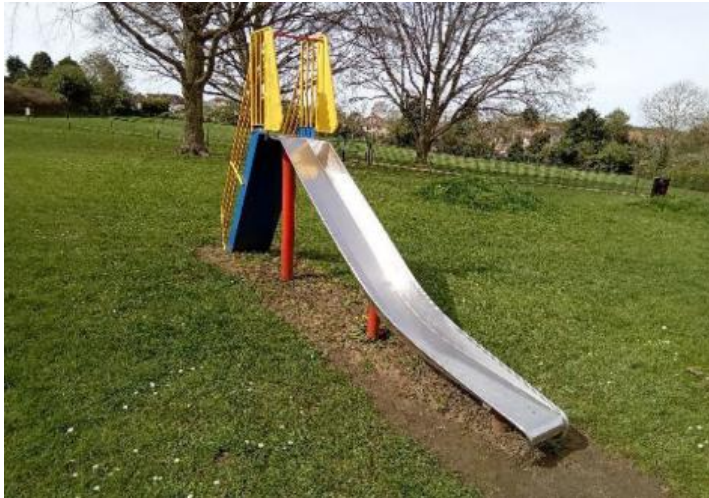
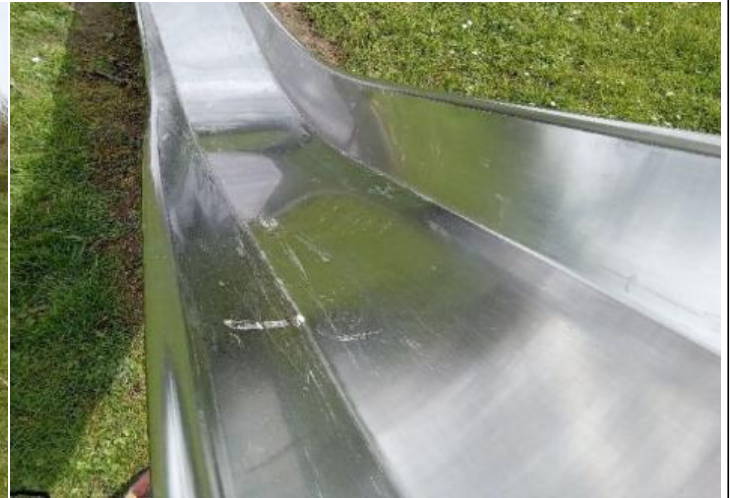
Item: Other - Free Standing Slide
Manufacturer: G L Jones Playgrounds Ltd

Risk Level: V - Very Low Risk
Surface: Grass Matrix Tiles

Finding: There are a number of dents in the slide surface

Action: Monitor for any further deterioration and repair as required

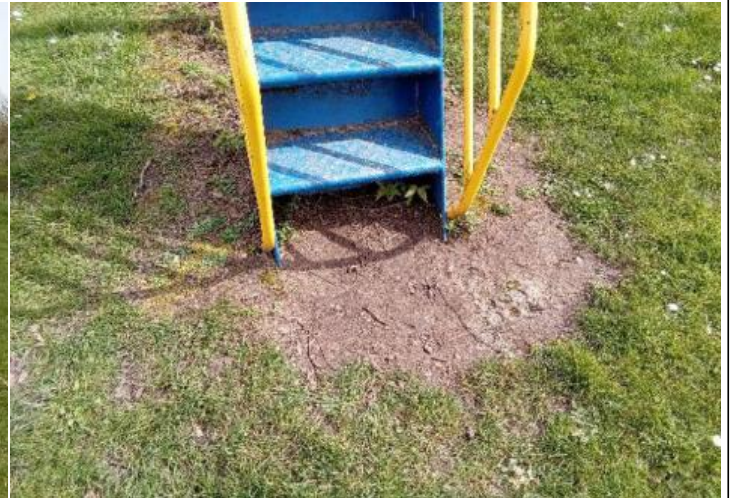
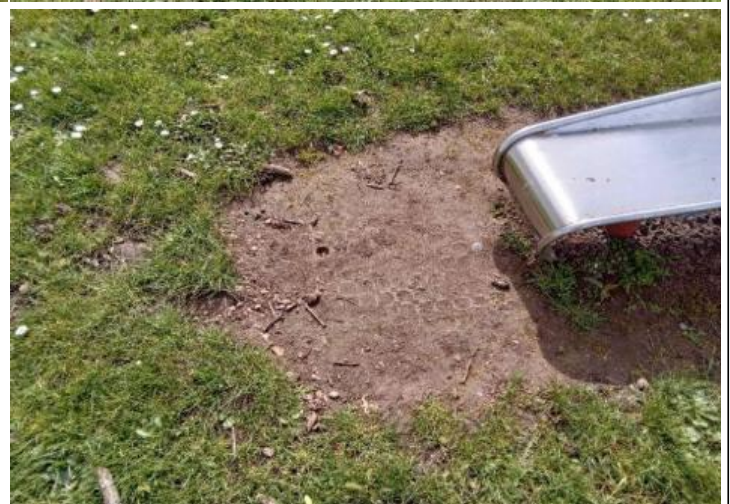
Item: Other - Free Standing Slide
Manufacturer: G L Jones Playgrounds Ltd

Risk Level: L - Low Risk
Surface: Grass Matrix Tiles

Finding: The grass mats are silted up, the soil is compacted and the area will become very slippery when the soil is wet. **Action:** Reinstate as required

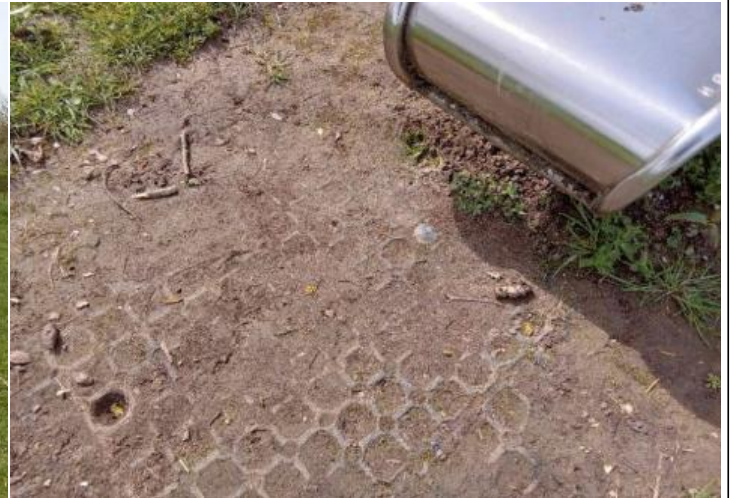
i 5 - Very Low Risk (Finding 3)

Item: Other - Free Standing Slide
Manufacturer: G L Jones Playgrounds Ltd

Risk Level: V - Very Low Risk
Surface: Grass Matrix Tiles

Finding: Fixing Pins have been installed in the impact areas of the grass mats
Action: Remove pins from impact areas

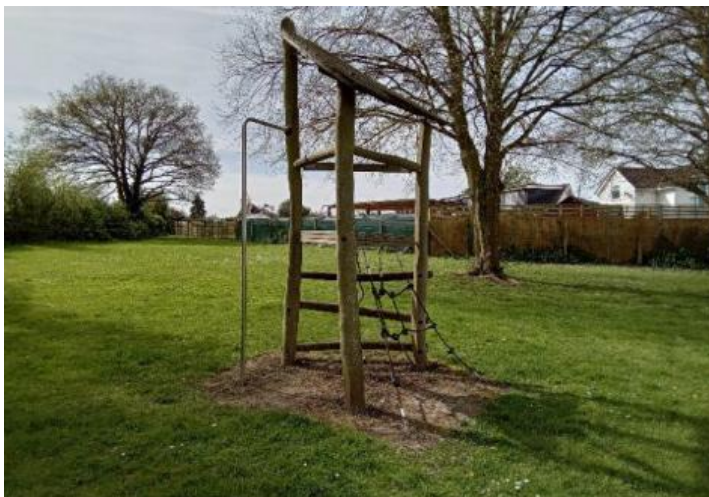
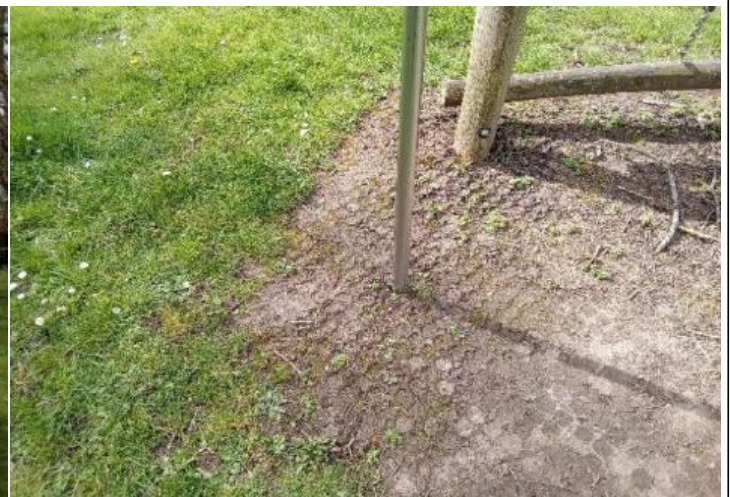
i 6 - Low Risk (Finding 1)

Item: Activity Equipment - Multi Play (Junior)
Manufacturer: Kompan Ltd

Risk Level: L - Low Risk
Surface: Grass Matrix Tiles

Finding: The item is slightly loose in its foundations
Action: Monitor for any further deterioration and repair as required

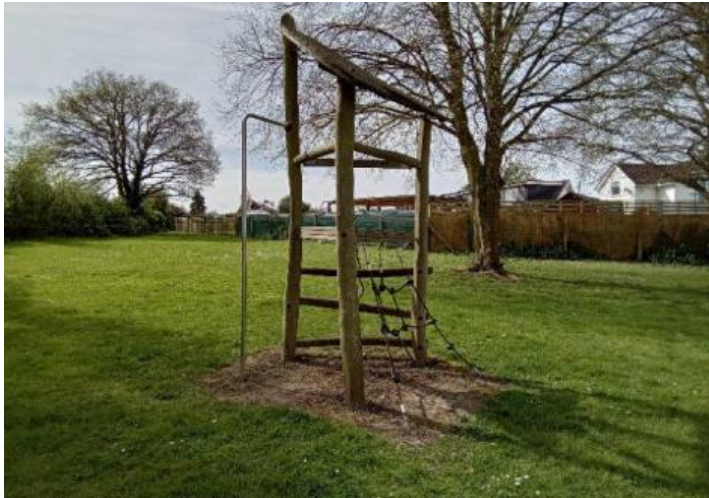
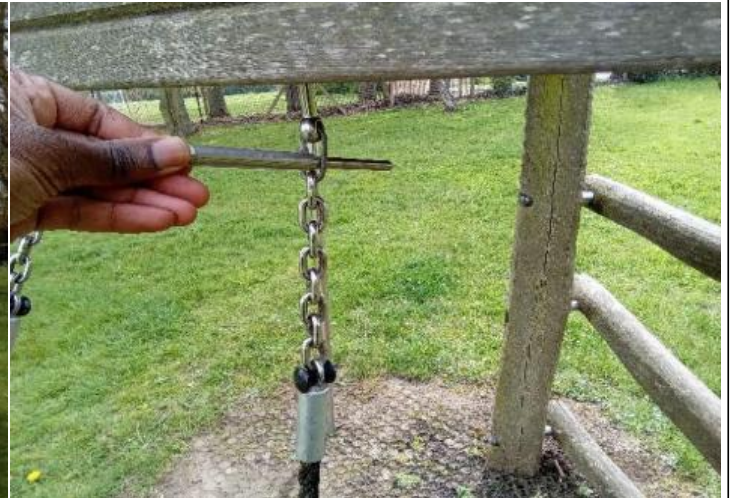
i 5 - Very Low Risk (Finding 2)

Item: Activity Equipment - Multi Play (Junior)
Manufacturer: Kompan Ltd

Risk Level: V - Very Low Risk
Surface: Grass Matrix Tiles

Finding: The chain openings are in excess of the 8.6mm as recommended by BS EN 1176
Action: Monitor - No remedial work recommended

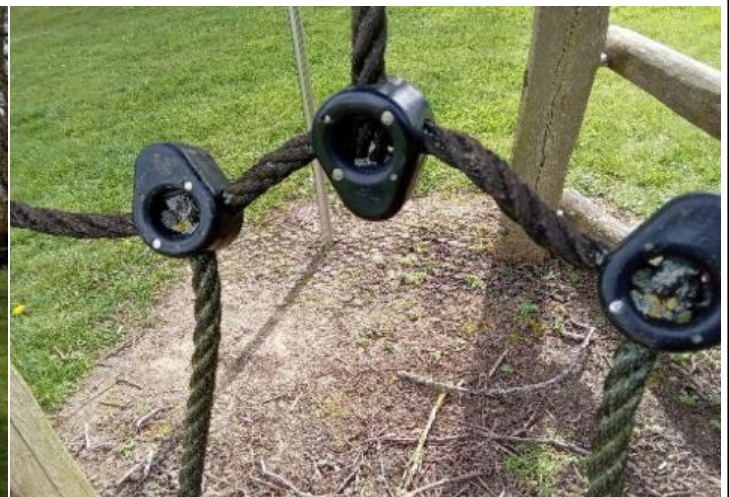
i 6 - Low Risk (Finding 3)

Item: Activity Equipment - Multi Play (Junior)
Manufacturer: Kompan Ltd

Risk Level: L - Low Risk
Surface: Grass Matrix Tiles

Finding: There is algae or moss on the surface of the equipment
Action: Clean and treat appropriately

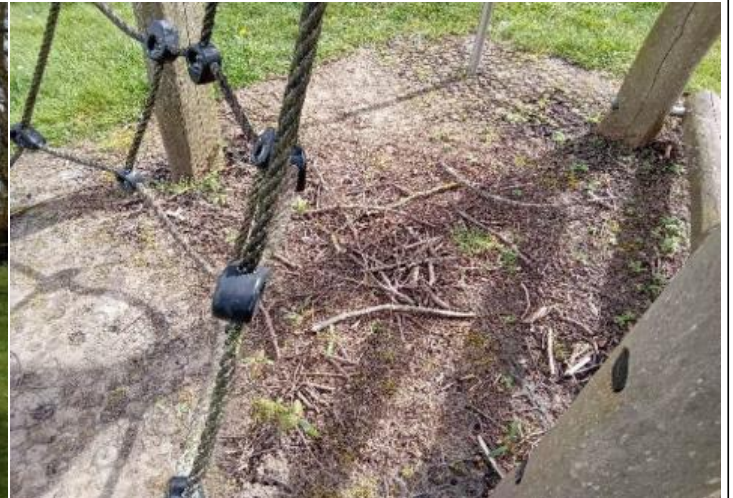
i 6 - Low Risk (Finding 4)

Item: Activity Equipment - Multi Play (Junior)
Manufacturer: Kompan Ltd

Risk Level: L - Low Risk
Surface: Grass Matrix Tiles

Finding: There is some tree debris on the surfacing

Action: Remove and maintain
