ST STEPHEN PARISH COUNCIL

You are summoned to the Fixed Assets Committee meeting
To take place on **Thursday 30 May 2024 at 7.30pm**
at St Stephen Suite, Parish Centre, Station Road, Bricket Wood, AL2 3PJ

- 2425/AC/07 To receive Annual Play Inspection Report and Grounds Team Action Report. Play Reports and Grounds Team Report attached.**
- 2425/AC/08 To discuss the option of creating additional allotment plots and possible beginner plots at Watford Road allotment site or North Close. Allotment report attached.**

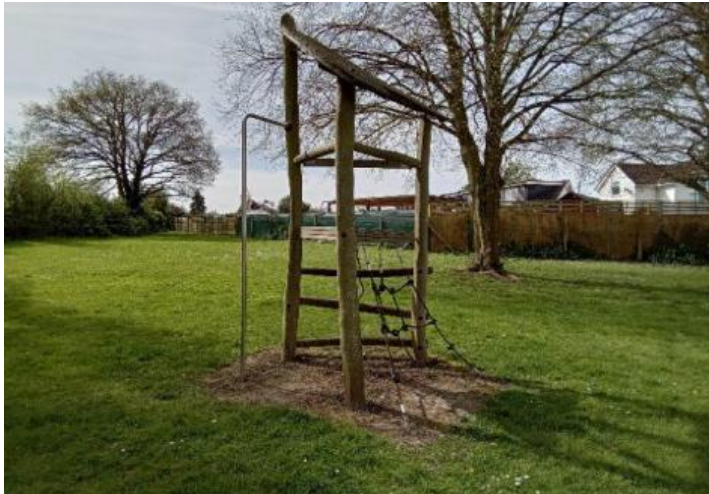
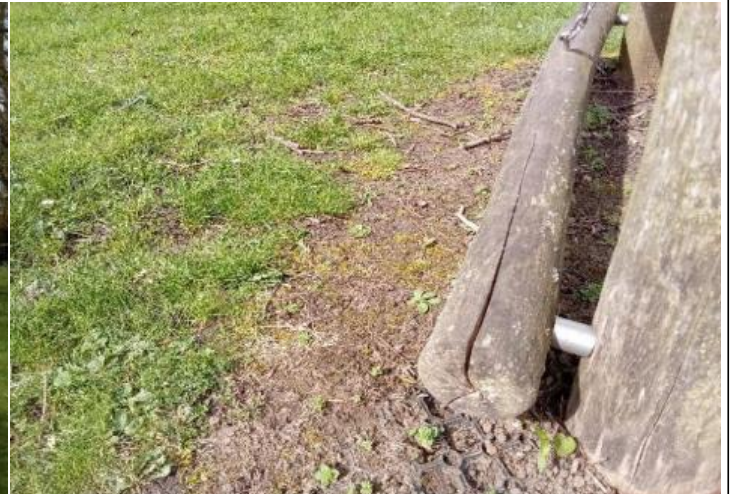
Item: Activity Equipment - Multi Play (Junior)
Manufacturer: Kompan Ltd

Risk Level: L - Low Risk
Surface: Grass Matrix Tiles

Finding: The timber has a number of splits/shakes or air cracks and this may affect the stability or allow water ingress which will accelerate the rotting process

Action: Monitor to ensure the splits do not cross through fixing points of the structure and/or cause any instability

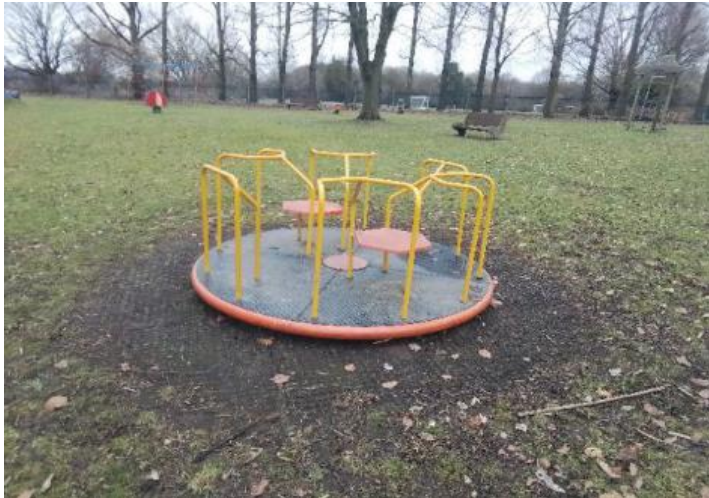
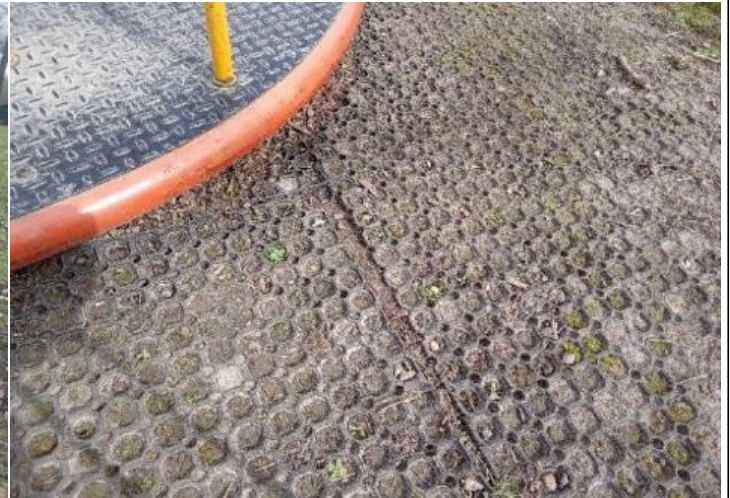
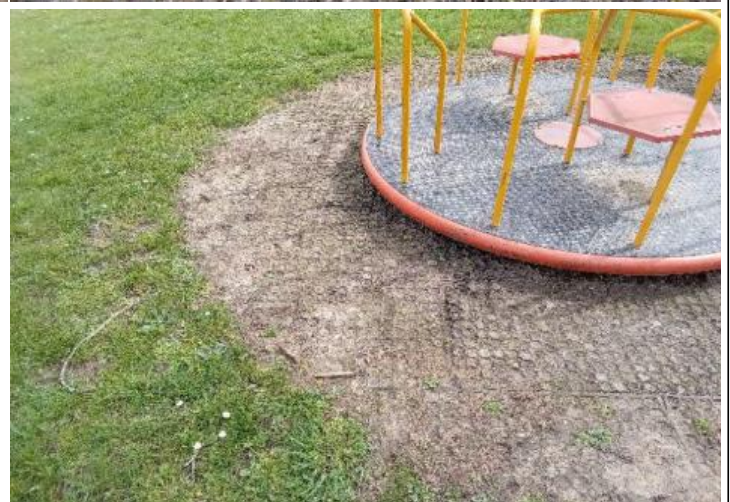
Item: Rotor Play - Roundabout
Manufacturer: Wicksteed Playgrounds

Risk Level: L - Low Risk
Surface: Grass Matrix Tiles

Finding: There are gaps opening between the grass mat tiles

Action: Provide additional ties or secure / reinstate surface

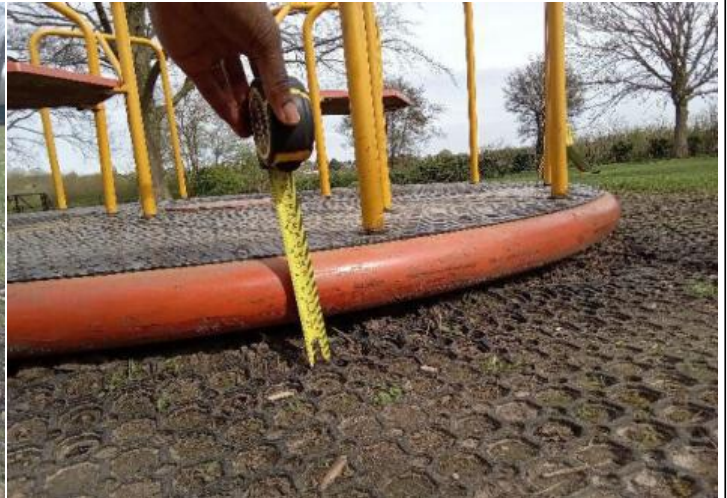
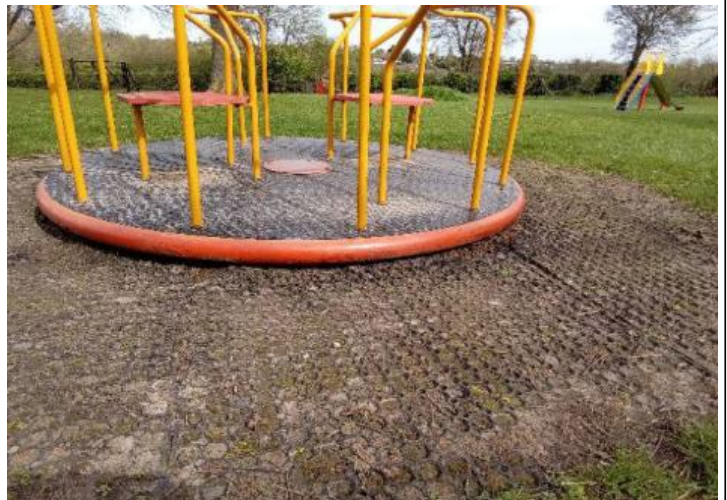
Item: Rotor Play - Roundabout
Manufacturer: Wicksteed Playgrounds

Risk Level: L - Low Risk
Surface: Grass Matrix Tiles

Finding: The distance between the underside of the roundabout platform and the playing surface is less than 60mm and contravenes the requirements of BS EN 1176 Part 5 which requires that the distance be maintained between 60mm-110mm for the entire circumference of the roundabout

Action: Monitor - No remedial work recommended

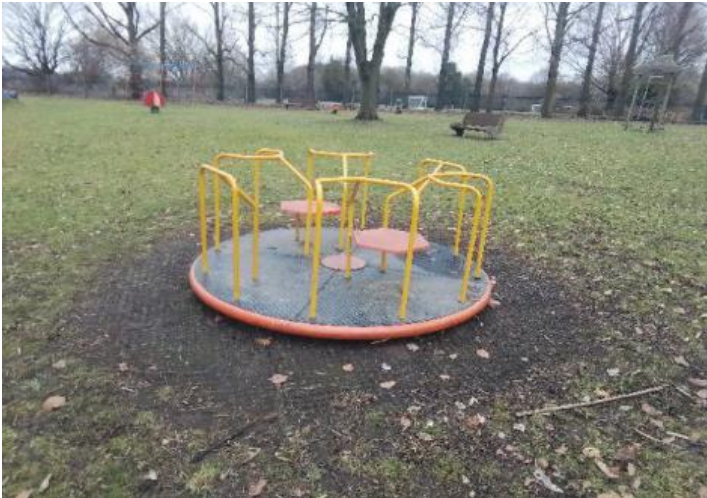
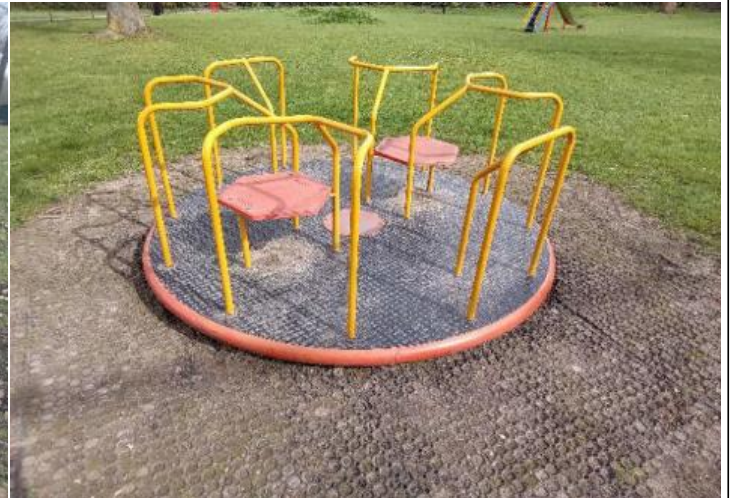
Item: Rotor Play - Roundabout
Manufacturer: Wicksteed Playgrounds

Risk Level: L - Low Risk
Surface: Grass Matrix Tiles

Finding: The bearing on the unit is dry

Action: Service and lubricate the bearing(s)

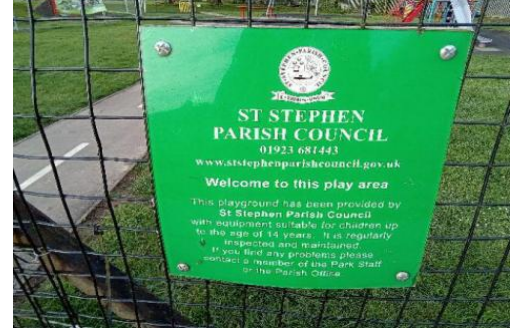
Item: Sign
Manufacturer: Owner/Operator
Surface Type: Grass
Item Quantity: 1
Equipment Compliance: N/A
Surface Area Compliance: N/A

BS EN 1176 Part 7 recommends that signage shall include the site name / address - Provide additional information

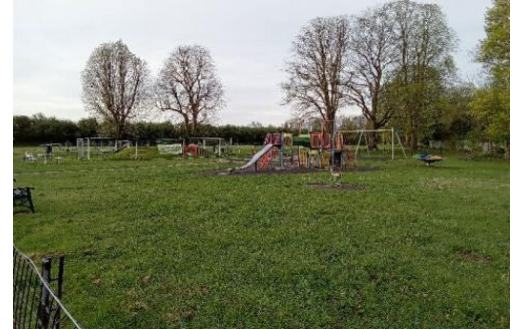
Item: Site General
Manufacturer: Owner/Operator
Surface Type: N/A
Item Quantity: 1
Equipment Compliance: N/A
Surface Area Compliance: N/A

There are holes in surface that may have been created purposely by users. - Infill to provide a sound reasonably level surface.

The surface has eroded in some areas and may be slippery in wet conditions - Reinstate the surface

There are gaps opening between the surfacing and the edging surround or between the joints in the surfacing - Monitor for any further deterioration and repair as required

It is recommended that Adult Outdoor Fitness equipment is installed a minimum of 25m away from a childrens playground or separated and screened to discourage access by younger children - Monitor use and review risk assessment regularly

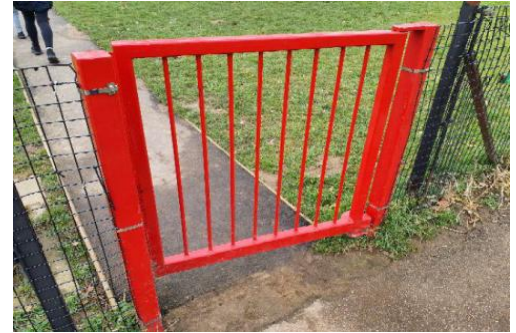
Item: Gate - Self Closing
Manufacturer: Owner/Operator
Surface Type: Grass
Item Quantity: 2
Equipment Compliance: N/A
Surface Area Compliance: N/A

There is some minor damage to the surface - Monitor for any further deterioration and repair as required

There are trip hazards at the edges of the surface - Reinstate surrounding surface levels to remove the trip points

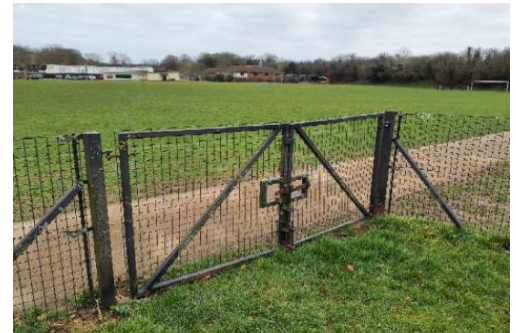
Item: Gate - Maintenance
Manufacturer: Owner/Operator
Surface Type: Grass
Item Quantity: 1
Equipment Compliance: N/A
Surface Area Compliance: N/A

The area under the gate has eroded leaving uneven areas, or the concrete foundations exposed, resulting in trip hazards at the entrance/exit to the playground - Reinstate to level with surrounding surfaces

Parts of the steel on this item have corroded excessively and the metal has perforated in places - Ensure all affected areas are treated and repaired

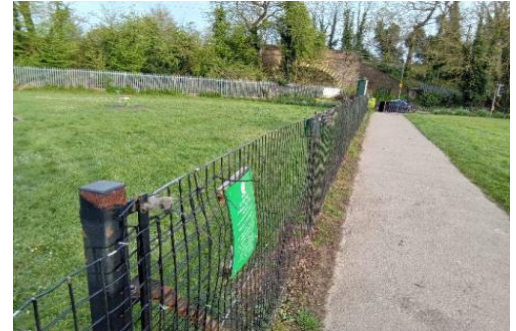
Item: Fence - Steel Mesh
Manufacturer: Owner/Operator
Surface Type: Grass
Item Quantity: 1
Equipment Compliance: N/A
Surface Area Compliance: N/A

Cable ties have been used on the item and there are sharp projecting ends - Remove if not required or replace with a more appropriate alternative fixing method if used as a fixing

Parts of the steel on this item have corroded excessively and the metal has perforated in places - Ensure all affected areas are treated and repaired

There are a number of loose posts around the fence - Monitor for any further deterioration and reset as required

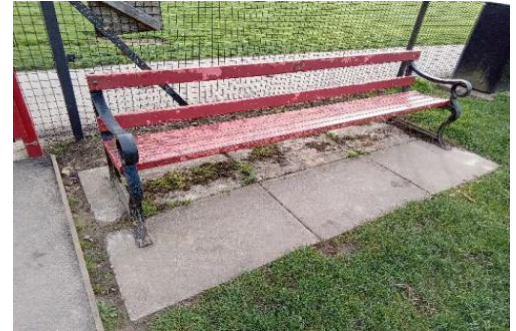
Item: Bench
Manufacturer: Owner/Operator
Surface Type: Paving Slabs
Item Quantity: 1
Equipment Compliance: N/A
Surface Area Compliance: N/A

There are trip hazards at the edges of the surface - Reinstate surrounding surface levels to remove the trip points

There is algae, silt or moss growth on the surface resulting in slippery conditions - Clean and treat appropriately

A number of fixing(s) have worked loose - Secure all loose fixings

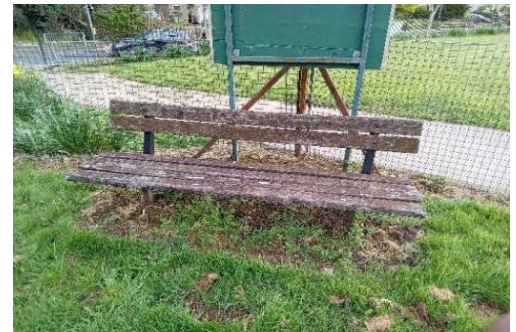
Item: Bench
Manufacturer: Owner/Operator
Surface Type: Grass
Item Quantity: 2
Equipment Compliance: N/A
Surface Area Compliance: N/A

There is some evidence of rot in the timber - Monitor for any further deterioration and replace as required

The item is slightly loose in its foundations - Monitor for any further deterioration and repair as required

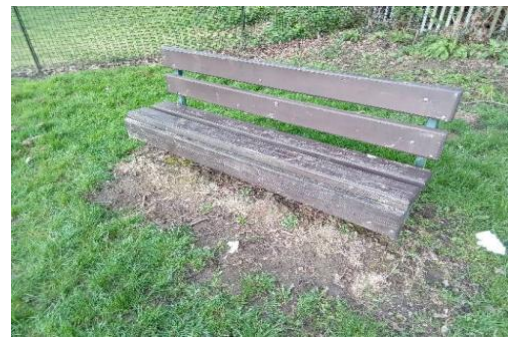
Item: Bench
Manufacturer: Not Identified
Surface Type: Grass
Item Quantity: 1
Equipment Compliance: N/A
Surface Area Compliance: N/A

The surface has eroded in some areas and may be slippery in wet conditions - Reinstate the surface | Finding 2
There is some evidence of rot in the timber - Monitor for any further deterioration and replace as required |

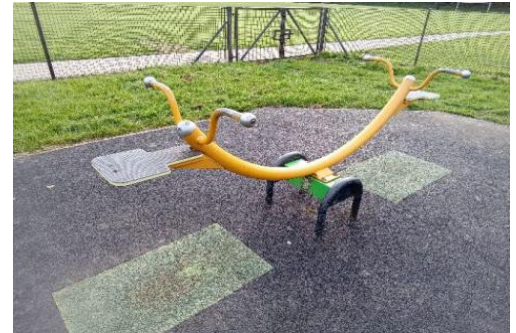
Item: See Saw
Manufacturer: Wicksteed Playgrounds
Surface Type: Wet Pour
Item Quantity: 1
Equipment Compliance: Yes
Surface Area Compliance: Yes
Life Expectancy: 5 -10 Years
Total Findings: 2

A number of fixing(s) have worked loose - Secure all loose fixings

The paintwork on this item has been damaged or worn exposing the metal underneath which is rusting / corroding - Treat affected areas and repaint

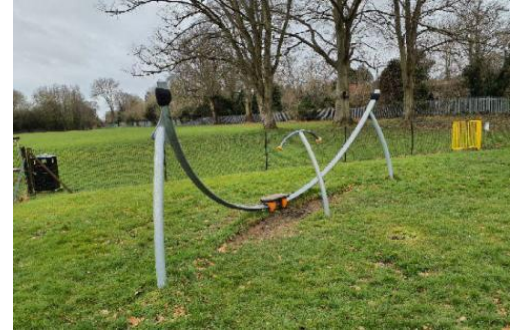
Item: Skate Unit
Manufacturer: Kompan Ltd
Surface Type: Grass Matrix Tiles
Item Quantity: 1
Equipment Compliance: Yes
Surface Area Compliance: Yes

The surface has subsided in some areas - Monitor for any further deterioration and repair as required

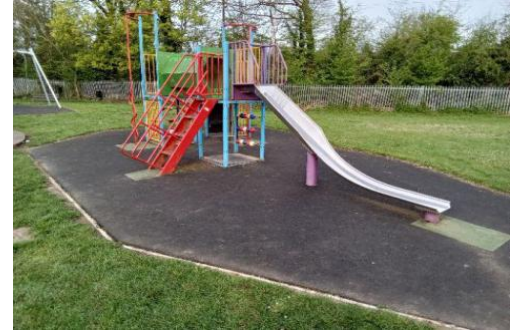
Item: Multi Play (Junior)
Manufacturer: Wicksteed Playgrounds
Surface Type: Wet Pour
Item Quantity: 1
Equipment Compliance: No
Surface Area Compliance: Yes
Life Expectancy: 5 -10 Years
Total Findings: 11

There is an opening in the barriers exceeding the width allowed (500mm) in BS EN 1176, this is a low risk failure and no remedial action is required - Monitor - No remedial work recommended

There are a number of dents in the slide surface - Monitor for any further deterioration and repair as required

The side of the slide is damaged - Monitor for any further deterioration and repair as required

There are areas or parts of the timber on the structure that have rotted - Replace all affected timbers

There is/are finger entrapment/s in the slide platform and the item fails to meet the requirements of BS EN 1176 Part 1 4.2.7.6 Entrapment of fingers - Monitor - No remedial work recommended

A number of fixing(s) have worked loose - Secure all loose fixings

There are post / end caps damaged from the item - Replace damaged post caps

Fixings are damaged and/or have sharp edges - Repair or replace as required

There is or are fixings missing on the item - Replace all missing fixings

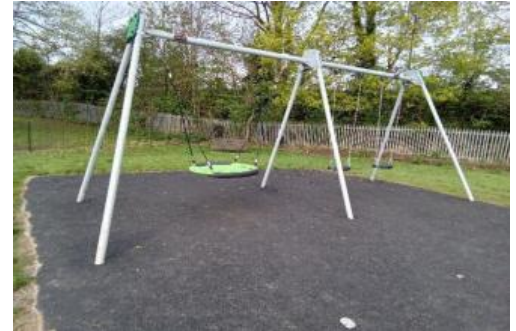
Item: 2 Bay 2 Flat 1 Basket Seat
Manufacturer: Kompan Ltd
Surface Type: Wet Pour
Item Quantity: 1
Equipment Compliance: Yes
Surface Area Compliance: Yes

Total Findings: 1

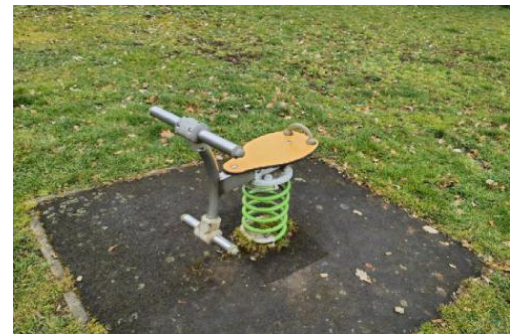
Item: Spring Bike
Manufacturer: Proludic
Surface Type: Wet Pour
Item Quantity: 1
Equipment Compliance: No
Surface Area Compliance: No
Life Expectancy: 3 - 5 Years
Total Findings: 6

The surfacing dimensions are short and do not meet with the requirements of the current applicable standard - Monitor - no remedial action recommended

The end of handgrips and/or footrests have a cross section of less than 15cm² and fail to meet the requirements of BS EN 1176 Part 6 - Monitor - No remedial work recommended

The spring clamps are loose - Tighten all loose fixings

The safety surface around the area is beginning to wear - Monitor for any further deterioration and repair as required

There are trip hazards at the edges of the surface - Reinstate surrounding surface levels to remove the trip points

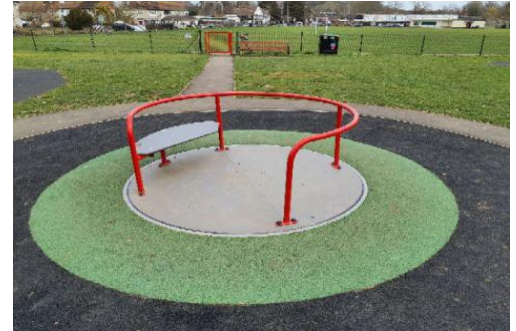
Item: Inclusive Roundabout
Manufacturer: Kompan Ltd
Surface Type: Wet Pour
Item Quantity: 1
Equipment Compliance: Yes
Surface Area Compliance: Yes

There is/are bolt cap covers missing or damaged on the item - Replace missing or damaged bolt cap covers

Roundabout is snagging against outer edge causing difficulty in rotating - Repair for rotation

There are trip hazards at the edges of the surface - Reinstate surrounding surface levels to remove the trip points

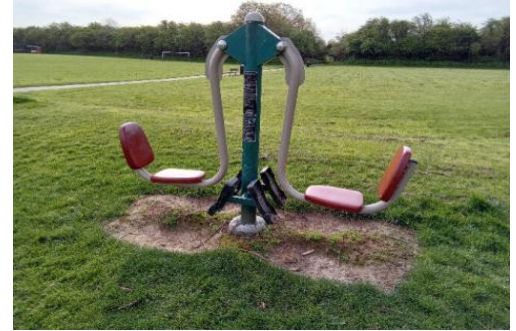
Item: Leg Press
Manufacturer: Fresh Air Fitness
Surface Type: Grass Matrix Tiles
Item Quantity: 1
Equipment Compliance: Yes
Surface Area Compliance: Yes
Life Expectancy: 5 -10 Years
Total Findings: 1

The surface has subsided in some areas - Monitor for any further deterioration and repair as required

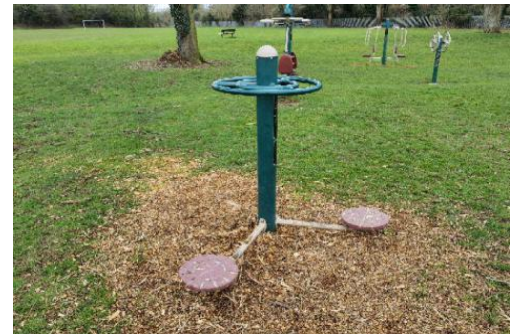
Item: Hip Twister
Manufacturer: Fresh Air Fitness
Surface Type: Grass Matrix Tiles
Item Quantity: 1
Equipment Compliance: No
Surface Area Compliance: Yes
Life Expectancy: 3 - 5 Years
Total Findings: 2

The deflection of the rotating user station exceeds the maximum 105 degrees required by BS EN 16630 - Monitor - No remedial work recommended

The rotating user station is not appropriately marked with a guideline of user direction and/or the original position as required by BS EN 16630 - Monitor - No remedial work recommended

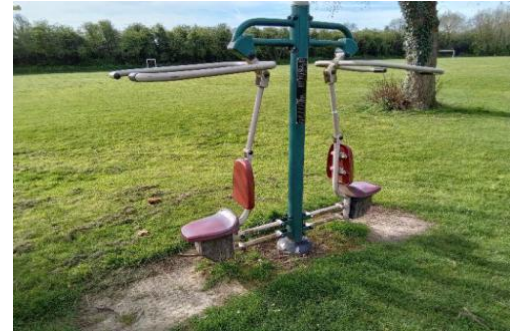
Item: Pull Down Challenger
Manufacturer: Fresh Air Fitness
Surface Type: Grass Matrix Tiles
Item Quantity: 1
Equipment Compliance: No
Surface Area Compliance: Yes
Life Expectancy: 5 -10 Years
Total Findings: 3

The distance between the underside of the item and the ground is less than the 60mm required by BS EN 16630 - Monitor - No remedial work recommended

One or more handgrip(s) are damaged or missing. - Replace missing or damaged handgrips

There is/are bolt cap covers missing or damaged on the item - Replace missing or damaged bolt cap covers

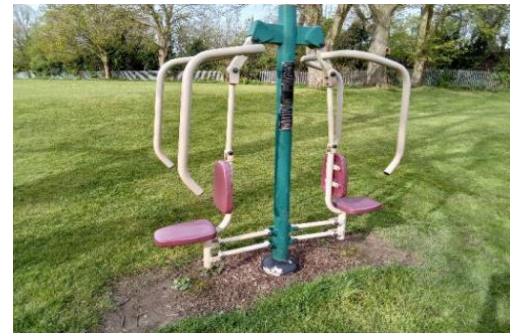
Item: Chest Press
Manufacturer: Fresh Air Fitness
Surface Type: Grass Matrix Tiles
Item Quantity: 1
Equipment Compliance: Yes
Surface Area Compliance: Yes
Life Expectancy: 5 -10 Years
Total Findings: 2

One or more handgrip(s) are damaged or missing. - Replace missing or damaged handgrips

The seat has been damaged - Monitor for any further deterioration and replace as required

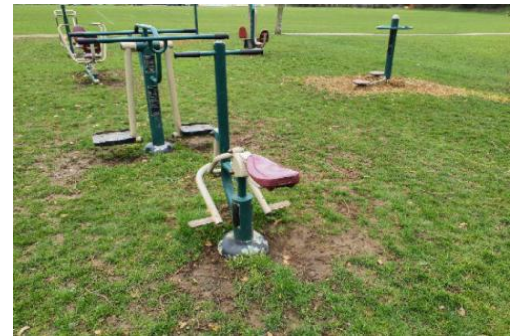
Item: Rider
Manufacturer: Fresh Air Fitness
Surface Type: Grass Matrix Tiles
Item Quantity: 1
Equipment Compliance: Yes
Surface Area Compliance: Yes
Life Expectancy: 5 -10 Years
Total Findings: 2

There are post / end caps missing from the item - Replace missing post caps

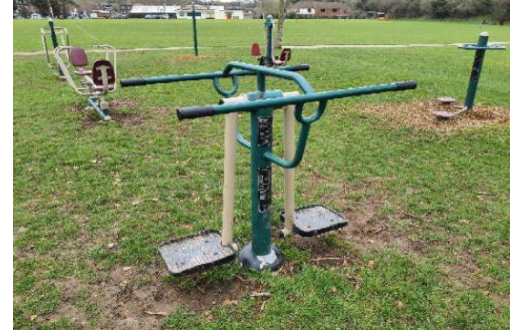
Item: Air Skier
Manufacturer: Fresh Air Fitness
Surface Type: Grass Matrix Tiles
Item Quantity: 1
Equipment Compliance: Yes
Surface Area Compliance: Yes
Life Expectancy: 5 -10 Years
Total Findings: 1

The paintwork on this item has been damaged or worn exposing the metal underneath which is rusting / corroding - Treat affected areas and repaint

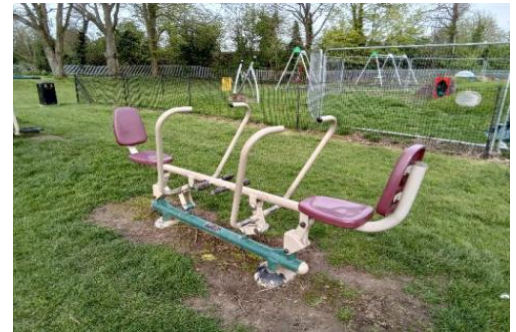
Item: Rower
Manufacturer: Fresh Air Fitness
Surface Type: Grass Matrix Tiles
Item Quantity: 1
Equipment Compliance: Yes
Surface Area Compliance: Yes
Life Expectancy: 5 -10 Years
Total Findings: 2

The paintwork on this item has been damaged or worn exposing the metal underneath which is rusting / corroding - Treat affected areas and repaint

One or more handgrip(s) are damaged or missing. - Replace missing or damaged handgrips

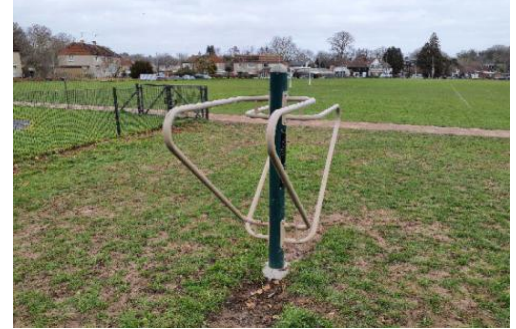
Item: Dip Station
Manufacturer: Fresh Air Fitness
Surface Type: Grass Matrix Tiles
Item Quantity: 1
Equipment Compliance: Yes
Surface Area Compliance: Yes
Life Expectancy: 5 -10 Years
Total Findings: 1

The paintwork on this item has been damaged or worn exposing the metal underneath which is rusting / corroding - Treat affected areas and repaint

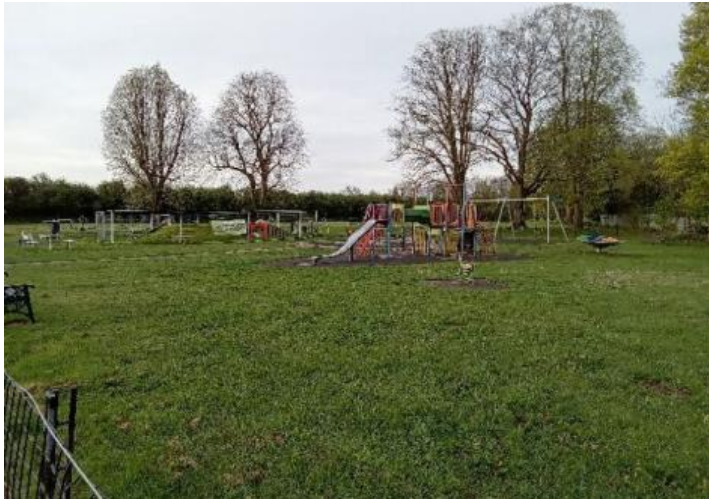
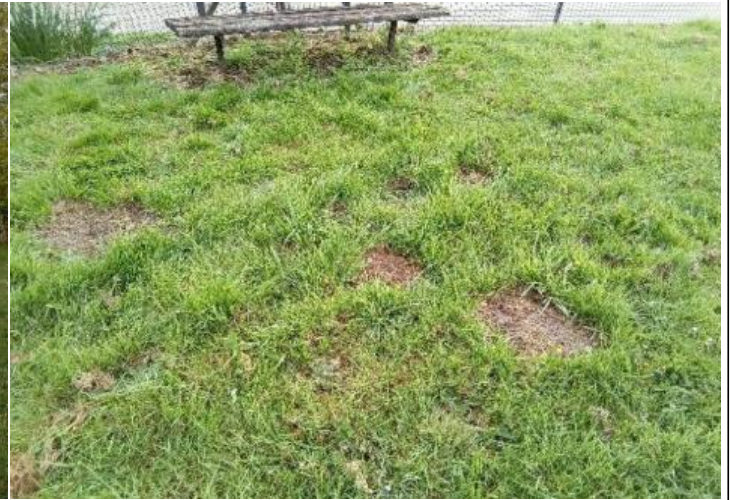
Finding: There are holes in surface that may have been created purposely by users.

Action: Infill to provide a sound reasonably level surface.

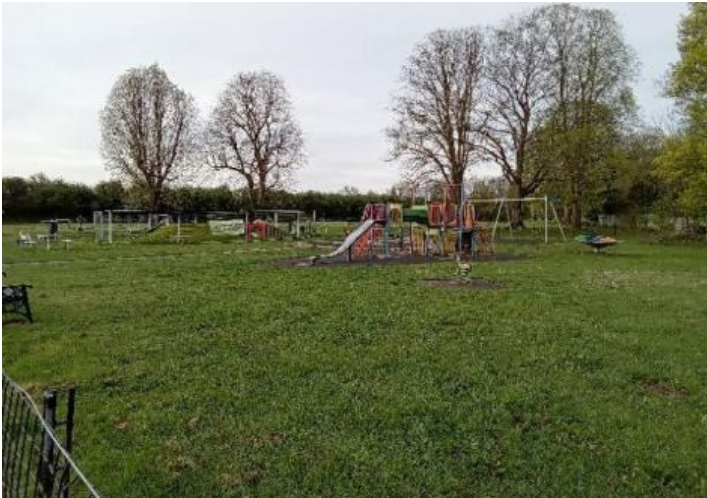
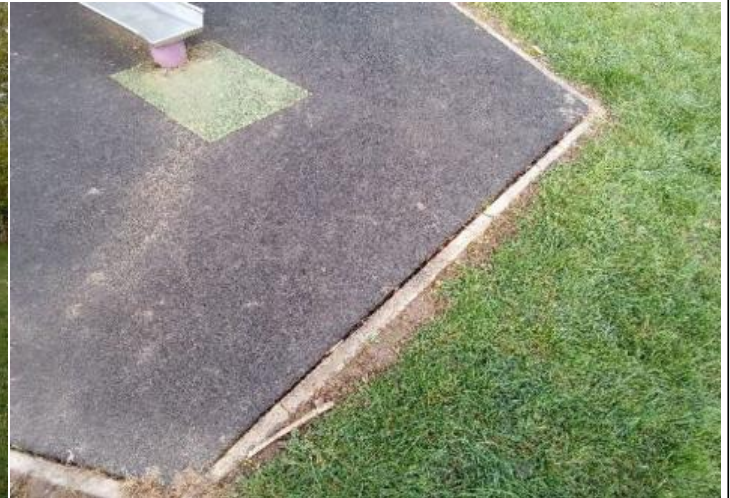
Finding: There are gaps opening between the surfacing and the edging surround or between the joints in the surfacing
Action: Monitor for any further deterioration and repair as required

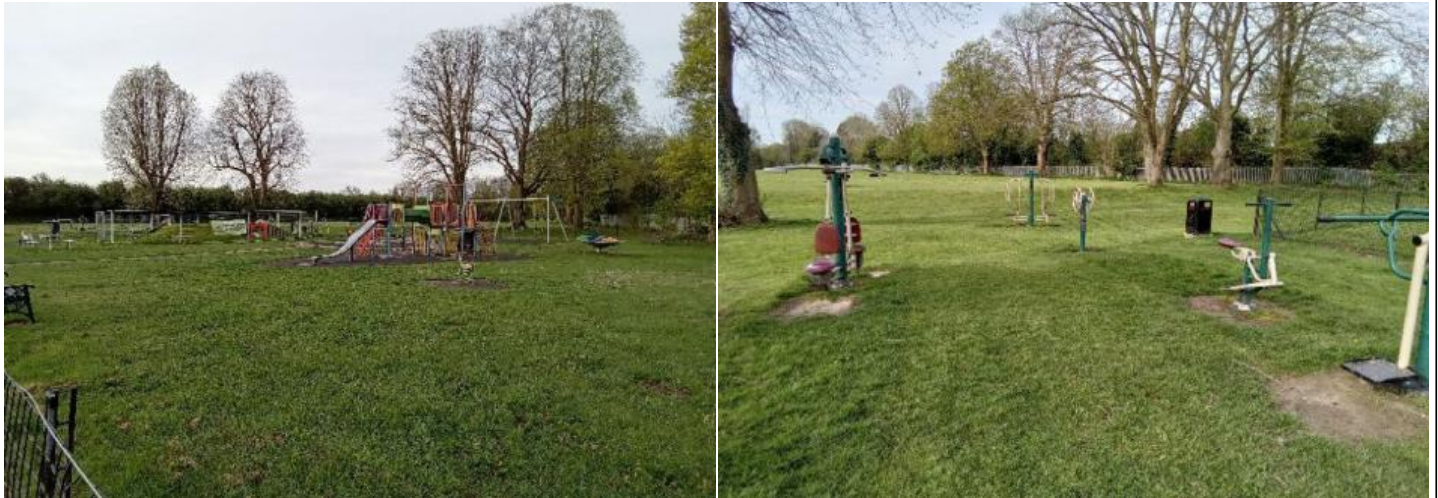
Finding: Signage should be provided for the outdoor fitness equipment in accordance with the requirements of BS EN 16630, key requirements of the sign include, but are not limited to, intended users, medical safety and emergency contact details
Action: Provide appropriate signage

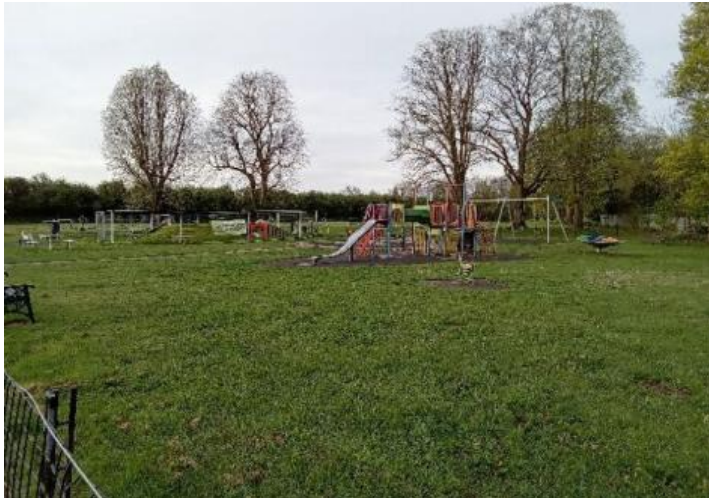
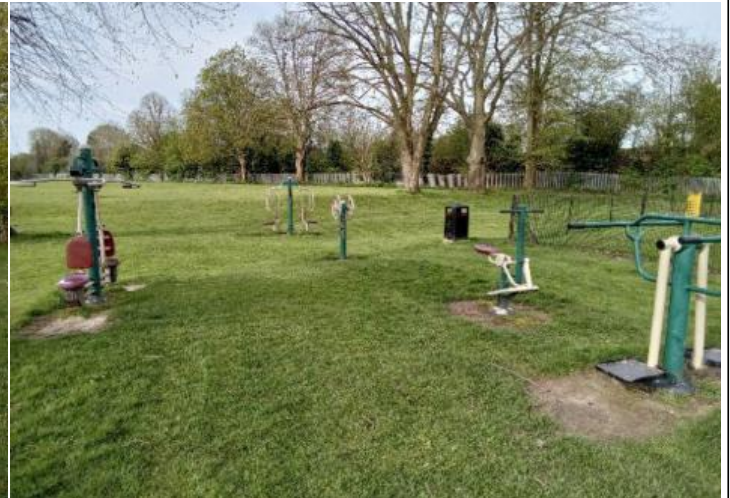
Finding: It is recommended that Adult Outdoor Fitness equipment is installed a minimum of 25m away from a childrens playground or separated and screened to discourage access by younger children

Action: Monitor use and review risk assessment regularly

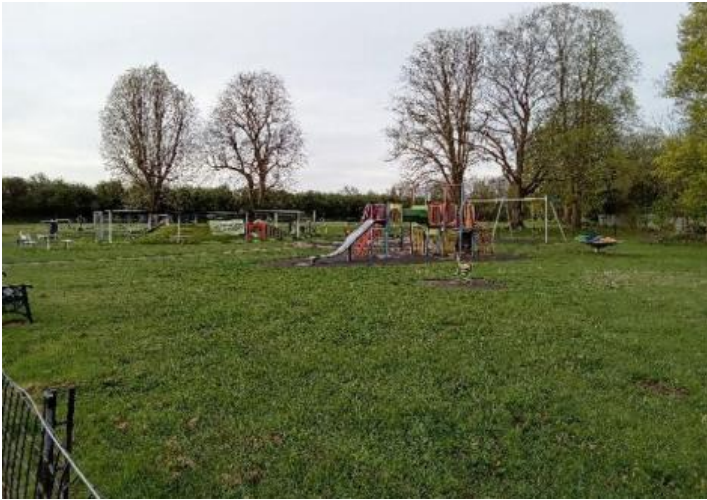
Finding: The surface has eroded in some areas and may be slippery in wet conditions
Action: Reinstate the surface

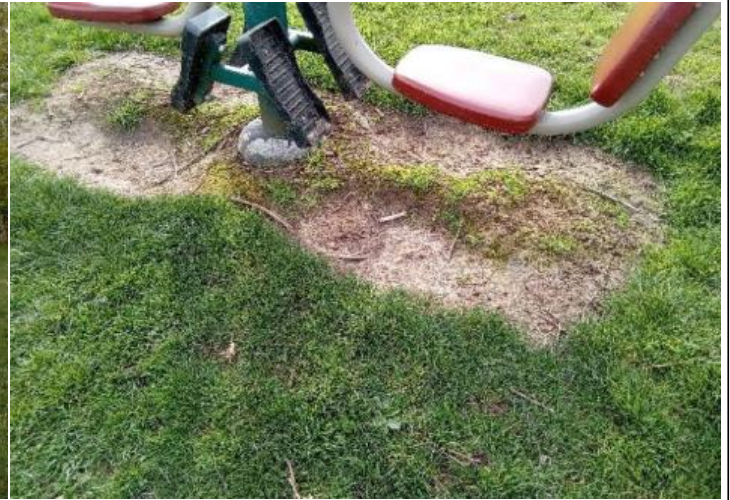
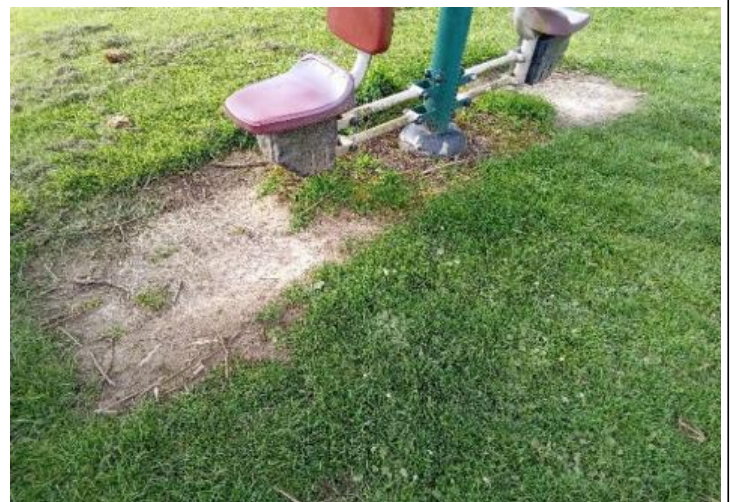
Finding: The grass mats are silted up, the soil is compacted and the area will become very slippery when the soil is wet. **Action:** Reinstate as required

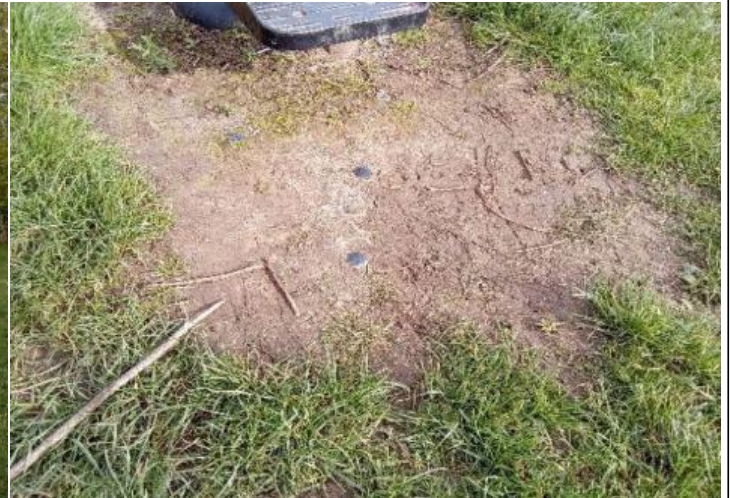
Finding: Fixing Pins have been installed in the impact areas of the grass mats
Action: Remove pins from impact areas

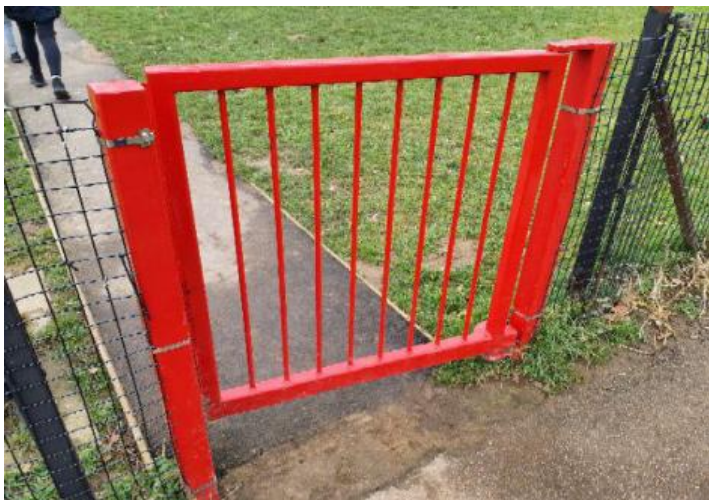
Finding: There is some minor damage to the surface

Action: Monitor for any further deterioration and repair as required

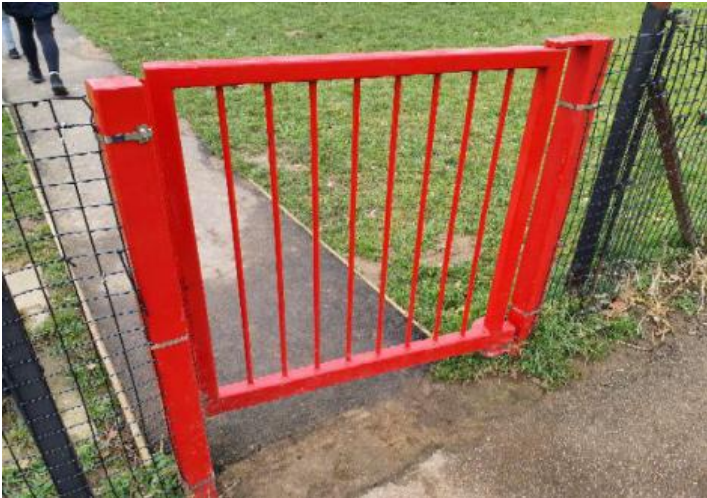
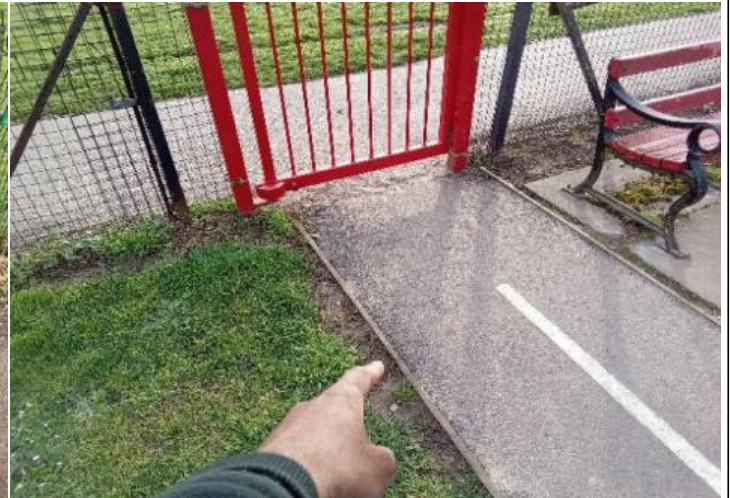
Finding: There are trip hazards at the edges of the surface
Action: Reinstate surrounding surface levels to remove the trip points

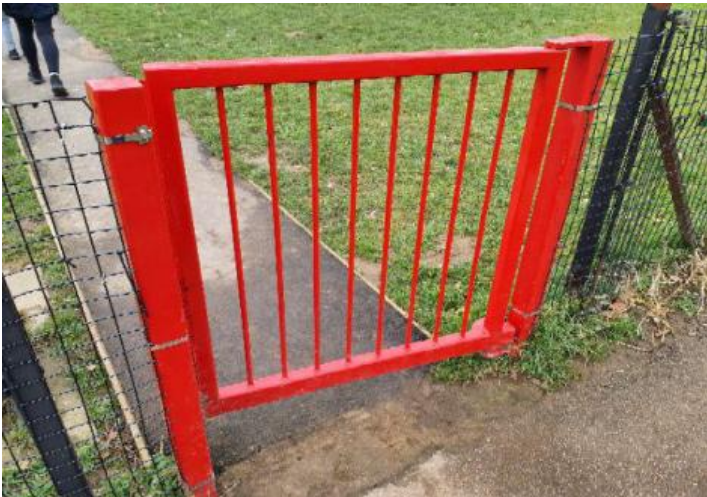
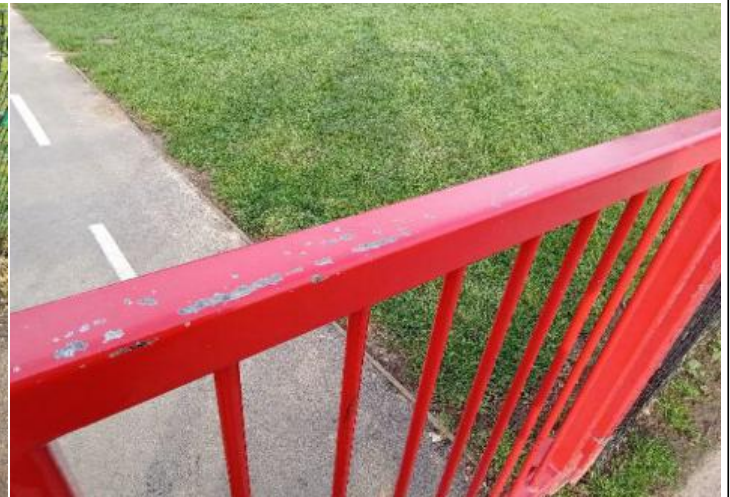
Finding: The paint is flaking off the metalwork
Action: Rub down and re-paint

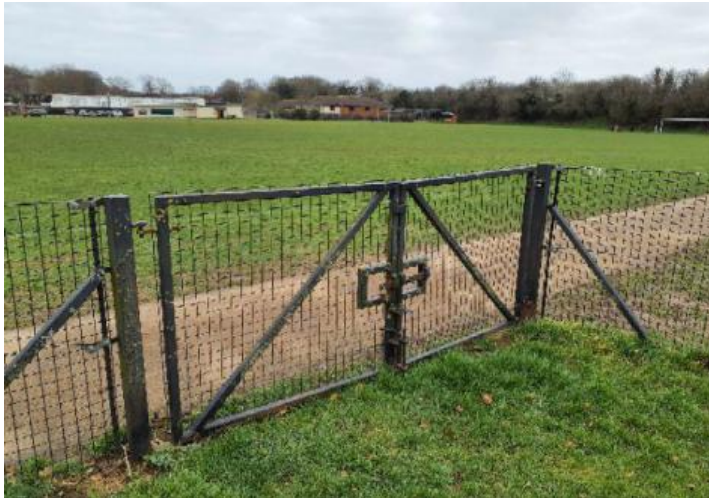
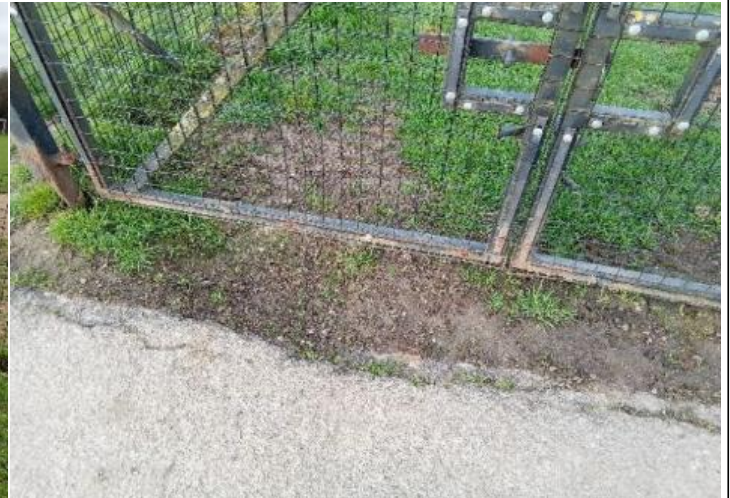
Finding: The area under the gate has eroded leaving uneven areas, or the concrete foundations exposed, resulting in trip hazards at the entrance/exit to the playground

Action: Reinstate to level with surrounding surfaces

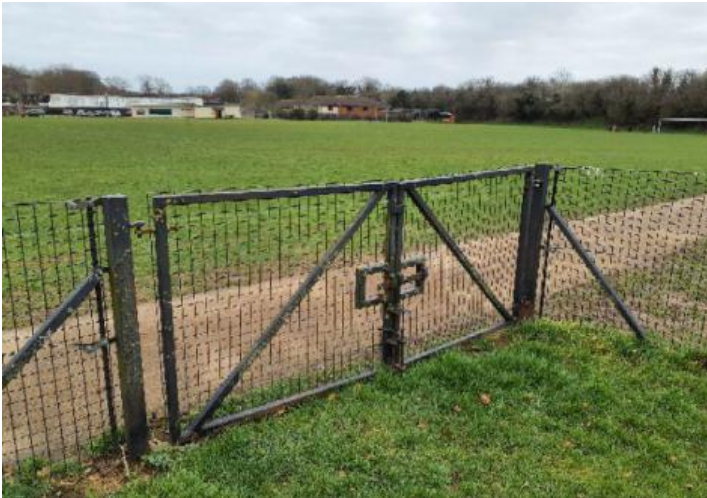
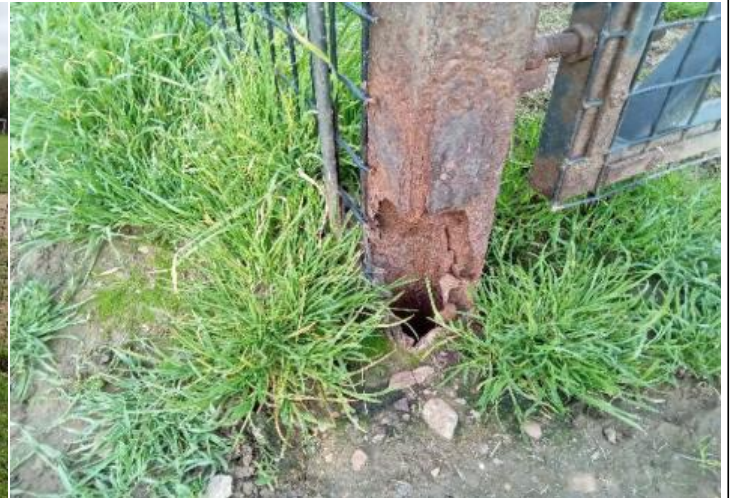
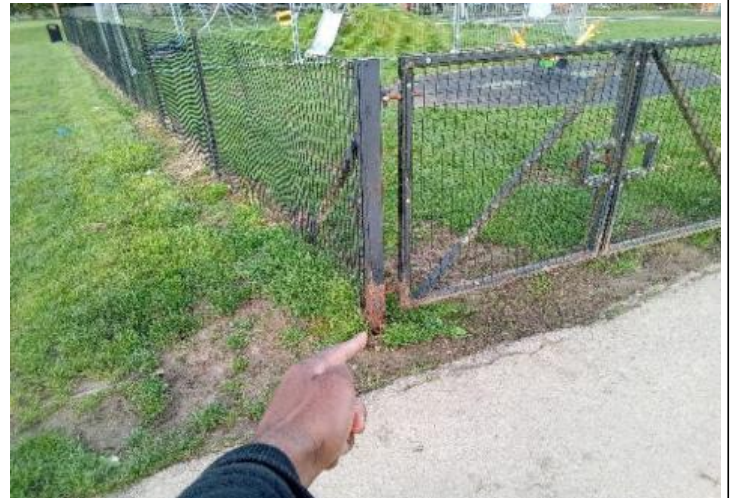
Finding: Parts of the steel on this item have corroded excessively and the metal has perforated in places

Action: Ensure all affected areas are treated and repaired

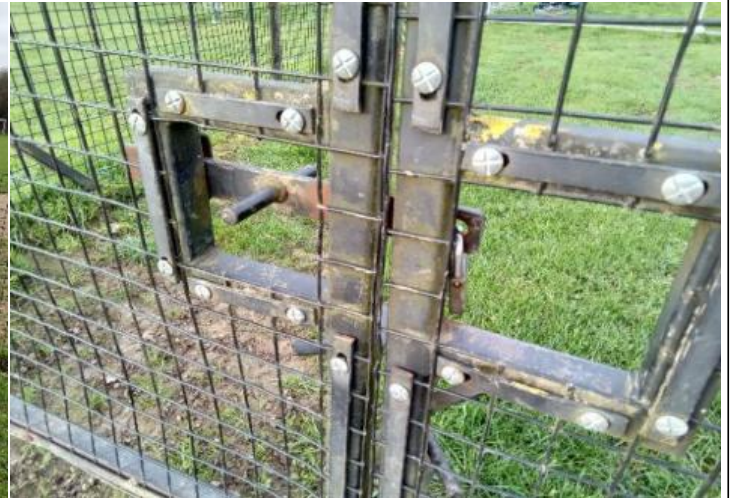
Finding: The maintenance gate was correctly padlocked at the time of inspection, however this means that the inspector was unable to fully assess the gate

Action: Ensure that there are 12mm gaps throughout the full range of motion on gate/s and between leaves where relevant

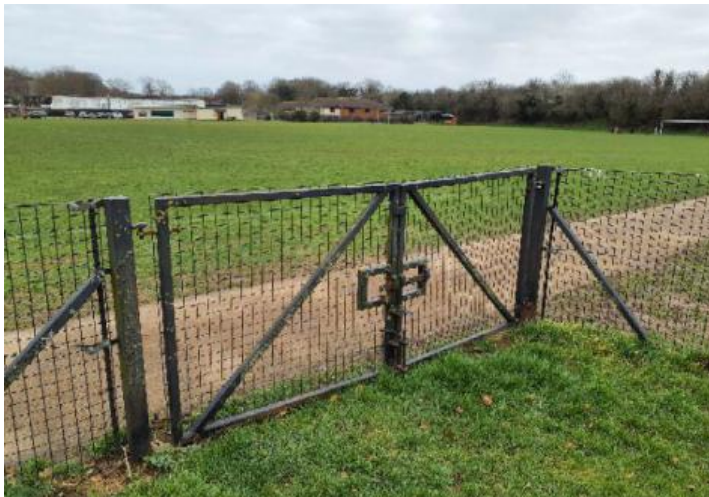
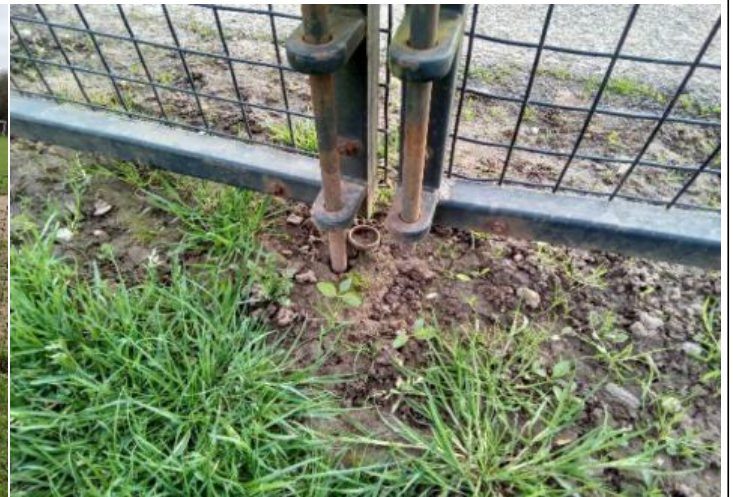
Finding: The gate has no drop bolt sleeves and/or drop bolts fitted

Action: Provide drop bolt sleeves and/or drop bolts

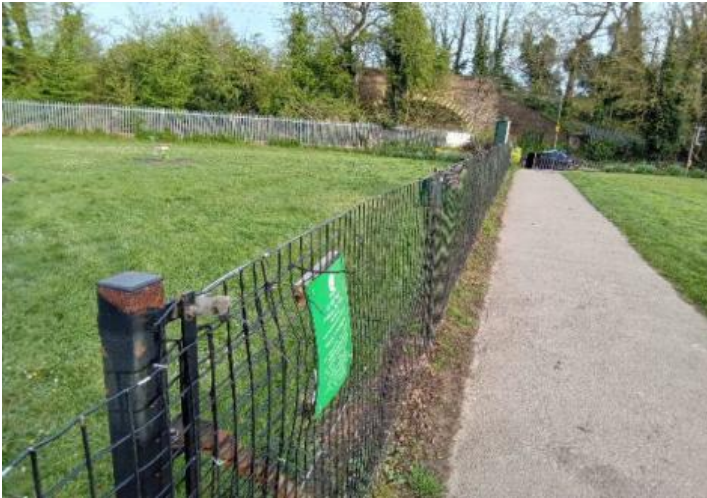
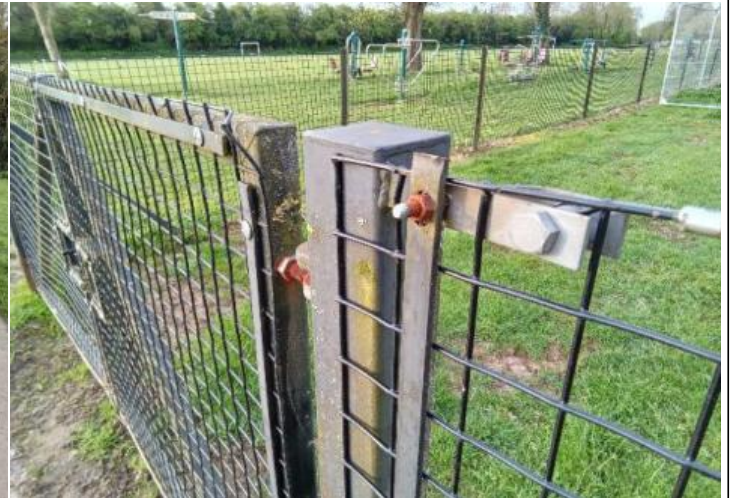
Item: Fences - Fence - Steel Mesh
Manufacturer: Owner/Operator

Finding: There are projecting bolt thread(s) present

Action: Remove excess thread length and deburr or provide cap

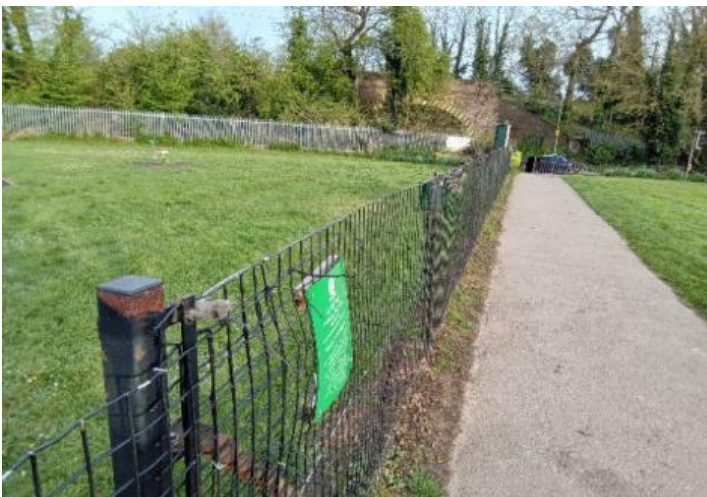
Item: Fences - Fence - Steel Mesh
Manufacturer: Owner/Operator

Finding: Cable ties have been used on the item and there are sharp projecting ends

Action: Remove if not required or replace with a more appropriate alternative fixing method if used as a fixing

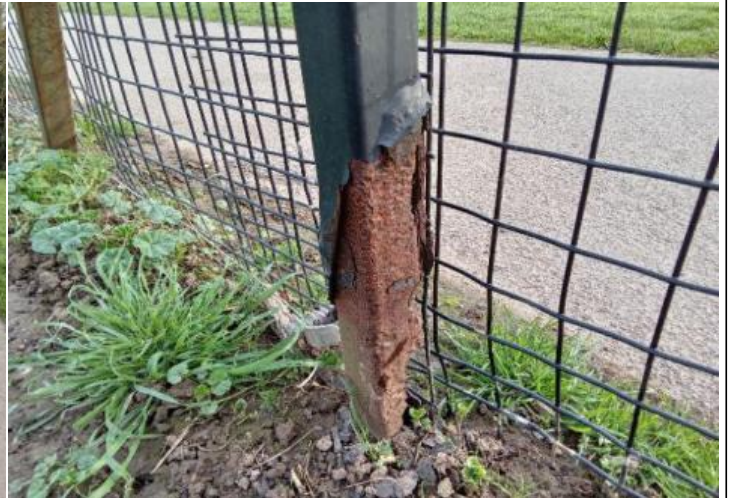
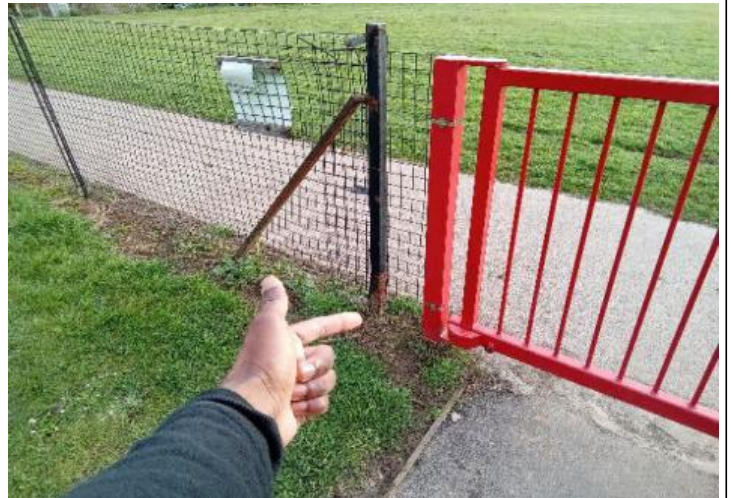
Item: Fences - Fence - Steel Mesh
Manufacturer: Owner/Operator

Finding: Parts of the steel on this item have corroded excessively and the metal has perforated in places

Action: Ensure all affected areas are treated and repaired

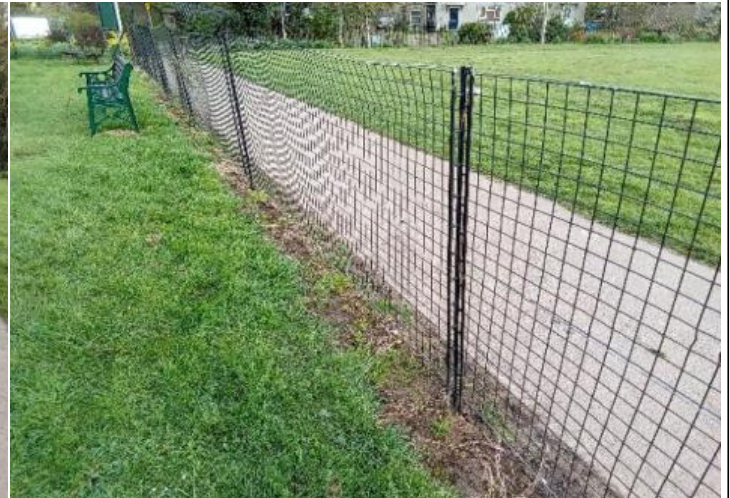
Item: Fences - Fence - Steel Mesh
Manufacturer: Owner/Operator

Finding: There are a number of loose posts around the fence

Action: Monitor for any further deterioration and reset as required
