ST STEPHEN PARISH COUNCIL

You are summoned to the Fixed Assets Committee meeting
To take place on **Thursday 30 May 2024 at 7.30pm**
at St Stephen Suite, Parish Centre, Station Road, Bricket Wood, AL2 3PJ

- 2425/AC/07 To receive Annual Play Inspection Report and Grounds Team Action Report. Play Reports and Grounds Team Report attached.**
- 2425/AC/08 To discuss the option of creating additional allotment plots and possible beginner plots at Watford Road allotment site or North Close. Allotment report attached.**

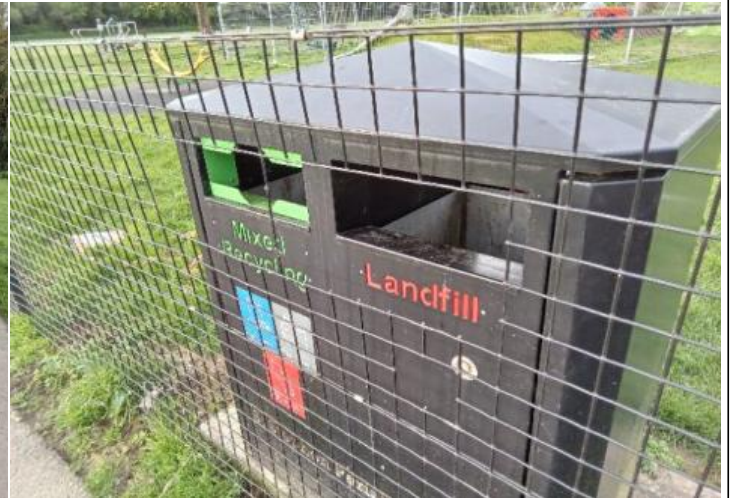
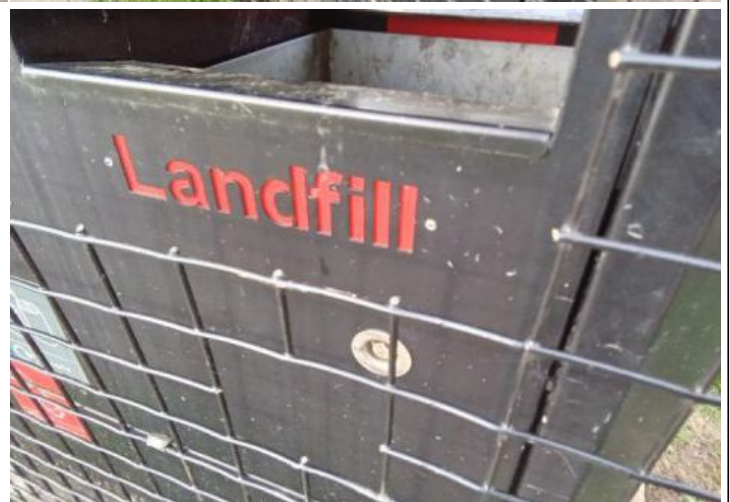
Item: Fences - Fence - Steel Mesh
Manufacturer: Owner/Operator

Finding: The fence panel has been cut to allow access to the litter bin from the outside of the play area. The cut sections have projections and sharp edges

Action: Remove projections and sharp edges

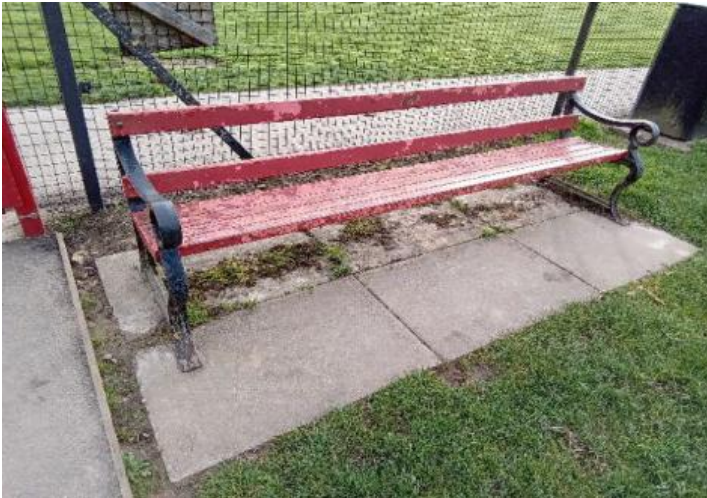
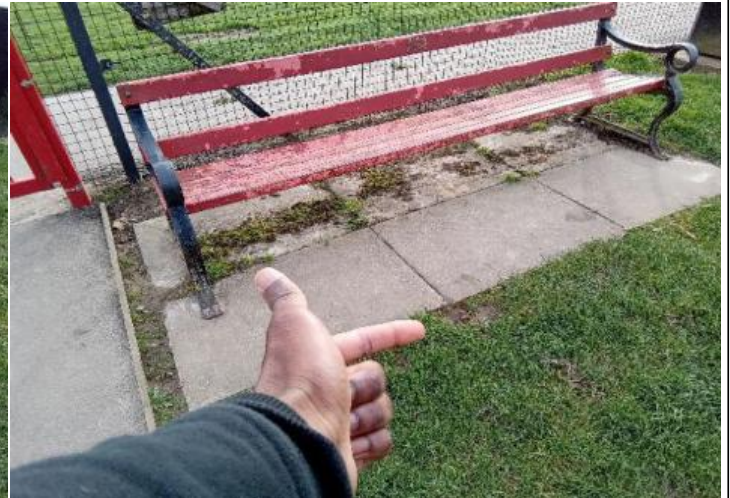
Item: Ancillary Items - Bench
Manufacturer: Owner/Operator

Finding: There are trip hazards at the edges of the surface

Action: Reinstate surrounding surface levels to remove the trip points

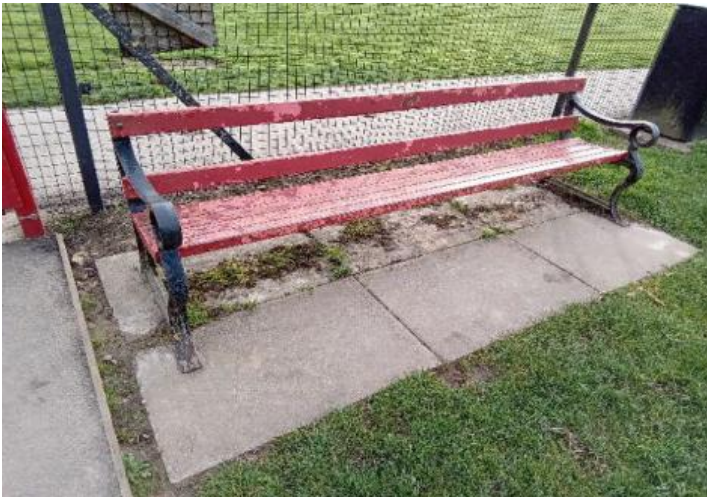
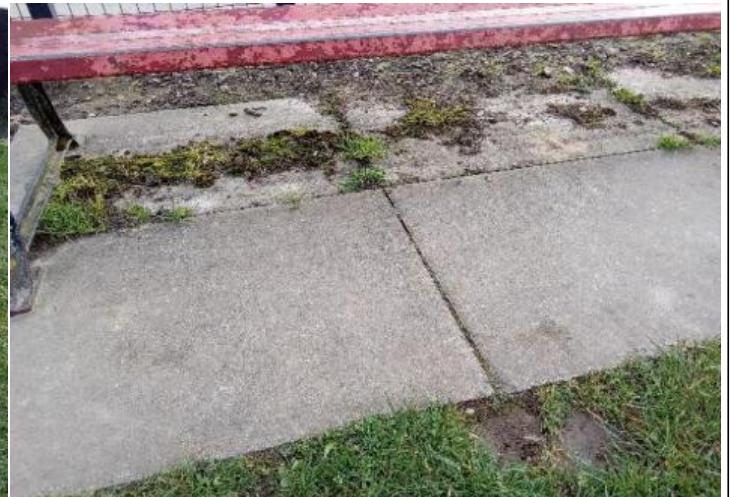
Item: Ancillary Items - Bench
Manufacturer: Owner/Operator

Finding: There is algae, silt or moss growth on the surface resulting in slippery conditions

Action: Clean and treat appropriately

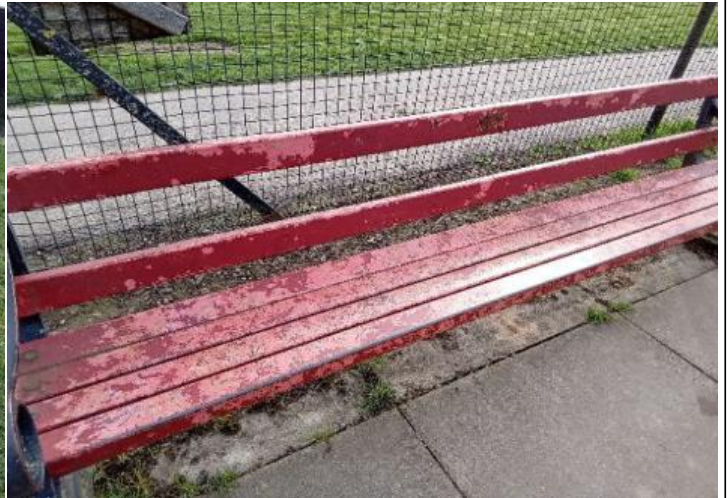
Item: Ancillary Items - Bench
Manufacturer: Owner/Operator

Finding: The paint is flaking off the metalwork

Action: Rub down and re-paint

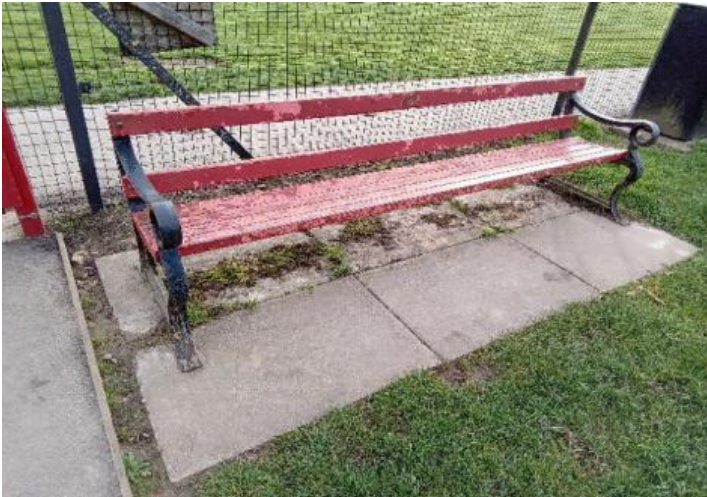
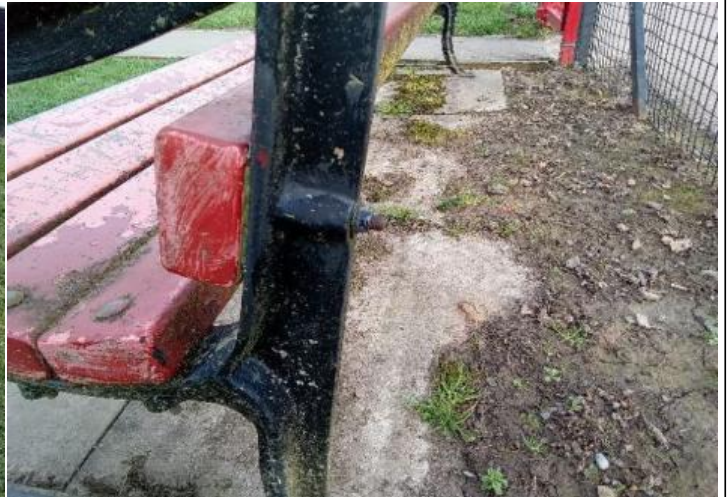
Item: Ancillary Items - Bench
Manufacturer: Owner/Operator

Finding: There are projecting bolt thread(s) present

Action: Remove excess thread length and deburr or provide cap

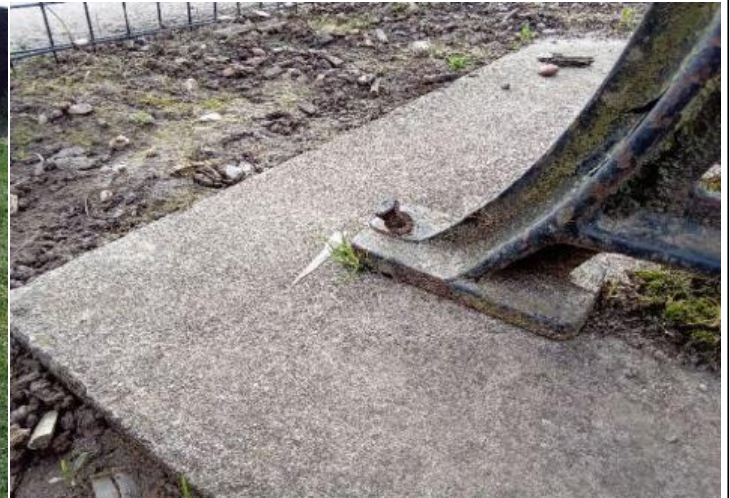
Item: Ancillary Items - Bench
Manufacturer: Owner/Operator

Finding: A number of fixing(s) have worked loose

Action: Secure all loose fixings

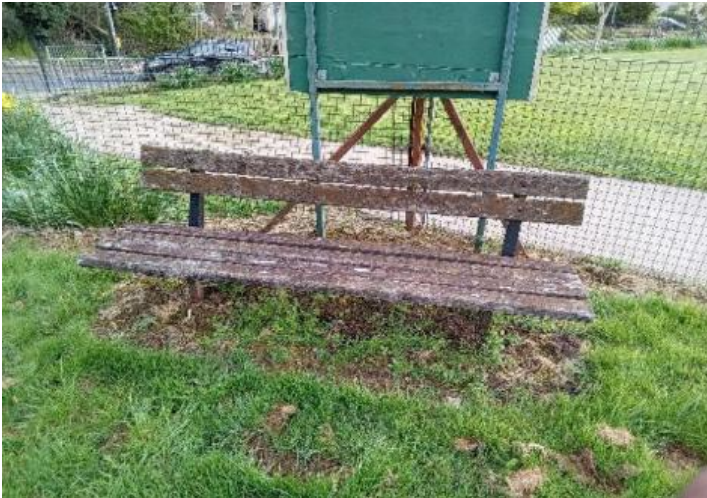
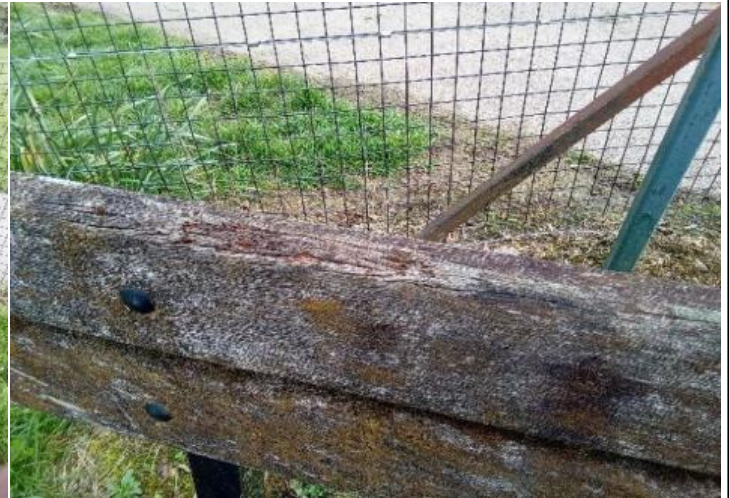
Item: Ancillary Items - Bench
Manufacturer: Owner/Operator

Finding: There is some evidence of rot in the timber

Action: Monitor for any further deterioration and replace as required

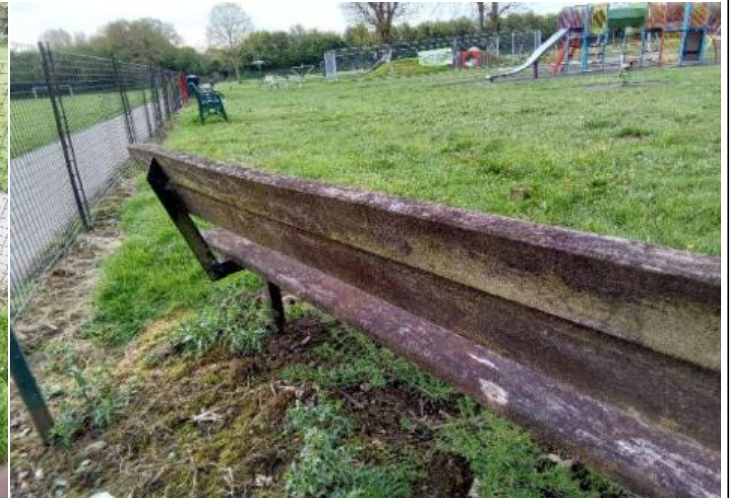
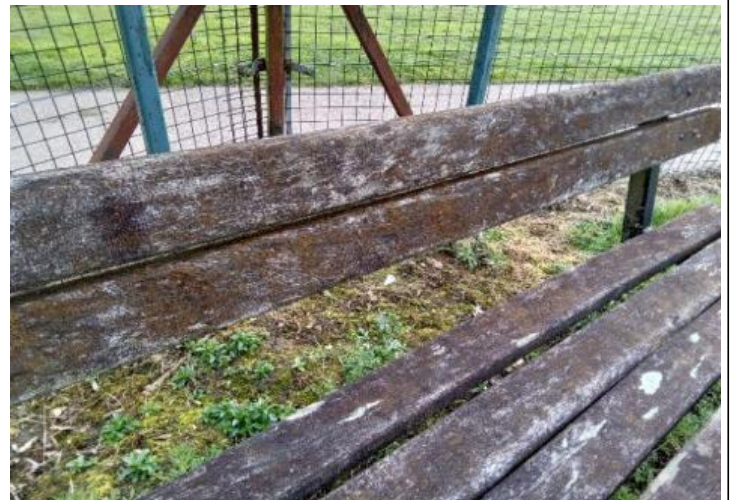
Item: Ancillary Items - Bench
Manufacturer: Owner/Operator

Finding: There is algae or moss on the surface of the equipment

Action: Clean and treat appropriately

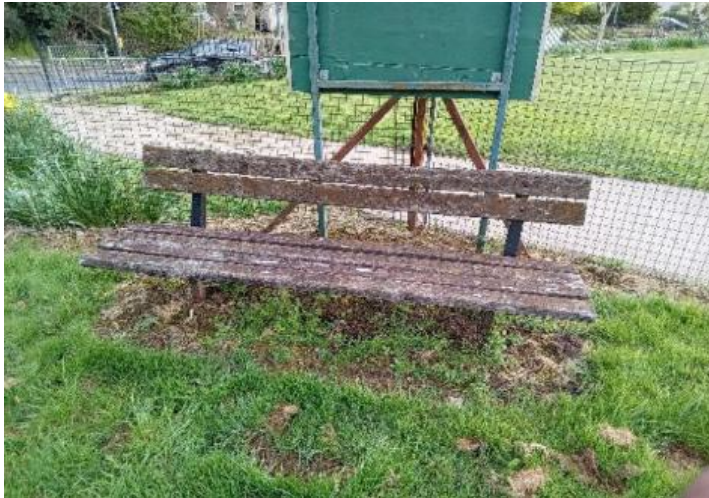
Item: Ancillary Items - Bench
Manufacturer: Owner/Operator

Finding: The item is slightly loose in its foundations

Action: Monitor for any further deterioration and repair as required

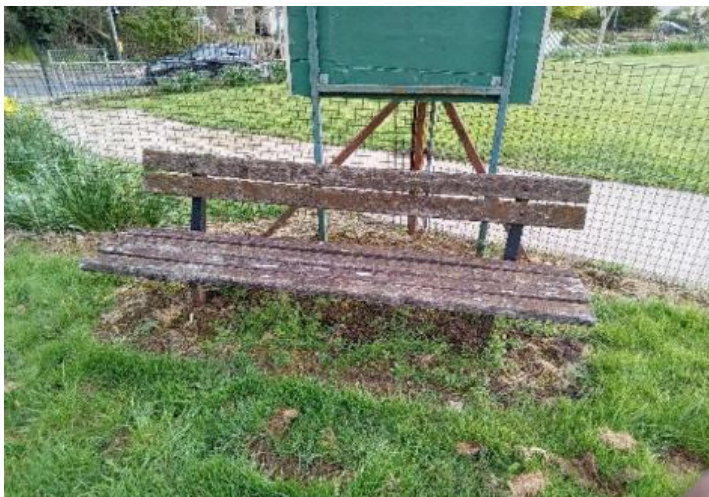
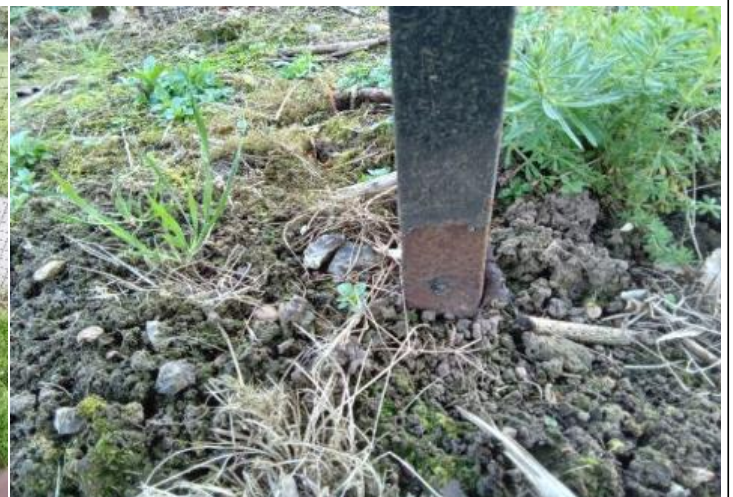
Item: Ancillary Items - Bench
Manufacturer: Owner/Operator

Finding: The paint is flaking off the metalwork

Action: Rub down and re-paint

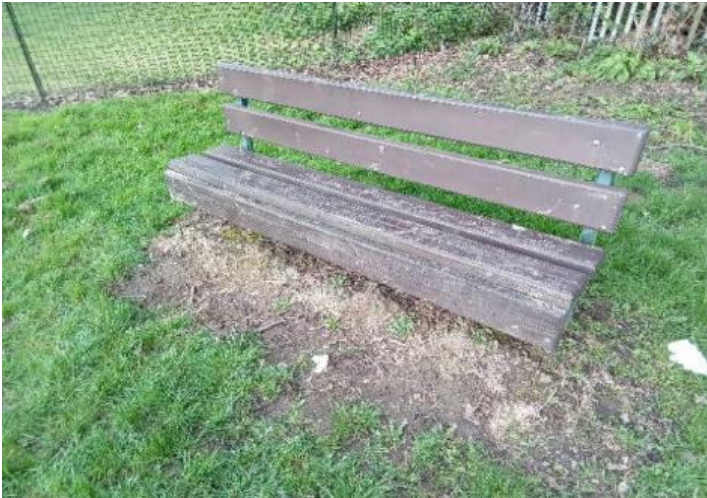
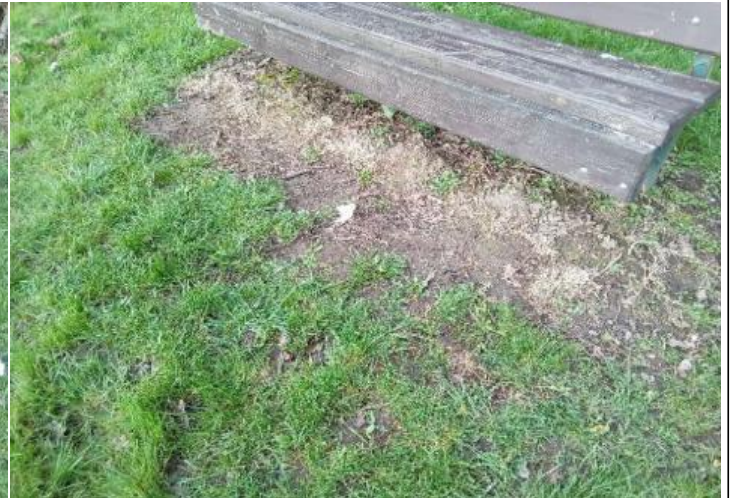
Item: Ancillary Items - Bench
Manufacturer: Not Identified

Finding: The surface has eroded in some areas and may be slippery in wet conditions
Action: Reinststate the surface

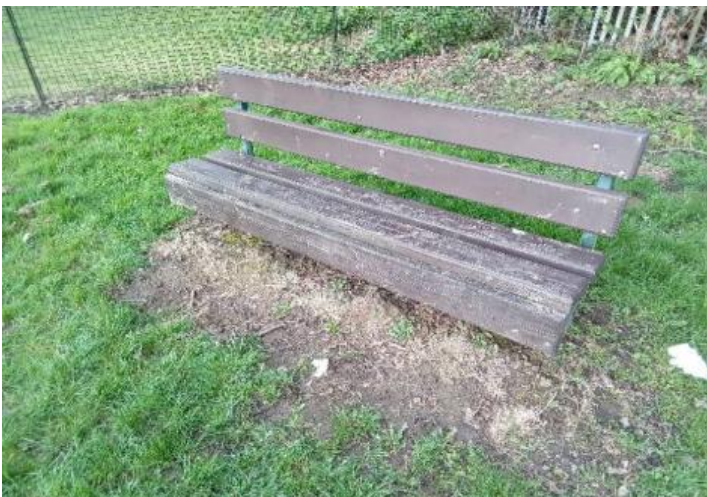
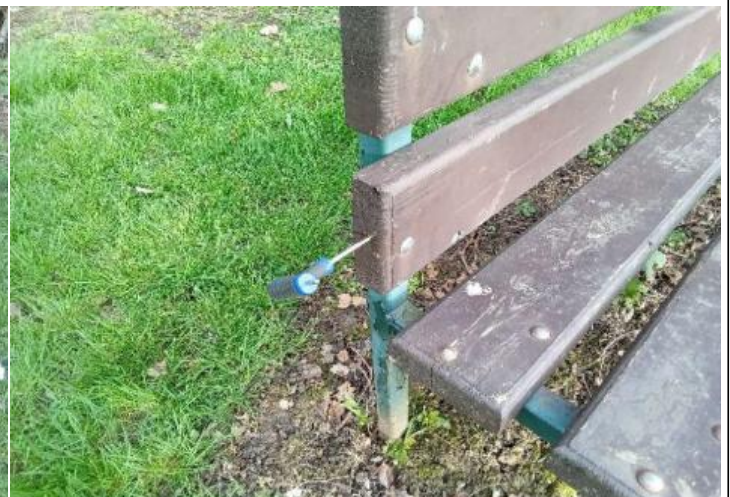
Item: Ancillary Items - Bench
Manufacturer: Not Identified

Finding: There is some evidence of rot in the timber

Action: Monitor for any further deterioration and replace as required

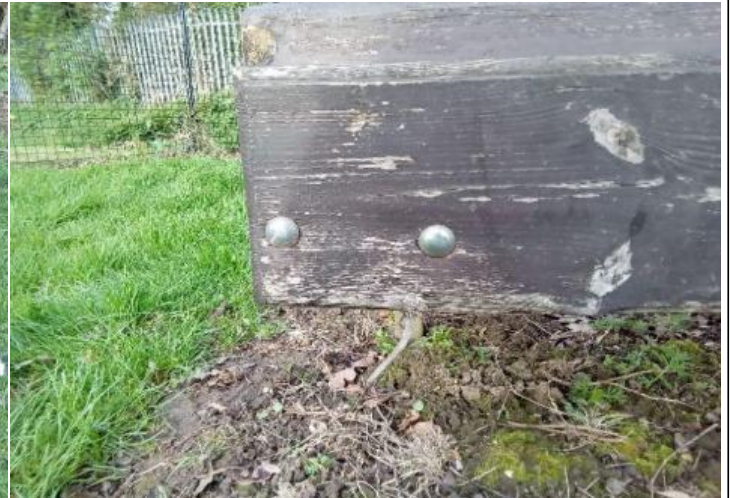
Item: Ancillary Items - Bench
Manufacturer: Not Identified
Risk Level: L - Low Risk
Surface: Grass

Finding: Parts of the timber are rough or splintered

Action: Remove all rough or sharp edges

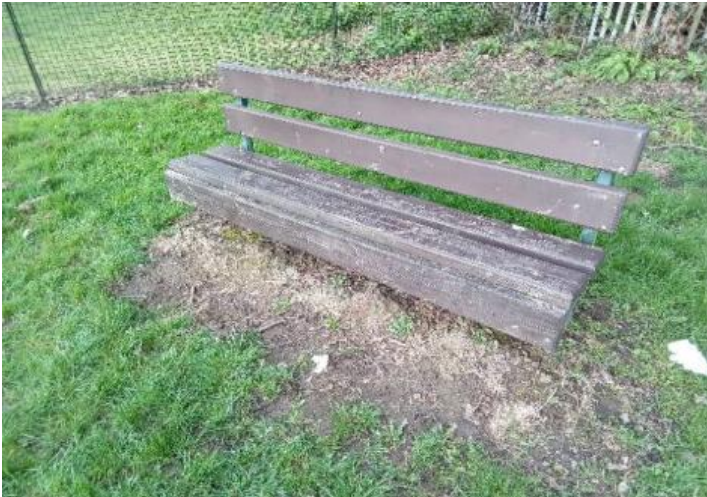
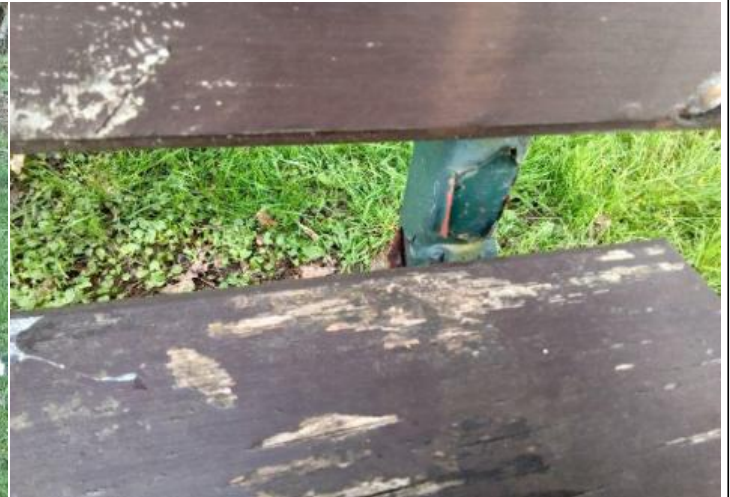
Item: Ancillary Items - Bench
Manufacturer: Not Identified
Risk Level: L - Low Risk
Surface: Grass

Finding: The paint is flaking off the metalwork

Action: Rub down and re-paint

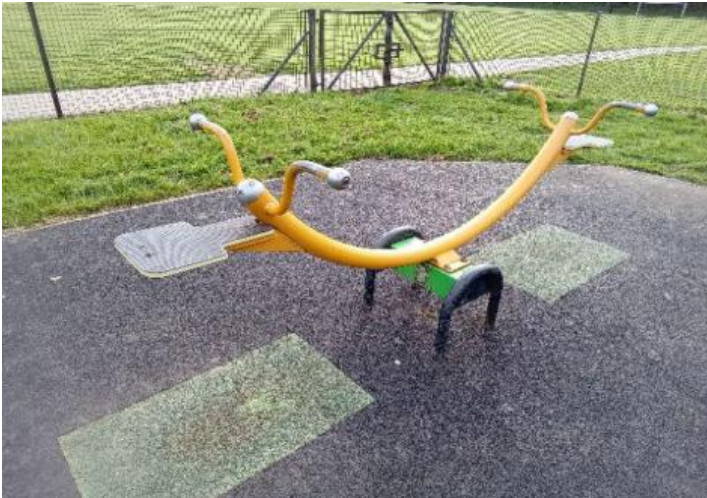
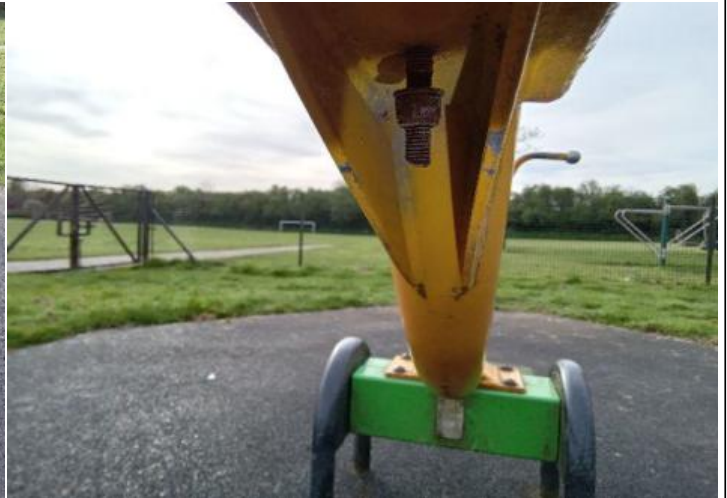
Item: Rocking Equipment - See Saw
Manufacturer: Wicksteed Playgrounds

Finding: A number of fixing(s) have worked loose

Action: Secure all loose fixings

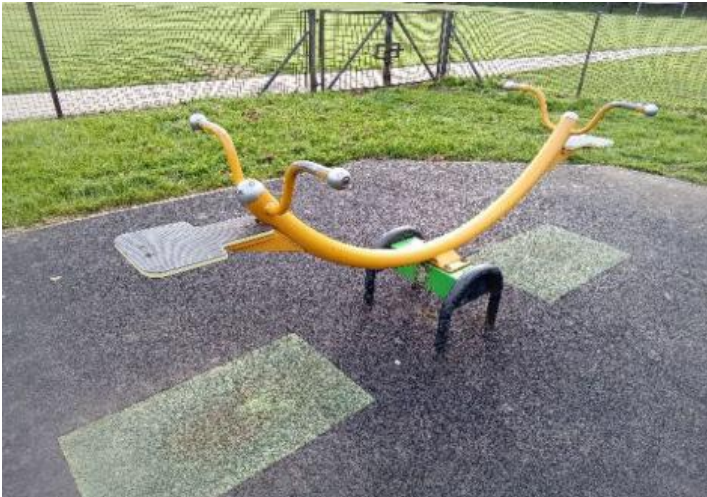
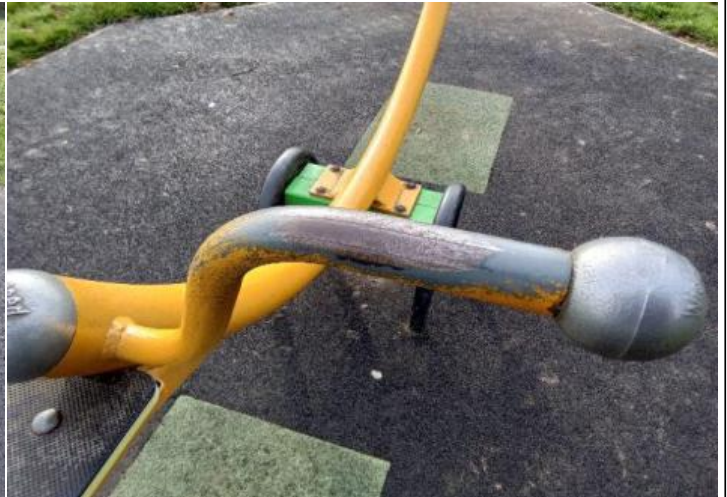
Item: Rocking Equipment - See Saw
Manufacturer: Wicksteed Playgrounds

Finding: The paintwork on this item has been damaged or worn exposing the metal underneath which is rusting / corroding

Action: Treat affected areas and repaint

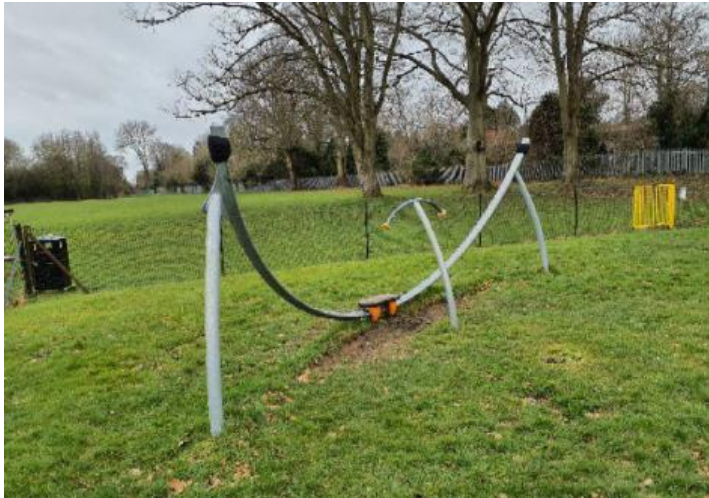
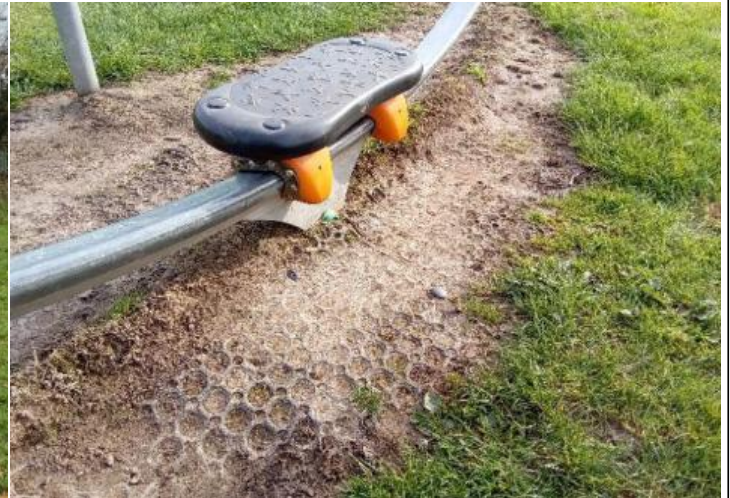
Item: Activity Equipment - Skate Unit
Manufacturer: Kompan Ltd

Finding: Fixing Pins have been installed in the impact areas of the grass mats
Action: Remove pins from impact areas

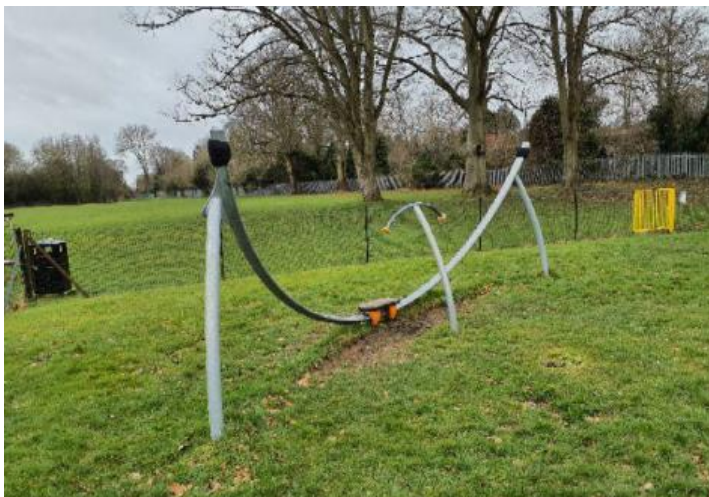
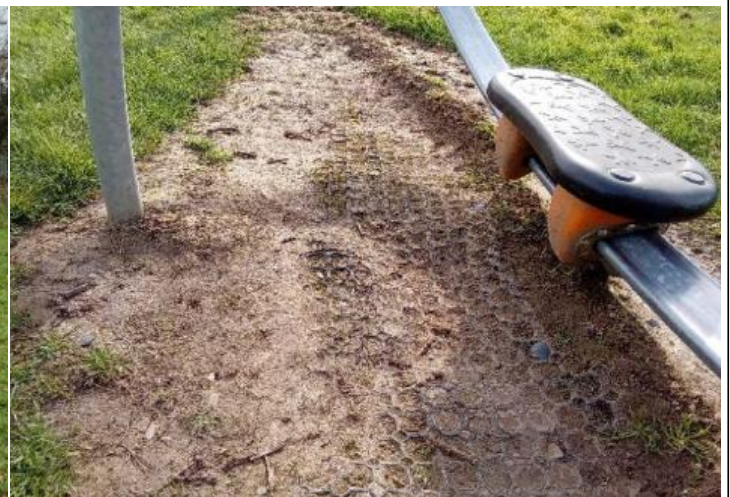
Item: Activity Equipment - Skate Unit
Manufacturer: Kompan Ltd

Finding: The surface has subsided in some areas
Action: Monitor for any further deterioration and repair as required

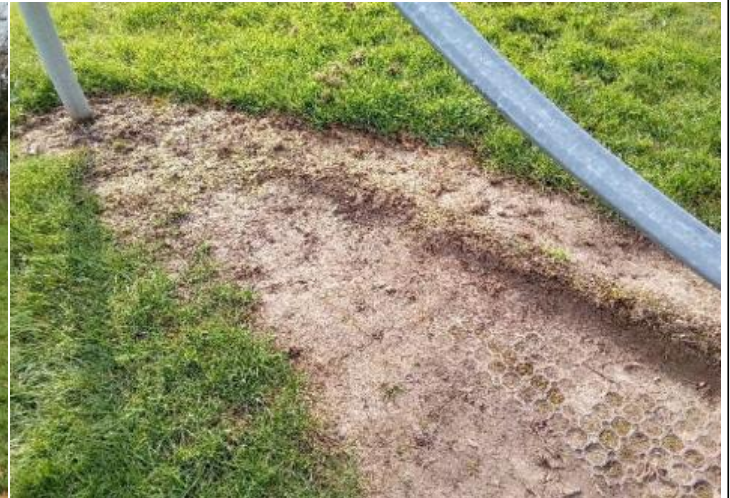
Item: Activity Equipment - Skate Unit
Manufacturer: Kompan Ltd

Finding: The grass mats are silted up, the soil is compacted and the area will become very slippery when the soil is wet. **Action:** Reinstate as required

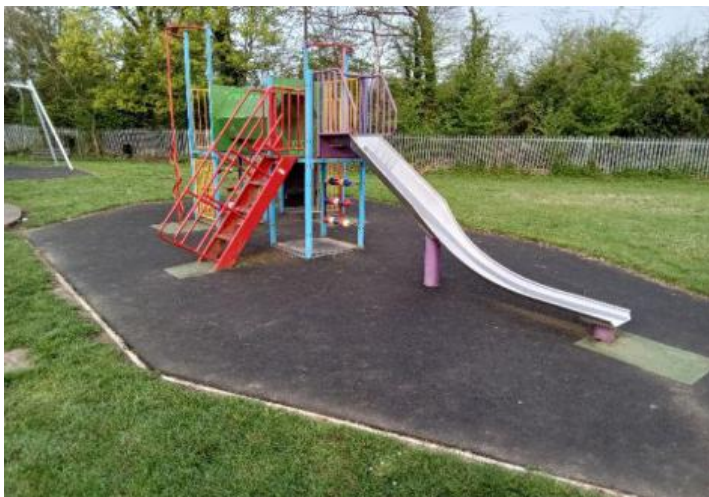
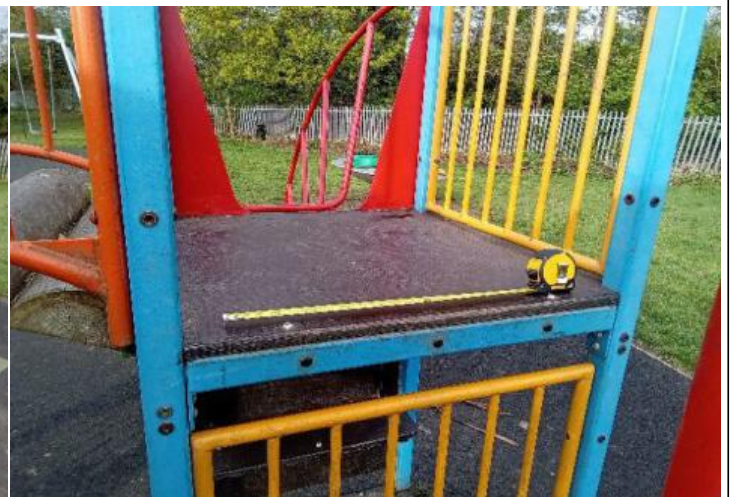
Item: Activity Equipment - Multi Play (Junior)
Manufacturer: Wicksteed Playgrounds

Finding: There is an opening in the barriers exceeding the width allowed (500mm) in BS EN 1176, this is a low risk failure and no remedial action is required **Action:** Monitor - No remedial work recommended

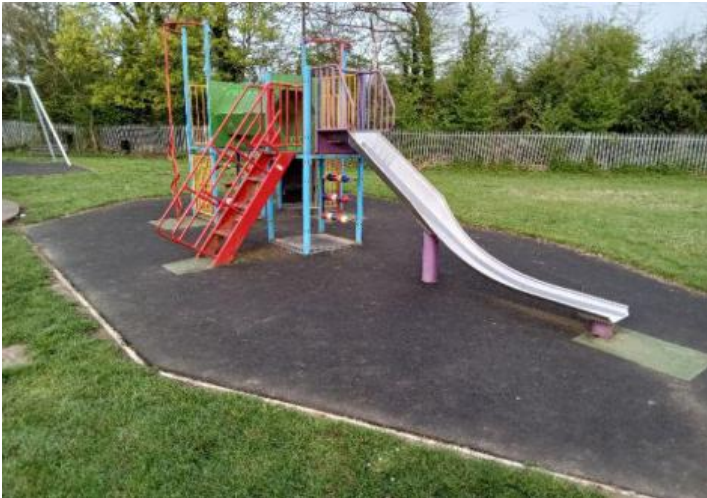
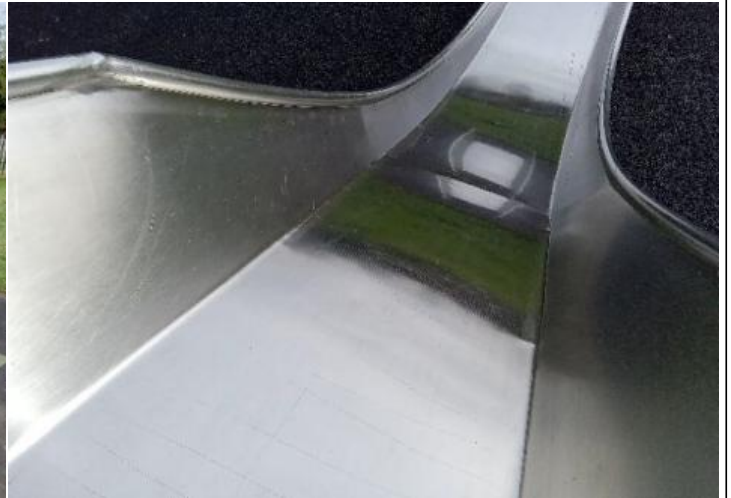
Item: Activity Equipment - Multi Play (Junior)
Manufacturer: Wicksteed Playgrounds

Finding: There are a number of dents in the slide surface

Action: Monitor for any further deterioration and repair as required

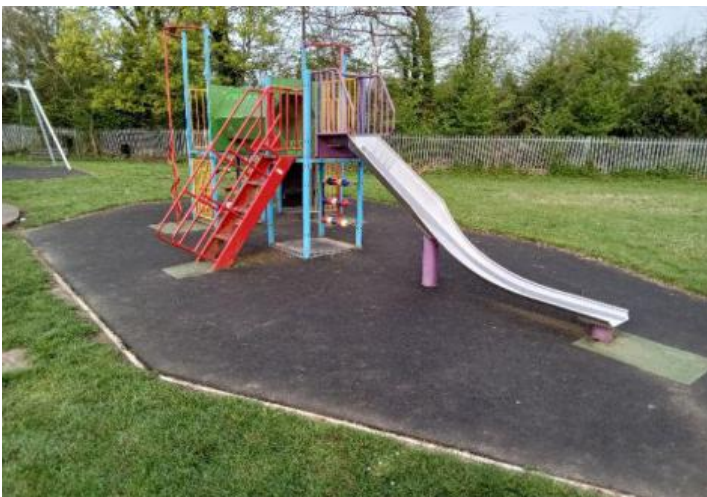
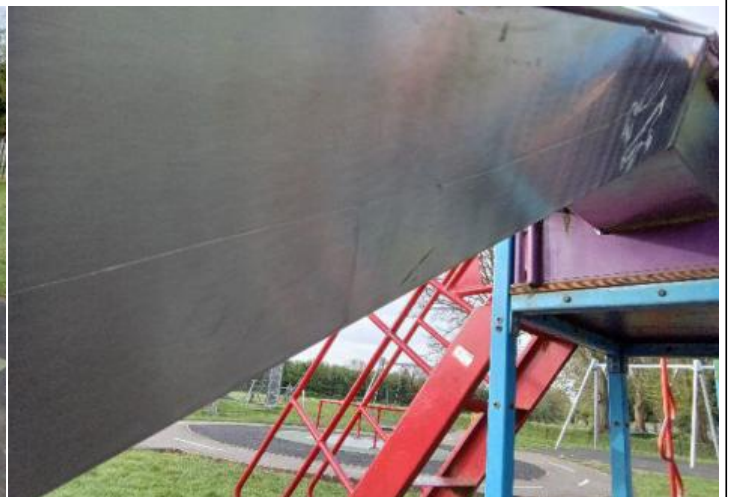
Finding: The side of the slide is damaged

Action: Monitor for any further deterioration and repair as required

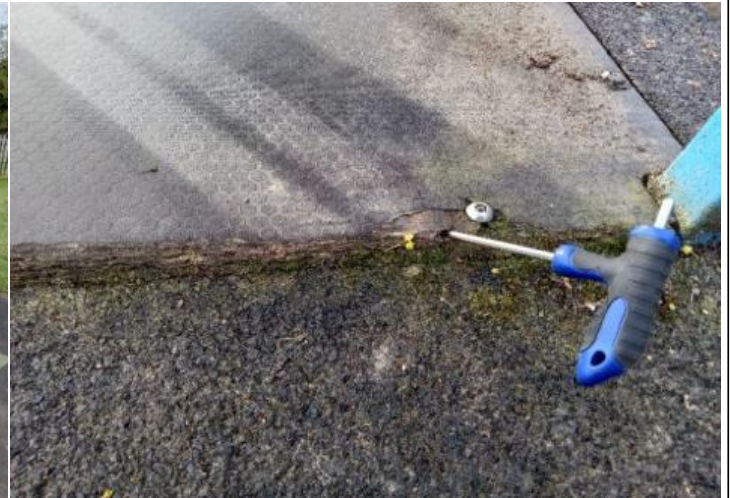
Finding: There are areas or parts of the timber on the structure that have rotted

Action: Replace all affected timbers

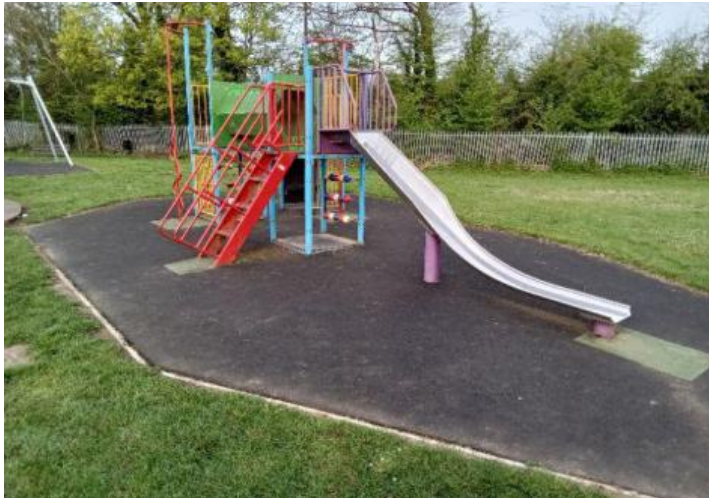
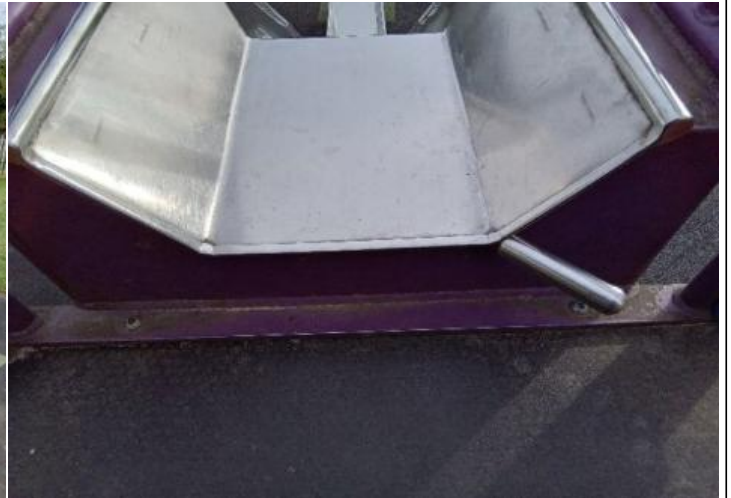
Finding: There is/are finger entrapment/s in the slide platform and the item fails to meet the requirements of BS EN 1176 Part 1 4.2.7.6 Entrapment of fingers

Action: Monitor - No remedial work recommended

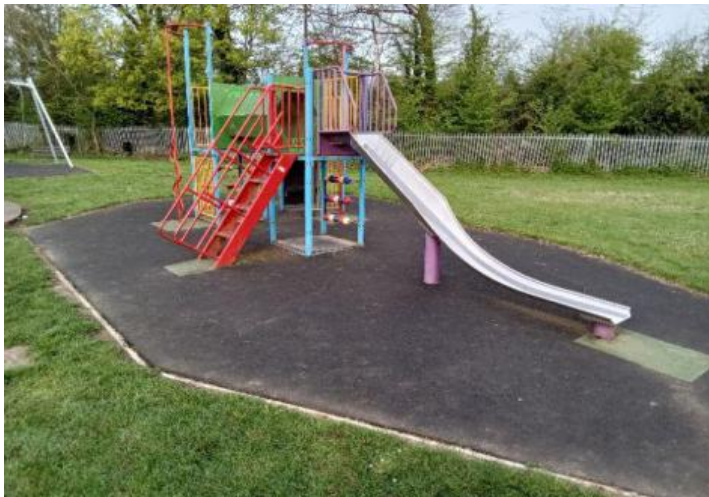
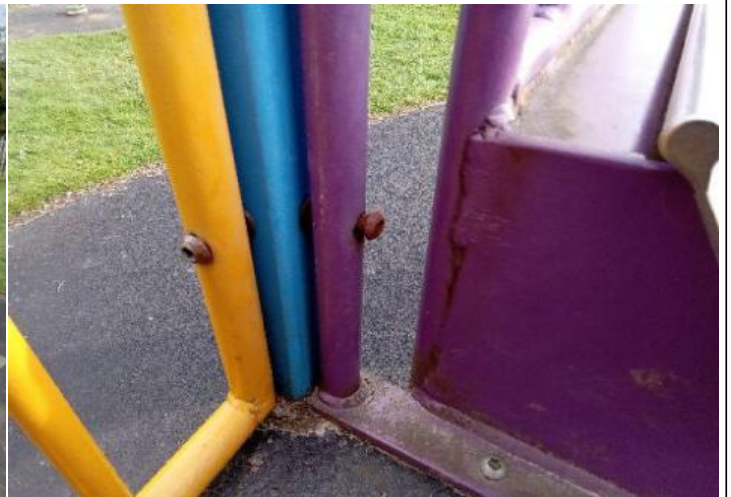
Finding: A number of fixing(s) have worked loose

Action: Secure all loose fixings

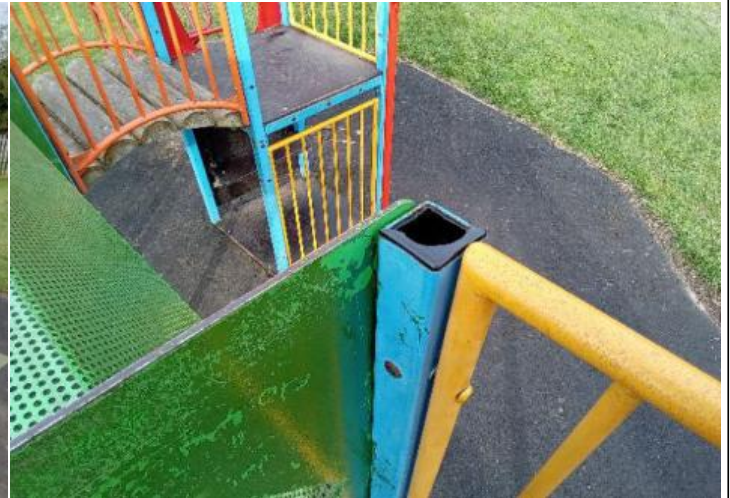
Finding: There are post / end caps damaged from the item **Action:** Replace damaged post caps

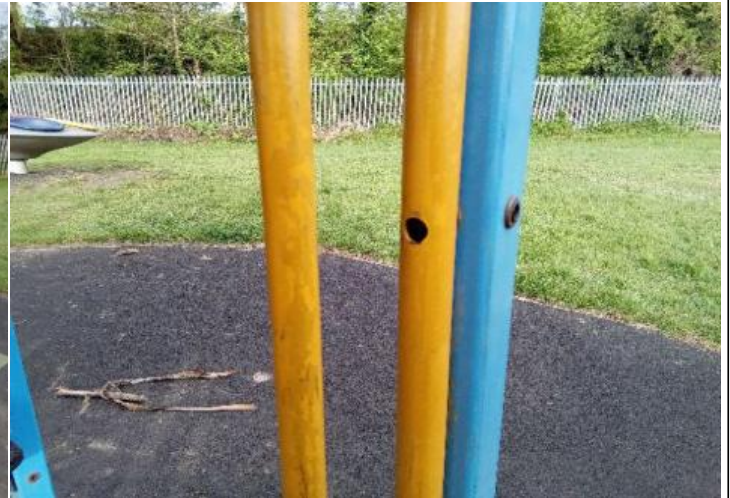
Finding: Fixings are damaged and/or have sharp edges

Action: Repair or replace as required

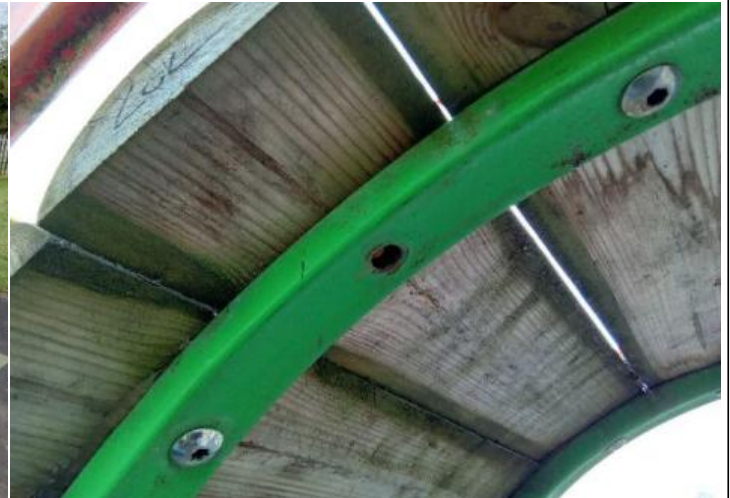
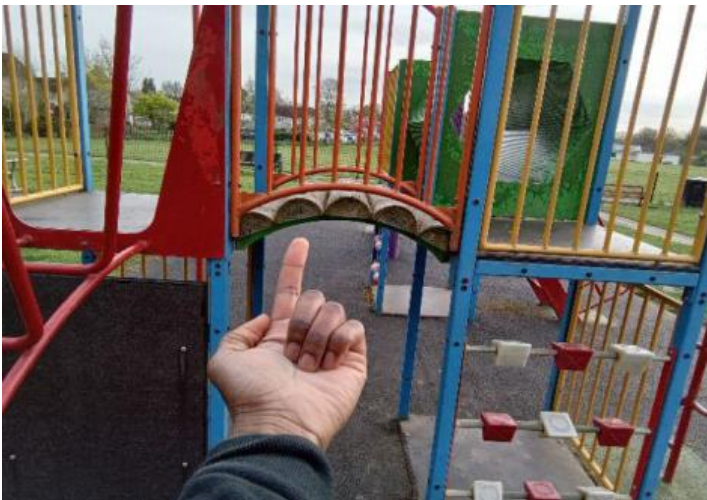
Finding: There is or are fixings missing on the item

Action: Replace all missing fixings

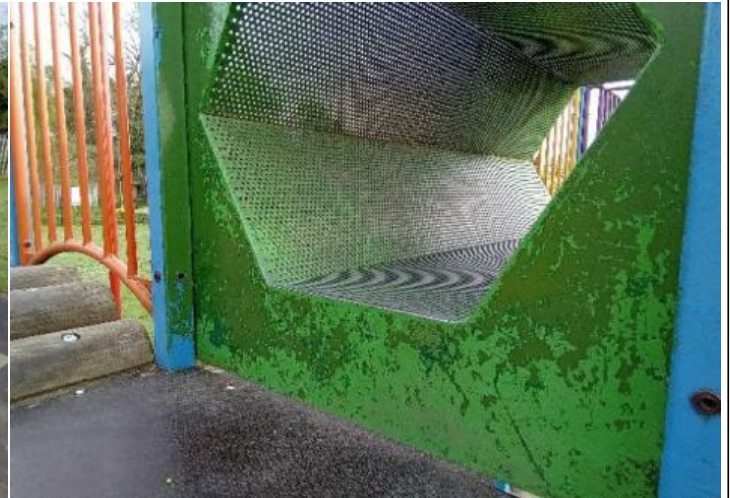
Finding: The paint is flaking off the metalwork

Action: Rub down and re-paint

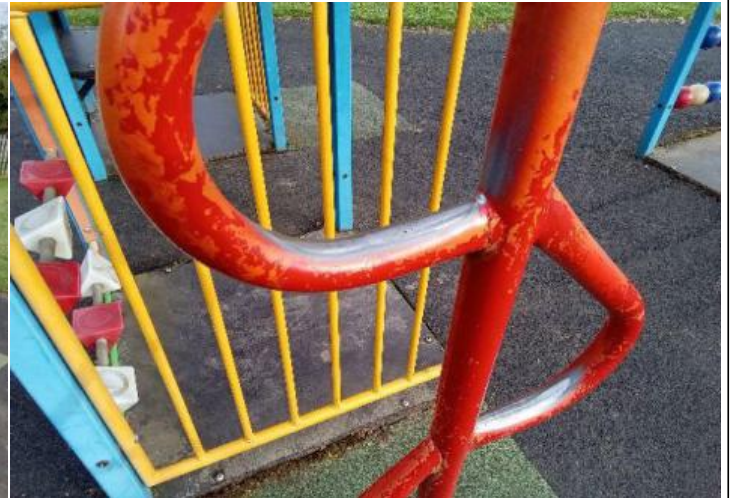
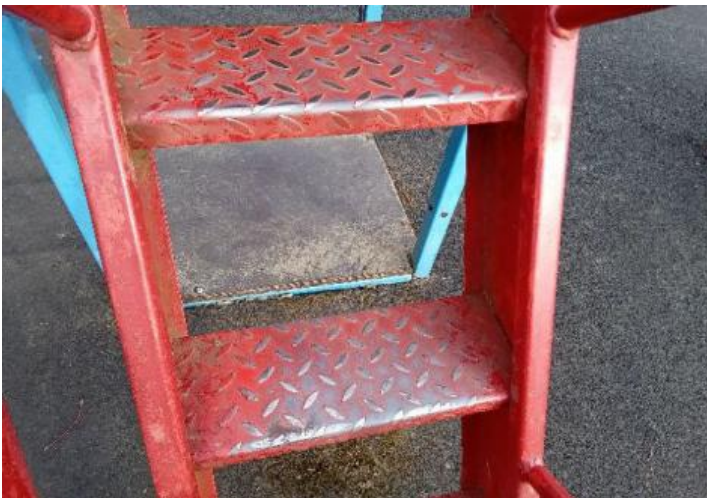
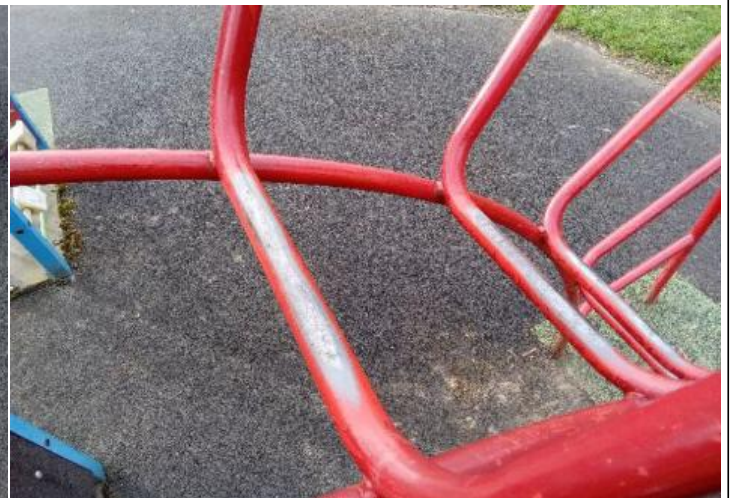
Finding: The paintwork on this item has been damaged or worn exposing the metal underneath which is rusting / corroding

Action: Treat affected areas and repaint

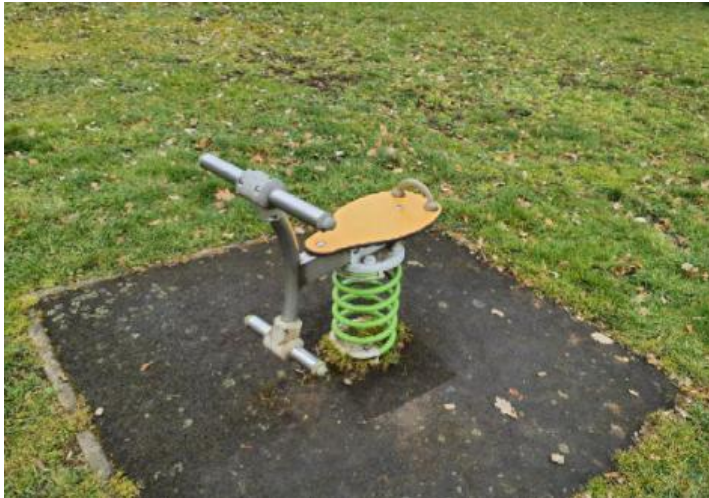
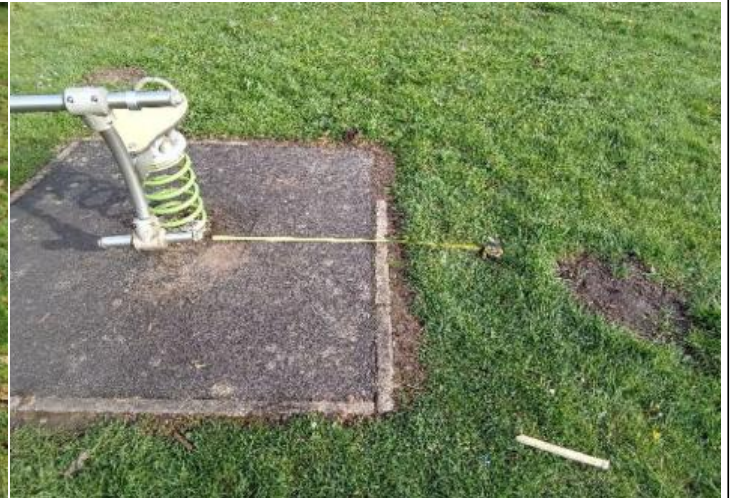
Finding: The surfacing dimensions are short and do not meet with the requirements of the current applicable standard

Action: Monitor - no remedial action recommended

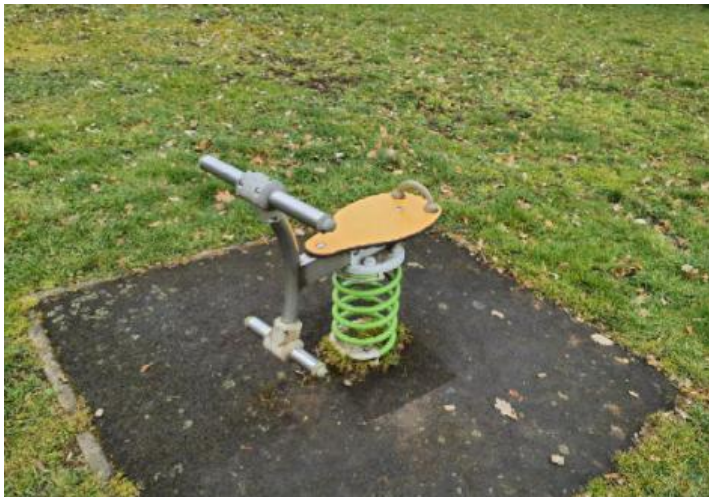
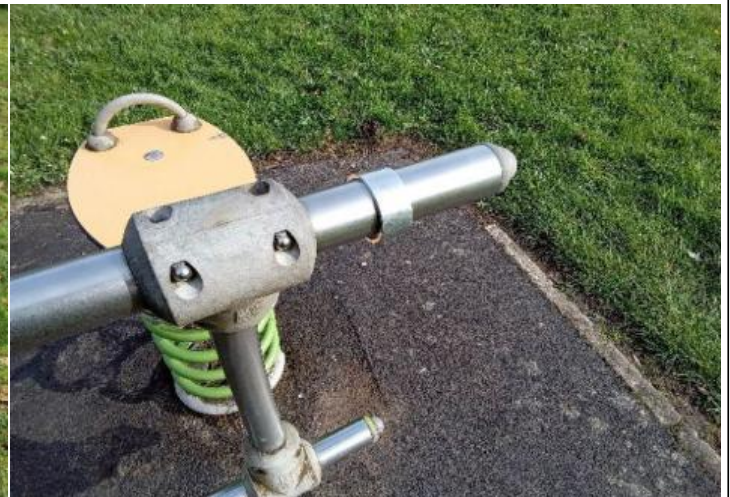
Finding: The end of handgrips and/or footrests have a cross section of less than 15cm² and fail to meet the requirements of BS EN 1176 Part 6

Action: Monitor - No remedial work recommended

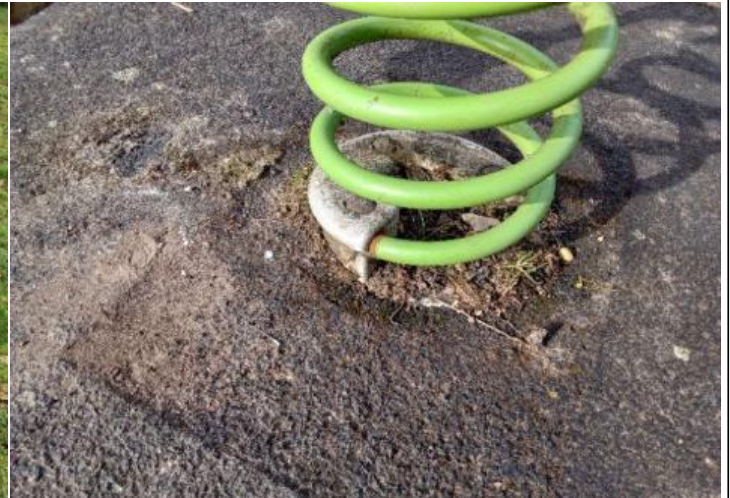
Finding: The spring rotates on the base

Action: Secure spring to prevent rotation

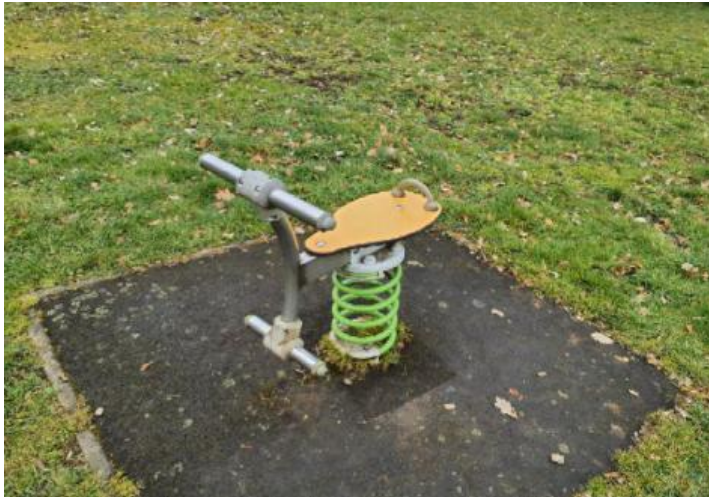
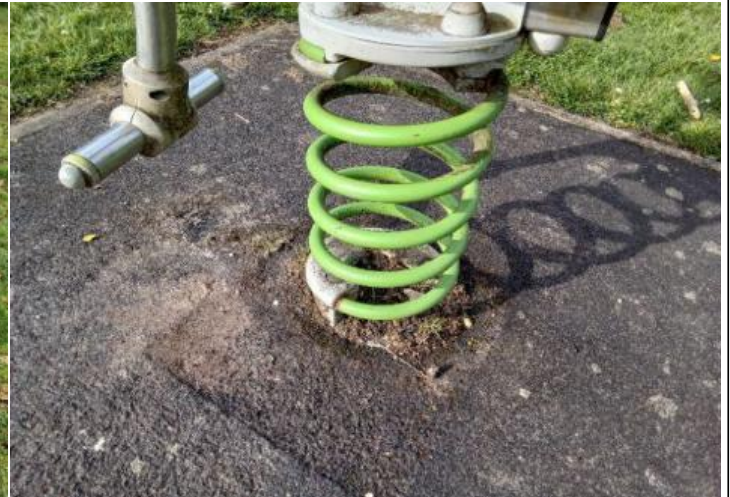
The spring clamps are loose - Tighten all loose fixings

Finding: The spring clamps are loose

Action: Tighten all loose fixings
