ST STEPHEN PARISH COUNCIL

You are summoned to the Fixed Assets Committee meeting
To take place on **Thursday 30 May 2024 at 7.30pm**
at St Stephen Suite, Parish Centre, Station Road, Bricket Wood, AL2 3PJ

- 2425/AC/07 To receive Annual Play Inspection Report and Grounds Team Action Report. Play Reports and Grounds Team Report attached.**
- 2425/AC/08 To discuss the option of creating additional allotment plots and possible beginner plots at Watford Road allotment site or North Close. Allotment report attached.**

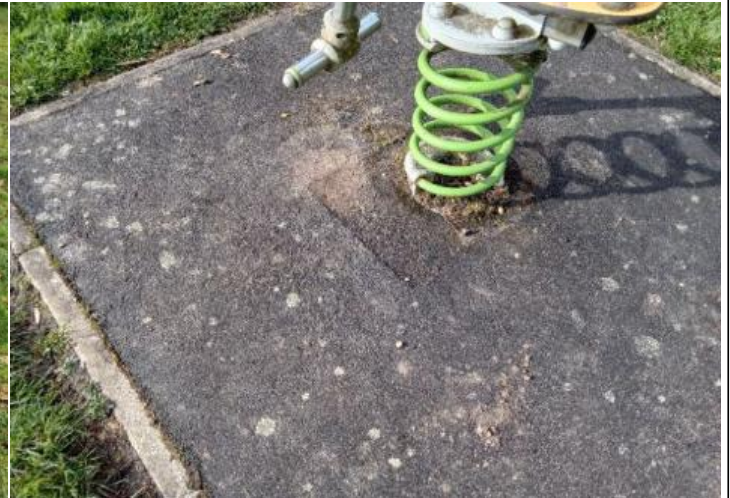
Finding: The safety surface around the area is beginning to wear

Action: Monitor for any further deterioration and repair as required

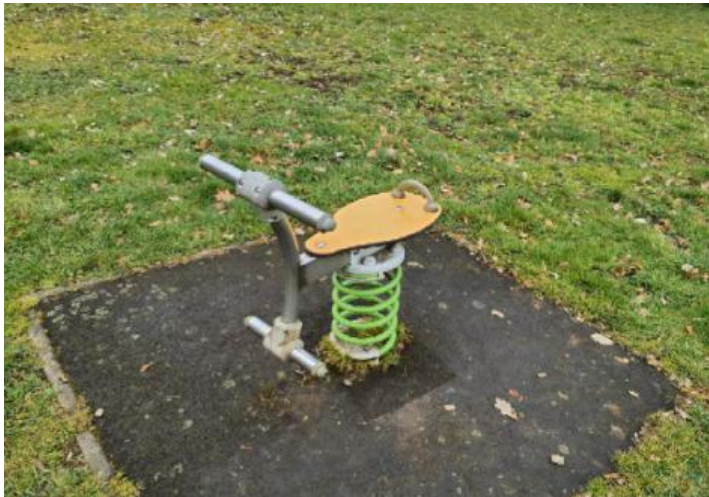
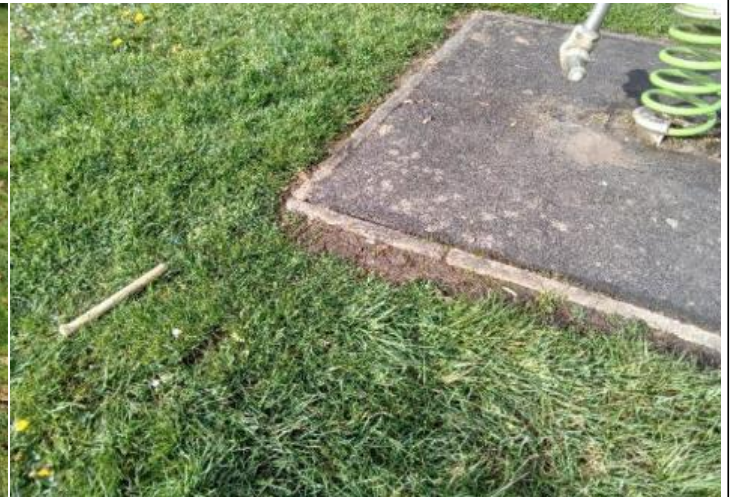
Finding: There are trip hazards at the edges of the surface

Action: Reinststate surrounding surface levels to remove the trip points

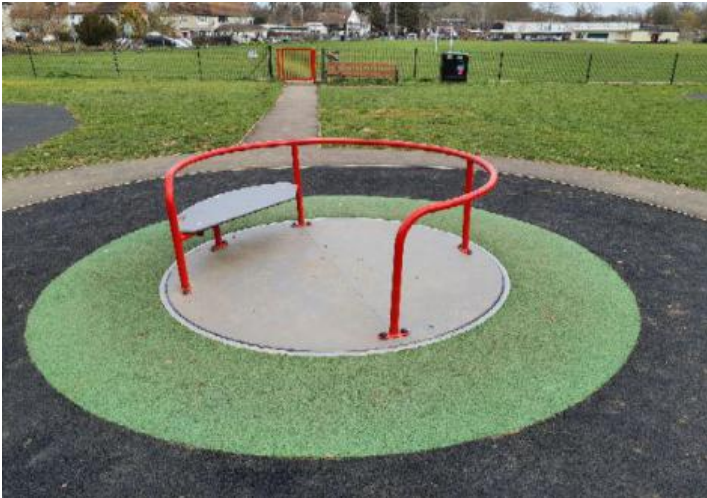
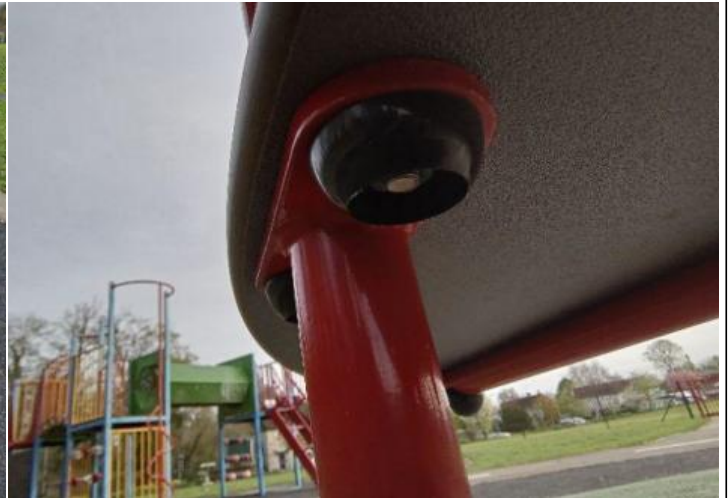
There is/are bolt cap covers missing or damaged on the item - Replace missing or damaged bolt cap covers

Finding: There is/are bolt cap covers missing or damaged on the item

Action: Replace missing or damaged bolt cap covers

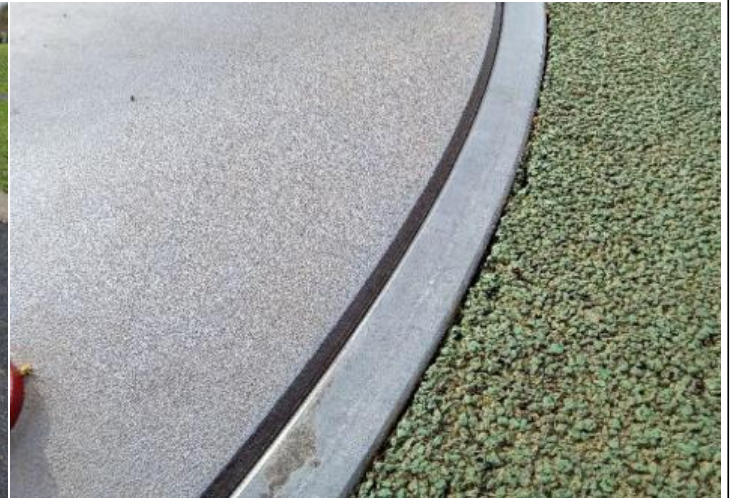
Roundabout is snagging against outer edge causing difficulty in rotating - Repair for rotation

Finding: Roundabout is snagging against outer edge causing difficulty in rotating

Action: Repair for rotation

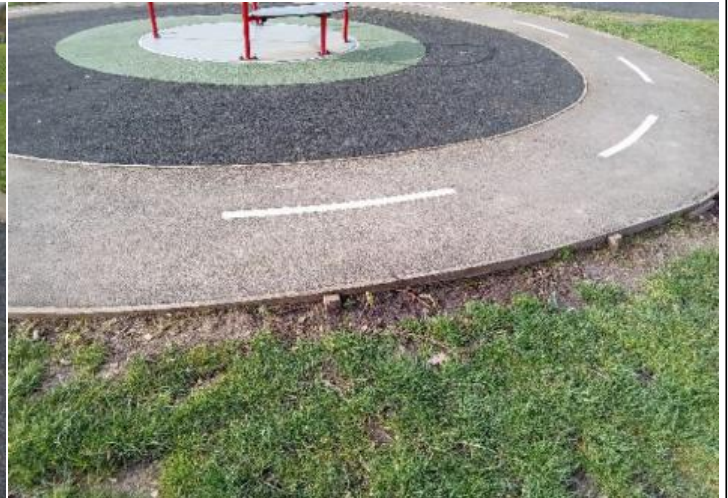
There are trip hazards at the edges of the surface - Reinstate surrounding surface levels to remove the trip points

Finding: There are trip hazards at the edges of the surface

Action: Reinstate surrounding surface levels to remove the trip points

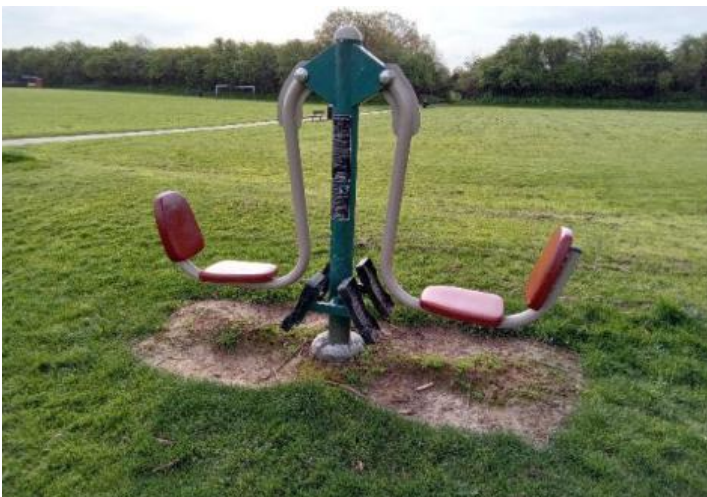
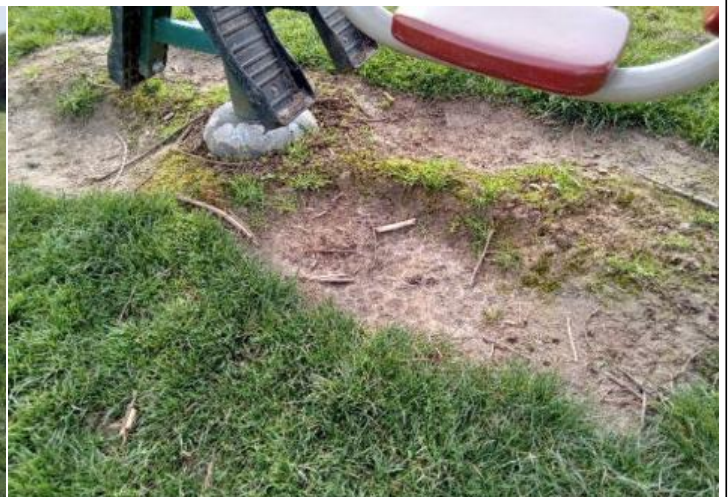
The surface has subsided in some areas - Monitor for any further deterioration and repair as required

Finding: The surface has subsided in some areas

Action: Monitor for any further deterioration and repair as required

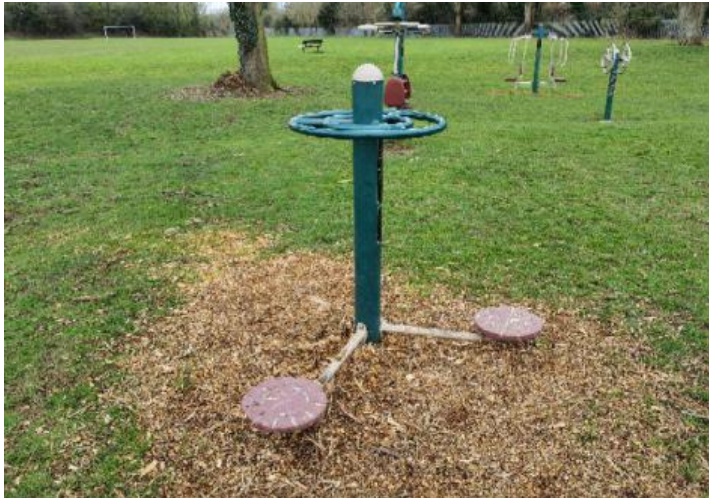
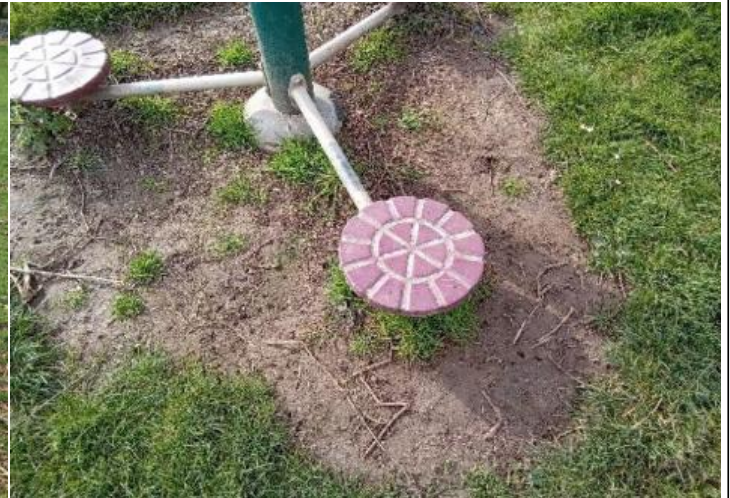
The deflection of the rotating user station exceeds the maximum 105 degrees required by BS EN 16630 - Monitor - No remedial work recommended

Finding: The deflection of the rotating user station exceeds the maximum 105 degrees required by BS EN 16630
Action: Monitor - No remedial work recommended

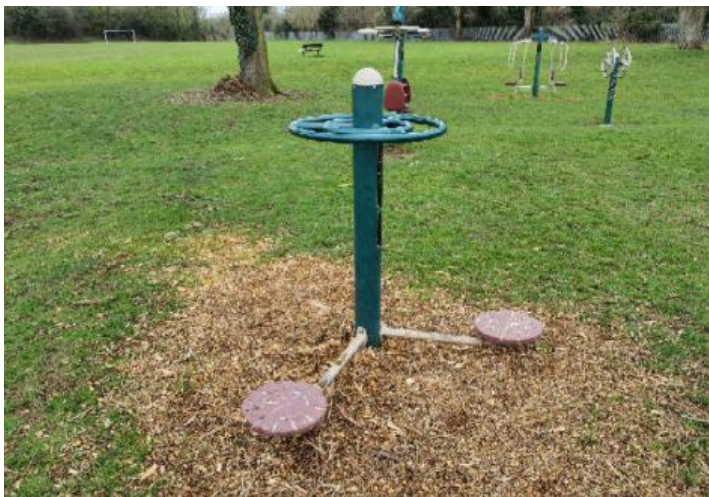
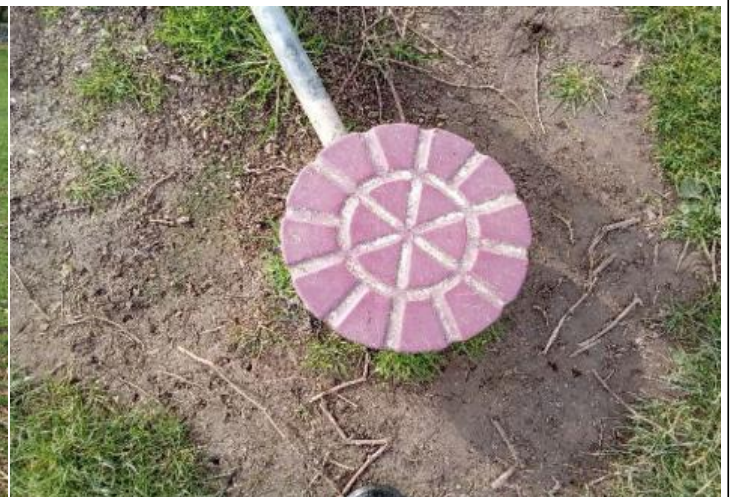
The rotating user station is not appropriately marked with a guideline of user direction and/or the original position as required by BS EN 16630 - Monitor - No remedial work recommended

Finding: The rotating user station is not appropriately marked with a guideline of user direction and/or the original position as required by BS EN 16630
Action: Monitor - No remedial work recommended

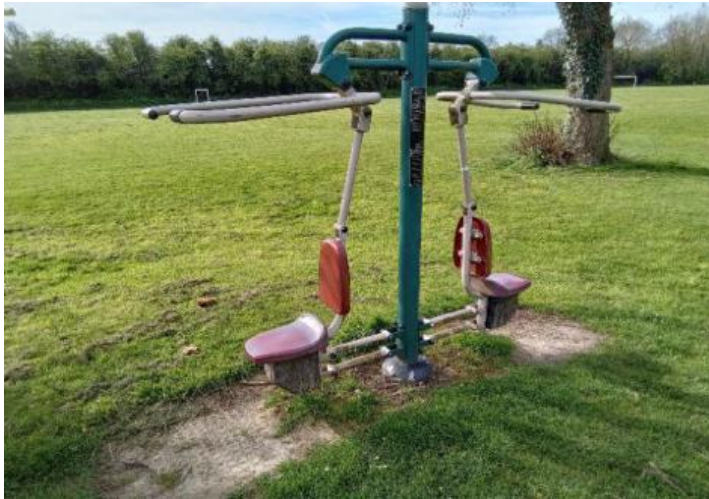
The distance between the underside of the item and the ground is less than the 60mm required by BS EN 16630 - Monitor - No remedial work recommended

Finding: The distance between the underside of the item and the ground is less than the 60mm required by BS EN 16630

Action: Monitor - No remedial work recommended

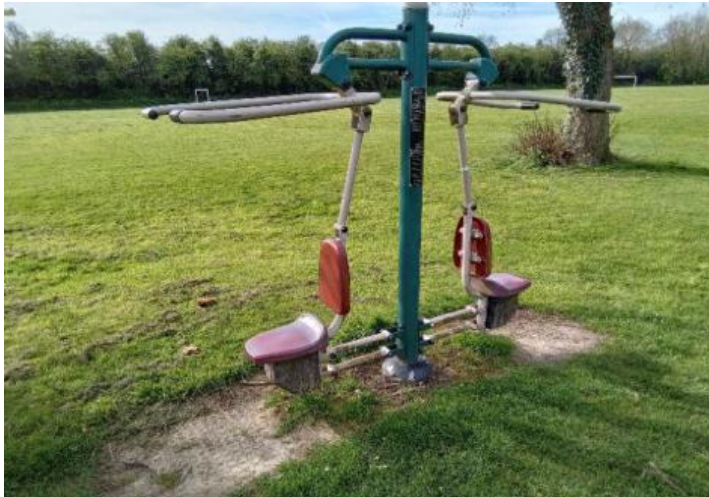
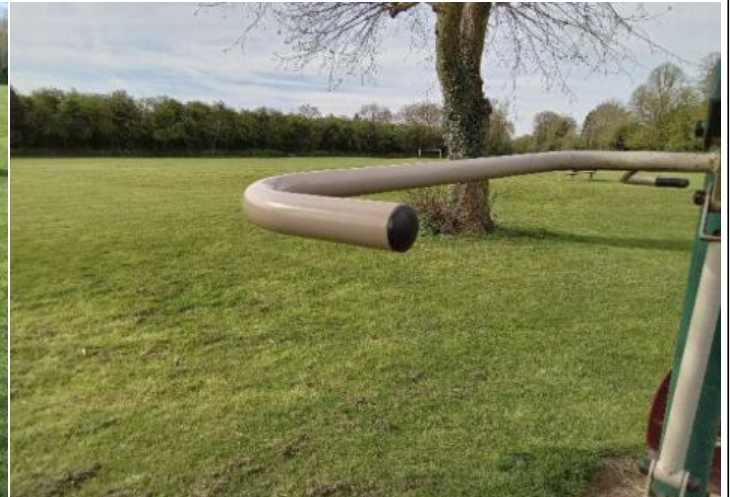
Item: Outdoor Fitness Equipment - Pull Down Challenger
Manufacturer: Fresh Air Fitness

Finding: One or more handgrip(s) are damaged or missing. **Action:** Replace missing or damaged handgrips

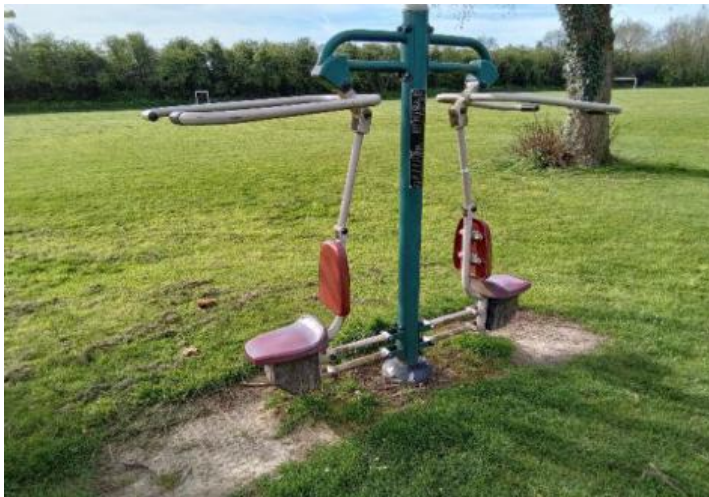
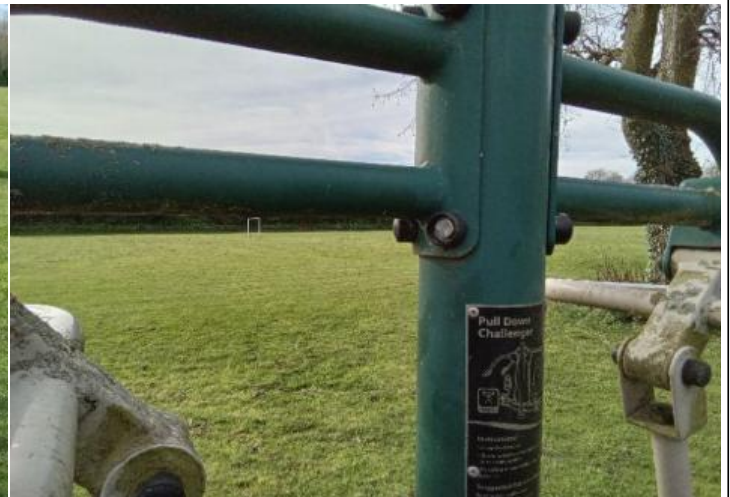
Item: Outdoor Fitness Equipment - Pull Down Challenger
Manufacturer: Fresh Air Fitness

Finding: There is/are bolt cap covers missing or damaged on the item **Action:** Replace missing or damaged bolt cap covers

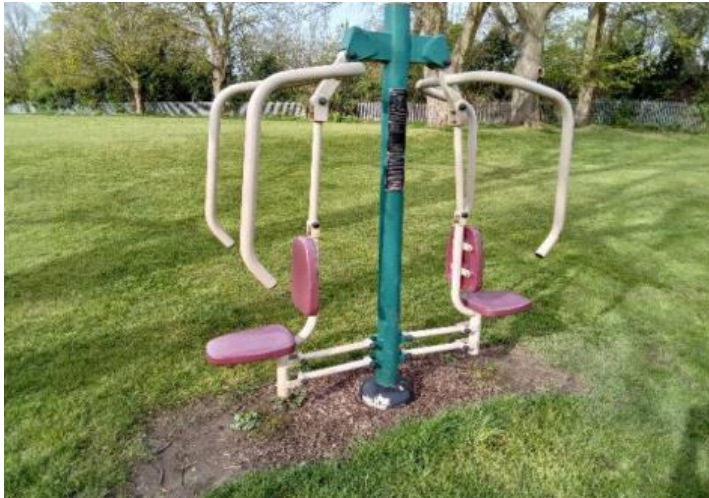
Item: Outdoor Fitness Equipment - Chest Press
Manufacturer: Fresh Air Fitness

Finding: One or more handgrip(s) are damaged or missing. **Action:** Replace missing or damaged handgrips

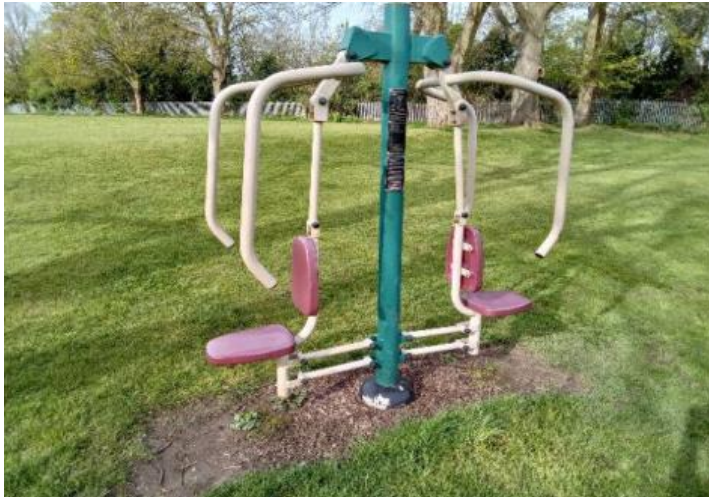
Item: Outdoor Fitness Equipment - Chest Press
Manufacturer: Fresh Air Fitness

Finding: The seat has been damaged

Action: Monitor for any further deterioration and replace as required

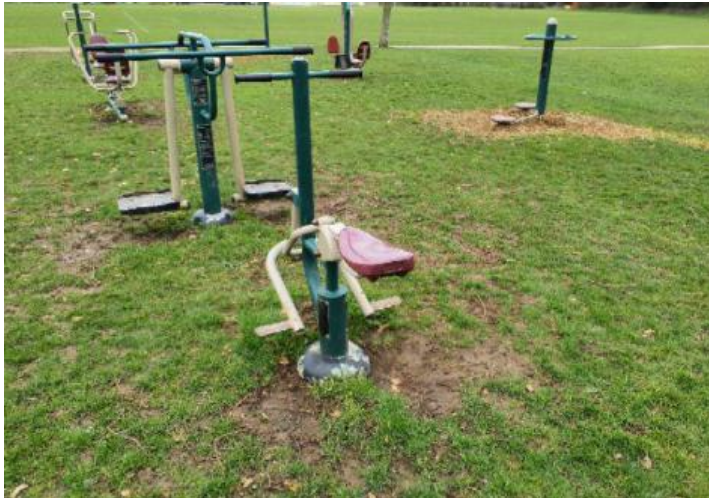
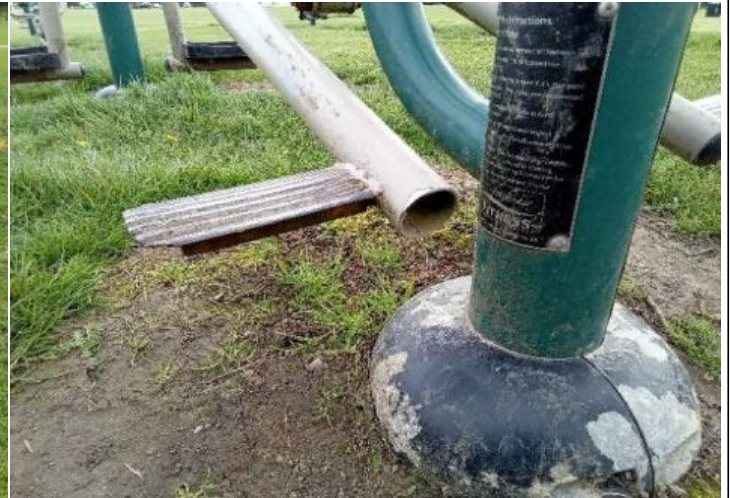
Item: Outdoor Fitness Equipment - Rider
Manufacturer: Fresh Air Fitness

Finding: There are post / end caps missing from the item

Action: Replace missing post caps

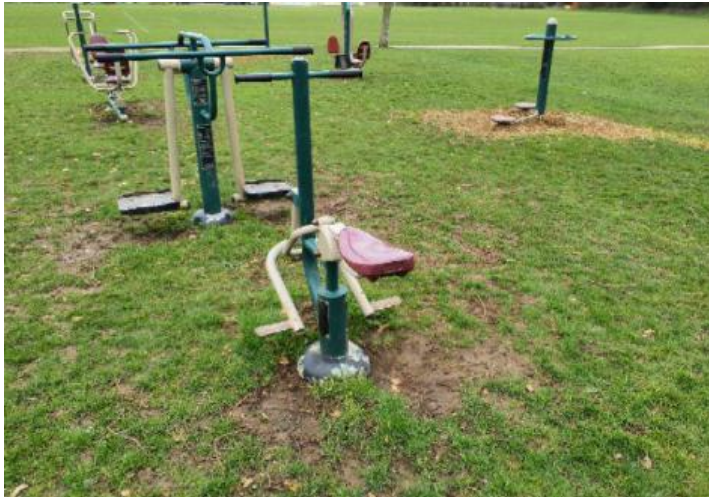
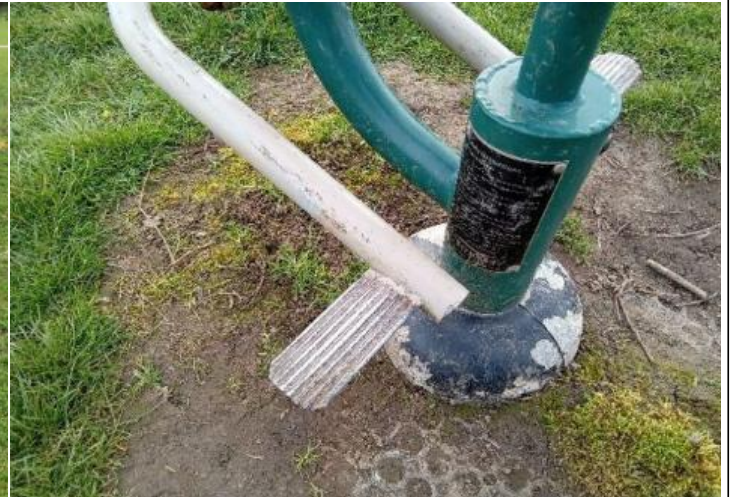
Item: Outdoor Fitness Equipment - Rider
Manufacturer: Fresh Air Fitness

Finding: The paint is flaking off the metalwork

Action: Rub down and re-paint

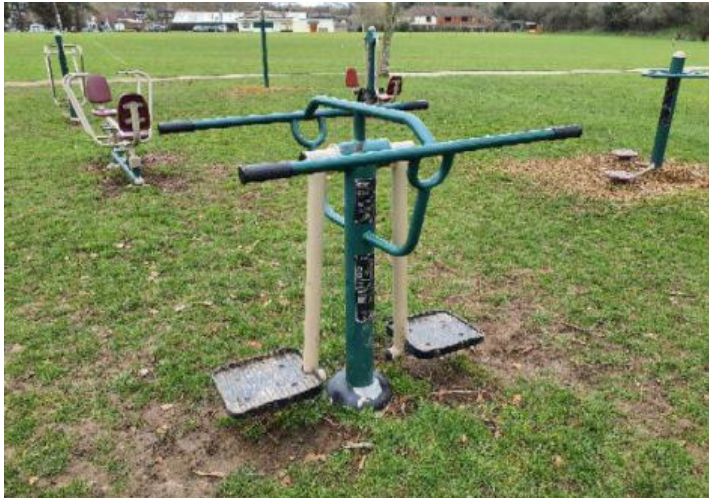
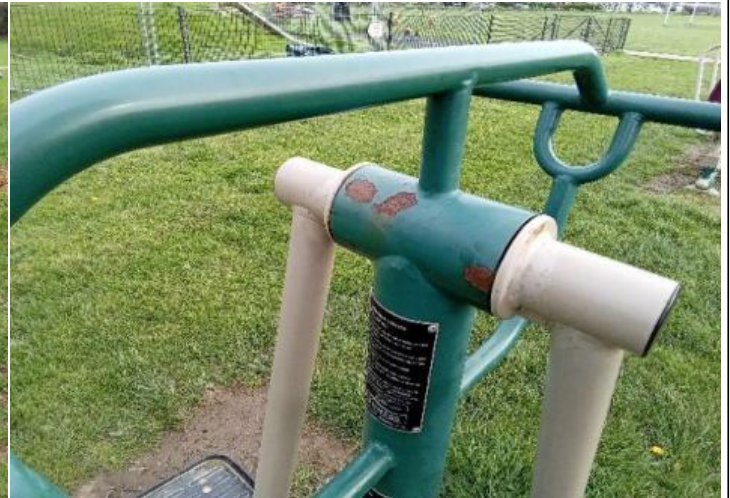
Item: Outdoor Fitness Equipment - Air Skier
Manufacturer: Fresh Air Fitness

Finding: The paintwork on this item has been damaged or worn exposing the metal underneath which is rusting / corroding

Action: Treat affected areas and repaint

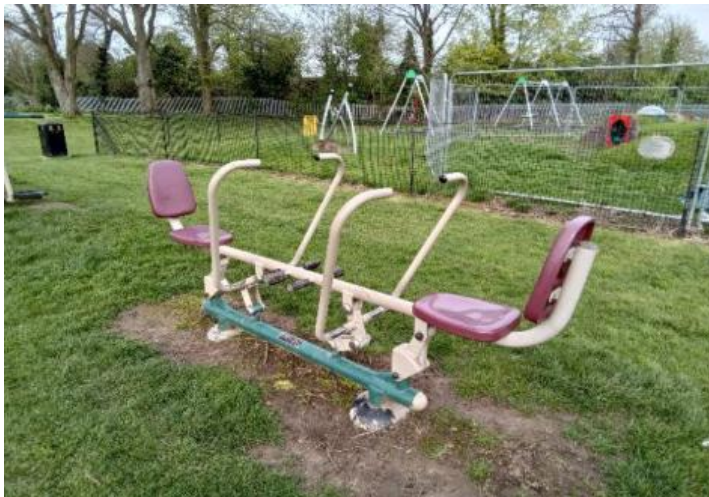
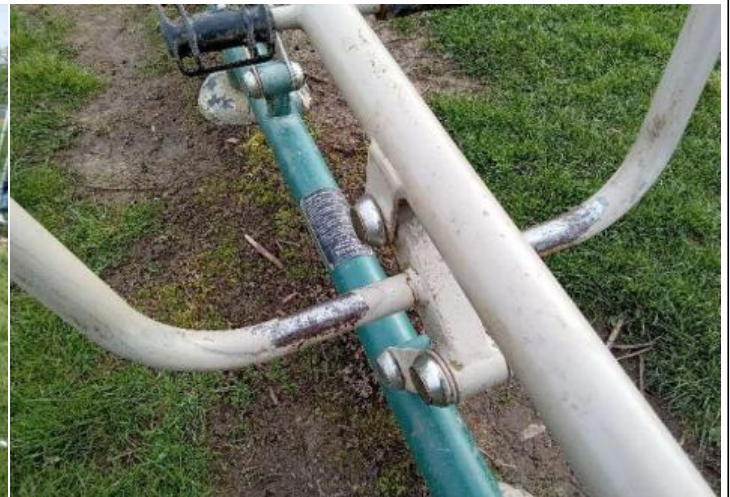
Item: Outdoor Fitness Equipment - Rower
Manufacturer: Fresh Air Fitness

Finding: The paintwork on this item has been damaged or worn exposing the metal underneath which is rusting / corroding

Action: Treat affected areas and repaint

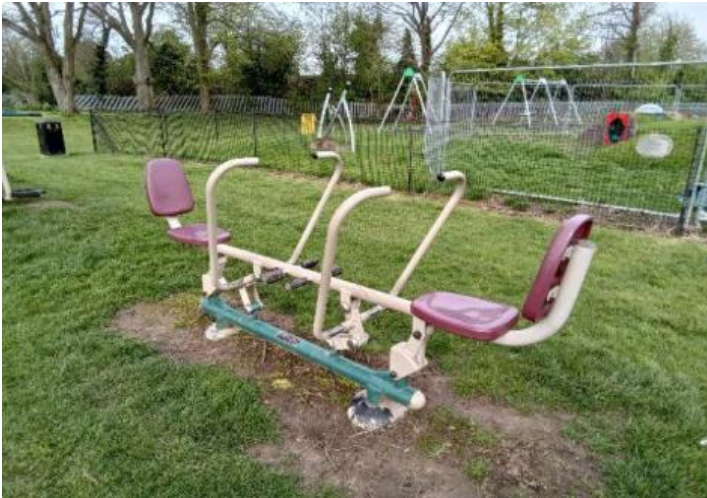
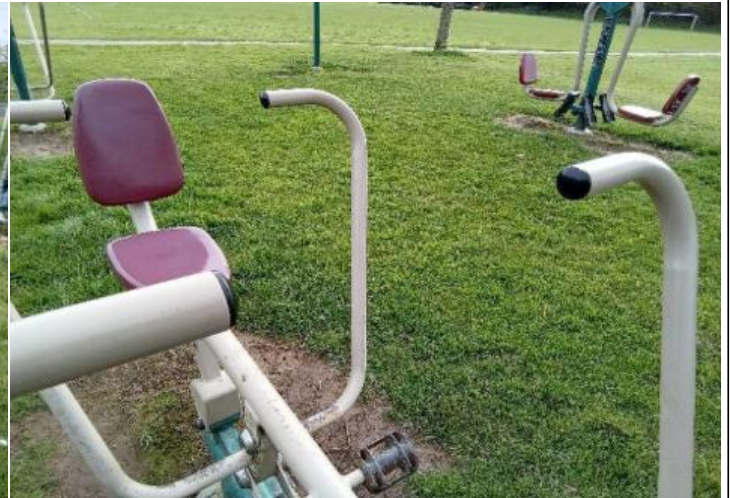
Item: Outdoor Fitness Equipment - Rower
Manufacturer: Fresh Air Fitness

Finding: One or more handgrip(s) are damaged or missing. **Action:** Replace missing or damaged handgrips

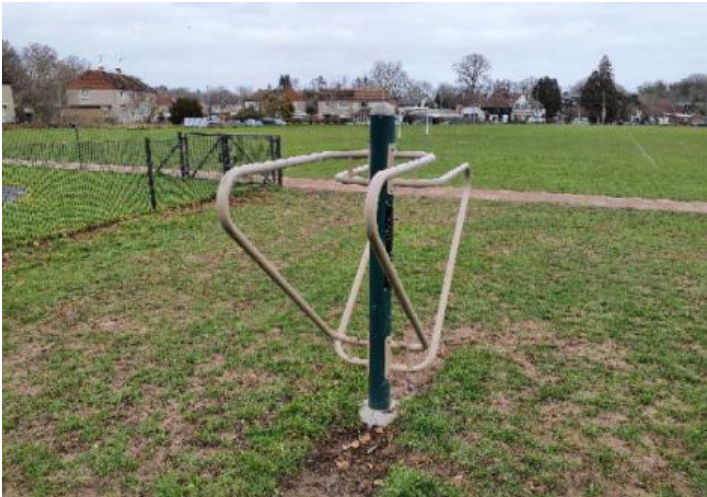
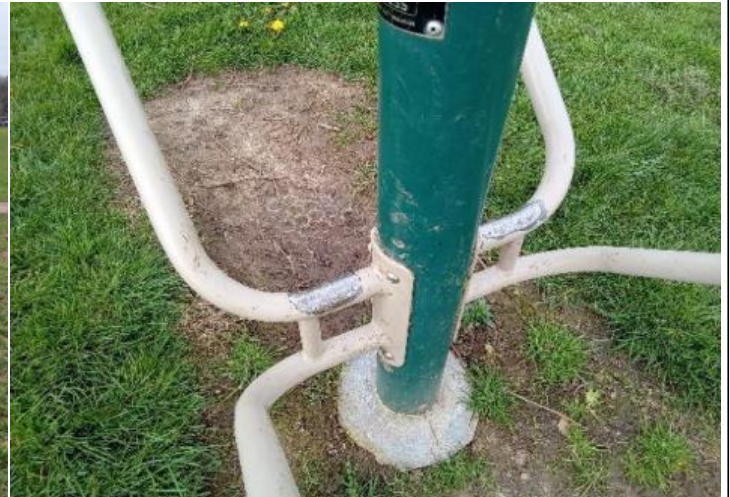
Item: Outdoor Fitness Equipment - Dip Station
Manufacturer: Fresh Air Fitness

Finding: The paintwork on this item has been damaged or worn exposing the metal underneath which is rusting / corroding **Action:** Treat affected areas and repaint
