# Product Safety Evaluation

## KIR evaluation

PCM-CUSTOM 726038

## Annual Inspection

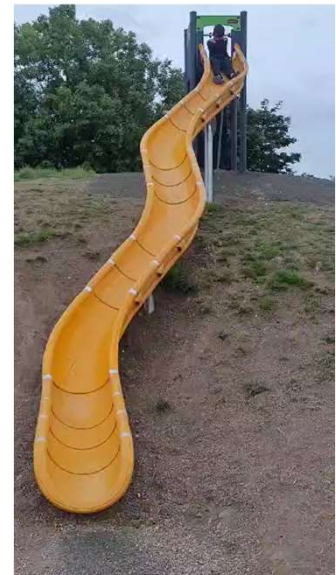
We generally recommend this type of slide for children aged 4 years and more. This is due to the bumps related to the turns. We know that children will bump into the sides when the direction is changed and the younger and thereby smaller the child is the heavier impact the turns will have.

The specific slide is designed in accordance with our intern guidelines regarding straight and curved sections as well as the official safety standard for playground equipment EN1176. Access is deliberately made difficult for the youngest to prevent users under the age of 3-4 years to access. Installation seems to be done correctly and the slide seems well maintained. From correspondence with the playground owner, we know that a post installation inspection was carried out concluding the slide is compliant with EN1176 and risk assessed to be low. Weekly maintenance inspections are also carried out.

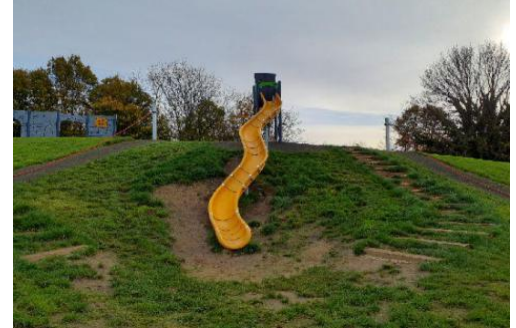
**Finding 1**

The grass has eroded within the impact area of the equipment and may not provide the necessary impact attenuating properties for the equipment fall height; the surface may also be slippery in wet weather - Reinstate the grass or provide an all weather surface
