ST STEPHEN PARISH COUNCIL

You are summoned to the Fixed Assets Committee meeting

AGENDA

| 2526/AC/013 | To receive Annual Play Inspection Reports. Reports attached. |

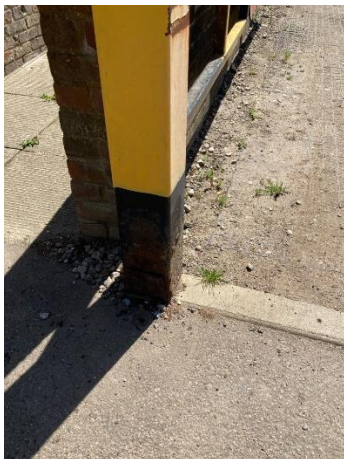
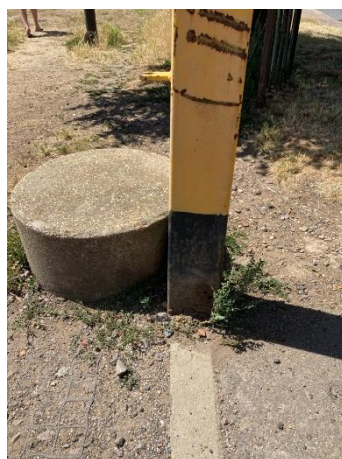
The existing height barrier has significantly deteriorated due to internal corrosion. Upon inspection, it has been found that the bottom section of the barrier has corroded from the inside out, resulting in visible holes. This level of damage compromises the structural integrity and effectiveness of the barrier.

Continued use of the current barrier in its weakened state presents a safety risk to both vehicles and pedestrians.

A full replacement of the barrier is required to ensure continued protection and control of vehicle access to the recreation ground. It is therefore essential to include the cost of a new barrier in the 2026 budget planning.

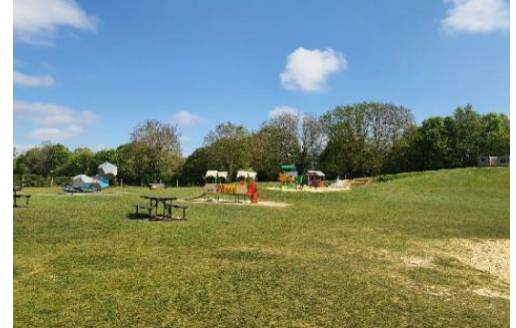
Item: Site General
Manufacturer: Owner/Operator
Surface Type: N/A
Item Quantity: 1
Equipment Compliance: N/A
Surface Area Compliance: N/A

The safety surface is low and the membrane is exposed creating trip points - Remove or resecure the exposed membrane and top up the surface to the correct level

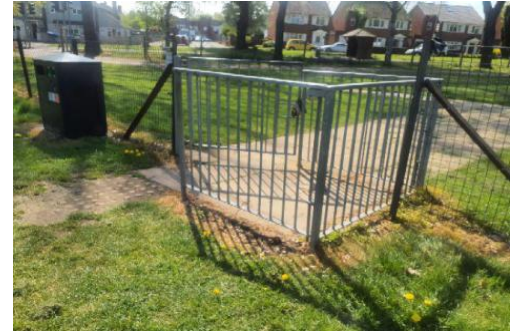
Item: Kissing Gate
Manufacturer: Not Identified
Surface Type: Paving Slabs
Item Quantity: 1
Equipment Compliance: N/A
Surface Area Compliance: N/A

There are trip hazards at the edges of the surface - Remove trip hazard

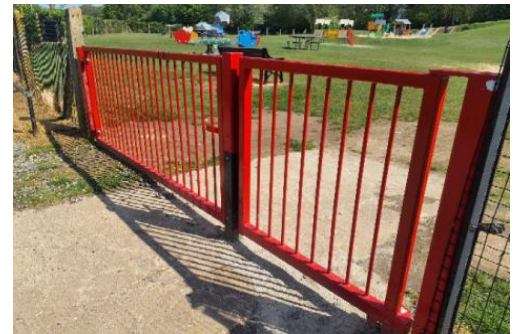
Item: Gate - Maintenance
Manufacturer: Not Identified
Surface Type: Concrete
Item Quantity: 1
Equipment Compliance: N/A
Surface Area Compliance: N/A

There are trip hazards at the edges of the surface - Remove trip hazard

The gate latch is damaged or missing - Repair or replace

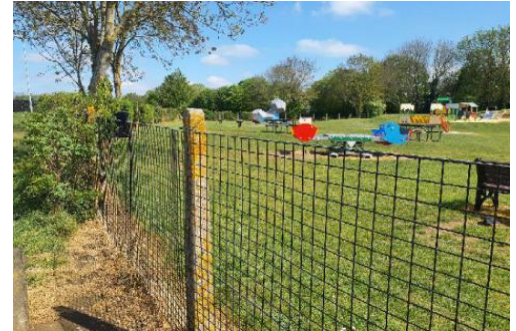
Item: Fence - Steel Mesh
Manufacturer: Not Identified
Surface Type: Grass
Item Quantity: 1
Equipment Compliance: N/A
Surface Area Compliance: N/A

There are a number of loose posts around the fence - Monitor for any further deterioration and reset as required

There is some damage to the fence sections - Monitor for any further deterioration and repair as required

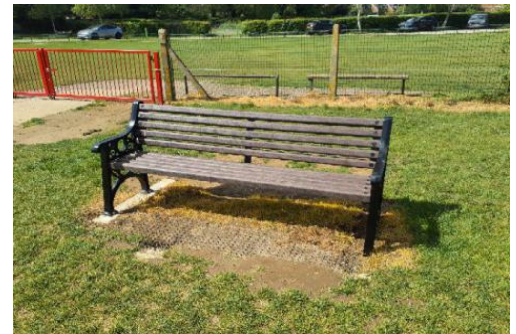
Item: Bench
Manufacturer: Not Identified
Surface Type: Grass
Item Quantity: 7
Equipment Compliance: N/A
Surface Area Compliance: N/A

The area around the item has eroded and may become slippery - Reinstate eroded area

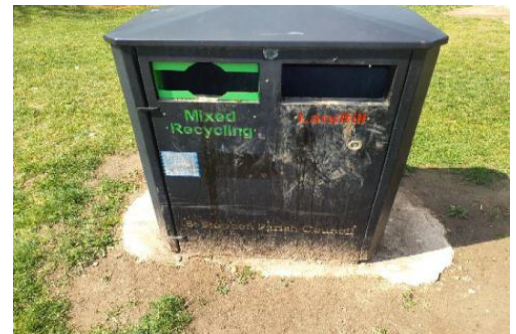
Item: Litter Bin
Manufacturer: Not Identified
Surface Type: Concrete
Item Quantity: 5
Equipment Compliance: N/A
Surface Area Compliance: N/A

The surface has eroded and the foundations are exposed - Reinstate surrounding surfaces to cover the foundations

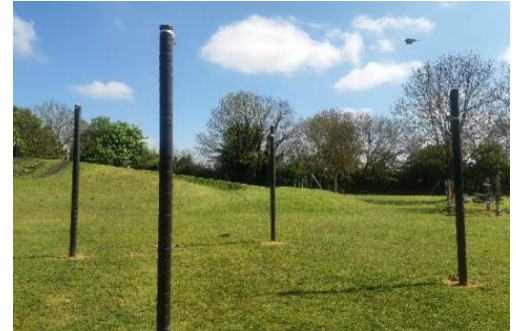
Item: Sun Canopy
Manufacturer: Not Identified
Surface Type: Grass
Item Quantity: 1
Equipment Compliance: N/A
Surface Area Compliance: N/A

Canopy has been removed. Posts remain - Consider replacing canopy

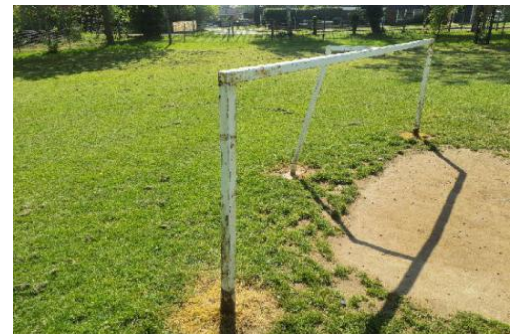
Item: 5 a side Goals
Manufacturer: Not Identified
Surface Type: Grass
Item Quantity: 1
Equipment Compliance: N/A
Surface Area Compliance: N/A
Life Expectancy: 5 -10 Years
Total Findings: 3

The area around the item has eroded and may become slippery - Reinstate eroded area

The paintwork on this item has been damaged or worn exposing the metal underneath which is rusting / corroding - Treat affected areas and repaint

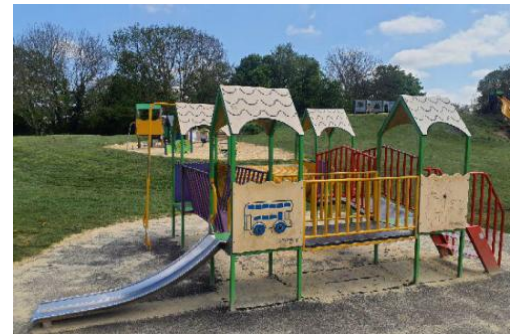
Item: Multi Play (Toddler)
Manufacturer: Wicksteed Playgrounds
Surface Type: Wet Pour
Item Quantity: 1
Equipment Compliance: Yes
Surface Area Compliance: Yes
Life Expectancy: 5 -10 Years
Total Findings: 5

The paintwork on this item has been damaged or worn exposing the metal underneath which is rusting / corroding - Treat affected areas and repaint

There are a number of dents in the slide surface - Monitor for any further deterioration and repair as required

Sand has migrated on to the safety surface and can be slippery in wet conditions - Clear and maintain

The tunnel has been damaged - Monitor for any further deterioration and replace as required

The paint has worn off the metalwork - Rub down and re-paint

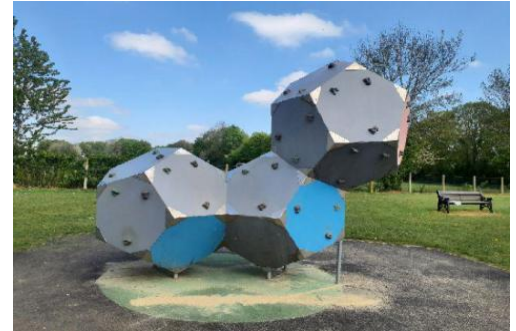
Item: Climbing Blocks
Manufacturer: Kompan Ltd
Surface Type: Wet Pour
Item Quantity: 1
Equipment Compliance: Yes
Surface Area Compliance: No
Life Expectancy: >10 Years
Total Findings: 1

The item has been damaged / vandalised - Monitor for any further deterioration and replace as required

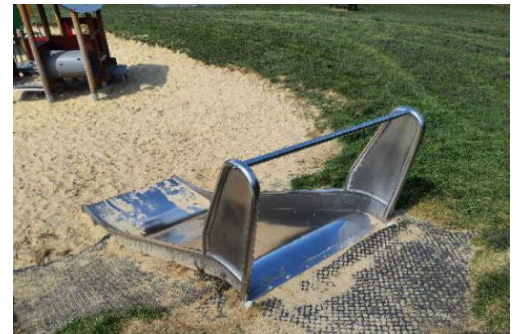
Item: Embankment Slide
Manufacturer: R&T Stainless A/S
Surface Type: Mixed Surface
Item Quantity: 1
Equipment Compliance: Yes
Surface Area Compliance: Yes
Life Expectancy: 5 -10 Years
Total Findings: 3

The edges of the grass mat surface are raised / lifting above the surrounding surface - Tuck in or pin edges of grass mats as per the API Code of Practice to remove trip hazards

There are gaps opening in between the tiles - Monitor for any further deterioration and repair as required

There are a number of dents in the slide surface - Monitor for any further deterioration and repair as required

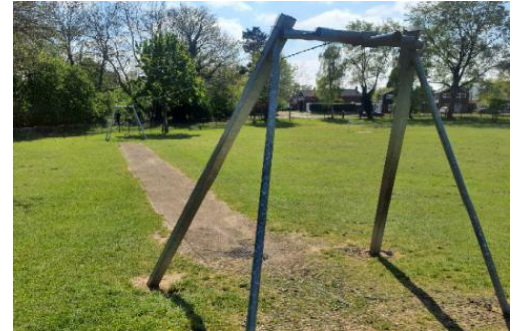
Item: Cable Runway
Manufacturer: Kompan Ltd
Surface Type: Grass Matrix Tiles
Item Quantity: 1
Equipment Compliance: Yes
Surface Area Compliance: Yes

The edges of the grass mat surface are raised / lifting above the surrounding surface - Tuck in or pin edges of grass mats as per the API Code of Practice to remove trip hazards

There is moderate damage to the surface - Repair the damaged areas of surfacing

We have completed a visual inspection of the suspension links, cable and fixing points from ground level, however it is not possible to fully inspect these areas without either hiring equipment to gain access or removing the cable and suspension and inspecting at ground level. We recommend that the main cable and fixing security is thoroughly inspected at least in accordance with the manufacturers recommendations to check for wear, damage, security or internal rusting; this will help to ensure the continued safe use of the equipment - Inspect in accordance with the manufacturers recommendations

The seat connection cannot be inspected without dismantling the seat - Dismantle the seat to inspect the seat connection for wear

The nylon inserts are worn or missing at the point the cable enters the traveller - Replace worn or missing inserts as required

A secondary safety has been added and the chain links are worn excessively and require renewing. - Replace worn chains

There is some wear to the shackles - Monitor for any further deterioration and replace when 40% worn

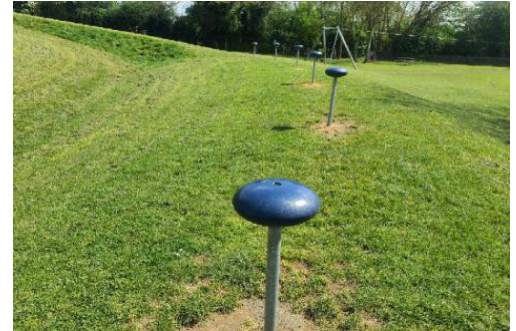
Item: Leap Frog
Manufacturer: Kompan Ltd
Surface Type: Grass Matrix Tiles
Item Quantity: 1
Equipment Compliance: Yes
Surface Area Compliance: Yes
Life Expectancy: 5 -10 Years
Total Findings: 1

There is moderate damage to the grass matrix tile surface - Repair the damaged areas of surfacing

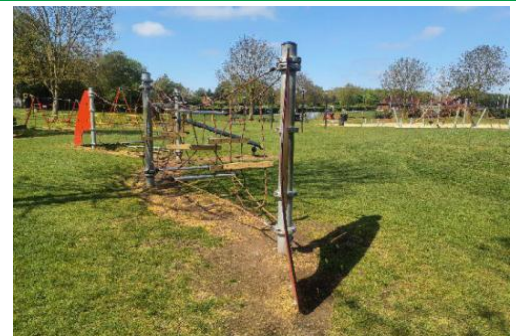
Item: Activity Trail
Manufacturer: Corocord
Surface Type: Grass Matrix Tiles
Item Quantity: 1
Equipment Compliance: No
Surface Area Compliance: Yes

The grass mats are silted up, the soil is compacted and the area will become very slippery when the soil is wet. - Reinstated as required

There is/are finger entrapment/s in the rope connection and the item fails to meet the requirements of BS EN 1176 Part 1 4.2.7.6 Entrapment of fingers - Monitor - No action given the risk assessment

There is/are bolt cap covers missing or damaged on the item - Replace missing or damaged bolt cap covers

The climbing wall has been damaged - Monitor for any further deterioration and replace as required

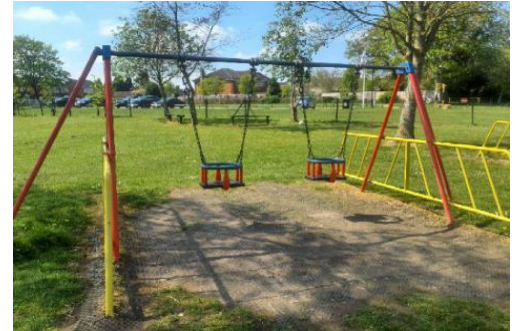
Item: 1 Bay 2 Seat (Cradle)
Manufacturer: GL Jones
Surface Type: Grass Matrix Tiles
Item Quantity: 1
Equipment Compliance: No
Surface Area Compliance: Yes
Life Expectancy: 5 -10 Years
Total Findings: 4

There is some notable evidence of chain wear - Monitor for any further deterioration and replace when 40% worn

The chain openings are in excess of 8.6mm and do not meet the recommendations of BS EN 1176 Part 1 - Monitor - No action given the risk assessment

There is some wear to the shackles - Monitor for any further deterioration and replace when 40% worn

The surface has subsided in some areas - Monitor for any further deterioration and repair as required

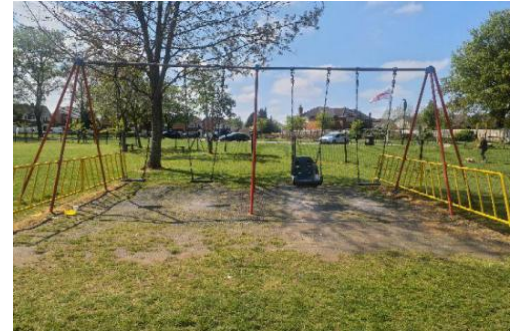
Item: 2 Bay 3 Flat 1 Inclusive Seat
Manufacturer: G L Jones Playgrounds Ltd
Surface Type: Grass Matrix Tiles
Item Quantity: 1
Equipment Compliance: No
Surface Area Compliance: Yes
Life Expectancy: 5 -10 Years
Total Findings: 9

There is some notable evidence of chain wear - Monitor for any further deterioration and replace when 40% worn

The chain openings are in excess of 8.6mm and do not meet the recommendations of BS EN 1176 Part 1 - Monitor - No action given the risk assessment

There is some wear to the shackles - Monitor for any further deterioration and replace when 40% worn

The fixings or components for this item were in excess of 2.5m above the standing surface and could not be fully accessed by the inspector. We have completed a visual inspection of the fixings from ground level but a maintenance inspection should be undertaken to assess the condition, security and wear of the components at intervals in accordance with the manufacturers recommendations. - Inspect in accordance with the manufacturers recommendations

The seat has minor damage or wear - Monitor for any further deterioration and replace as required

The swing seat connectors have some wear present - Monitor for further deterioration and replace when 40% worn

BS EN 1176 Part 2: Annex A makes a recommendation that fences or enclosures should be upto 1.50m from the edges of the swing seat to the sides, and subject to risk assessment, from the edge of the impact area. This is however, a low risk finding and no remedial action is recommended. - Monitor - No action given the risk assessment

The swing seat connectors are loose - Tighten to secure

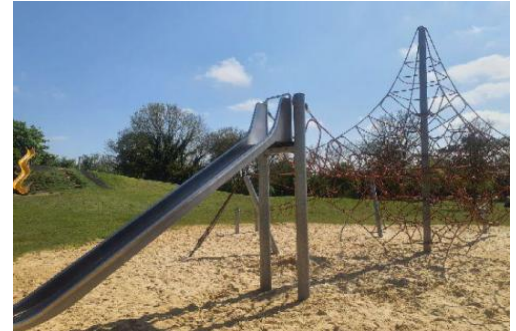
Item: Space Net
Manufacturer: Corocord
Surface Type: Sand
Item Quantity: 1
Equipment Compliance: No
Surface Area Compliance: Yes

There are a number of dents in the slide surface - Monitor for any further deterioration and repair as required

The side of the slide is damaged - Monitor for any further deterioration and repair as required

The ropes/nets are worn/damaged in places - Monitor for any further deterioration and repair or replace as required

The height of the slide runout is in excess of 350mm and does not meet the requirements of BS EN 1176: Part 3 - Top up surrounding surfaces to recommended levels

There is/are finger entrapment/s in the rope connection and the item fails to meet the requirements of BS EN 1176 Part 1 4.2.7.6 Entrapment of fingers - Monitor - No action given the risk assessment

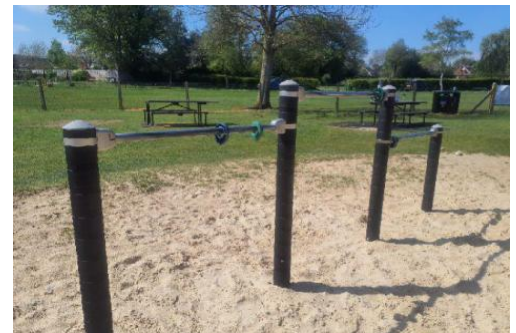
Item: Somersault Bars
Manufacturer: Kompan Ltd
Surface Type: Sand
Item Quantity: 1
Equipment Compliance: No
Surface Area Compliance: Yes

There is/are finger entrapment/s / crush in the Somersault bars fixing and the item fails to meet the requirements of BS EN 1176 Part 1 4.2.7.6 Entrapment of fingers - Monitor - No remedial work recommended

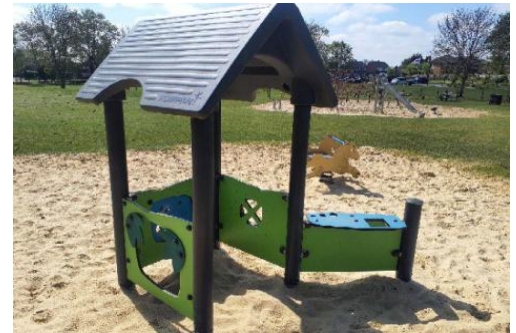
Item: Playhouse
Manufacturer: Kompan Ltd
Surface Type: Sand
Item Quantity: 1
Equipment Compliance: Yes
Surface Area Compliance: Yes

The item has missing component(s) - Consider replacing missing components

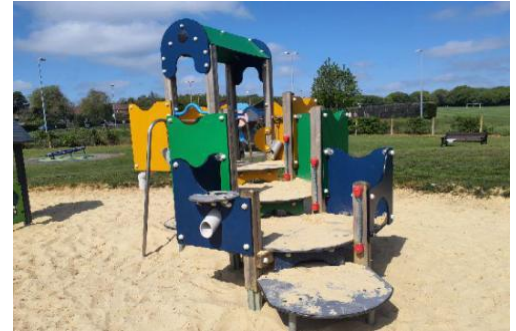
Item: Sand Play Unit
Manufacturer: Kompan Ltd
Surface Type: Sand
Item Quantity: 1
Equipment Compliance: Yes
Surface Area Compliance: Yes

There is some evidence of rot in the timber posts - Monitor for any further deterioration and replace as required

There is/are bolt cap covers missing or damaged on the item - Replace missing or damaged bolt cap covers

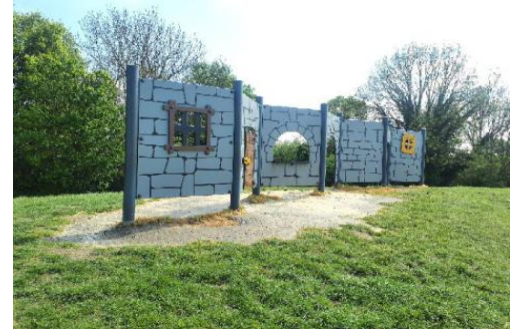
Item: Play Panel
Manufacturer: Kompan Ltd
Surface Type: Grass Matrix Tiles
Item Quantity: 1
Equipment Compliance: No
Surface Area Compliance: N/A

The item is slightly loose in its foundations - Monitor for any further deterioration and repair as required

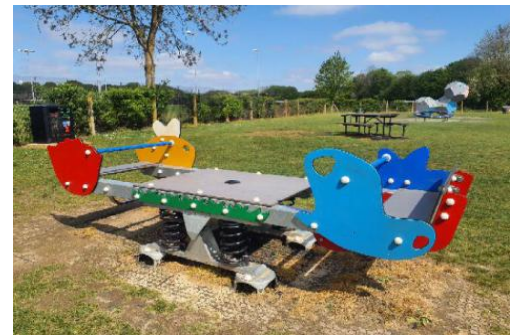
Item: See Saw
Manufacturer: Kompan Ltd
Surface Type: Grass Matrix Tiles
Item Quantity: 1
Equipment Compliance: Yes
Surface Area Compliance: Yes

The grass mats are silted up, the soil is compacted and the area will become very slippery when the soil is wet. - Reinstate as required

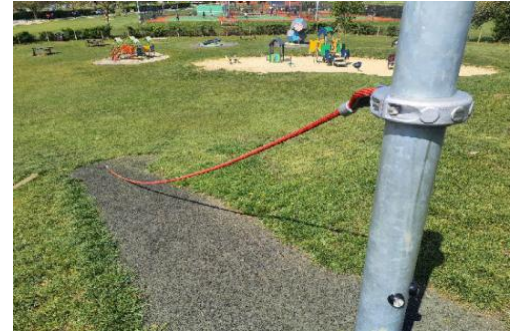
Item: Rope Pull
Manufacturer: Corocord
Surface Type: Bonded Rubber Mulch
Item Quantity: 1
Equipment Compliance: Yes
Surface Area Compliance: Yes

The ropes/nets are worn/damaged in places - Monitor for any further deterioration and repair or replace as required

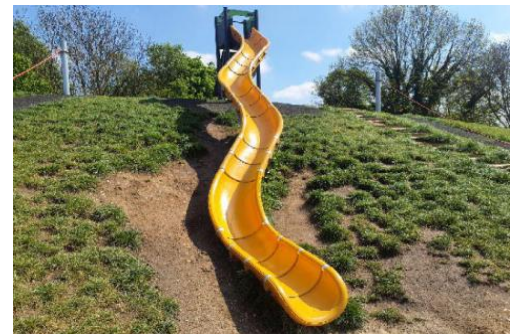
Item: Embankment Slide
Manufacturer: Kompan Ltd
Surface Type: Mixed Surface
Item Quantity: 1
Equipment Compliance: Yes
Surface Area Compliance: Yes

The grass has eroded within the impact area of the equipment and may not provide the necessary impact attenuating properties for the equipment fall height; the surface may also be slippery in wet weather - Reinstate the grass or provide an all weather surface

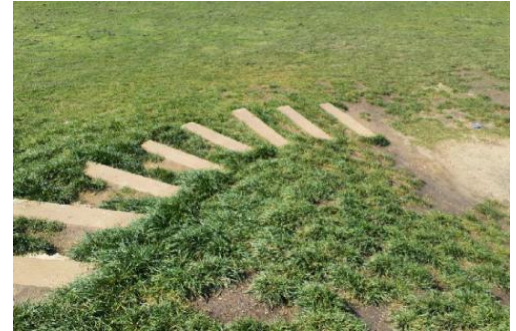
Item: Steps
Manufacturer: Not Identified
Surface Type: Grass
Item Quantity: 1
Equipment Compliance: N/A
Surface Area Compliance: N/A

The surface has eroded and the foundations are exposed -
Reinstate surrounding surfaces to cover the foundations

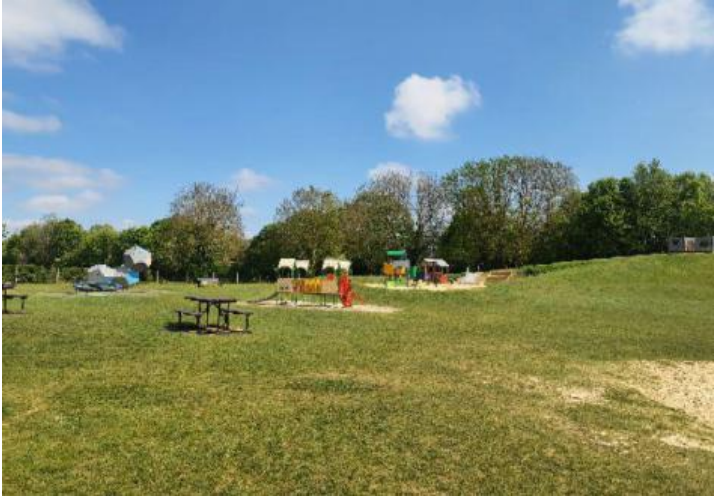
Item: Ancillary Items - Site General
Manufacturer: Owner/Operator

Finding: The safety surface is low and the membrane is exposed creating trip points

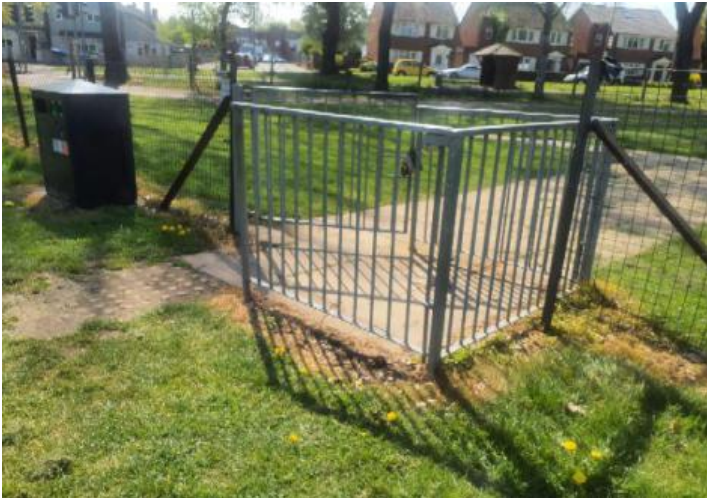
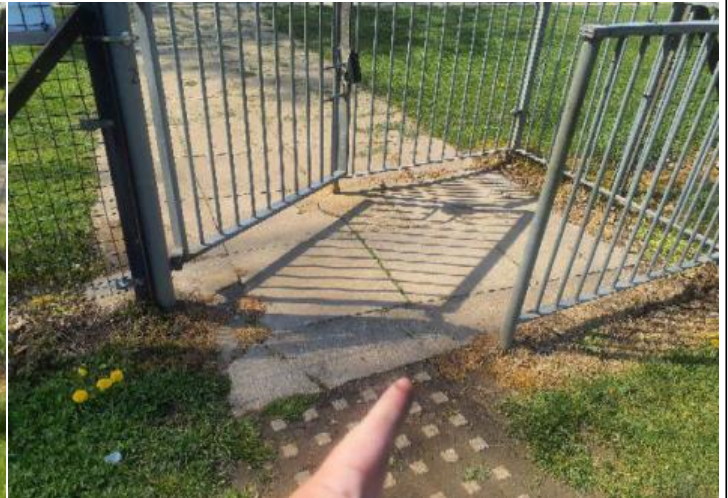
Item: Gates - Kissing Gate
Manufacturer: Not Identified

Risk Level: L - Low Risk
Surface: Paving Slabs

Finding: There are trip hazards at the edges of the surface **Action:** Remove trip hazard

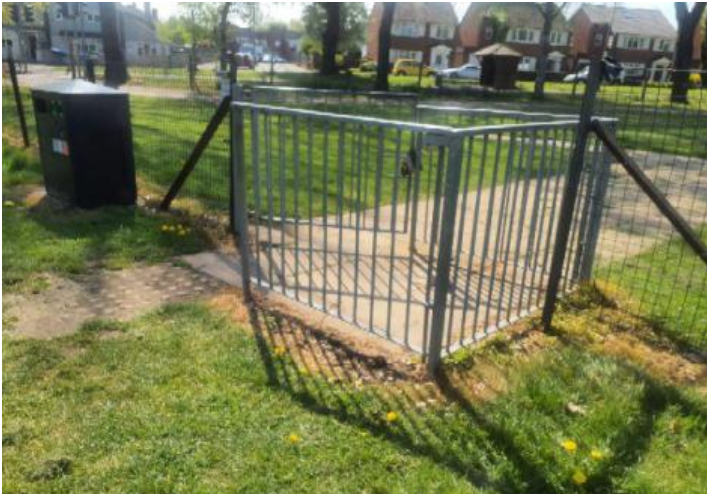
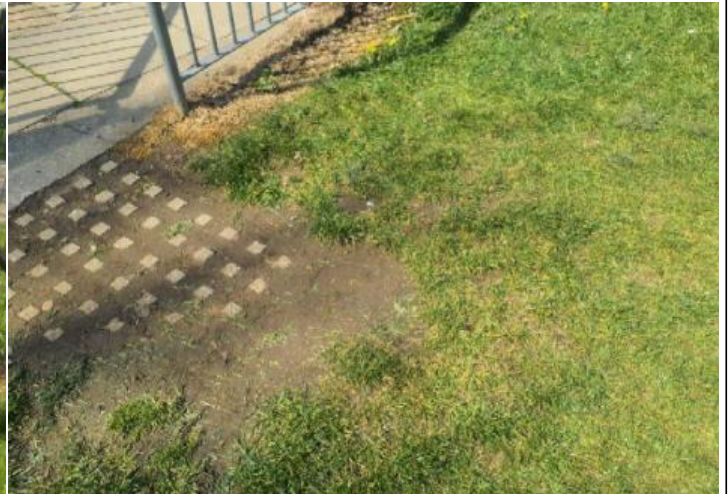
Item: Gates - Kissing Gate
Manufacturer: Not Identified

Risk Level: L - Low Risk
Surface: Paving Slabs

Finding: Unauthorised general waste has been left on site **Action:** Arrange removal of waste from site

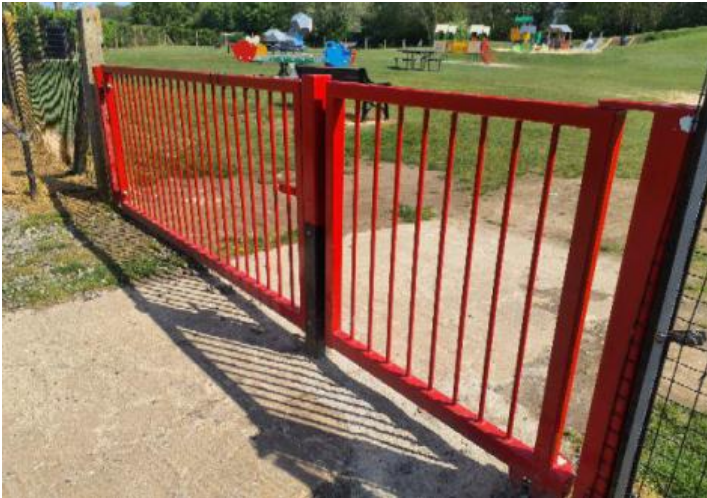
Item: Gates - Gate - Maintenance
Manufacturer: Not Identified

Risk Level: L - Low Risk
Surface: Concrete

Finding: There are trip hazards at the edges of the surface **Action:** Remove trip hazard

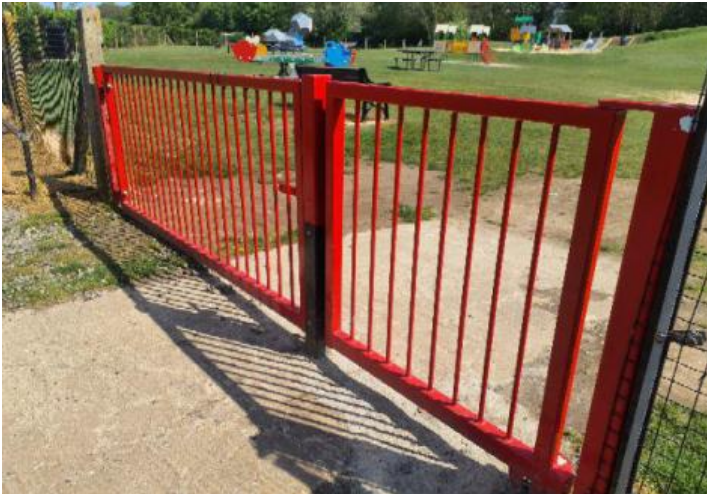
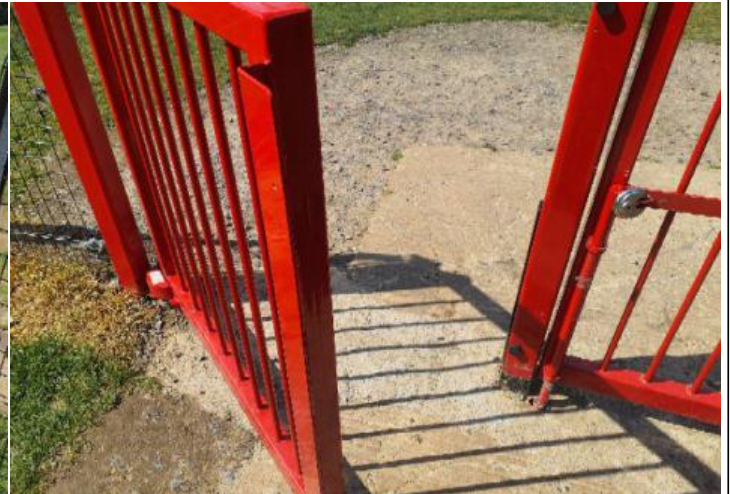
Item: Gates - Gate - Maintenance
Manufacturer: Not Identified

Risk Level: V - Very Low Risk
Surface: Concrete

Finding: The gate is closing too slowly (in excess of 8 seconds)

Action: Take effective action to ensure the gate closes between 4 and 8 seconds from 90 degrees

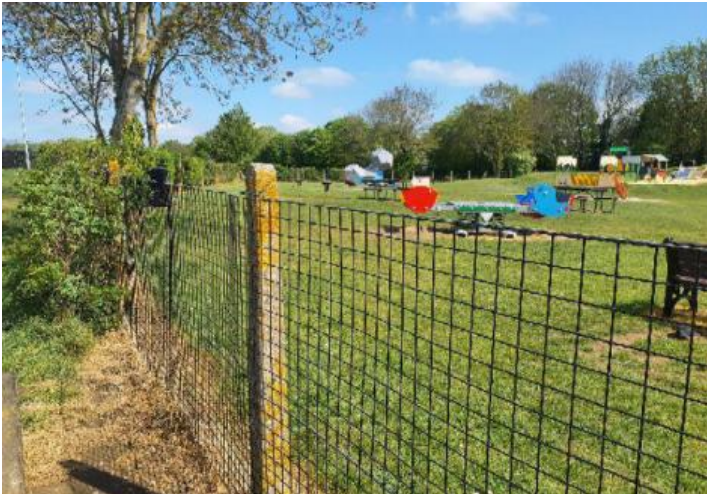
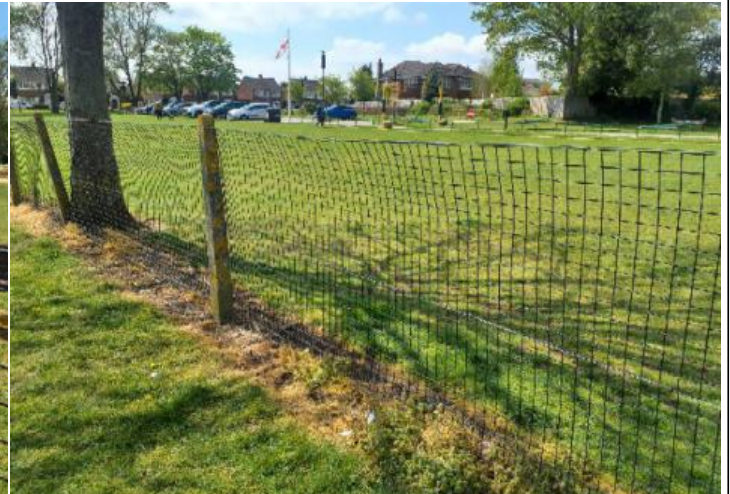
Item: Fences - Fence - Steel Mesh
Manufacturer: Not Identified

Risk Level: L - Low Risk
Surface: Grass

Finding: There are a number of loose posts around the fence

Action: Monitor for any further deterioration and reset as required

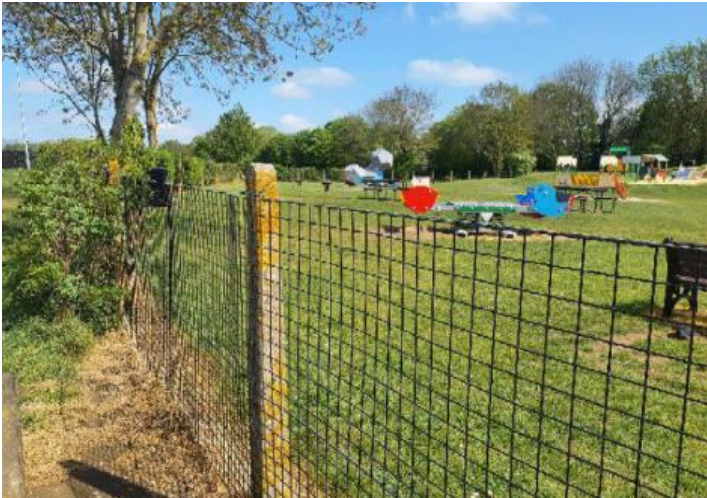
Item: Fences - Fence - Steel Mesh
Manufacturer: Not Identified

Risk Level: L - Low Risk
Surface: Grass

Finding: There is some damage to the fence sections

Action: Monitor for any further deterioration and repair as required

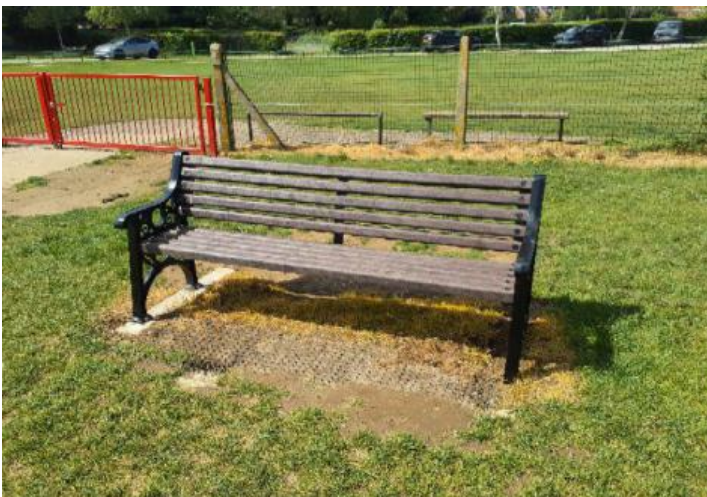
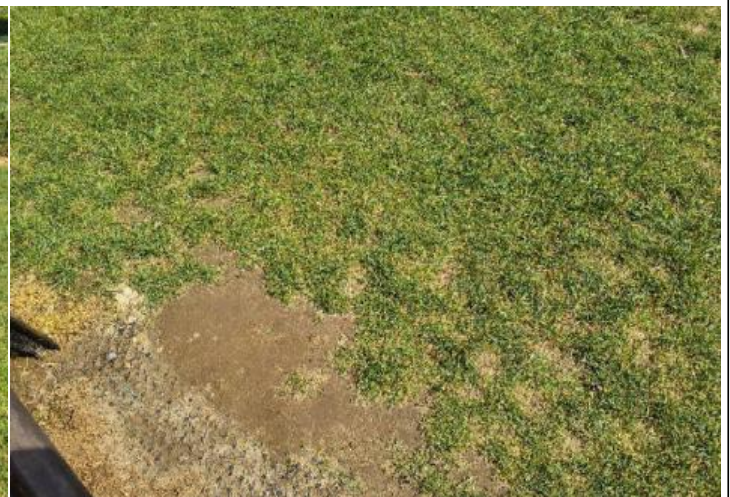
Item: Ancillary Items - Bench
Manufacturer: Not Identified

Risk Level: L - Low Risk
Surface: Grass

Finding: The area around the item has eroded and may become slippery

Action: Reinststate eroded area

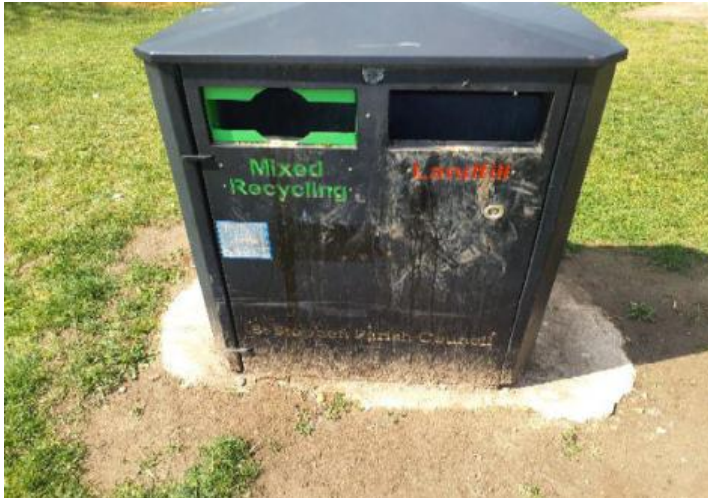
Item: Ancillary Items - Litter Bin
Manufacturer: Not Identified

Risk Level: L - Low Risk
Surface: Concrete

Finding: The surface has eroded and the foundations are exposed

Action: Reinstate surrounding surfaces to cover the foundations

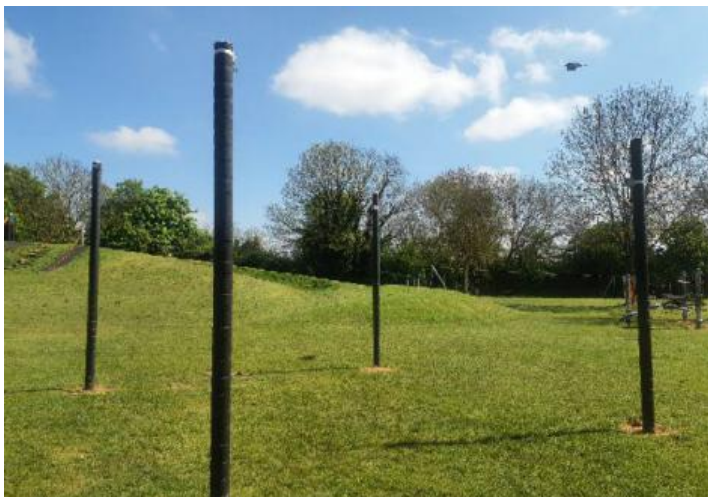
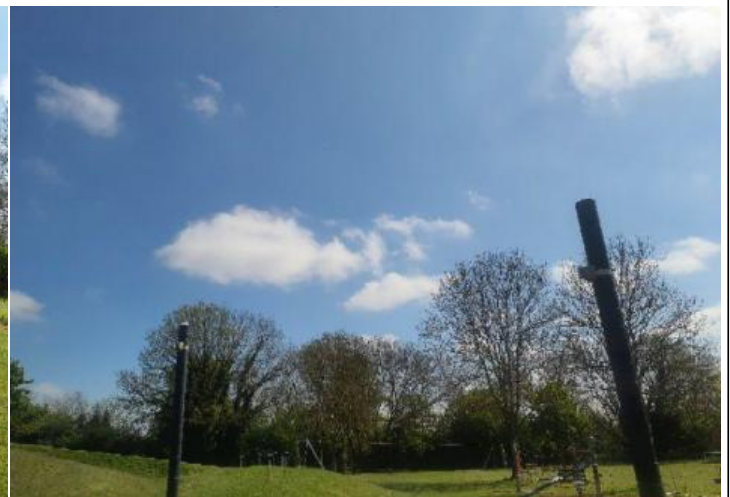
Item: Ancillary Items - Sun Canopy
Manufacturer: Not Identified

Risk Level: L - Low Risk
Surface: Grass

Finding: Canopy has been removed. Posts remain

Action: Consider replacing canopy

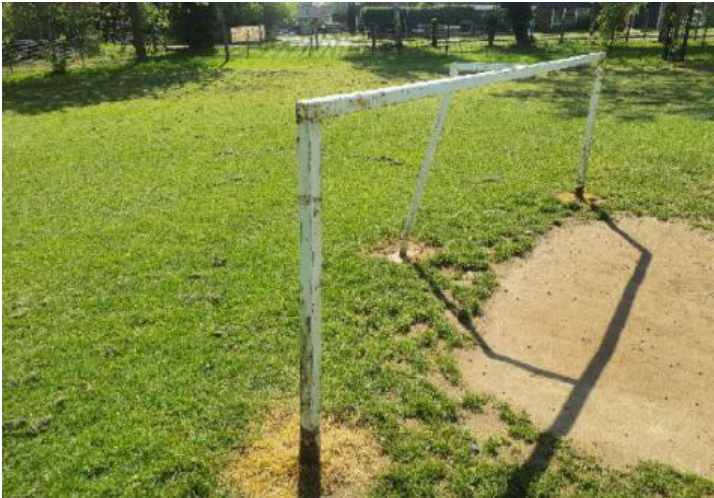
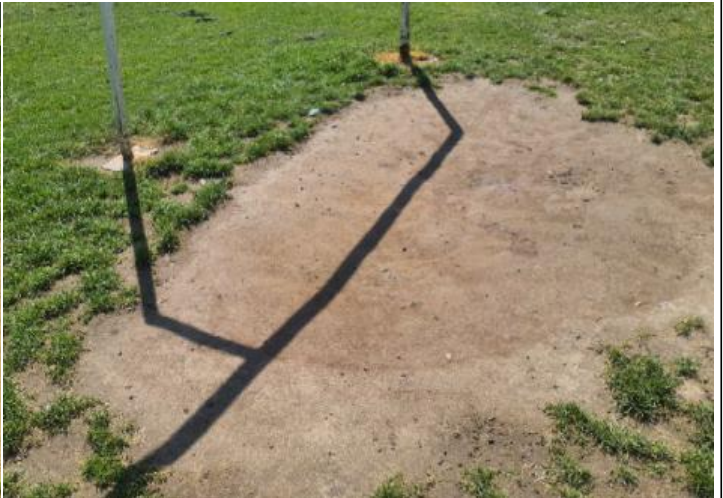
Item: Multi Use Games Area - 5 a side Goals
Manufacturer: Not Identified

Risk Level: L - Low Risk
Surface: Grass

Finding: The area around the item has eroded and may become slippery

Action: Reinststate eroded area

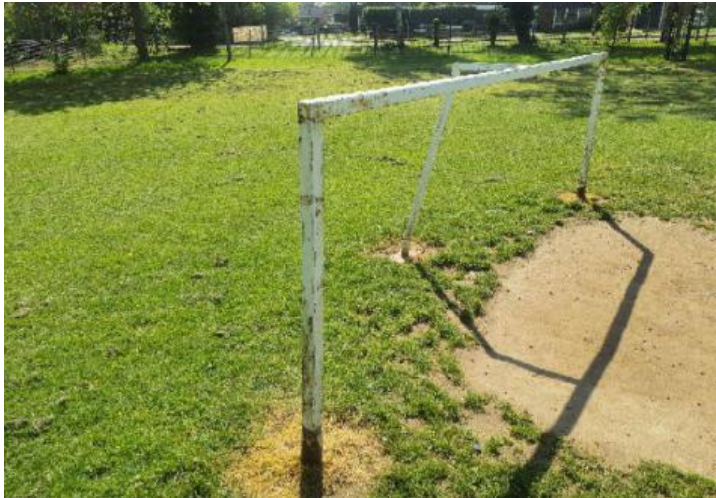
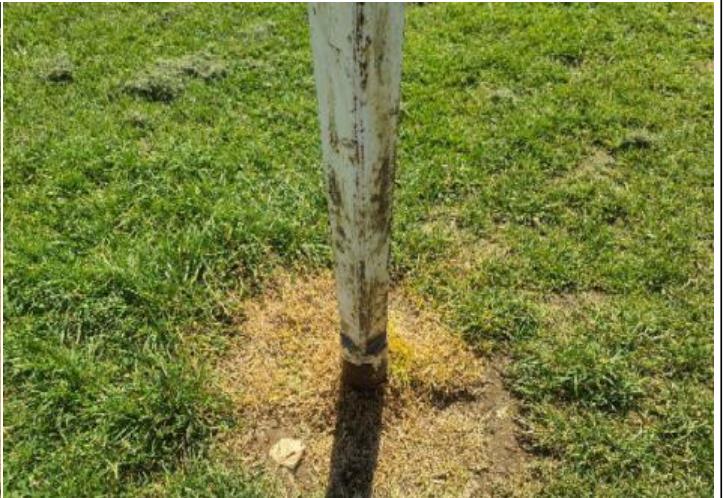
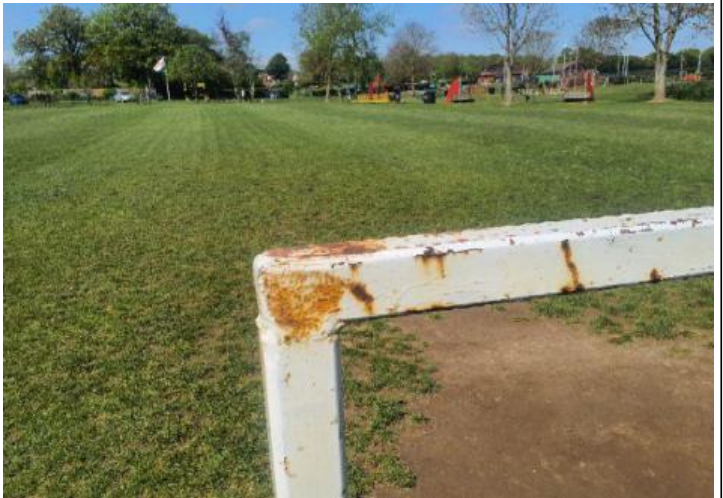
Item: Multi Use Games Area - 5 a side Goals
Manufacturer: Not Identified

Risk Level: L - Low Risk
Surface: Grass

Finding: The paintwork on this item has been damaged or worn exposing the metal underneath which is rusting / corroding

Action: Treat affected areas and repaint

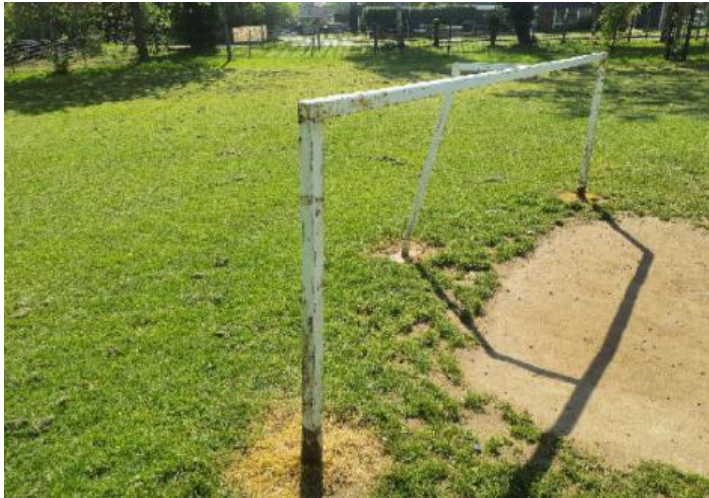
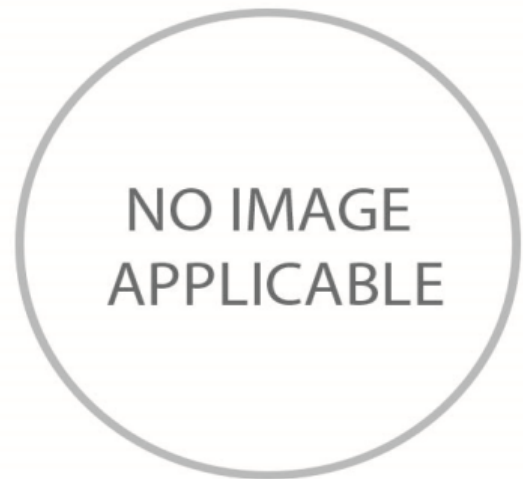
Item: Multi Use Games Area - 5 a side Goals
Manufacturer: Not Identified

Risk Level: N - Risk Assessment not Undertaken
Surface: Grass

Finding: NB: We have undertaken a maintenance inspection only of the football goal(s); full load testing falls outside the scope of our inspection.

Action: Implement load testing as required

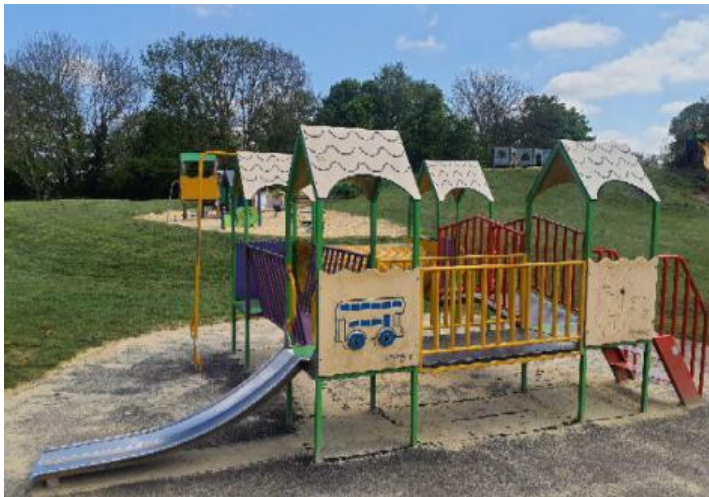
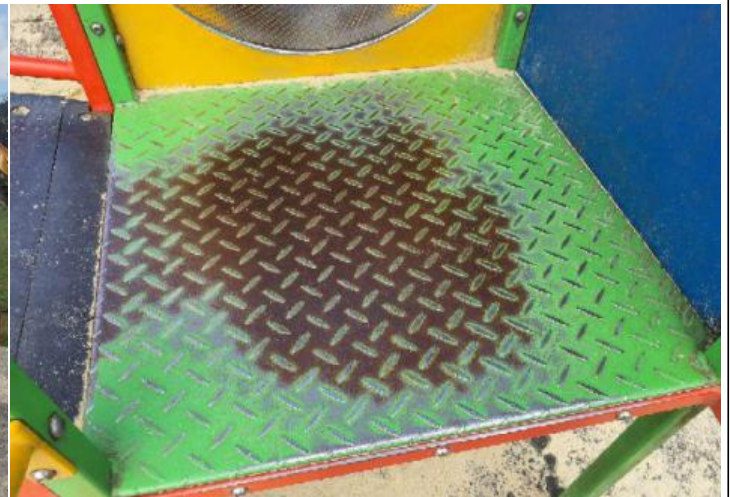
Item: Activity Equipment - Multi Play (Toddler)
Manufacturer: Wicksteed Playgrounds

Risk Level: L - Low Risk
Surface: Wet Pour

Finding: The paintwork on this item has been damaged or worn exposing the metal underneath which is rusting / corroding

Action: Treat affected areas and repaint

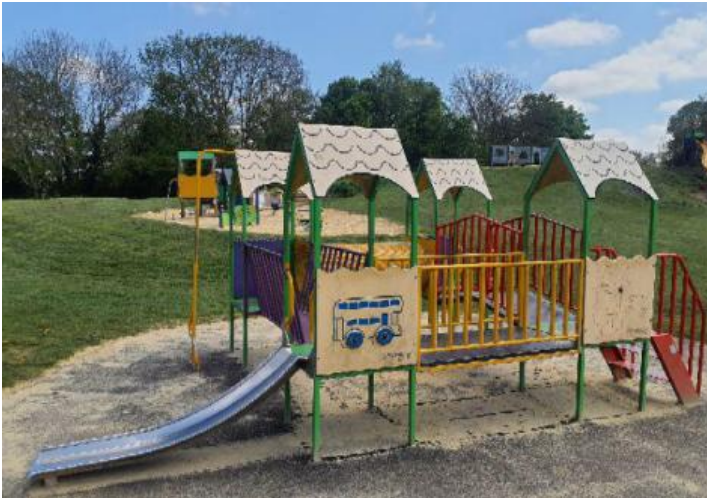
Item: Activity Equipment - Multi Play (Toddler)
Manufacturer: Wicksteed Playgrounds

Risk Level: L - Low Risk
Surface: Wet Pour

Finding: The tunnel has been damaged

Action: Monitor for any further deterioration and replace as required

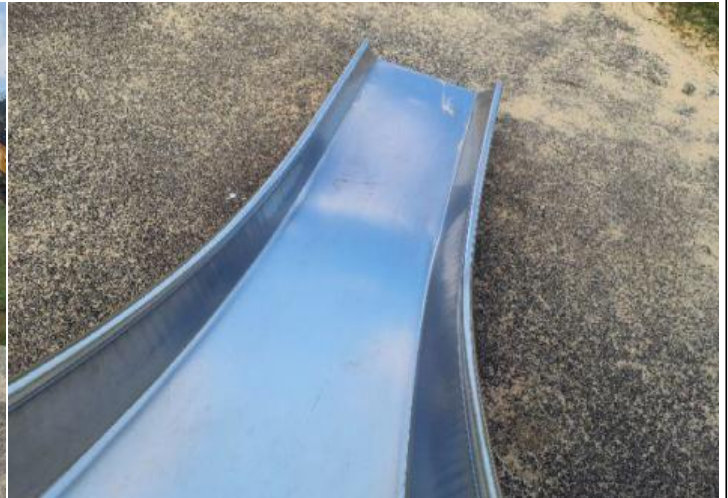
Item: Activity Equipment - Multi Play (Toddler)
Manufacturer: Wicksteed Playgrounds

Risk Level: V - Very Low Risk
Surface: Wet Pour

Finding: There are a number of dents in the slide surface

Action: Monitor for any further deterioration and repair as required

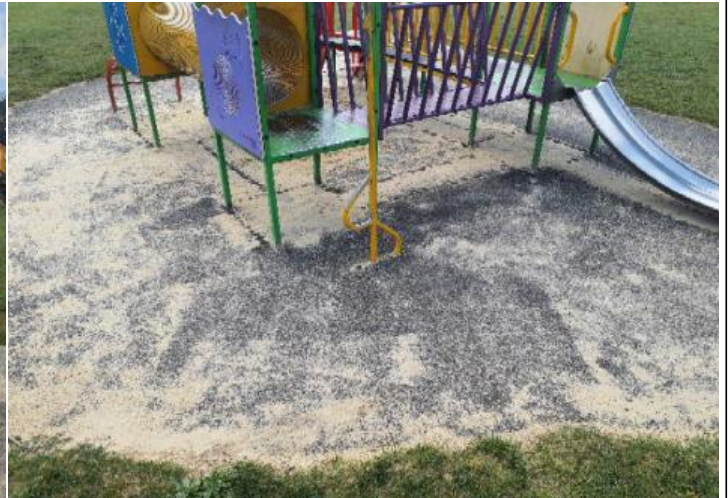
Item: Activity Equipment - Multi Play (Toddler)
Manufacturer: Wicksteed Playgrounds

Risk Level: L - Low Risk
Surface: Wet Pour

Finding: Sand has migrated on to the safety surface and can be slippery in wet conditions

Action: Clear and maintain

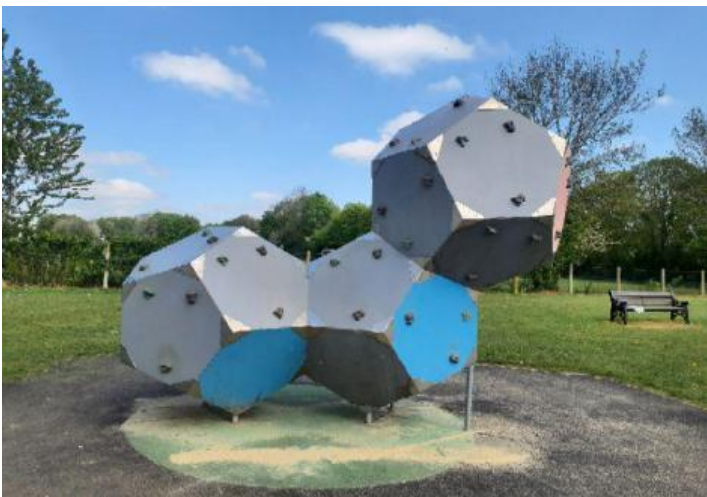
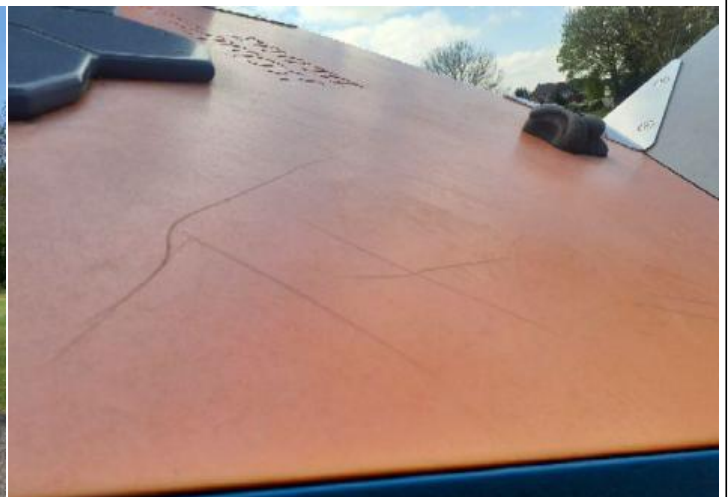
Item: Activity Equipment - Climbing Blocks
Manufacturer: Kompan Ltd

Risk Level: L - Low Risk
Surface: Wet Pour

Finding: The item has been damaged / vandalised

Action: Monitor for any further deterioration and replace as required

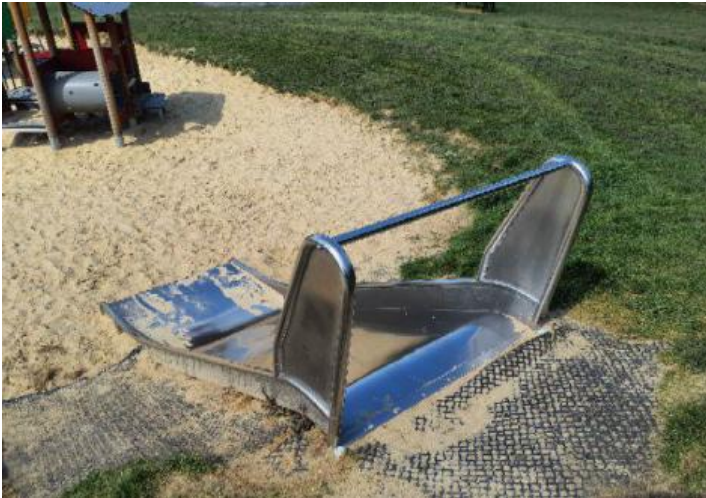
Item: Other - Embankment Slide
Manufacturer: R&T Stainless A/S

Risk Level: L - Low Risk
Surface: Mixed Surface

Finding: The edges of the grass mat surface are raised / lifting above the surrounding surface

Action: Tuck in or pin edges of grass mats as per the API Code of Practice to remove trip hazards

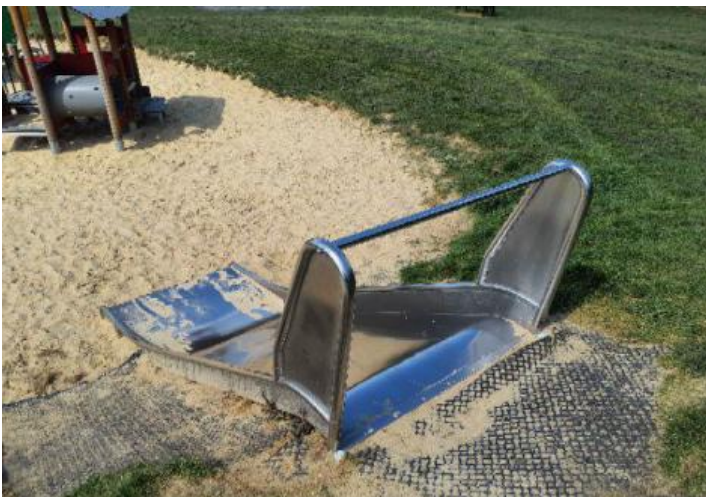
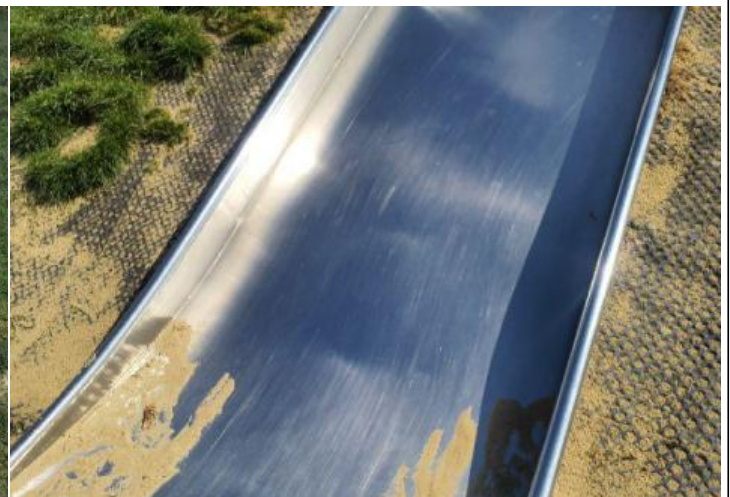
Item: Other - Embankment Slide
Manufacturer: R&T Stainless A/S

Risk Level: V - Very Low Risk
Surface: Mixed Surface

Finding: There are a number of dents in the slide surface

Action: Monitor for any further deterioration and repair as required

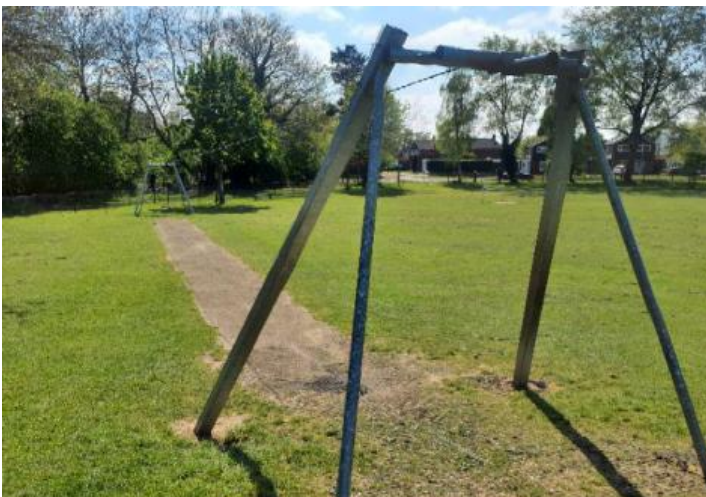
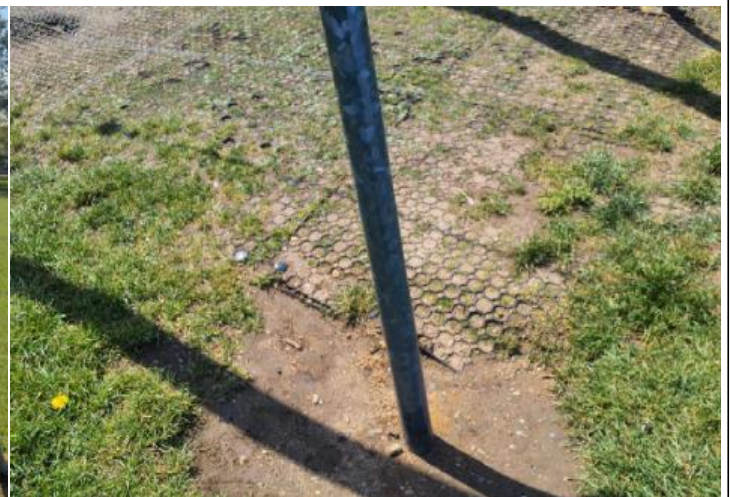
Item: Other - Cable Runway
Manufacturer: Kompan Ltd

Risk Level: L - Low Risk
Surface: Grass Matrix Tiles

Finding: The edges of the grass mat surface are raised / lifting above the surrounding surface

Action: Tuck in or pin edges of grass mats as per the API Code of Practice to remove trip hazards

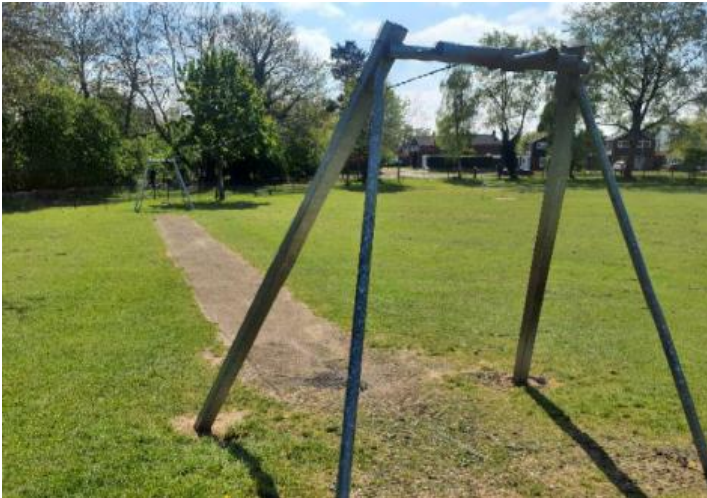
Item: Other - Cable Runway
Manufacturer: Kompan Ltd

Risk Level: L - Low Risk
Surface: Grass Matrix Tiles

Finding: There is moderate damage to the surface

Action: Repair the damaged areas of surfacing
