ST STEPHEN PARISH COUNCIL

You are summoned to the Fixed Assets Committee meeting

AGENDA

| 2526/AC/013 | To receive Annual Play Inspection Reports. Reports attached. |

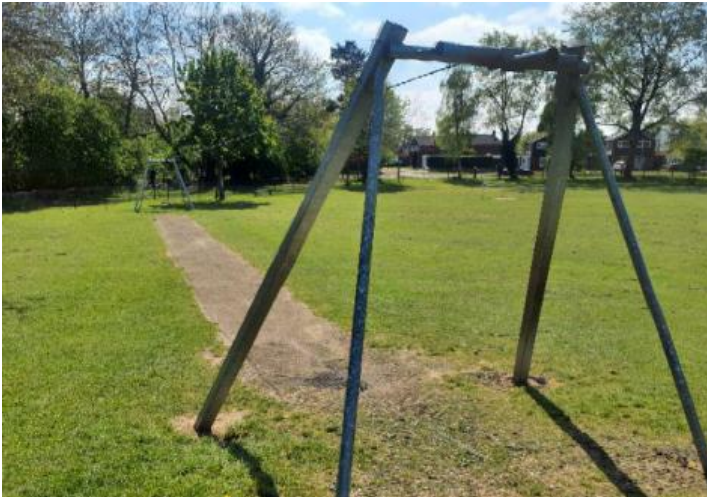
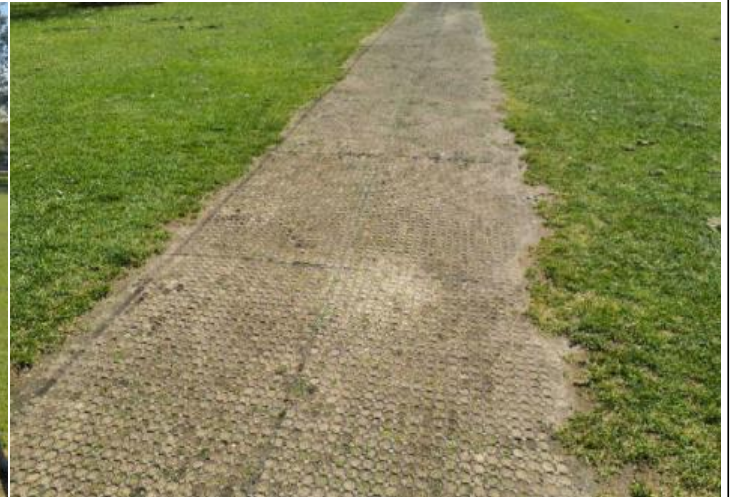
Item: Other - Cable Runway
Manufacturer: Kompan Ltd

Risk Level: L - Low Risk
Surface: Grass Matrix Tiles

Finding: The grass mats are silted up, the soil is compacted and the area will become very slippery when the soil is wet.

Action: Reinststate as required

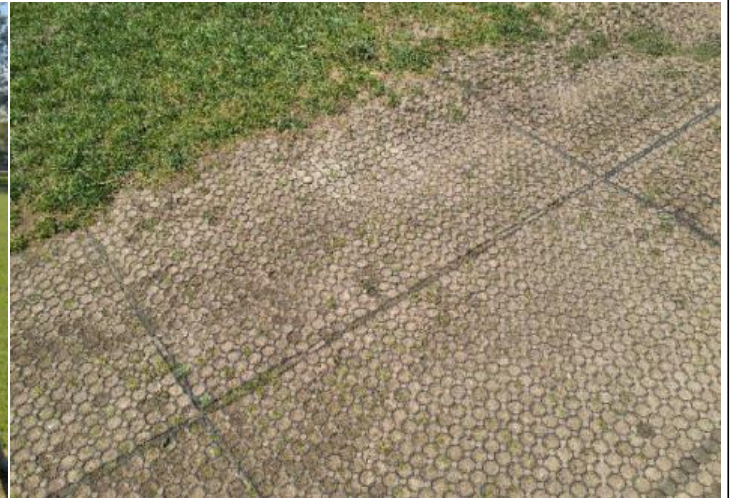
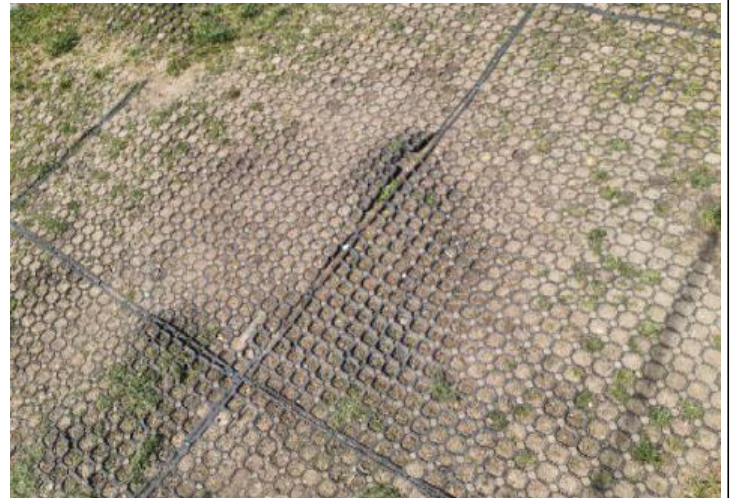
Item: Other - Cable Runway
Manufacturer: Kompan Ltd

Risk Level: L - Low Risk
Surface: Grass Matrix Tiles

Finding: There are gaps opening between the grass mat tiles

Action: Provide additional ties or secure / reinstate surface

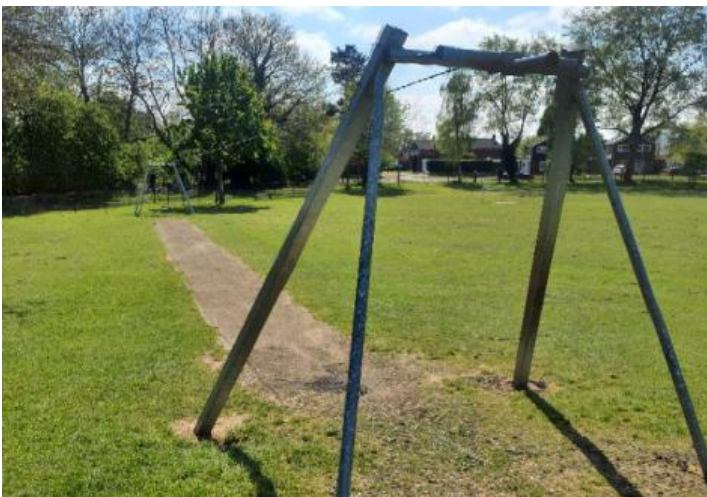
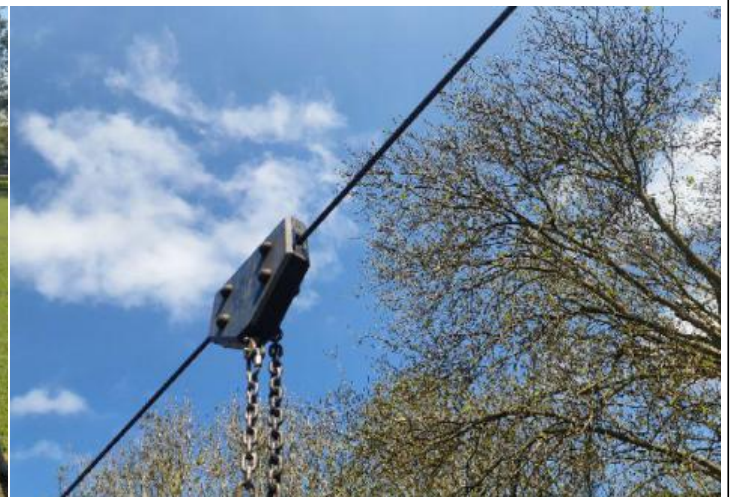
Item: Other - Cable Runway
Manufacturer: Kompan Ltd

Risk Level: V - Very Low Risk
Surface: Grass Matrix Tiles

Finding: The nylon inserts are worn or missing at the point the cable enters the traveller

Action: Replace worn or missing inserts as required

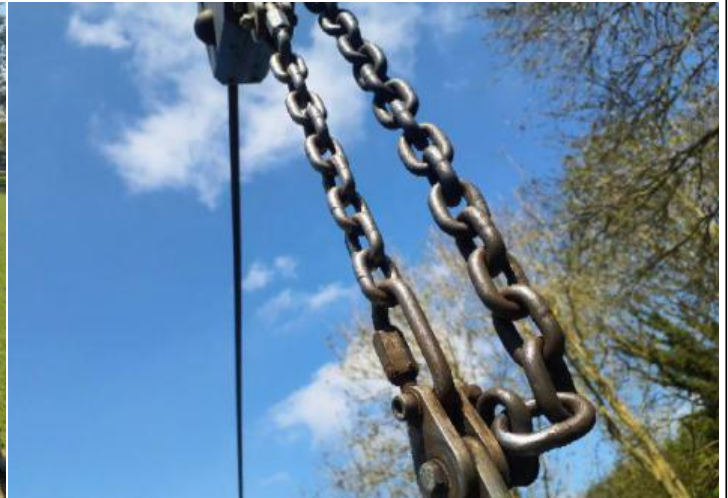
Item: Other - Cable Runway
Manufacturer: Kompan Ltd

Risk Level: L - Low Risk
Surface: Grass Matrix Tiles

Finding: A secondary safety has been added and the chain links are worn excessively and require renewing.

Action: Replace worn chains

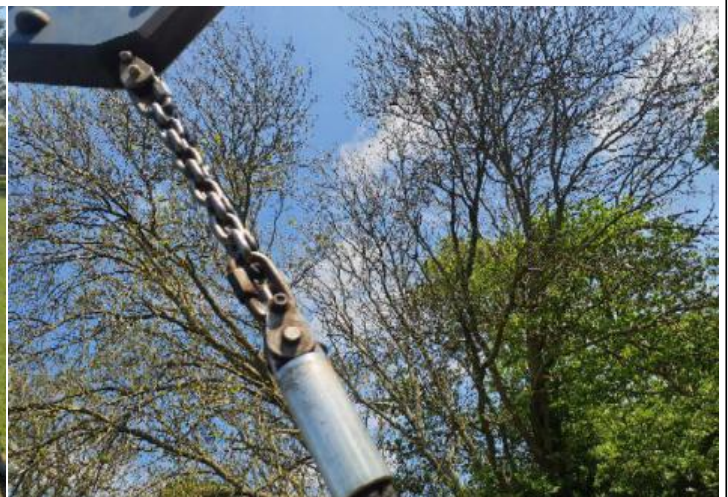
Item: Other - Cable Runway
Manufacturer: Kompan Ltd

Risk Level: L - Low Risk
Surface: Grass Matrix Tiles

Finding: There is some wear to the shackles

Action: Monitor for any further deterioration and replace when 40% worn

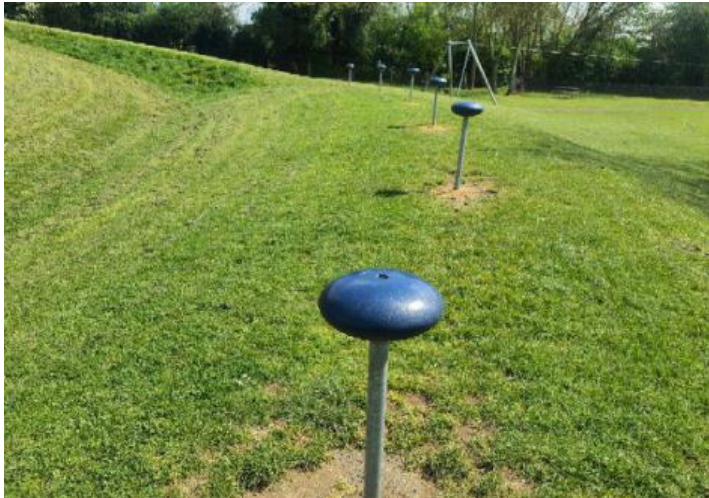
Item: Activity Equipment - Leap Frog
Manufacturer: Kompan Ltd

Risk Level: L - Low Risk
Surface: Grass Matrix Tiles

Finding: There is moderate damage to the grass matrix tile surface **Action:** Repair the damaged areas of surfacing

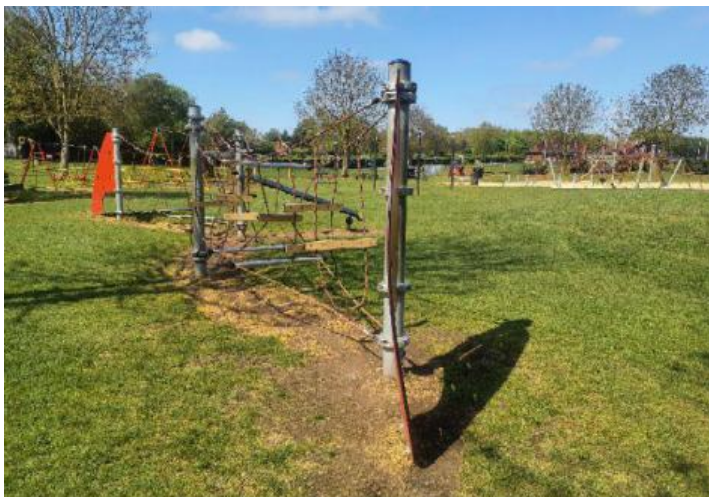
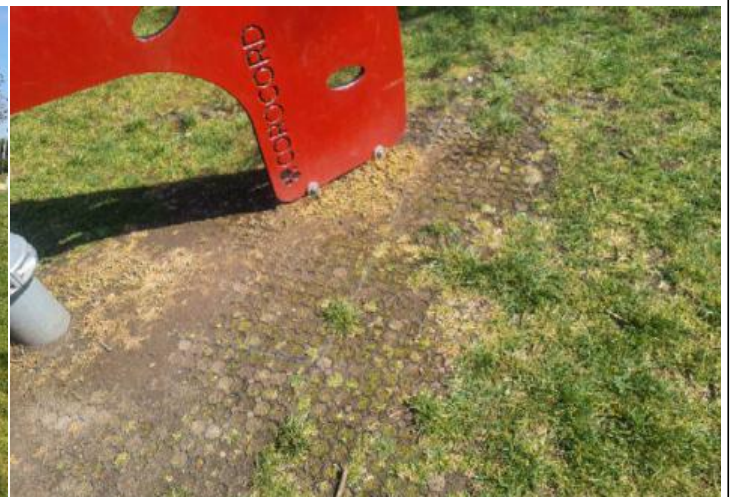
Item: Activity Equipment - Activity Trail
Manufacturer: Corocord

Risk Level: L - Low Risk
Surface: Grass Matrix Tiles

Finding: The grass mats are silted up, the soil is compacted and the area will become very slippery when the soil is wet. **Action:** Reinstate as required

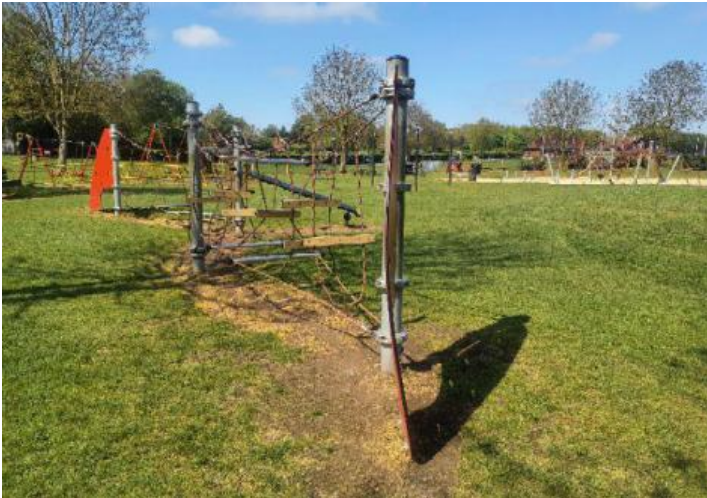
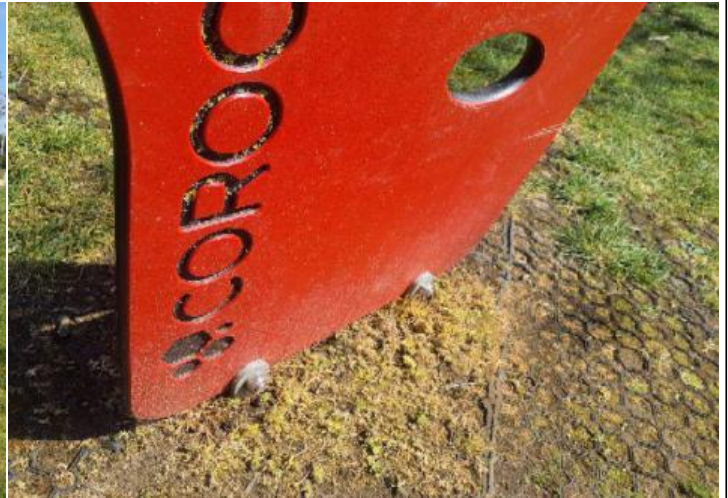
Item: Activity Equipment - Activity Trail
Manufacturer: Corocord

Risk Level: V - Very Low Risk
Surface: Grass Matrix Tiles

Finding: There is/are bolt cap covers missing or damaged on the item

Action: Replace missing or damaged bolt cap covers

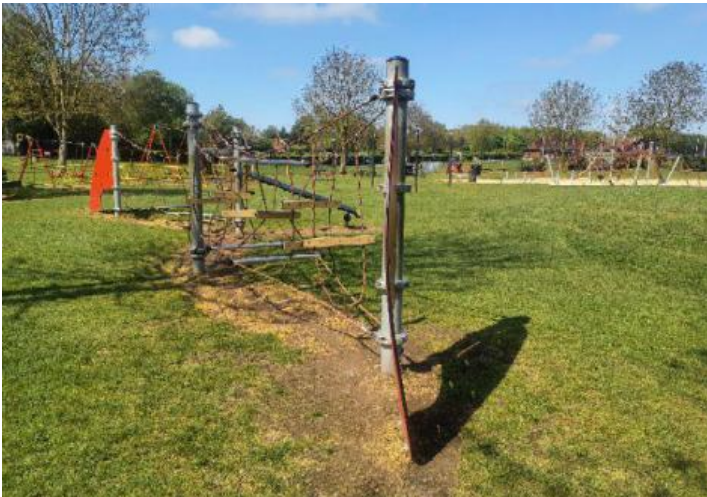
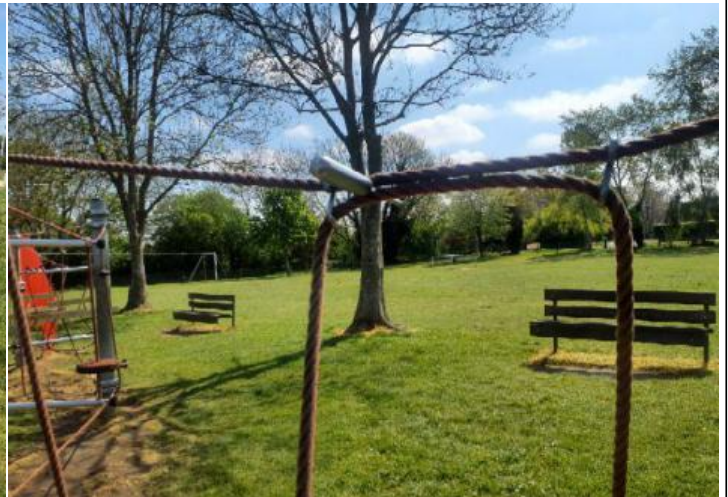
Item: Activity Equipment - Activity Trail
Manufacturer: Corocord

Risk Level: V - Very Low Risk
Surface: Grass Matrix Tiles

Finding: There is/are finger entrapment/s in the rope connection and the item fails to meet the requirements of BS EN 1176 Part 1 4.2.7.6 Entrapment of fingers

Action: Monitor - No action given the risk assessment

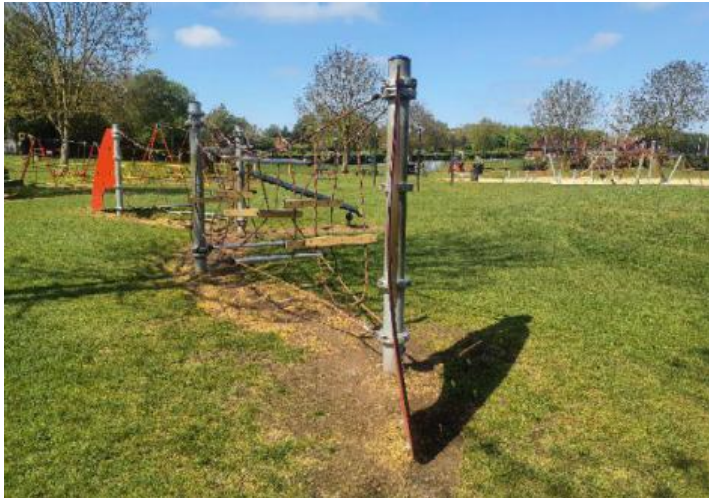
Item: Activity Equipment - Activity Trail
Manufacturer: Corocord

Risk Level: L - Low Risk
Surface: Grass Matrix Tiles

Finding: The climbing wall has been damaged

Action: Monitor for any further deterioration and replace as required

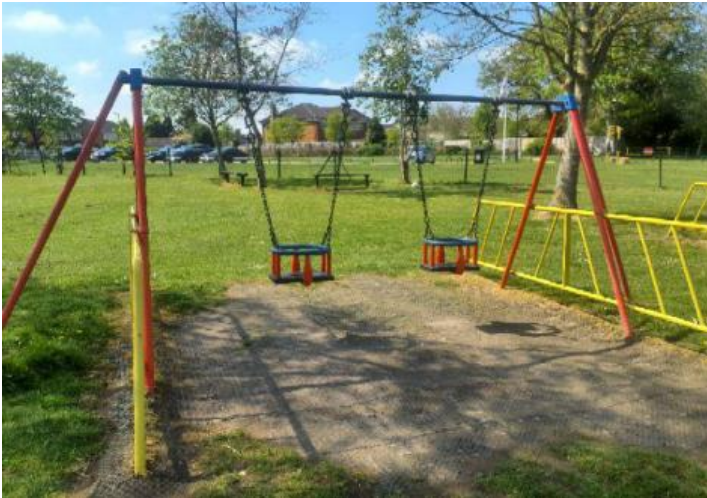
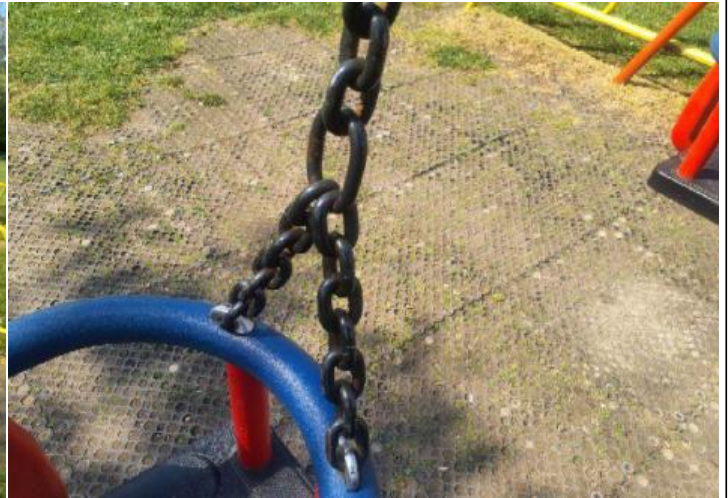
Item: Swings - 1 Bay 2 Seat (Cradle)
Manufacturer: GL Jones

Risk Level: L - Low Risk
Surface: Grass Matrix Tiles

Finding: There is some notable evidence of chain wear

Action: Monitor for any further deterioration and replace when 40% worn

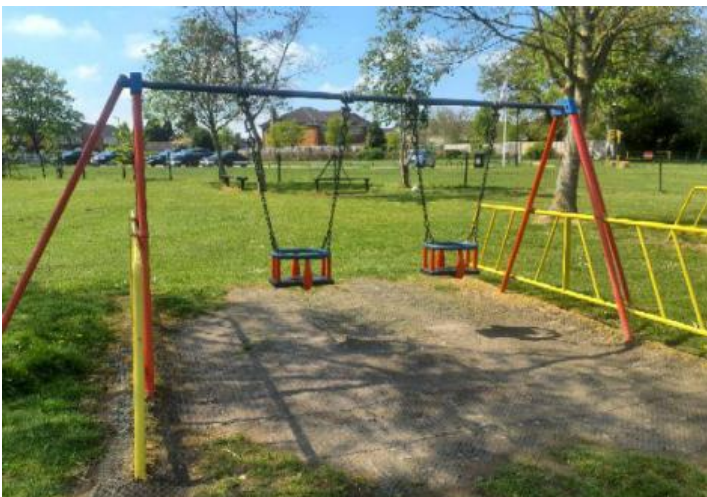
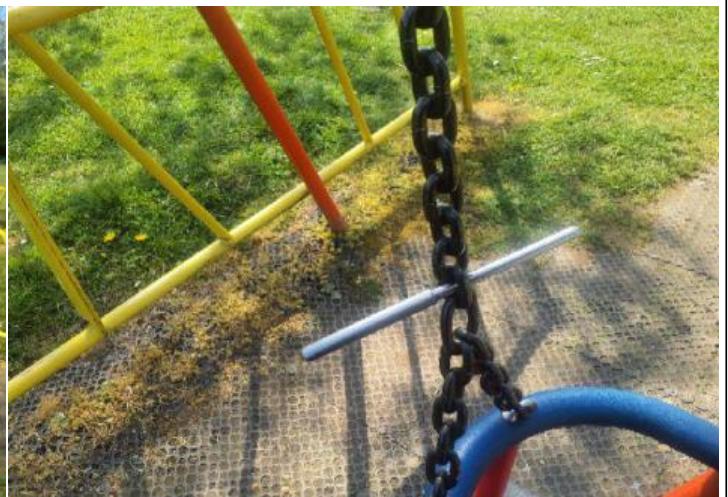
Item: Swings - 1 Bay 2 Seat (Cradle)
Manufacturer: GL Jones

Risk Level: V - Very Low Risk
Surface: Grass Matrix Tiles

Finding: The chain openings are in excess of 8.6mm and do not meet the recommendations of BS EN 1176 Part 1

Action: Monitor - No action given the risk assessment

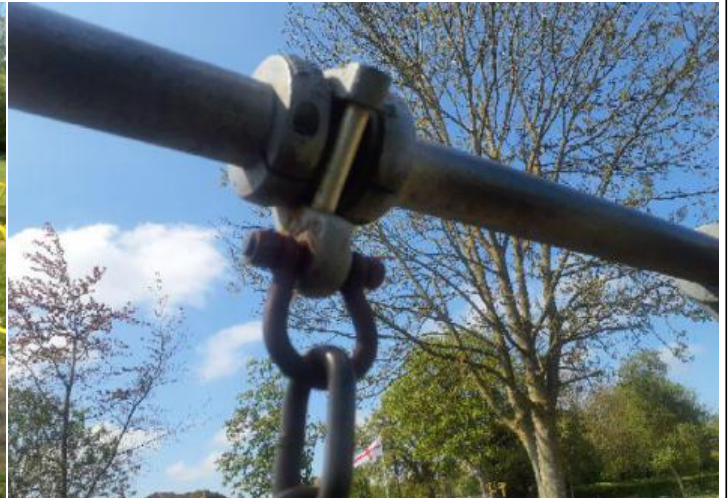
Item: Swings - 1 Bay 2 Seat (Cradle)
Manufacturer: GL Jones

Risk Level: L - Low Risk
Surface: Grass Matrix Tiles

Finding: There is some wear to the shackles

Action: Monitor for any further deterioration and replace when 40% worn

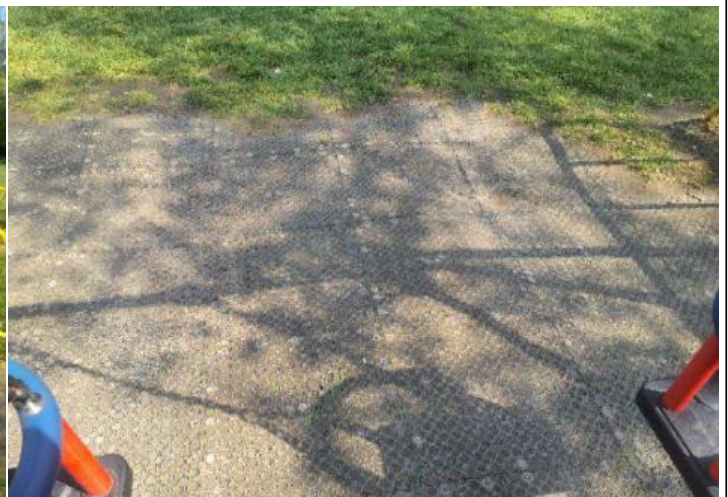
Item: Swings - 1 Bay 2 Seat (Cradle)
Manufacturer: GL Jones

Risk Level: L - Low Risk
Surface: Grass Matrix Tiles

Finding: The surface has subsided in some areas

Action: Monitor for any further deterioration and repair as required

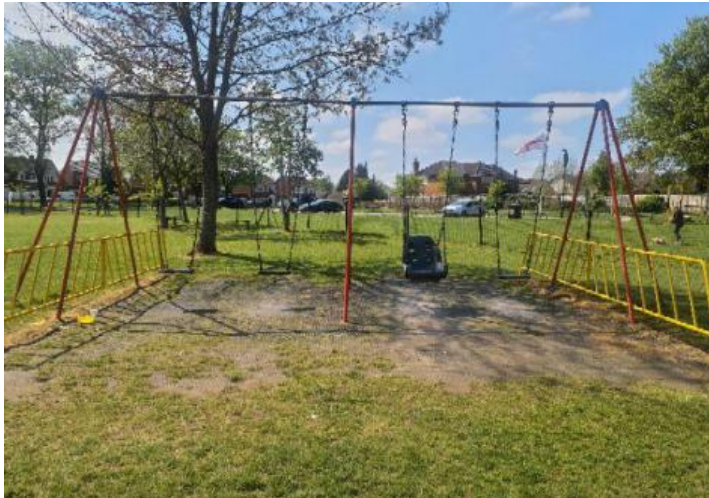
Item: Swings - 2 Bay 3 Flat 1 Inclusive Seat
Manufacturer: G L Jones Playgrounds Ltd

Risk Level: L - Low Risk
Surface: Grass Matrix Tiles

Finding: There is some notable evidence of chain wear

Action: Monitor for any further deterioration and replace when 40% worn

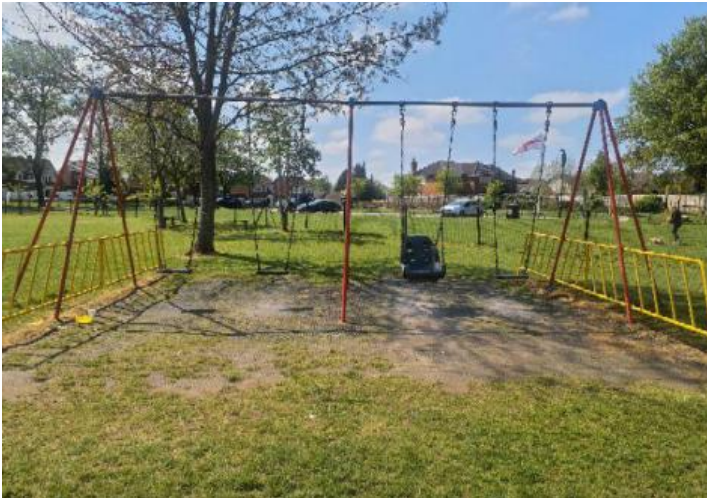
Item: Swings - 2 Bay 3 Flat 1 Inclusive Seat
Manufacturer: G L Jones Playgrounds Ltd

Risk Level: V - Very Low Risk
Surface: Grass Matrix Tiles

Finding: The chain openings are in excess of 8.6mm and do not meet the recommendations of BS EN 1176 Part 1

Action: Monitor - No action given the risk assessment

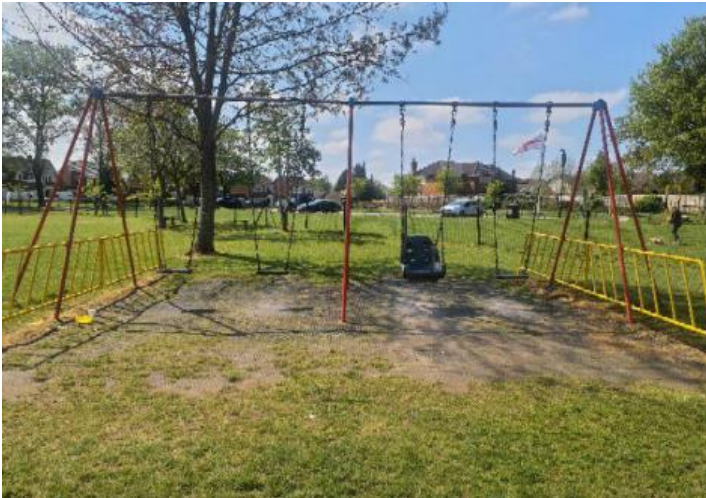
Item: Swings - 2 Bay 3 Flat 1 Inclusive Seat
Manufacturer: G L Jones Playgrounds Ltd

Risk Level: L - Low Risk
Surface: Grass Matrix Tiles

Finding: There is some wear to the shackles

Action: Monitor for any further deterioration and replace when 40% worn

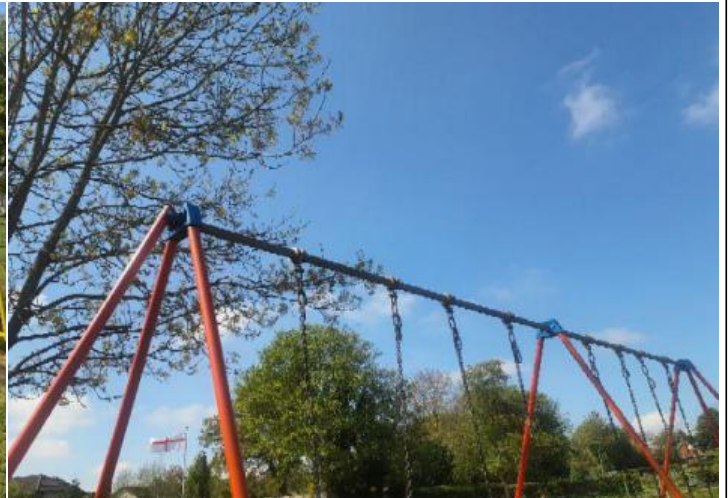
Item: Swings - 2 Bay 3 Flat 1 Inclusive Seat
Manufacturer: G L Jones Playgrounds Ltd

Risk Level: N - Risk Assessment not Undertaken
Surface: Grass Matrix Tiles

Finding: The fixings or components for this item were in excess of 2.5m above the standing surface and could not be fully accessed by the inspector. We have completed a visual inspection of the fixings from ground level but a maintenance inspection should be undertaken to assess the condition, security and wear of the components at intervals in accordance with the manufacturers recommendations.

Action: Inspect in accordance with the manufacturers recommendations

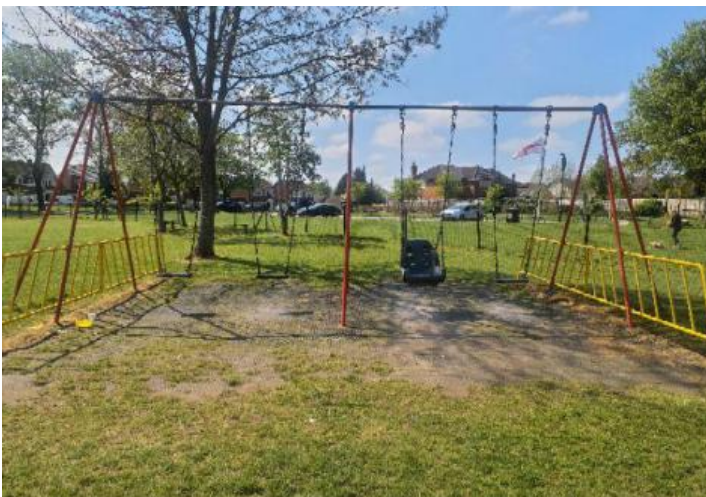
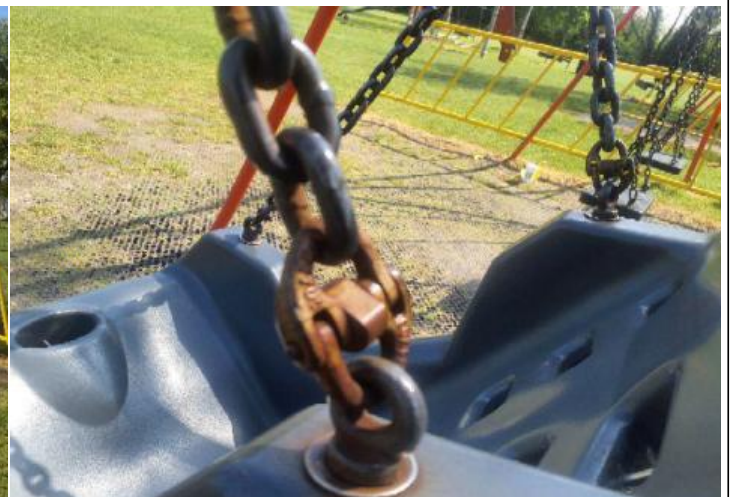
Item: Swings - 2 Bay 3 Flat 1 Inclusive Seat
Manufacturer: G L Jones Playgrounds Ltd

Risk Level: L - Low Risk
Surface: Grass Matrix Tiles

Finding: There is some wear to the shackles

Action: Monitor for any further deterioration and replace when 40% worn

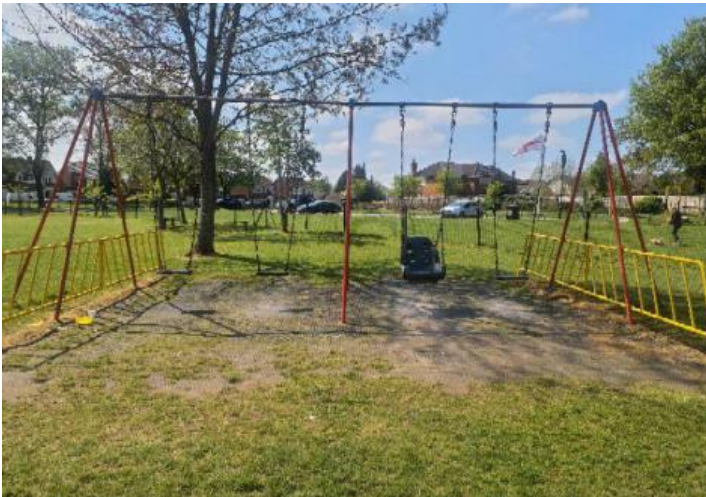
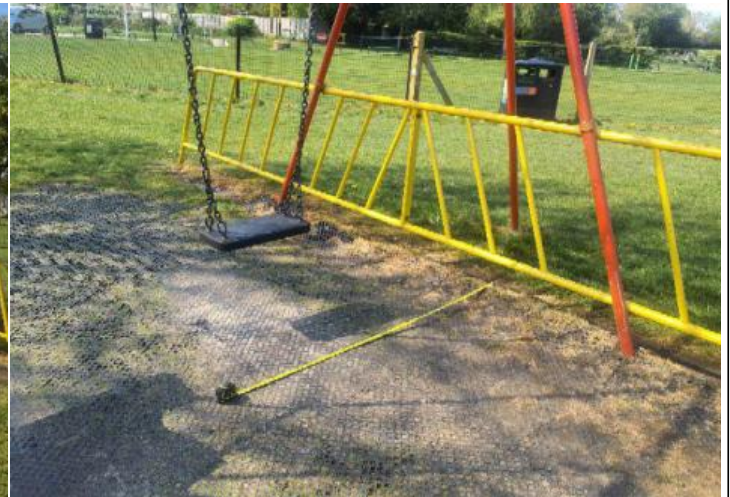
Item: Swings - 2 Bay 3 Flat 1 Inclusive Seat
Manufacturer: G L Jones Playgrounds Ltd

Risk Level: L - Low Risk
Surface: Grass Matrix Tiles

Finding: BS EN 1176 Part 2: Annex A makes a recommendation that fences or enclosures should be up to 1.50m from the edges of the swing seat to the sides, and subject to risk assessment, from the edge of the impact area. This is however, a low risk finding and no remedial action is recommended.

Action: Monitor - No action given the risk assessment

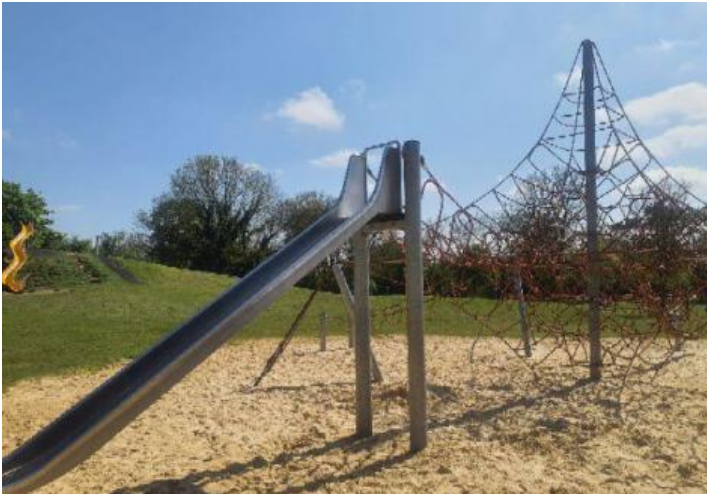
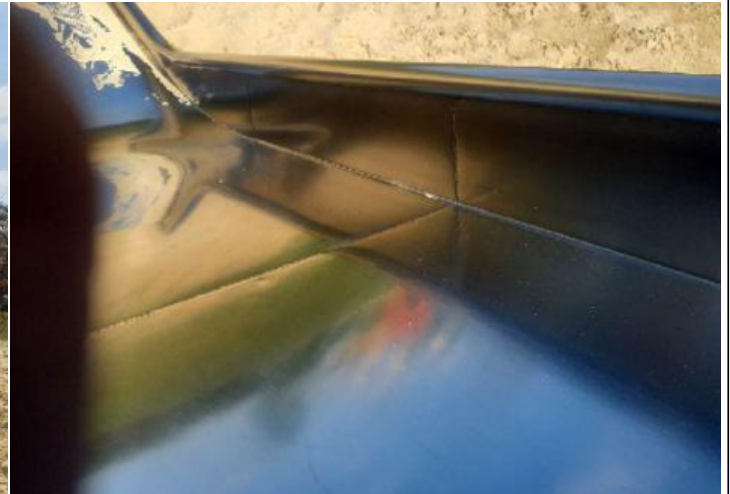
Item: Activity Equipment - Space Net
Manufacturer: Corocord

Risk Level: V - Very Low Risk
Surface: Sand

Finding: There are a number of dents in the slide surface

Action: Monitor for any further deterioration and repair as required

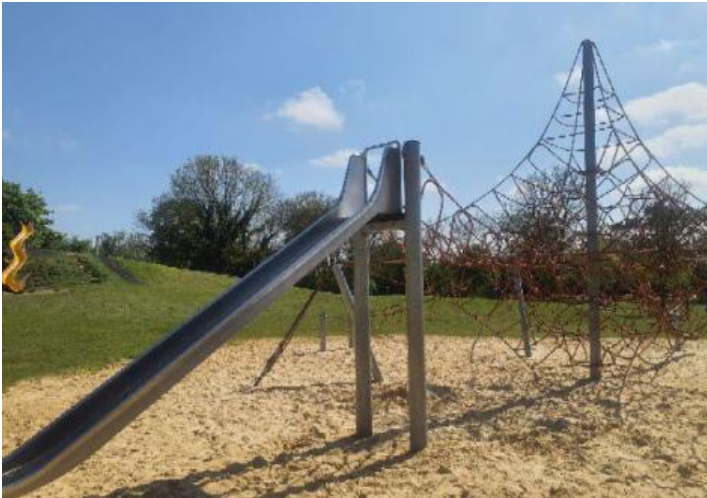
Item: Activity Equipment - Space Net
Manufacturer: Corocord

Risk Level: L - Low Risk
Surface: Sand

Finding: The height of the slide runout is in excess of 350mm and does not meet the requirements of BS EN 1176: levels Part 3

Action: Top up surrounding surfaces to recommended

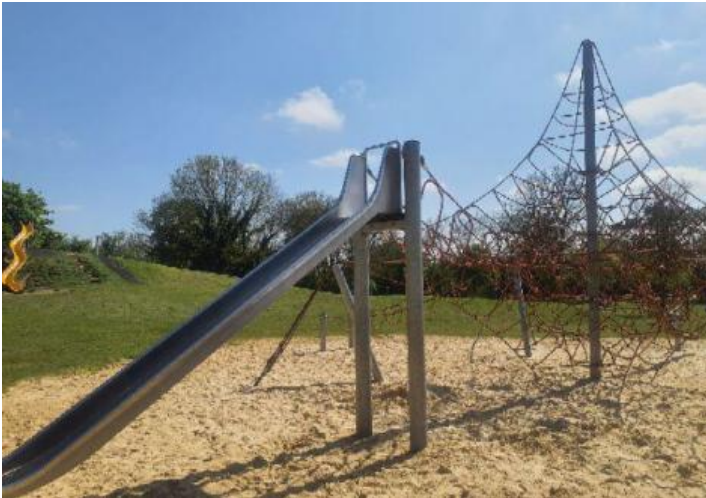
Item: Activity Equipment - Space Net
Manufacturer: Corocord

Risk Level: L - Low Risk
Surface: Sand

Finding: The side of the slide is damaged

Action: Monitor for any further deterioration and repair as required

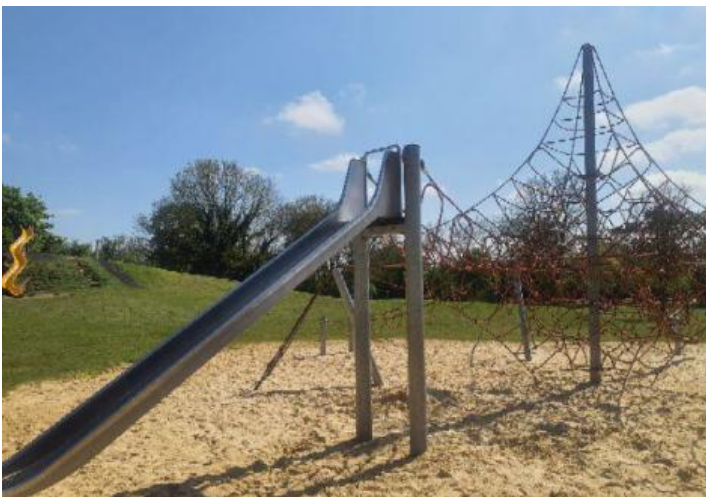
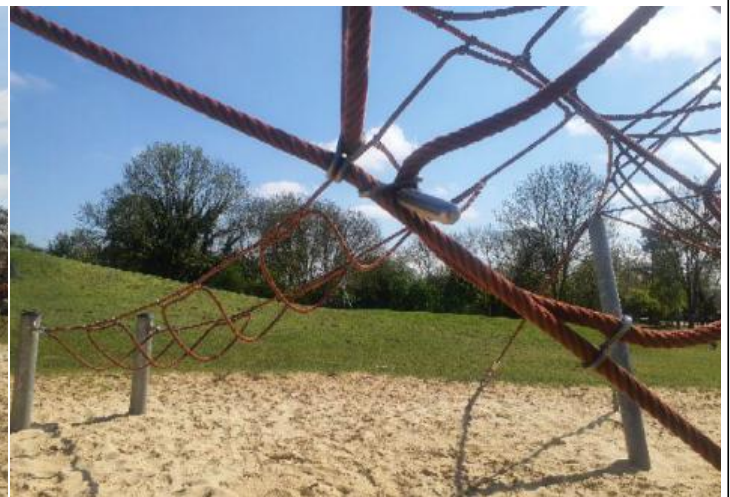
Item: Activity Equipment - Space Net
Manufacturer: Corocord

Risk Level: V - Very Low Risk
Surface: Sand

Finding: There is/are finger entrapment/s in the rope connection and the item fails to meet the requirements of BS EN 1176 Part 1 4.2.7.6 Entrapment of fingers

Action: Monitor - No action given the risk assessment

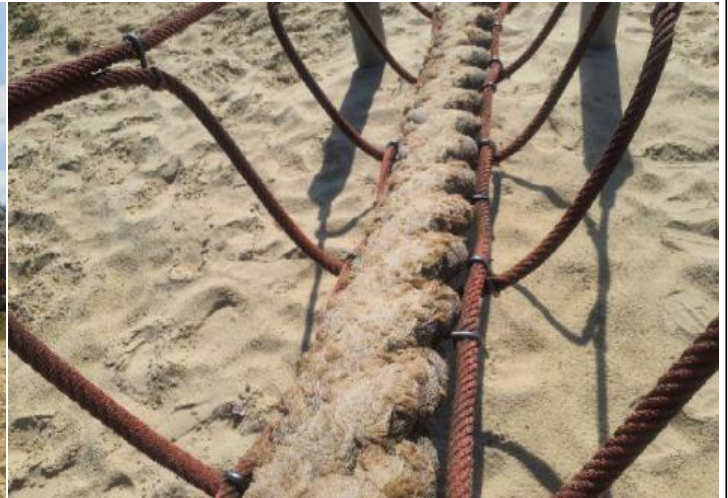
Item: Activity Equipment - Space Net
Manufacturer: Corocord

Risk Level: L - Low Risk
Surface: Sand

Finding: The ropes/nets are worn/damaged in places

Action: Monitor for any further deterioration and repair or replace as required

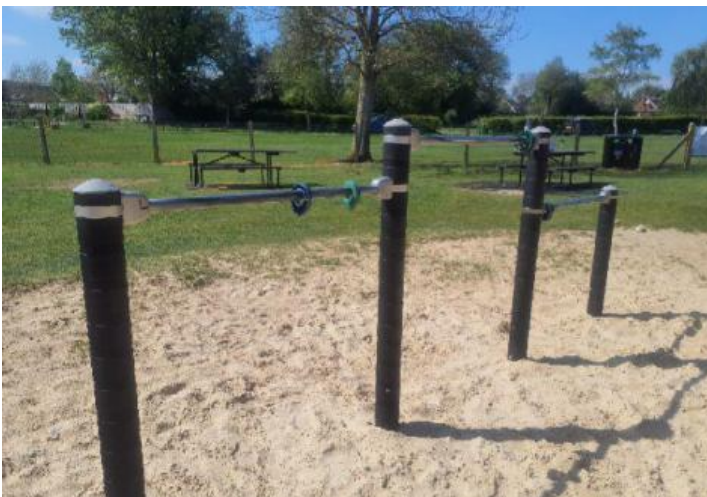
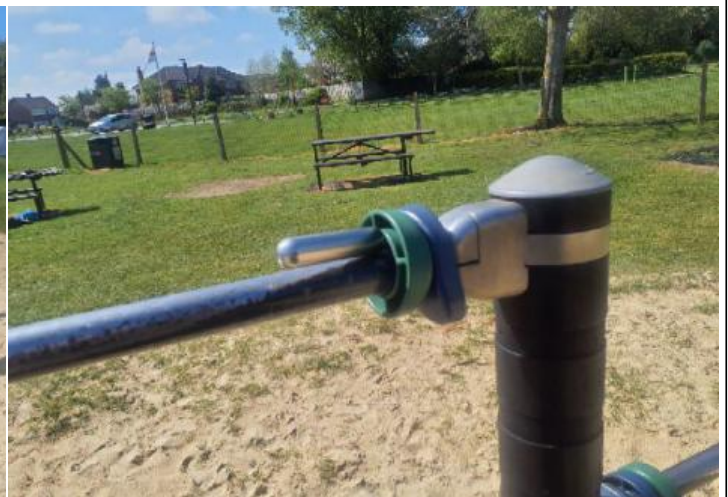
Item: Activity Equipment - Somersault Bars
Manufacturer: Kompan Ltd

Risk Level: L - Low Risk
Surface: Sand

Finding: There is/are finger entrapment/s / crush in the Somersault bars fixing and the item fails to meet the requirements of BS EN 1176 Part 1 4.2.7.6 Entrapment of fingers

Action: Monitor - No remedial work recommended

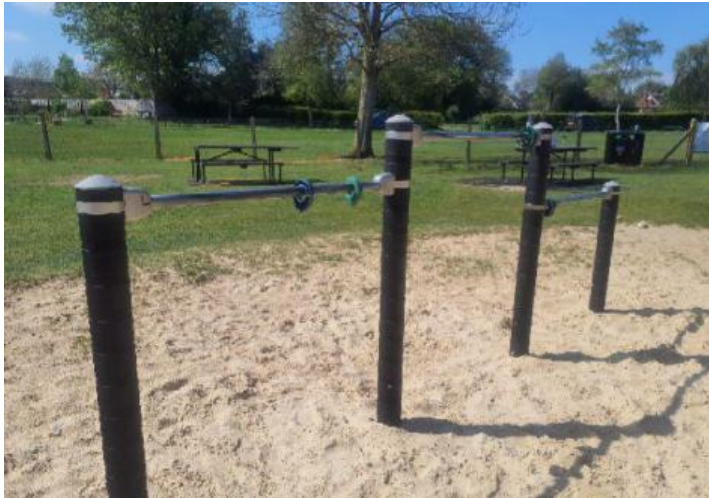
Item: Activity Equipment - Somersault Bars
Manufacturer: Kompan Ltd

Risk Level: L - Low Risk
Surface: Sand

Finding: The paintwork on this item has been damaged or worn exposing the metal underneath which is rusting / corroding

Action: Treat affected areas and repaint

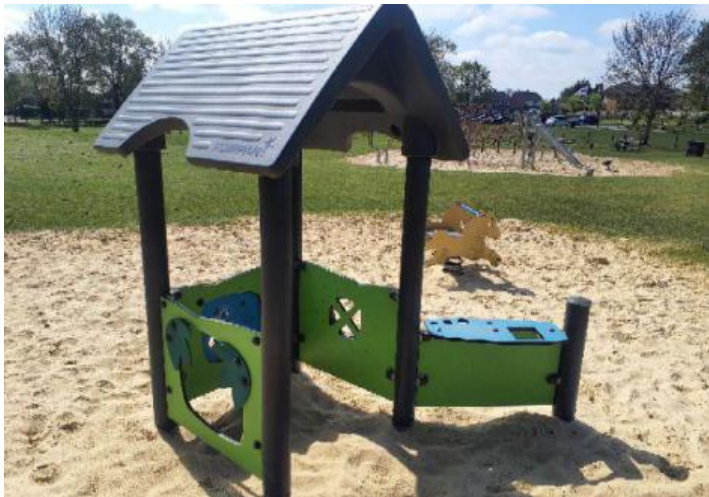
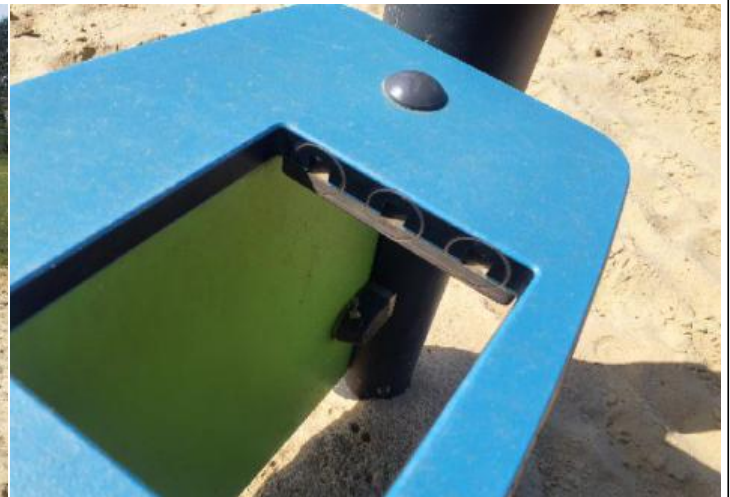
Item: Activity Equipment - Playhouse
Manufacturer: Kompan Ltd

Risk Level: L - Low Risk
Surface: Sand

Finding: The item has missing component(s)

Action: Consider replacing missing components

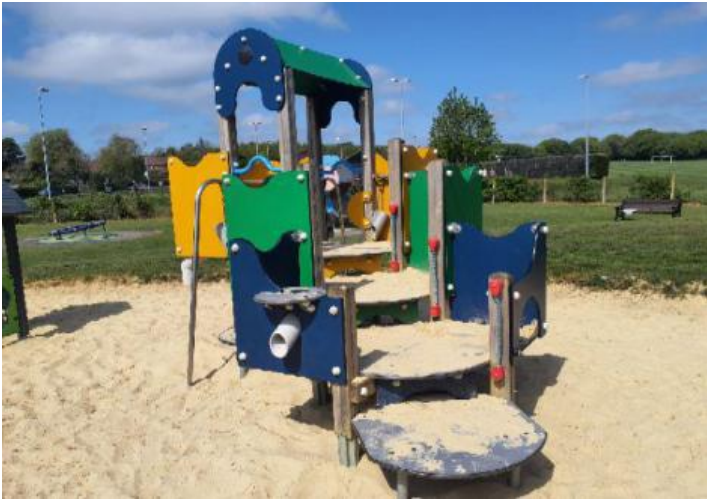
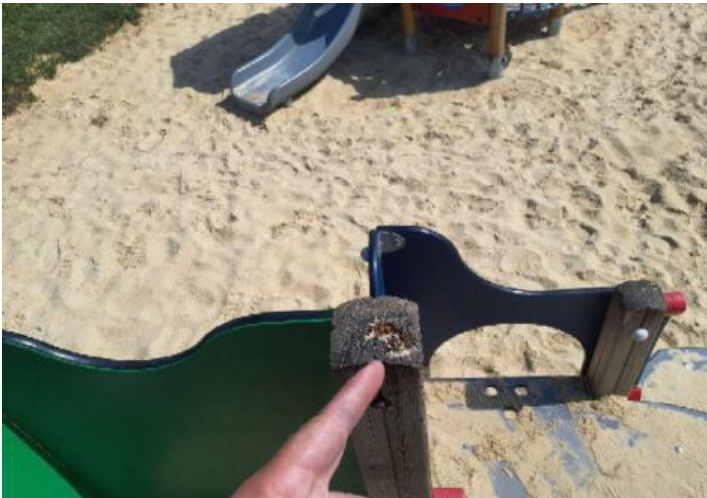
Item: Activity Equipment - Sand Play Unit
Manufacturer: Kompan Ltd

Risk Level: L - Low Risk
Surface: Sand

Finding: There is some evidence of rot in the timber posts

Action: Monitor for any further deterioration and replace as required

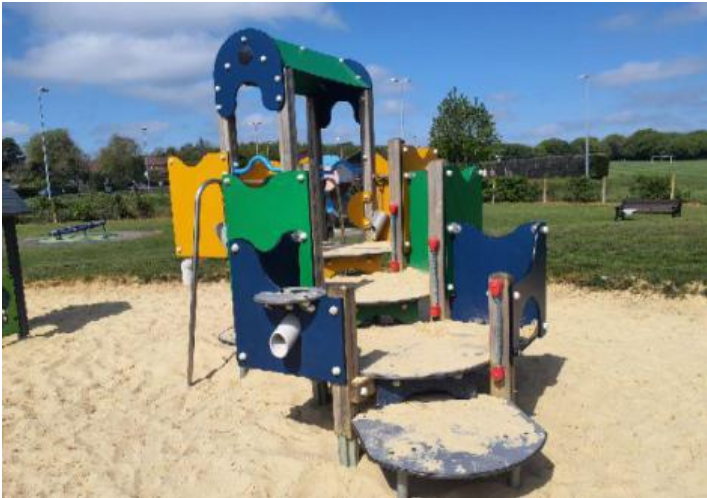
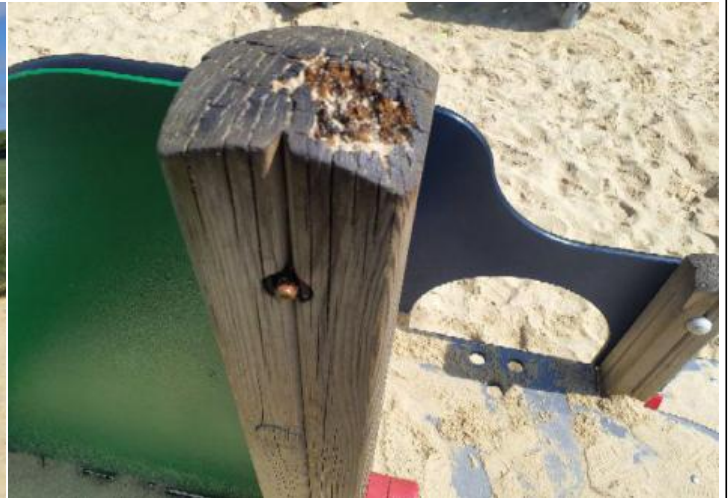
Item: Activity Equipment - Sand Play Unit
Manufacturer: Kompan Ltd

Risk Level: L - Low Risk
Surface: Sand

Finding: There are projecting bolt thread(s) present

Action: Remove excess thread length and deburr or provide cap

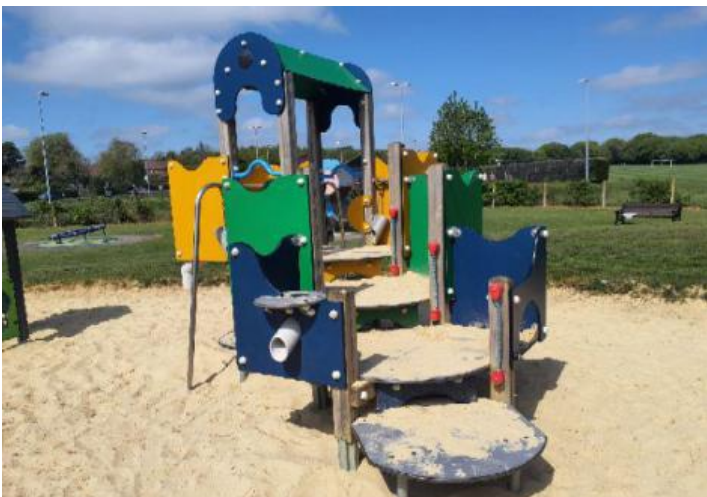
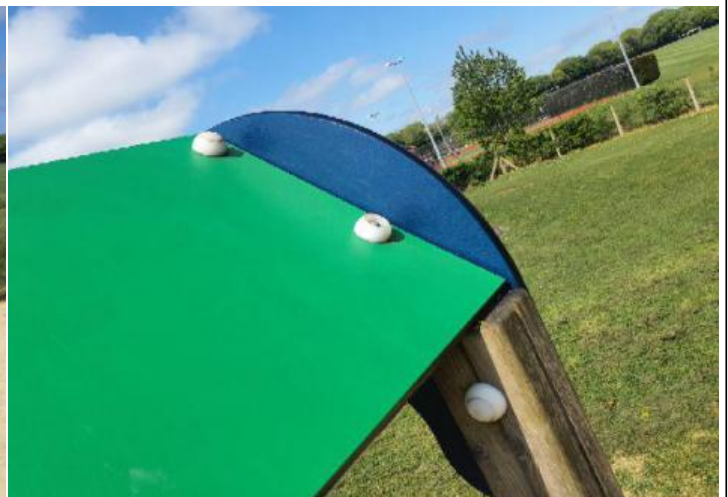
Item: Activity Equipment - Sand Play Unit
Manufacturer: Kompan Ltd

Risk Level: V - Very Low Risk
Surface: Sand

Finding: There is/are bolt cap covers missing or damaged on the item

Action: Replace missing or damaged bolt cap covers

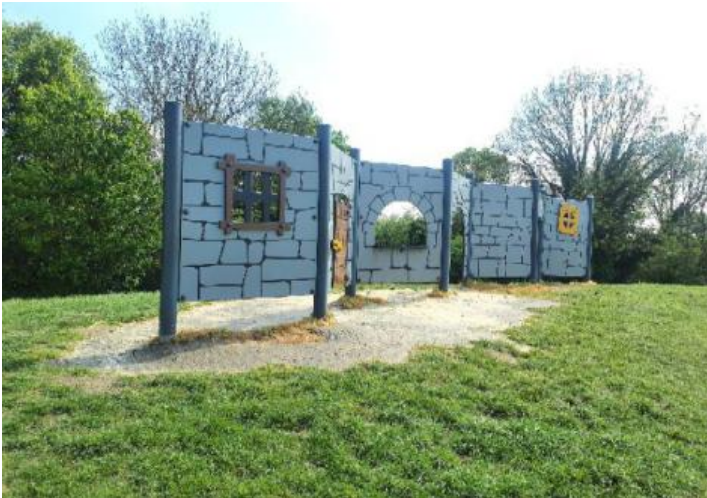
Item: Activity Equipment - Play Panel
Manufacturer: Kompan Ltd

Risk Level: L - Low Risk
Surface: Grass Matrix Tiles

Finding: The item is slightly loose in its foundations

Action: Monitor for any further deterioration and repair as required

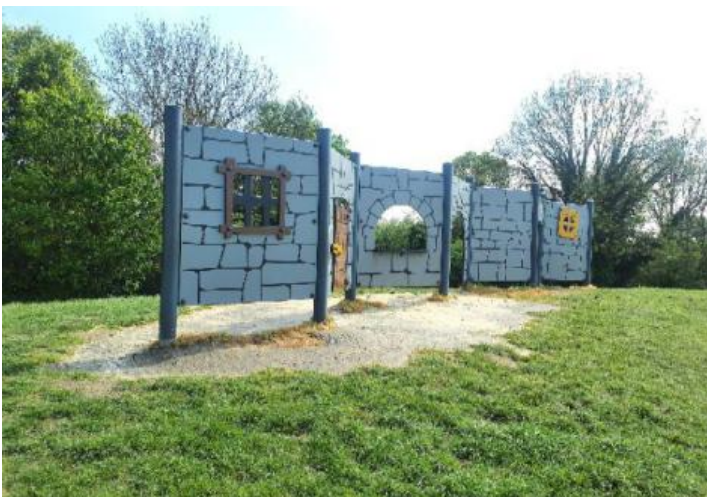
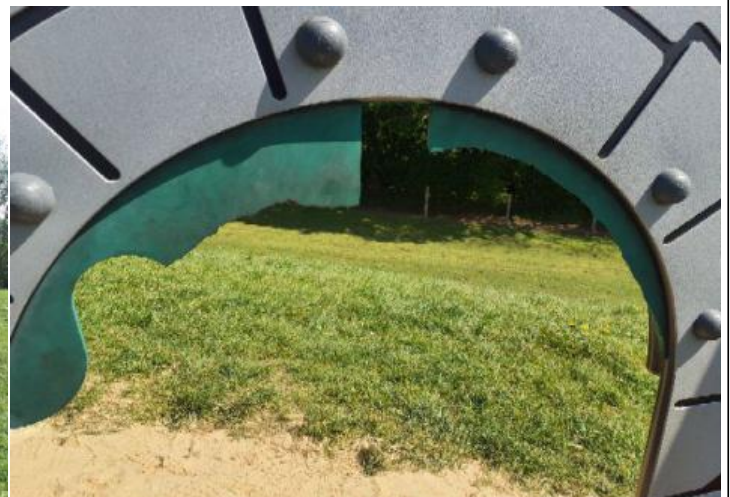
Item: Activity Equipment - Play Panel
Manufacturer: Kompan Ltd

Risk Level: L - Low Risk
Surface: Grass Matrix Tiles

Finding: The play component has been damaged

Action: Repair damaged item

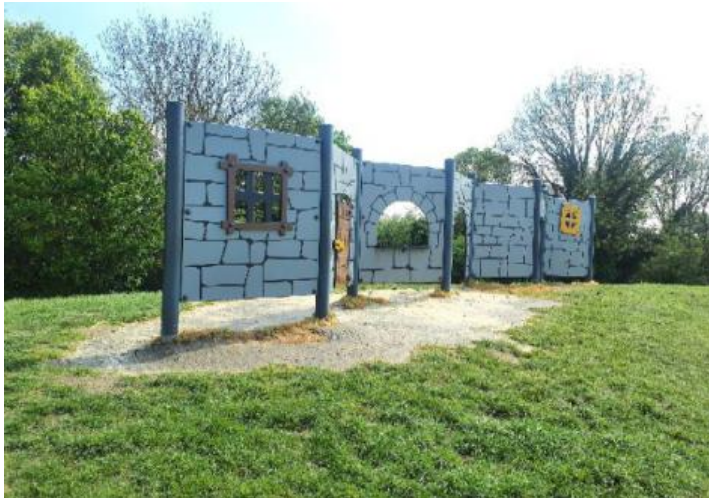
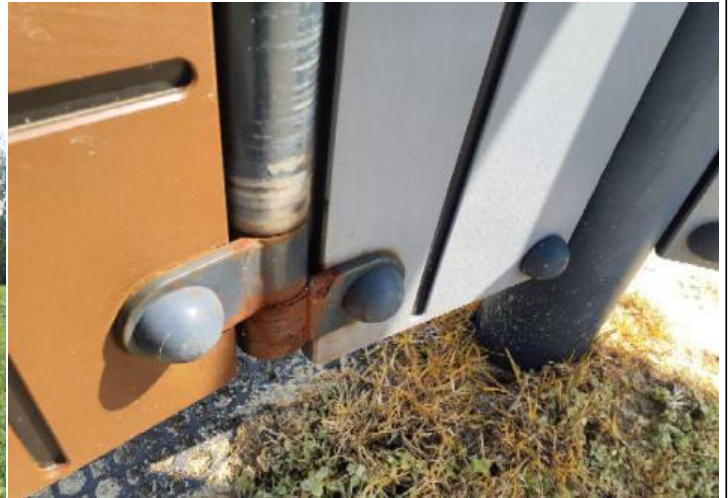
Item: Activity Equipment - Play Panel
Manufacturer: Kompan Ltd

Risk Level: L - Low Risk
Surface: Grass Matrix Tiles

Finding: The paintwork on this item has been damaged or worn exposing the metal underneath which is rusting / corroding

Action: Treat affected areas and repaint

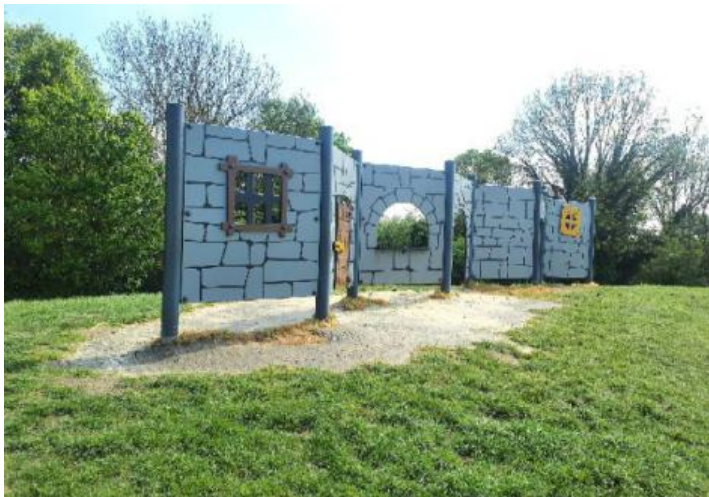
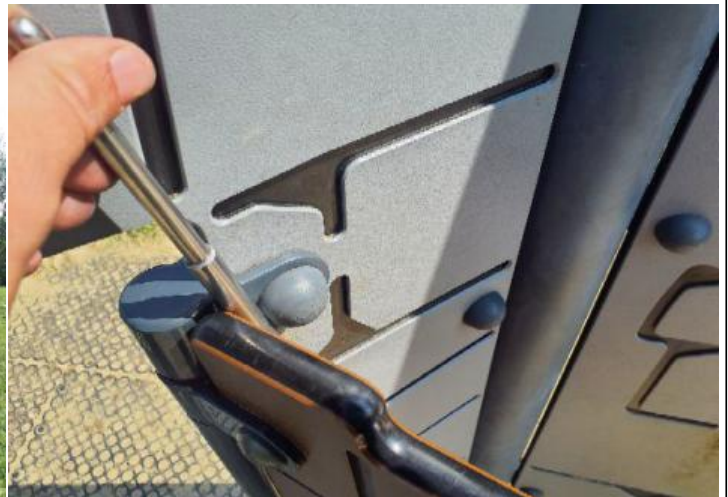
Item: Activity Equipment - Play Panel
Manufacturer: Kompan Ltd

Risk Level: L - Low Risk
Surface: Grass Matrix Tiles

Finding: There is a potential crush point between the play panel door in contravention of BS EN 1176 Part 1 - 4.2.7.6 - gaps whose dimensions change during use of the equipment shall have a minimum dimension in any position of 12mm

Action: Monitor - No remedial work recommended
