ST STEPHEN PARISH COUNCIL

You are summoned to the Fixed Assets Committee meeting

AGENDA

| 2526/AC/013 | To receive Annual Play Inspection Reports. Reports attached. |

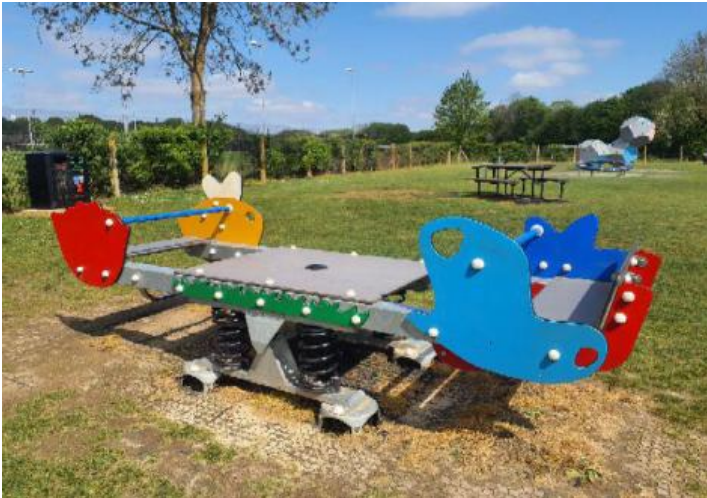
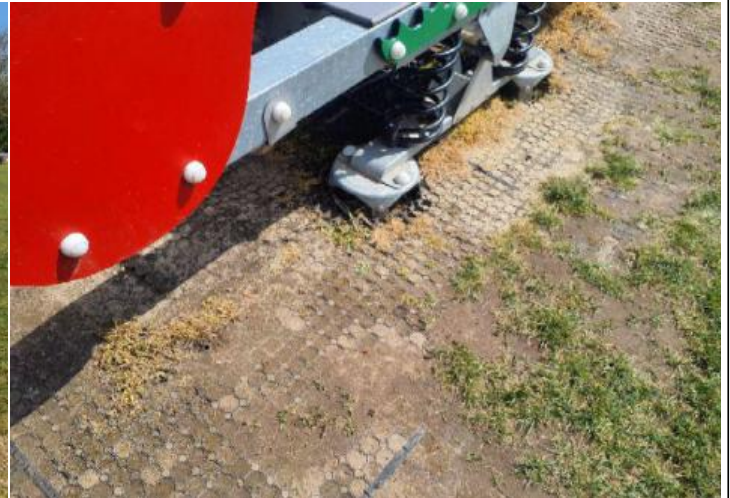
Item: Rocking Equipment - See Saw
Manufacturer: Kompan Ltd

Risk Level: L - Low Risk
Surface: Grass Matrix Tiles

Finding: The grass mats are silted up, the soil is compacted and the area will become very slippery when the soil is wet. **Action:** Reinststate as required

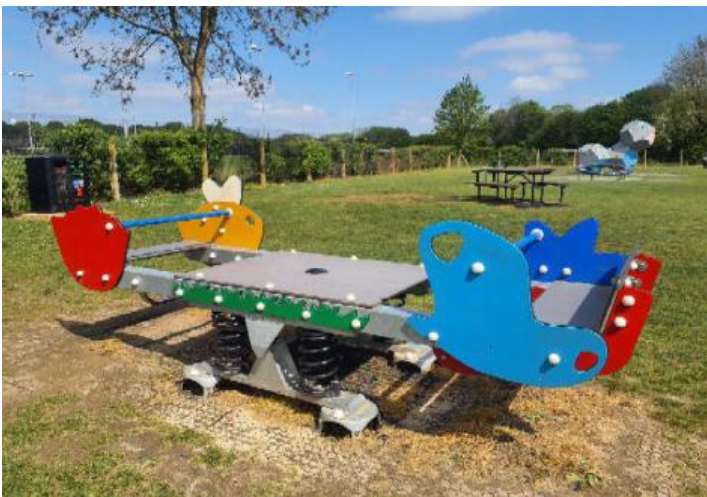
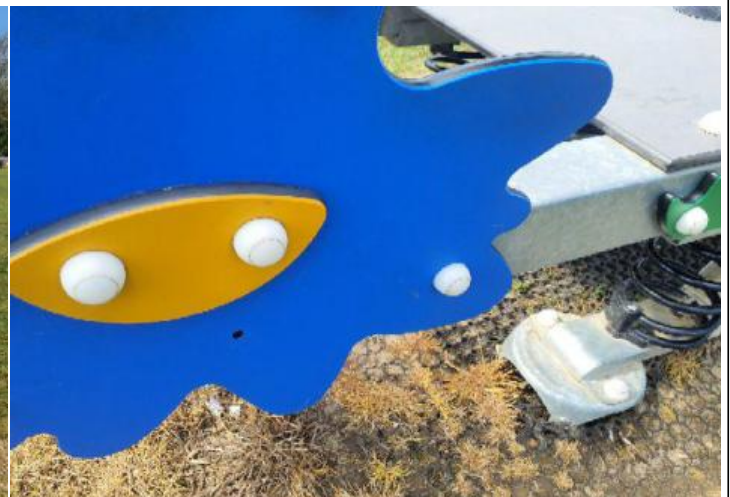
Item: Rocking Equipment - See Saw
Manufacturer: Kompan Ltd

Risk Level: L - Low Risk
Surface: Grass Matrix Tiles

Finding: There is or are fixings missing on the item **Action:** Replace all missing fixings

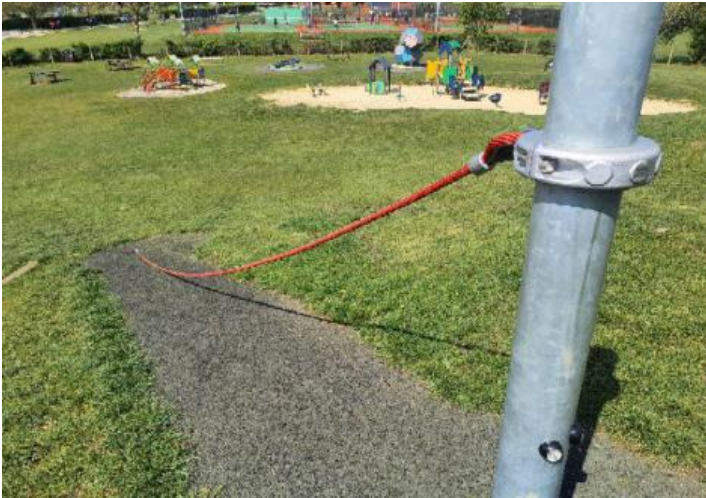
Item: Activity Equipment - Rope Pull
Manufacturer: Corocord

Risk Level: L - Low Risk
Surface: Bonded Rubber Mulch

Finding: The ropes/nets are worn/damaged in places

Action: Monitor for any further deterioration and repair or replace as required

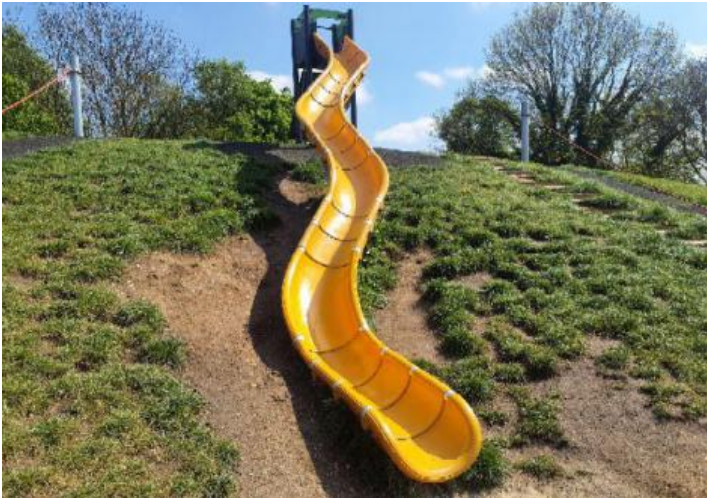
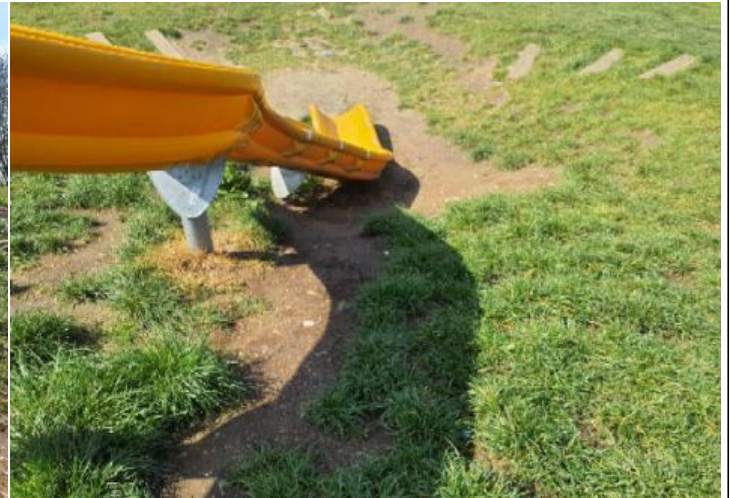
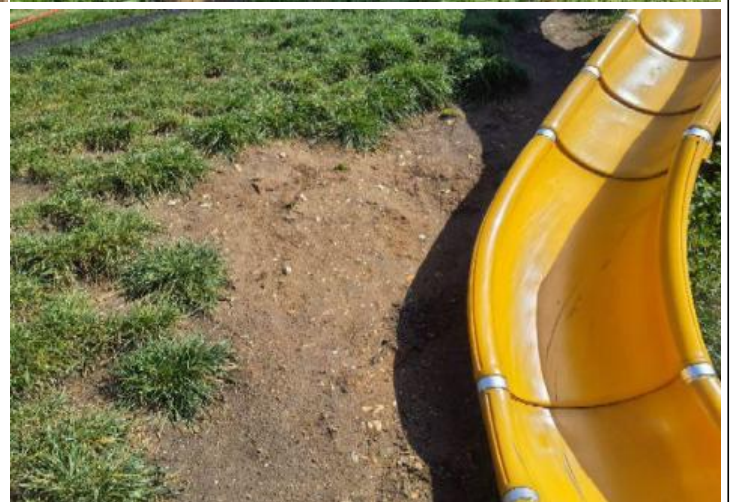
Item: Other - Embankment Slide
Manufacturer: Kompan Ltd

Risk Level: L - Low Risk
Surface: Mixed Surface

Finding: The grass has eroded within the impact area of the equipment and may not provide the necessary impact attenuating properties for the equipment fall height; the surface may also be slippery in wet weather

Action: Reinststate the grass or provide an all weather surface

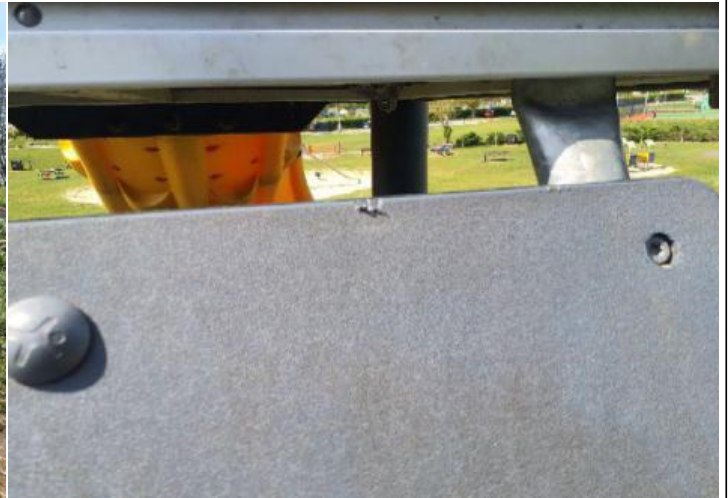
Item: Other - Embankment Slide
Manufacturer: Kompan Ltd

Risk Level: L - Low Risk
Surface: Mixed Surface

Finding: The climbing wall has been damaged

Action: Monitor for any further deterioration and replace as required

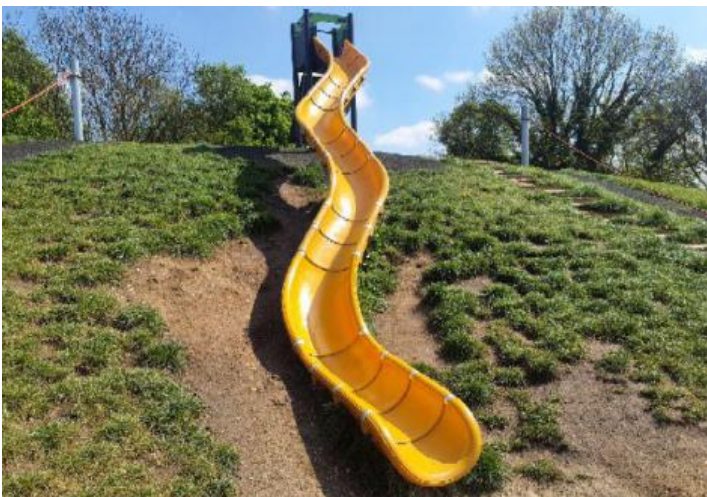
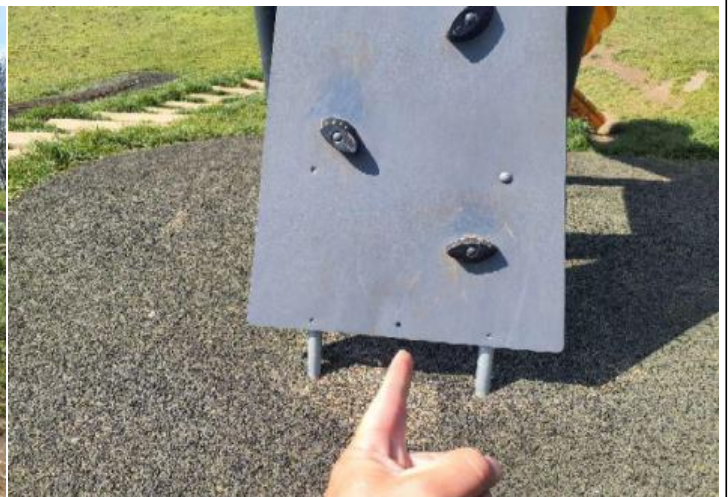
Item: Other - Embankment Slide
Manufacturer: Kompan Ltd

Risk Level: L - Low Risk
Surface: Mixed Surface

Finding: There is or are fixings missing on the item

Action: Replace all missing fixings

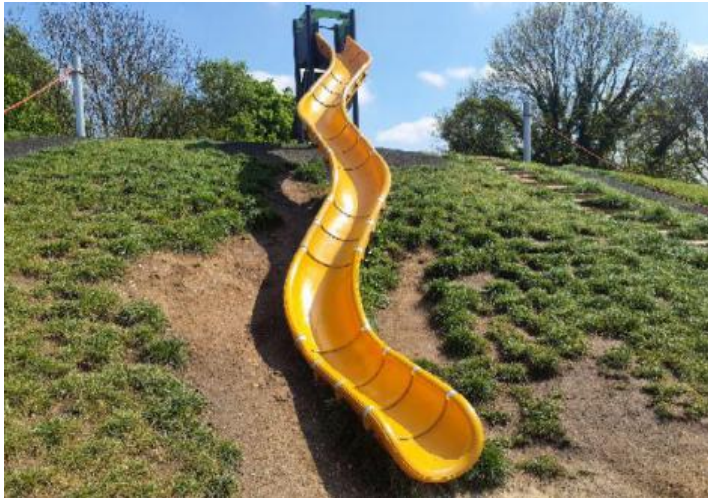
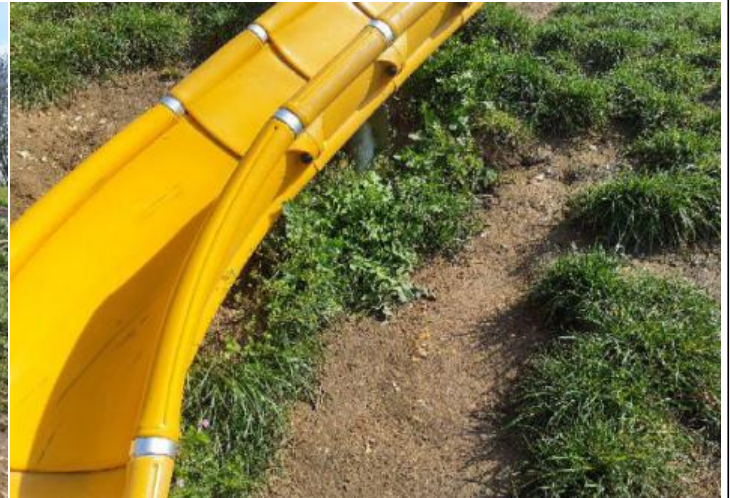
Item: Other - Embankment Slide
Manufacturer: Kompan Ltd

Risk Level: L - Low Risk
Surface: Mixed Surface

Finding: There is weed / vegetation growth within the surface

Action: Remove weed / vegetation growth

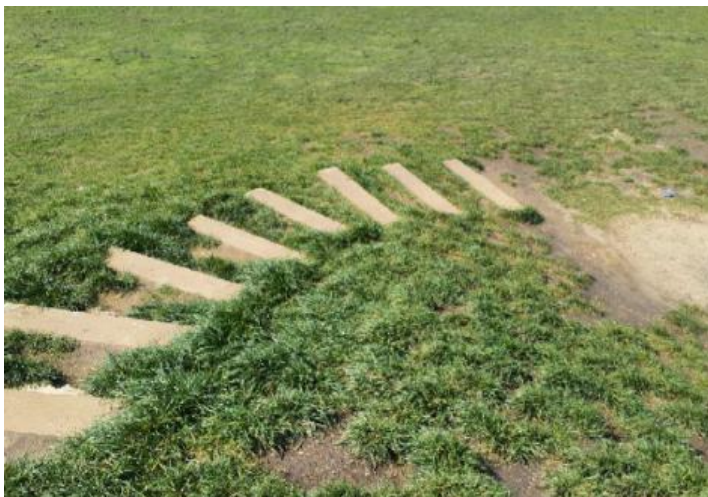
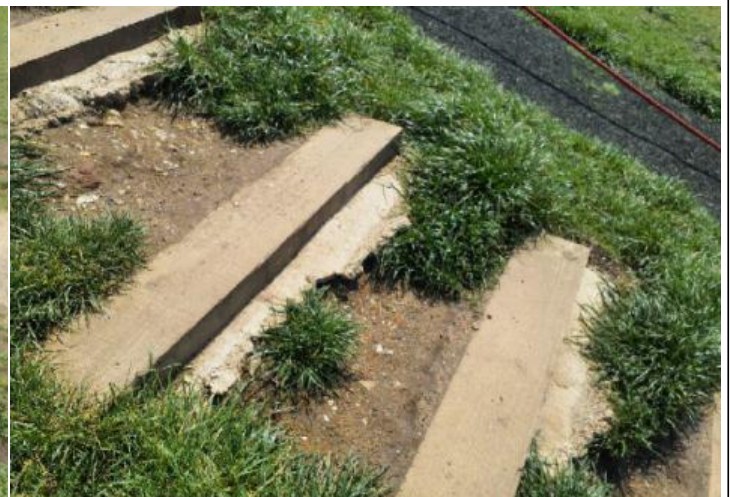
Item: Ancillary Items - Steps
Manufacturer: Not Identified

Risk Level: L - Low Risk
Surface: Grass

Finding: The surface has eroded and the foundations are exposed

Action: Reinstall surrounding surfaces to cover the foundations

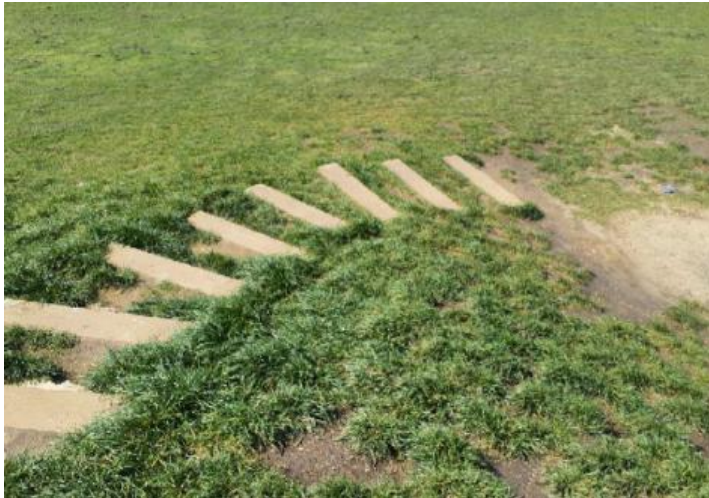
Item: Ancillary Items - Steps
Manufacturer: Not Identified

Risk Level: L - Low Risk
Surface: Grass

Finding: The grass is overgrown within the play area and may hide hazards

Action: Reduce the length of grass to an acceptable height and maintain

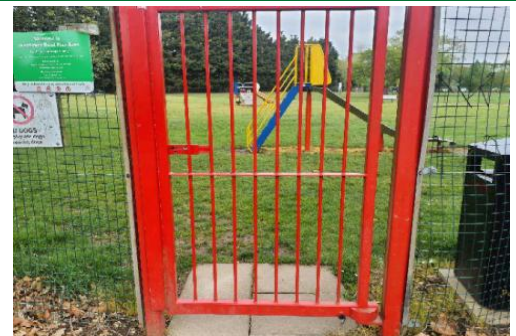
Item: Gate - Self Closing
Manufacturer: Not Identified
Surface Type: Grass
Item Quantity: 2
Equipment Compliance: N/A
Surface Area Compliance: N/A

There are trip hazards at the edges of the surface - Remove trip hazard

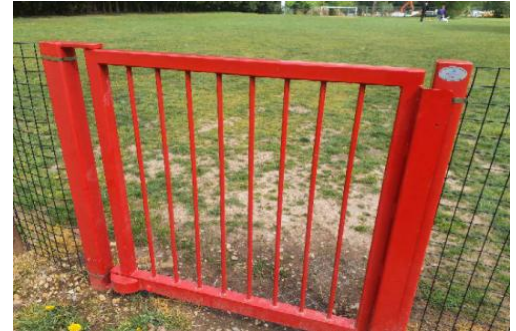
Item: Gate - Self Closing
Manufacturer: Easy Gate Ltd
Surface Type: Grass
Item Quantity: 1
Equipment Compliance: N/A
Surface Area Compliance: N/A

The area around the item has eroded and may become slippery - Reinstate eroded area

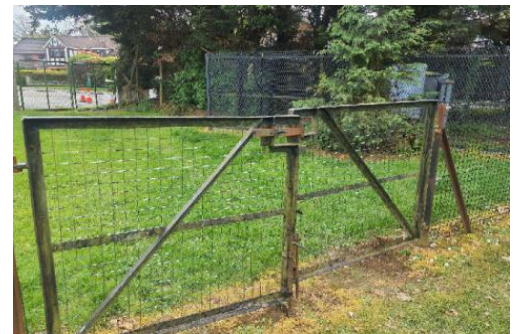
Item: Gate - Maintenance
Manufacturer: Not Identified
Surface Type: Grass
Item Quantity: 1
Equipment Compliance: N/A
Surface Area Compliance: N/A

There is no padlock on the maintenance gate - Provide a padlock to secure the gate

The paintwork on this item has been damaged or worn exposing the metal underneath which is rusting / corroding - Treat affected areas and repaint

The mesh fence has been damaged - Monitor for any further deterioration and replace as required

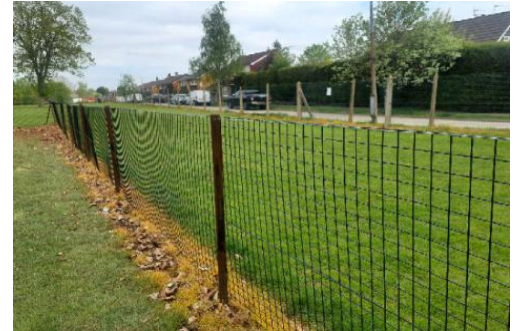
Item: Fence - Chainlink
Manufacturer: Not Identified
Surface Type: Grass
Item Quantity: 1
Equipment Compliance: N/A
Surface Area Compliance: N/A

The paintwork on this item has been damaged or worn exposing the metal underneath which is rusting / corroding - Treat affected areas and repaint

There are a number of loose posts around the fence - Monitor for any further deterioration and reset as required

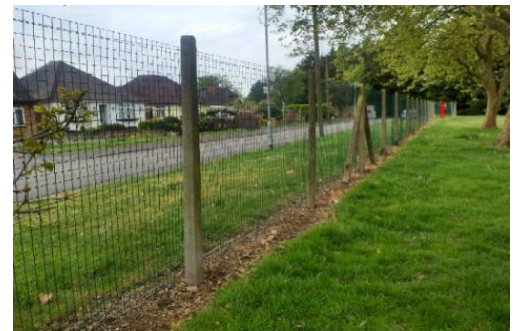
Item: Fence - Steel Mesh
Manufacturer: Not Identified
Surface Type: Grass
Item Quantity: 1
Equipment Compliance: N/A
Surface Area Compliance: N/A

The adjacent foliage is overhanging the fencing - Cut back and maintain

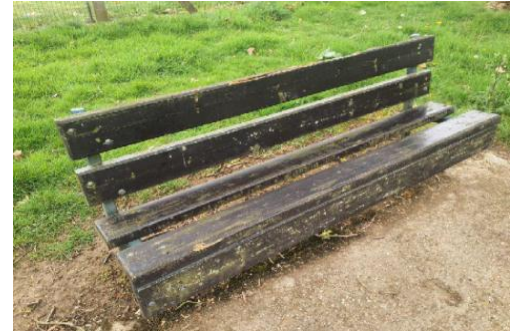
Item: Bench
Manufacturer: Not Identified
Surface Type: Grass
Item Quantity: 2
Equipment Compliance: N/A
Surface Area Compliance: N/A

There are areas or parts of the timber on the structure that have rotted - Replace all affected timbers

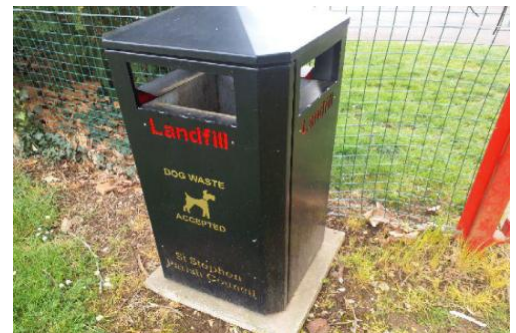
Item: Litter Bin
Manufacturer: Not Identified
Surface Type: Grass
Item Quantity: 2
Equipment Compliance: N/A
Surface Area Compliance: N/A

The bin is not securely fixed to the surface and there is some possibility of the item tipping or rolling over - Secure the bin to the ground

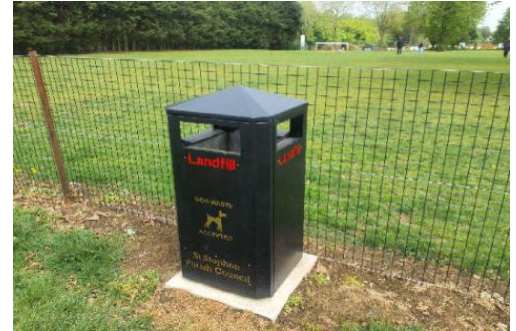
Item: Litter Bin
Manufacturer: Broxap
Surface Type: Paving Slabs
Item Quantity: 1
Equipment Compliance: N/A
Surface Area Compliance: N/A

The bin is not securely fixed to the surface and there is some possibility of the item tipping or rolling over - Secure the bin to the ground

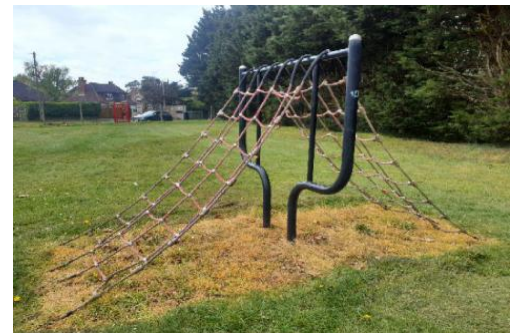
Item: Net Climber
Manufacturer: Wicksteed Playgrounds
Surface Type: Grass Matrix Tiles
Item Quantity: 1
Equipment Compliance: Yes
Surface Area Compliance: Yes
Life Expectancy: 5 -10 Years
Total Findings: 2

The rope has worn and wire strands are exposed - Replace rope or net

The shackles are worn in excess of 40% and require renewing - Replace worn shackles

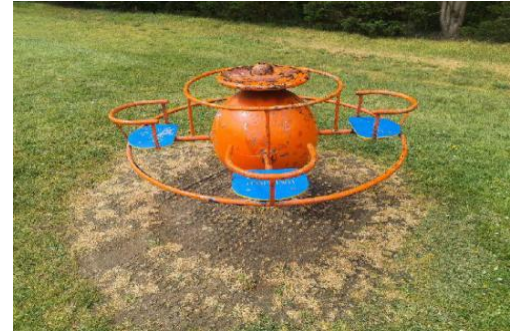
Item: Roundabout
Manufacturer: Wicksteed Playgrounds
Surface Type: Grass Matrix Tiles
Item Quantity: 1
Equipment Compliance: No
Surface Area Compliance: Yes
Life Expectancy: 3 - 5 Years
Total Findings: 8

The paint is flaking off the metalwork - Rub down and re-paint

There is/are bolt cap covers missing or damaged on the item - Replace missing or damaged bolt cap covers

There is/are finger entrapment/s in the framework / seat and the item fails to meet the requirements of BS EN 1176 Part 1 4.2.7.6 Entrapment of fingers - Monitor - No action given the risk assessment

The item fails to meet the requirements of BS EN 1176 Part 1 4.2.7.2 for head and neck entrapment in the framework - Monitor - No action given the risk assessment

The bearing is showing signs of wear - Monitor for any further deterioration and replace as required

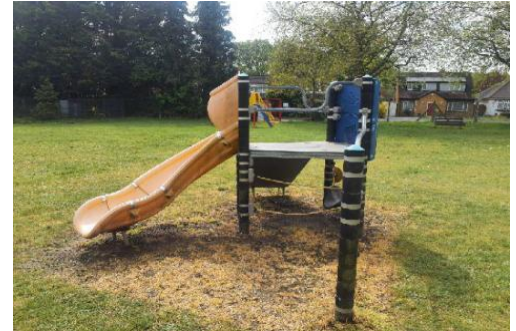
Item: Multi Play (Junior)
Manufacturer: Kompan Ltd
Surface Type: Grass Matrix Tiles
Item Quantity: 1
Equipment Compliance: No
Surface Area Compliance: Yes
Life Expectancy: >10 Years
Total Findings: 6

There is some graffiti present - Remove the graffiti

The slide surface has been damaged - Monitor for any further deterioration and replace as required

A number of fixing(s) have worked loose on guardrail - Secure all loose fixings

There is/are finger entrapment/s in the framework and the item fails to meet the requirements of BS EN 1176 Part 1 4.2.7.6 Entrapment of fingers - Monitor - No action given the risk assessment

There are a number of dents in the slide surface - Monitor for any further deterioration and repair as required

The side of the slide is damaged - Monitor for any further deterioration and repair as required

The paintwork on this item has been damaged or worn exposing the metal underneath which is rusting / corroding - Treat affected areas and repaint

There is some notable evidence of chain wear - Monitor for any further deterioration and replace when 40% worn

The chain openings are in excess of 8.6mm and do not meet the recommendations of BS EN 1176 Part 1 - Monitor - No action given the risk assessment

There is some wear to the shackles - Monitor for any further deterioration and replace when 40% worn

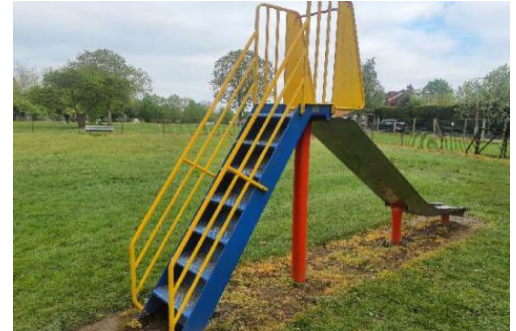
Item:	Free Standing Slide
Manufacturer:	G L Jones Playgrounds Ltd
Surface Type:	Grass Matrix Tiles
Item Quantity:	1
Equipment Compliance:	Yes
Surface Area Compliance:	Yes
Life Expectancy:	5 -10 Years
Total Findings:	5

The grass mats are silted up, the soil is compacted and the area will become very slippery when the soil is wet. - Reinstate as required

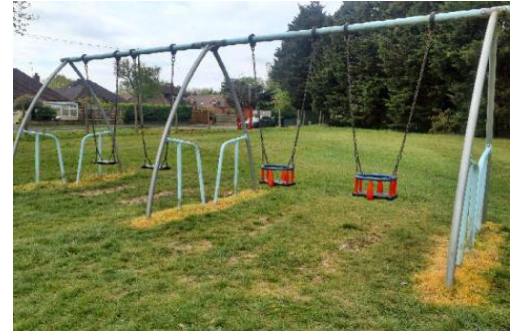
Item: 2 Bay (2 Flat, 2 Cradle)
Manufacturer: Record RSS
Surface Type: Grass Matrix Tiles
Item Quantity: 1
Equipment Compliance: No
Surface Area Compliance: Yes
Life Expectancy: >10 Years
Total Findings: 6

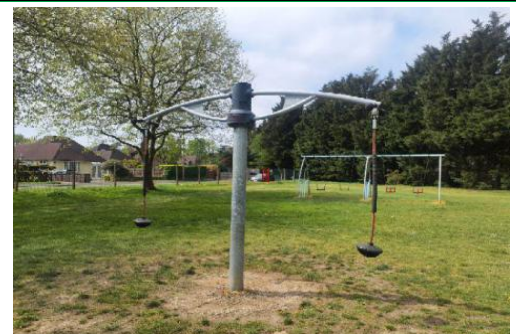
Item: Overhead Rotator
Manufacturer: Kompan Ltd
Surface Type: Grass Matrix Tiles
Item Quantity: 1
Equipment Compliance: Yes
Surface Area Compliance: Yes

The grass mats are silted up, the soil is compacted and the area will become very slippery when the soil is wet. - Reinstate as required

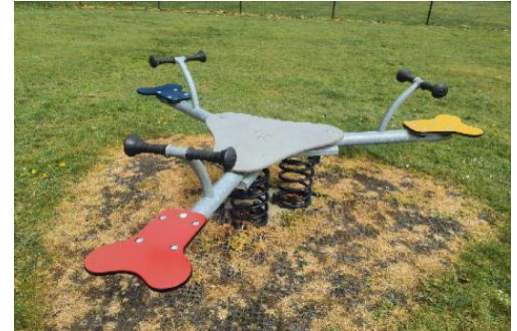
Item: Three Way Springer
Manufacturer: Kompan Ltd
Surface Type: Grass Matrix Tiles
Item Quantity: 1
Equipment Compliance: Yes
Surface Area Compliance: Yes

A number of fixing(s) have worked loose - Secure all loose fixings

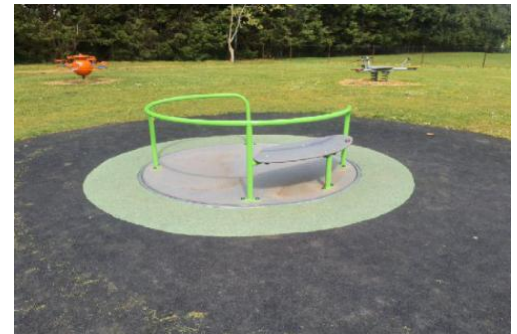
Item: Inclusive Roundabout
Manufacturer: Kompan Ltd
Surface Type: Wet Pour
Item Quantity: 1
Equipment Compliance: Yes
Surface Area Compliance: Yes

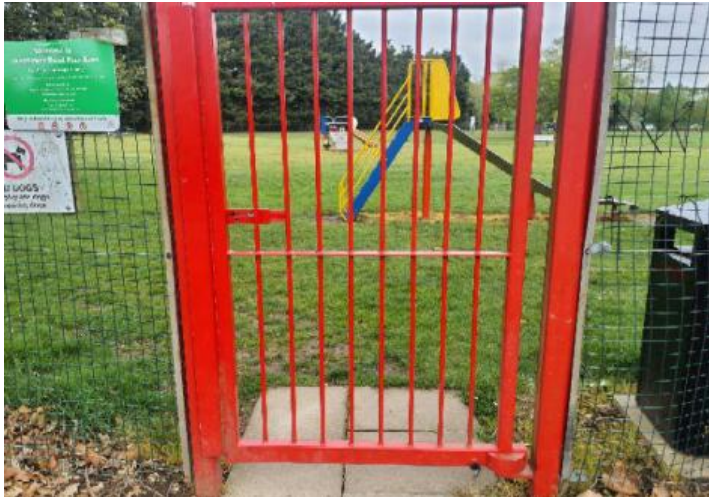
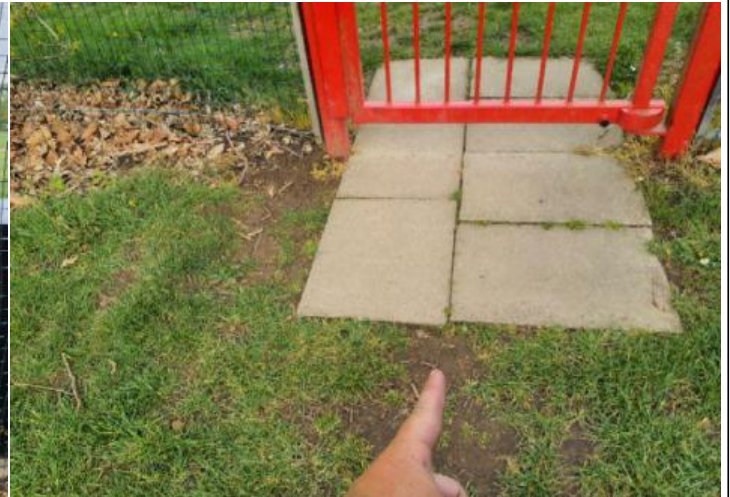
Item: Gates - Gate - Self Closing
Manufacturer: Not Identified

Finding: There are trip hazards at the edges of the surface **Action:** Remove trip hazard

8 - Low Risk (Finding 1)

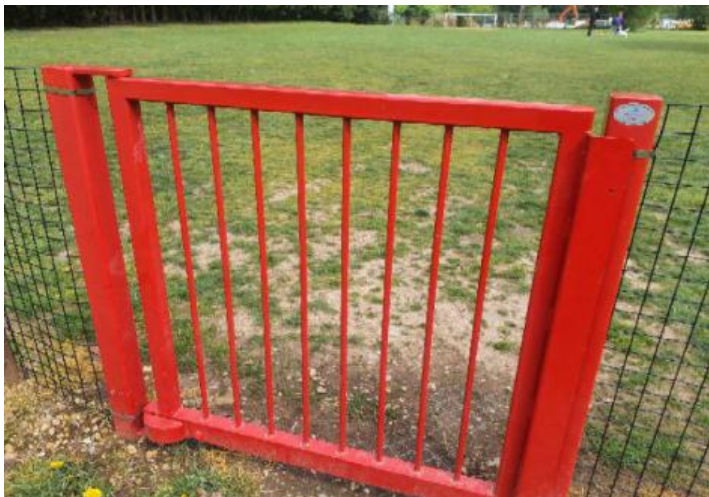
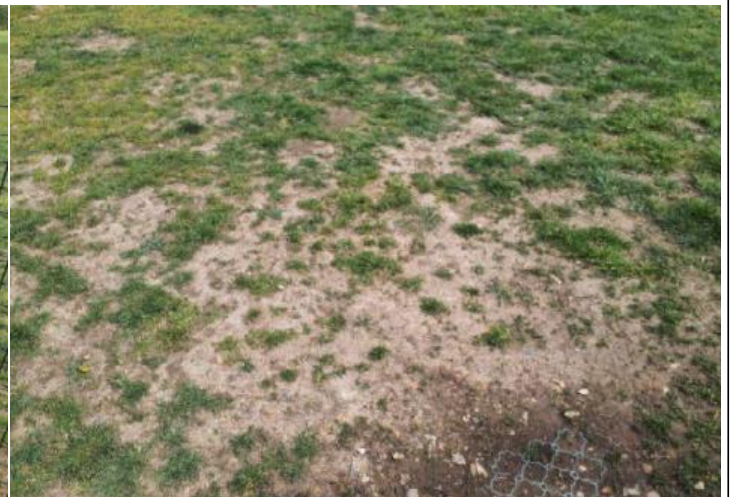
Item: Gates - Gate - Self Closing
Manufacturer: Easy Gate Ltd

Finding: The area around the item has eroded and may become slippery **Action:** Reinststate eroded area

6 - Low Risk (Finding 1)

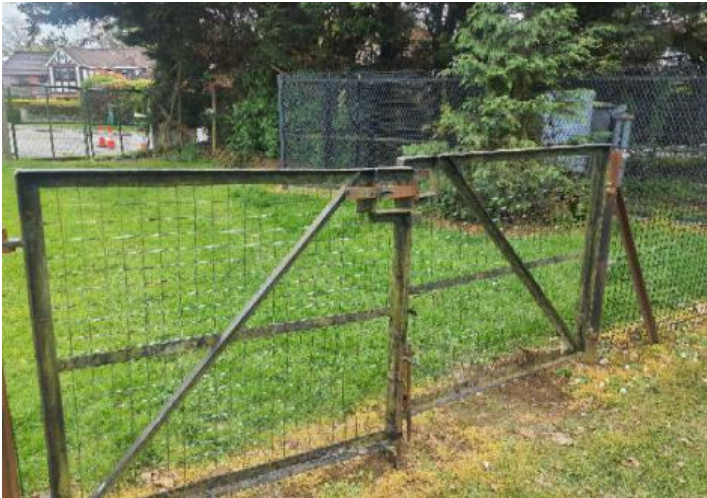
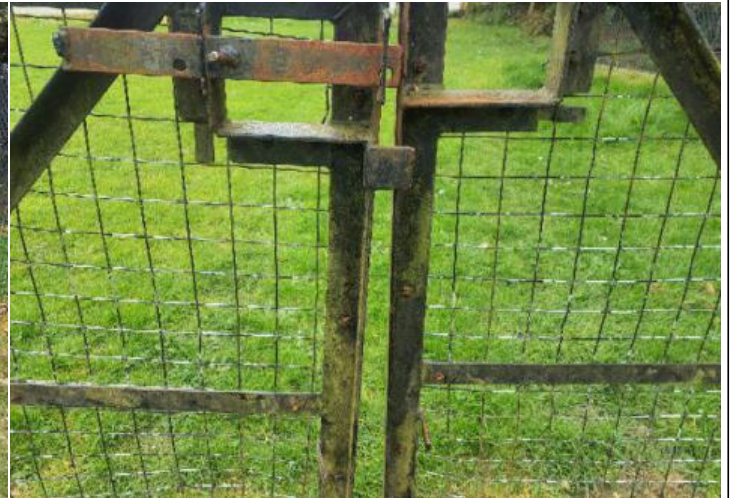
Finding: There is no padlock on the maintenance gate

Action: Provide a padlock to secure the gate

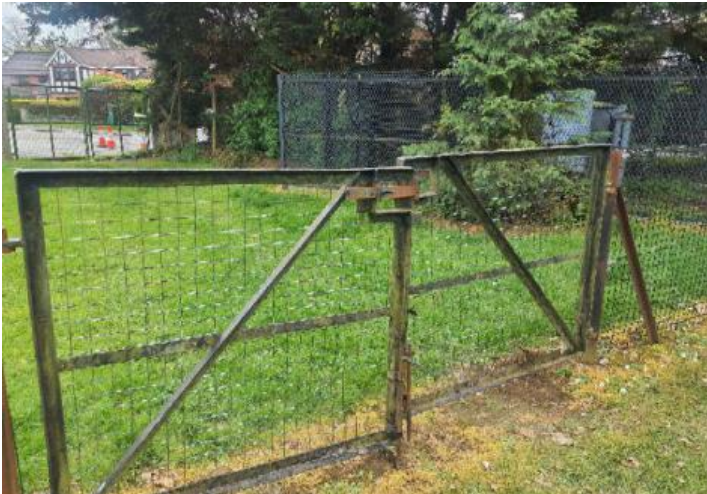
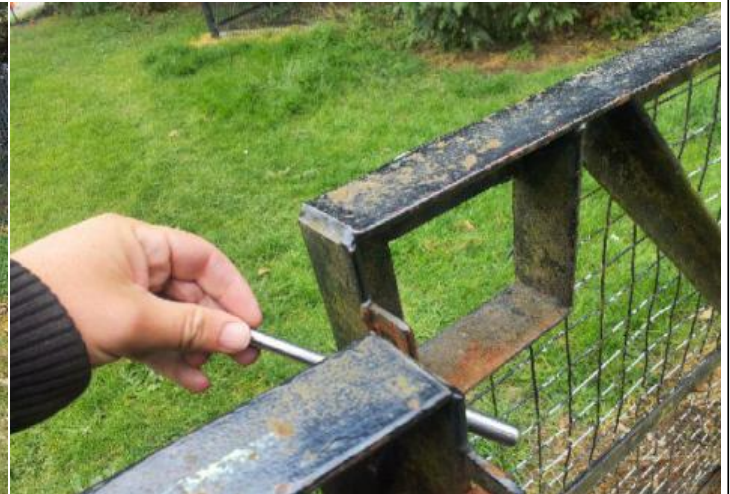
Finding: There are openings that are less than 12mm that could trap or crush fingers

Action: Provide a 12mm gap throughout full range of motion at both sides of gate

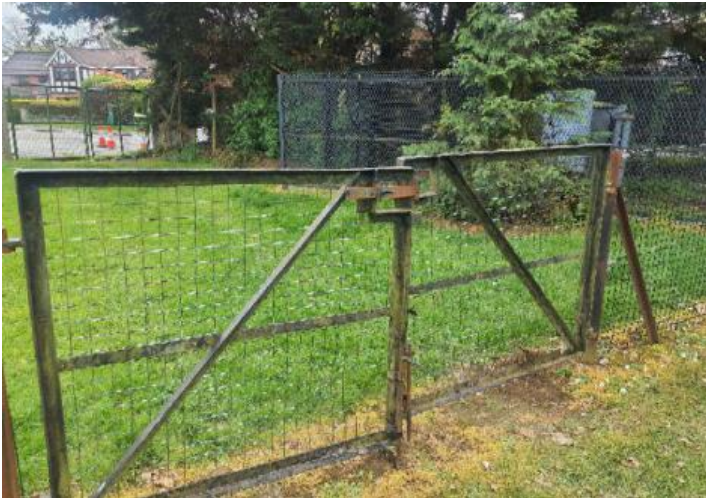
Finding: The paintwork on this item has been damaged or worn exposing the metal underneath which is rusting / corroding

Action: Treat affected areas and repaint

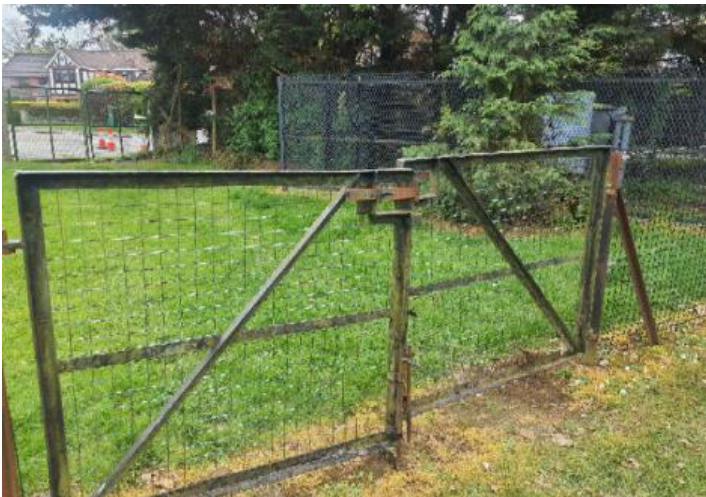
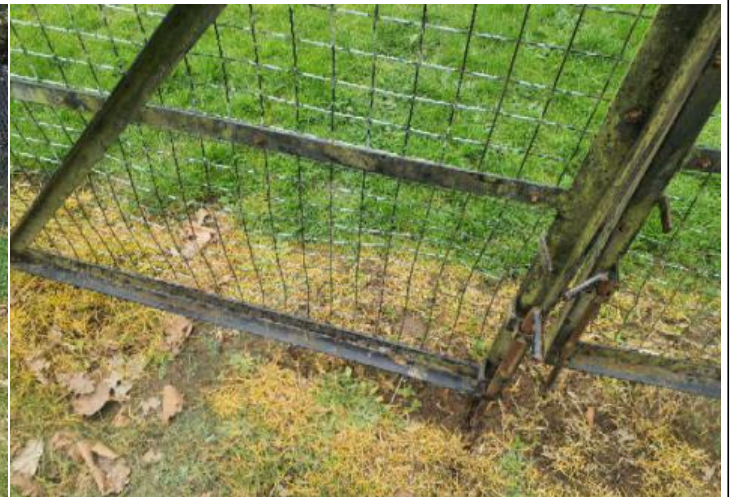
Finding: The mesh fence has been damaged

Action: Monitor for any further deterioration and replace as required

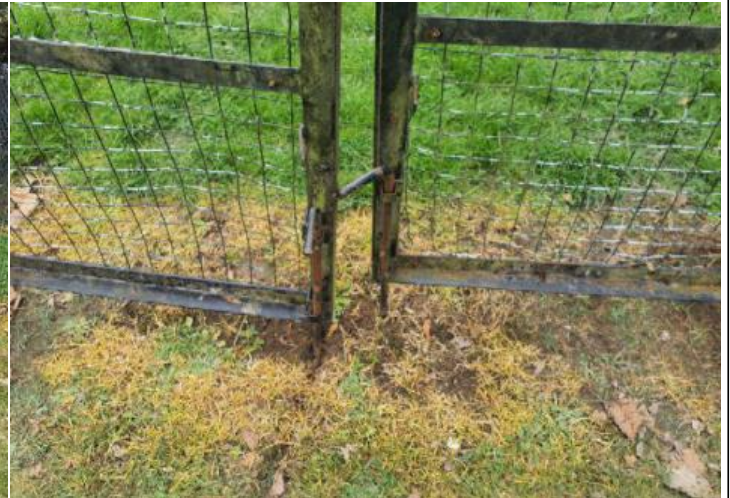
Finding: The gate has no drop bolt sleeves and/or drop bolts fitted

Action: Provide drop bolt sleeves and/or drop bolts

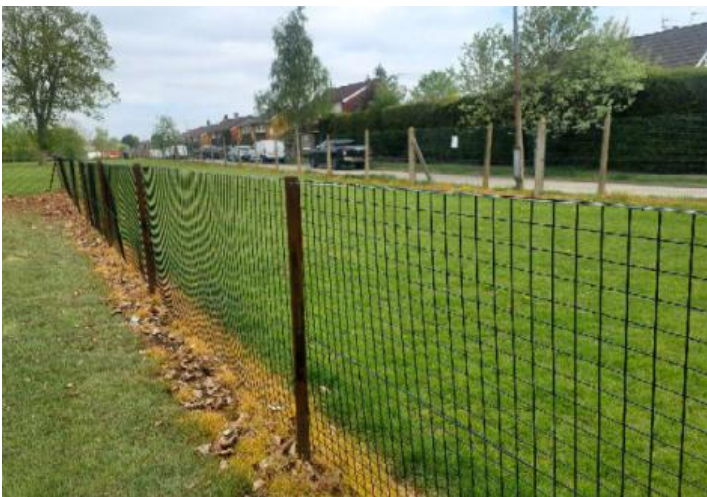
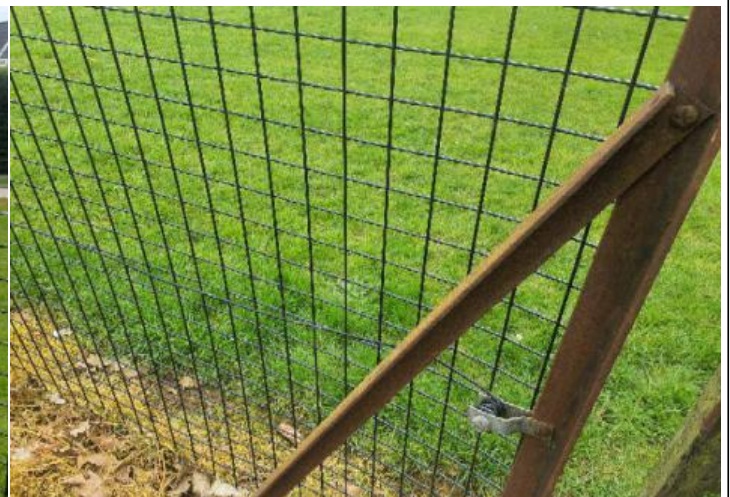
Finding: The paintwork on this item has been damaged or worn exposing the metal underneath which is rusting / corroding

Action: Treat affected areas and repaint

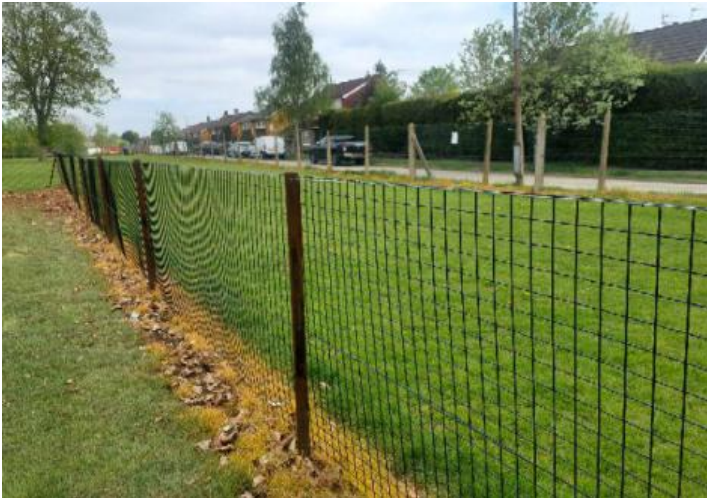
Finding: There are a number of loose posts around the fence

Action: Monitor for any further deterioration and reset as required

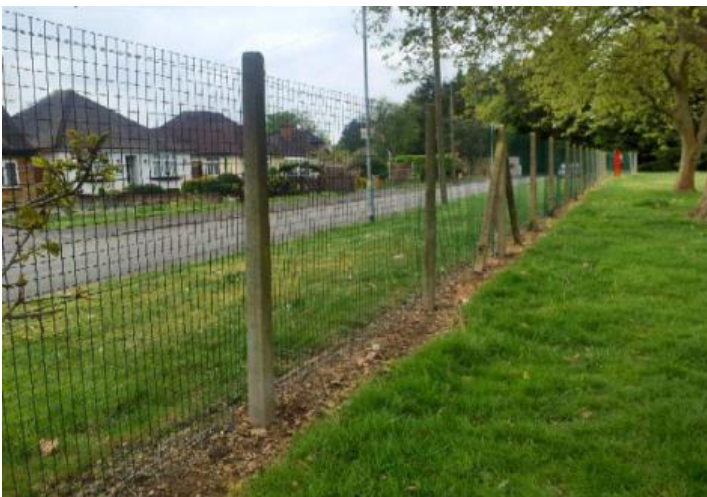
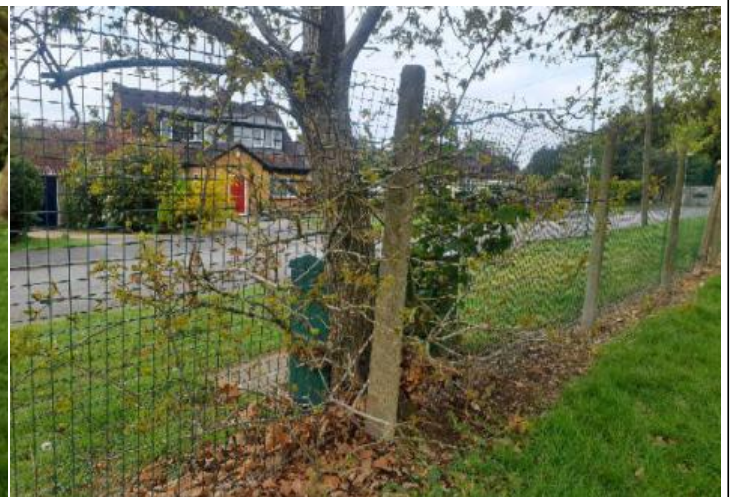
Finding: The adjacent foliage is overhanging the fencing

Action: Cut back and maintain

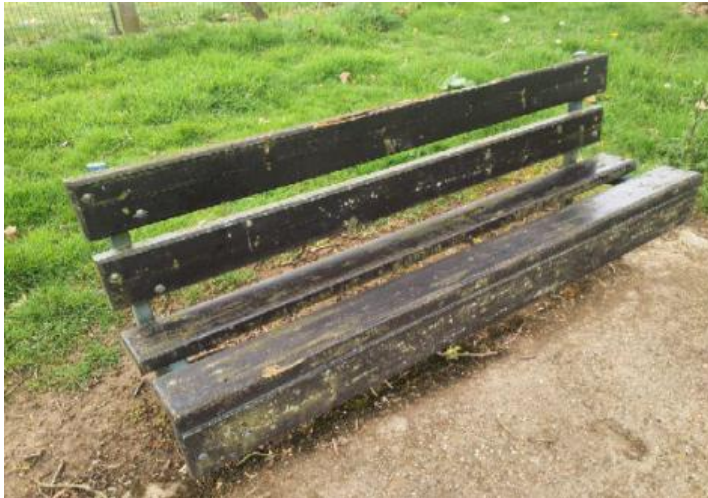
Finding: There are areas or parts of the timber on the structure that have rotted

Action: Replace all affected timbers

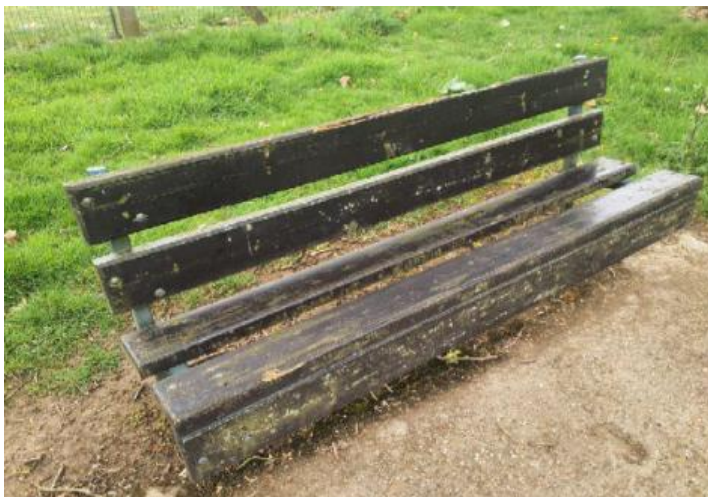
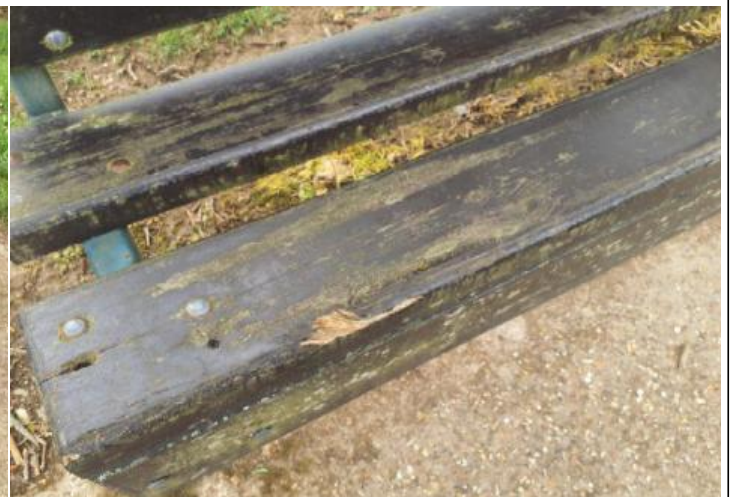
Finding: Parts of the timber are rough or splintered

Action: Remove all rough or sharp edges

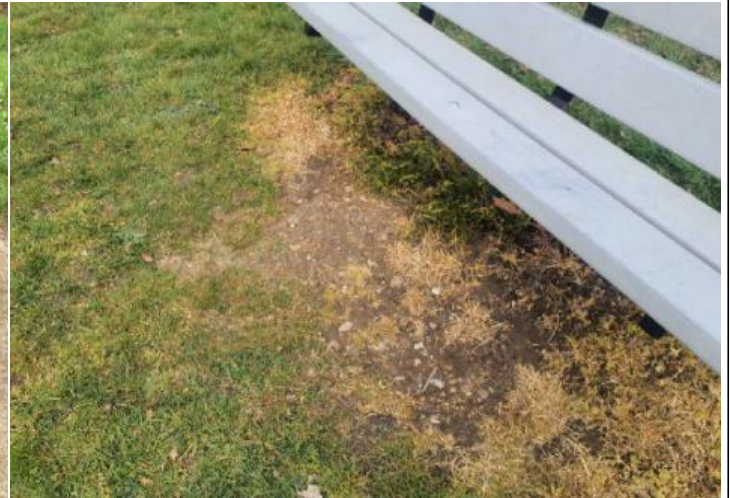
Finding: The area around the item has eroded and may become slippery

Action: Reinstate eroded area

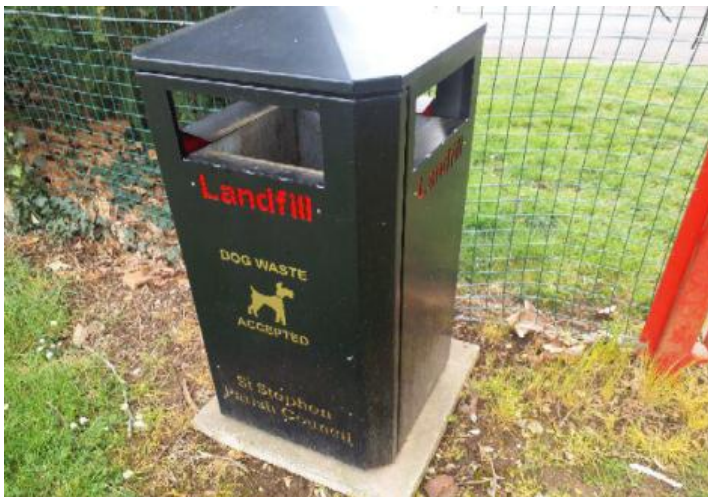
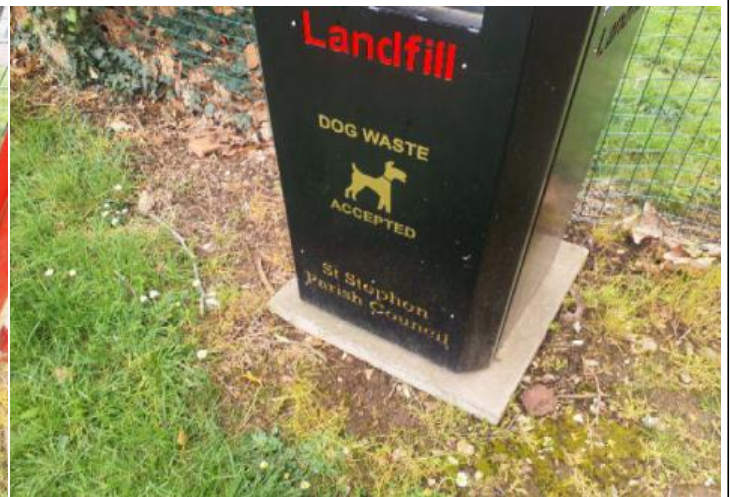
Finding: The bin is not securely fixed to the surface and there is some possibility of the item tipping or rolling over

Action: Secure the bin to the ground

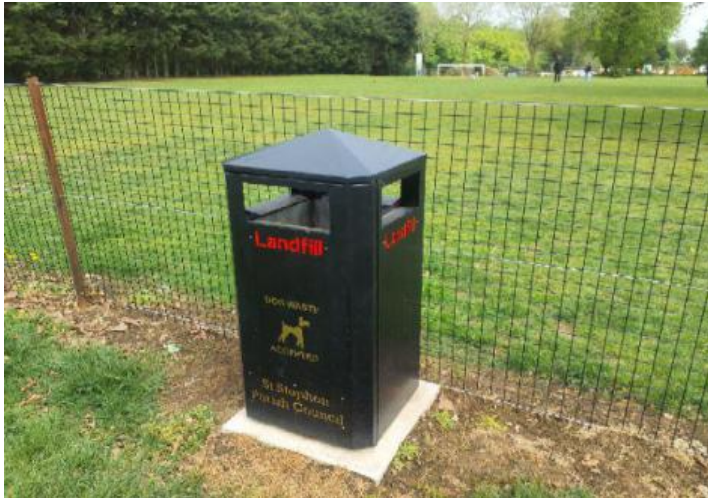
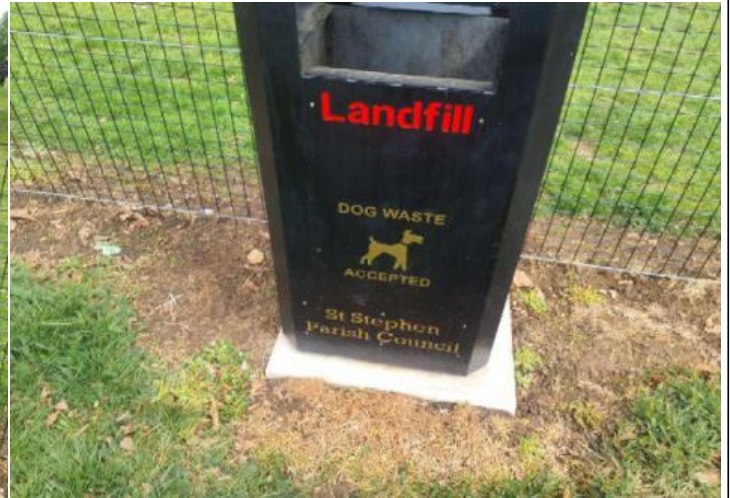
Finding: The bin is not securely fixed to the surface and there is some possibility of the item tipping or rolling over

Action: Secure the bin to the ground

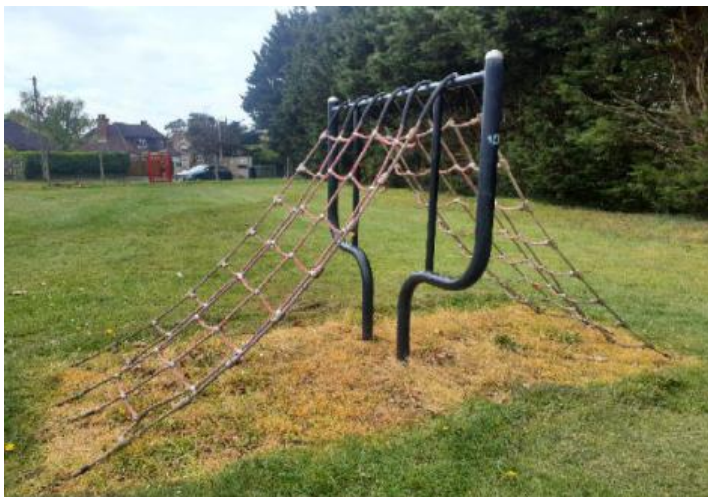
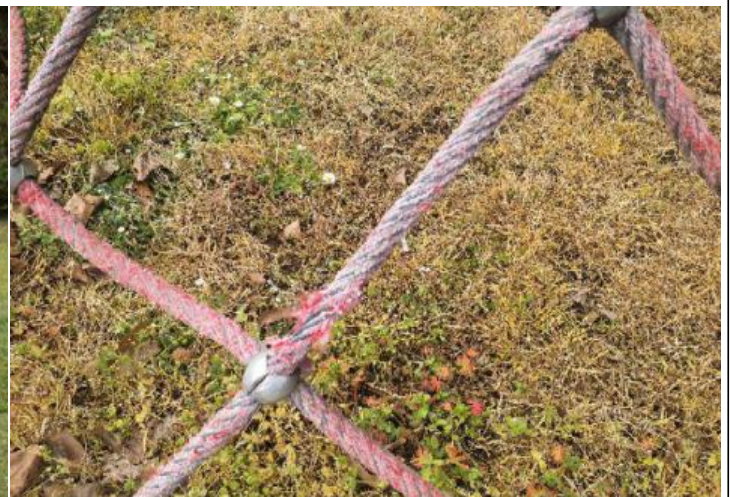
Finding: The rope has worn and wire strands are exposed

Action: Replace rope or net

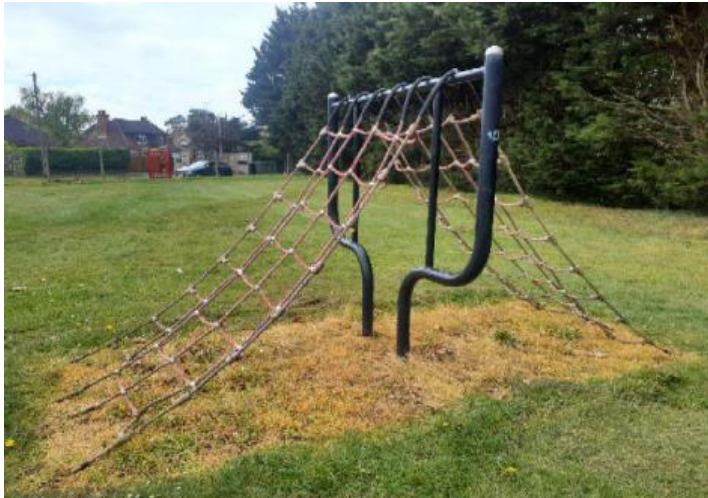
Finding: The shackles are worn in excess of 40% and require renewing

Action: Replace worn shackles

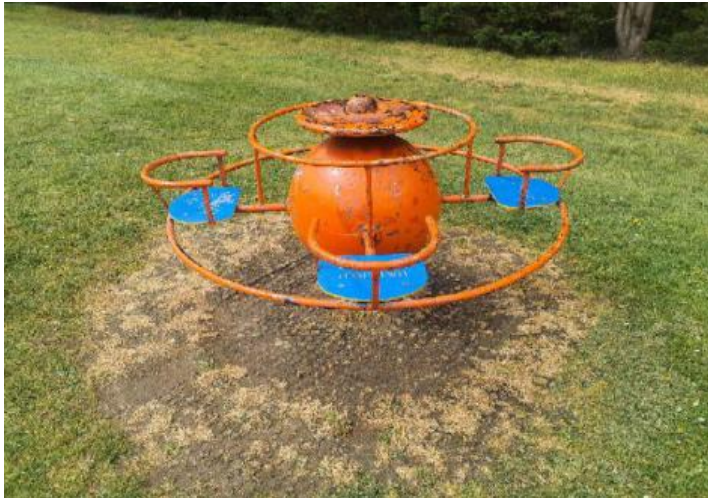
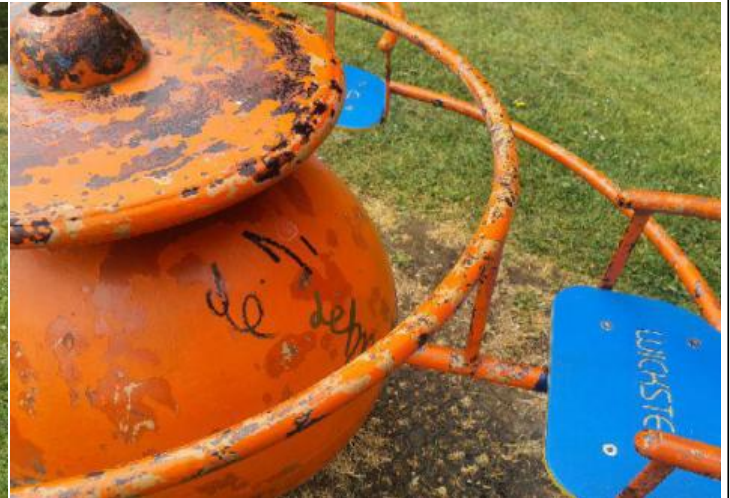
Finding: The paint is flaking off the metalwork

Action: Rub down and re-paint
