ST STEPHEN PARISH COUNCIL

You are summoned to the Fixed Assets Committee meeting

AGENDA

| 2526/AC/013 | To receive Annual Play Inspection Reports. Reports attached. |

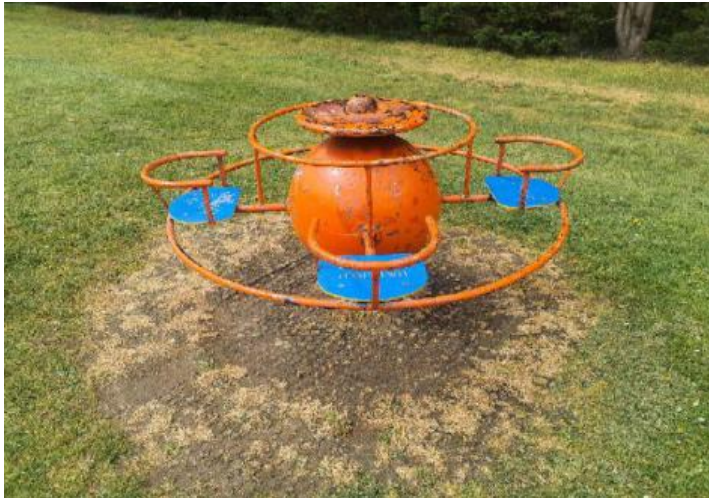
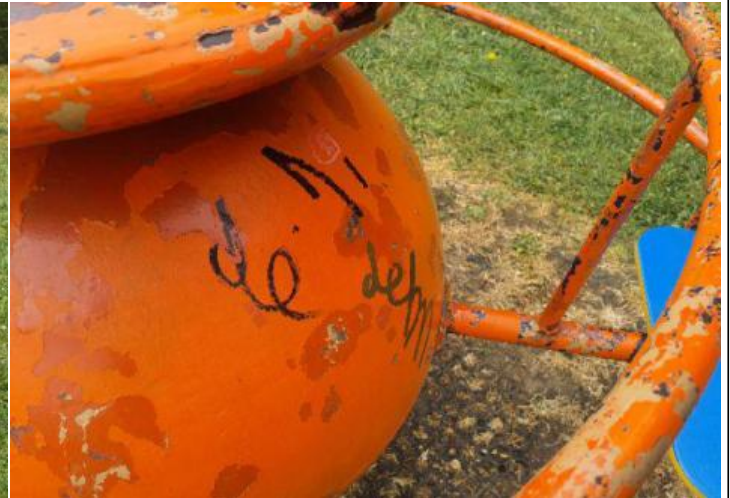
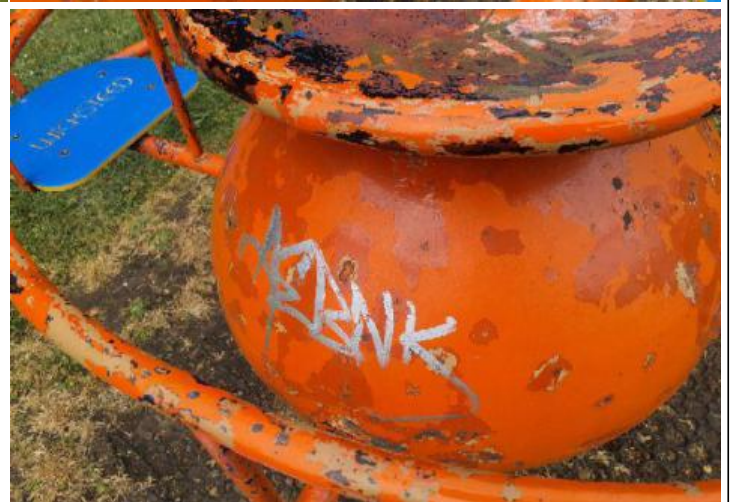
Finding: There is some graffiti present

Action: Remove the graffiti

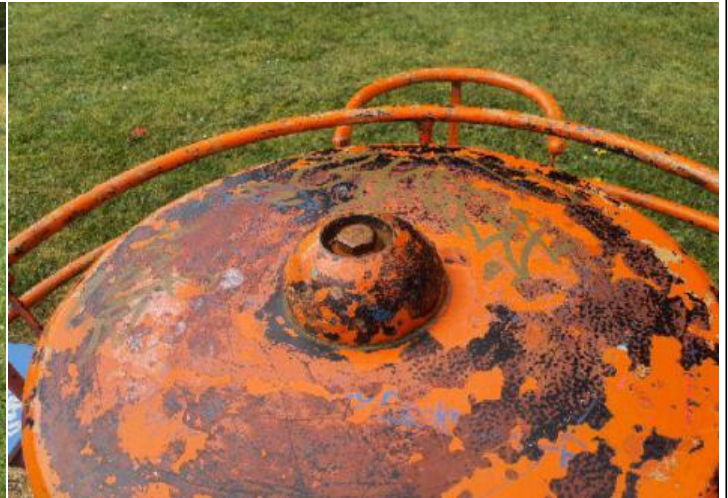
Finding: There is/are bolt cap covers missing or damaged on the item

Action: Replace missing or damaged bolt cap covers

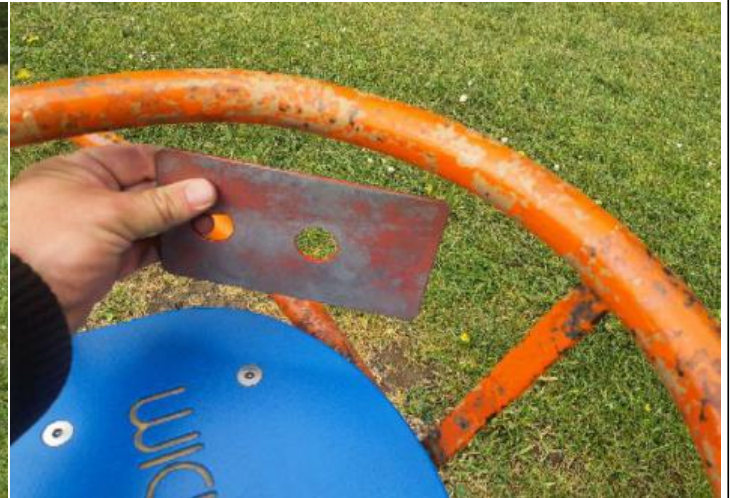
Finding: The item fails to meet the requirements of BS EN 1176 Part 1 4.2.7.2 for head and neck entrapment in the framework

Action: Monitor - No action given the risk assessment

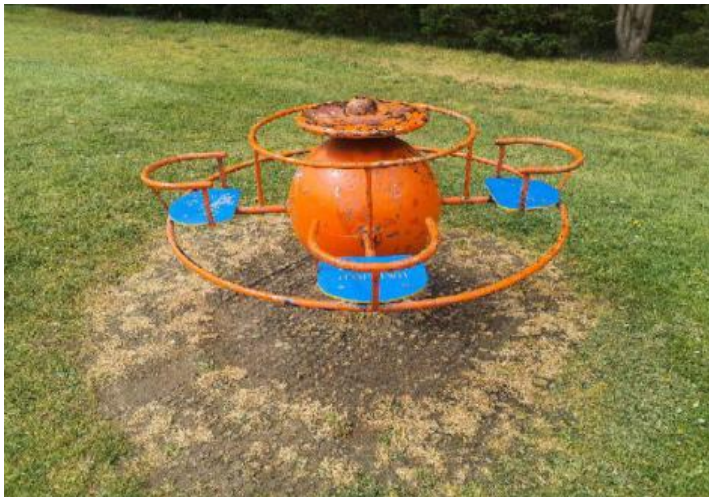
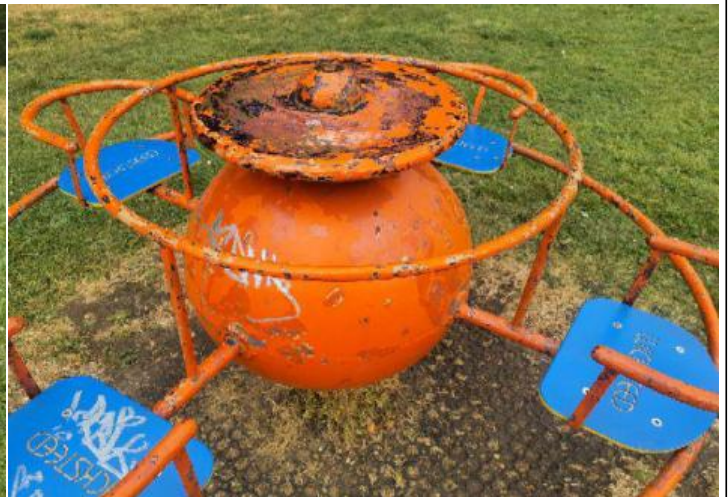
Finding: The bearing is showing signs of wear

Action: Monitor for any further deterioration and replace as required

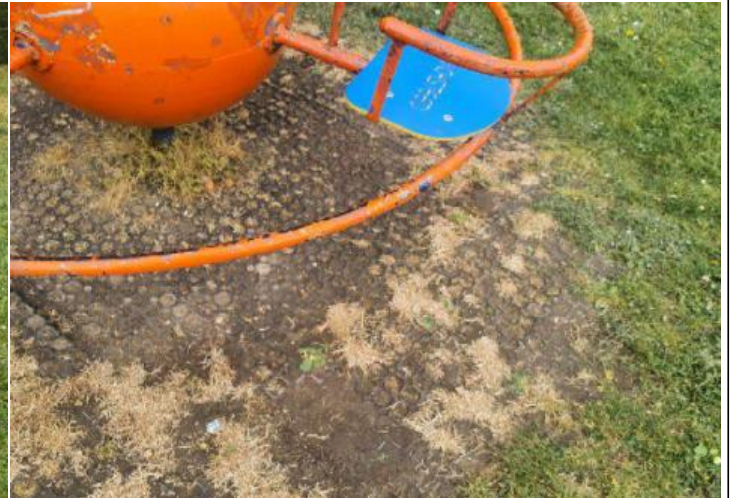
Finding: The grass mats are silted up, the soil is compacted and the area will become very slippery when the soil is wet. **Action:** Reinststate as required

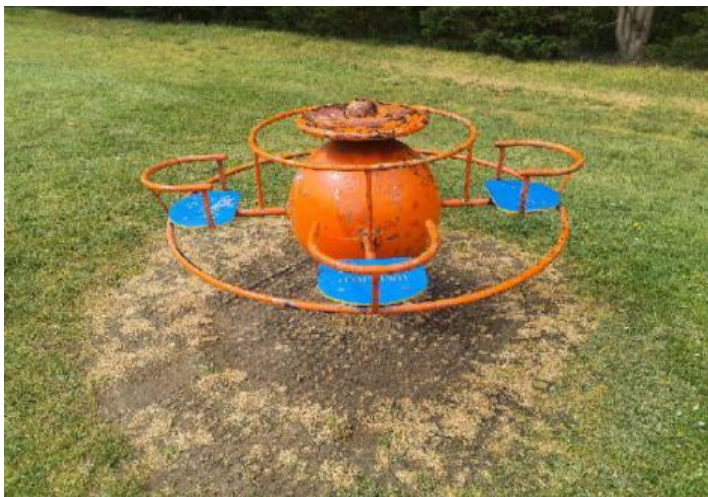
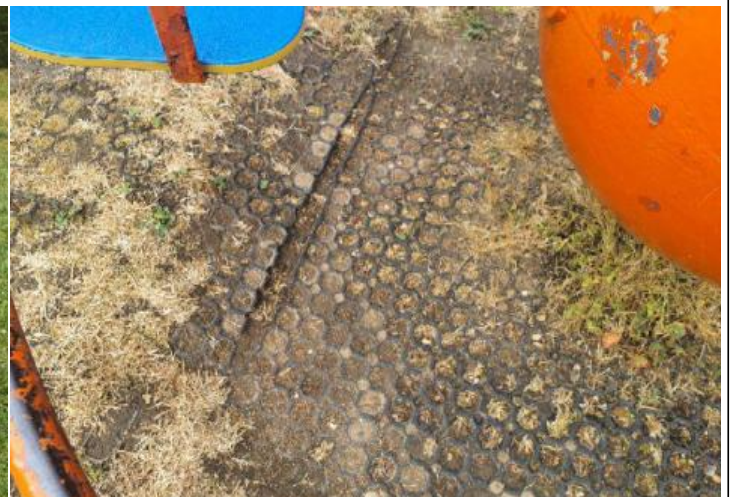
Finding: There are gaps opening between the grass mat tiles **Action:** Provide additional ties or secure / reinstate surface tiles

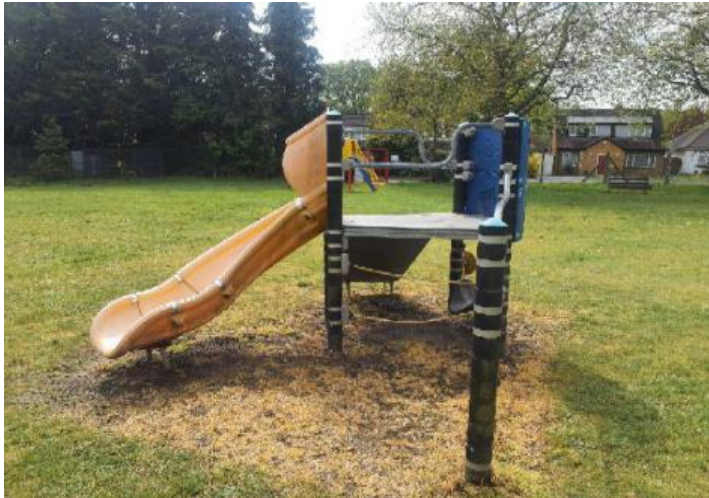
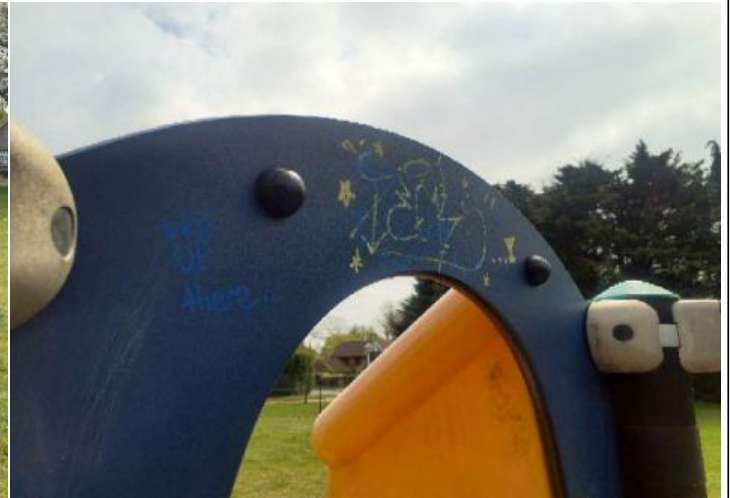
Finding: There is some graffiti present

Action: Remove the graffiti

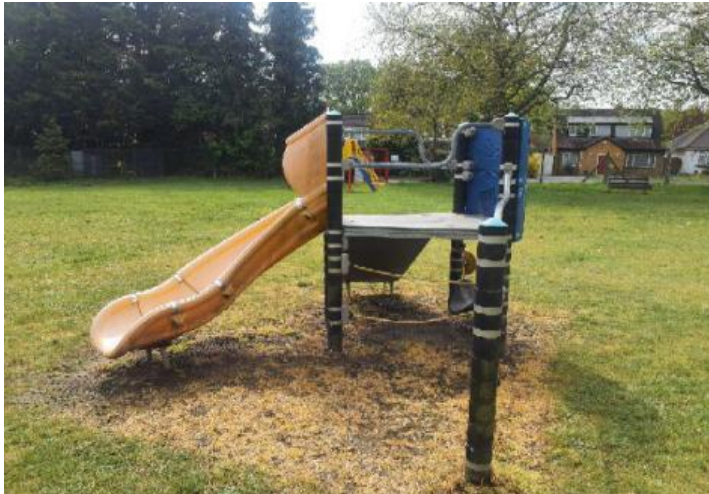
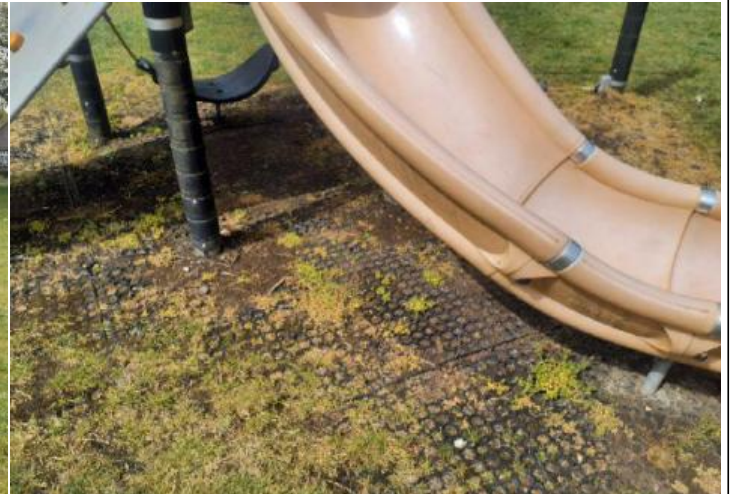
Finding: The grass mats are silted up, the soil is compacted and the area will become very slippery when the soil is wet.

Action: Reinstate as required

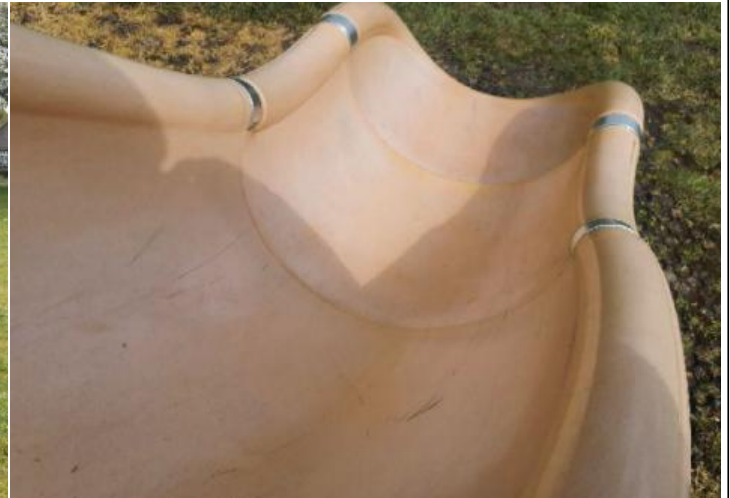
Finding: The slide surface has been damaged

Action: Monitor for any further deterioration and replace as required

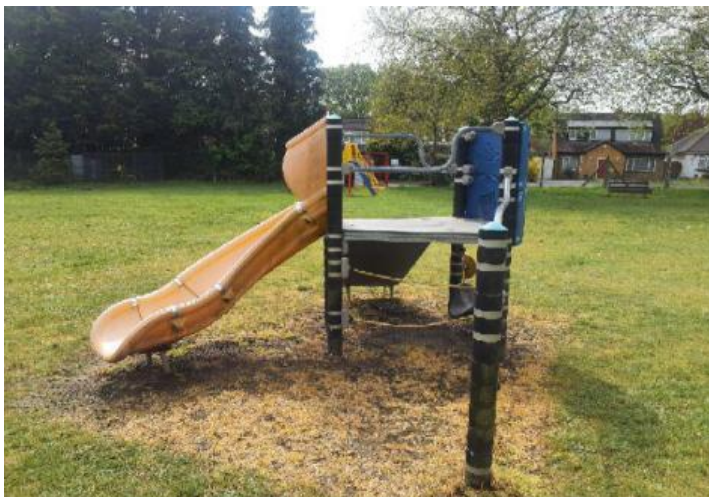
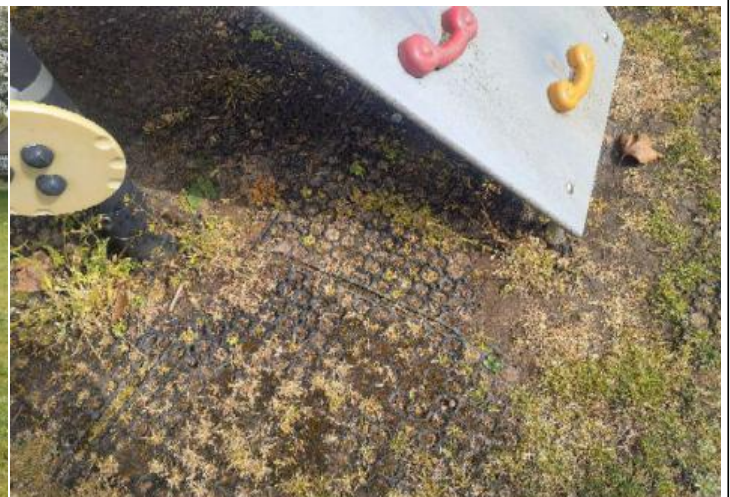
Finding: There are gaps opening between the grass mat tiles

Action: Provide additional ties or secure / reinstate surface

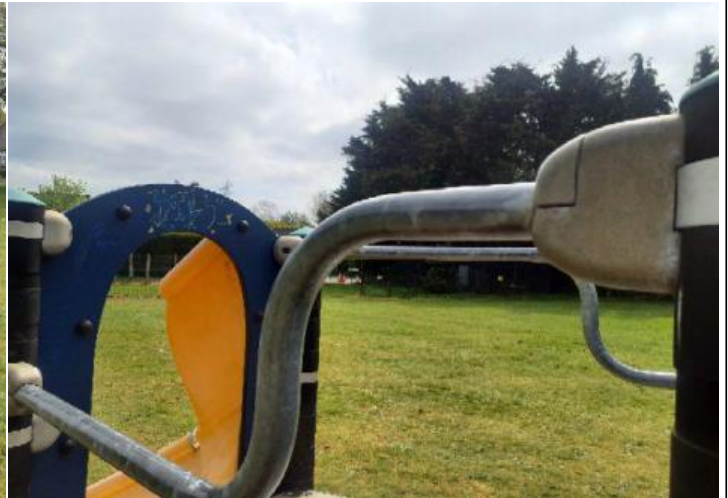
Finding: A number of fixing(s) have worked loose on guardrail

Action: Secure all loose fixings

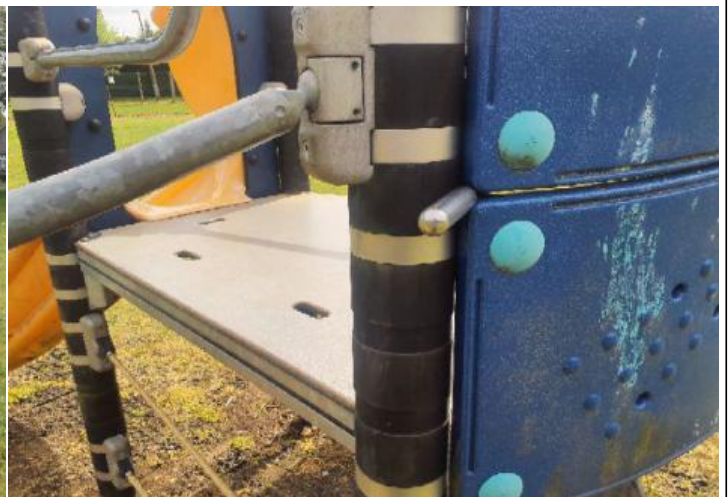
Finding: There is/are finger entrapment/s in the framework and the item fails to meet the requirements of BS EN 1176 Part 1 4.2.7.6 Entrapment of fingers

Action: Monitor - No action given the risk assessment

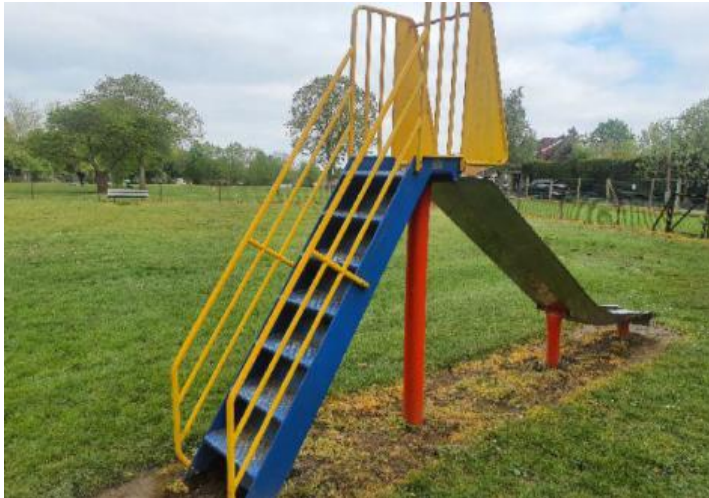
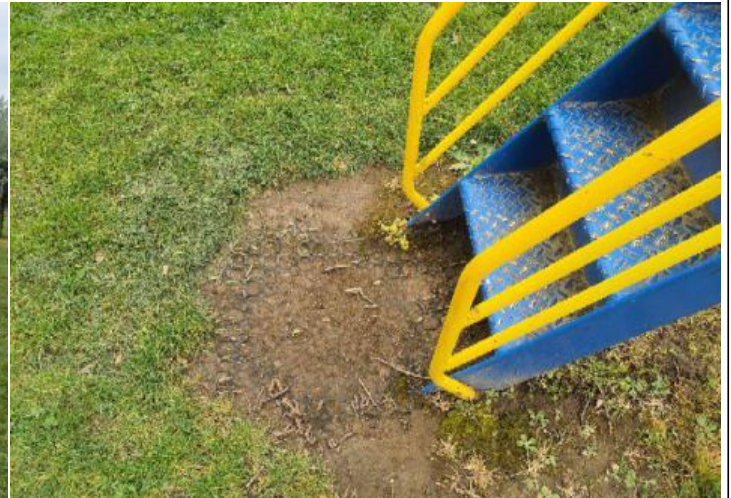
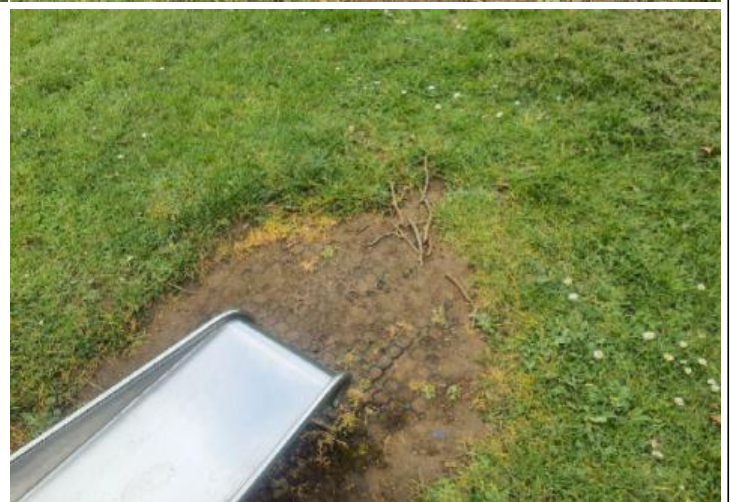
Finding: The grass mats are silted up, the soil is compacted and the area will become very slippery when the soil is wet. **Action:** Reinststate as required

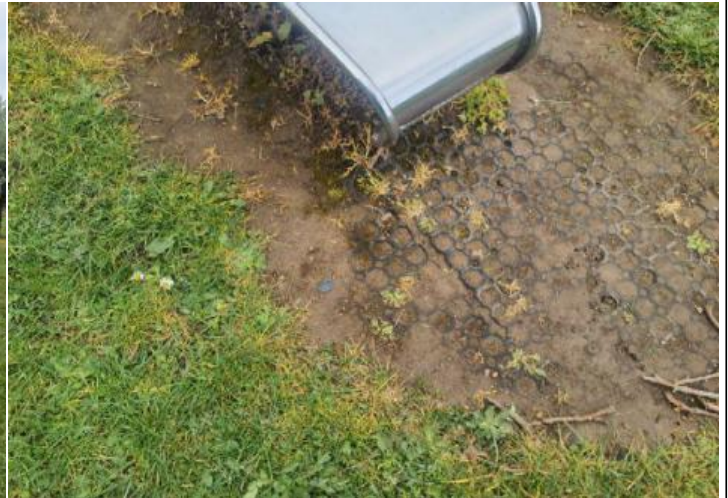
Finding: Fixing Pins have been installed in the impact areas of the grass mats **Action:** Remove pins from impact areas

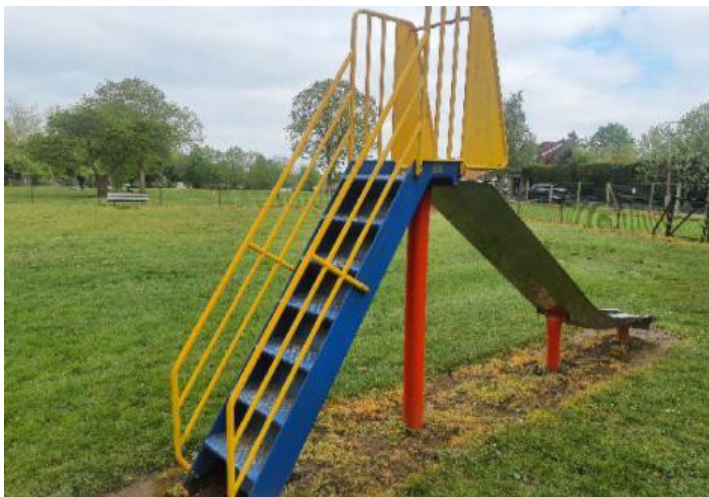
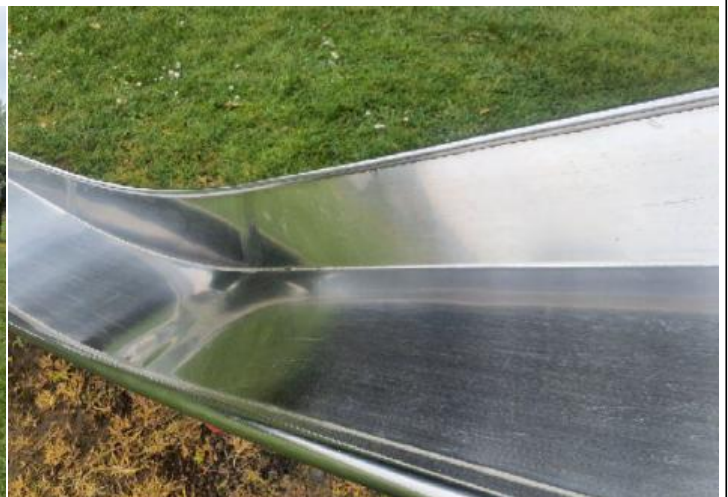
Finding: There are a number of dents in the slide surface **Action:** Monitor for any further deterioration and repair as required

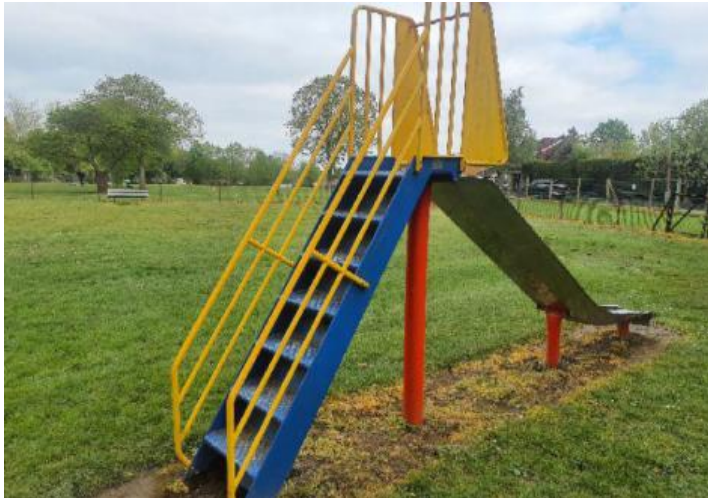
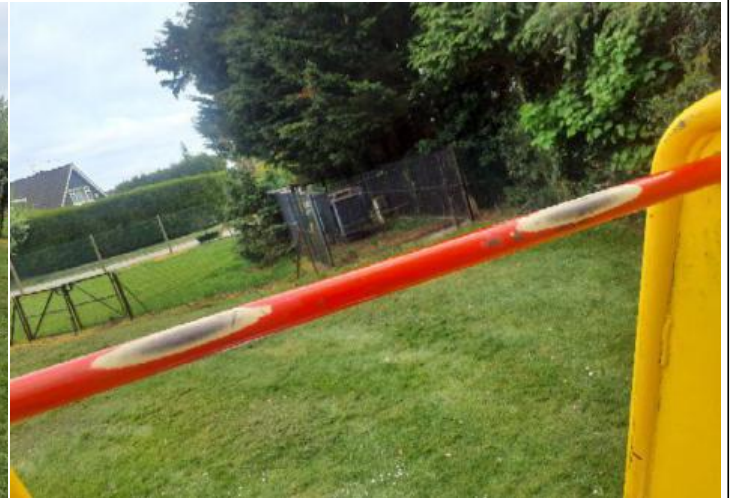
Finding: The paintwork on this item has been damaged or worn exposing the metal underneath which is rusting / corroding

Action: Treat affected areas and repaint

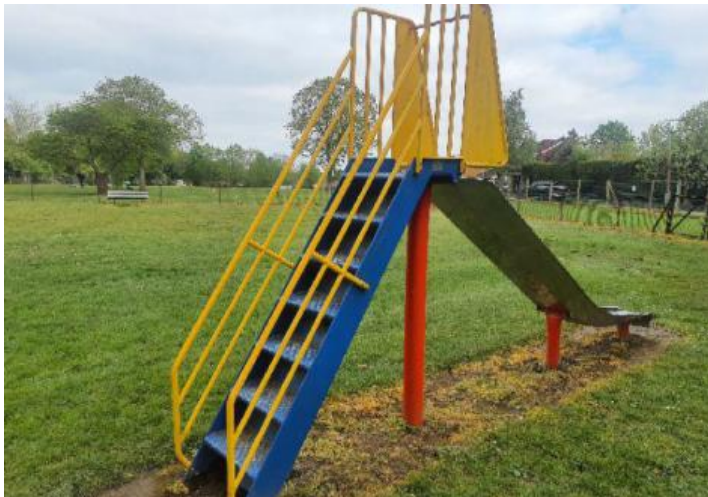
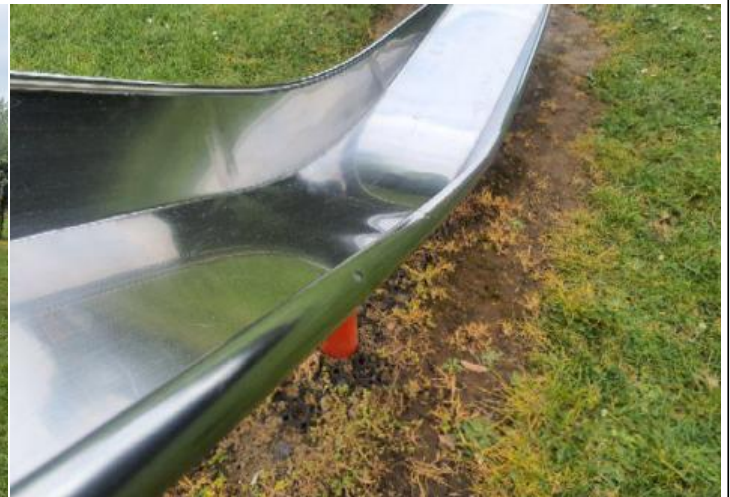
Finding: The side of the slide is damaged

Action: Monitor for any further deterioration and repair as required

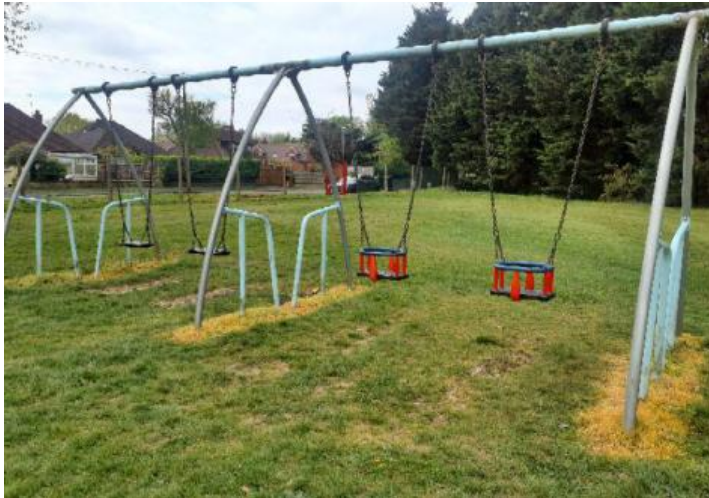
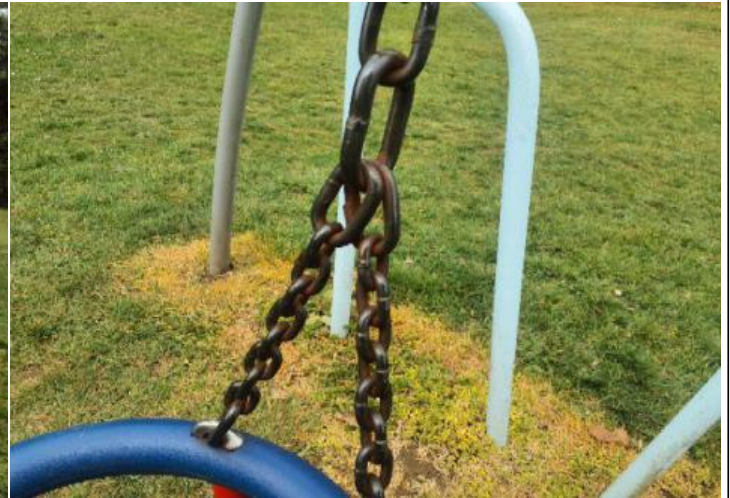
Finding: There is some notable evidence of chain wear

Action: Monitor for any further deterioration and replace when 40% worn

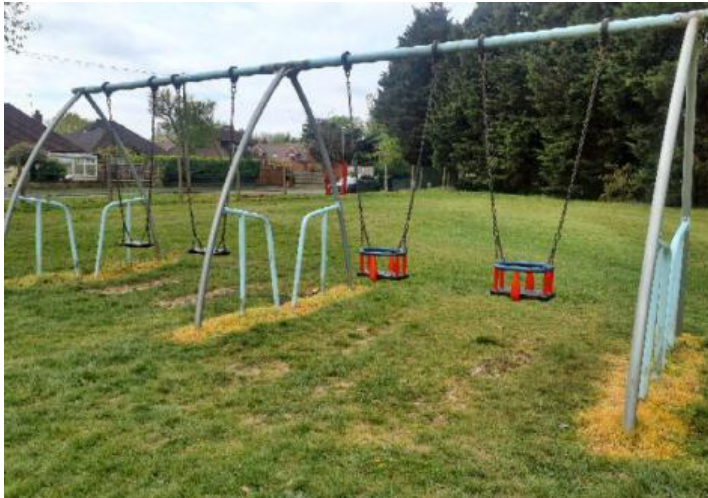
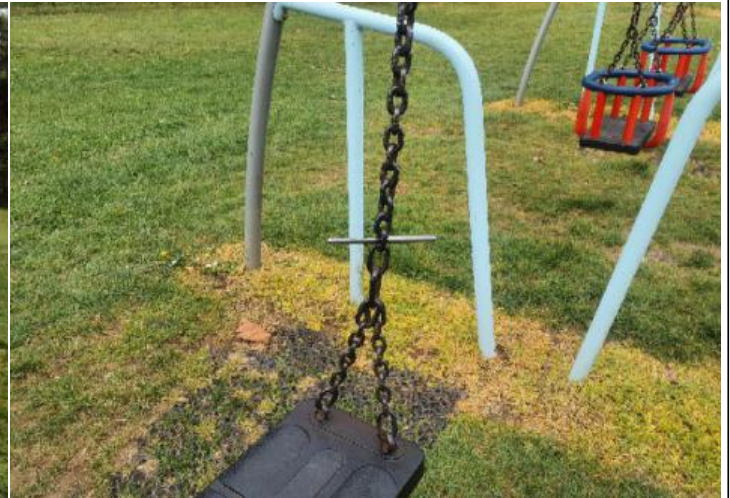
Finding: The chain openings are in excess of 8.6mm and do not meet the recommendations of BS EN 1176 Part 1

Action: Monitor - No action given the risk assessment

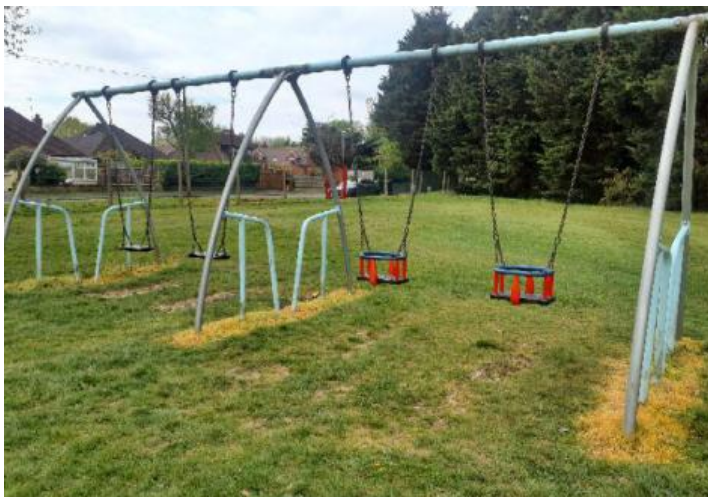
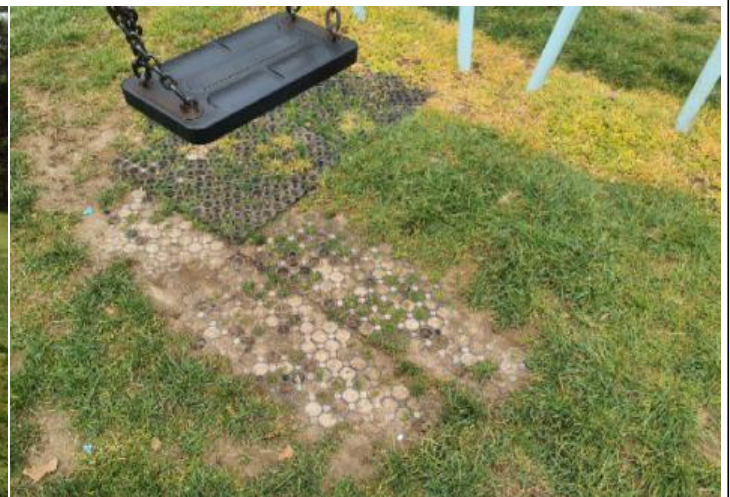
Finding: The grass mats are silted up, the soil is compacted and the area will become very slippery when the soil is wet.

Action: Reinstate as required

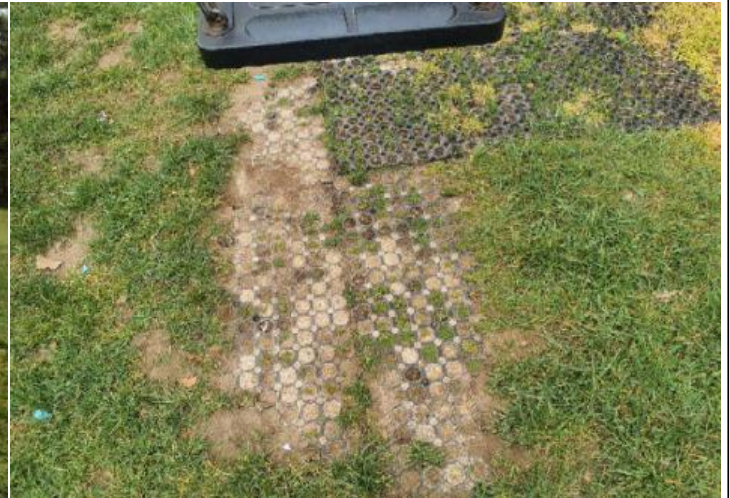
Finding: There are gaps opening between the grass mat tiles

Action: Provide additional ties or secure / reinstate surface

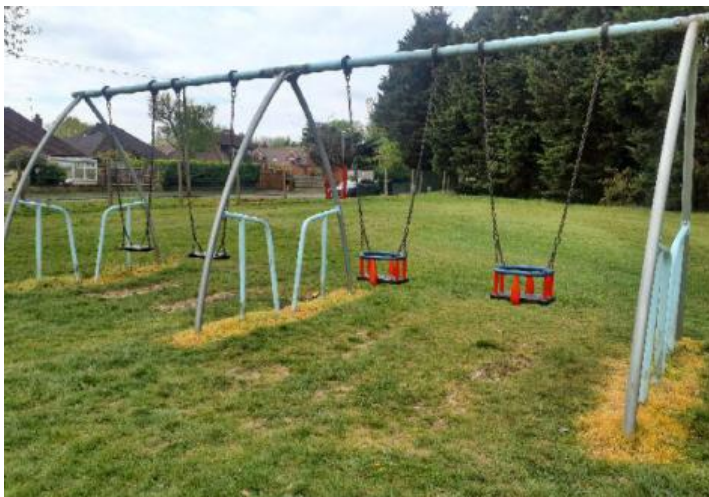
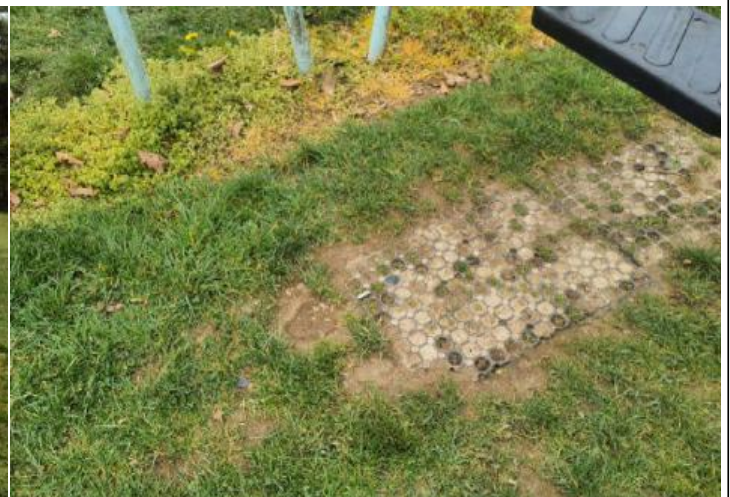
Finding: Fixing Pins have been installed in the impact areas of the grass mats

Action: Remove pins from impact areas

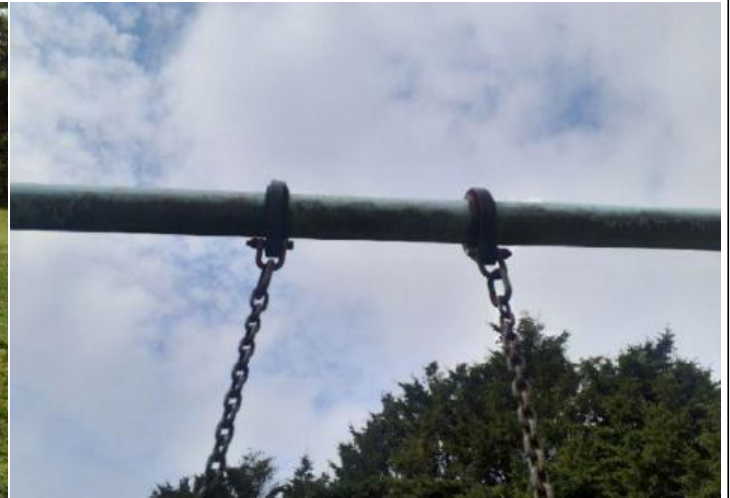
Finding: There is some wear to the shackles

Action: Monitor for any further deterioration and replace when 40% worn

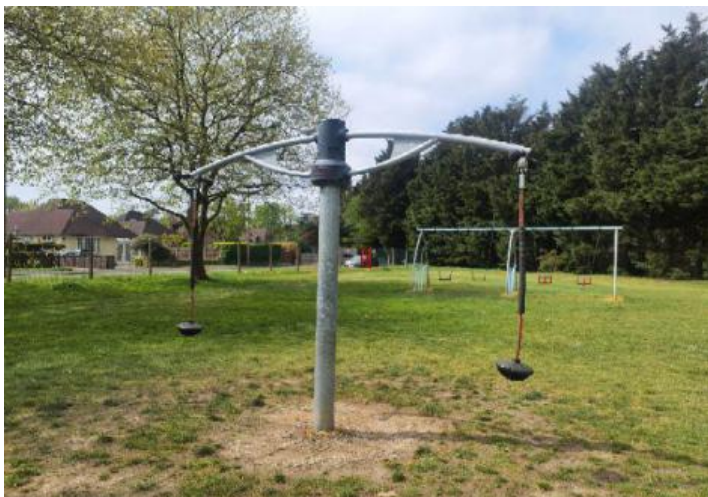
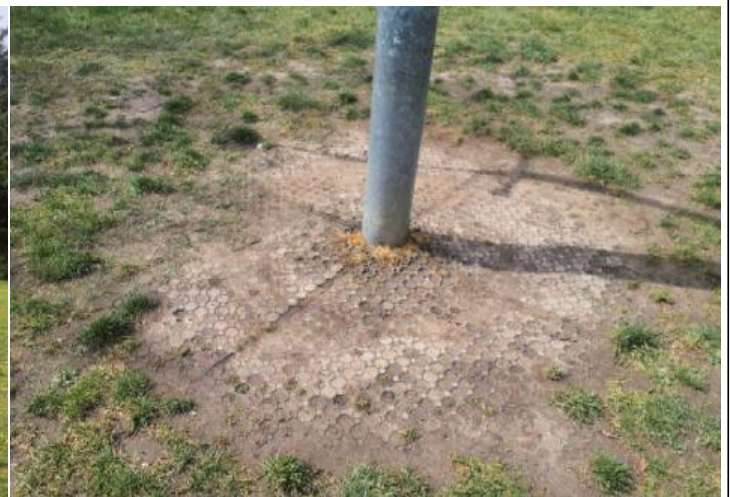
Finding: The grass mats are silted up, the soil is compacted and the area will become very slippery when the soil is wet.

Action: Reinstate as required

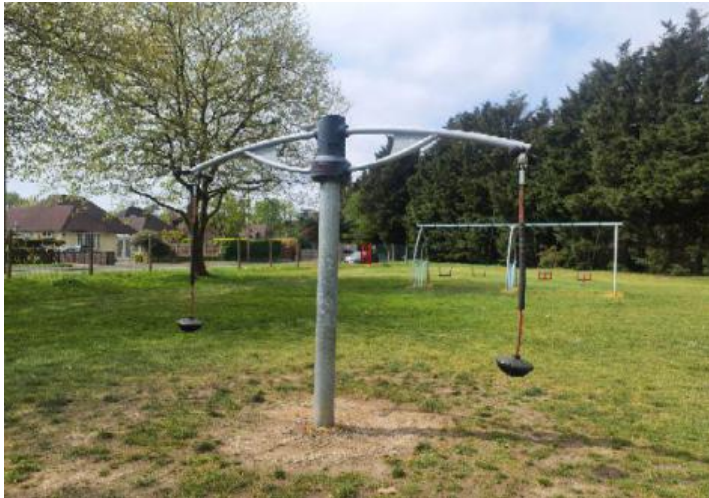
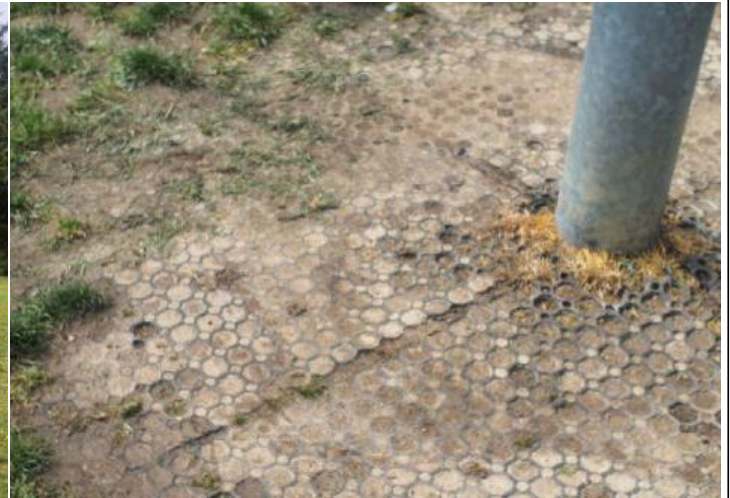
Finding: There are gaps opening between the grass mat tiles

Action: Provide additional ties or secure / reinstate surface

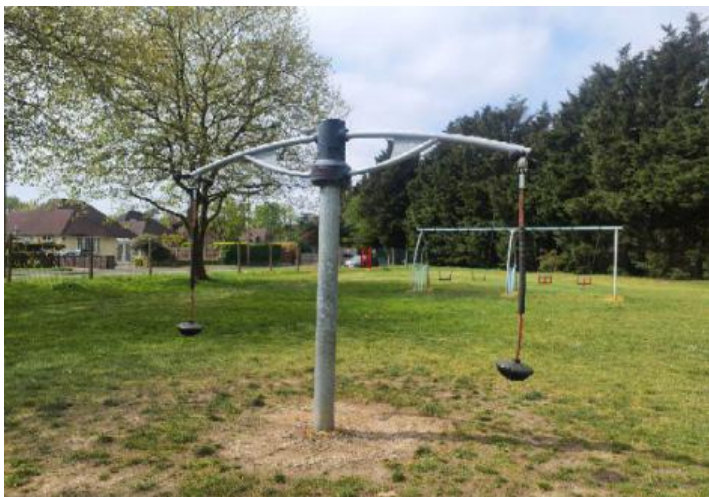
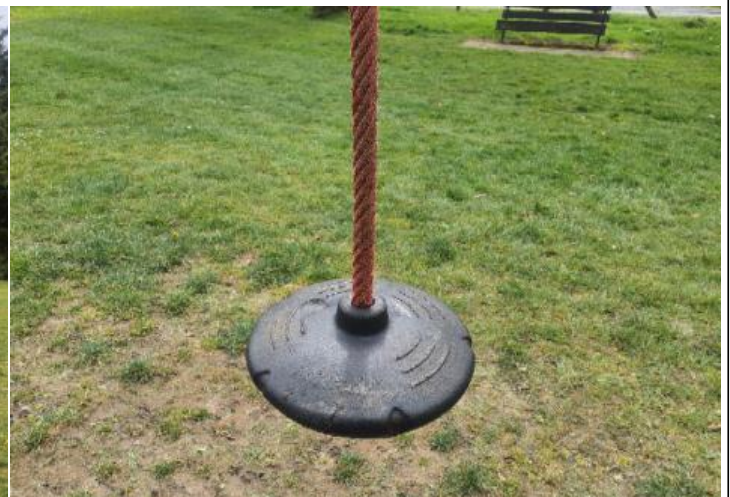
Item: Rotor Play - Overhead Rotator
Manufacturer: Kompan Ltd

Finding: The seat connection cannot be inspected without dismantling the seat

Action: Dismantle the seat to inspect the seat connection for wear

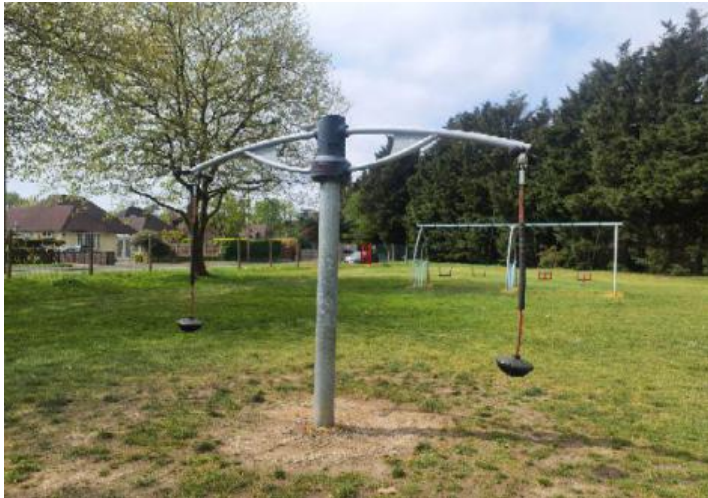
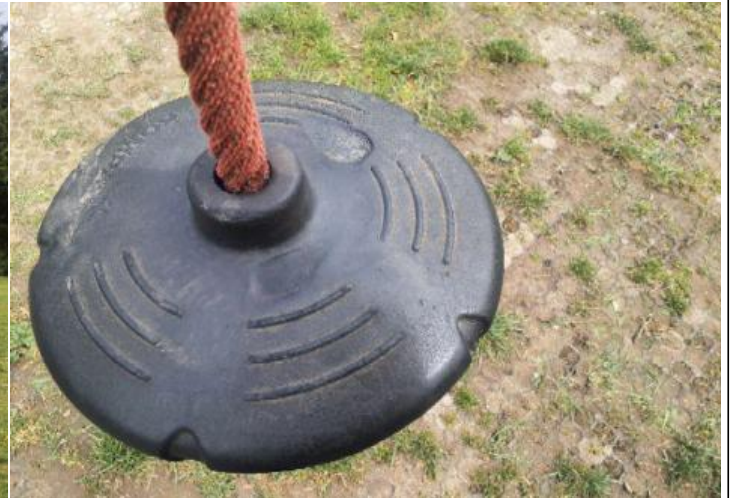
Item: Rotor Play - Overhead Rotator
Manufacturer: Kompan Ltd

Finding: The seat has been damaged

Action: Monitor for any further deterioration and replace as required

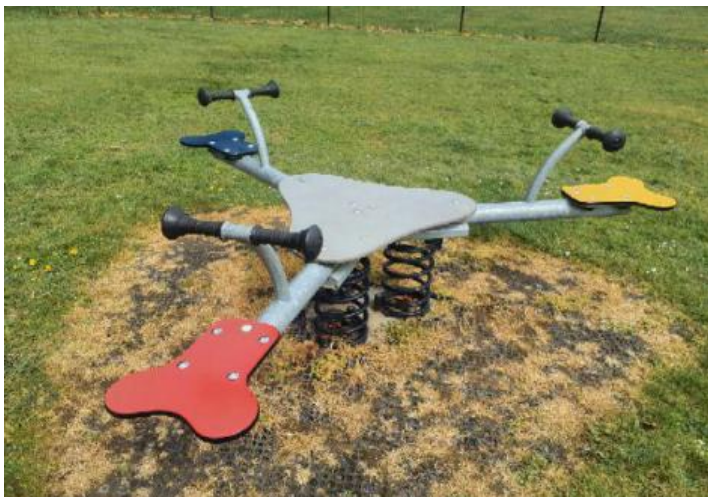
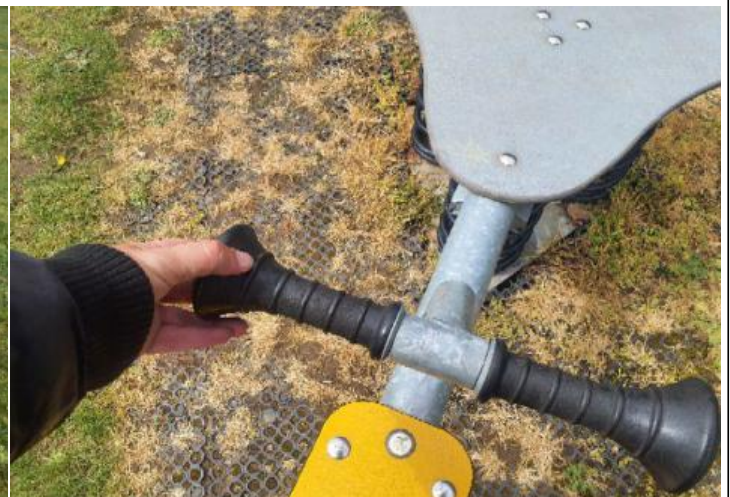
Item: Rocking Equipment - Three Way Springer
Manufacturer: Kompan Ltd

Finding: A number of fixing(s) have worked loose

Action: Secure all loose fixings

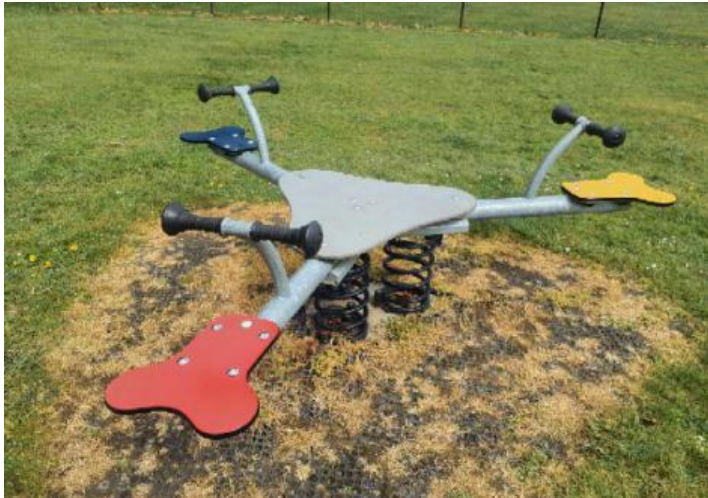
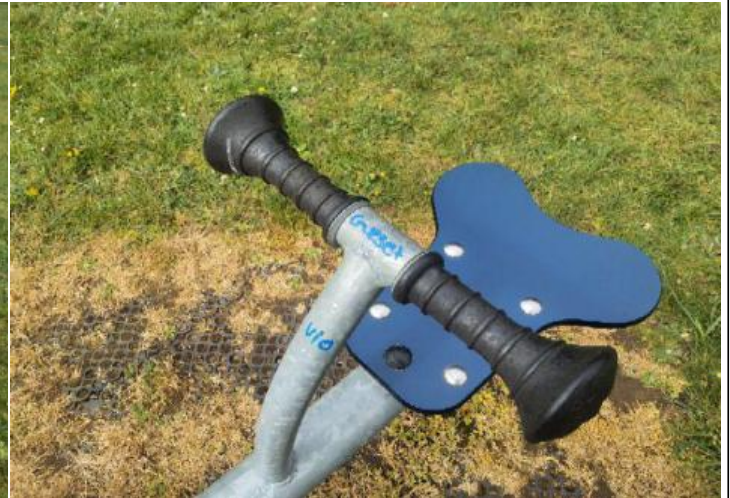
Item: Rocking Equipment - Three Way Springer
Manufacturer: Kompan Ltd

Finding: There is some graffiti present

Action: Remove the graffiti

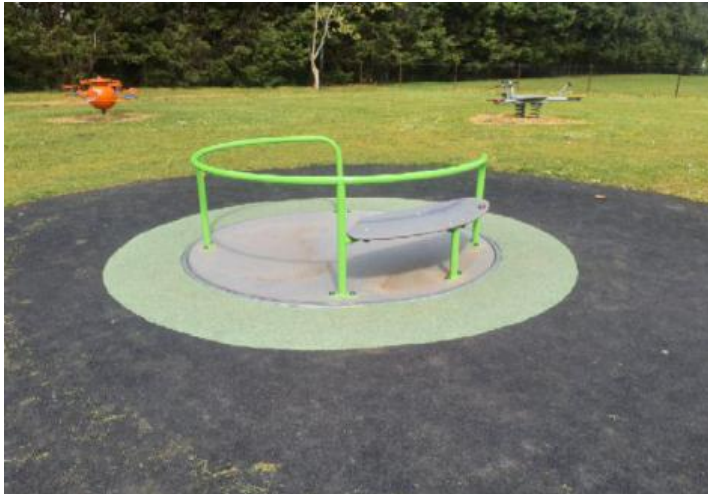
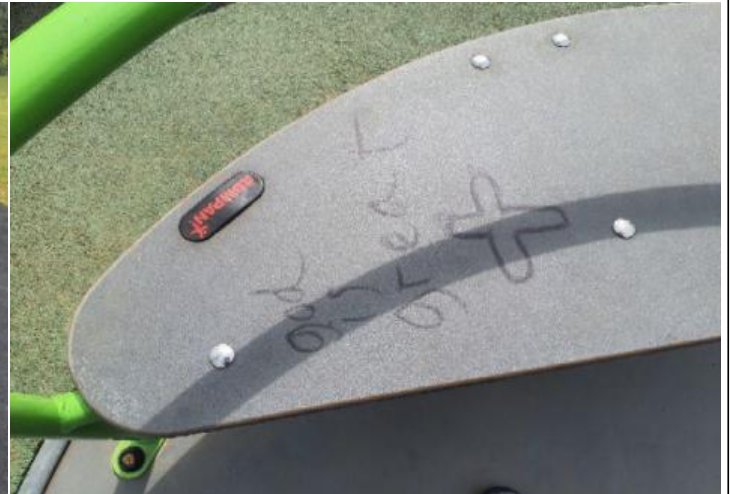
Item: Rotor Play - Inclusive Roundabout
Manufacturer: Kompan Ltd

Finding: There is some graffiti present

Action: Remove the graffiti

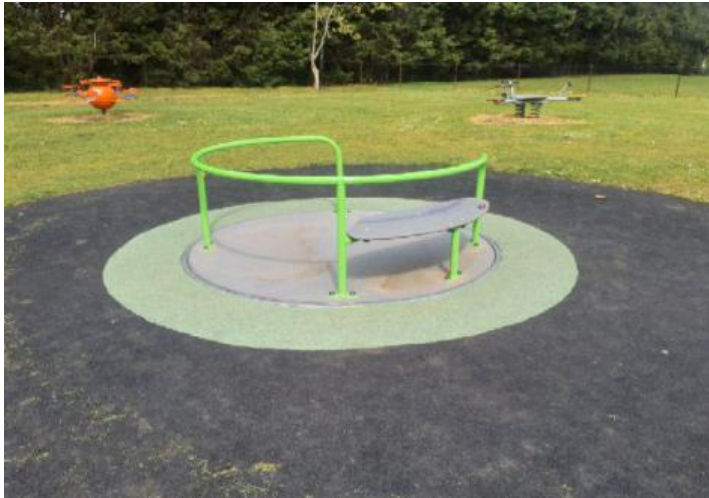
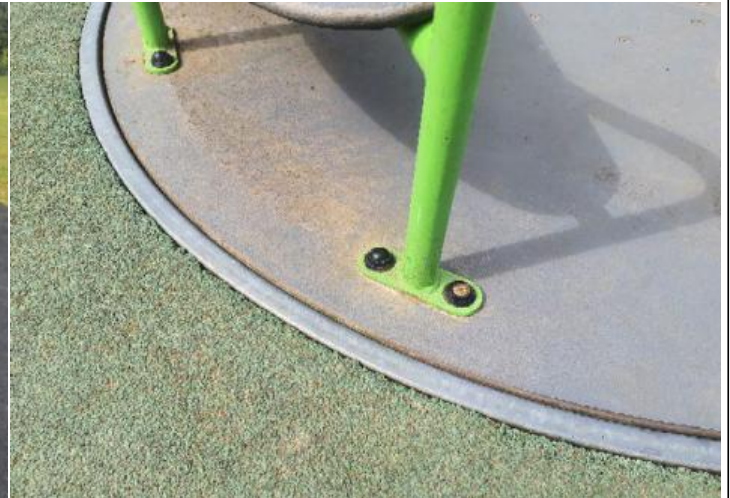
Item: Rotor Play - Inclusive Roundabout
Manufacturer: Kompan Ltd

Finding: There is/are bolt cap covers missing or damaged on the item

Action: Replace missing or damaged bolt cap covers

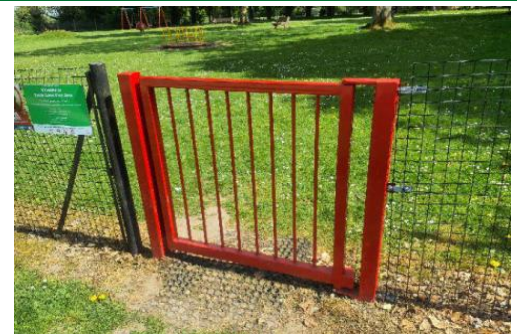
Item: Gate - Self Closing
Manufacturer: Easy Gate Ltd
Surface Type: Grass Matrix Tiles
Item Quantity: 1
Equipment Compliance: N/A
Surface Area Compliance: N/A

There are trip hazards caused by the grass matrix tiles at the edges of the surface - Adjust grass matrix tile and reinstate surrounding surface levels to remove the trip points

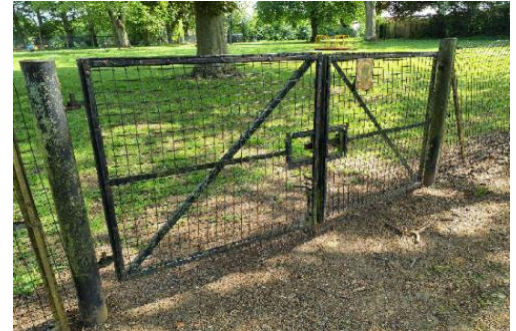
Item: Gate - Maintenance
Manufacturer: Not Identified
Surface Type: Grass
Item Quantity: 1
Equipment Compliance: N/A
Surface Area Compliance: N/A

There is no padlock on the maintenance gate - Provide a padlock to secure the gate

The drop bolt sleeves are damaged - Repair or replace

The paintwork on this item has been damaged or worn exposing the metal underneath which is rusting / corroding - Treat affected areas and repaint

The gate mesh has been damaged - Monitor for any further deterioration and replace as required

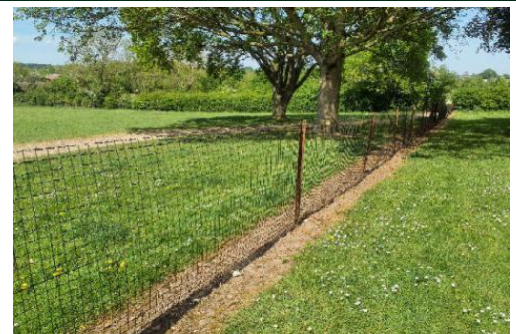
Item: Fence - Steel Mesh
Manufacturer: Not Identified
Surface Type: Grass
Item Quantity: 1
Equipment Compliance: N/A
Surface Area Compliance: N/A

There is a damaged sign on the fence - Remove

There is some damage to the fence sections - Monitor for any further deterioration and repair as required

Cable ties are present and there are sharp projecting ends - Replace with a more appropriate fixing method

The paintwork on this item has been damaged or worn exposing the metal underneath which is rusting / corroding - Treat affected areas and repaint

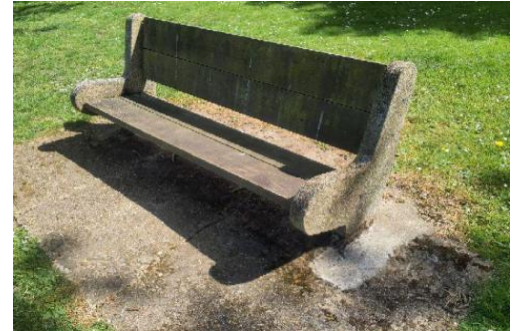
Item: Bench
Manufacturer: Not Identified
Surface Type: Concrete
Item Quantity: 3
Equipment Compliance: N/A
Surface Area Compliance: N/A

There is some minor damage to the surface - Monitor for any further deterioration and repair as required

There are trip hazards at the edges of the surface - Remove trip hazard

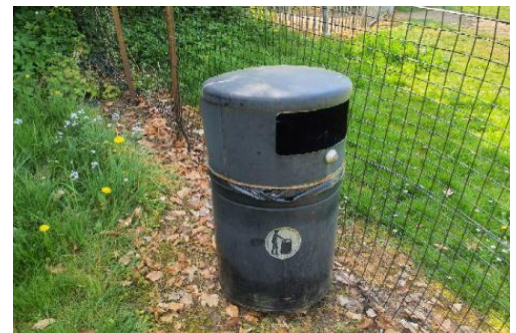
Item: Litter Bin
Manufacturer: Not Identified
Surface Type: Grass
Item Quantity: 1
Equipment Compliance: N/A
Surface Area Compliance: N/A

The item has been damaged - Monitor for any further deterioration and replace as required

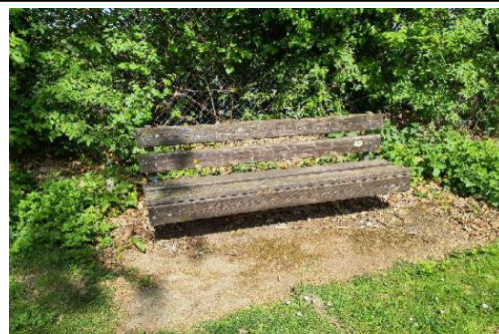
Item: Bench
Manufacturer: Not Identified
Surface Type: N/A
Item Quantity: 1
Equipment Compliance: N/A
Surface Area Compliance: N/A

There are areas or parts of the timber on the structure that have rotted - Replace all affected timbers

There is algae, silt or moss growth on the surface resulting in slippery conditions - Clean and treat appropriately

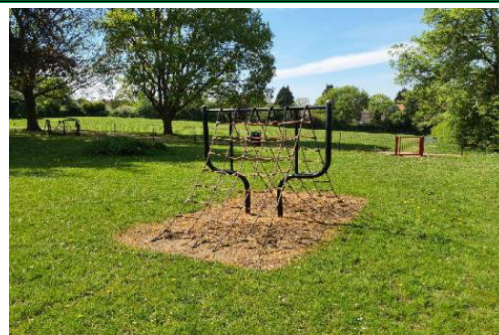
Item: Net Climber
Manufacturer: Wicksteed Playgrounds
Surface Type: Grass Matrix Tiles
Item Quantity: 1
Equipment Compliance: Yes
Surface Area Compliance: Yes
Life Expectancy: 5 -10 Years
Total Findings: 2

The rope has worn and wire strands are exposed - Replace rope or net

The chain/rope covering is damaged - Monitor for any further deterioration and replace as required
