ST STEPHEN PARISH COUNCIL

You are summoned to the Fixed Assets Committee meeting

AGENDA

| 2526/AC/013 | To receive Annual Play Inspection Reports. Reports attached. |

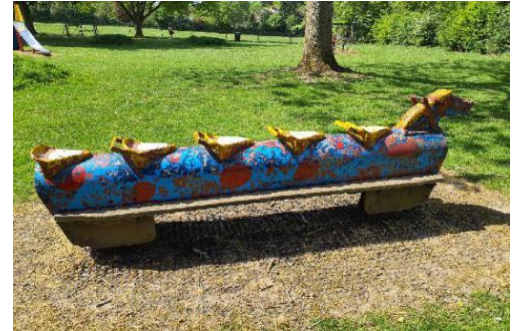
Item: Rocking Horse
Manufacturer: Wicksteed Playgrounds
Surface Type: Grass Matrix Tiles
Item Quantity: 1
Equipment Compliance: No
Surface Area Compliance: Yes
Life Expectancy: 5 -10 Years
Total Findings: 5

The paint is flaking off the metalwork - Rub down and re-paint

The item is noisy during operation - Service the item in accordance with the manufacturers recommendations

There are areas or parts of the timber on the structure that have rotted - Replace all affected timbers

There is no gaiter protection for accessible moving parts (possible shear trap) as recommended in BS EN 1176 Part 1; 4.2.6 Moving Parts - Monitor - No action given the risk assessment

The seat has minor damage or wear - Monitor for any further deterioration and replace as required

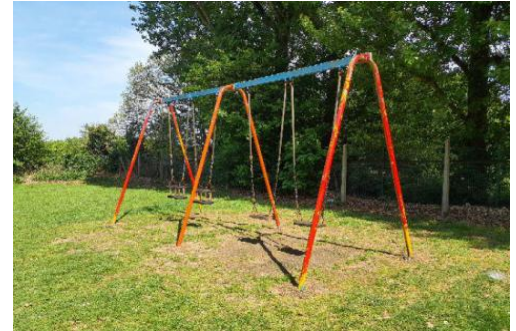
Item: 2 Bay (2 Flat, 2 Cradle)
Manufacturer: Hags
Surface Type: Grass Matrix Tiles
Item Quantity: 1
Equipment Compliance: No
Surface Area Compliance: Yes
Life Expectancy: 5 -10 Years
Total Findings: 9

The fixings or components for this item were in excess of 2.5m above the standing surface and could not be fully accessed by the inspector. We have completed a visual inspection of the fixings from ground level but a maintenance inspection should be undertaken to assess the condition, security and wear of the components at intervals in accordance with the manufacturers recommendations. - Inspect in accordance with the manufacturers recommendations

There is some minor damage to the surface - Monitor for any further deterioration and repair as required

The connecting links are in excess of 8.6mm and less than 12mm and fail the requirements of BS EN 1176 Part 1; clause 4.2.13, Chains - Monitor - No action given the risk assessment

The seats are too close to each other as defined in BS EN 1176 Part 2; this is a low risk failure and no remedial action is required - Monitor - No action given the risk assessment

There are caps missing from the underside of the seats - Replace missing caps under the seats

There is some wear to the shackles - Monitor for any further deterioration and replace when 40% worn

The seat has minor damage or wear - Monitor for any further deterioration and replace as required

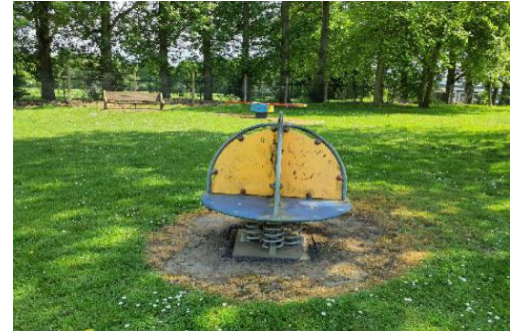
Item:	Spring Board
Manufacturer:	Kompan Ltd
Surface Type:	Grass Matrix Tiles
Item Quantity:	1
Equipment Compliance:	Yes
Surface Area Compliance:	Yes
Life Expectancy:	>10 Years
Total Findings:	2

The paintwork on the spring has been damaged or worn exposing the metal underneath which is rusting - Treat any rusting components and repaint

There is/are bolt cap covers missing or damaged on the item - Replace missing or damaged bolt cap covers

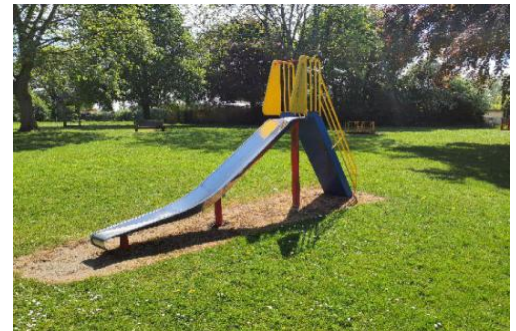
Item:	Free Standing Slide
Manufacturer:	G L Jones Playgrounds Ltd
Surface Type:	Grass Matrix Tiles
Item Quantity:	1
Equipment Compliance:	Yes
Surface Area Compliance:	Yes
Life Expectancy:	>10 Years
Total Findings:	4

Hard fixing pins have been installed in the grass mat tiles within the impact area of the equipment. Grass mat pins should only be installed at the perimeter of the tiles, and outside of any equipment impact areas. NOTE - where grass mat wear pads have been provided and the impact area includes surrounding surfaces, the grass mats should be tucked into the turf, and not pinned - Remove pins from impact areas

There are a number of dents in the slide surface - Monitor for any further deterioration and repair as required

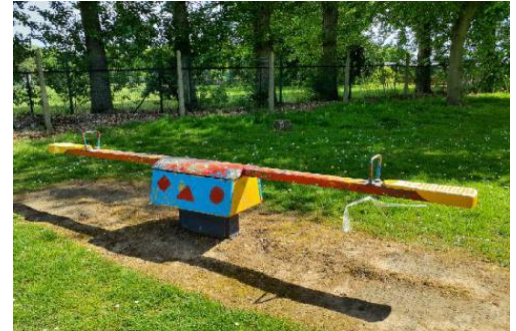
Item:	See Saw
Manufacturer:	Wicksteed Playgrounds
Surface Type:	Grass Matrix Tiles
Item Quantity:	1
Equipment Compliance:	No
Surface Area Compliance:	Yes
Life Expectancy:	5 -10 Years
Total Findings:	5

The item fails to meet the requirements of BS EN 1176 Part 1 4.2.7.2 for head and neck entrapment in the handles - Monitor - No action given the risk assessment

There is no gaiter protection for accessible moving parts (possible shear trap) as recommended in BS EN 1176 Part 1; 4.2.6 Moving Parts - Monitor - No action given the risk assessment

The seat has minor damage or wear - Monitor for any further deterioration and replace as required

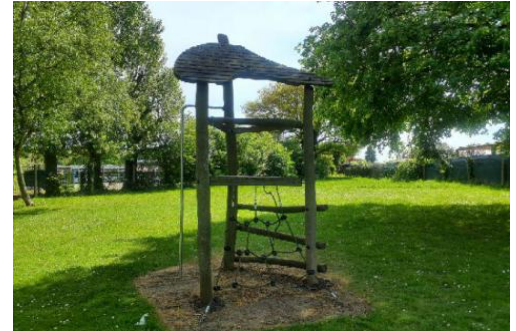
Item: Multi Play (Junior)
Manufacturer: Kompan Ltd
Surface Type: Grass Matrix Tiles
Item Quantity: 1
Equipment Compliance: No
Surface Area Compliance: Yes

The grass mats are silted up and the soil is compacted; this may have an effect on the impact absorbing properties of the surface. Consideration should be given to HIC testing the surface to verify impact attenuating properties (<https://playinspections.co.uk/inspection-services/safety-surface-testing/>) - Contact our office for a quotation for this service

The item is slightly loose in its foundations - Monitor for any further deterioration and repair as required

There are splits running through the timber that cross through or near fixing points and may cause instability in the future - Monitor stability of fixings

The chain openings are in excess of 8.6mm and do not meet the recommendations of BS EN 1176 Part 1 - Monitor
- No action given the risk assessment

A number of fixing(s) have worked loose - Secure all loose fixings

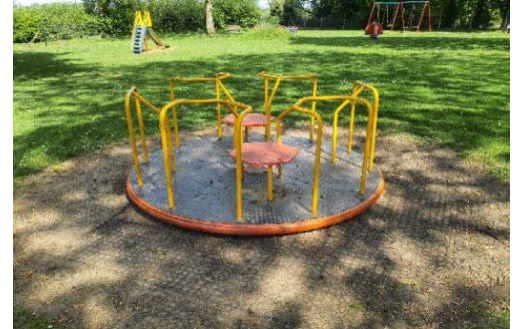
Item:	Roundabout
Manufacturer:	Wicksteed Playgrounds
Surface Type:	Grass Matrix Tiles
Item Quantity:	1
Equipment Compliance:	No
Surface Area Compliance:	Yes
Life Expectancy:	>10 Years
Total Findings:	4

There is moderate damage to the surface - Repair the damaged areas of surfacing

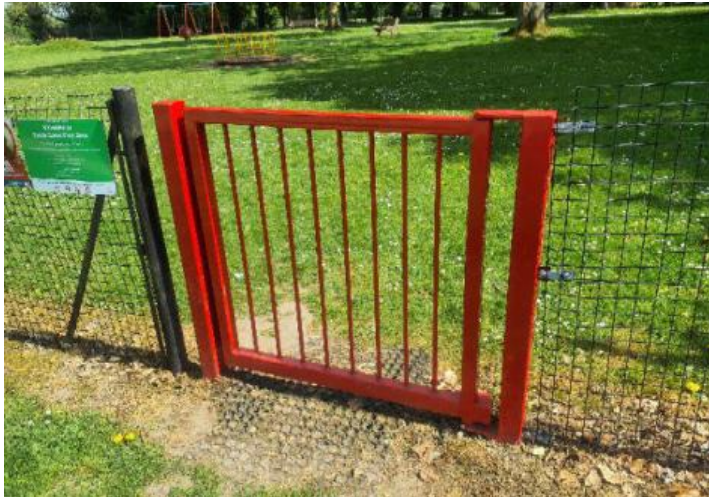
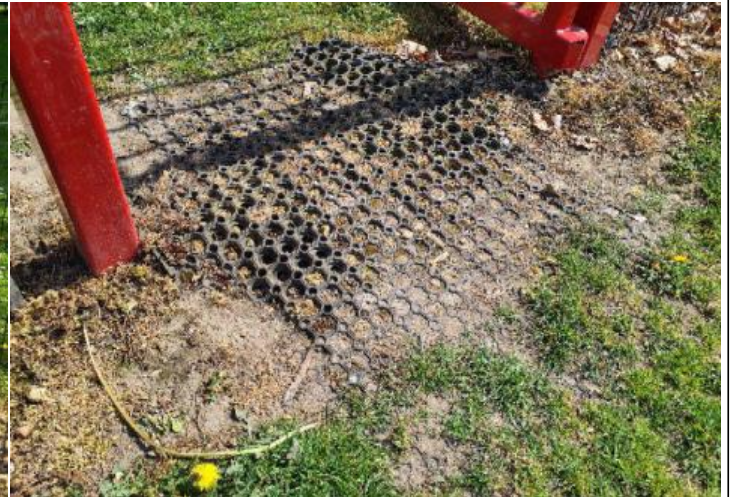
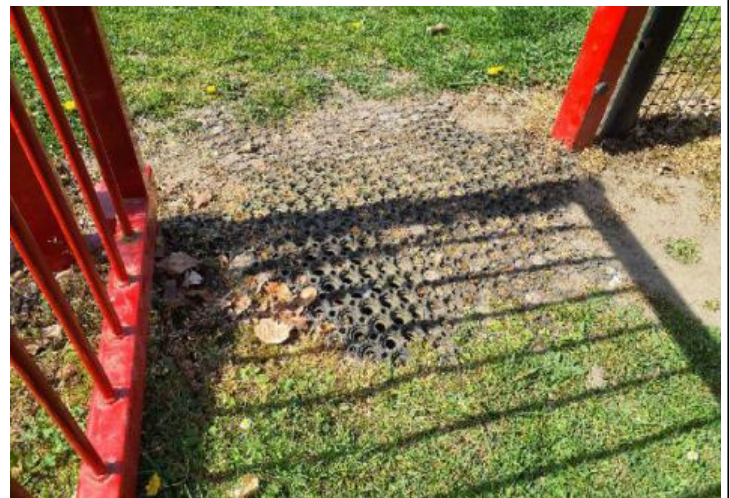
Item: Gates - Gate - Self Closing
Manufacturer: Easy Gate Ltd

Finding: There are trip hazards caused by the grass matrix tiles at the edges of the surface

Action: Adjust grass matrix tile and reinstate surrounding surface levels to remove the trip points

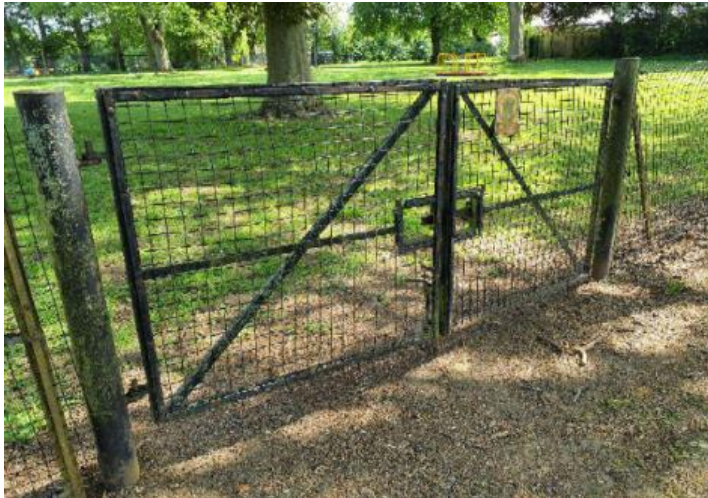
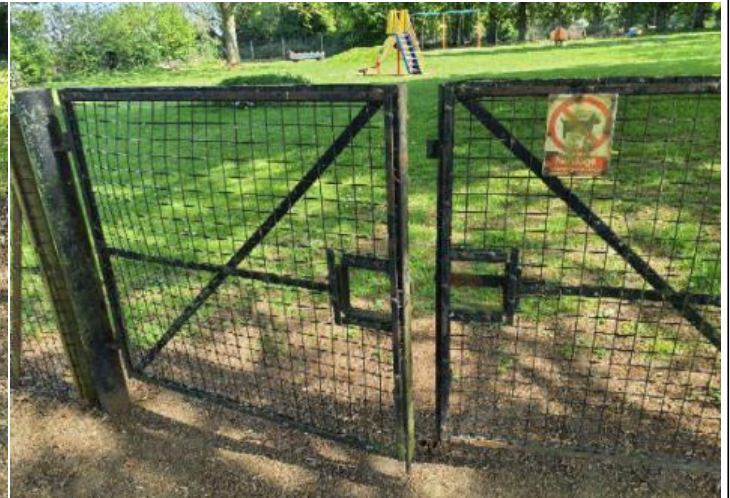
Item: Gates - Gate - Maintenance
Manufacturer: Not Identified

Finding: There is no padlock on the maintenance gate

Action: Provide a padlock to secure the gate

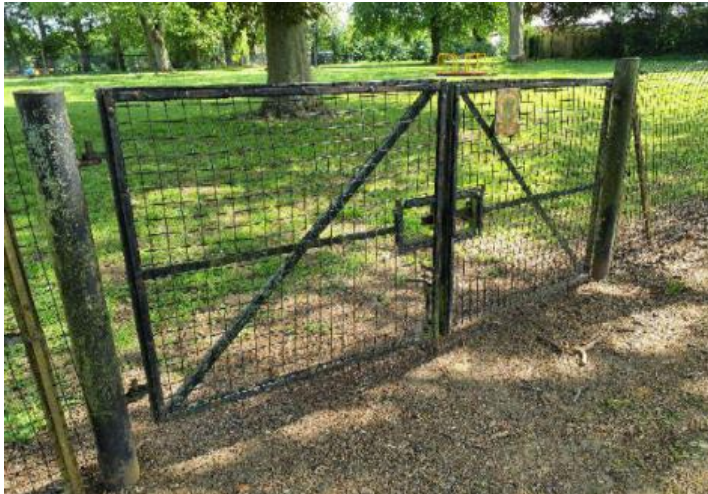
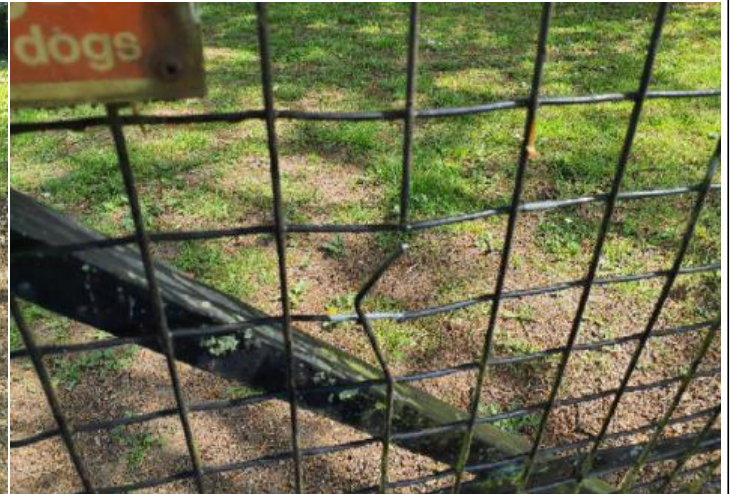
Item: Gates - Gate - Maintenance
Manufacturer: Not Identified

Finding: The gate mesh has been damaged

Action: Monitor for any further deterioration and replace as required

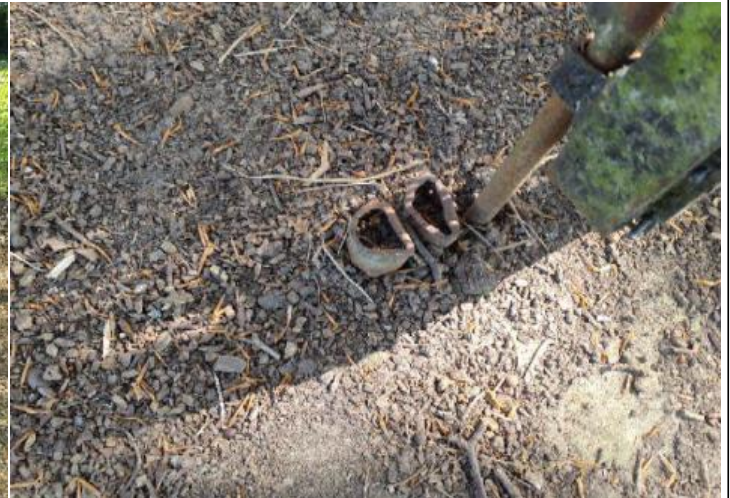
Item: Gates - Gate - Maintenance
Manufacturer: Not Identified

Finding: The drop bolt sleeves are damaged

Action: Repair or replace

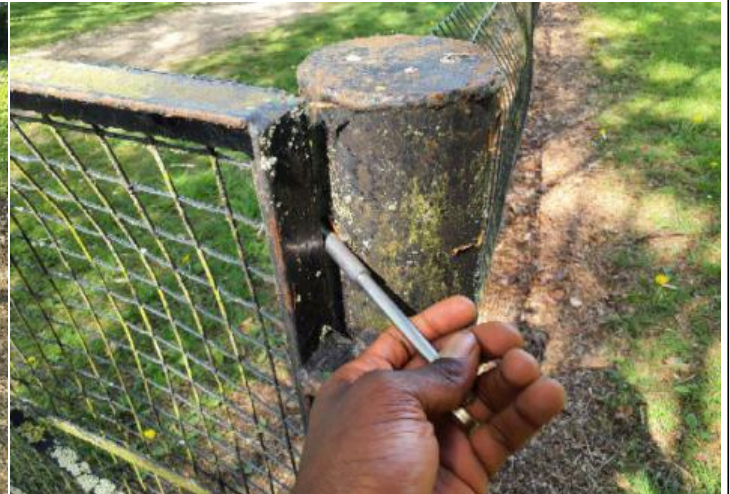
Item: Gates - Gate - Maintenance
Manufacturer: Not Identified

Finding: There are openings that are less than 12mm that could trap or crush fingers

Action: Provide a 12mm gap throughout full range of motion at both sides of gate

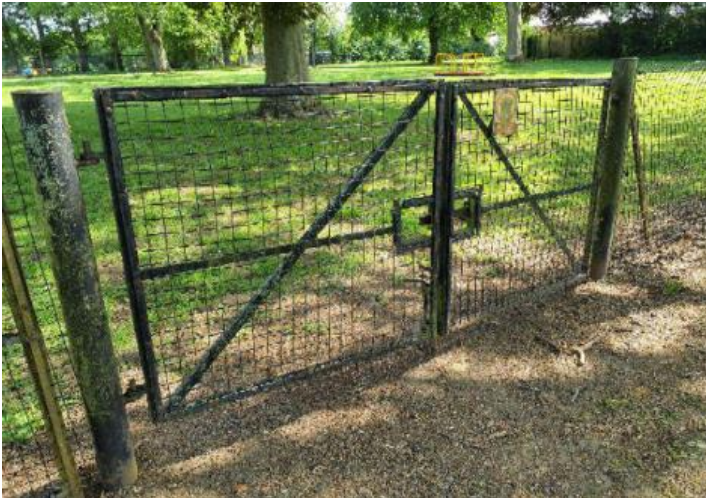
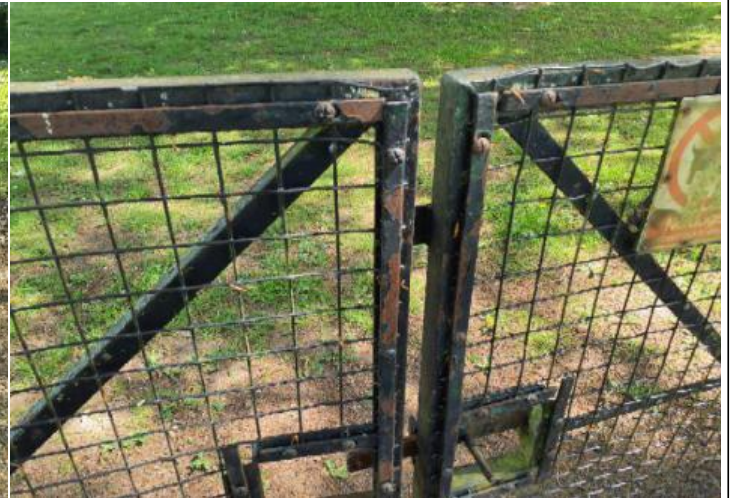
Item: Gates - Gate - Maintenance
Manufacturer: Not Identified

Finding: The paintwork on this item has been damaged or worn exposing the metal underneath which is rusting / corroding

Action: Treat affected areas and repaint

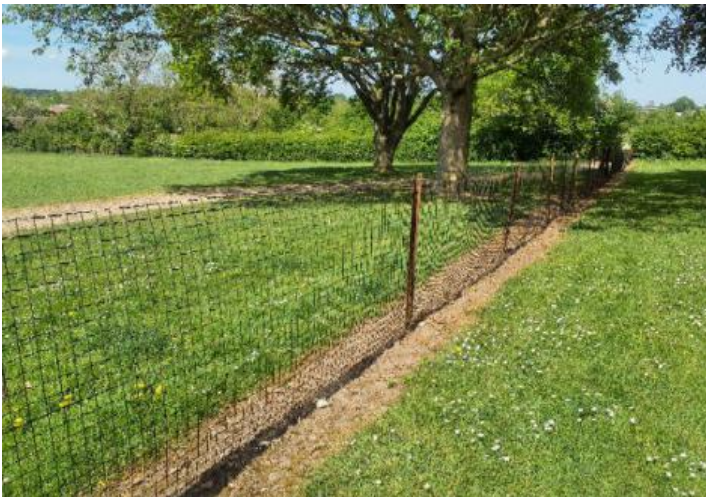
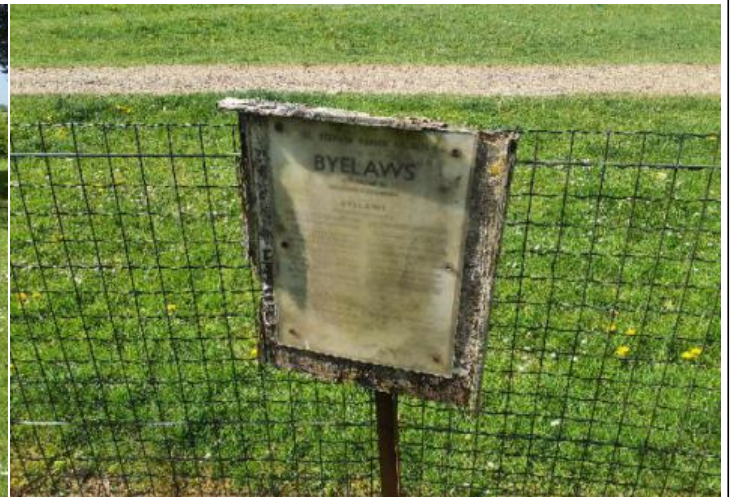
Item: Fences - Fence - Steel Mesh
Manufacturer: Not Identified

Risk Level: L - Low Risk
Surface: Grass

Finding: There is a damaged sign on the fence

Action: Remove

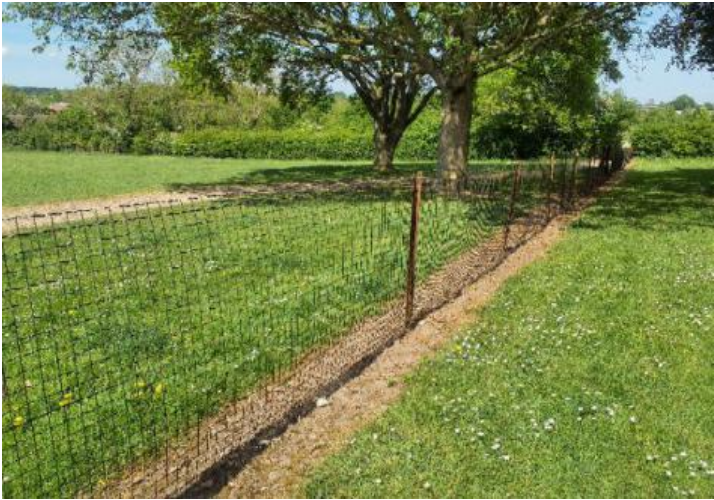
Item: Fences - Fence - Steel Mesh
Manufacturer: Not Identified

Risk Level: L - Low Risk
Surface: Grass

Finding: Cable ties are present and there are sharp projecting ends

Action: Replace with a more appropriate fixing method

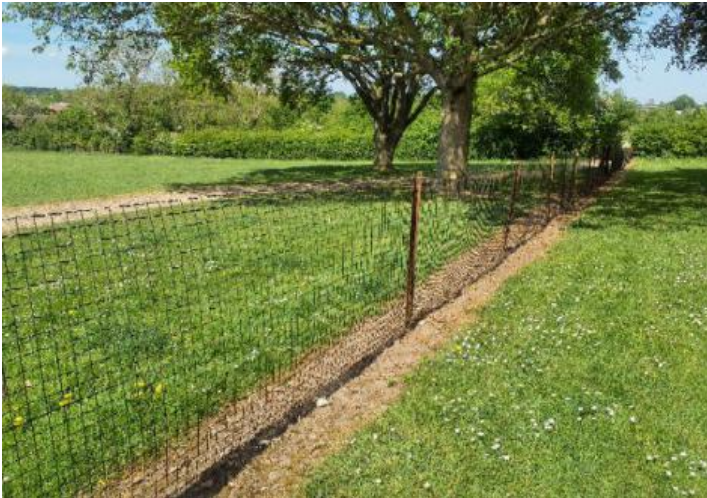
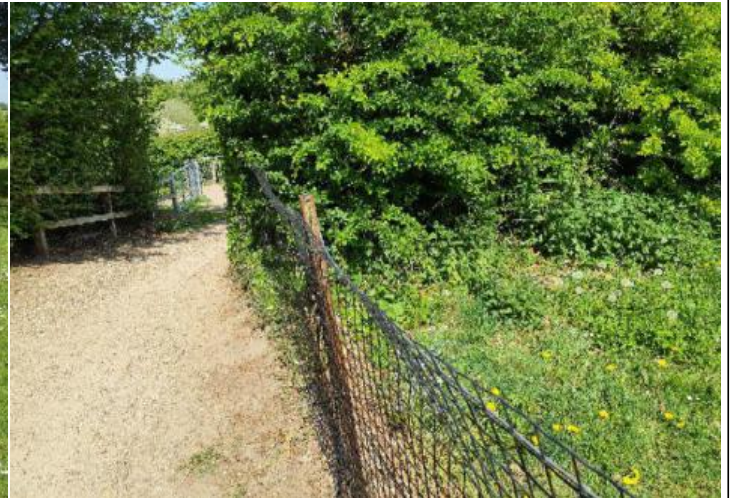
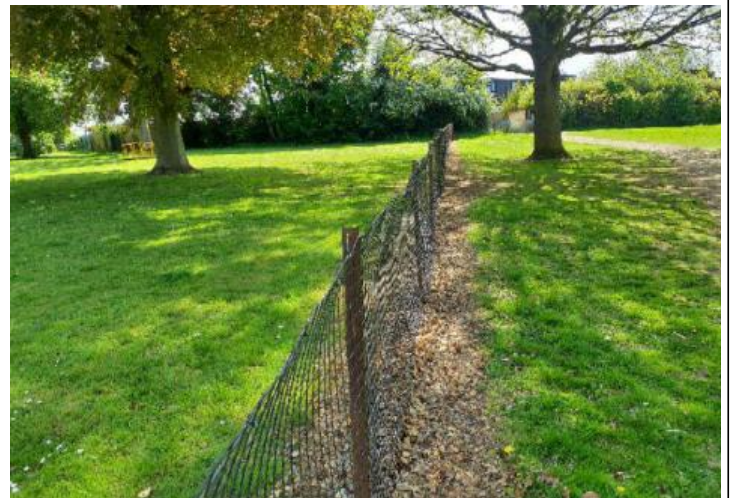
Item: Fences - Fence - Steel Mesh
Manufacturer: Not Identified

Risk Level: L - Low Risk
Surface: Grass

Finding: There is some damage to the fence sections

Action: Monitor for any further deterioration and repair as required

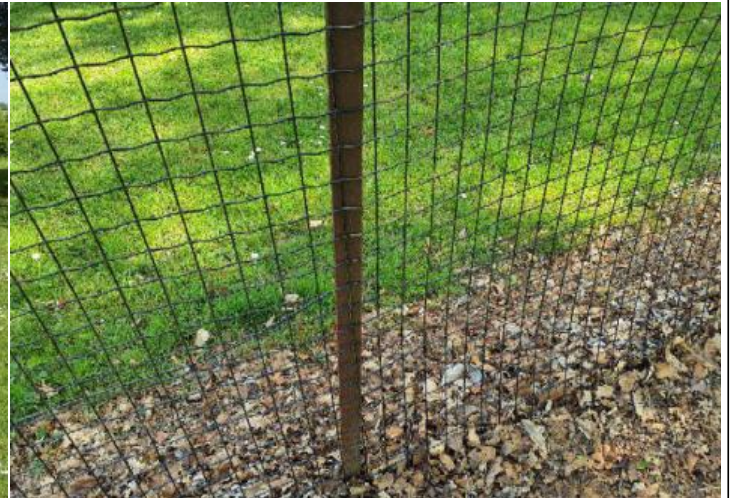
Item: Fences - Fence - Steel Mesh
Manufacturer: Not Identified

Risk Level: L - Low Risk
Surface: Grass

Finding: The paintwork on this item has been damaged or worn exposing the metal underneath which is rusting / corroding

Action: Treat affected areas and repaint

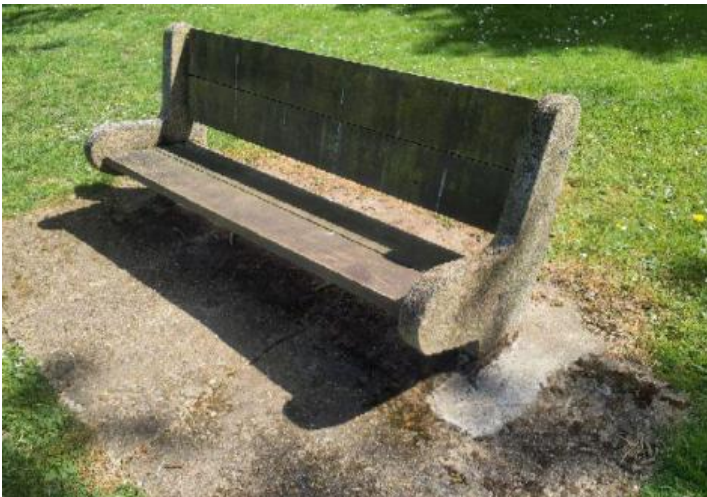
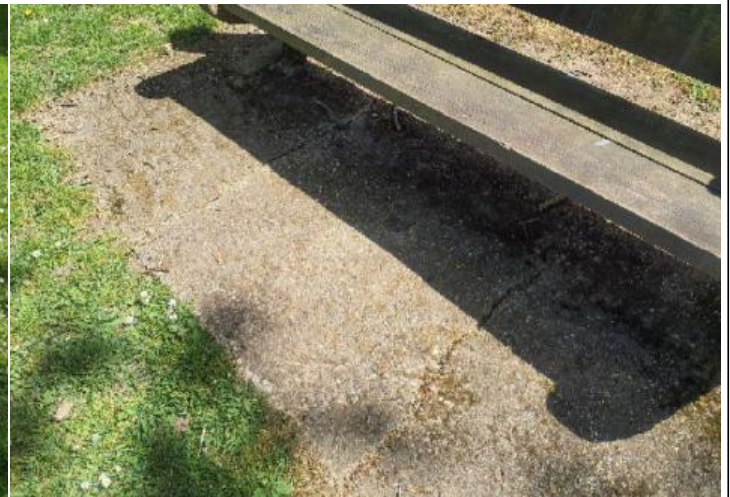
Item: Ancillary Items - Bench
Manufacturer: Not Identified

Risk Level: L - Low Risk
Surface: Concrete

Finding: There is some minor damage to the surface

Action: Monitor for any further deterioration and repair as required

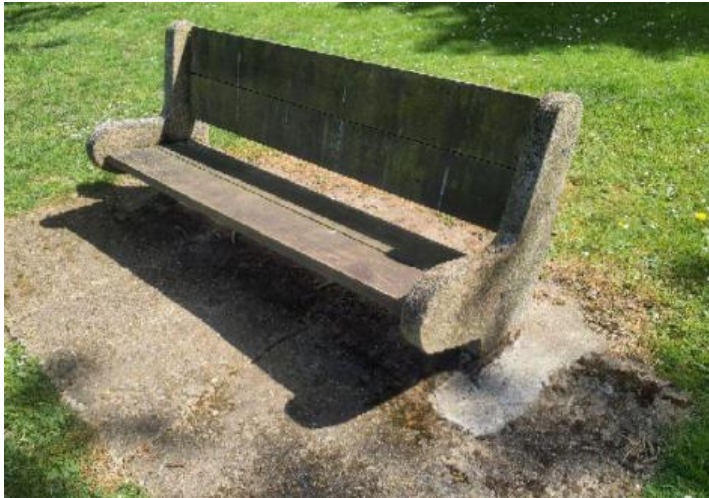
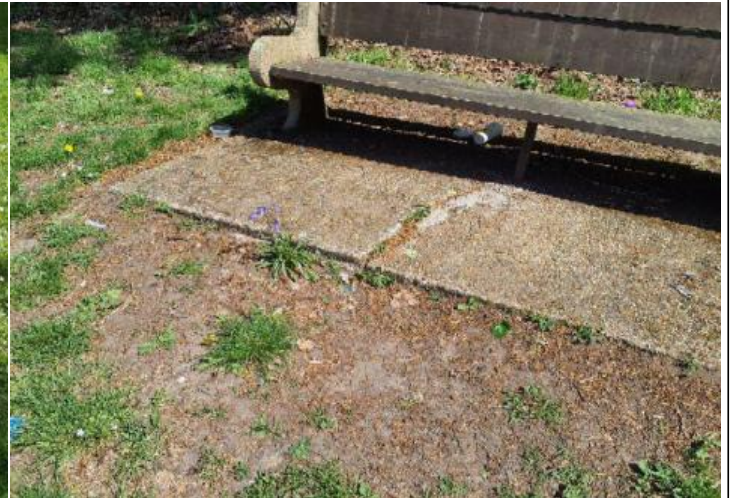
Item: Ancillary Items - Bench
Manufacturer: Not Identified

Risk Level: L - Low Risk
Surface: Concrete

Finding: There are trip hazards at the edges of the surface **Action:** Remove trip hazard

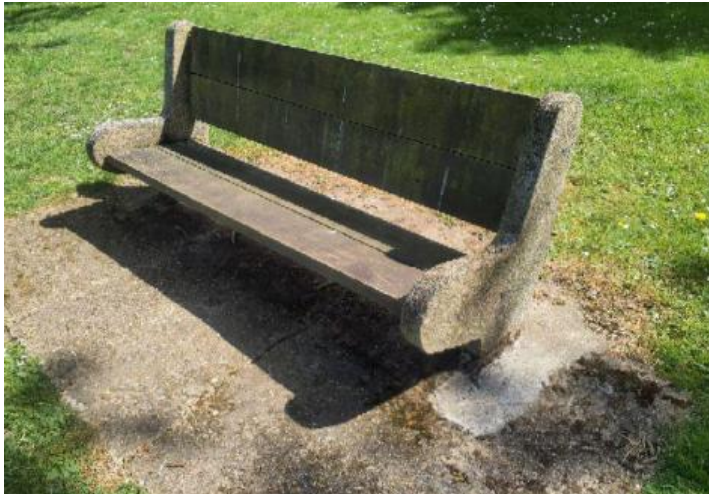
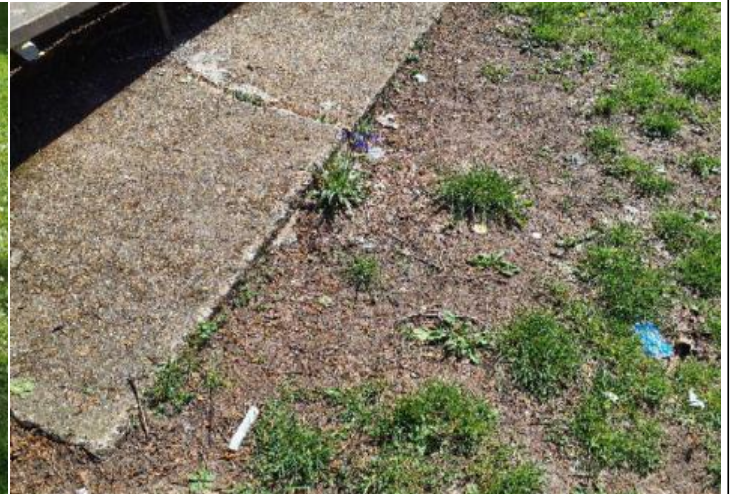
Item: Ancillary Items - Bench
Manufacturer: Not Identified

Risk Level: L - Low Risk
Surface: Concrete

Finding: The area around the item has eroded and may become slippery **Action:** Reinstate eroded area

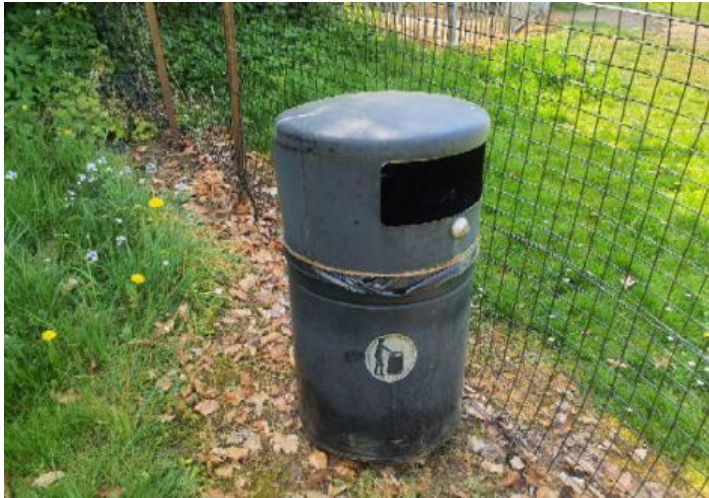
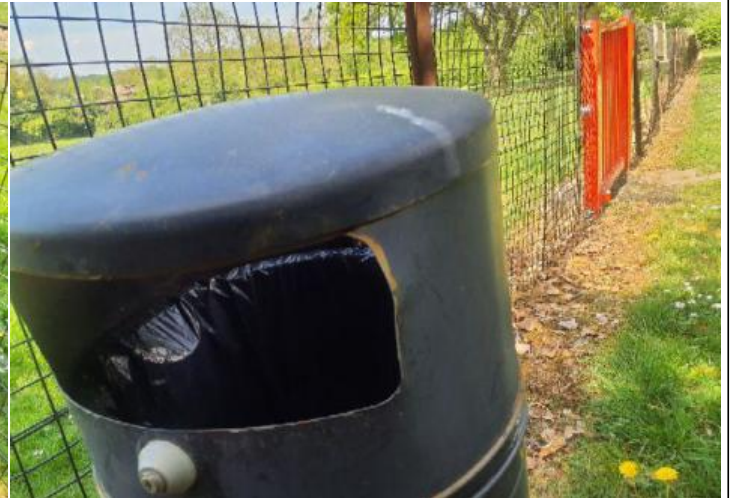
Item: Ancillary Items - Litter Bin
Manufacturer: Not Identified

Risk Level: L - Low Risk
Surface: Grass

Finding: The item has been damaged

Action: Monitor for any further deterioration and replace as required

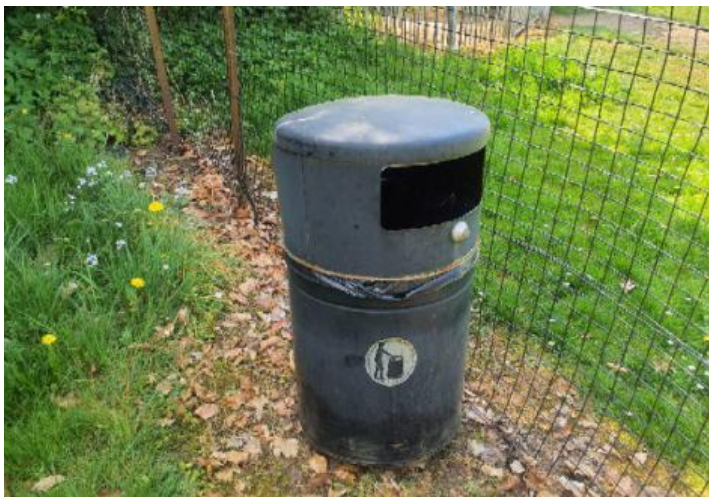
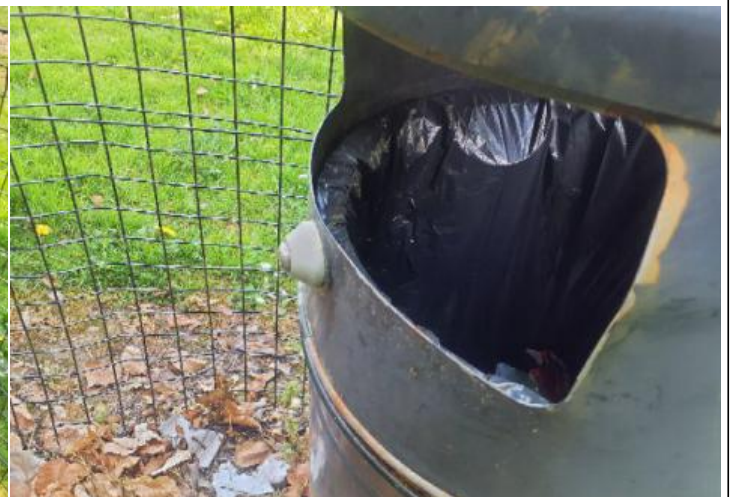
Item: Ancillary Items - Litter Bin
Manufacturer: Not Identified

Risk Level: L - Low Risk
Surface: Grass

Finding: The lid or door of the litter bin is not secured

Action: Ensure the lid or door is kept locked

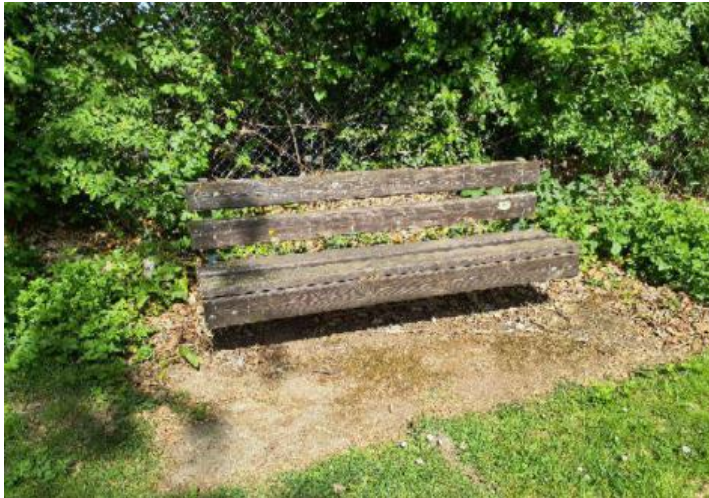
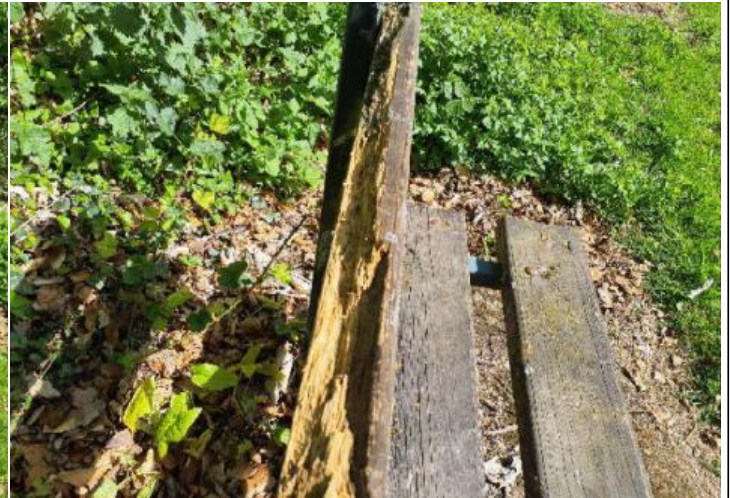
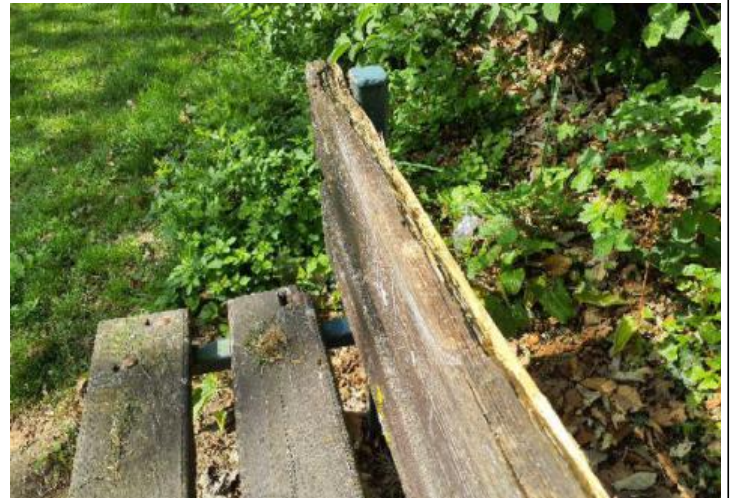
Item: Ancillary Items - Bench
Manufacturer: Not Identified

Risk Level: L - Low Risk
Surface: N/A

Finding: There are areas or parts of the timber on the structure that have rotted

Action: Replace all affected timbers

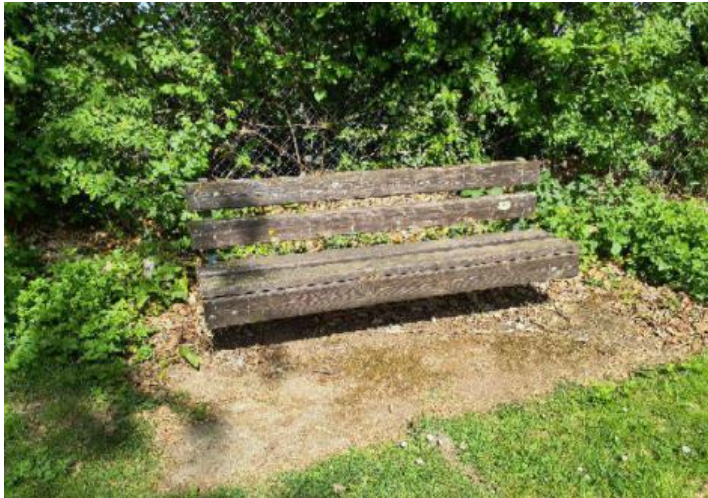
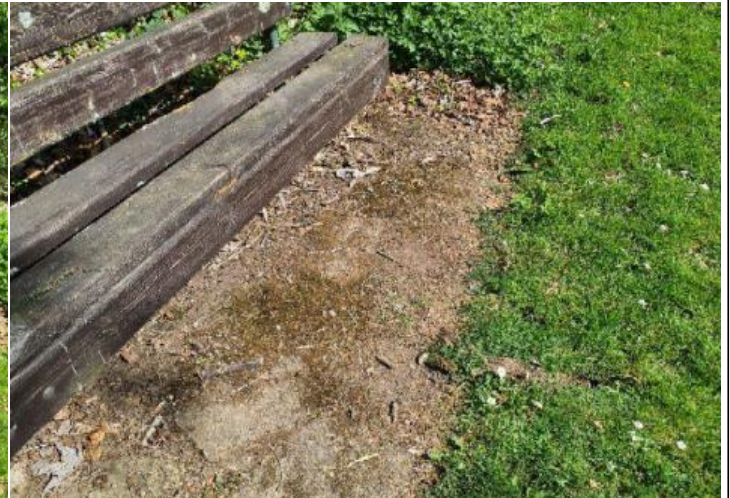
Item: Ancillary Items - Bench
Manufacturer: Not Identified

Risk Level: L - Low Risk
Surface: N/A

Finding: There is algae, silt or moss growth on the surface resulting in slippery conditions

Action: Clean and treat appropriately

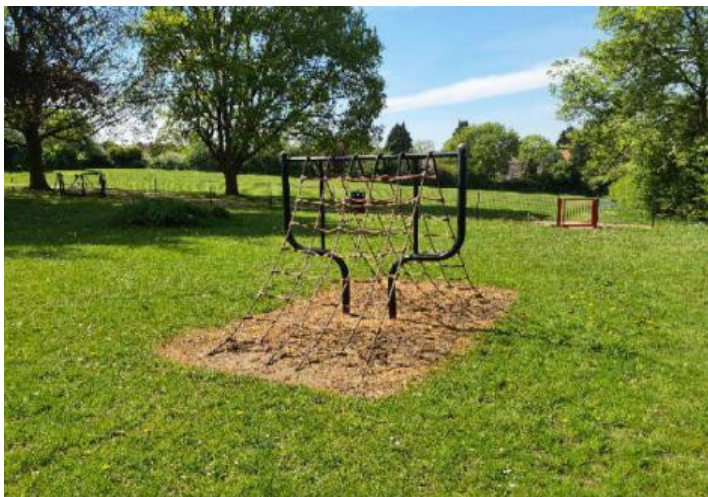
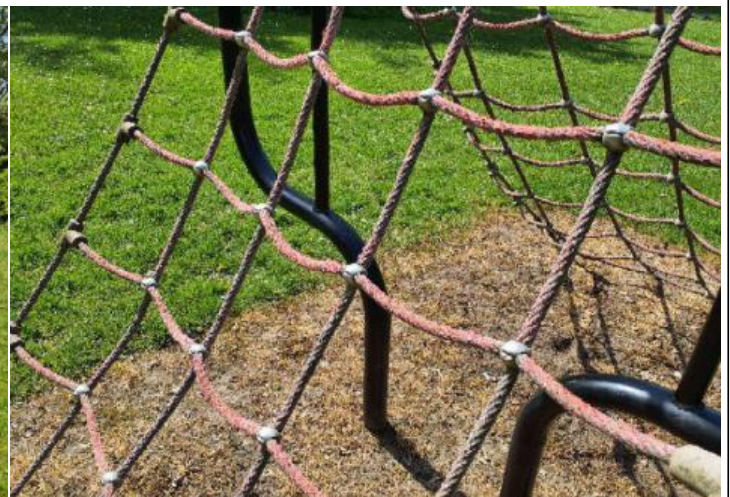
Item: Activity Equipment - Net Climber
Manufacturer: Wicksteed Playgrounds

Risk Level: L - Low Risk
Surface: Grass Matrix Tiles

Finding: The rope has worn and wire strands are exposed

Action: Replace rope or net

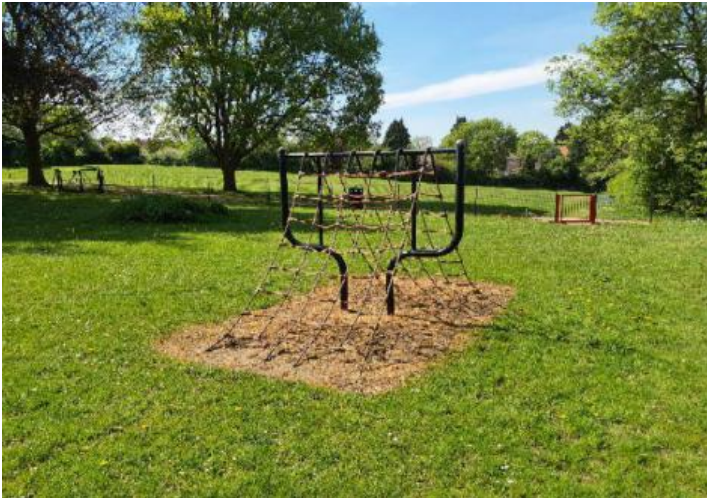
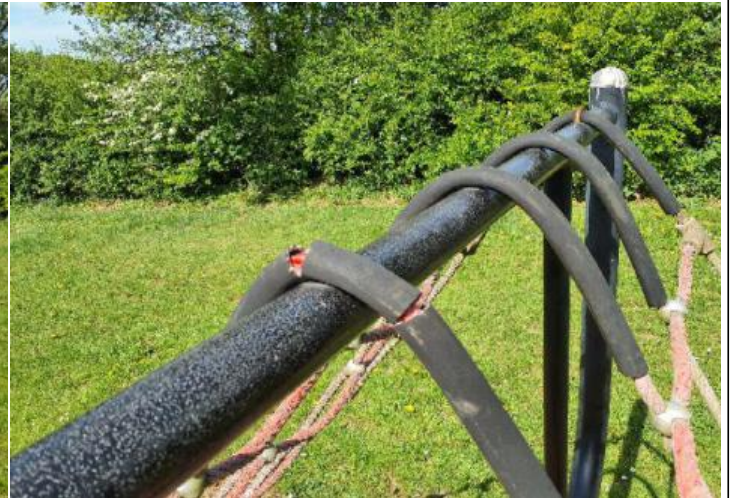
Item: Activity Equipment - Net Climber
Manufacturer: Wicksteed Playgrounds

Risk Level: L - Low Risk
Surface: Grass Matrix Tiles

Finding: The chain/rope covering is damaged

Action: Monitor for any further deterioration and replace as required

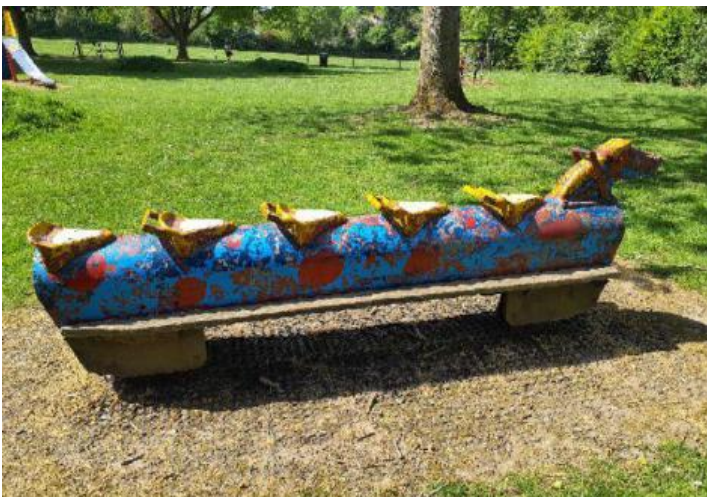
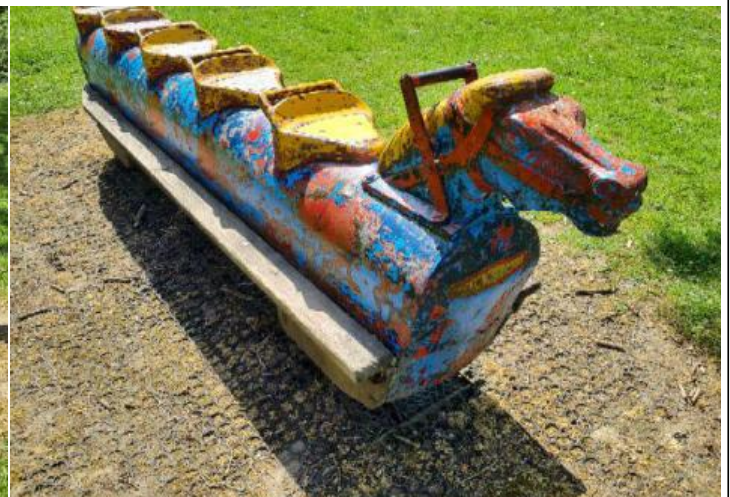
Item: Rocking Equipment - Rocking Horse
Manufacturer: Wicksteed Playgrounds

Risk Level: L - Low Risk
Surface: Grass Matrix Tiles

Finding: The paint is flaking off the metalwork

Action: Rub down and re-paint

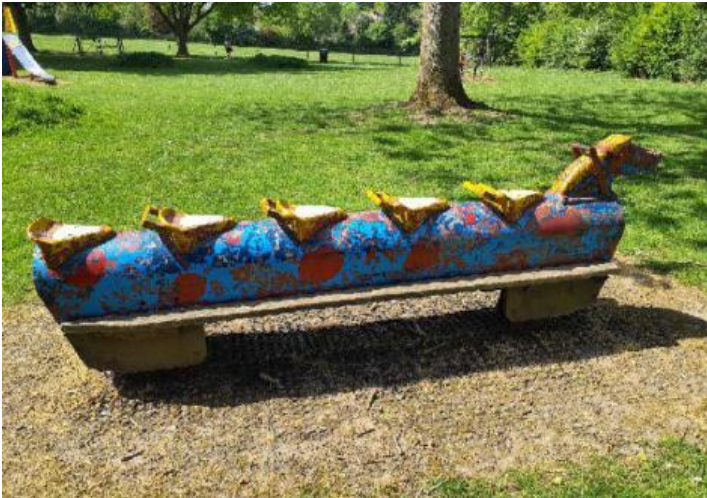
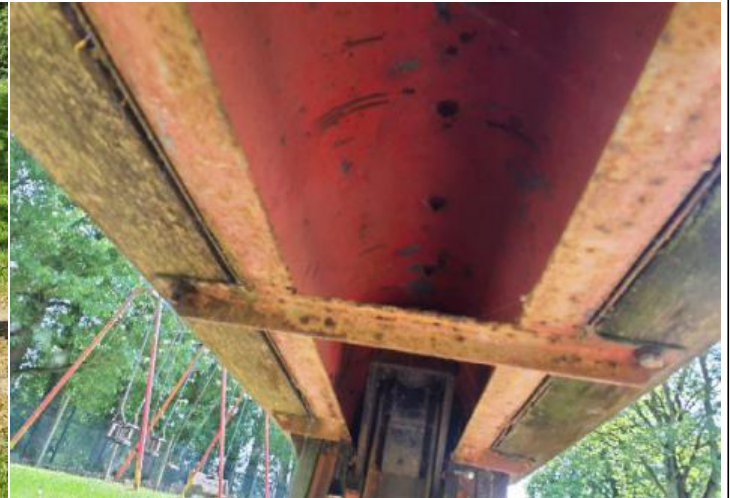
Item: Rocking Equipment - Rocking Horse
Manufacturer: Wicksteed Playgrounds

Risk Level: V - Very Low Risk
Surface: Grass Matrix Tiles

Finding: There is no gaiter protection for accessible moving parts (possible shear trap) as recommended in BS EN 1176 Part 1; 4.2.6 Moving Parts

Action: Monitor - No action given the risk assessment

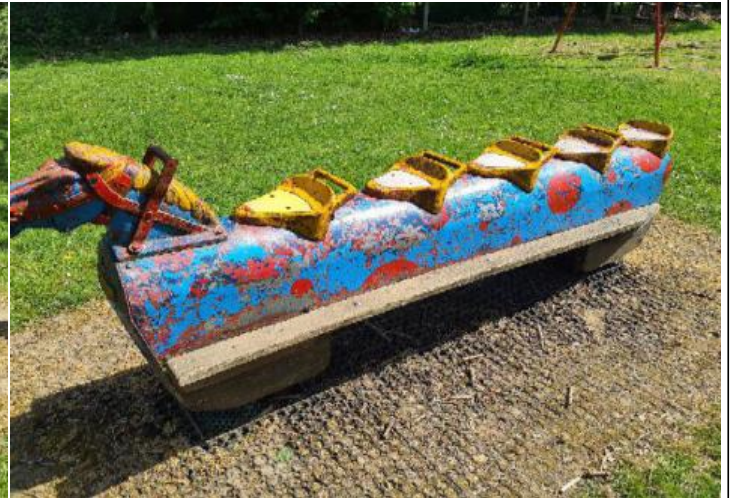
Item: Rocking Equipment - Rocking Horse
Manufacturer: Wicksteed Playgrounds

Risk Level: L - Low Risk
Surface: Grass Matrix Tiles

Finding: The item is noisy during operation

Action: Service the item in accordance with the manufacturers recommendations

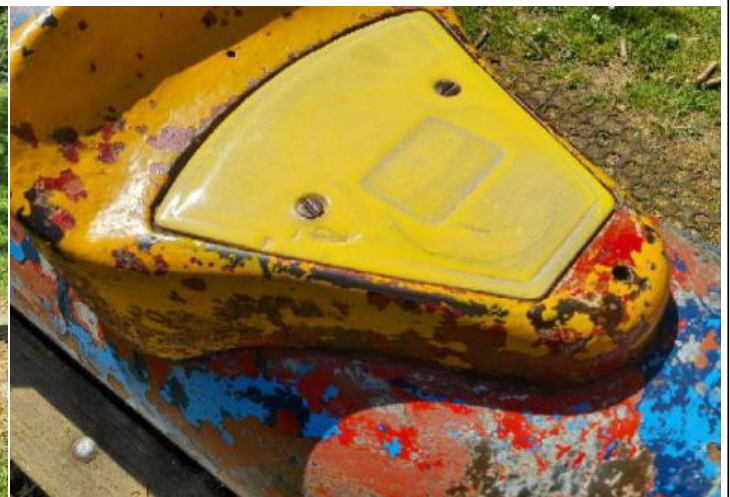
Item: Rocking Equipment - Rocking Horse
Manufacturer: Wicksteed Playgrounds

Risk Level: L - Low Risk
Surface: Grass Matrix Tiles

Finding: The seat has minor damage or wear

Action: Monitor for any further deterioration and replace as required

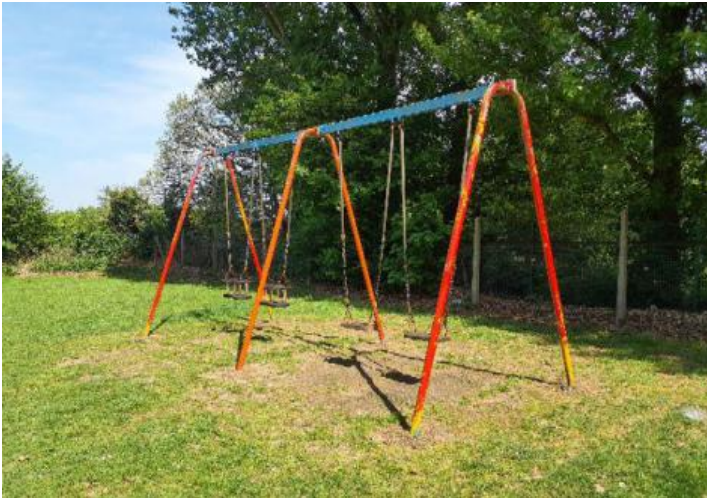
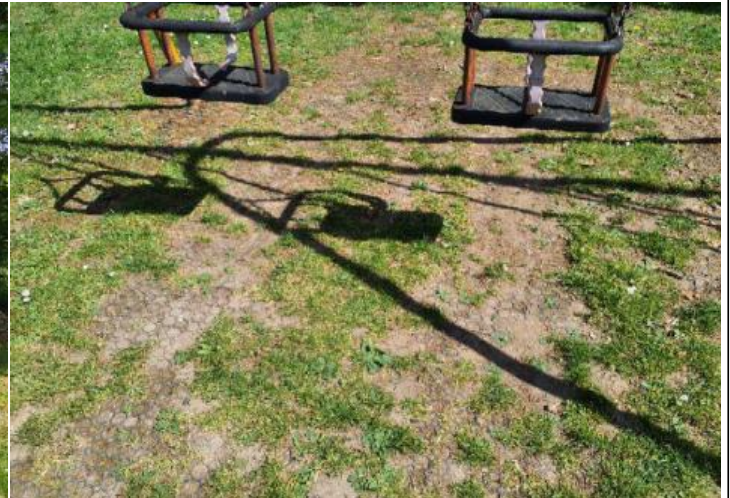
Item: Swings - 2 Bay (2 Flat, 2 Cradle)
Manufacturer: Hags

Risk Level: L - Low Risk
Surface: Grass Matrix Tiles

Finding: The grass mats are silted up and the soil is compacted; this may have an effect on the impact absorbing properties of the surface. Consideration should be given to HIC testing the surface to verify impact attenuating properties (<https://playinspections.co.uk/inspection-services/safety-surface-testing/>)

Action: Contact our office for a quotation for this service

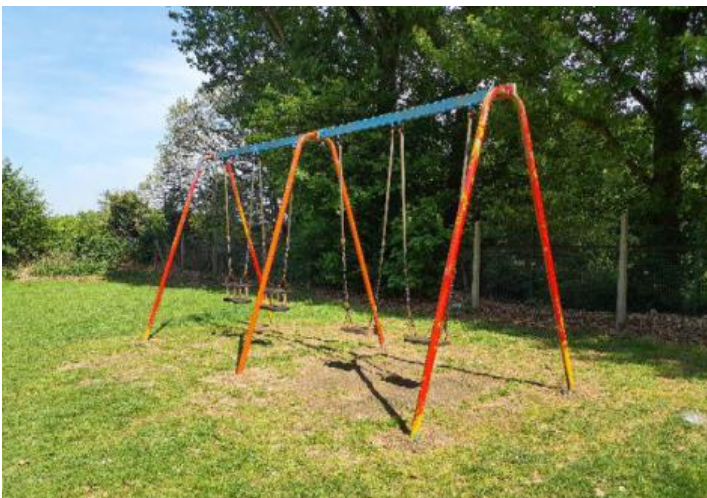
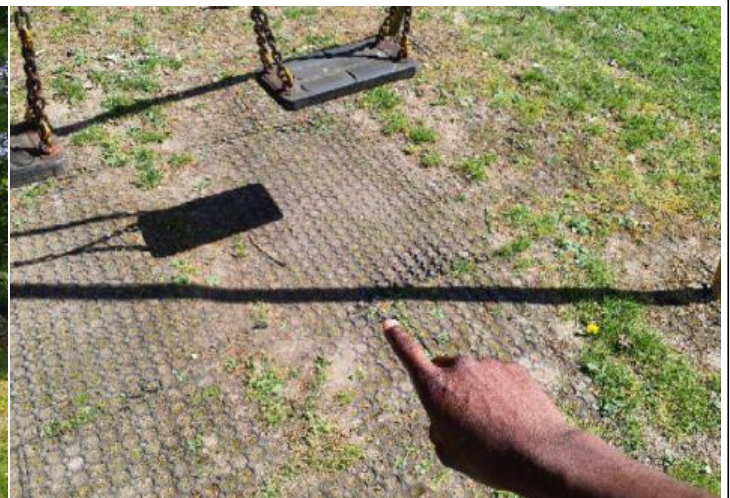
Item: Swings - 2 Bay (2 Flat, 2 Cradle)
Manufacturer: Hags

Risk Level: V - Very Low Risk
Surface: Grass Matrix Tiles

Finding: There is some minor damage to the surface

Action: Monitor for any further deterioration and repair as required

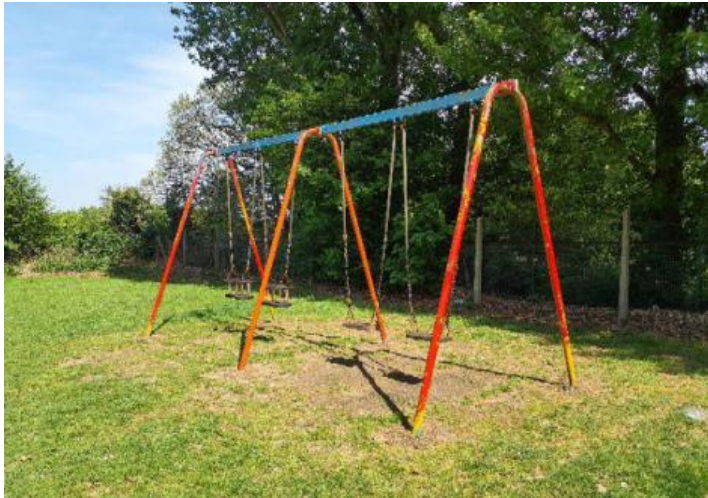
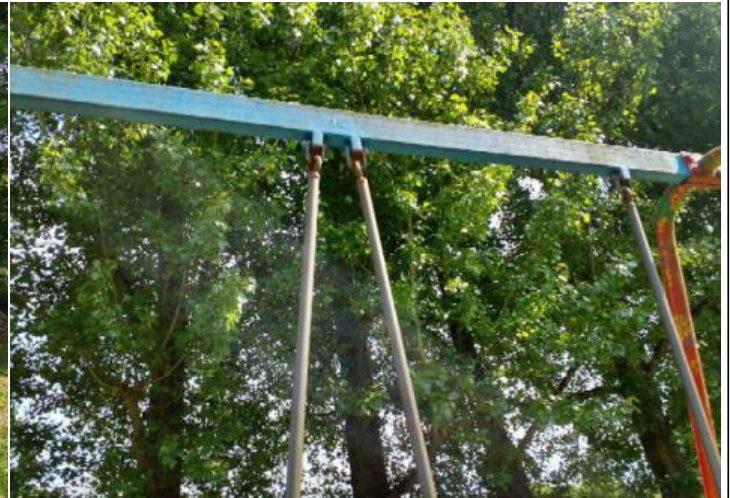
Item: Swings - 2 Bay (2 Flat, 2 Cradle)
Manufacturer: Hags

Risk Level: L - Low Risk
Surface: Grass Matrix Tiles

Finding: There is some wear to the shackles

Action: Monitor for any further deterioration and replace when 40% worn

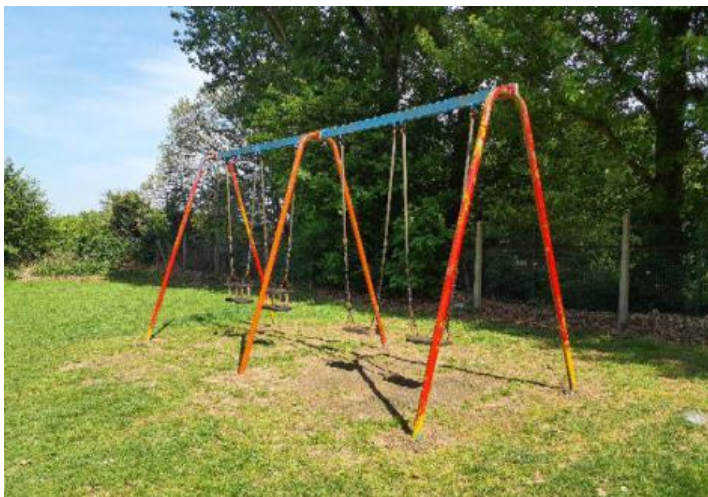
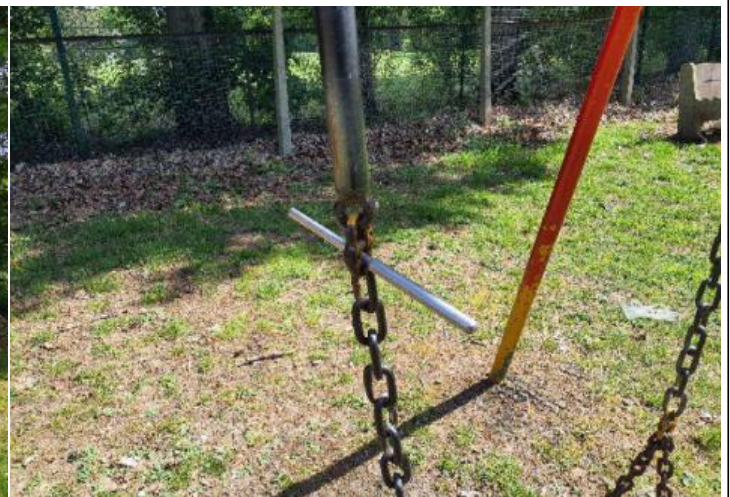
Item: Swings - 2 Bay (2 Flat, 2 Cradle)
Manufacturer: Hags

Risk Level: V - Very Low Risk
Surface: Grass Matrix Tiles

Finding: The connecting links are in excess of 8.6mm and less than 12mm and fail the requirements of BS EN 1176 Part 1; clause 4.2.13, Chains

Action: Monitor - No action given the risk assessment
