ST STEPHEN PARISH COUNCIL

You are summoned to the Fixed Assets Committee meeting

AGENDA

| 2526/AC/013 | To receive Annual Play Inspection Reports. Reports attached. |

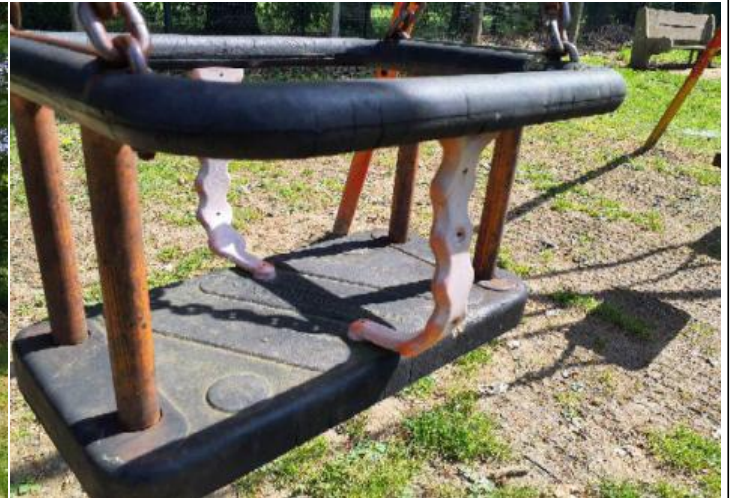
Finding: The seat has minor damage or wear

Action: Monitor for any further deterioration and replace as required

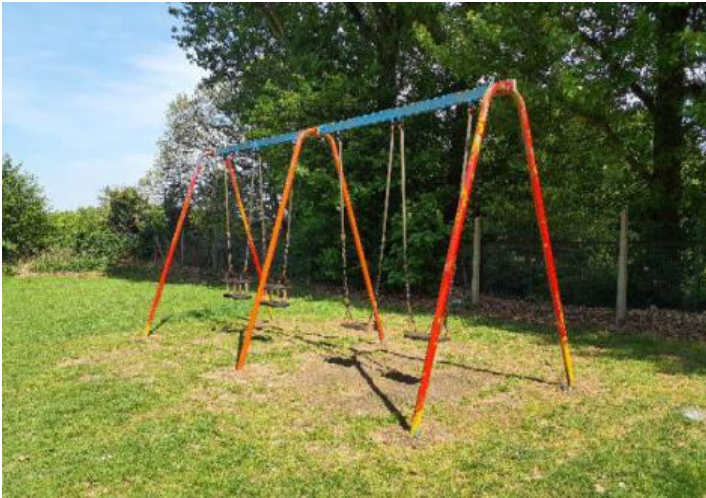
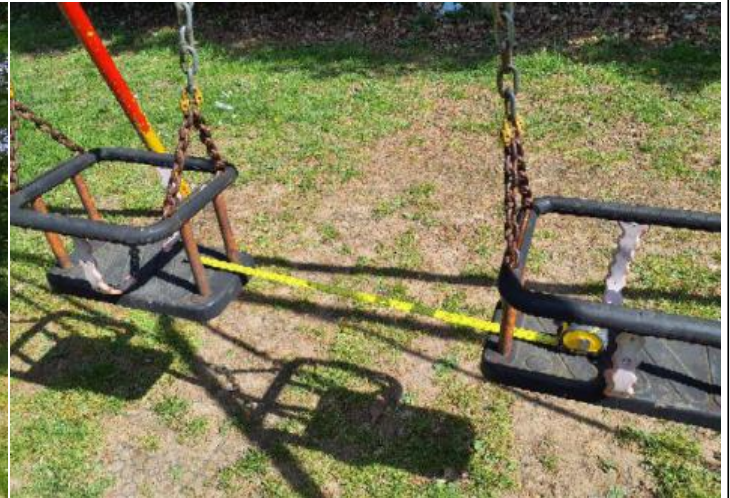
Finding: The seats are too close to each other as defined in BS EN 1176 Part 2; this is a low risk failure and no remedial action is required
Action: Monitor - No action given the risk assessment

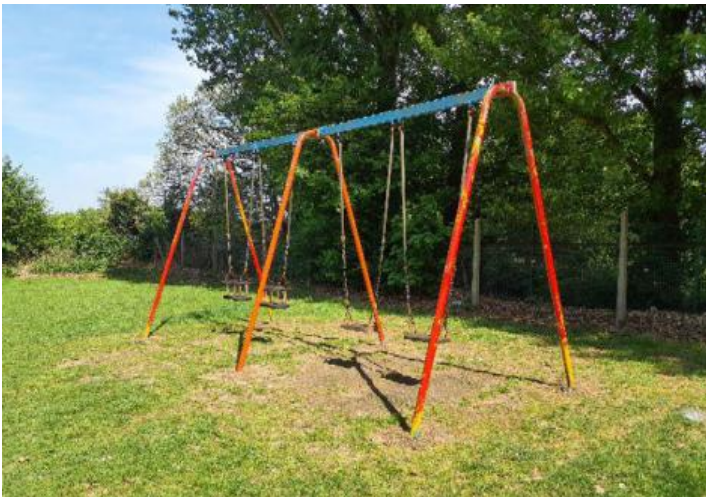
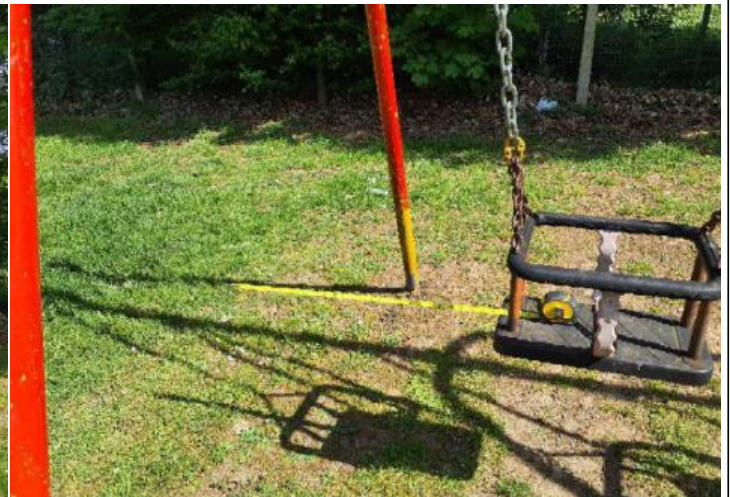
Finding: The seat/s is / are too close to the frame as defined in BS EN 1176 Part 2
Action: Monitor - No action given the risk assessment

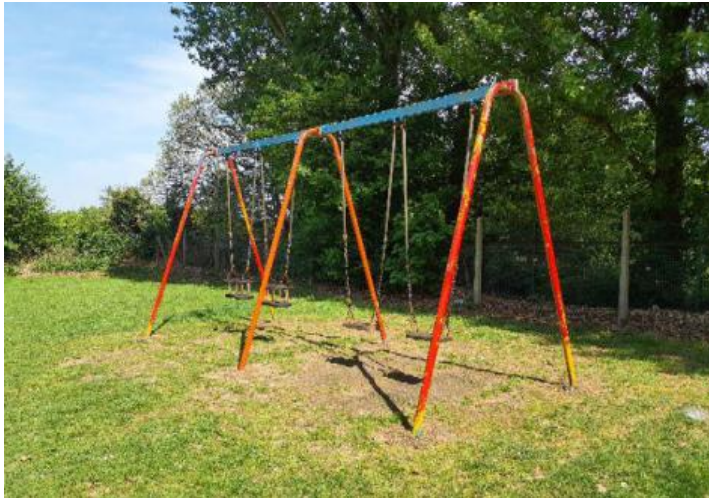
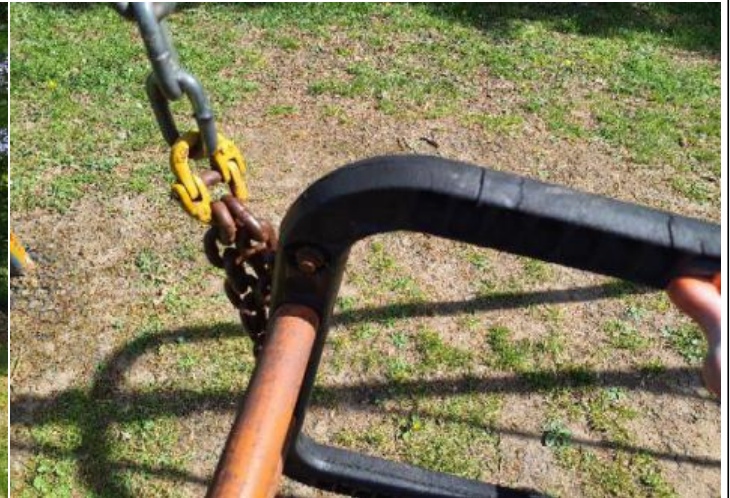
Finding: There are caps missing from the underside of the seats

Action: Replace missing caps under the seats

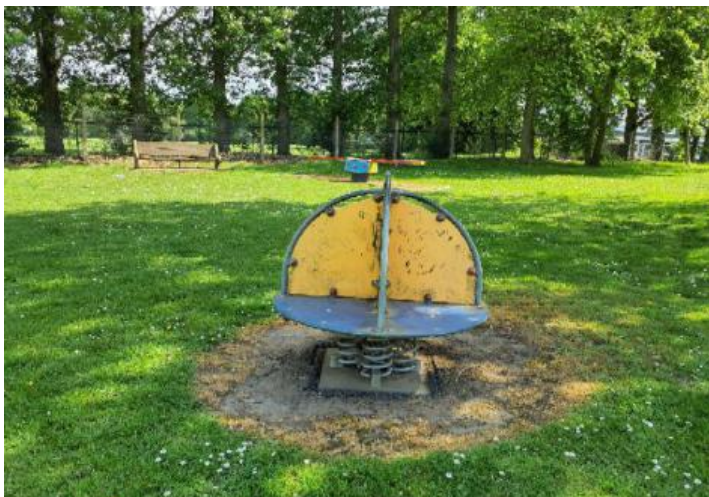
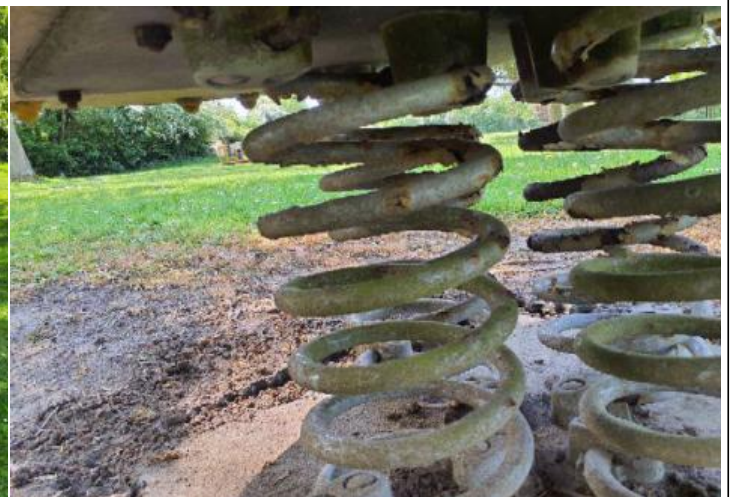
Finding: The paintwork on the spring has been damaged or worn exposing the metal underneath which is rusting

Action: Treat any rusting components and repaint

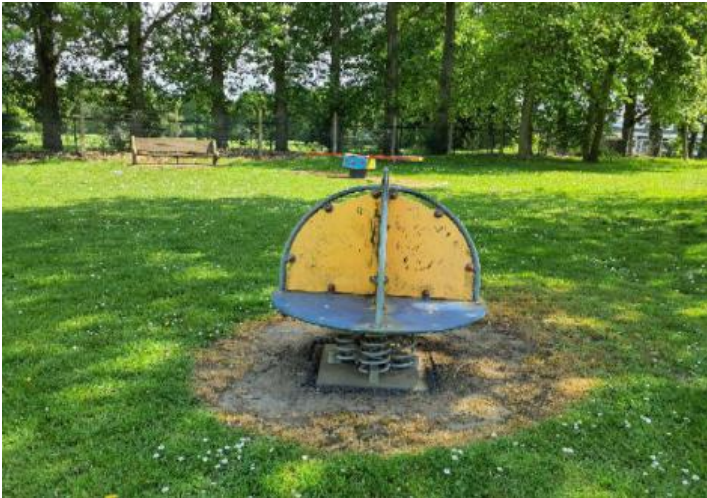
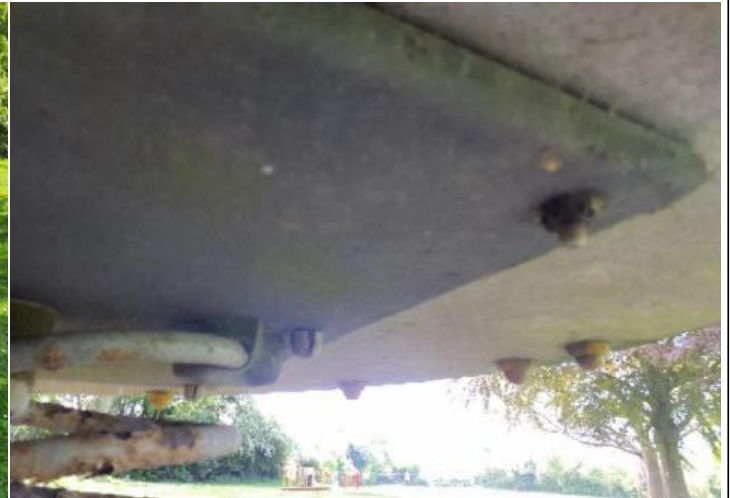
Finding: There is/are bolt cap covers missing or damaged on the item

Action: Replace missing or damaged bolt cap covers

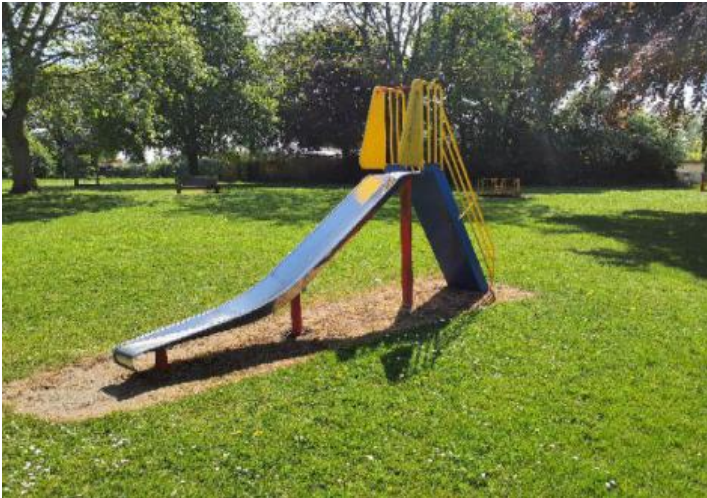
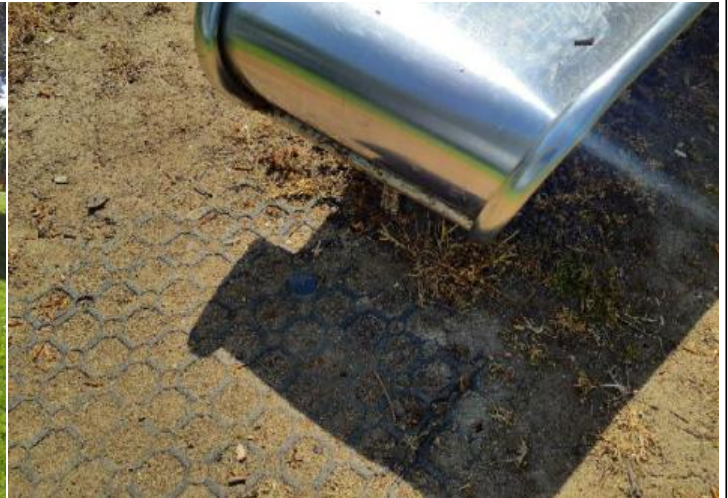
Finding: Hard fixing pins have been installed in the grass mat tiles within the impact area of the equipment. Grass mat pins should only be installed at the perimeter of the tiles, and outside of any equipment impact areas. NOTE - where grass mat wear pads have been provided and the impact area includes surrounding surfaces, the grass mats should be tucked into the turf, and not pinned

Action: Remove pins from impact areas

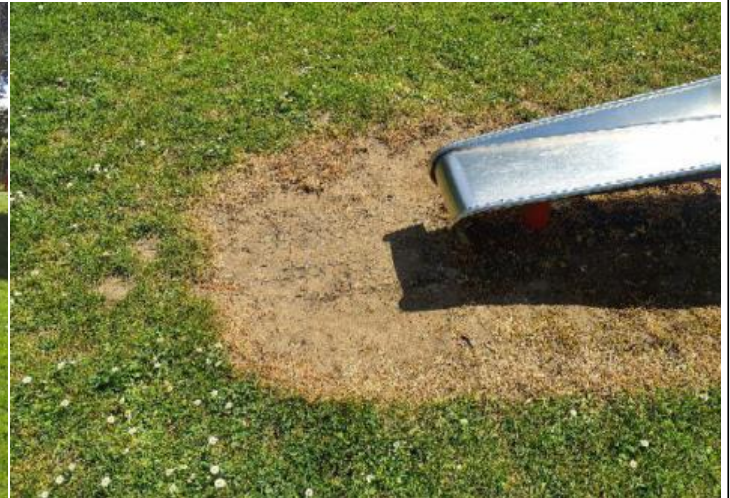
Finding: The grass mats are silted up, the soil is compacted and the area will become very slippery when the soil is wet. **Action:** Reinststate as required

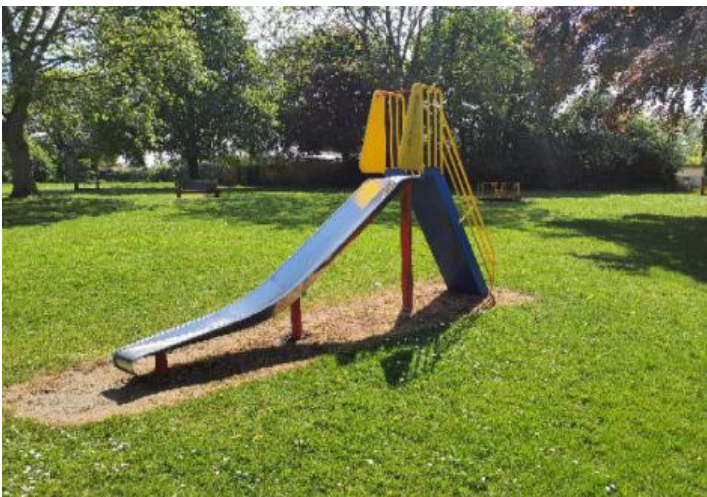
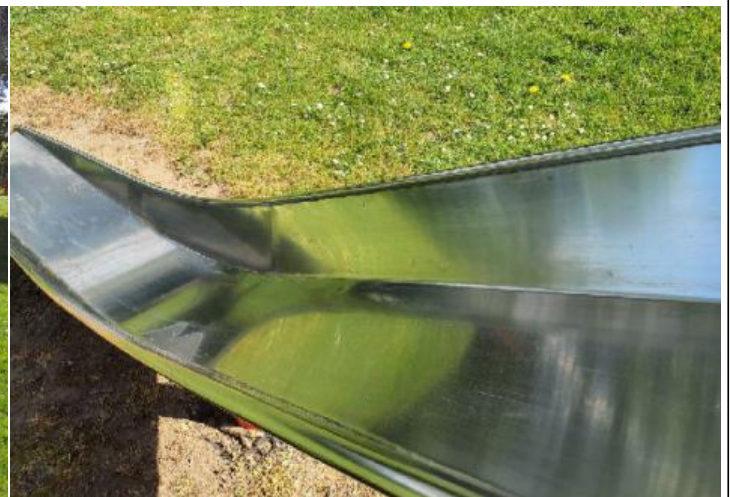
Finding: There are a number of dents in the slide surface **Action:** Monitor for any further deterioration and repair as required

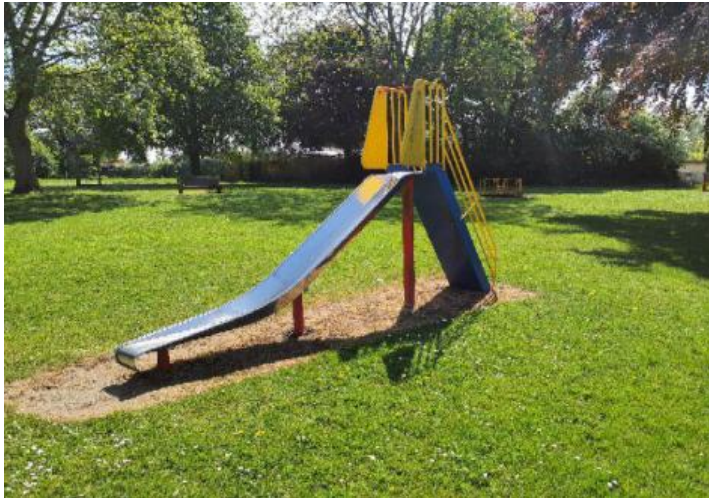
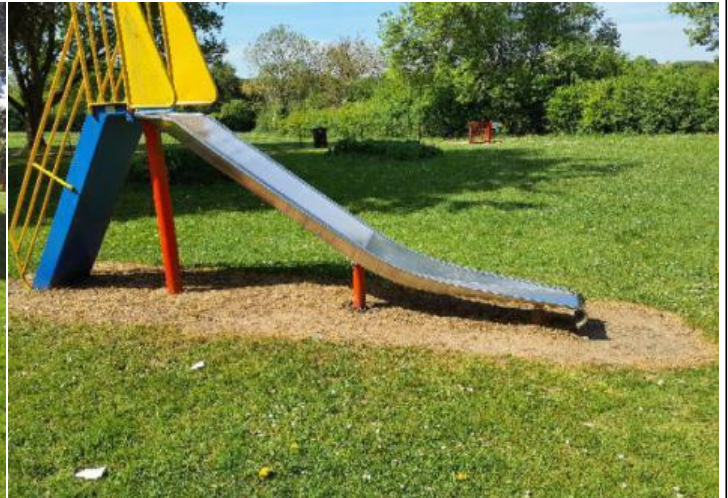
Finding: The slide is predominately south facing and will catch the majority of the sun's heat during the day. Slide surfaces can become very warm during periods of sustained sunny weather

Action: Monitor - No action given the risk assessment

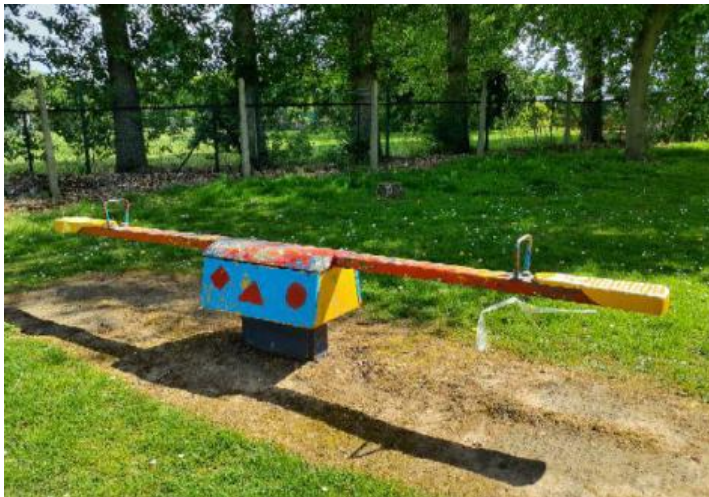
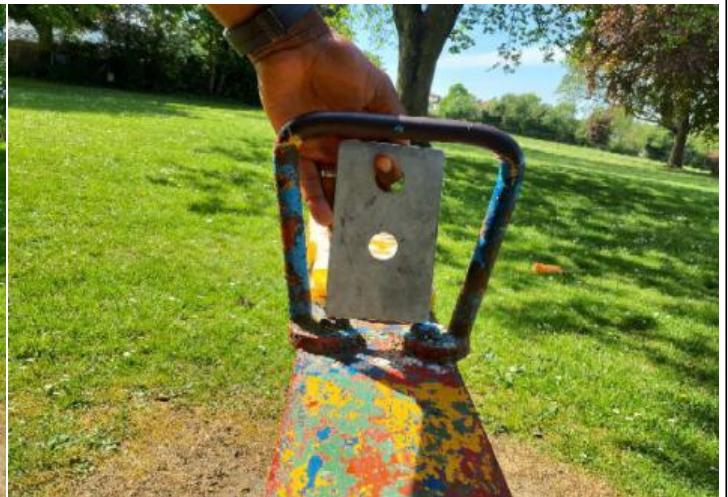
Finding: The item fails to meet the requirements of BS EN 1176 Part 1 4.2.7.2 for head and neck entrapment in the handles

Action: Monitor - No action given the risk assessment

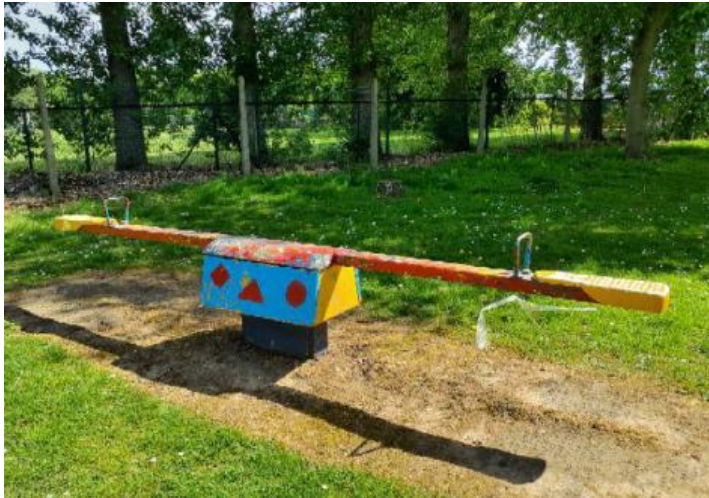
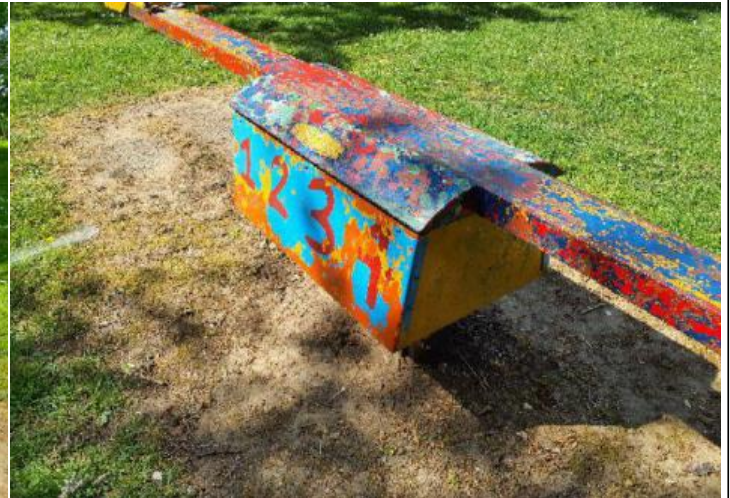
Finding: There is no gaiter protection for accessible moving parts (possible shear trap) as recommended in BS EN 1176 Part 1; 4.2.6 Moving Parts

Action: Monitor - No action given the risk assessment

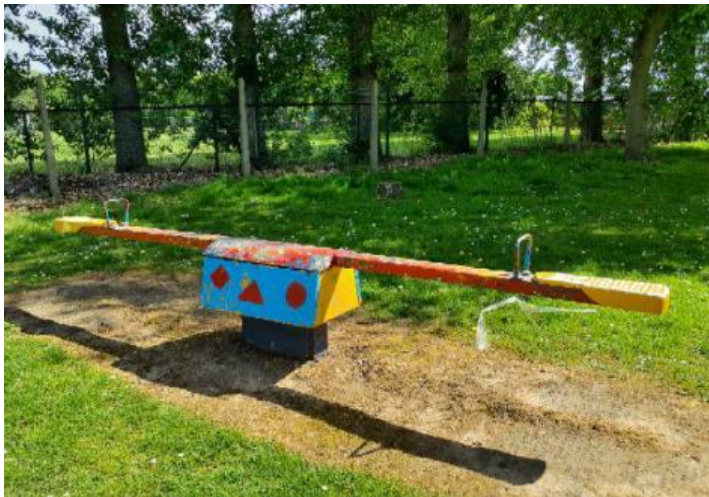
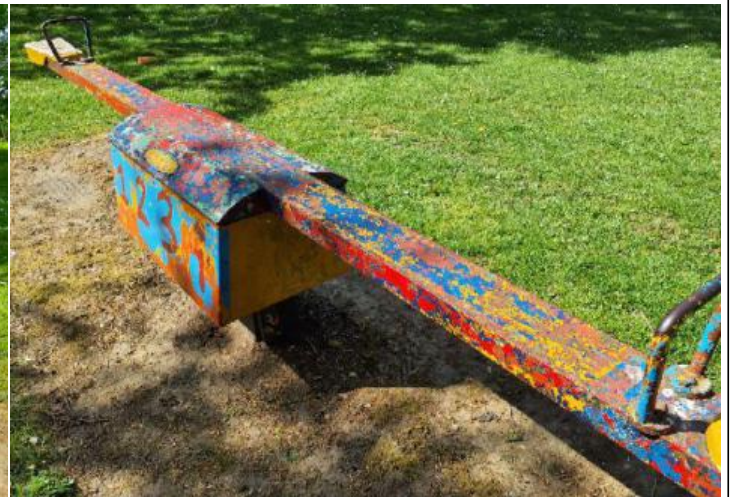
Finding: The paint is flaking off the metalwork

Action: Rub down and re-paint

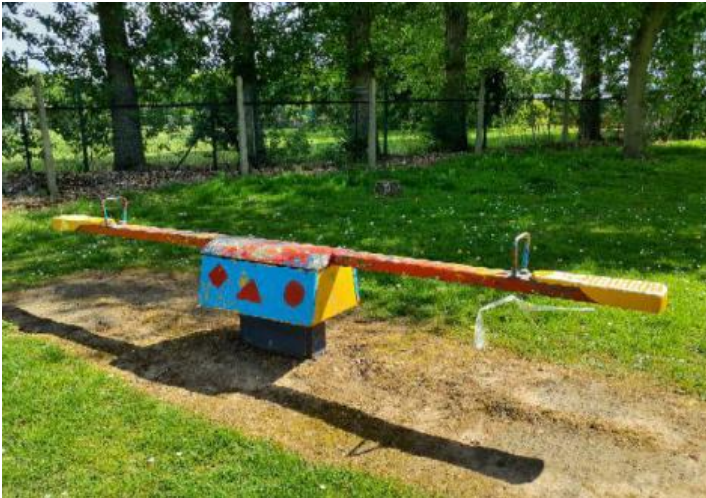
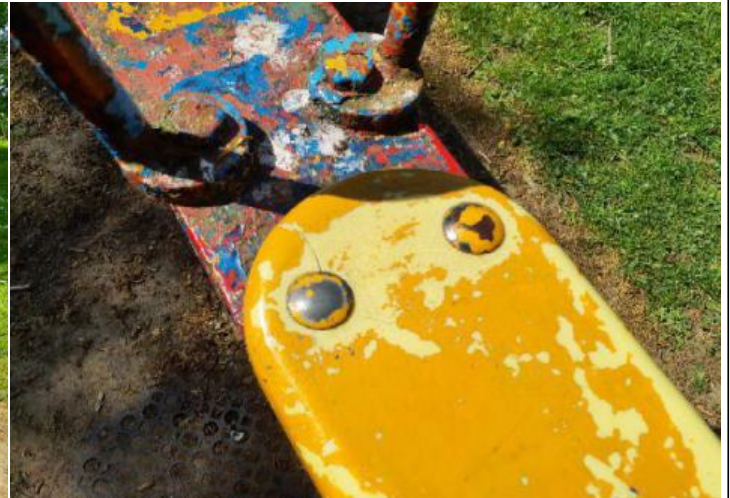
Finding: The seat has minor damage or wear

Action: Monitor for any further deterioration and replace as required

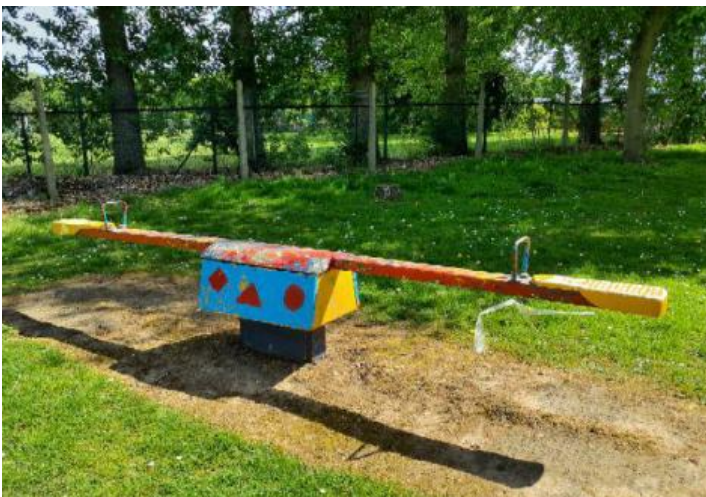
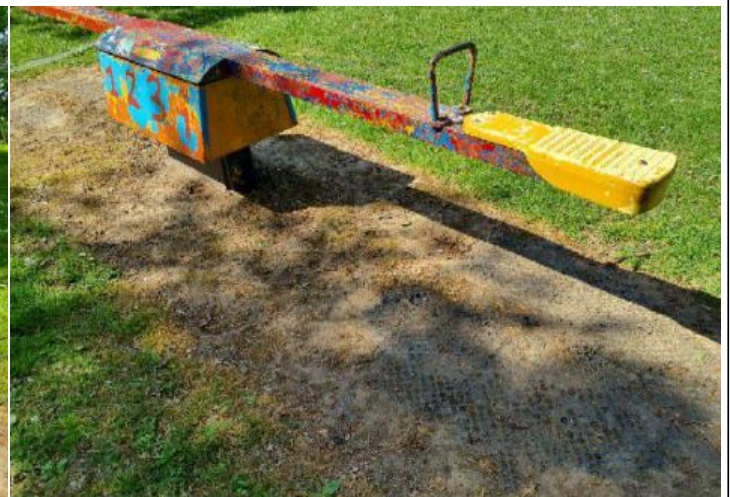
Finding: The grass mats are silted up and the soil is compacted; this may have an effect on the impact absorbing properties of the surface. Consideration should be given to HIC testing the surface to verify impact attenuating properties (<https://playinspections.co.uk/inspection-services/safety-surface-testing/>)

Action: Contact our office for a quotation for this service

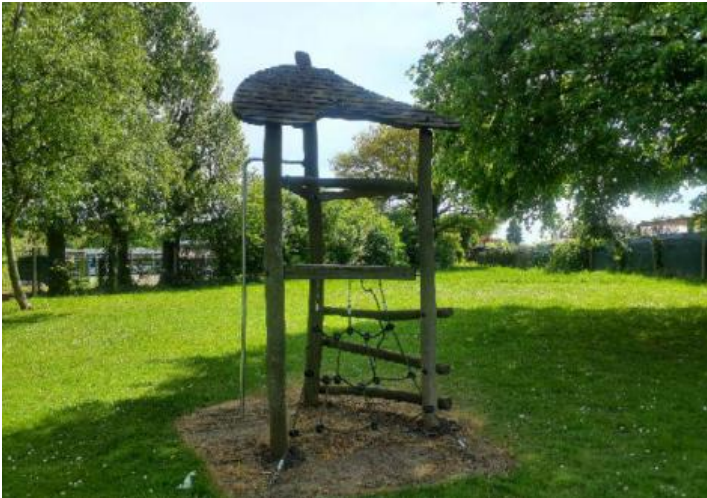
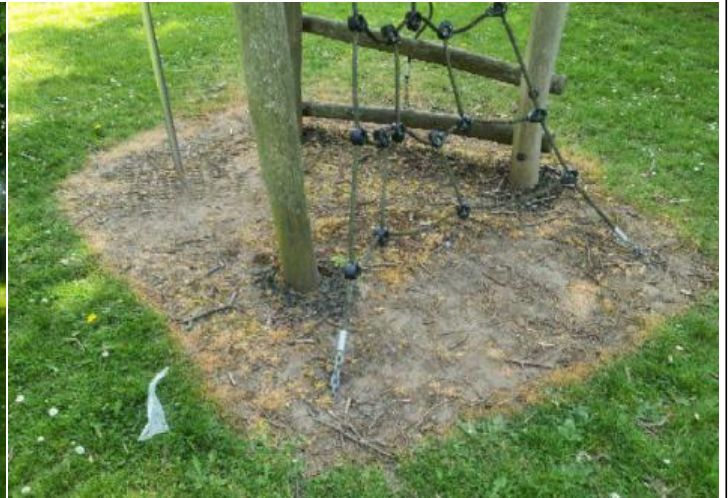
Finding: The grass mats are silted up and the soil is compacted; this may have an effect on the impact absorbing properties of the surface. Consideration should be given to HIC testing the surface to verify impact attenuating properties (<https://playinspections.co.uk/inspection-services/safety-surface-testing/>)

Action: Contact our office for a quotation for this service

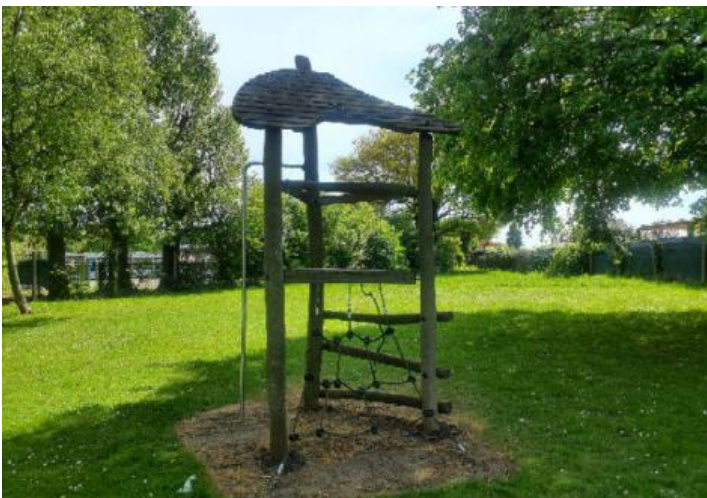
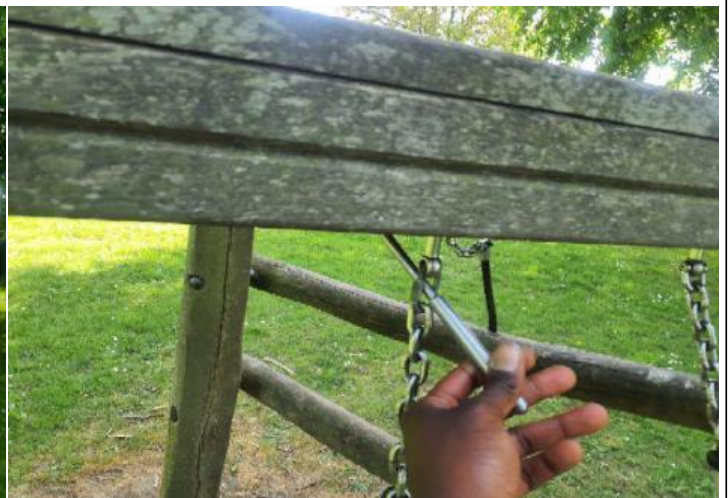
Finding: The chain openings are in excess of 8.6mm and do not meet the recommendations of BS EN 1176 Part 1

Action: Monitor - No action given the risk assessment

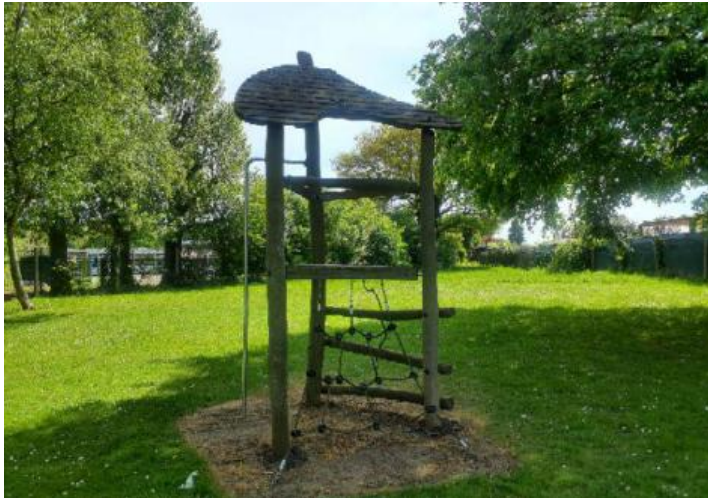
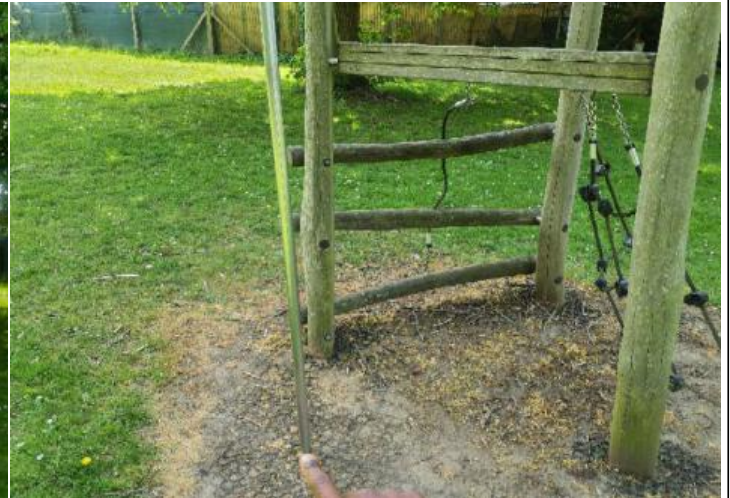
Finding: The item is slightly loose in its foundations

Action: Monitor for any further deterioration and repair as required

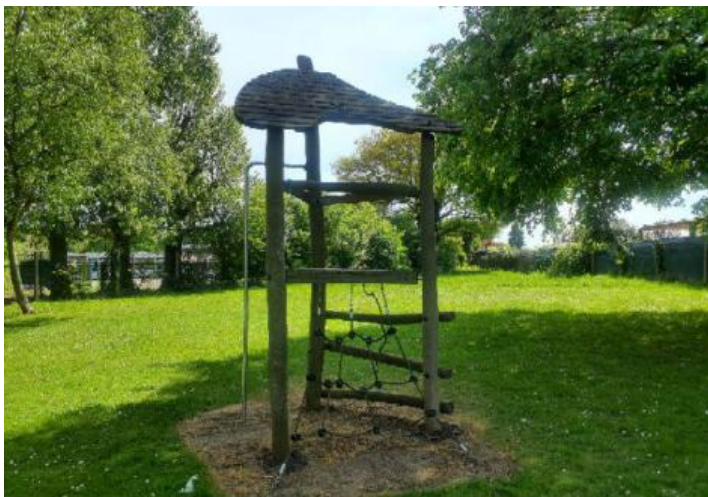
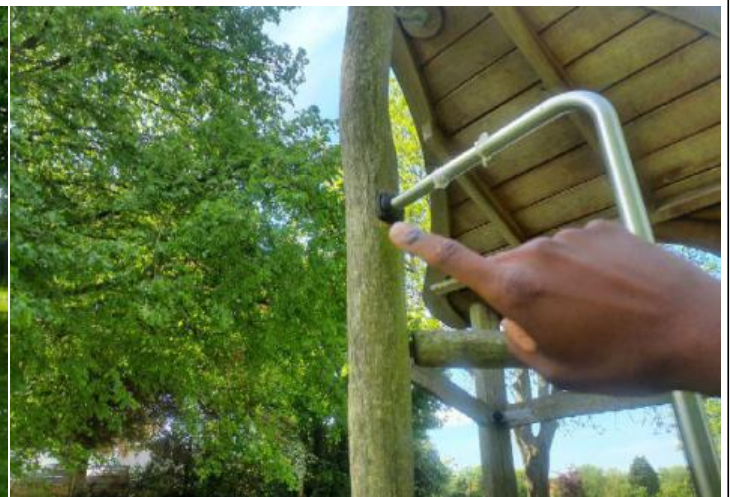
Finding: A number of fixing(s) have worked loose

Action: Secure all loose fixings

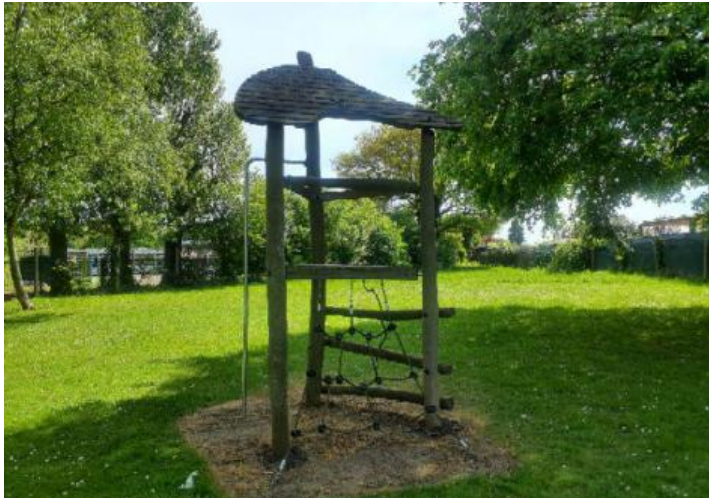
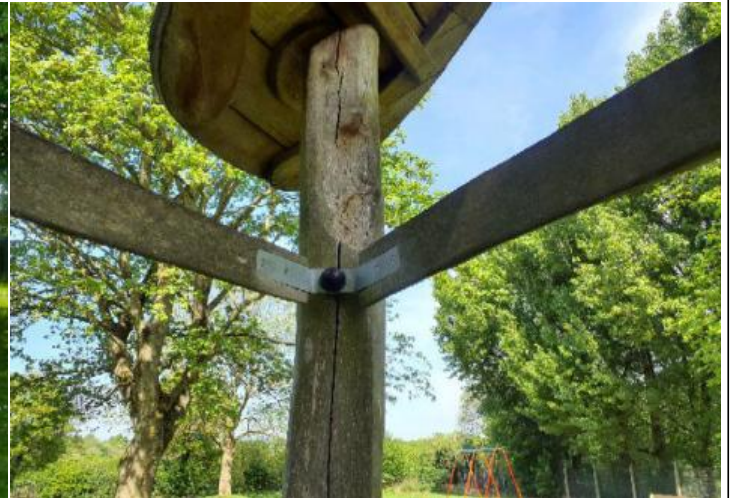
Finding: There are splits running through the timber that cross through or near fixing points and may cause instability in the future

Action: Monitor stability of fixings

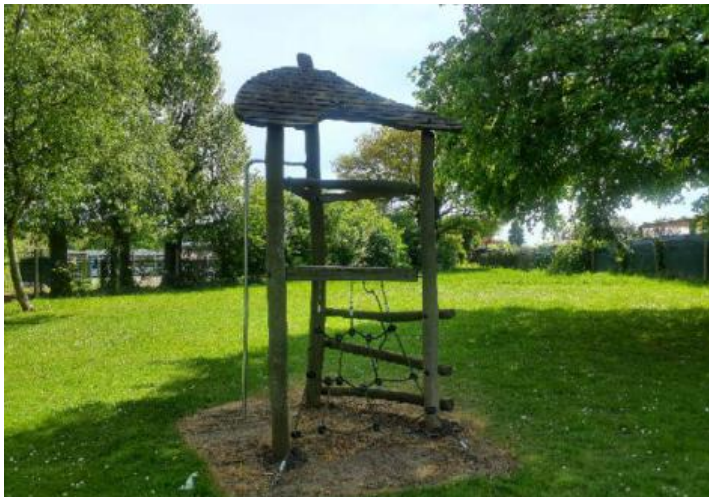
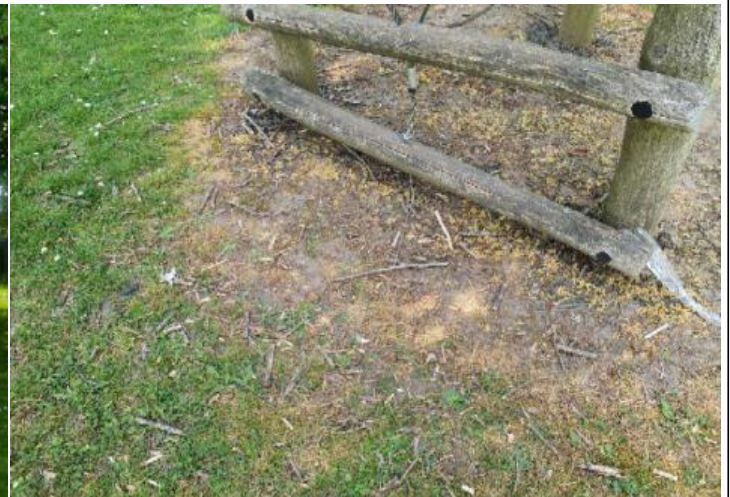
Finding: There is some tree debris on the surfacing

Action: Remove and maintain

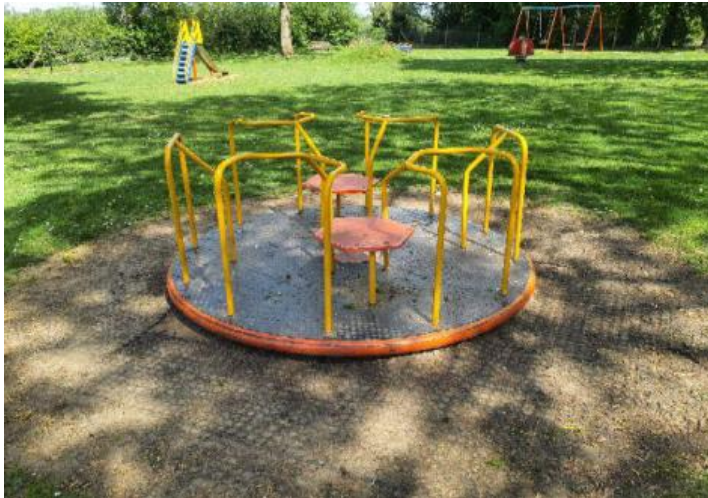
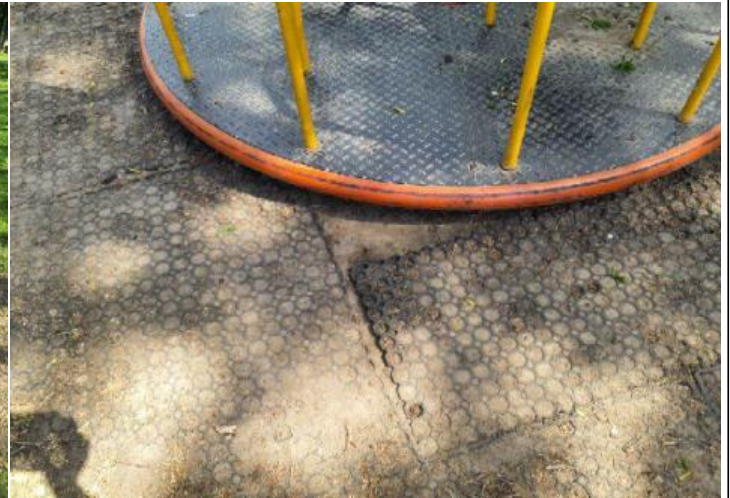
Item: Rotor Play - Roundabout
Manufacturer: Wicksteed Playgrounds

Finding: There is moderate damage to the surface

Action: Repair the damaged areas of surfacing

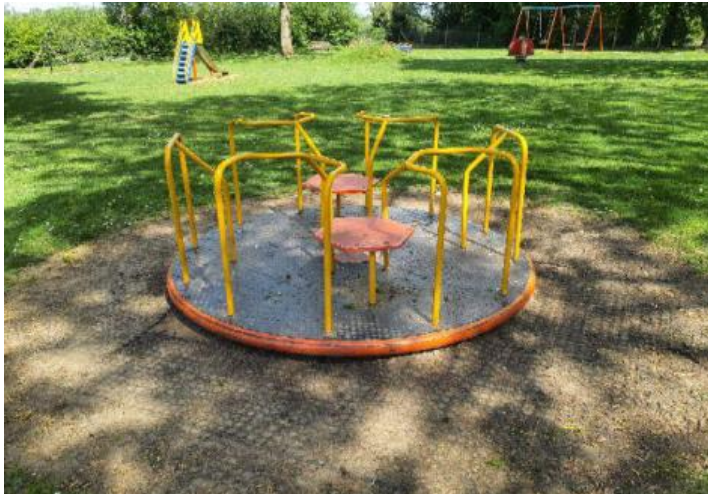
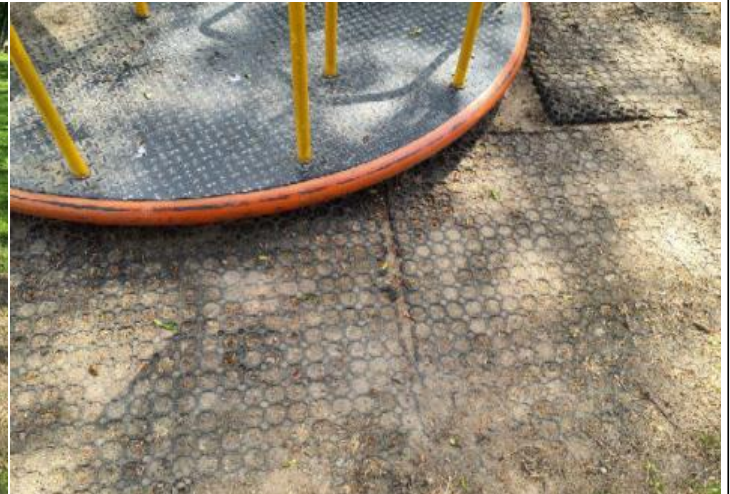
Item: Rotor Play - Roundabout
Manufacturer: Wicksteed Playgrounds

Finding: There are gaps opening between the grass mat tiles

Action: Provide additional ties or secure / reinstate surface tiles

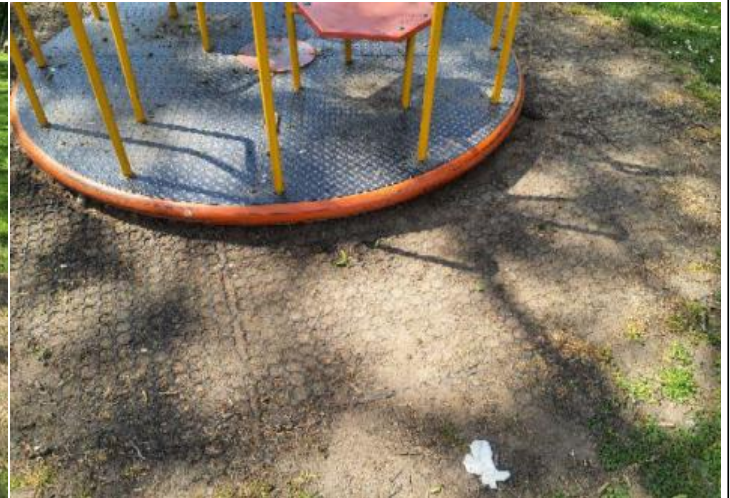
Item: Rotor Play - Roundabout
Manufacturer: Wicksteed Playgrounds

Finding: The grass mats are silted up and the soil is compacted; this may have an effect on the impact absorbing properties of the surface. Consideration should be given to HIC testing the surface to verify impact attenuating properties (<https://playinspections.co.uk/inspection-services/safety-surface-testing/>)

Action: Contact our office for a quotation for this service

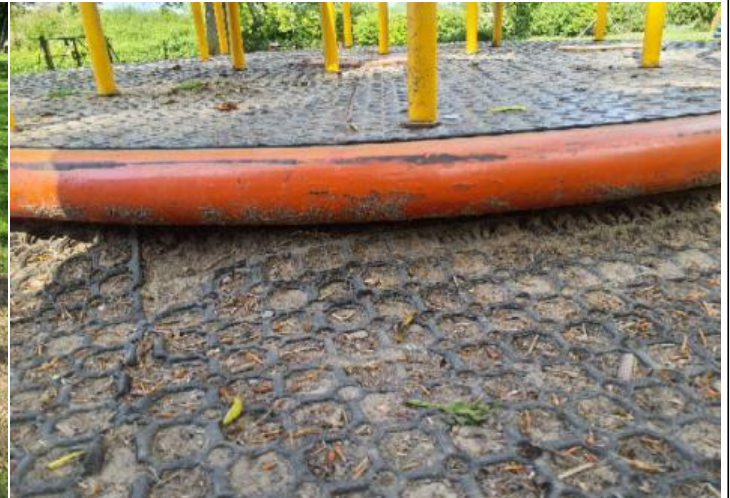
Item: Rotor Play - Roundabout
Manufacturer: Wicksteed Playgrounds

Finding: The distance between the underside of the roundabout platform and the playing surface is less than 60mm and contravenes the requirements of BS EN 1176 Part 5 which requires that the distance be maintained between 60mm-110mm for the entire circumference of the roundabout

Action: Monitor - No action given the risk assessment

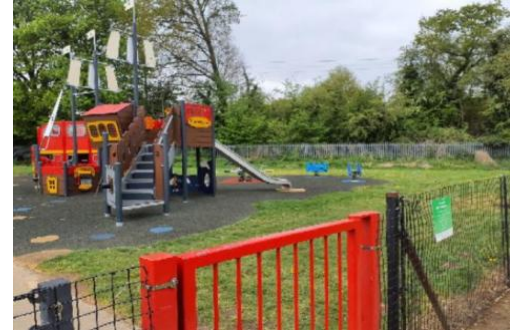
Item: Site General
Manufacturer: Owner/Operator
Surface Type: N/A
Item Quantity: 1
Equipment Compliance: N/A
Surface Area Compliance: N/A

There are a number of molehills within the area and these may present unforeseen hazards for users - Remove moles by appropriate means, reinstate surfaces to level and maintain the area

There are trip hazards at the edges of the surface - Remove trip hazard

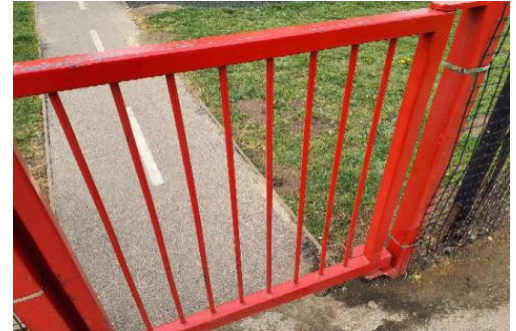
Item: Gate - Self Closing
Manufacturer: Not Identified
Surface Type: Grass
Item Quantity: 2
Equipment Compliance: N/A
Surface Area Compliance: N/A

There are trip hazards at the edges of the surface - Remove trip hazard

The bitumen surface is worn or damaged - Repair the bitumen to provide a uniform surface

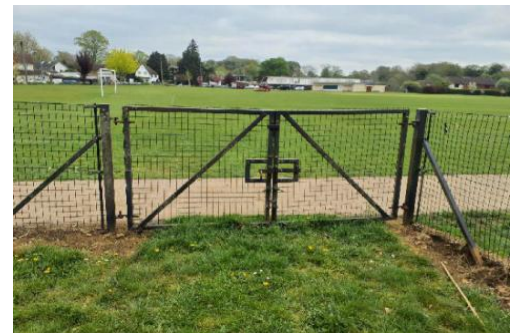
Item: Gate - Maintenance
Manufacturer: Not Identified
Surface Type: Grass
Item Quantity: 1
Equipment Compliance: N/A
Surface Area Compliance: N/A

The maintenance gate was correctly padlocked at the time of inspection, however this means that the inspector was unable to fully assess the gate - Ensure that there are 12mm gaps throughout the full range of motion on gate/s and between leaves where relevant

The paintwork on this item has been damaged or worn exposing the metal underneath which is rusting / corroding - Treat affected areas and repaint

Parts of the steel on this item have corroded excessively and the metal has perforated in places - Ensure all affected areas are treated and repaired

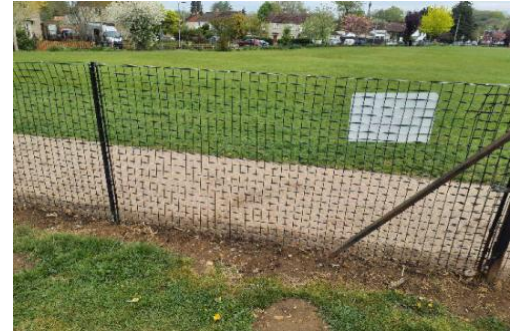
Item: Fence - Steel Mesh
Manufacturer: Not Identified
Surface Type: Grass
Item Quantity: 1
Equipment Compliance: N/A
Surface Area Compliance: N/A

The paintwork on this item has been damaged or worn exposing the metal underneath which is rusting / corroding - Treat affected areas and repaint

There are a number of loose posts around the fence - Monitor for any further deterioration and reset as required

There is some damage to the fence sections - Monitor for any further deterioration and repair as required

Parts of the steel on this item have corroded excessively and the metal has perforated in places - Ensure all affected areas are treated and repaired

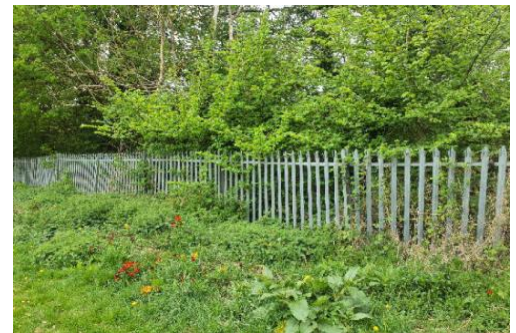
Item: Fence
Manufacturer: Not Identified
Surface Type: Grass
Item Quantity: 1
Equipment Compliance: N/A
Surface Area Compliance: N/A

There are a number of loose posts around the fence - Monitor for any further deterioration and reset as required

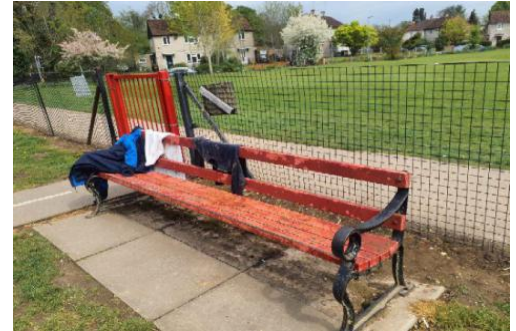
Item: Bench
Manufacturer: Not Identified
Surface Type: Paving Slabs
Item Quantity: 1
Equipment Compliance: N/A
Surface Area Compliance: N/A

The paint is flaking off the metalwork - Rub down and re-paint

The paintwork on this item has been damaged or worn exposing the metal underneath which is rusting / corroding - Treat affected areas and repaint

There is or are fixings missing on the item - Replace all missing fixings

There are trip hazards at the edges of the surface - Remove trip hazard

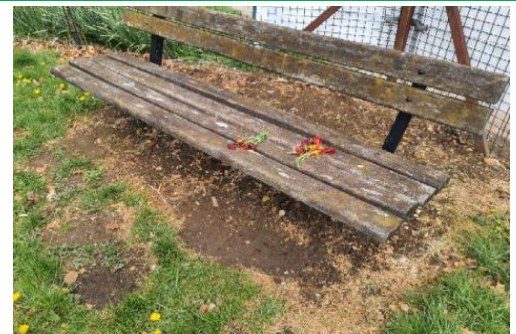
Item: Bench
Manufacturer: Not Identified
Surface Type: Grass
Item Quantity: 2
Equipment Compliance: N/A
Surface Area Compliance: N/A

There is algae or moss on the surface of the equipment - Clean and treat appropriately

There is some evidence of rot in the timber - Monitor for any further deterioration and replace as required

The paintwork on this item has been damaged or worn exposing the metal underneath which is rusting / corroding - Treat affected areas and repaint

The item is slightly loose in its foundations - Monitor for any further deterioration and repair as required

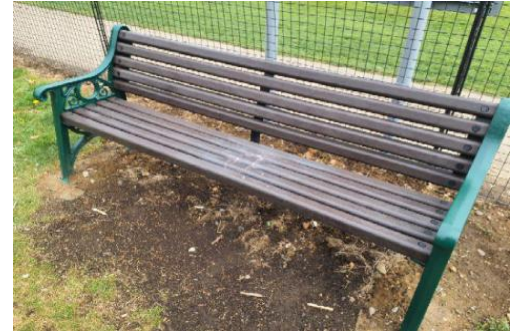
Item: Bench
Manufacturer: Not Identified
Surface Type: Grass
Item Quantity: 1
Equipment Compliance: N/A
Surface Area Compliance: N/A

The surface has eroded and the foundations are exposed - Reinstate surrounding surfaces to cover the foundations

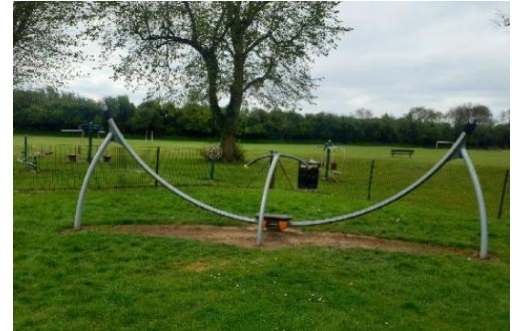
Item: Skate Unit
Manufacturer: Kompan Ltd
Surface Type: Grass Matrix Tiles
Item Quantity: 1
Equipment Compliance: Yes
Surface Area Compliance: Yes

Fixing Pins have been installed in the impact areas of the grass mats - Remove pins from impact areas

The surface has subsided in some areas - Monitor for any further deterioration and repair as required

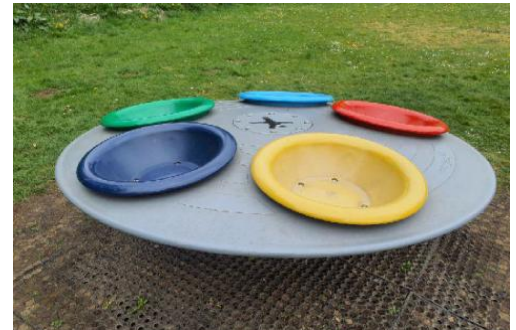
Item: Roundabout
Manufacturer: Kompan Ltd
Surface Type: Grass Matrix Tiles
Item Quantity: 1
Equipment Compliance: Yes
Surface Area Compliance: Yes
Life Expectancy: >10 Years
Total Findings: 1

The grass mats are silted up, the soil is compacted and the area will become very slippery when the soil is wet. - Reinstate as required

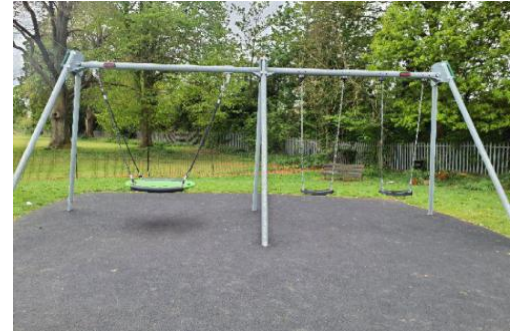
Item: 2 Bay 2 Flat 1 Basket Seat
Manufacturer: Kompan Ltd
Surface Type: Wet Pour
Item Quantity: 1
Equipment Compliance: Yes
Surface Area Compliance: Yes

There is some notable evidence of chain wear - Monitor for any further deterioration and replace when 40% worn

The bushes are showing signs of wear - Monitor for any further deterioration and replace as required

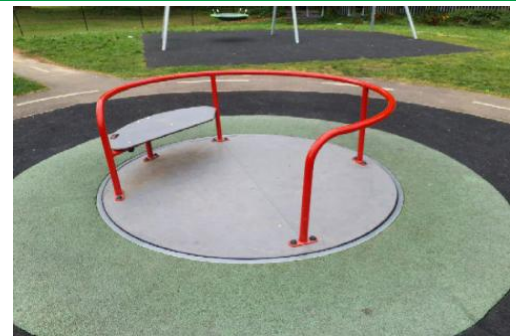
Item: Inclusive Roundabout
Manufacturer: Kompan Ltd
Surface Type: Wet Pour
Item Quantity: 1
Equipment Compliance: Yes
Surface Area Compliance: Yes

There are trip hazards at the edges of the surface - Remove trip hazard

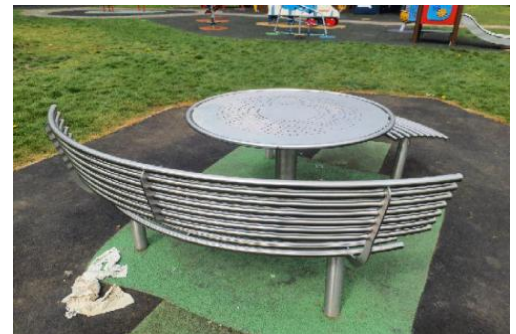
Item: Picnic Table
Manufacturer: Not Identified
Surface Type: Wet Pour
Item Quantity: 1
Equipment Compliance: N/A
Surface Area Compliance: N/A

The surface has subsided in some areas - Monitor for any further deterioration and repair as required

There are significant gaps (over 30mm) between the surface and the edging or between the joints in the surface; these are large enough for a small foot to enter - Repair surfacing

The surface is lifting at the edges and creating trip points - Repair perimeter of surfacing to remove trip points

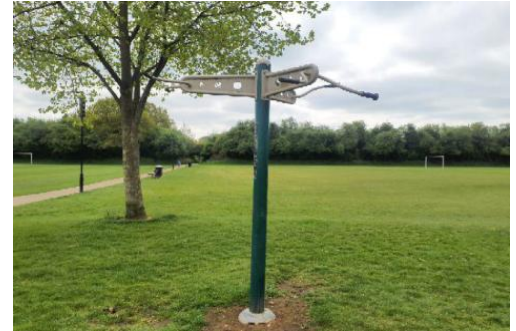
Item: Pull Up Station
Manufacturer: Fresh Air Fitness
Surface Type: Grass Matrix Tiles
Item Quantity: 1
Equipment Compliance: Yes
Surface Area Compliance: Yes
Life Expectancy: 5 -10 Years
Total Findings: 1

There is surface corrosion / rust present on the item - Consider treating the item

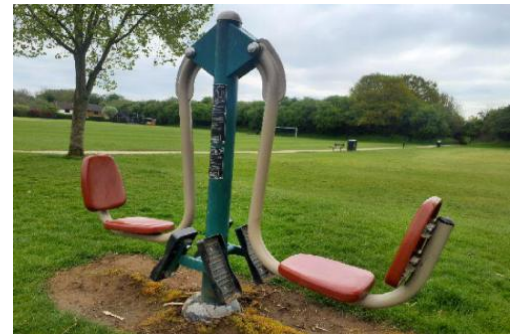
Item: Leg Press
Manufacturer: Fresh Air Fitness
Surface Type: Grass Matrix Tiles
Item Quantity: 1
Equipment Compliance: Yes
Surface Area Compliance: Yes
Life Expectancy: 5 -10 Years
Total Findings: 2

The surface has subsided in some areas - Monitor for any further deterioration and repair as required

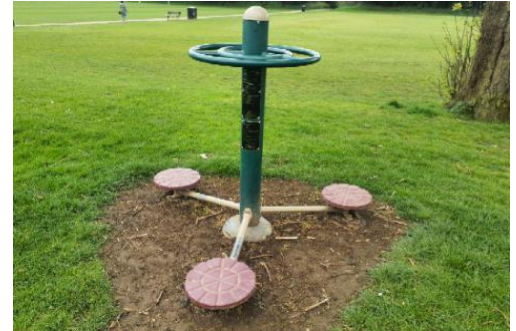
Item: Hip Twister
Manufacturer: Fresh Air Fitness
Surface Type: Grass Matrix Tiles
Item Quantity: 1
Equipment Compliance: No
Surface Area Compliance: Yes
Life Expectancy: 3 - 5 Years
Total Findings: 3

The rotating user station is not appropriately marked with a guideline of user direction and/or the original position as required by BS EN 16630 - Monitor - No action given the risk assessment

There is surface corrosion / rust present on the item - Consider treating the item

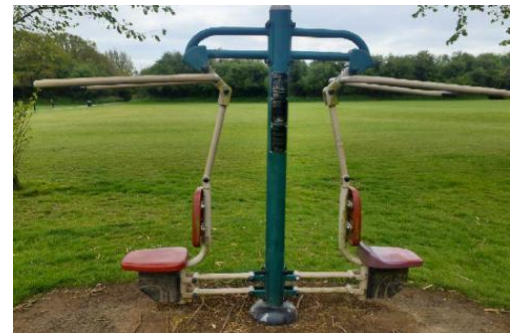
Item: Pull Down Challenger
Manufacturer: Fresh Air Fitness
Surface Type: Grass Matrix Tiles
Item Quantity: 1
Equipment Compliance: No
Surface Area Compliance: Yes
Life Expectancy: 5 -10 Years
Total Findings: 3

The distance between the underside of the item and the ground is less than the 60mm required by BS EN 16630 - Monitor - No remedial work recommended

There is/are bolt cap covers missing or damaged on the item - Replace missing or damaged bolt cap covers

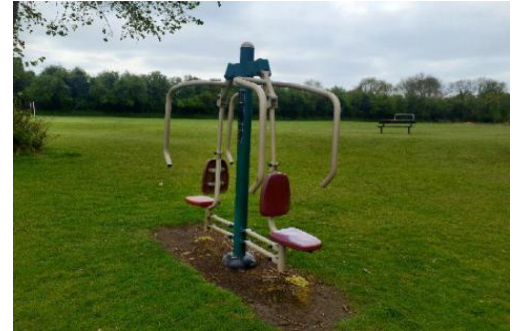
Item: Chest Press
Manufacturer: Fresh Air Fitness
Surface Type: Grass Matrix Tiles
Item Quantity: 1
Equipment Compliance: Yes
Surface Area Compliance: Yes
Life Expectancy: 5 -10 Years
Total Findings: 1

One or more handgrip(s) are damaged or missing. - Replace missing or damaged handgrips
