ST STEPHEN PARISH COUNCIL

You are summoned to the Fixed Assets Committee meeting

AGENDA

| 2526/AC/013 | To receive Annual Play Inspection Reports. Reports attached. |

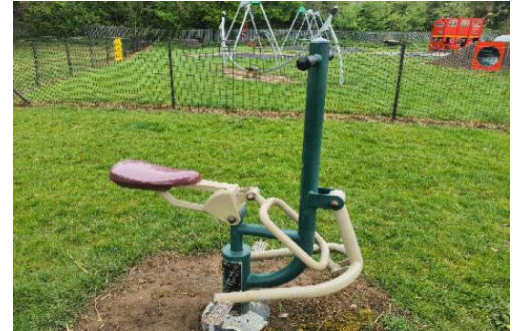
Item: Rider
Manufacturer: Fresh Air Fitness
Surface Type: Grass Matrix Tiles
Item Quantity: 1
Equipment Compliance: Yes
Surface Area Compliance: Yes
Life Expectancy: 5 -10 Years
Total Findings: 2

There is / are post or end caps missing / damaged on the item - Replace missing / damaged post or end caps

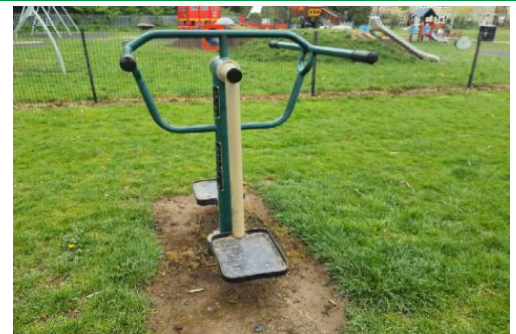
Item: Air Skier
Manufacturer: Fresh Air Fitness
Surface Type: Grass Matrix Tiles
Item Quantity: 1
Equipment Compliance: Yes
Surface Area Compliance: Yes
Life Expectancy: 5 -10 Years
Total Findings: 2

The paintwork on this item has been damaged or worn exposing the metal underneath which is rusting / corroding - Treat affected areas and repaint

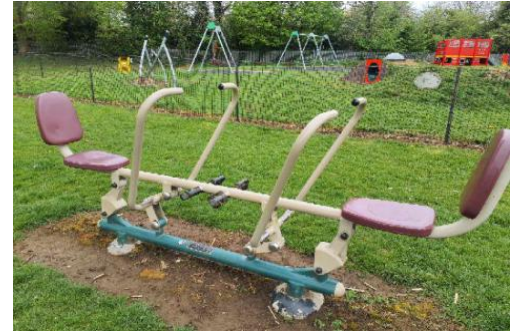
Item: Rower
Manufacturer: Fresh Air Fitness
Surface Type: Grass Matrix Tiles
Item Quantity: 1
Equipment Compliance: Yes
Surface Area Compliance: Yes
Life Expectancy: 5 -10 Years
Total Findings: 4

The paint is flaking off the metalwork - Rub down and re-paint

The paintwork on this item has been damaged or worn exposing the metal underneath which is rusting / corroding - Treat affected areas and repaint

The seat has been damaged - Monitor for any further deterioration and replace as required

One or more handgrips are loose - Secure all loose handgrips

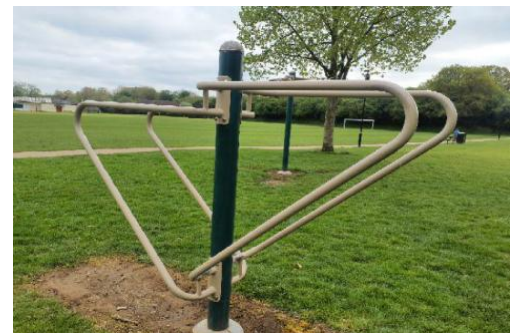
Item: Dip Station
Manufacturer: Fresh Air Fitness
Surface Type: Grass Matrix Tiles
Item Quantity: 1
Equipment Compliance: Yes
Surface Area Compliance: Yes
Life Expectancy: 5 -10 Years
Total Findings: 1

There is surface corrosion / rust present on the item - Consider treating the item

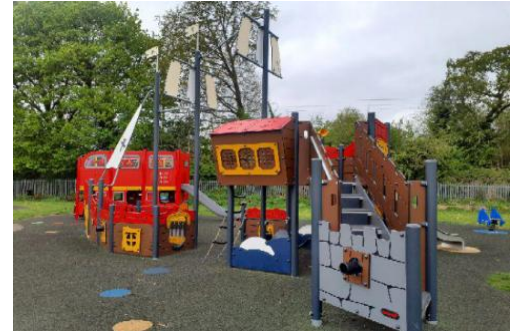
Item: Boat
Manufacturer: Kompan Ltd
Surface Type: Bonded Rubber Mulch
Item Quantity: 1
Equipment Compliance: Yes
Surface Area Compliance: Yes

There is some graffiti present - Remove the graffiti

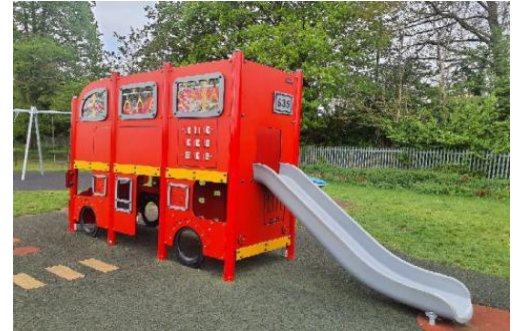
There is some graffiti present - Remove the graffiti

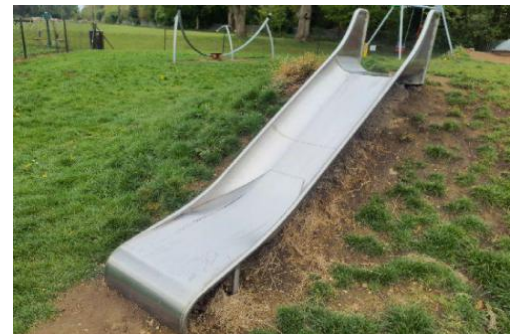
The surface has eroded and the foundations are exposed - Reinstate surrounding surfaces to cover the foundations

There are a number of dents in the slide surface - Monitor for any further deterioration and repair as required

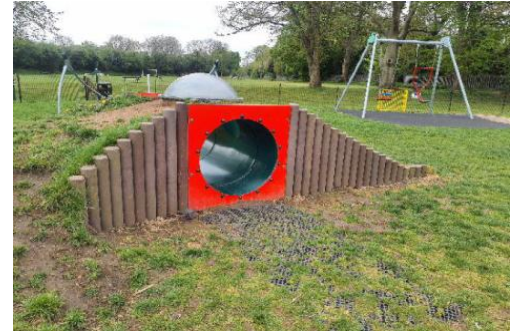
This design / configuration of tunnel mound is well established and has been successfully included in large quantities of playgrounds throughout the UK. Whilst the design does not fully meet the requirements of BS EN 1176 with regards to falls in excess of 600mm over the edge of the tunnel to the surface below, it has been risk assessed as fit for purpose in this regard and no changes are recommended to the design unless otherwise stated in additional findings - Monitor - No action given the risk assessment

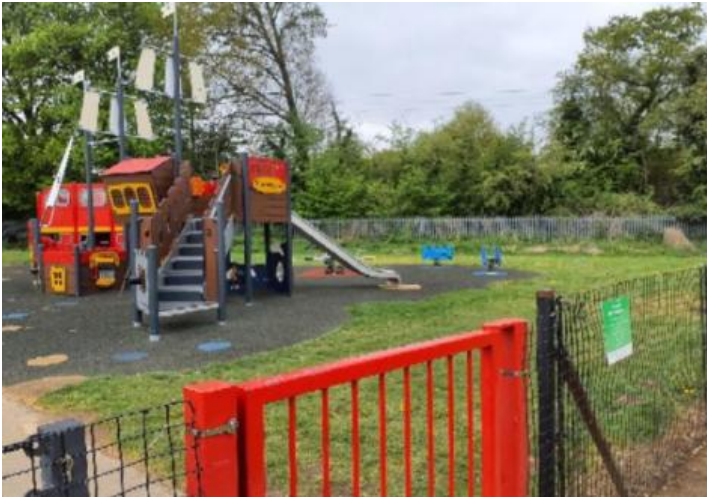
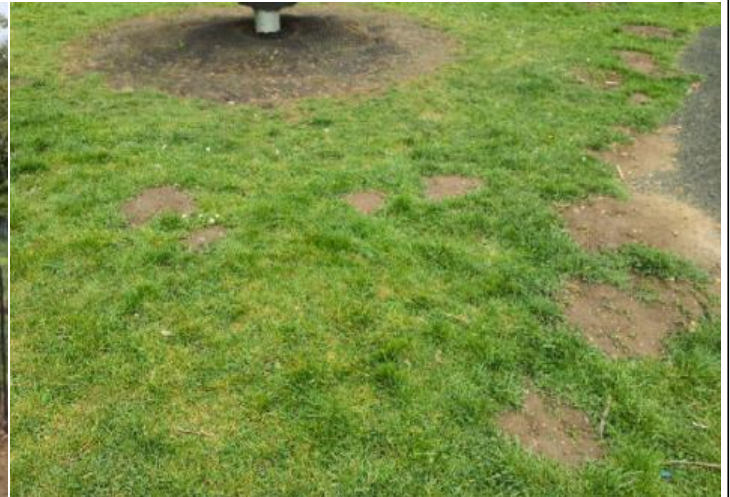
Finding: There are a number of molehills within the area and these may present unforeseen hazards for users

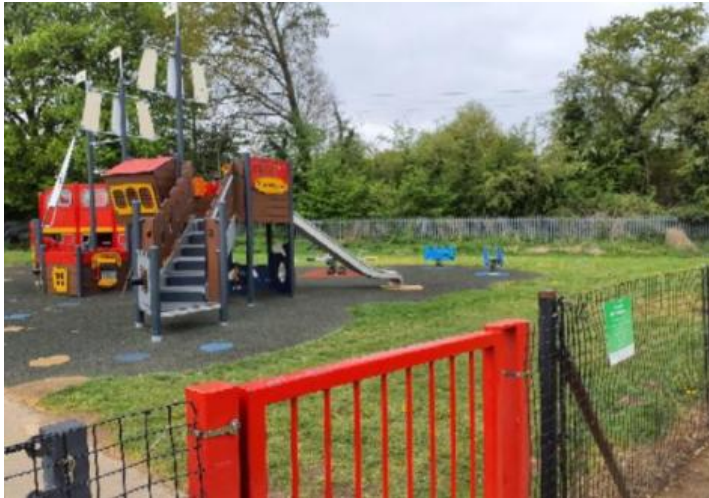
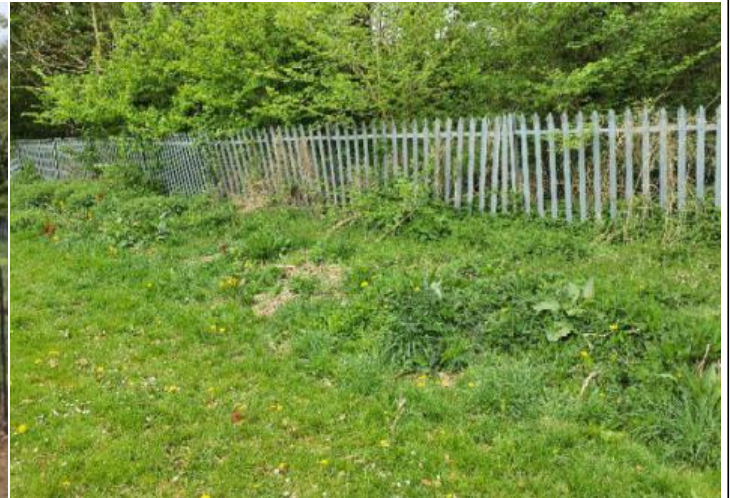
Finding: There is weed / vegetation growth within the surface

Action: Remove weed / vegetation growth

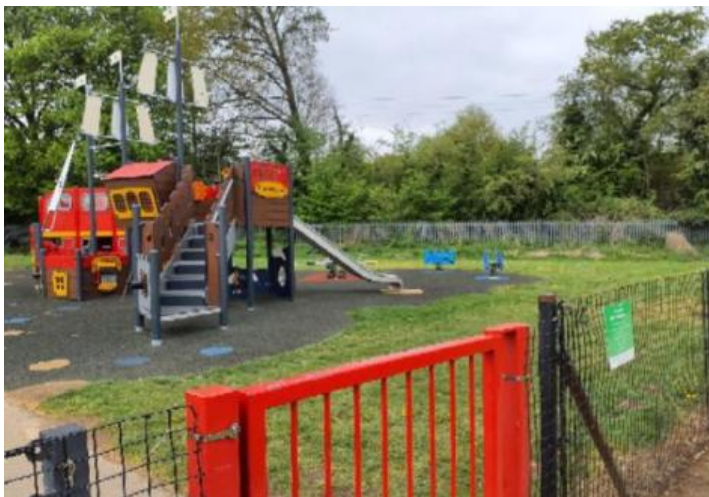
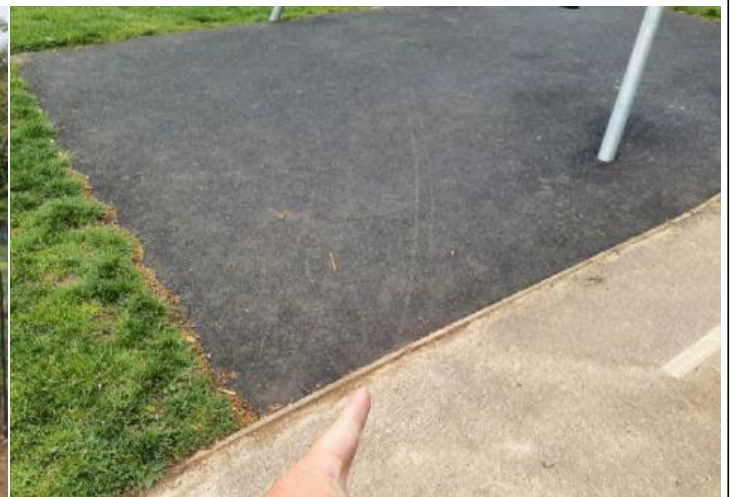
Finding: There are trip hazards at the edges of the surface

Action: Remove trip hazard

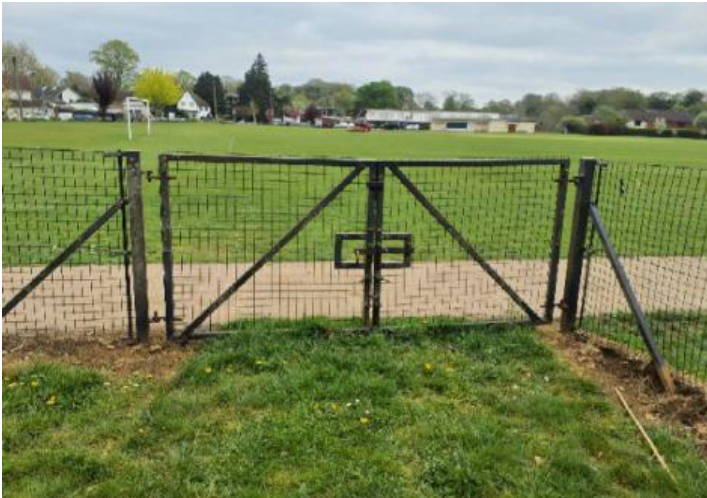
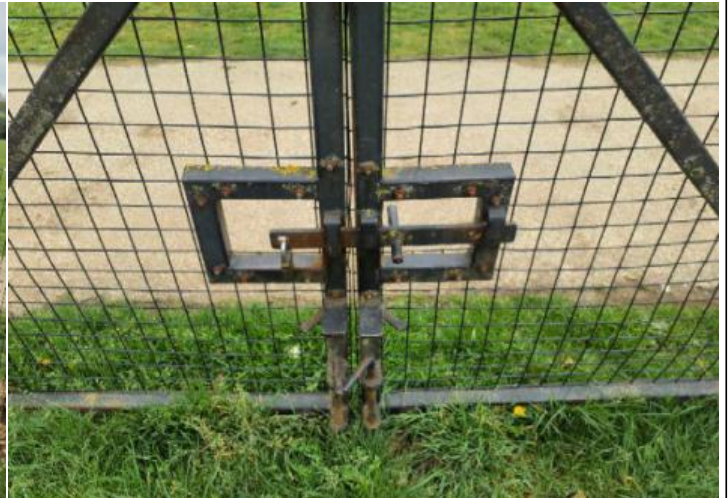
Finding: The maintenance gate was correctly padlocked at the time of inspection, however this means that the inspector was unable to fully assess the gate

Action: Ensure that there are 12mm gaps throughout the full range of motion on gate/s and between leaves where relevant

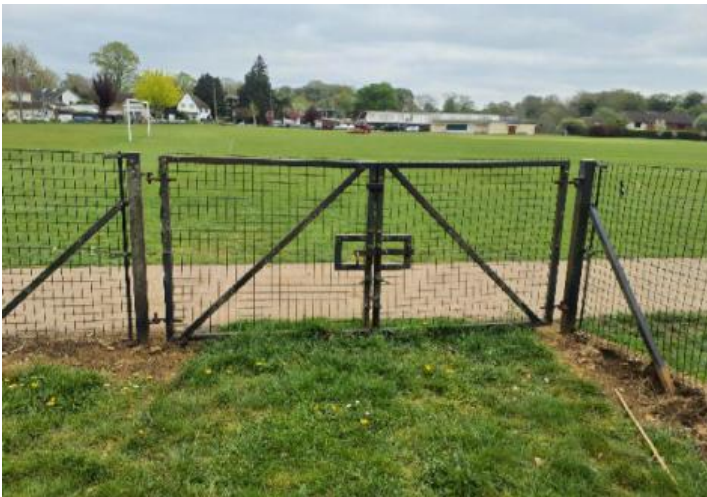
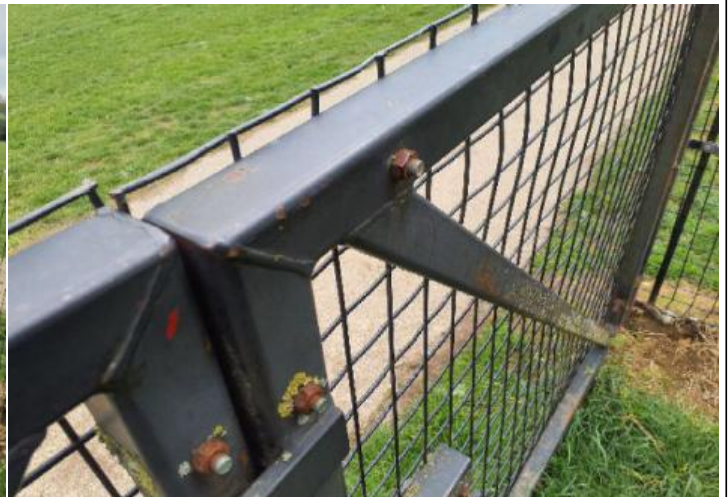
Finding: There are projecting bolt thread(s) present

Action: Remove excess thread length and deburr or provide cap

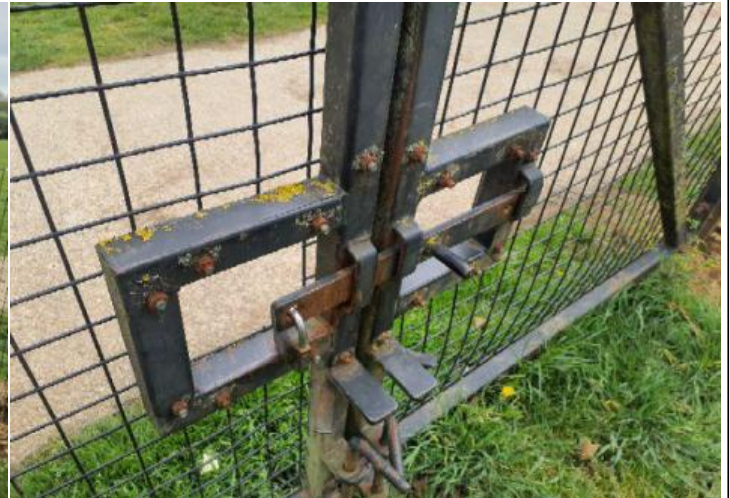
Finding: The paintwork on this item has been damaged or worn exposing the metal underneath which is rusting / corroding

Action: Treat affected areas and repaint

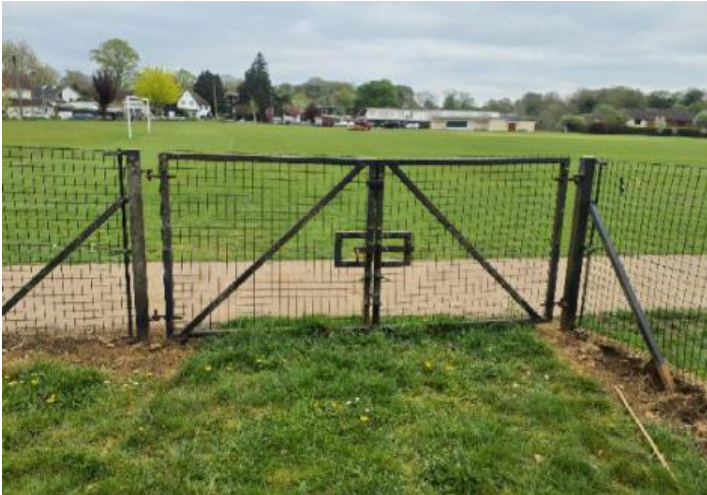
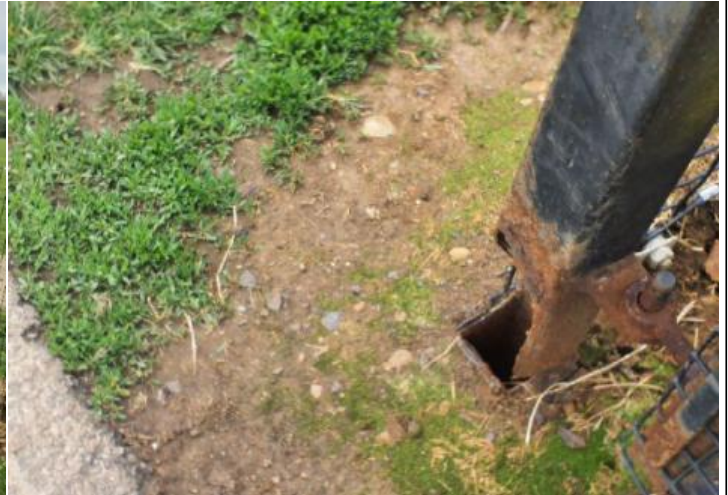
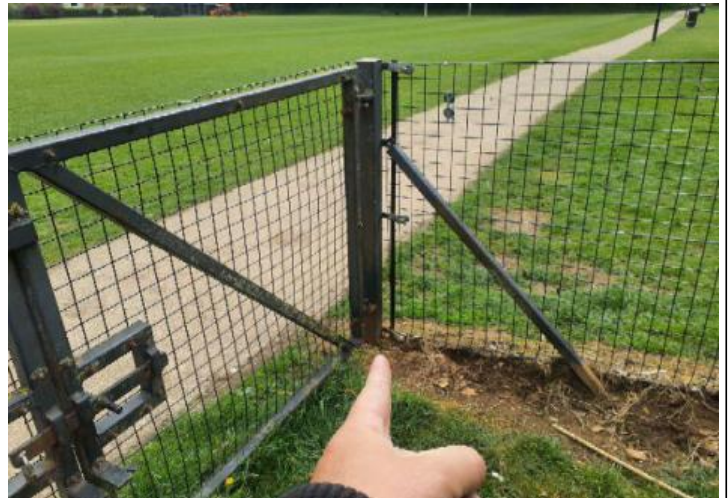
Finding: Parts of the steel on this item have corroded excessively and the metal has perforated in places

Action: Ensure all affected areas are treated and repaired

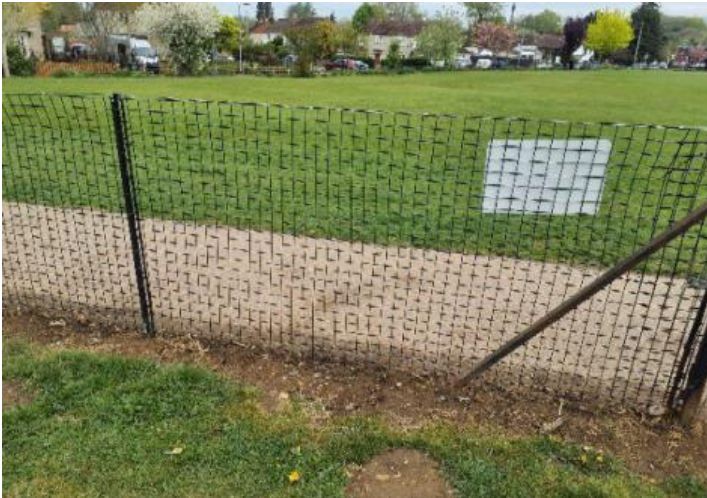
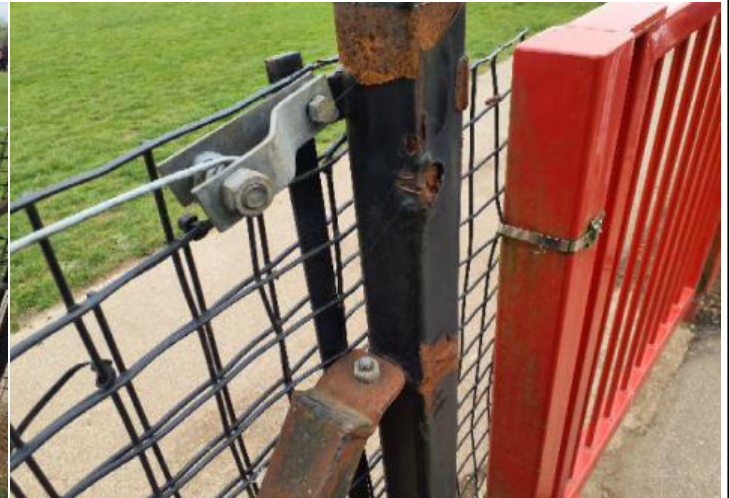
Finding: The paintwork on this item has been damaged or worn exposing the metal underneath which is rusting / corroding

Action: Treat affected areas and repaint

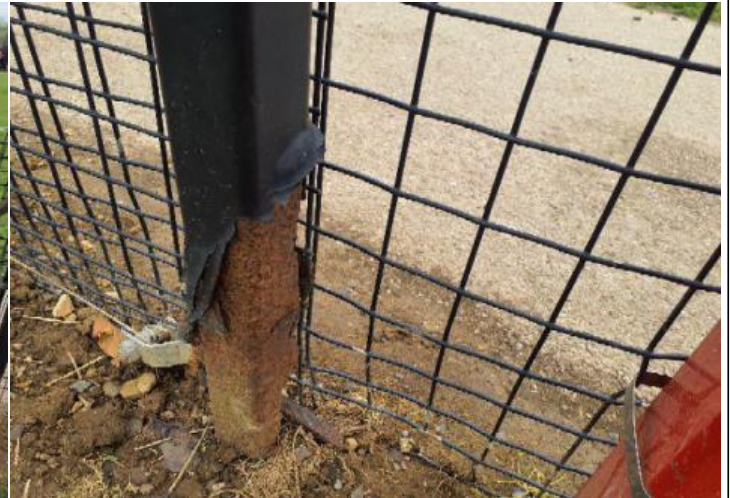
Finding: Parts of the steel on this item have corroded excessively and the metal has perforated in places

Action: Ensure all affected areas are treated and repaired

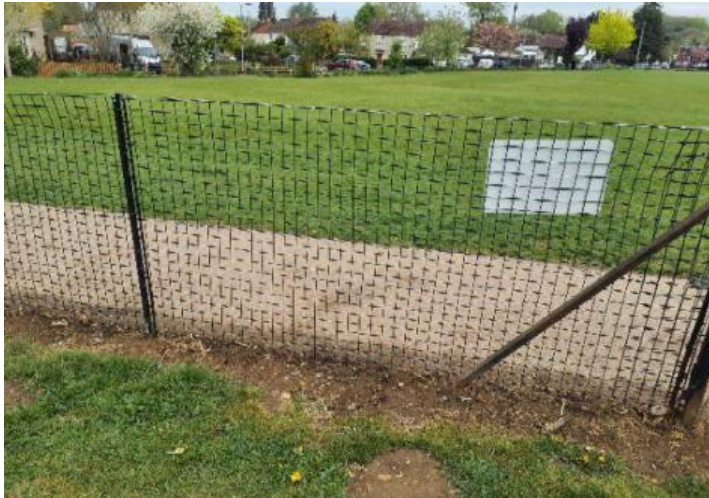
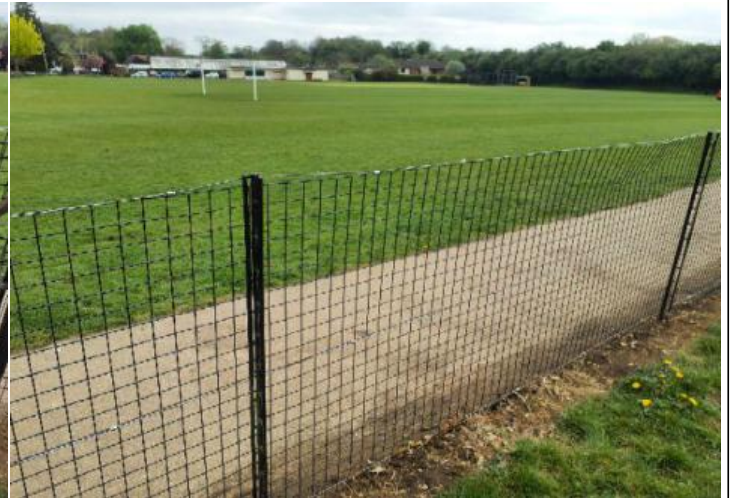
Finding: There are a number of loose posts around the fence

Action: Monitor for any further deterioration and reset as required

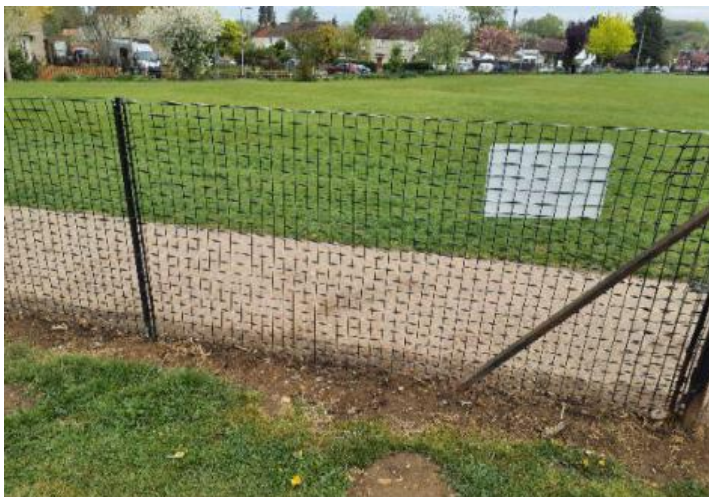
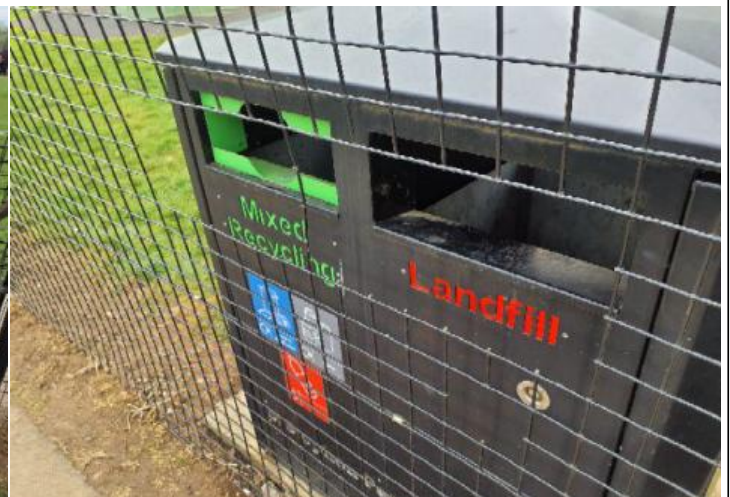
Finding: The fence panel has been cut to allow access to the litter bin from the outside of the play area. The cut sections have projections and sharp edges

Action: Remove projections and sharp edges

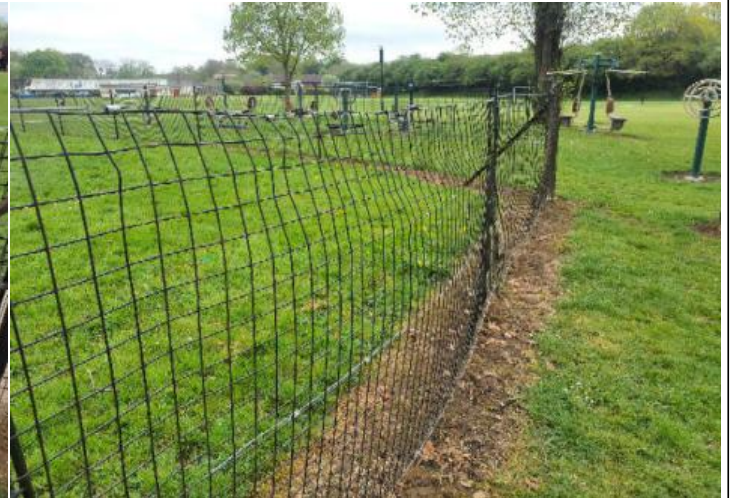
Finding: There is some damage to the fence sections

Action: Monitor for any further deterioration and repair as required

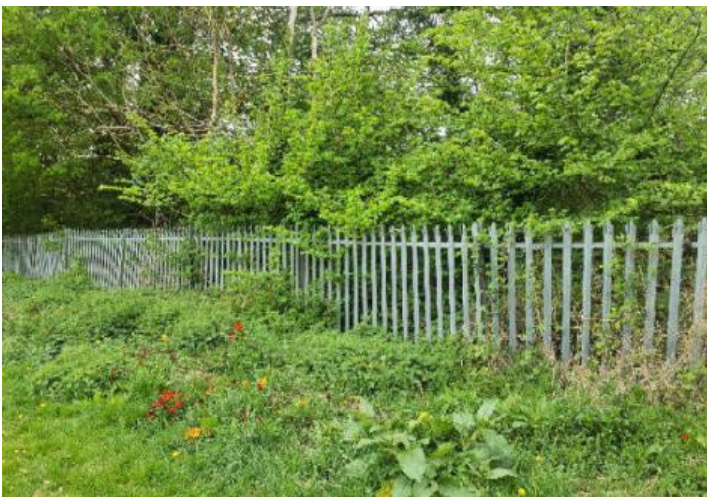
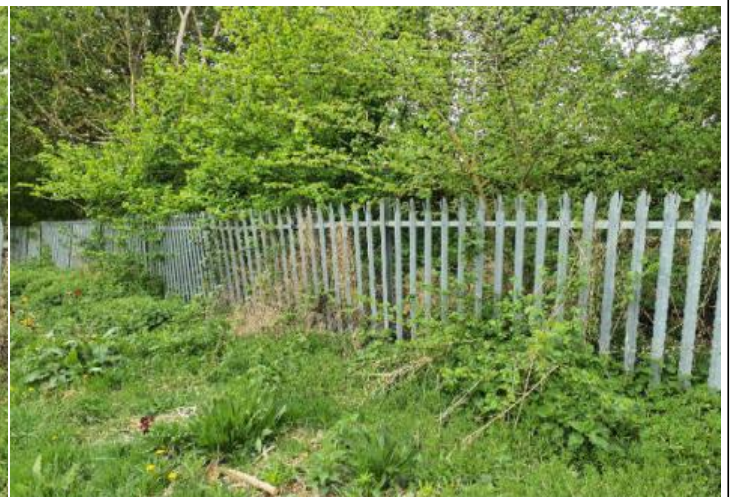
Finding: There are a number of loose posts around the fence

Action: Monitor for any further deterioration and reset as required

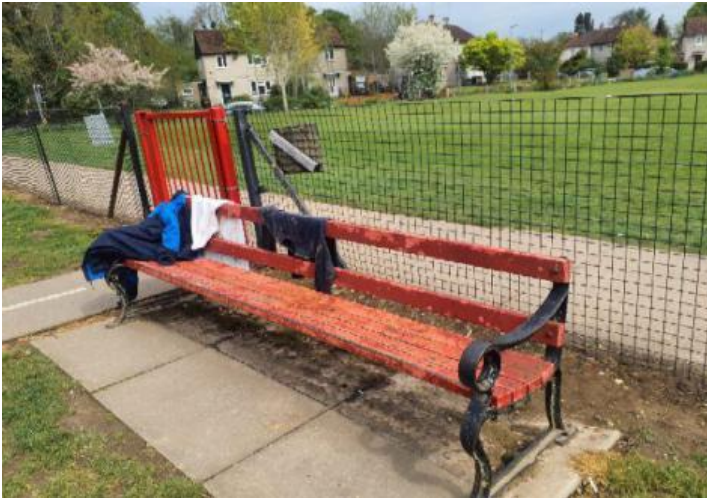
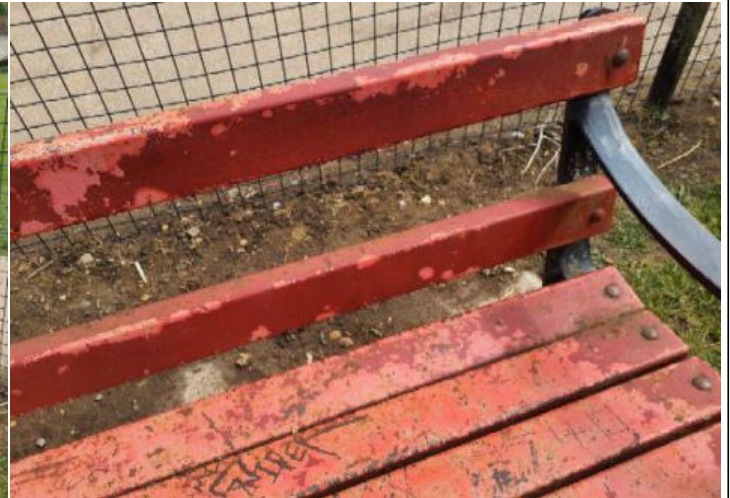
Finding: The paint is flaking off the metalwork

Action: Rub down and re-paint

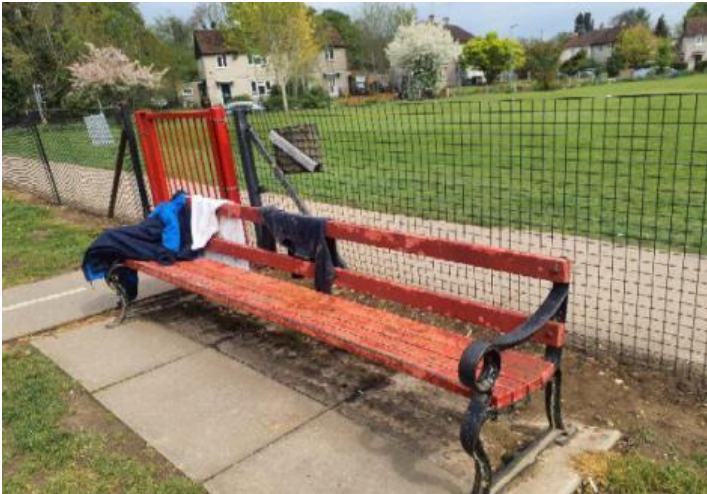
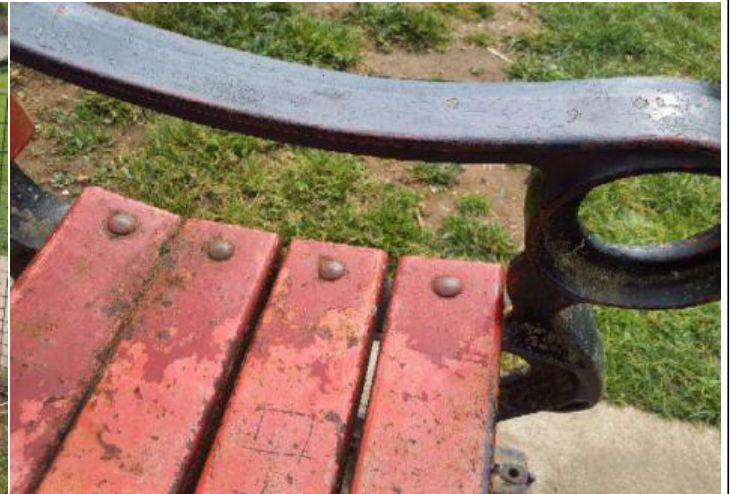
Finding: The paintwork on this item has been damaged or worn exposing the metal underneath which is rusting / corroding

Action: Treat affected areas and repaint

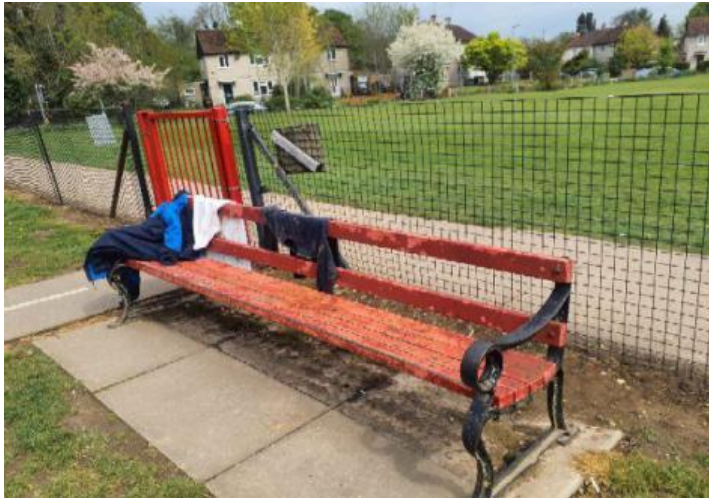
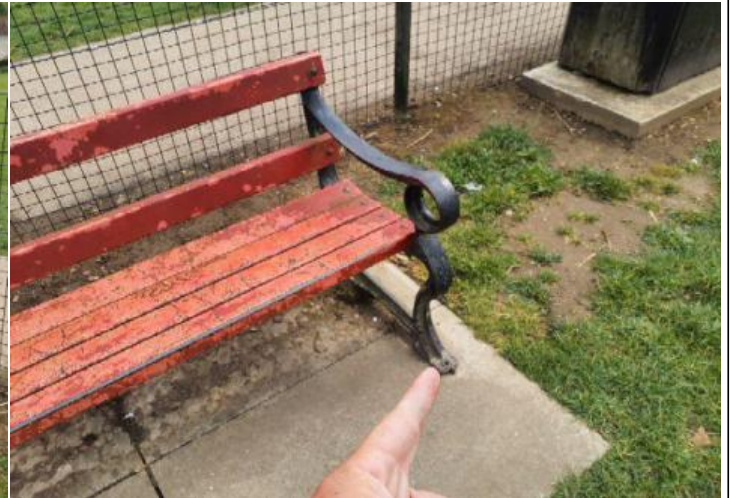
Finding: There is or are fixings missing on the item

Action: Replace all missing fixings

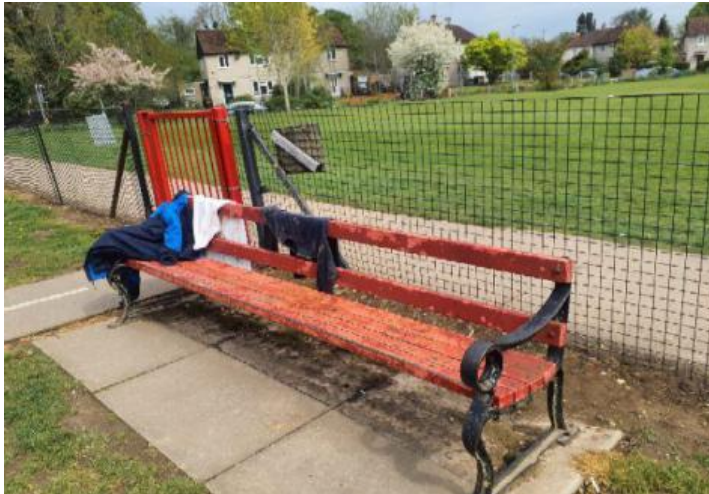
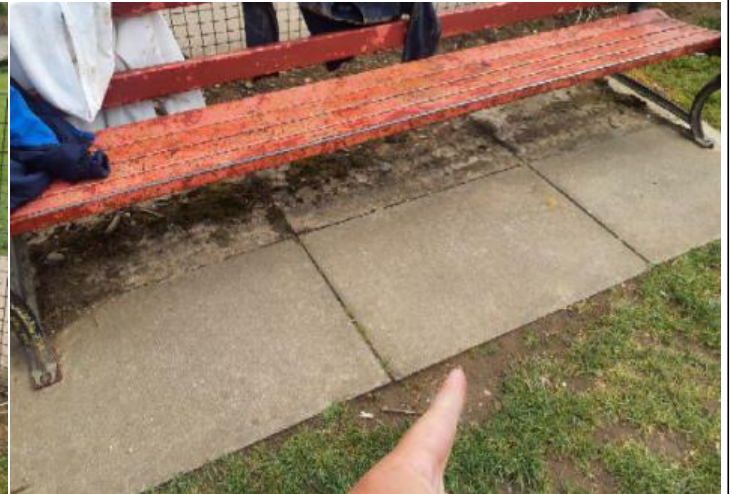
Finding: There are trip hazards at the edges of the surface

Action: Remove trip hazard

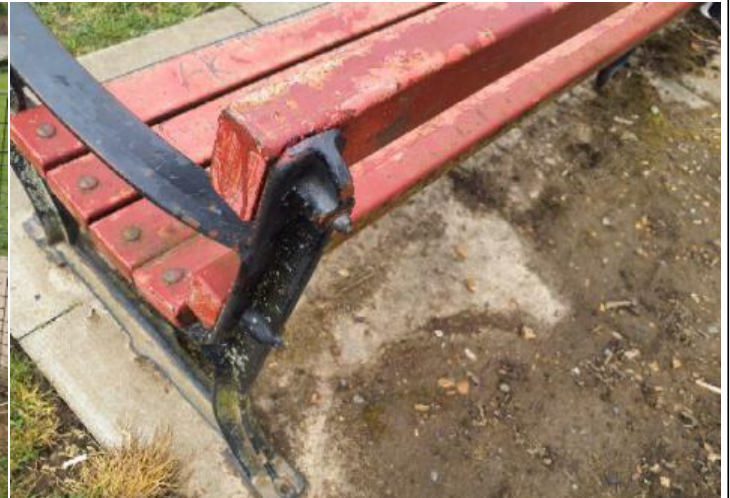
Finding: There are projecting bolt thread(s) present

Action: Remove excess thread length and deburr or provide cap

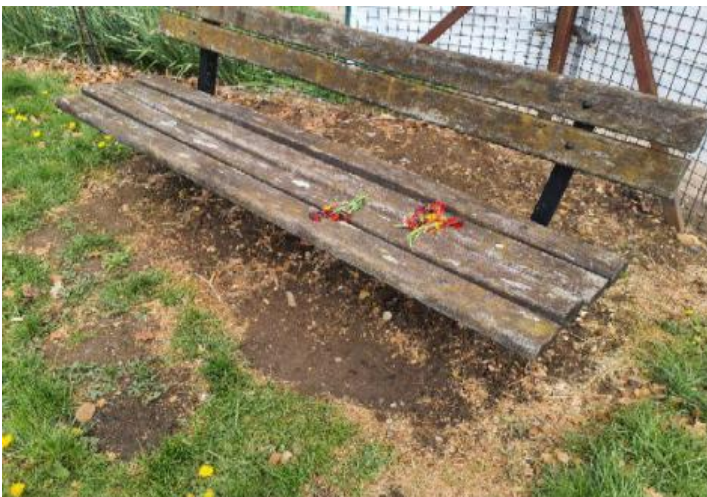
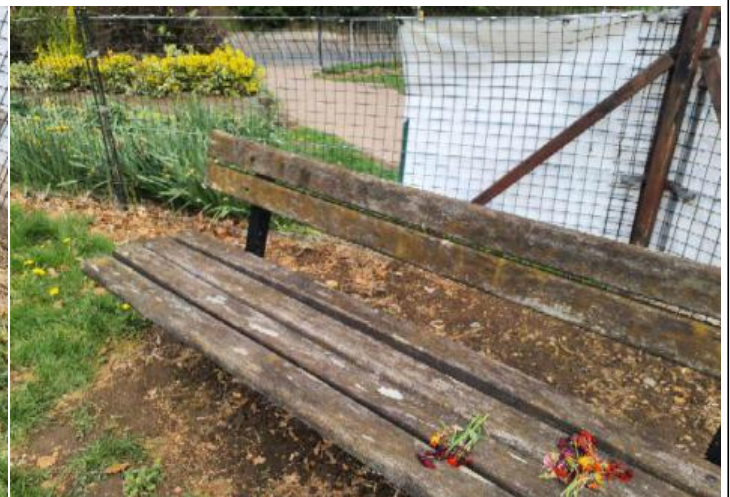
Item: Ancillary Items - Bench
Manufacturer: Not Identified

Finding: There is algae or moss on the surface of the equipment

Action: Clean and treat appropriately

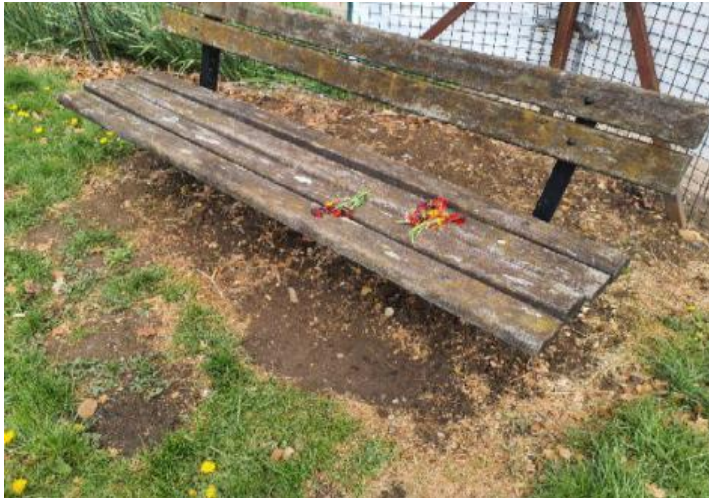
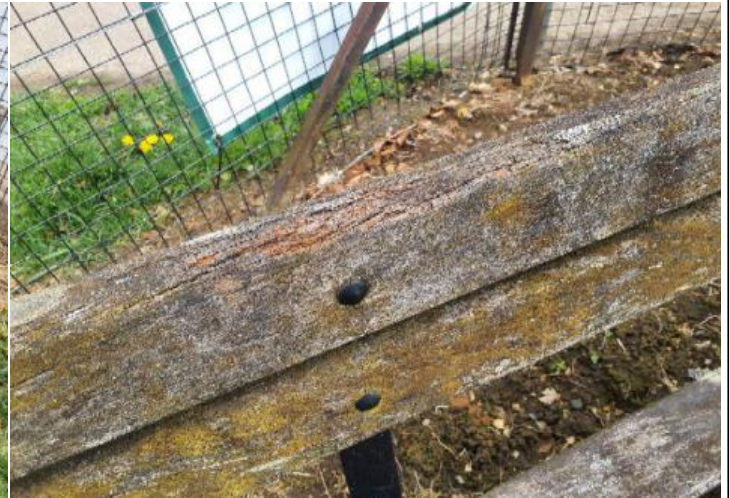
Item: Ancillary Items - Bench
Manufacturer: Not Identified

Finding: There is some evidence of rot in the timber

Action: Monitor for any further deterioration and replace as required

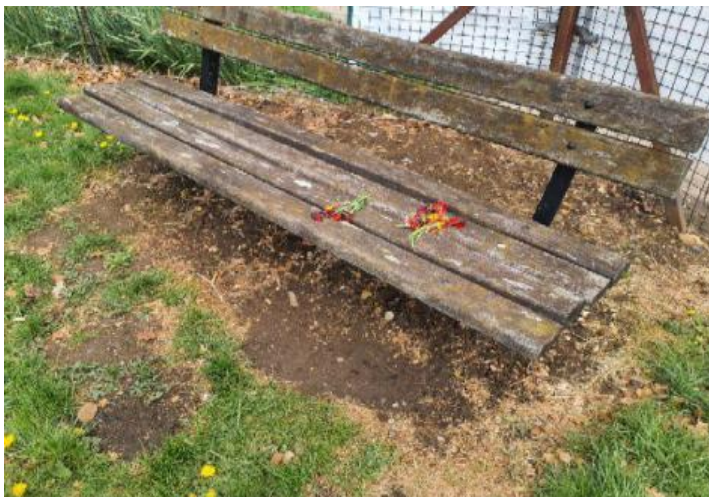
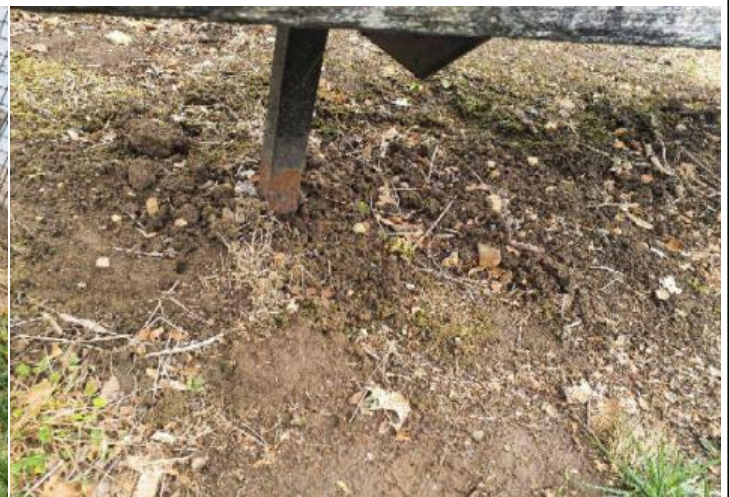
Item: Ancillary Items - Bench
Manufacturer: Not Identified

Finding: The paintwork on this item has been damaged or worn exposing the metal underneath which is rusting / corroding

Action: Treat affected areas and repaint

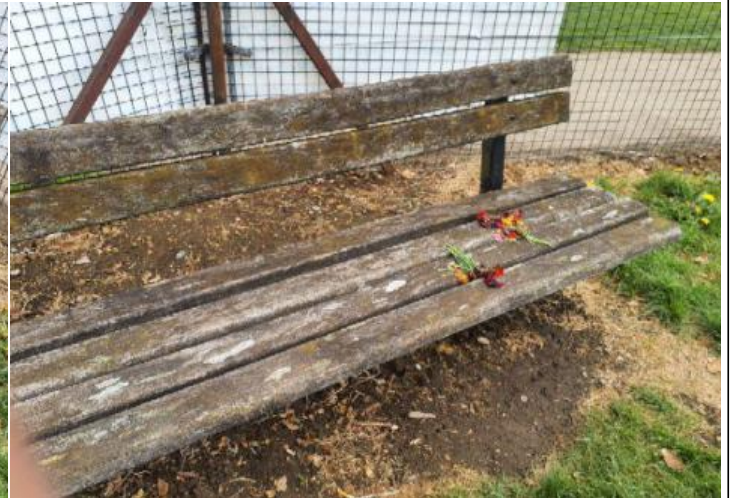
Item: Ancillary Items - Bench
Manufacturer: Not Identified

Finding: The item is slightly loose in its foundations

Action: Monitor for any further deterioration and repair as required

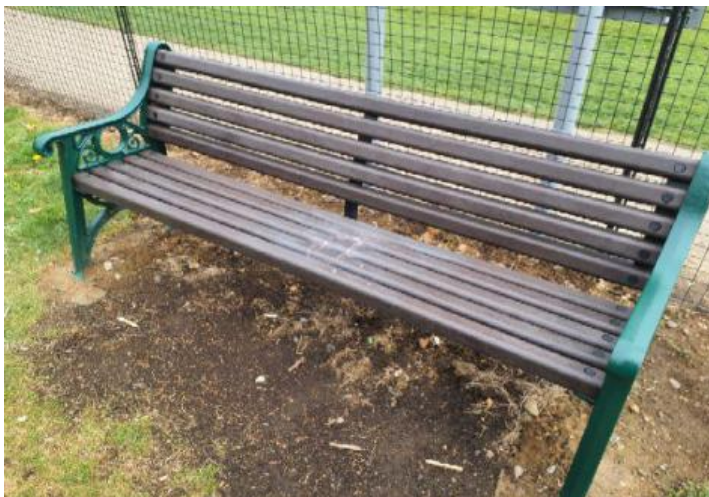
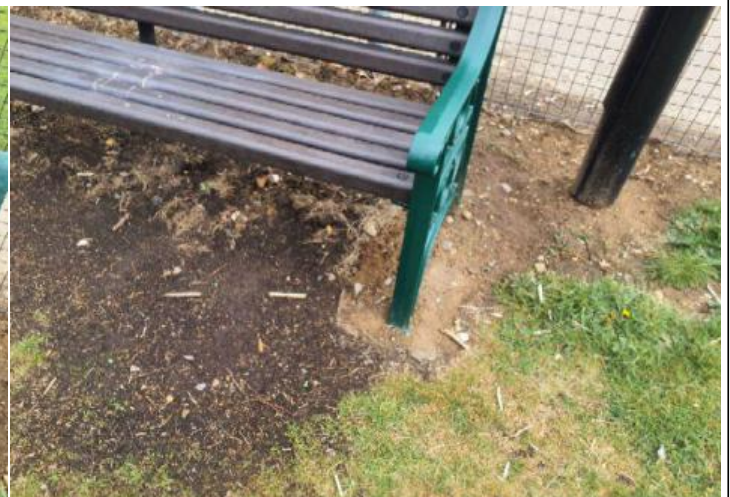
Item: Ancillary Items - Bench
Manufacturer: Not Identified

Finding: The surface has eroded and the foundations are exposed

Action: Reinstall surrounding surfaces to cover the foundations

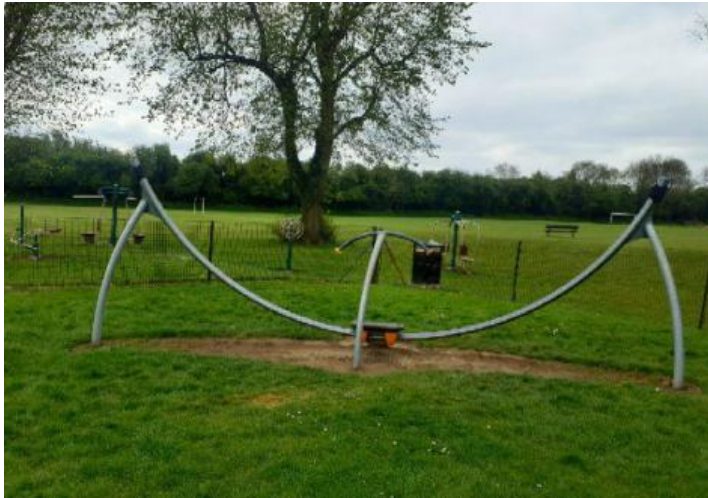
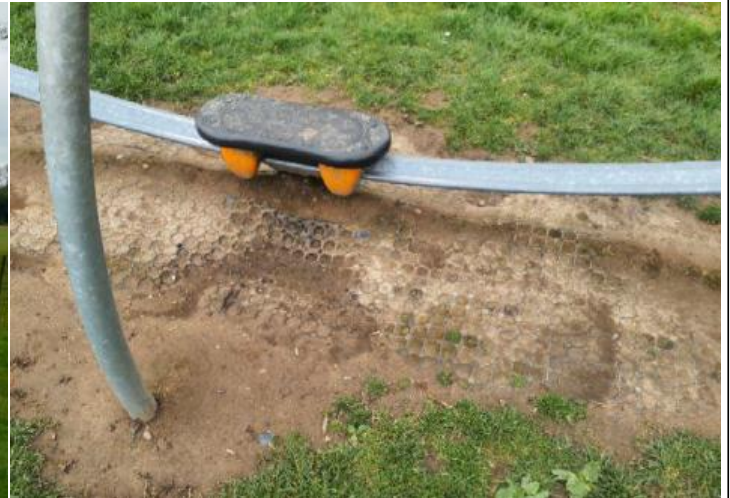
Item: Activity Equipment - Skate Unit
Manufacturer: Kompan Ltd

Finding: Fixing Pins have been installed in the impact areas of the grass mats **Action:** Remove pins from impact areas

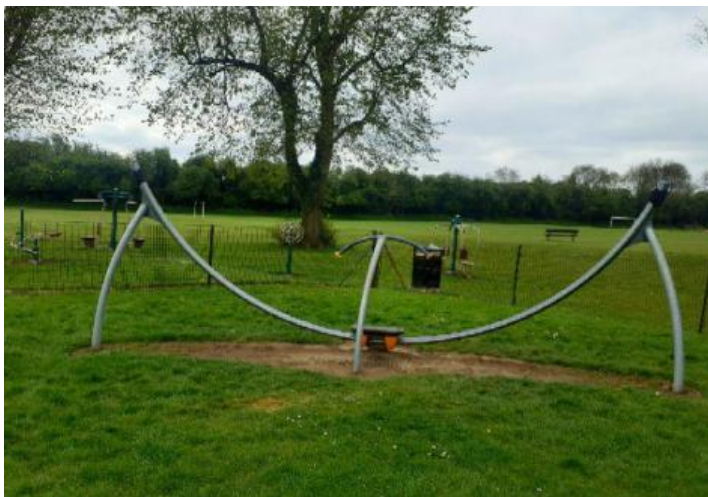
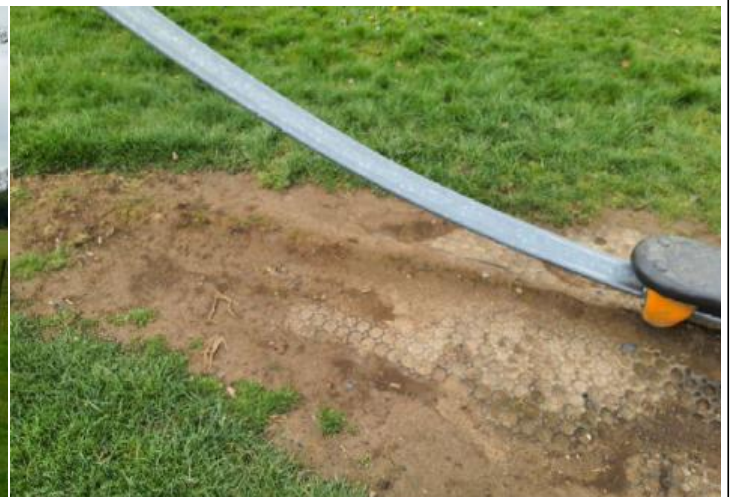
Item: Activity Equipment - Skate Unit
Manufacturer: Kompan Ltd

Finding: The grass mats are silted up, the soil is compacted and the area will become very slippery when the soil is wet. **Action:** Reinstate as required

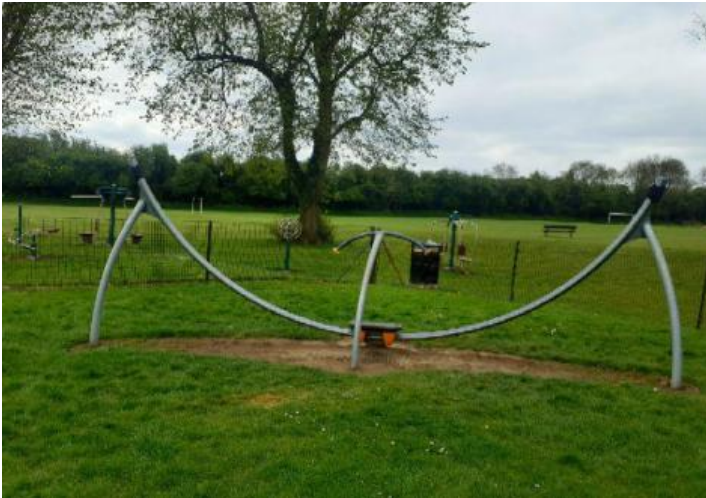
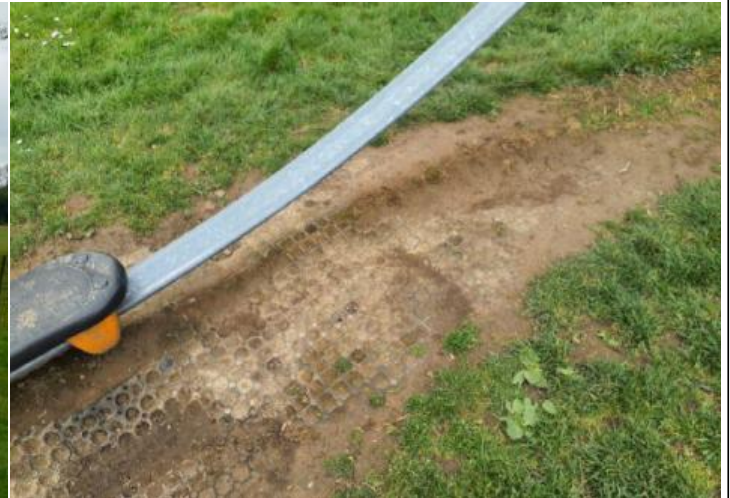
Item: Activity Equipment - Skate Unit
Manufacturer: Kompan Ltd

Finding: The surface has subsided in some areas

Action: Monitor for any further deterioration and repair as required

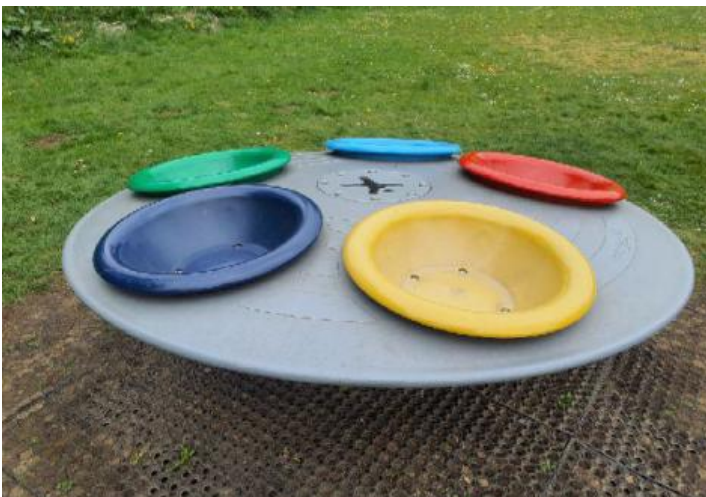
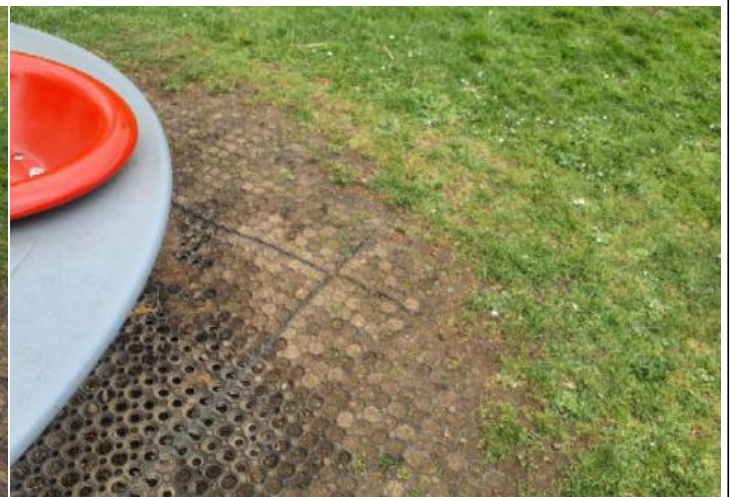
Item: Rotor Play - Roundabout
Manufacturer: Kompan Ltd

Finding: The grass mats are silted up, the soil is compacted and the area will become very slippery when the soil is wet.

Action: Reinstate as required

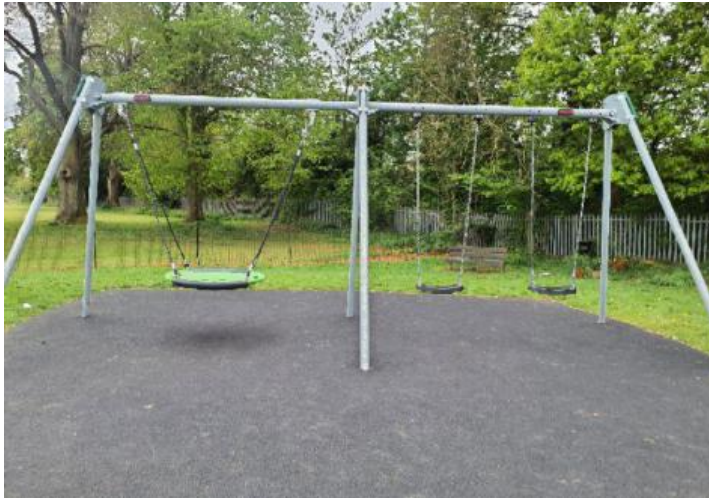
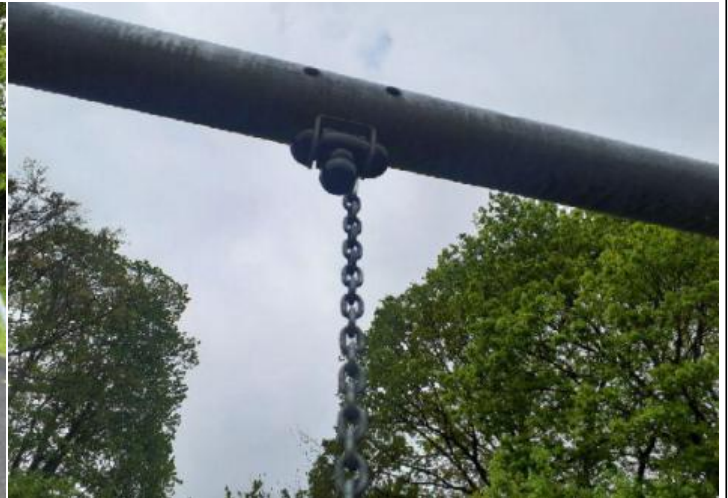
Item: Swings - 2 Bay 2 Flat 1 Basket Seat
Manufacturer: Kompan Ltd

Finding: There is some notable evidence of chain wear

Action: Monitor for any further deterioration and replace when 40% worn

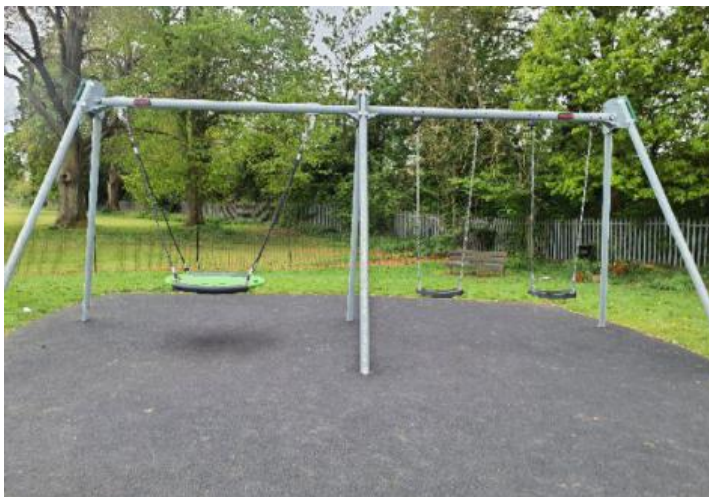
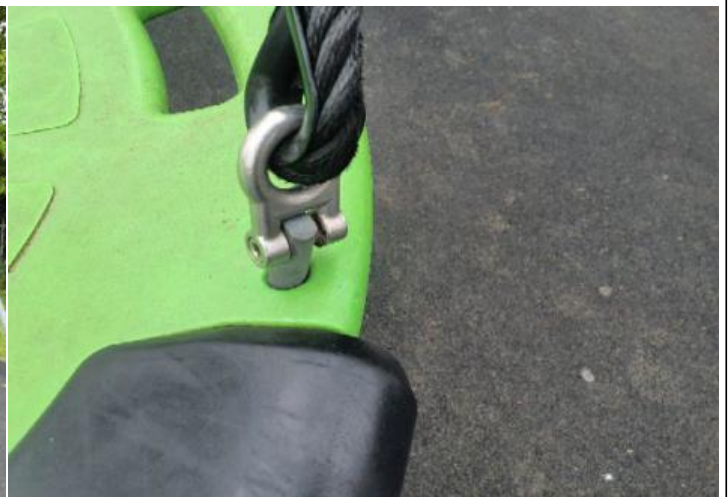
Item: Swings - 2 Bay 2 Flat 1 Basket Seat
Manufacturer: Kompan Ltd

Finding: The bushes are showing signs of wear

Action: Monitor for any further deterioration and replace as required
