ST STEPHEN PARISH COUNCIL

You are summoned to the Fixed Assets Committee meeting

AGENDA

| 2526/AC/013 | To receive Annual Play Inspection Reports. Reports attached. |

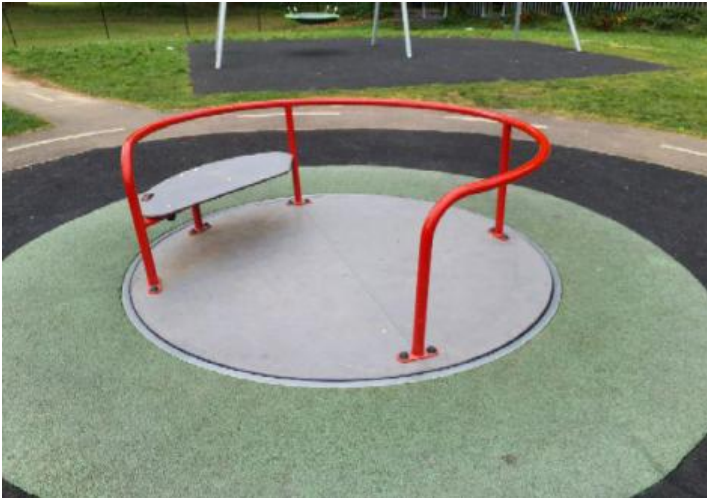
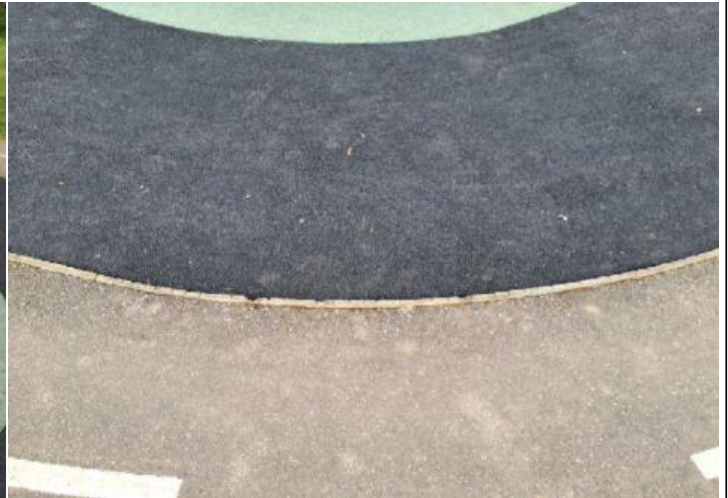
Item: Rotor Play - Inclusive Roundabout
Manufacturer: Kompan Ltd

Finding: There are trip hazards at the edges of the surface **Action:** Remove trip hazard

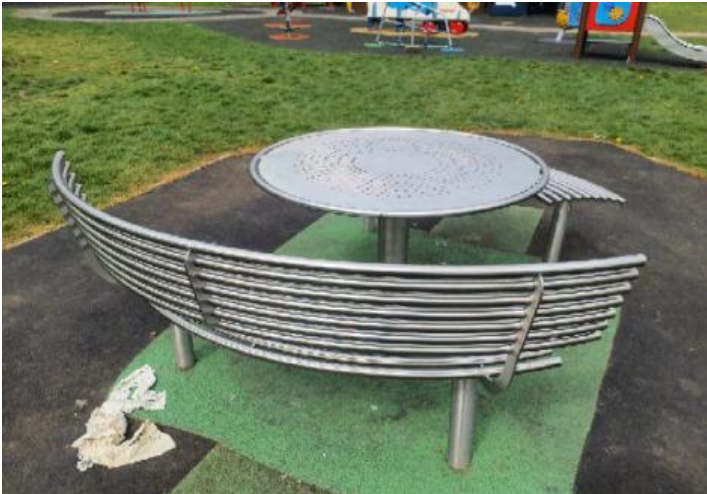
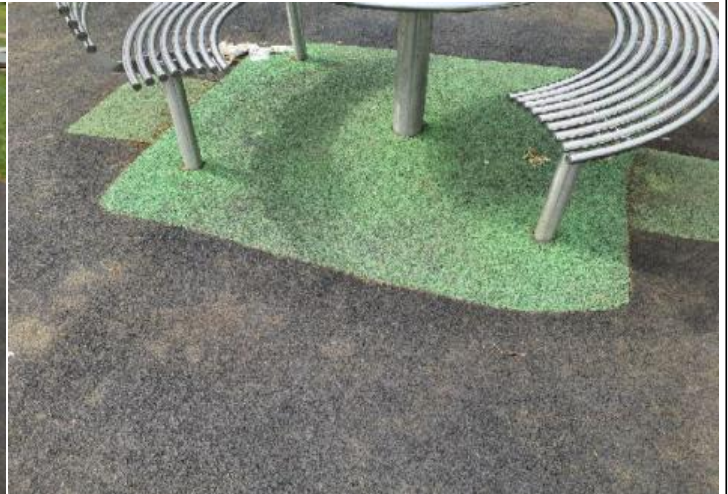
Item: Ancillary Items - Picnic Table
Manufacturer: Not Identified

Finding: The surface has subsided in some areas **Action:** Monitor for any further deterioration and repair as required

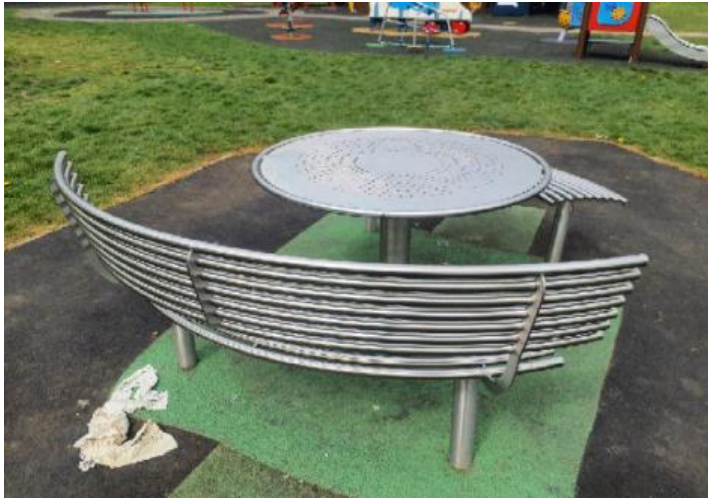
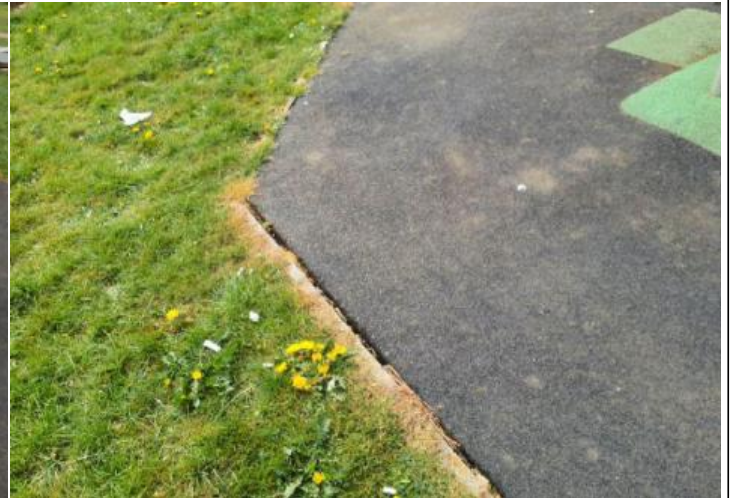
Item: Ancillary Items - Picnic Table
Manufacturer: Not Identified

Finding: There are significant gaps (over 30mm) between the surface and the edging or between the joints in the surface; these are large enough for a small foot to enter

Action: Repair surfacing

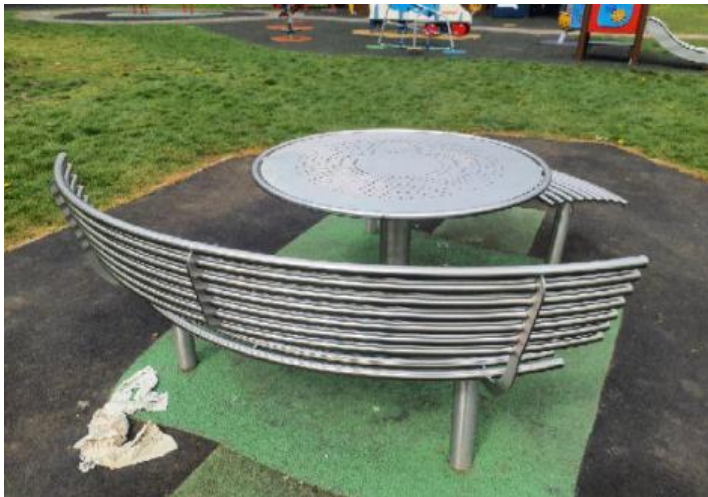
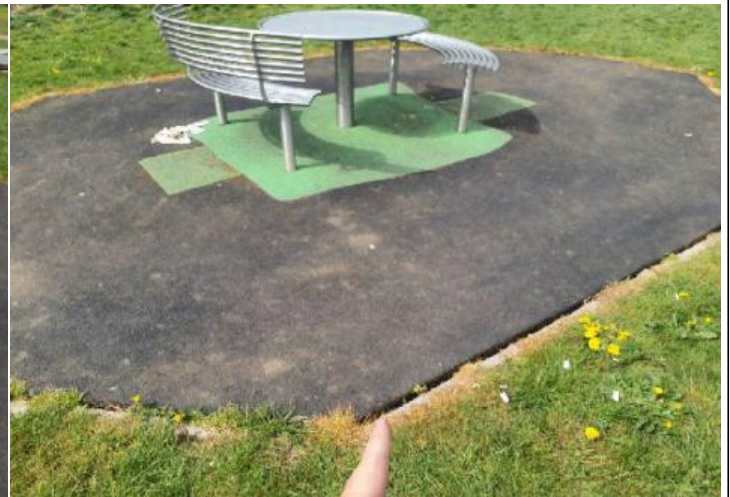
Item: Ancillary Items - Picnic Table
Manufacturer: Not Identified

Finding: The surface is lifting at the edges and creating trip points

Action: Repair perimeter of surfacing to remove trip points

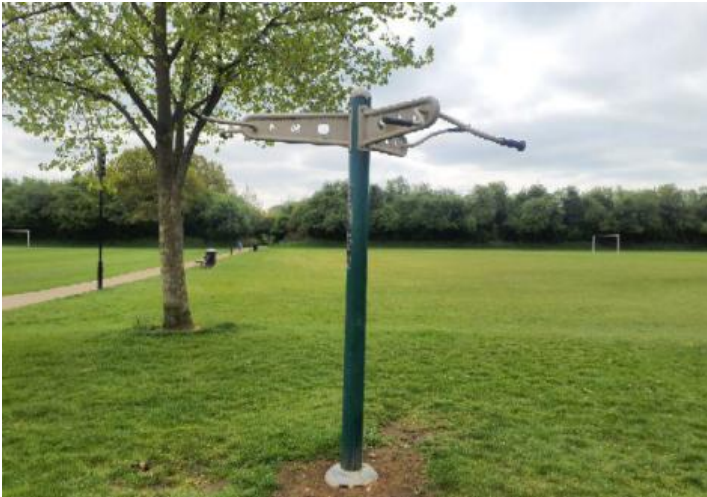
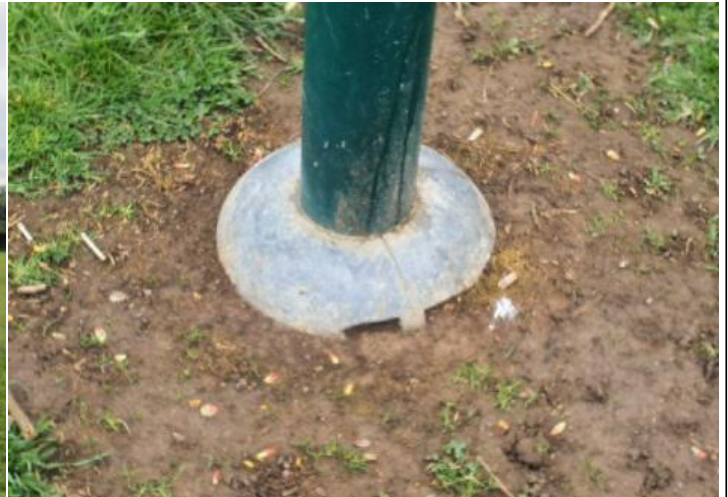
Finding: There is surface corrosion / rust present on the item

Action: Consider treating the item

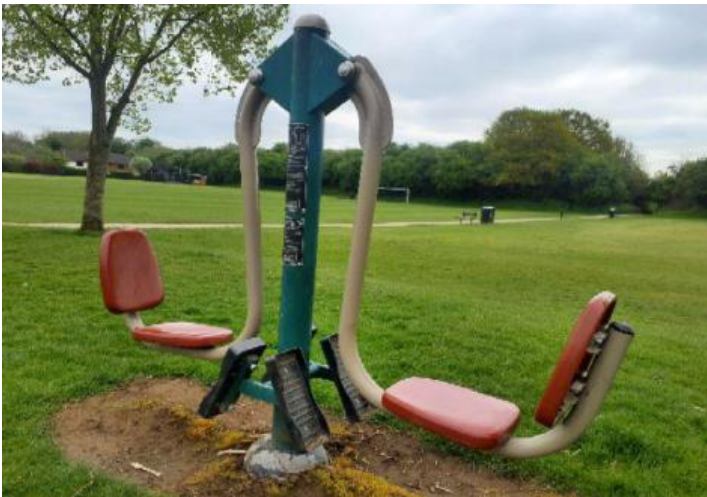
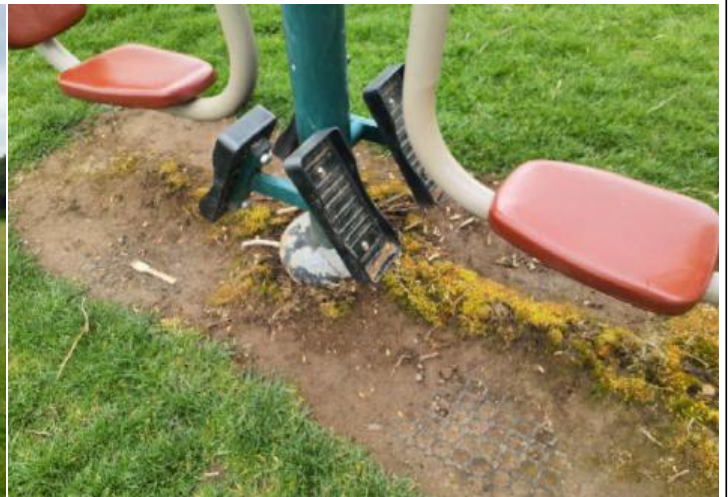
Finding: The surface has subsided in some areas

Action: Monitor for any further deterioration and repair as required

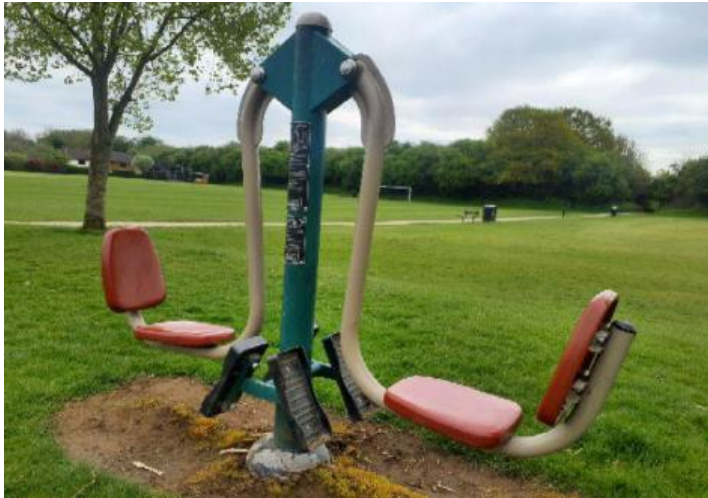
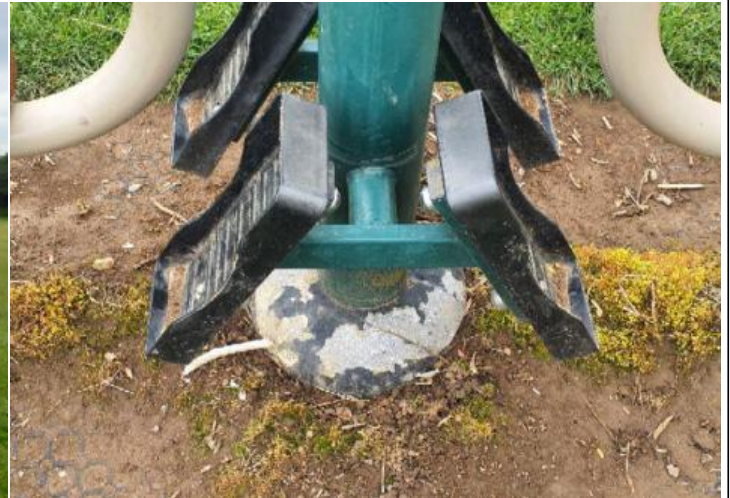
Item: Outdoor Fitness Equipment - Leg Press
Manufacturer: Fresh Air Fitness

Finding: The paint is flaking off the metalwork

Action: Rub down and re-paint

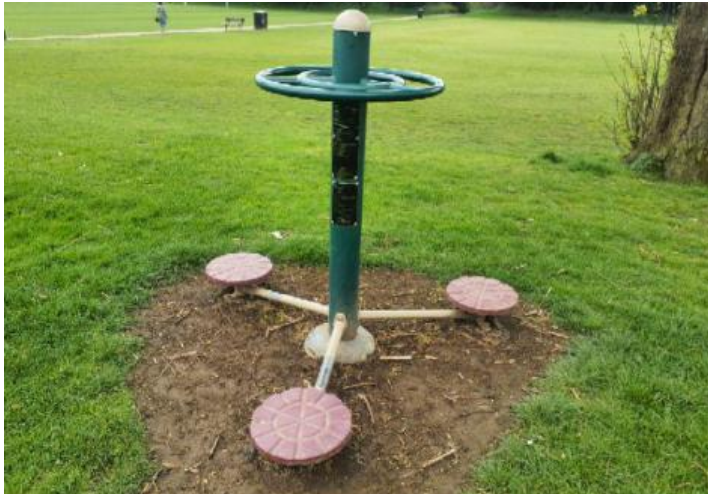
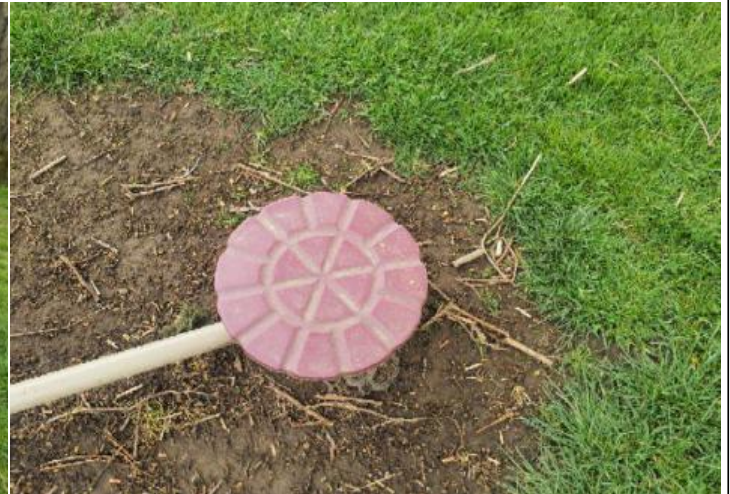
Item: Outdoor Fitness Equipment - Hip Twister
Manufacturer: Fresh Air Fitness

Finding: The rotating user station is not appropriately marked with a guideline of user direction and/or the original position as required by BS EN 16630

Action: Monitor - No action given the risk assessment

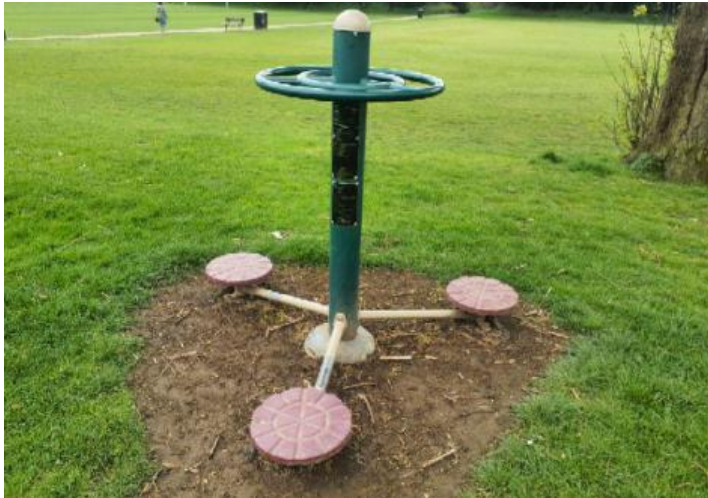
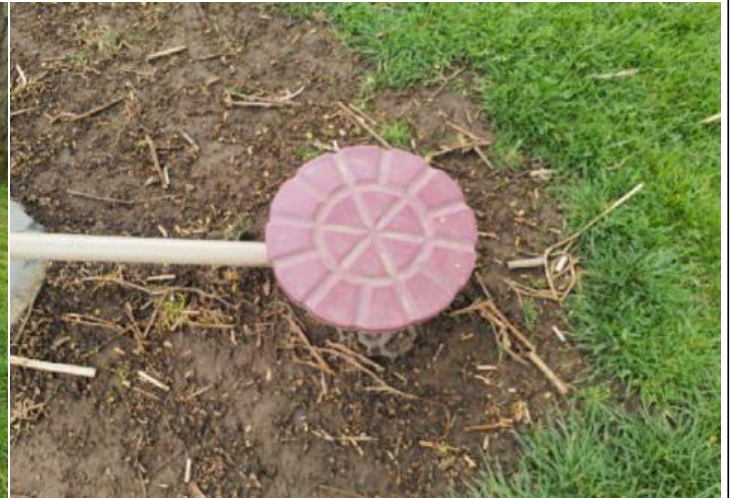
Item: Outdoor Fitness Equipment - Hip Twister
Manufacturer: Fresh Air Fitness

Finding: The deflection of the rotating user station exceeds the maximum 105 degrees required by BS EN 16630

Action: Monitor - No action given the risk assessment

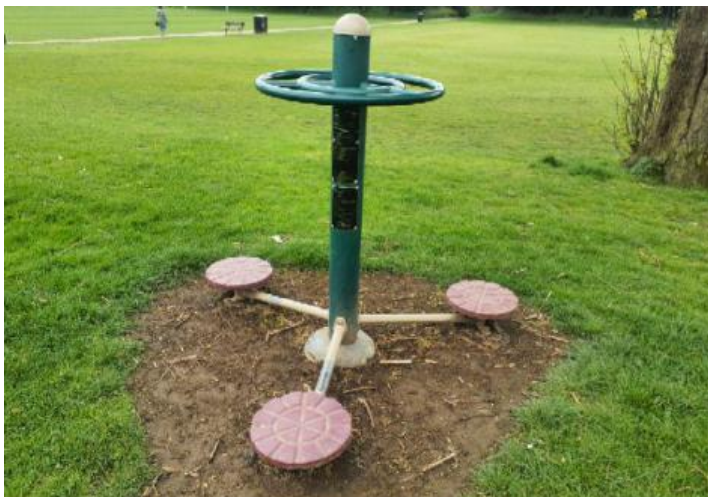
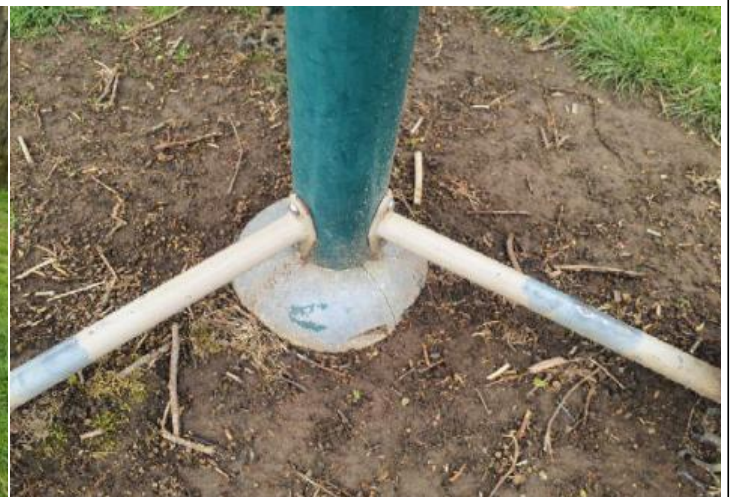
Item: Outdoor Fitness Equipment - Hip Twister
Manufacturer: Fresh Air Fitness

Finding: There is surface corrosion / rust present on the item

Action: Consider treating the item

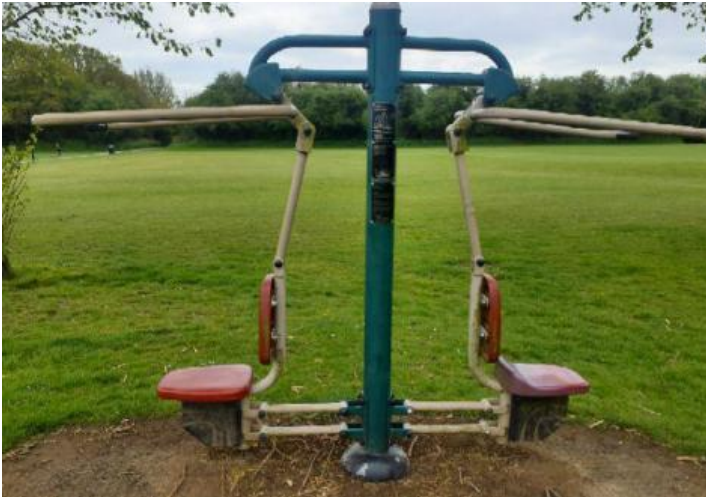
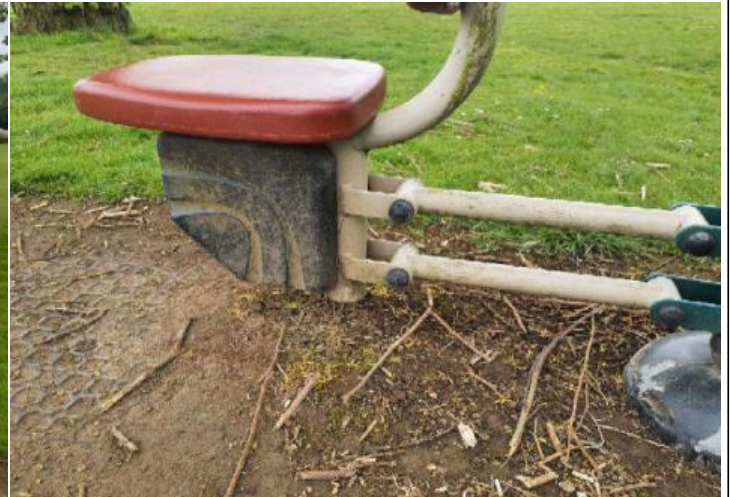
Item: Outdoor Fitness Equipment - Pull Down Challenger
Manufacturer: Fresh Air Fitness

Finding: The distance between the underside of the item and the ground is less than the 60mm required by BS EN 16630

Action: Monitor - No remedial work recommended

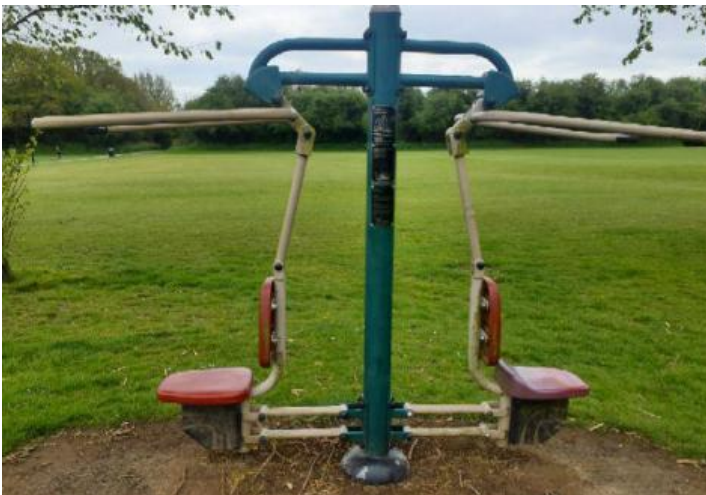
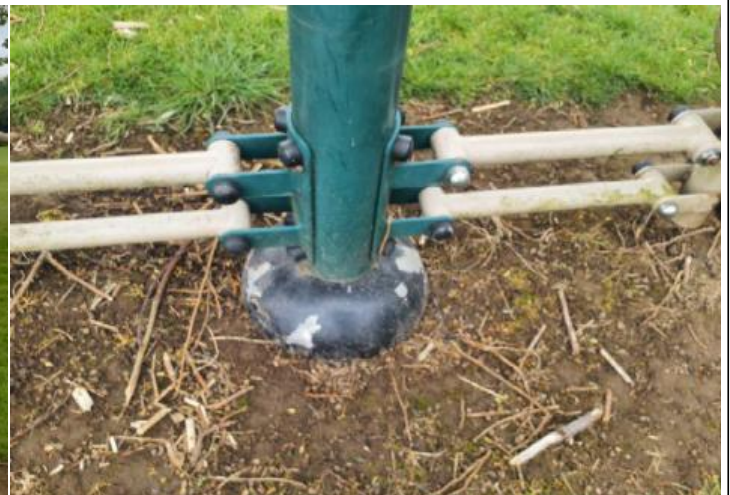
Item: Outdoor Fitness Equipment - Pull Down Challenger
Manufacturer: Fresh Air Fitness

Finding: The paint is flaking off the metalwork

Action: Rub down and re-paint

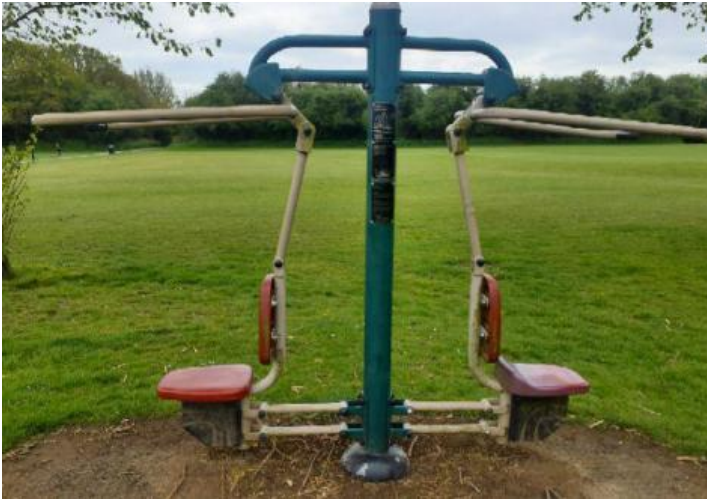
Item: Outdoor Fitness Equipment - Pull Down Challenger
Manufacturer: Fresh Air Fitness

Finding: There is/are bolt cap covers missing or damaged on the item

Action: Replace missing or damaged bolt cap covers

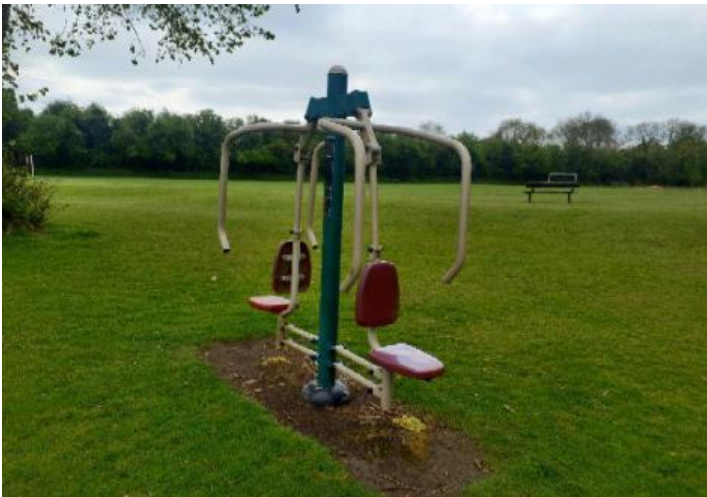
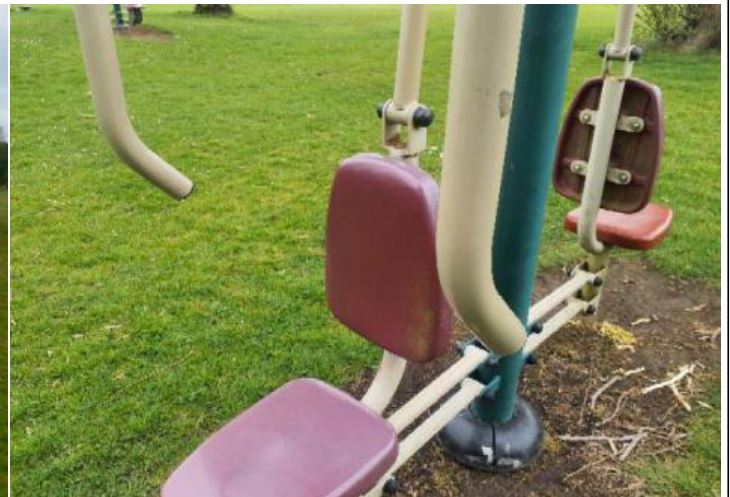
Item: Outdoor Fitness Equipment - Chest Press
Manufacturer: Fresh Air Fitness

Finding: One or more handgrip(s) are damaged or missing. **Action:** Replace missing or damaged handgrips

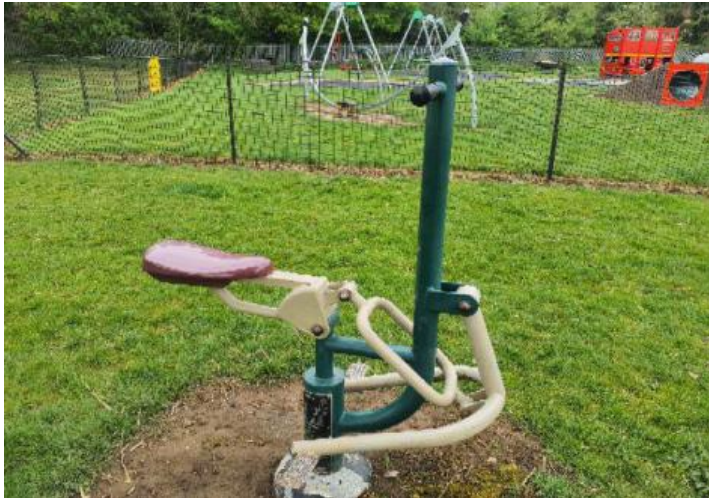
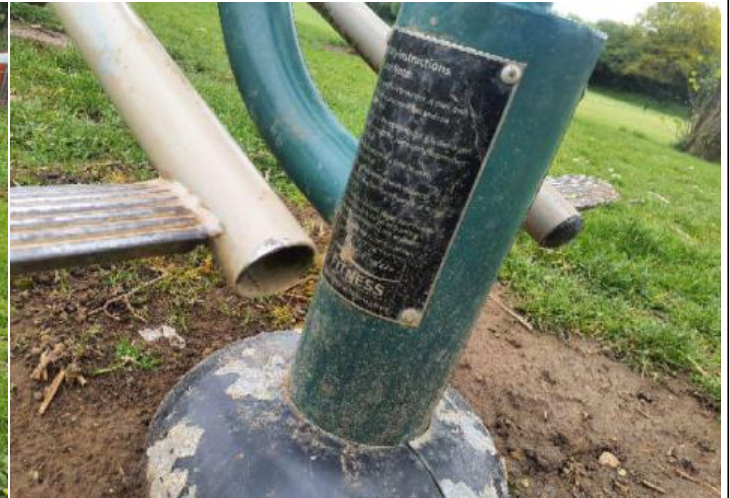
Item: Outdoor Fitness Equipment - Rider
Manufacturer: Fresh Air Fitness

Finding: There is / are post or end caps missing / damaged on the item
Action: Replace missing / damaged post or end caps

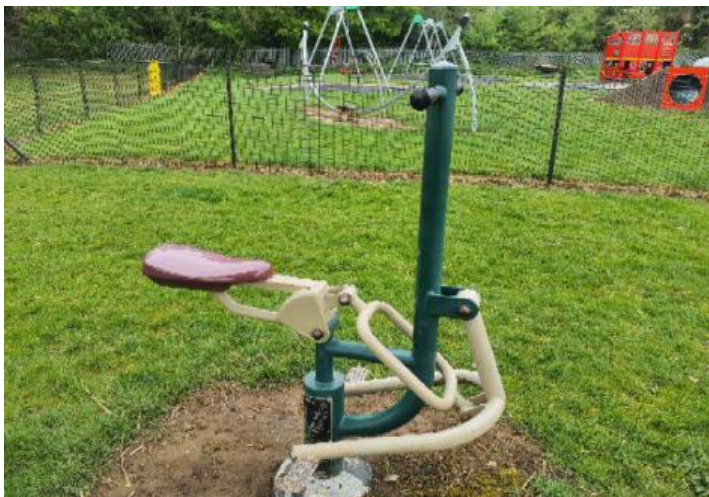
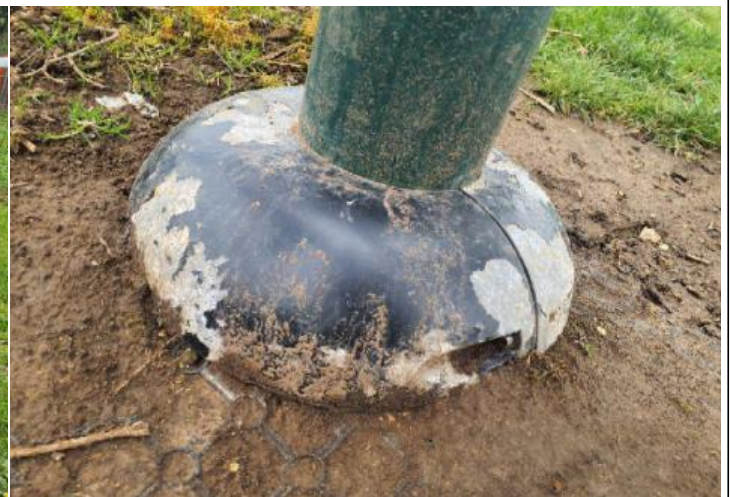
Item: Outdoor Fitness Equipment - Rider
Manufacturer: Fresh Air Fitness

Finding: The paint is flaking off the metalwork
Action: Rub down and re-paint

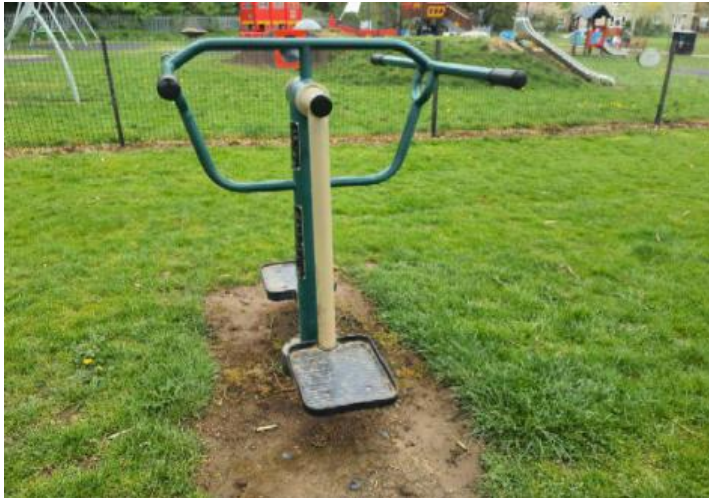
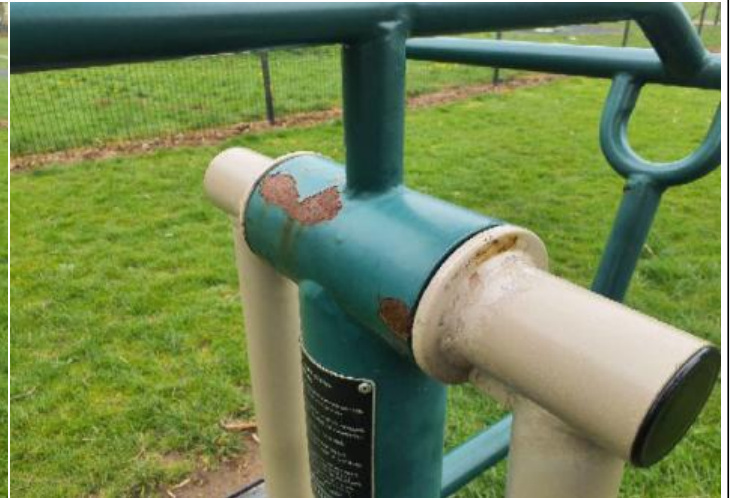
Item: Outdoor Fitness Equipment - Air Skier
Manufacturer: Fresh Air Fitness

Finding: The paintwork on this item has been damaged or worn exposing the metal underneath which is rusting / corroding

Action: Treat affected areas and repaint

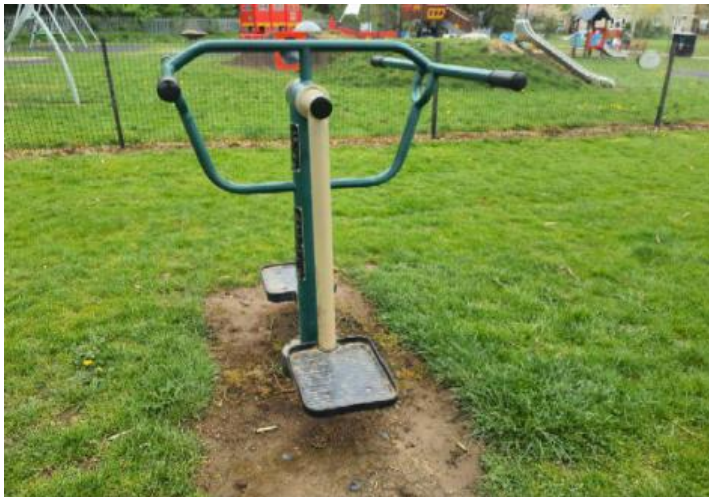
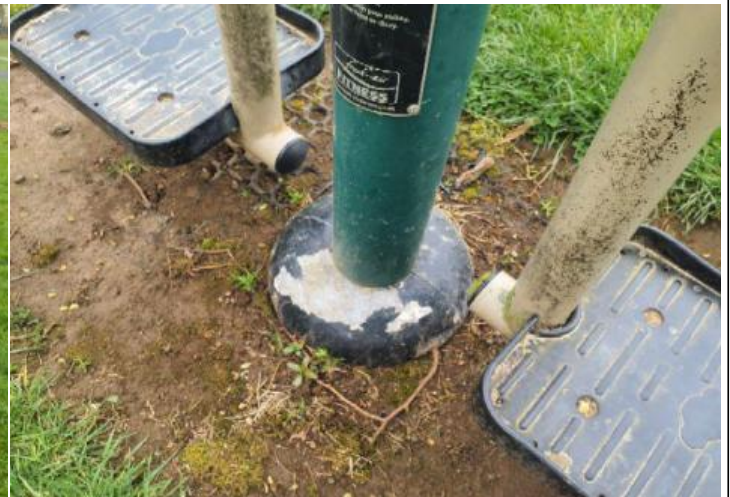
Item: Outdoor Fitness Equipment - Air Skier
Manufacturer: Fresh Air Fitness

Finding: The paint is flaking off the metalwork

Action: Rub down and re-paint

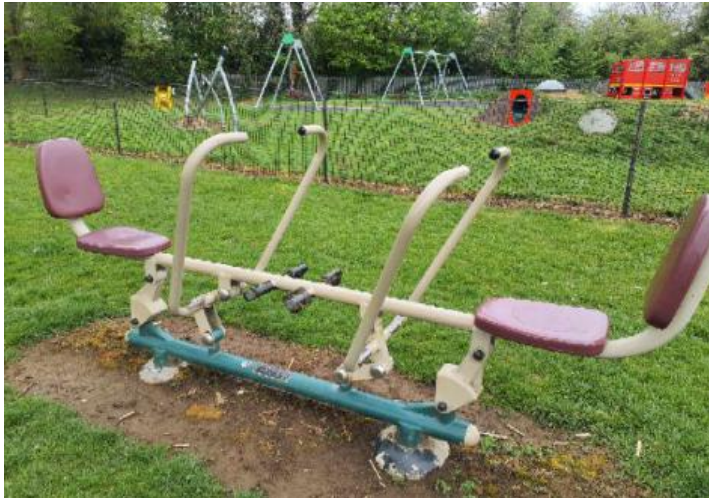
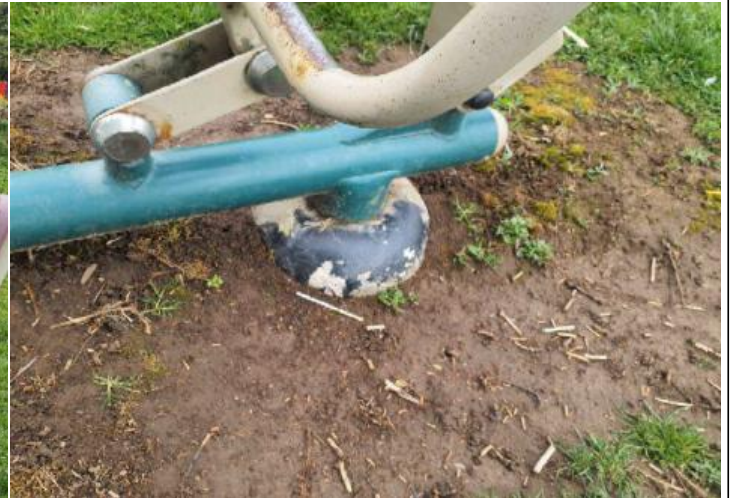
Item: Outdoor Fitness Equipment - Rower
Manufacturer: Fresh Air Fitness

Finding: The paint is flaking off the metalwork

Action: Rub down and re-paint

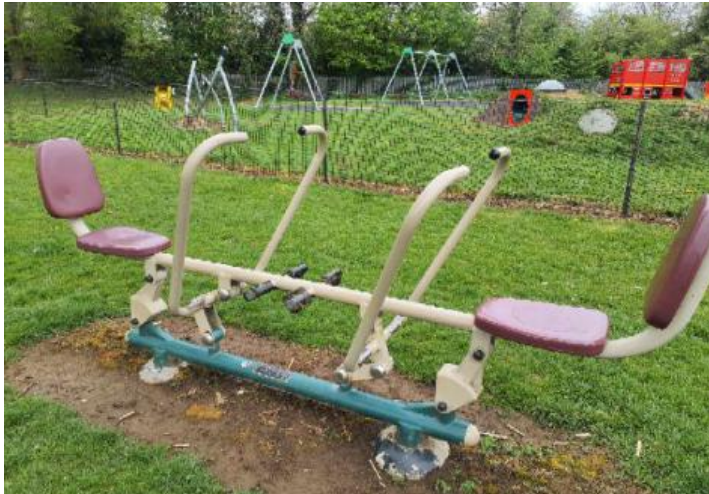
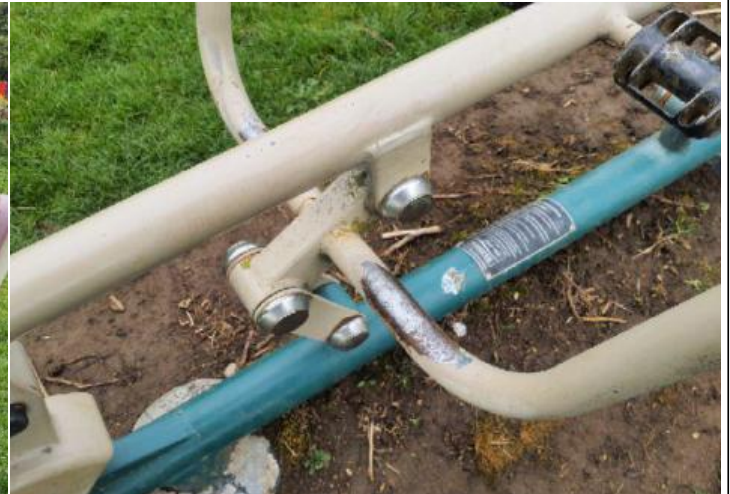
Item: Outdoor Fitness Equipment - Rower
Manufacturer: Fresh Air Fitness

Finding: The paintwork on this item has been damaged or worn exposing the metal underneath which is rusting / corroding

Action: Treat affected areas and repaint

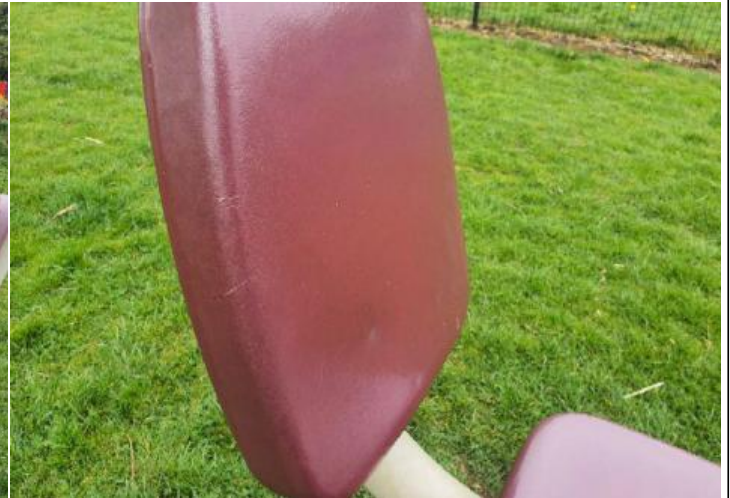
Item: Outdoor Fitness Equipment - Rower
Manufacturer: Fresh Air Fitness

Finding: The seat has been damaged

Action: Monitor for any further deterioration and replace as required

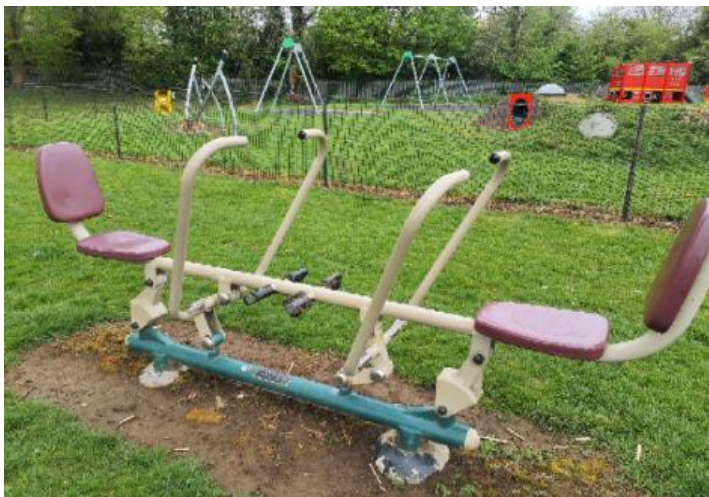
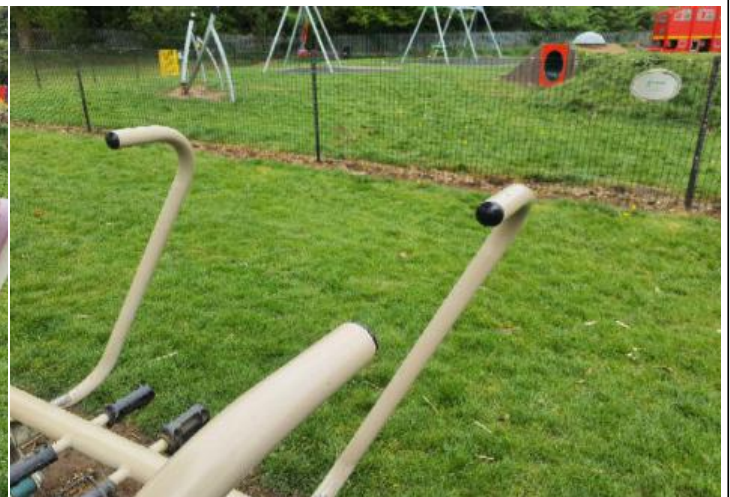
Item: Outdoor Fitness Equipment - Rower
Manufacturer: Fresh Air Fitness

Finding: One or more handgrips are loose

Action: Secure all loose handgrips

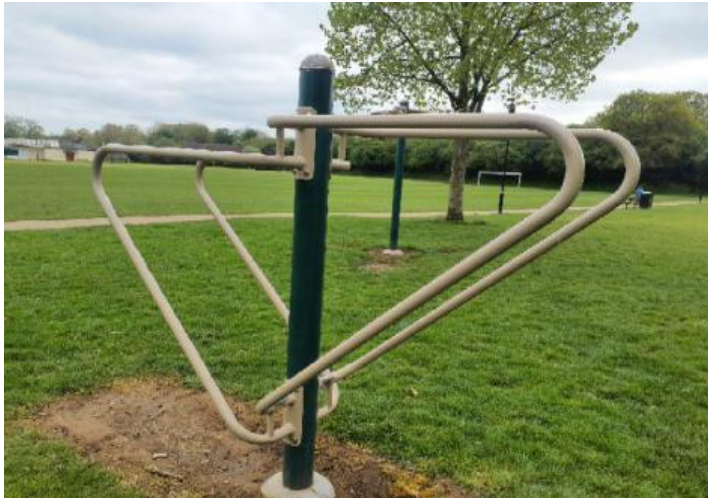
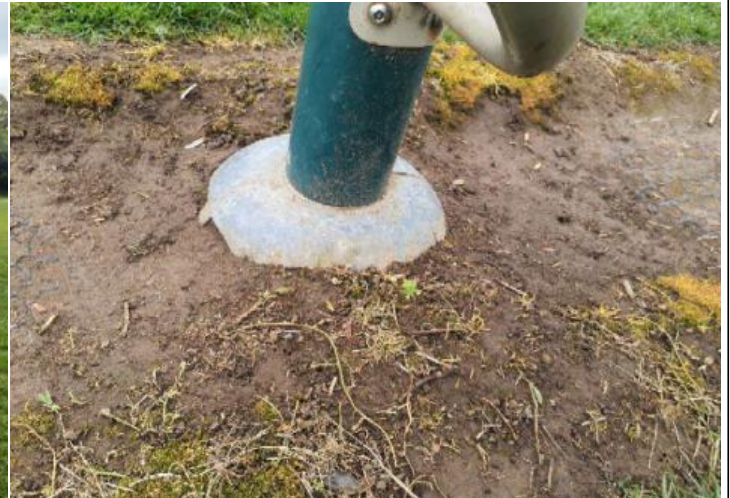
Item: Outdoor Fitness Equipment - Dip Station
Manufacturer: Fresh Air Fitness

Finding: There is surface corrosion / rust present on the item

Action: Consider treating the item

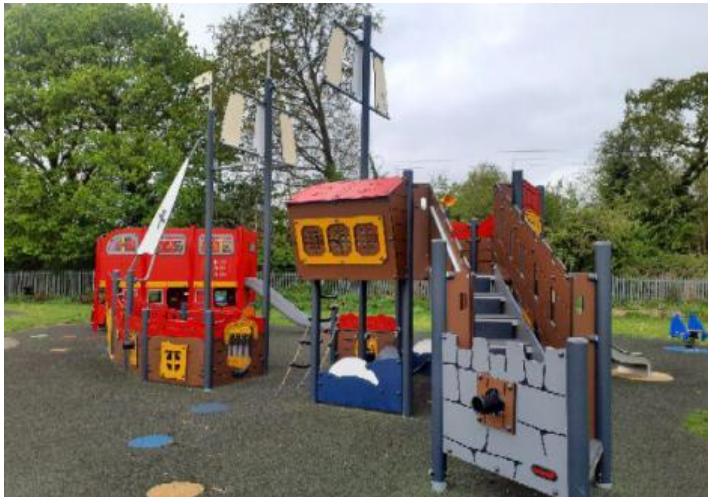
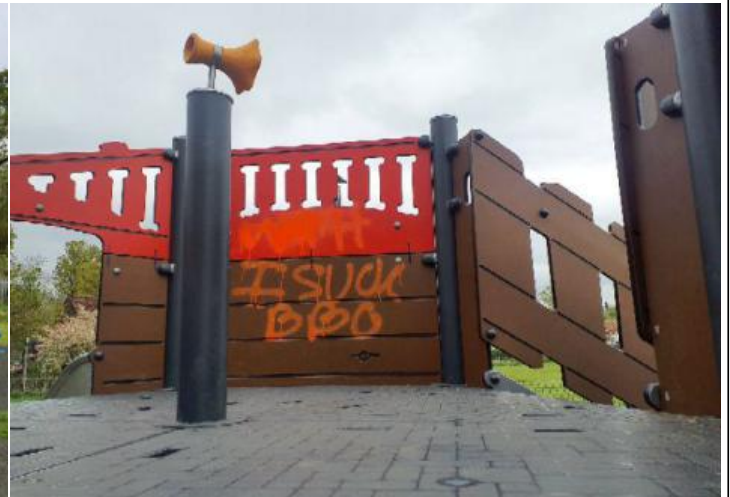
Item: Activity Equipment - Boat
Manufacturer: Kompan Ltd

Finding: There is some graffiti present

Action: Remove the graffiti

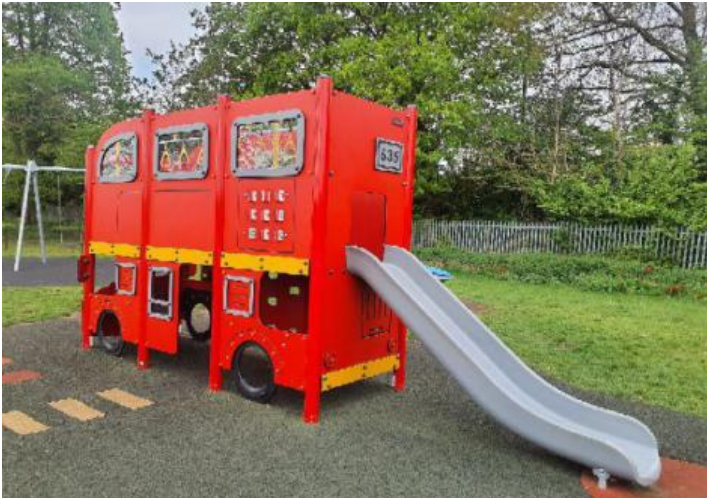
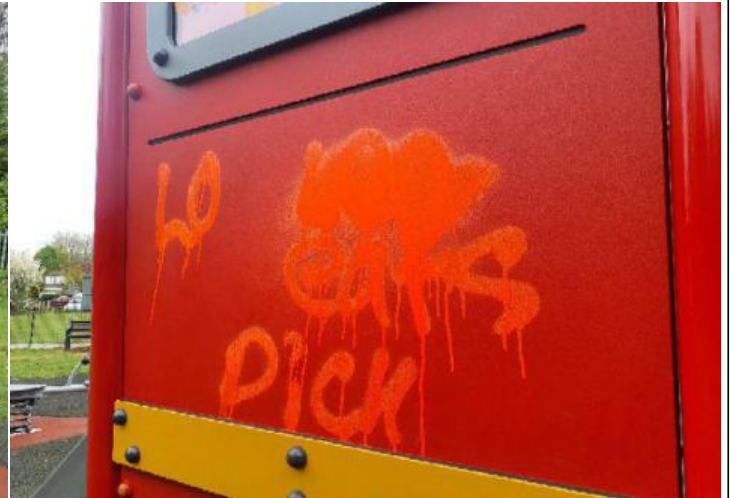
Item: Activity Equipment - Multi Play (Junior)
Manufacturer: Kompan Ltd

Finding: There is some graffiti present

Action: Remove the graffiti

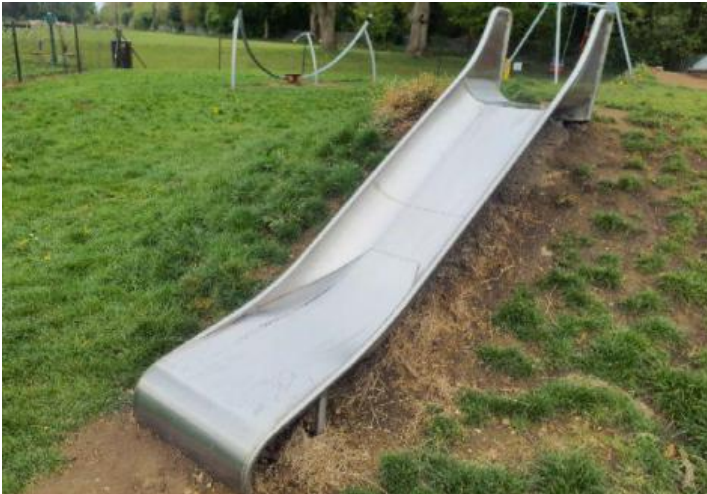
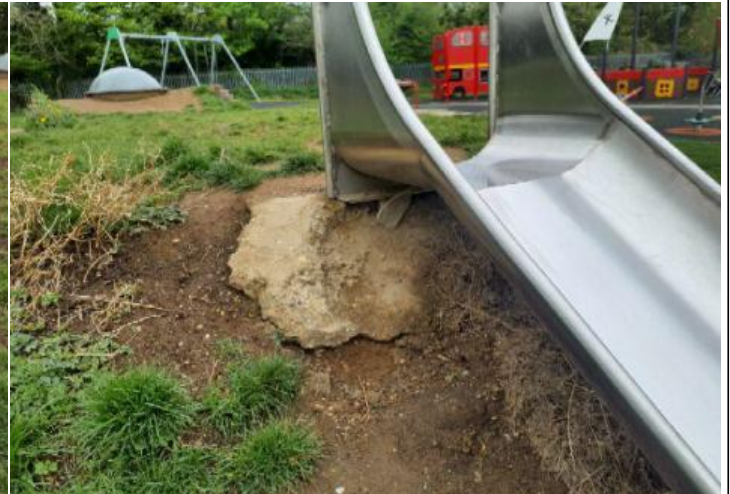
Item: Other - Embankment Slide
Manufacturer: Not Identified

Finding: The surface has eroded and the foundations are exposed

Action: Reinststate surrounding surfaces to cover the foundations

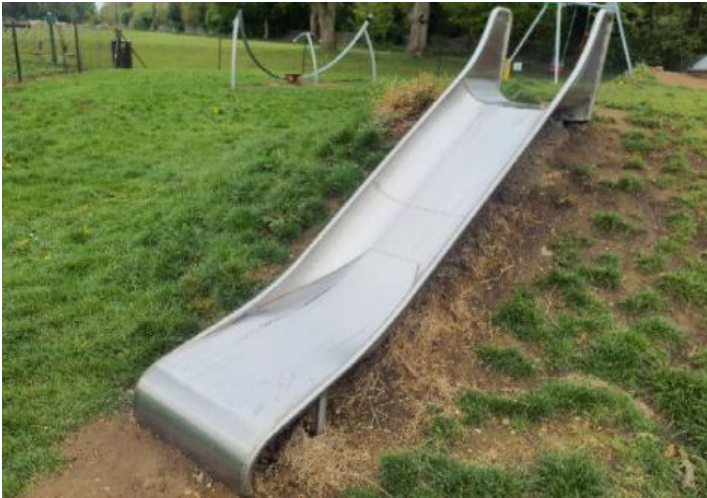
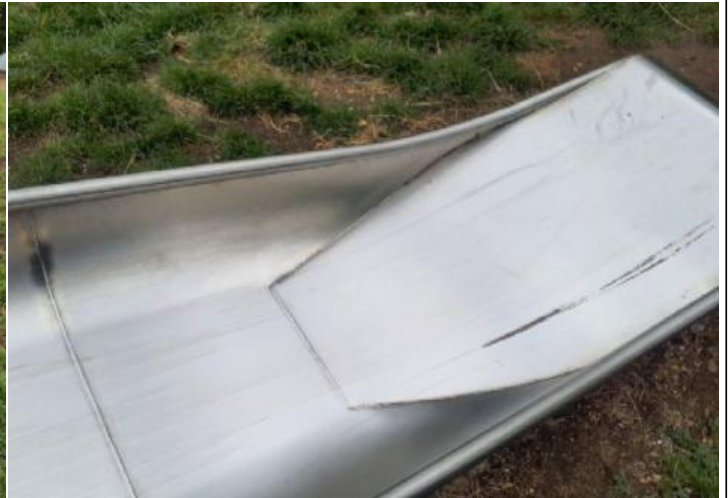
Item: Other - Embankment Slide
Manufacturer: Not Identified

Finding: There are a number of dents in the slide surface

Action: Monitor for any further deterioration and repair as required

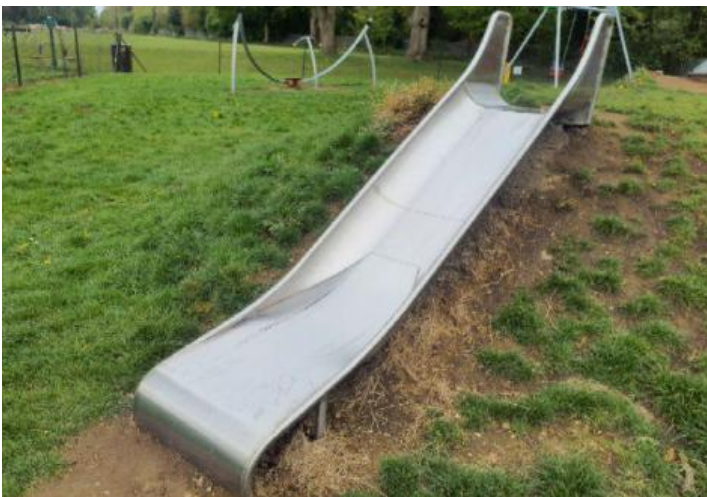
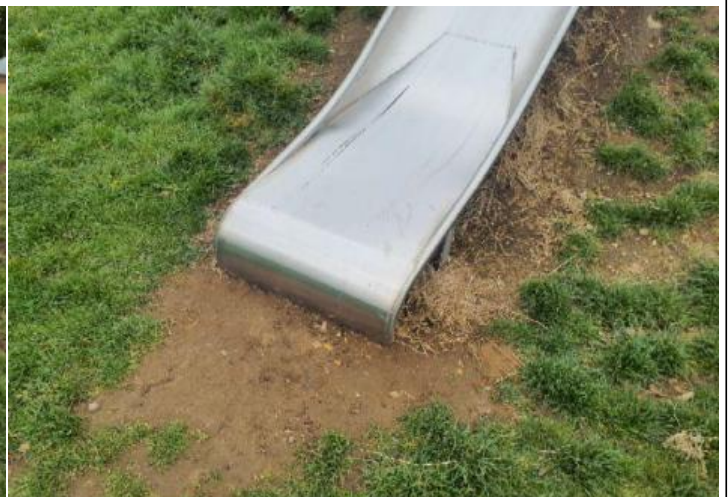
Item: Other - Embankment Slide
Manufacturer: Not Identified

Finding: The grass has eroded within the impact area of the equipment and may not provide the necessary impact attenuating properties for the equipment fall height; the surface may also be slippery in wet weather

Action: Reinstate the grass or provide an all weather surface

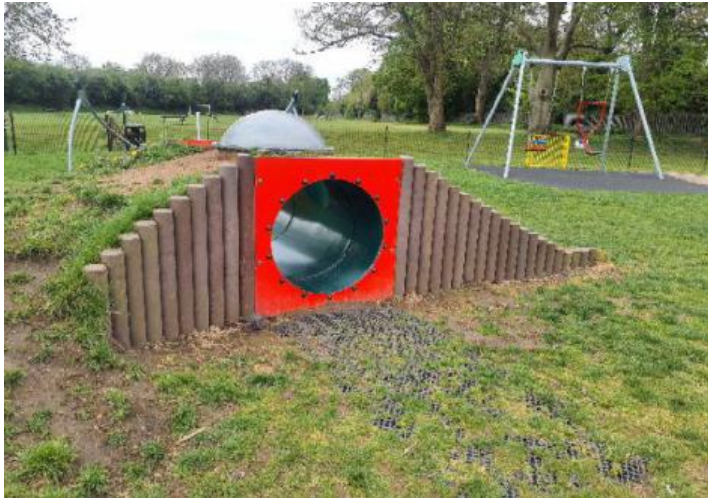
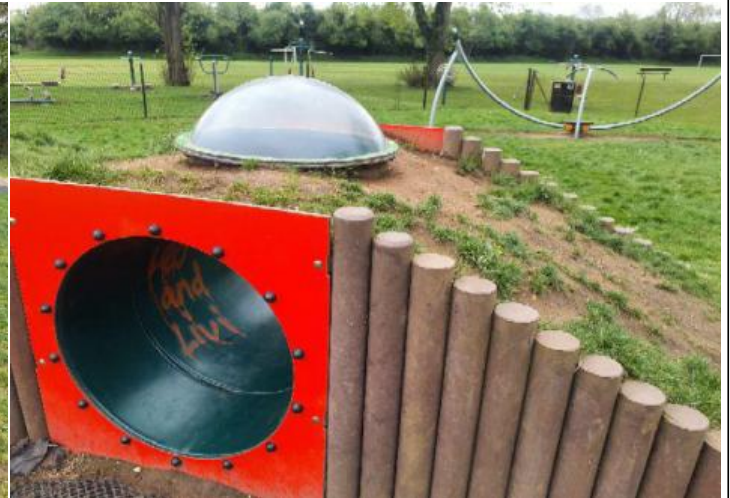
Item: Other - Tunnel Mound
Manufacturer: Playdale Playgrounds Ltd

Finding: This design / configuration of tunnel mound is well established and has been successfully included in large quantities of playgrounds throughout the UK. Whilst the design does not fully meet the requirements of BS EN 1176 with regards to falls in excess of 600mm over the edge of the tunnel to the surface below, it has been risk assessed as fit for purpose in this regard and no changes are recommended to the design unless otherwise stated in additional findings

Action: Monitor - No action given the risk assessment

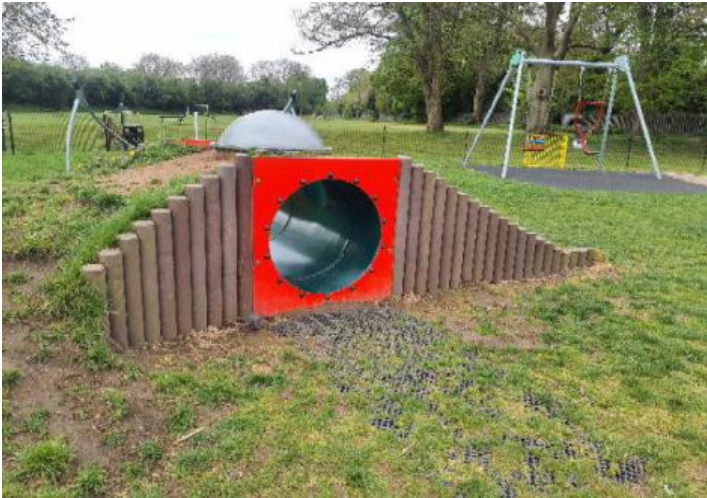
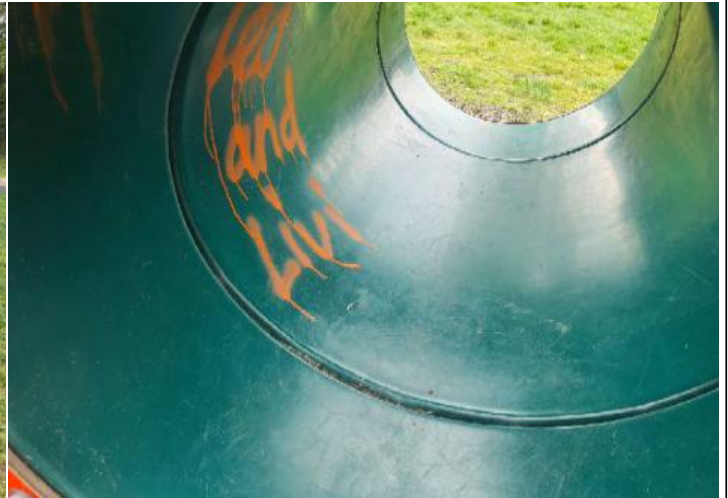
Item: Other - Tunnel Mound
Manufacturer: Playdale Playgrounds Ltd

Finding: There is some graffiti present

Action: Remove the graffiti

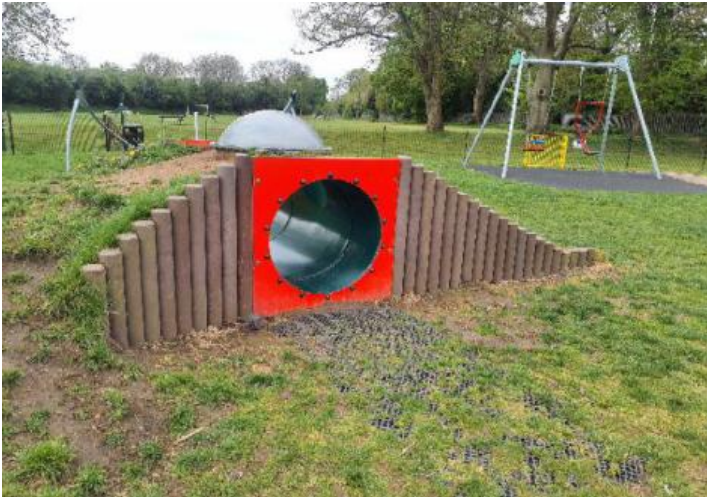
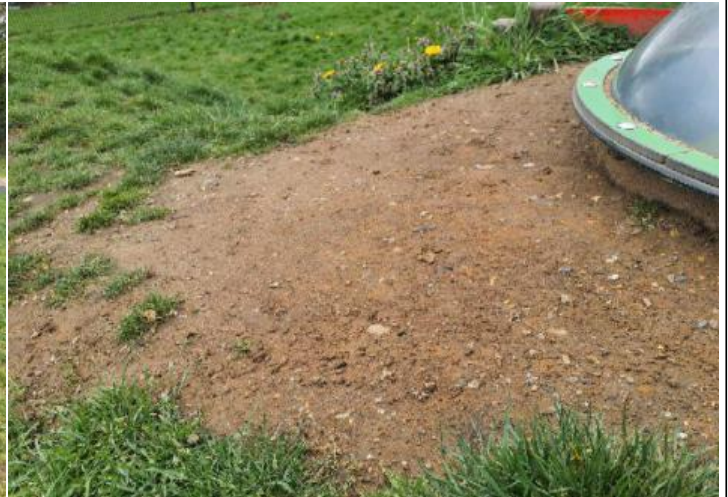
Item: Other - Tunnel Mound
Manufacturer: Playdale Playgrounds Ltd

Finding: The area around the item has eroded and may become slippery

Action: Reinstate eroded area
