ST STEPHEN PARISH COUNCIL

You are summoned to the Fixed Assets Committee meeting

AGENDA

| 2526/AC/013 | To receive Annual Play Inspection Reports. Reports attached. |

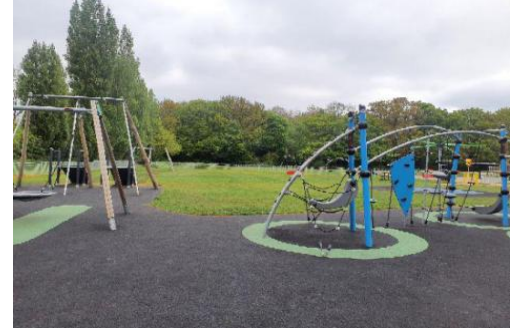
Item: Site General
Manufacturer: Owner/Operator
Surface Type: N/A
Item Quantity: 1
Equipment Compliance: N/A
Surface Area Compliance: N/A

There are trip hazards at the edges of the surface - Remove trip hazard

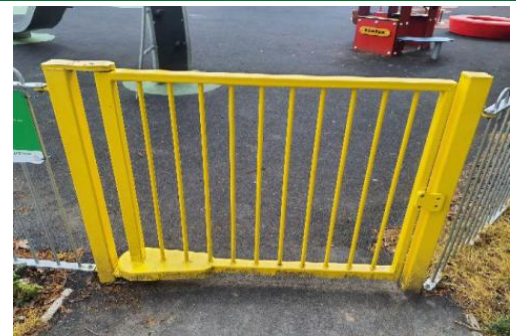
Item: Gate - Self Closing
Manufacturer: I.A.E. Fencing
Surface Type: Wet Pour
Item Quantity: 1
Equipment Compliance: N/A
Surface Area Compliance: N/A

There are trip hazards at the edges of the surface - Remove trip hazard

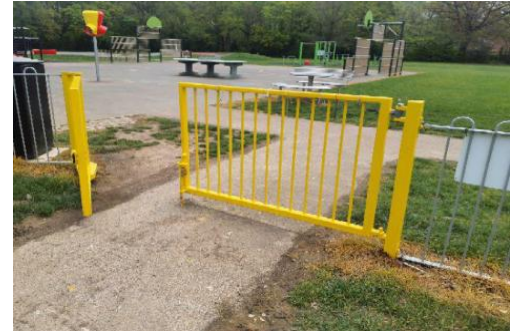
Item: Gate - Combination
Manufacturer: I.A.E. Fencing
Surface Type: Concrete
Item Quantity: 1
Equipment Compliance: N/A
Surface Area Compliance: N/A

The gate is not operating correctly - Take effective action to ensure the gate closes between 4 and 8 seconds

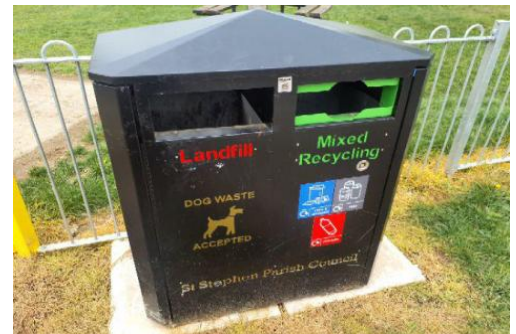
Item: Litter Bin
Manufacturer: Broxap
Surface Type: Grass
Item Quantity: 3
Equipment Compliance: N/A
Surface Area Compliance: N/A

The bin is not securely fixed to the surface and there is some possibility of the item tipping or rolling over - Secure the bin to the ground

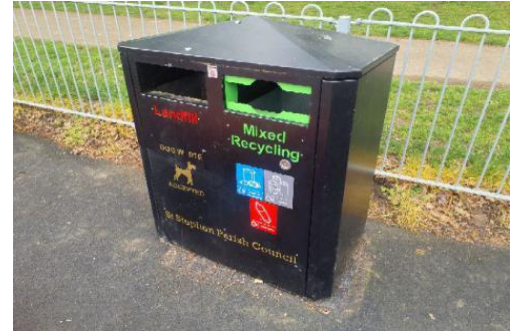
Item: Litter Bin
Manufacturer: Broxap
Surface Type: Wet Pour
Item Quantity: 1
Equipment Compliance: N/A
Surface Area Compliance: N/A

The bin is not securely fixed to the surface and there is some possibility of the item tipping or rolling over - Secure the bin to the ground

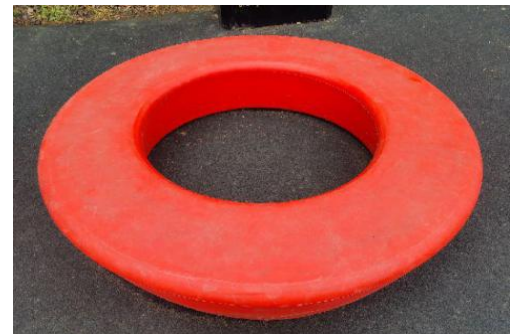
Item: Seating Area
Manufacturer: Not Identified
Surface Type: Wet Pour
Item Quantity: 1
Equipment Compliance: N/A
Surface Area Compliance: N/A

The bench/es is/are not securely fixed to the surface and there is some possibility of the item/s tipping or rolling over -
Secure to the ground

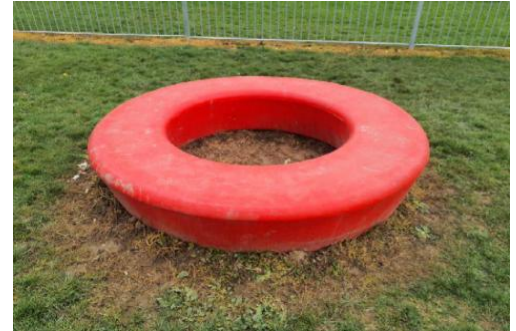
Item: Seating Area
Manufacturer: Not Identified
Surface Type: Grass
Item Quantity: 1
Equipment Compliance: N/A
Surface Area Compliance: N/A

The bench/es is/are not securely fixed to the surface and there is some possibility of the item/s tipping or rolling over - Secure to the ground

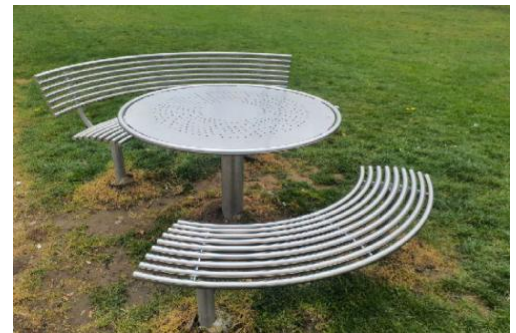
Item: Picnic Table
Manufacturer: Not Identified
Surface Type: Grass
Item Quantity: 2
Equipment Compliance: N/A
Surface Area Compliance: N/A

The surface has eroded and the foundations are exposed - Reinststate surrounding surfaces to cover the foundations

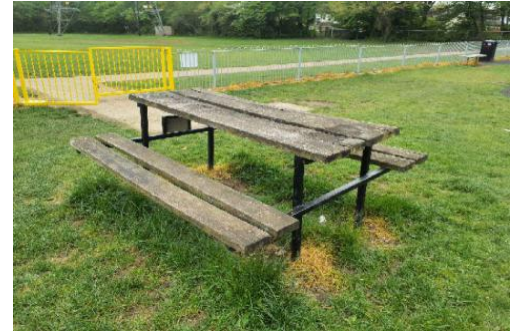
Item: Picnic Table
Manufacturer: Not Identified
Surface Type: Grass
Item Quantity: 1
Equipment Compliance: N/A
Surface Area Compliance: N/A

There is some evidence of fire damage to the item - Monitor for any further deterioration and repair as required

There is some evidence of rot in the timber - Monitor for any further deterioration and replace as required

The timber has a number of splits/shakes or air cracks and this may affect the stability or allow water ingress which will accelerate the rotting process - Monitor to ensure the splits do not cross through fixing points of the structure and/or cause any instability

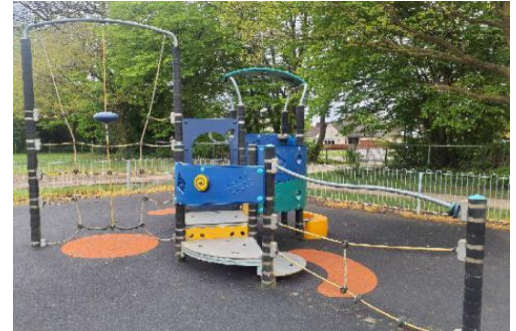
Item: Multi Play (Junior)
Manufacturer: Kompan Ltd
Surface Type: Wet Pour
Item Quantity: 1
Equipment Compliance: No
Surface Area Compliance: Yes
Life Expectancy: >10 Years
Total Findings: 5

There is/are finger entrapment/s due to missing end cap and the item fails to meet the requirements of BS EN 1176 Part 1 4.2.7.6 Entrapment of fingers - Replace missing end cap to remove entrapment

A number of fixing(s) have worked loose - Secure all loose fixings

The ropes/nets are worn/damaged in places - Monitor for any further deterioration and repair or replace as required

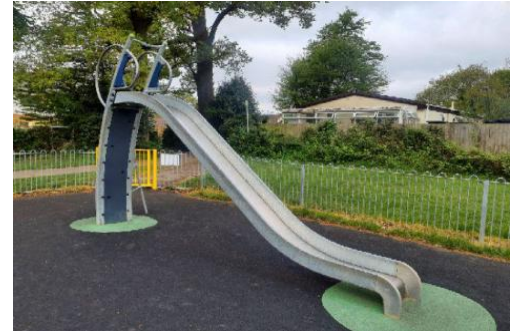
Item: Free Standing Slide
Manufacturer: Kompan Ltd
Surface Type: Wet Pour
Item Quantity: 1
Equipment Compliance: No
Surface Area Compliance: Yes

There are a number of dents in the slide surface - Monitor for any further deterioration and repair as required

There is/are finger entrapment/s due to missing fixings and the item fails to meet the requirements of BS EN 1176 Part 1 4.2.7.6 Entrapment of fingers - Replace missing fixings to remove entrapment

There is/are finger entrapment/s in the starting section of the slide and the item fails to meet the requirements of BS EN 1176 Part 1 4.2.7.6 Entrapment of fingers - Monitor - No action given the risk assessment

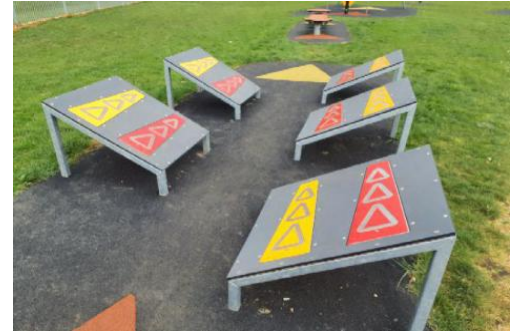
Item: Slanted Steps
Manufacturer: Proludic
Surface Type: Wet Pour
Item Quantity: 1
Equipment Compliance: No
Surface Area Compliance: Yes

The item has exposed edges and corners that are sharp, or with a radius of less than 3mm, and does not meet the requirements of BS EN 1176 Part 1 - 4.2.5 - Provide a 3mm radius to all exposed edges and corners, or remove sharp edge

There is or are fixings missing on the item - Replace all missing fixings

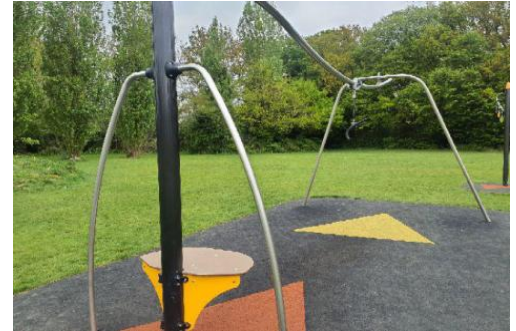
Item: Cable Runway - Hanging
Manufacturer: Proludic
Surface Type: Wet Pour
Item Quantity: 1
Equipment Compliance: Yes
Surface Area Compliance: Yes

There is/are bolt cap covers missing or damaged on the item - Replace missing or damaged bolt cap covers

There is some notable evidence of chain wear - Monitor for any further deterioration and replace when 40% worn

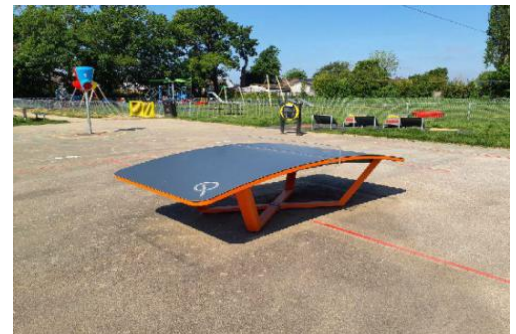
Item: Head Tennis Table
Manufacturer: Teqball
Surface Type: Bitmac
Item Quantity: 1
Equipment Compliance: Yes
Surface Area Compliance: N/A

There is/are bolt cap covers missing or damaged on the item - Replace missing or damaged bolt cap covers

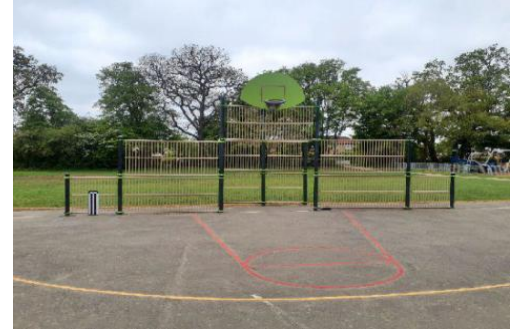
Item:	Multi Use Games Area (MUGA)
Manufacturer:	Proludic
Surface Type:	Bitmac
Item Quantity:	1
Equipment Compliance:	Yes
Surface Area Compliance:	N/A
Life Expectancy:	>10 Years
Total Findings:	2

A clearly visible facility sign should be provided in a prominent position with the wording as detailed BS EN 15312- the equipment is not intended for children less than 3 years old- the warning - Do not climb on the framework or nets- the warning - Do not hang on the ring (if provided)- the warning - Do not wear rings or other jewellery- name and telephone number of the administrator- number to call in case of accident - Provide signage to BS EN 15312

There is / are post or end caps missing / damaged on the item - Replace missing / damaged post or end caps

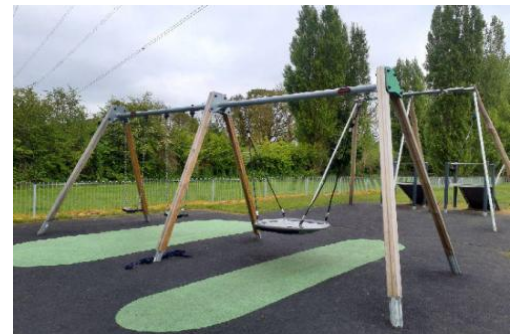
Item: 2 Bay 2 Flat 1 Basket Seat
Manufacturer: Kompan Ltd
Surface Type: Wet Pour
Item Quantity: 1
Equipment Compliance: Yes
Surface Area Compliance: Yes

The secondary safety shackles are worn in excess of 40% and require renewing - Replace worn shackles

The bushes are showing signs of wear - Monitor for any further deterioration and replace as required

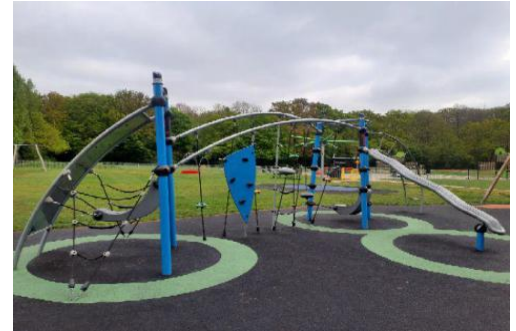
Item: Climbing Frame
Manufacturer: Kompan Ltd
Surface Type: Wet Pour
Item Quantity: 1
Equipment Compliance: No
Surface Area Compliance: Yes

There is/are finger entrapment/s in the framework / climbing wall and the item fails to meet the requirements of BS EN 1176 Part 1 4.2.7.6 Entrapment of fingers - Monitor - No action given the risk assessment

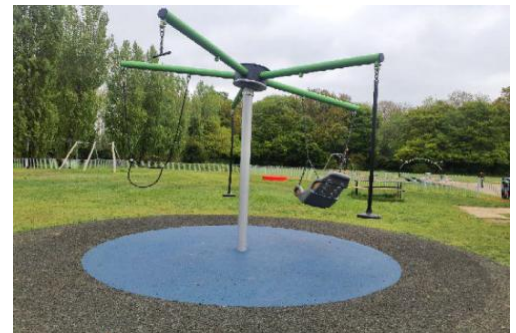
Item: Titan
Manufacturer: Hags
Surface Type: Mixed Surface
Item Quantity: 1
Equipment Compliance: Yes
Surface Area Compliance: Yes

The seat has been damaged - Monitor for any further deterioration and replace as required

The seat connection cannot be inspected without dismantling the seat - Dismantle the seat to inspect the seat connection for wear

There is some notable evidence of chain wear - Monitor for any further deterioration and replace when 40% worn

The split pins are missing from the shackles - Insert split pins to secure the shackles

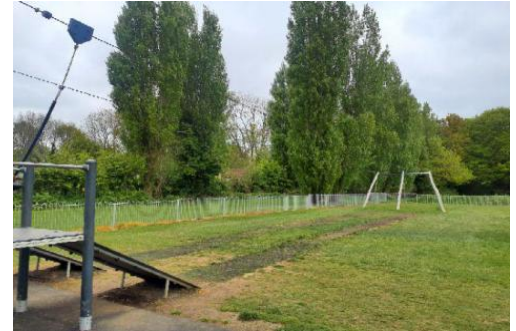
Finding 1

The edges of the grass mat surface are raised / lifting above the surrounding surface - Tuck in or pin edges of grass mats as per the API Code of Practice to remove trip hazards

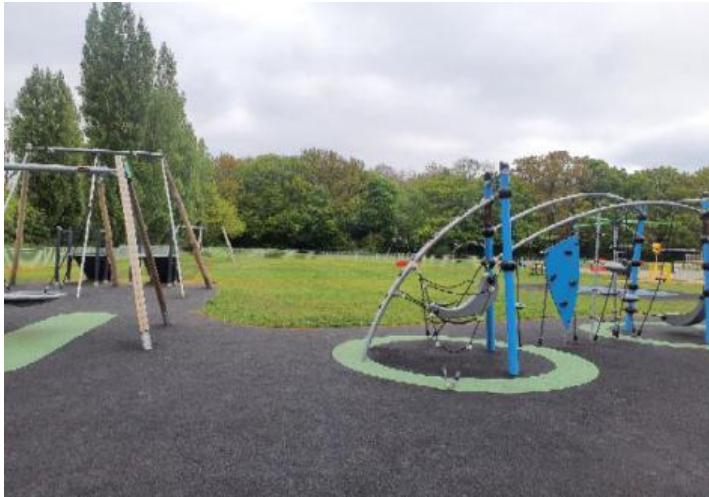
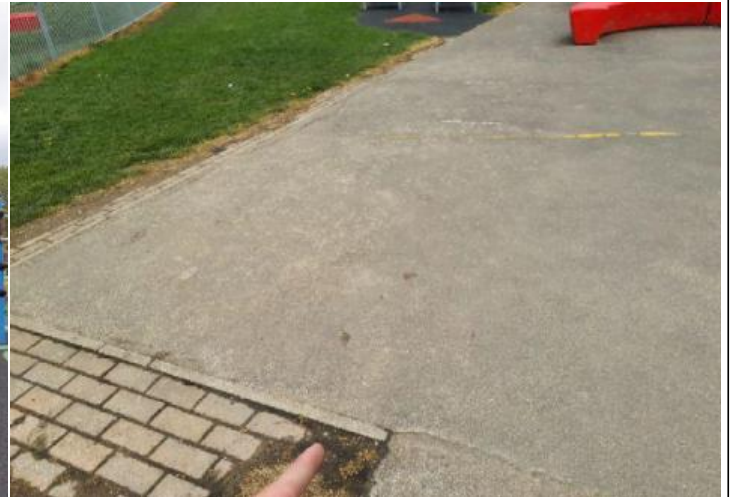
Item: Ancillary Items - Site General
Manufacturer: Owner/Operator

Finding: There are trip hazards at the edges of the surface **Action:** Remove trip hazard

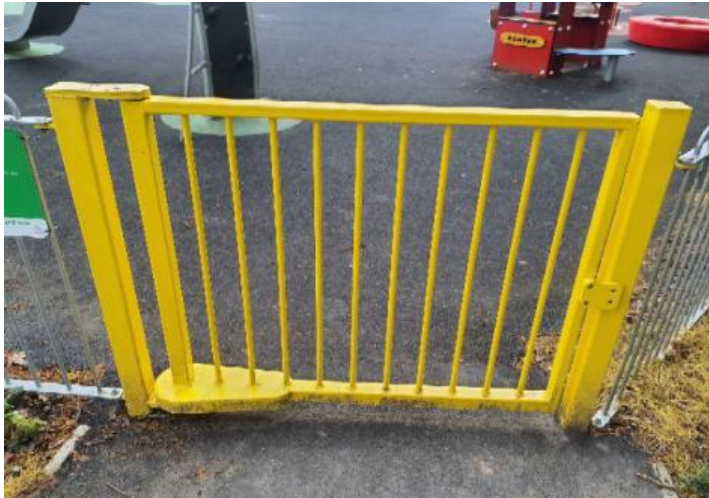
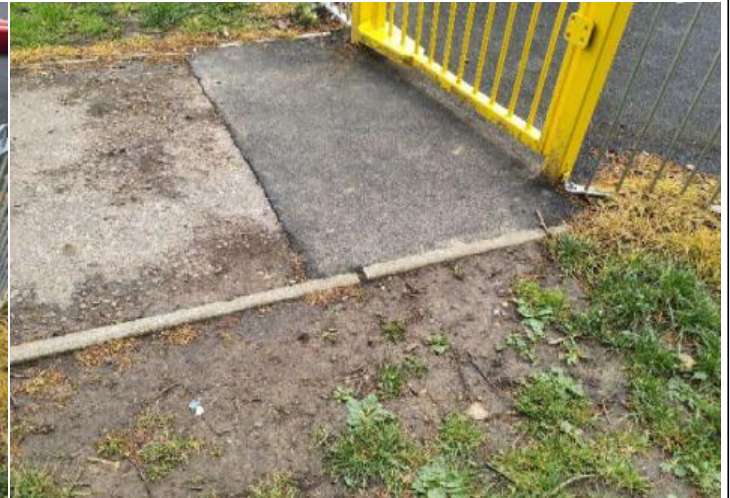
Item: Gates - Gate - Self Closing
Manufacturer: I.A.E. Fencing

Finding: There are trip hazards at the edges of the surface **Action:** Remove trip hazard

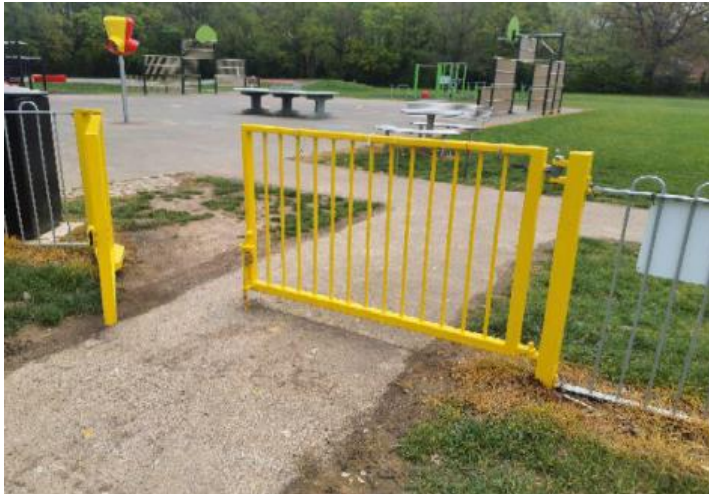
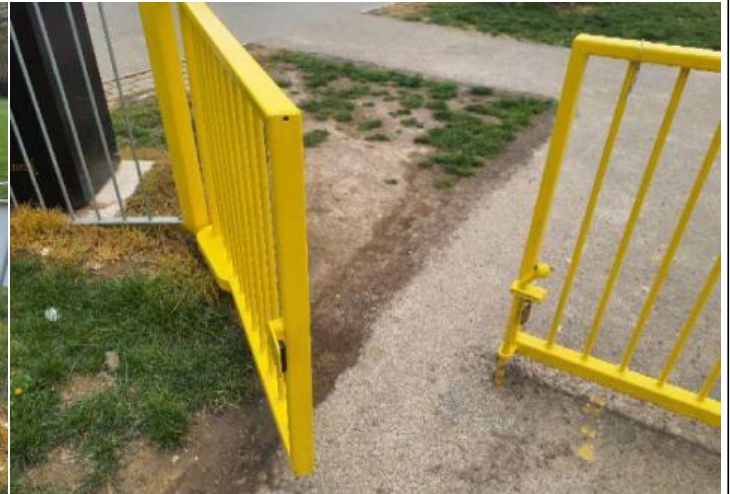
Item: Gates - Gate - Combination
Manufacturer: I.A.E. Fencing

Finding: The gate is not operating correctly **Action:** Take effective action to ensure the gate closes between 4 and 8 seconds

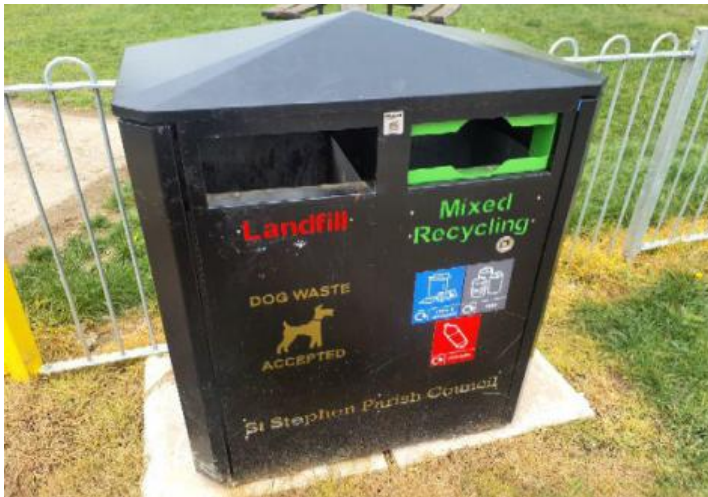
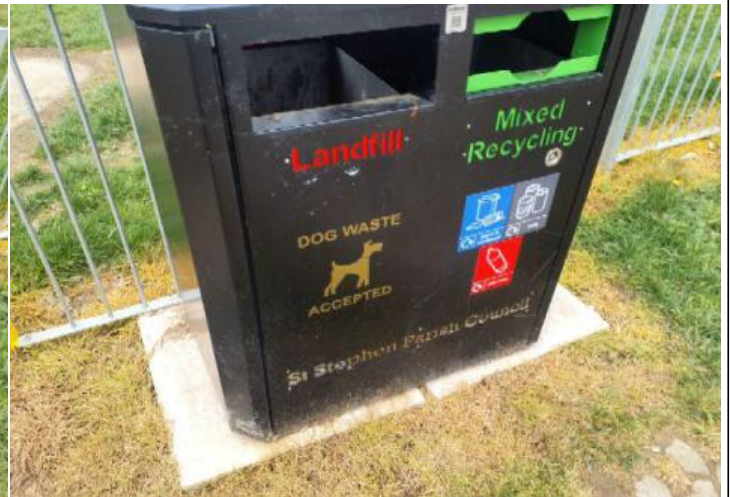
Item: Ancillary Items - Litter Bin
Manufacturer: Broxap

Finding: The bin is not securely fixed to the surface and there is some possibility of the item tipping or rolling over

Action: Secure the bin to the ground

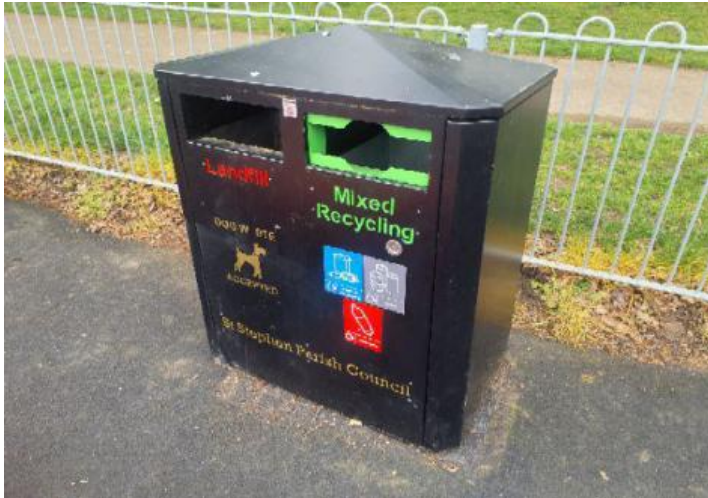
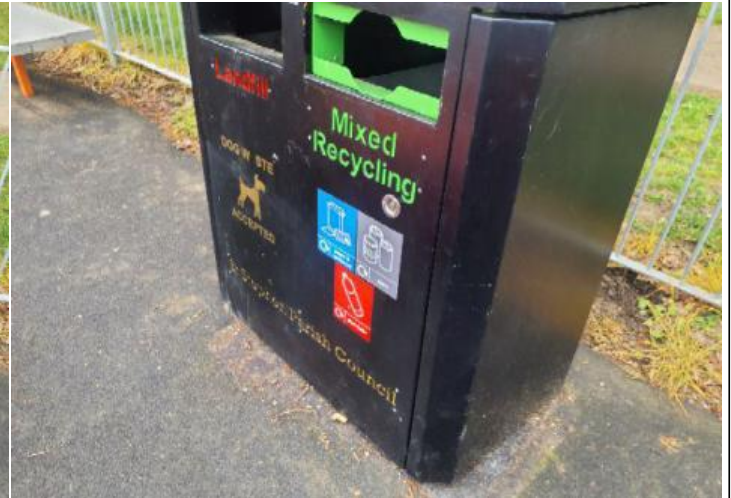
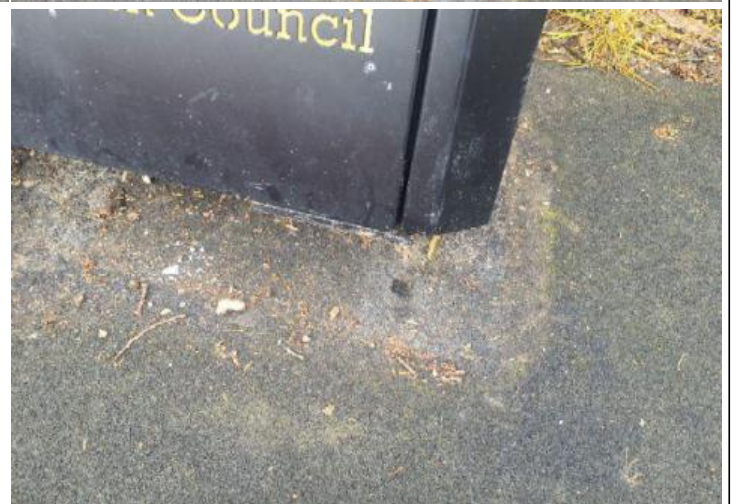
Item: Ancillary Items - Litter Bin
Manufacturer: Broxap

Finding: The bin is not securely fixed to the surface and there is some possibility of the item tipping or rolling over

Action: Secure the bin to the ground

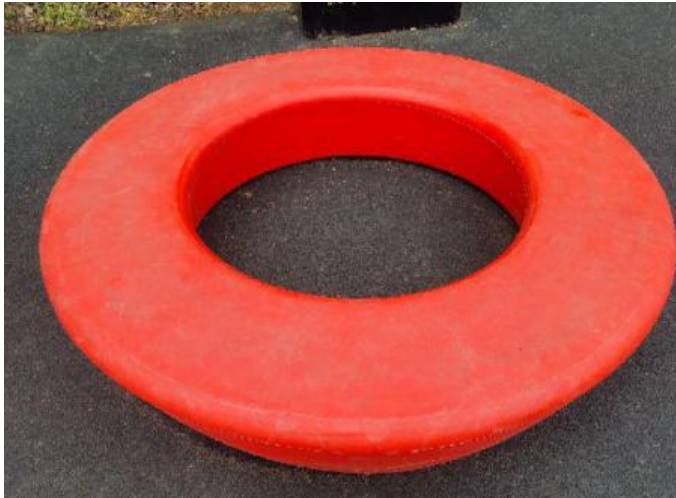
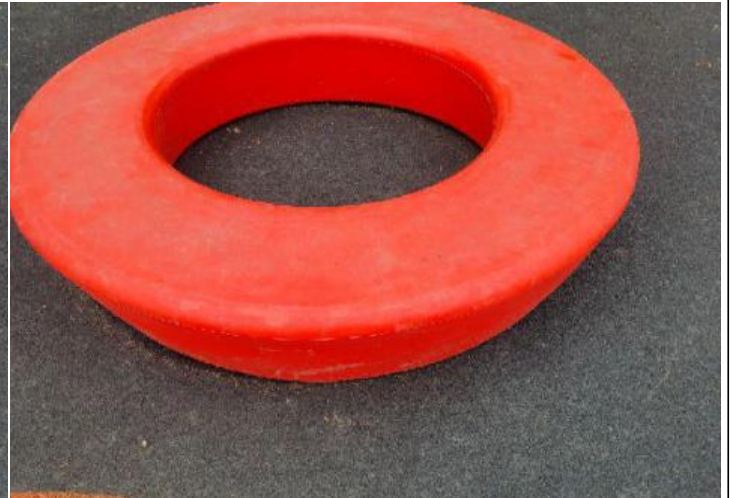
Item: Ancillary Items - Seating Area
Manufacturer: Not Identified

Finding: The bench/es is/are not securely fixed to the surface and there is some possibility of the item/s tipping or rolling over

Action: Secure to the ground

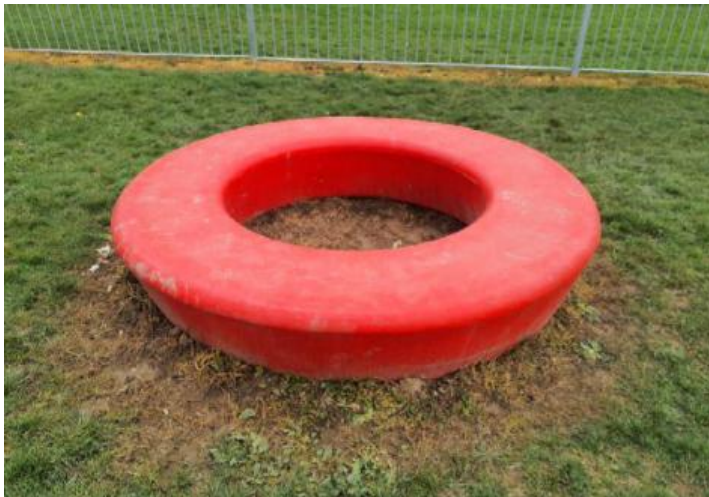
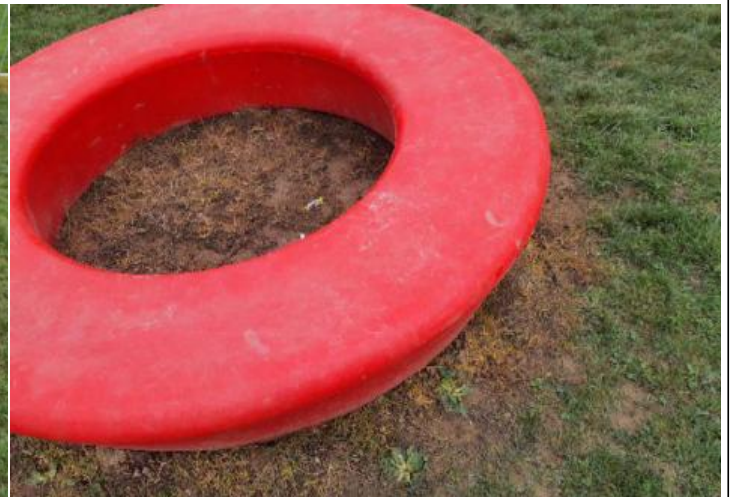
Item: Ancillary Items - Seating Area
Manufacturer: Not Identified

Finding: The bench/es is/are not securely fixed to the surface and there is some possibility of the item/s tipping or rolling over

Action: Secure to the ground

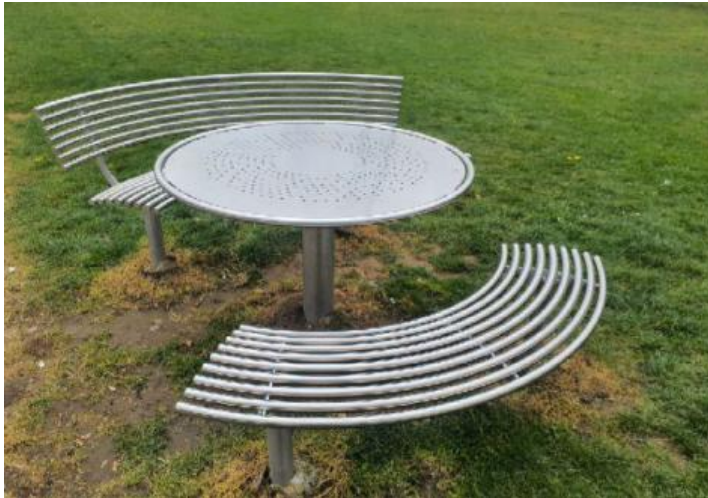
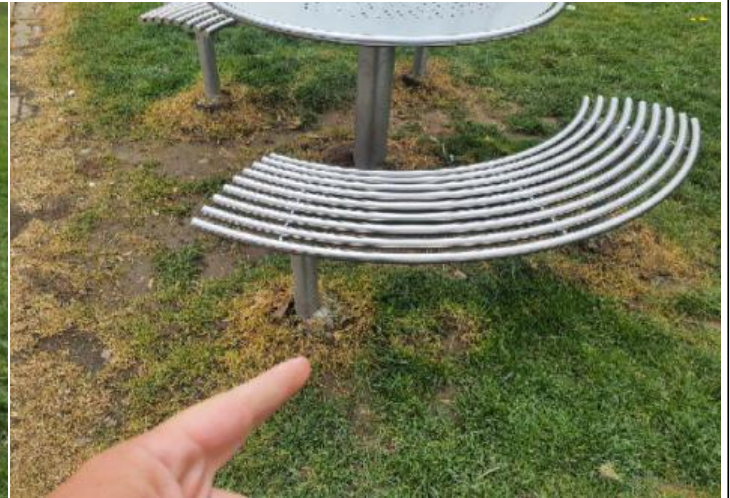
Item: Ancillary Items - Picnic Table
Manufacturer: Not Identified

Finding: The surface has eroded and the foundations are exposed

Action: Reinstall surrounding surfaces to cover the foundations

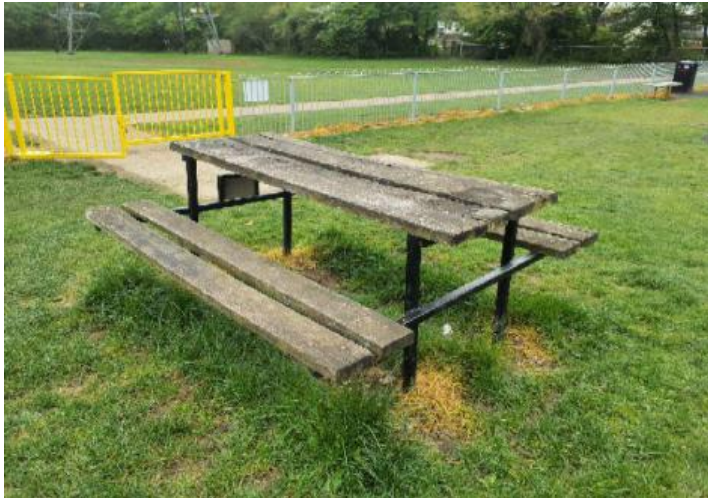
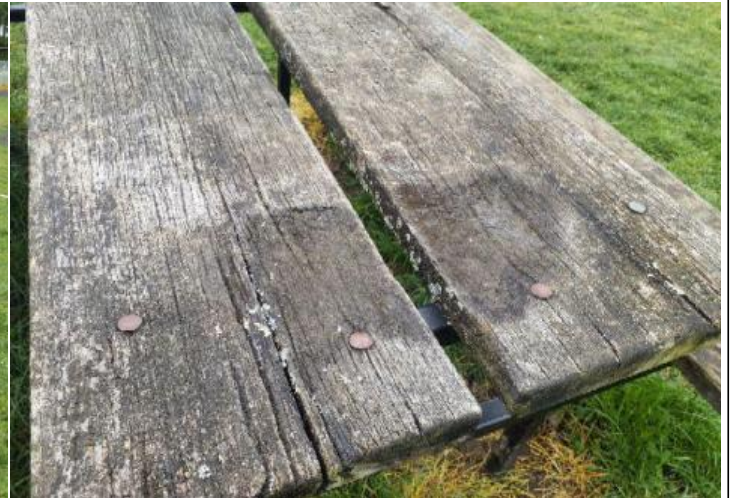
Item: Ancillary Items - Picnic Table
Manufacturer: Not Identified

Finding: There is some evidence of fire damage to the item **Action:** Monitor for any further deterioration and repair as required

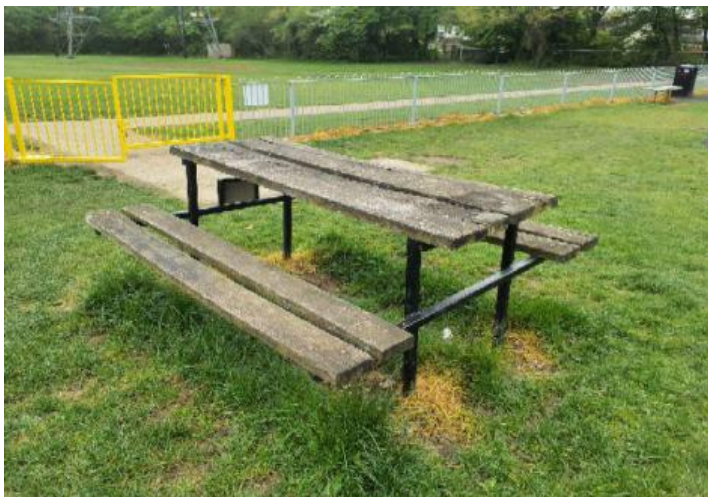
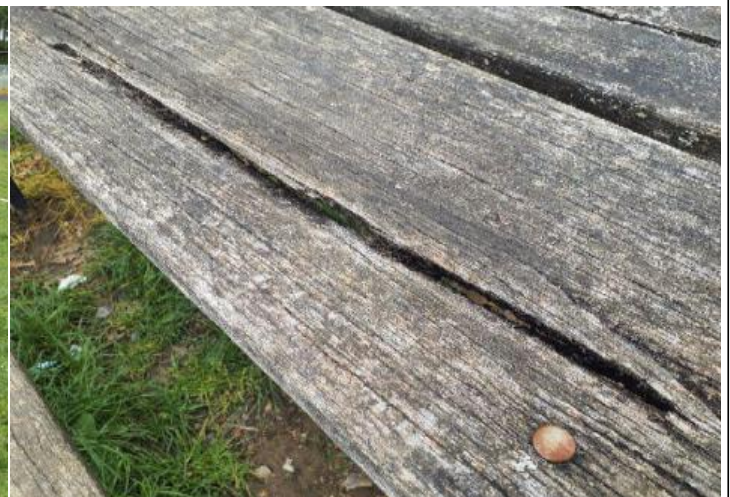
Item: Ancillary Items - Picnic Table
Manufacturer: Not Identified

Finding: There is some evidence of rot in the timber **Action:** Monitor for any further deterioration and replace as required

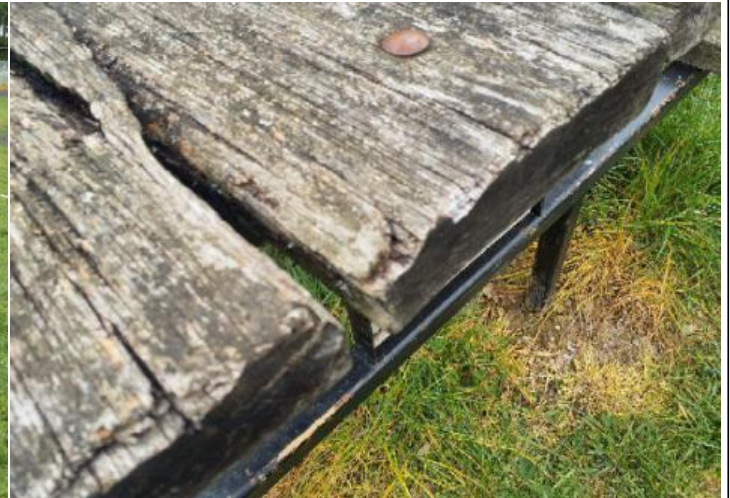
Item: Ancillary Items - Picnic Table
Manufacturer: Not Identified

Finding: Parts of the timber are rough or splintered

Action: Remove all rough or sharp edges

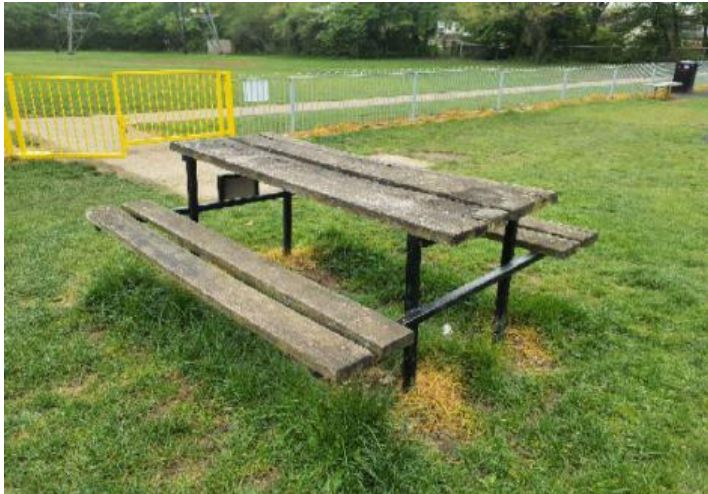
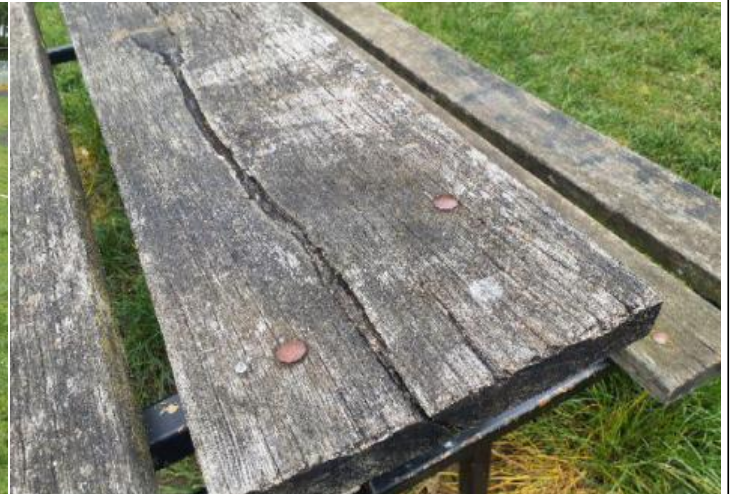
Item: Ancillary Items - Picnic Table
Manufacturer: Not Identified

Finding: The timber has a number of splits/shakes or air cracks and this may affect the stability or allow water ingress which will accelerate the rotting process

Action: Monitor to ensure the splits do not cross through fixing points of the structure and/or cause any instability

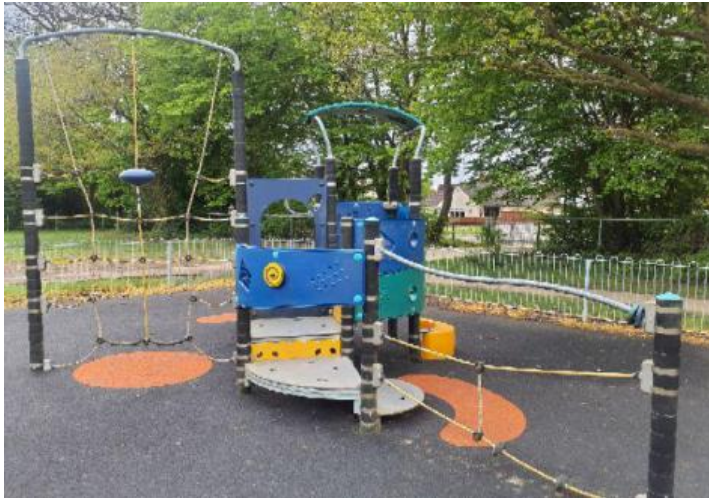
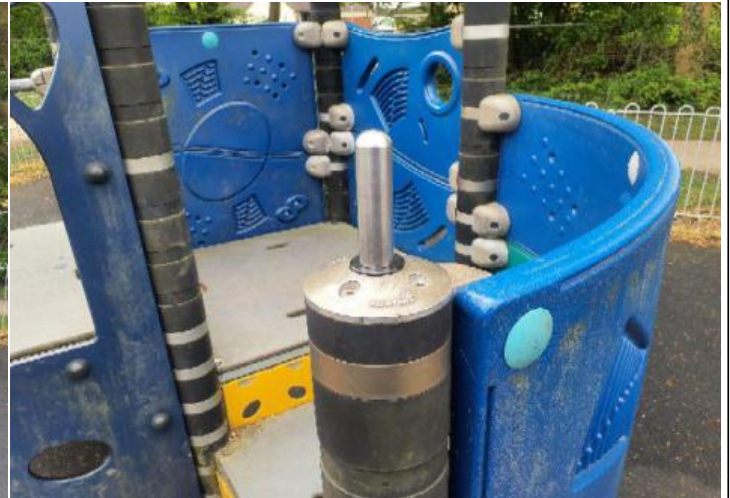
Item: Activity Equipment - Multi Play (Junior)
Manufacturer: Kompan Ltd

Finding: There is/are finger entrapment/s due to missing end cap and the item fails to meet the requirements of BS EN 1176 Part 1 4.2.7.6 Entrapment of fingers

Action: Replace missing end cap to remove entrapment

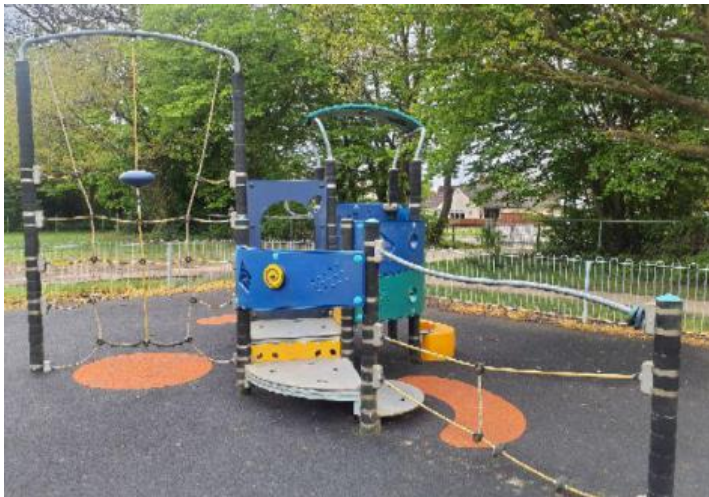
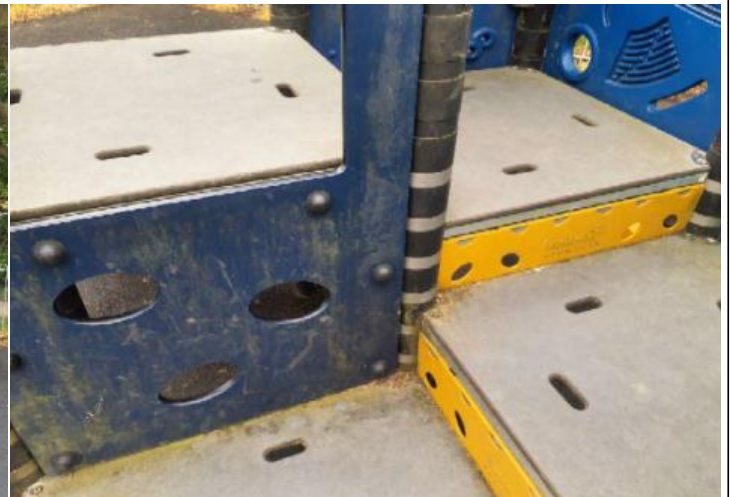
Item: Activity Equipment - Multi Play (Junior)
Manufacturer: Kompan Ltd

Finding: There is algae or moss on the surface of the equipment

Action: Clean and treat appropriately

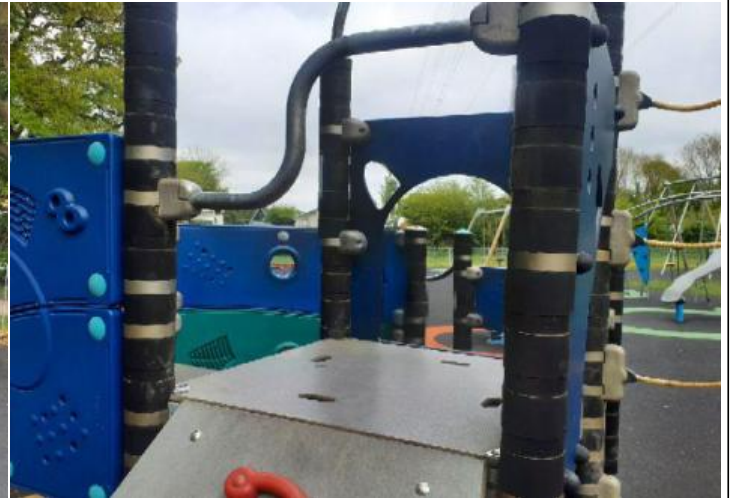
Item: Activity Equipment - Multi Play (Junior)
Manufacturer: Kompan Ltd

Finding: The unit is easily accessible and has an opening in the barrier to steep play elements in excess of 500mm in contravention of BS EN 1176 Part 1

Action: Monitor - No action given the risk assessment

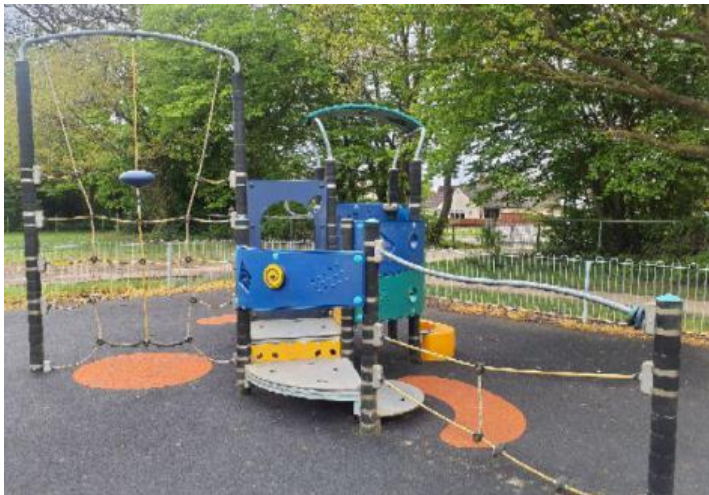
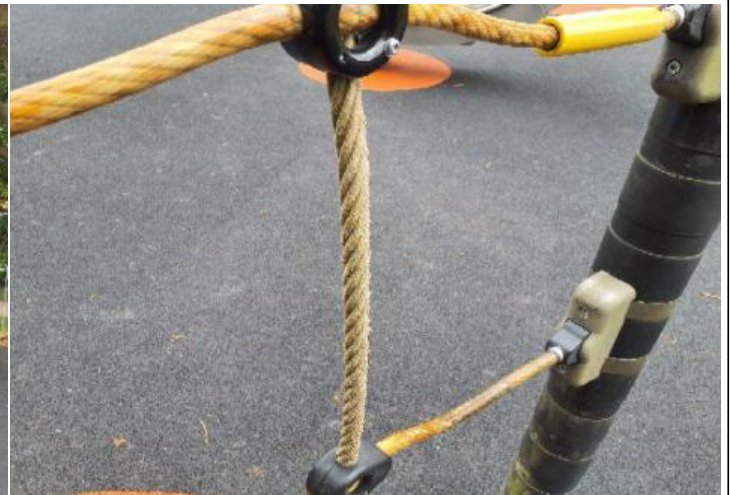
Item: Activity Equipment - Multi Play (Junior)
Manufacturer: Kompan Ltd

Finding: The ropes/nets are worn/damaged in places

Action: Monitor for any further deterioration and repair or replace as required

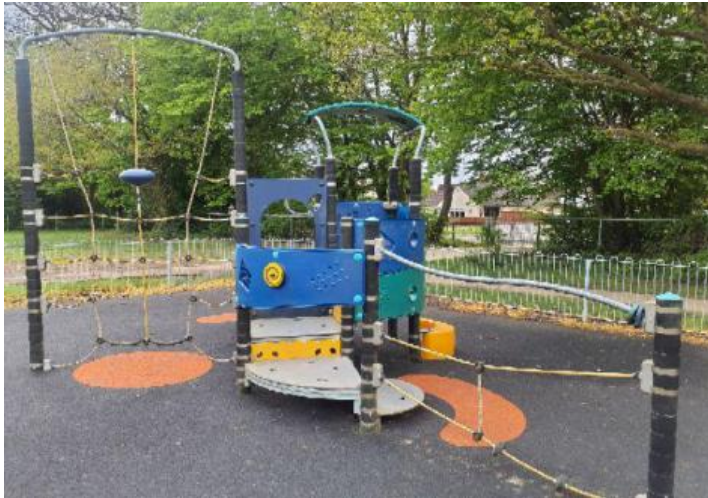
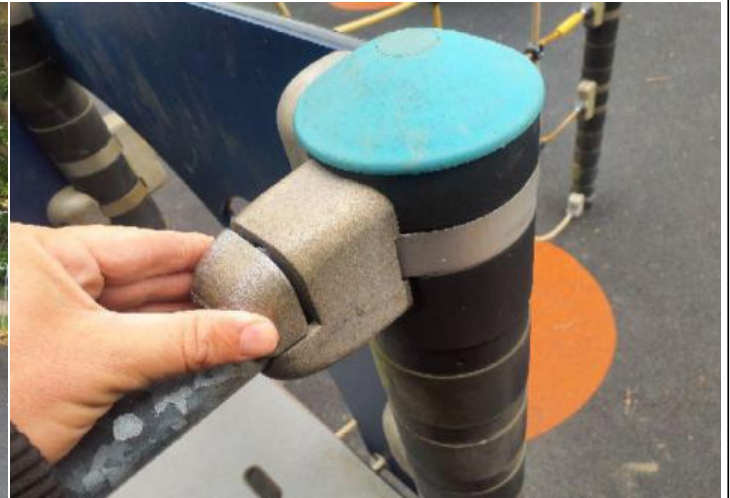
Item: Activity Equipment - Multi Play (Junior)
Manufacturer: Kompan Ltd

Finding: A number of fixing(s) have worked loose

Action: Secure all loose fixings

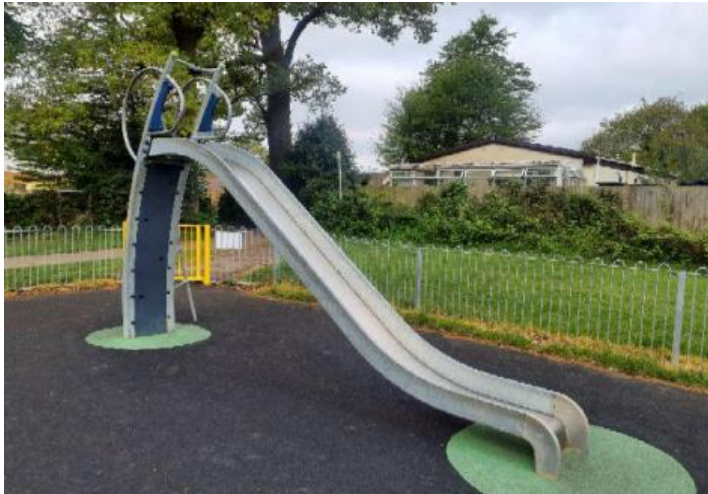
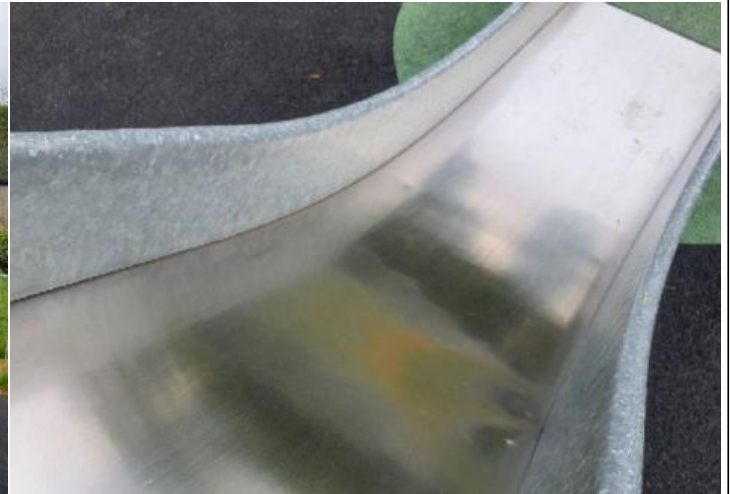
Item: Other - Free Standing Slide
Manufacturer: Kompan Ltd

Finding: There are a number of dents in the slide surface

Action: Monitor for any further deterioration and repair as required

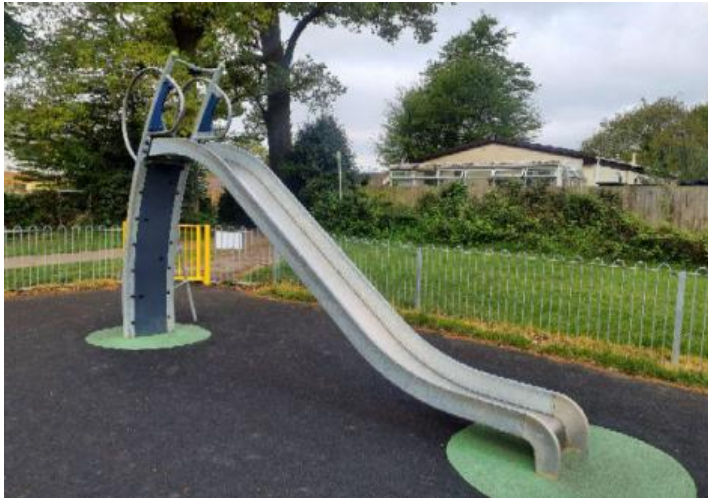
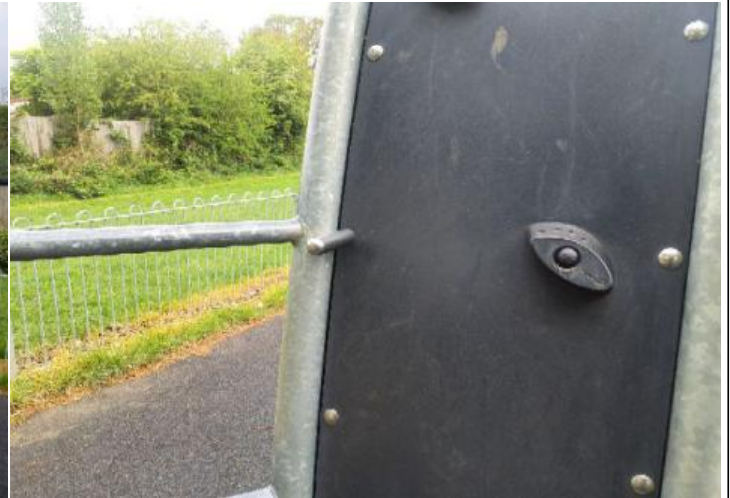
Item: Other - Free Standing Slide
Manufacturer: Kompan Ltd

Finding: There is/are finger entrapment/s due to missing fixings and the item fails to meet the requirements of BS EN 1176 Part 1 4.2.7.6 Entrapment of fingers

Action: Replace missing fixings to remove entrapment

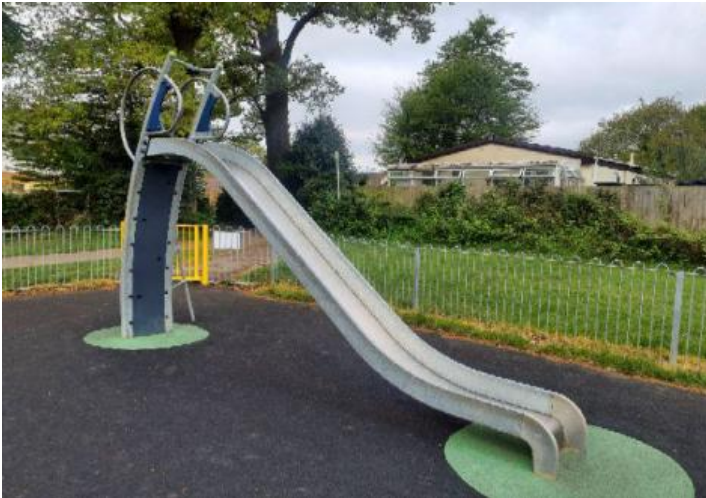
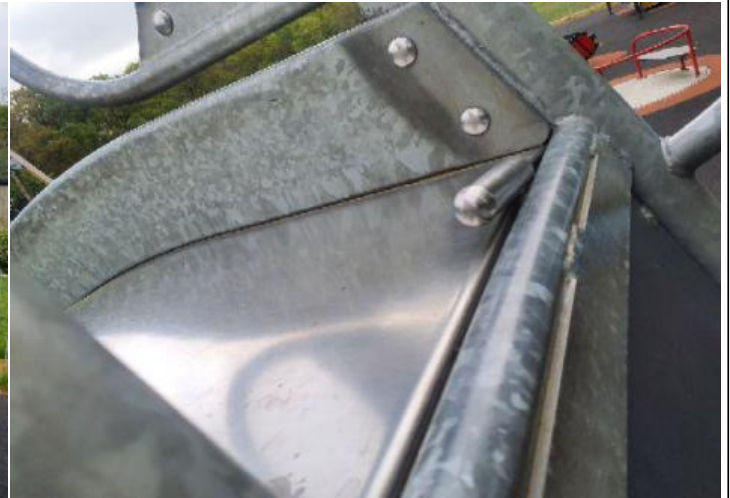
Item: Other - Free Standing Slide
Manufacturer: Kompan Ltd

Finding: There is/are finger entrapment/s in the starting section of the slide and the item fails to meet the requirements of BS EN 1176 Part 1 4.2.7.6 Entrapment of fingers

Action: Monitor - No action given the risk assessment

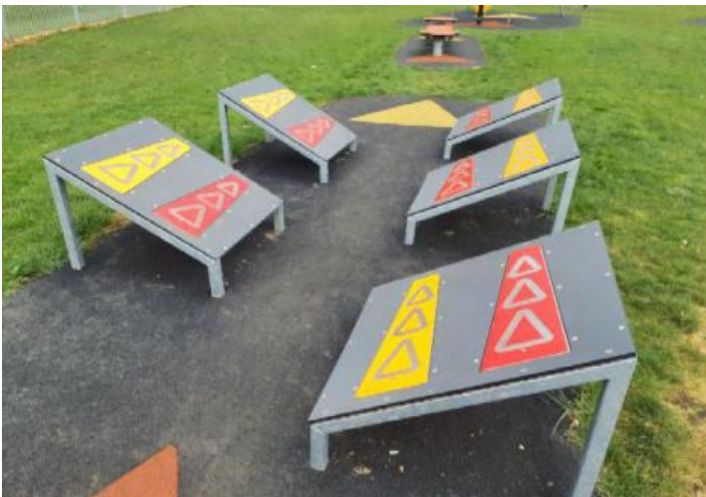
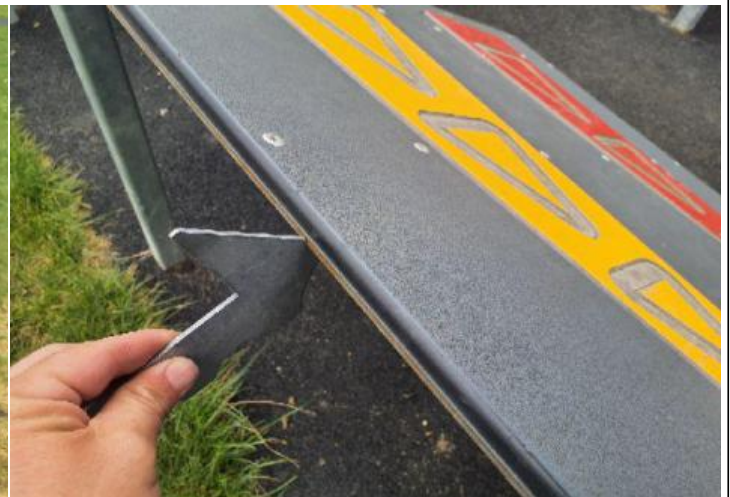
Item: Outdoor Fitness Equipment - Slanted Steps
Manufacturer: Proludic

Finding: The item has exposed edges and corners that are sharp, or with a radius of less than 3mm, and does not meet the requirements of BS EN 1176 Part 1 - 4.2.5

Action: Provide a 3mm radius to all exposed edges and corners, or remove sharp edge

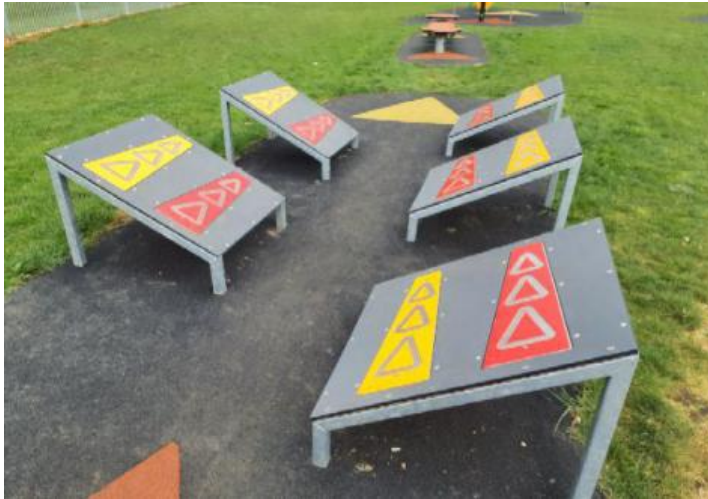
Item: Outdoor Fitness Equipment - Slanted Steps
Manufacturer: Proludic

Finding: There is or are fixings missing on the item

Action: Replace all missing fixings

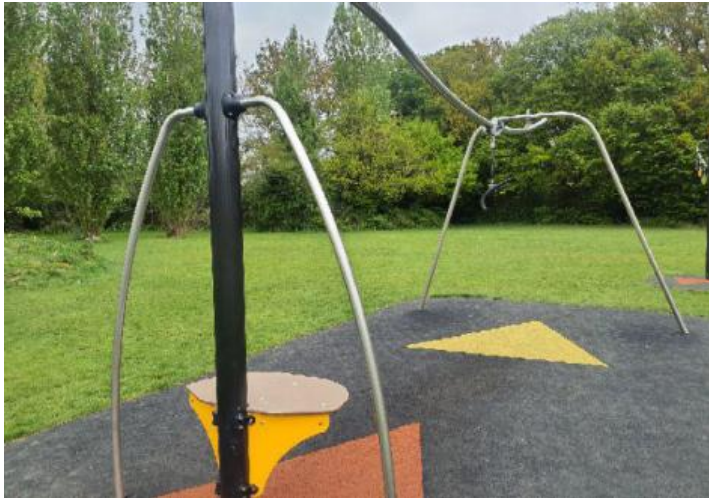
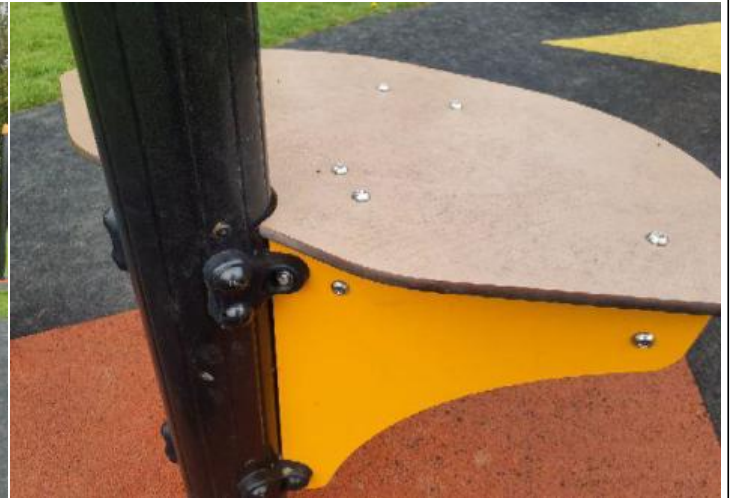
Item: Other - Cable Runway - Hanging
Manufacturer: Proludic

Finding: There is/are bolt cap covers missing or damaged on the item

Action: Replace missing or damaged bolt cap covers
