ST STEPHEN PARISH COUNCIL

You are summoned to the Fixed Assets Committee meeting

AGENDA

| 2526/AC/013 | To receive Annual Play Inspection Reports. Reports attached. |

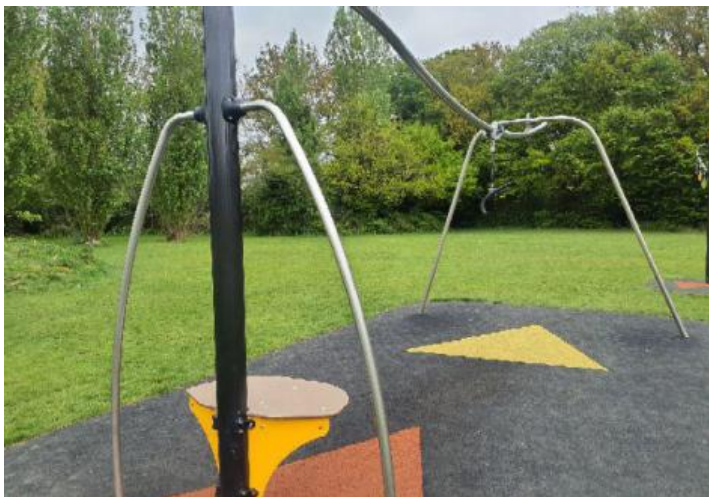
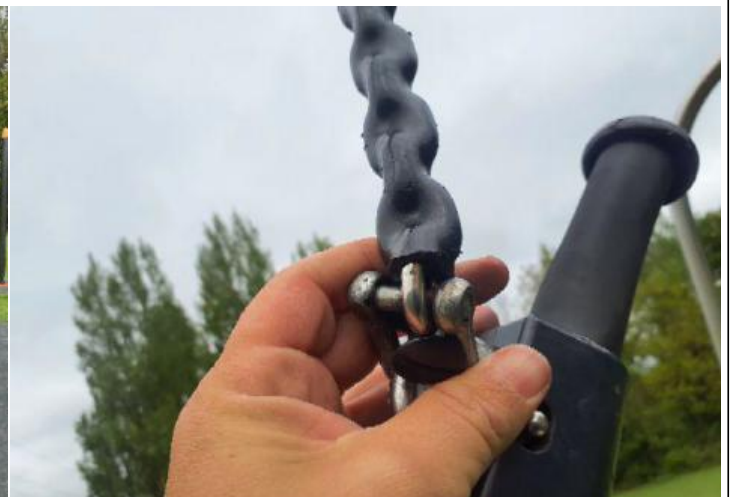
Item: Other - Cable Runway - Hanging
Manufacturer: Proludic

Finding: There is some notable evidence of chain wear

Action: Monitor for any further deterioration and replace when 40% worn

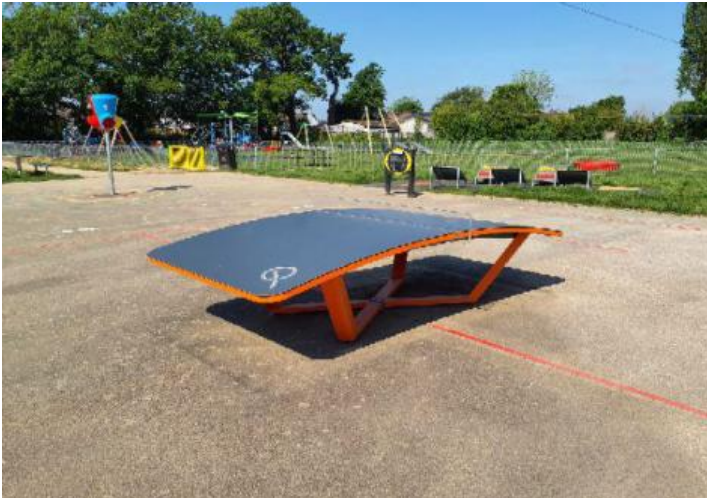
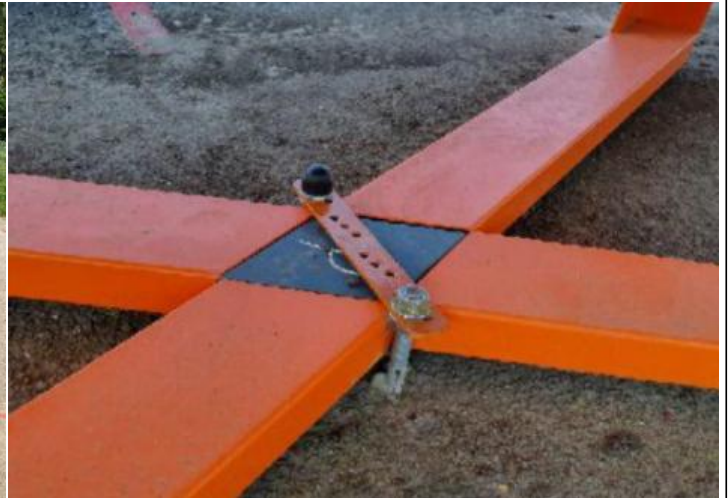
Item: Other - Head Tennis Table
Manufacturer: Teqball

Finding: There is/are bolt cap covers missing or damaged on the item

Action: Replace missing or damaged bolt cap covers

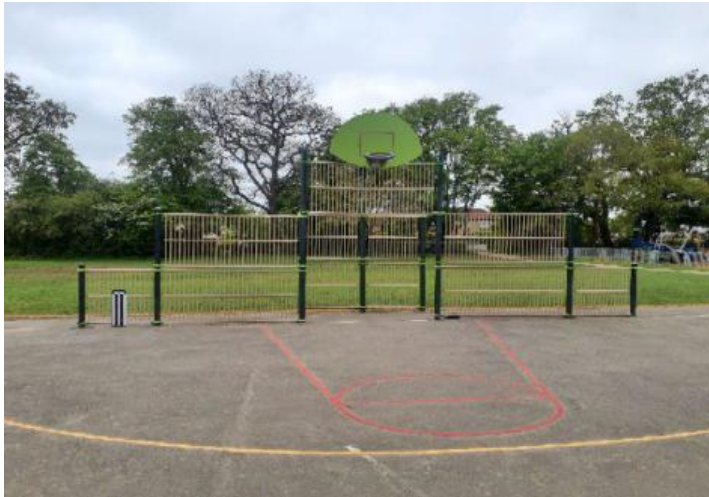
Item: Multi Use Games Area - Multi Use Games Area (MUGA)
Manufacturer: Proludic

Finding: A clearly visible facility sign should be provided in a prominent position with the wording as detailed BS EN 15312- the equipment is not intended for children less than 3 years old- the warning - Do not climb on the framework or nets- the warning - Do not hang on the ring (if provided)- the warning - Do not wear rings or other jewellery- name and telephone number of the administrator- number to call in case of accident

Action: Provide signage to BS EN 15312

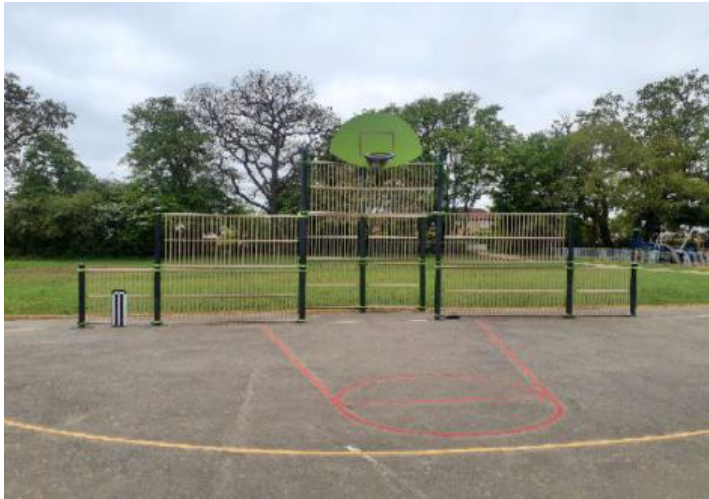
Item: Multi Use Games Area - Multi Use Games Area (MUGA)
Manufacturer: Proludic

Finding: There is / are post or end caps missing / damaged on the item
Action: Replace missing / damaged post or end caps

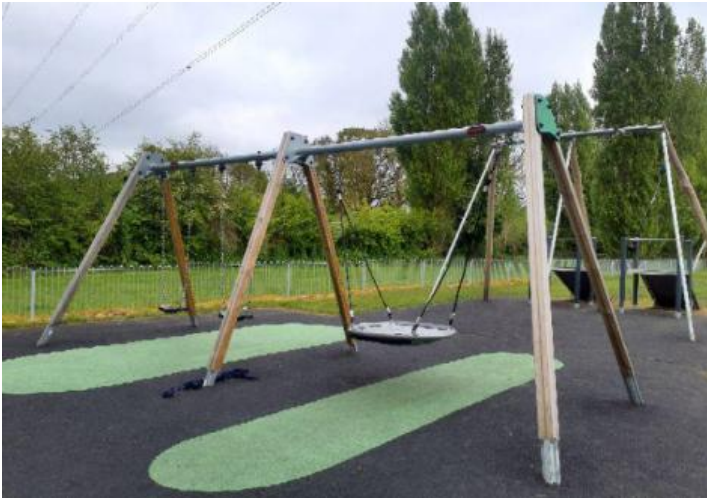
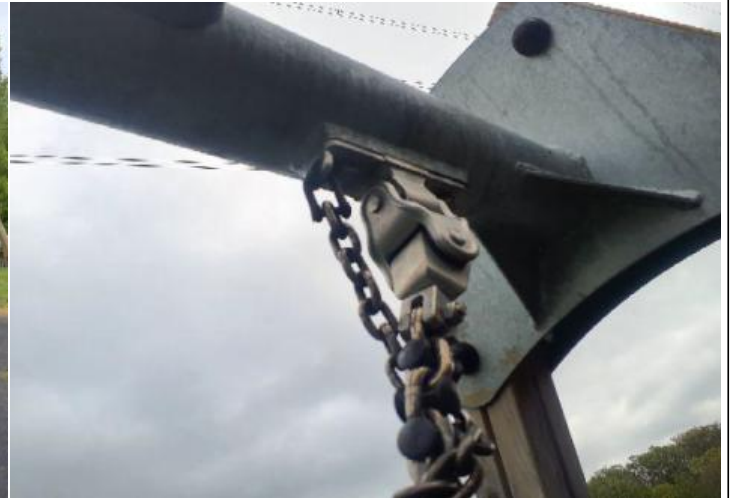
Item: Swings - 2 Bay 2 Flat 1 Basket Seat
Manufacturer: Kompan Ltd

Finding: The secondary safety shackles are worn in excess of 40% and require renewing **Action:** Replace worn shackles

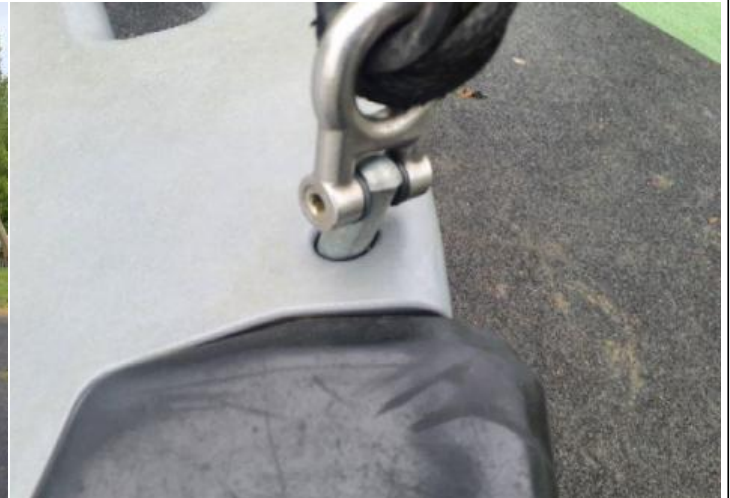
Item: Swings - 2 Bay 2 Flat 1 Basket Seat
Manufacturer: Kompan Ltd

Finding: The bushes are showing signs of wear

Action: Monitor for any further deterioration and replace as required

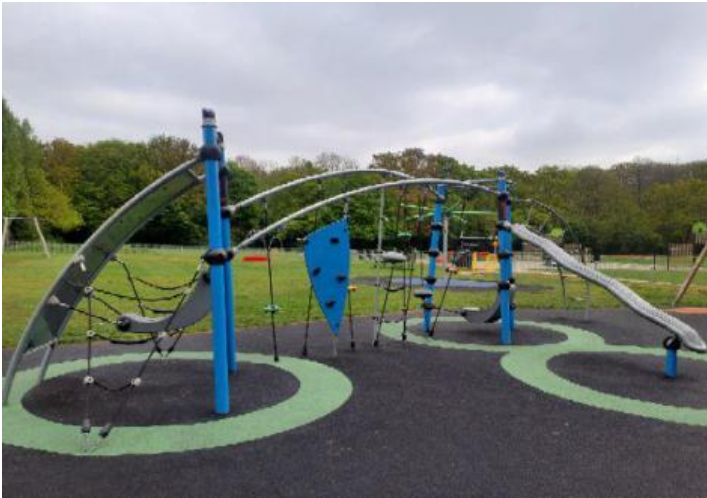
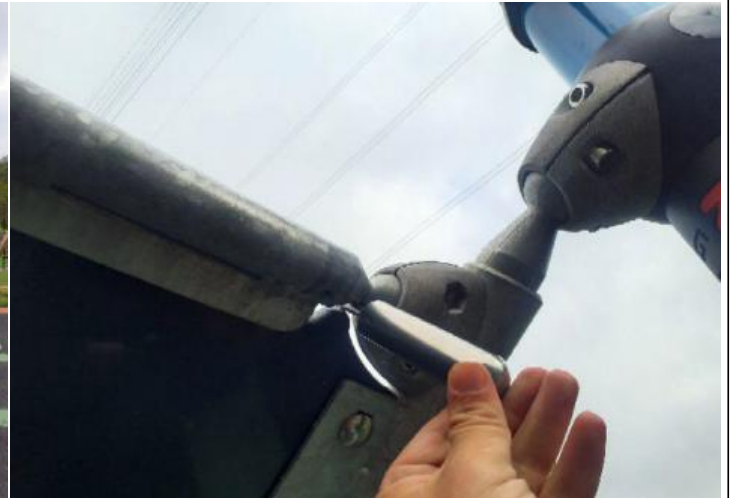
Item: Activity Equipment - Climbing Frame
Manufacturer: Kompan Ltd

Finding: There is/are finger entrapment/s in the framework / climbing wall and the item fails to meet the requirements of BS EN 1176 Part 1 4.2.7.6 Entrapment of fingers
Action: Monitor - No action given the risk assessment

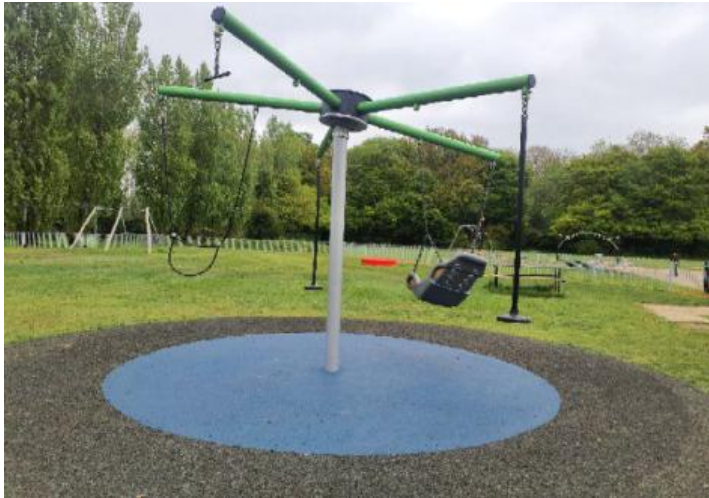
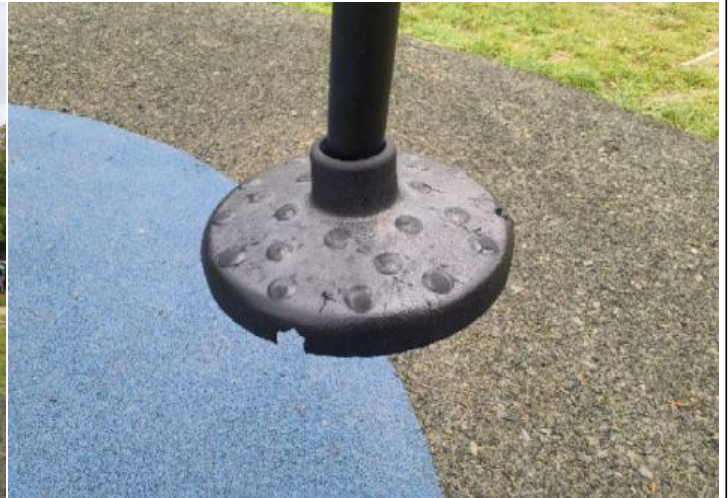
Item: Rotor Play - Titan
Manufacturer: Hags

Finding: The seat has been damaged

Action: Monitor for any further deterioration and replace as required

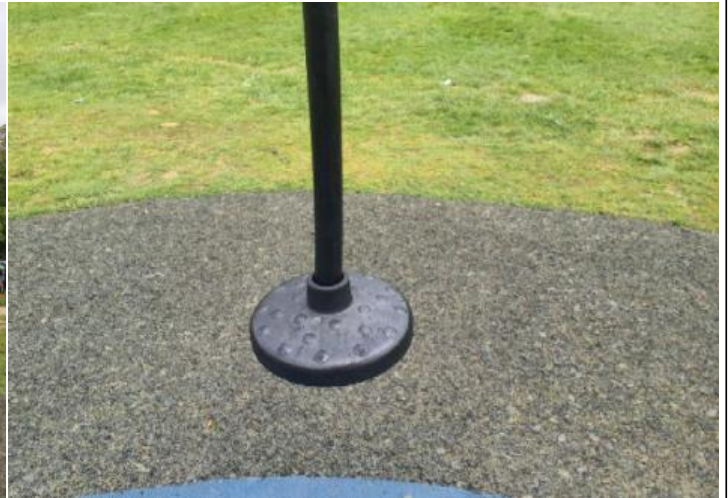
Item: Rotor Play - Titan
Manufacturer: Hags

Finding: The seat connection cannot be inspected without dismantling the seat

Action: Dismantle the seat to inspect the seat connection for wear

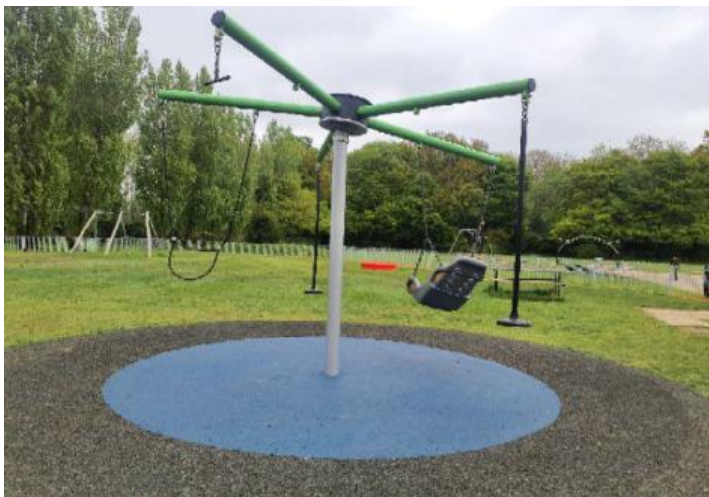
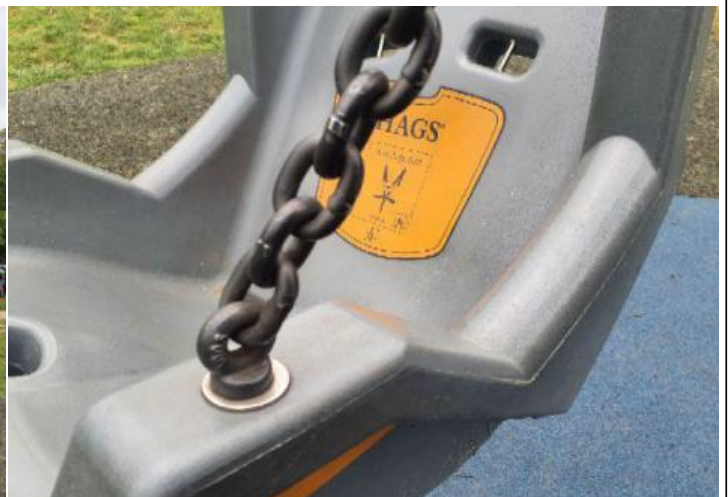
Item: Rotor Play - Titan
Manufacturer: Hags

Finding: There is some notable evidence of chain wear

Action: Monitor for any further deterioration and replace when 40% worn

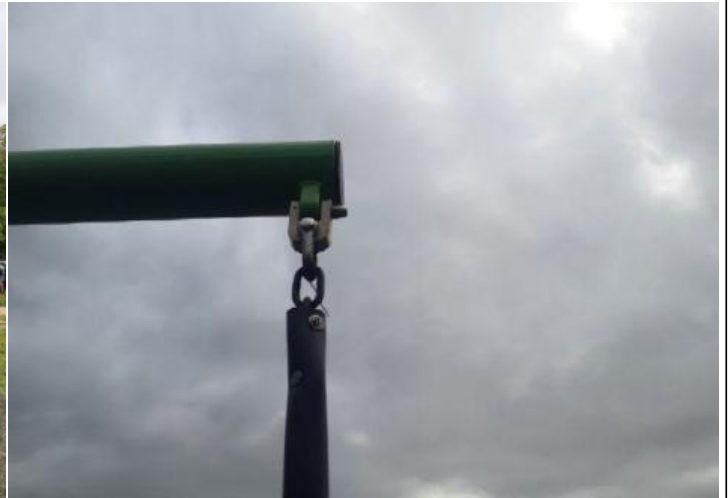
Item: Rotor Play - Titan
Manufacturer: Hags

Finding: The split pins are missing from the shackles

Action: Insert split pins to secure the shackles

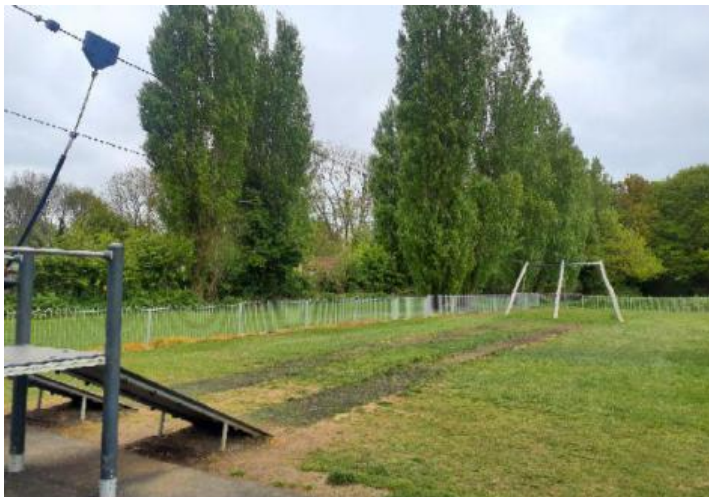
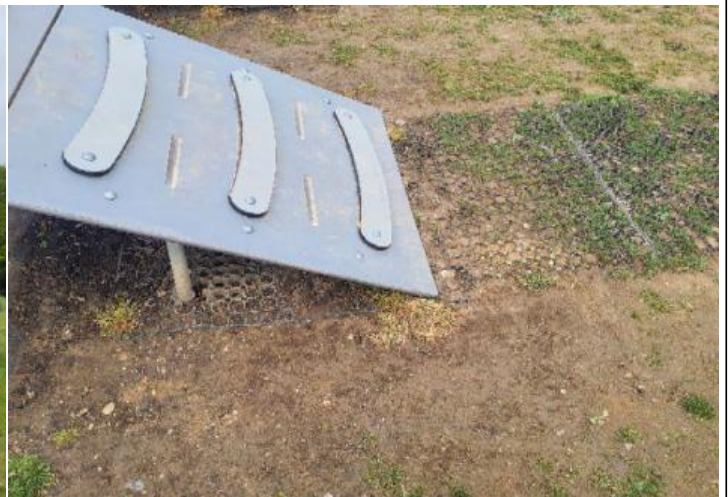
Item: Other - Cable Runway
Manufacturer: Kompan Ltd

Finding: The edges of the grass mat surface are raised / lifting above the surrounding surface

Action: Tuck in or pin edges of grass mats as per the API Code of Practice to remove trip hazards

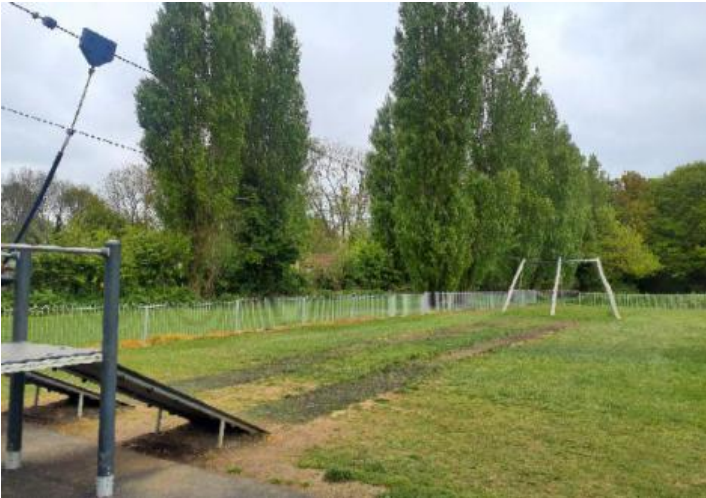
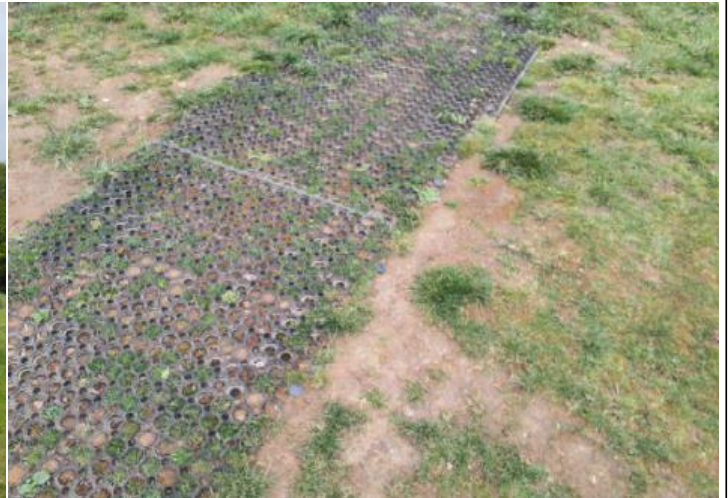
Item: Other - Cable Runway
Manufacturer: Kompan Ltd

Finding: Fixing Pins have been installed in the impact areas of the grass mats **Action:** Remove pins from impact areas

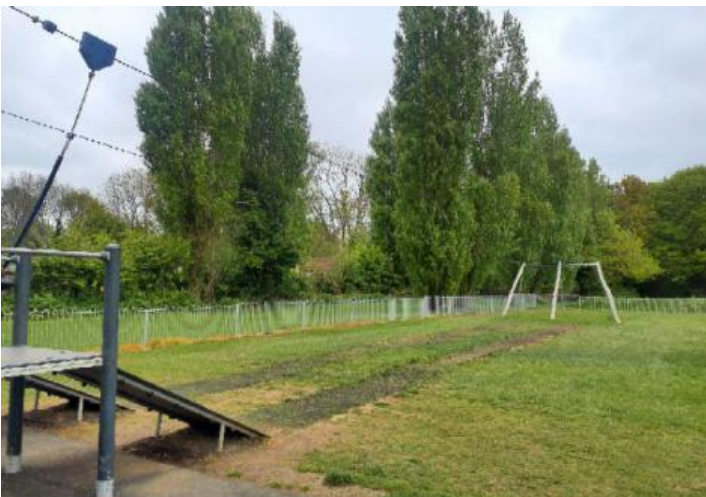
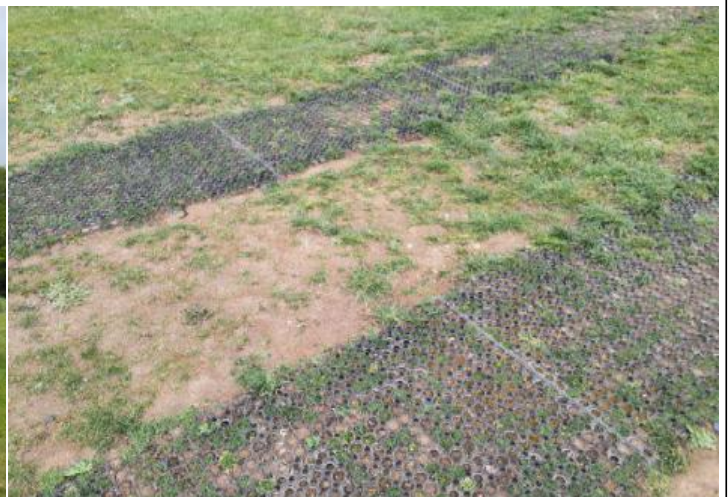
Item: Other - Cable Runway
Manufacturer: Kompan Ltd

Finding: There is a lack of growth within the grass area **Action:** Encourage growth with grass seeds

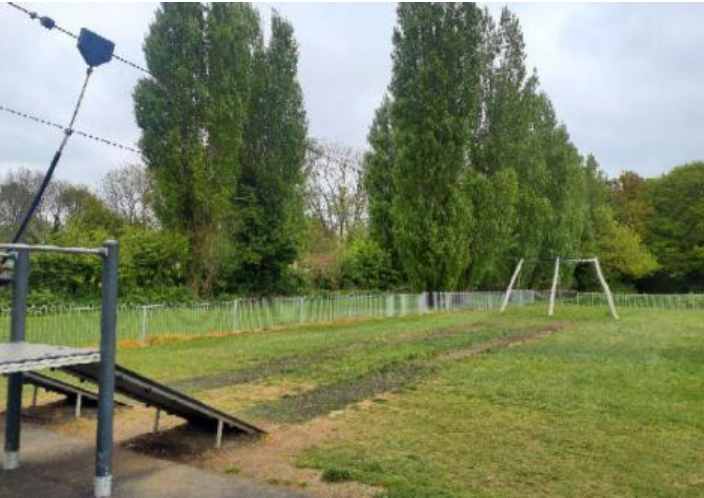
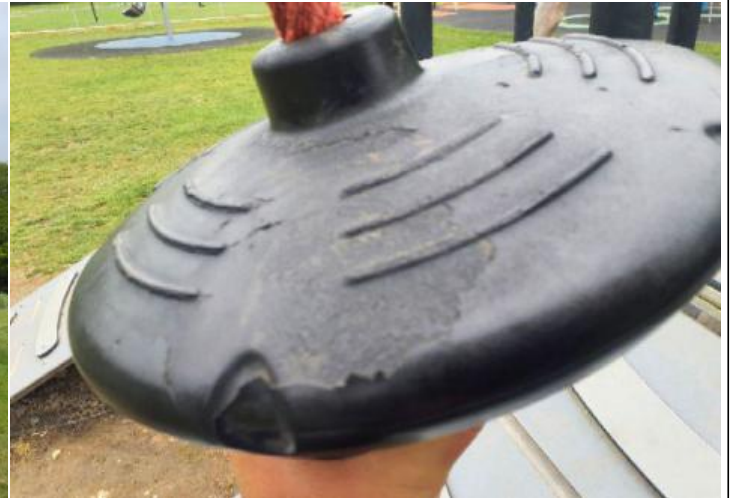
Item: Other - Cable Runway
Manufacturer: Kompan Ltd

Finding: The cableway seat has been damaged

Action: Monitor for any further deterioration and replace as required

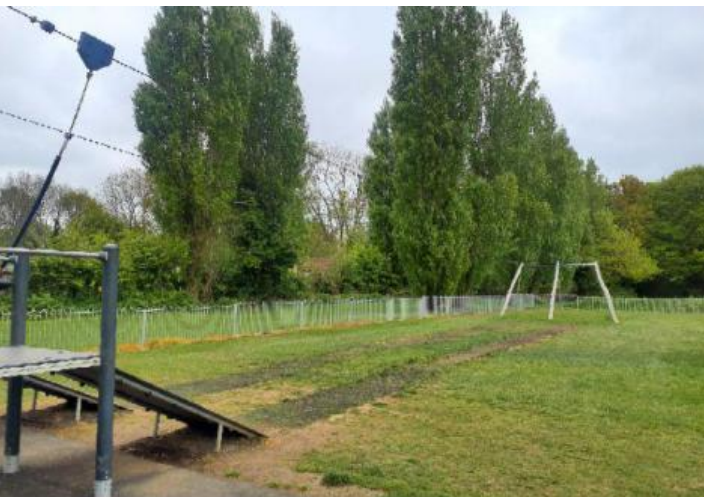
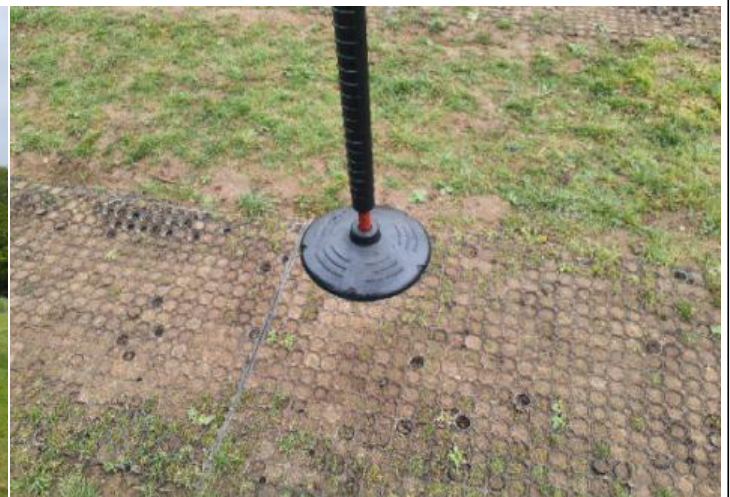
Item: Other - Cable Runway
Manufacturer: Kompan Ltd

Finding: The height of the seat is less than 350mm when loaded and does not meet the requirements of BS EN 1176 Part 4

Action: Ensure the seat is a minimum of 350mm above ground level when loaded with 69.5kg

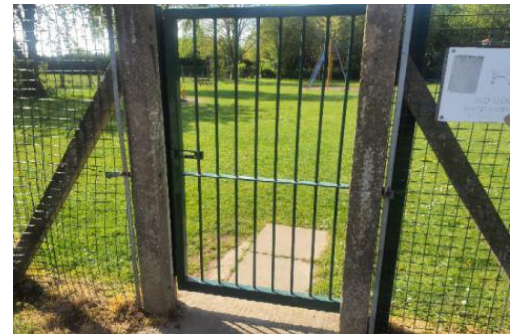
Item: Gate
Manufacturer: Not Identified
Surface Type: Paving Slabs
Item Quantity: 2
Equipment Compliance: N/A
Surface Area Compliance: N/A

There are trip hazards at the edges of the surface - Remove trip hazard

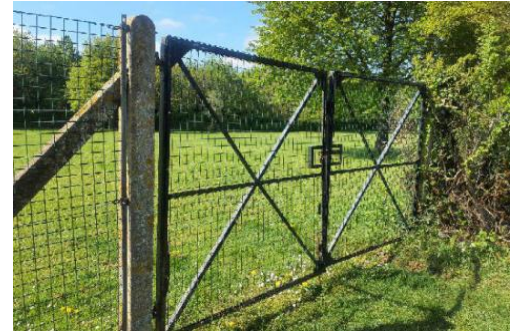
Item: Gate - Maintenance
Manufacturer: Not Identified
Surface Type: Grass
Item Quantity: 1
Equipment Compliance: N/A
Surface Area Compliance: N/A

The maintenance gate was correctly padlocked at the time of inspection, however this means that the inspector was unable to fully assess the gate - Ensure that there are 12mm gaps throughout the full range of motion on gate/s and between leaves where relevant

The paintwork on this item has been damaged or worn exposing the metal underneath which is rusting / corroding - Treat affected areas and repaint

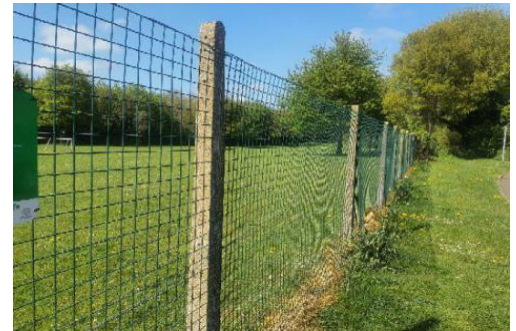
Item: Fence - Steel Mesh
Manufacturer: Not Identified
Surface Type: Grass
Item Part Number:
Item Quantity: 1
Equipment Compliance: N/A
Surface Area Compliance: N/A
Total Findings: 1

There are a number of loose posts around the fence - Monitor for any further deterioration and reset as required

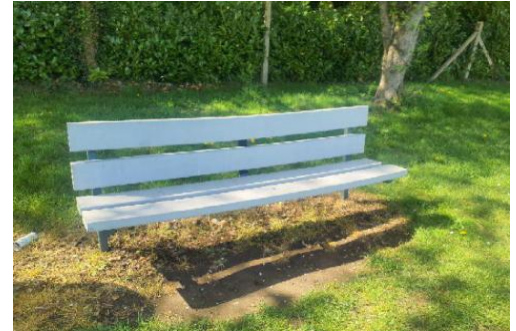
Item: Bench
Manufacturer: Not Identified
Surface Type: Grass
Item Quantity: 1
Equipment Compliance: N/A
Surface Area Compliance: N/A

The area around the item has eroded and may become slippery - Reinstate eroded area

The paintwork on this item has been damaged or worn exposing the metal underneath which is rusting / corroding - Treat affected areas and repaint

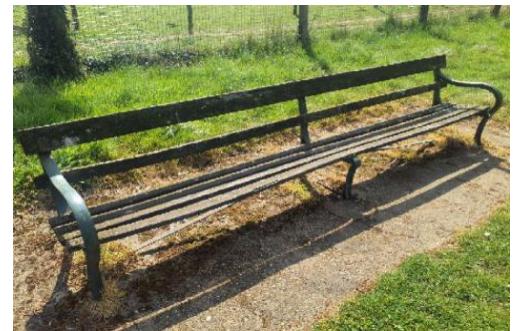
Item: Bench
Manufacturer: Not Identified
Surface Type: Concrete
Item Quantity: 1
Equipment Compliance: N/A
Surface Area Compliance: N/A

Parts of the timber are rough or splintered - Remove all rough or sharp edges

There is some evidence of rot in the timber - Monitor for any further deterioration and replace as required

There is algae, silt or moss growth on the surface resulting in slippery conditions - Clean and treat appropriately

The paintwork on this item has been damaged or worn exposing the metal underneath which is rusting / corroding - Treat affected areas and repaint

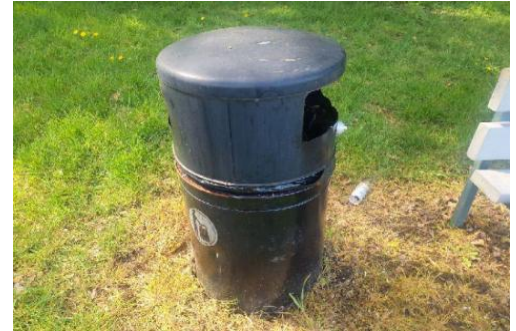
Item: Litter Bin
Manufacturer: Not Identified
Surface Type: Grass
Item Quantity: 1
Equipment Compliance: N/A
Surface Area Compliance: N/A

The lid or door of the litter bin is not secured - Ensure the lid or door is kept locked

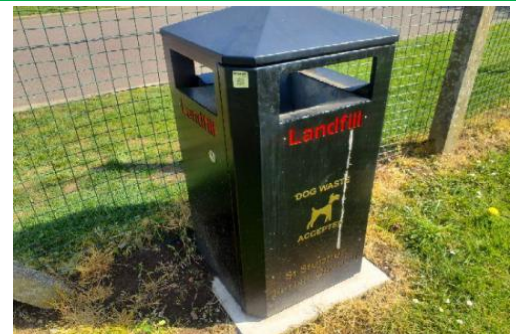
Item: Litter Bin
Manufacturer: Not Identified
Surface Type: N/A
Item Quantity: 2
Equipment Compliance: N/A
Surface Area Compliance: N/A

The bin is not securely fixed to the surface and there is some possibility of the item tipping or rolling over - Secure the bin to the ground

8 - Low Risk

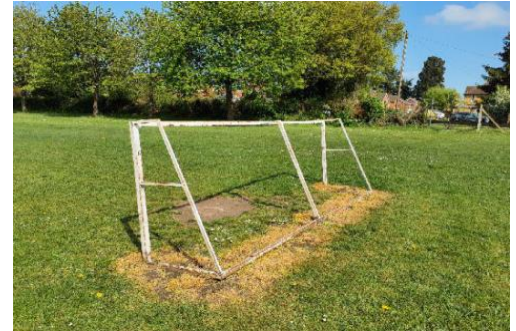
Item: 5 a side Goals
Manufacturer: Not Identified
Surface Type: Grass
Item Part Number:
Item Quantity: 1
Equipment Compliance: N/A
Surface Area Compliance: N/A
Life Expectancy: 5 -10 Years
Total Findings: 4

The area around the item has eroded and may become slippery - Reinstate eroded area

There is/are inserts missing - Replace missing inserts

The paintwork on this item has been damaged or worn exposing the metal underneath which is rusting / corroding - Treat affected areas and repaint

The goal frame has only been secured at one end - Refer to manufacturer recommendations and provide as required

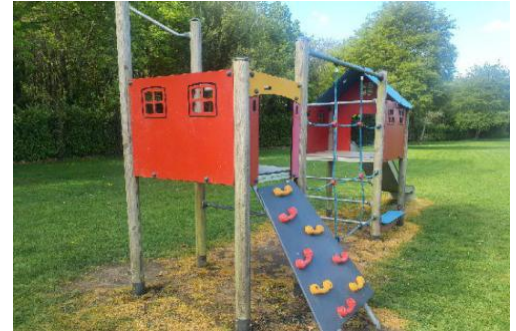
Item: Multi Play (Junior)
Manufacturer: Kompan Ltd
Surface Type: Grass Matrix Tiles
Item Quantity: 1
Equipment Compliance: Yes
Surface Area Compliance: Yes

The connecting lugs are showing signs of wear - Monitor for any further deterioration and repair as required

There are a number of dents in the slide surface - Monitor for any further deterioration and repair as required

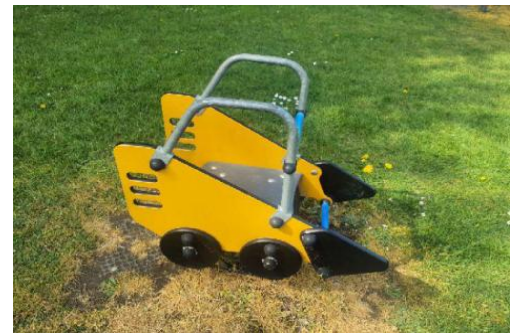
Item: Spring Bulldozer
Manufacturer: Kompan Ltd
Surface Type: Grass Matrix Tiles
Item Quantity: 1
Equipment Compliance: Yes
Surface Area Compliance: Yes

There is algae or moss on the surface of the equipment - Clean and treat appropriately

There is/are bolt cap covers missing or damaged on the item - Replace missing or damaged bolt cap covers

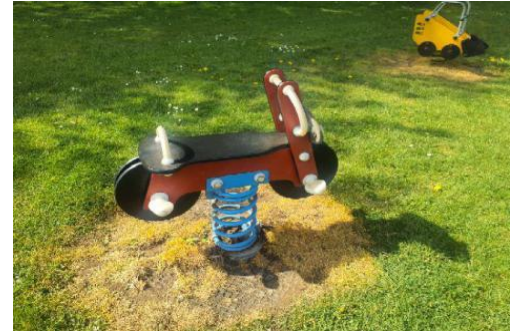
Item: Spring Bike
Manufacturer: Kompan Ltd
Surface Type: Grass Matrix Tiles
Item Quantity: 1
Equipment Compliance: Yes
Surface Area Compliance: Yes

The item is slightly loose in its foundations - Monitor for any further deterioration and repair as required

10 - Low Risk

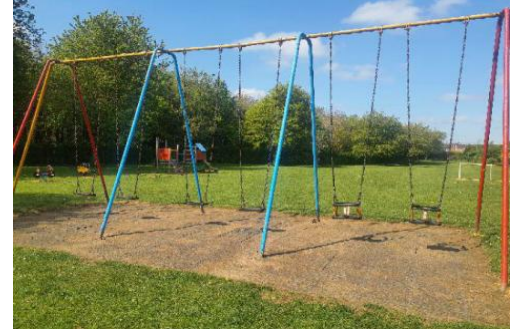
Item: 3 Bay Swing
Manufacturer: Hags
Surface Type: Grass Matrix Tiles
Item Quantity: 1
Equipment Compliance: No
Surface Area Compliance: Yes
Life Expectancy: >10 Years
Total Findings: 14

The fixings or components for this item were in excess of 2.5m above the standing surface and could not be fully accessed by the inspector. We have completed a visual inspection of the fixings from ground level but a maintenance inspection should be undertaken to assess the condition, security and wear of the components at intervals in accordance with the manufacturers recommendations. - Inspect in accordance with the manufacturers recommendations

The seats are too close to each other as defined in BS EN 1176 Part 2; this is a low risk failure and no remedial action is required - Monitor - No action given the risk assessment

The chain openings are in excess of 8.6mm and do not meet the recommendations of BS EN 1176 Part 1 - Monitor - No action given the risk assessment

The paintwork on this item has been damaged or worn exposing the metal underneath which is rusting / corroding - Treat affected areas and repaint

The seat has been severely damaged - Repair / replace the seat as required

The seat has minor damage or wear - Monitor for any further deterioration and replace as required

The bushes are showing signs of wear - Monitor for any further deterioration and replace as required

There is some notable evidence of chain wear - Monitor for any further deterioration and replace when 40% worn

There is some wear to the shackles - Monitor for any further deterioration and replace when 40% worn

The swing seat connectors are loose - Tighten to secure

The swing seat connectors have some wear present - Monitor for further deterioration and replace when 40% worn

There is moderate damage to the surface and there are trip hazards present - Repair the damaged areas of surfacing to remove any trip points

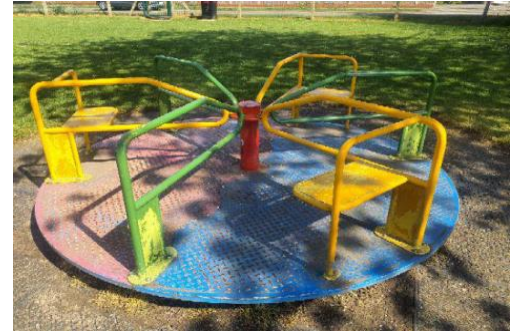
Item: Roundabout
Manufacturer: G L Jones Playgrounds Ltd
Surface Type: Grass Matrix Tiles
Item Quantity: 1
Equipment Compliance: No
Surface Area Compliance: Yes
Life Expectancy: >10 Years
Total Findings: 5

There are gaps opening in between the tiles - Monitor for any further deterioration and repair as required

The surface has subsided in some areas - Monitor for any further deterioration and repair as required

The bearing is worn / damaged and the item is not operating correctly - Repair / replace

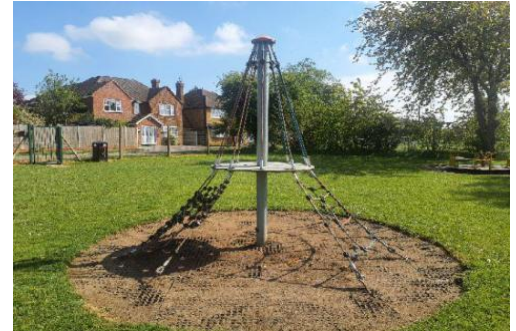
Item: Rope Climber
Manufacturer: Kompan Ltd
Surface Type: Grass Matrix Tiles
Item Quantity: 1
Equipment Compliance: Yes
Surface Area Compliance: Yes

The grass mats are silted up, the soil is compacted and the area will become very slippery when the soil is wet. - Reinstate as required

There is some minor damage to the surface - Monitor for any further deterioration and repair as required

The ropes/nets are worn/damaged in places - Monitor for any further deterioration and repair or replace as required

There is/are bolt cap covers missing or damaged on the item - Replace missing or damaged bolt cap covers

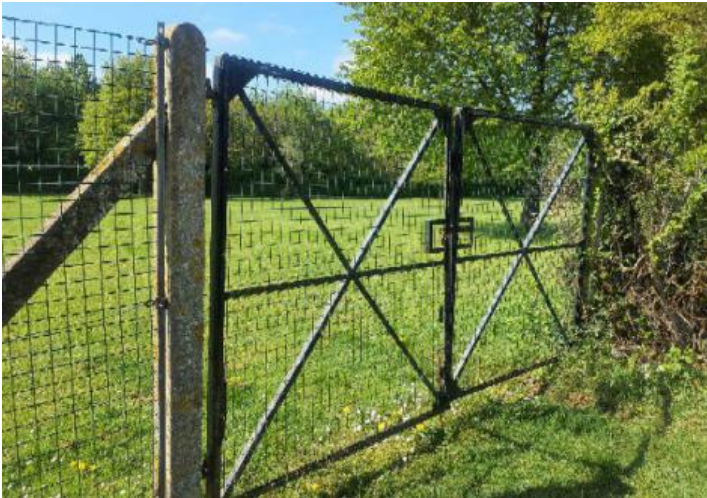
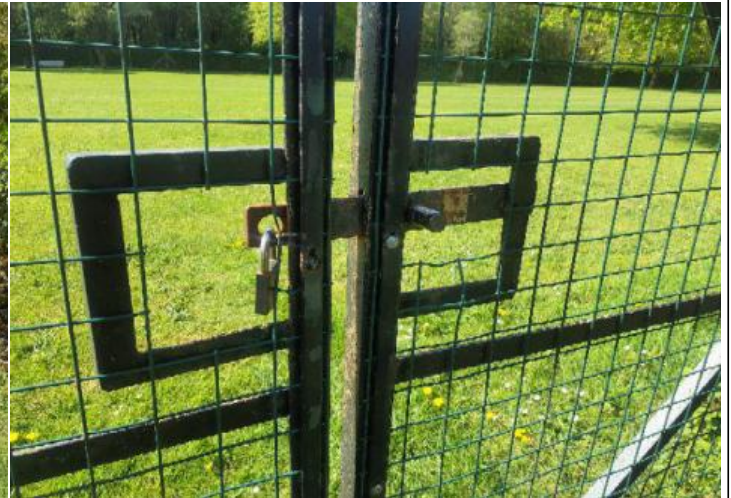
Item: Gates - Gate - Maintenance
Manufacturer: Not Identified

Finding: The maintenance gate was correctly padlocked at the time of inspection, however this means that the inspector was unable to fully assess the gate

Action: Ensure that there are 12mm gaps throughout the full range of motion on gate/s and between leaves where relevant

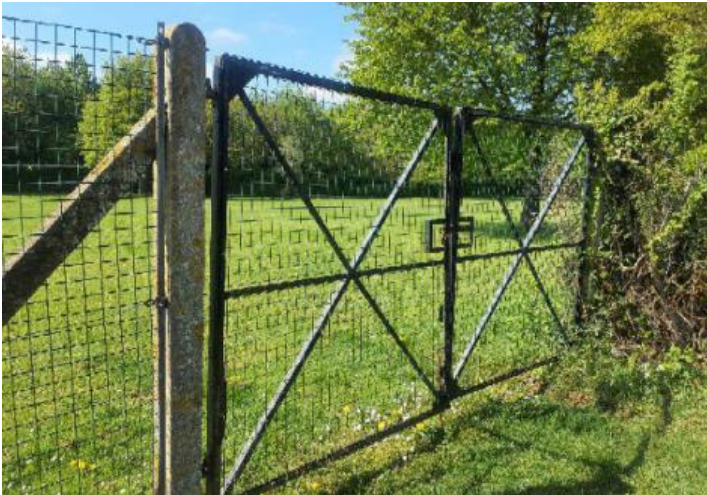
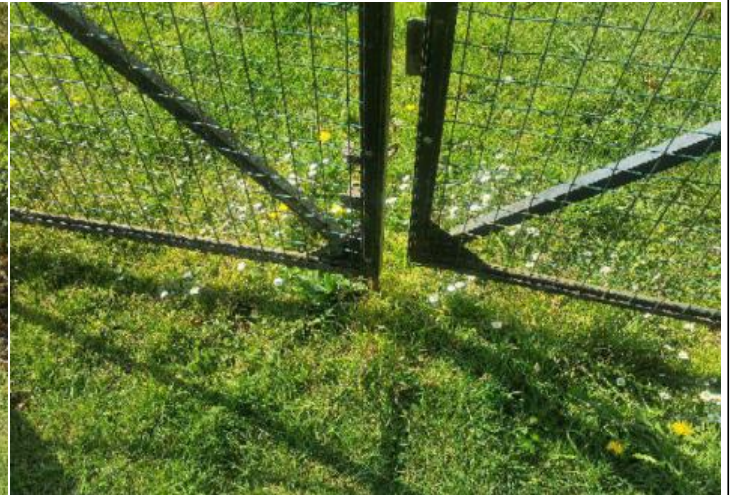
Item: Gates - Gate - Maintenance
Manufacturer: Not Identified

Finding: The gate has no drop bolt sleeves and/or drop bolts fitted

Action: Provide drop bolt sleeves and/or drop bolts

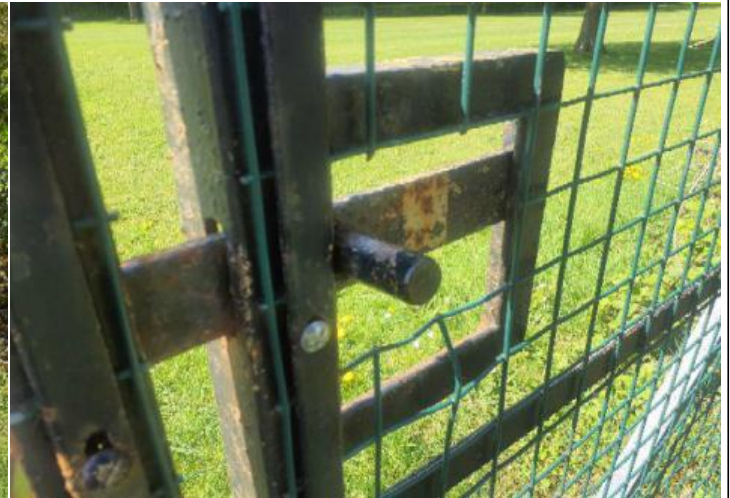
Item: Gates - Gate - Maintenance
Manufacturer: Not Identified

Finding: The paintwork on this item has been damaged or worn exposing the metal underneath which is rusting / corroding

Action: Treat affected areas and repaint

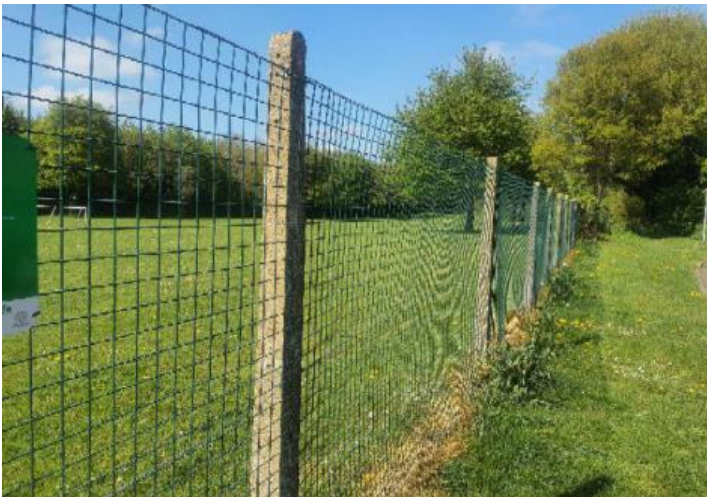
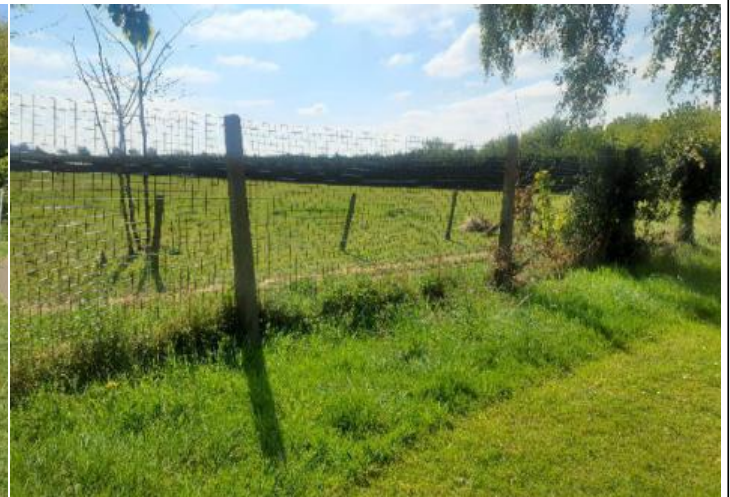
Item: Fences - Fence - Steel Mesh
Manufacturer: Not Identified

Finding: There are a number of loose posts around the fence

Action: Monitor for any further deterioration and reset as required

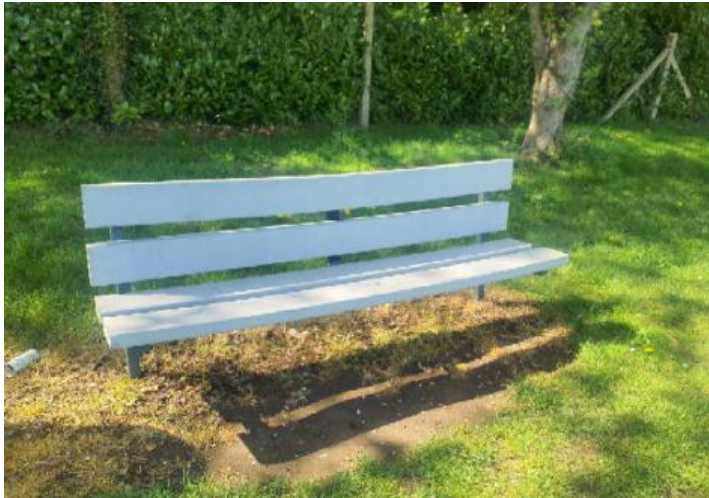
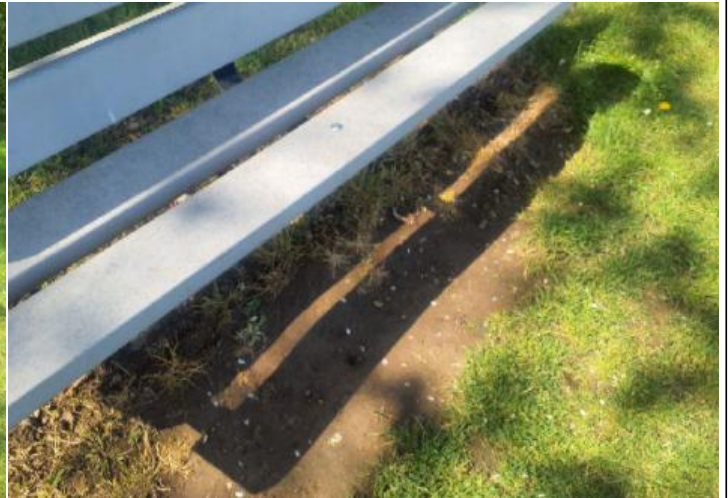
Item: Ancillary Items - Bench
Manufacturer: Not Identified

Finding: The area around the item has eroded and may become slippery

Action: Reinststate eroded area

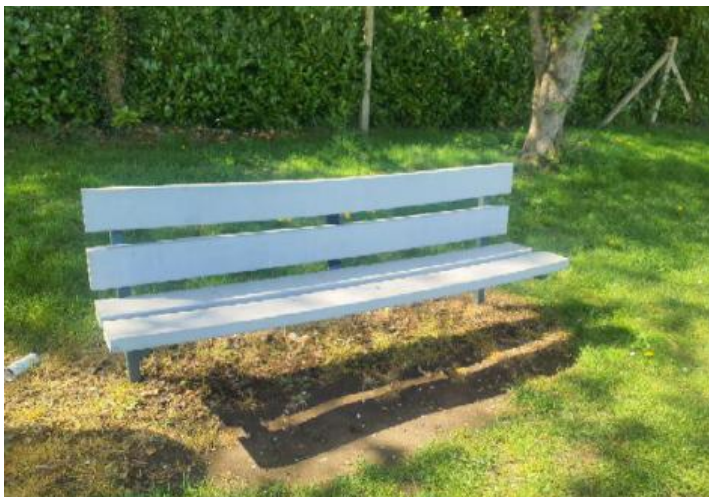
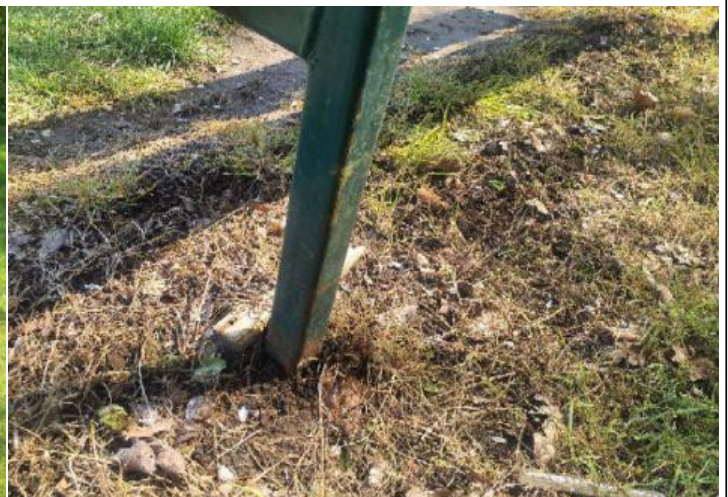
Item: Ancillary Items - Bench
Manufacturer: Not Identified

Finding: The paintwork on this item has been damaged or worn exposing the metal underneath which is rusting / corroding

Action: Treat affected areas and repaint

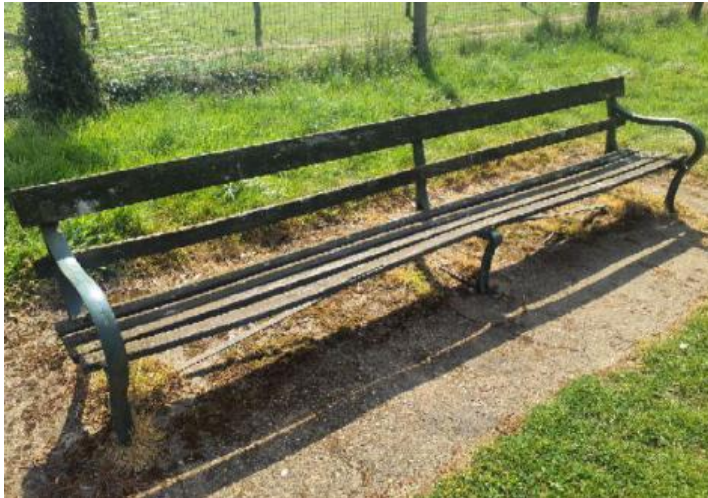
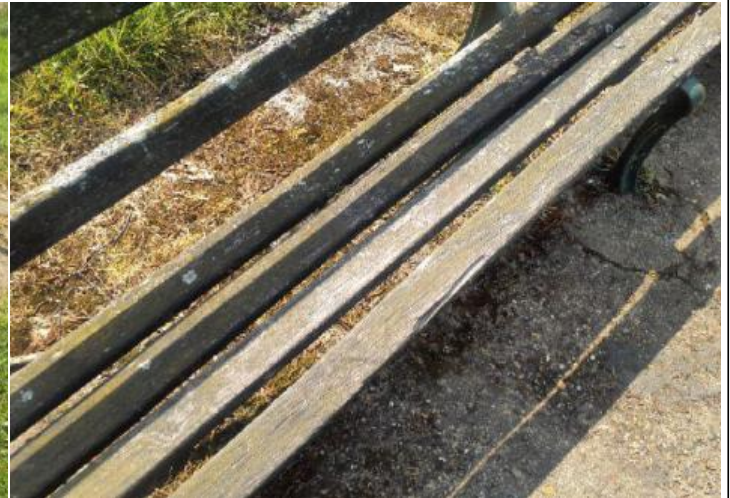
Item: Ancillary Items - Bench
Manufacturer: Not Identified

Finding: Parts of the timber are rough or splintered

Action: Remove all rough or sharp edges

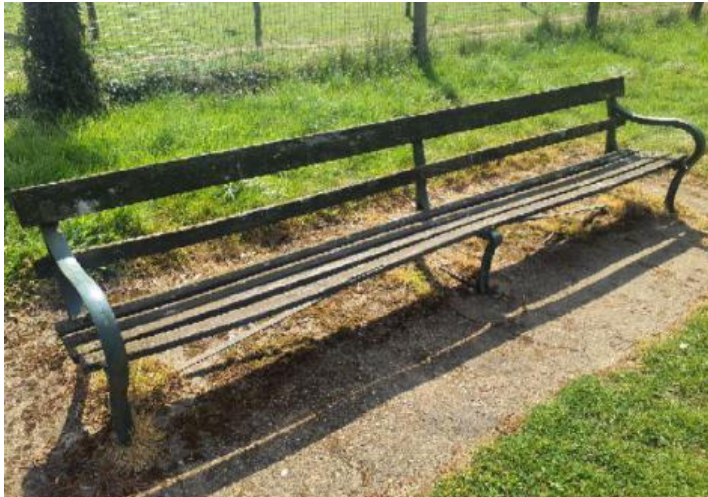
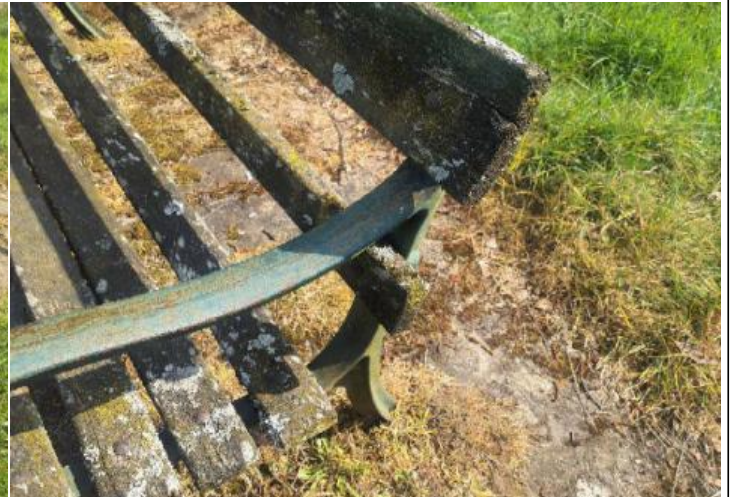
Item: Ancillary Items - Bench
Manufacturer: Not Identified

Finding: There is some evidence of rot in the timber

Action: Monitor for any further deterioration and replace as required

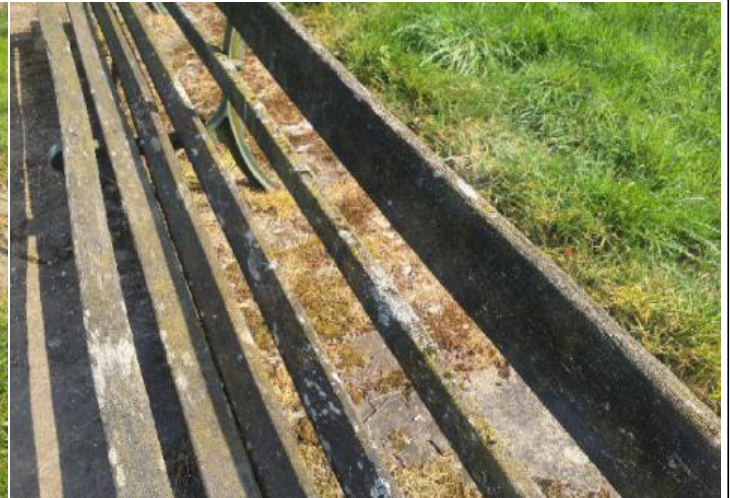
Item: Ancillary Items - Bench
Manufacturer: Not Identified

Finding: There is algae or moss on the surface of the bench **Action:** Clean and treat appropriately

8 - Low Risk (Finding 4)

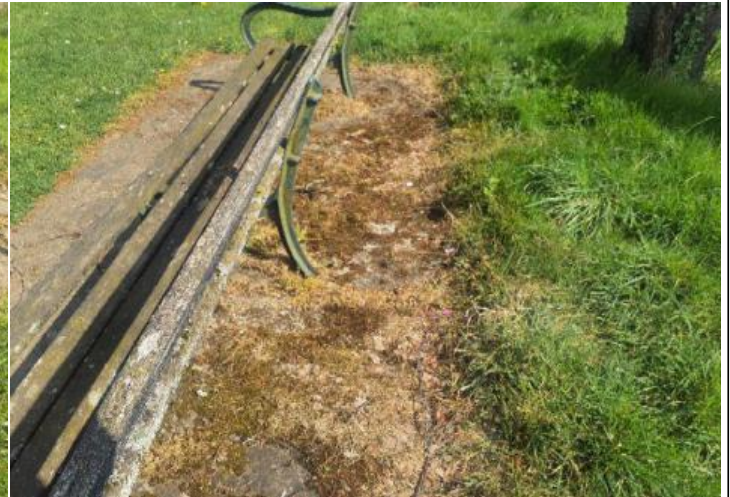
Item: Ancillary Items - Bench
Manufacturer: Not Identified

Finding: There is algae, silt or moss growth on the surface resulting in slippery conditions **Action:** Clean and treat appropriately

i 6 - Low Risk (Finding 5)

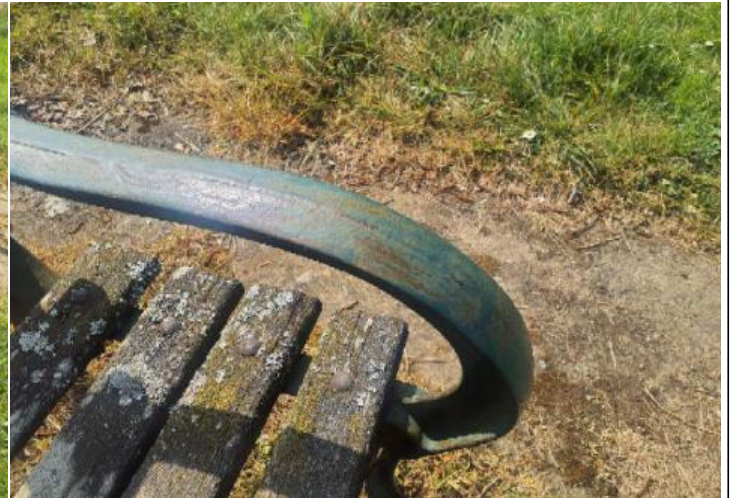
Item: Ancillary Items - Bench
Manufacturer: Not Identified

Finding: The paintwork on this item has been damaged or worn exposing the metal underneath which is rusting / corroding

Action: Treat affected areas and repaint

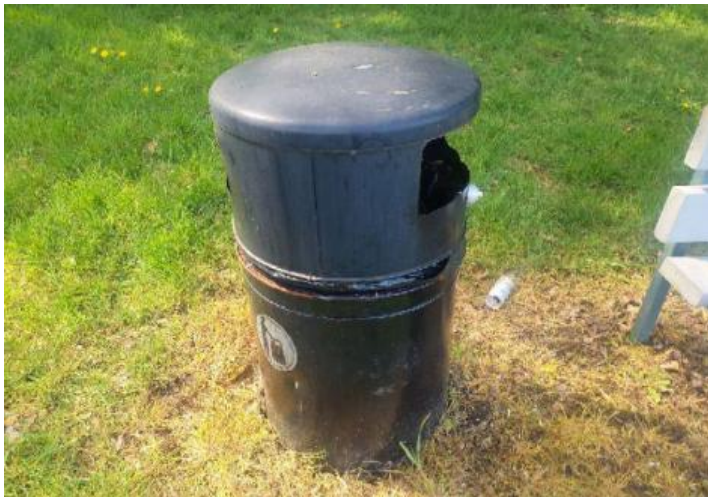
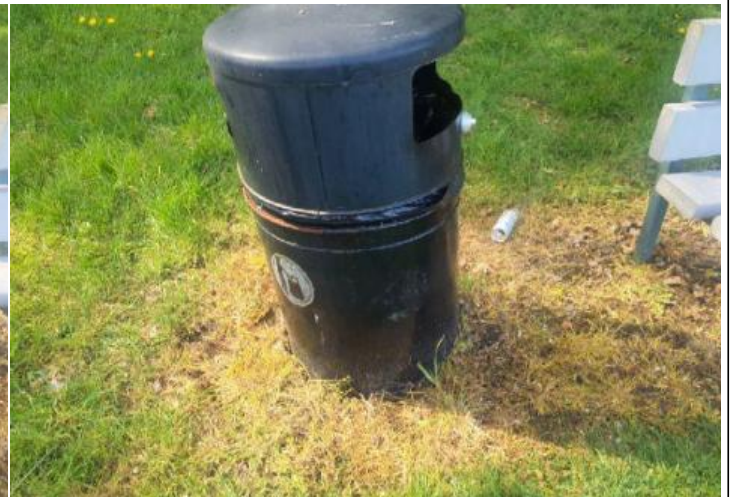
Item: Ancillary Items - Litter Bin
Manufacturer: Not Identified

Finding: The lid or door of the litter bin is not secured

Action: Ensure the lid or door is kept locked
