ST STEPHEN PARISH COUNCIL

You are summoned to the Fixed Assets Committee meeting

AGENDA

| 2526/AC/013 | To receive Annual Play Inspection Reports. Reports attached. |

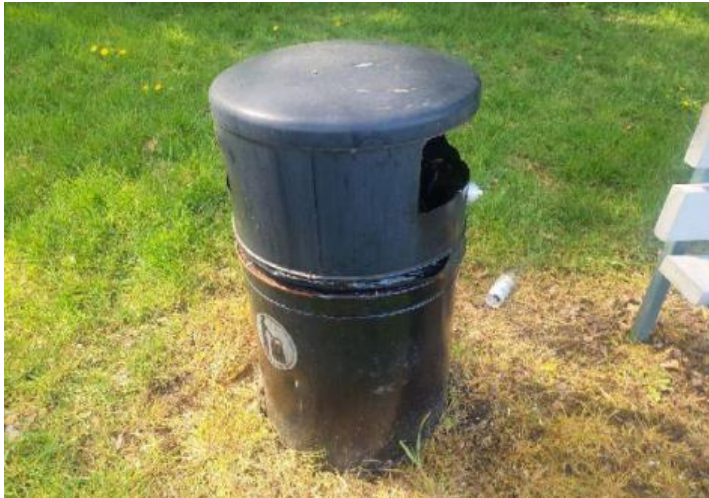
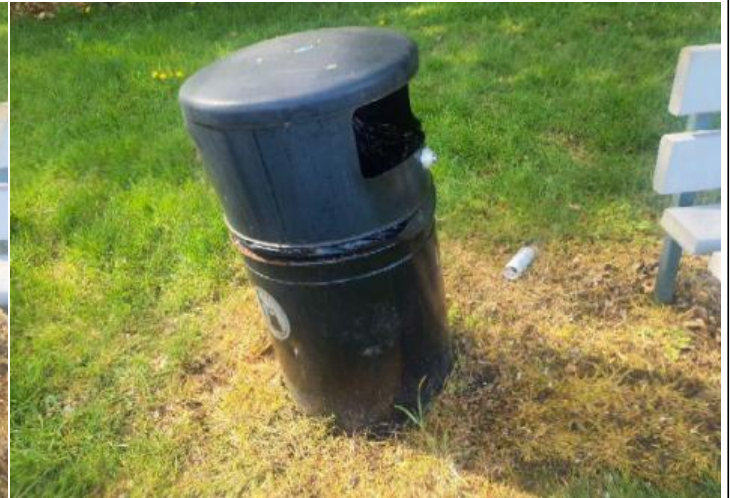
Item: Ancillary Items - Litter Bin
Manufacturer: Not Identified

Finding: The bin is not securely fixed to the surface and there is some possibility of the item tipping or rolling over

Action: Secure the bin to the ground

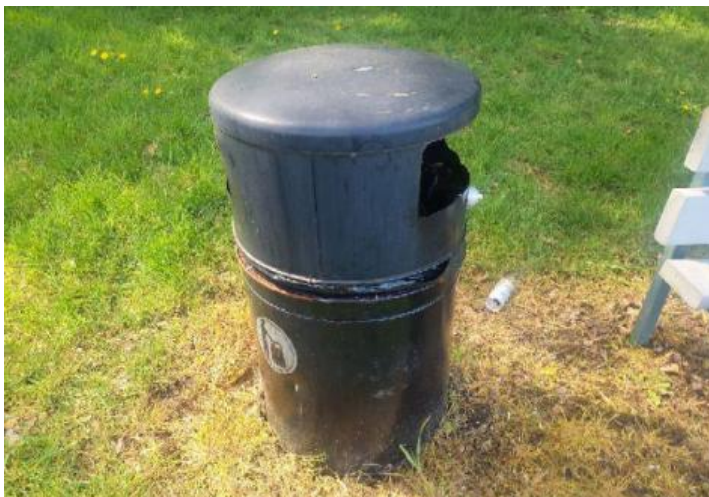
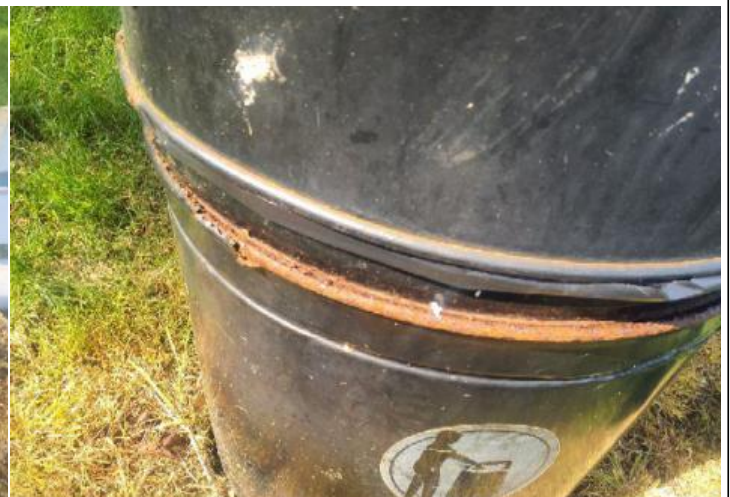
Item: Ancillary Items - Litter Bin
Manufacturer: Not Identified

Finding: The paintwork on this item has been damaged or worn exposing the metal underneath which is rusting / corroding

Action: Treat affected areas and repaint

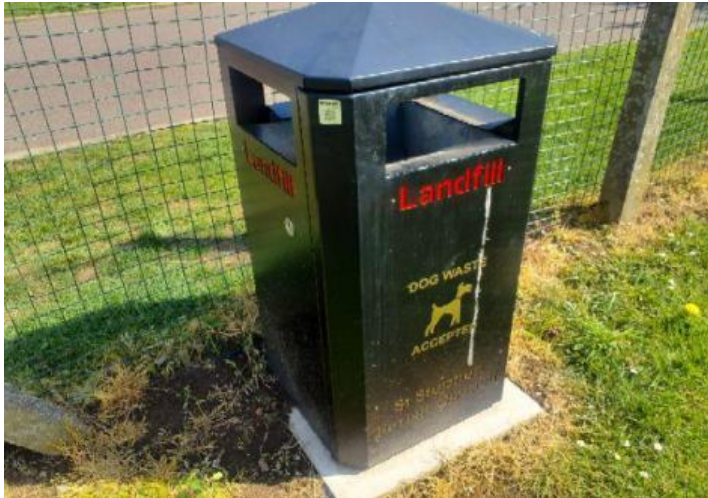
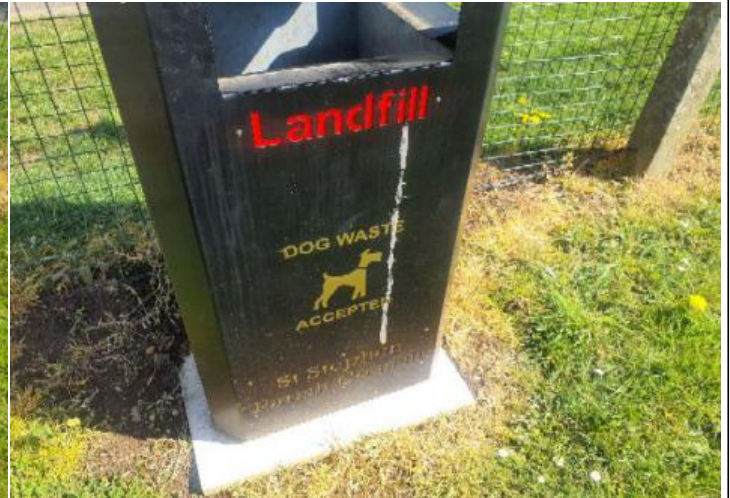
Item: Ancillary Items - Litter Bin
Manufacturer: Not Identified

Finding: The bin is not securely fixed to the surface and there is some possibility of the item tipping or rolling over

Action: Secure the bin to the ground

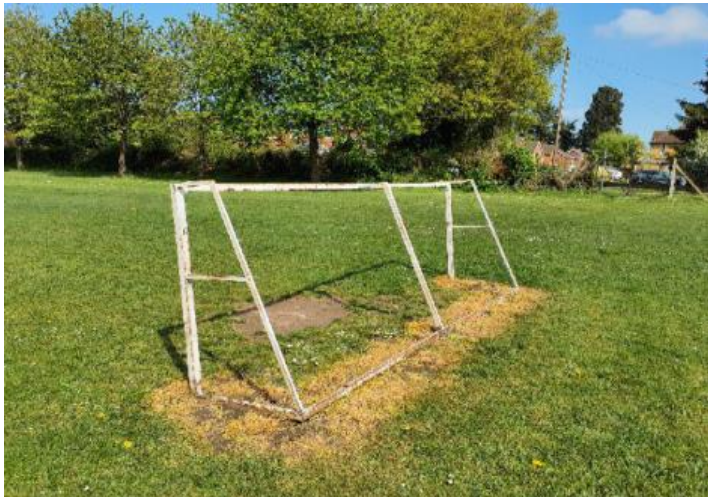
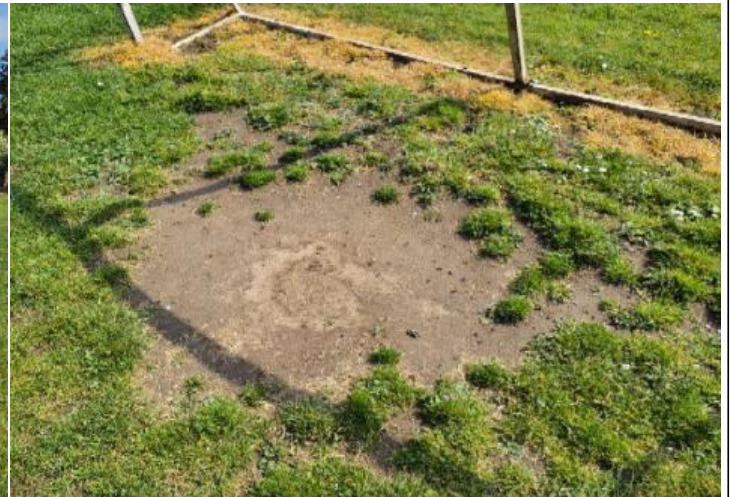
Item: Multi Use Games Area - 5 a side Goals
Manufacturer: Not Identified

Finding: The area around the item has eroded and may become slippery

Action: Reinstate eroded area

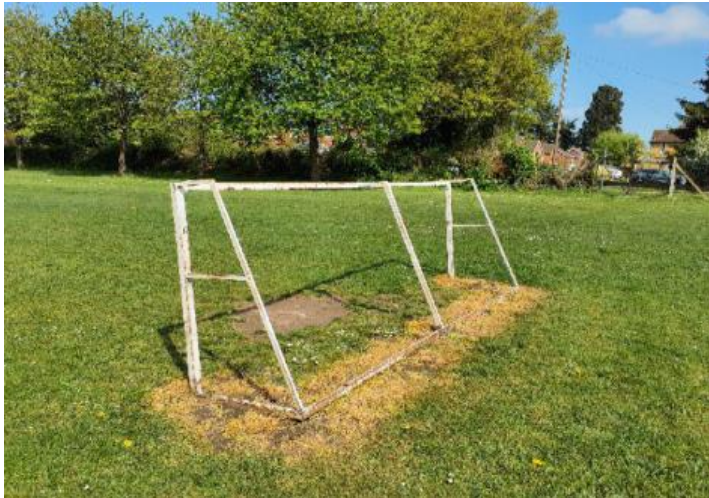
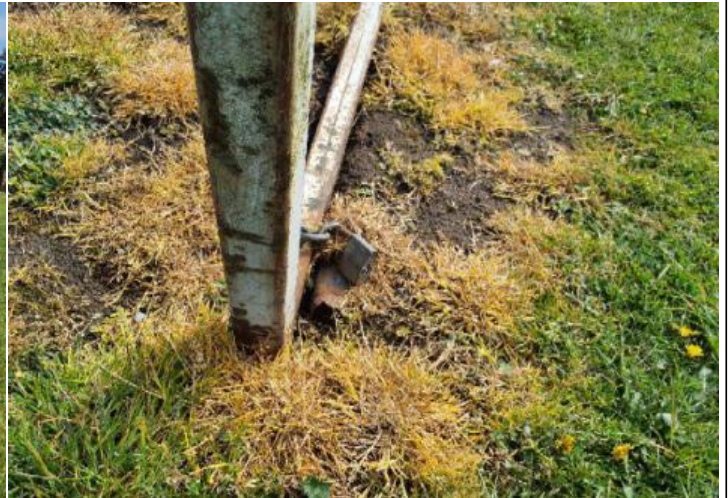
Item: Multi Use Games Area - 5 a side Goals
Manufacturer: Not Identified

Finding: The paintwork on this item has been damaged or worn exposing the metal underneath which is rusting / corroding

Action: Treat affected areas and repaint

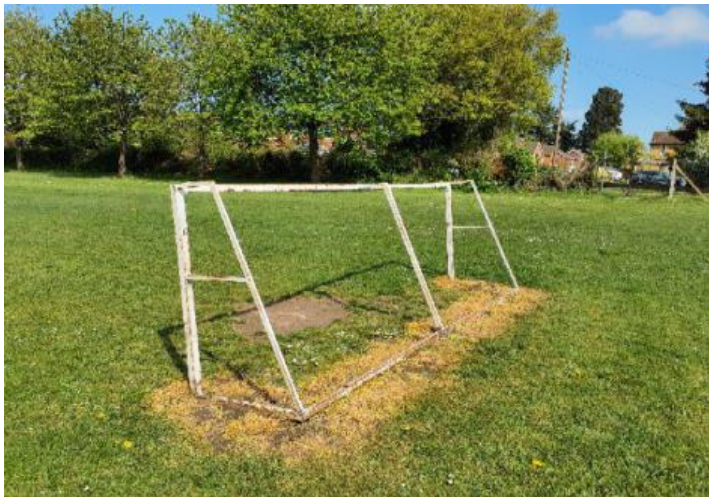
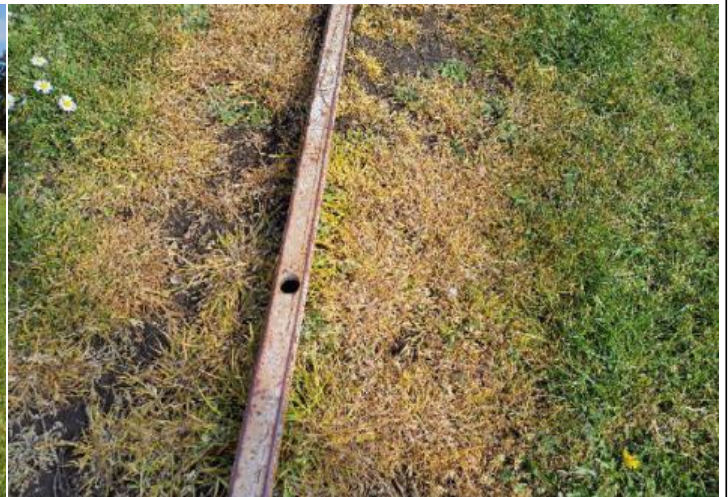
Item: Multi Use Games Area - 5 a side Goals
Manufacturer: Not Identified

There is/are inserts missing - Replace missing inserts

Finding: There is/are inserts missing

Action: Replace missing inserts

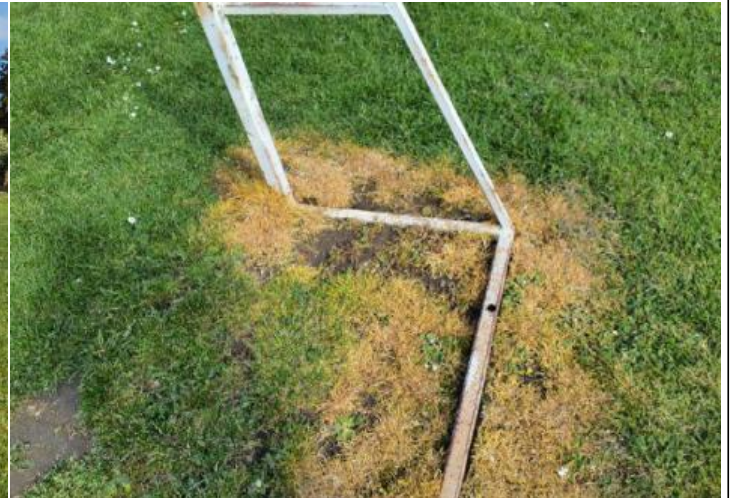
Item: Multi Use Games Area - 5 a side Goals
Manufacturer: Not Identified

The goal frame has only been secured at one end - Refer to manufacturer recommendations and provide as required

Finding: The goal frame has only been secured at one end

Action: Refer to manufacturer recommendations and provide as required

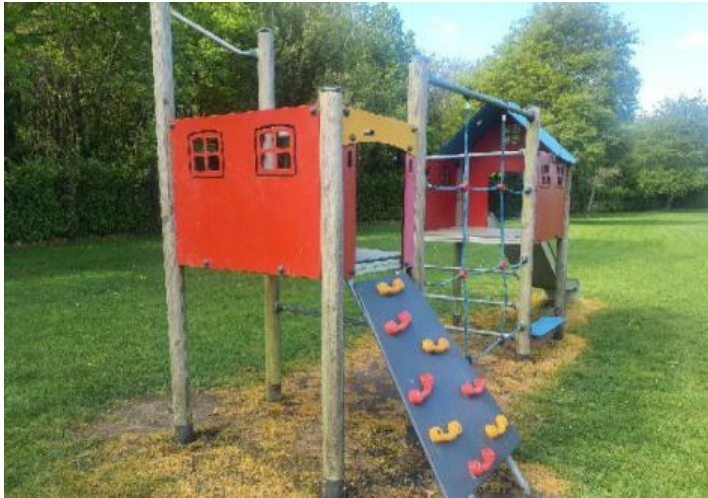
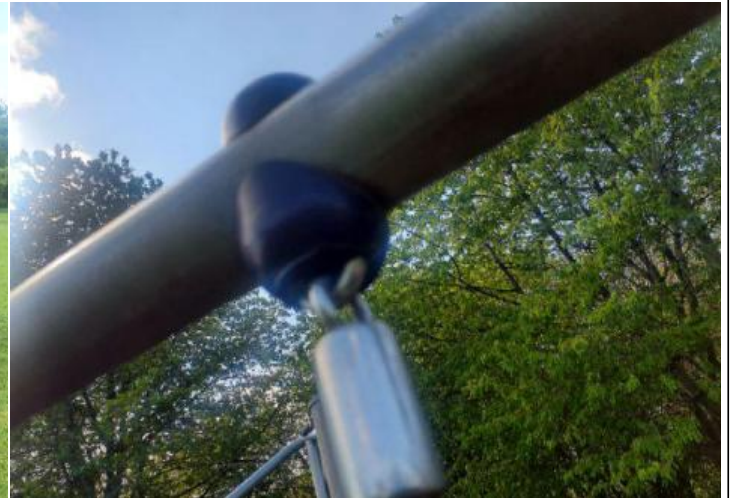
Item: Activity Equipment - Multi Play (Junior)
Manufacturer: Kompan Ltd

The connecting lugs are showing signs of wear - Monitor for any further deterioration and repair as required

Finding: The connecting lugs are showing signs of wear

Action: Monitor for any further deterioration and repair as required

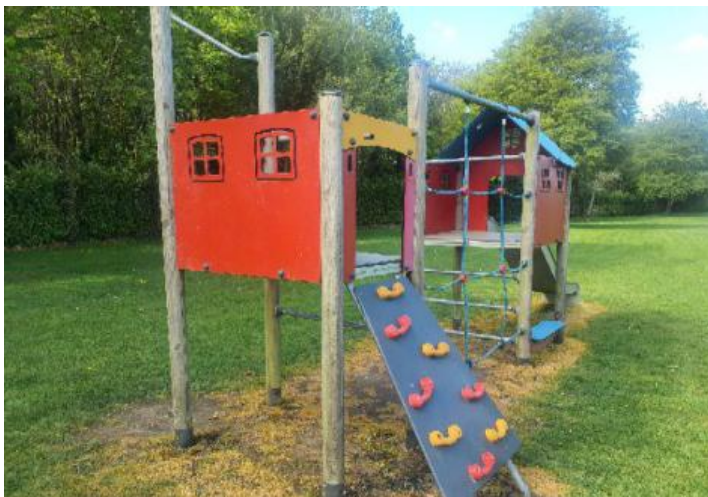
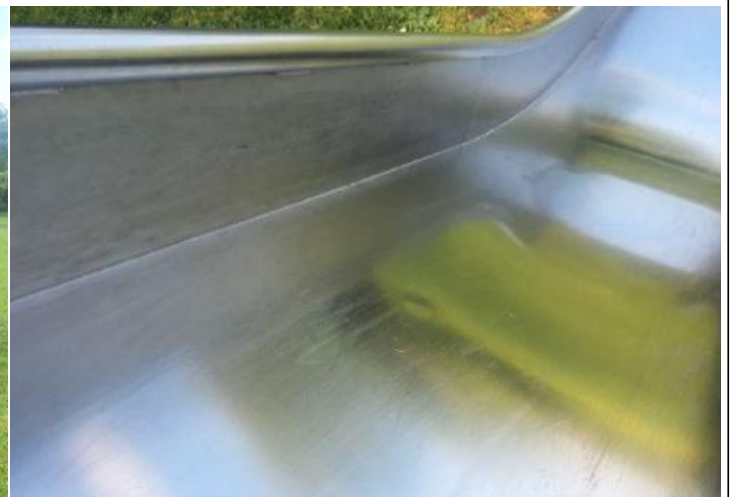
Item: Activity Equipment - Multi Play (Junior)
Manufacturer: Kompan Ltd

There are a number of dents in the slide surface - Monitor for any further deterioration and repair as required

Finding: There are a number of dents in the slide surface

Action: Monitor for any further deterioration and repair as required

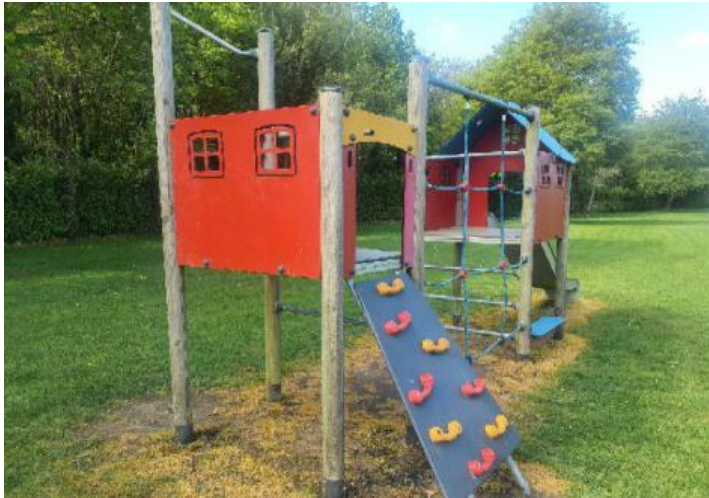
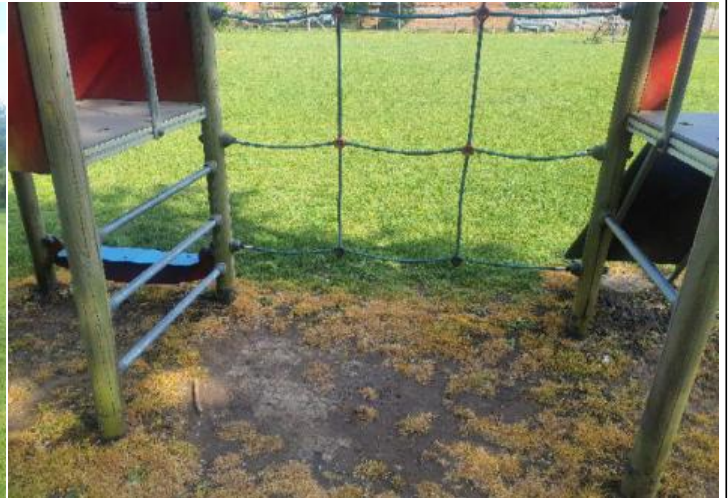
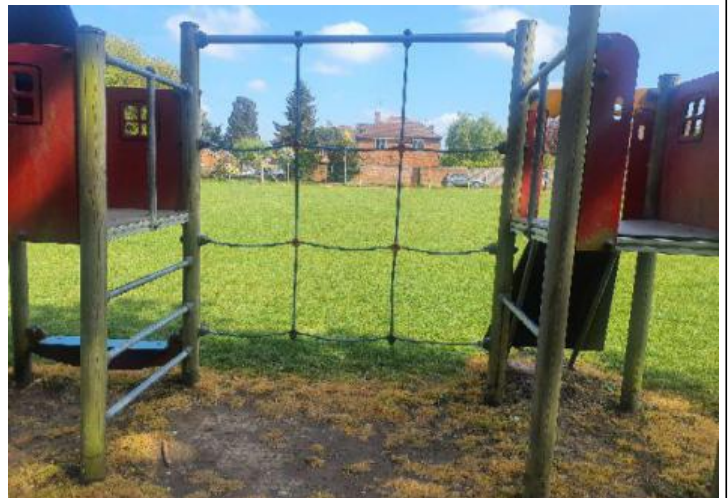
Item: Activity Equipment - Multi Play (Junior)
Manufacturer: Kompan Ltd

Finding: The grass mats are silted up and the soil is compacted; this may have an effect on the impact absorbing properties of the surface. Consideration should be given to HIC testing the surface to verify impact attenuating properties (<https://playinspections.co.uk/inspection-services/safety-surface-testing/>)

Action: Contact our office for a quotation for this service

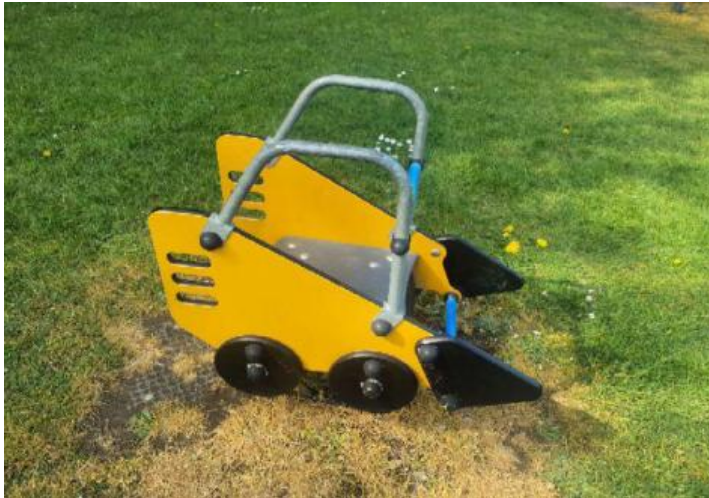
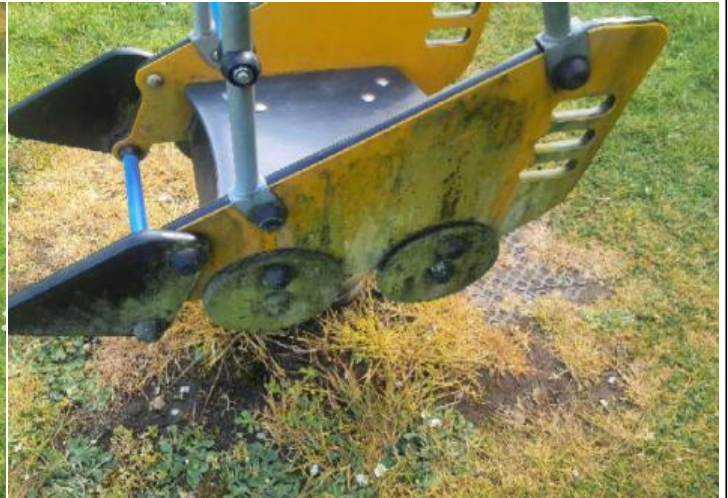
Item: Rocking Equipment - Spring Bulldozer
Manufacturer: Kompan Ltd

Finding: There is algae or moss on the surface of the equipment

Action: Clean and treat appropriately

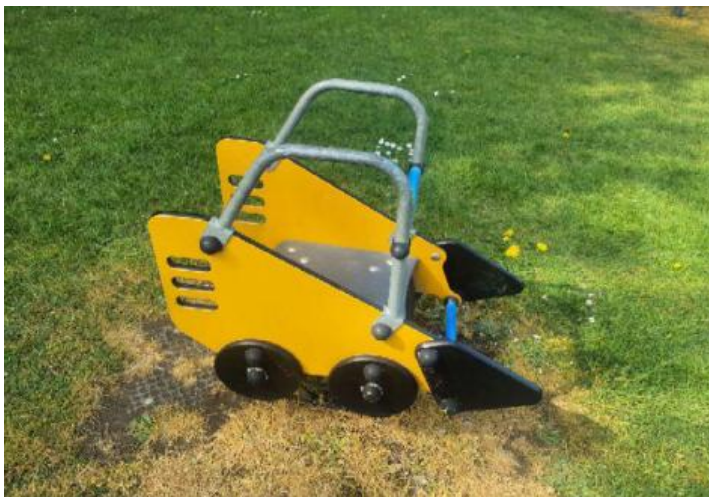
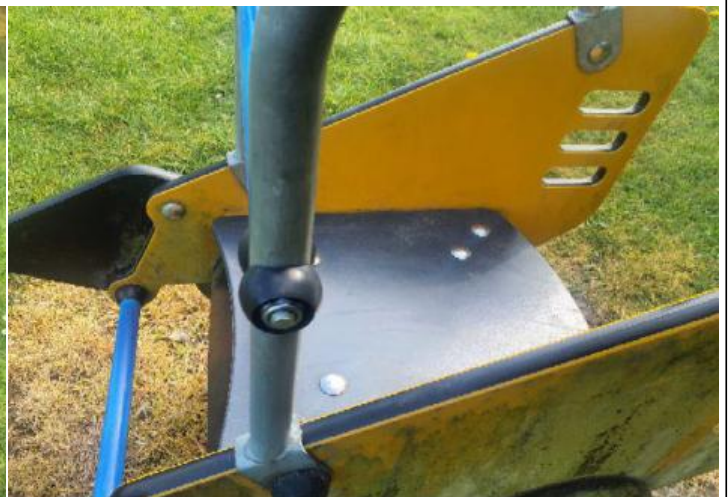
Item: Rocking Equipment - Spring Bulldozer
Manufacturer: Kompan Ltd

There is/are bolt cap covers missing or damaged on the item - Replace missing or damaged bolt cap covers

Finding: There is/are bolt cap covers missing or damaged on the item

Action: Replace missing or damaged bolt cap covers

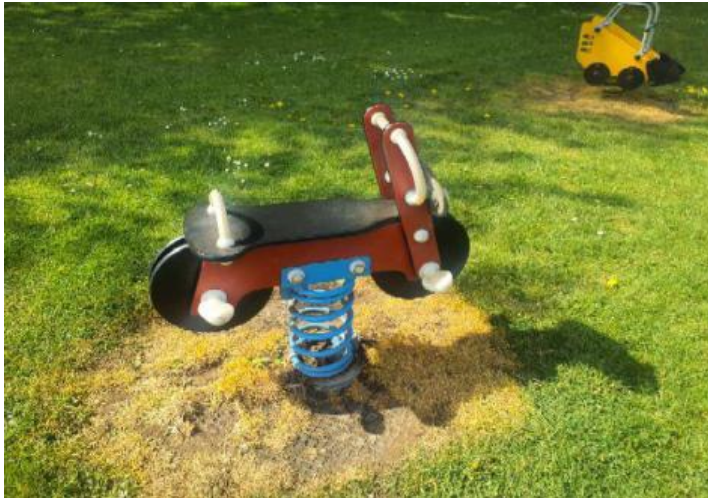
Item: Rocking Equipment - Spring Bike
Manufacturer: Kompan Ltd

The item is slightly loose in its foundations - Monitor for any further deterioration and repair as required

Finding: The item is slightly loose in its foundations

Action: Monitor for any further deterioration and repair as required

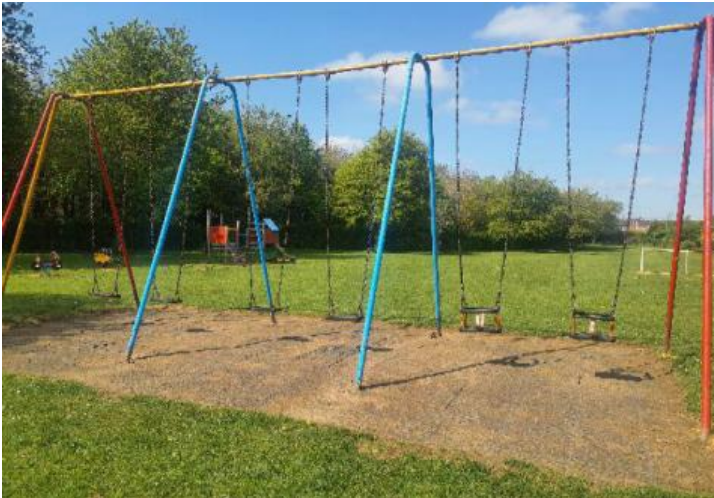
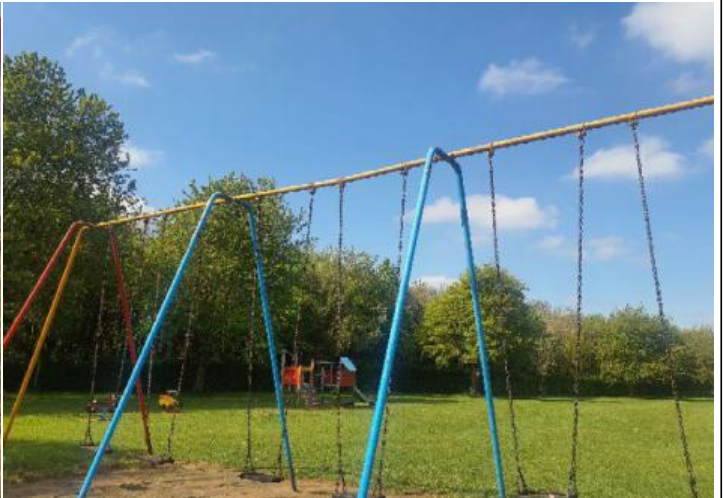
Item: Swings - 3 Bay Swing
Manufacturer: Hags

The fixings or components for this item were in excess of 2.5m above the standing surface and could not be fully accessed by the inspector. We have completed a visual inspection of the fixings from ground level but a maintenance inspection should be undertaken to assess the condition, security and wear of the components at intervals in accordance with the manufacturers recommendations. - Inspect in accordance with the manufacturers recommendations

Finding: The fixings or components for this item were in excess of 2.5m above the standing surface and could not be fully accessed by the inspector. We have completed a visual inspection of the fixings from ground level but a maintenance inspection should be undertaken to assess the condition, security and wear of the components at intervals in accordance with the manufacturers recommendations.

Action: Inspect in accordance with the manufacturers recommendations

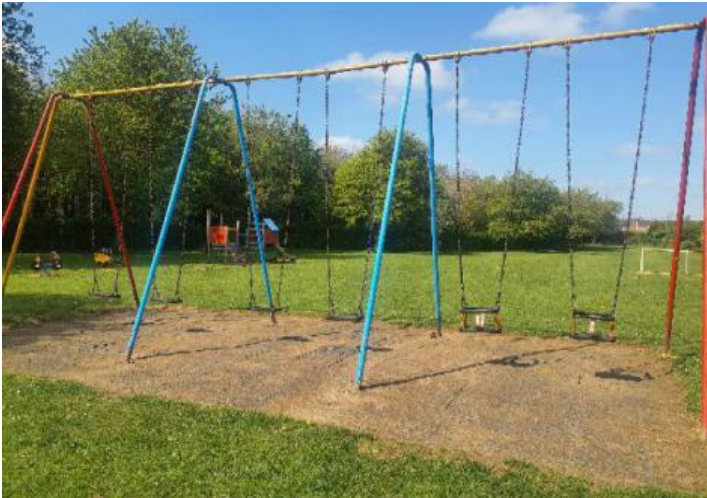
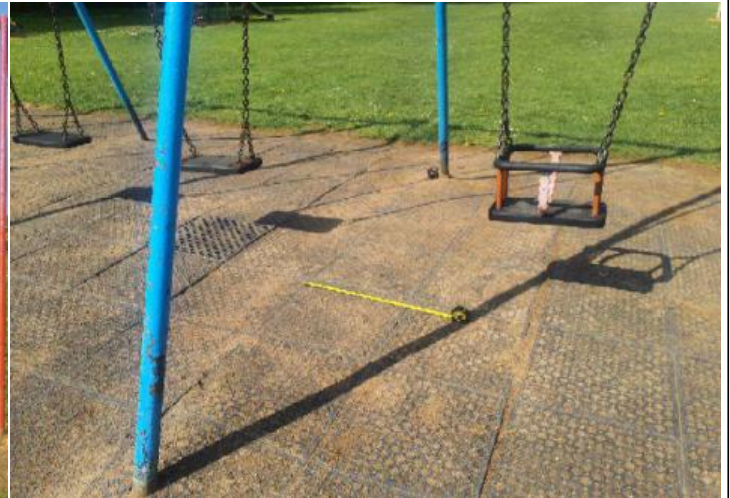
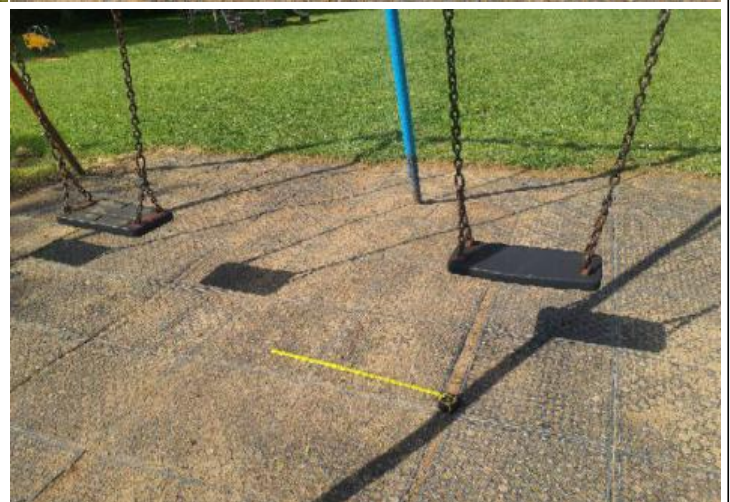
Item: Swings - 3 Bay Swing
Manufacturer: Hags

Finding: The seat/s is / are too close to the frame as defined in BS EN 1176 Part 2

Action: Monitor - No action given the risk assessment

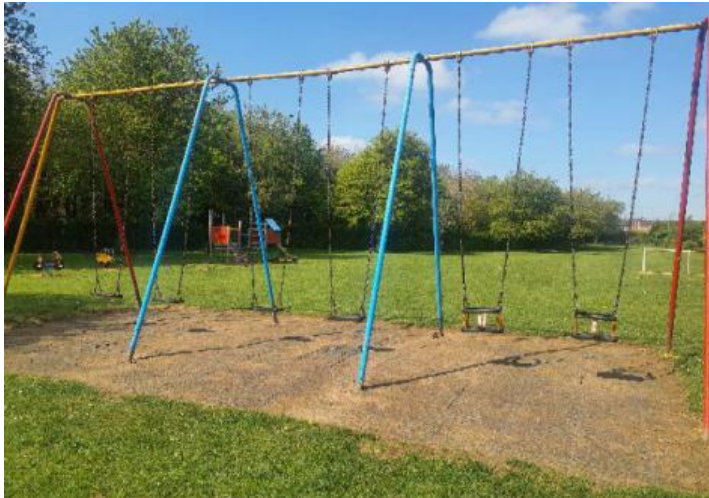
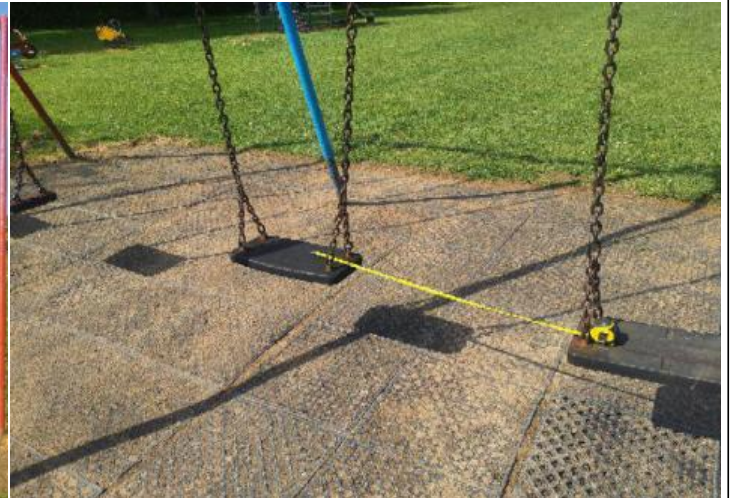
Item: Swings - 3 Bay Swing
Manufacturer: Hags

The seats are too close to each other as defined in BS EN 1176 Part 2; this is a low risk failure and no remedial action is required - Monitor - No action given the risk assessment

Finding: The seats are too close to each other as defined in BS EN 1176 Part 2; this is a low risk failure and no remedial action is required

Action: Monitor - No action given the risk assessment

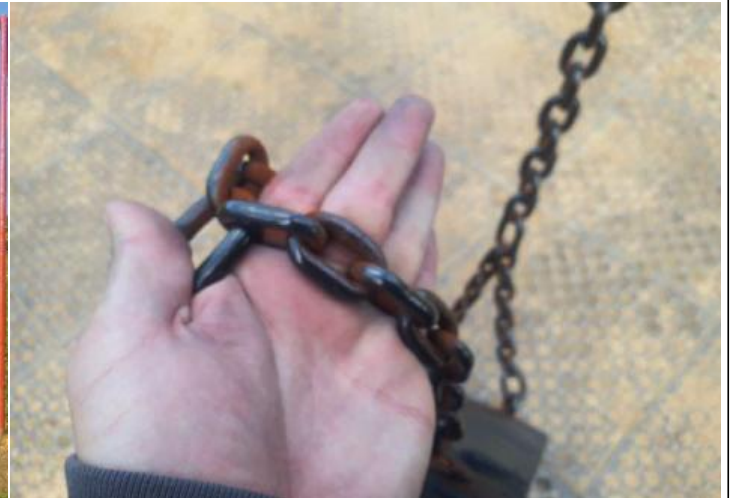
Item: Swings - 3 Bay Swing
Manufacturer: Hags

There is some notable evidence of chain wear - Monitor for any further deterioration and replace when 40% worn

Finding: There is some notable evidence of chain wear

Action: Monitor for any further deterioration and replace when 40% worn

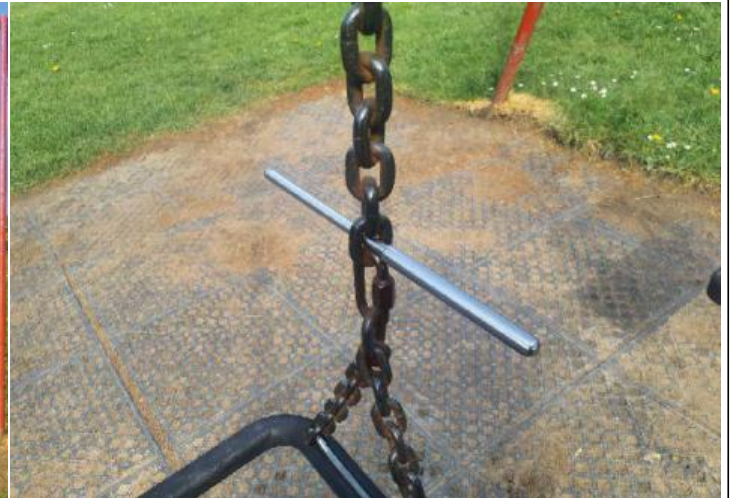
Item: Swings - 3 Bay Swing
Manufacturer: Hags

The chain openings are in excess of 8.6mm and do not meet the recommendations of BS EN 1176 Part 1 - Monitor - No action given the risk assessment

Finding: The chain openings are in excess of 8.6mm and do not meet the recommendations of BS EN 1176 Part 1

Action: Monitor - No action given the risk assessment

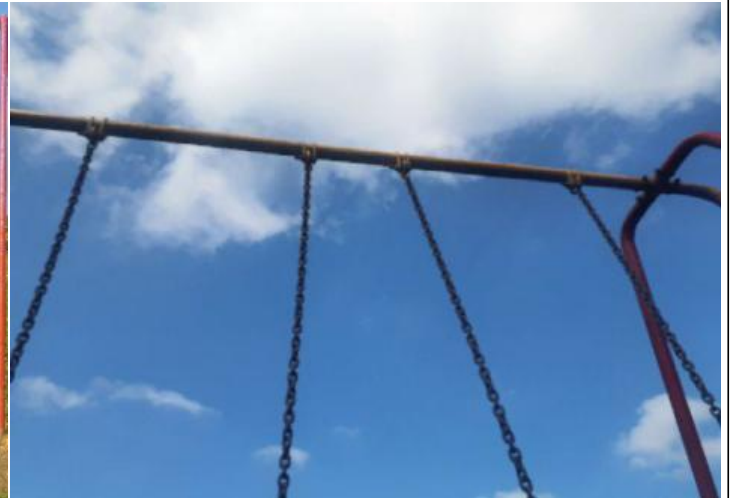
Item: Swings - 3 Bay Swing
Manufacturer: Hags

There is some wear to the shackles - Monitor for any further deterioration and replace when 40% worn

Finding: There is some wear to the shackles

Action: Monitor for any further deterioration and replace when 40% worn

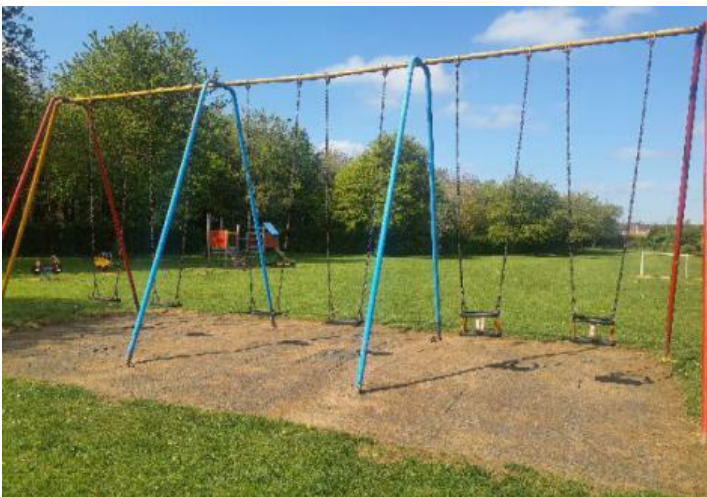
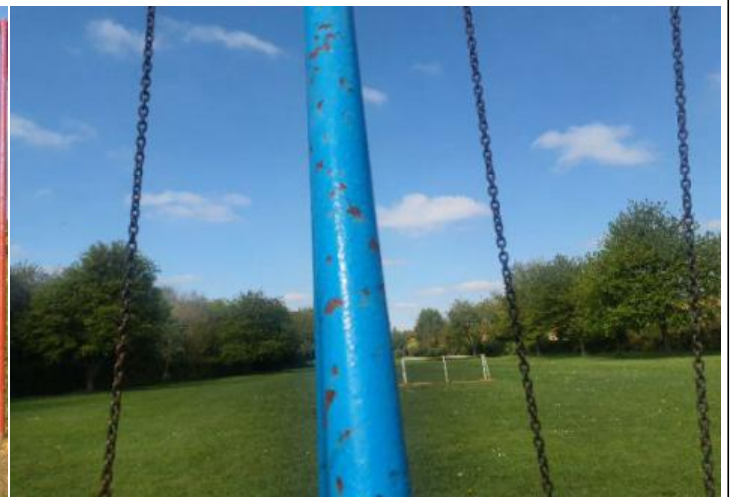
Item: Swings - 3 Bay Swing
Manufacturer: Hags

Finding: The paintwork on this item has been damaged or worn exposing the metal underneath which is rusting / corroding

Action: Treat affected areas and repaint

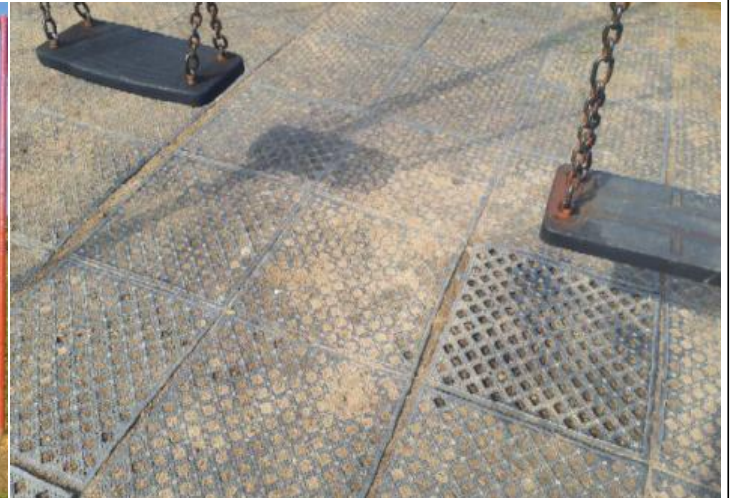
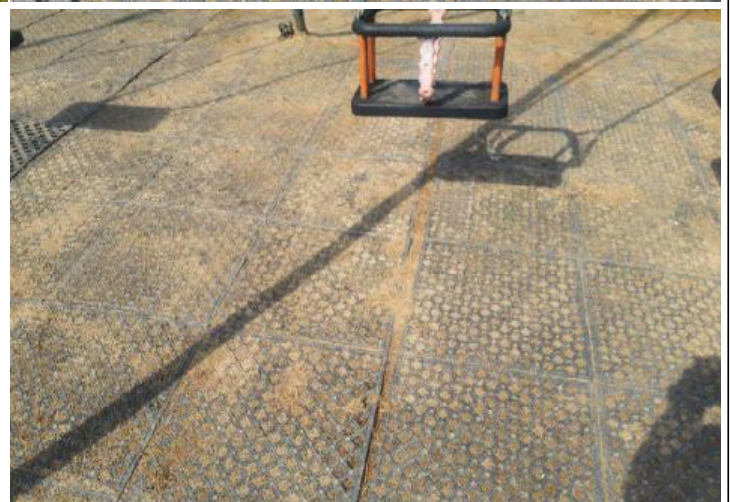
Item: Swings - 3 Bay Swing
Manufacturer: Hags

Finding: There are gaps opening in between the tiles

Action: Provide additional ties or secure / reinstate surface

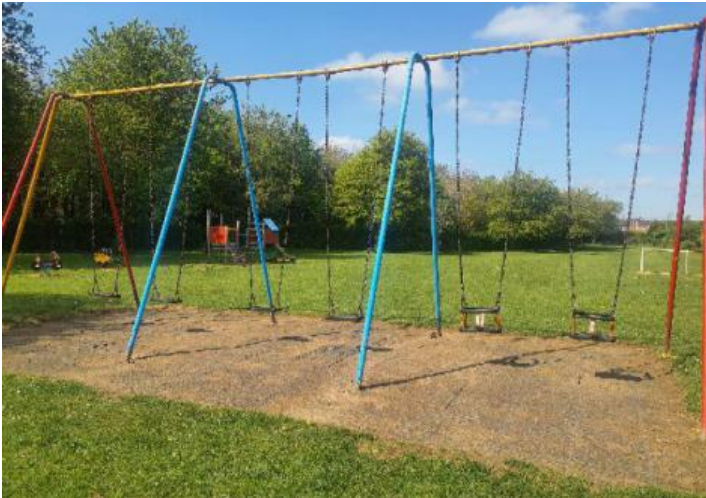
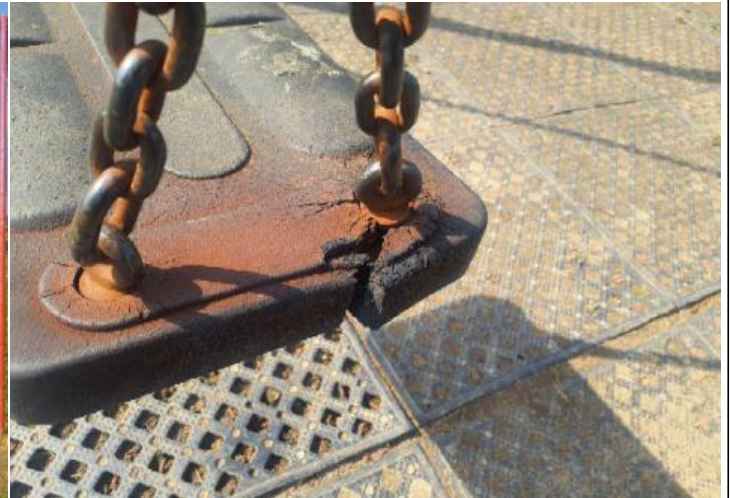
Item: Swings - 3 Bay Swing
Manufacturer: Hags

The seat has been severely damaged - Repair / replace the seat as required

Finding: The seat has been severely damaged

Action: Repair / replace the seat as required

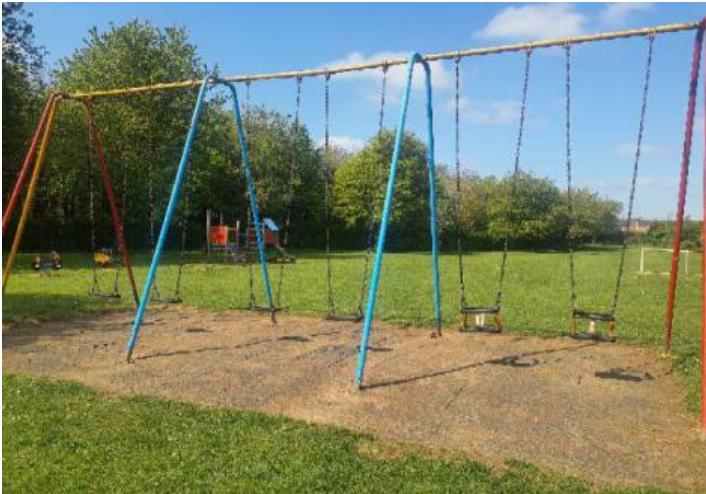
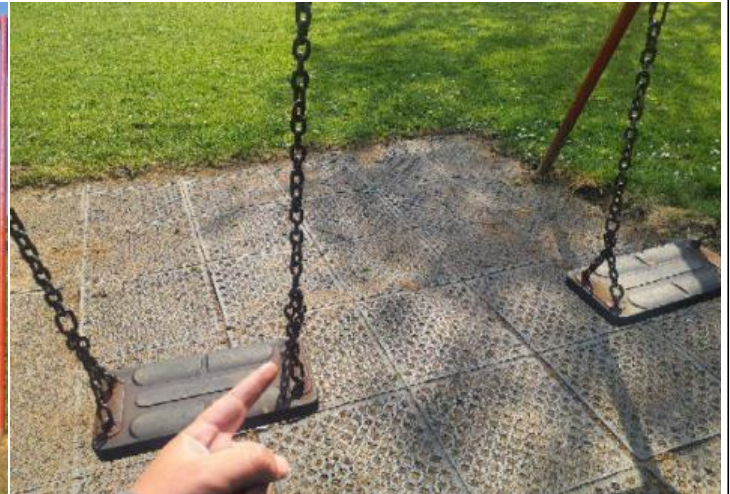
Item: Swings - 3 Bay Swing
Manufacturer: Hags

The swing seat connectors are loose - Tighten to secure

Finding: The swing seat connectors are loose

Action: Tighten to secure

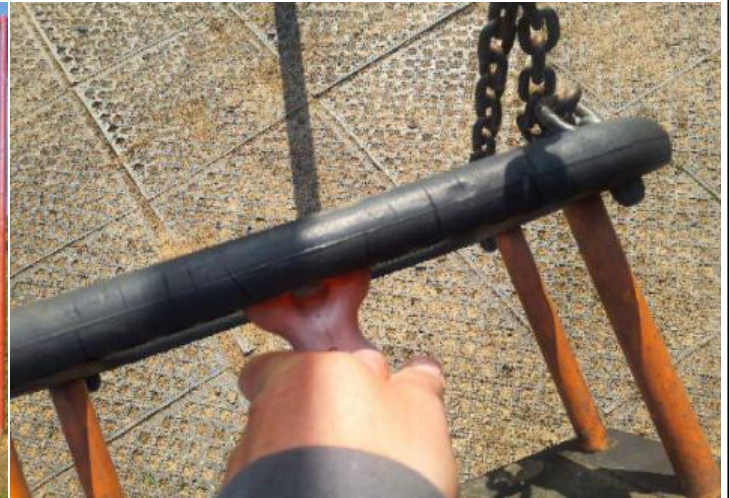
Item: Swings - 3 Bay Swing
Manufacturer: Hags

The seat has minor damage or wear - Monitor for any further deterioration and replace as required

Finding: The seat has minor damage or wear

Action: Monitor for any further deterioration and replace as required

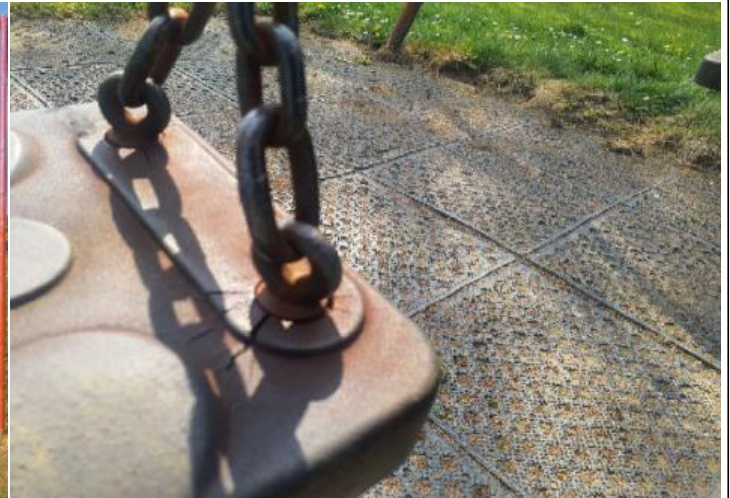
Item: Swings - 3 Bay Swing
Manufacturer: Hags

The swing seat connectors have some wear present - Monitor for further deterioration and replace when 40% worn

Finding: The swing seat connectors have some wear present

Action: Monitor for further deterioration and replace when 40% worn

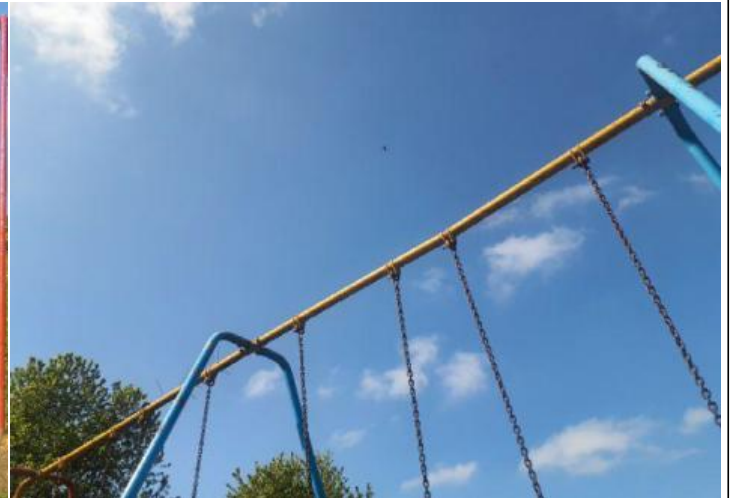
Item: Swings - 3 Bay Swing
Manufacturer: Hags

The bushes are showing signs of wear - Monitor for any further deterioration and replace as required

Finding: The bushes are showing signs of wear

Action: Monitor for any further deterioration and replace as required

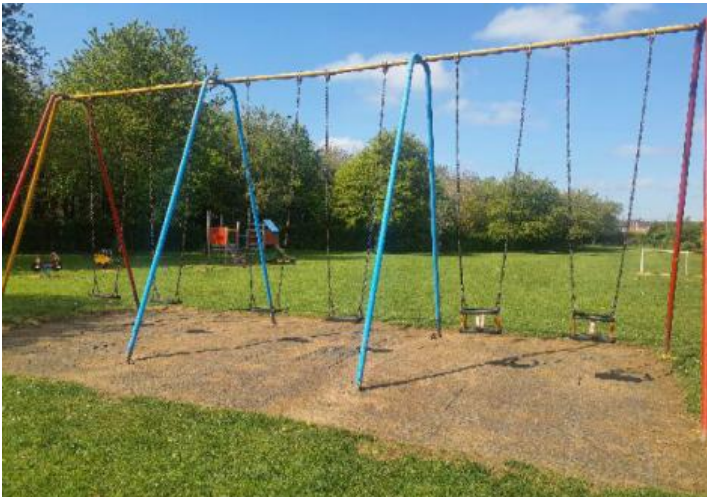
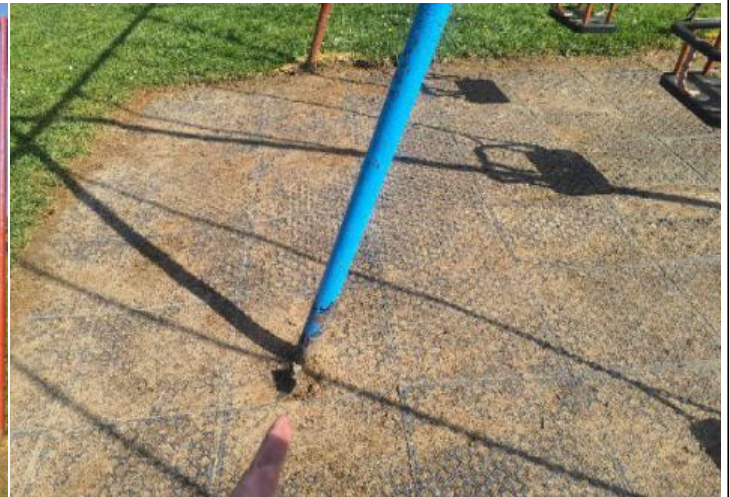
Item: Swings - 3 Bay Swing
Manufacturer: Hags

There is moderate damage to the surface and there are trip hazards present - Repair the damaged areas of surfacing to remove any trip points

Finding: There is moderate damage to the surface and there are trip hazards present

Action: Repair the damaged areas of surfacing to remove any trip points

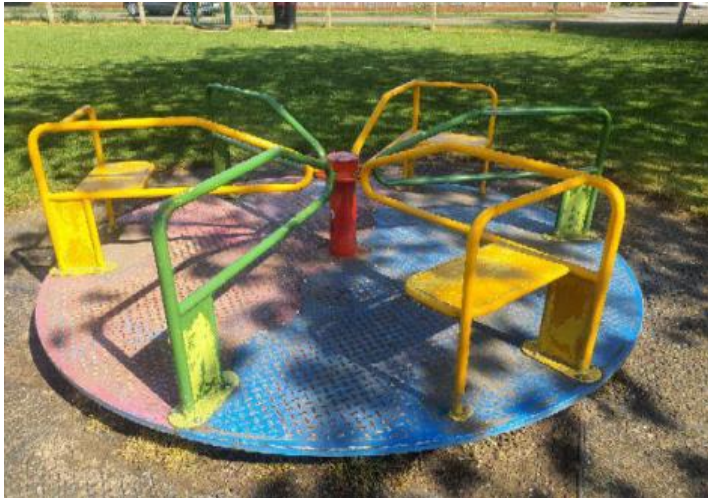
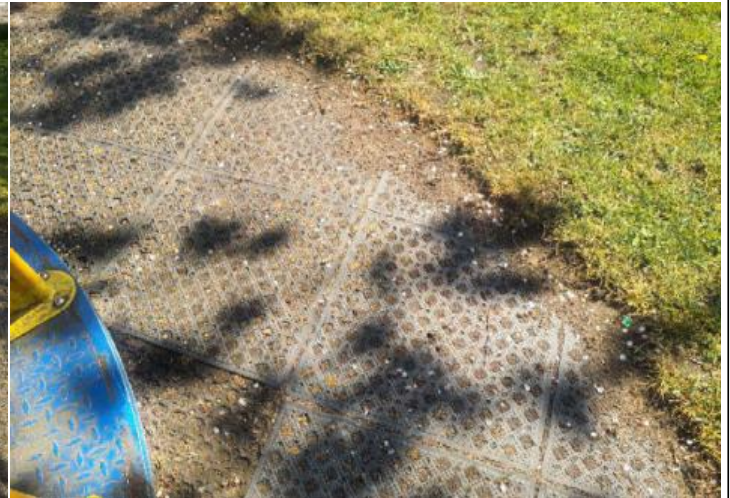
Item: Rotor Play - Roundabout
Manufacturer: G L Jones Playgrounds Ltd

There are gaps opening in between the tiles - Monitor for any further deterioration and repair as required

Finding: There are gaps opening in between the tiles

Action: Monitor for any further deterioration and repair as required

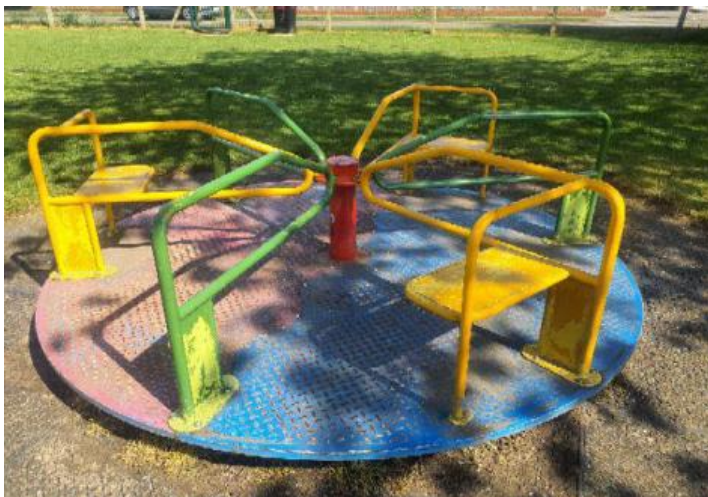
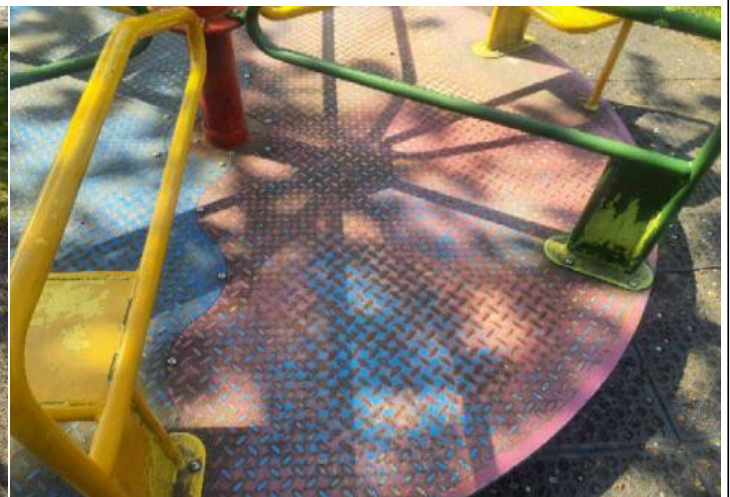
Item: Rotor Play - Roundabout
Manufacturer: G L Jones Playgrounds Ltd

Risk Level: L - Low Risk
Surface: Grass Matrix Tiles

Finding: The bearing is worn / damaged and the item is not operating correctly

Action: Repair / replace

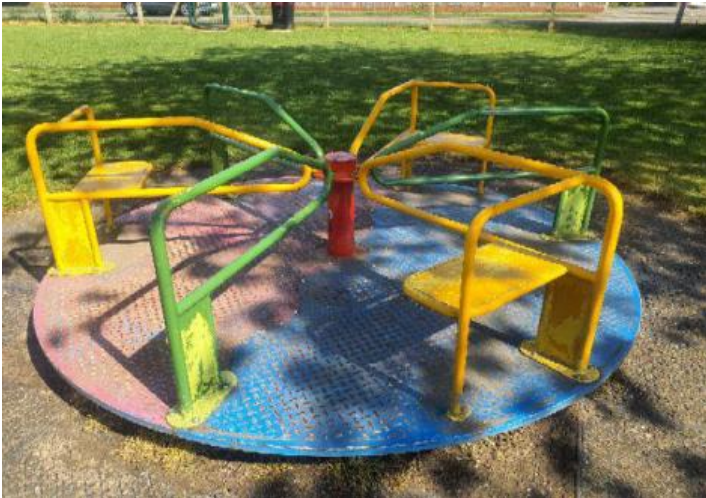
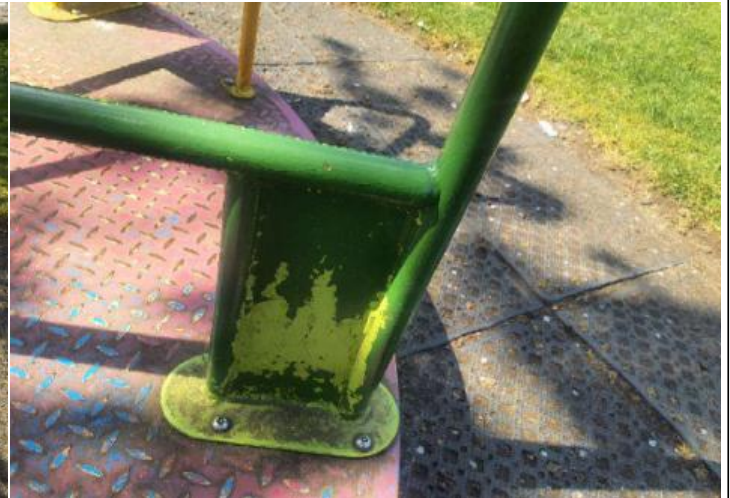
Item: Rotor Play - Roundabout
Manufacturer: G L Jones Playgrounds Ltd

Risk Level: L - Low Risk
Surface: Grass Matrix Tiles

Finding: The paint is flaking off the metalwork

Action: Rub down and re-paint

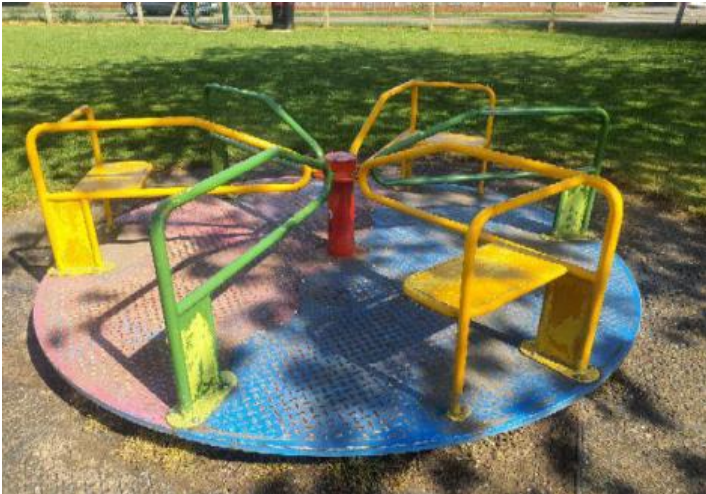
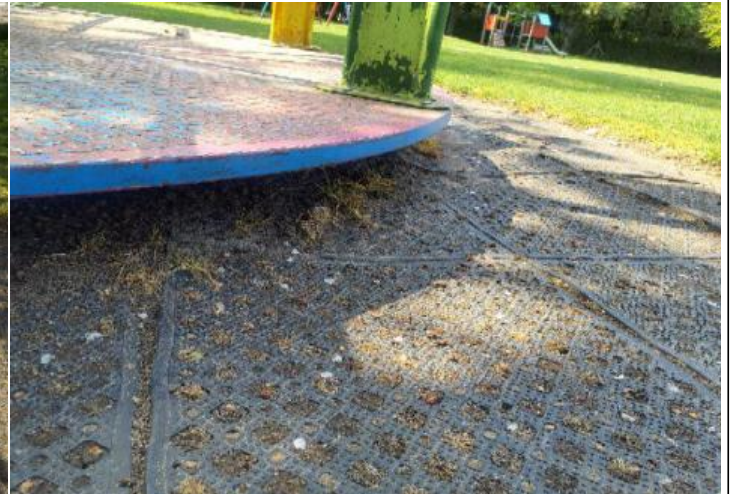
Item: Rotor Play - Roundabout
Manufacturer: G L Jones Playgrounds Ltd

Risk Level: L - Low Risk
Surface: Grass Matrix Tiles

Finding: The distance between the underside of the roundabout platform and the playing surface is in excess of 110mm and contravenes the requirements of BS EN 1176 Part 5 which requires that the distance be maintained between 60mm-110mm - for the entire circumference of the roundabout

Action: Monitor - No action given the risk assessment

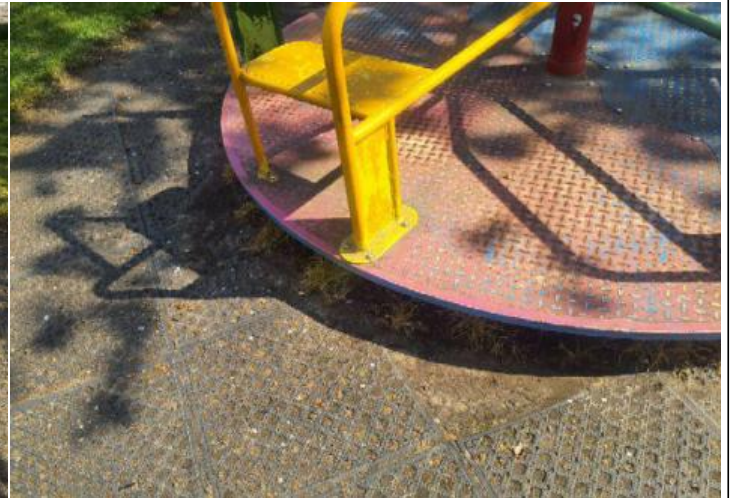
Item: Rotor Play - Roundabout
Manufacturer: G L Jones Playgrounds Ltd

Risk Level: L - Low Risk
Surface: Grass Matrix Tiles

Finding: The surface has subsided in some areas

Action: Monitor for any further deterioration and repair as required
