ST STEPHEN PARISH COUNCIL

You are summoned to the Fixed Assets Committee meeting

AGENDA

| 2526/AC/013 | To receive Annual Play Inspection Reports. Reports attached. |

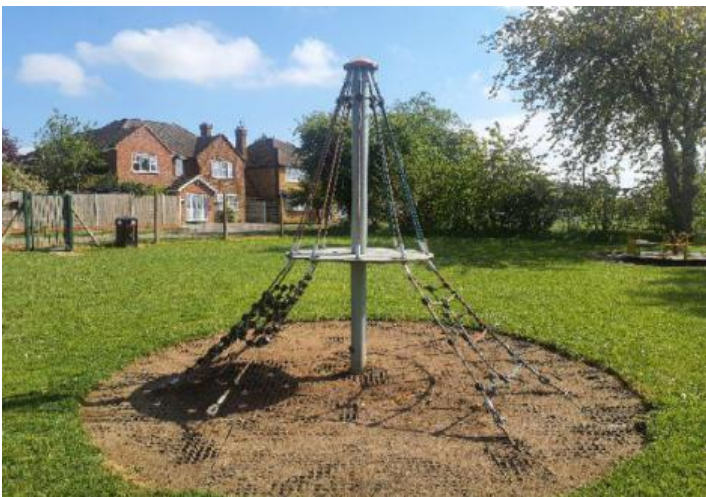
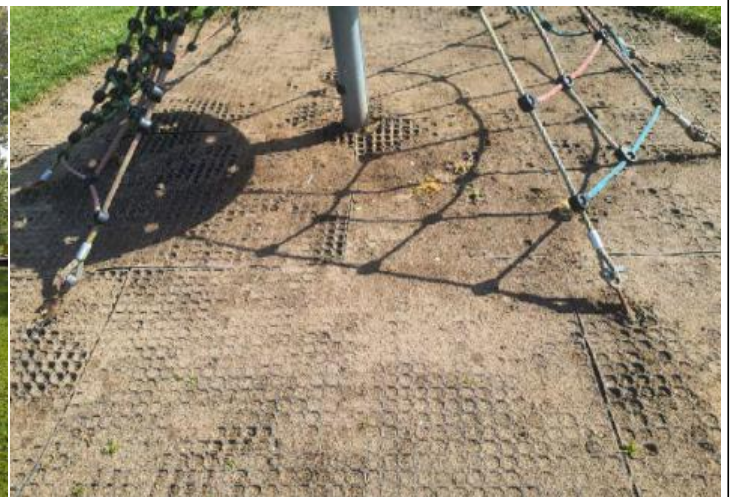
Item: Activity Equipment - Rope Climber
Manufacturer: Kompan Ltd

Risk Level: L - Low Risk
Surface: Grass Matrix Tiles

Finding: The grass mats are silted up, the soil is compacted and the area will become very slippery when the soil is wet.

Action: Reinstate as required

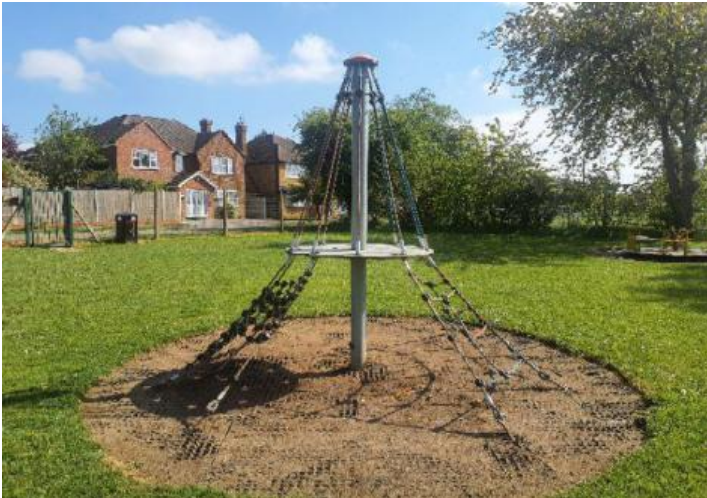
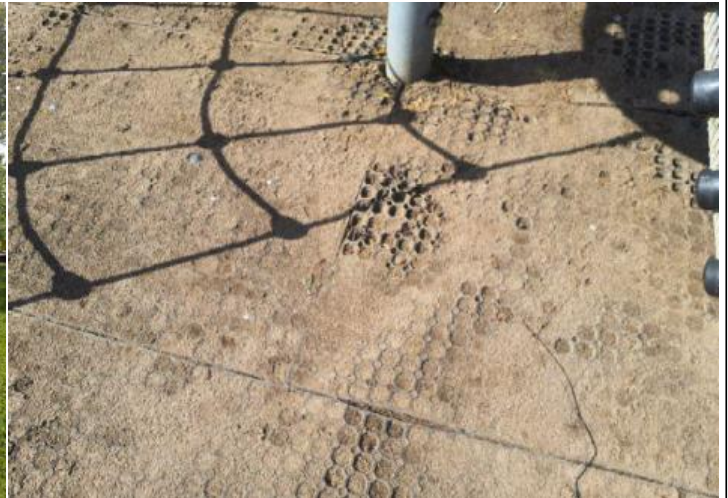
Item: Activity Equipment - Rope Climber
Manufacturer: Kompan Ltd

Risk Level: L - Low Risk
Surface: Grass Matrix Tiles

Finding: There are gaps opening between the grass mat tiles

Action: Provide additional ties or secure / reinstate surface tiles

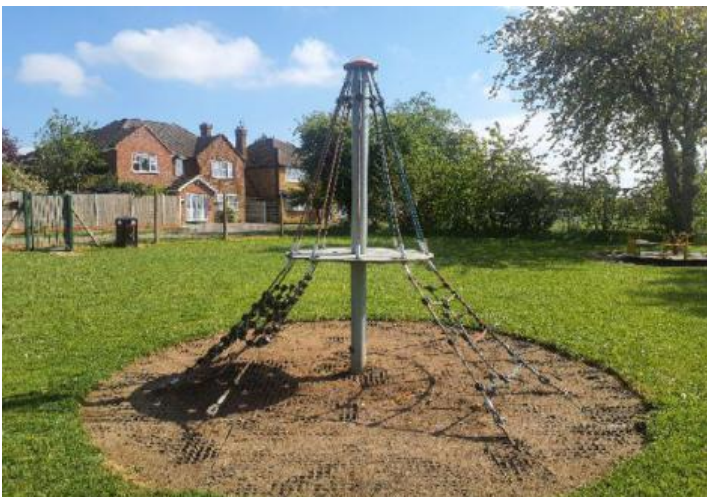
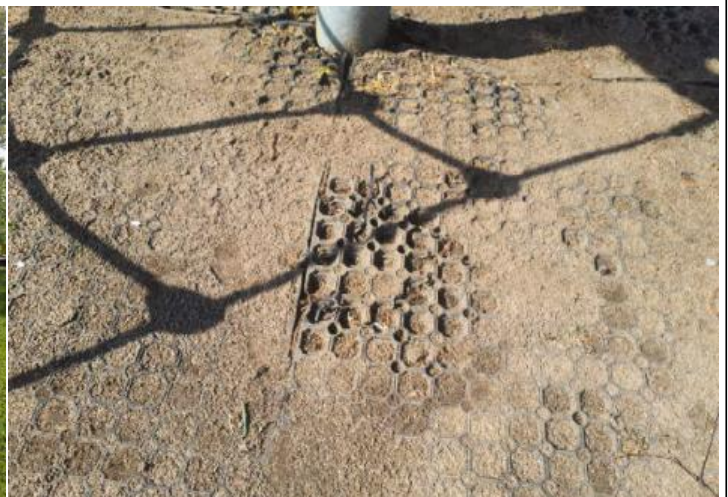
Item: Activity Equipment - Rope Climber
Manufacturer: Kompan Ltd

Risk Level: V - Very Low Risk
Surface: Grass Matrix Tiles

Finding: There is some minor damage to the surface

Action: Monitor for any further deterioration and repair as required

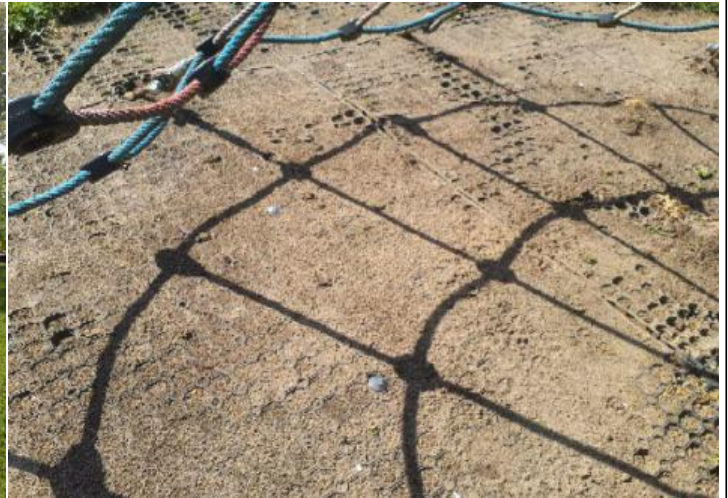
Item: Activity Equipment - Rope Climber
Manufacturer: Kompan Ltd

Risk Level: V - Very Low Risk
Surface: Grass Matrix Tiles

Finding: Fixing Pins have been installed in the impact areas of the grass mats
Action: Remove pins from impact areas

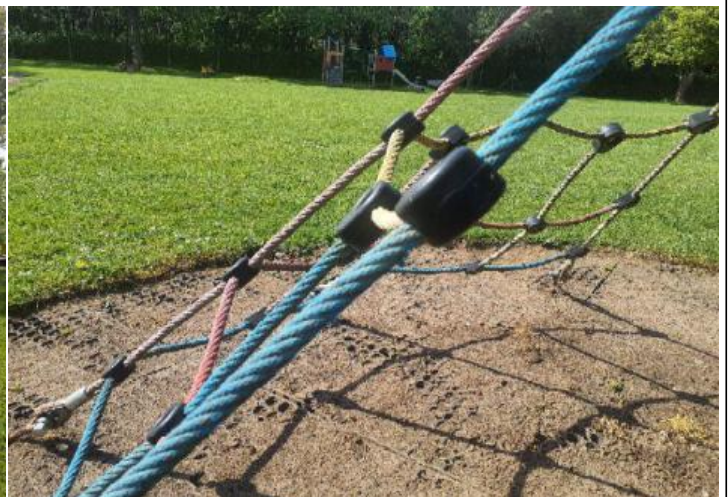
i 6 - Low Risk (Finding 5)

Item: Activity Equipment - Rope Climber
Manufacturer: Kompan Ltd

Risk Level: L - Low Risk
Surface: Grass Matrix Tiles

Finding: The ropes/nets are worn/damaged in places

Action: Monitor for any further deterioration and repair or replace as required

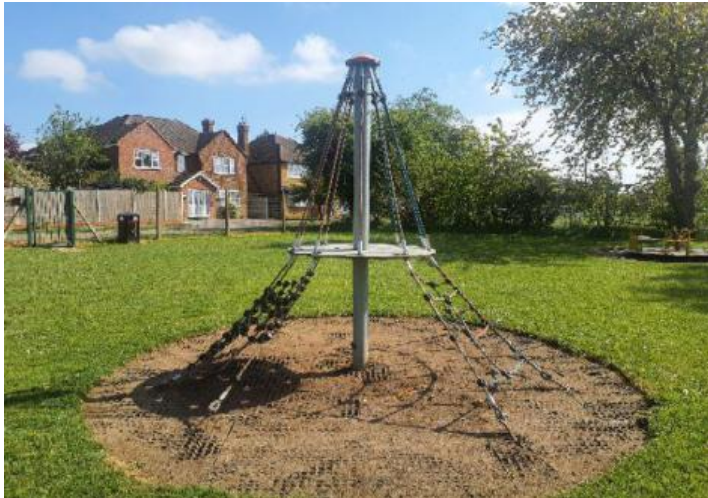
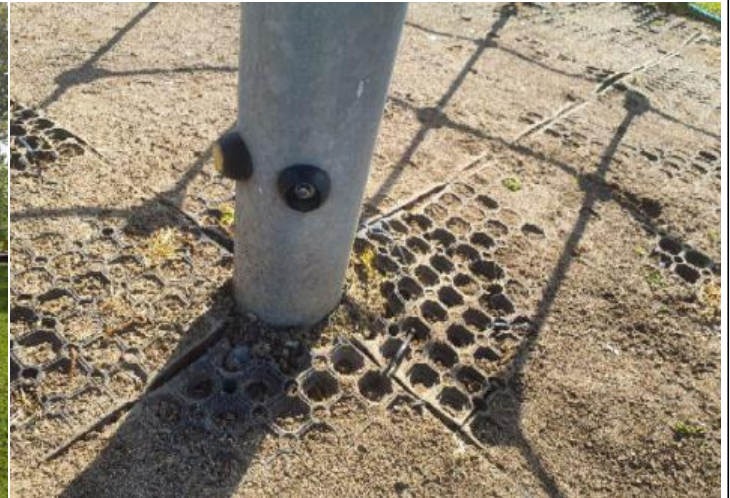
Item: Activity Equipment - Rope Climber
Manufacturer: Kompan Ltd

Risk Level: V - Very Low Risk
Surface: Grass Matrix Tiles

Finding: There is/are bolt cap covers missing or damaged on the item

Action: Replace missing or damaged bolt cap covers
